## PRE-CONSTRUCTION DILAPIDATION REPORT

### 6-20 HINKLER AVENUE & 319-333 TAREN POINT ROAD, CARINGBAH

| PRE-CONSTRUCTION DILAPIDATION REPORT<br>6-20 Hinkler Avenue & 319-333 Taren Point Road,<br>Caringbah NSW 2229 | | | | | Project Number: 21039 |

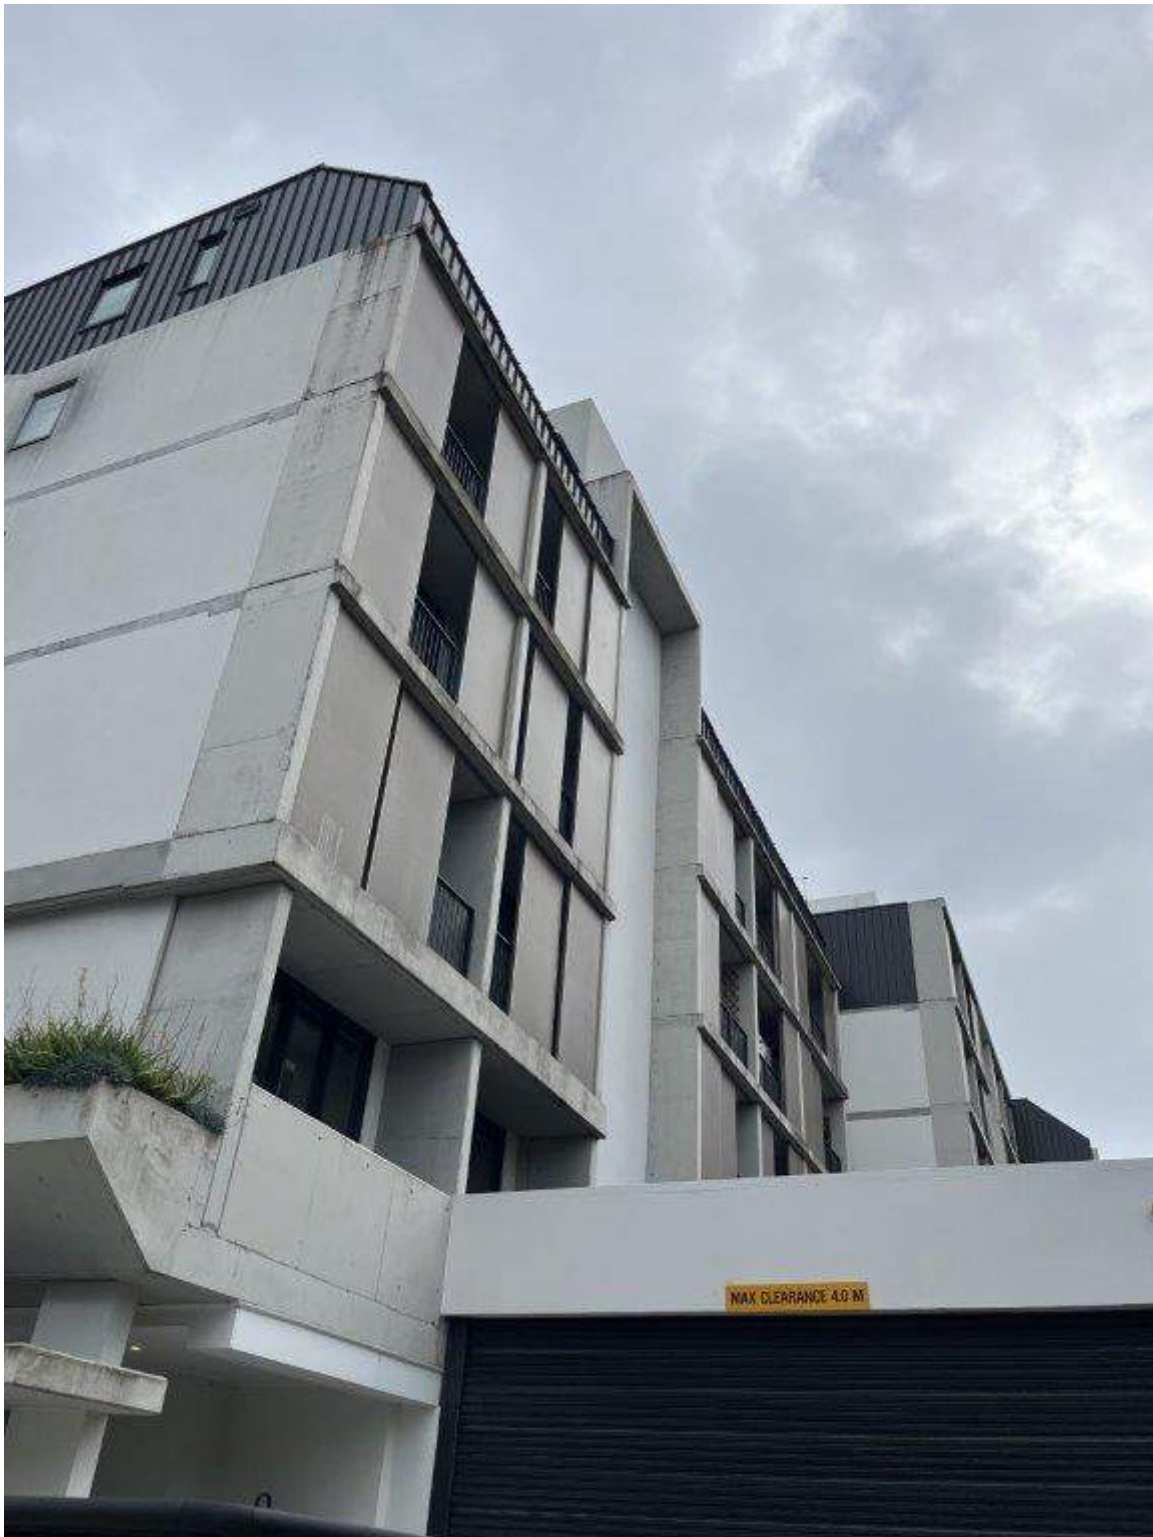
Photo 1 - Hinkler Avenue - Existing condition of external facade

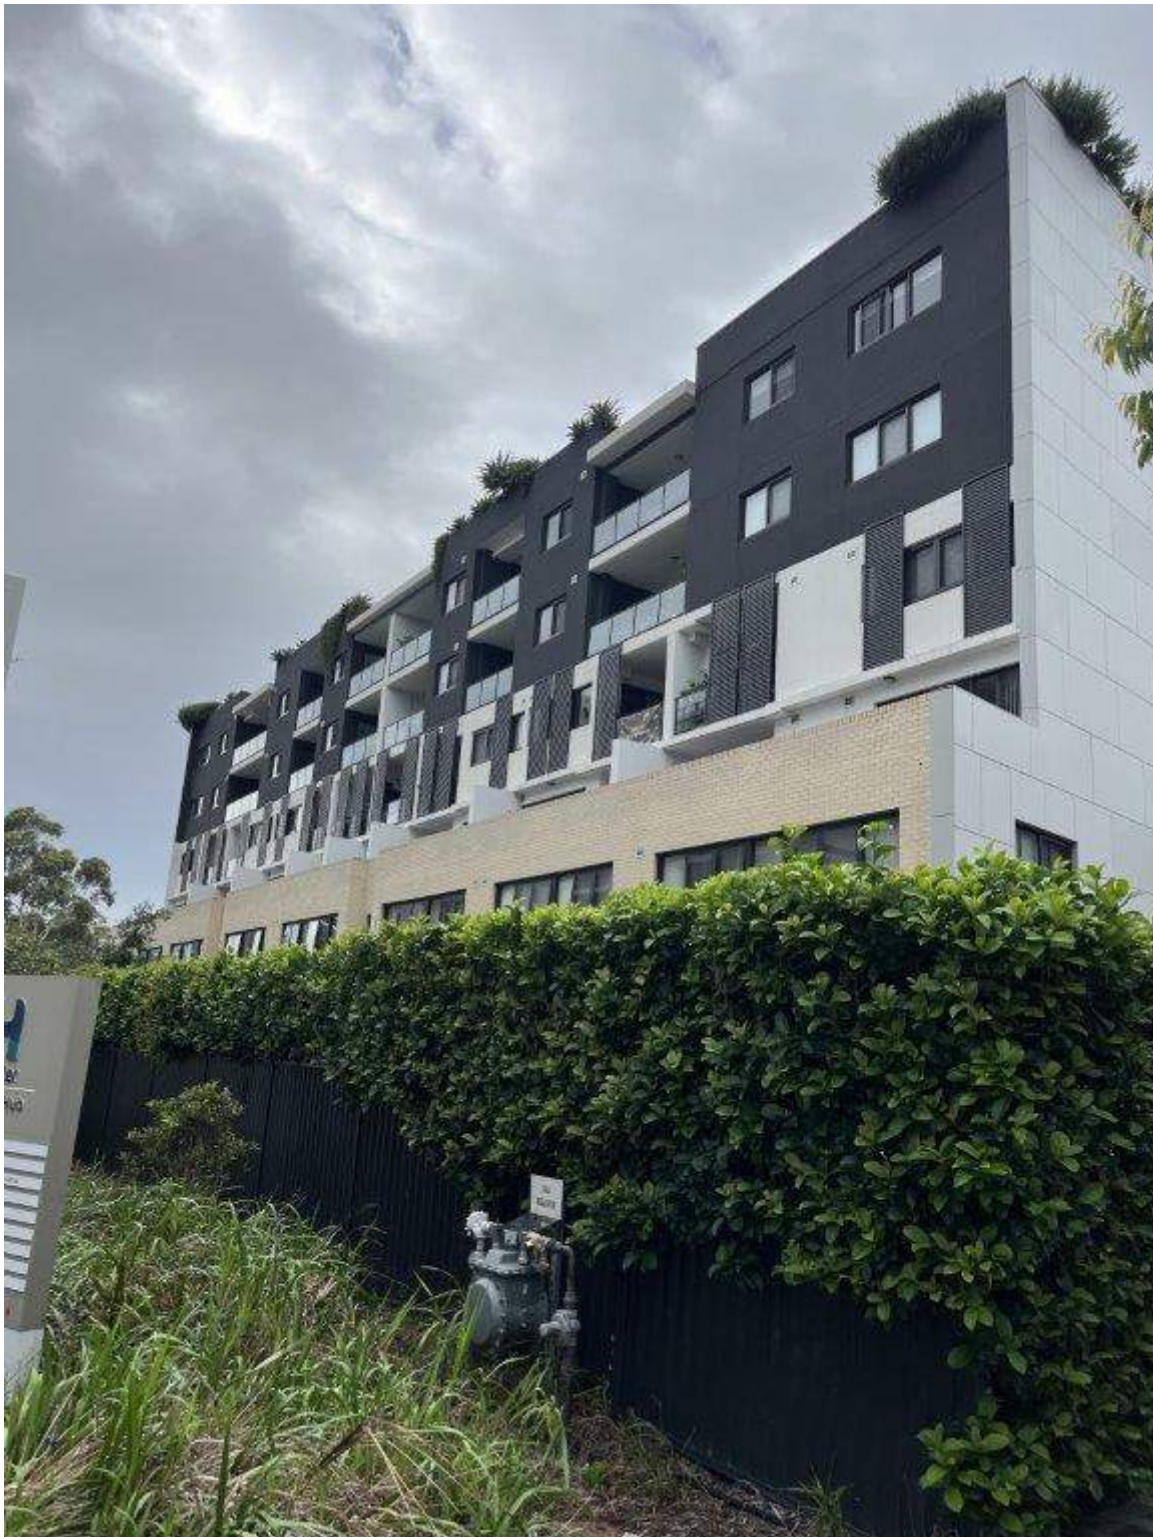
Photo 3 - Hinkler Avenue - Existing condition of external façade

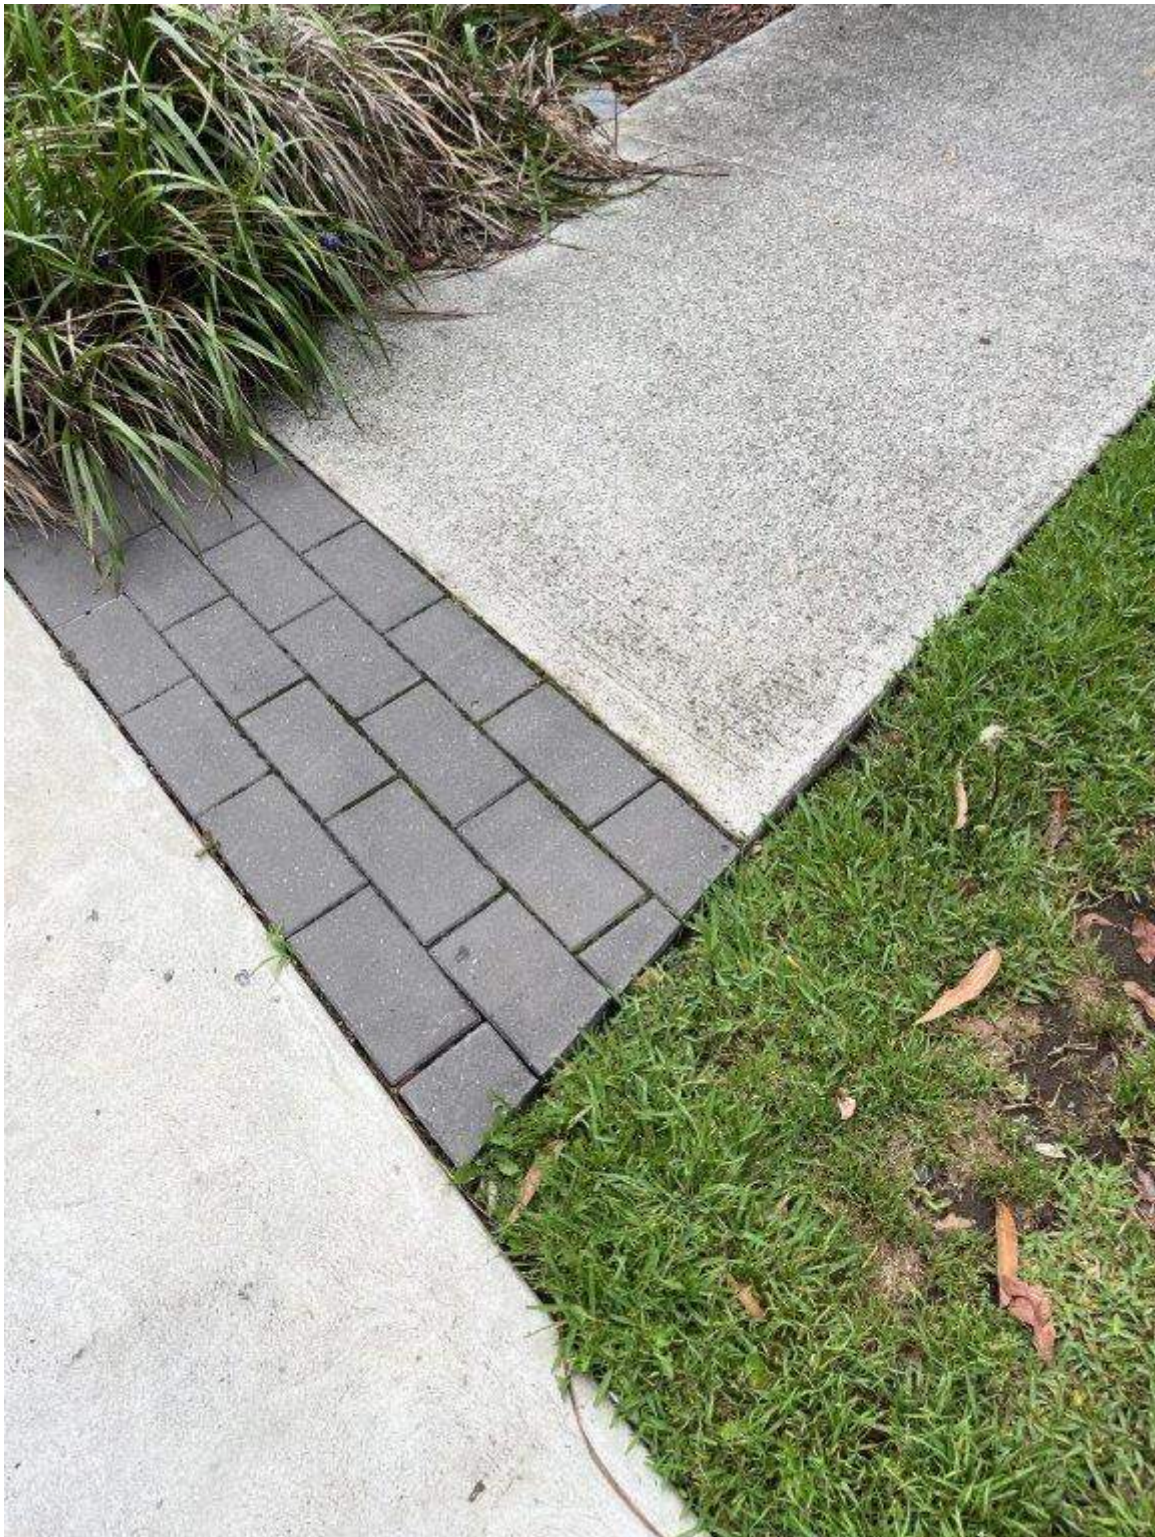
Photo 4 - Hinkler Avenue - Existing condition of pavement

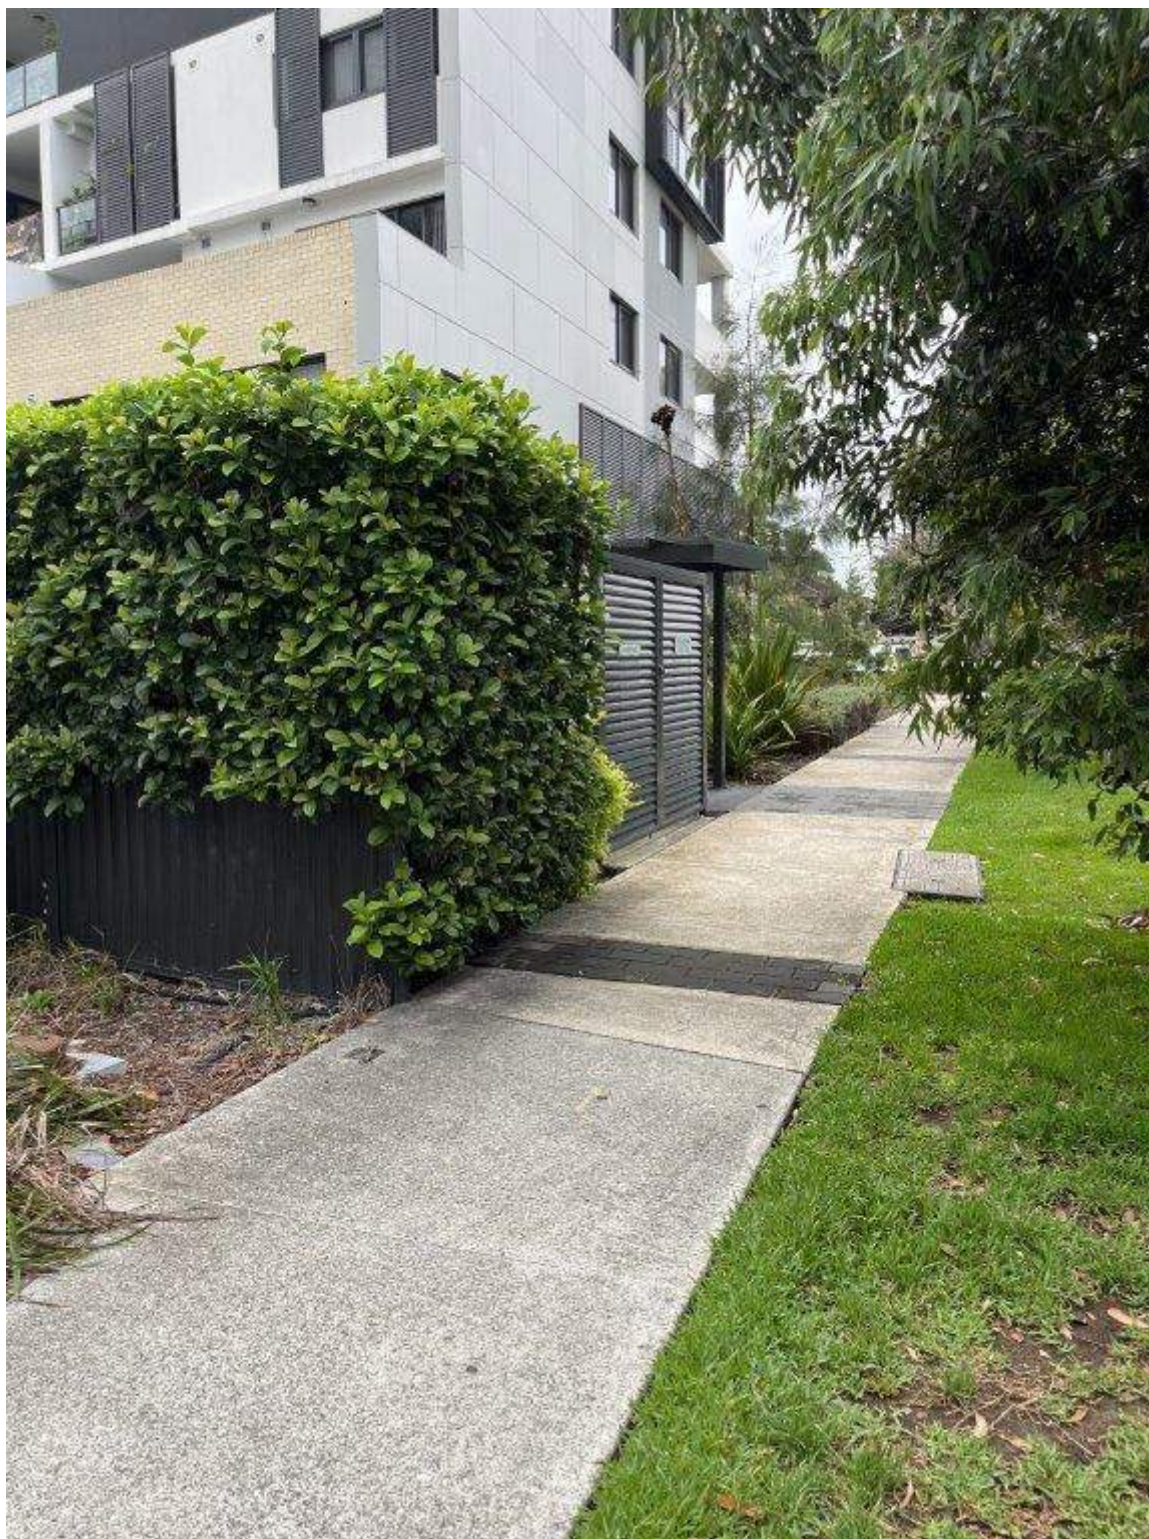
Photo 5 - Hinkler Avenue - Existing condition of pavement and vegetation

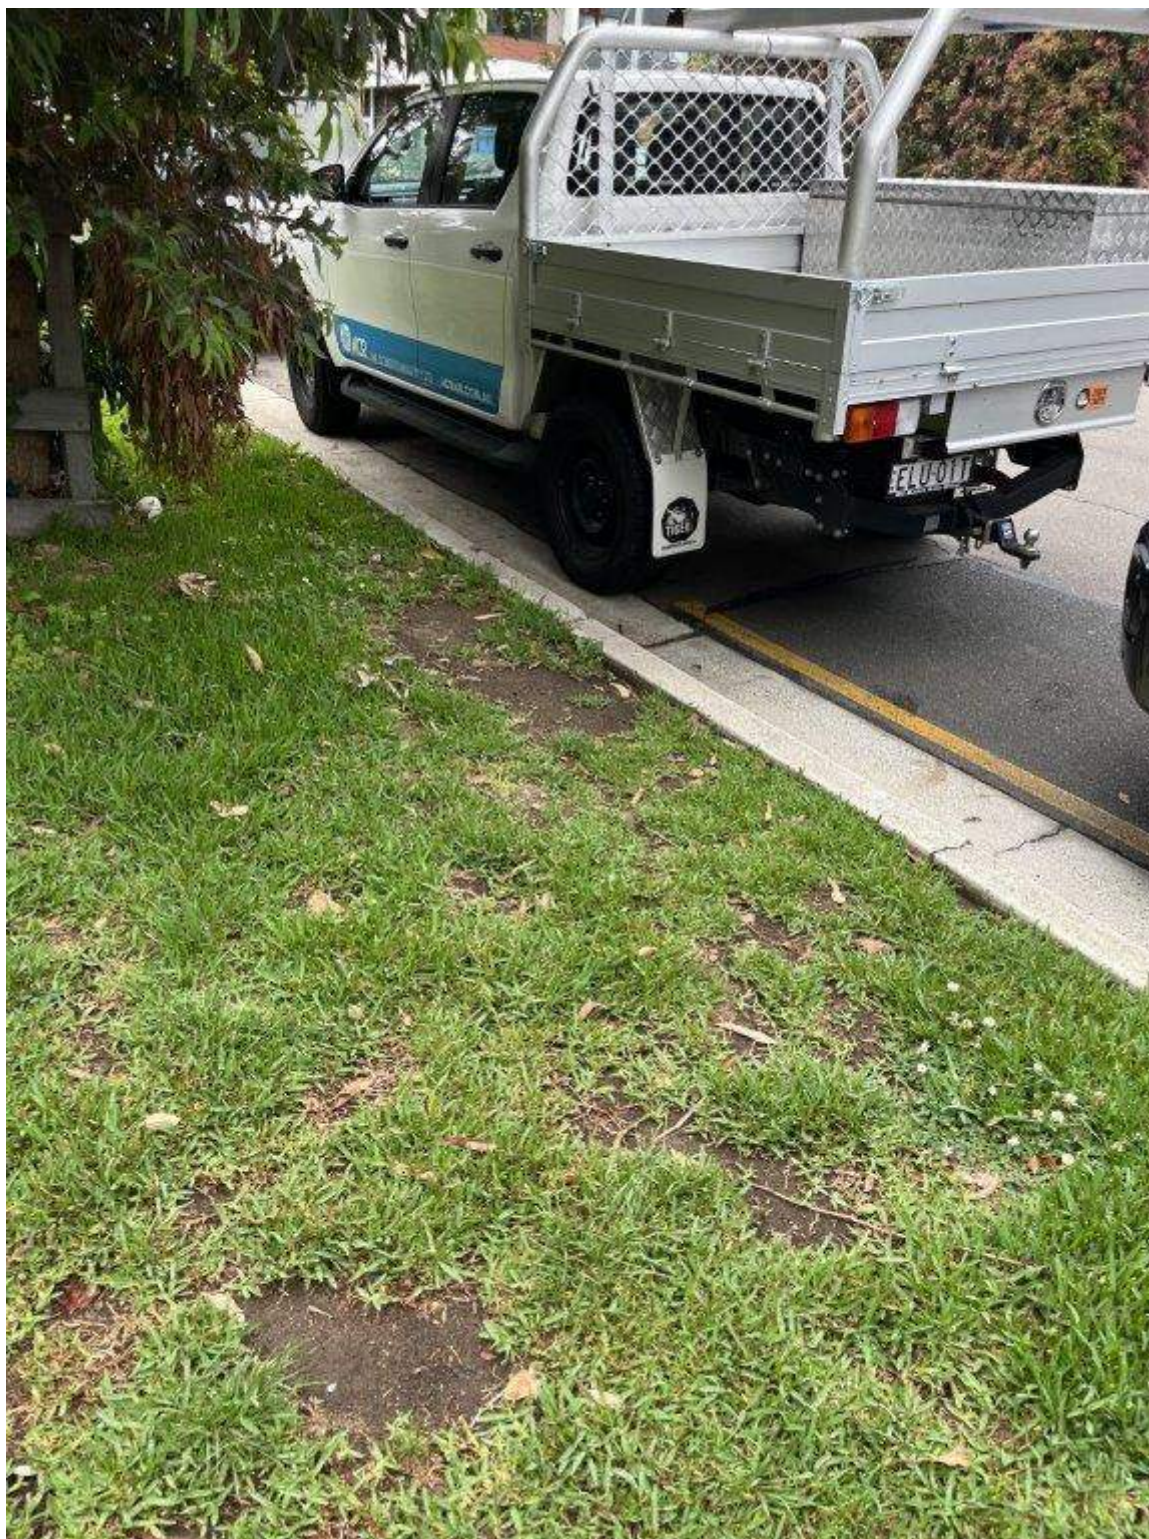
Photo 6 - Hinkler Avenue - Existing condition of pavement and vegetation

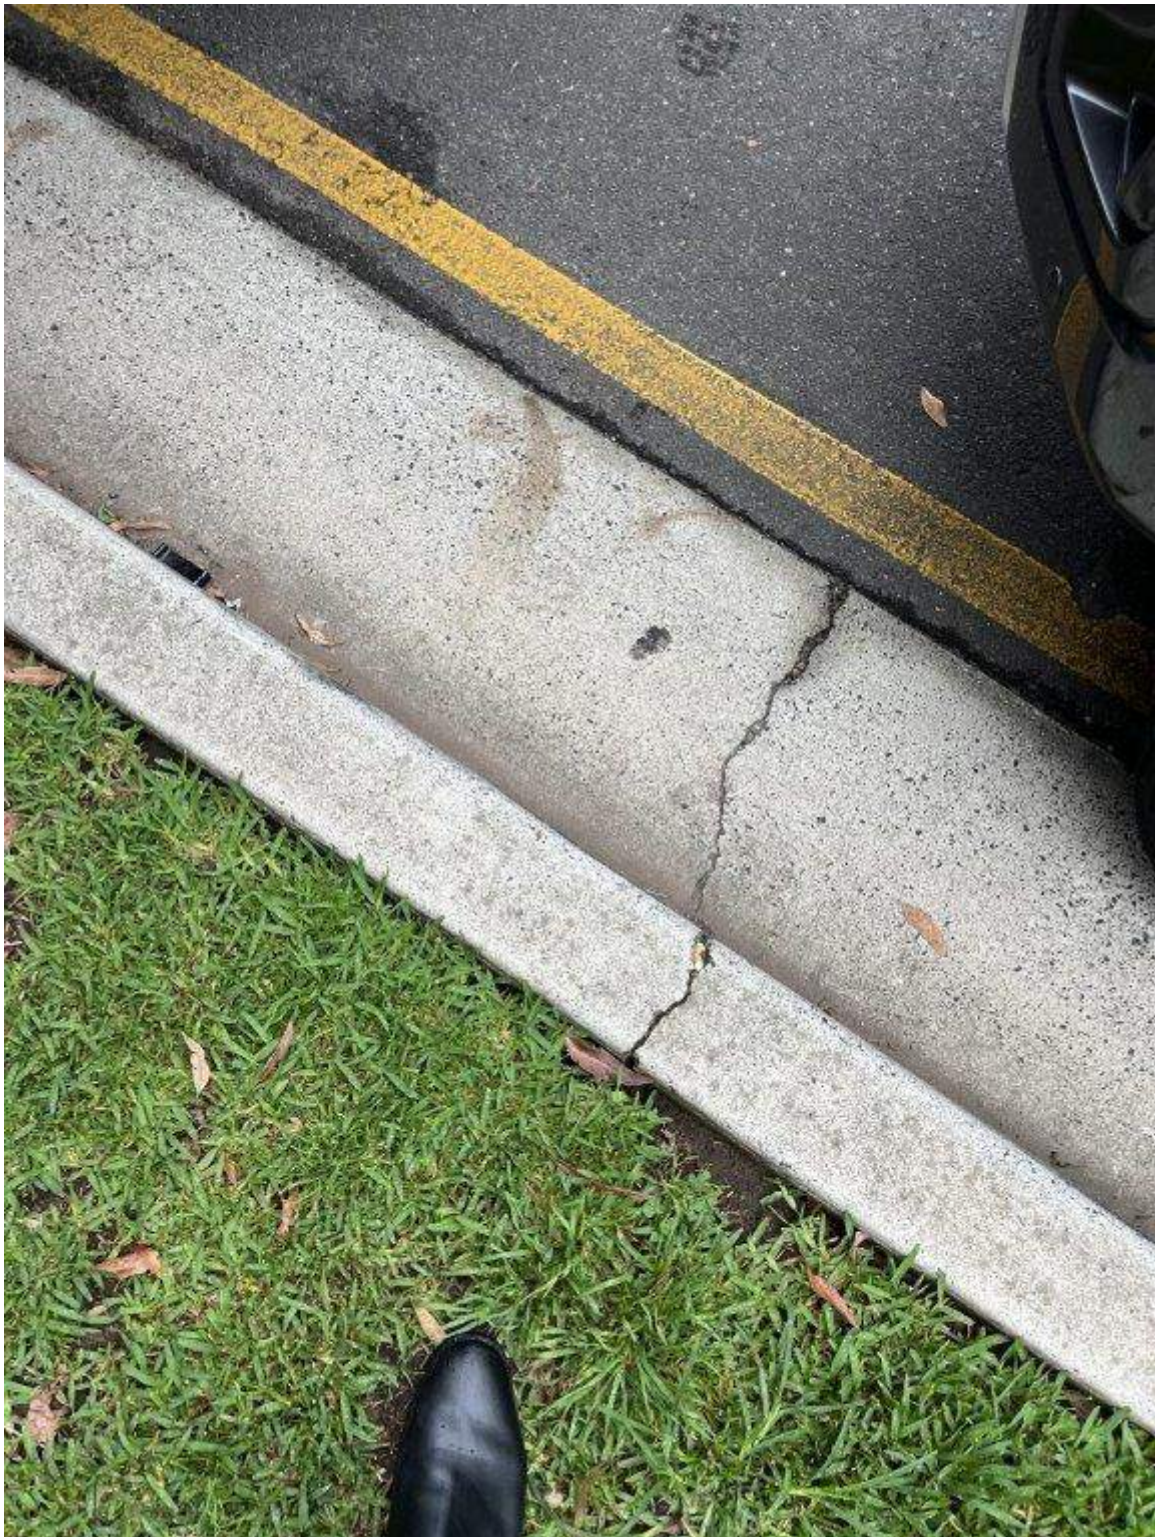
Photo 7 - Hinkler Avenue - Cracking of kerb and pavement

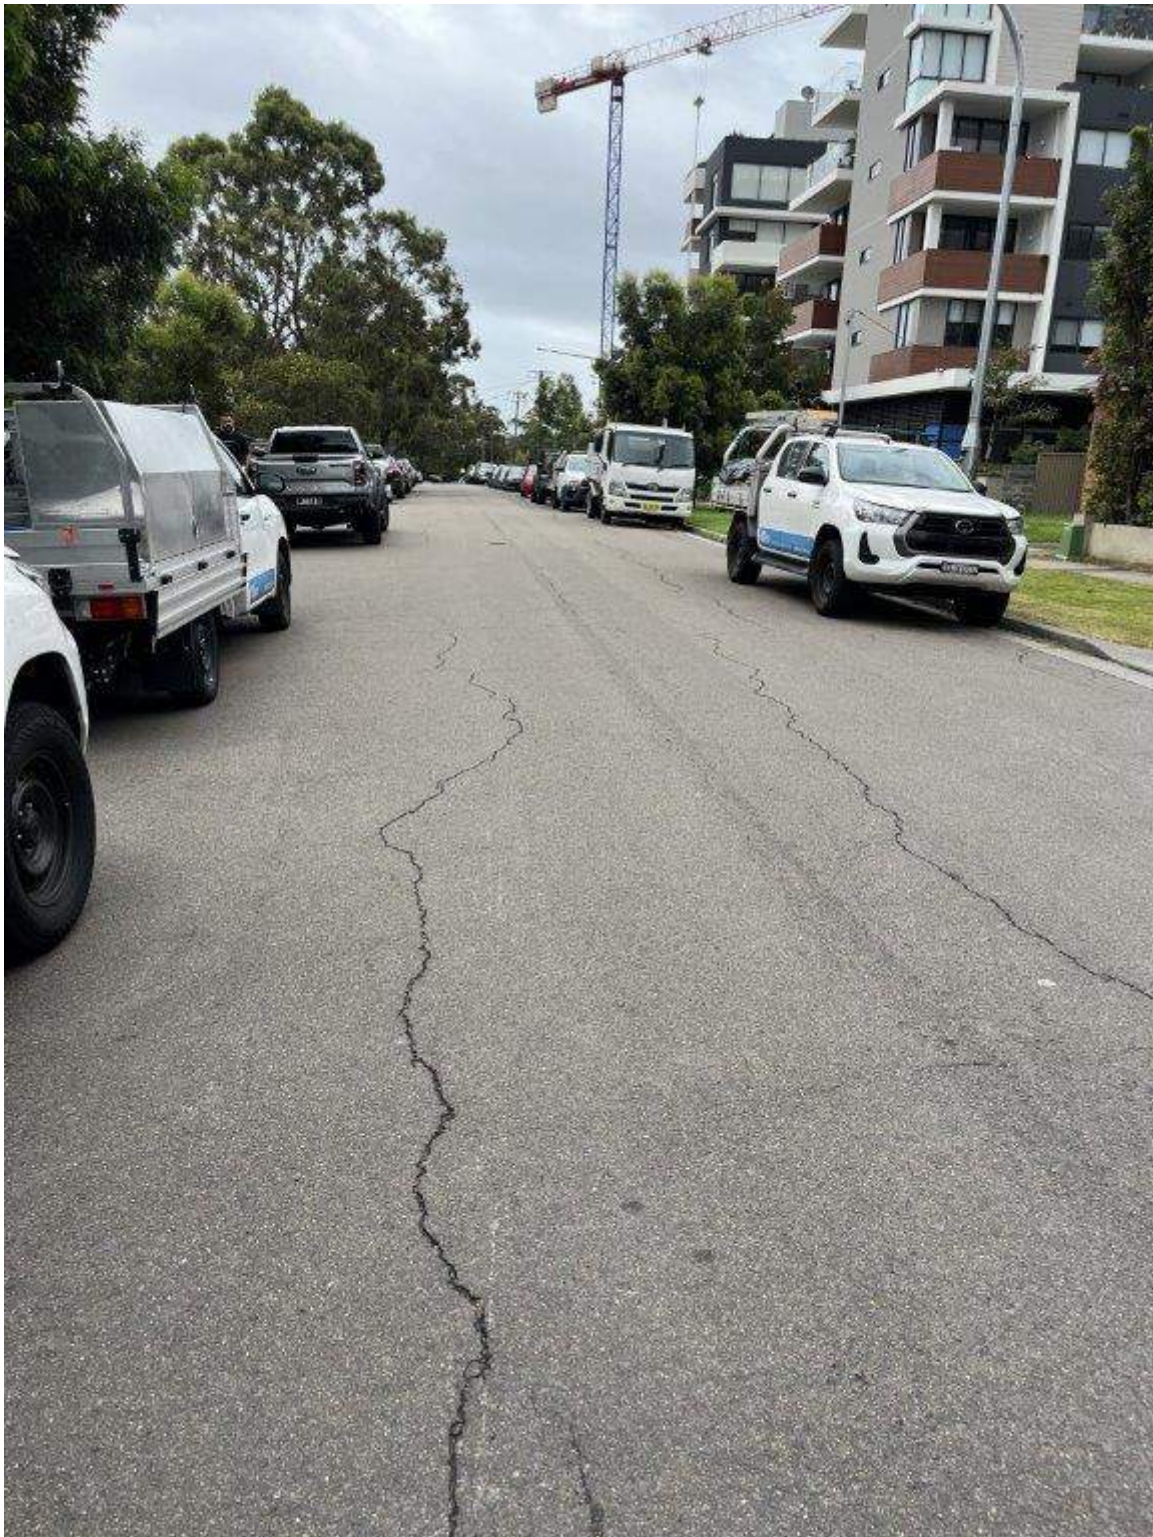
Photo 10 - Hinkler Avenue - Cracking of pavement

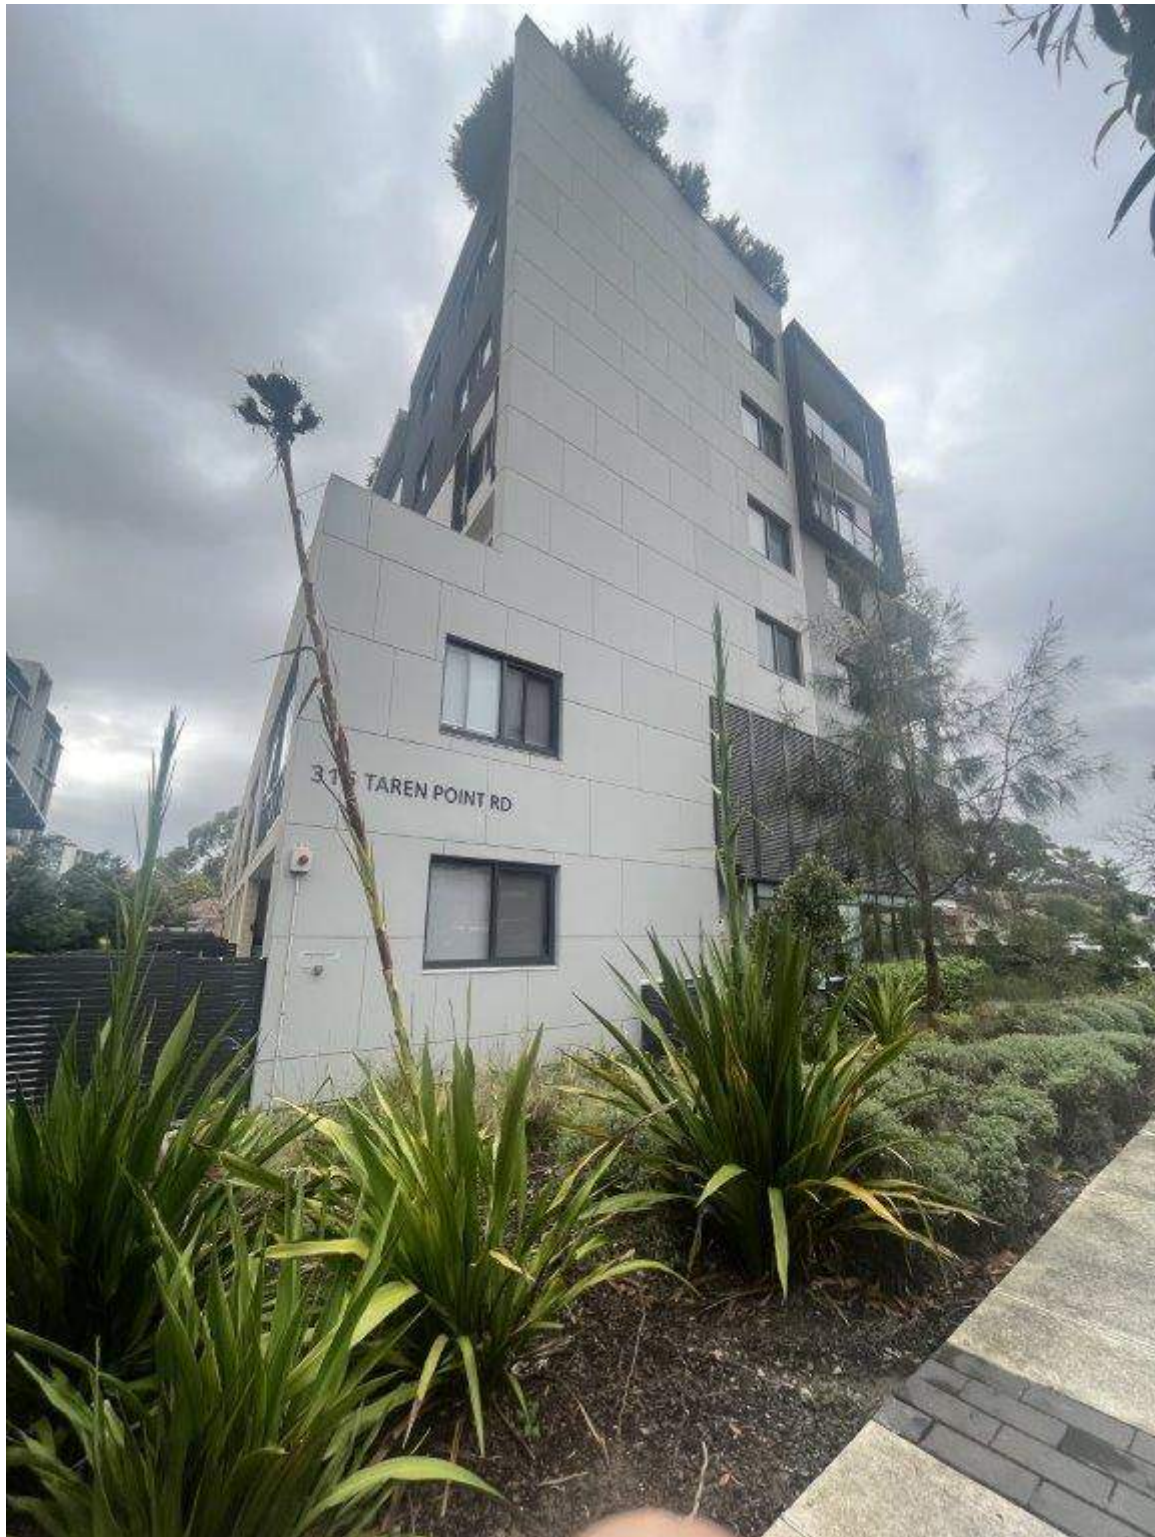
Photo 13 - Hinkler Avenue - Existing condition of external facade

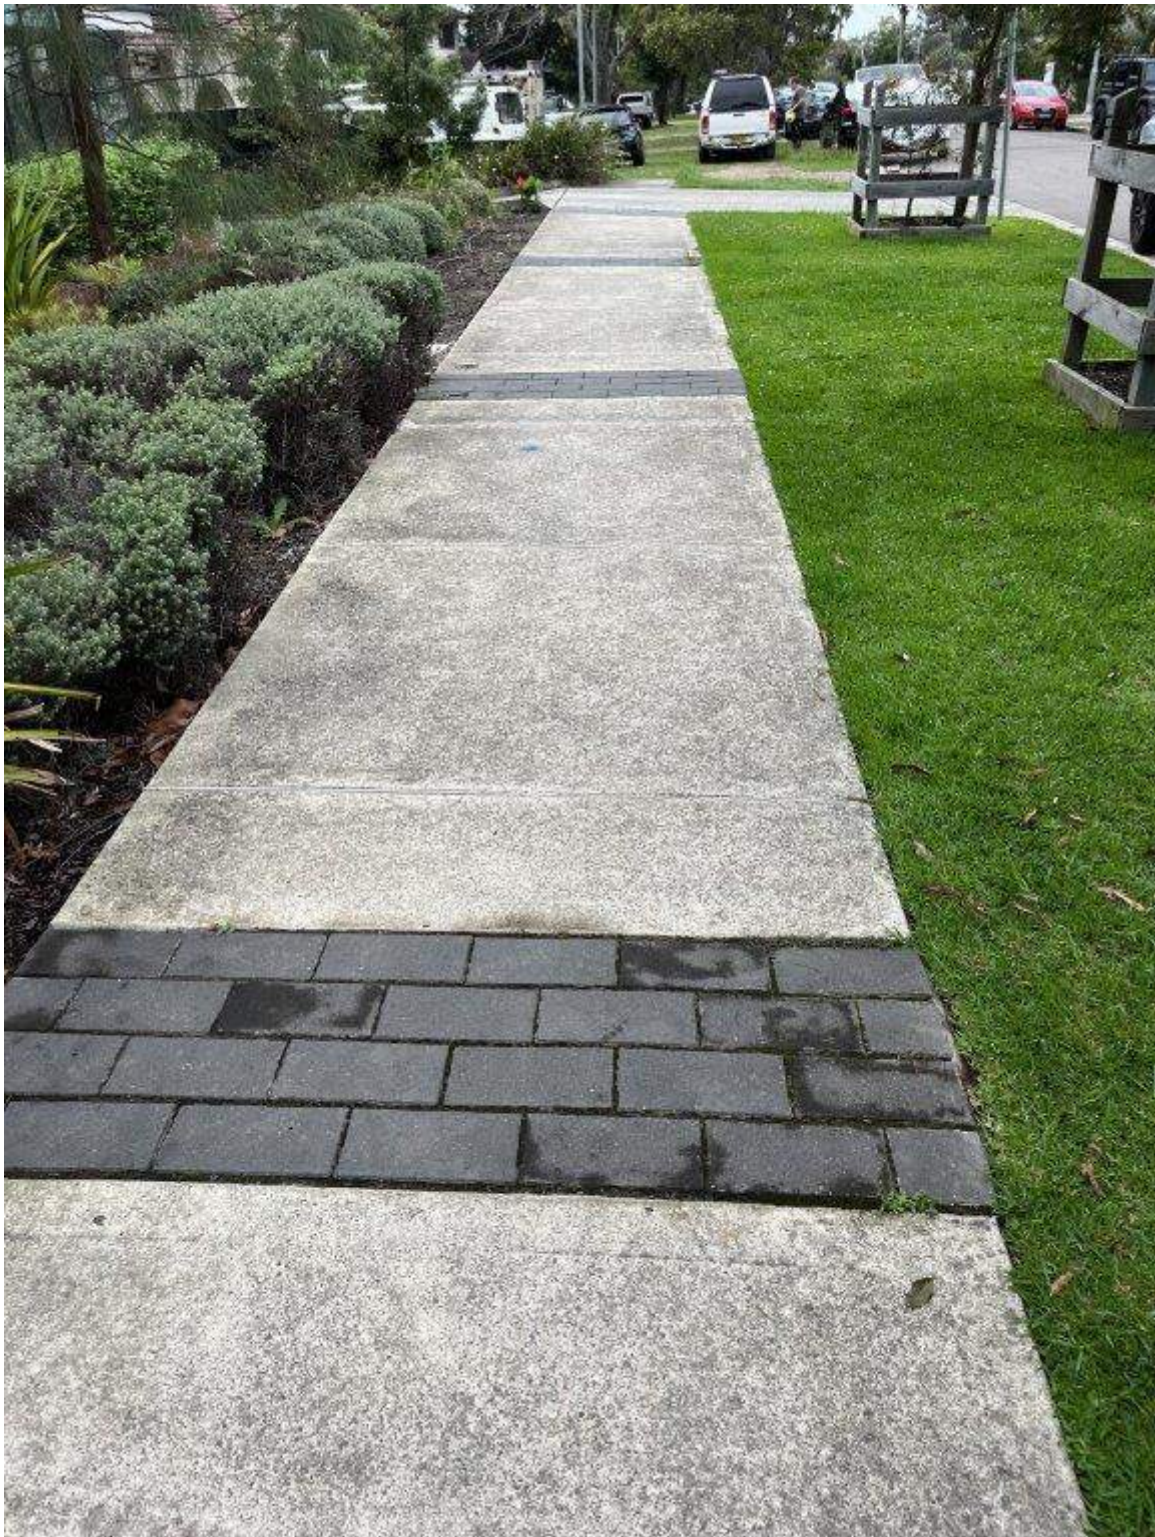
Photo 14 - Hinkler Avenue - Existing condition of pavement and vegetation

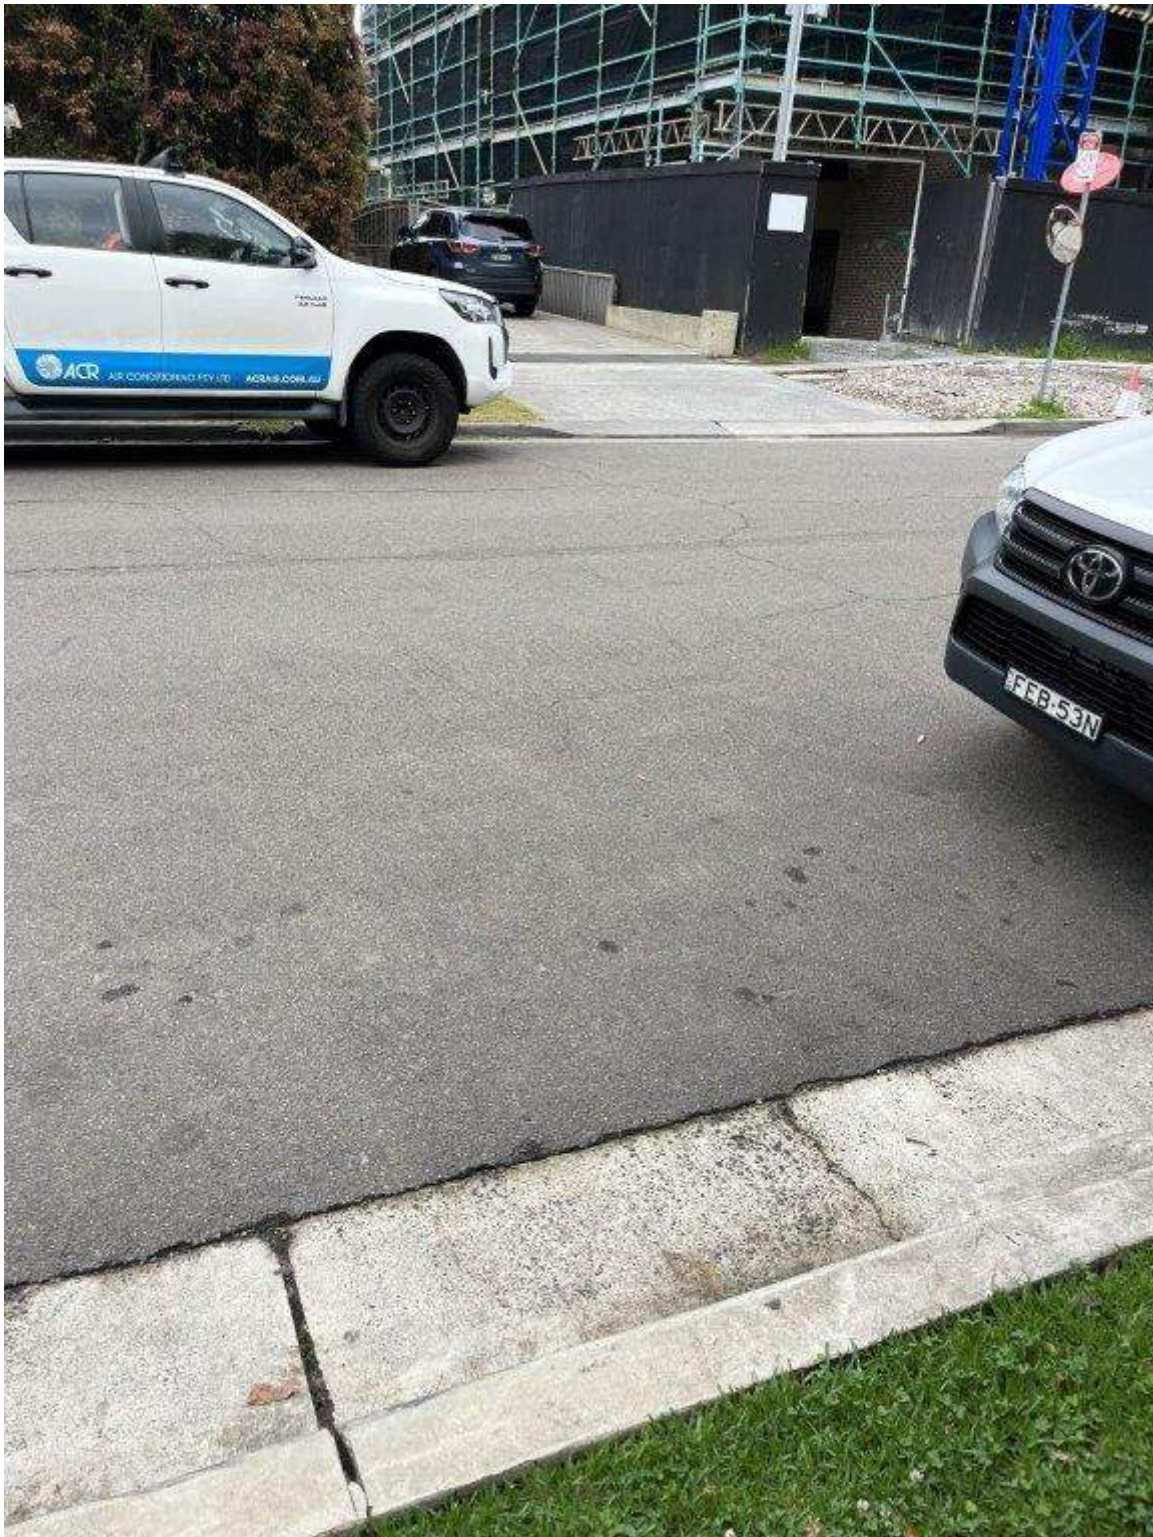
Photo 15 - Hinkler Avenue - Cracking of pavement

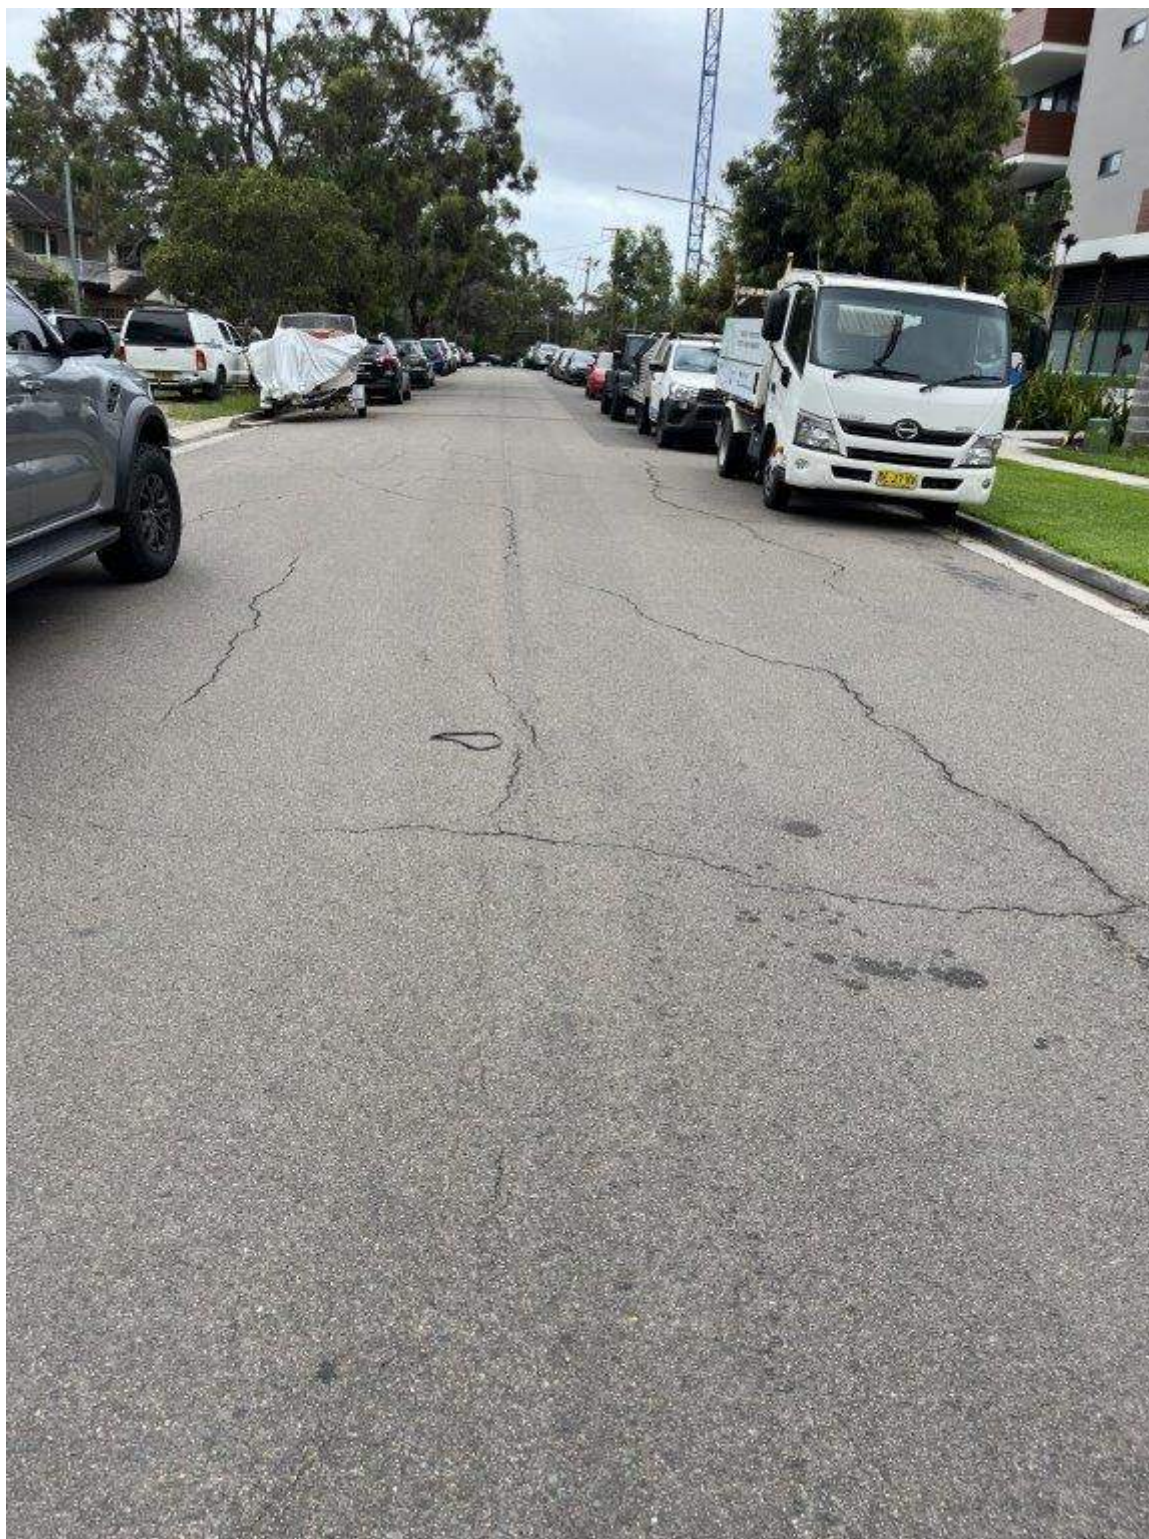
Photo 16 - Hinkler Avenue - Cracking of pavement

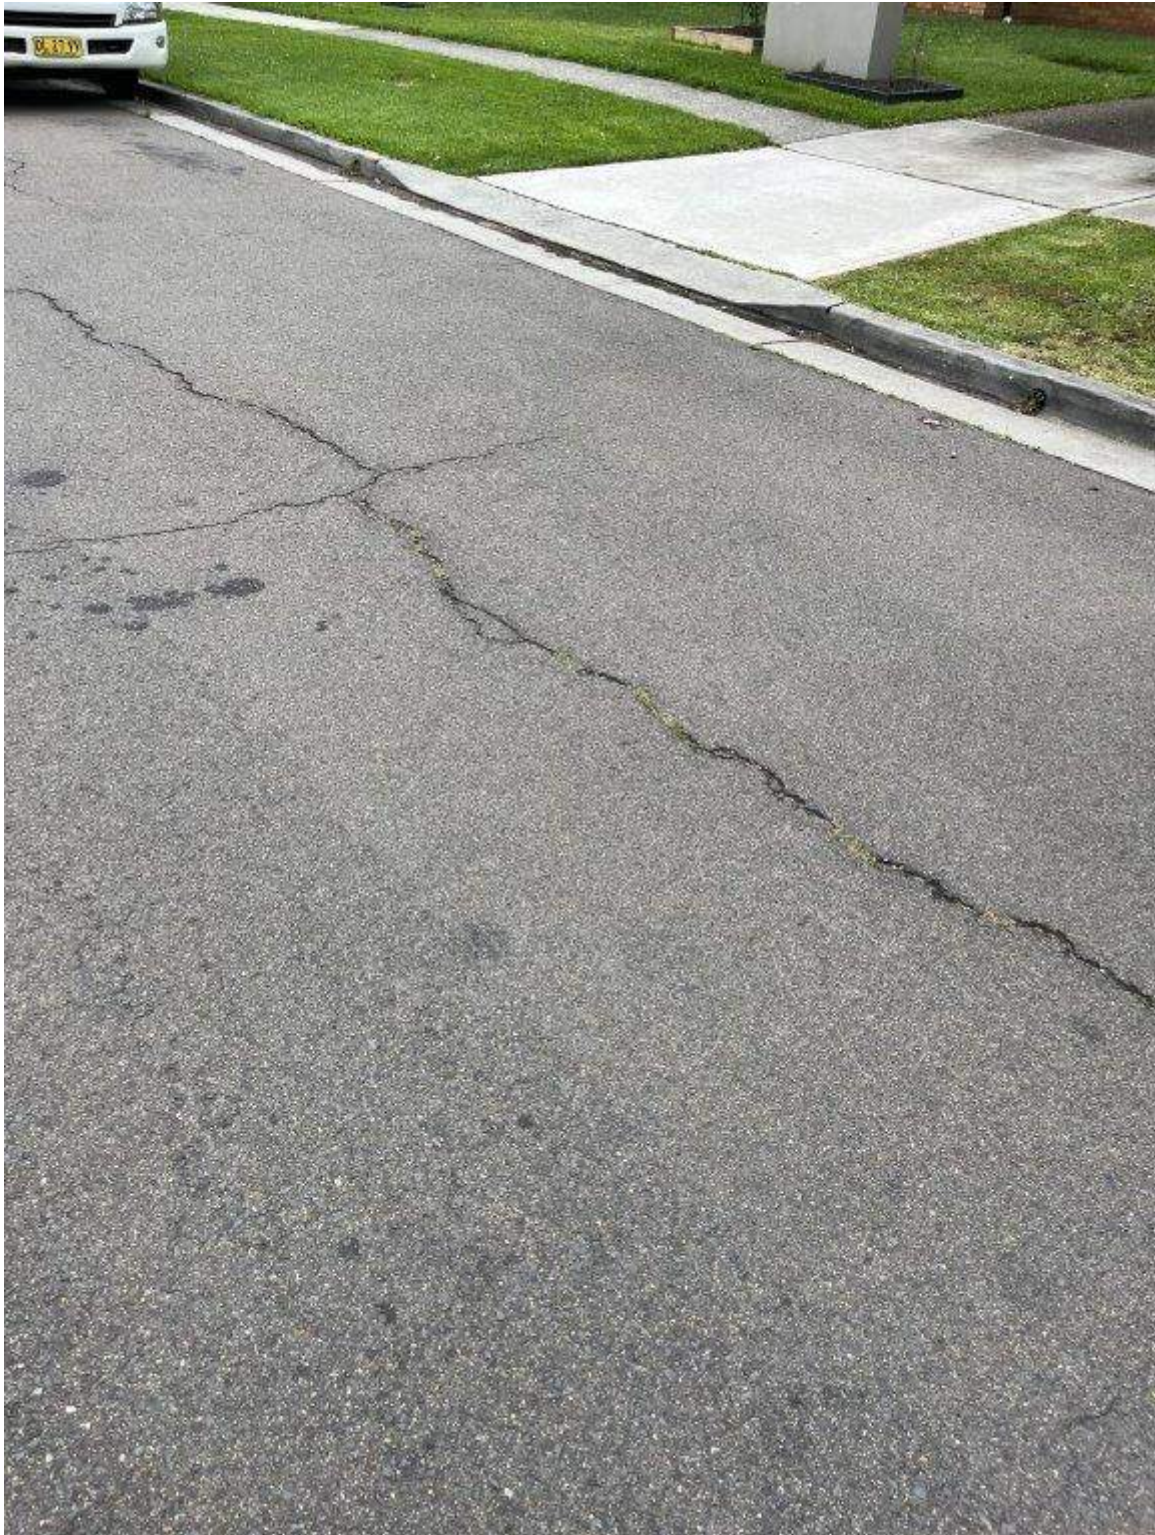
Photo 17 - Hinkler Avenue - Cracking of pavement

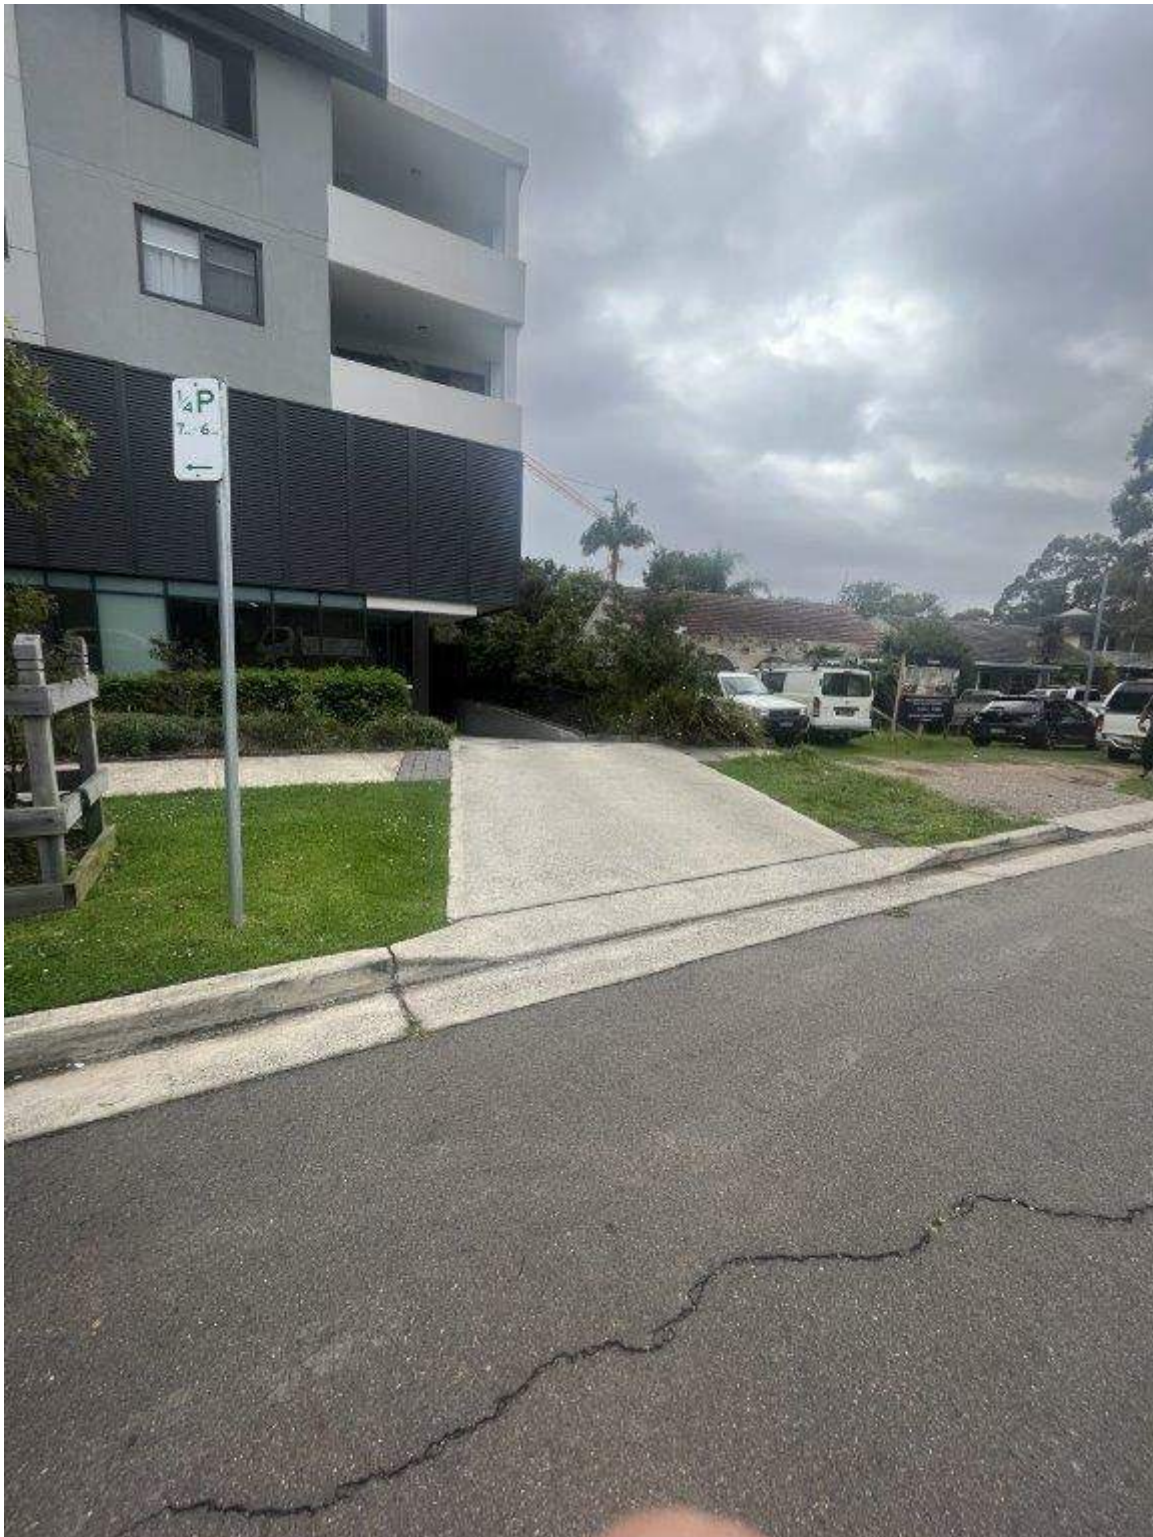
Photo 18 - Hinkler Avenue - Cracking of pavement
