## PRE-CONSTRUCTION DILAPIDATION REPORT

### 6-20 HINKLER AVENUE & 319-333 TAREN POINT ROAD, CARINGBAH

| PRE-CONSTRUCTION DILAPIDATION REPORT<br>6-20 Hinkler Avenue & 319-333 Taren Point Road,<br>Caringbah NSW 2229 | | | | | Project Number: 21039 |

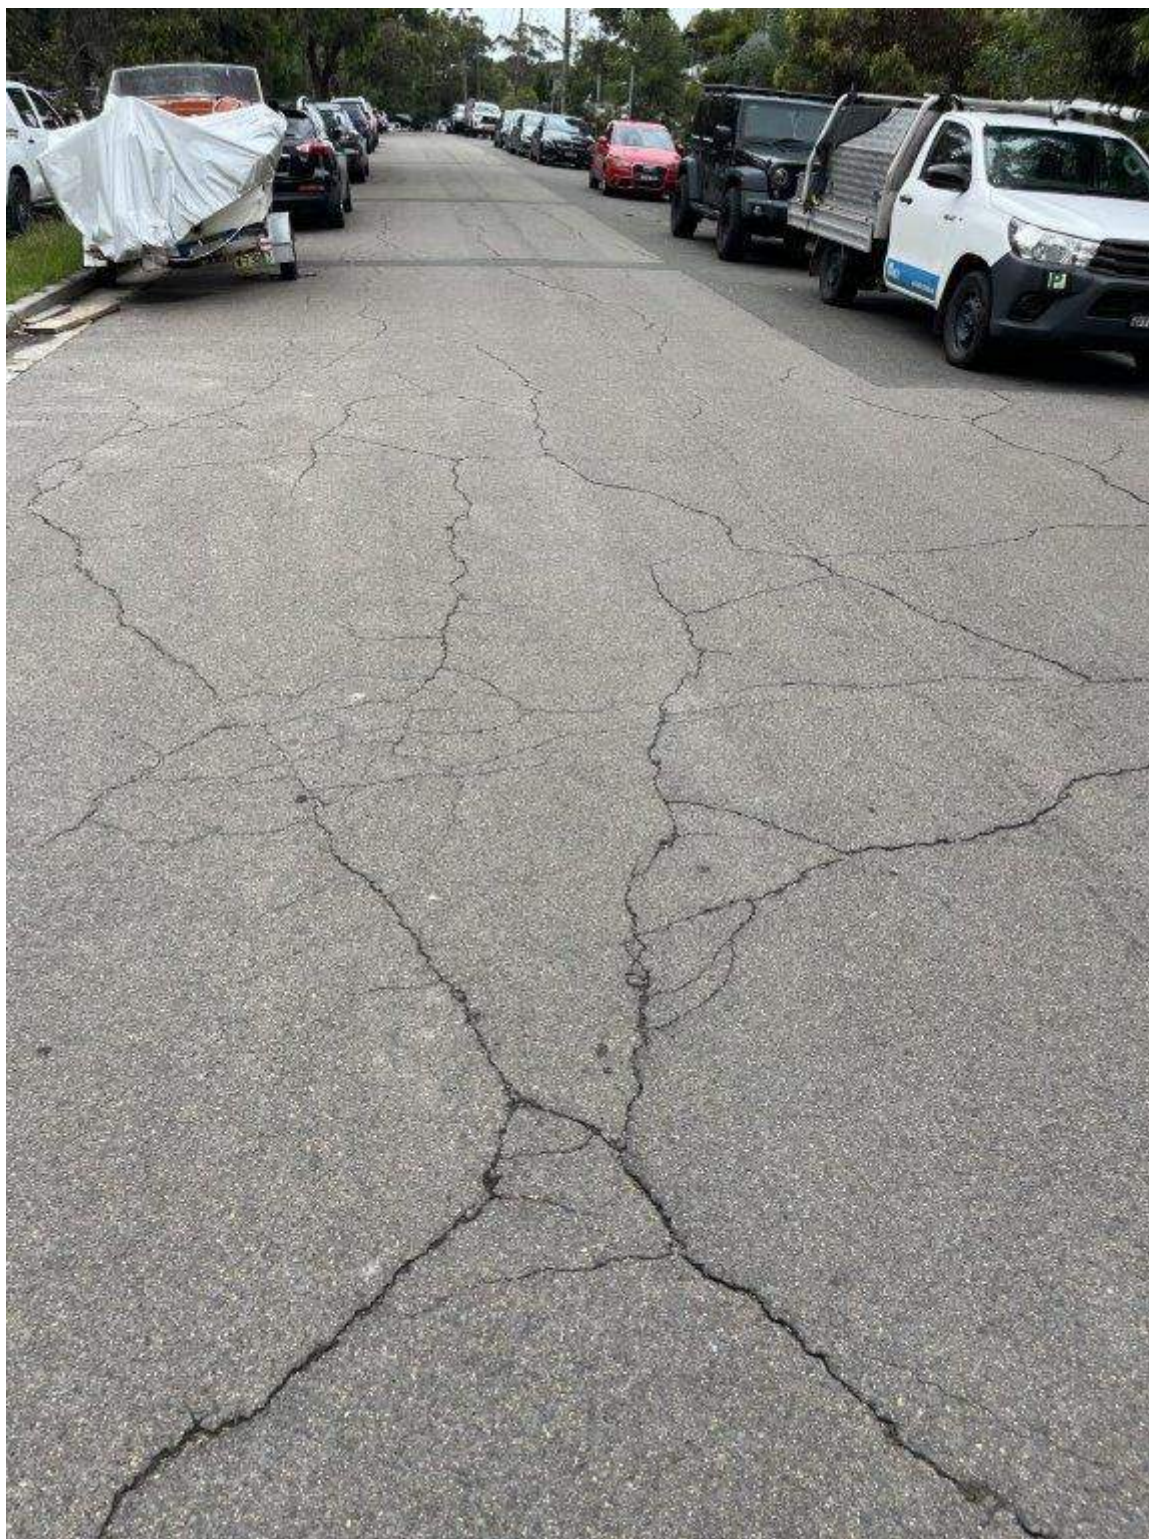
Photo 20 - Hinkler Avenue - Cracking of pavement

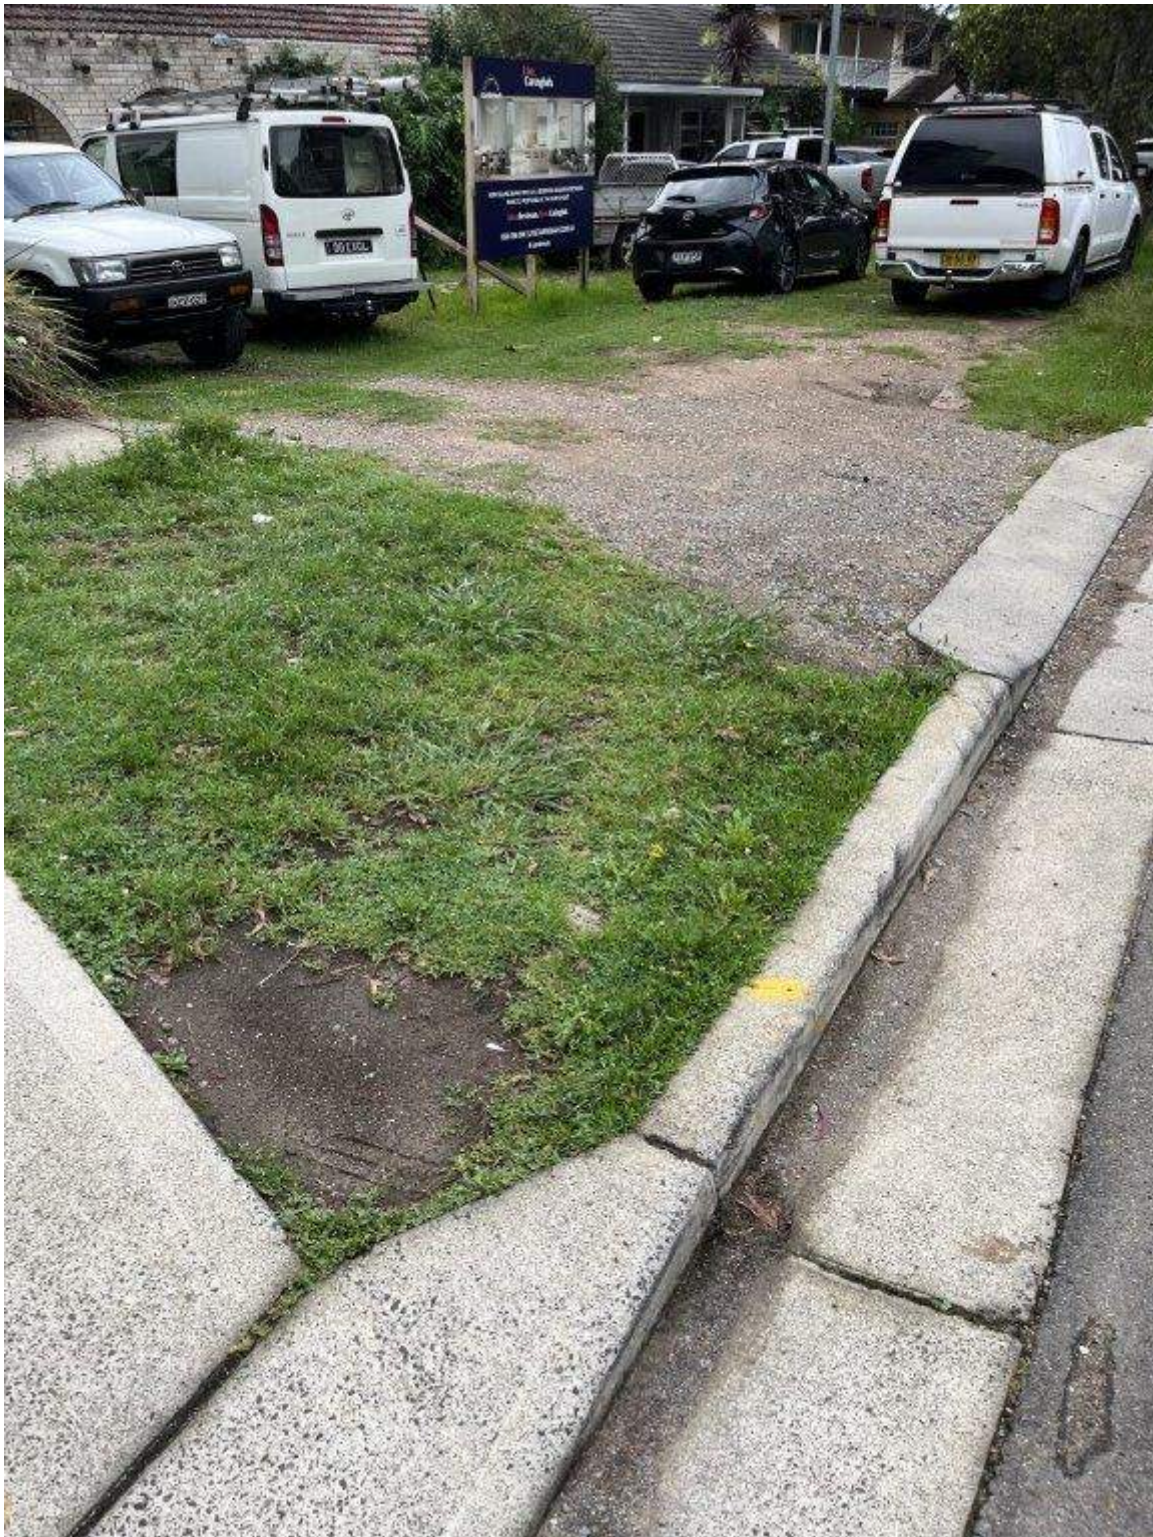
Photo 21 - Hinkler Avenue - Existing condition of pavement and vegetation

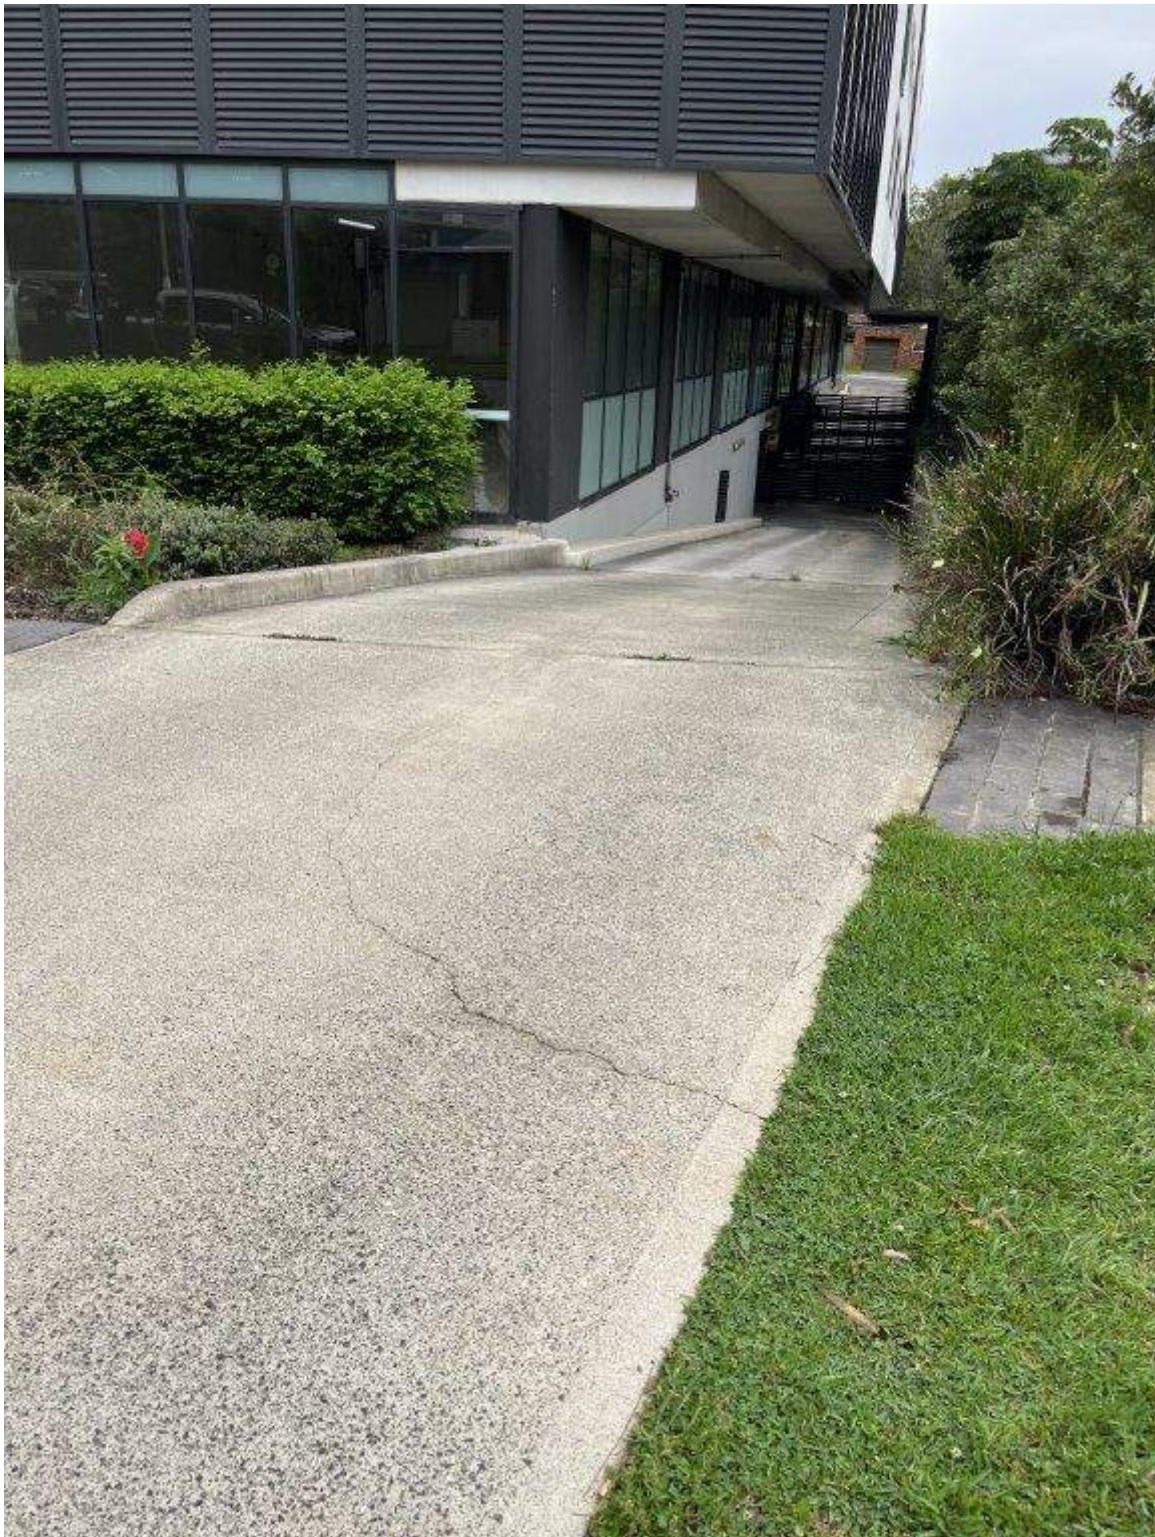
Photo 22 - Hinkler Avenue - Cracking of pavement

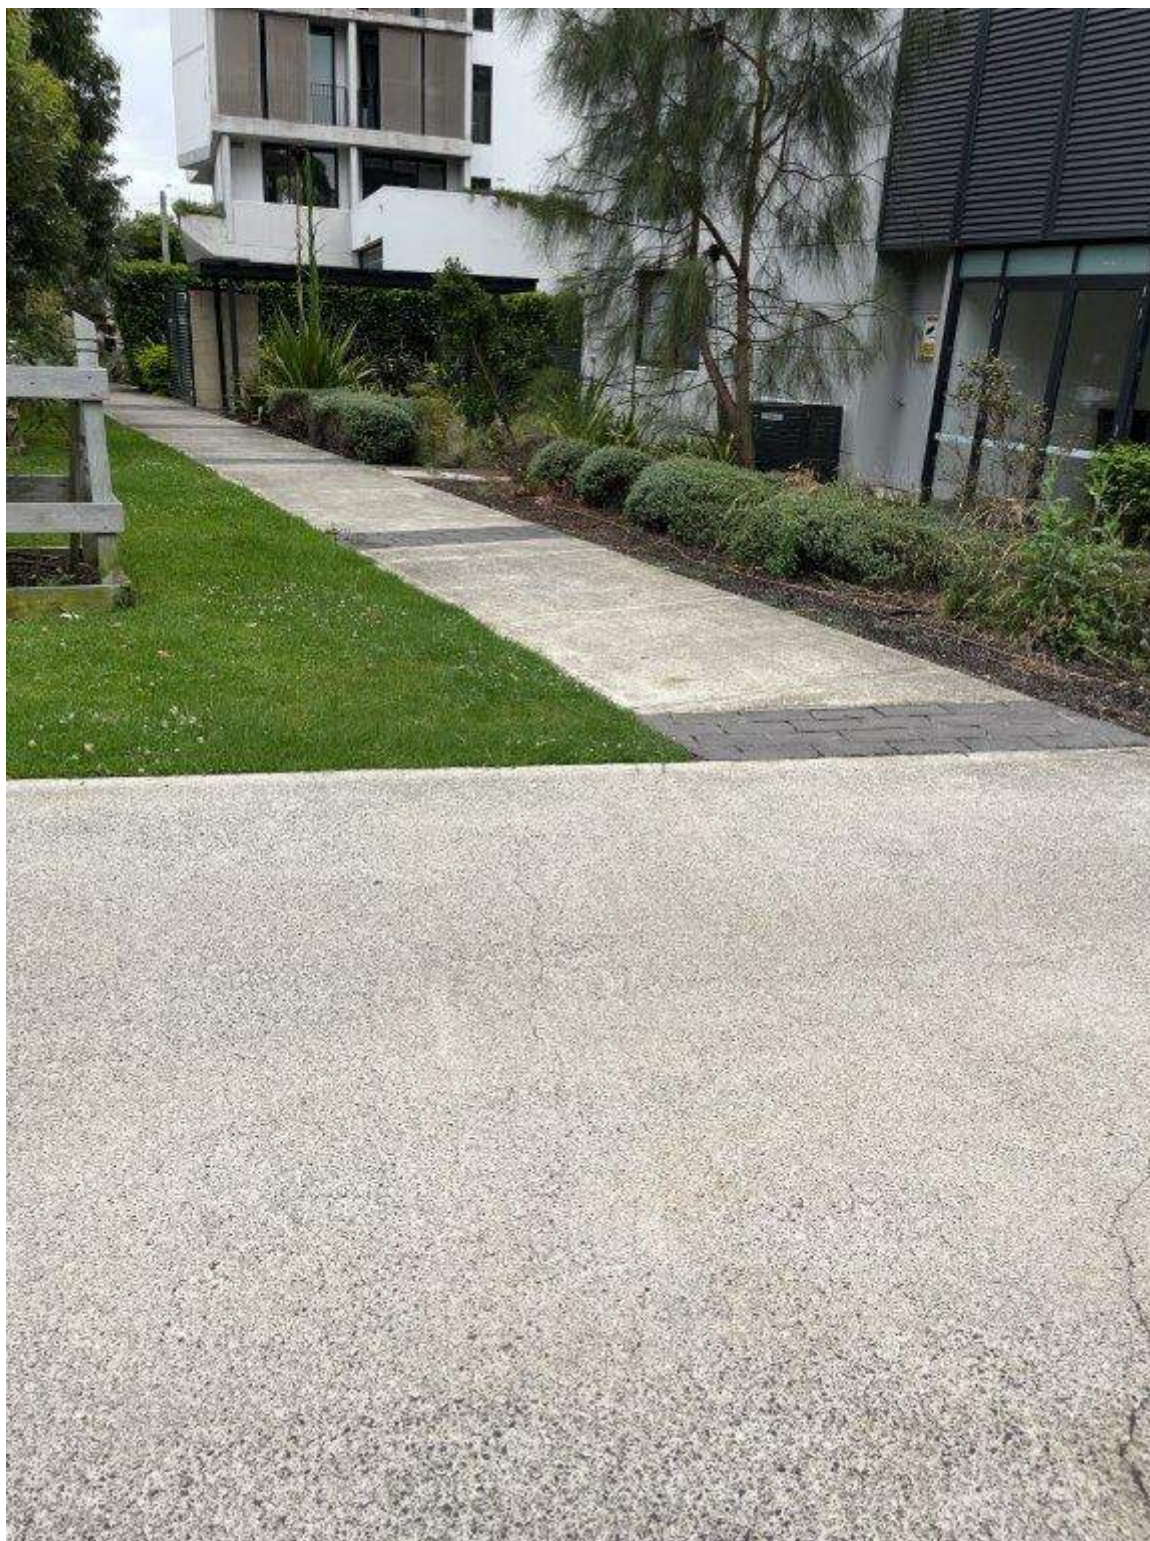
Photo 23 - Hinkler Avenue - Cracking of pavement

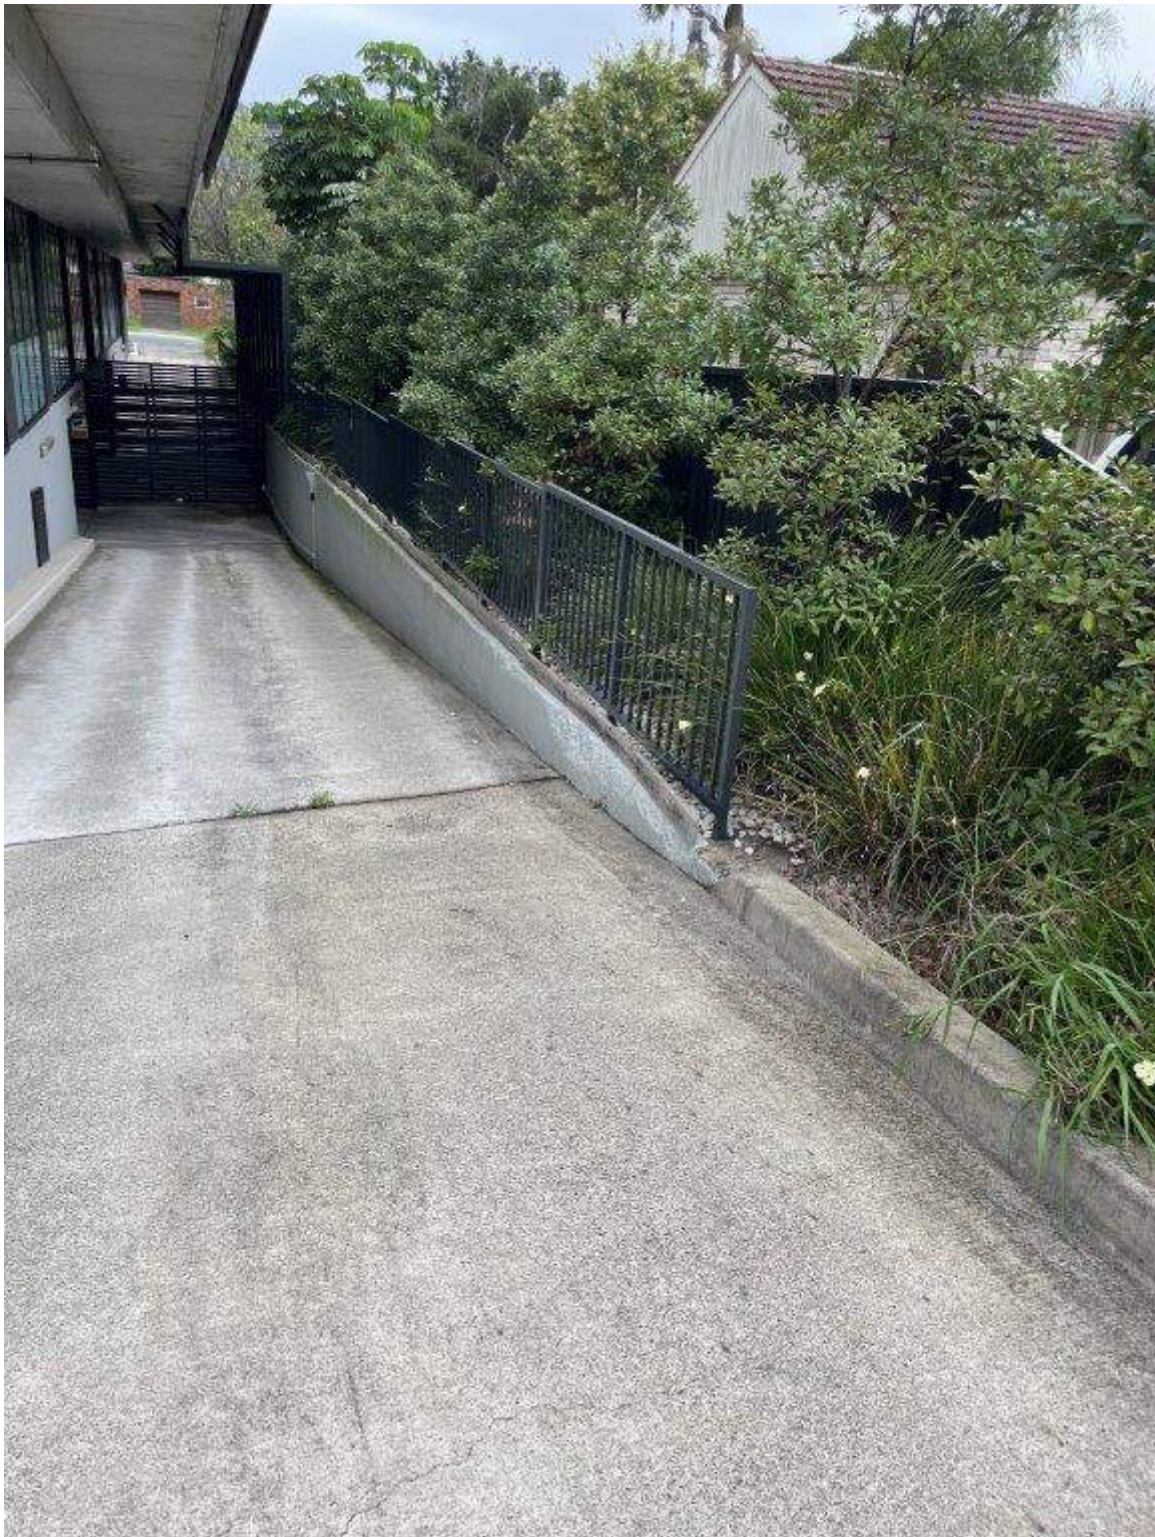
Photo 25 - Hinkler Avenue - Cracking of pavement

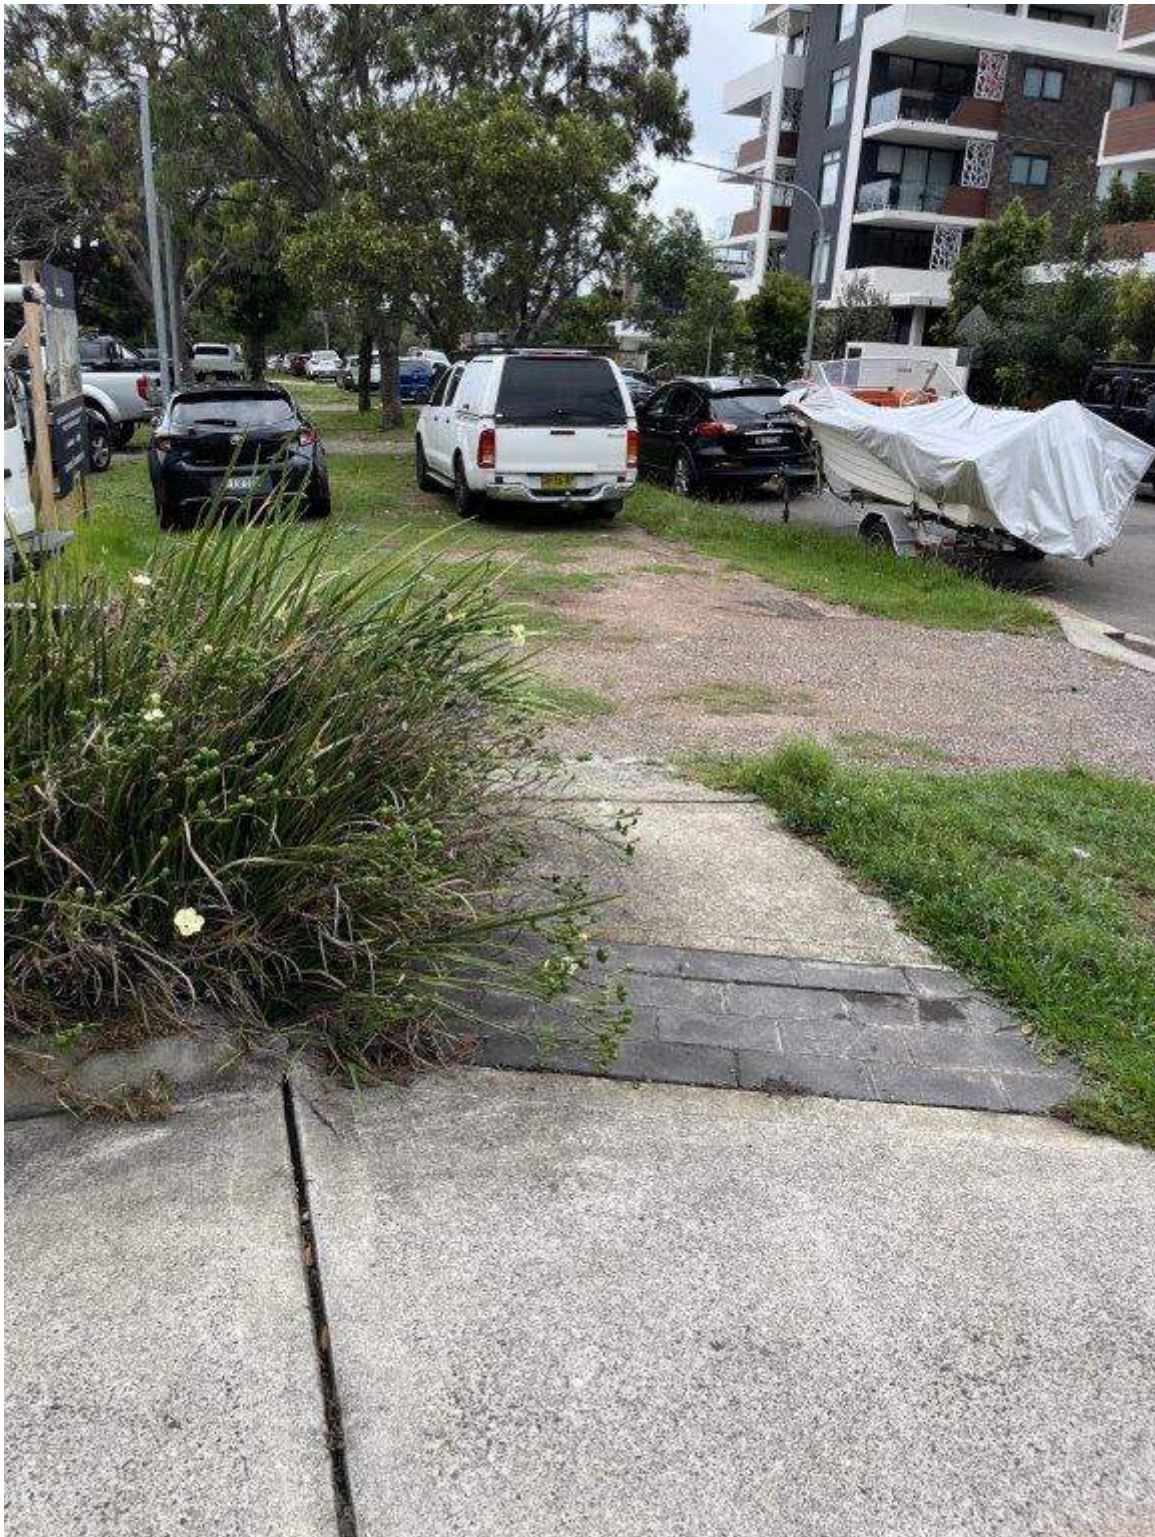
Photo 27 - Hinkler Avenue - Existing condition of pavement and vegetation

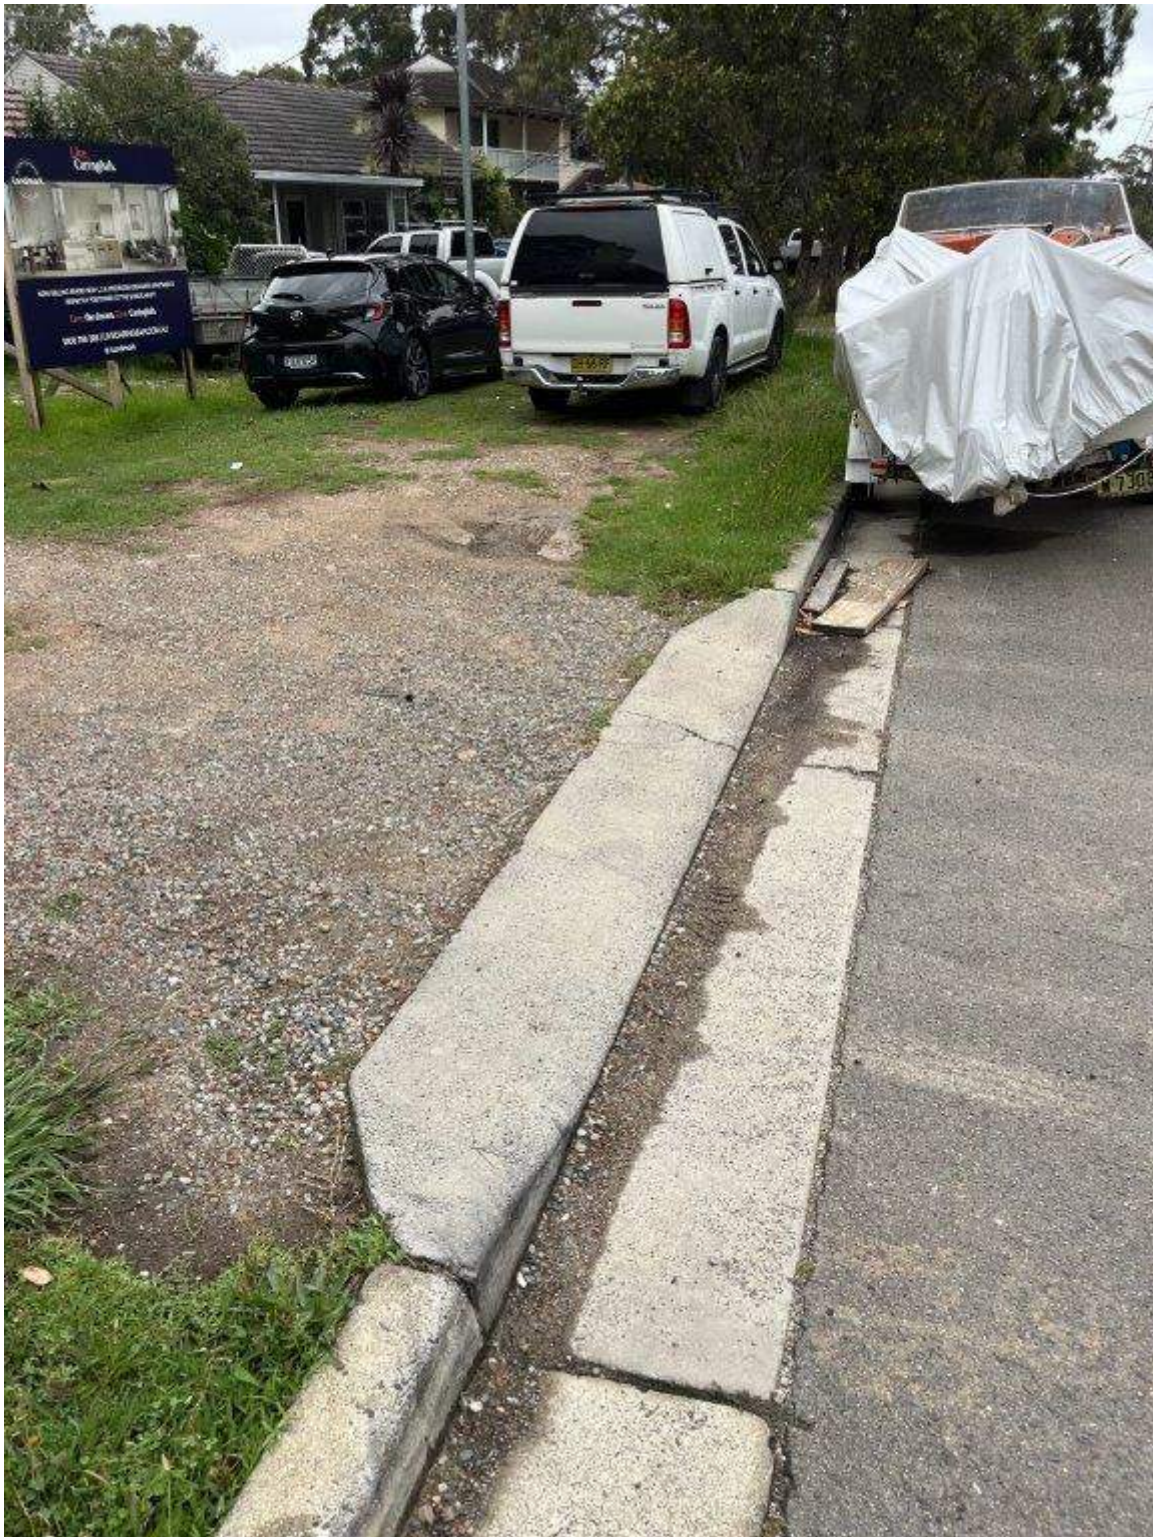
Photo 28 - Hinkler Avenue - Cracking of pavement

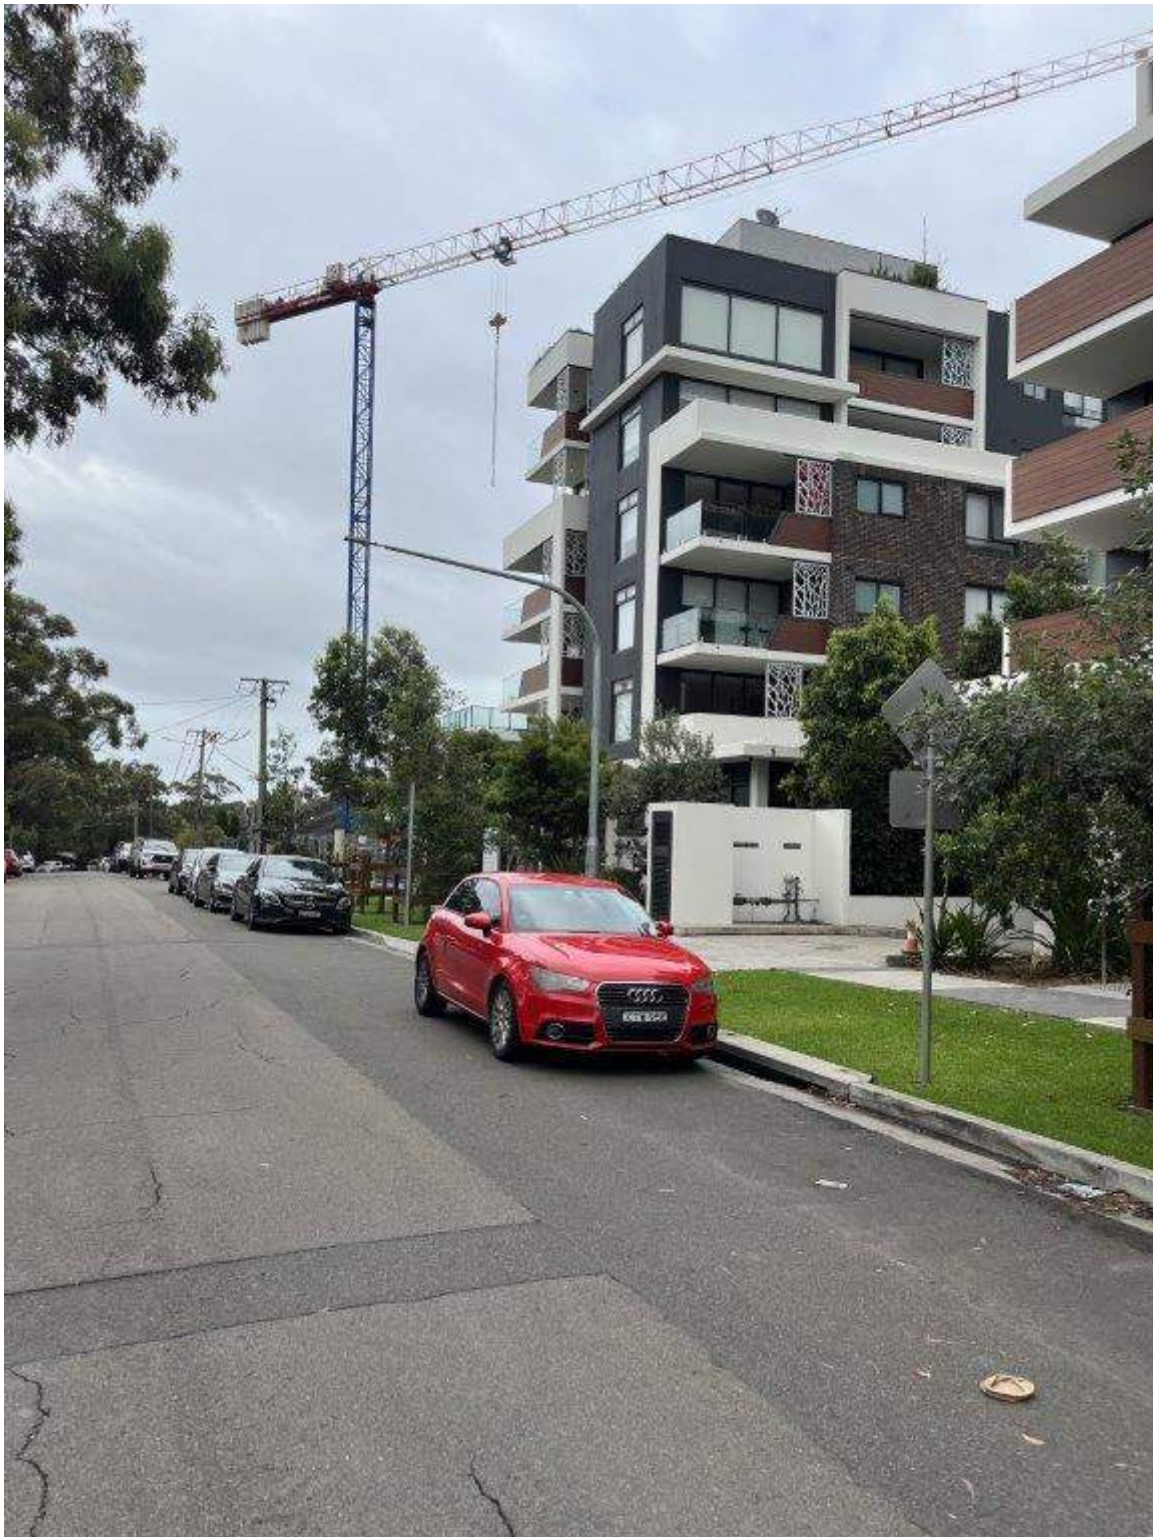
Photo 30 - Hinkler Avenue – Existing condition of pavement

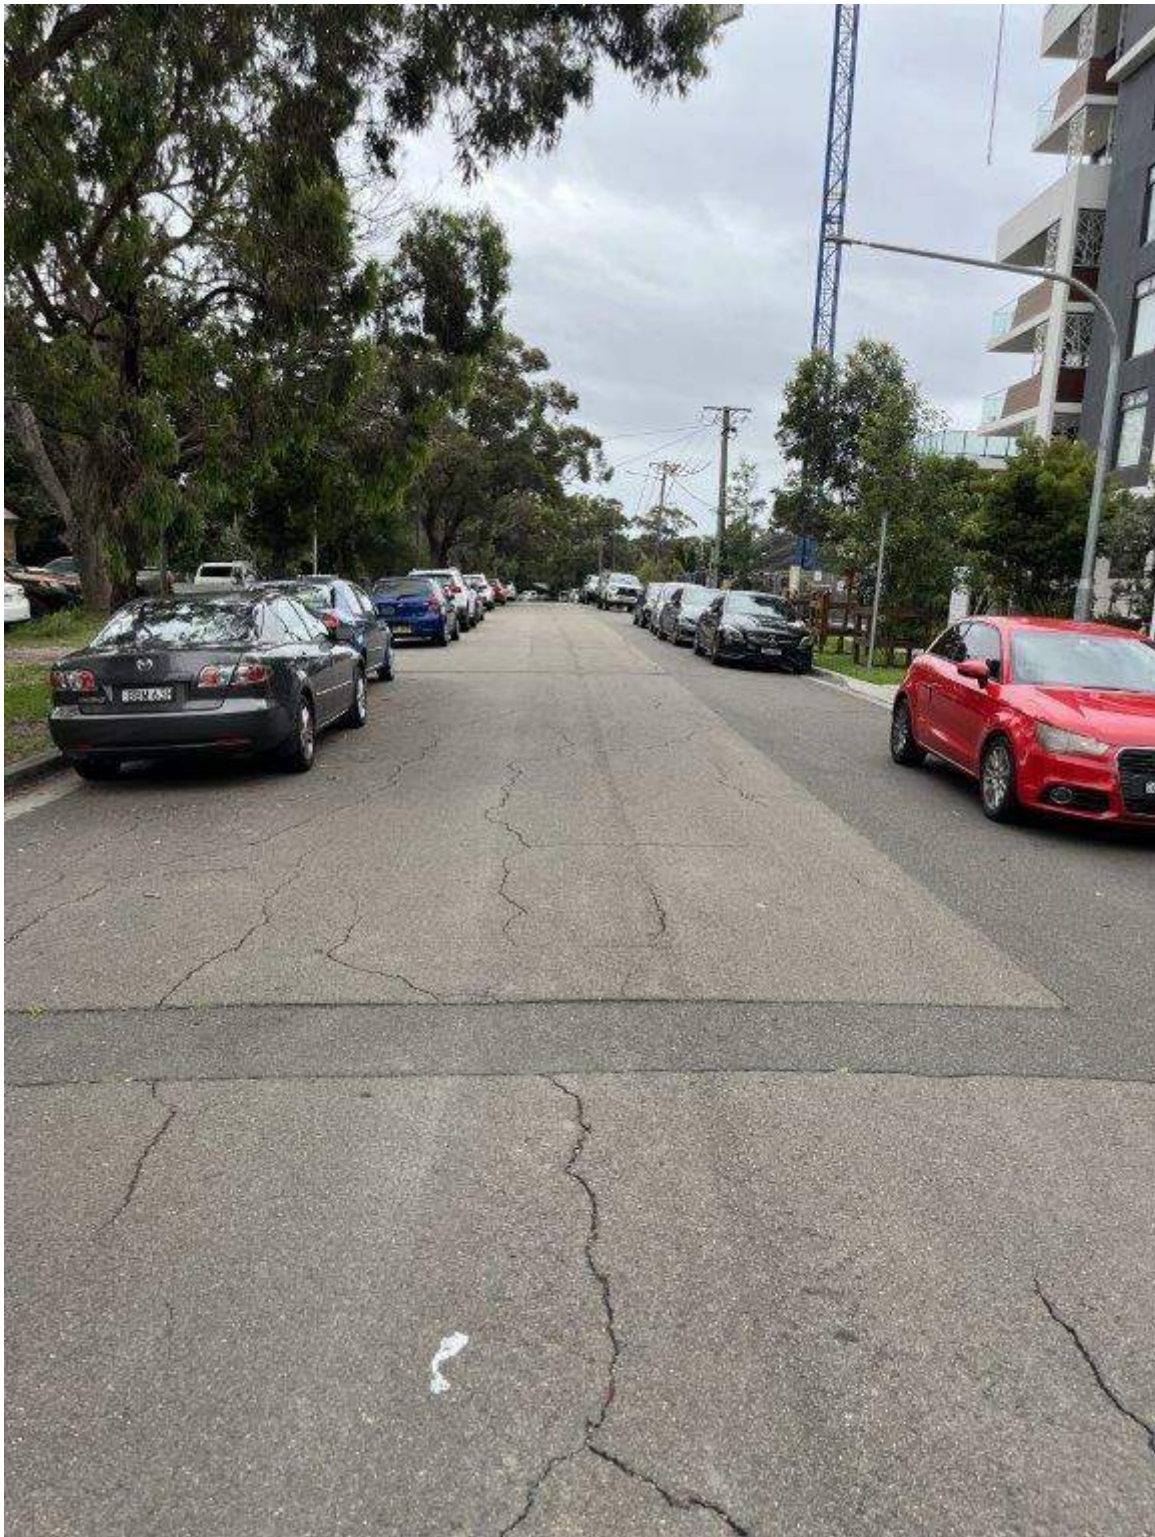
Photo 31 - Hinkler Avenue - Cracking of pavement

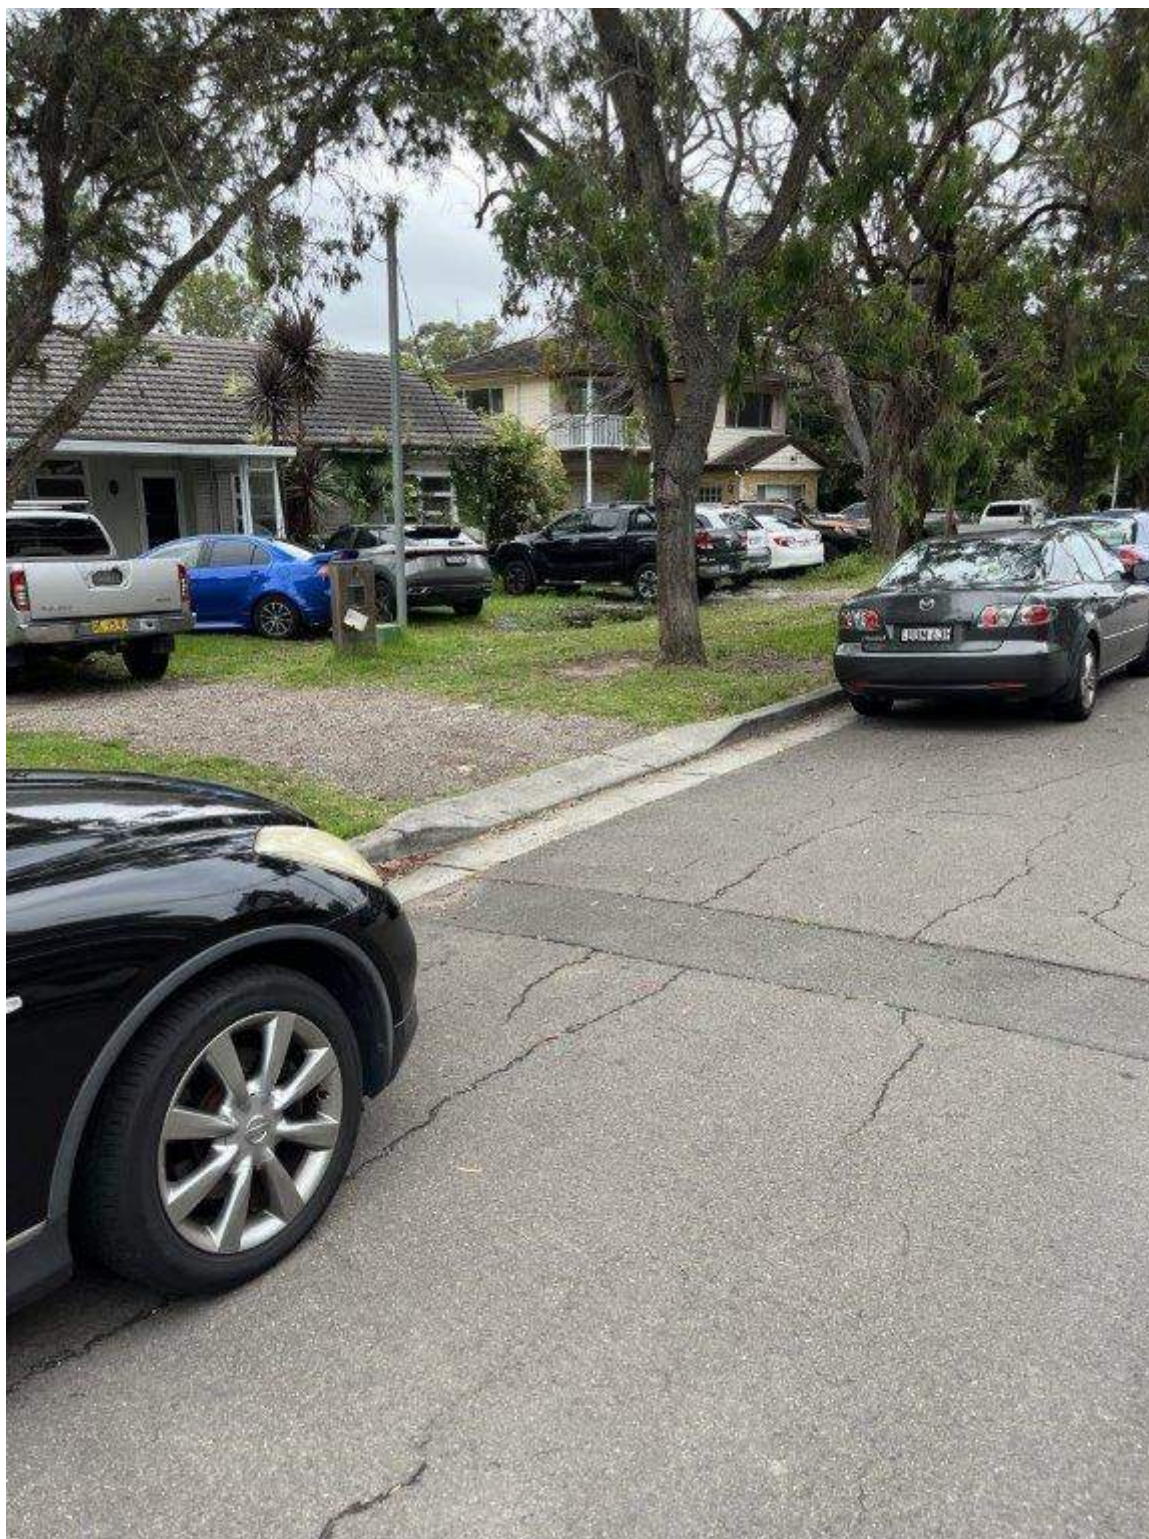
Photo 32 - Hinkler Avenue - Cracking of pavement

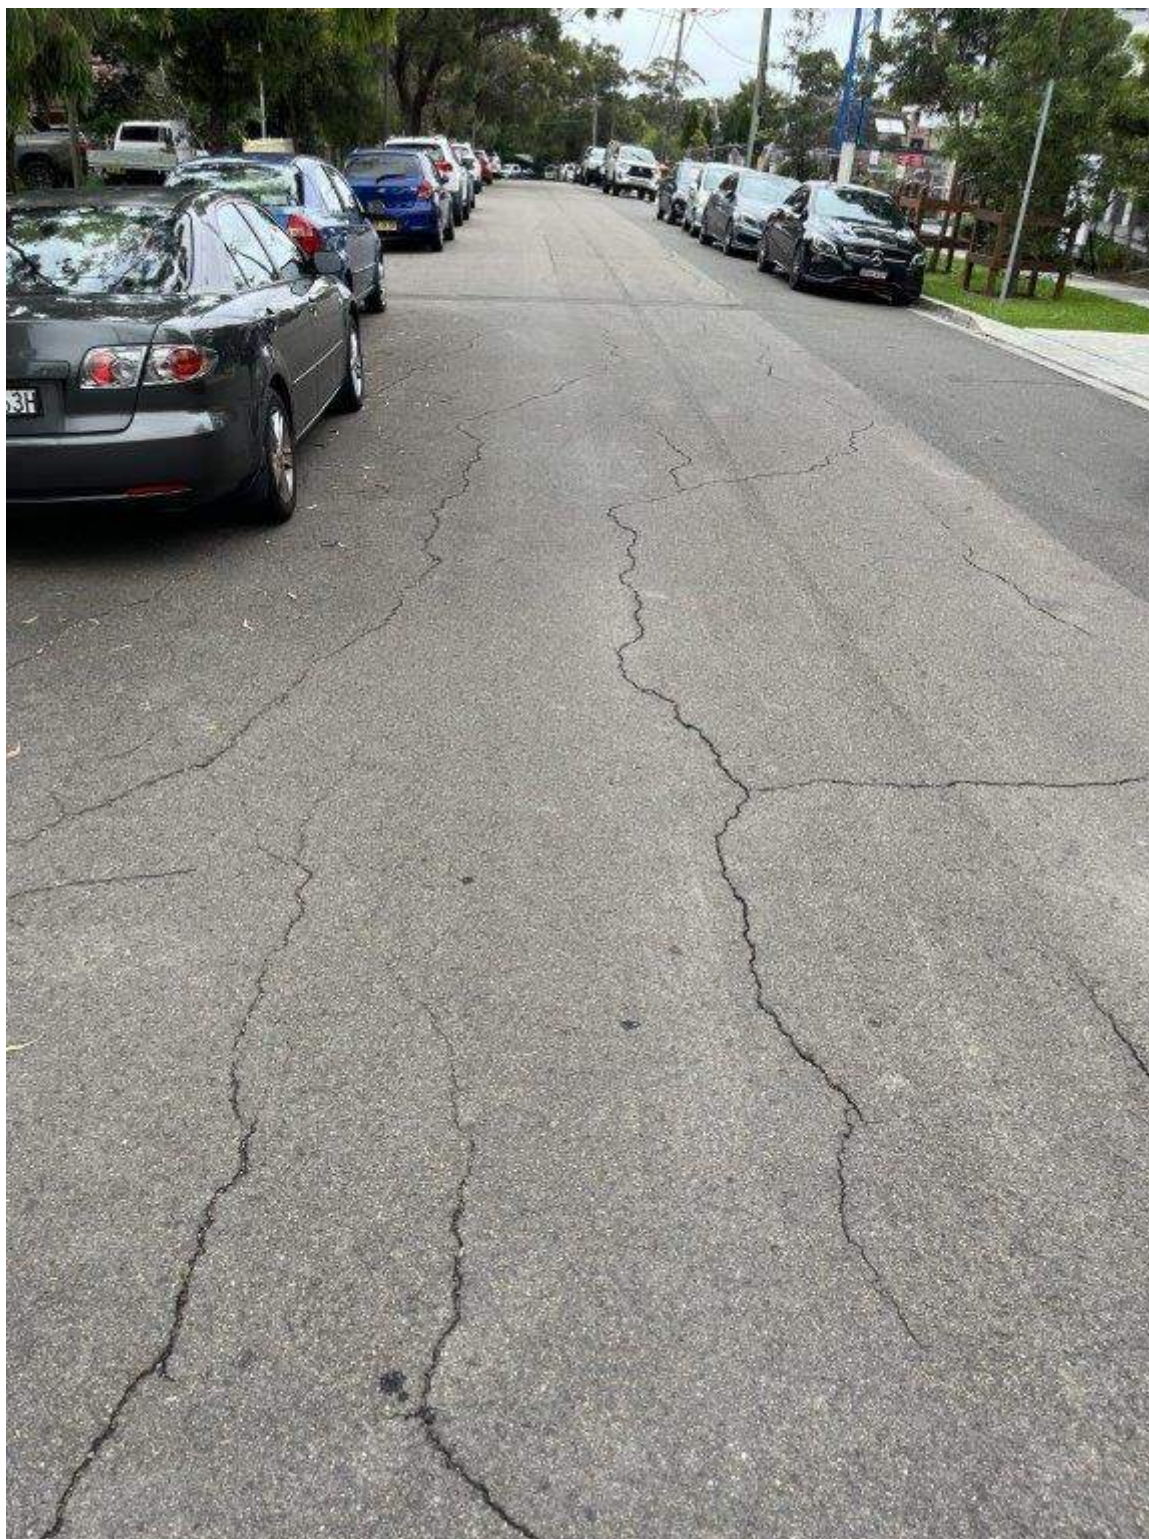
Photo 33 - Hinkler Avenue - Cracking of pavement

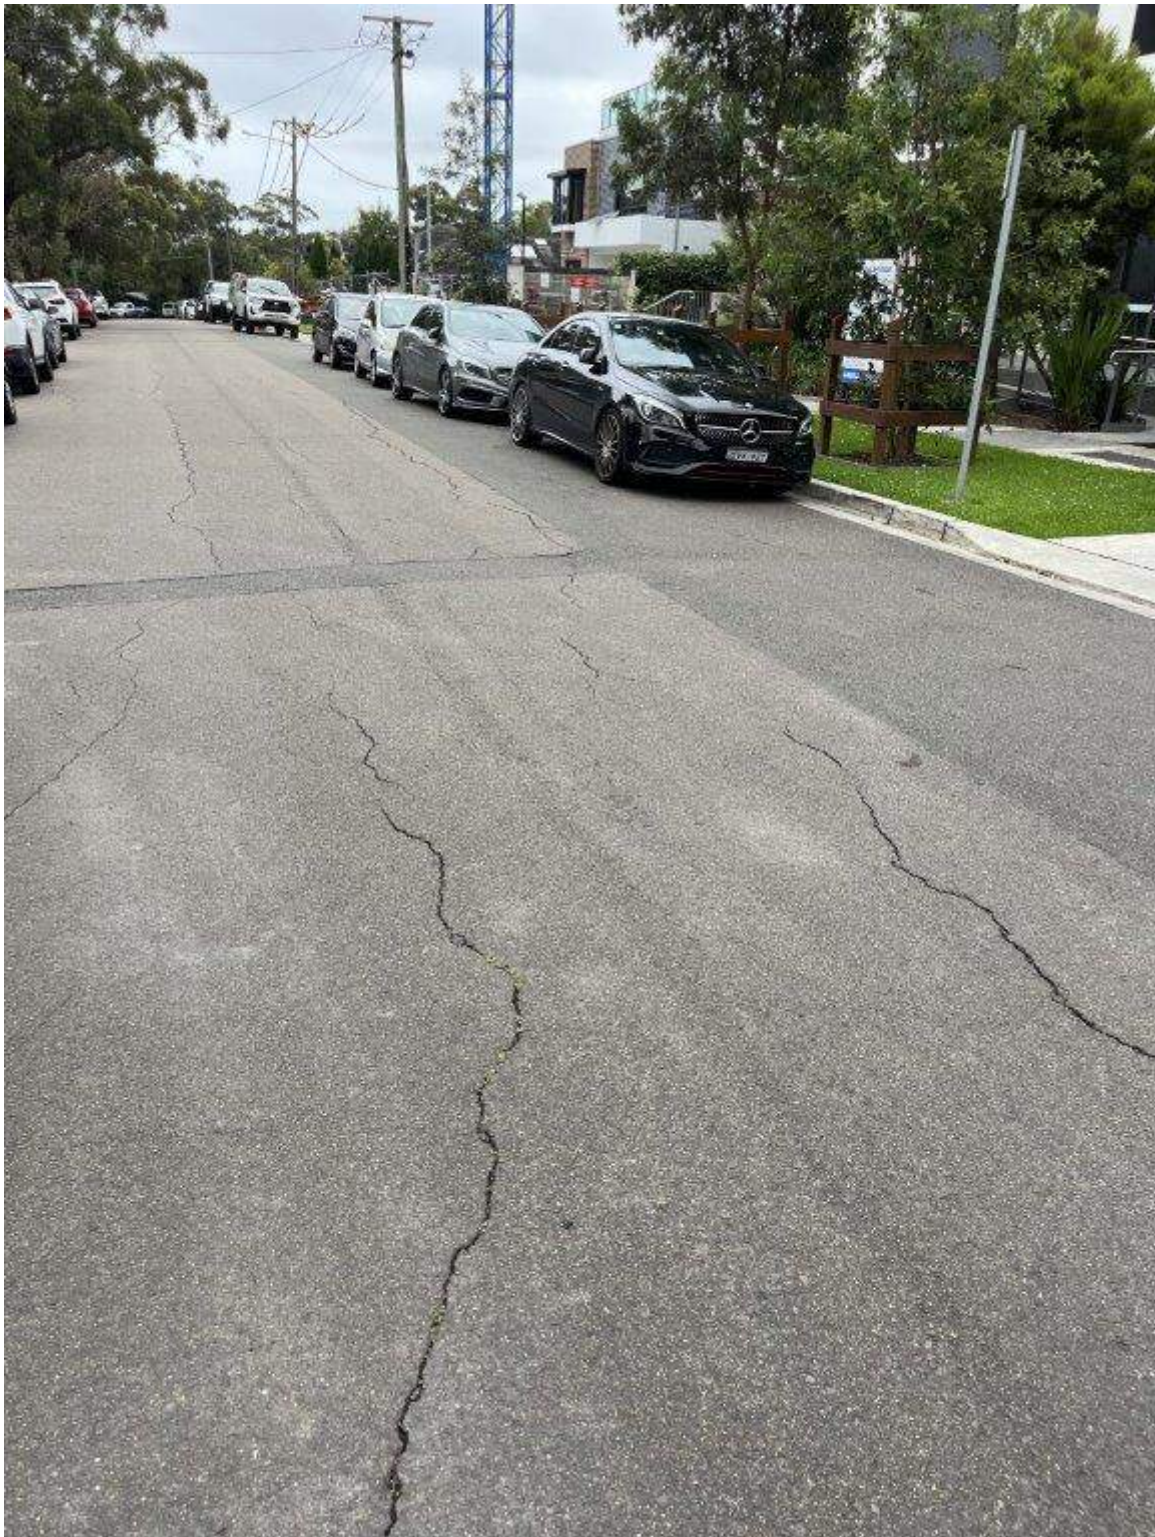
Photo 37 - Hinkler Avenue - Cracking of pavement

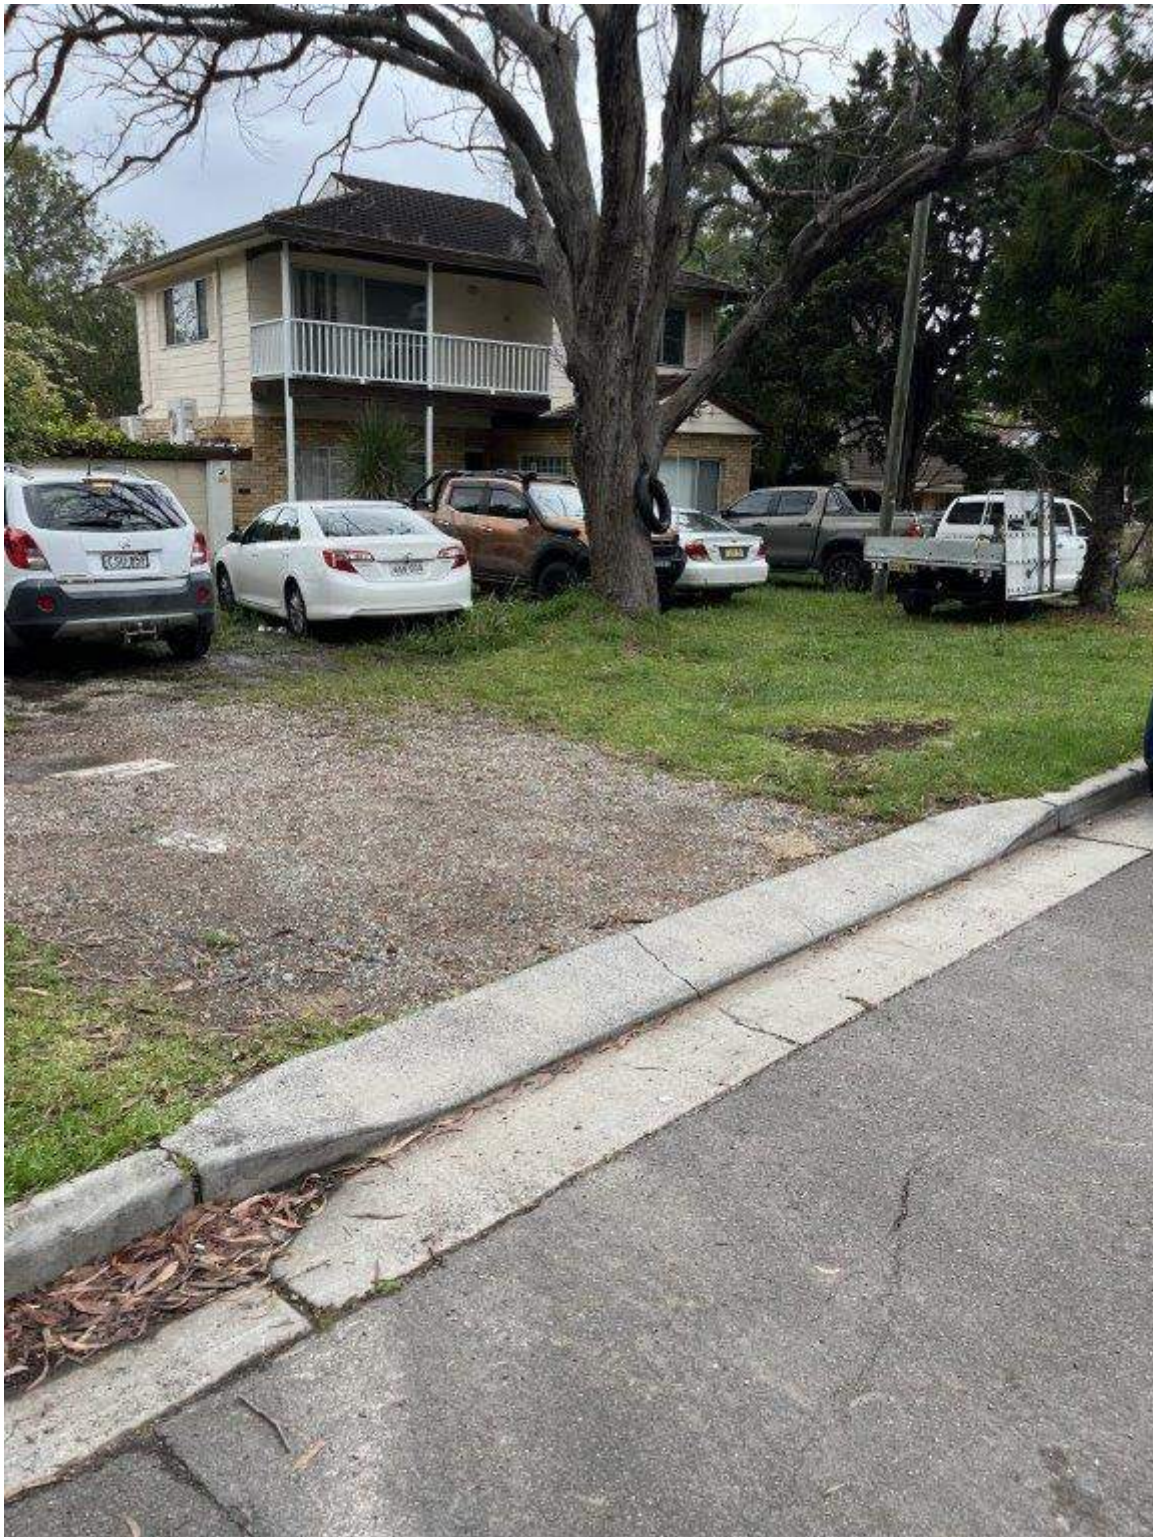
Photo 39 - Hinkler Avenue - Cracking of pavement
