## PRE-CONSTRUCTION DILAPIDATION REPORT

### 6-20 HINKLER AVENUE & 319-333 TAREN POINT ROAD, CARINGBAH

| PRE-CONSTRUCTION DILAPIDATION REPORT<br>6-20 Hinkler Avenue & 319-333 Taren Point Road,<br>Caringbah NSW 2229 | | | | | Project Number: 21039 |

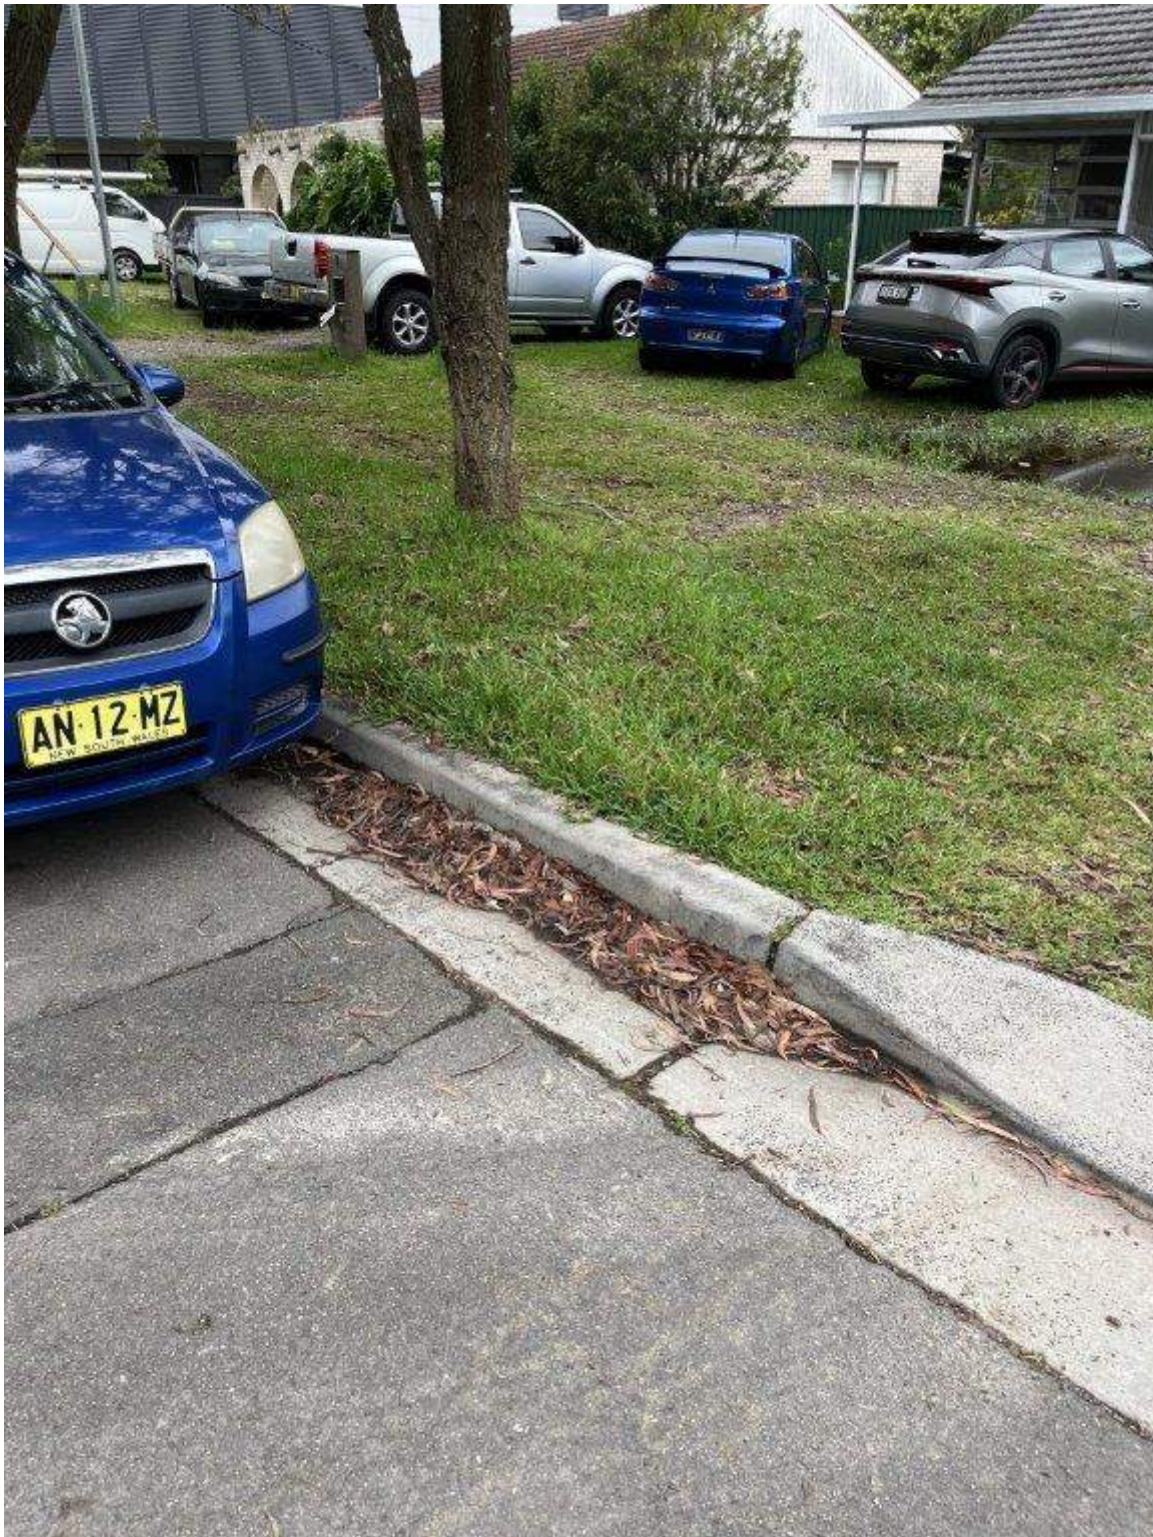
Photo 40 - Hinkler Avenue - Existing condition of pavement and vegetation

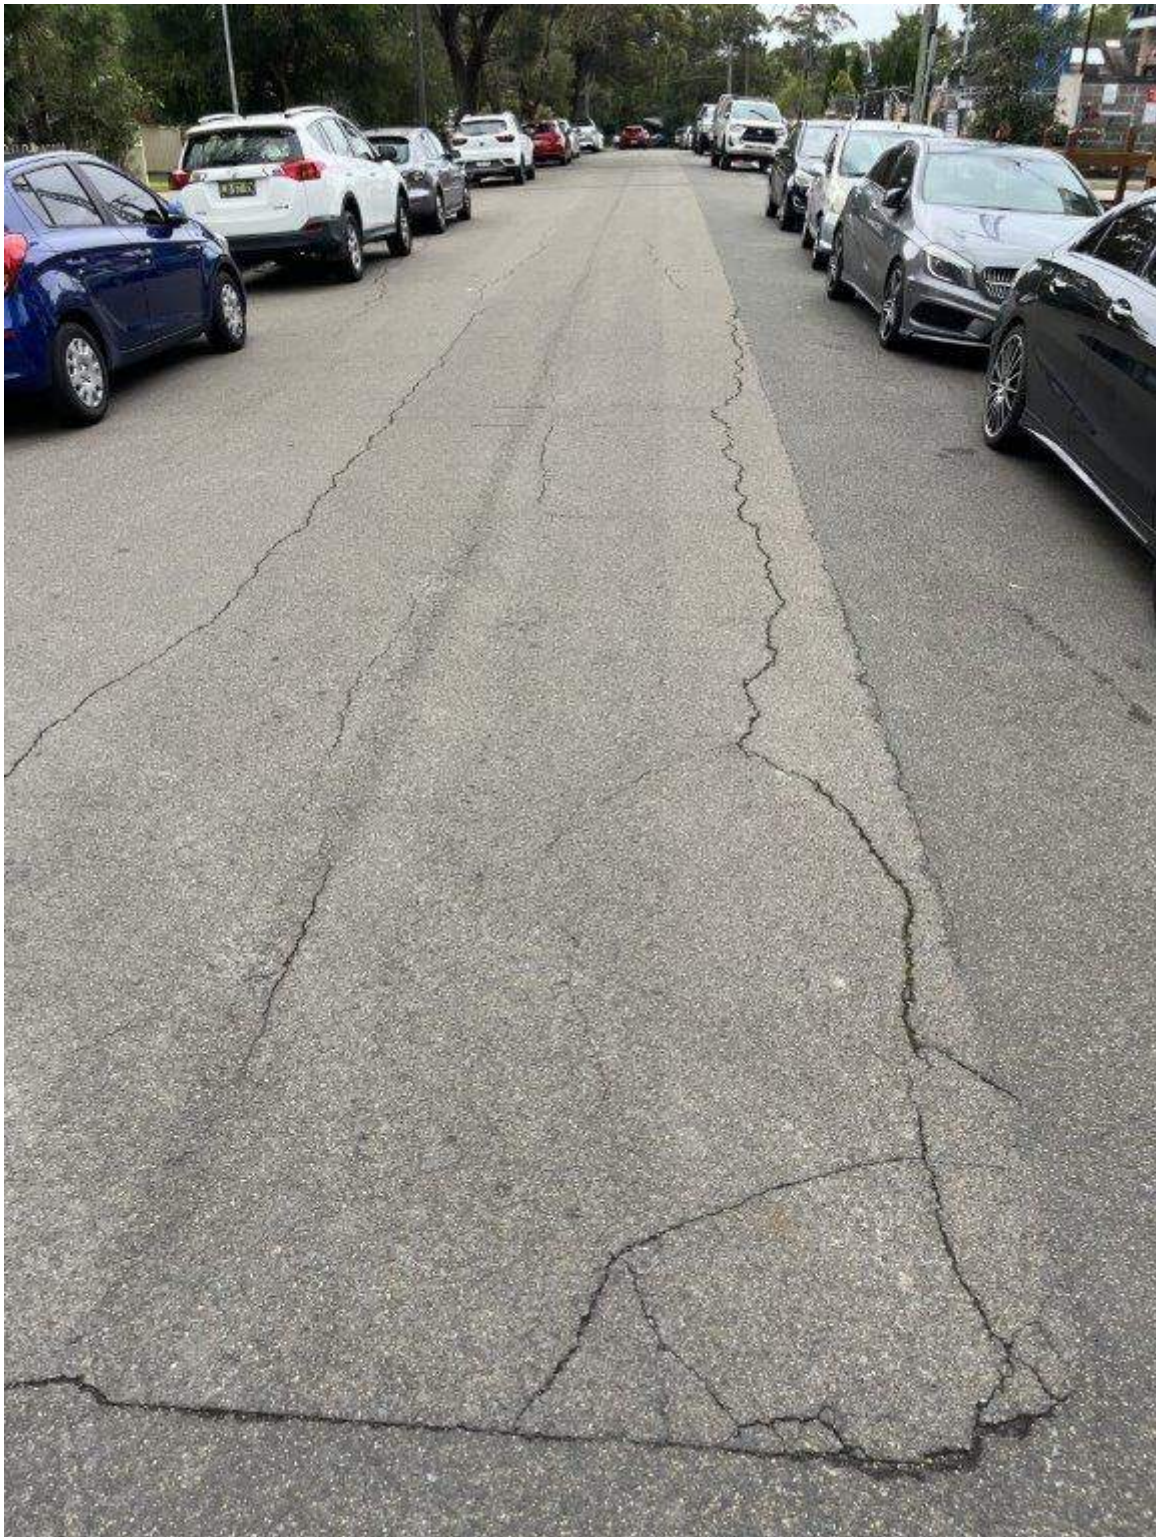
Photo 41 - Hinkler Avenue - Cracking of pavement

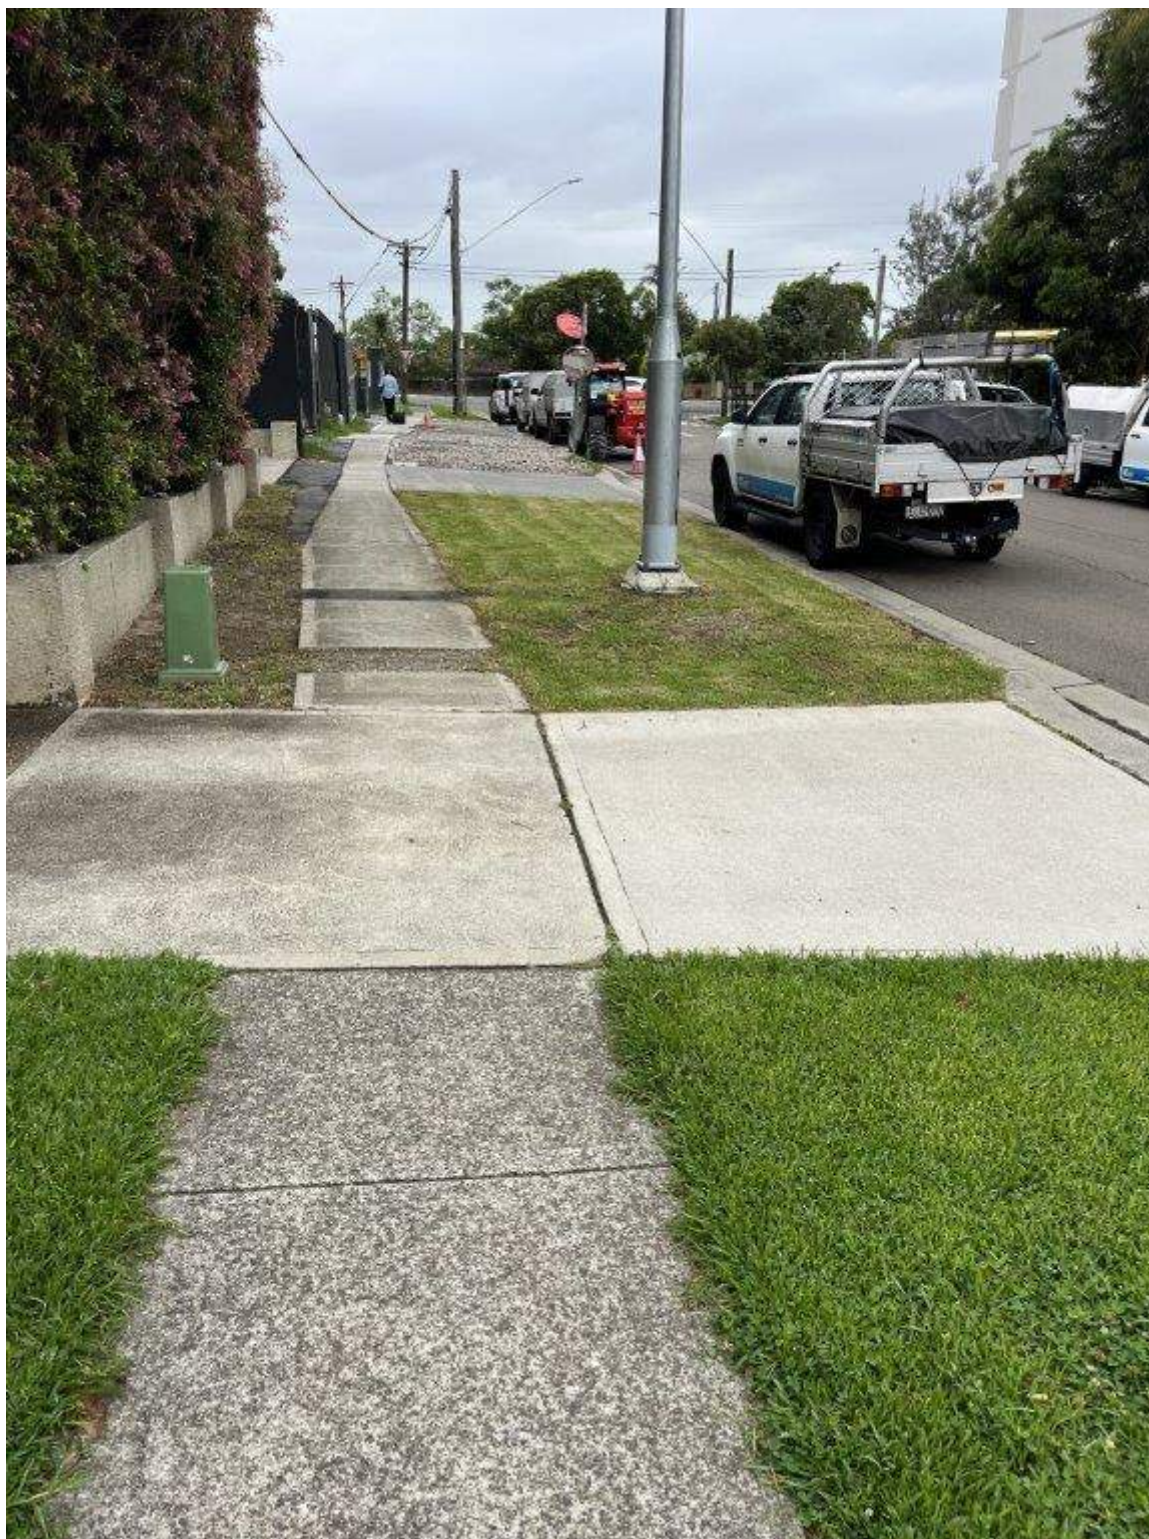
Photo 42 - Hinkler Avenue - Existing condition of pavement and vegetation

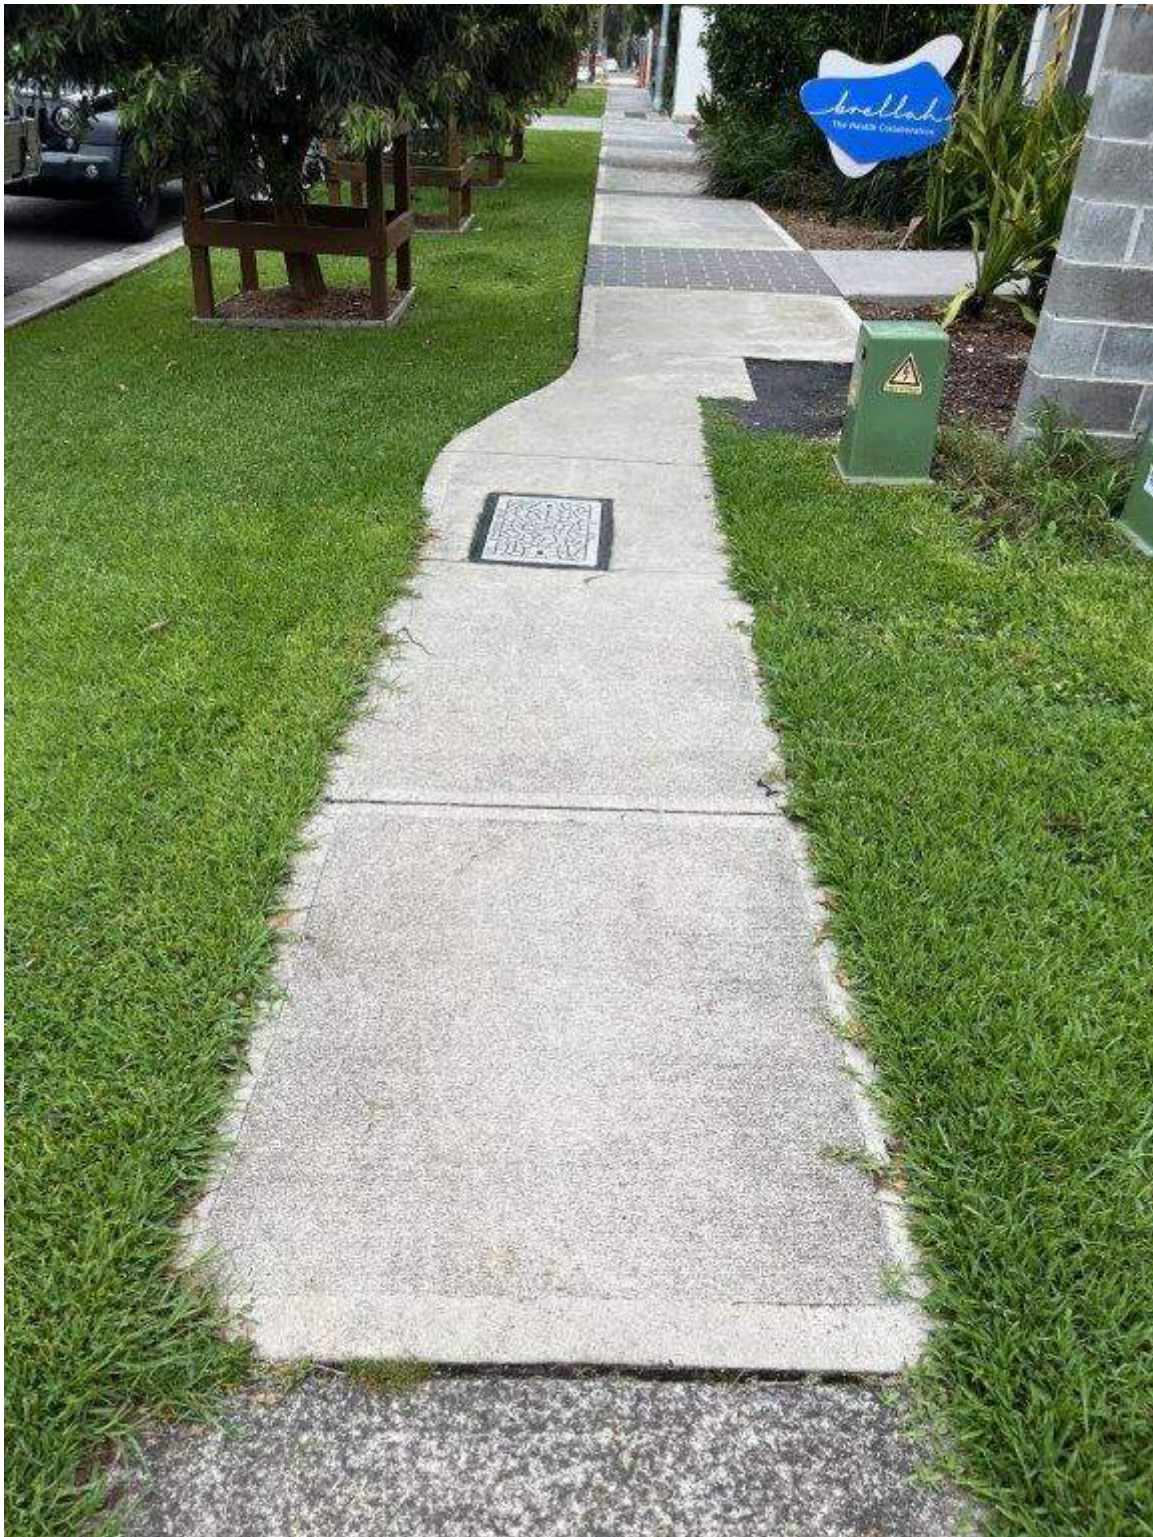
Photo 45 - Hinkler Avenue - Existing condition of pavement and vegetation

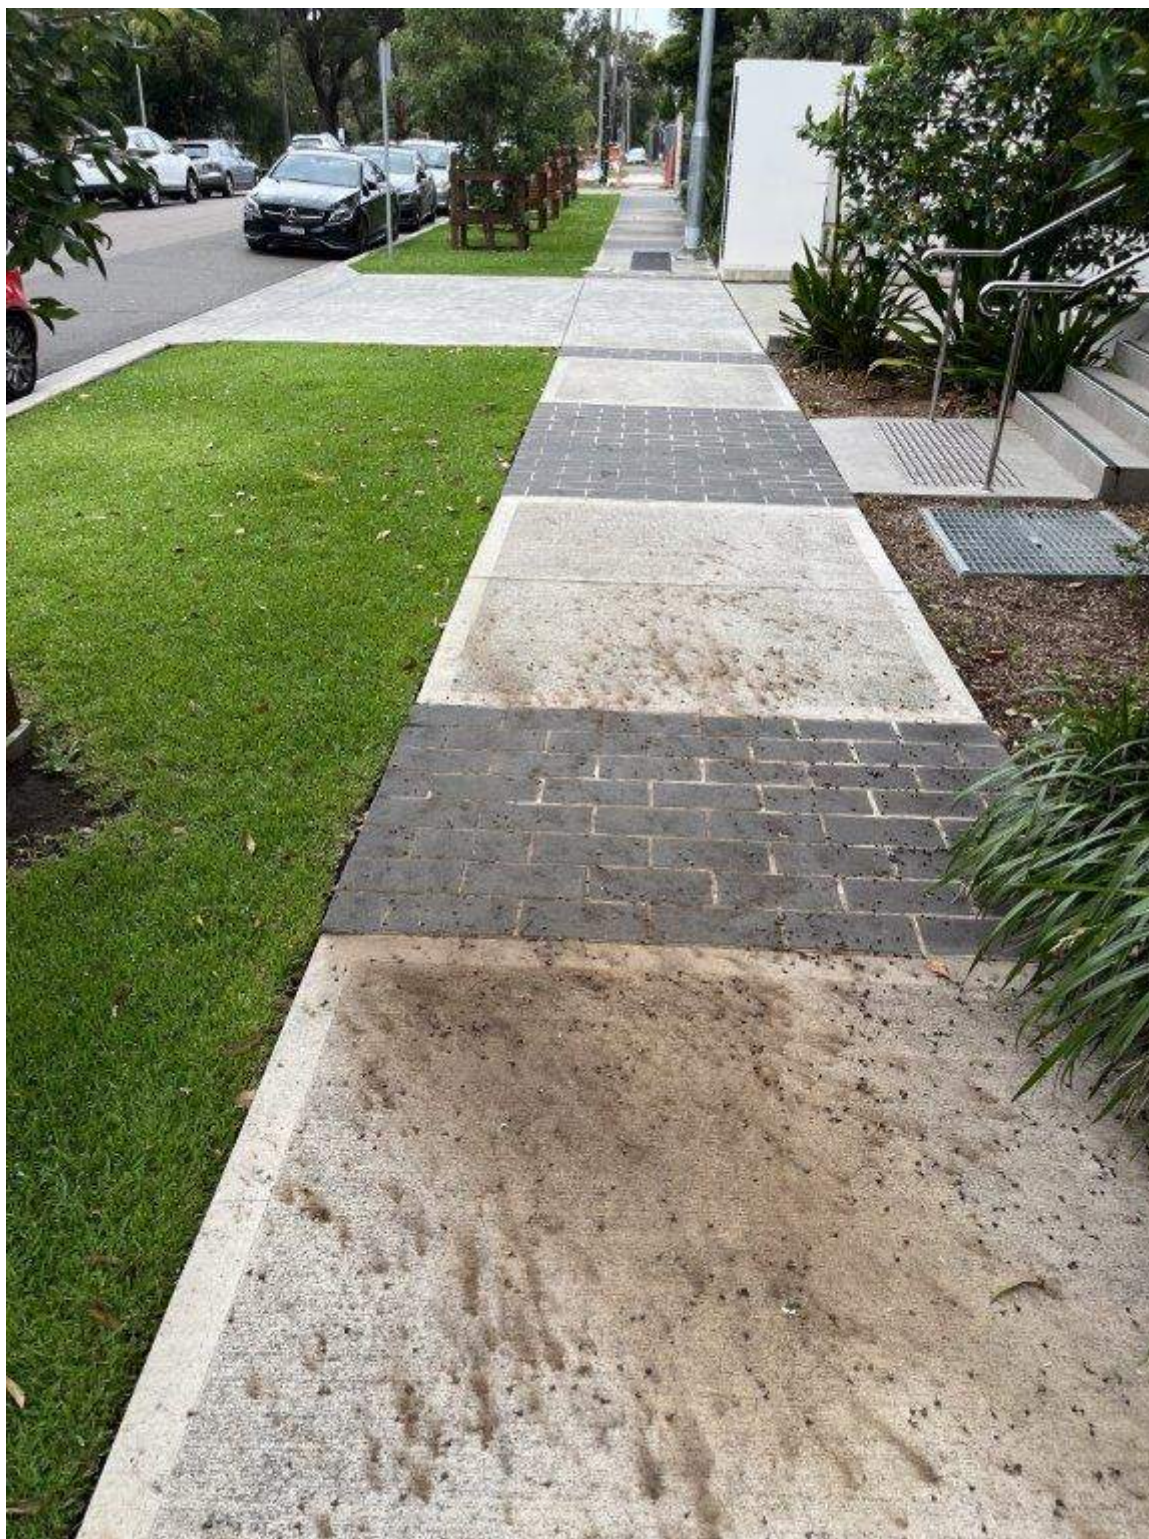
Photo 47 - Hinkler Avenue - Existing condition of pavement and vegetation

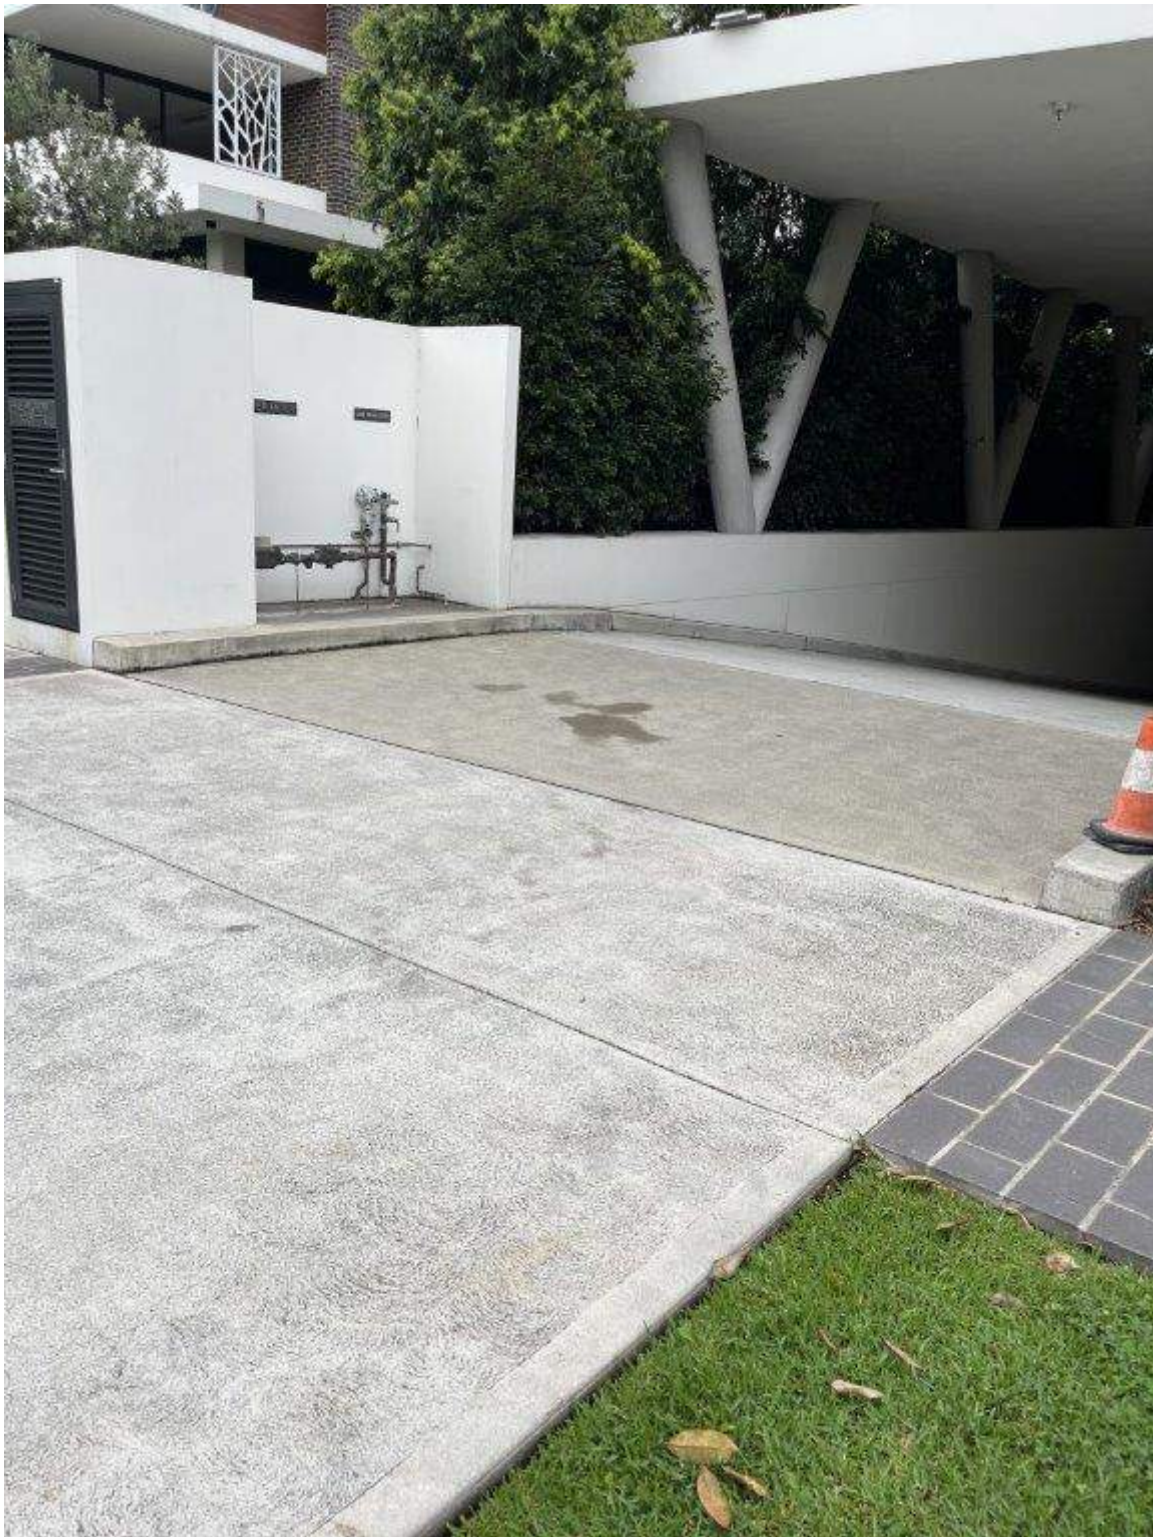
Photo 48 - Hinkler Avenue - Existing condition of pavement

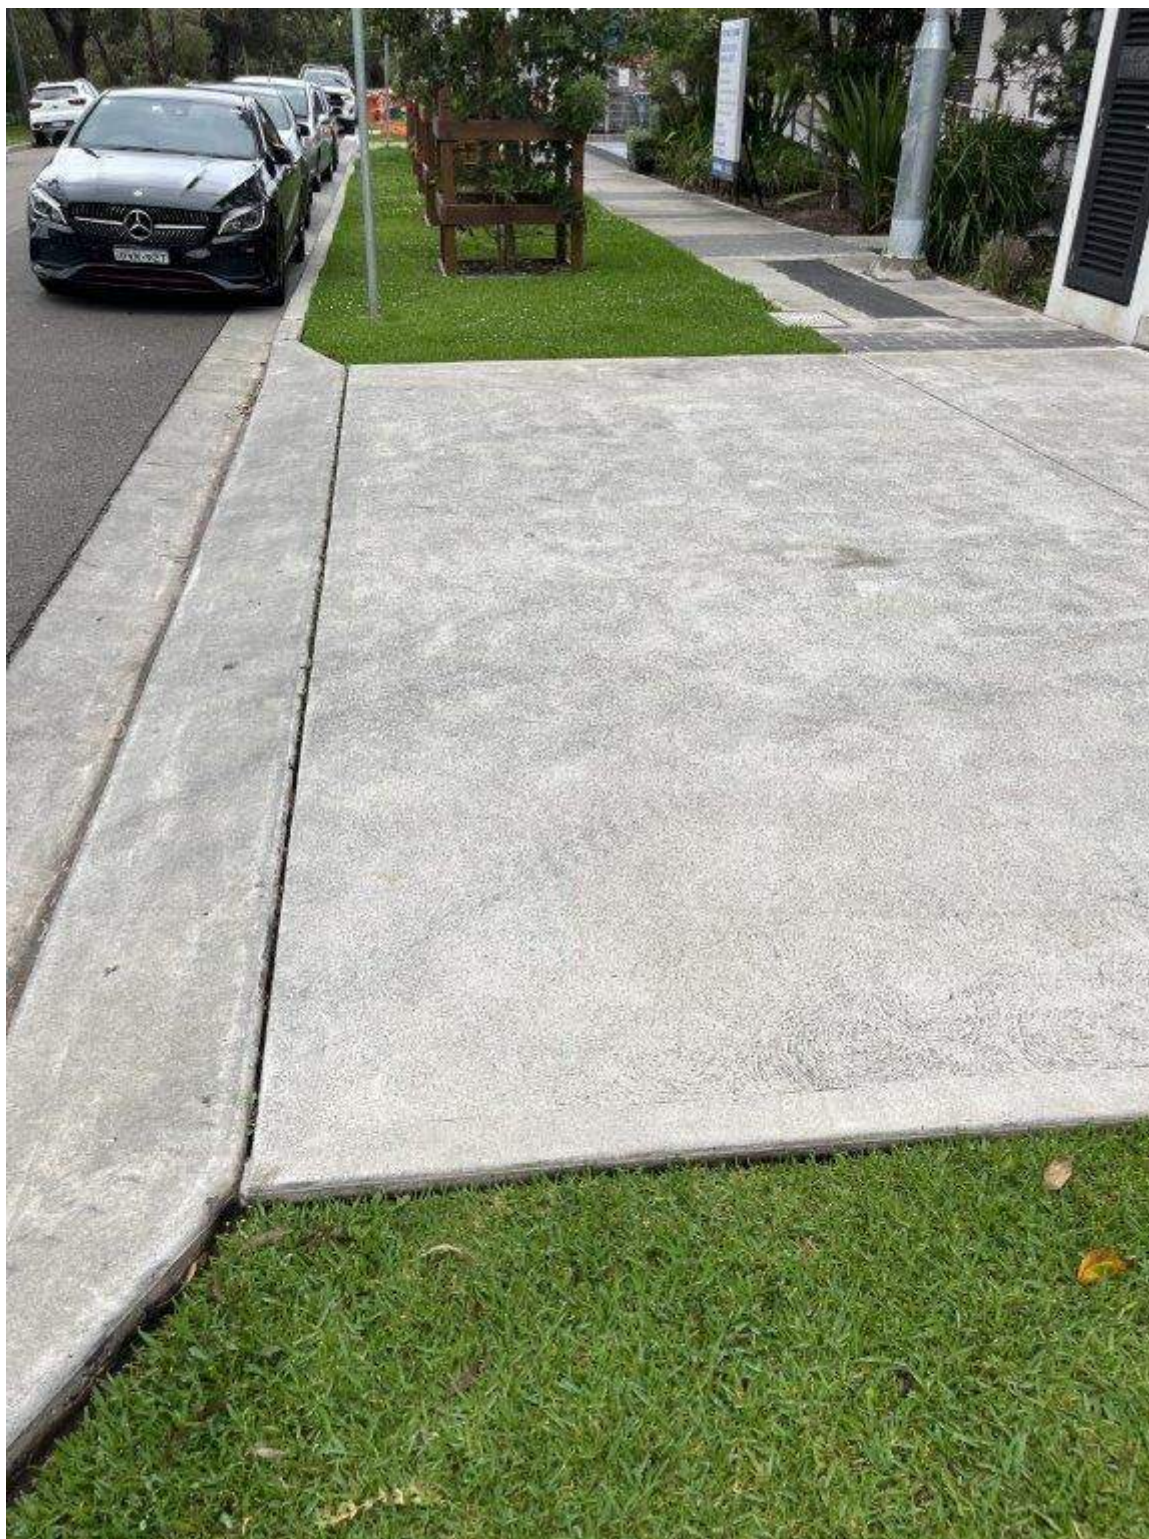
Photo 49 - Hinkler Avenue - Existing condition of pavement

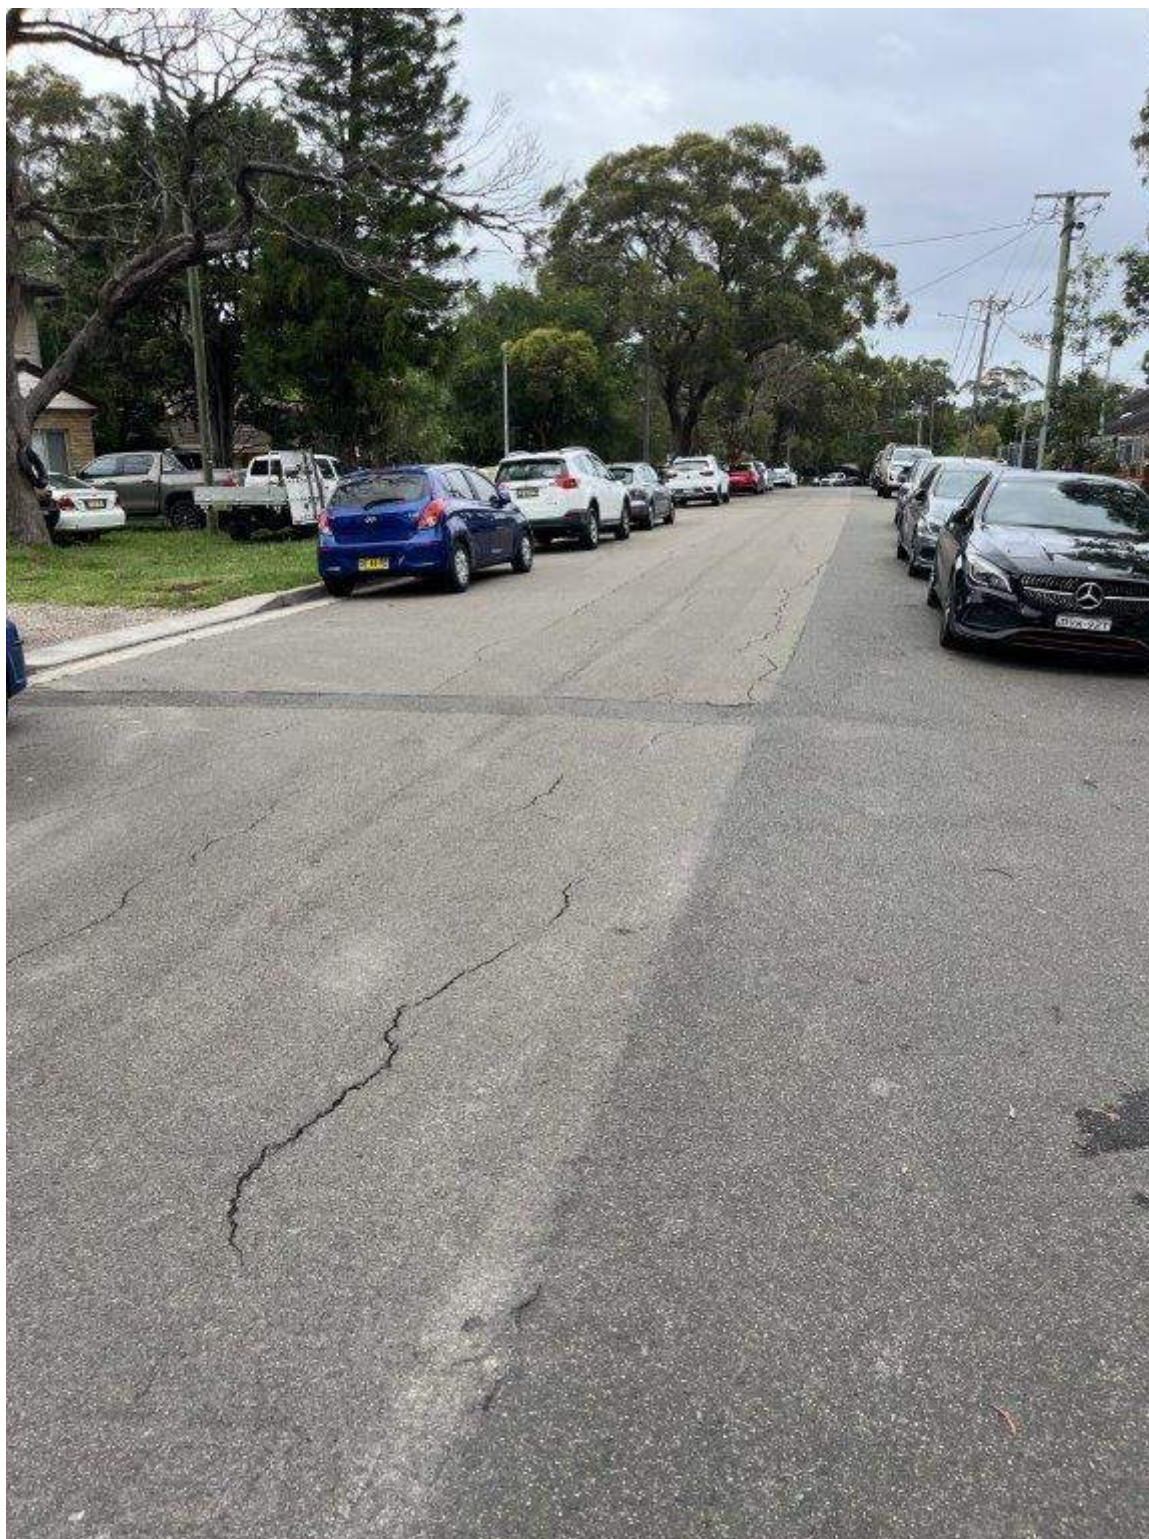
Photo 50 - Hinkler Avenue - Cracking of pavement

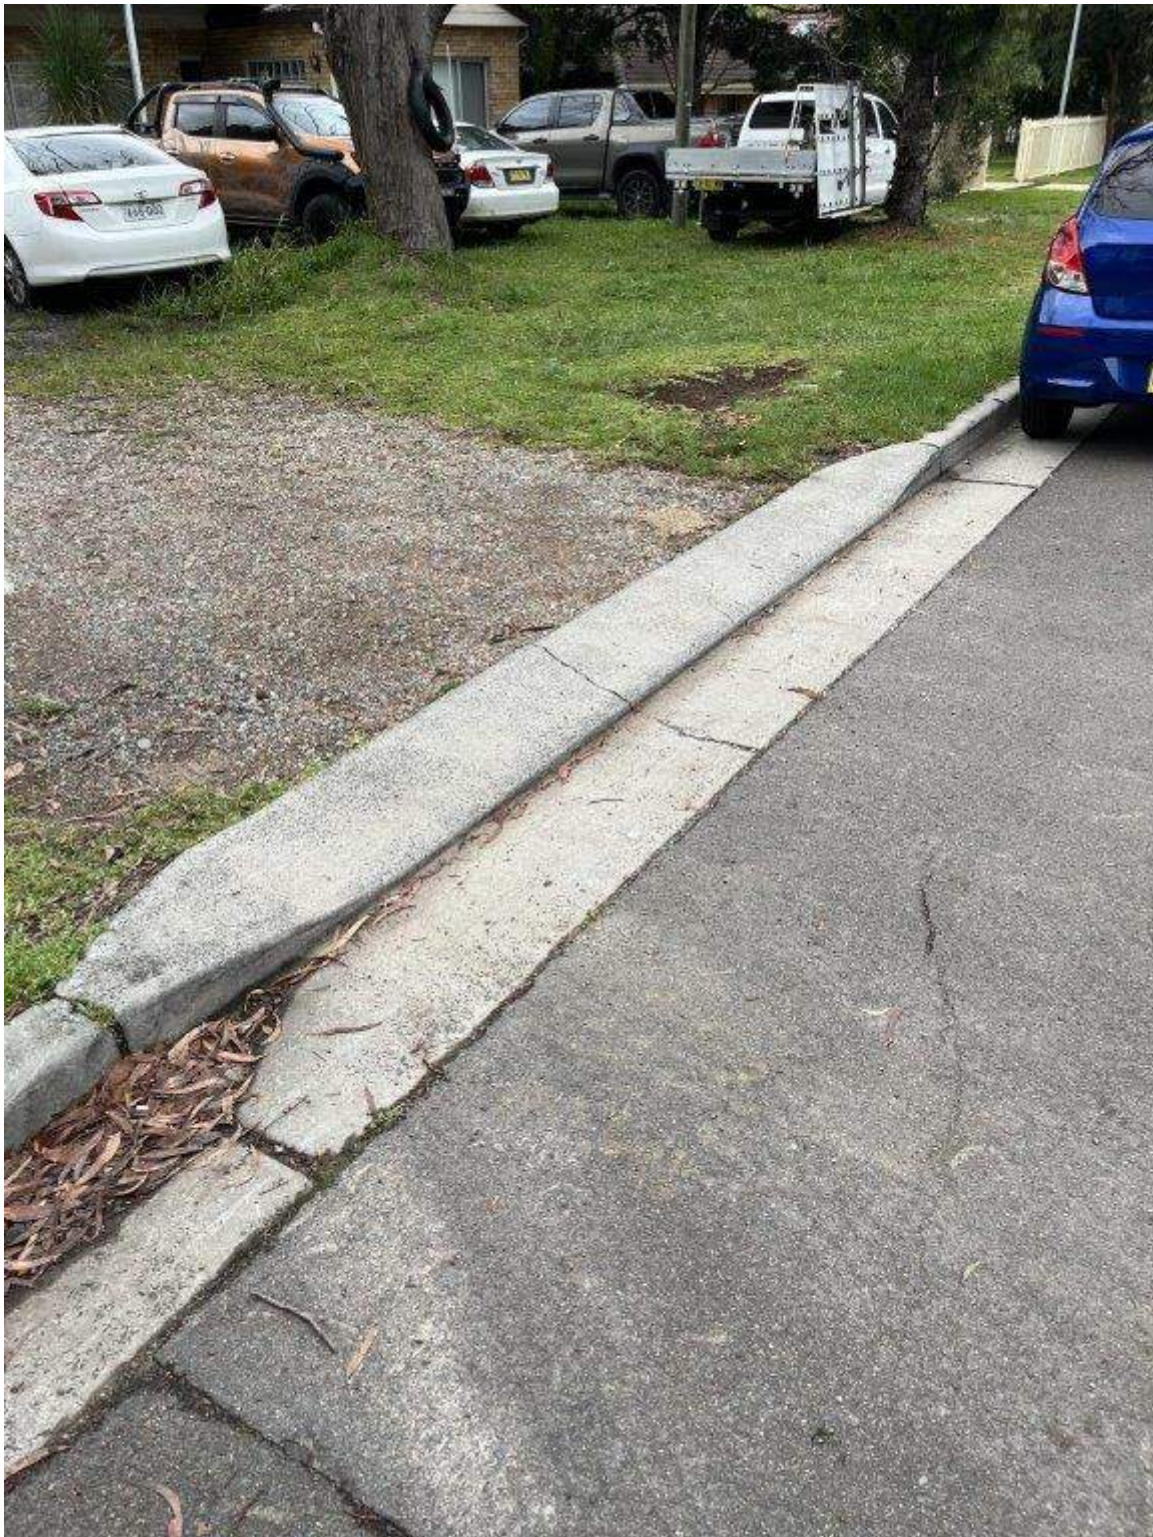
Photo 51 - Hinkler Avenue - Cracking of pavement

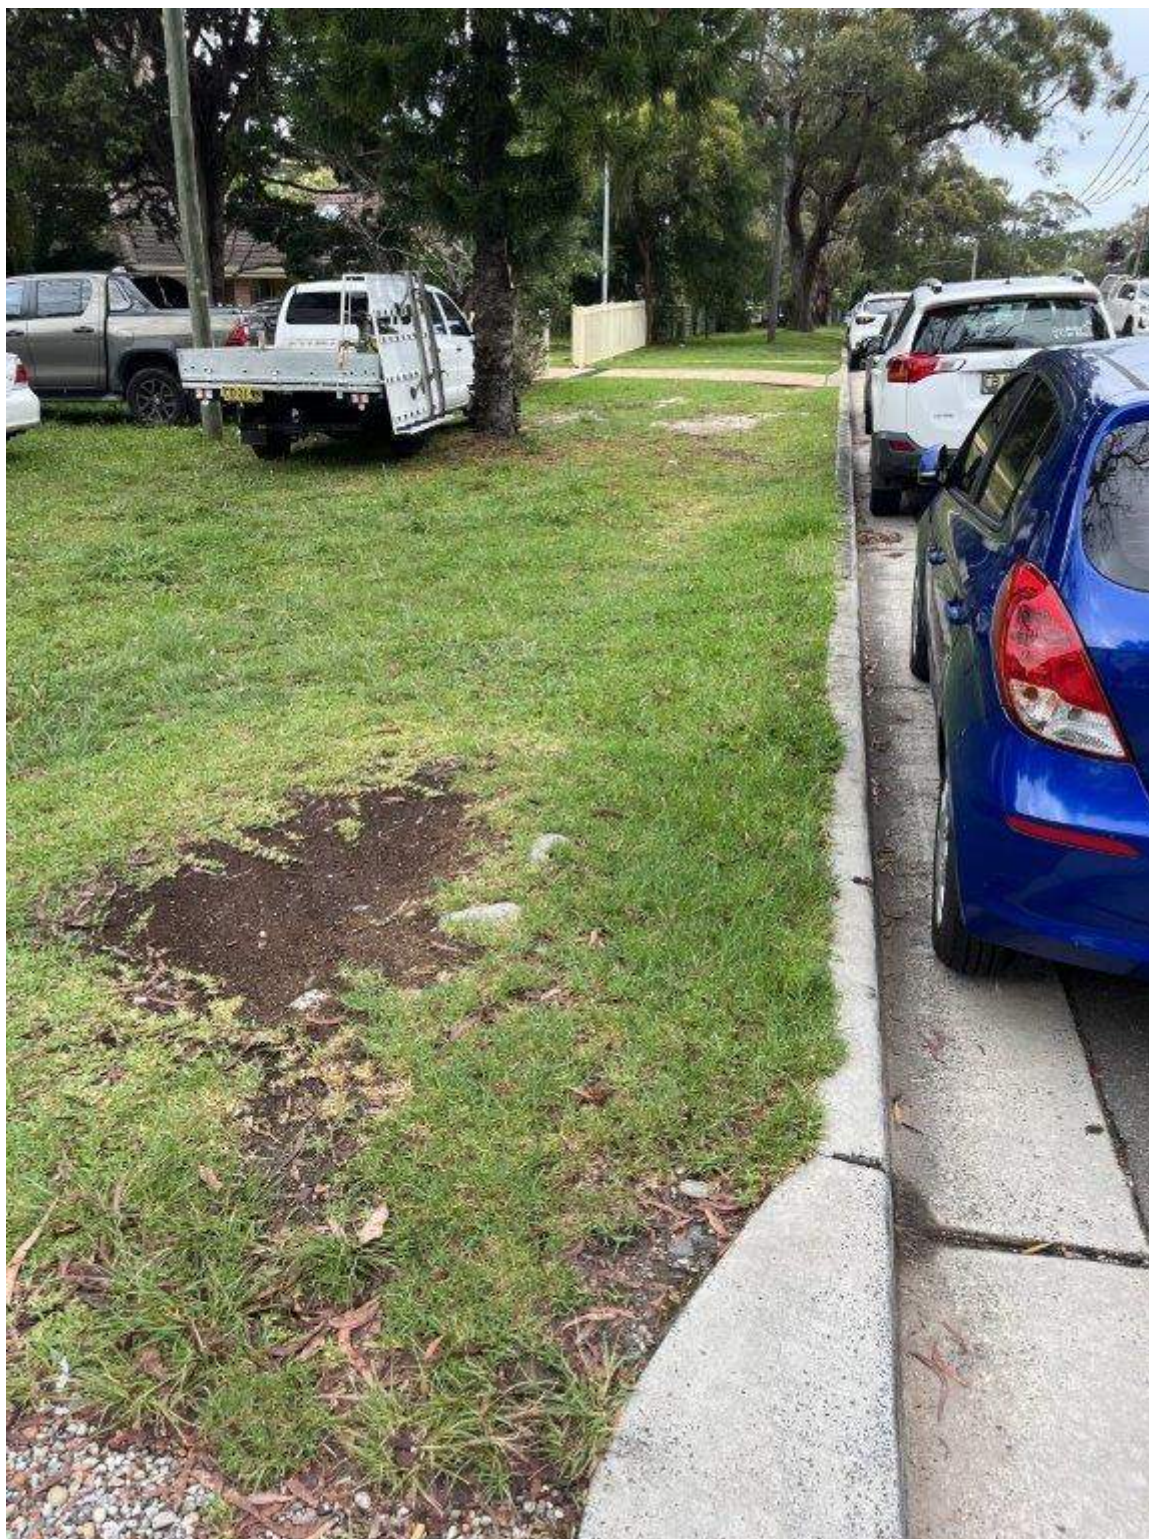
Photo 52 - Hinkler Avenue - Cracking of pavement

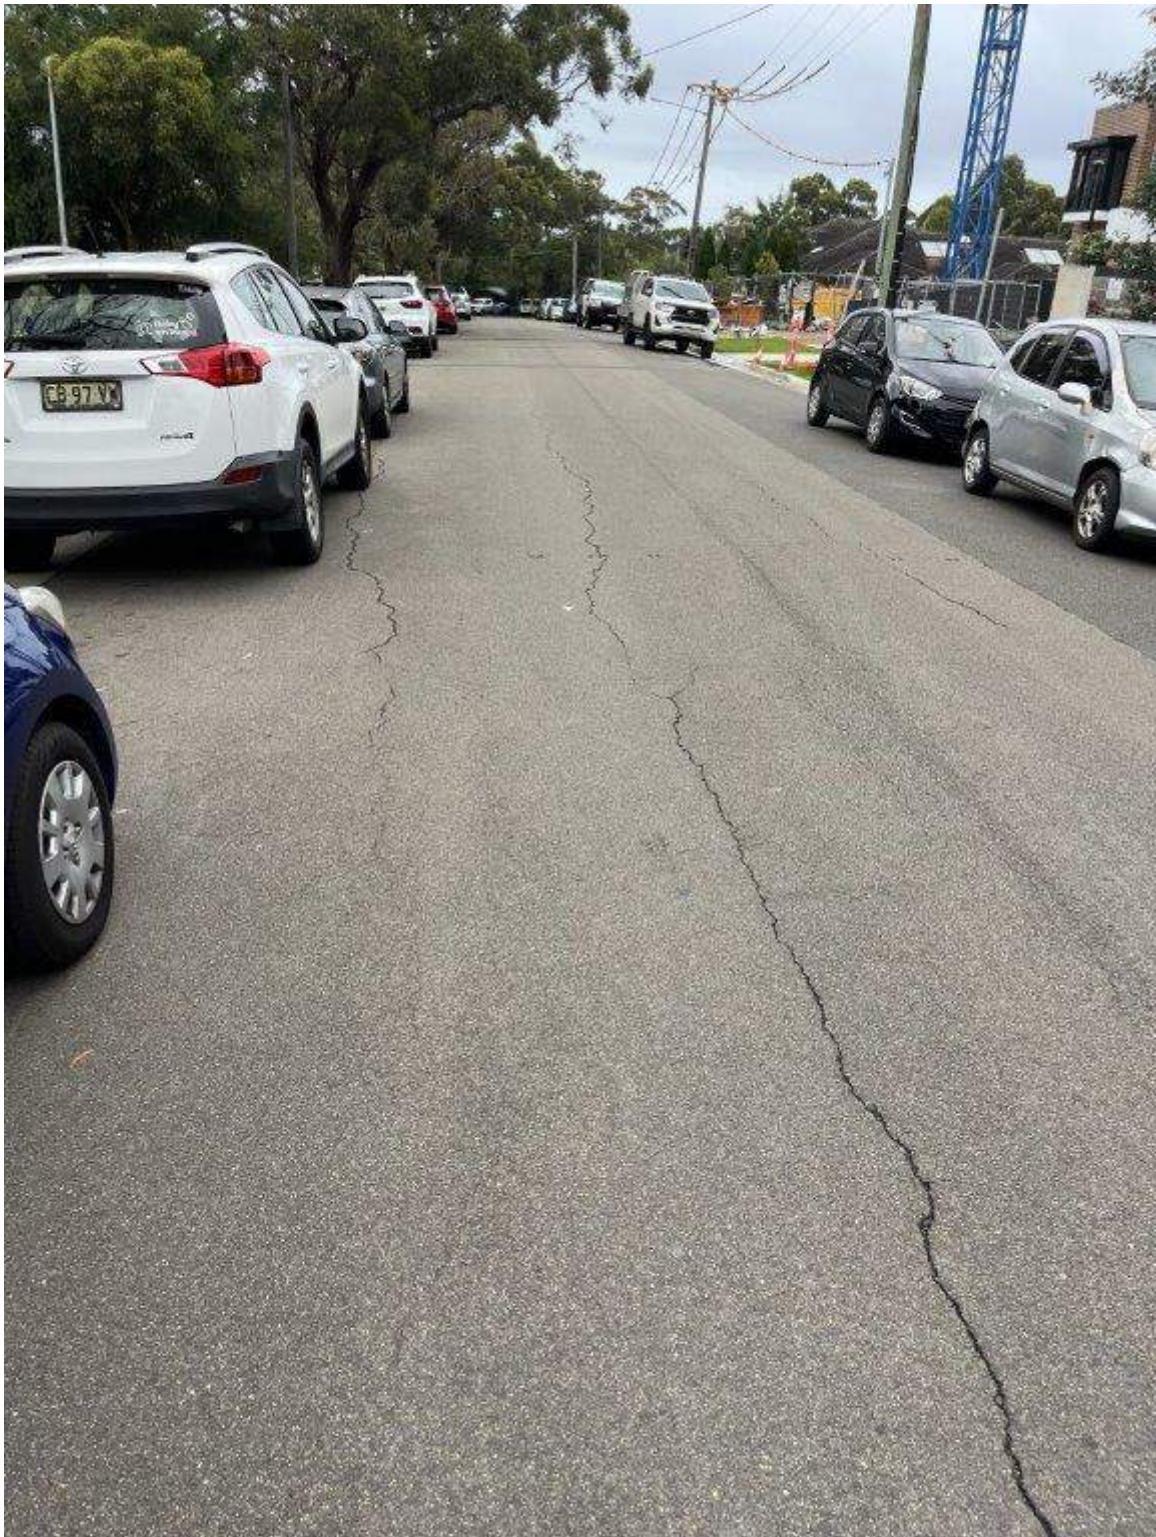
Photo 53 - Hinkler Avenue - Existing condition of pavement and vegetation

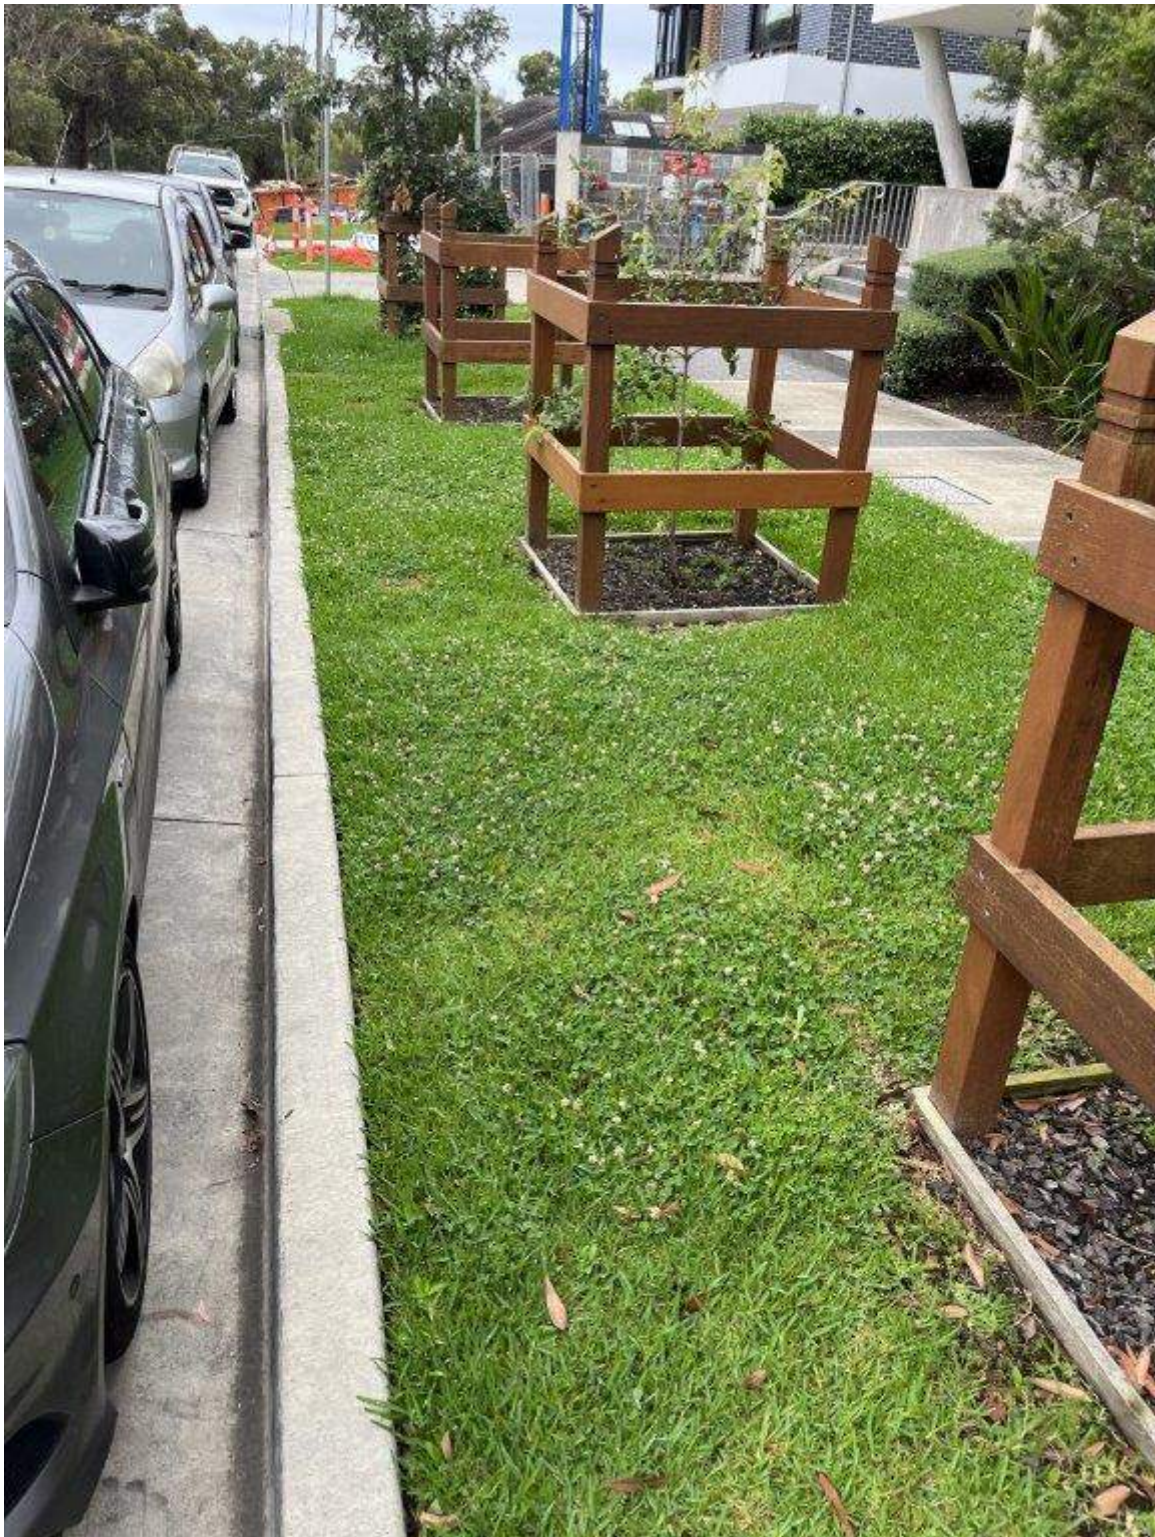
Photo 54 - Hinkler Avenue - Cracking of pavement

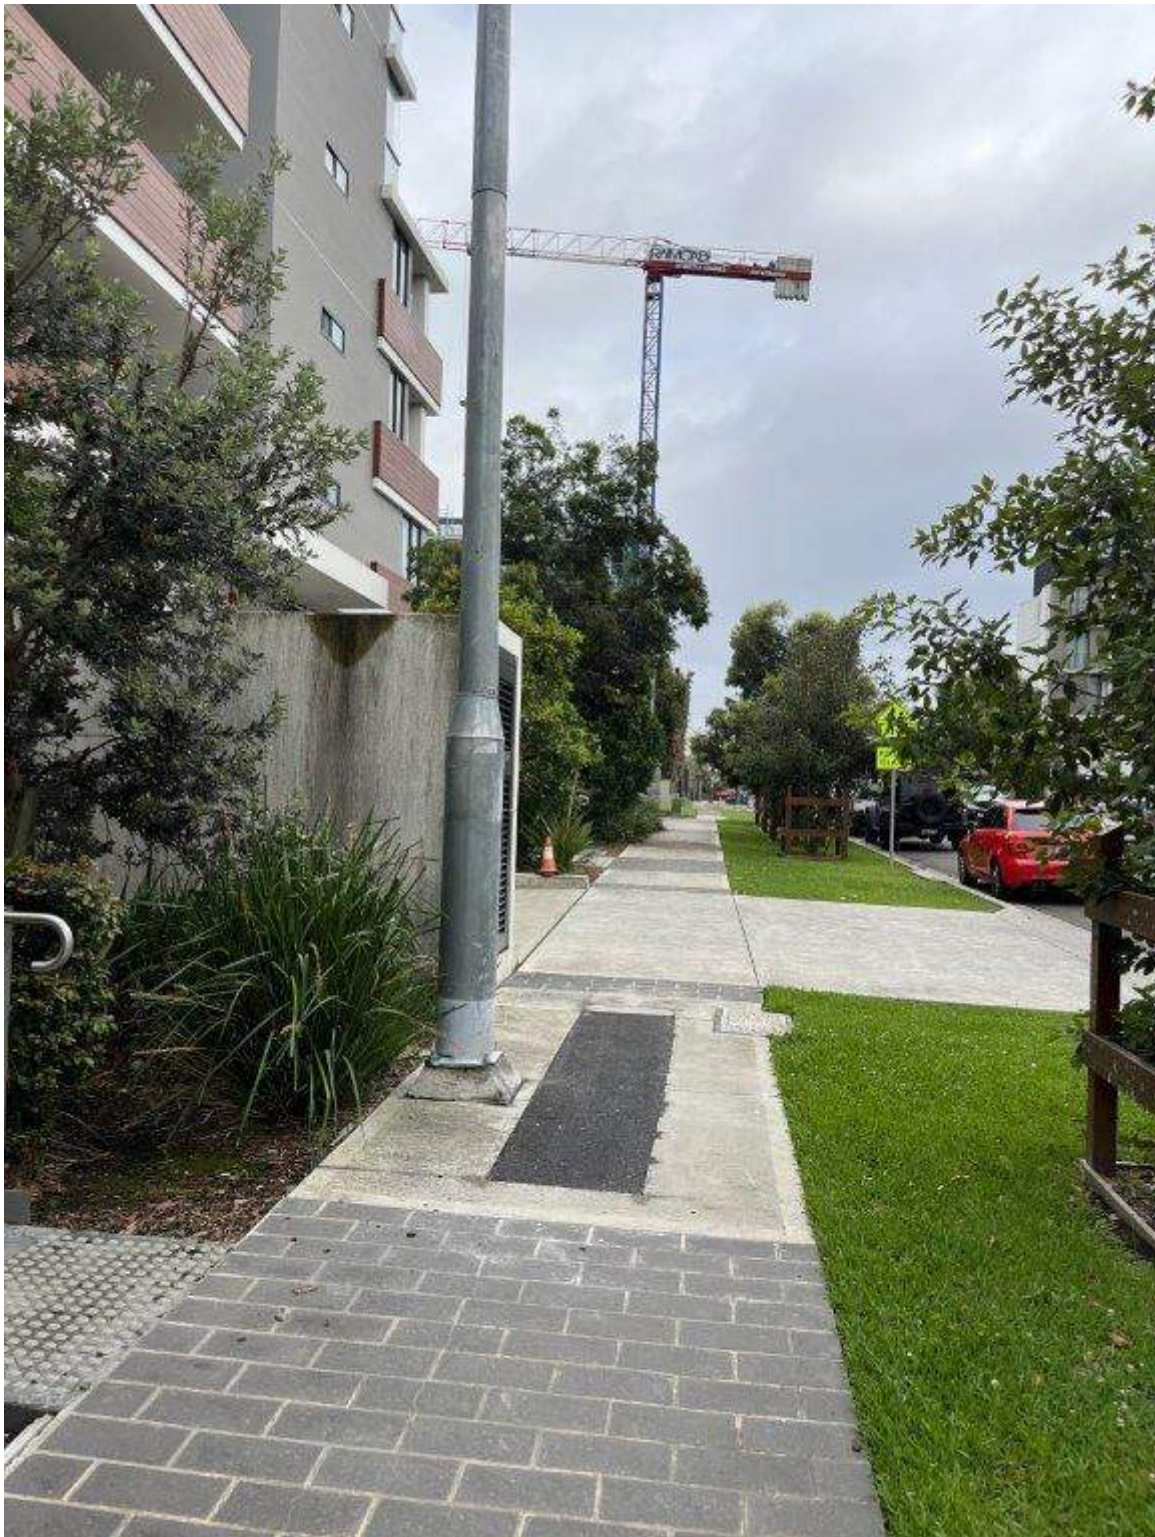
Photo 55 - Hinkler Avenue - Existing condition of pavement and vegetation
