## PRE-CONSTRUCTION DILAPIDATION REPORT

### 6-20 HINKLER AVENUE & 319-333 TAREN POINT ROAD, CARINGBAH

| PRE-CONSTRUCTION DILAPIDATION REPORT<br>6-20 Hinkler Avenue & 319-333 Taren Point Road,<br>Caringbah NSW 2229 | | | | | Project Number: 21039 |

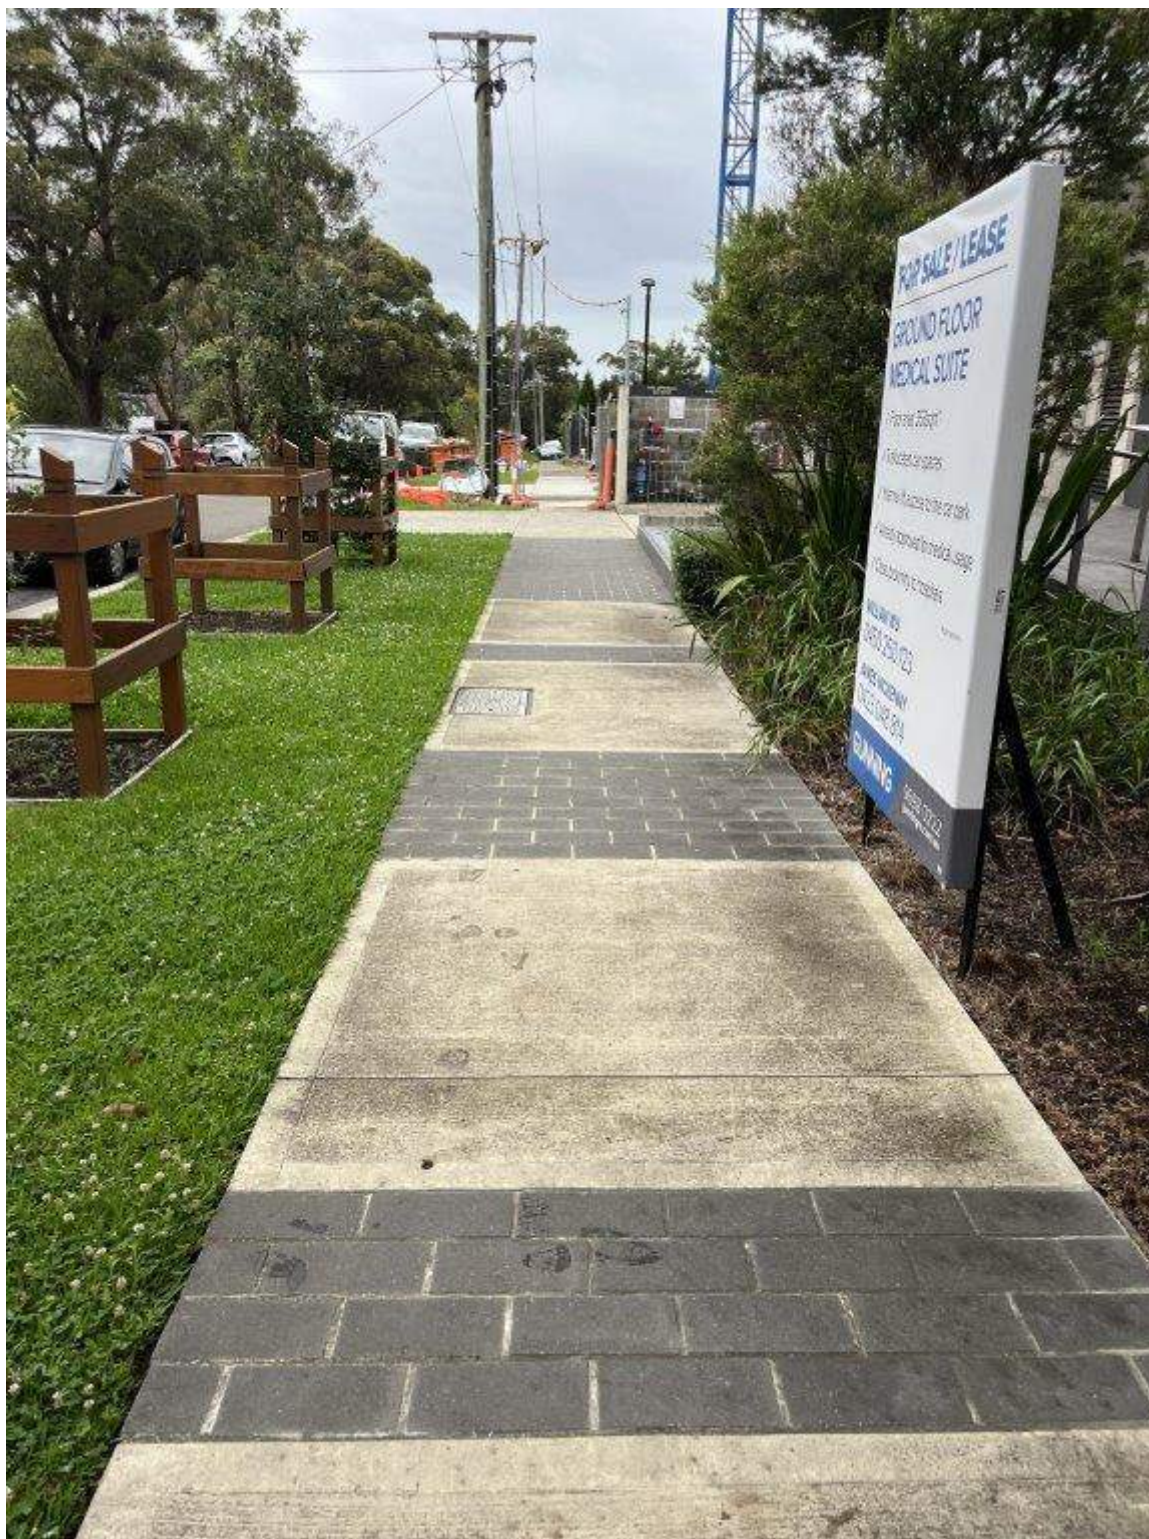
Photo 56 - Hinkler Avenue - Existing condition of pavement and post

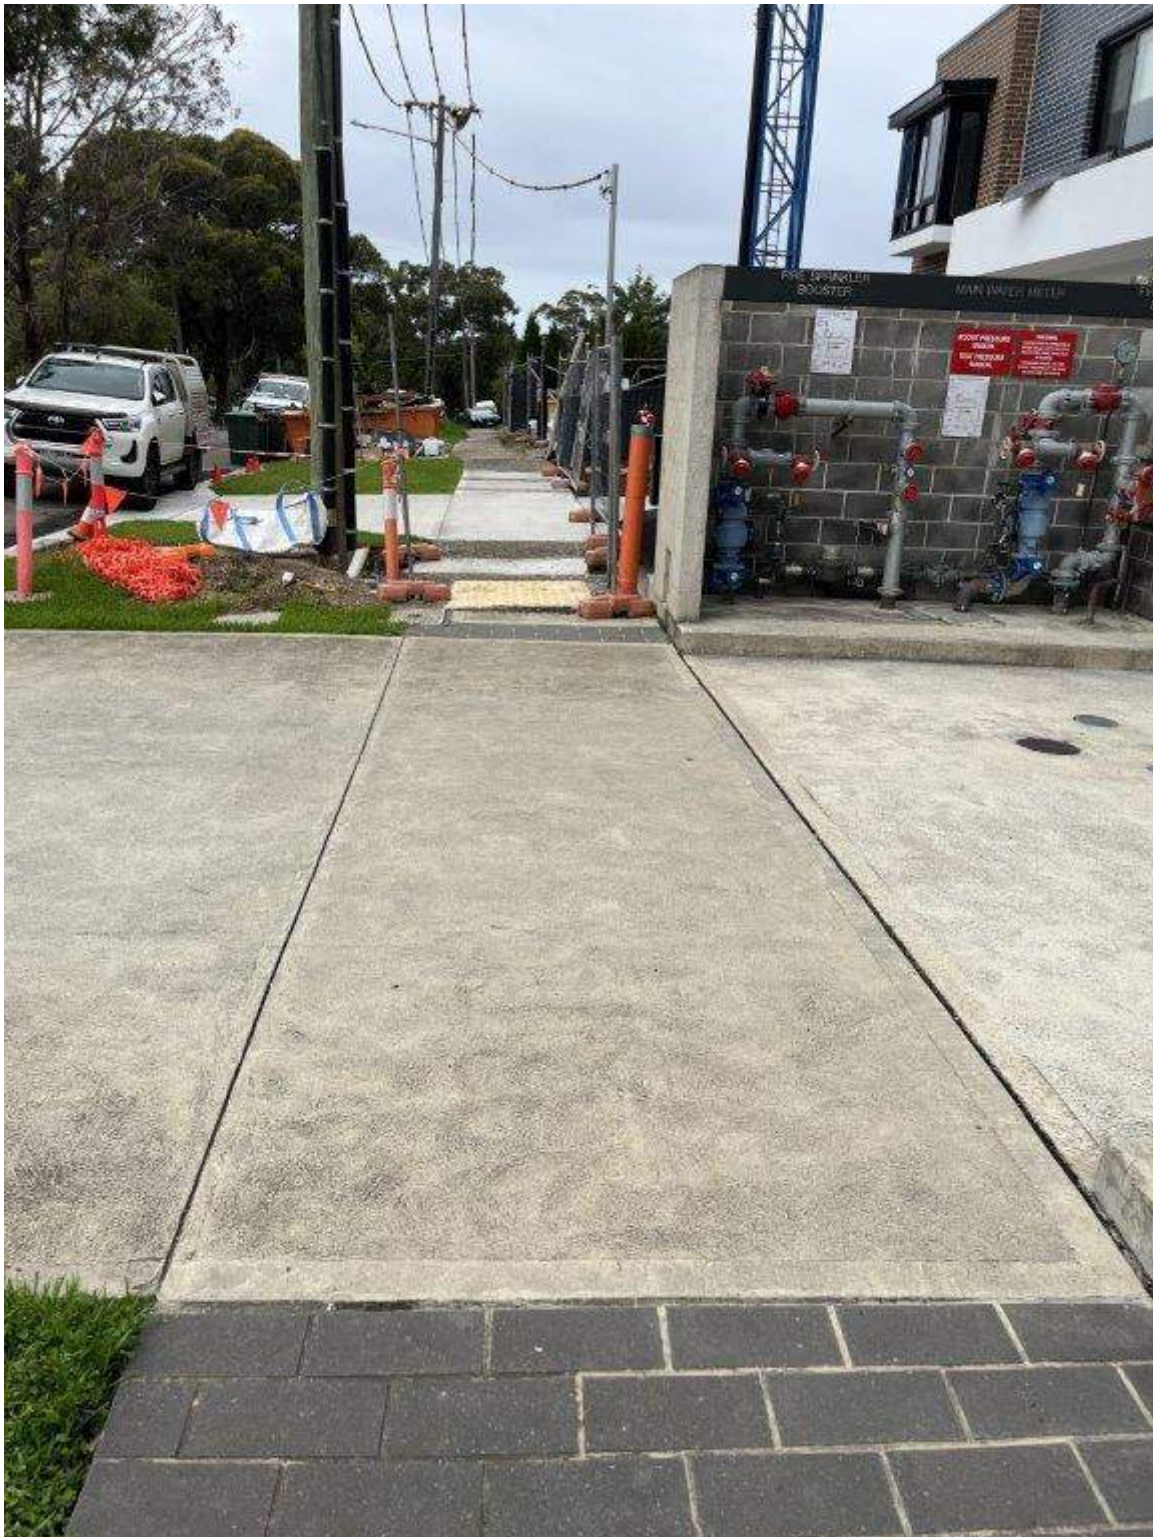
Photo 57 - Hinkler Avenue - Existing condition of pavement and vegetation

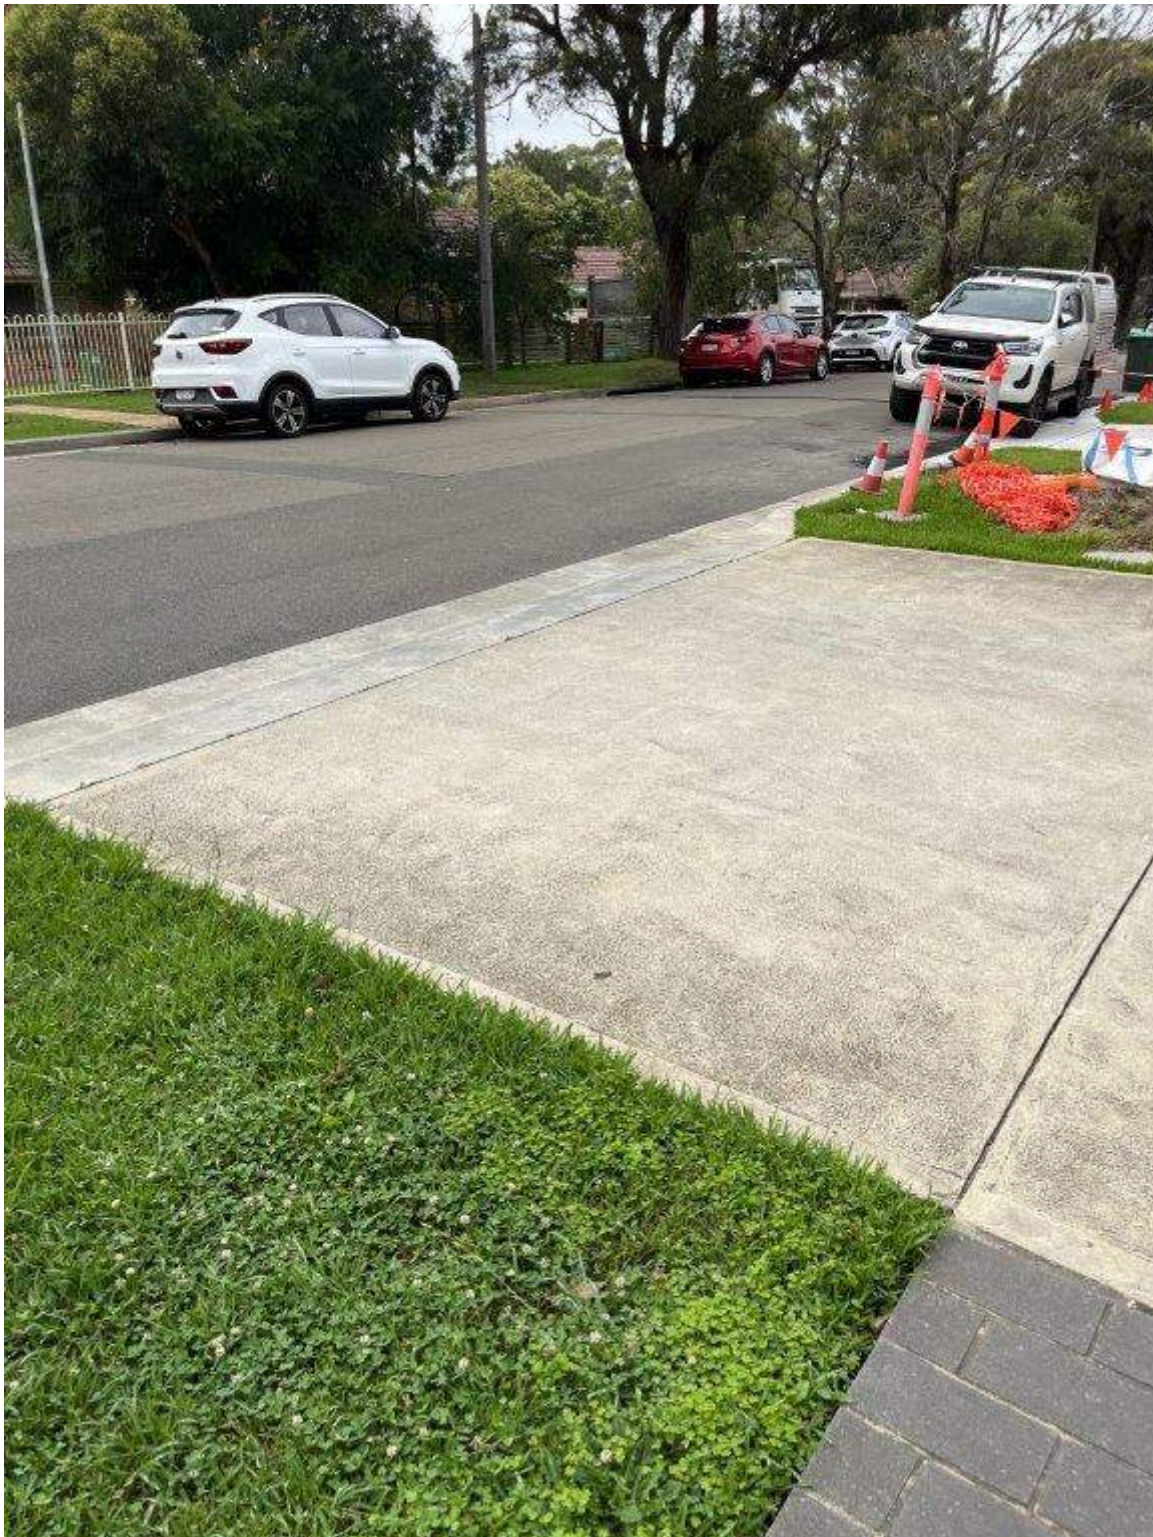
Photo 58 - Hinkler Avenue - Existing condition of pavement

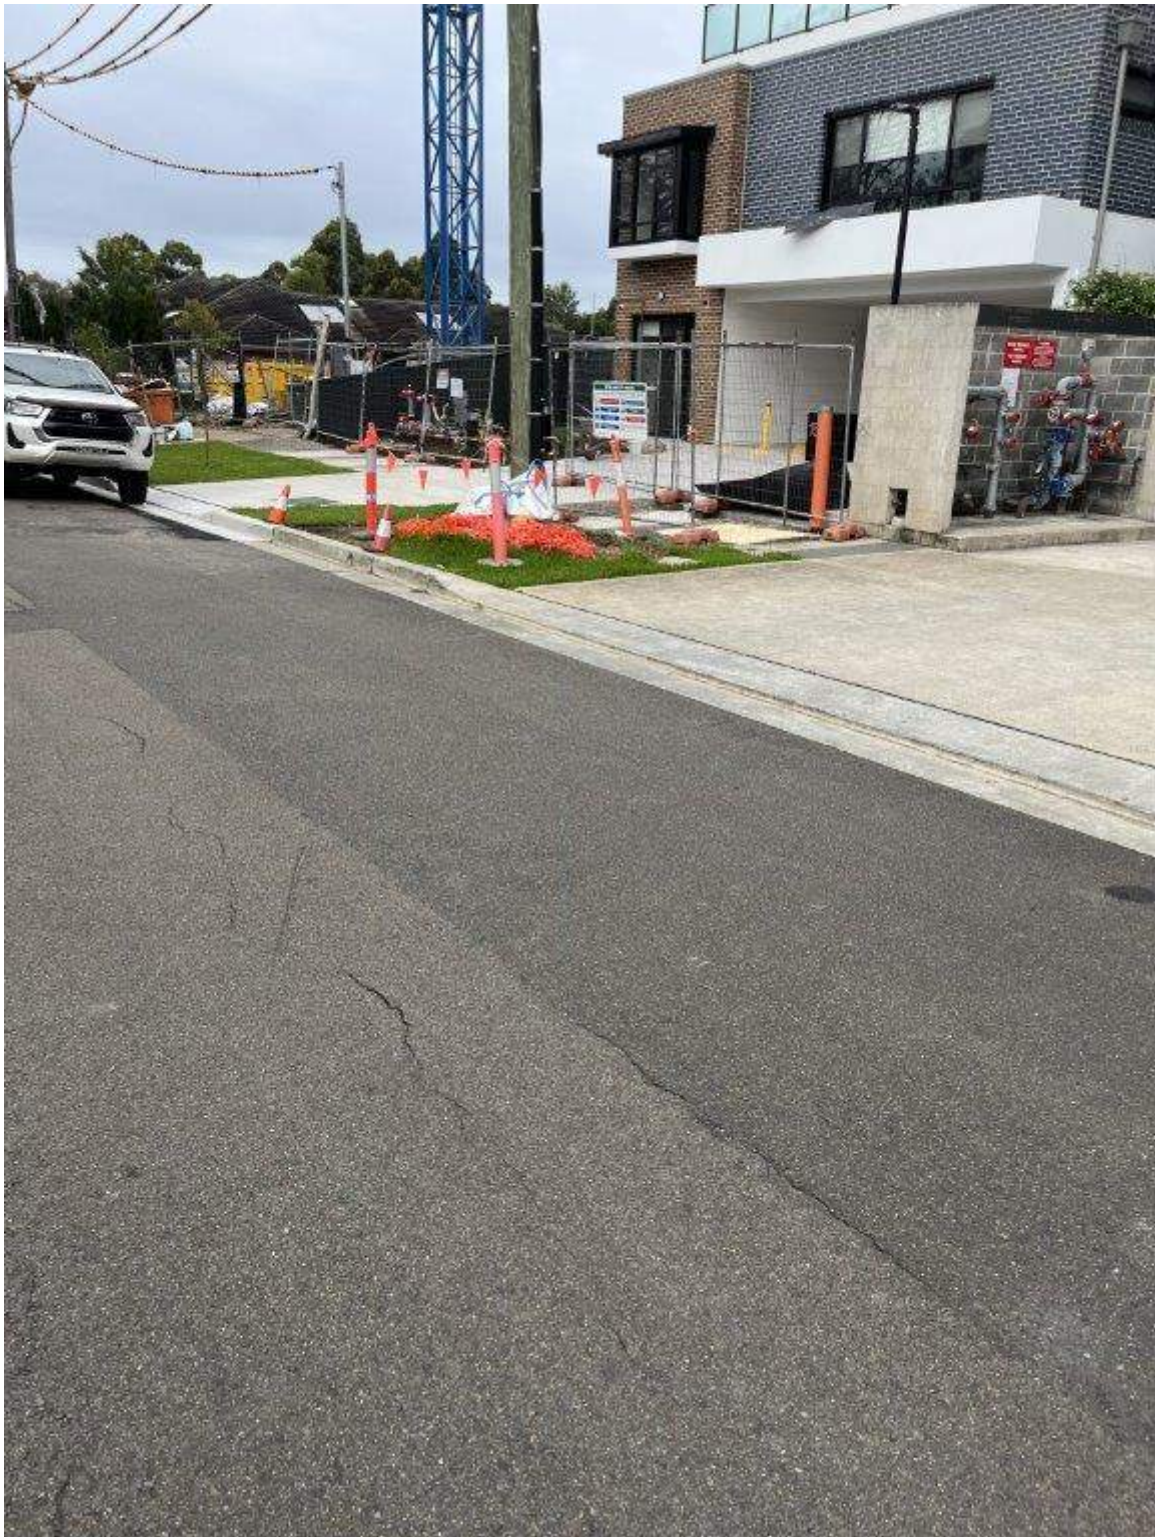
Photo 59 - Hinkler Avenue - Existing condition of pavement

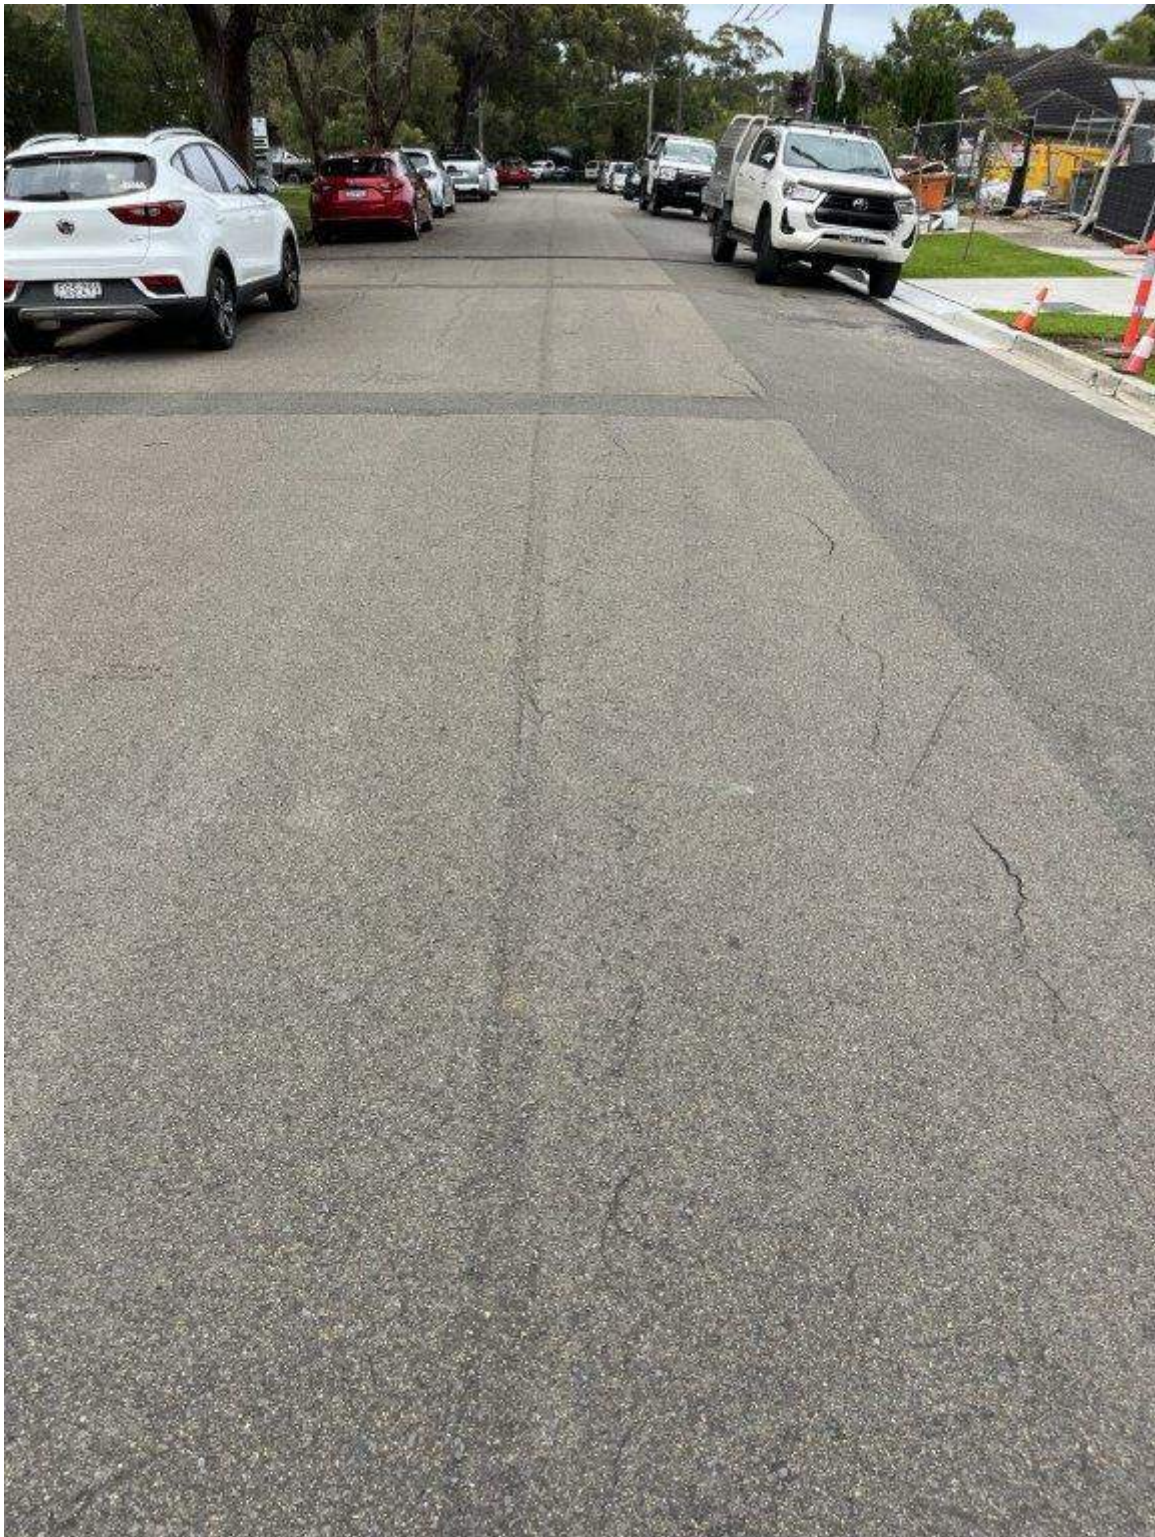
Photo 60 - Hinkler Avenue - Cracking of pavement

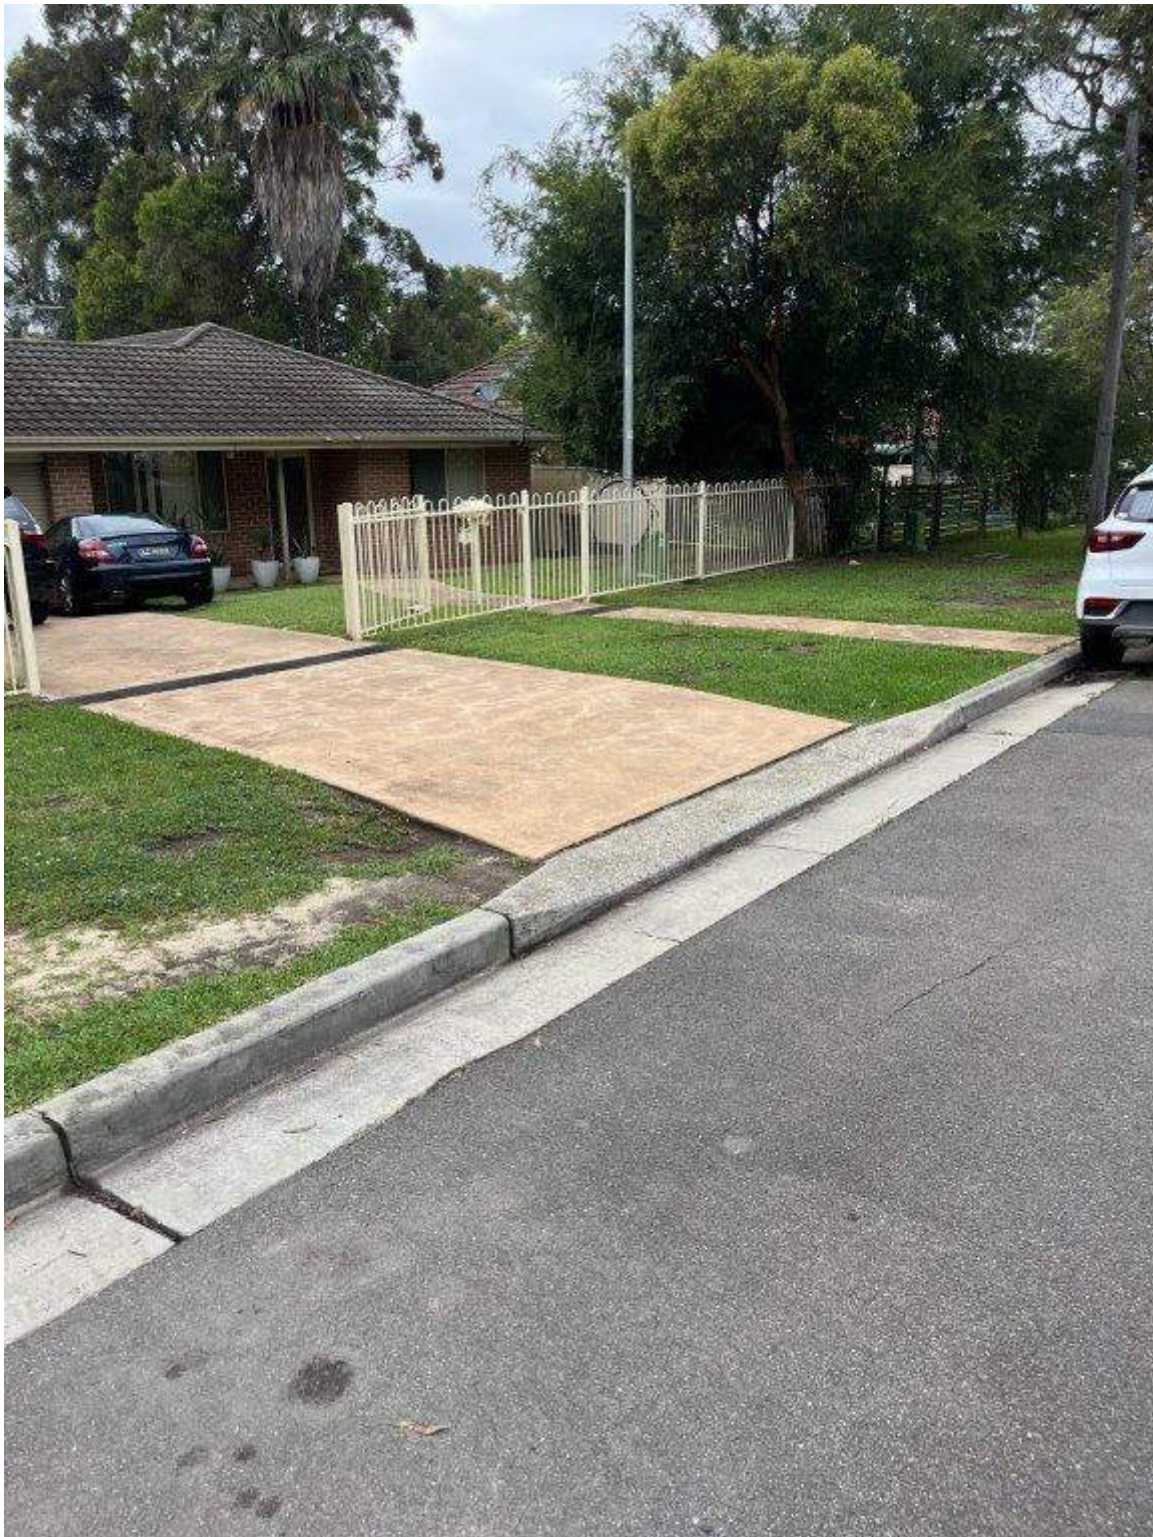
Photo 61 - Hinkler Avenue - Cracking of pavement

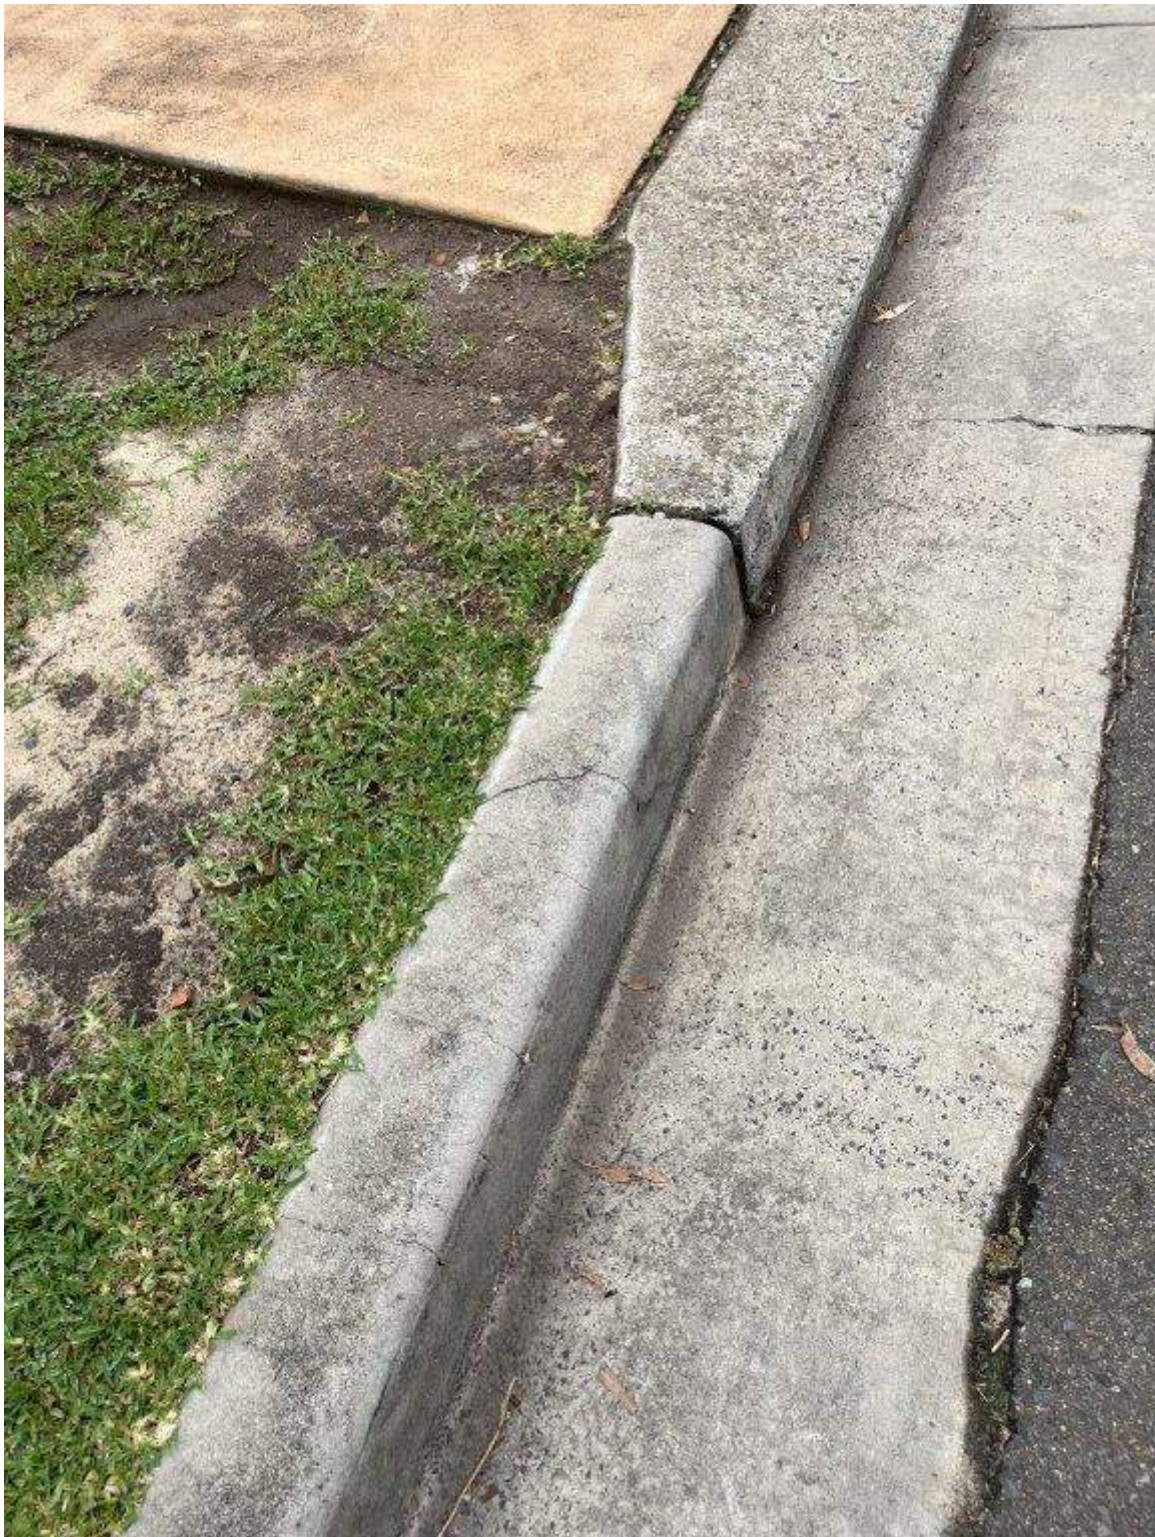
Photo 62 - Hinkler Avenue - Existing condition of pavement and vegetation

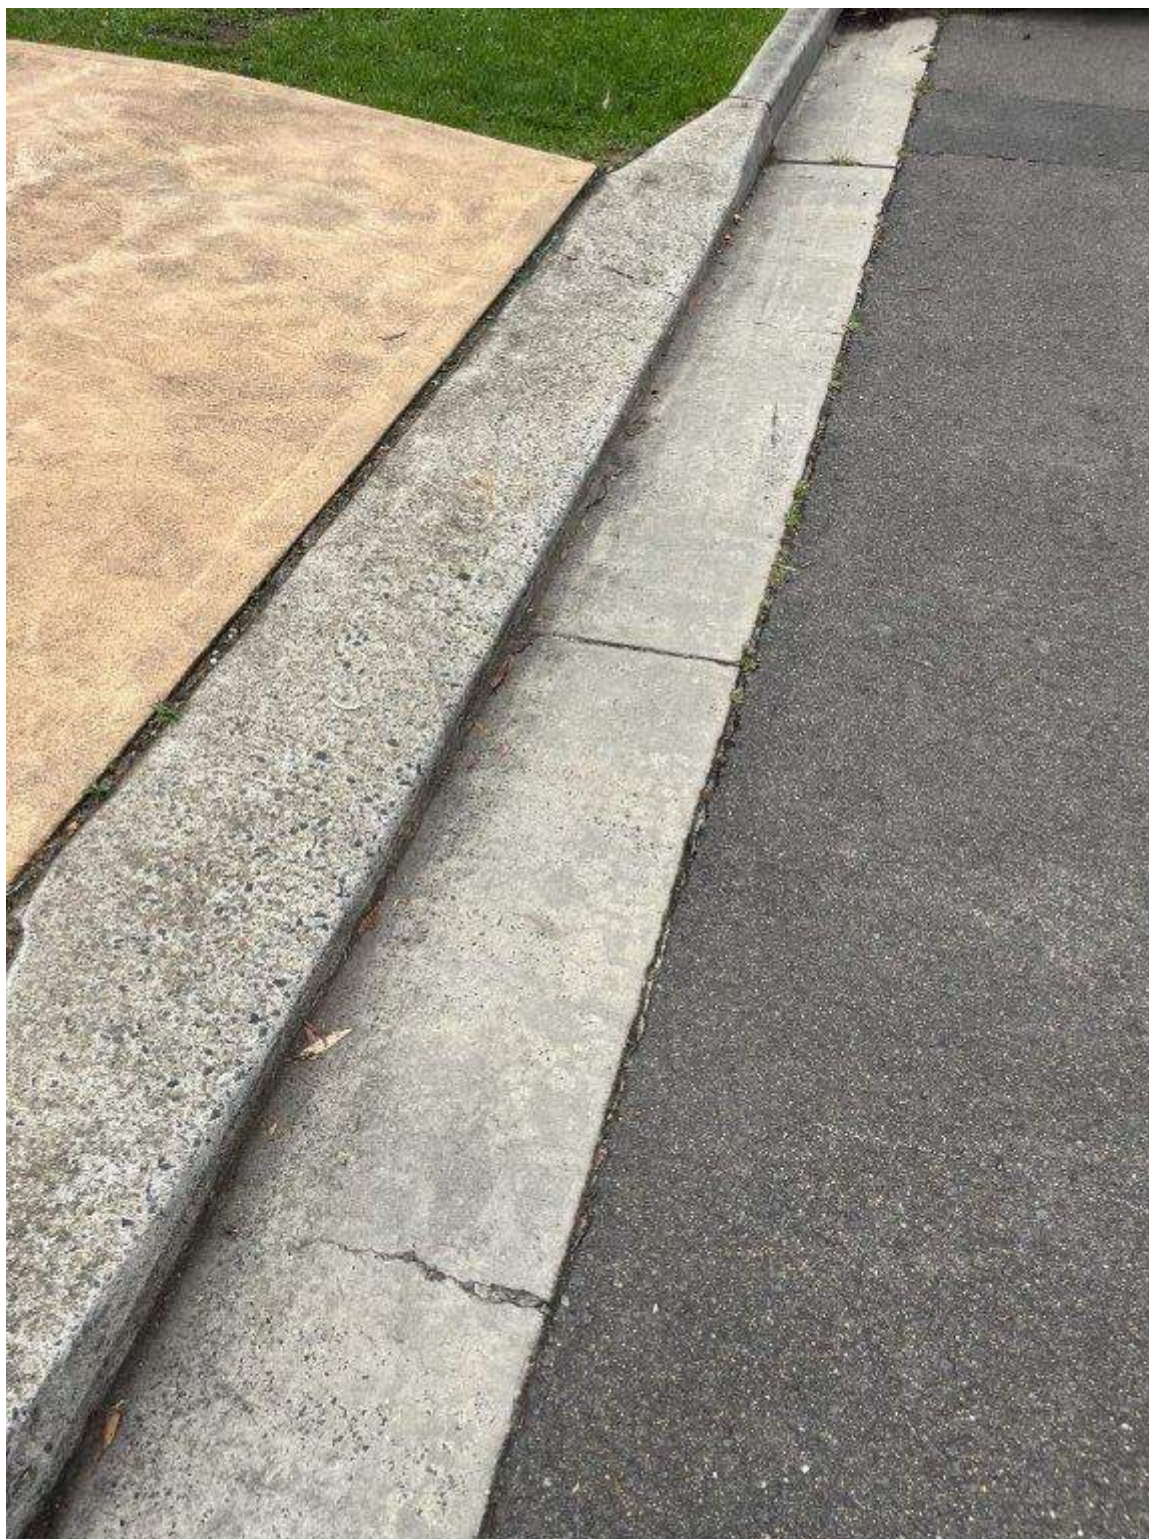
Photo 63 - Hinkler Avenue - Cracking of kerb and pavement

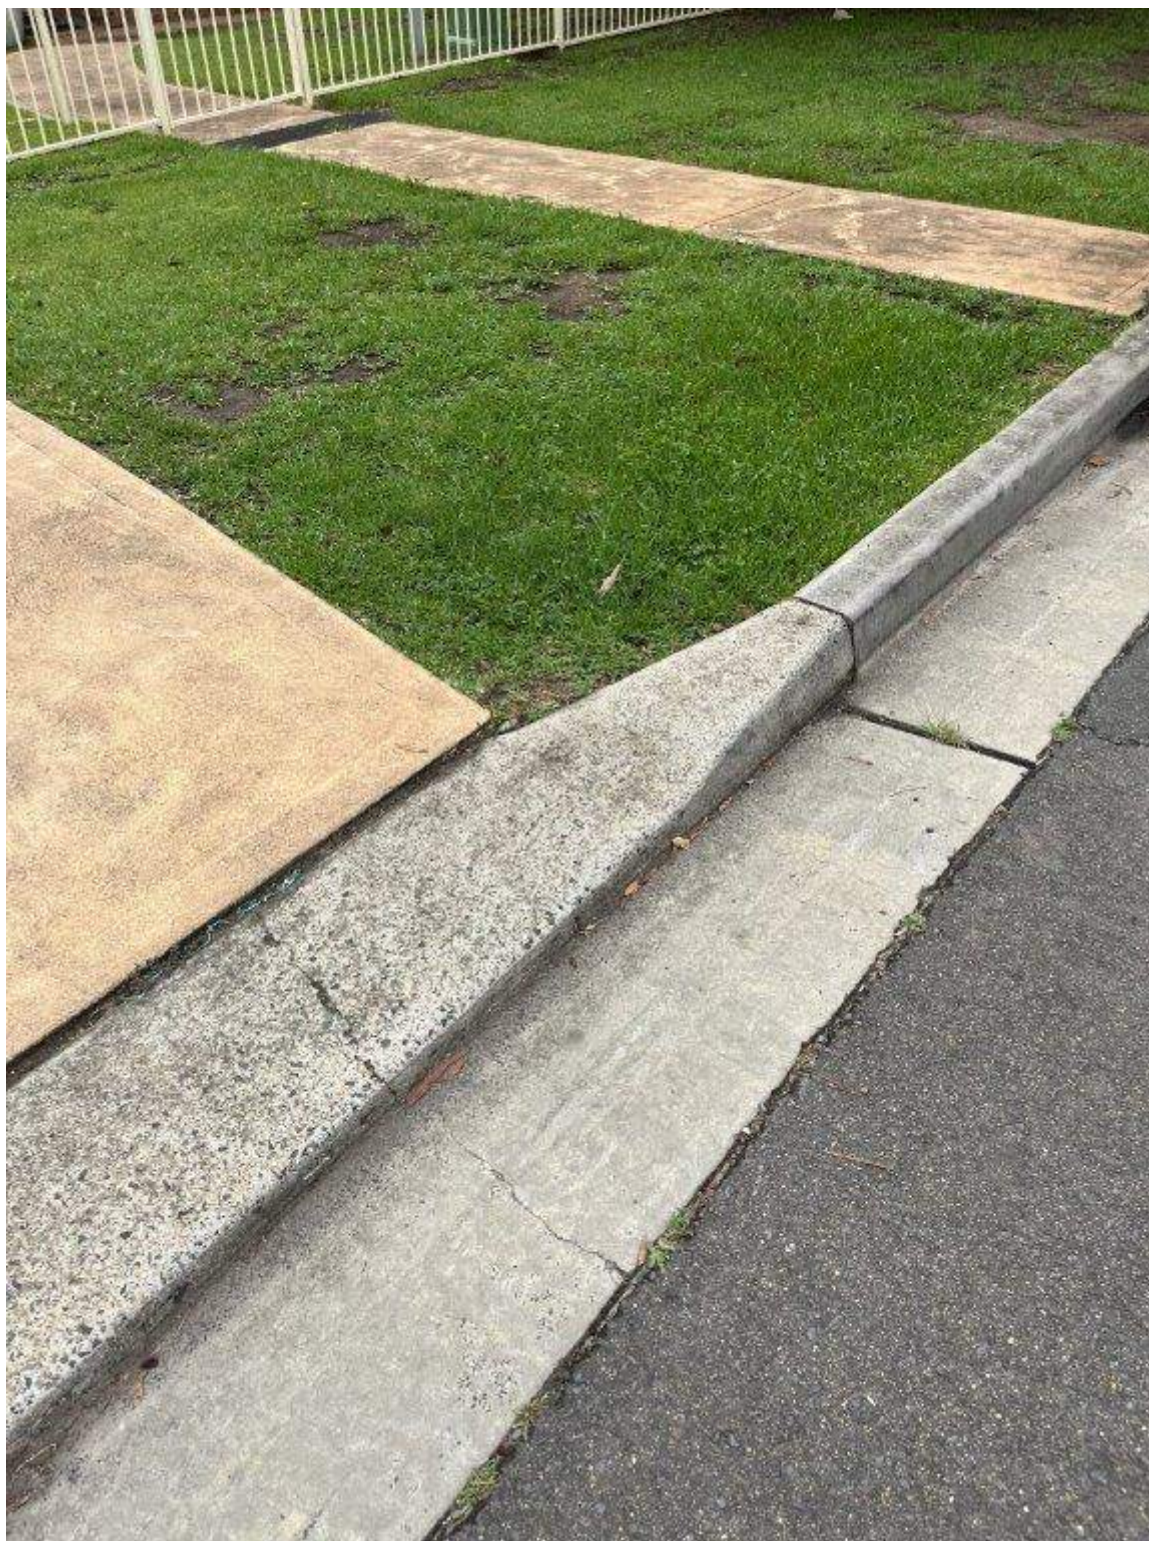
Photo 64 - Hinkler Avenue - Cracking of pavement

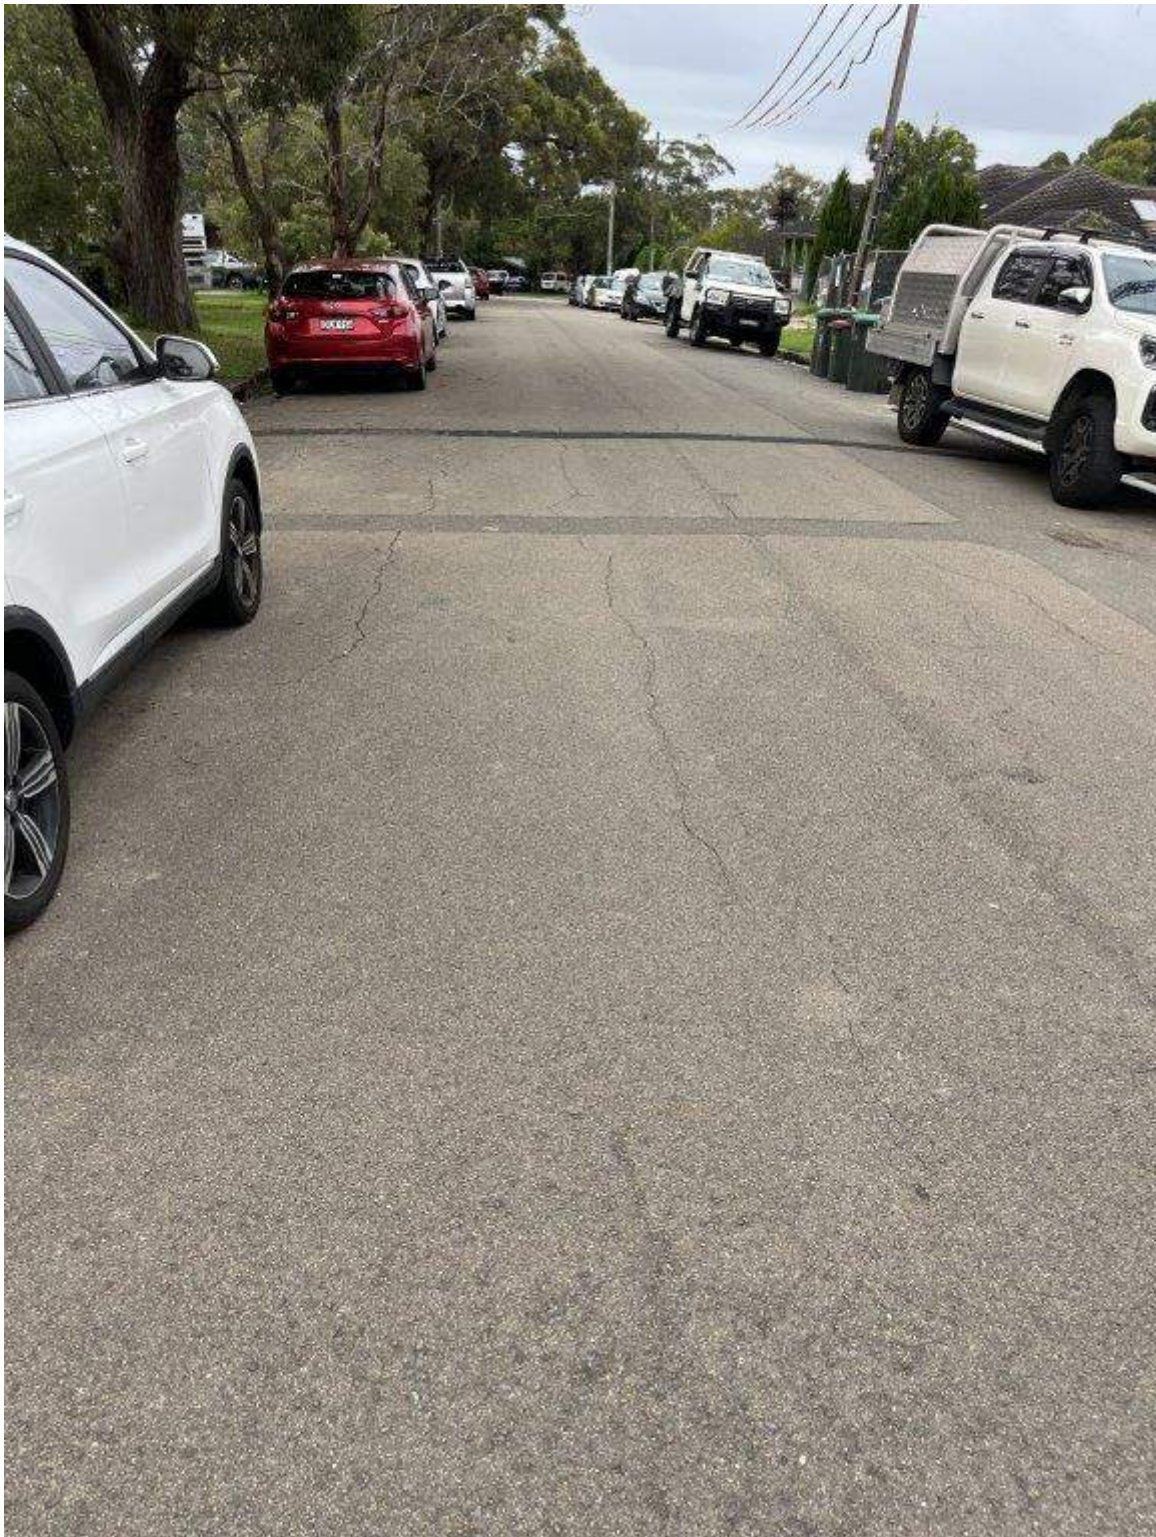
Photo 65 - Hinkler Avenue - Cracking of pavement

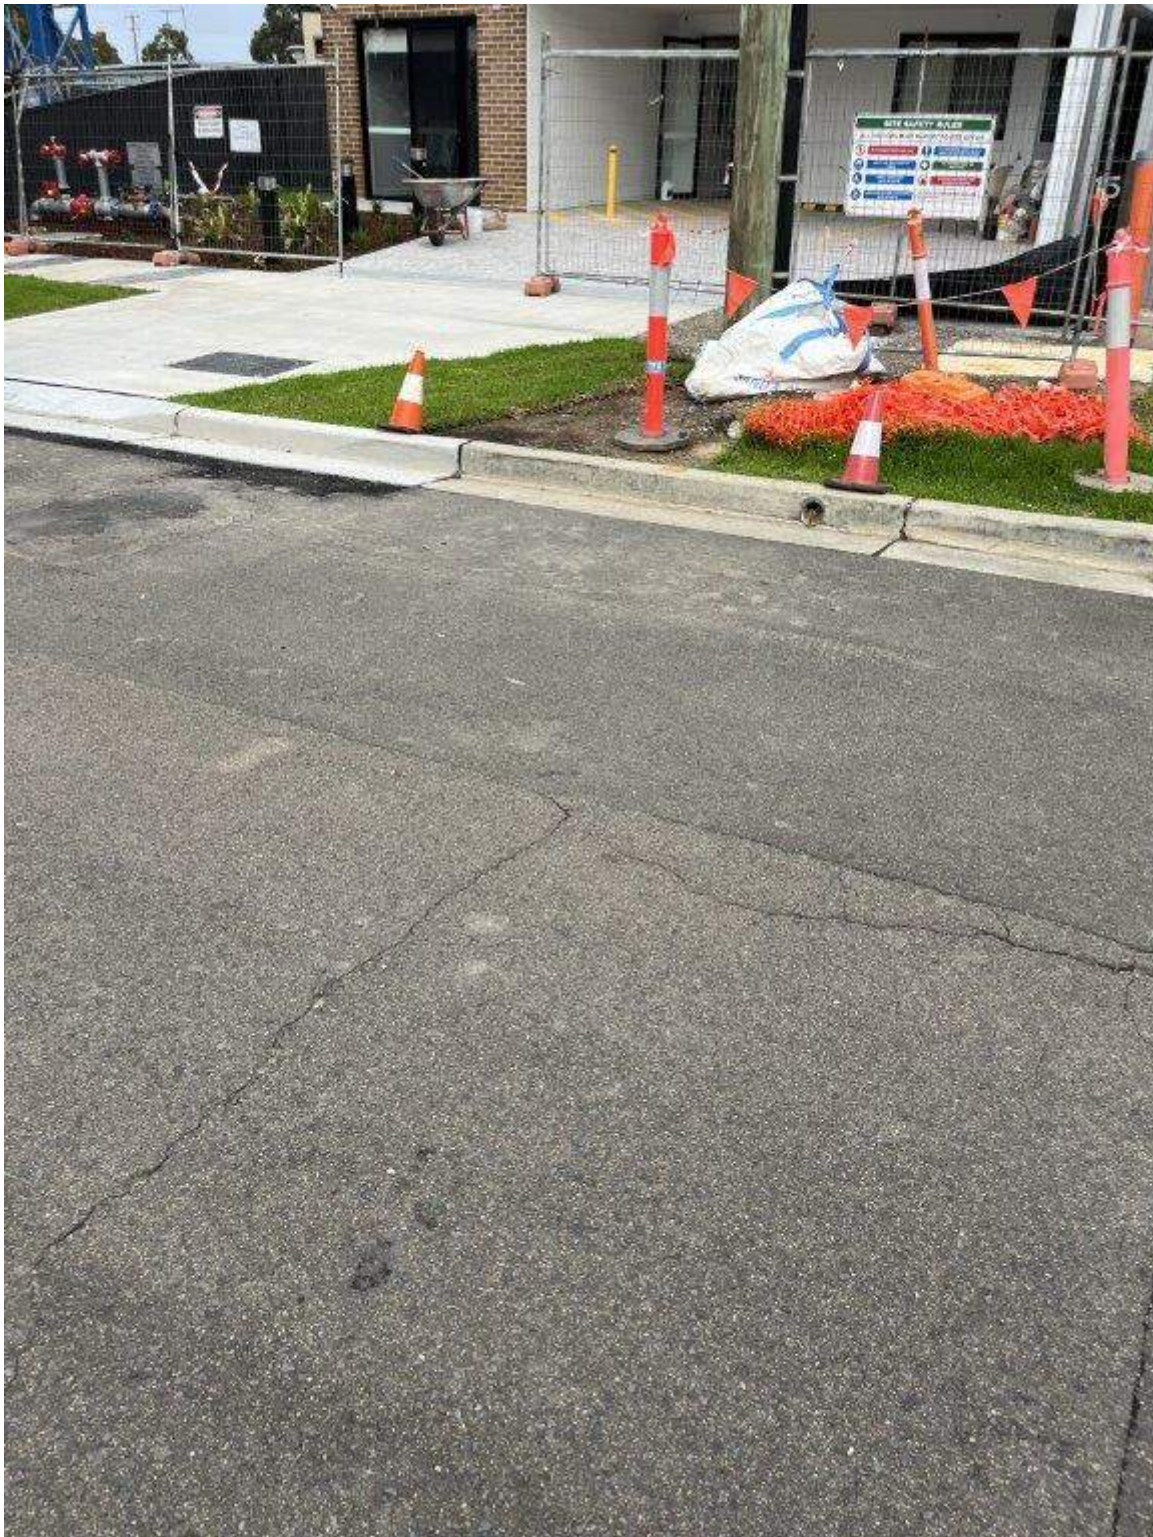
Photo 66 - Hinkler Avenue - Cracking of pavement

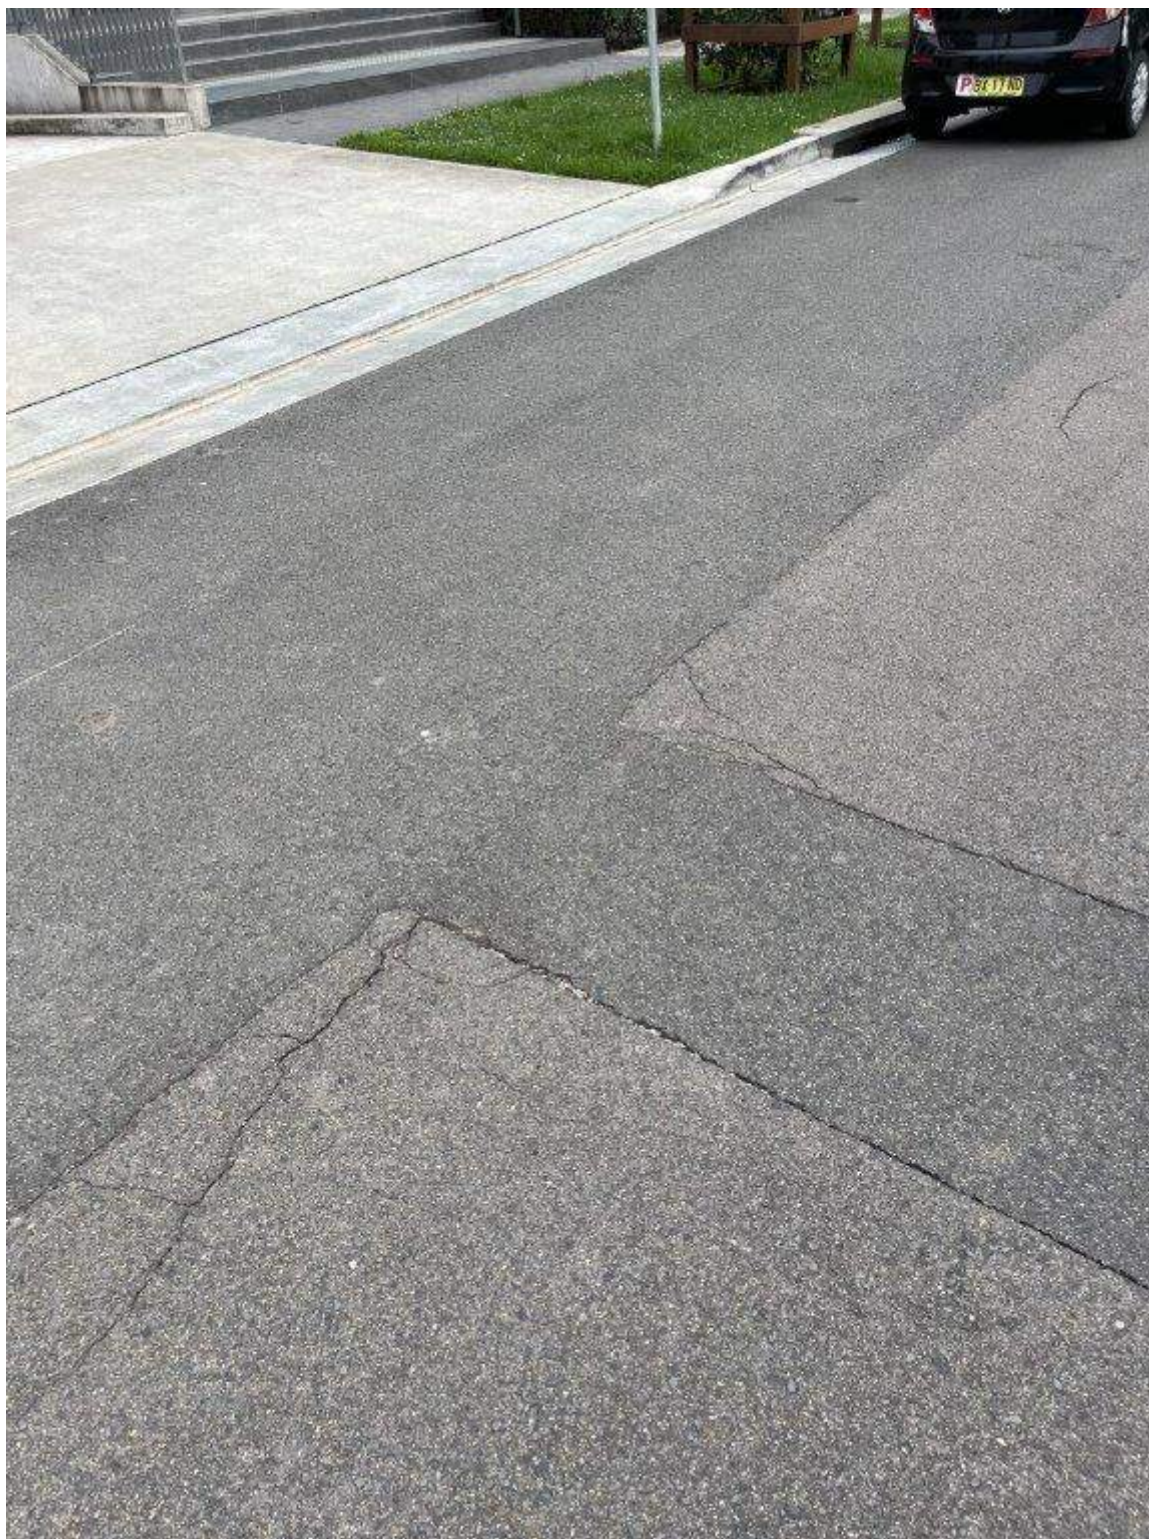
Photo 67 - Hinkler Avenue - Cracking of pavement

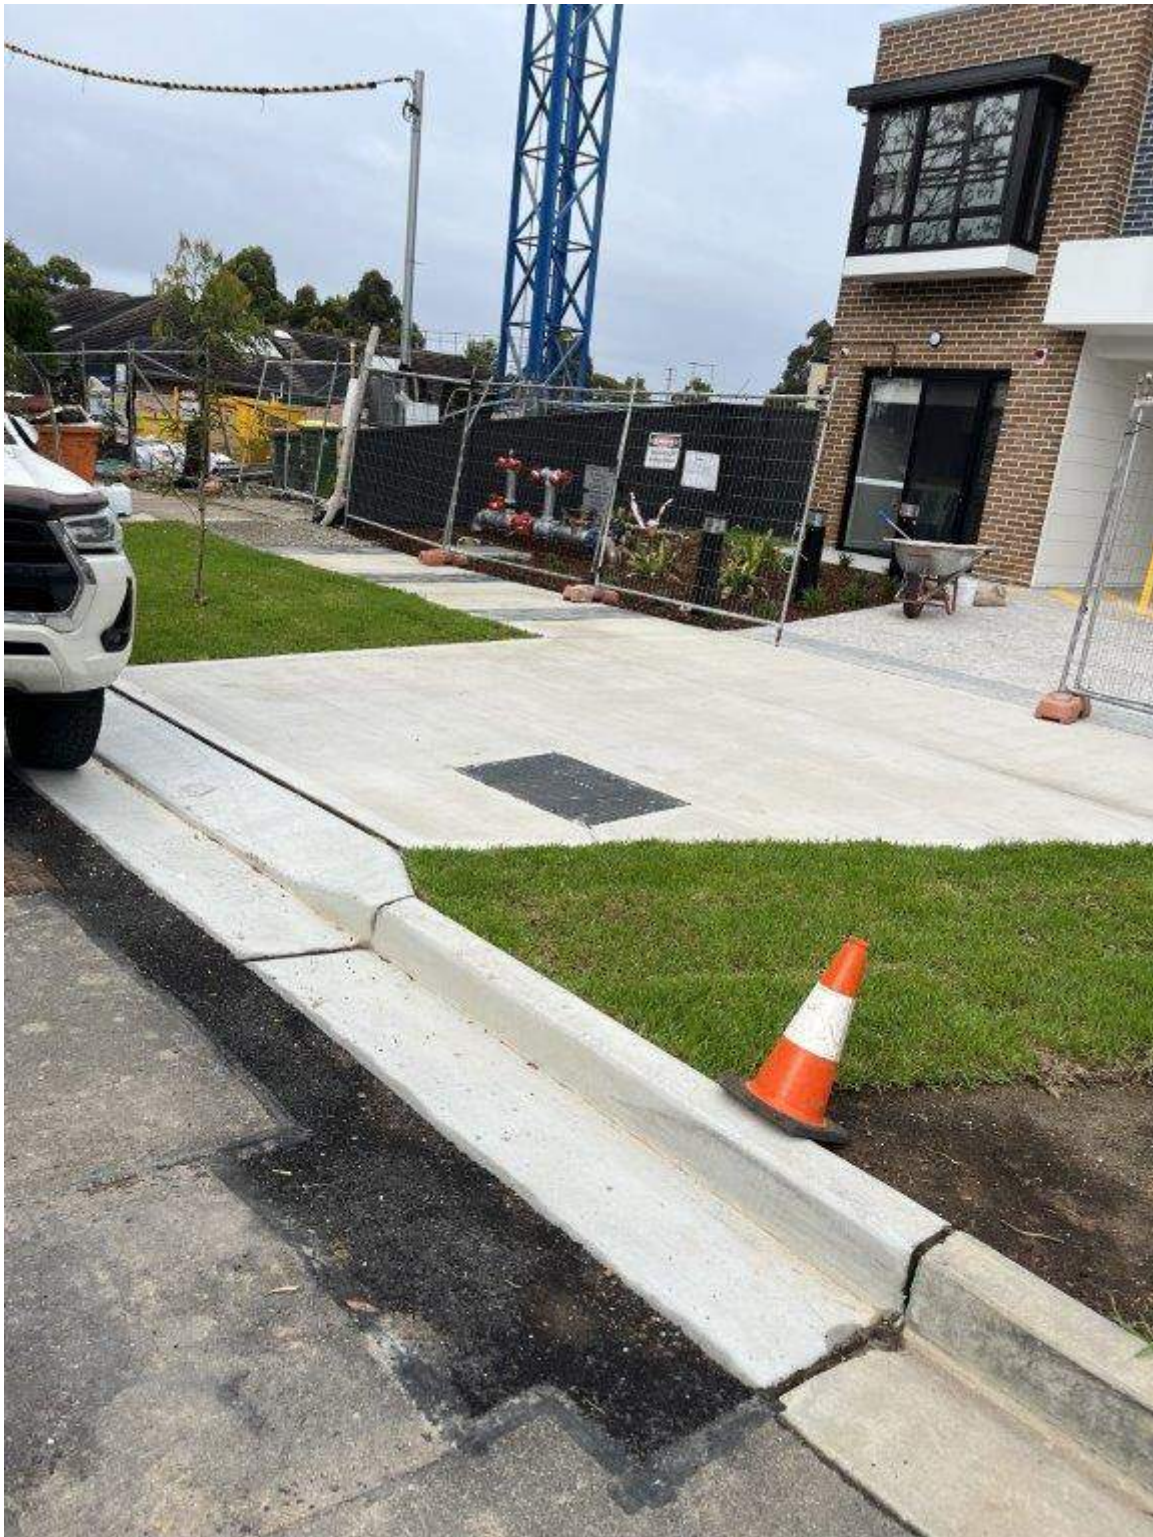
Photo 68 - Hinkler Avenue - Cracking of pavement
