## PRE-CONSTRUCTION DILAPIDATION REPORT

### 6-20 HINKLER AVENUE & 319-333 TAREN POINT ROAD, CARINGBAH

| PRE-CONSTRUCTION DILAPIDATION REPORT<br>6-20 Hinkler Avenue & 319-333 Taren Point Road,<br>Caringbah NSW 2229 | | | | | Project Number: 21039 |

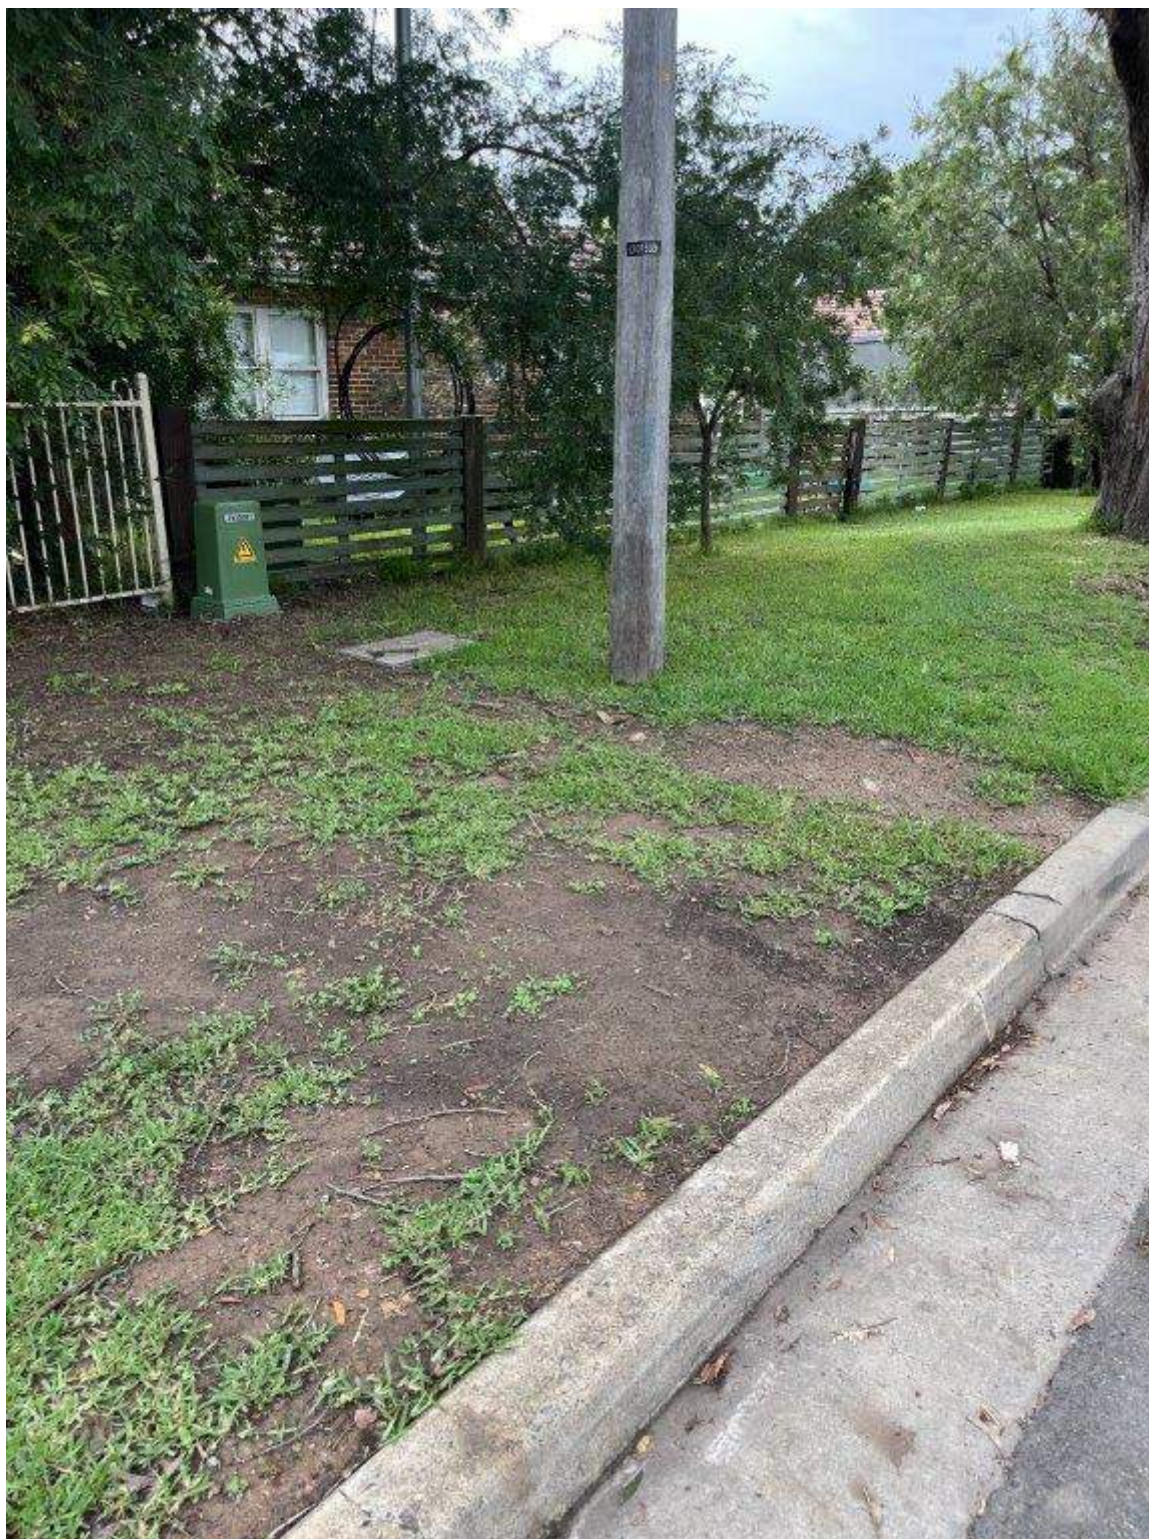
Photo 69 - Hinkler Avenue - Existing condition of pavement

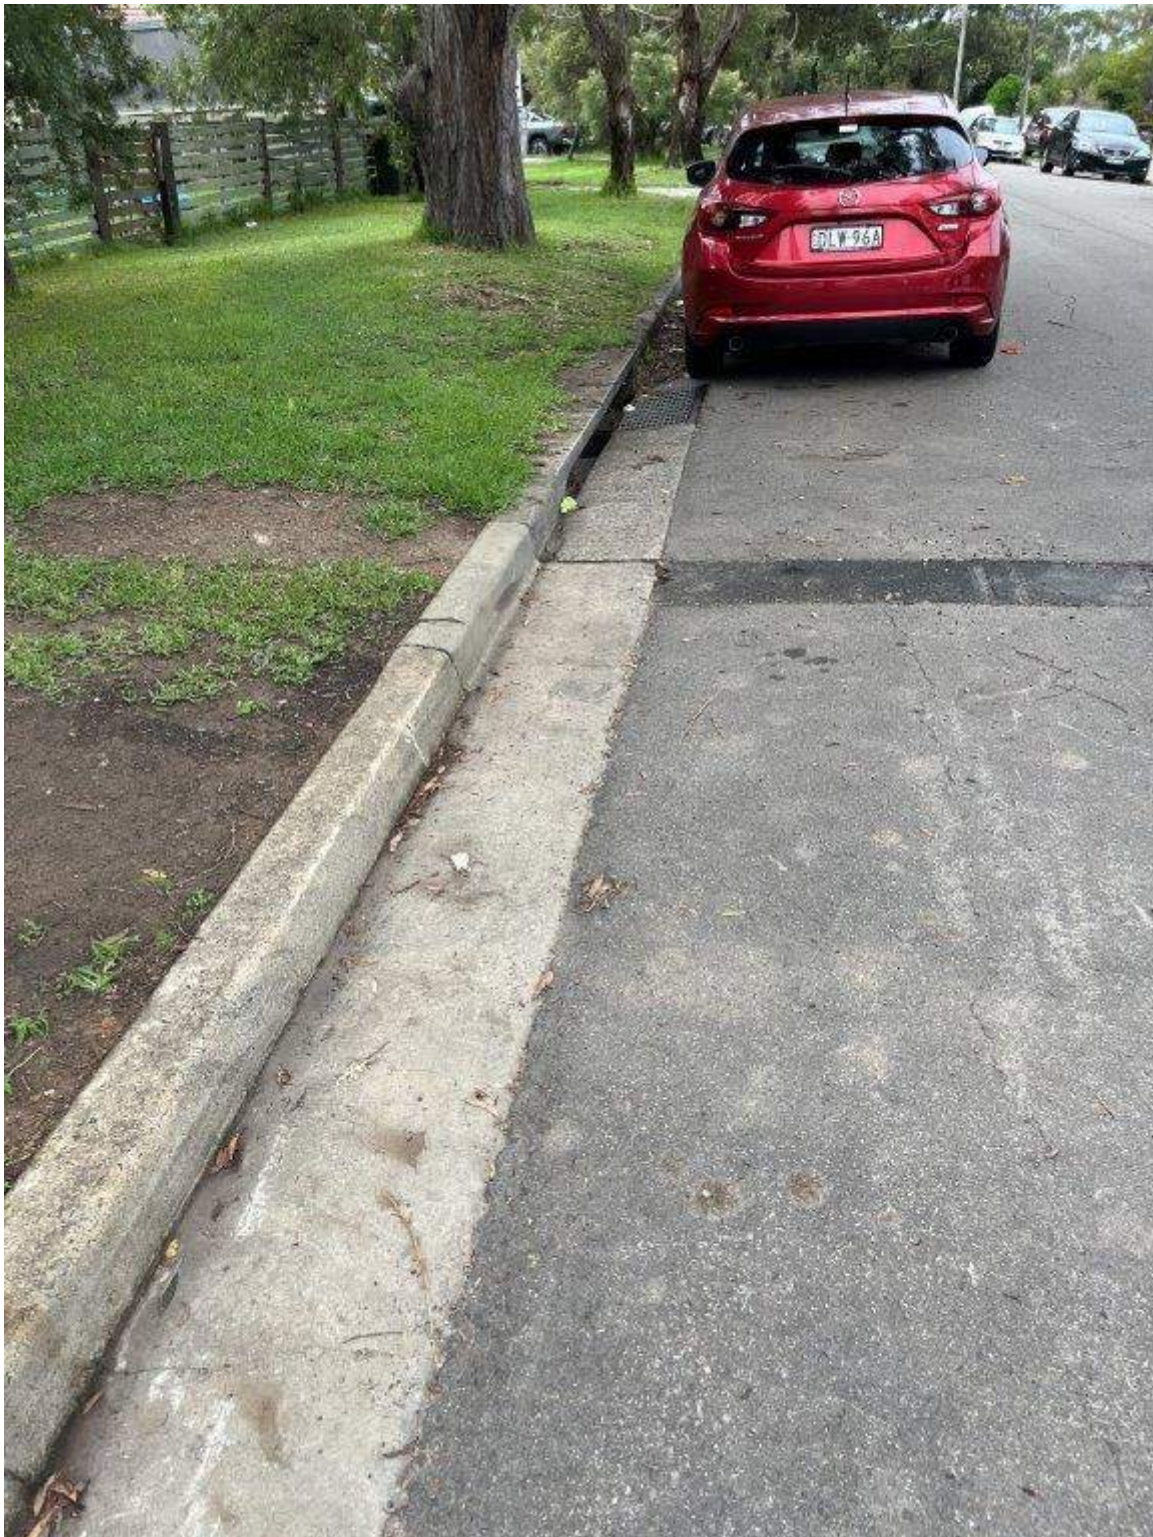
Photo 70 - Hinkler Avenue - Existing condition of pavement, post and vegetation

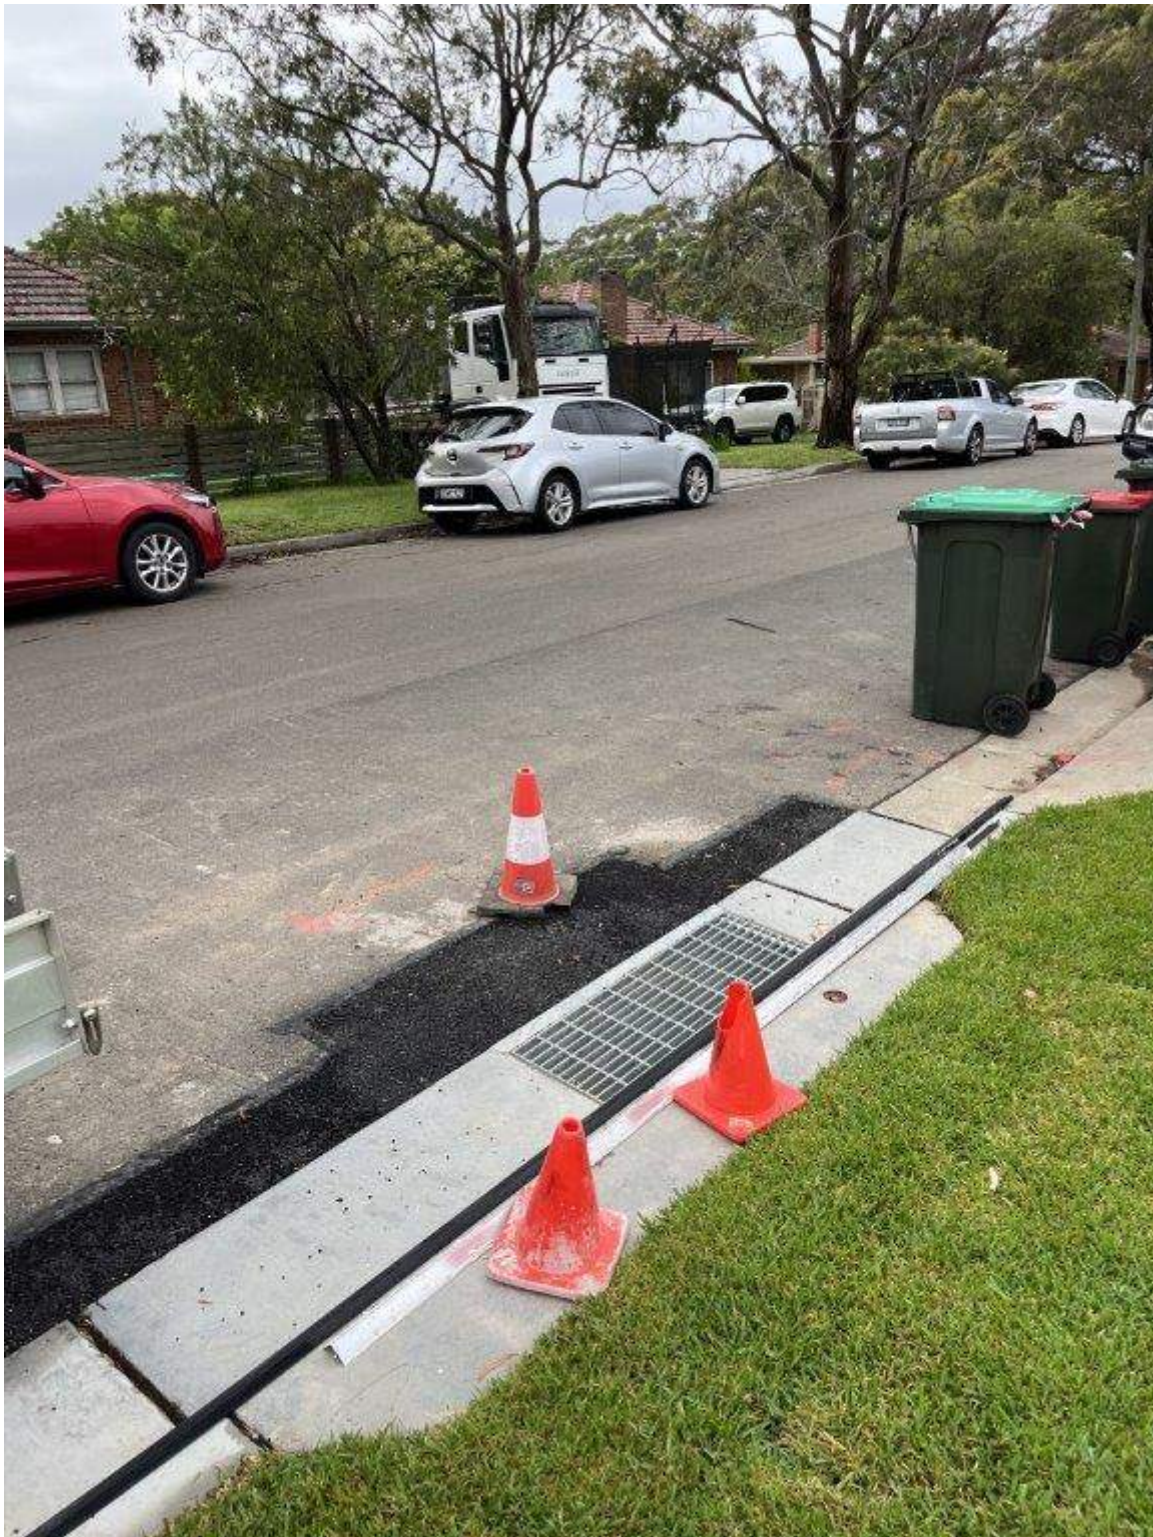
Photo 71 - Hinkler Avenue - Cracking of pavement

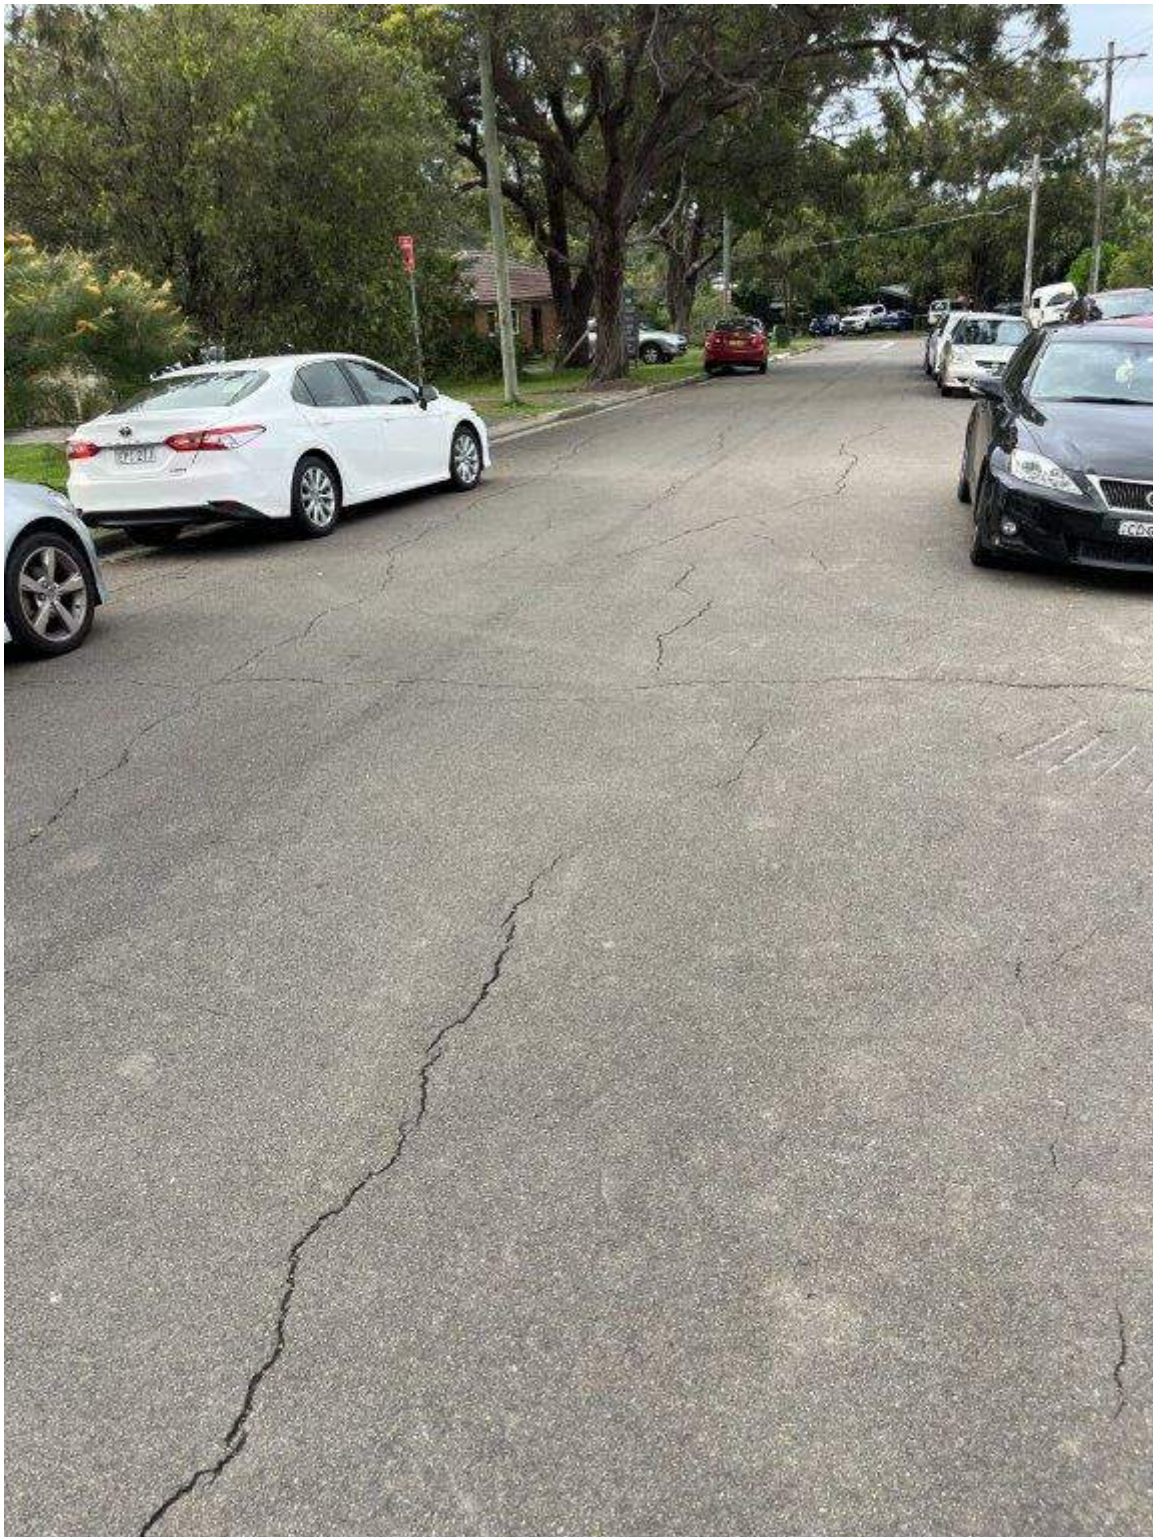
Photo 75 - Hinkler Avenue - Cracking of pavement

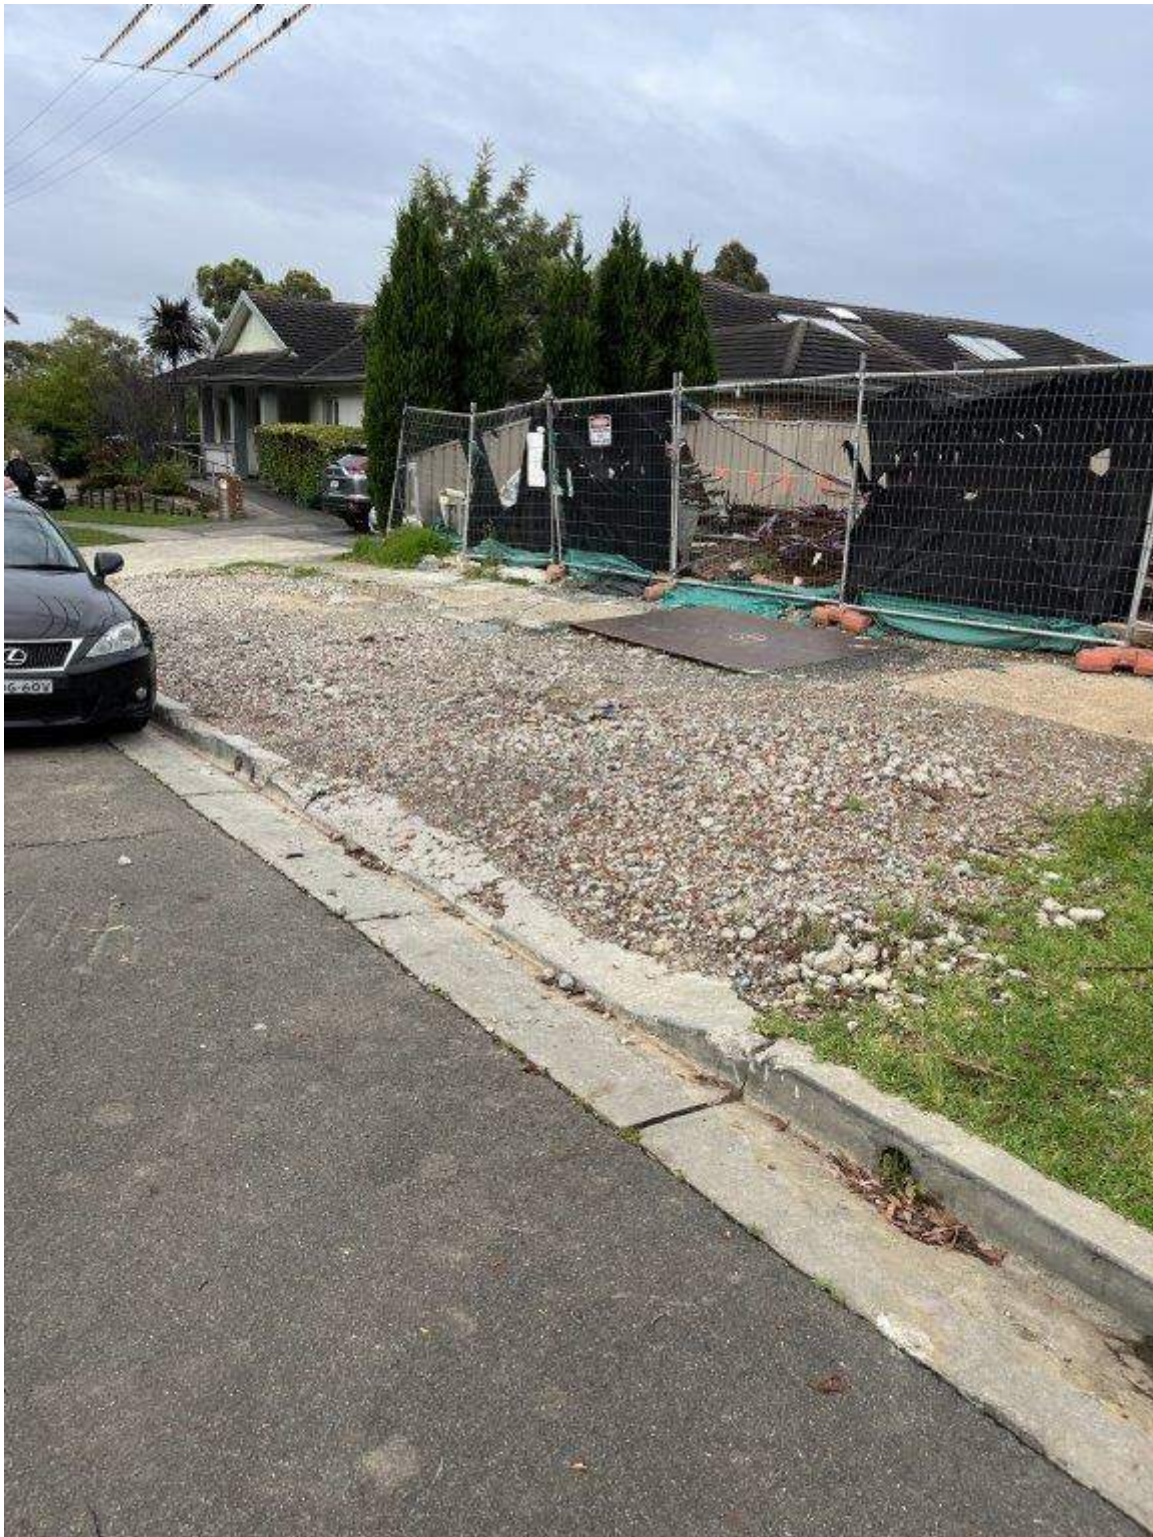
Photo 76 - Hinkler Avenue - Cracking of pavement

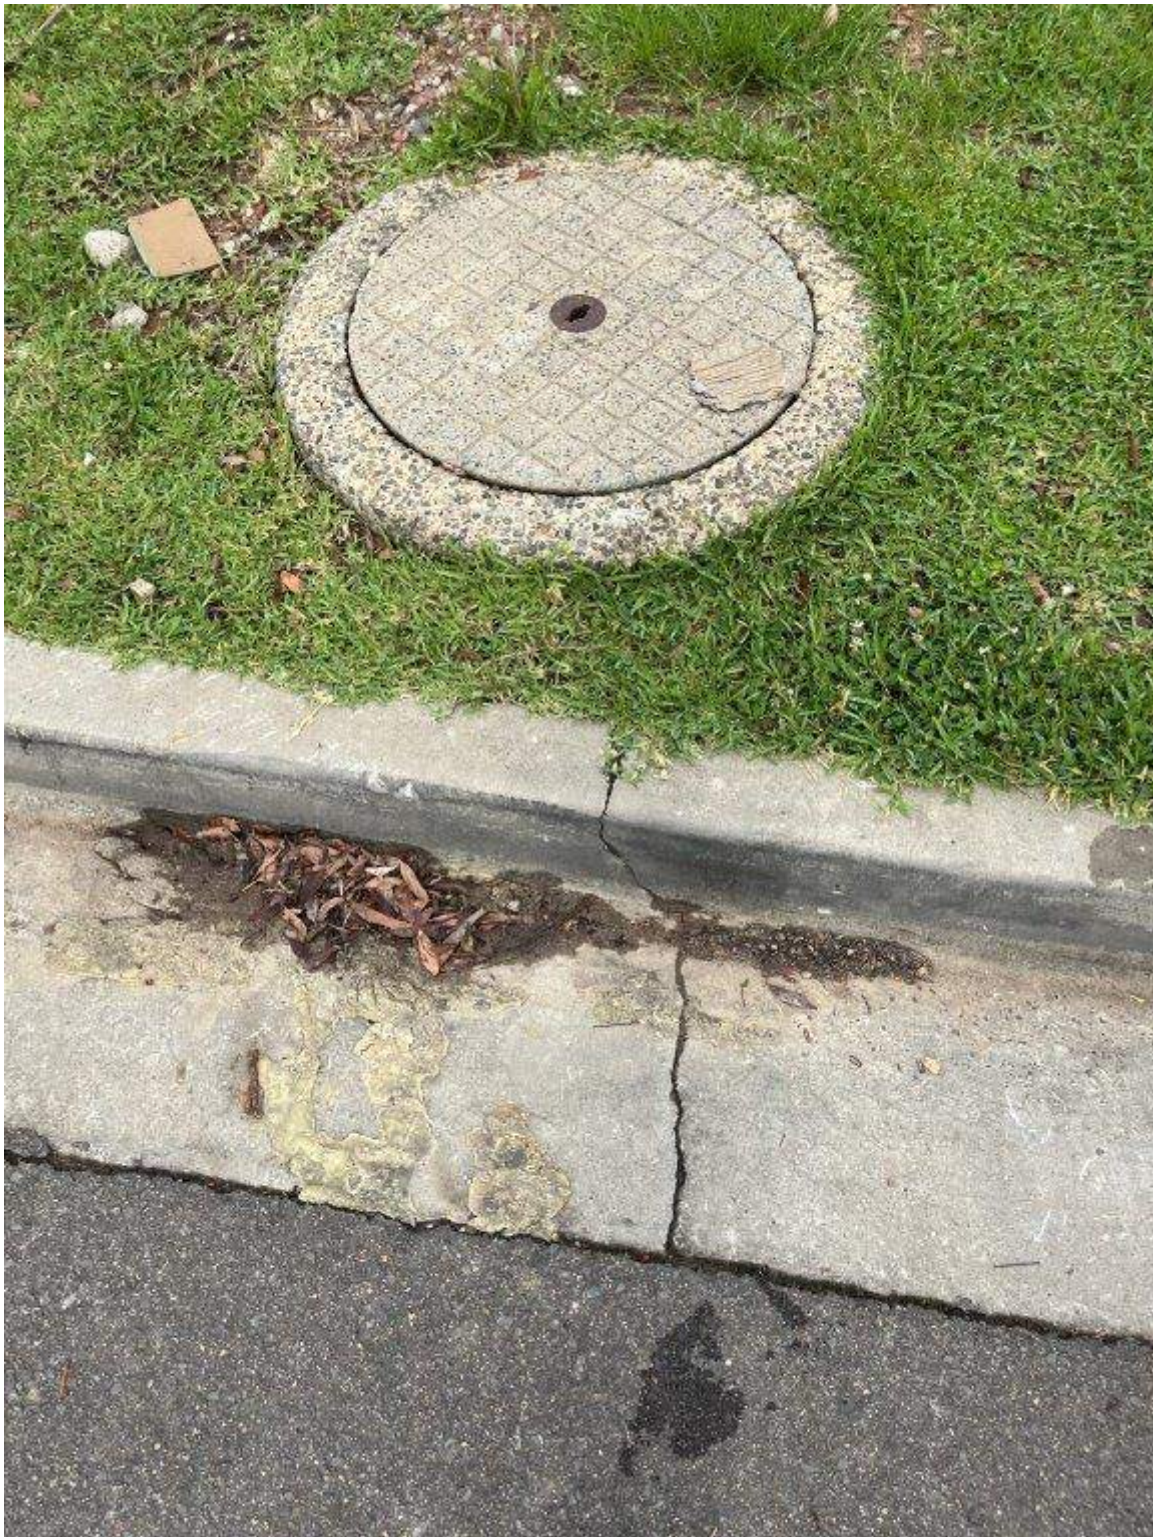
Photo 78 - Hinkler Avenue - Cracking of kerb and pavement

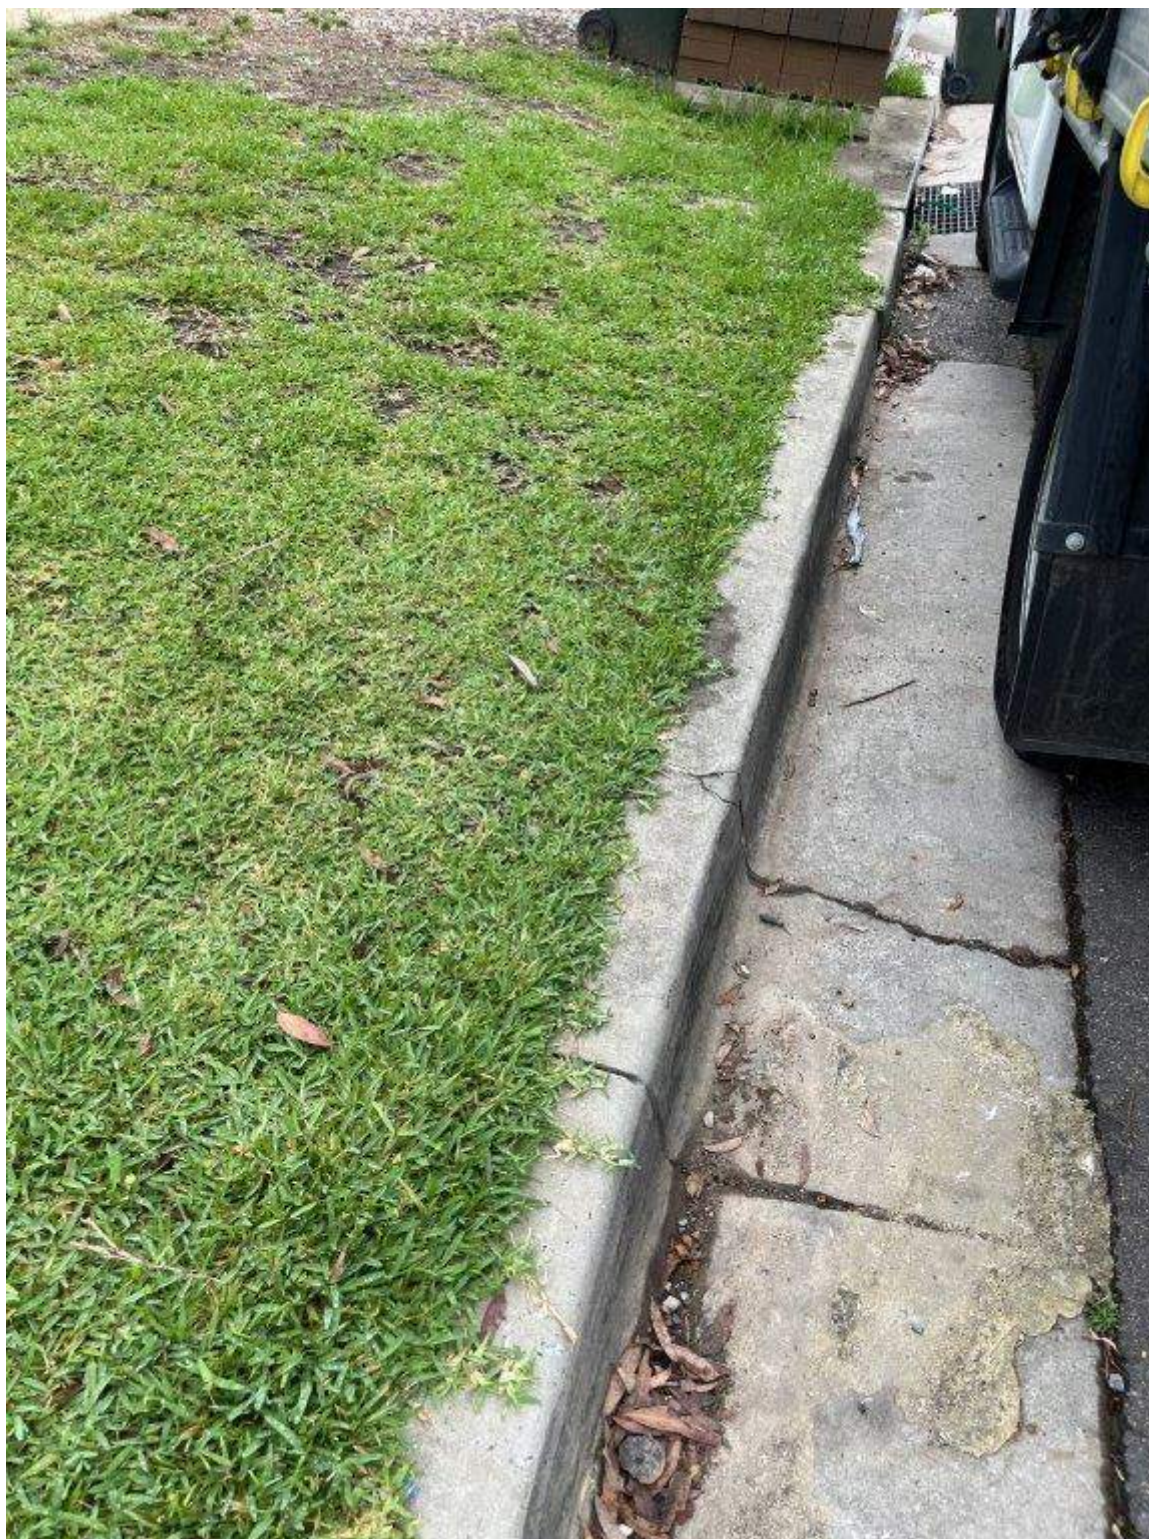
Photo 79 - Hinkler Avenue - Cracking of kerb and pavement

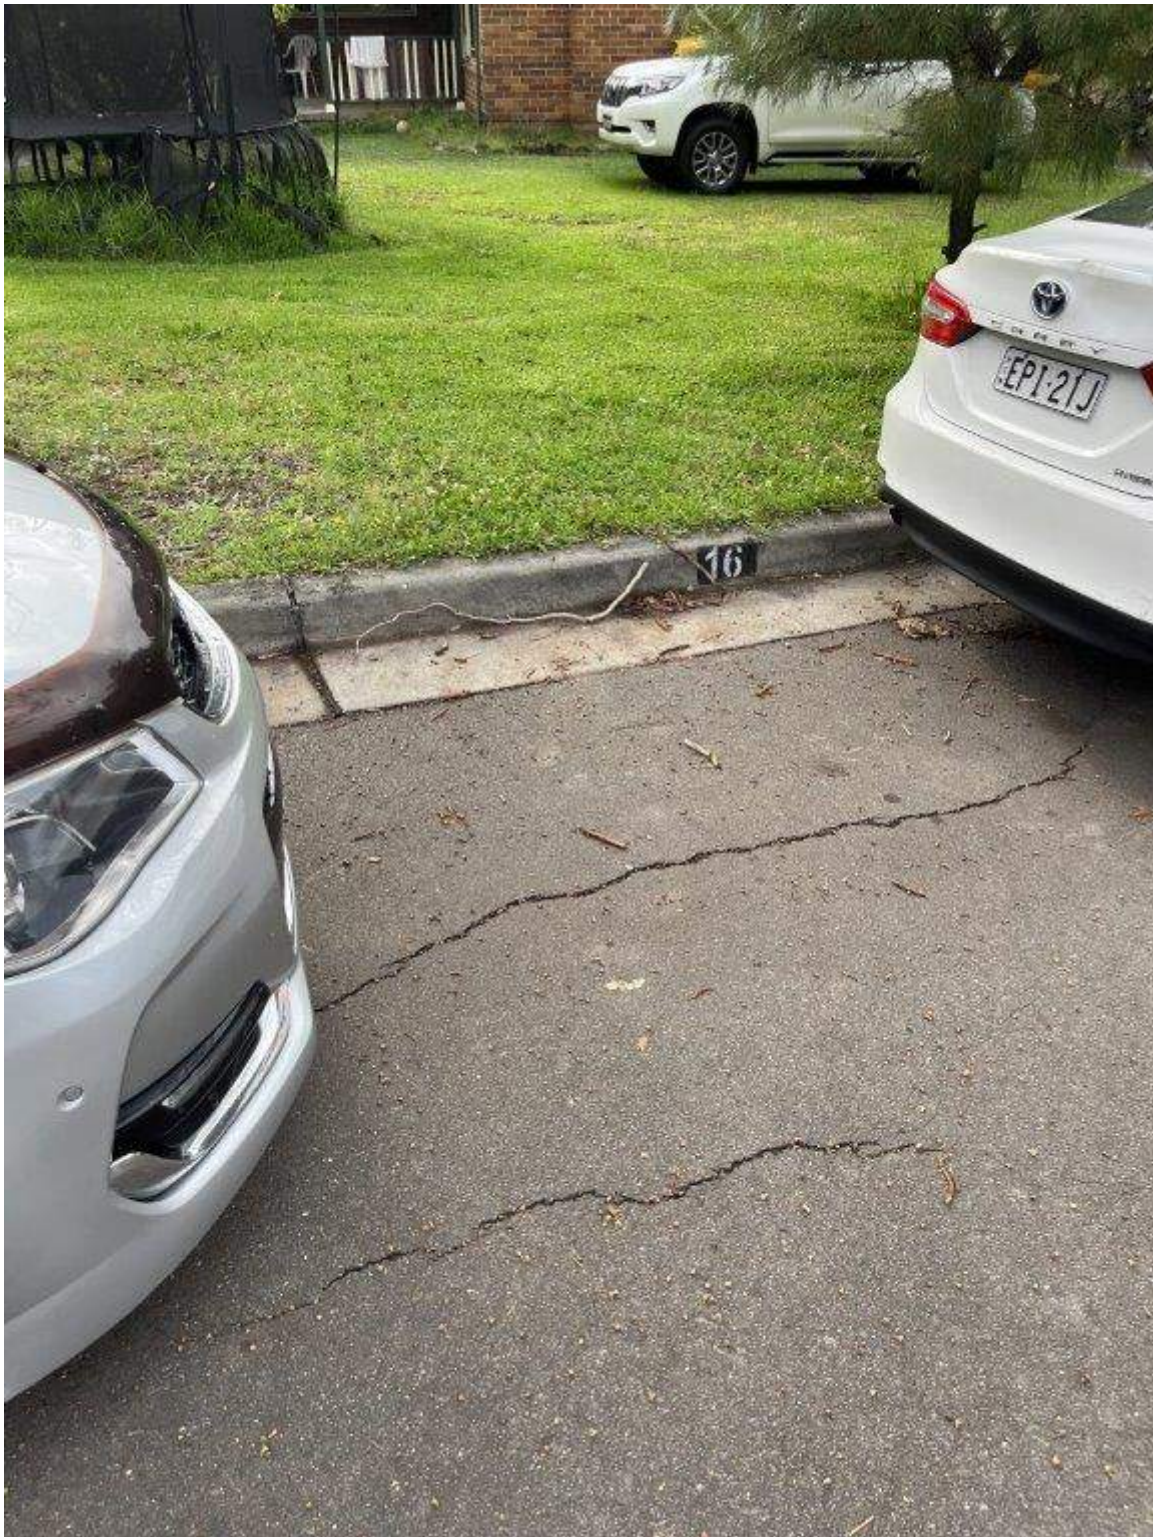
Photo 81 - Hinkler Avenue - Cracking of pavement

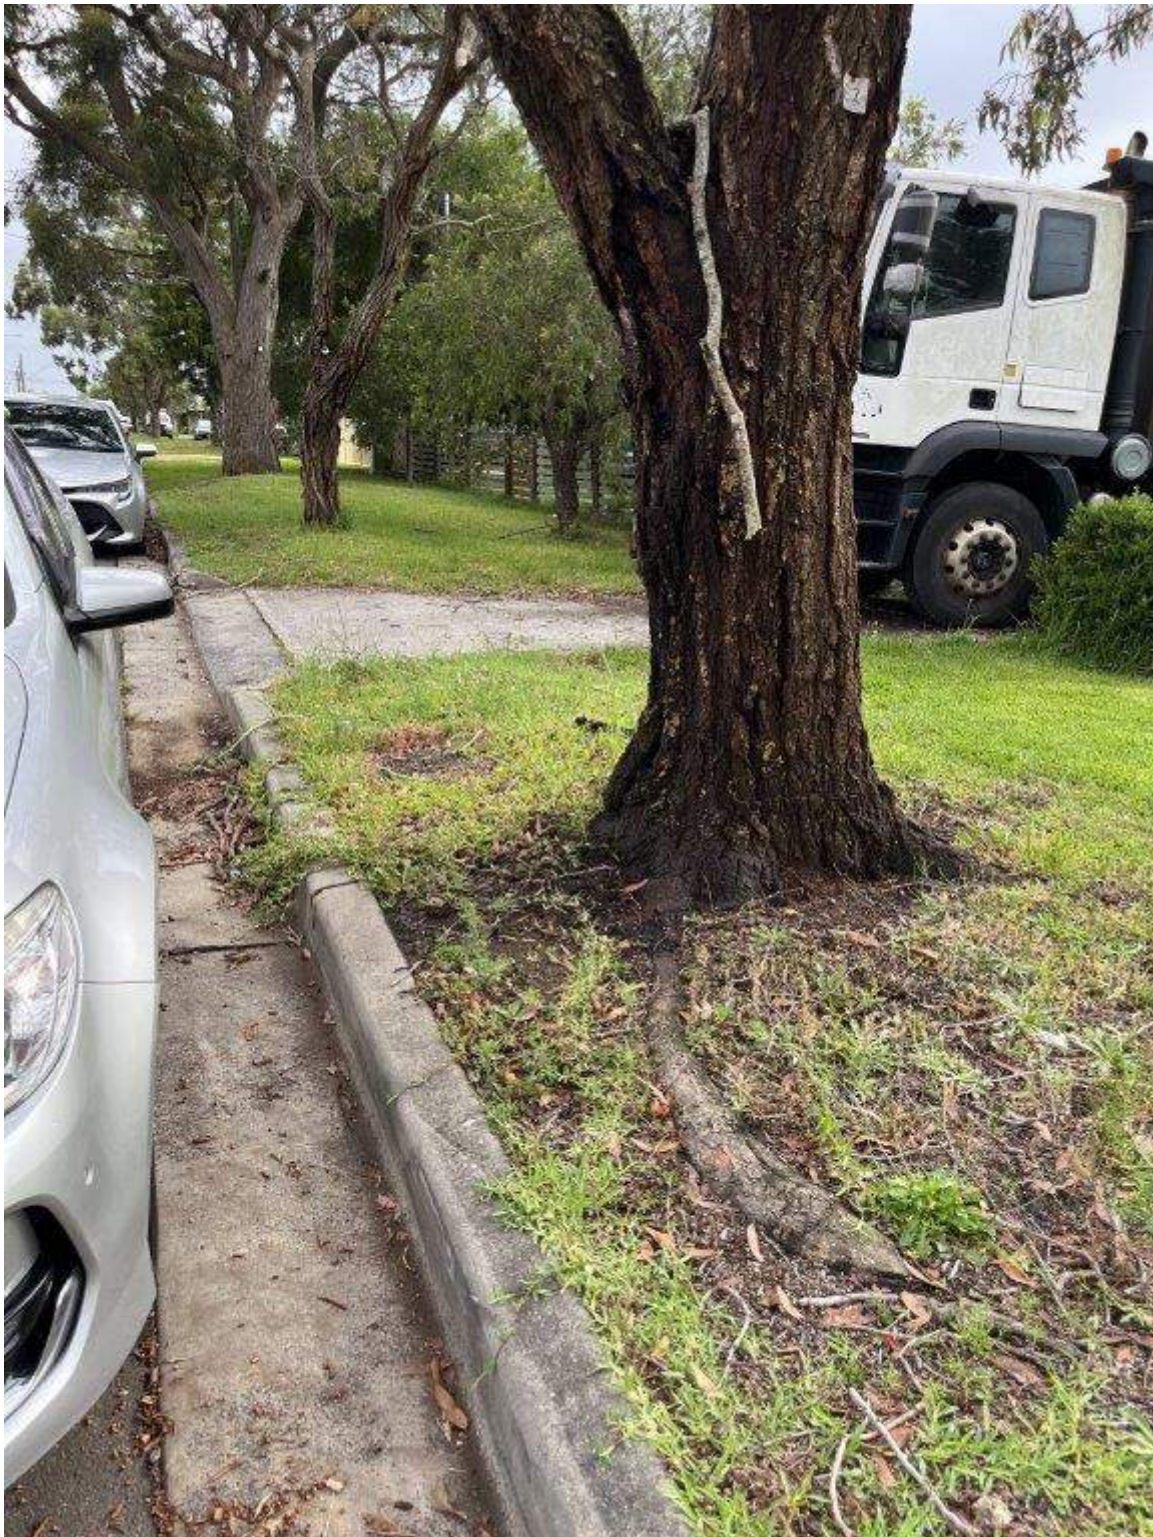
Photo 82 - Hinkler Avenue - Cracking of pavement

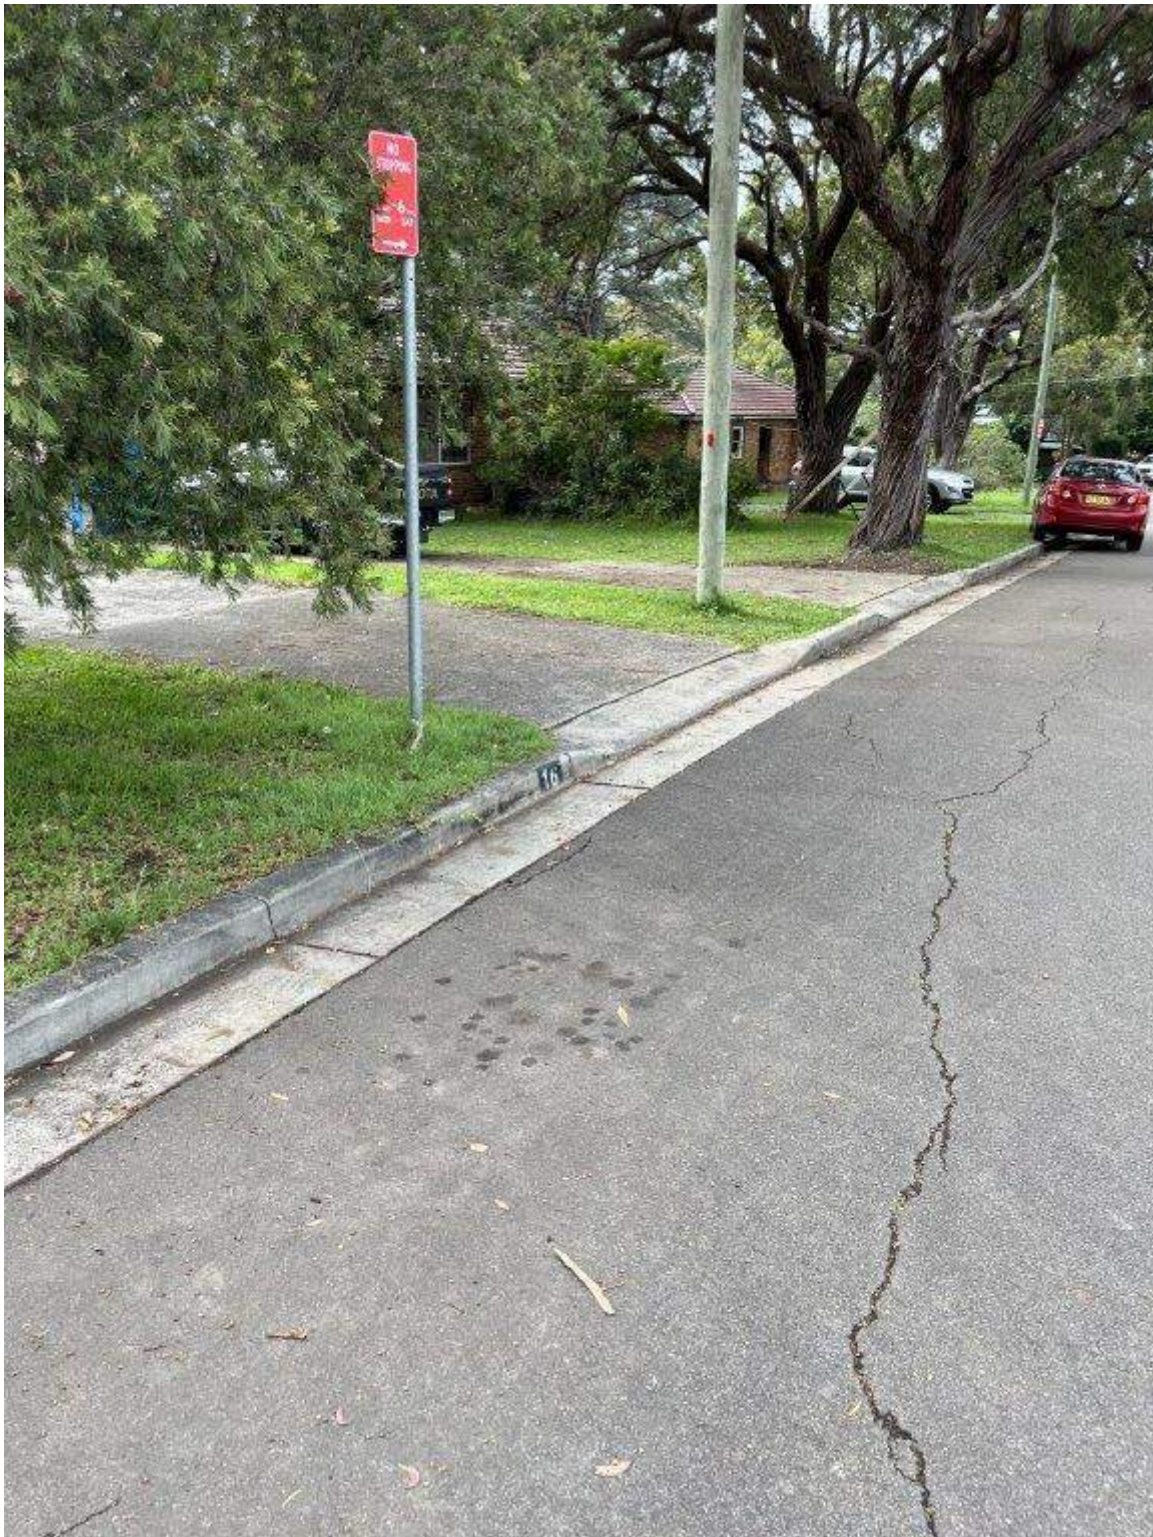
Photo 83 - Hinkler Avenue - Existing condition of pavement and vegetation

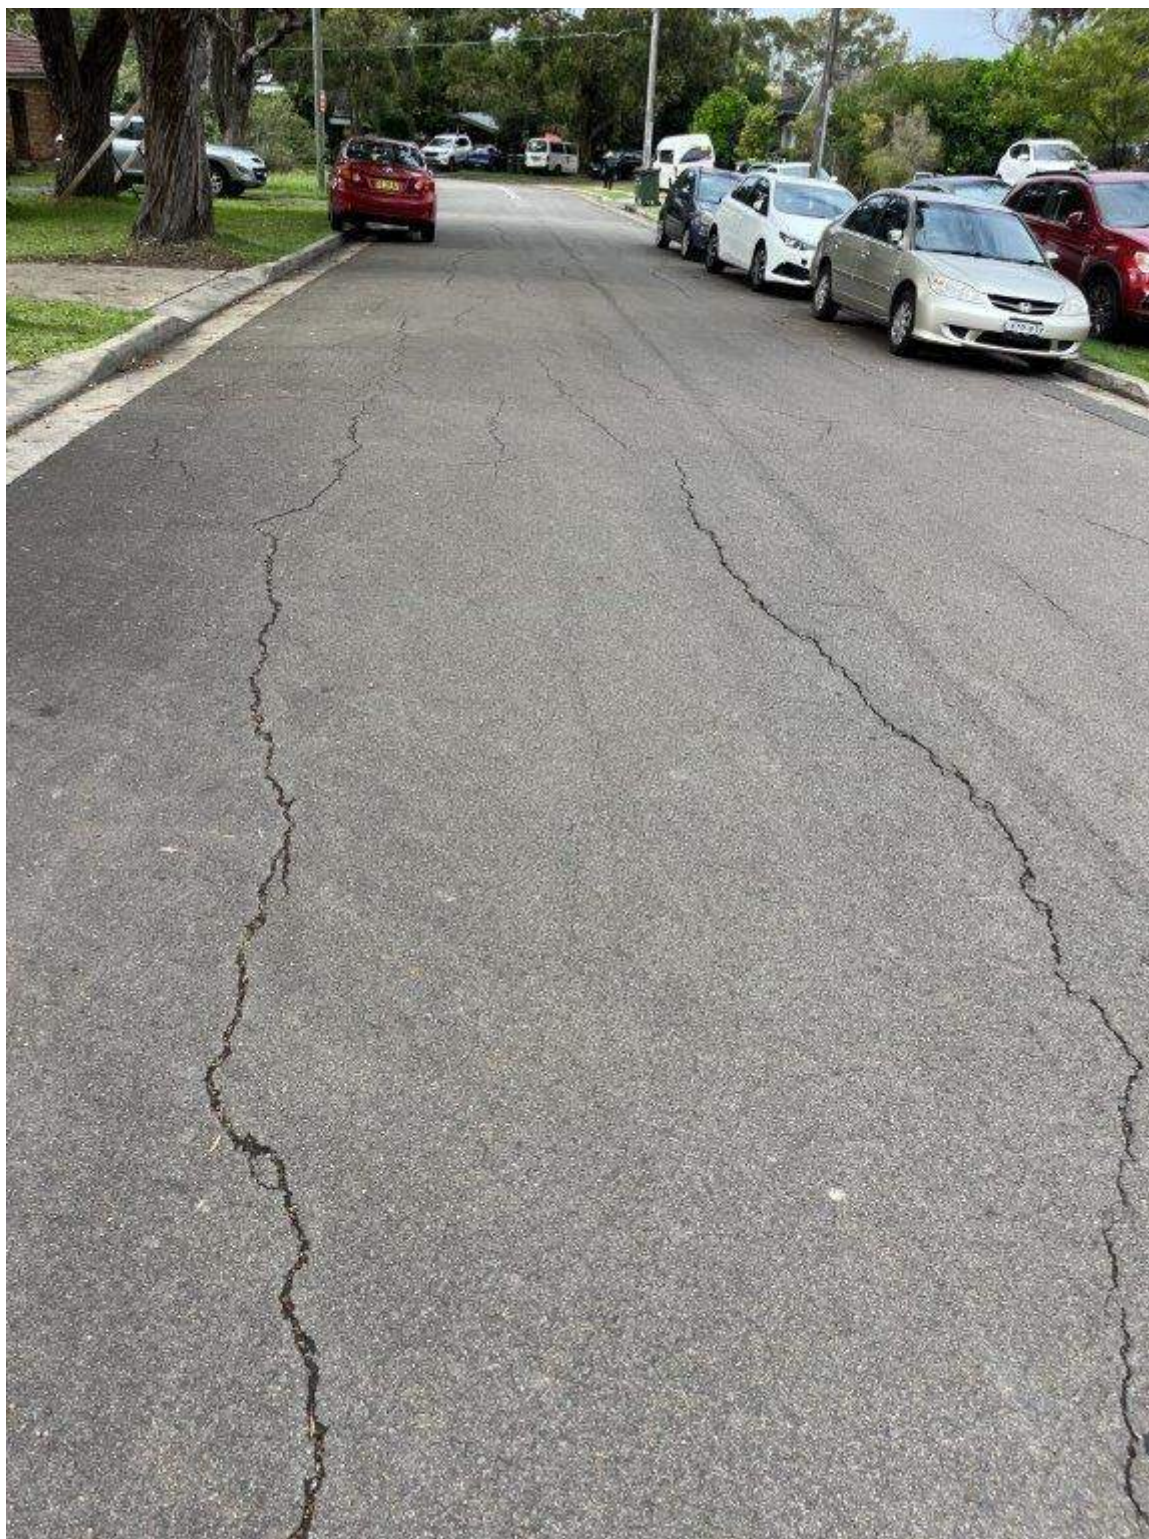
Photo 84 - Hinkler Avenue - Cracking of pavement

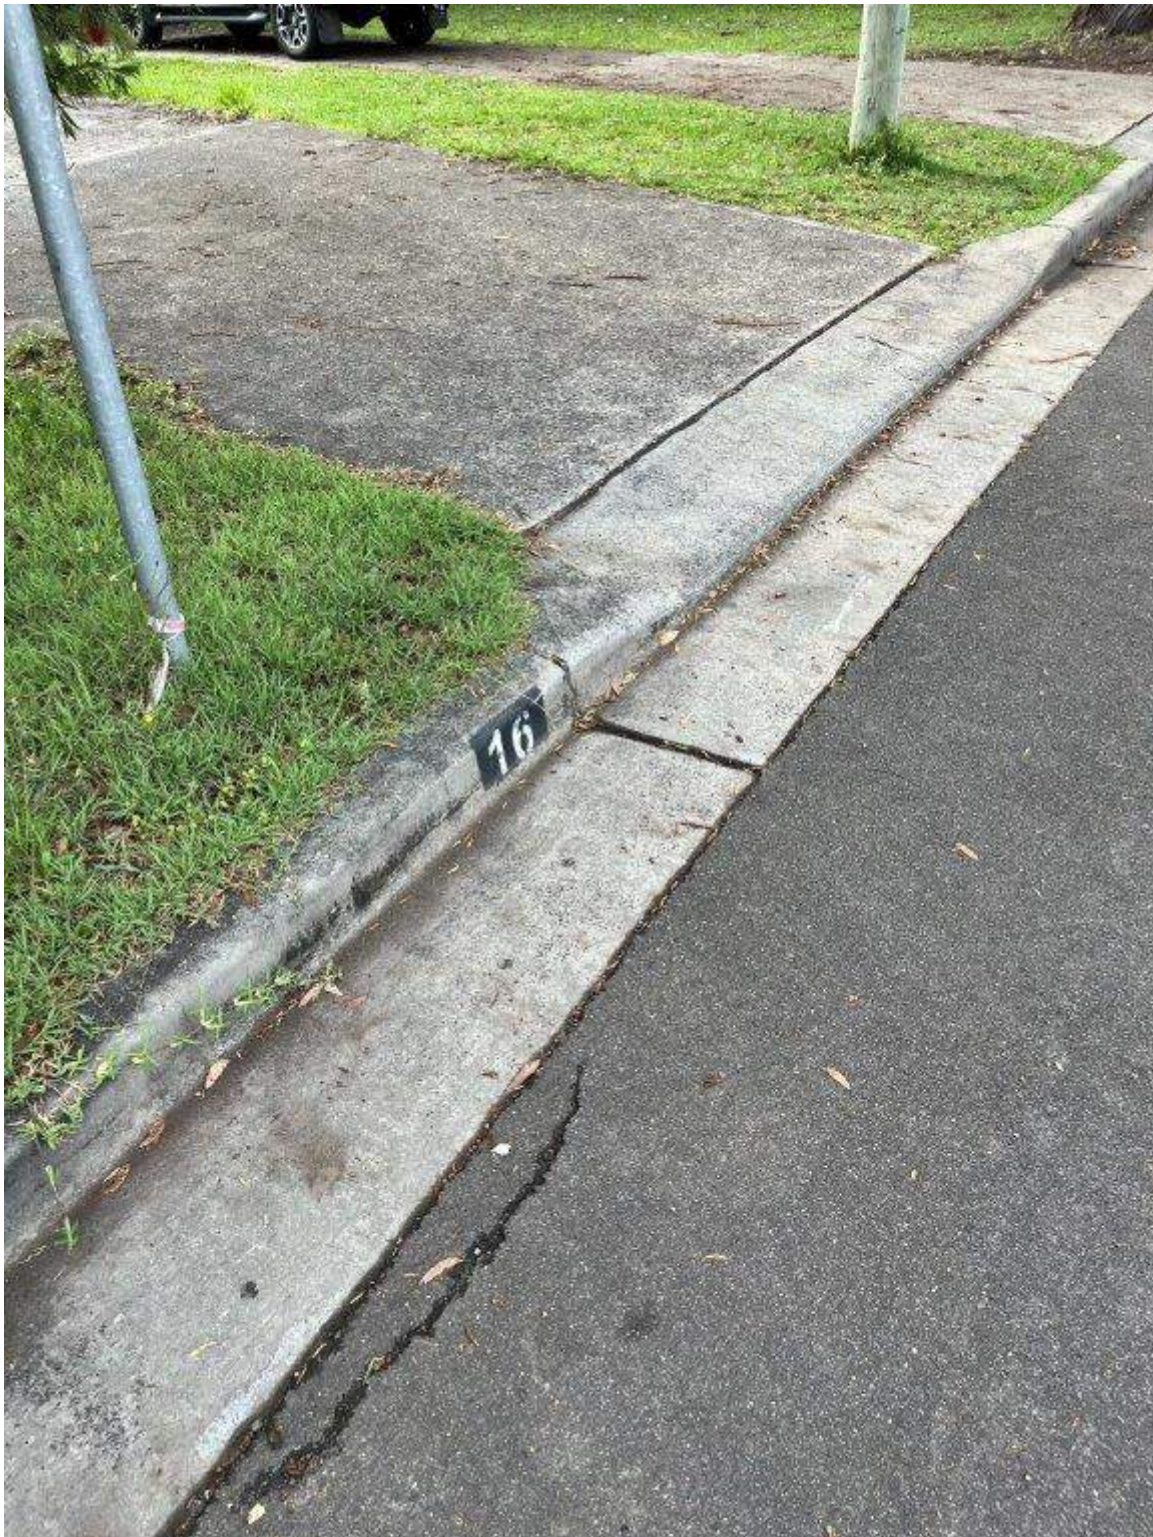
Photo 85 - Hinkler Avenue - Cracking of pavement

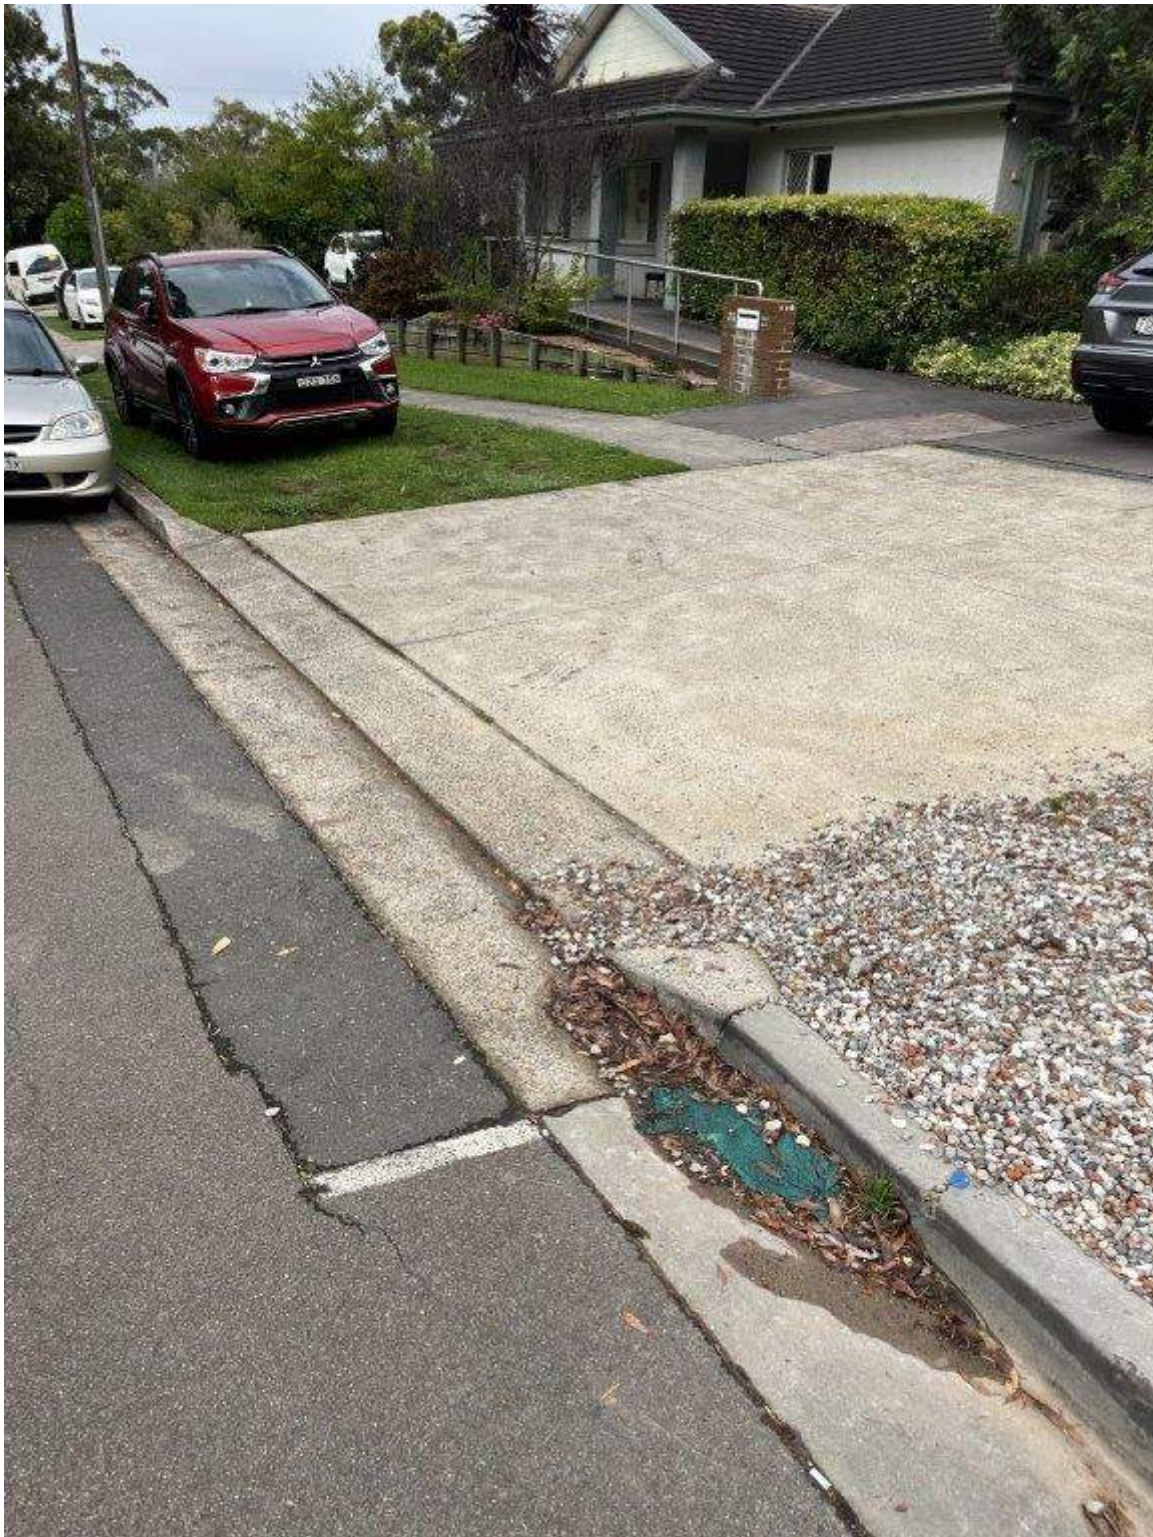
Photo 86 - Hinkler Avenue - Existing condition of pavement
