## PRE-CONSTRUCTION DILAPIDATION REPORT

### 6-20 HINKLER AVENUE & 319-333 TAREN POINT ROAD, CARINGBAH

| PRE-CONSTRUCTION DILAPIDATION REPORT<br>6-20 Hinkler Avenue & 319-333 Taren Point Road,<br>Caringbah NSW 2229 | | | | | Project Number: 21039 |

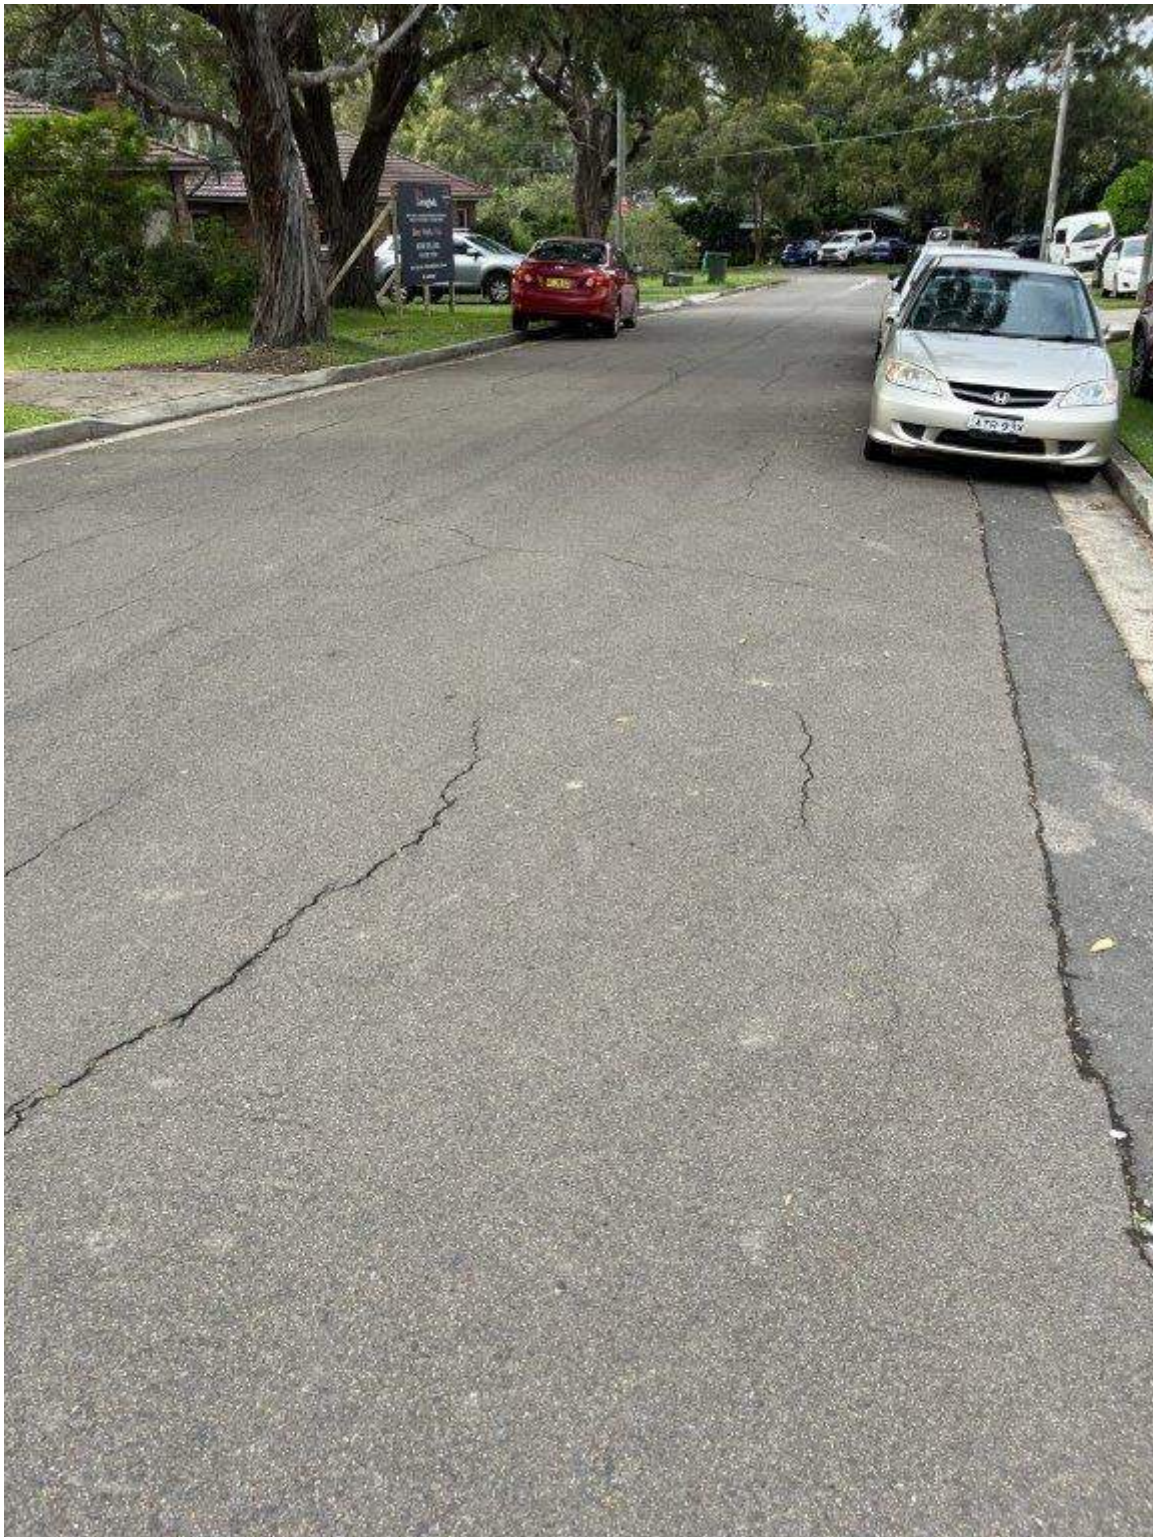
Photo 87 - Hinkler Avenue - Existing condition of pavement

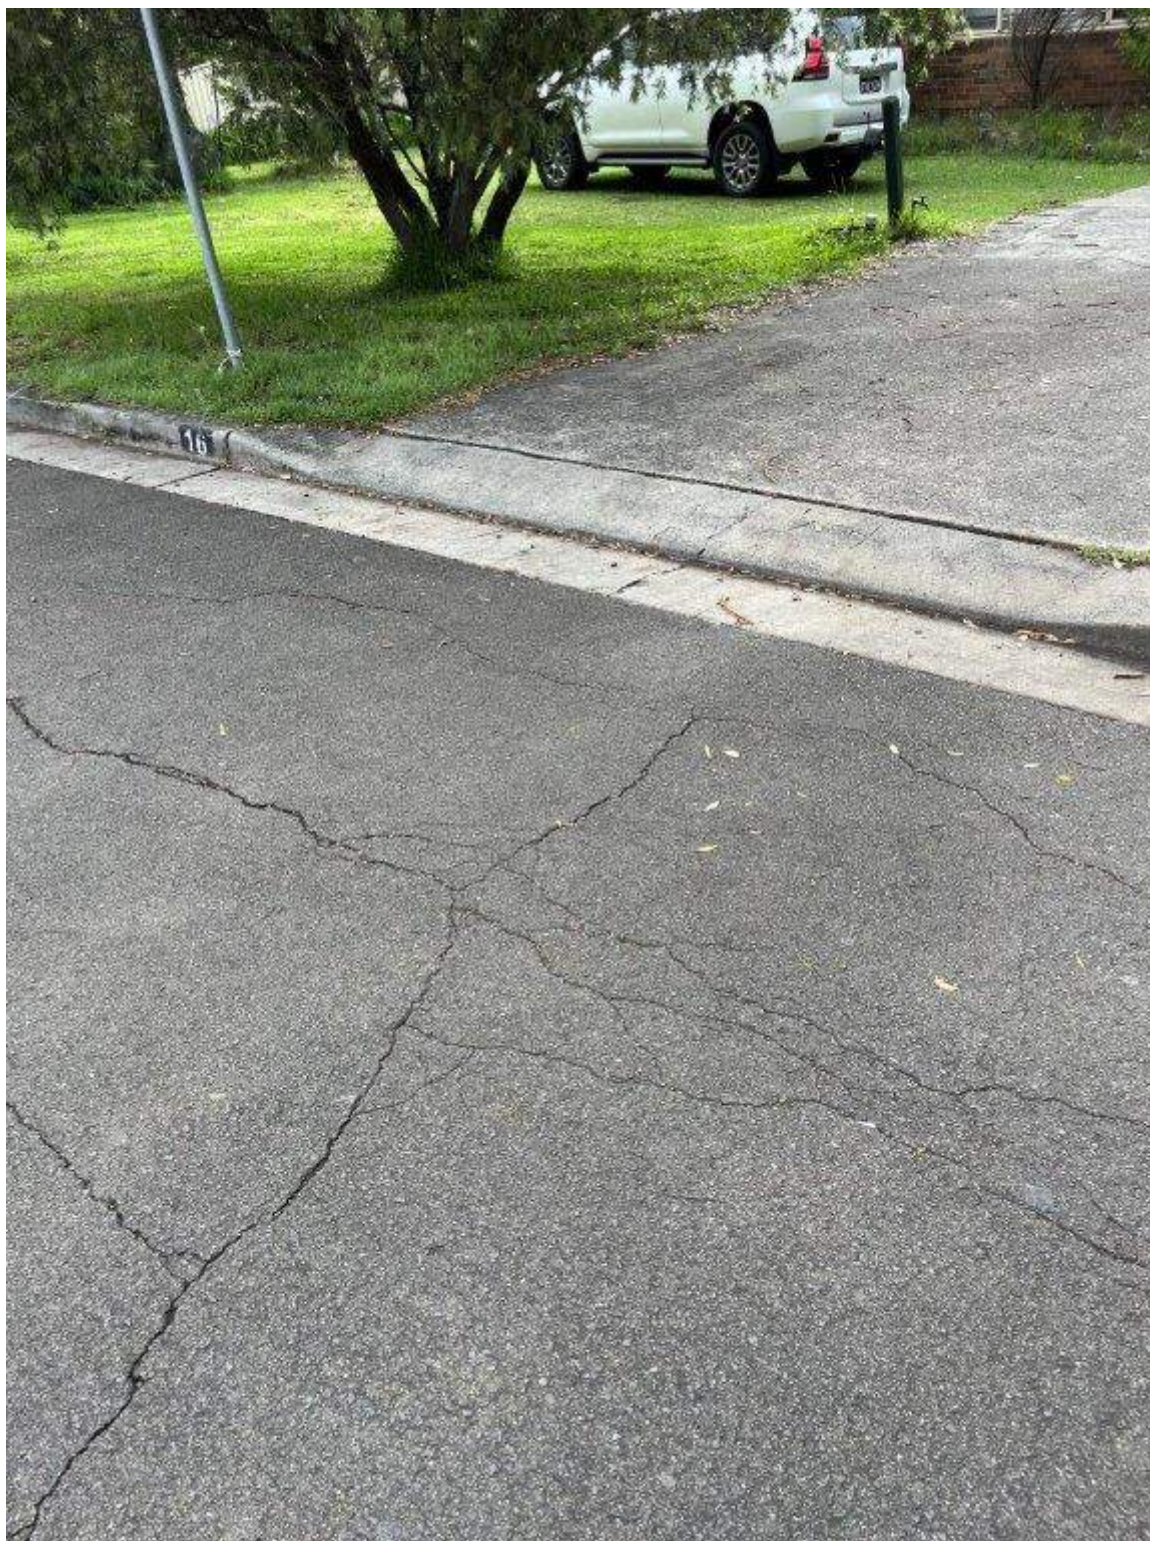
Photo 88 - Hinkler Avenue - Cracking of pavement

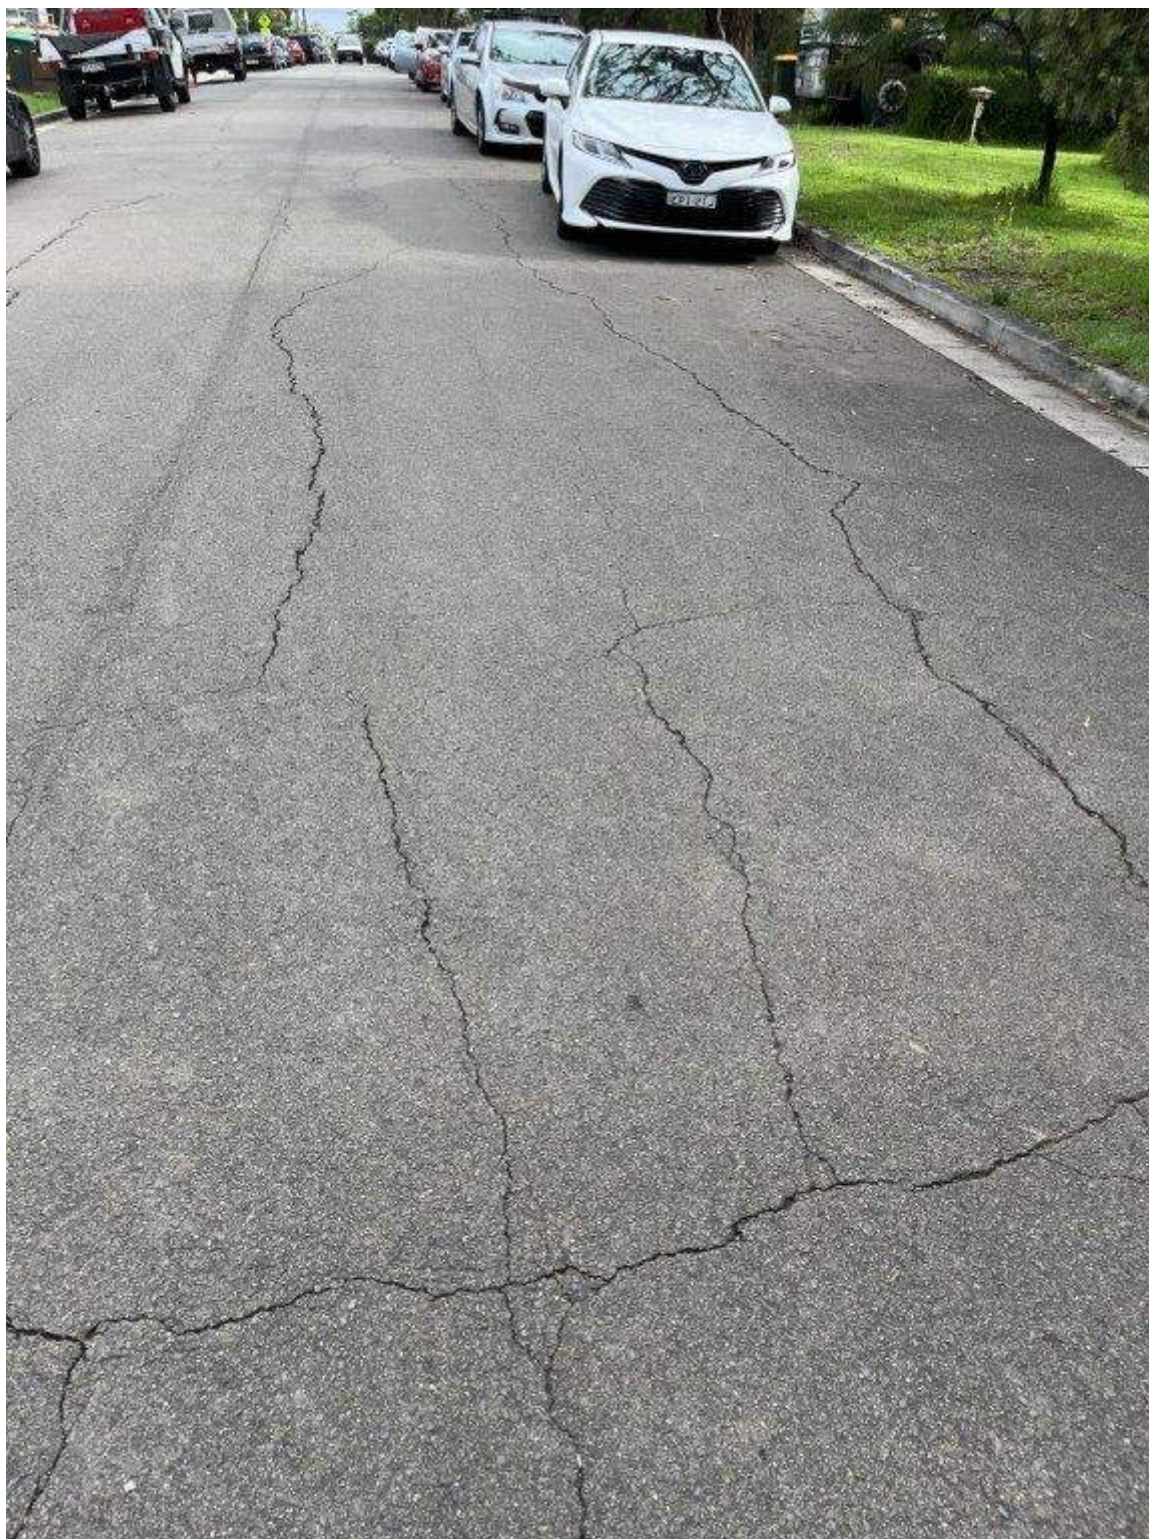
Photo 89 - Hinkler Avenue - Cracking of pavement

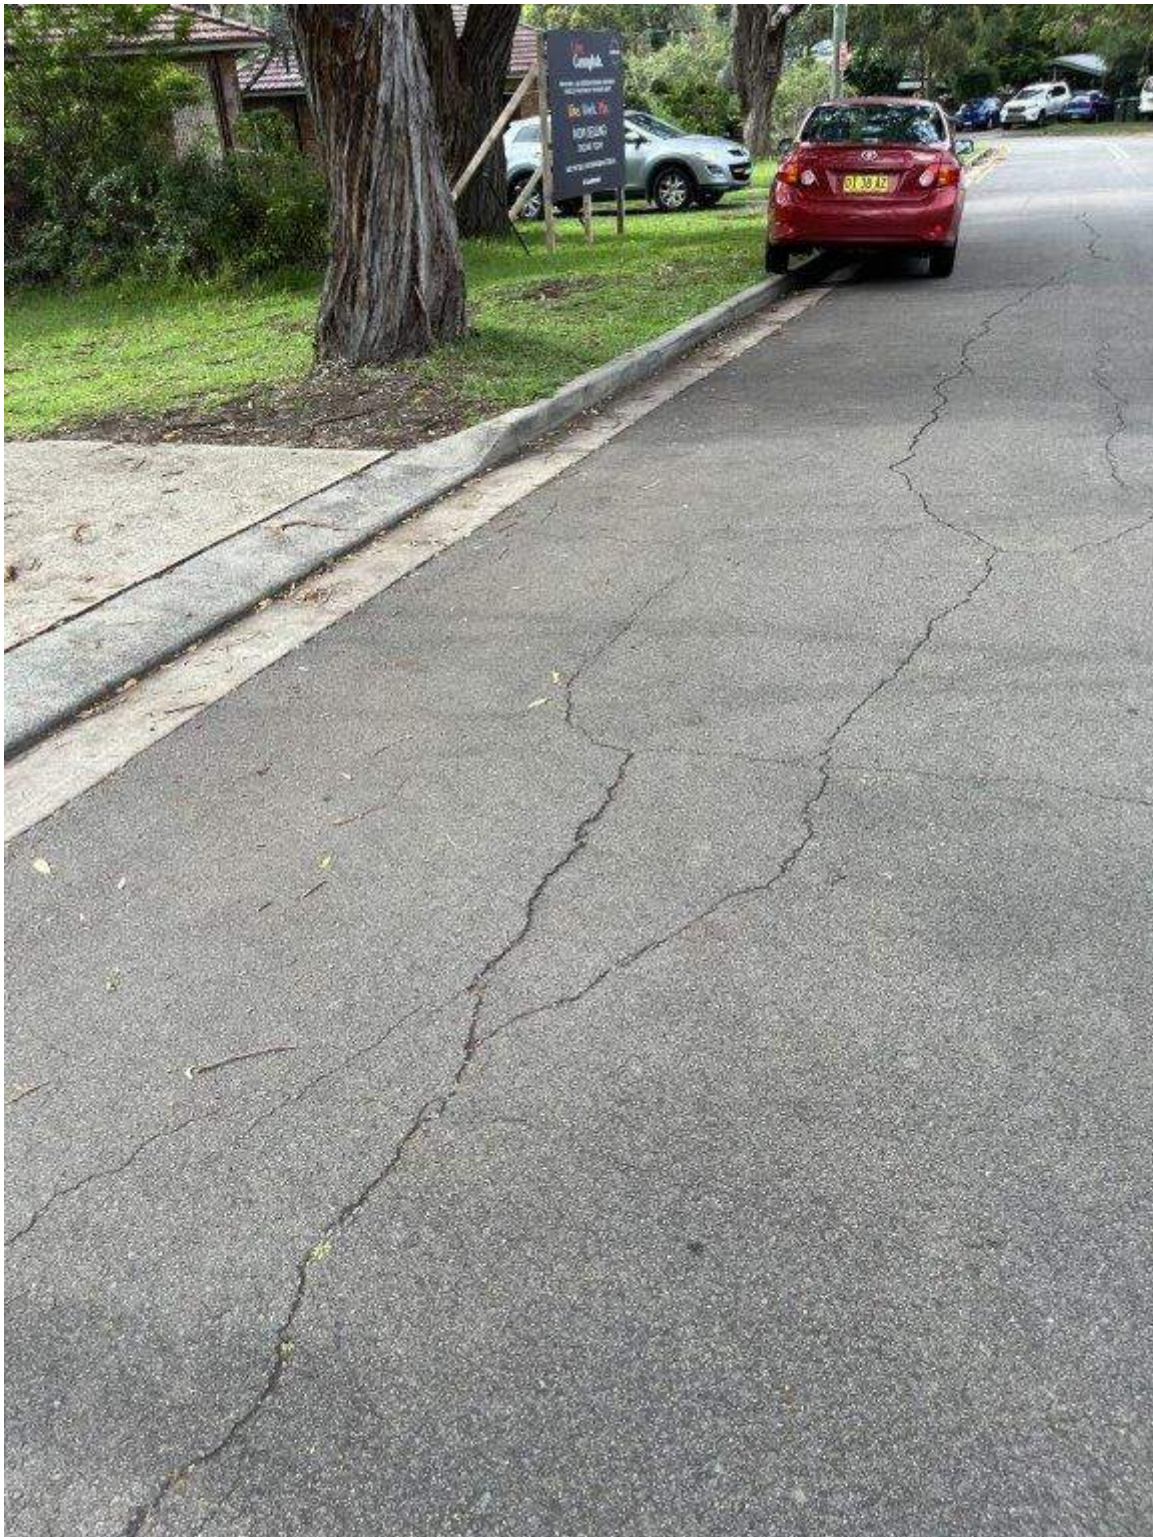
Photo 90 - Hinkler Avenue - Cracking of pavement

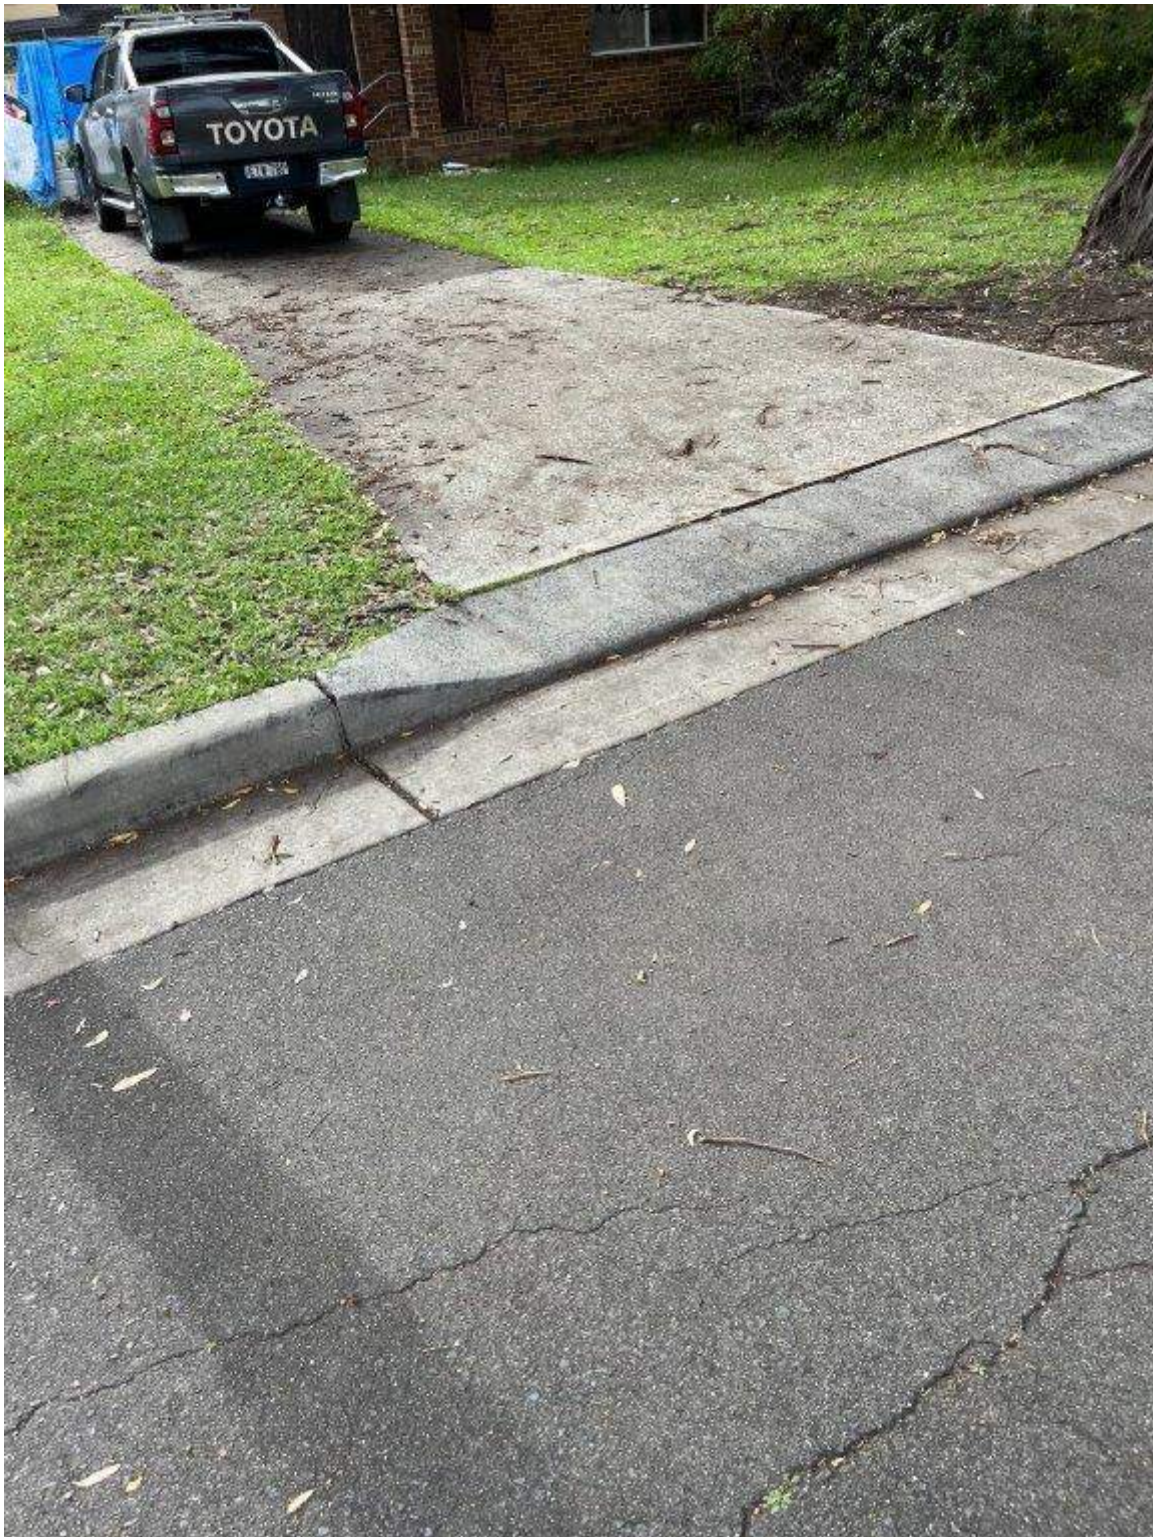
Photo 91 - Hinkler Avenue - Cracking of pavement

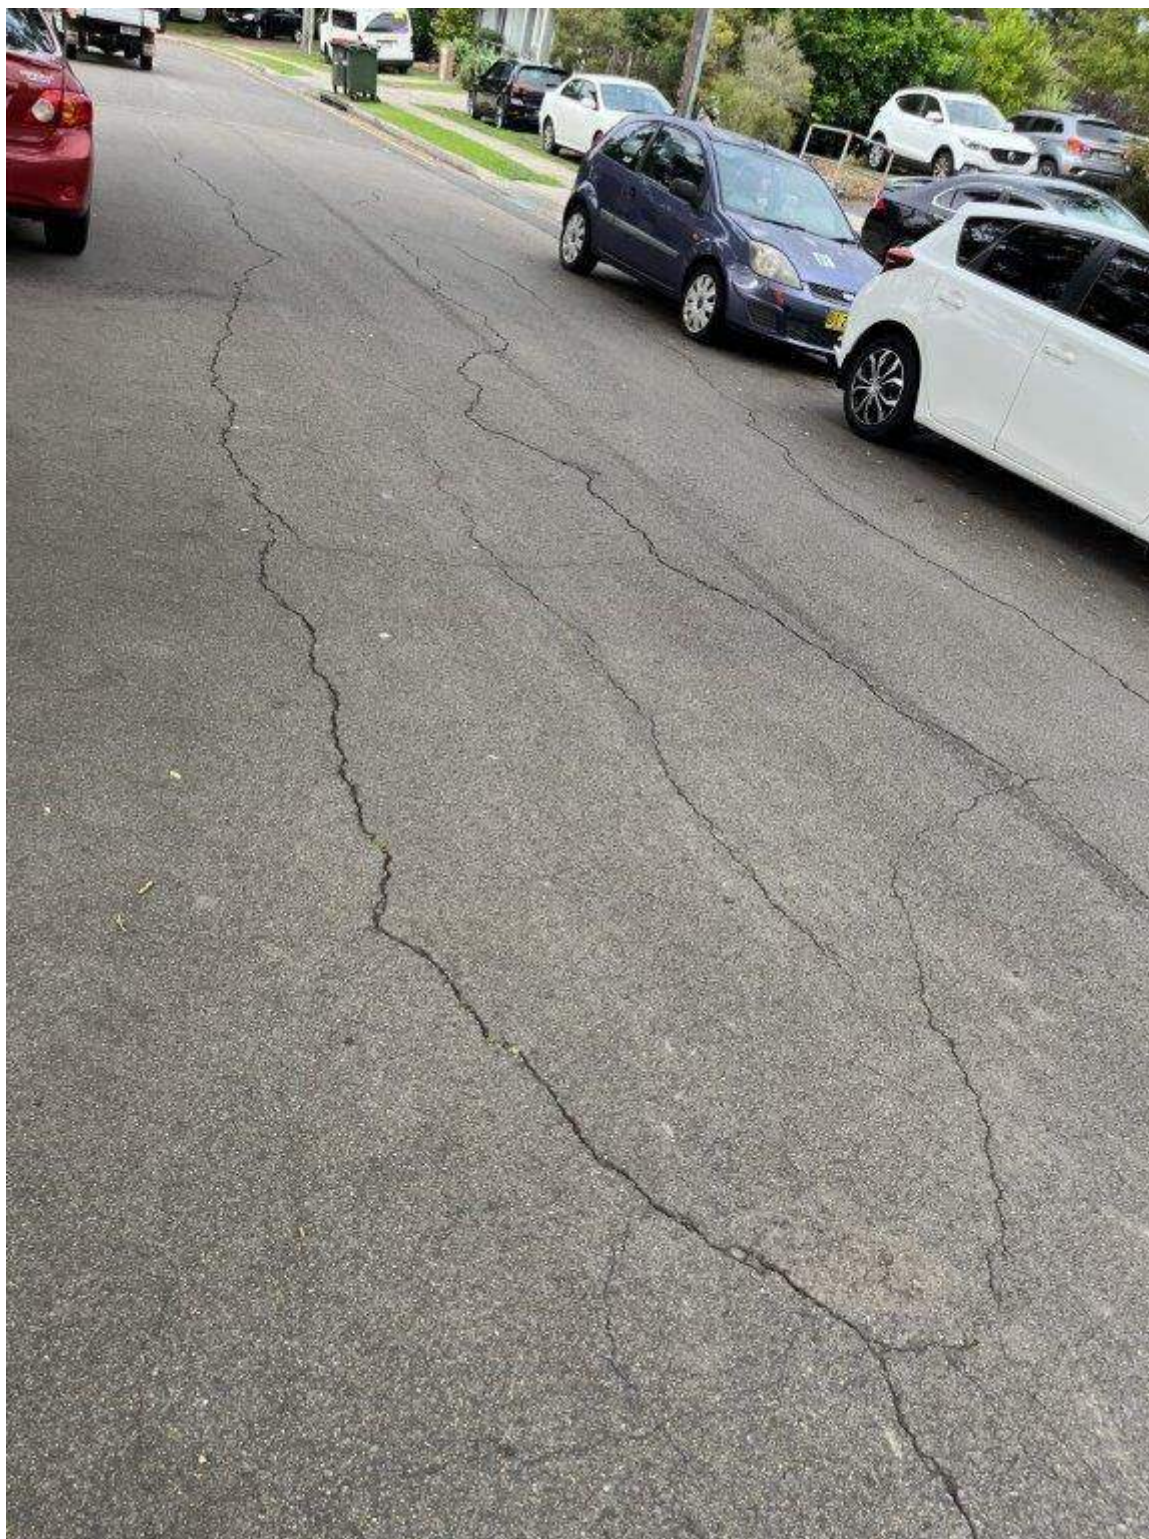
Photo 92 - Hinkler Avenue - Cracking of pavement

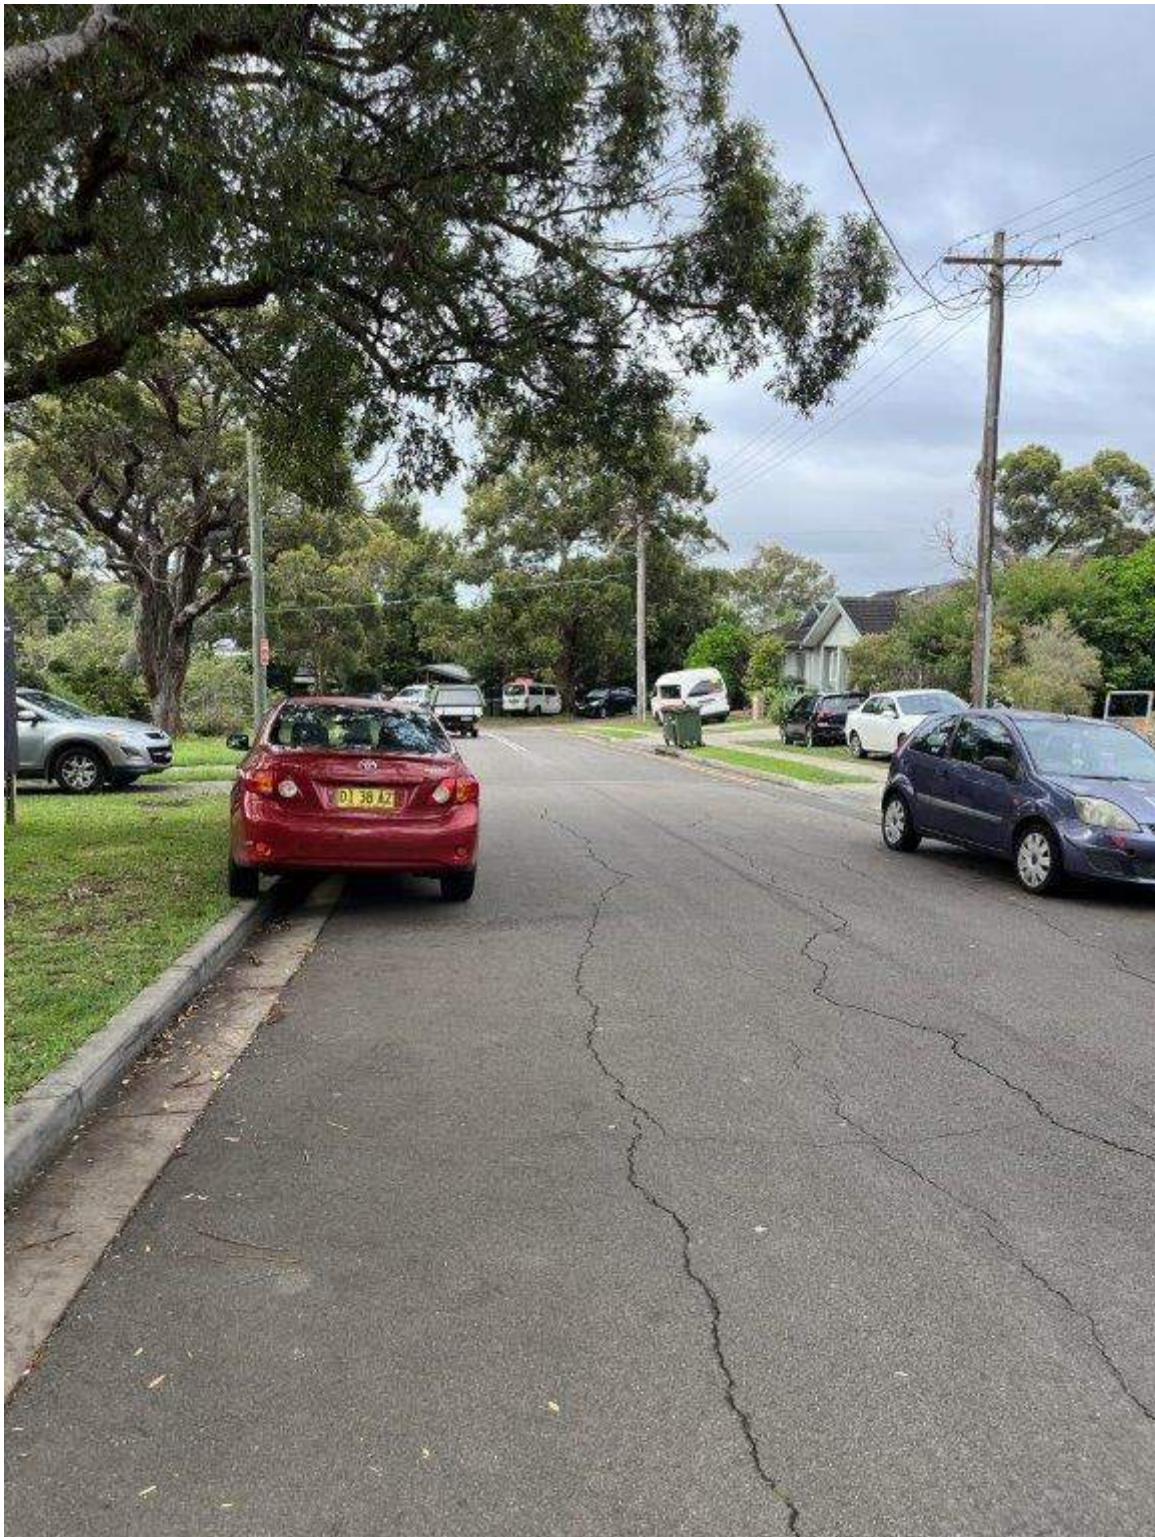
Photo 93 - Hinkler Avenue - Cracking of pavement

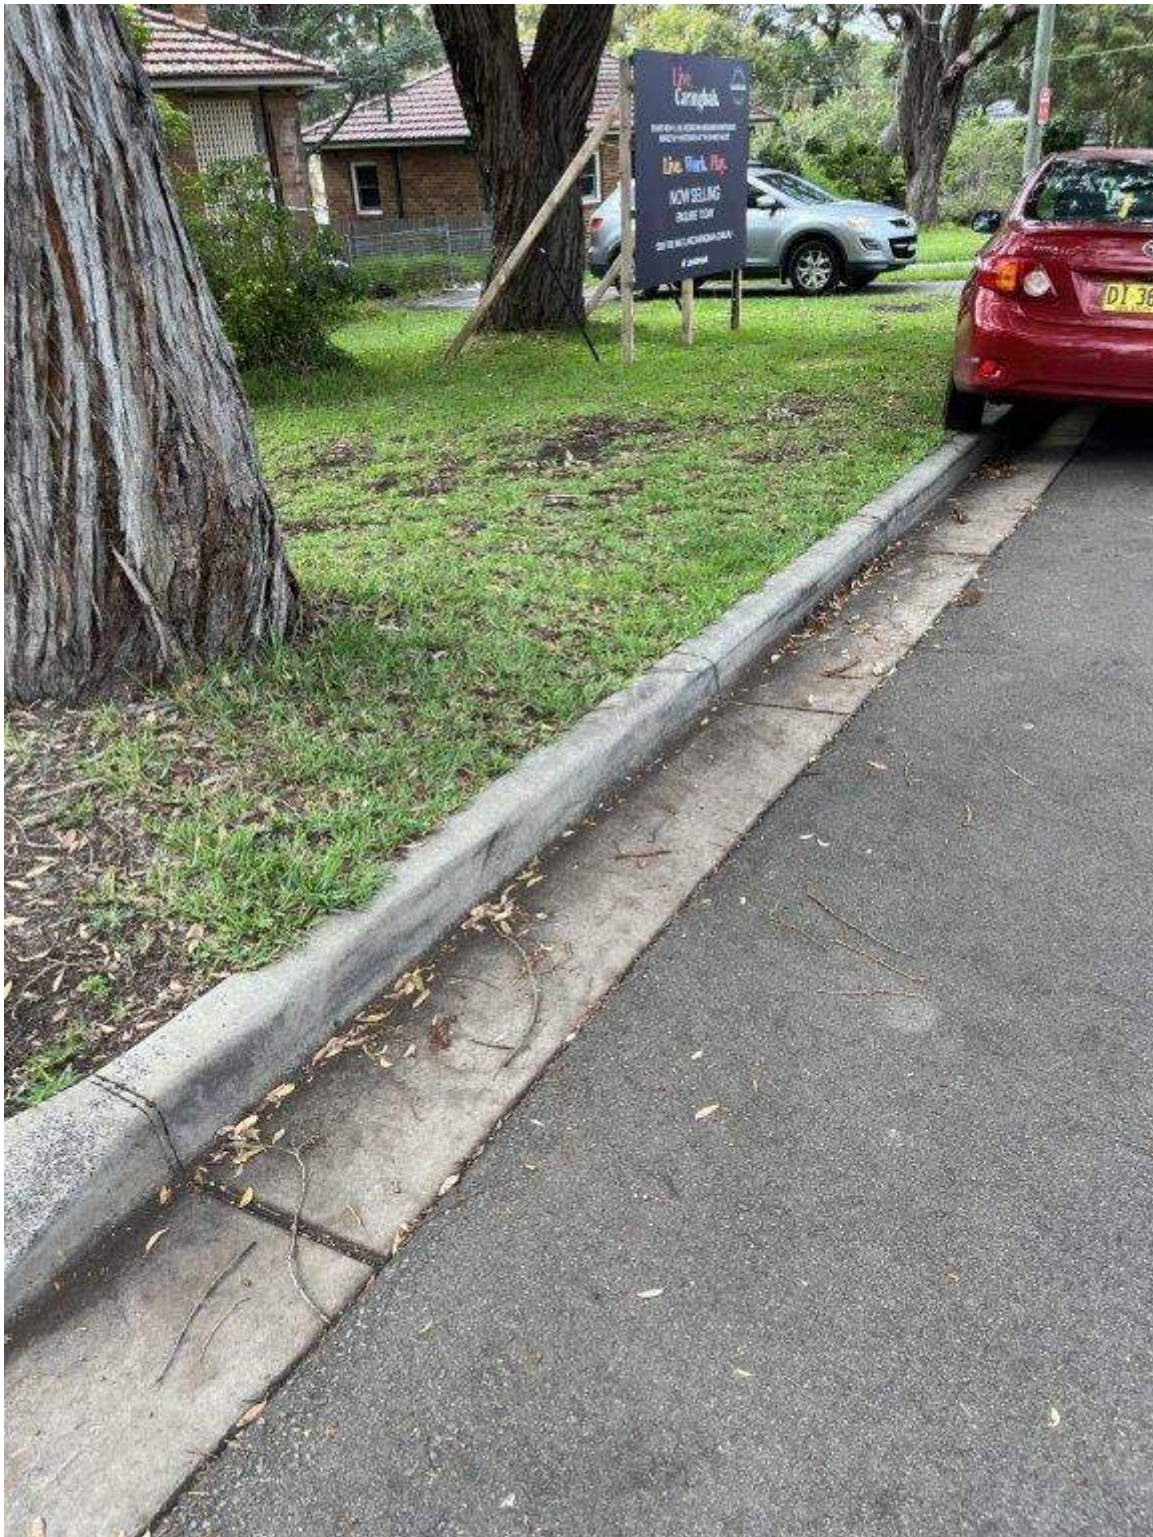
Photo 94 - Hinkler Avenue - Cracking of pavement

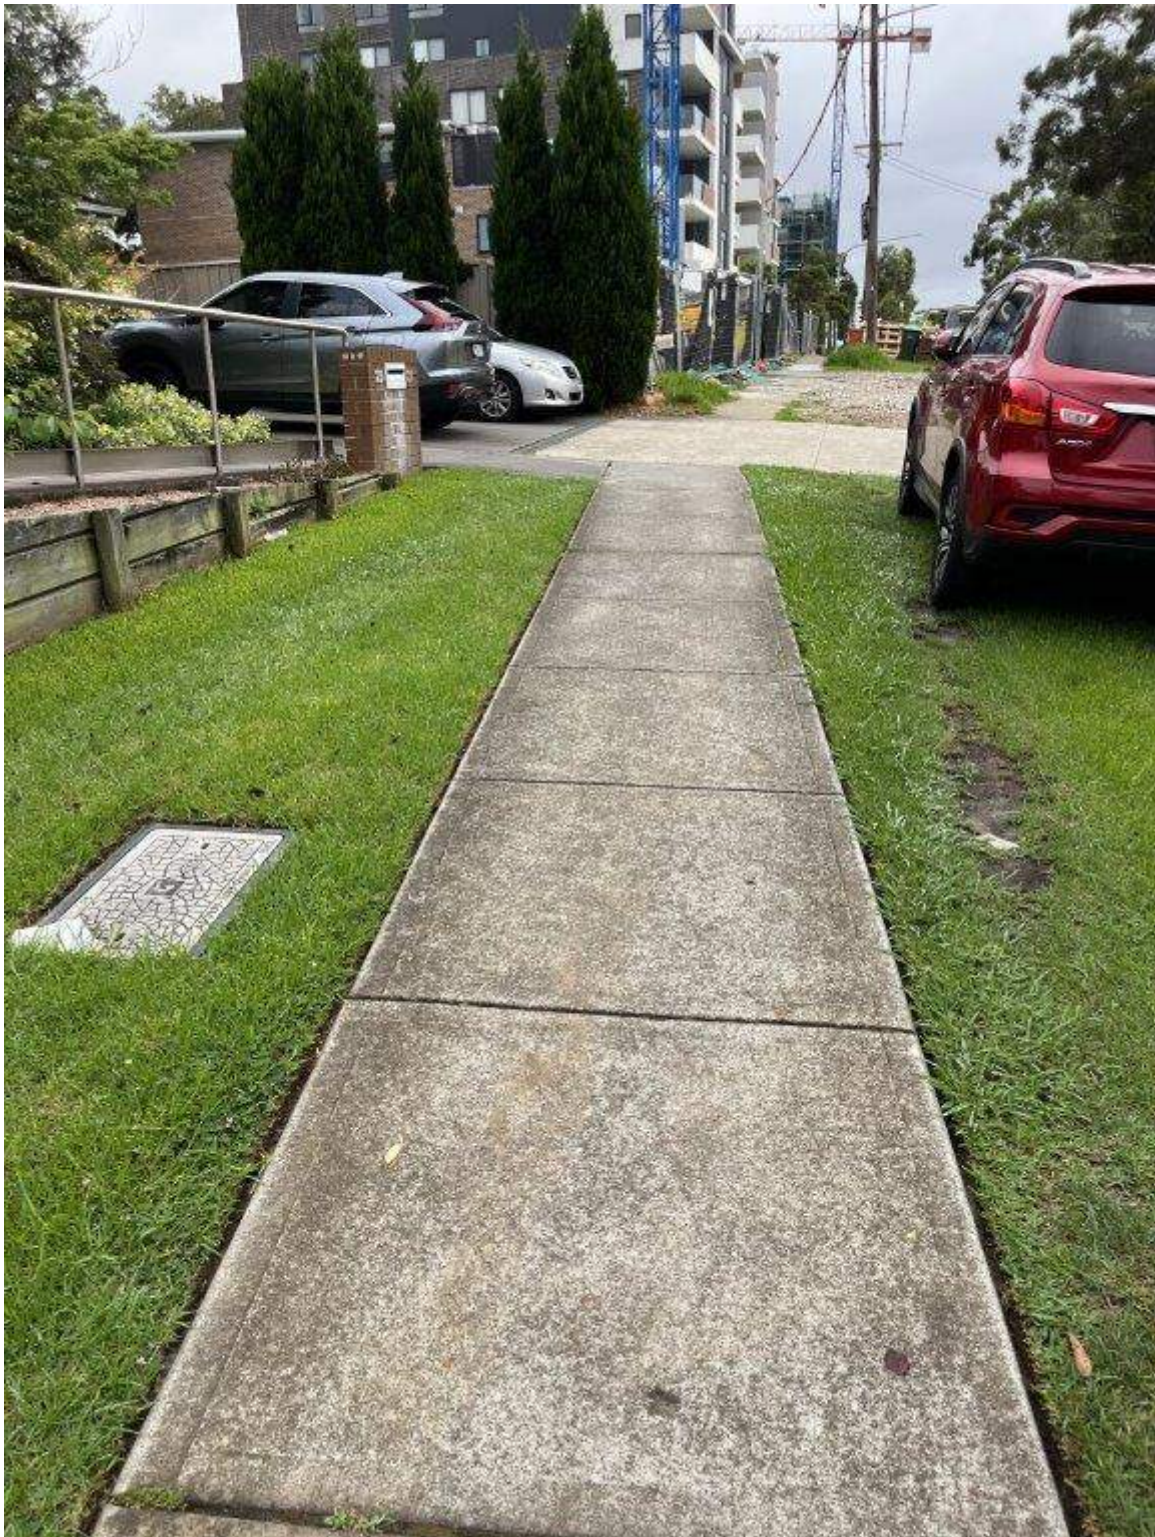
Photo 95 - Hinkler Avenue - Existing condition of pavement and vegetation

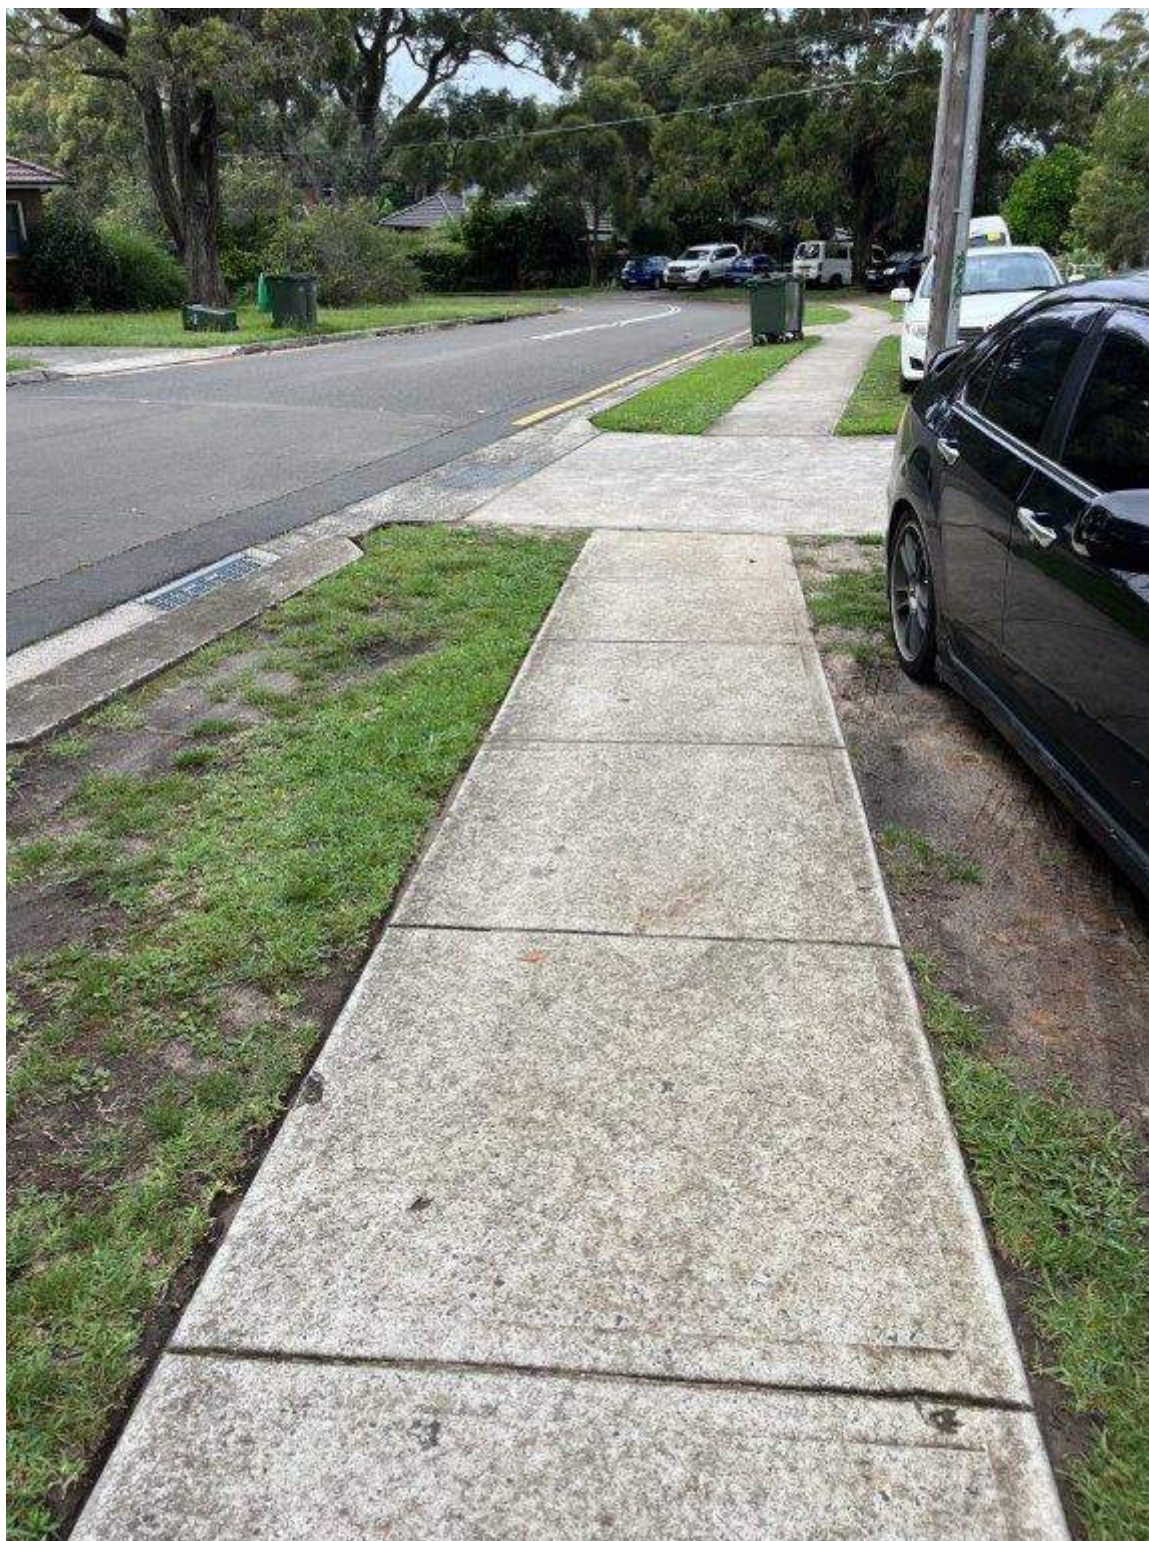
Photo 96 - Hinkler Avenue - Existing condition of pavement

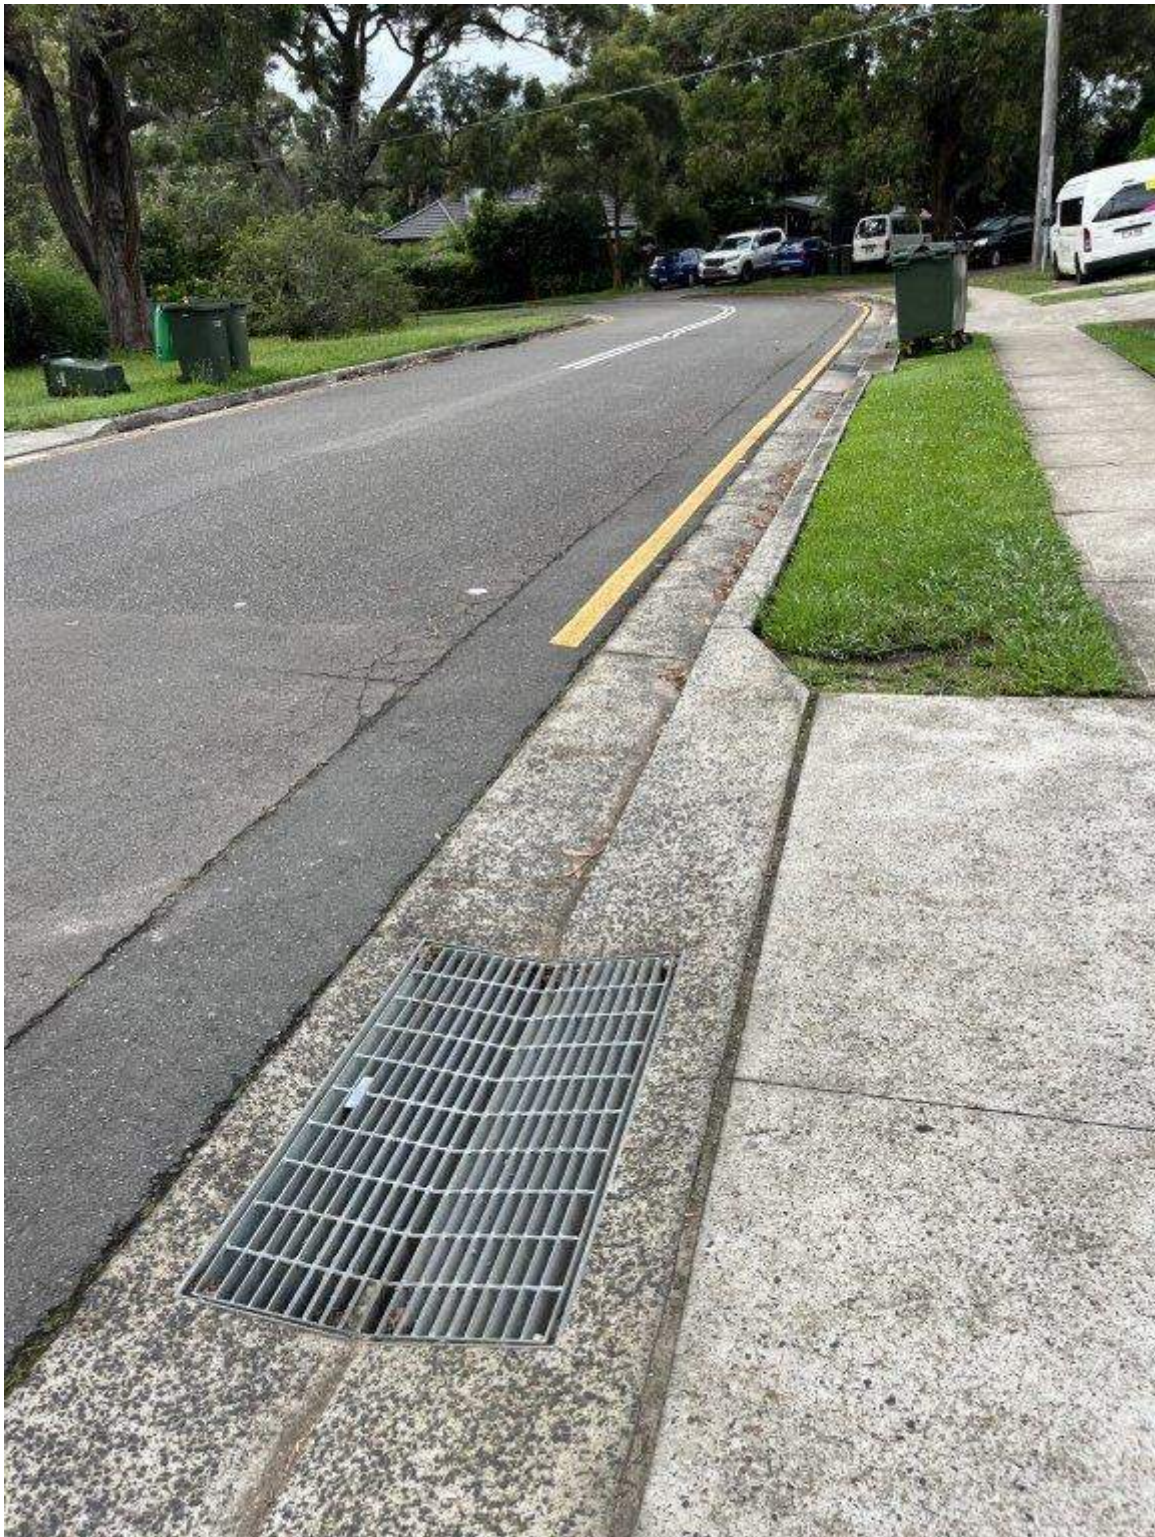
Photo 97 - Hinkler Avenue - Existing condition of pavement

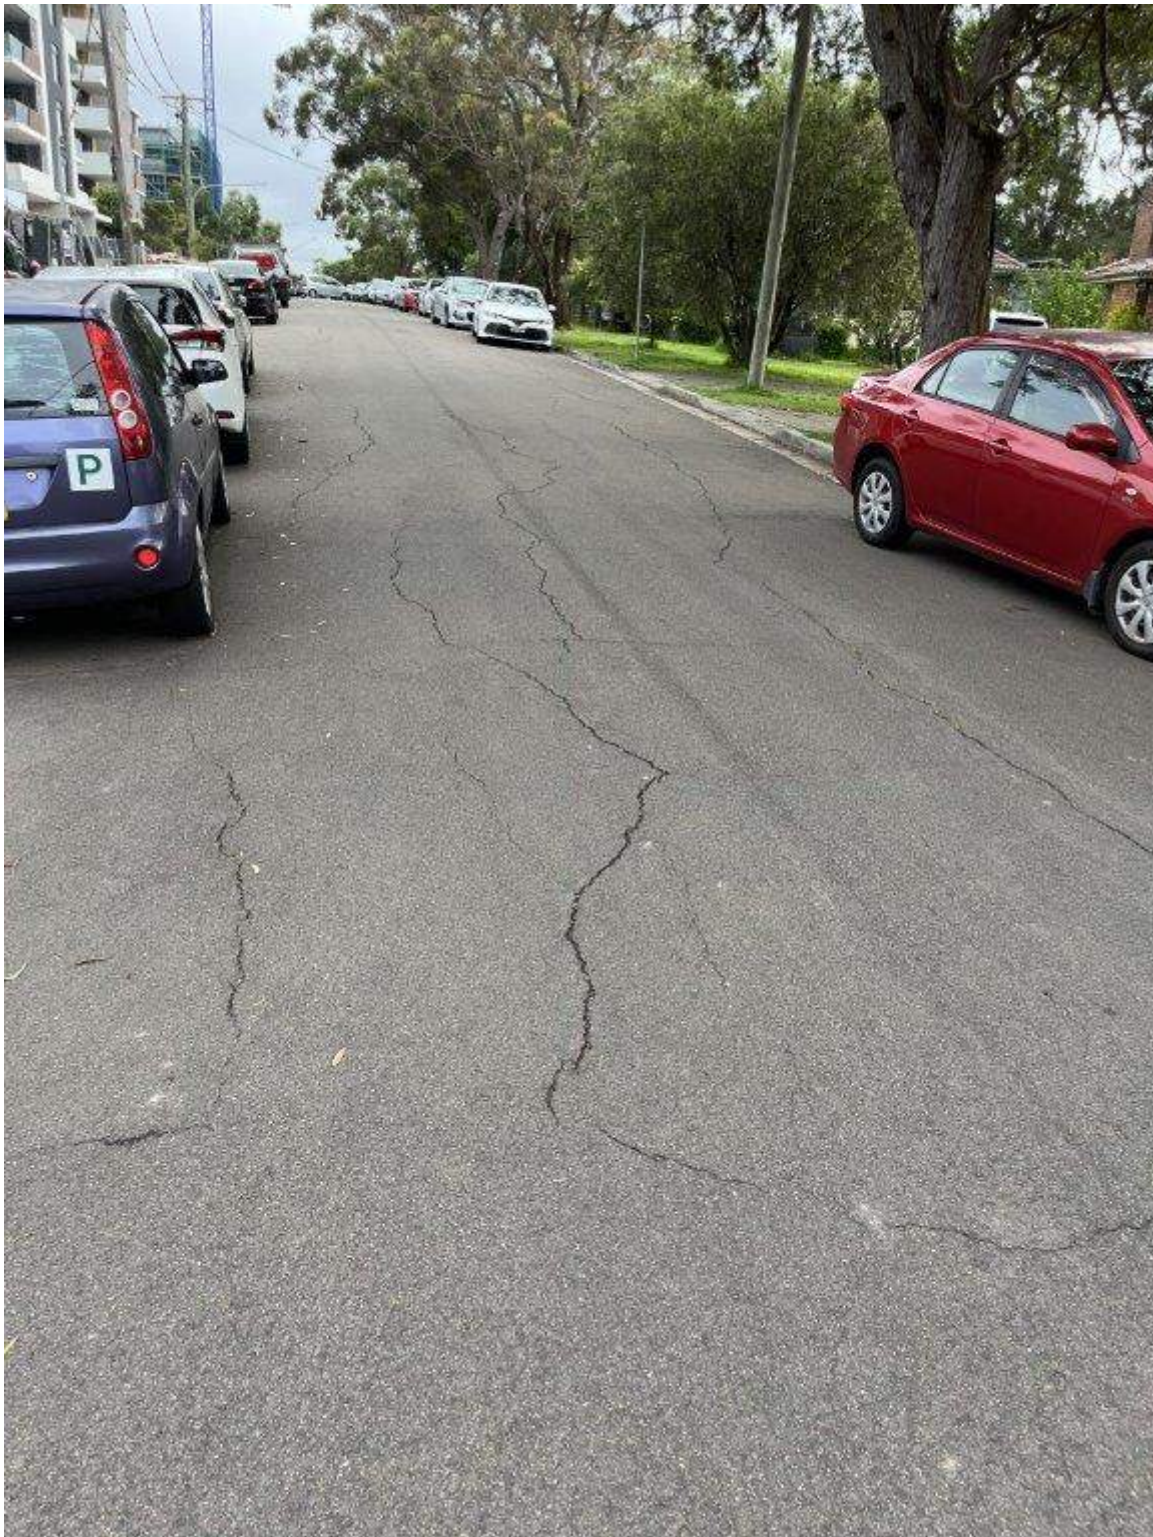
Photo 98 - Hinkler Avenue - Existing condition of steel grate and pavement

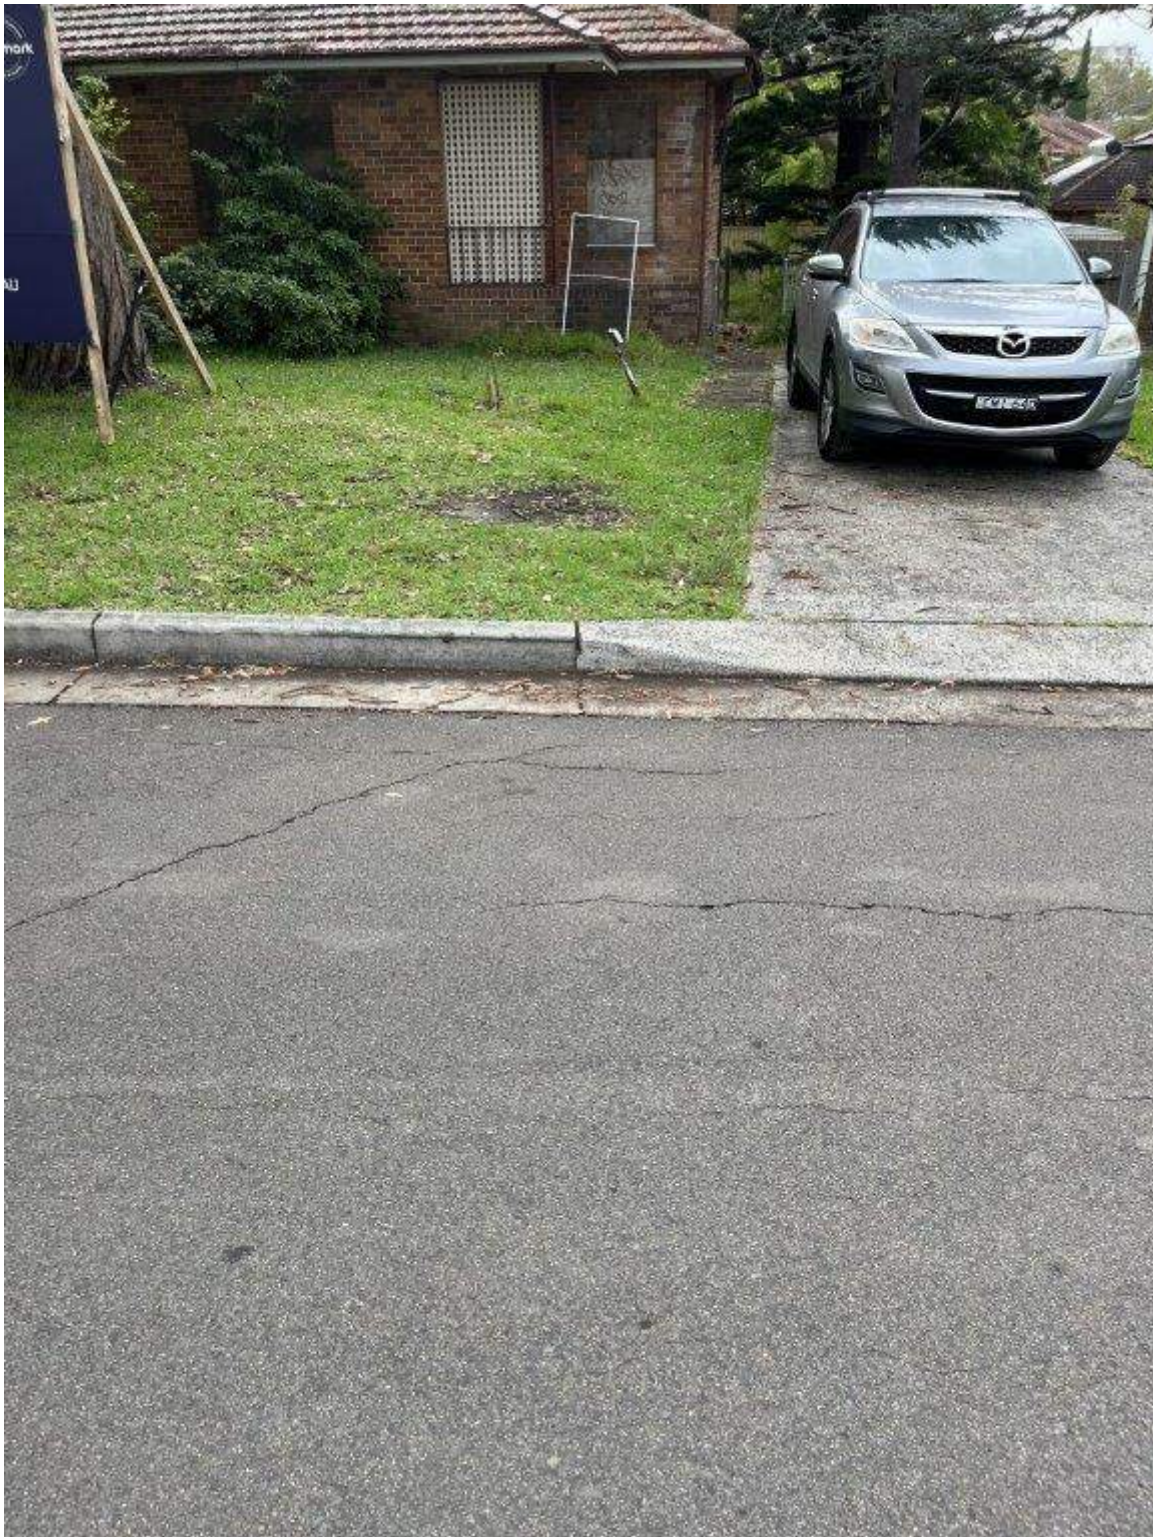
Photo 99 - Hinkler Avenue - Cracking of pavement
