## PRE-CONSTRUCTION DILAPIDATION REPORT

### 6-20 HINKLER AVENUE & 319-333 TAREN POINT ROAD, CARINGBAH

| PRE-CONSTRUCTION DILAPIDATION REPORT<br>6-20 Hinkler Avenue & 319-333 Taren Point Road,<br>Caringbah NSW 2229 | | | | | Project Number: 21039 |

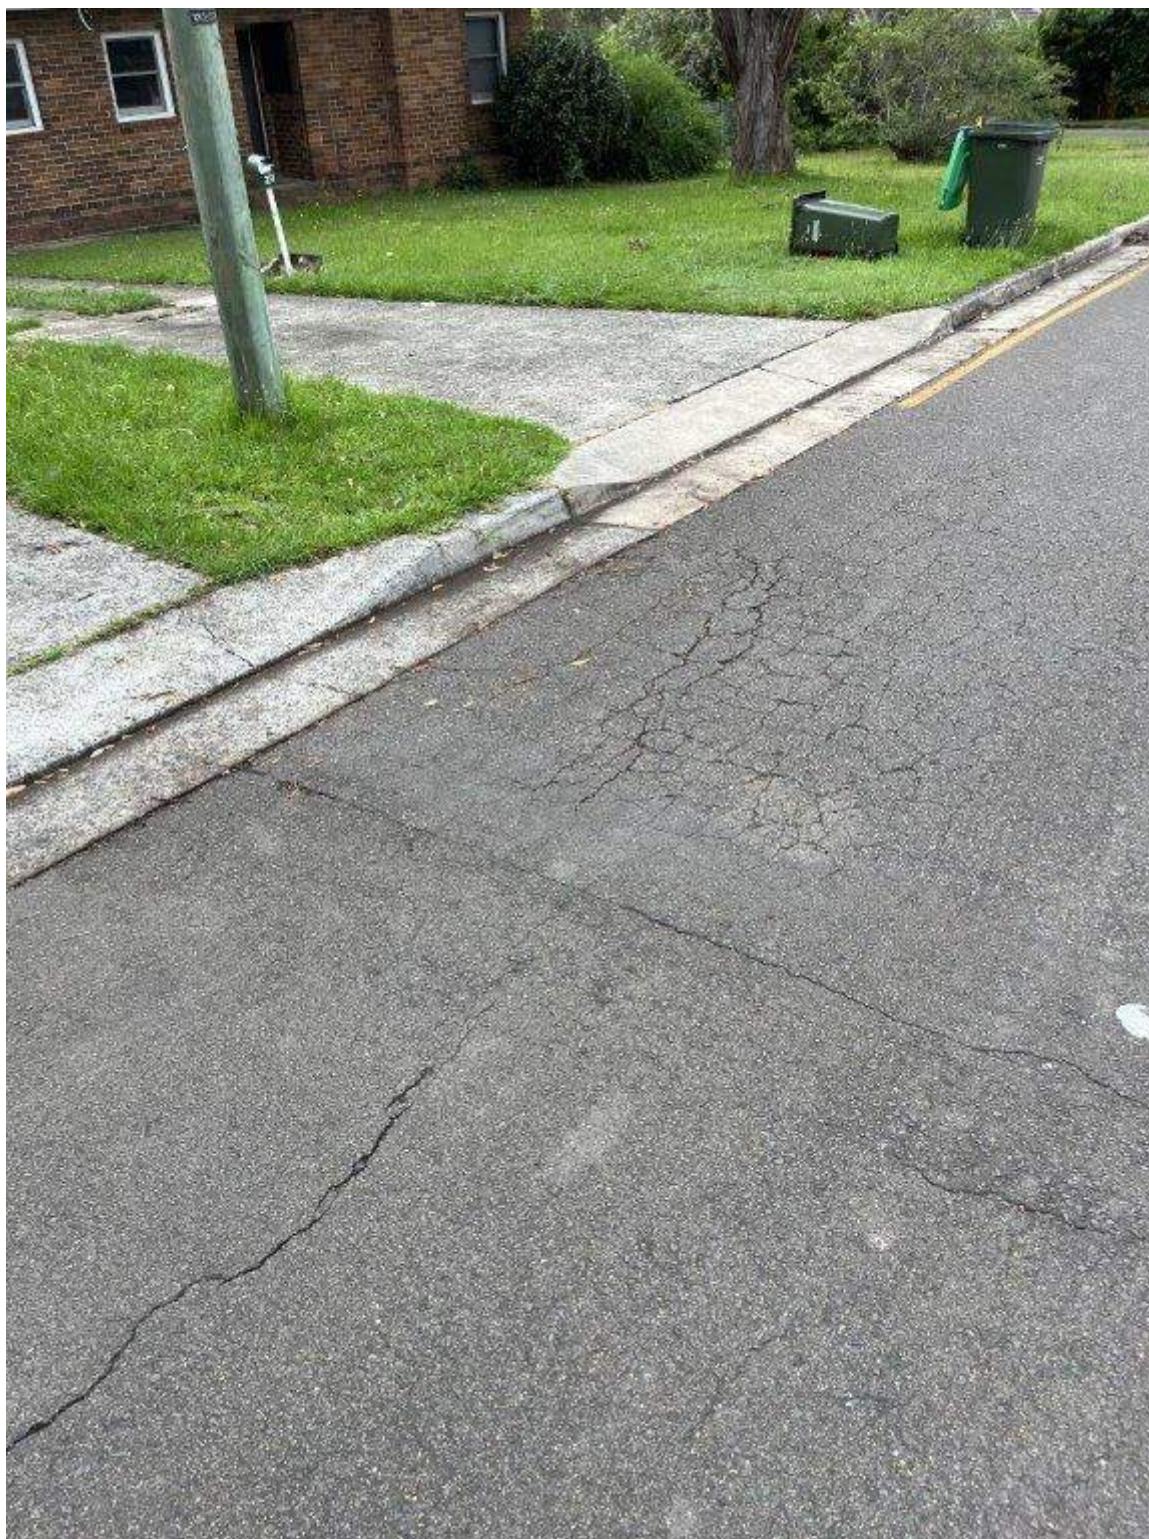
Photo 100 - Hinkler Avenue - Cracking of pavement

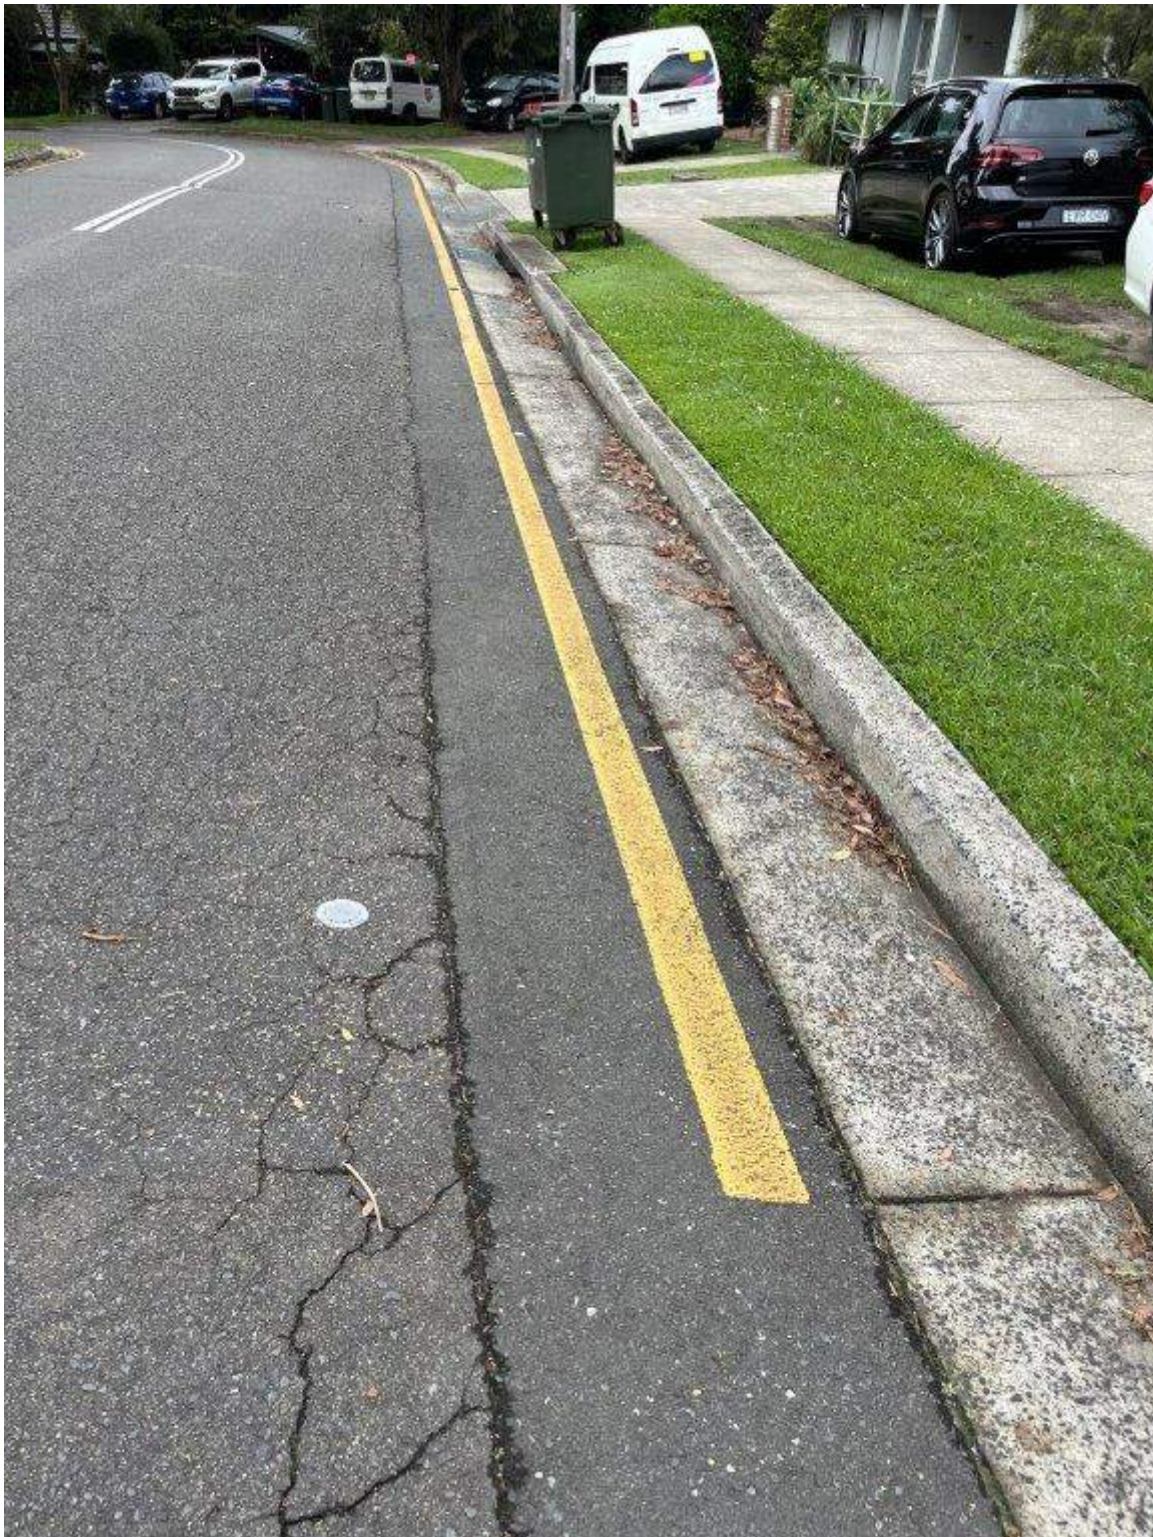
Photo 101 - Hinkler Avenue - Cracking of pavement

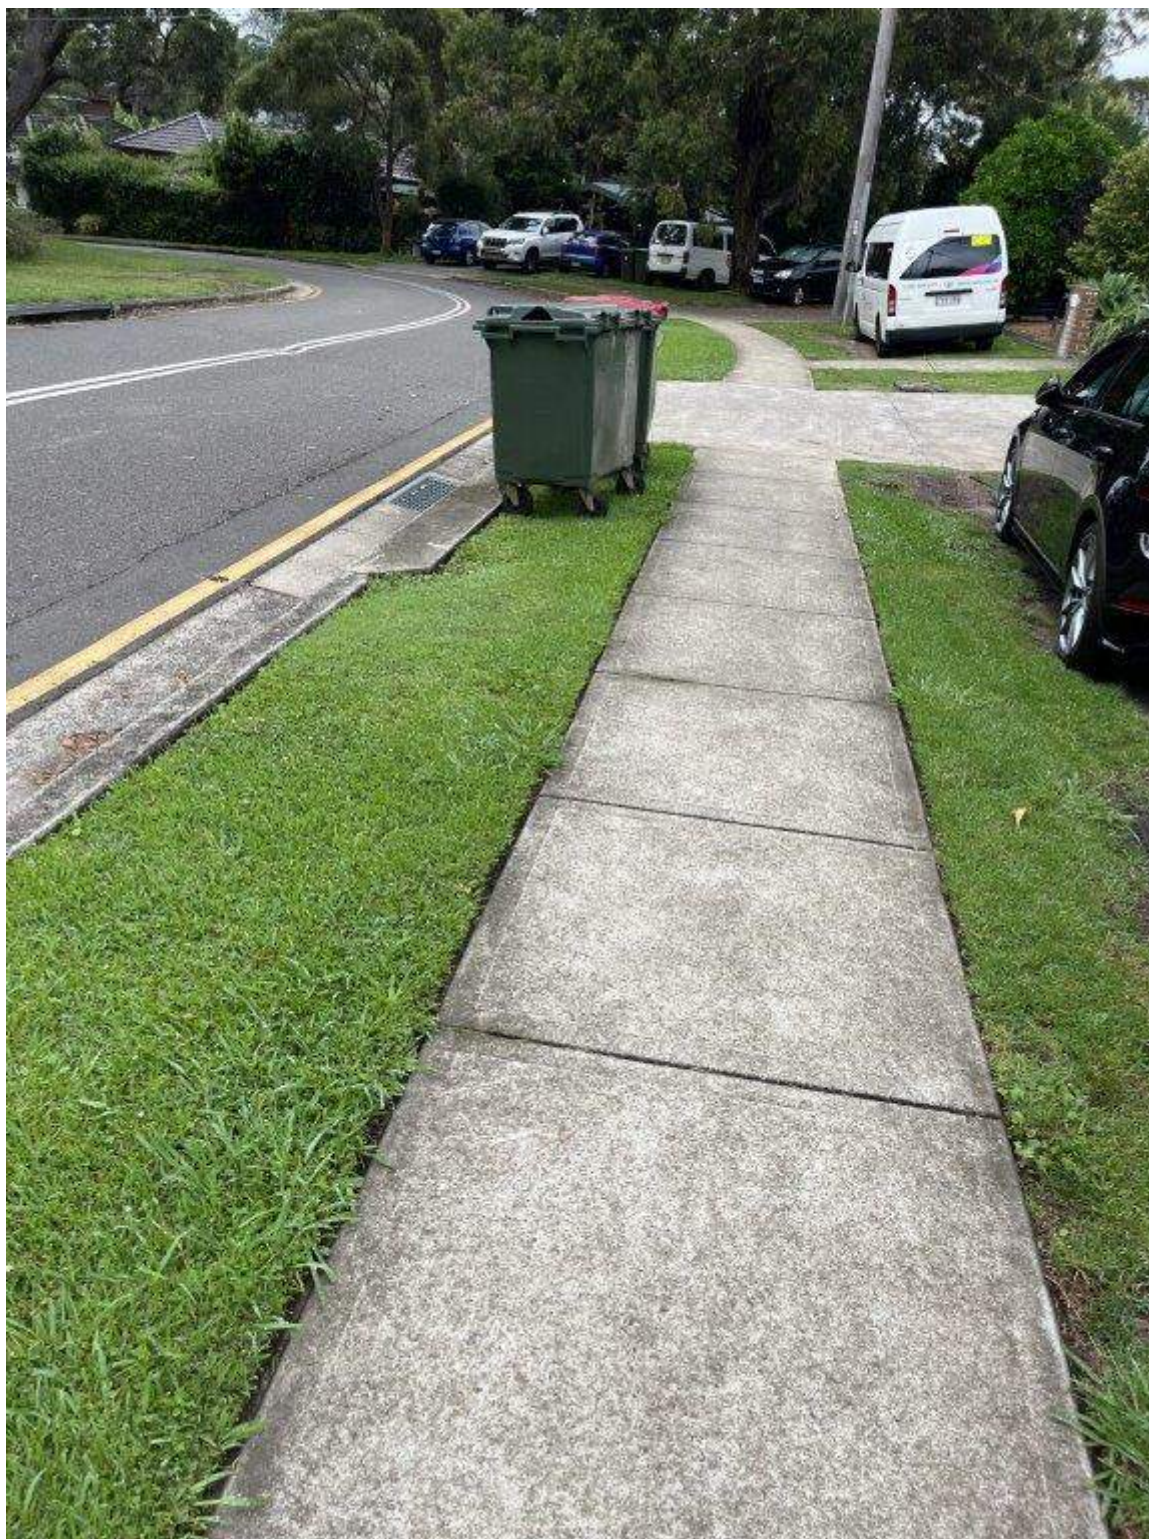
Photo 102 - Hinkler Avenue - Cracking of pavement

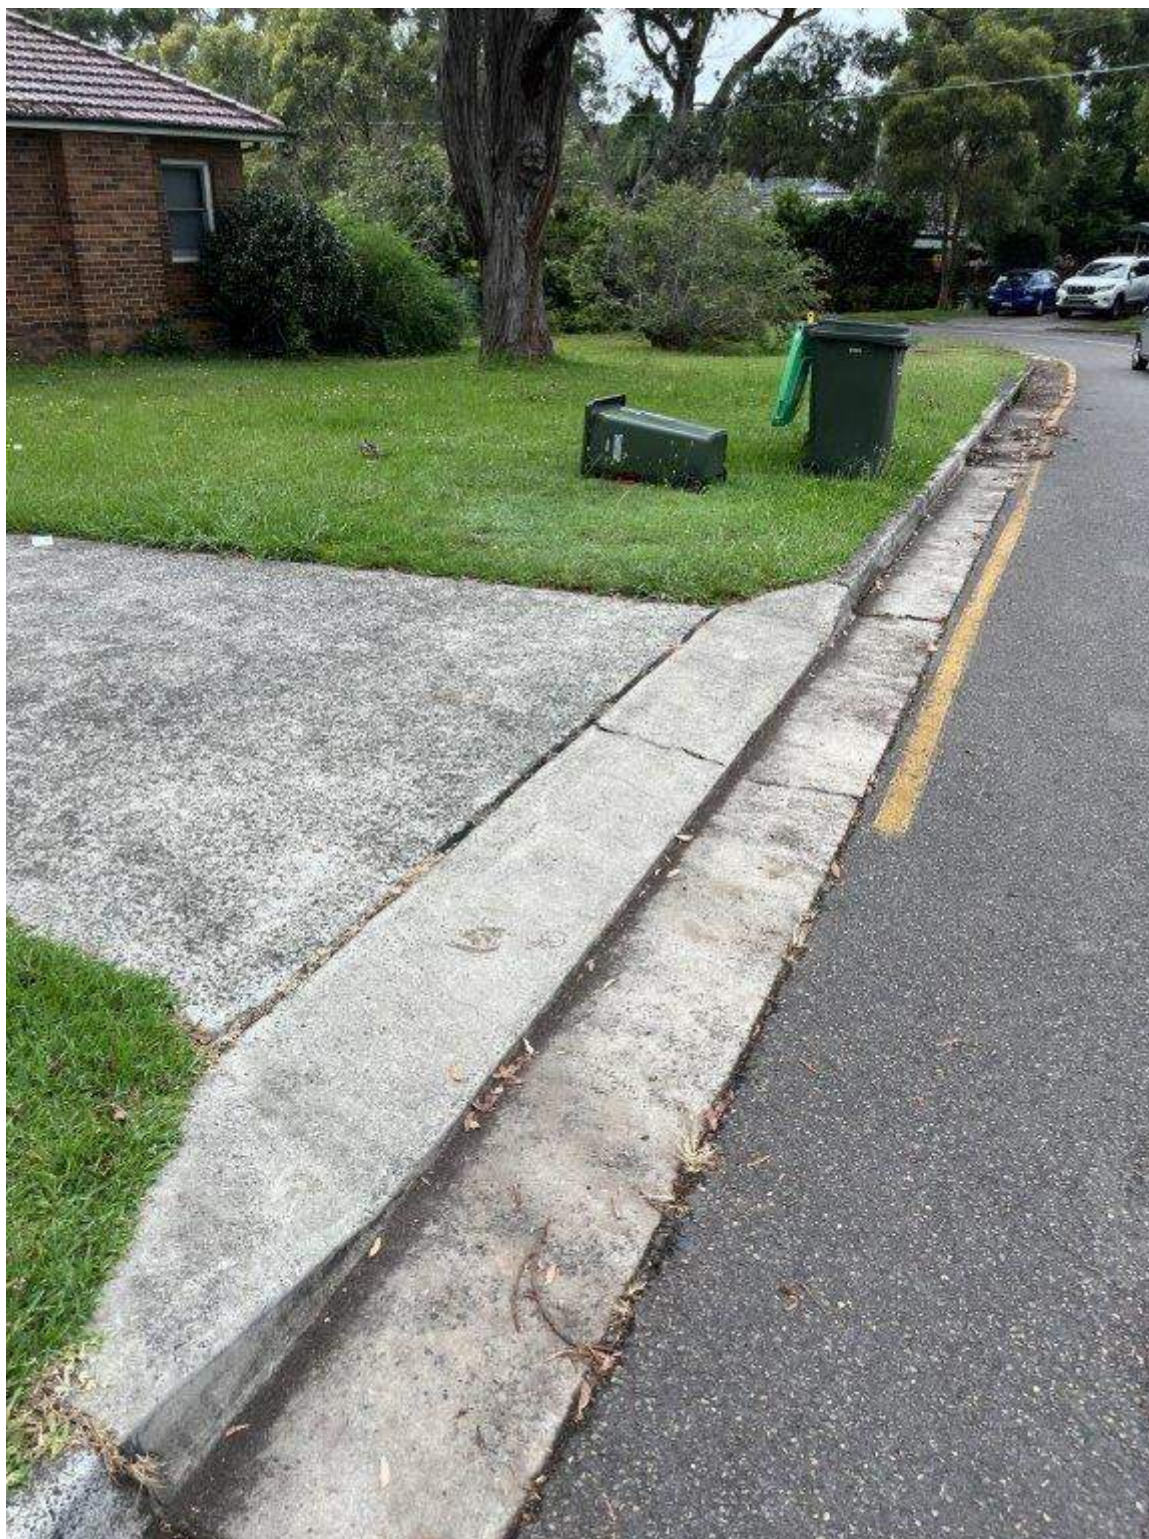
Photo 103 - Hinkler Avenue - Existing condition of pavement and vegetation

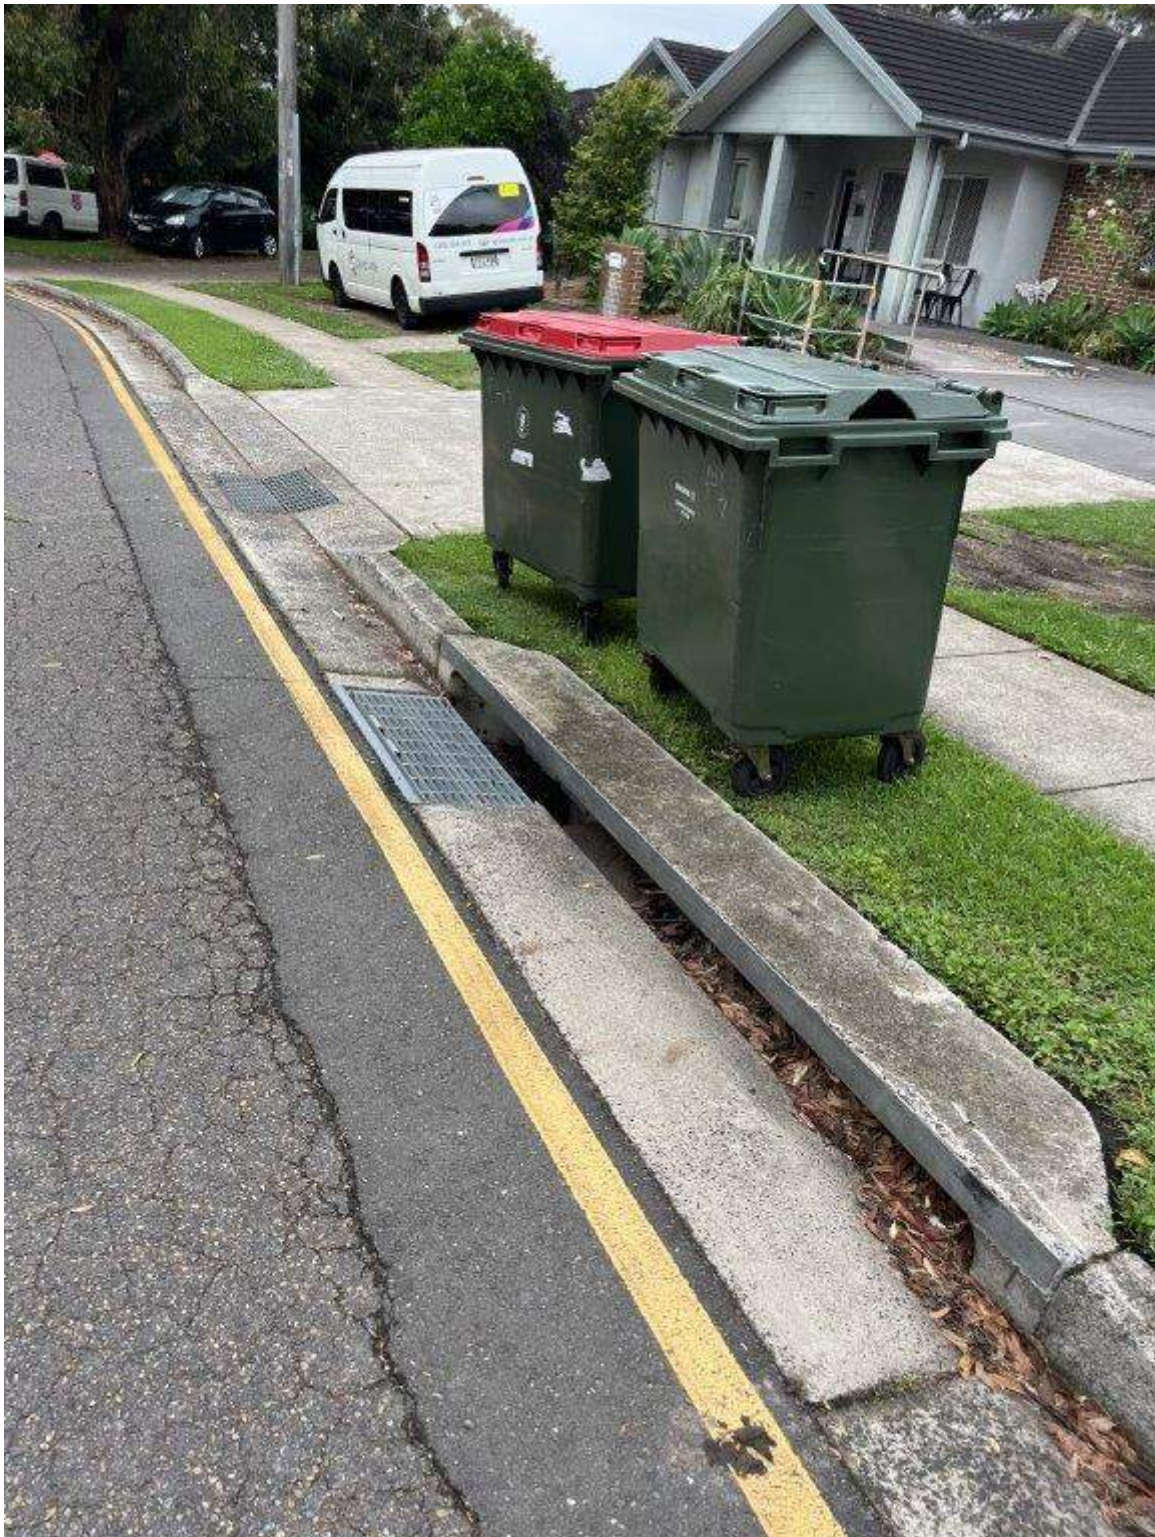
Photo 104 - Hinkler Avenue - Cracking of pavement

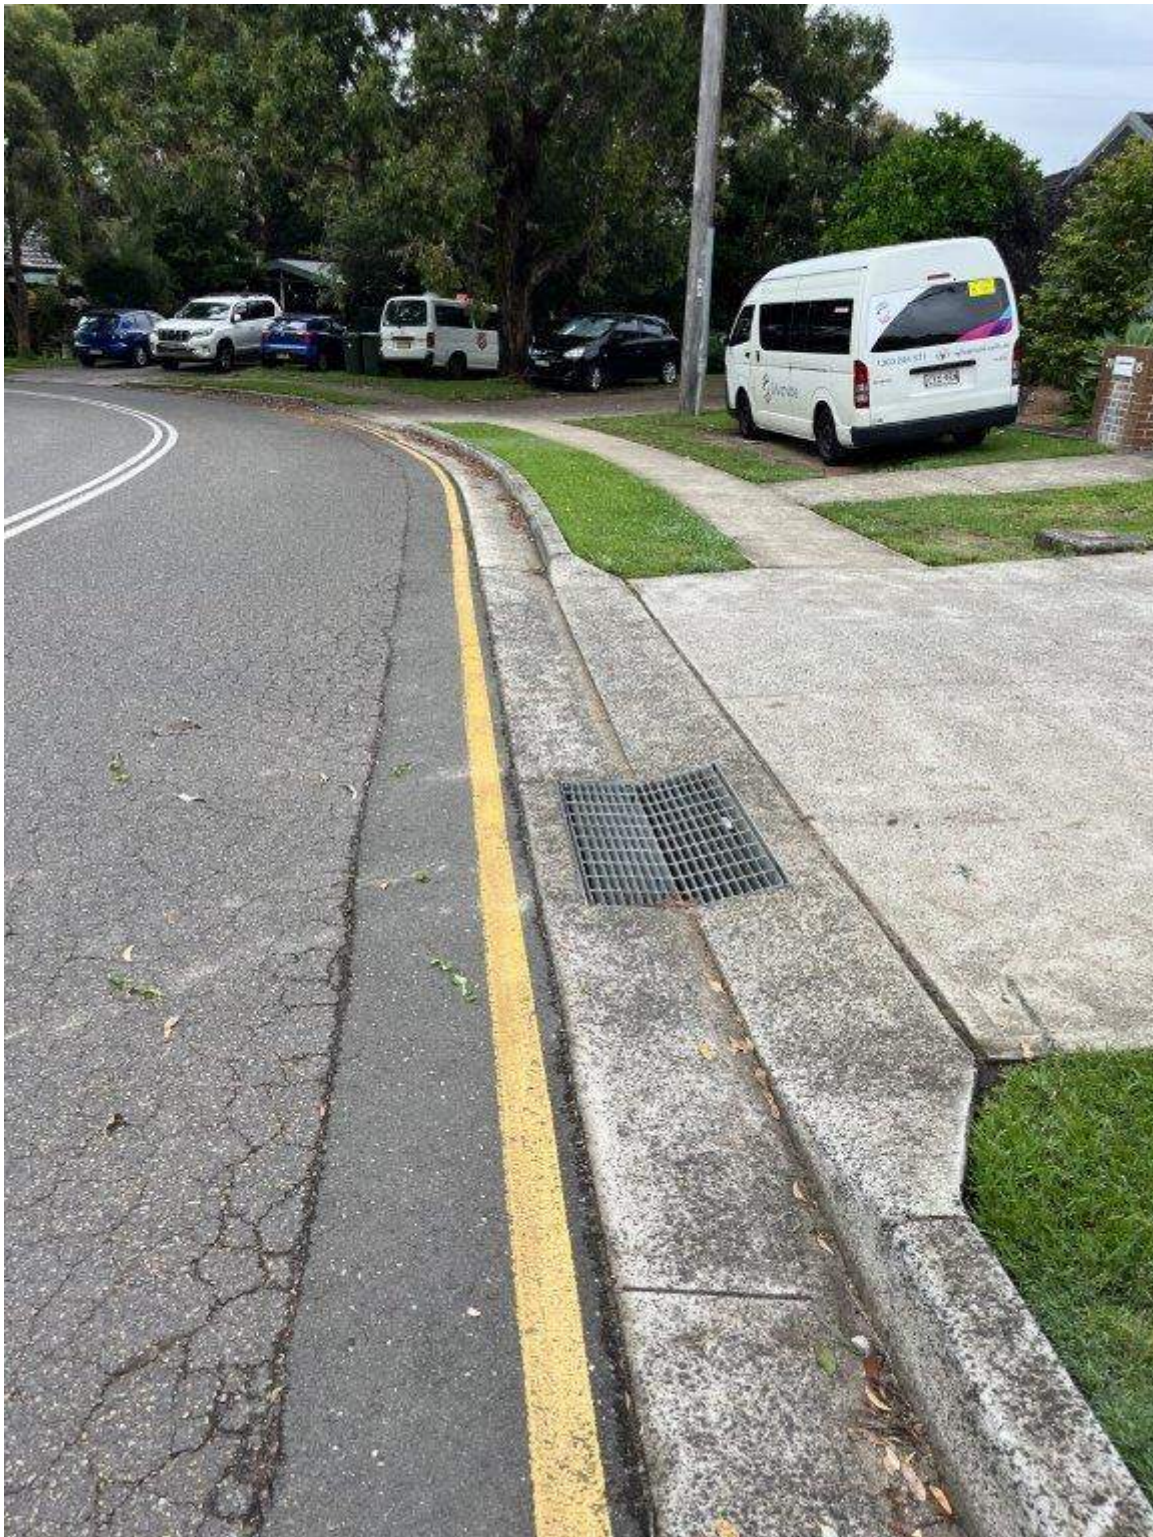
Photo 105 - Hinkler Avenue - Cracking of pavement

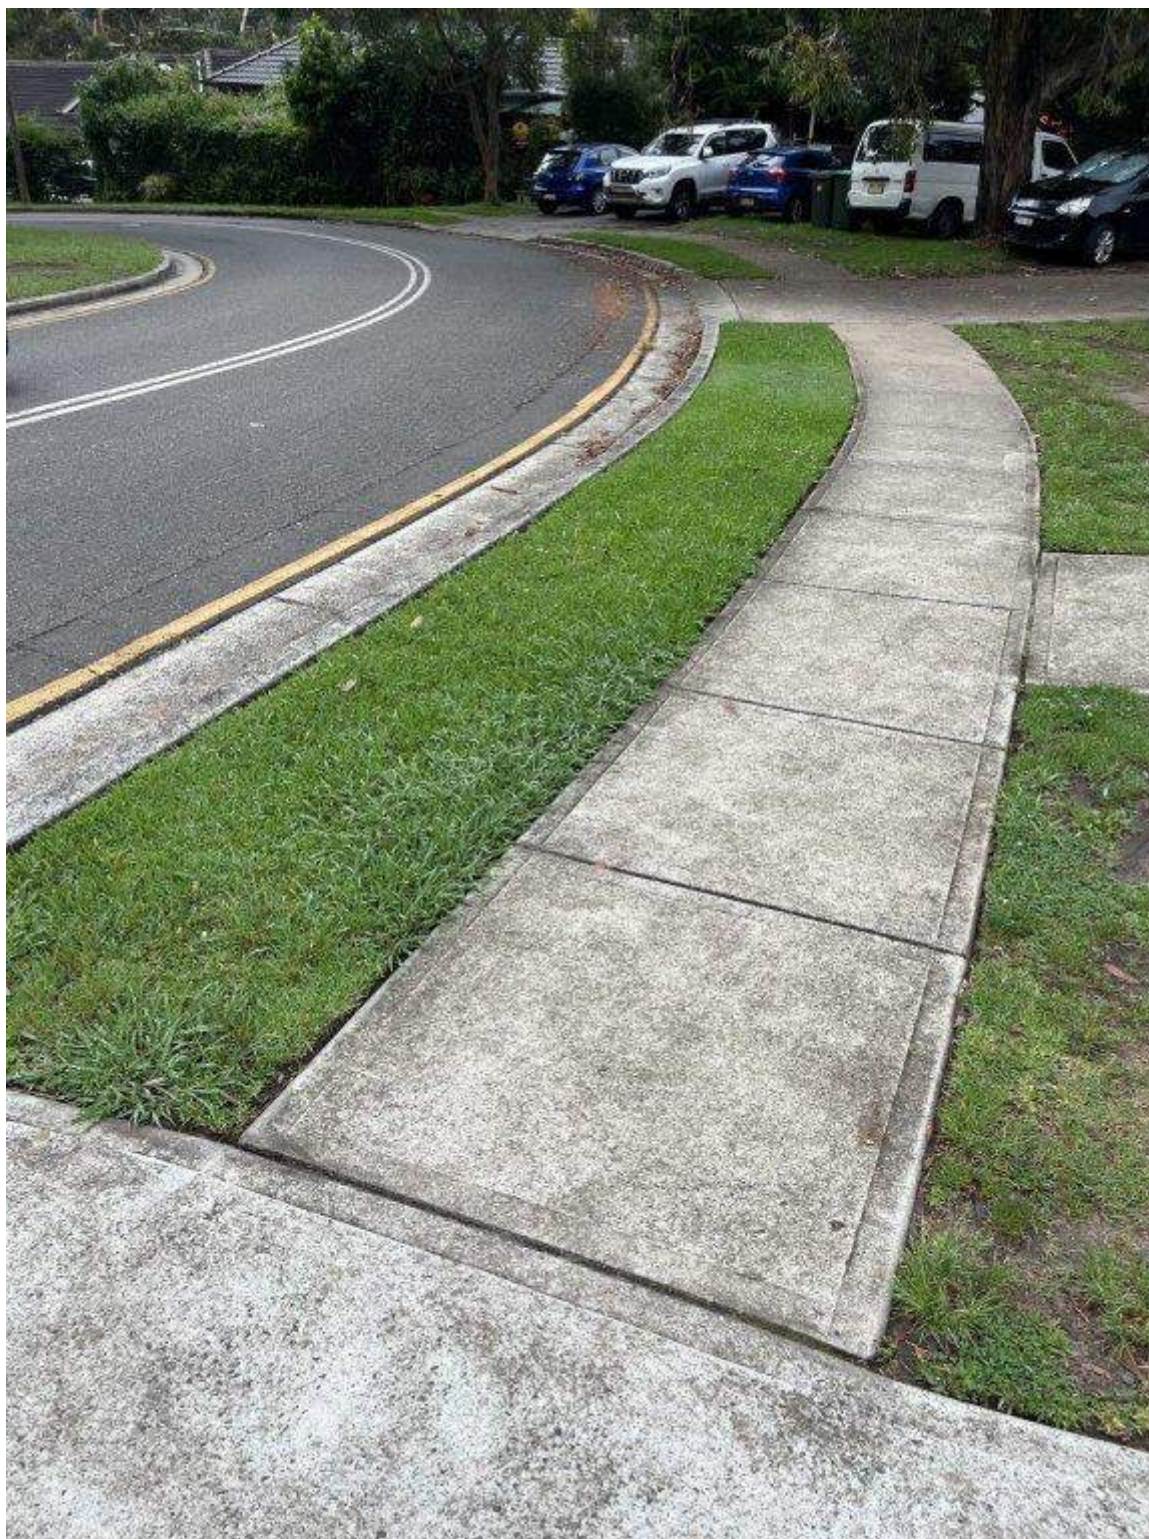
Photo 106 - Hinkler Avenue - Cracking of pavement

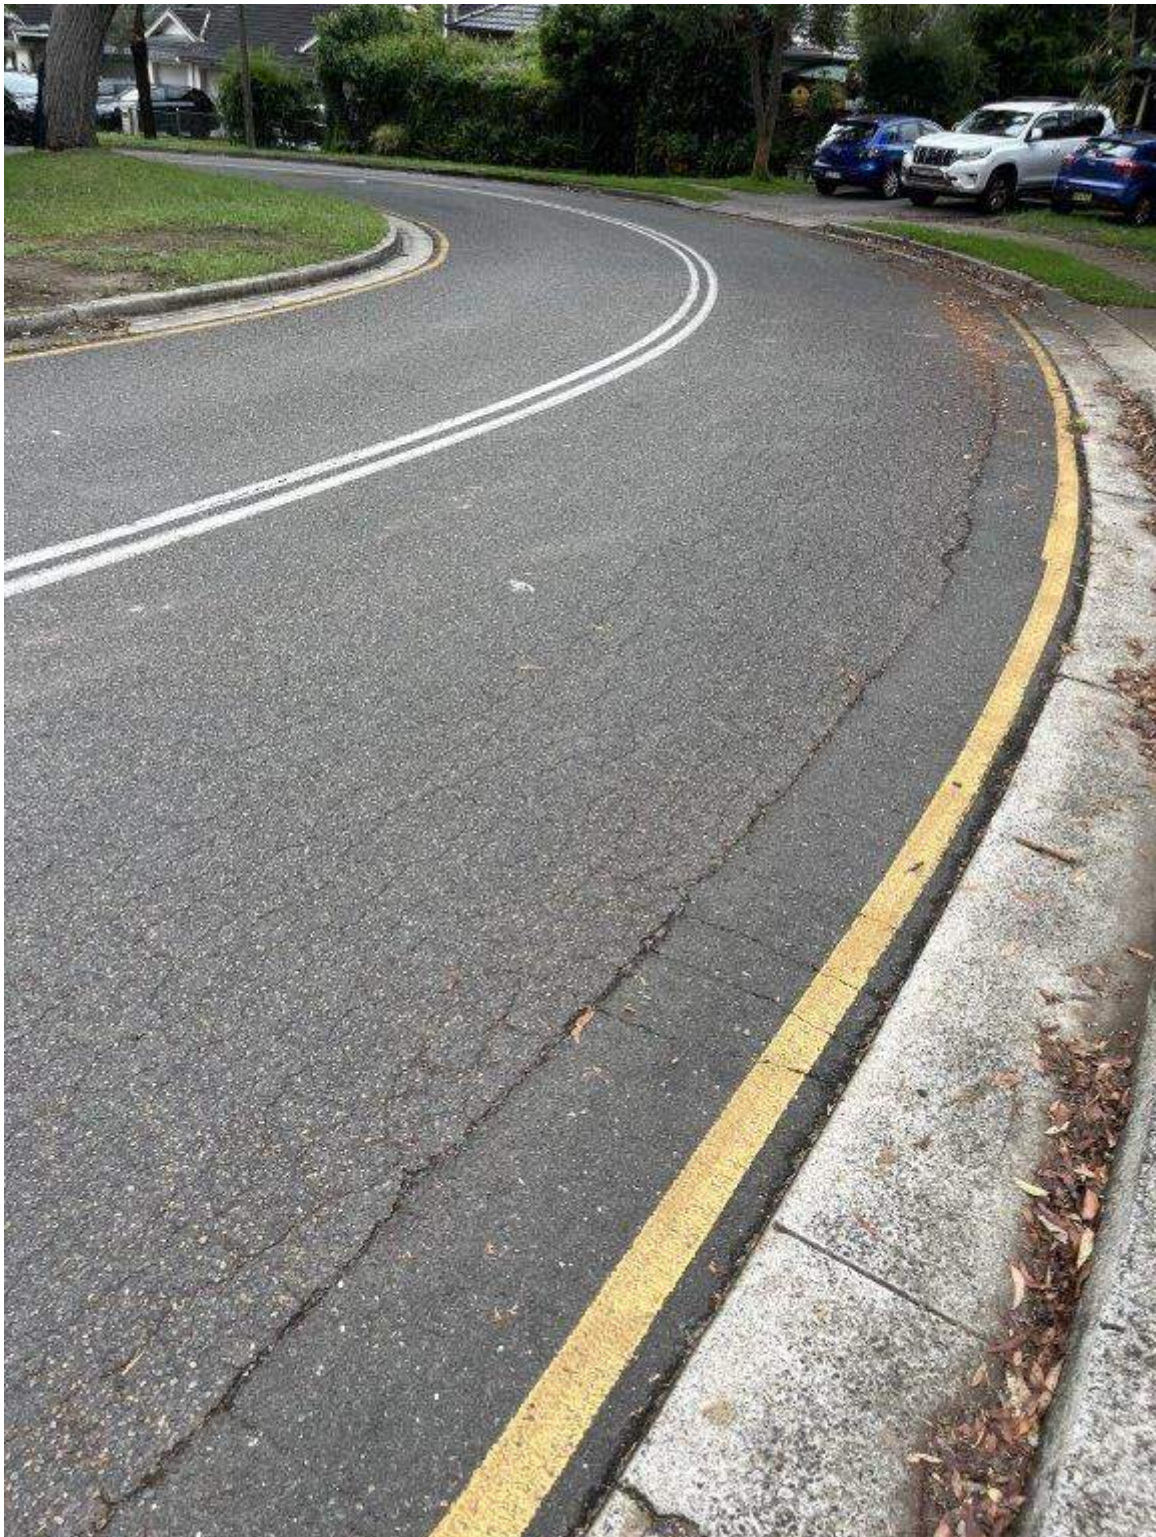
Photo 107 - Hinkler Avenue - Existing condition of pavement and vegetation

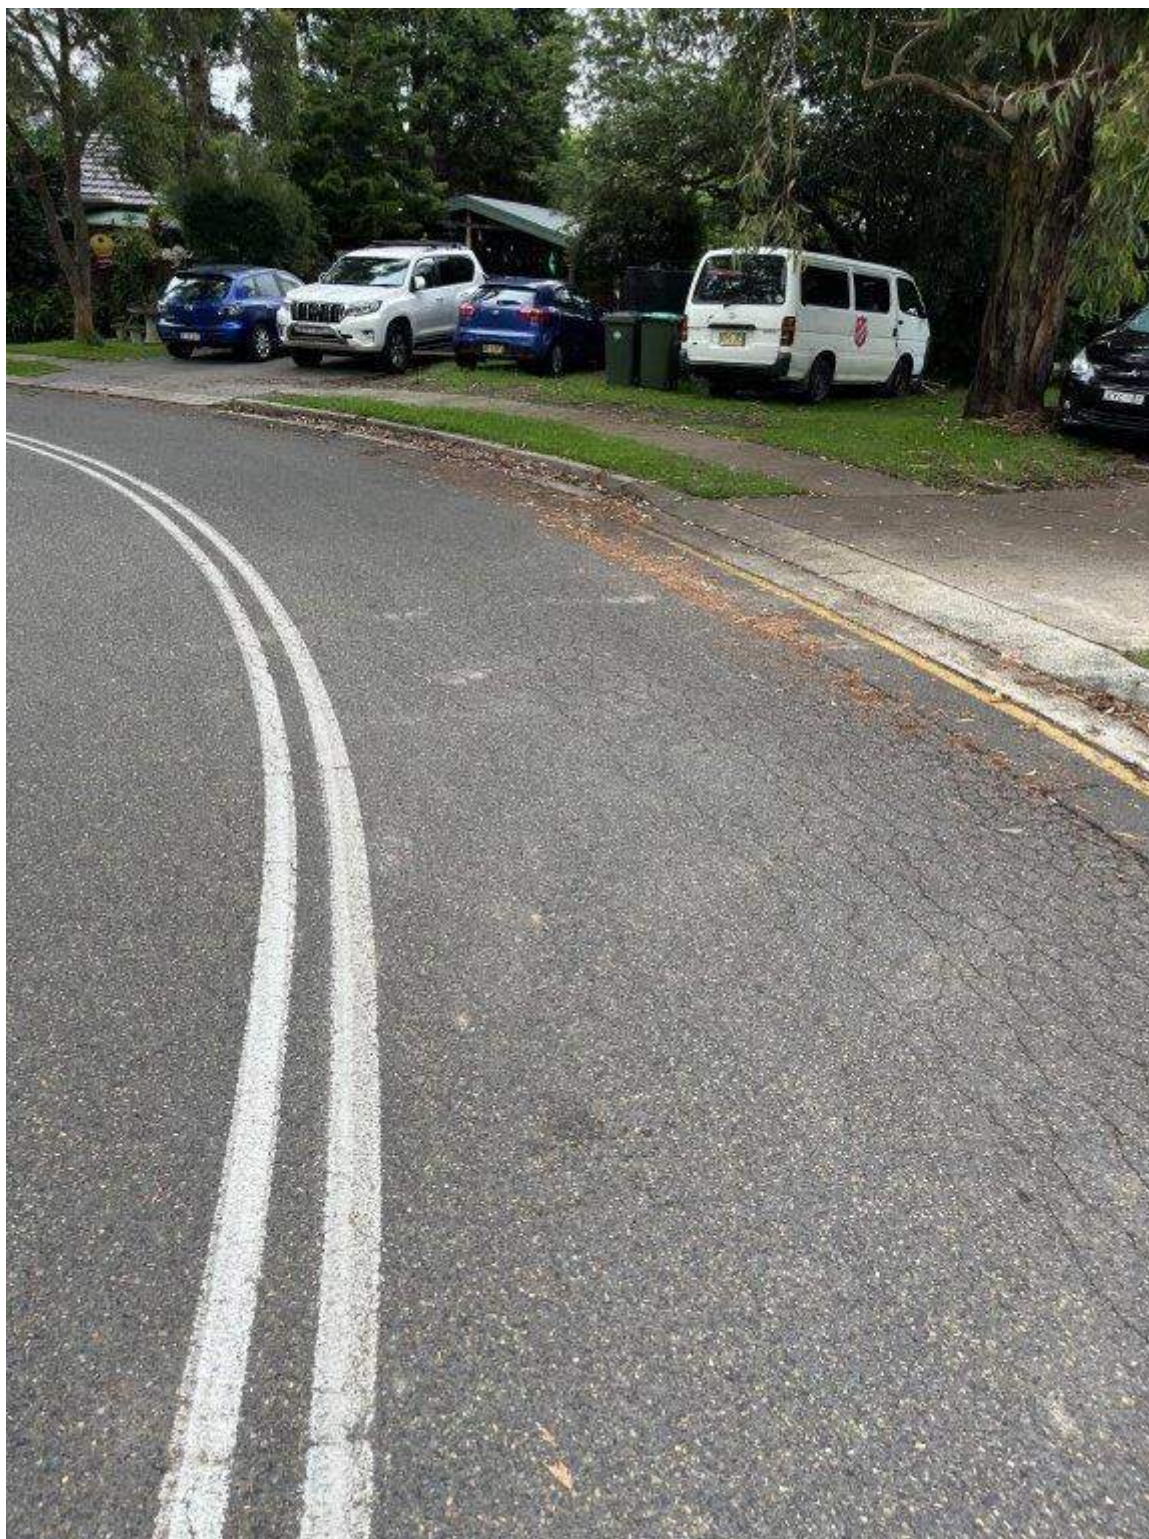
Photo 108 - Hinkler Avenue - Cracking of pavement

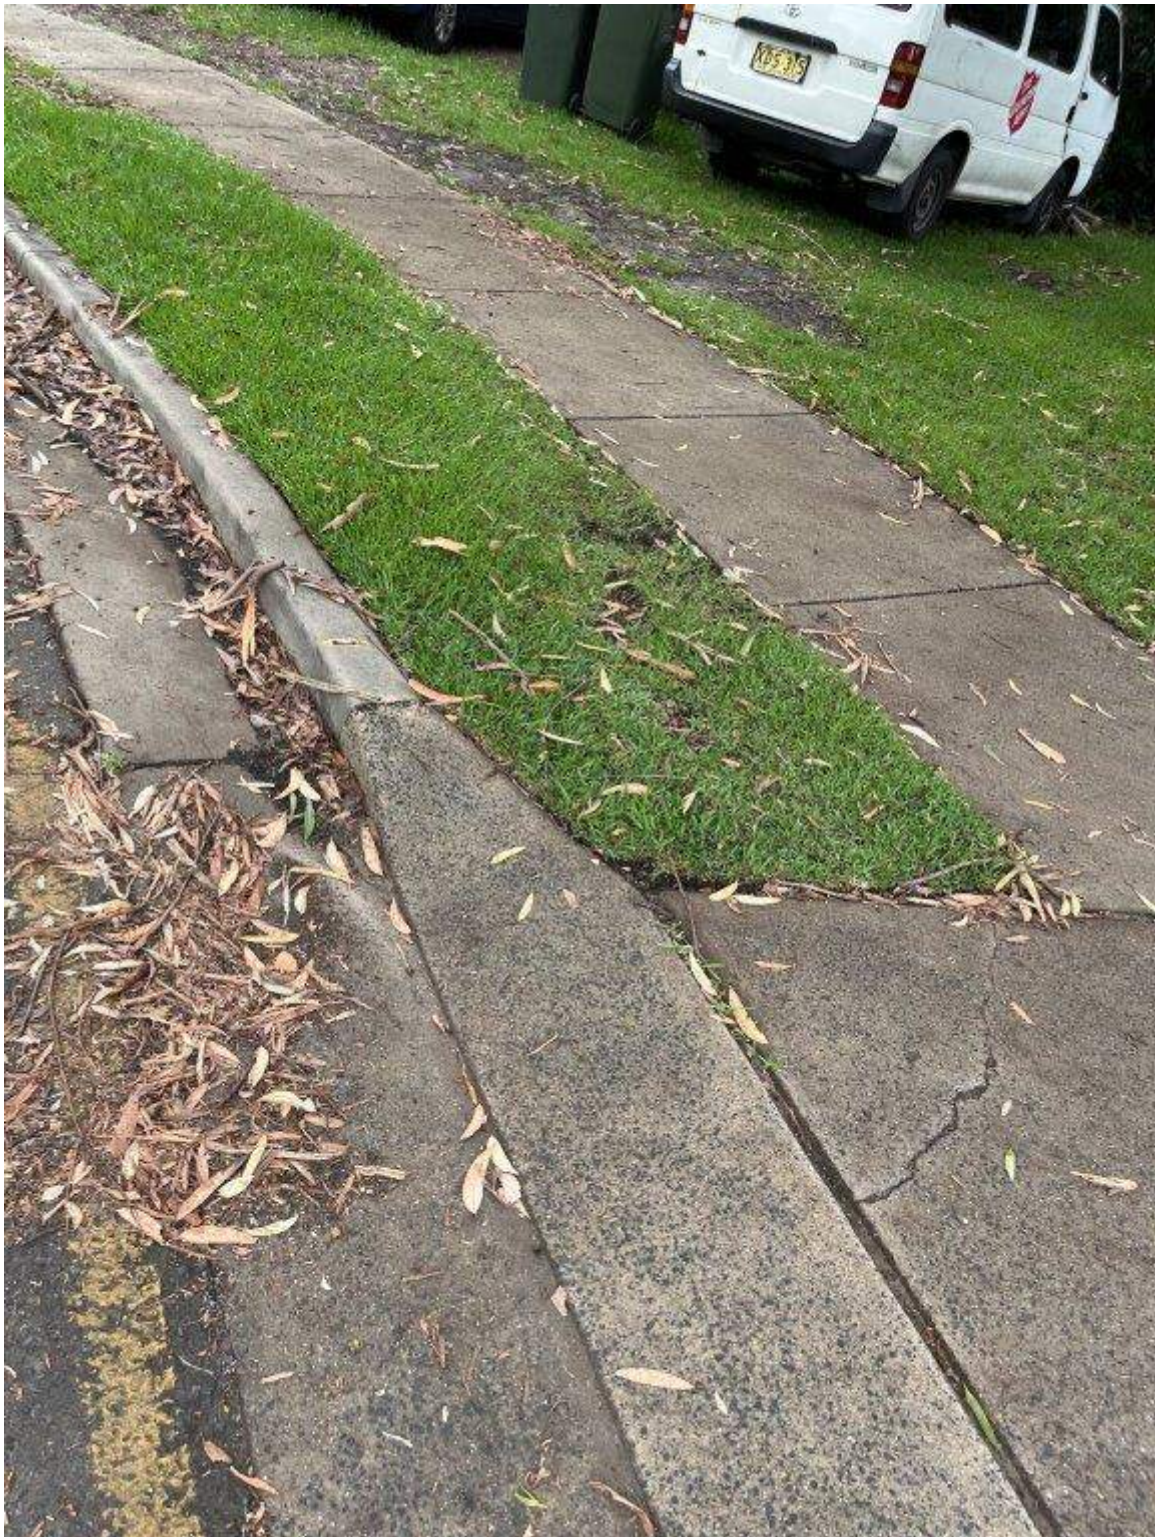
Photo 109 - Hinkler Avenue - Cracking of pavement

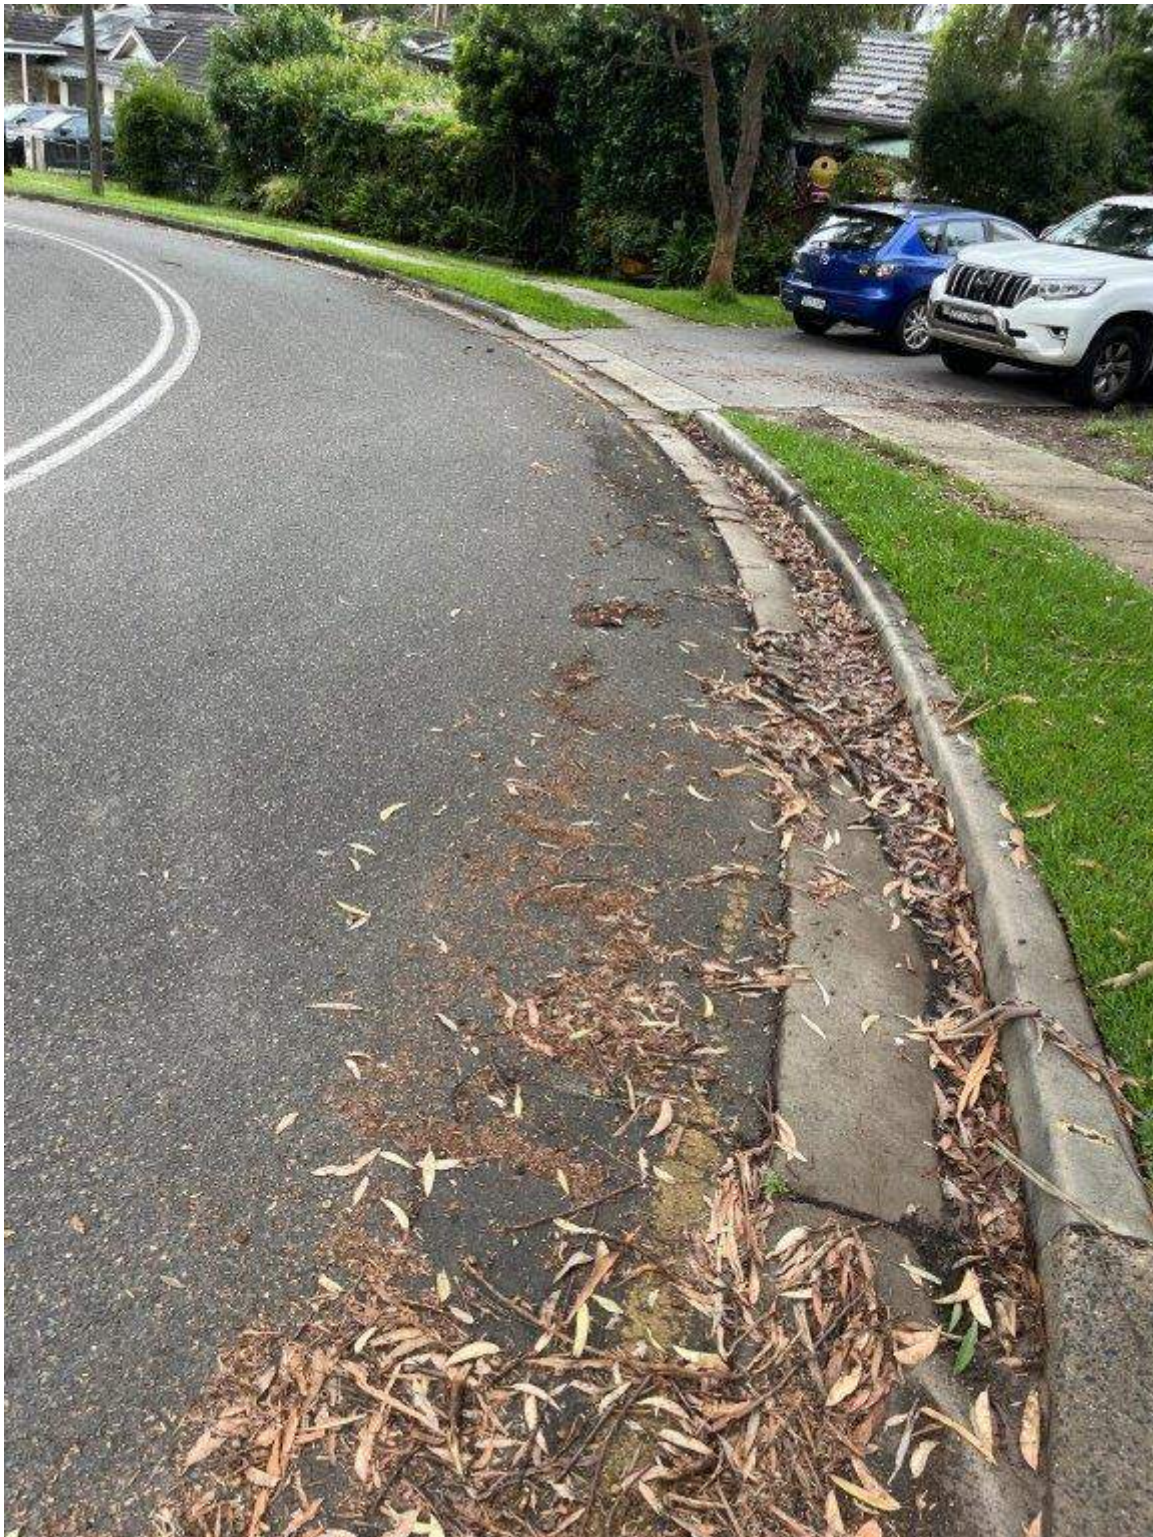
Photo 110 - Hinkler Avenue - Cracking of pavement

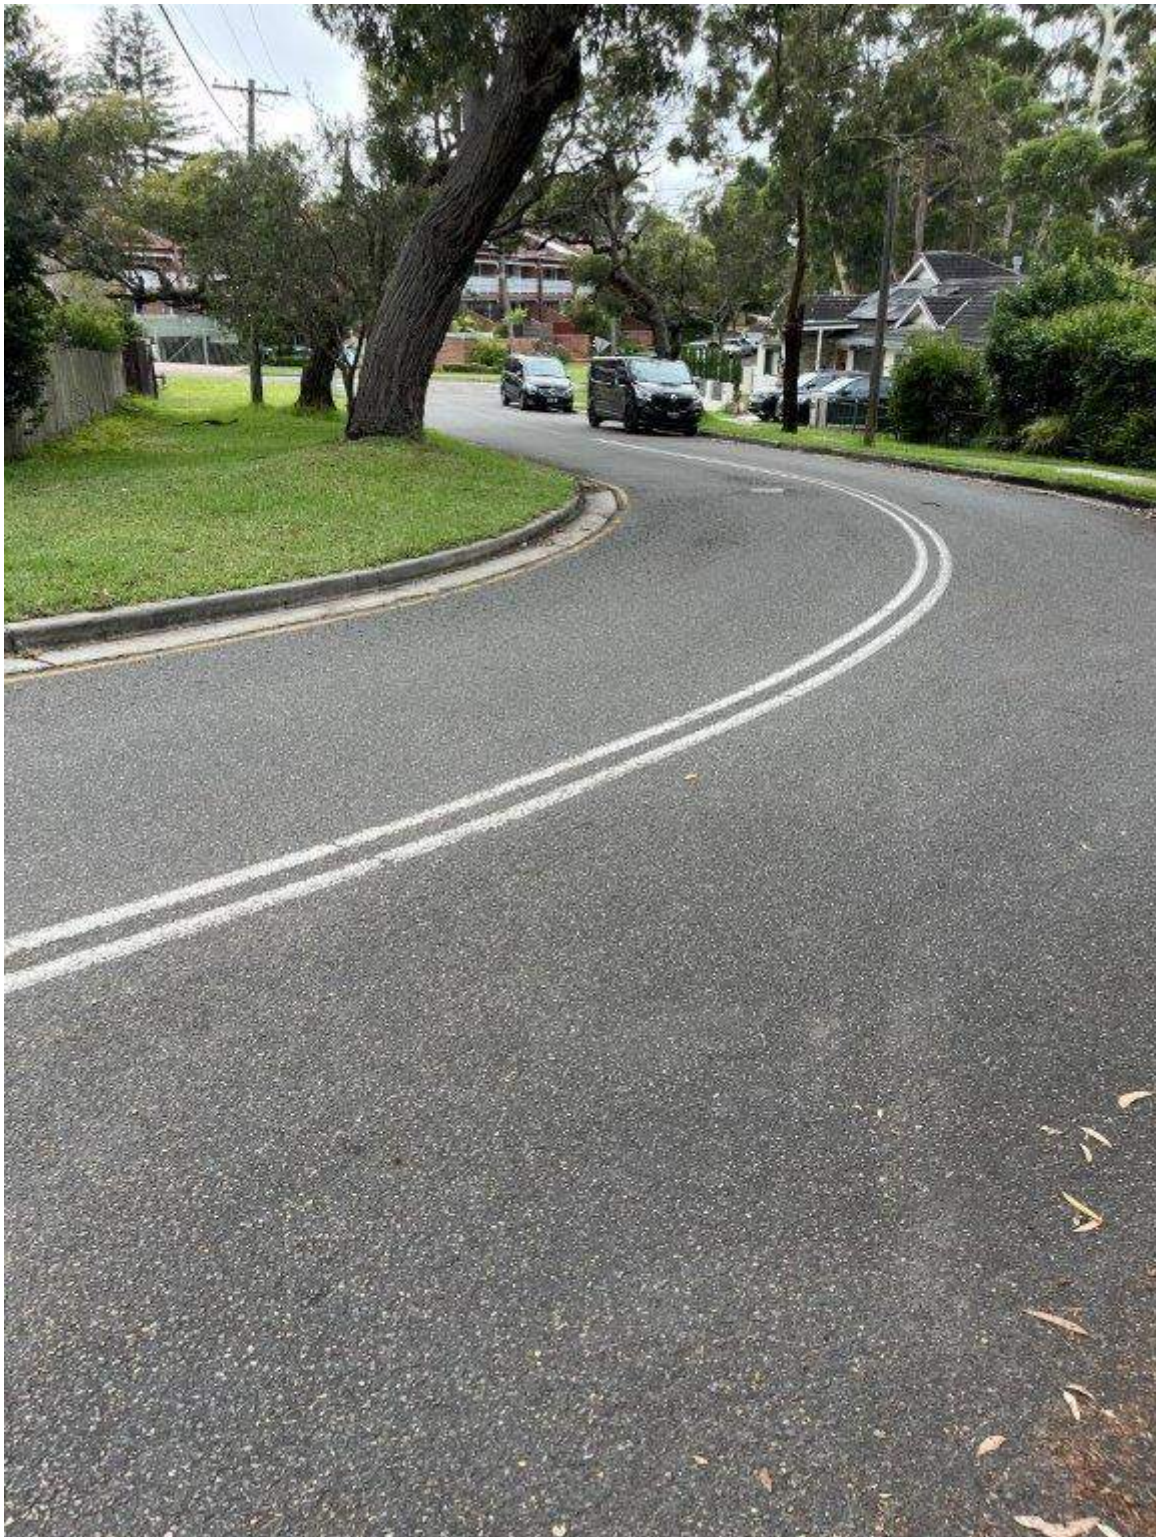
Photo 111 - Hinkler Avenue - Existing condition of pavement

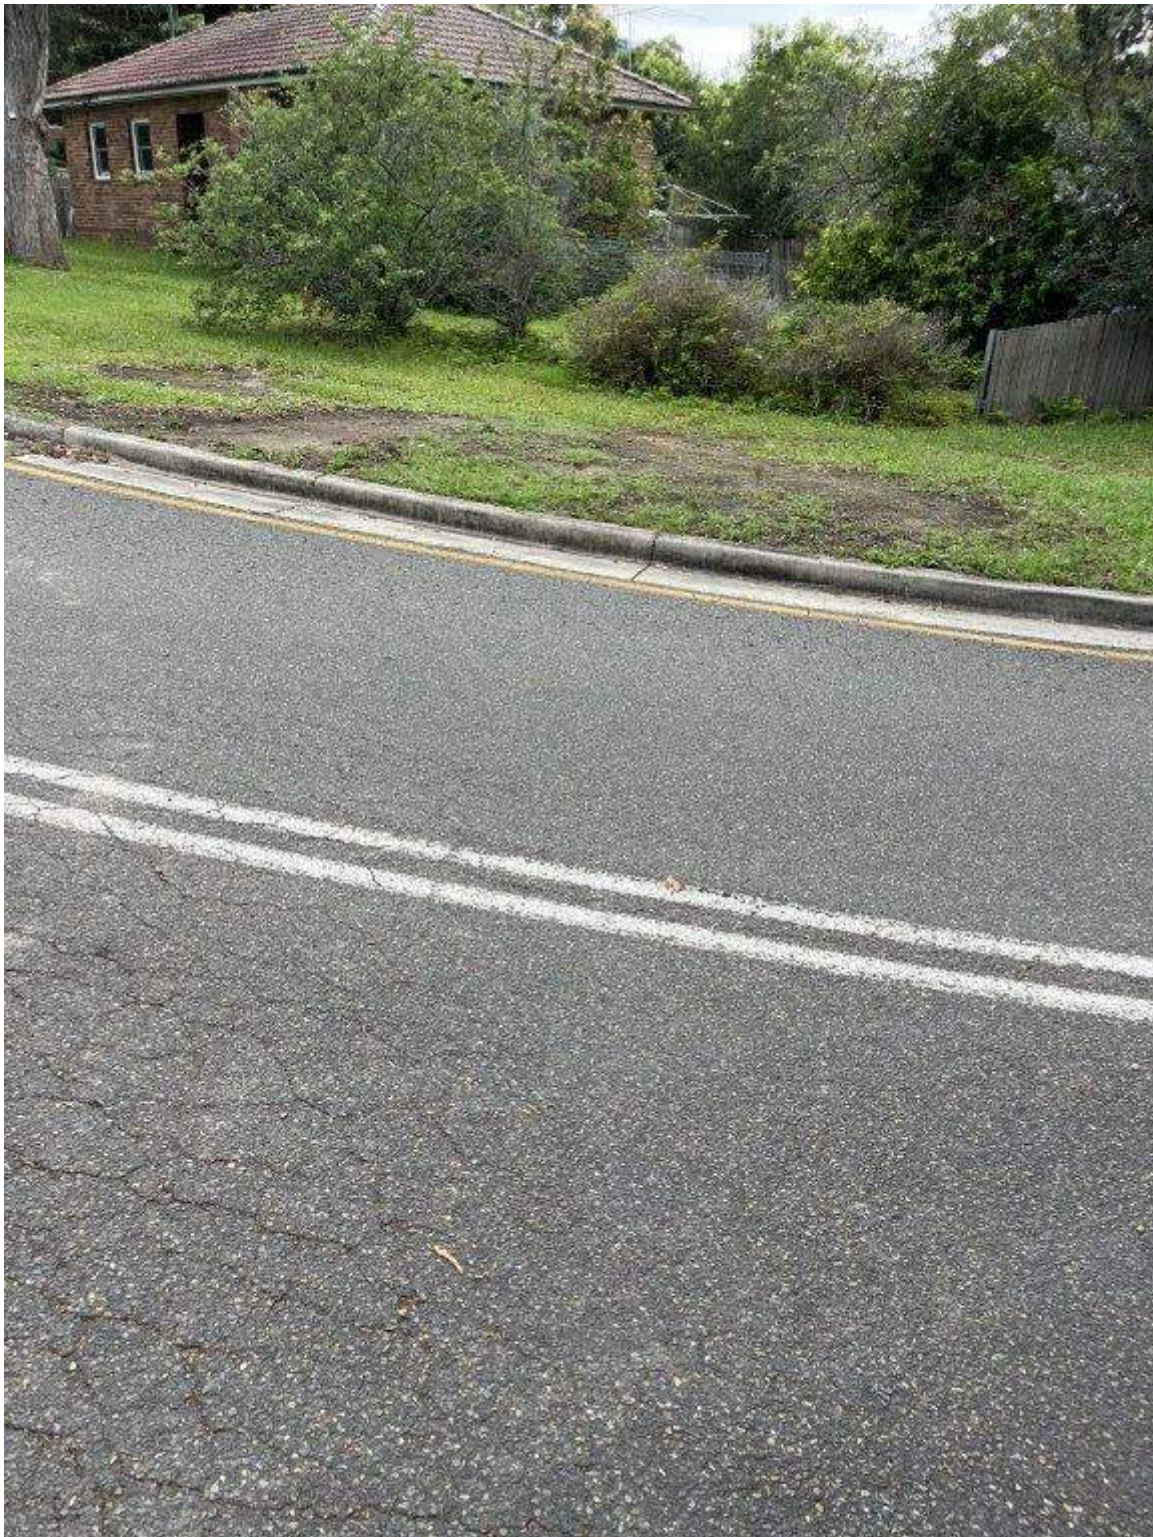
Photo 112 - Hinkler Avenue - Existing condition of pavement
