## PRE-CONSTRUCTION DILAPIDATION REPORT

### 6-20 HINKLER AVENUE & 319-333 TAREN POINT ROAD, CARINGBAH

| PRE-CONSTRUCTION DILAPIDATION REPORT<br>6-20 Hinkler Avenue & 319-333 Taren Point Road,<br>Caringbah NSW 2229 | | | | | Project Number: 21039 |

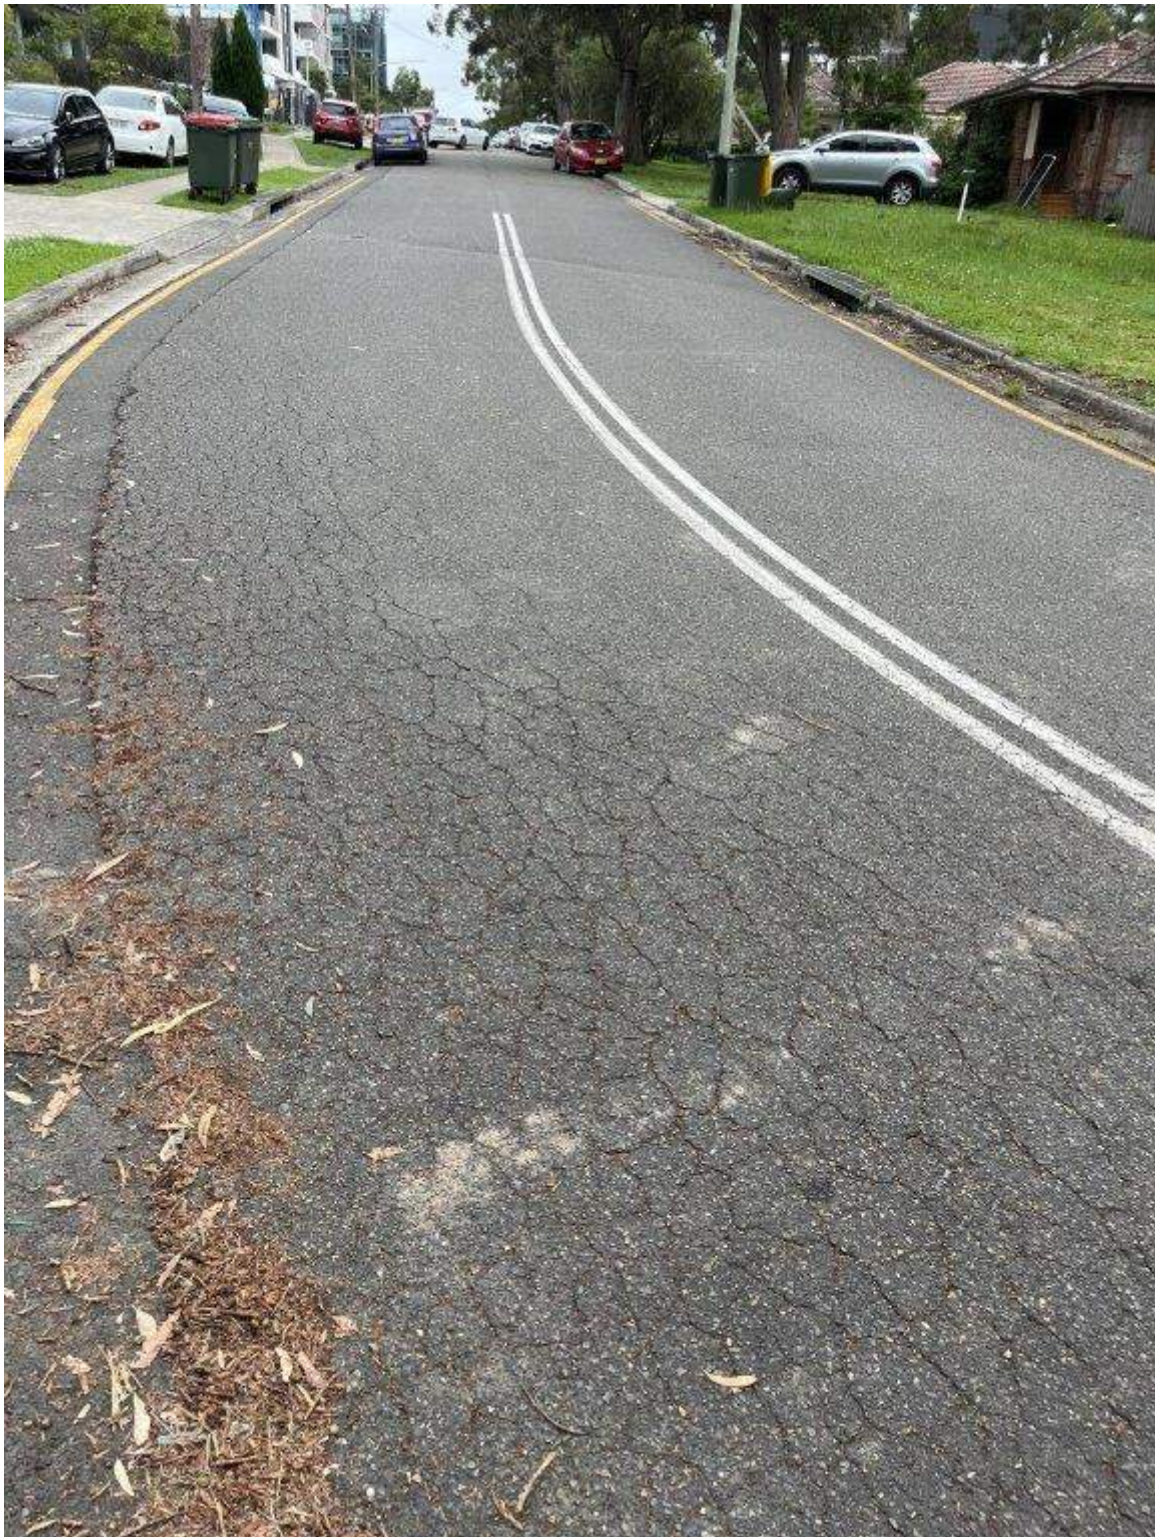
Photo 113 - Hinkler Avenue - Cracking of pavement

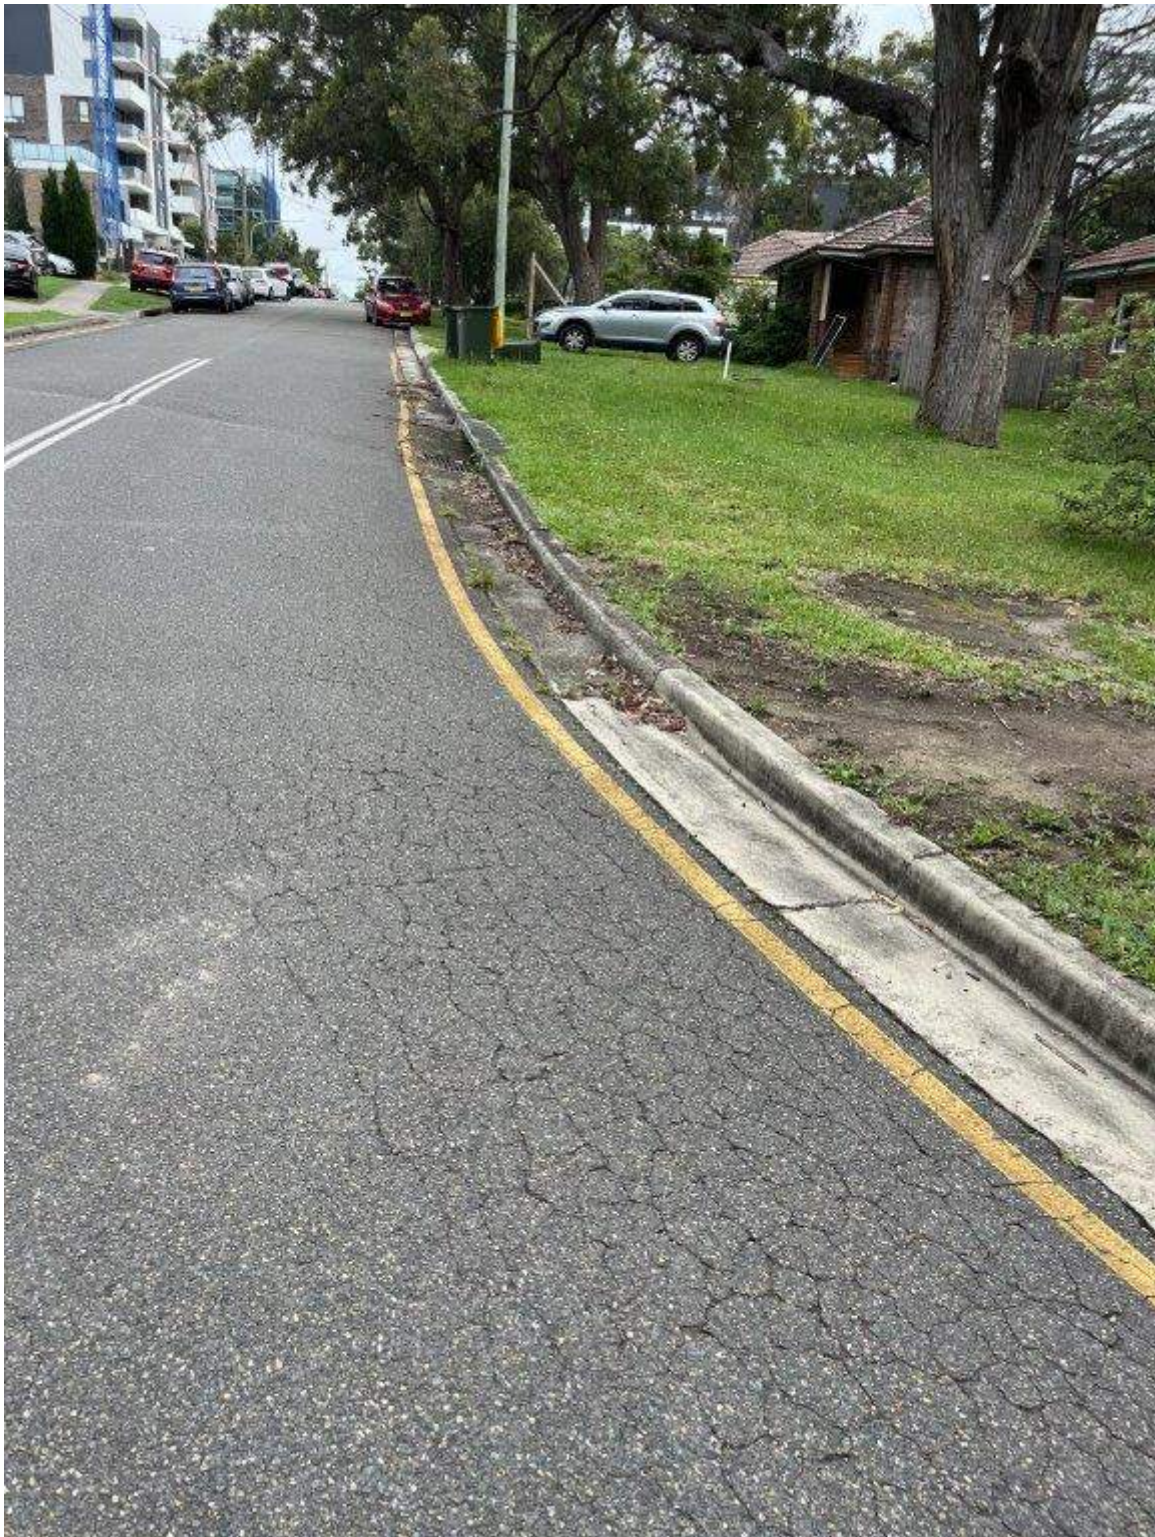
Photo 114 - Hinkler Avenue - Cracking of pavement

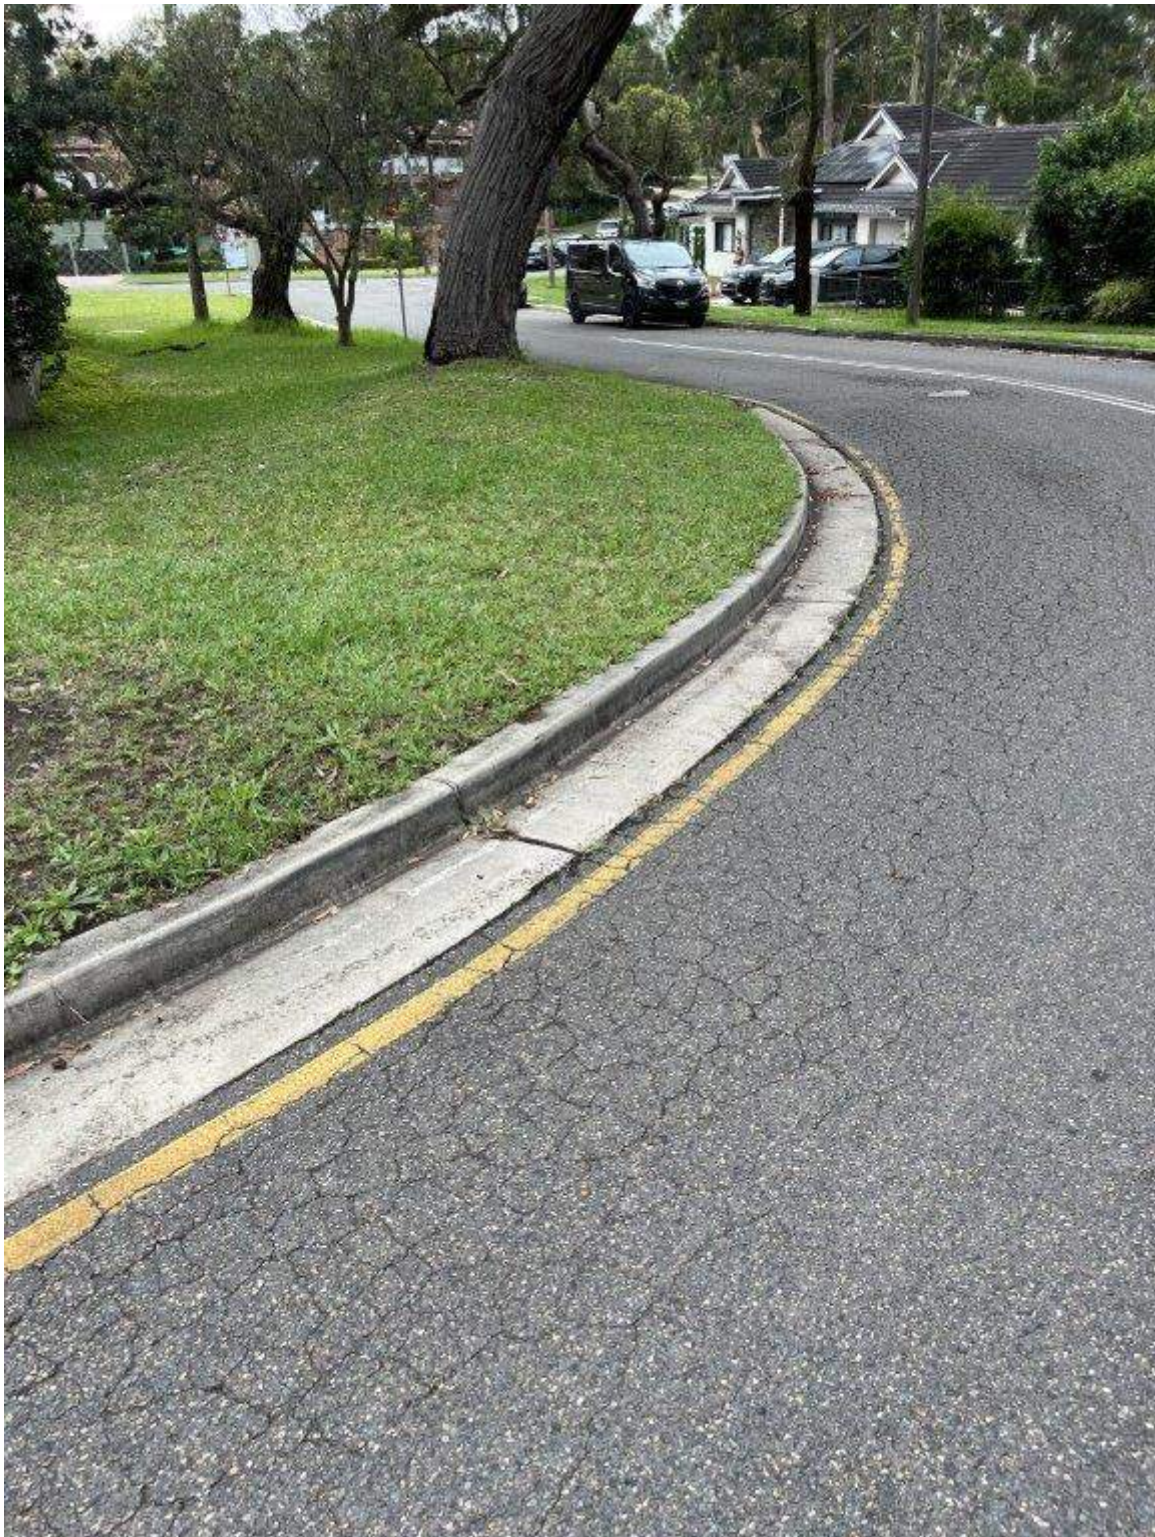
Photo 116 - Hinkler Avenue - Cracking of pavement

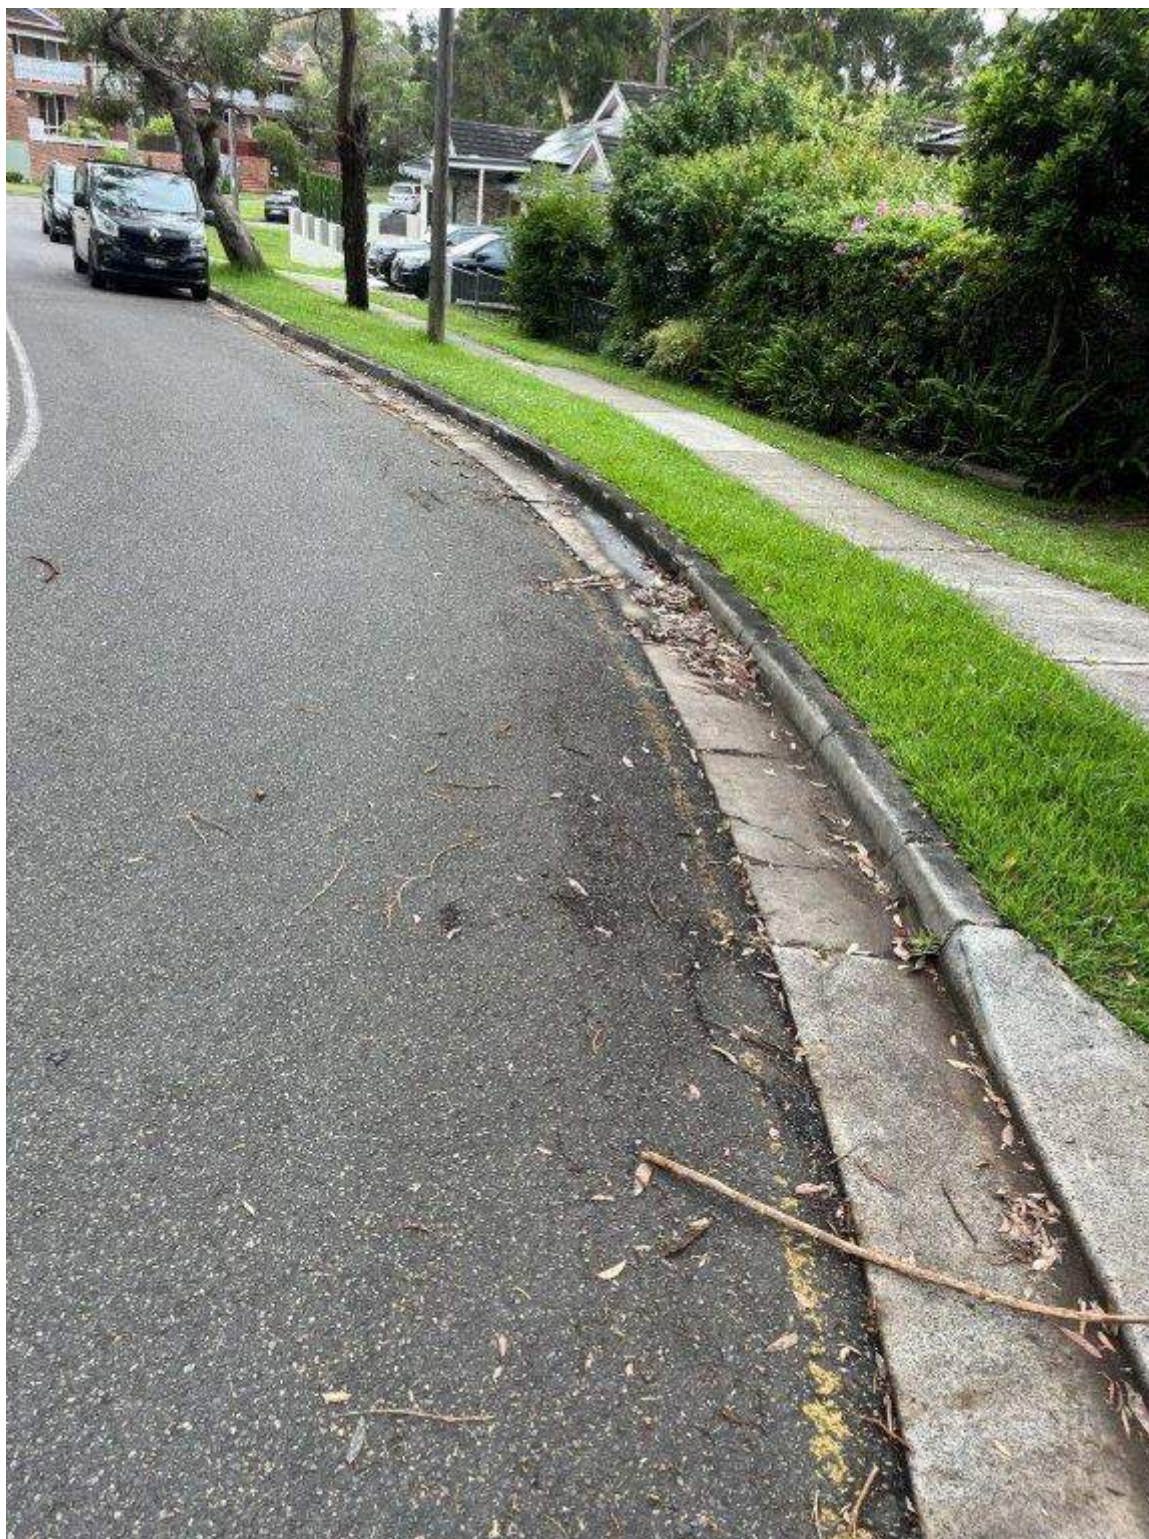
Photo 117 - Hinkler Avenue - Cracking of pavement

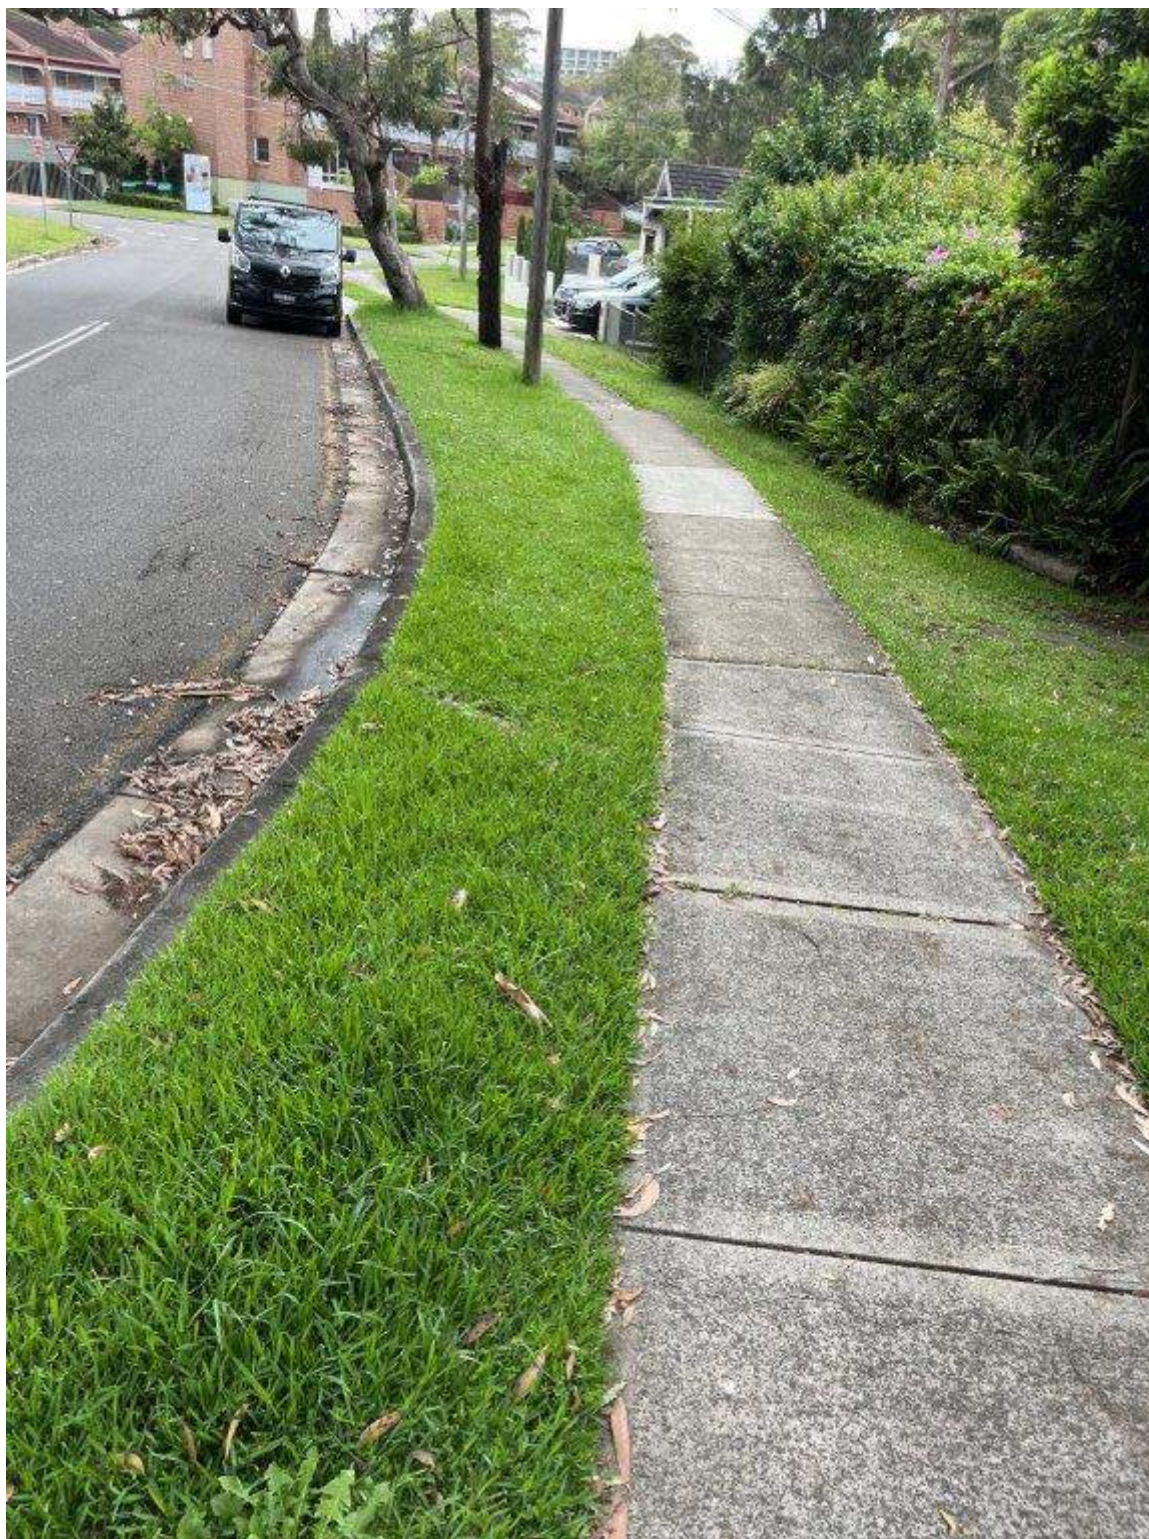
Photo 118 - Hinkler Avenue - Cracking of pavement

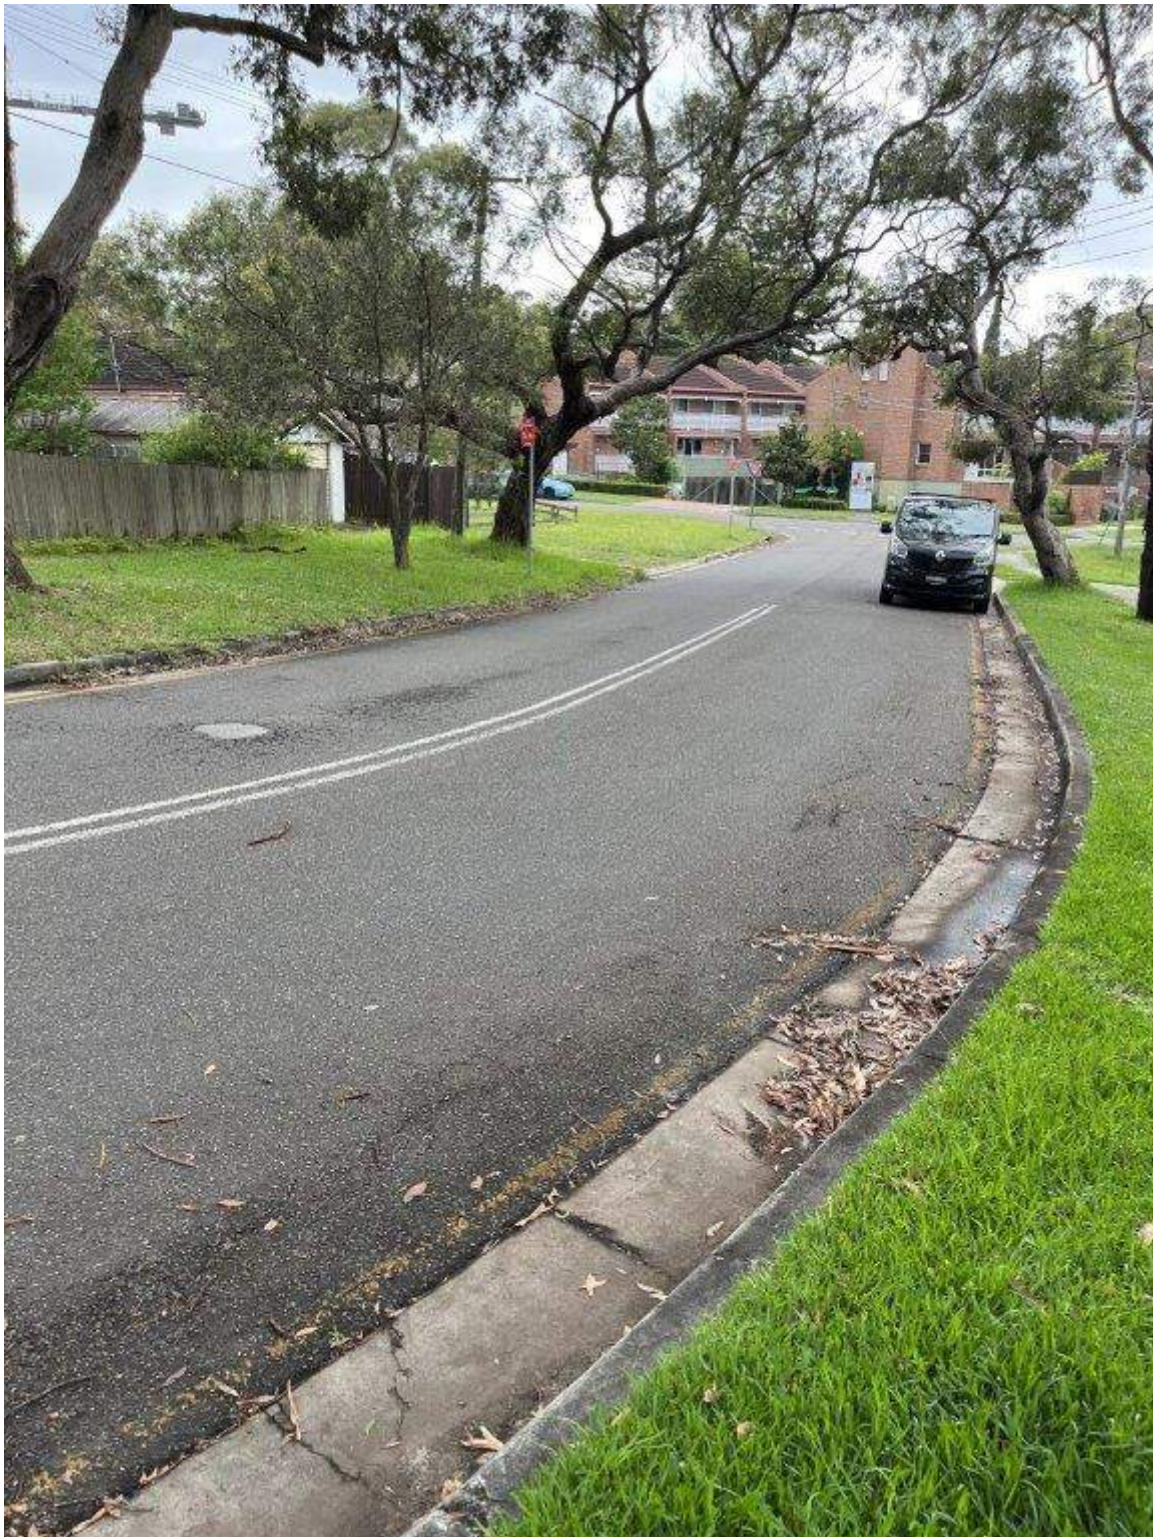
Photo 119 - Hinkler Avenue - Existing condition of pavement and vegetation

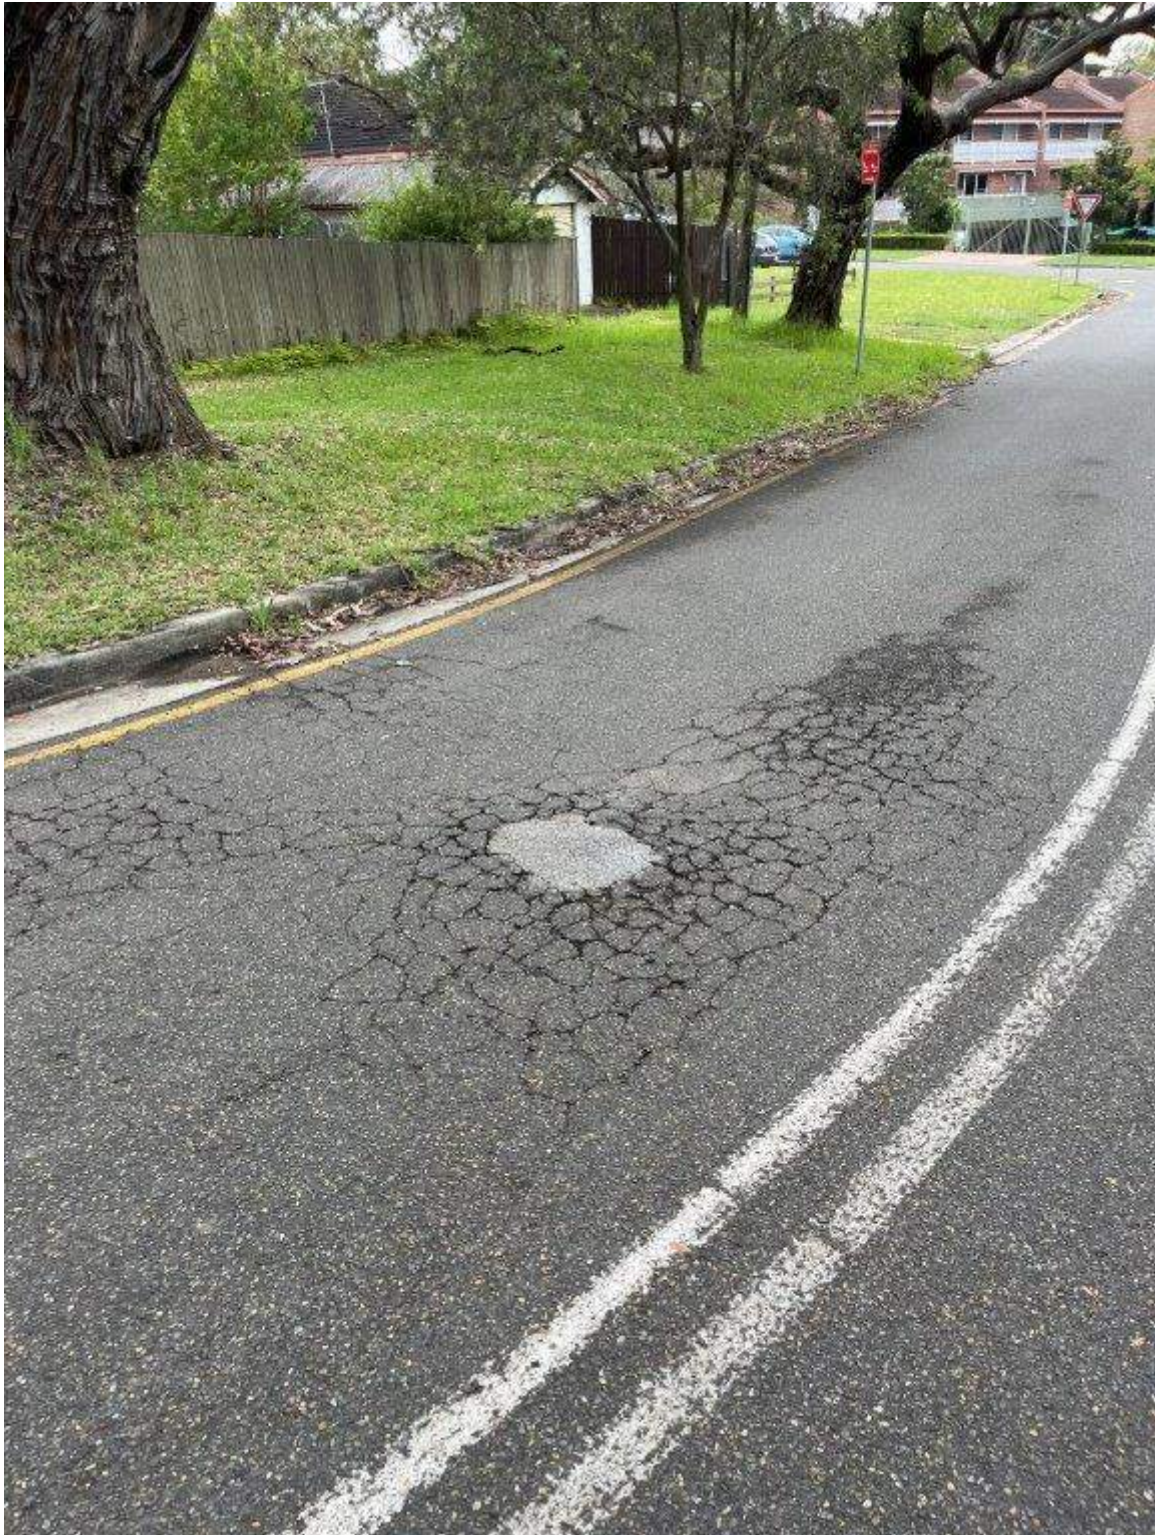
Photo 120 - Hinkler Avenue - Existing condition of pavement

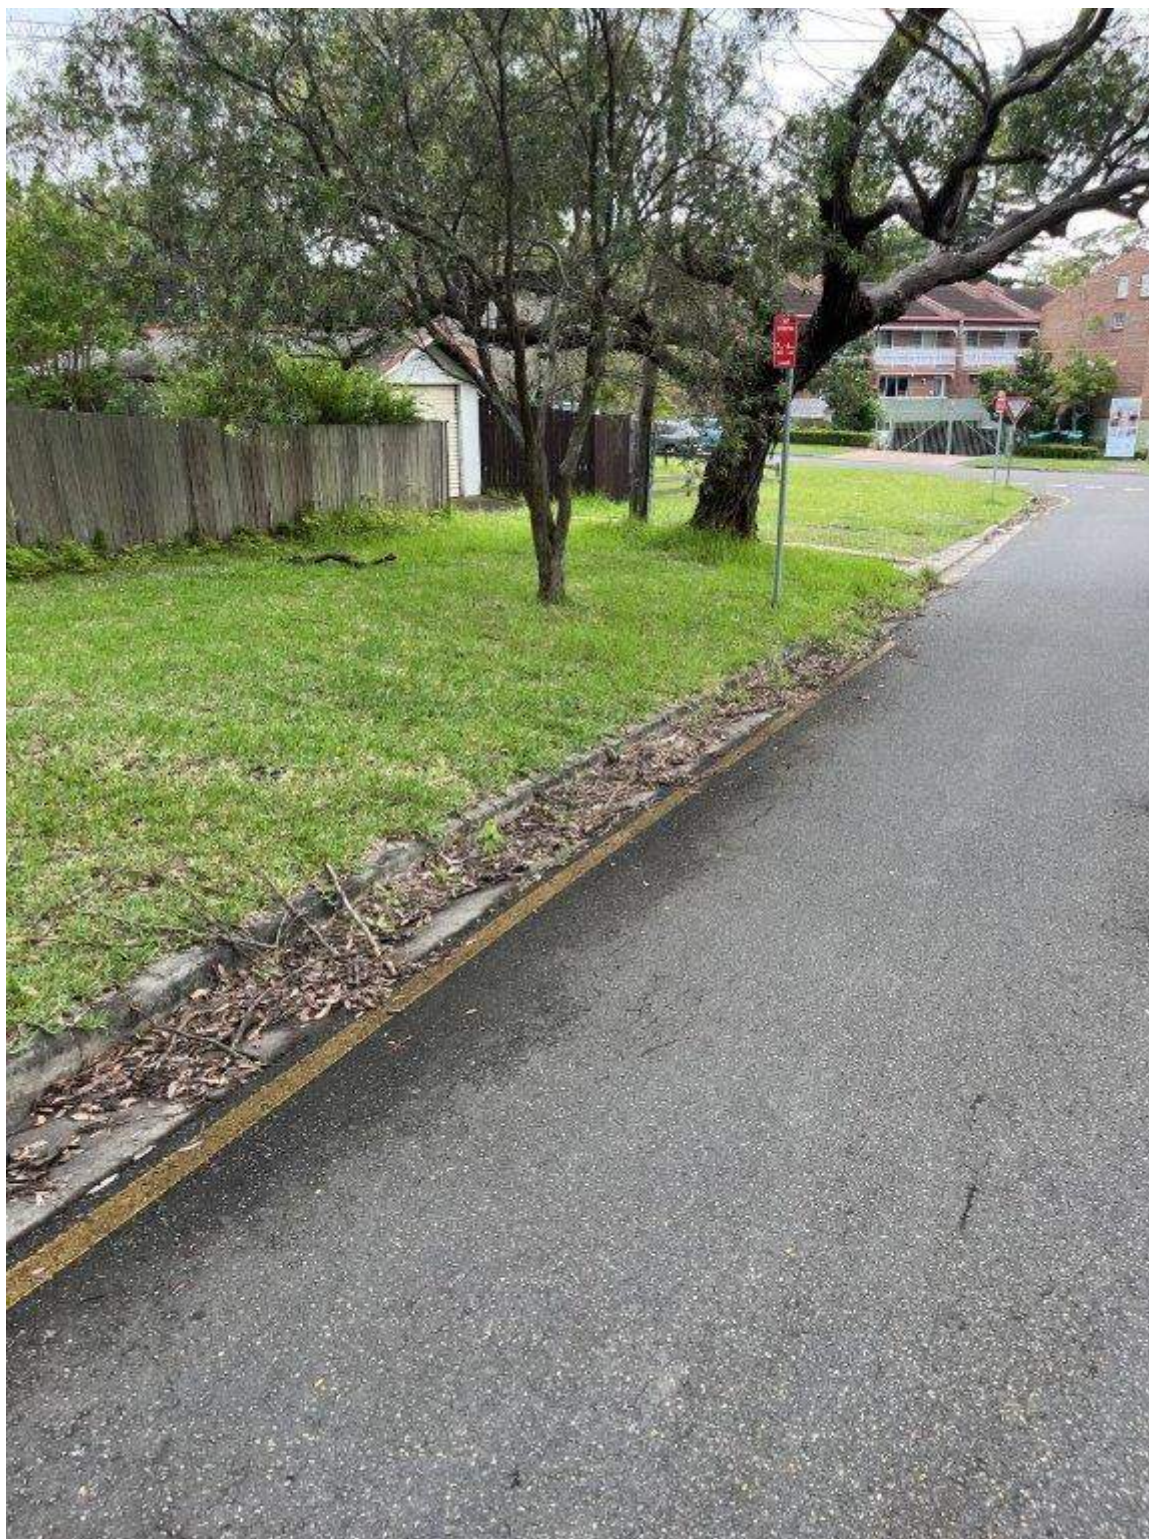
Photo 122 - Hinkler Avenue - Cracking of pavement

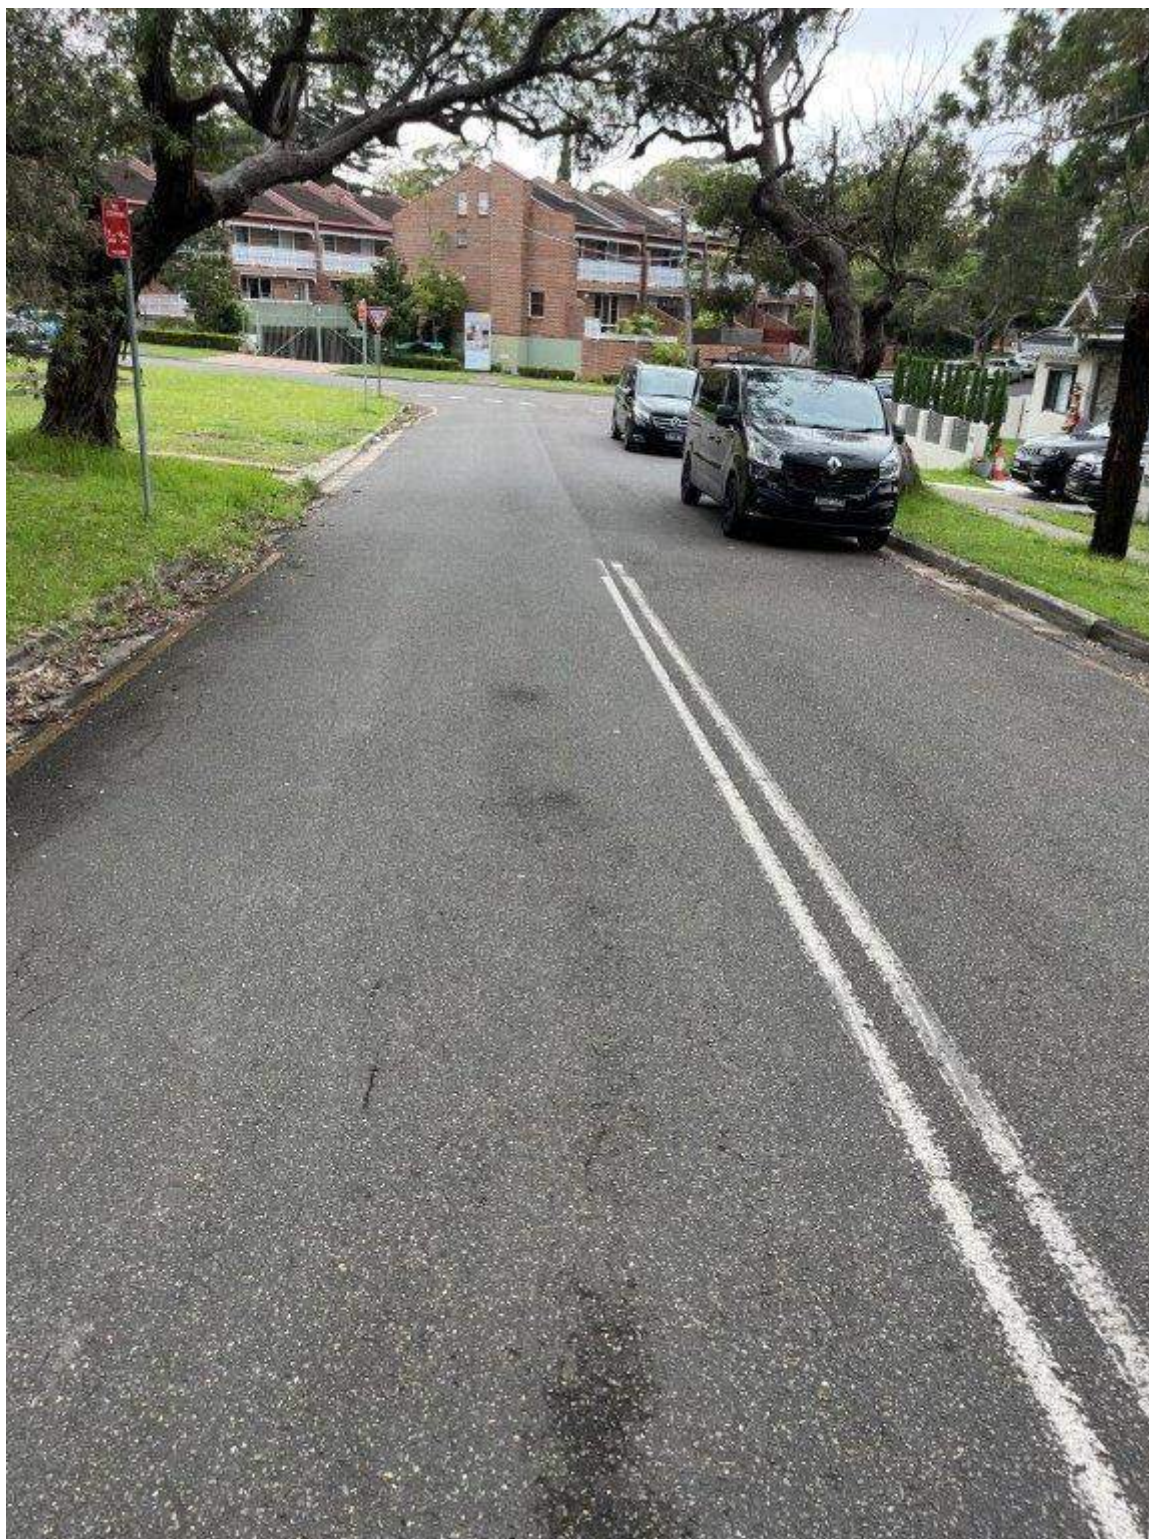
Photo 123 - Hinkler Avenue - Existing condition of pavement and vegetation

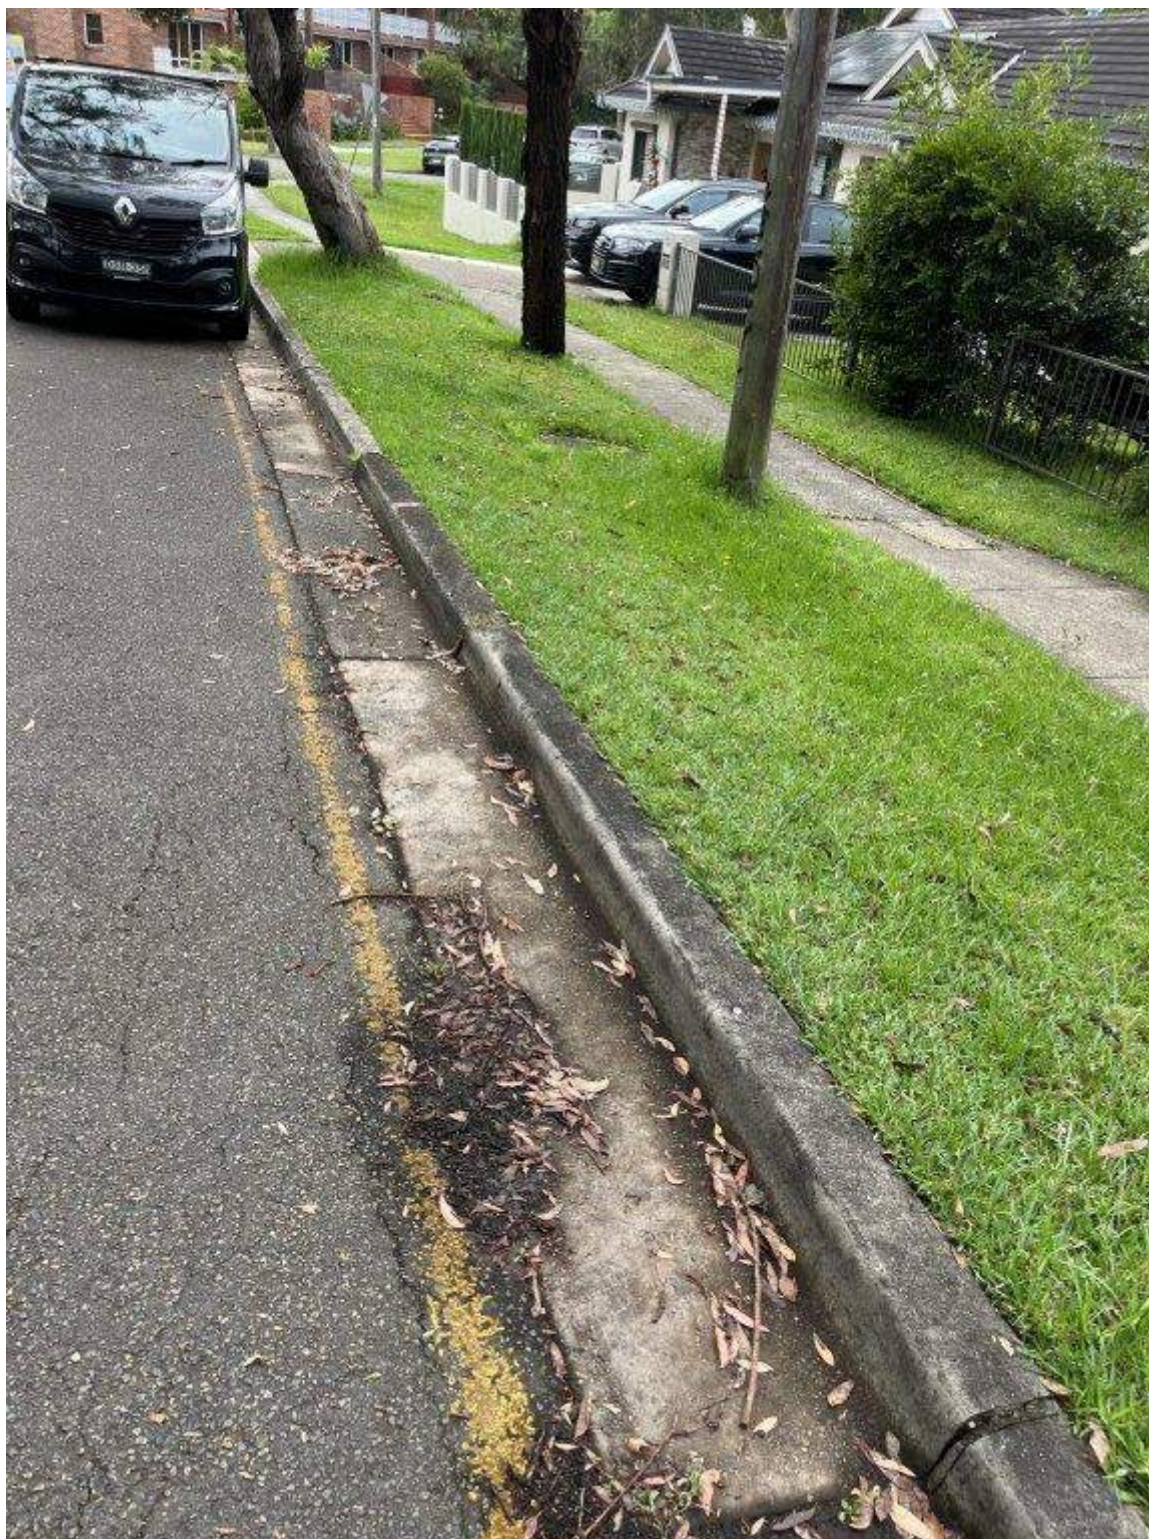
Photo 124 - Hinkler Avenue - Existing condition of pavement

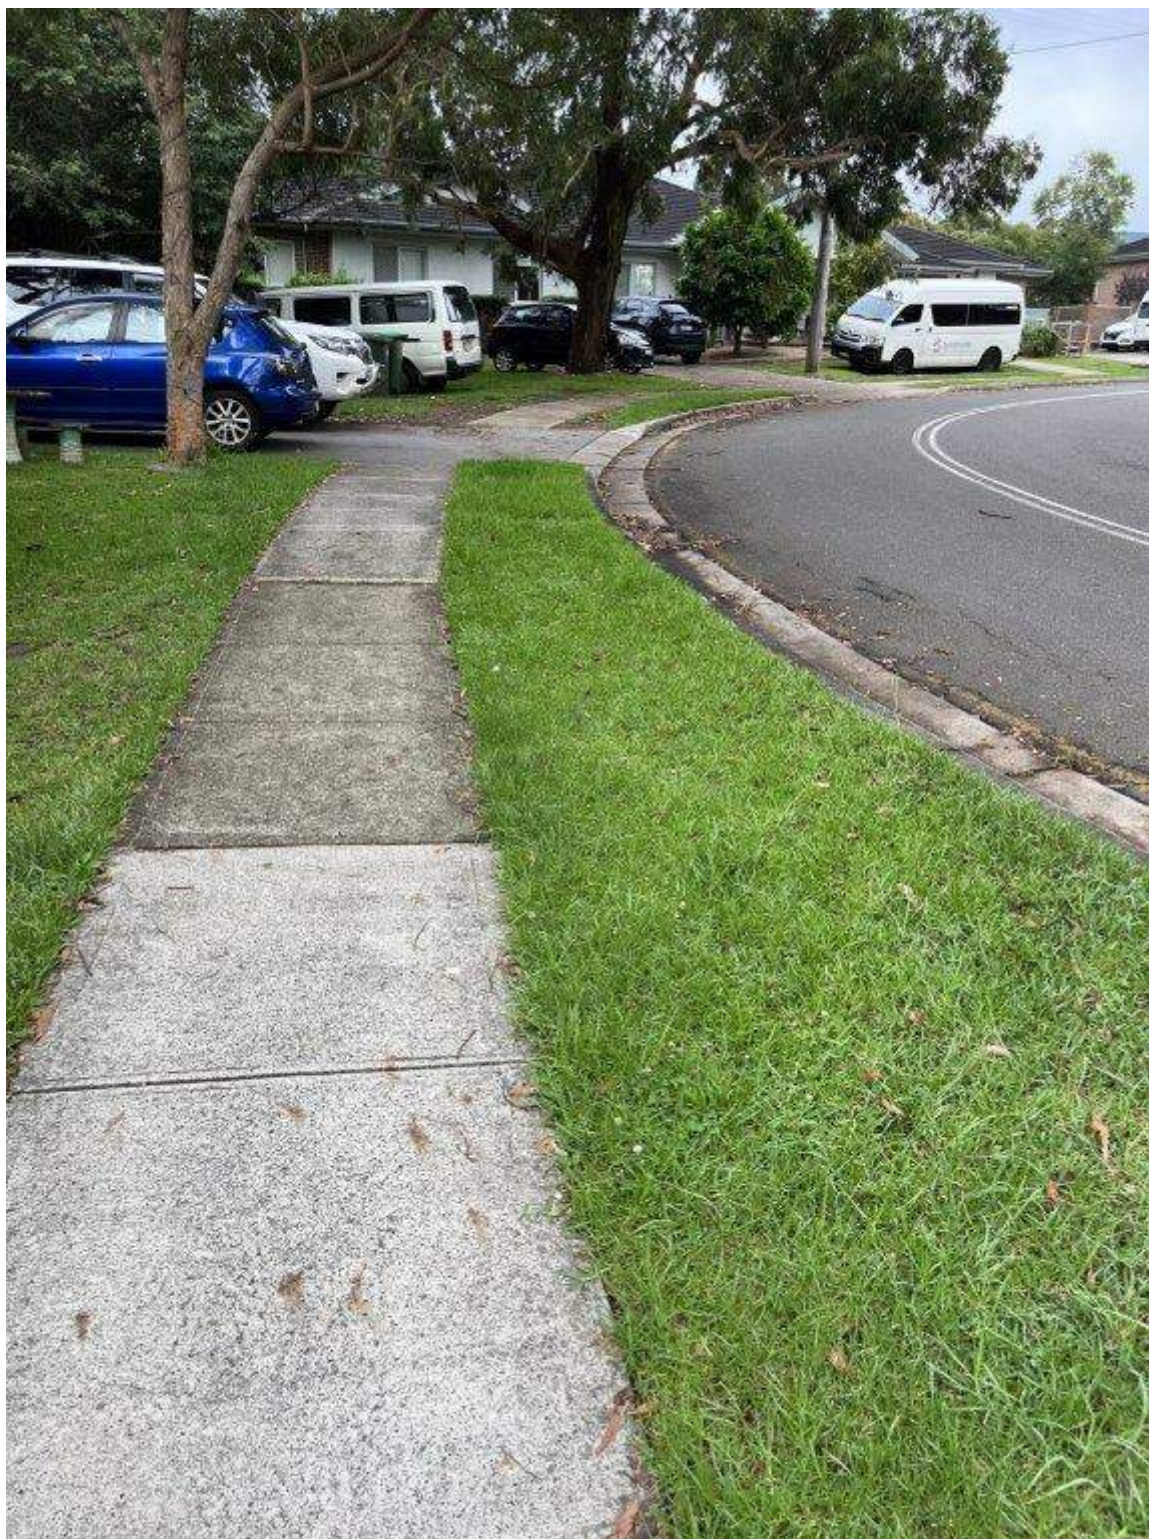
Photo 125 - Hinkler Avenue - Existing condition of pavement and vegetation

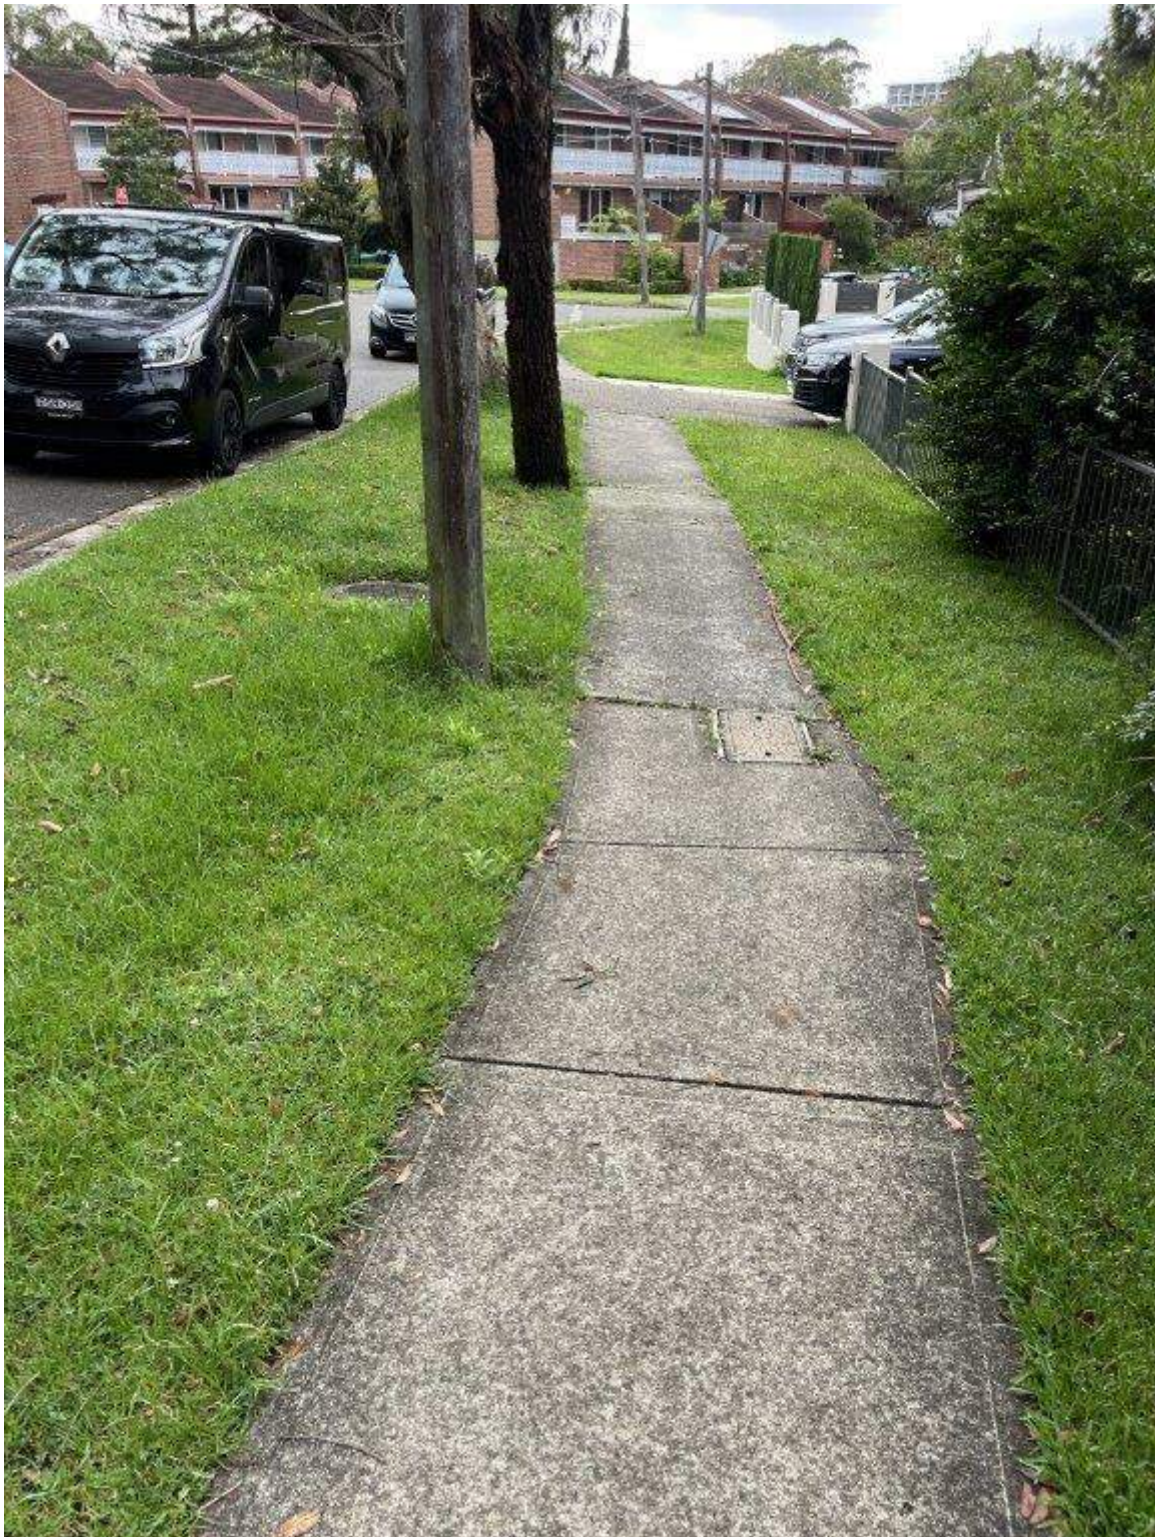
Photo 126 - Hinkler Avenue - Existing condition of pavement and vegetation

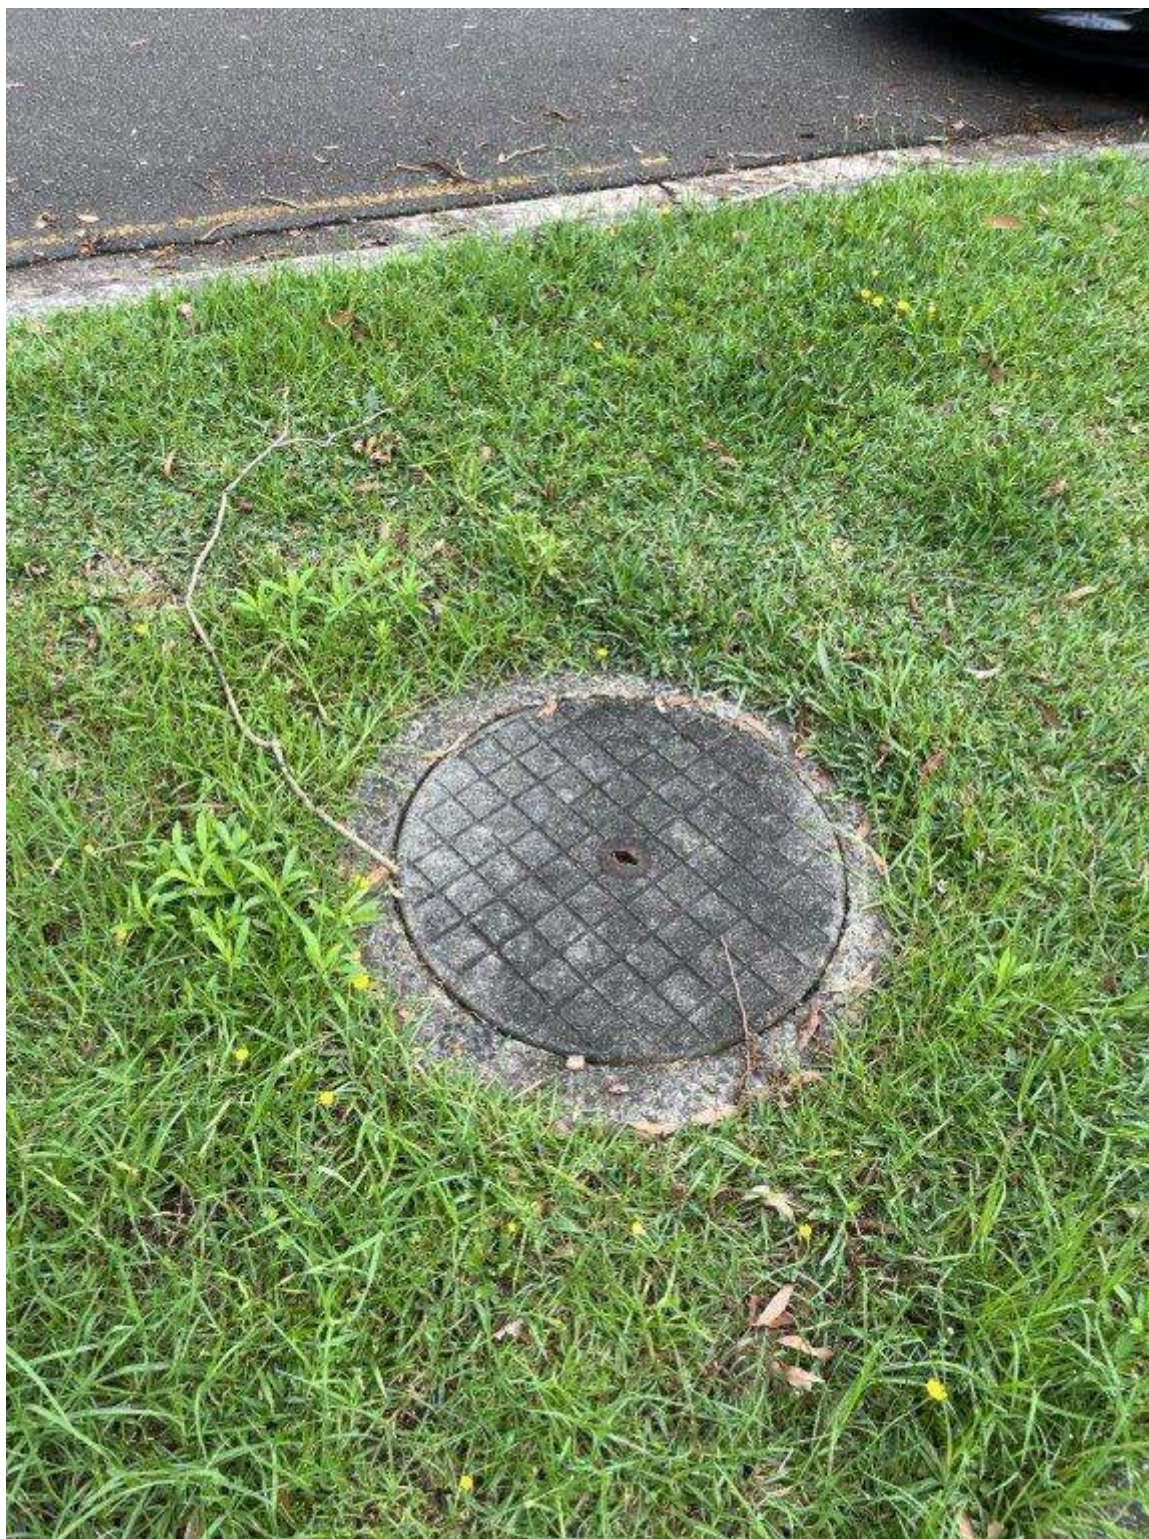
Photo 128 - Hinkler Avenue - Existing condition of service pit
