## PRE-CONSTRUCTION DILAPIDATION REPORT

### 6-20 HINKLER AVENUE & 319-333 TAREN POINT ROAD, CARINGBAH

| PRE-CONSTRUCTION DILAPIDATION REPORT<br>6-20 Hinkler Avenue & 319-333 Taren Point Road,<br>Caringbah NSW 2229 | | | | | Project Number: 21039 |

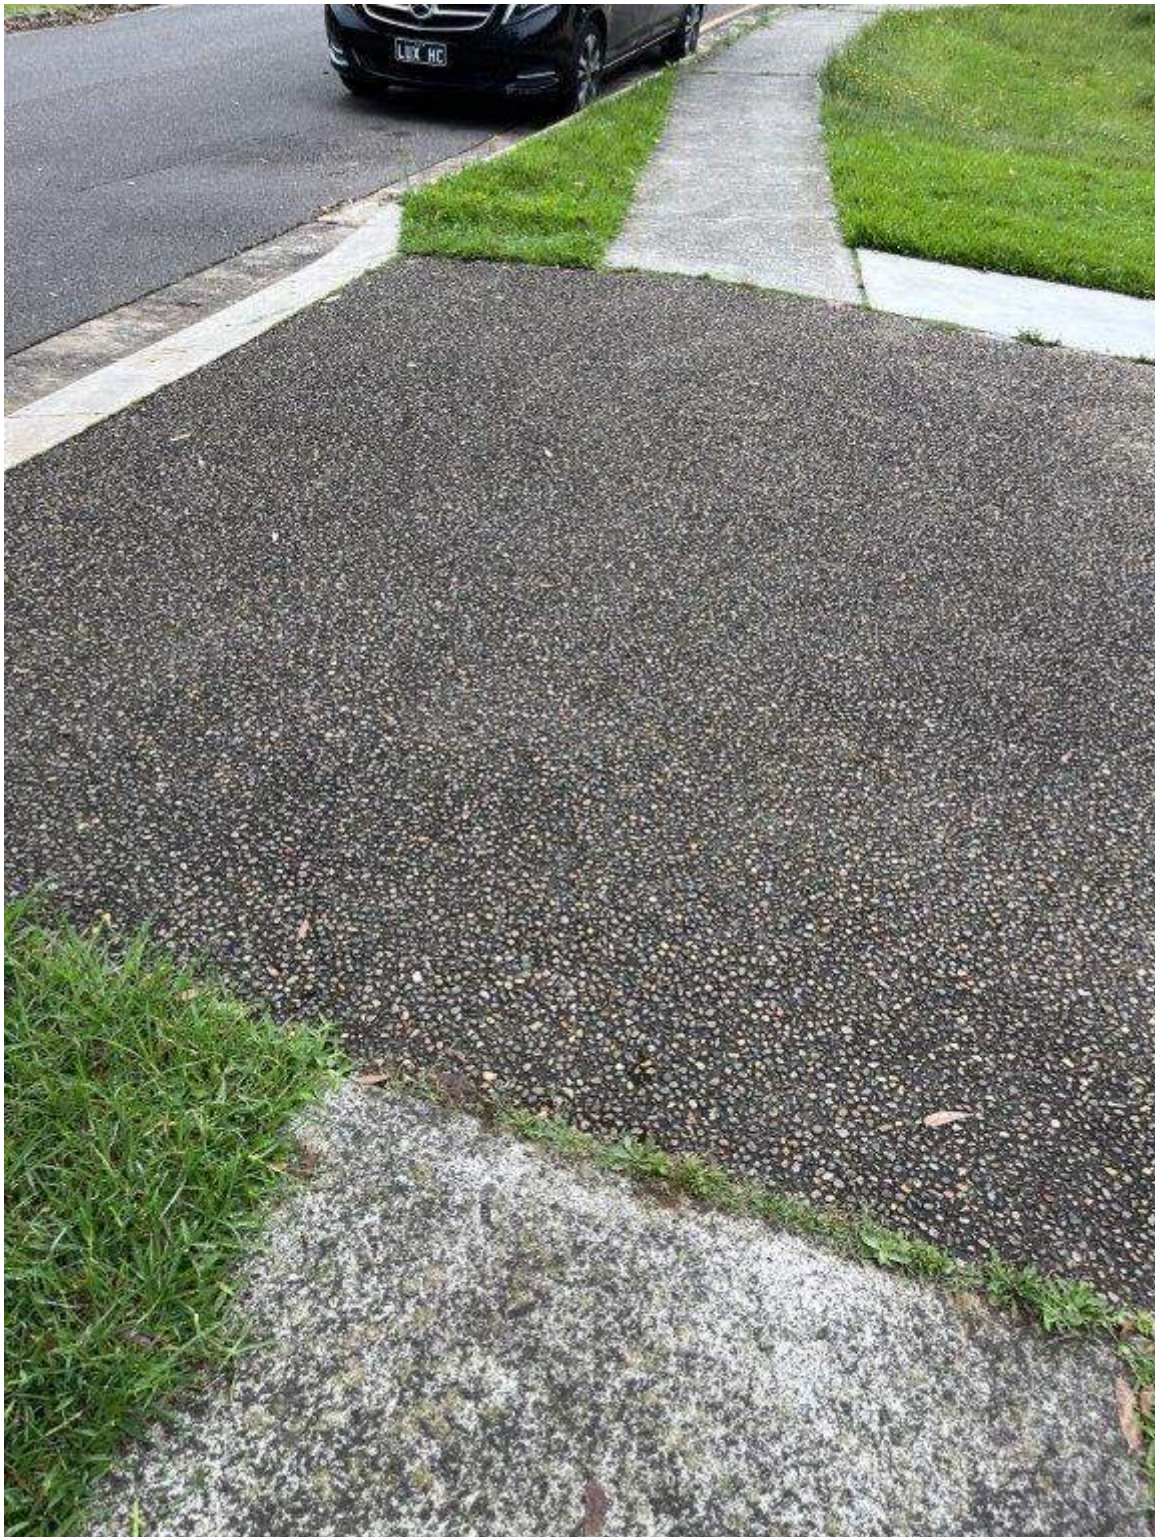
Photo 129 - Hinkler Avenue - Existing condition of manhole

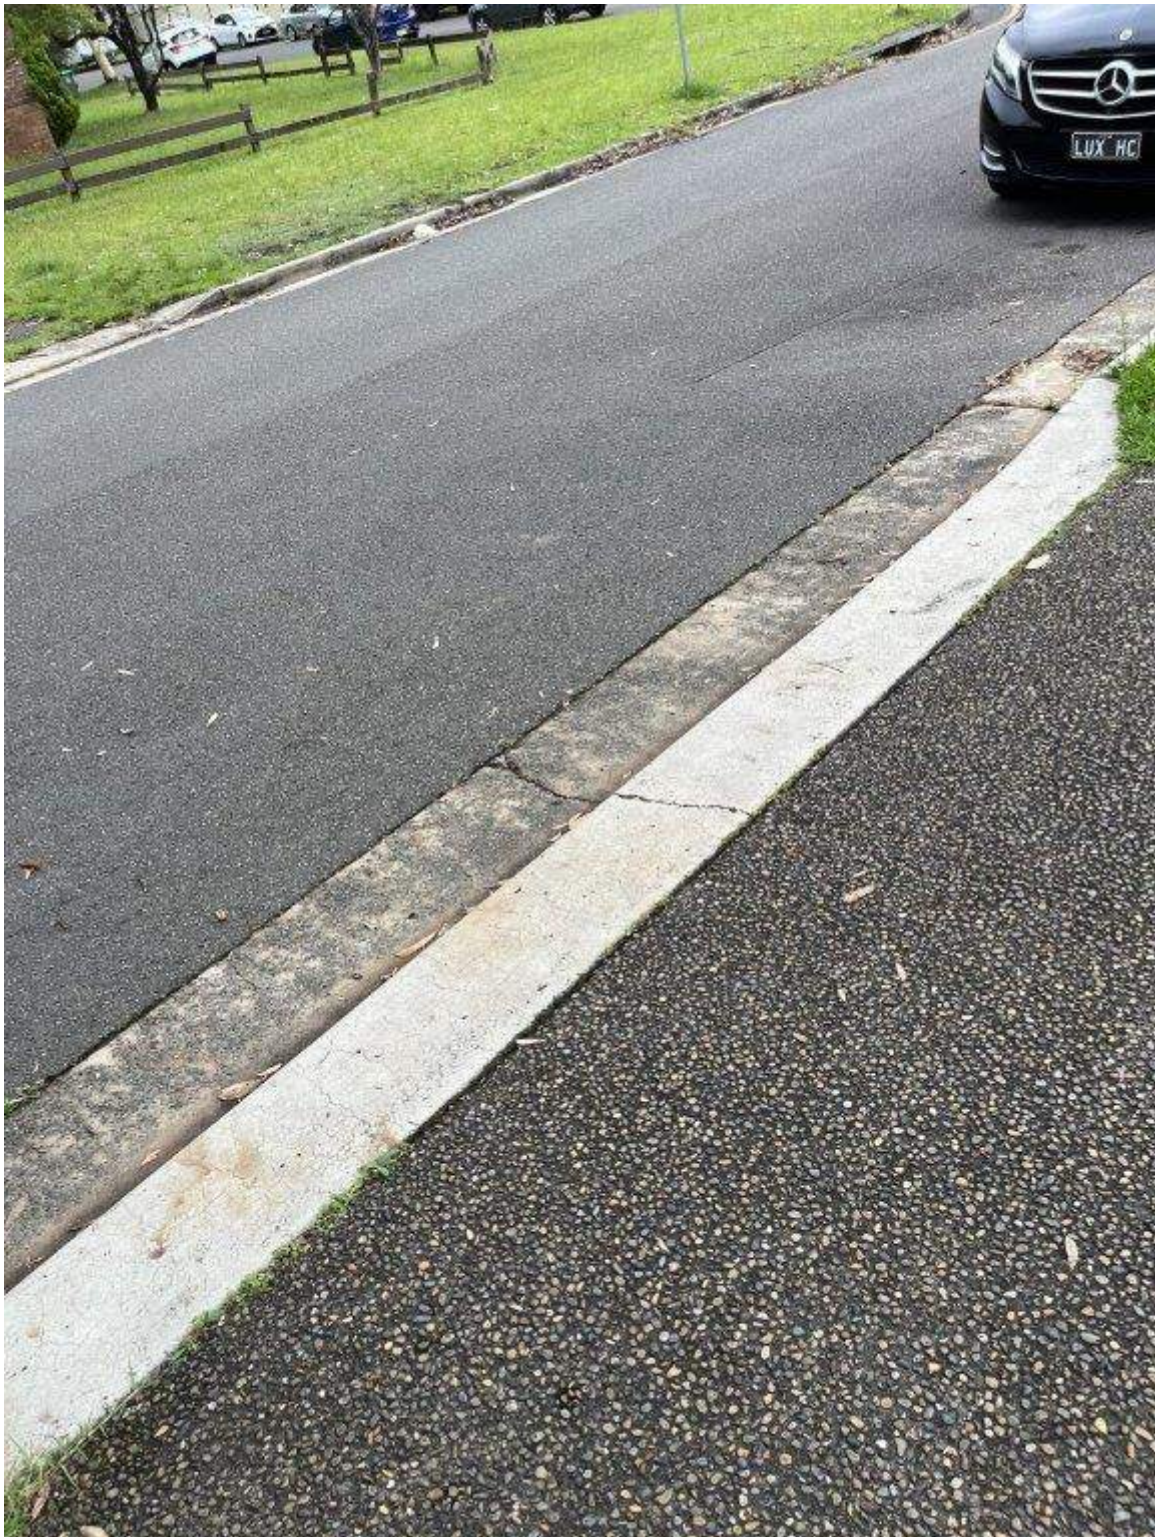
Photo 130 - Hinkler Avenue - Existing condition of pavement

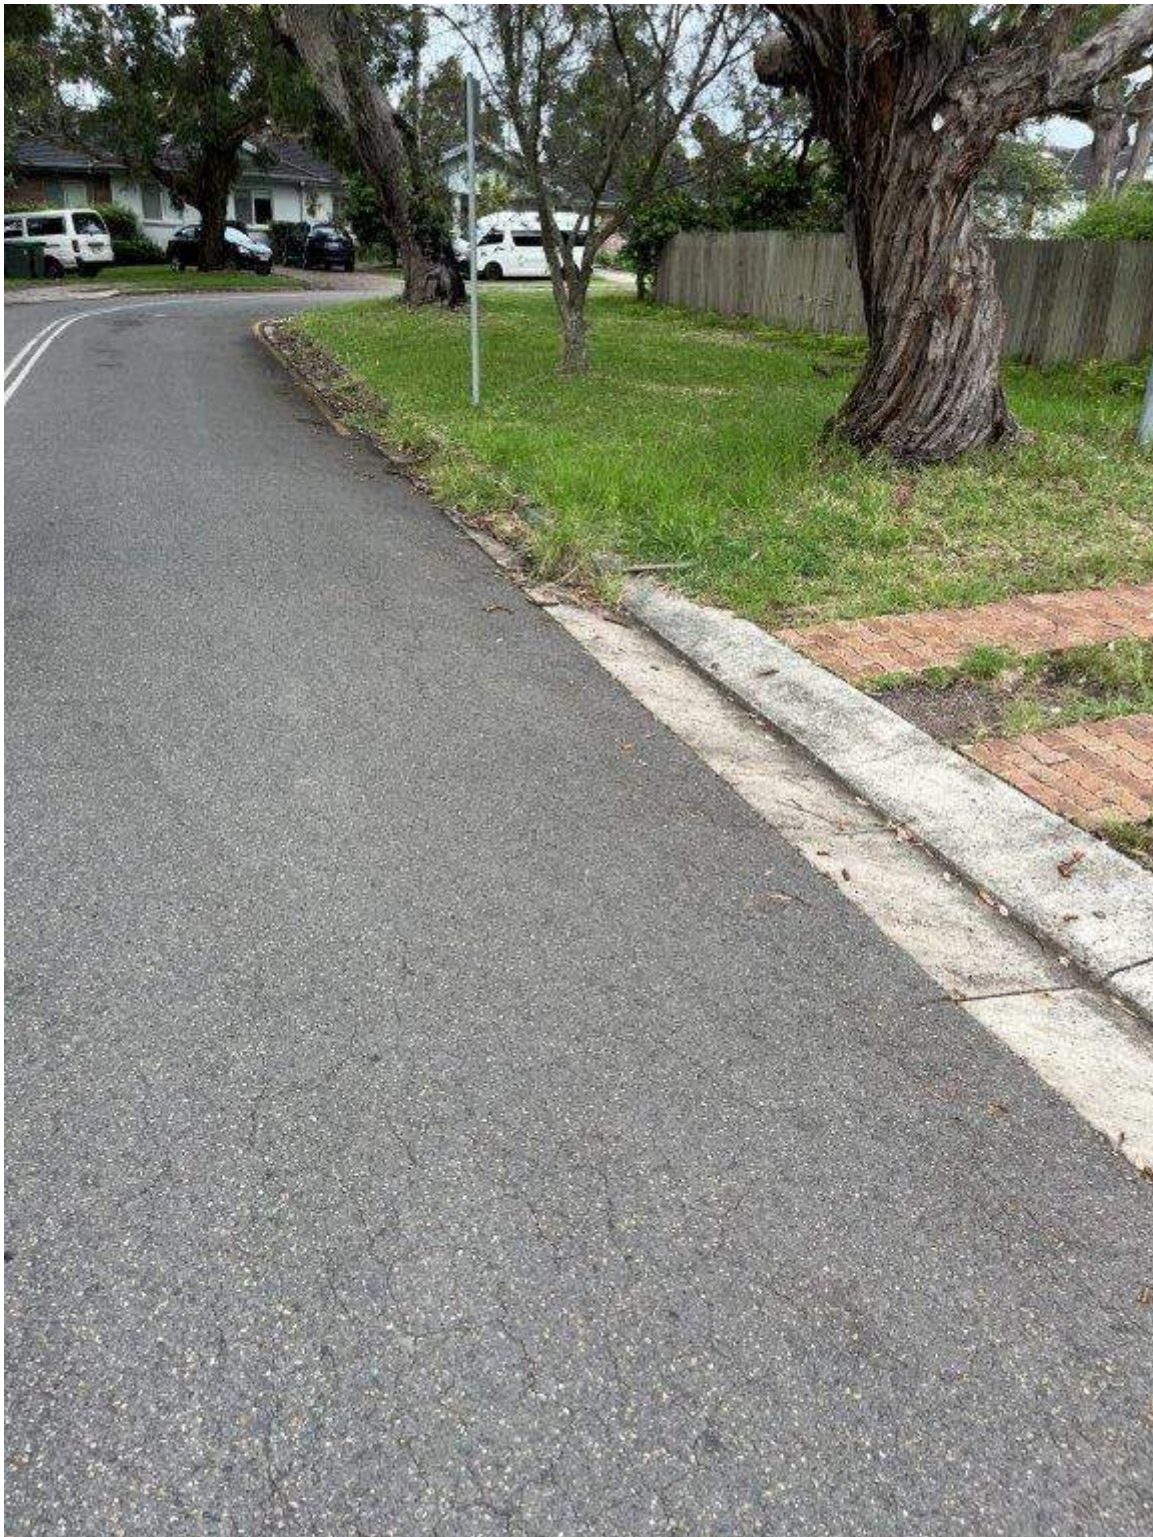
Photo 131 - Hinkler Avenue - Cracking of pavement

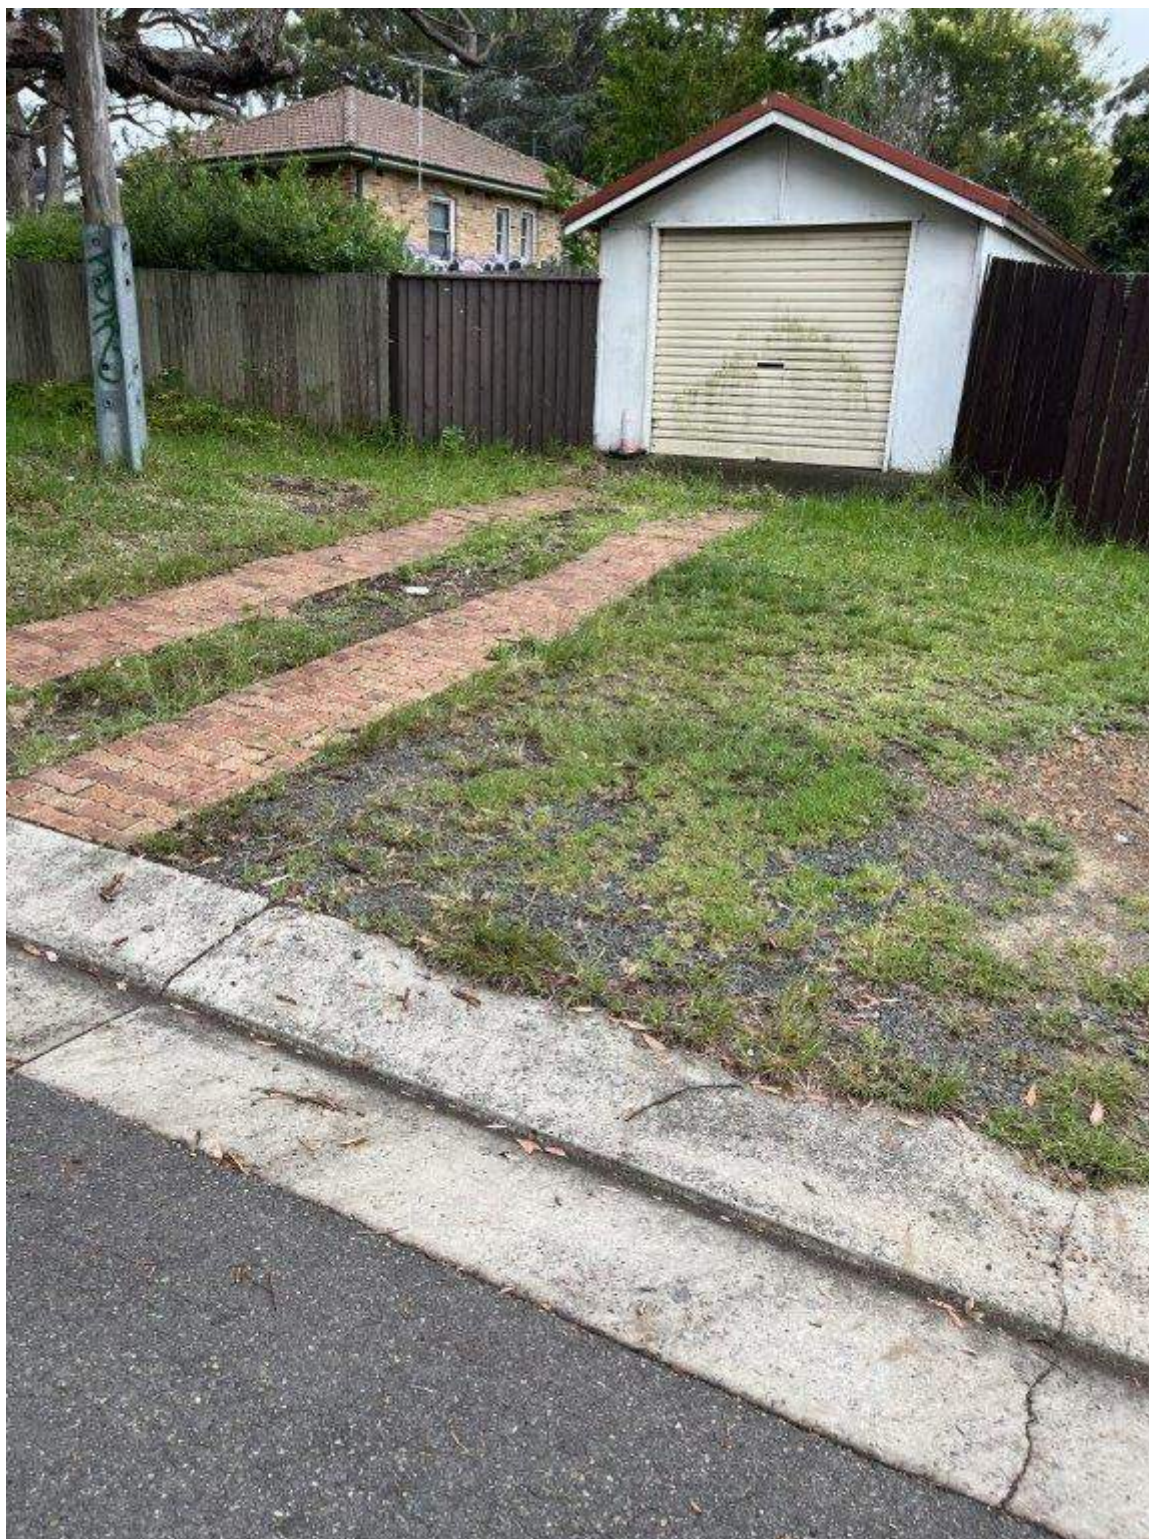
Photo 132 - Hinkler Avenue - Existing condition of pavement and vegetation

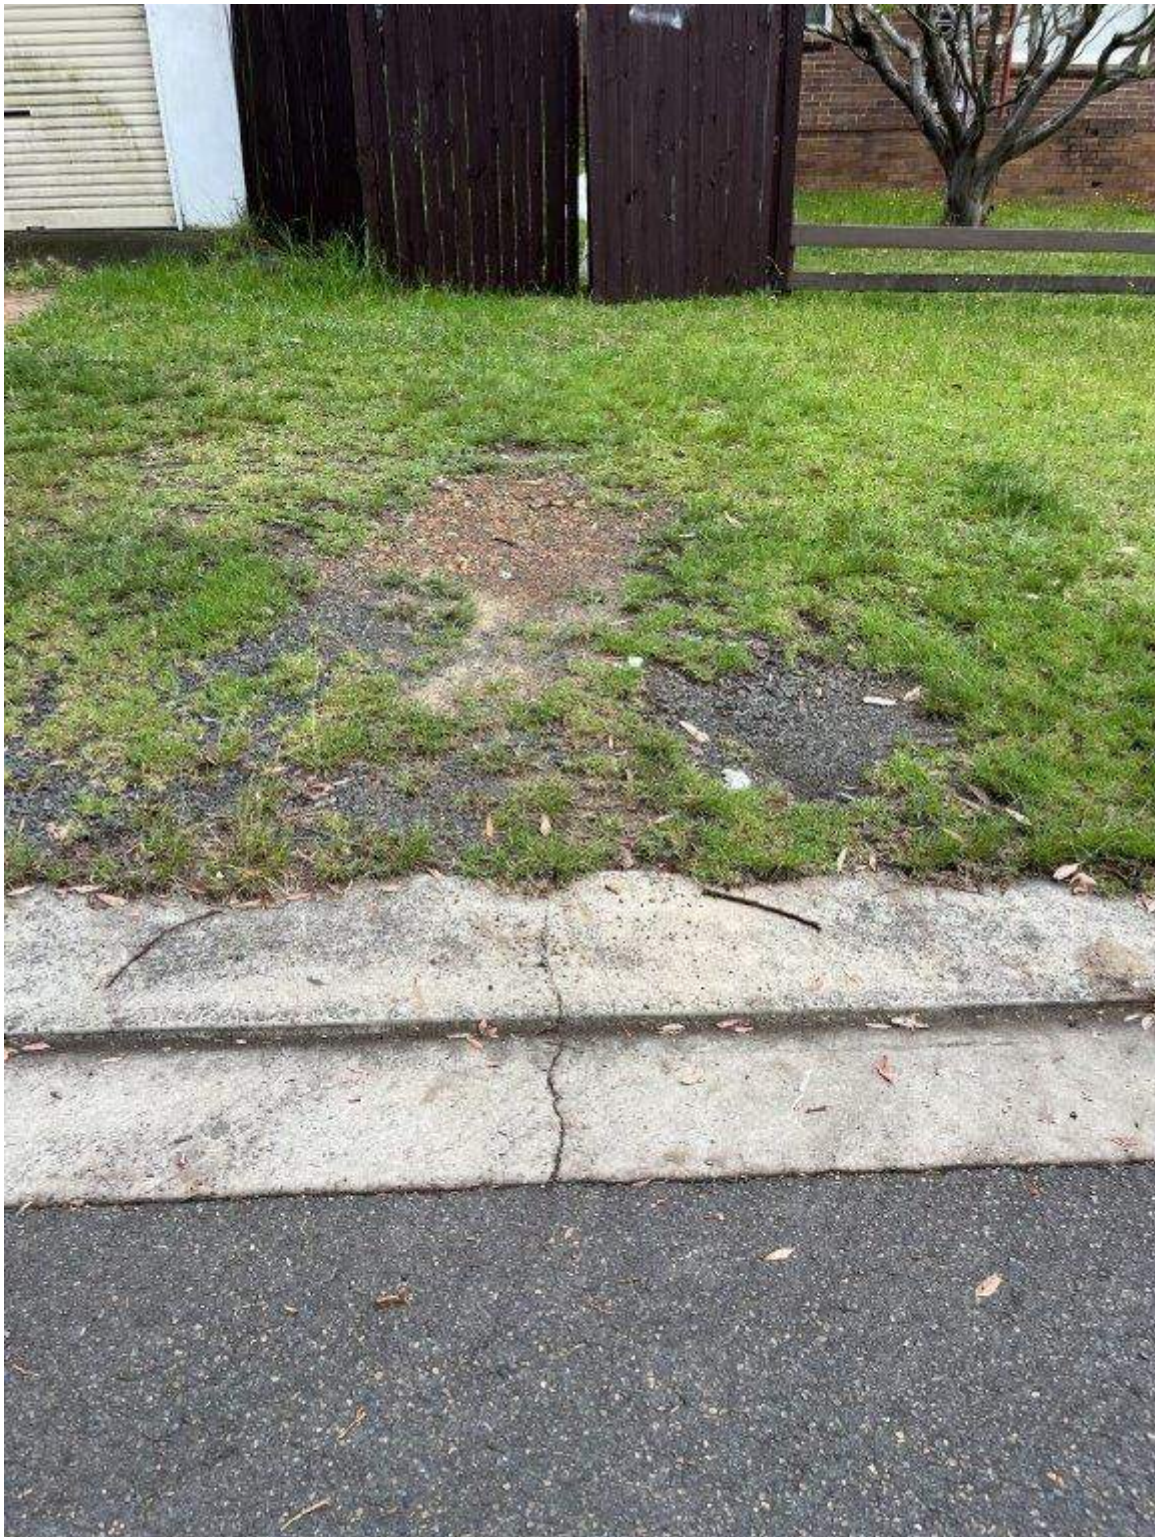
Photo 133 - Hinkler Avenue - Cracking of pavement

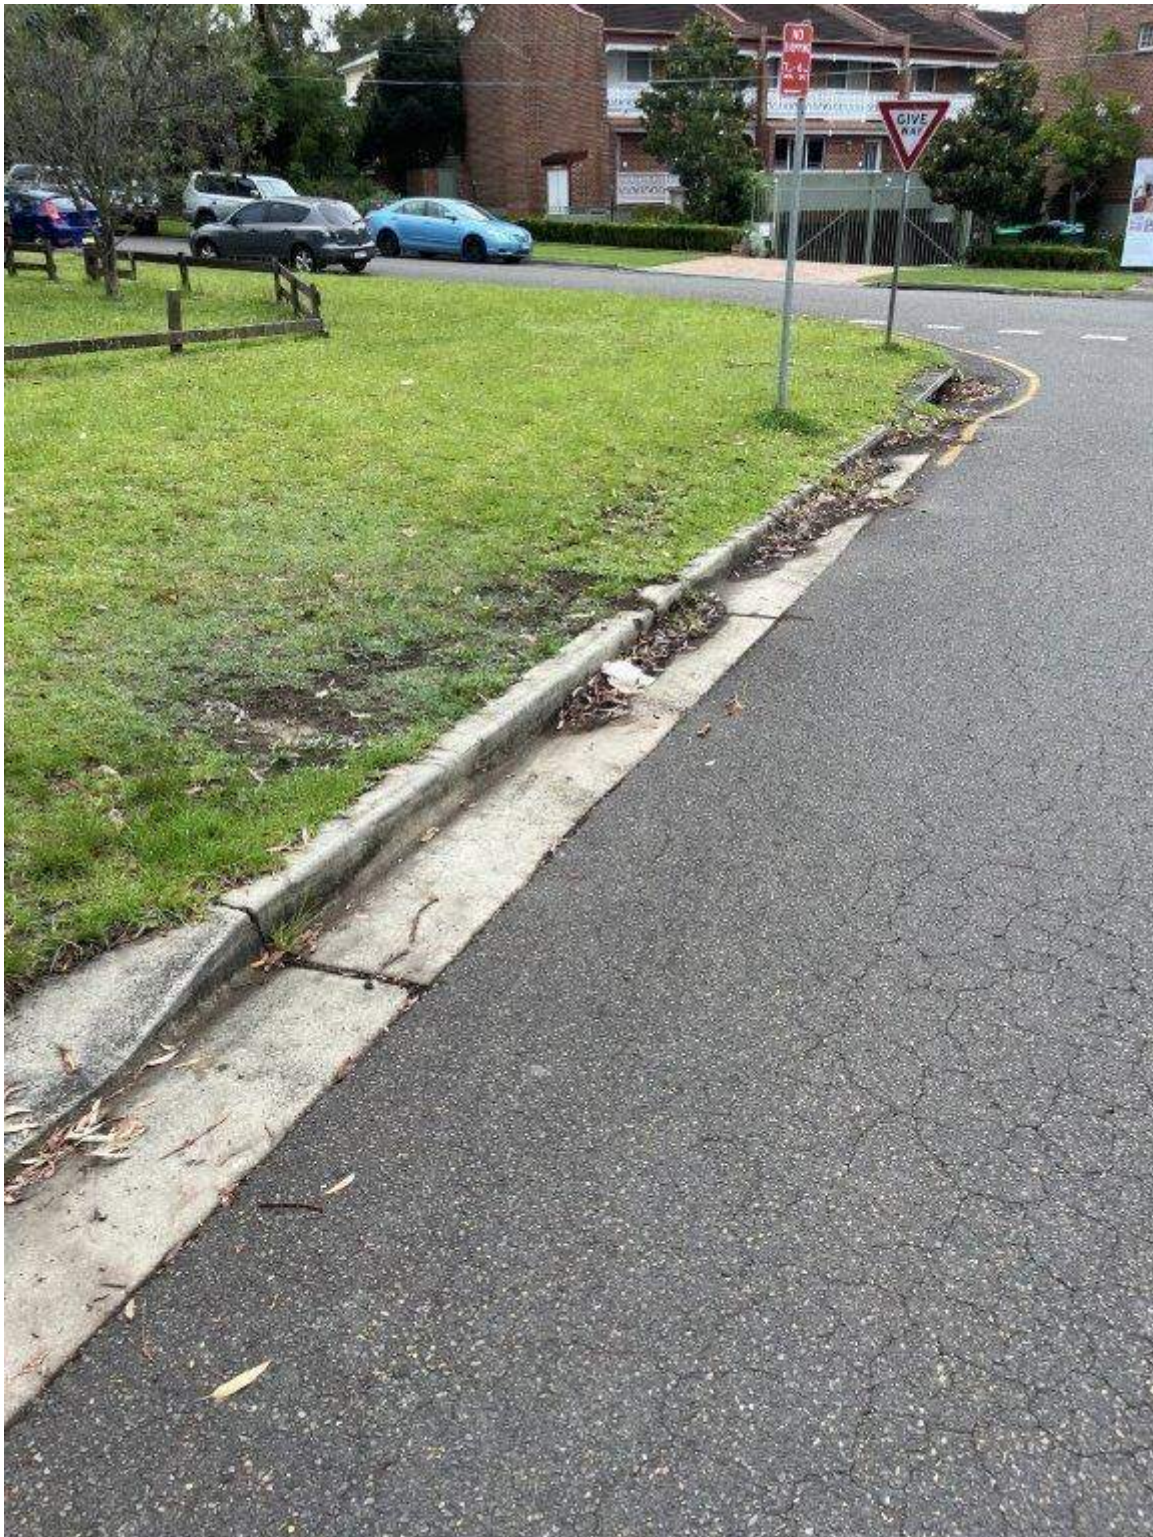
Photo 134 - Hinkler Avenue - Cracking of pavement

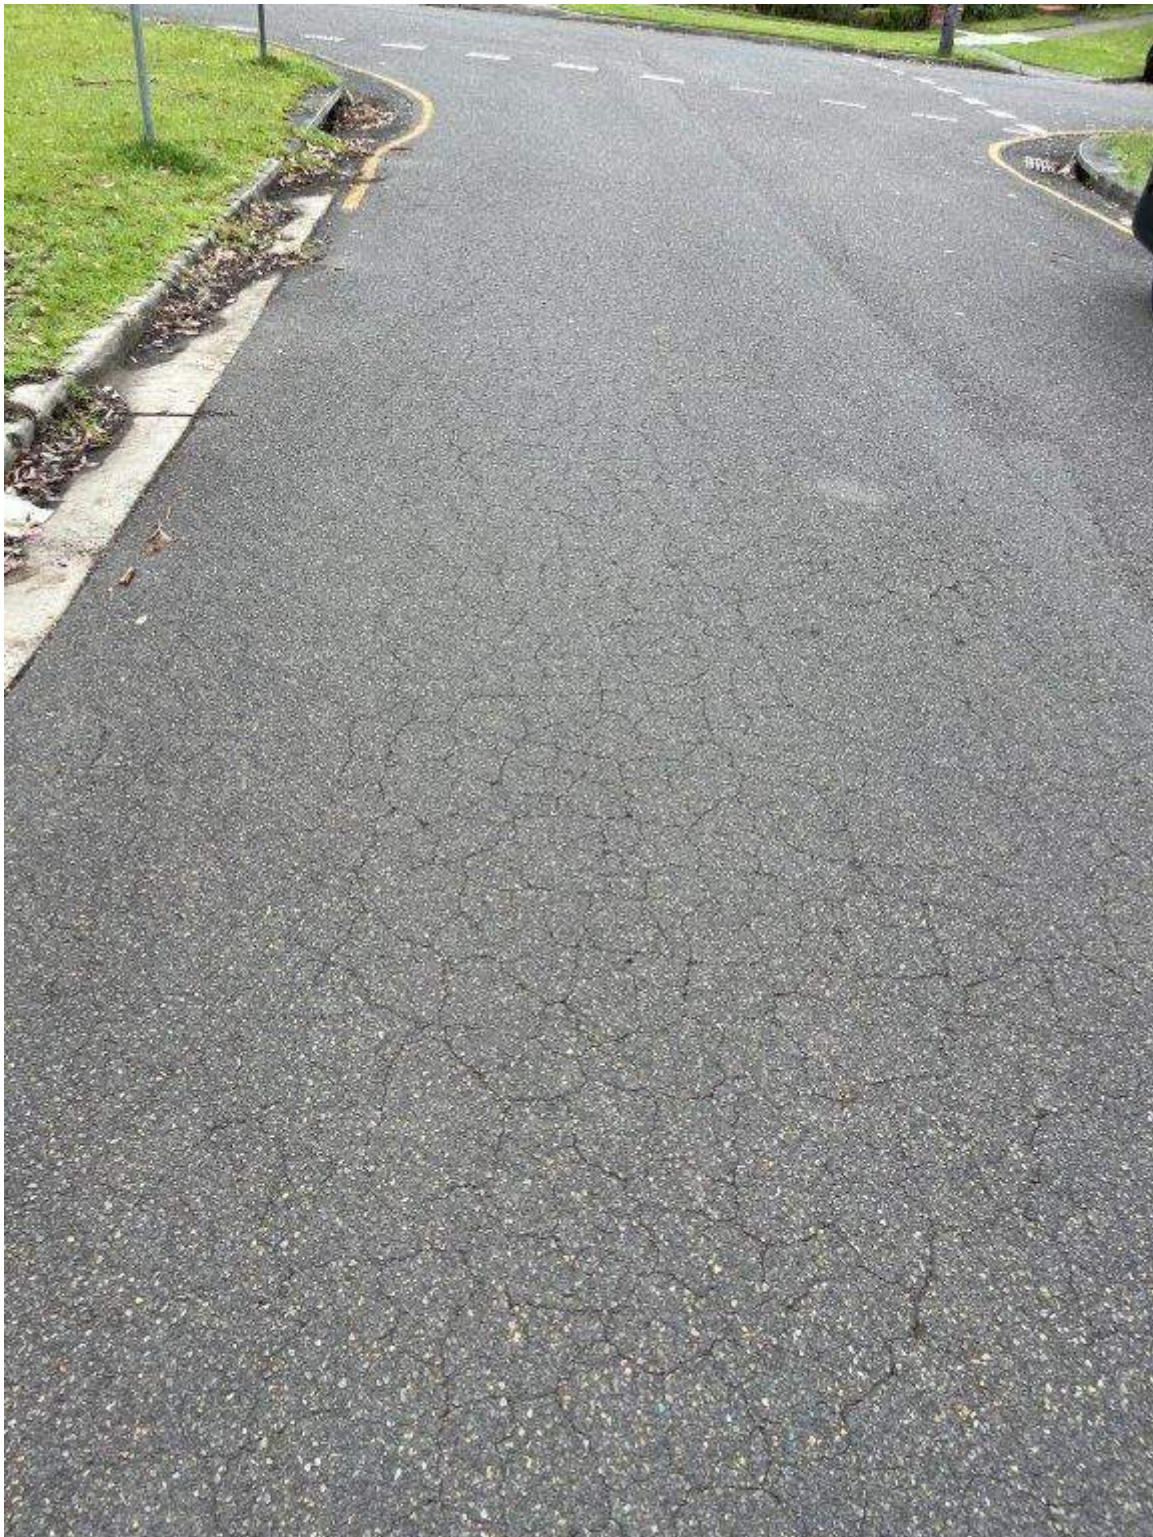
Photo 136 - Hinkler Avenue - Cracking of pavement

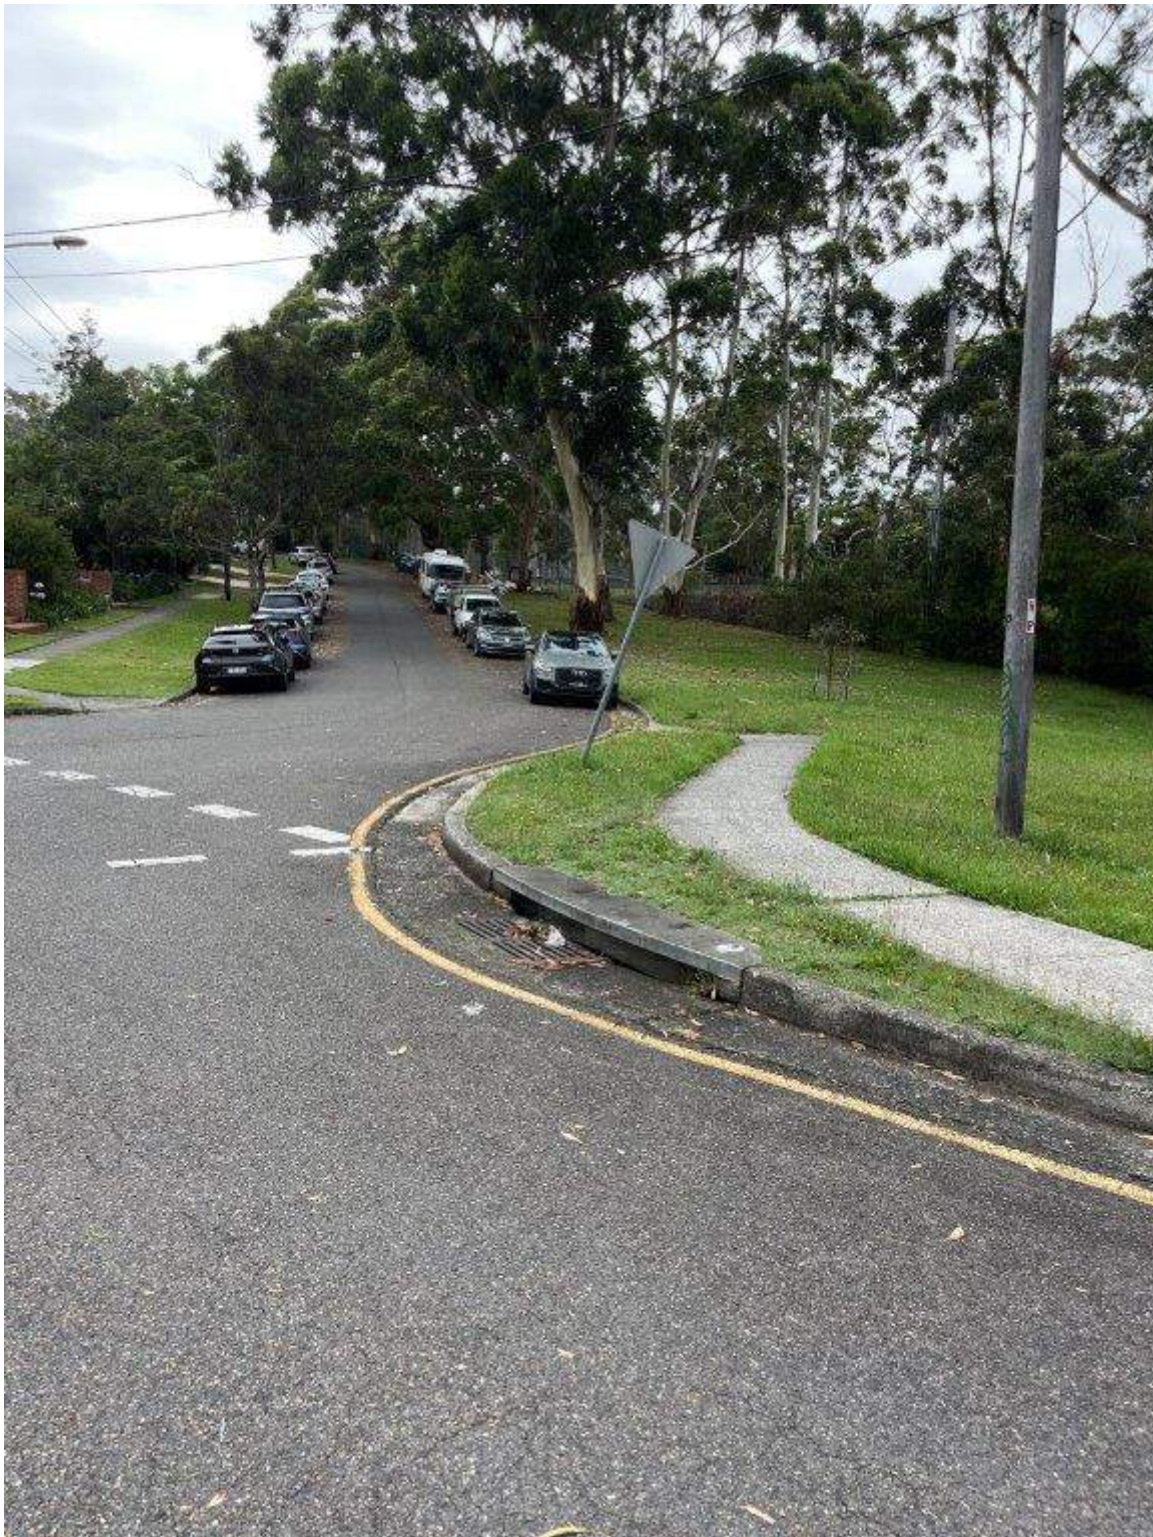
Photo 137 - Hinkler Avenue - Existing condition of pavement and vegetation

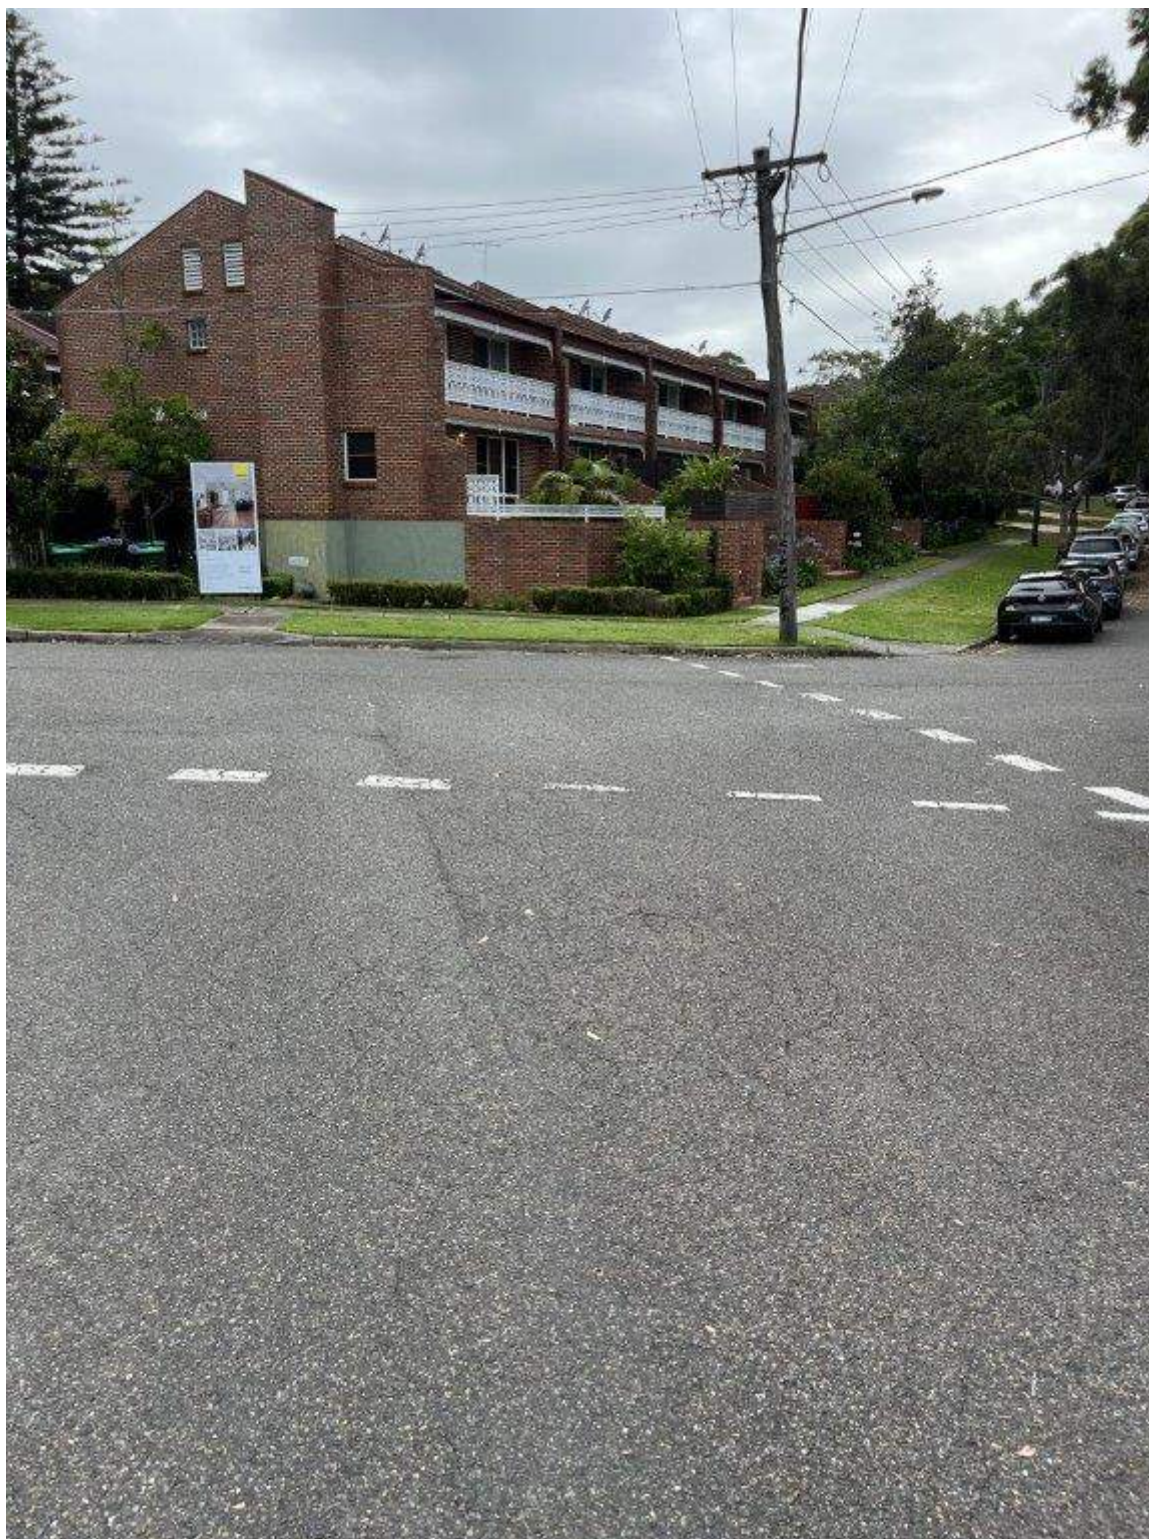
Photo 138 - Hinkler Avenue - Existing condition of pavement and vegetation

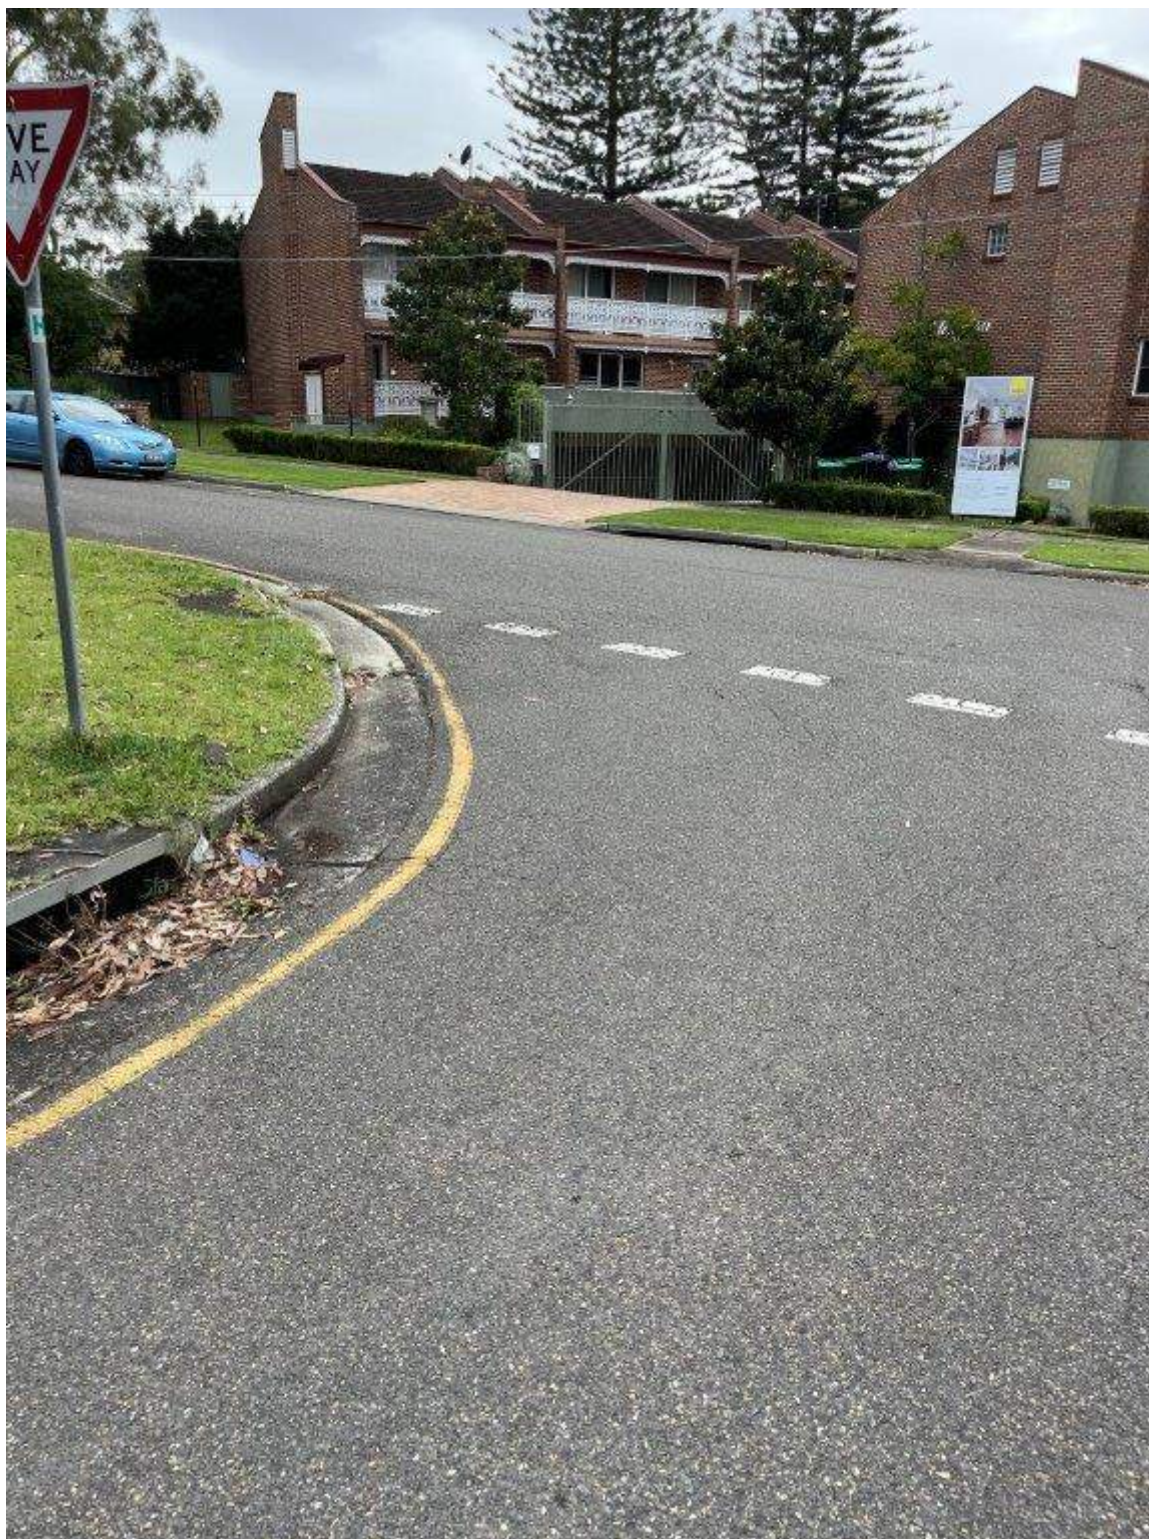
Photo 139 - Hinkler Avenue - Existing condition of pavement and vegetation

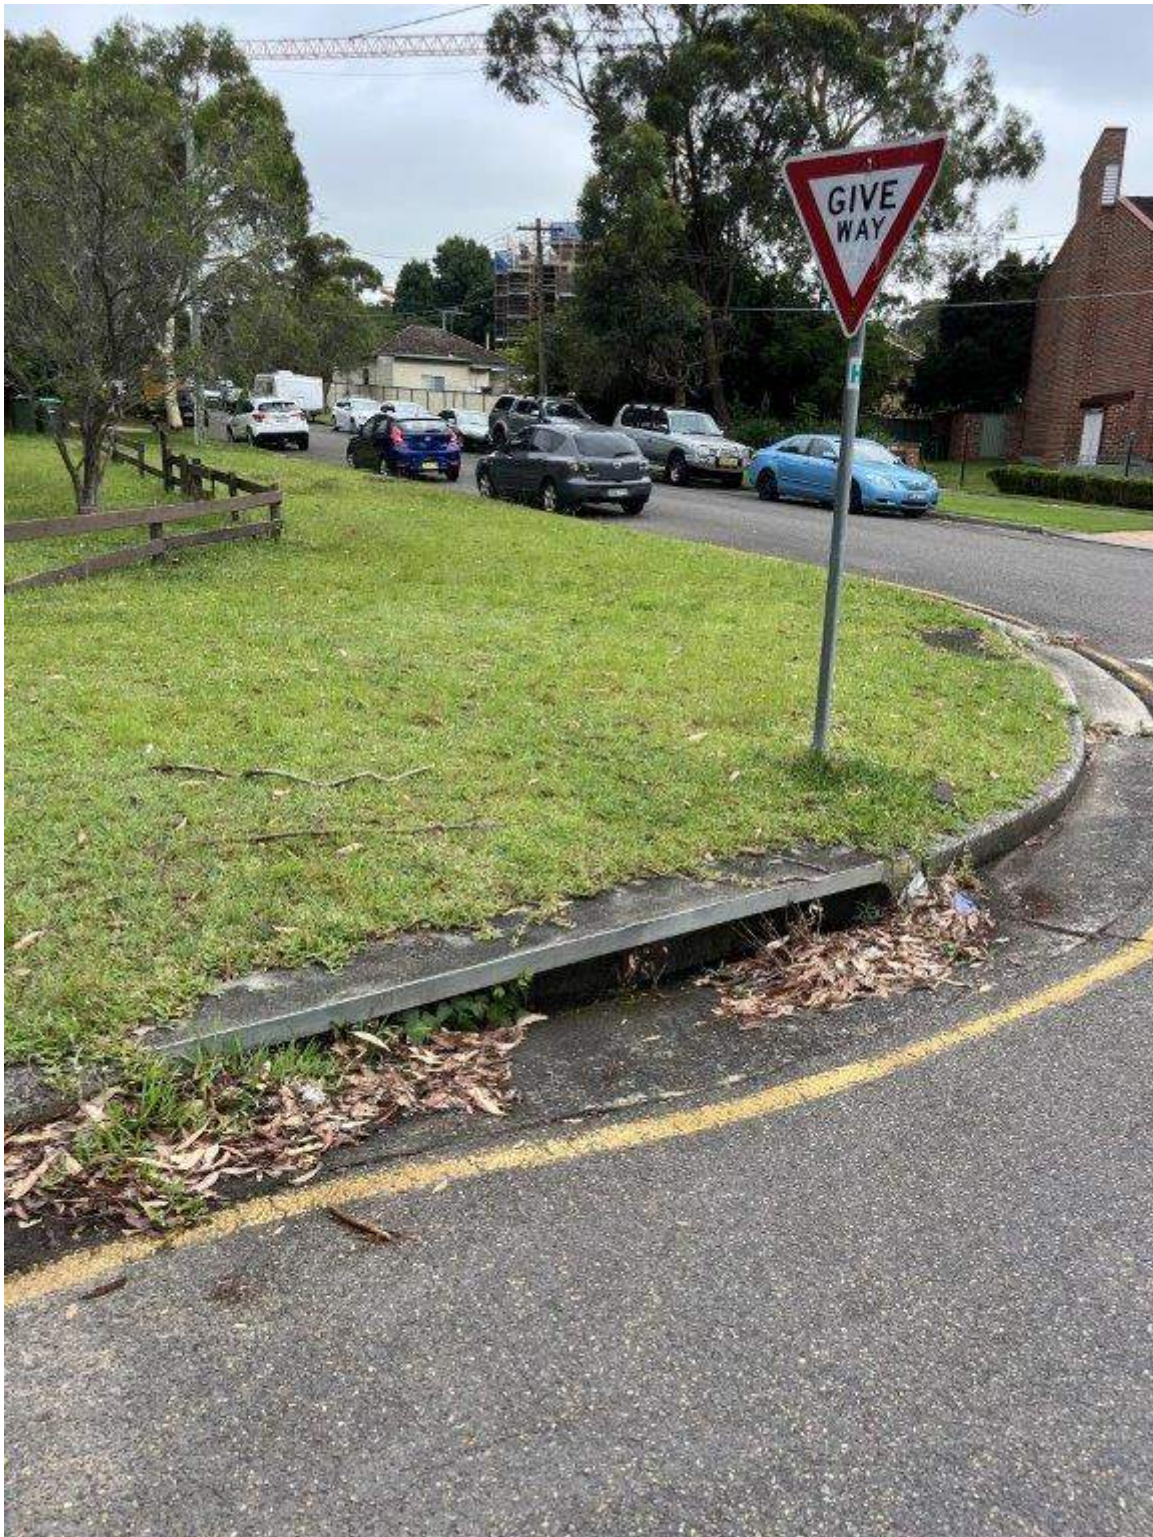
Photo 140 - Hinkler Avenue - Existing condition of signpost

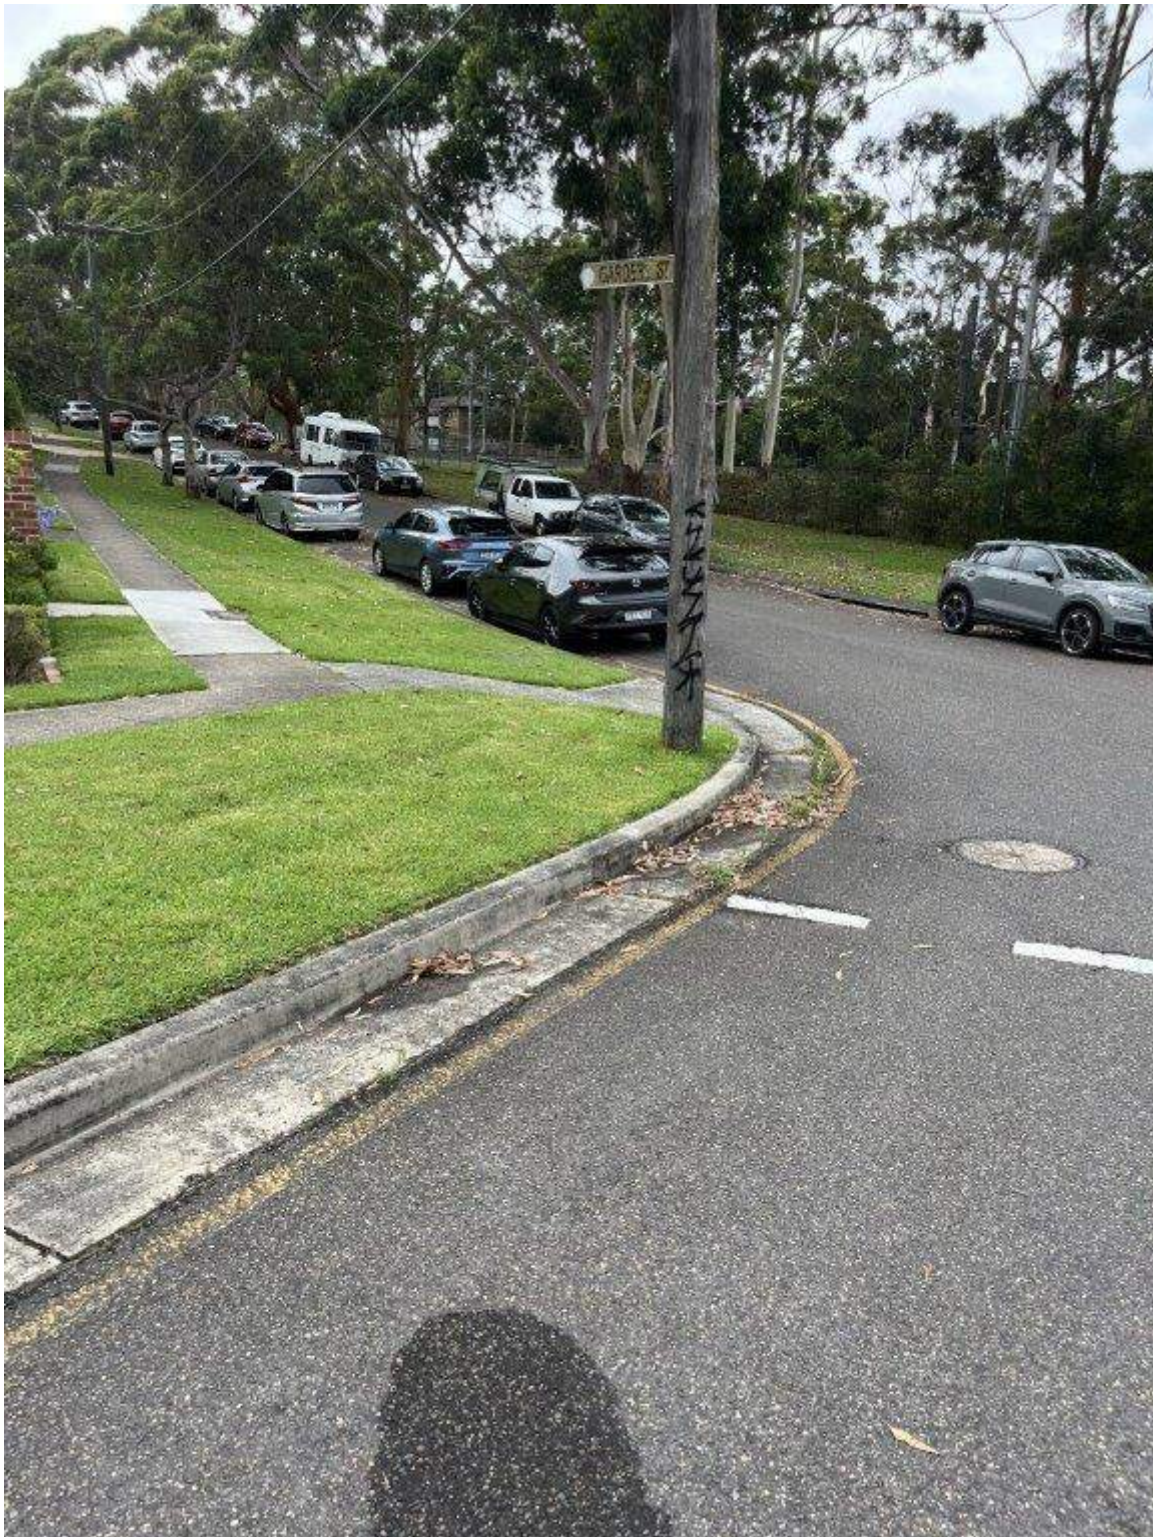
Photo 141 - Taren Point Road - Existing condition of pavement and post

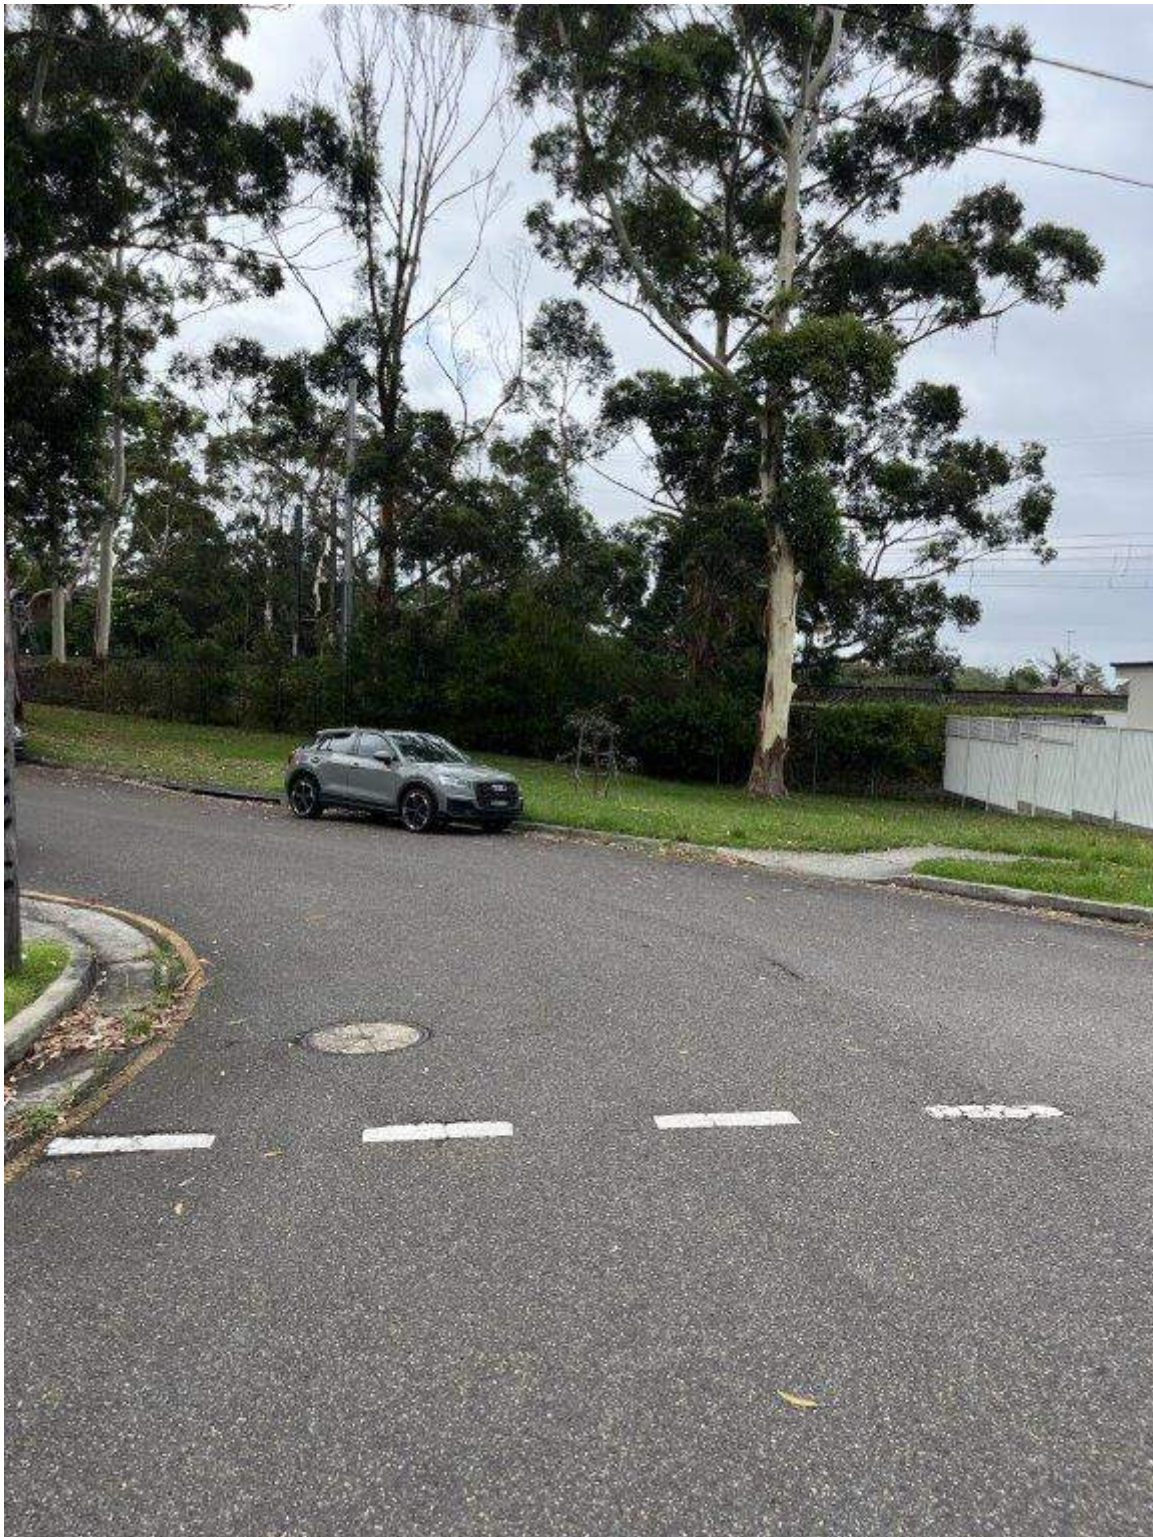
Photo 142 - Taren Point Road - Existing condition of pavement and manhole
