## PRE-CONSTRUCTION DILAPIDATION REPORT

### 6-20 HINKLER AVENUE & 319-333 TAREN POINT ROAD, CARINGBAH

| PRE-CONSTRUCTION DILAPIDATION REPORT<br>6-20 Hinkler Avenue & 319-333 Taren Point Road,<br>Caringbah NSW 2229 | | | | | Project Number: 21039 |

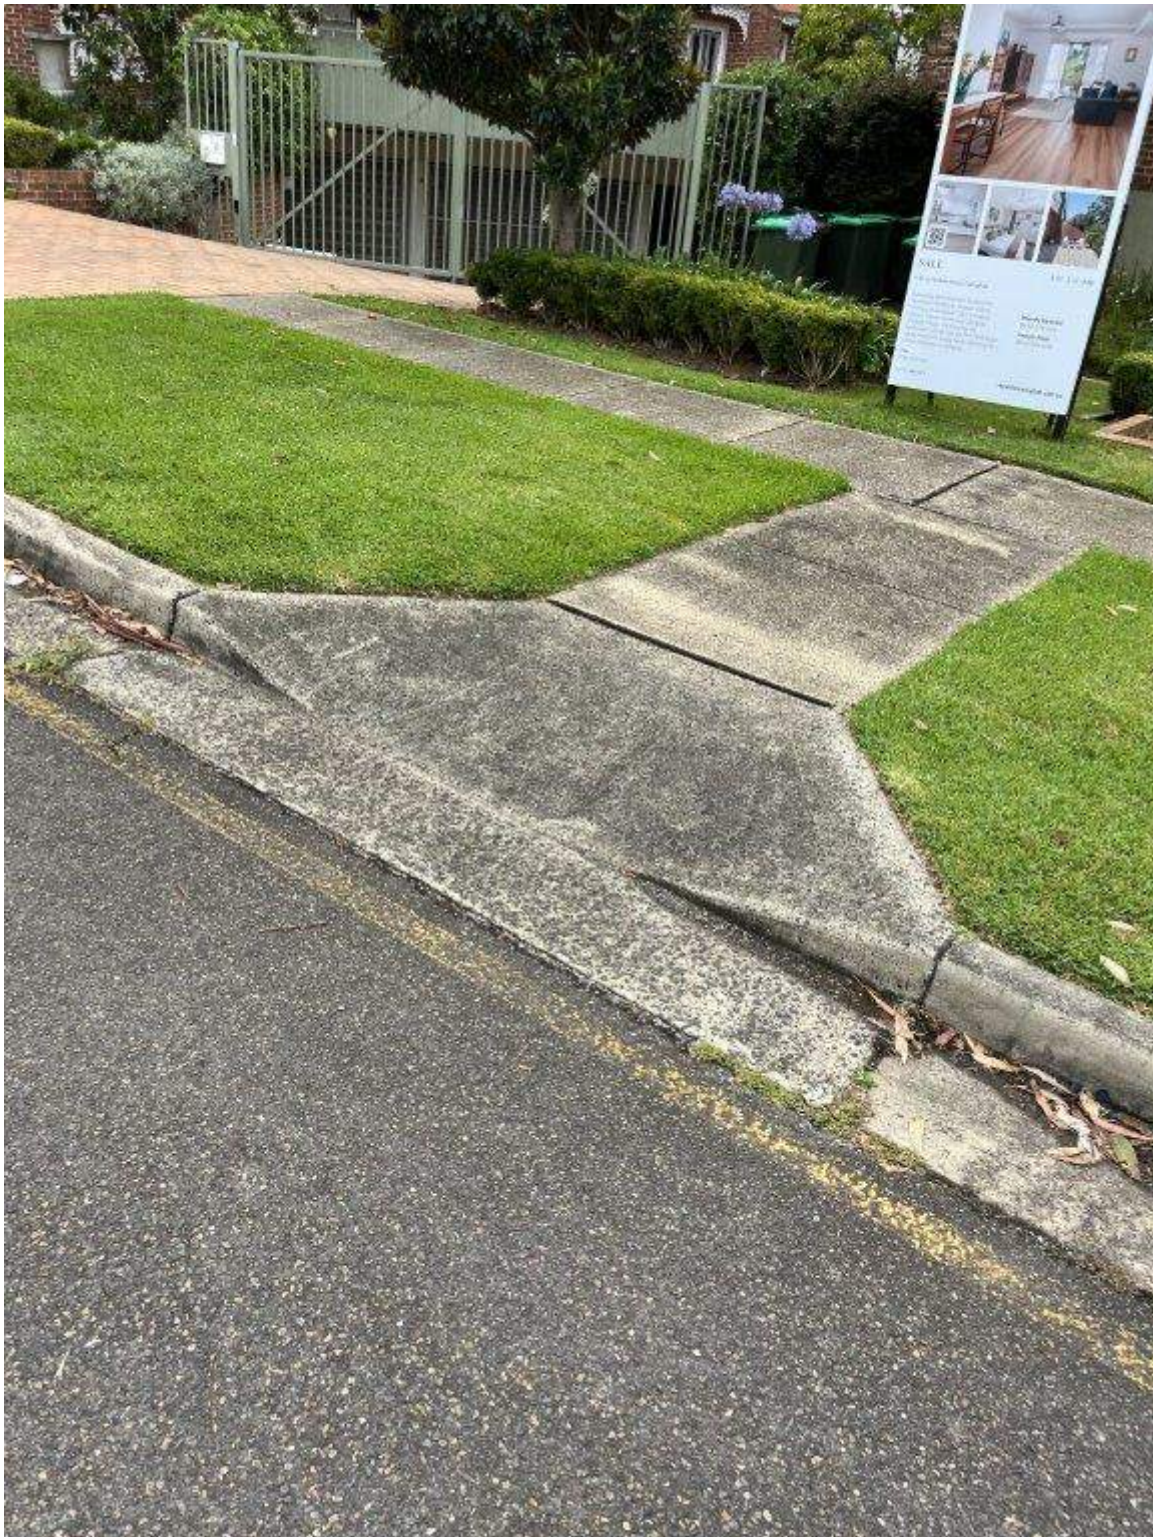
Photo 143 - Taren Point Road - Existing condition of pavement

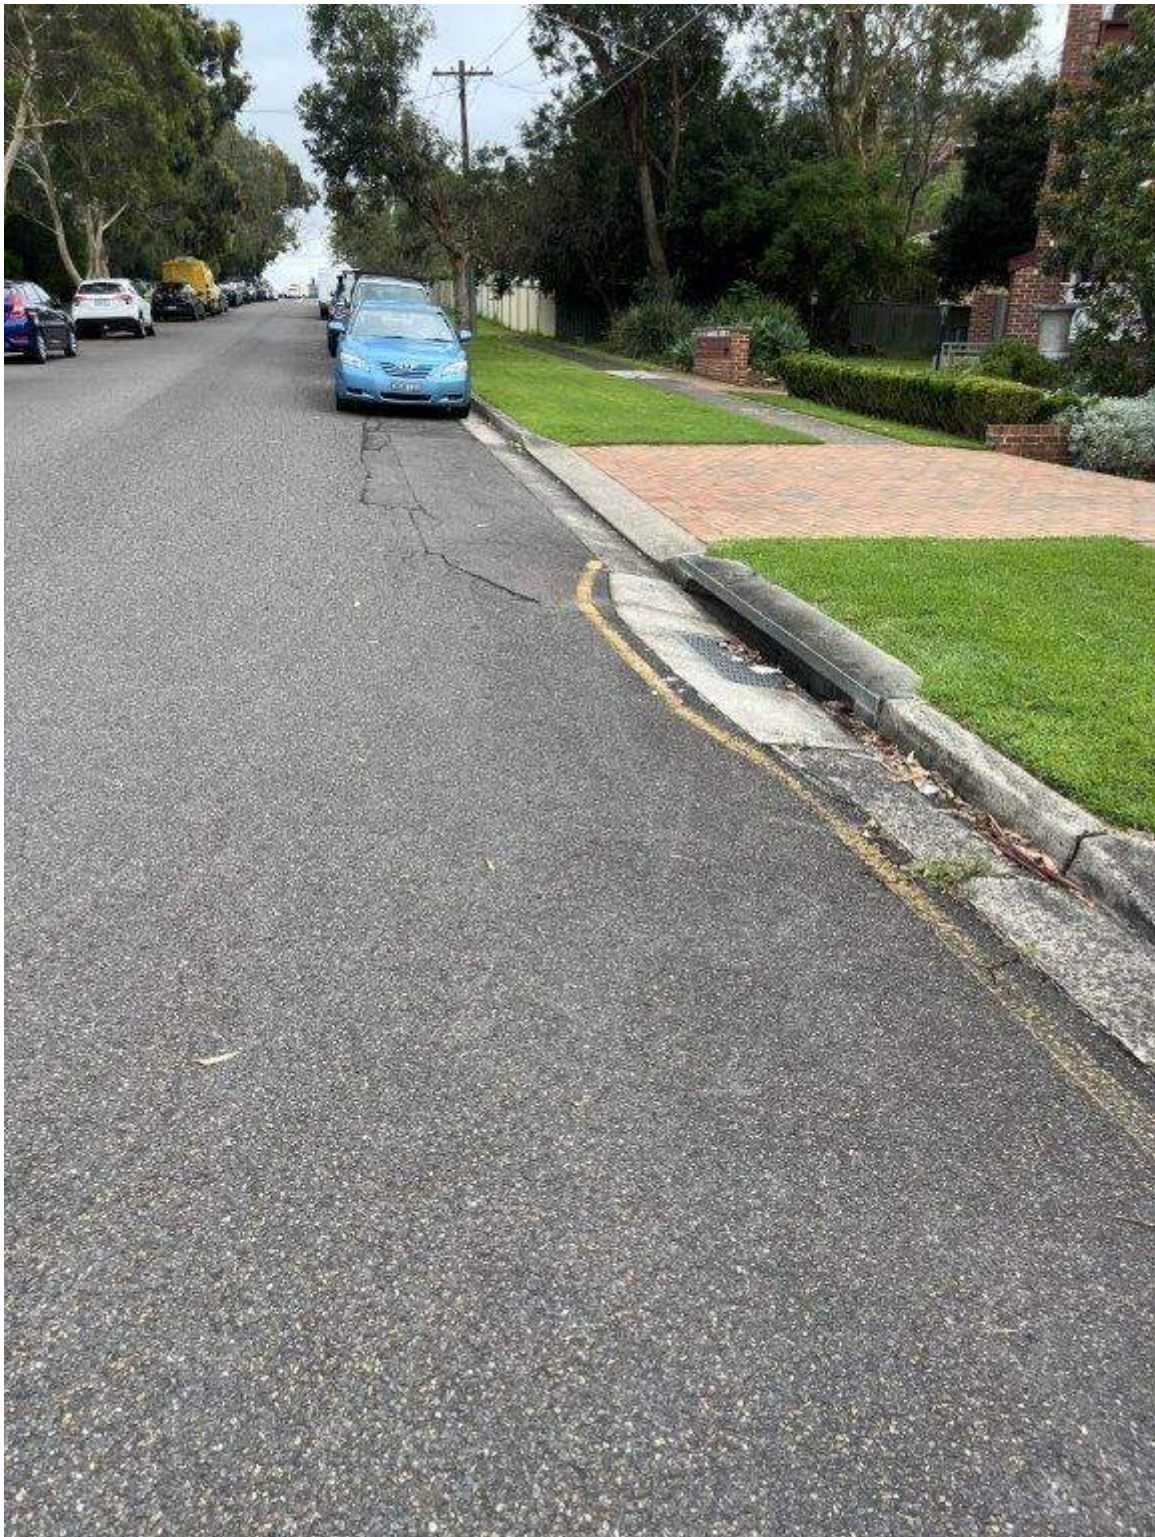
Photo 144 - Taren Point Road - Cracking of pavement

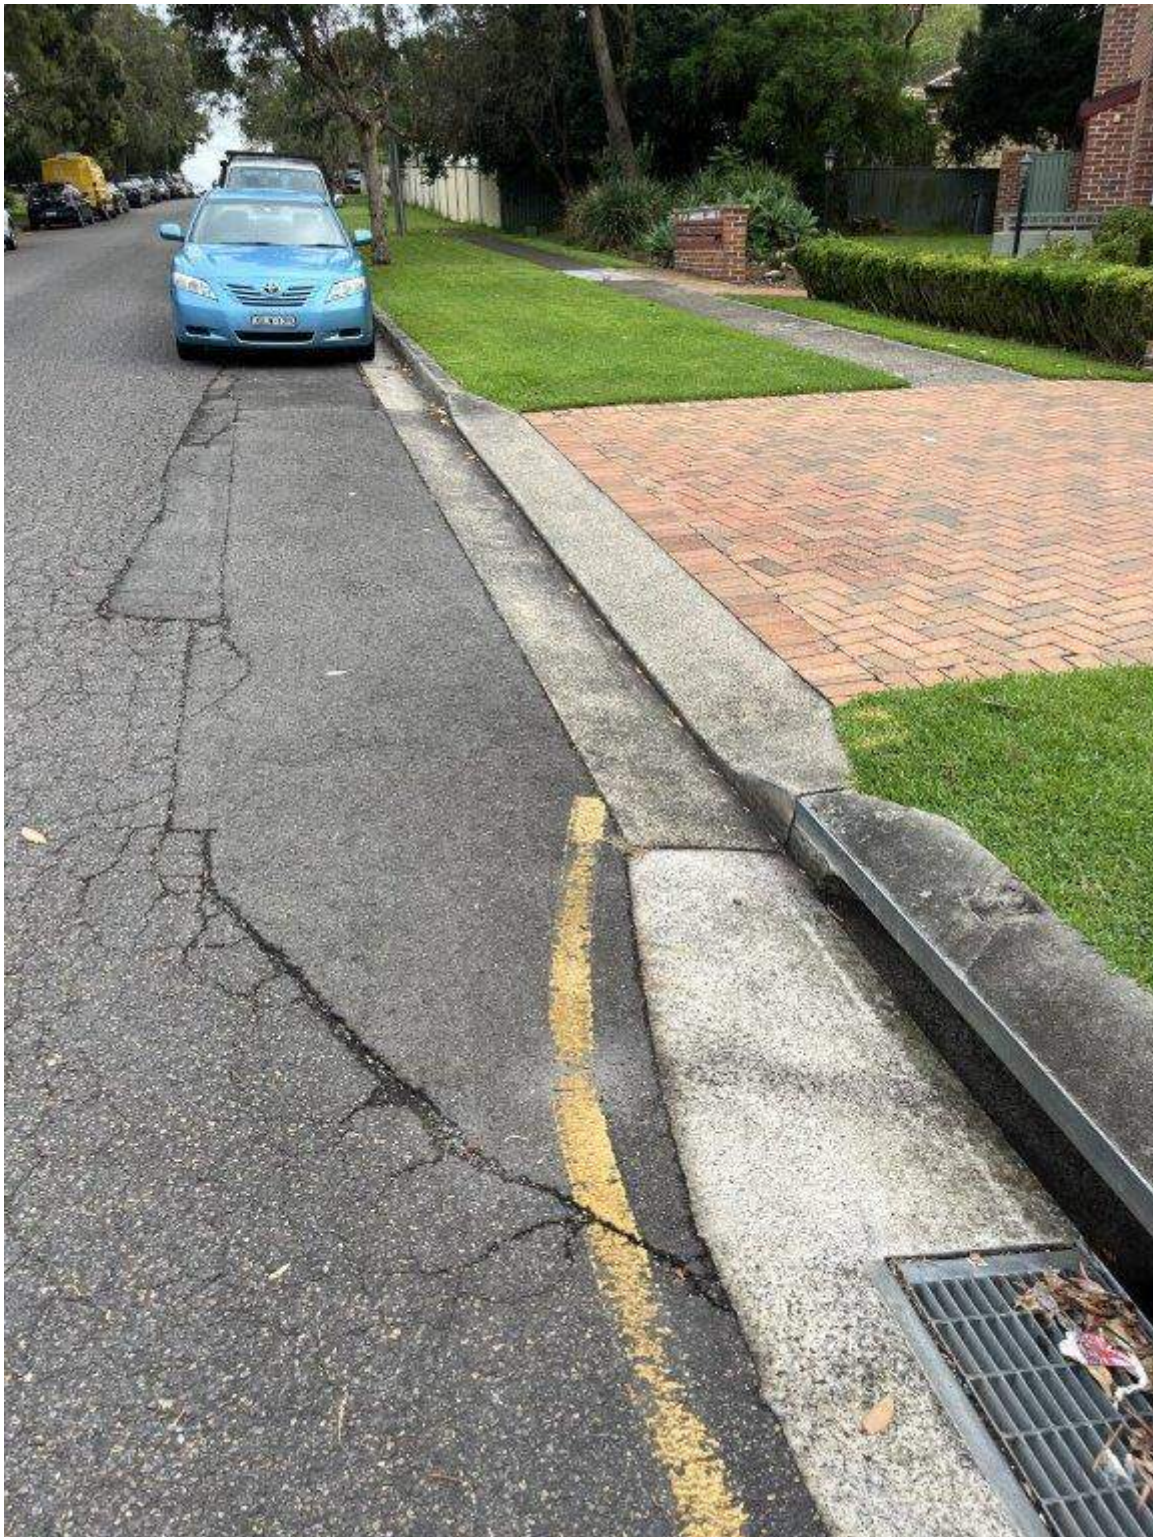
Photo 145 - Taren Point Road - Cracking of pavement

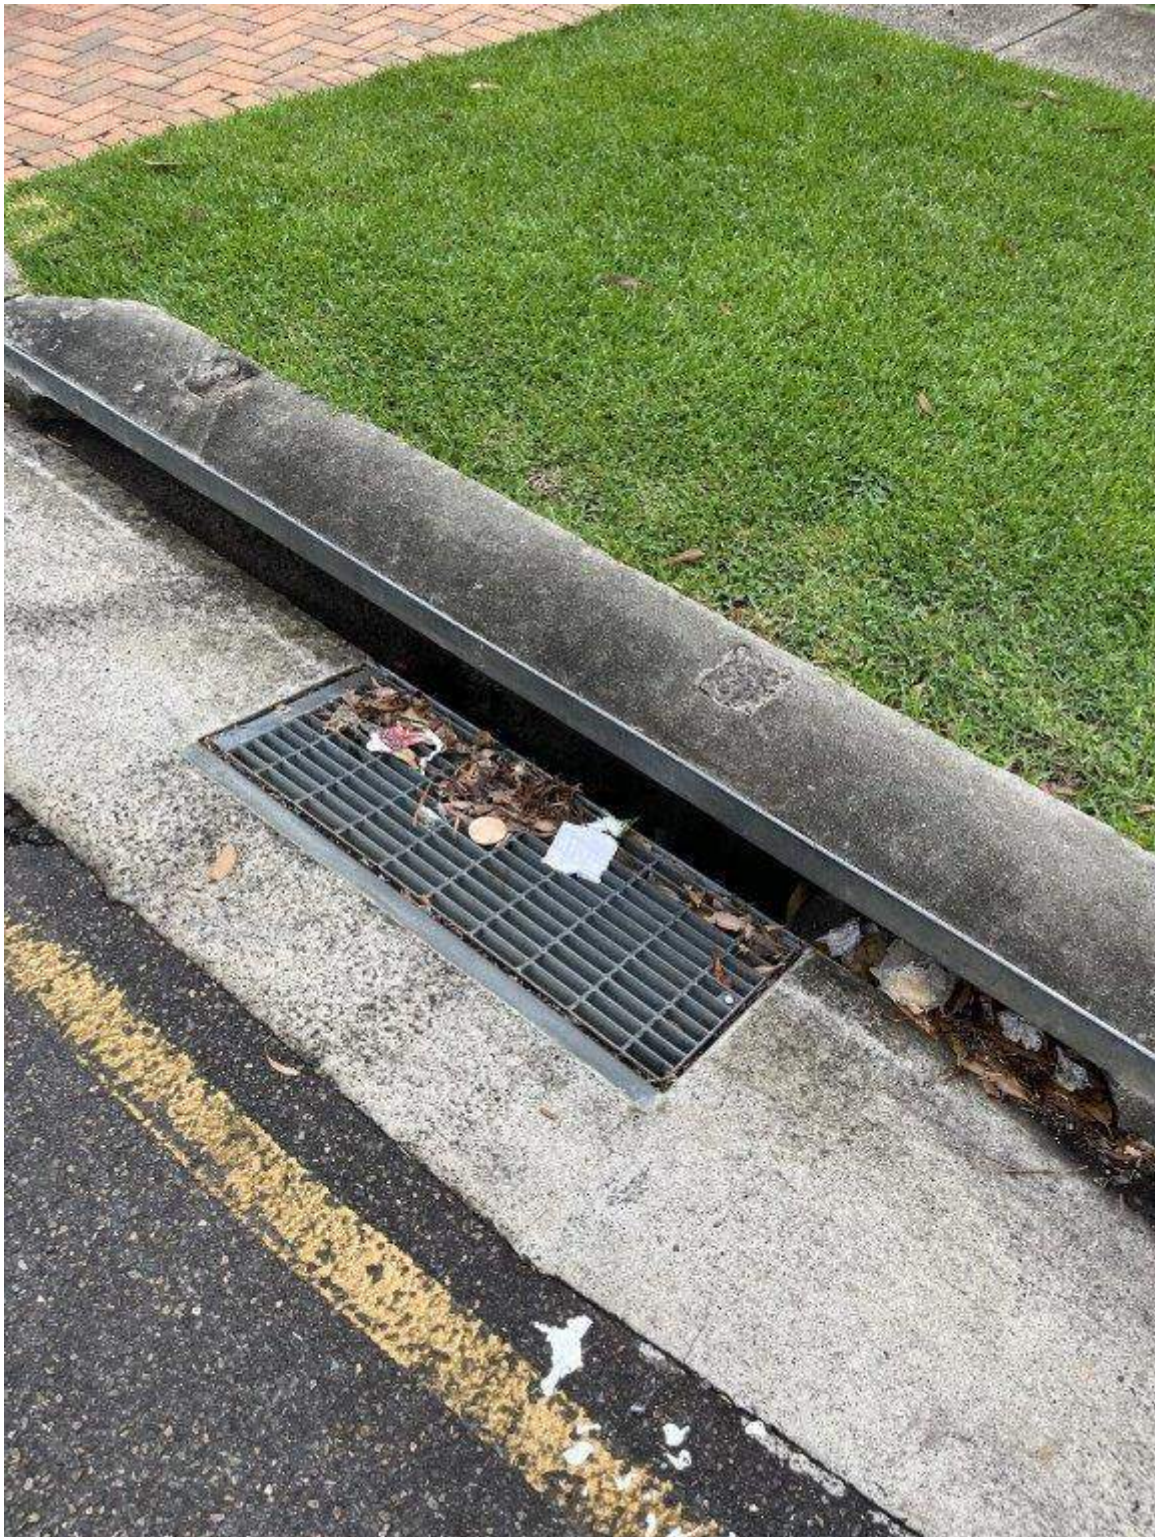
Photo 146 - Taren Point Road - Existing condition of steel grate

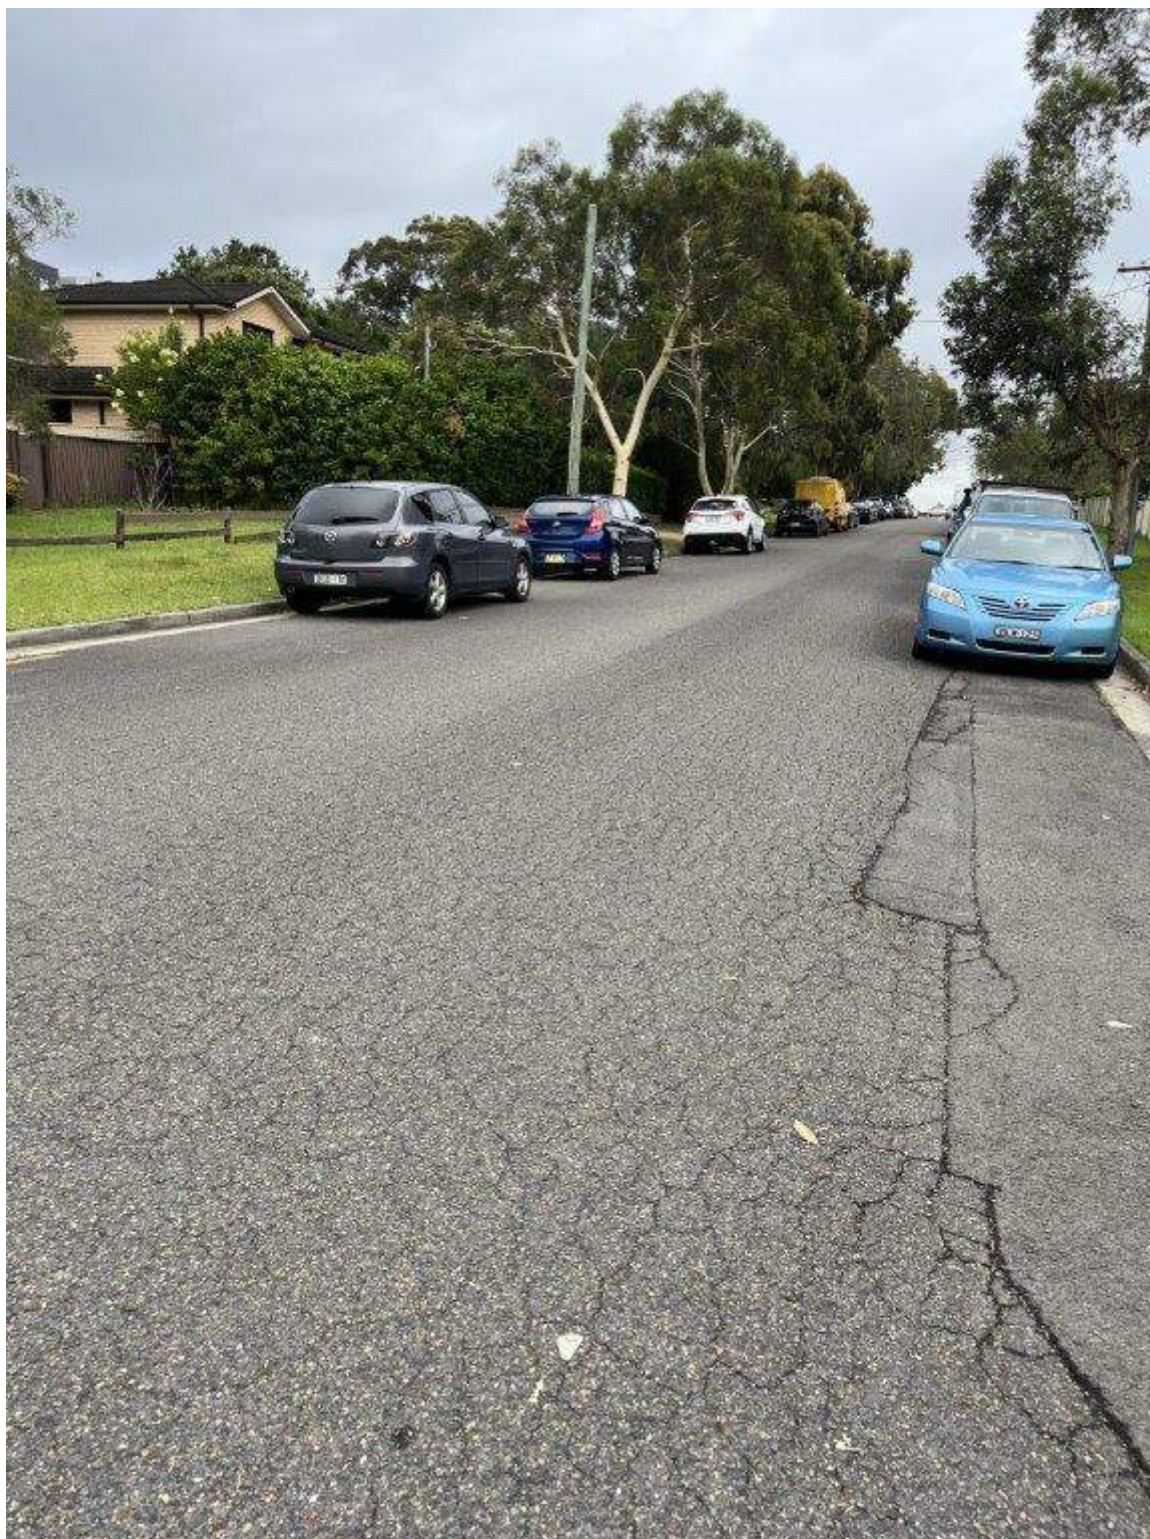
Photo 147 - Taren Point Road - Cracking of pavement

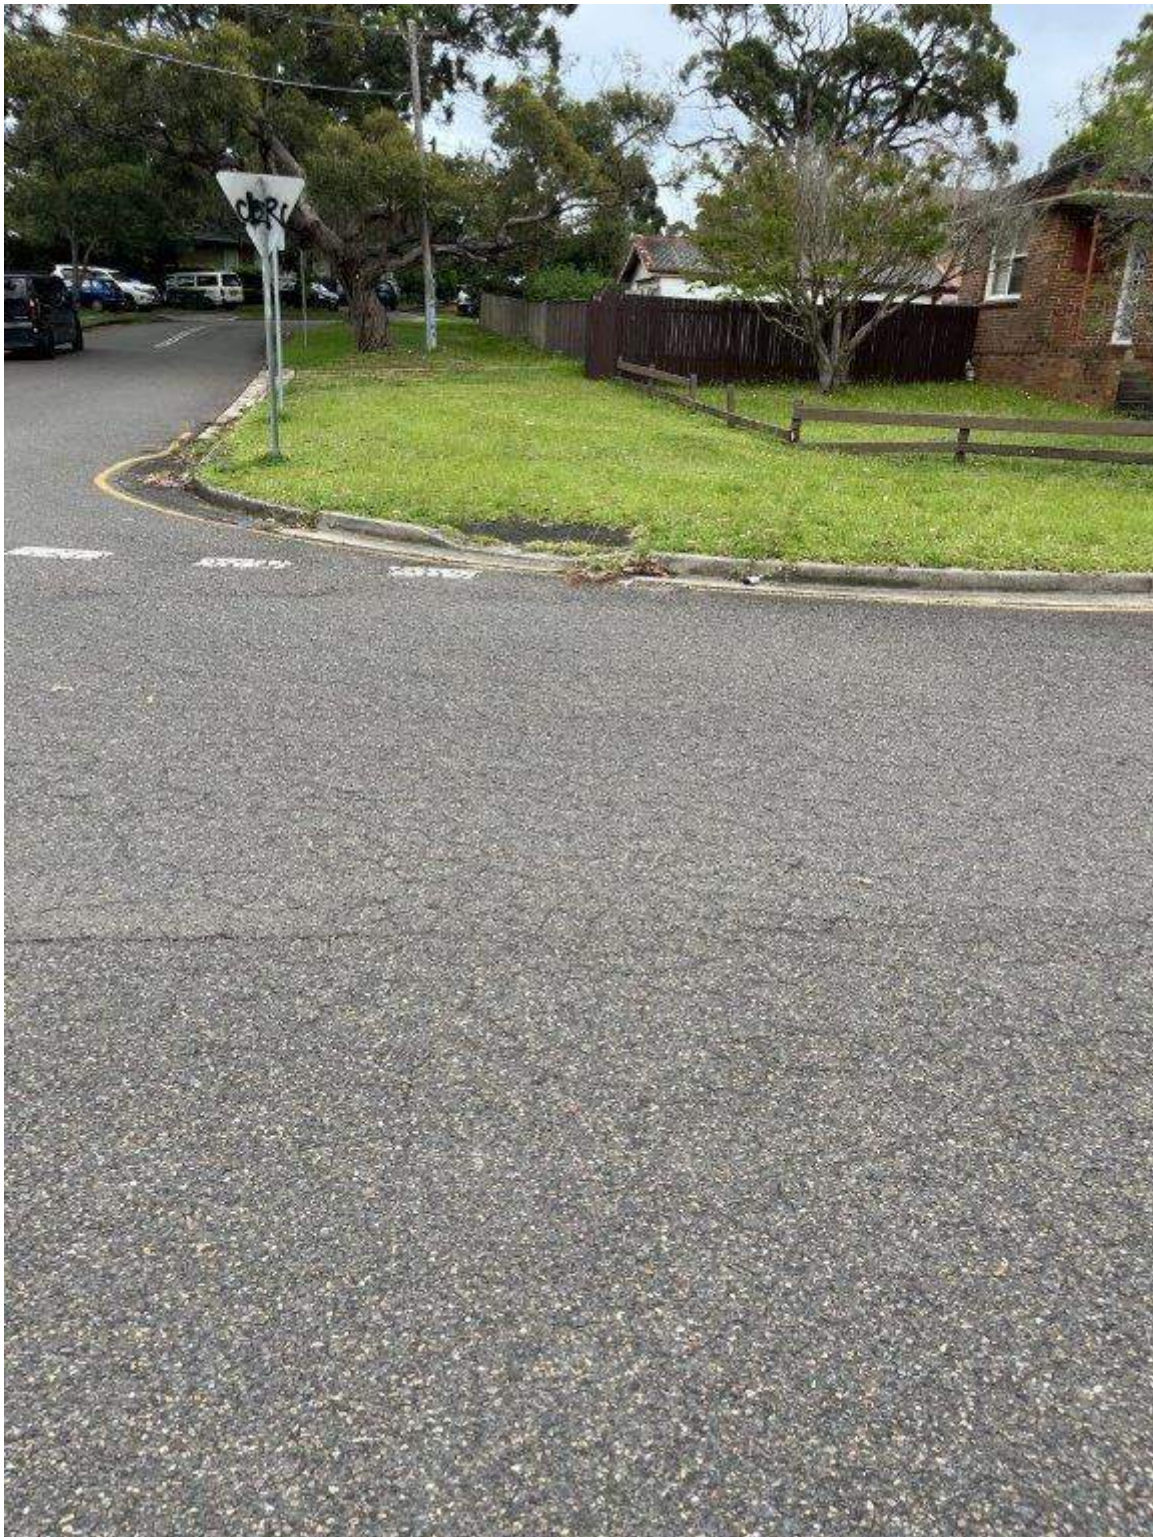
Photo 148 - Taren Point Road - Existing condition of pavement

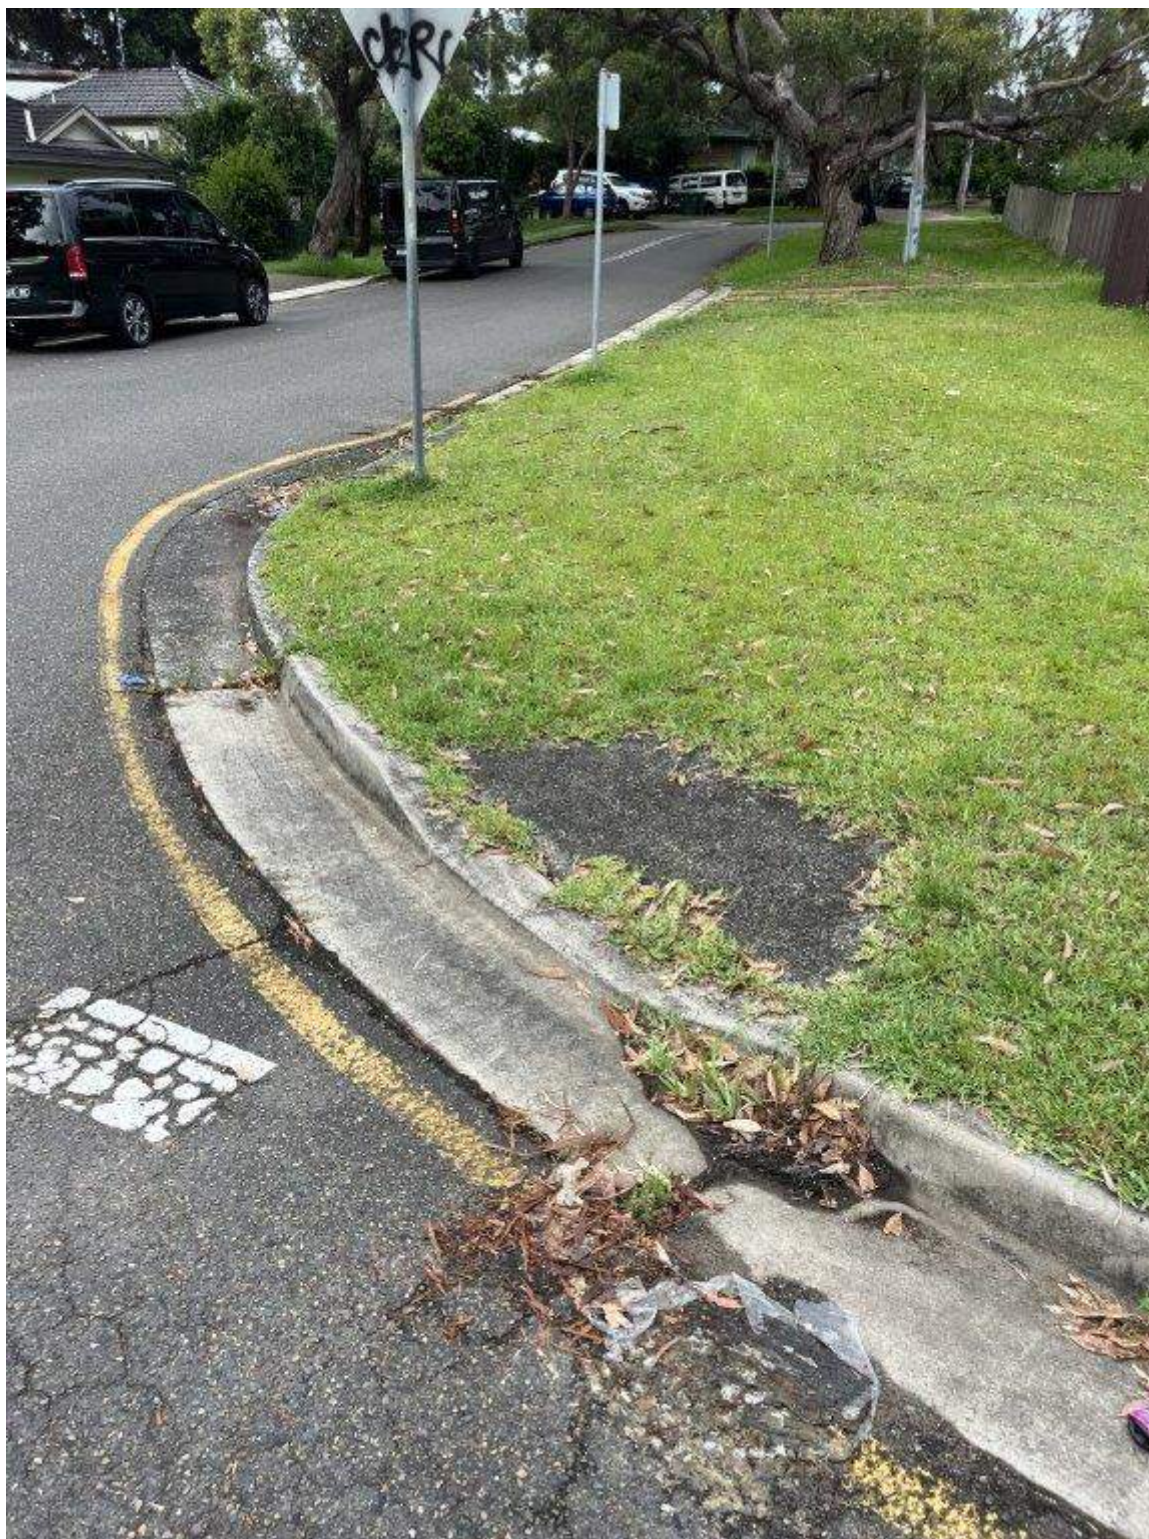
Photo 149 - Taren Point Road - Cracking of pavement

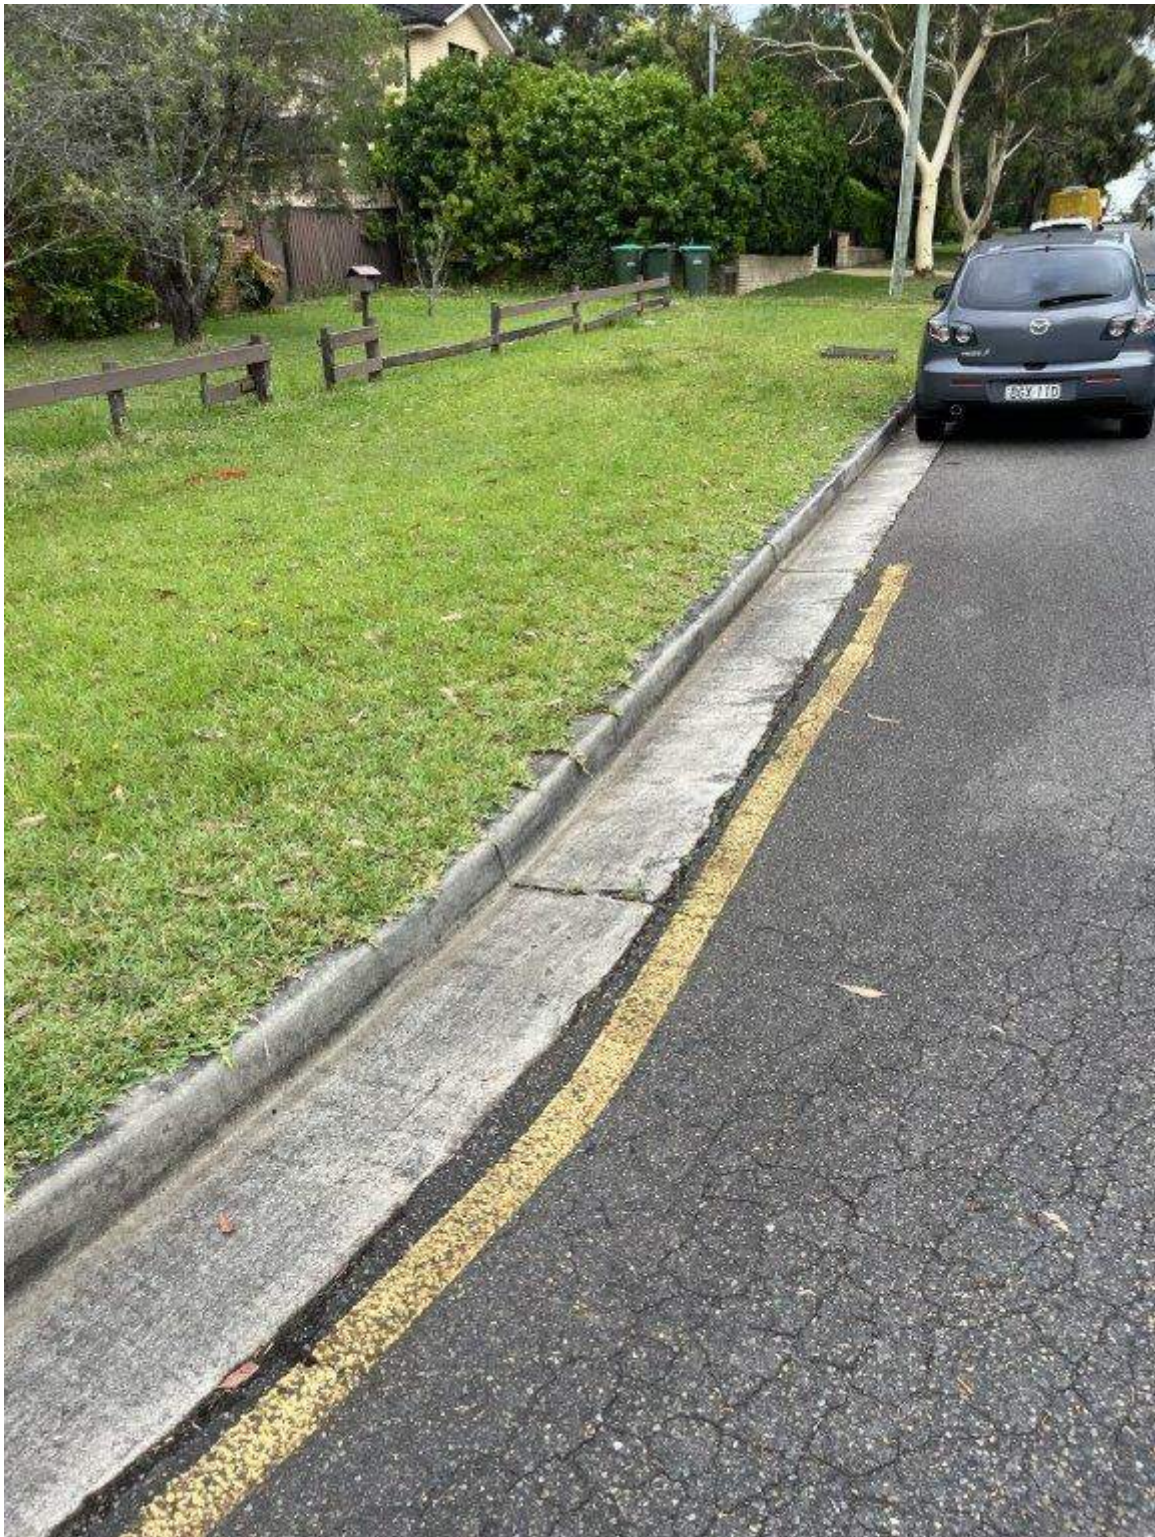
Photo 150 - Taren Point Road - Cracking of pavement

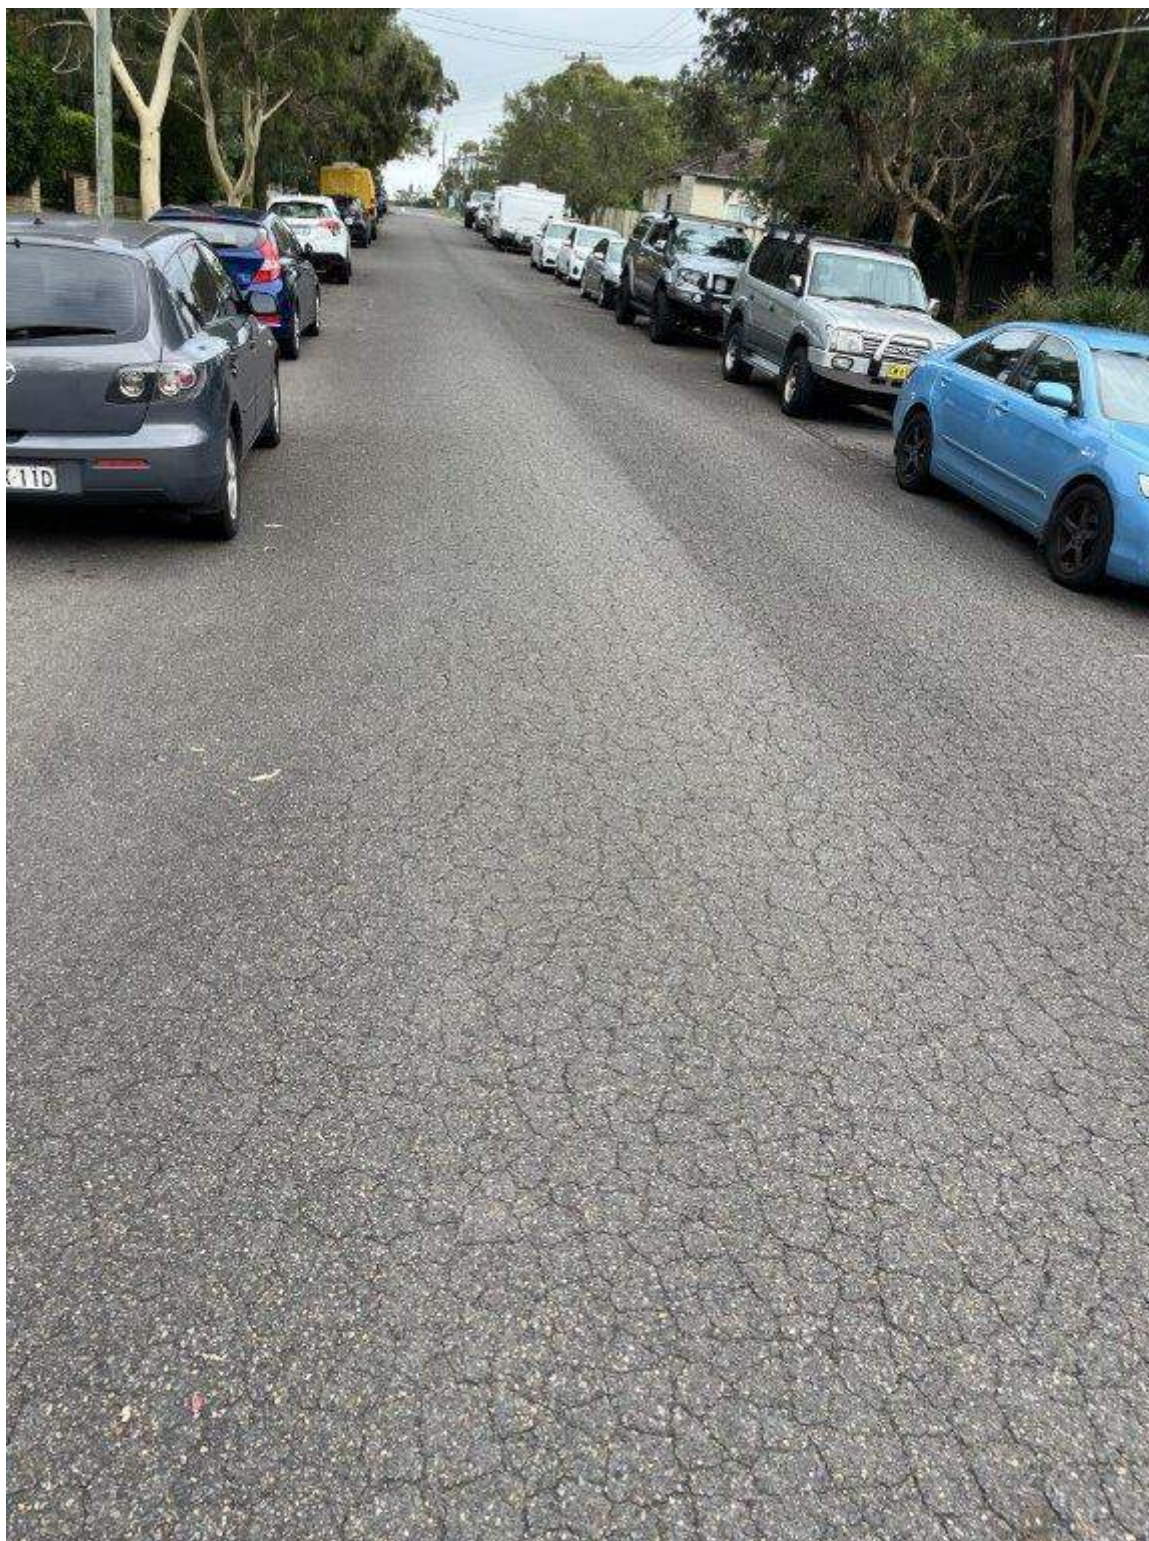
Photo 151 - Taren Point Road - Cracking of pavement

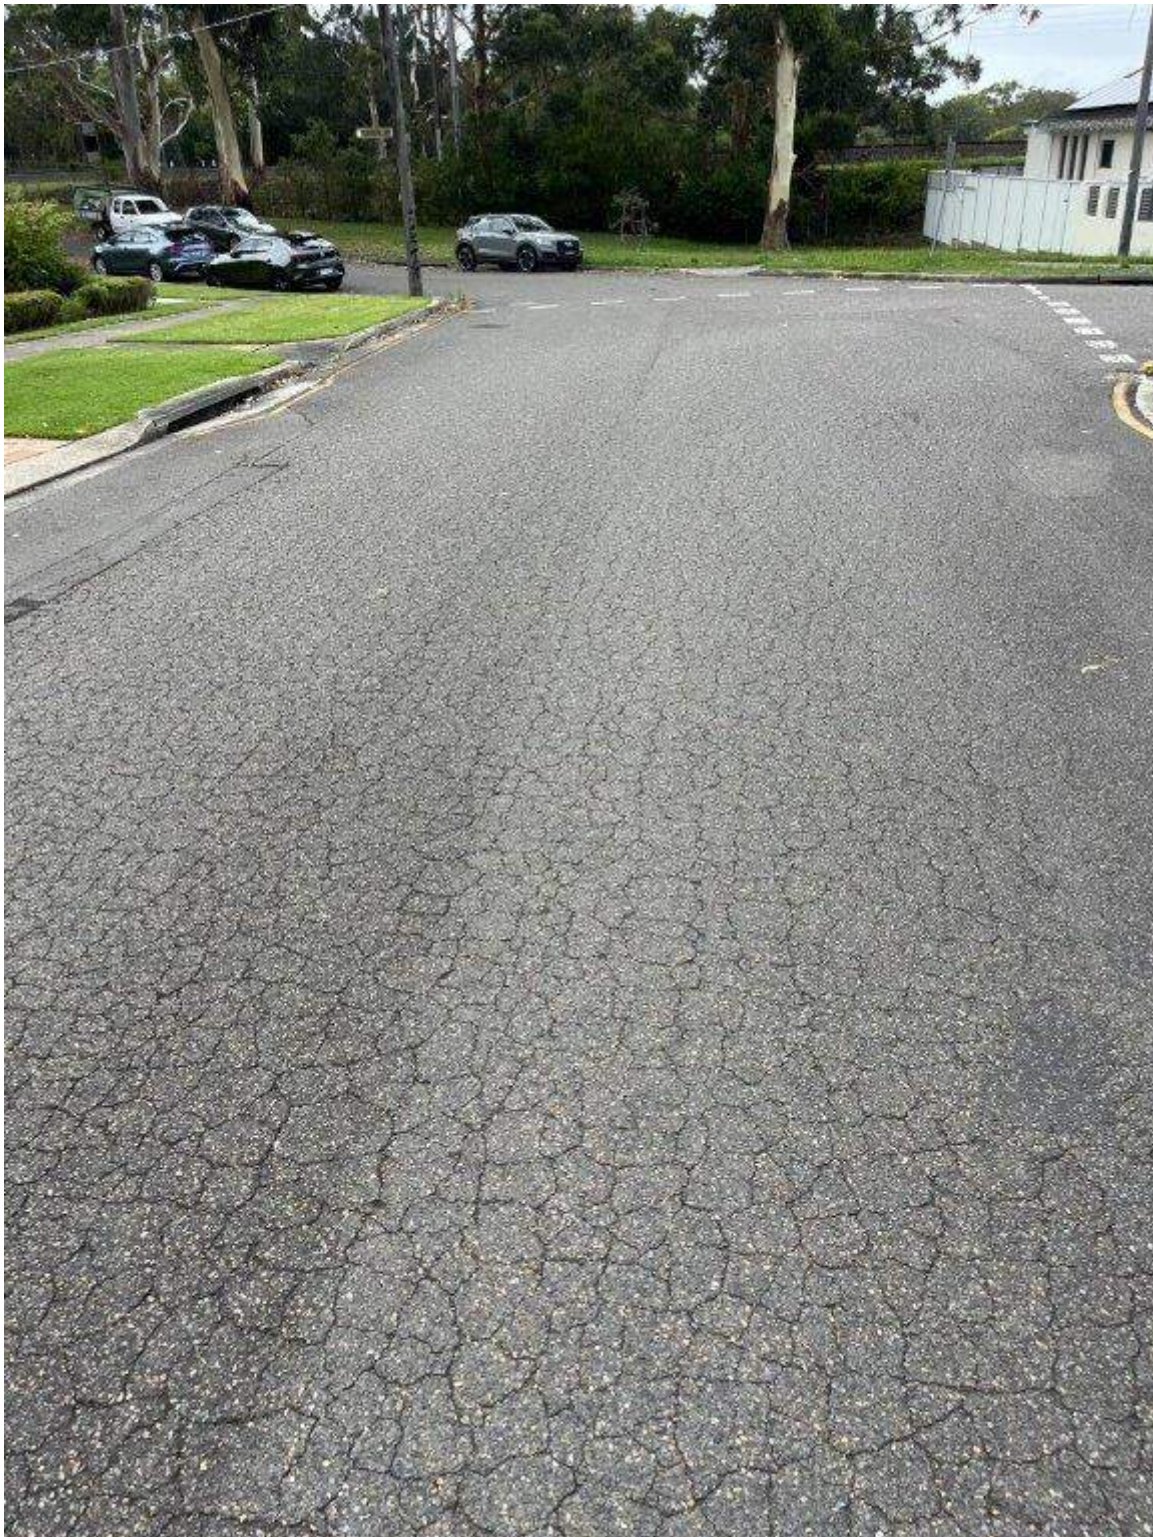
Photo 152 - Taren Point Road - Cracking of pavement

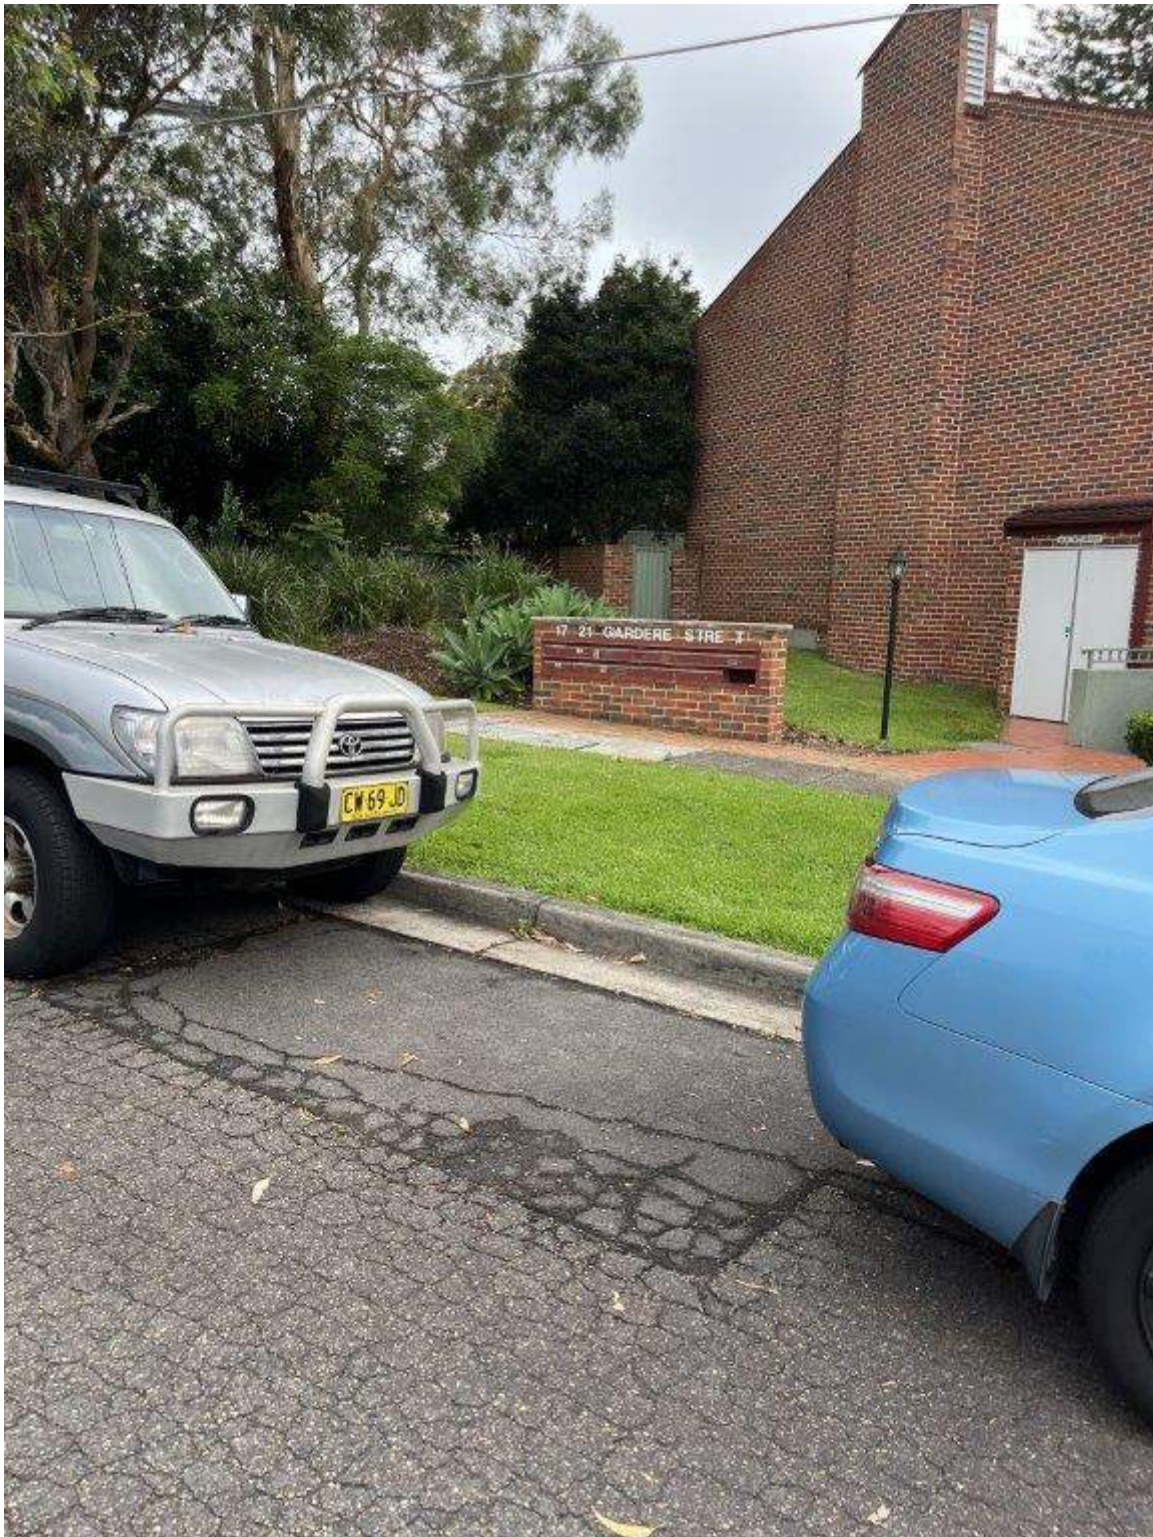
Photo 153 - Taren Point Road - Cracking of pavement

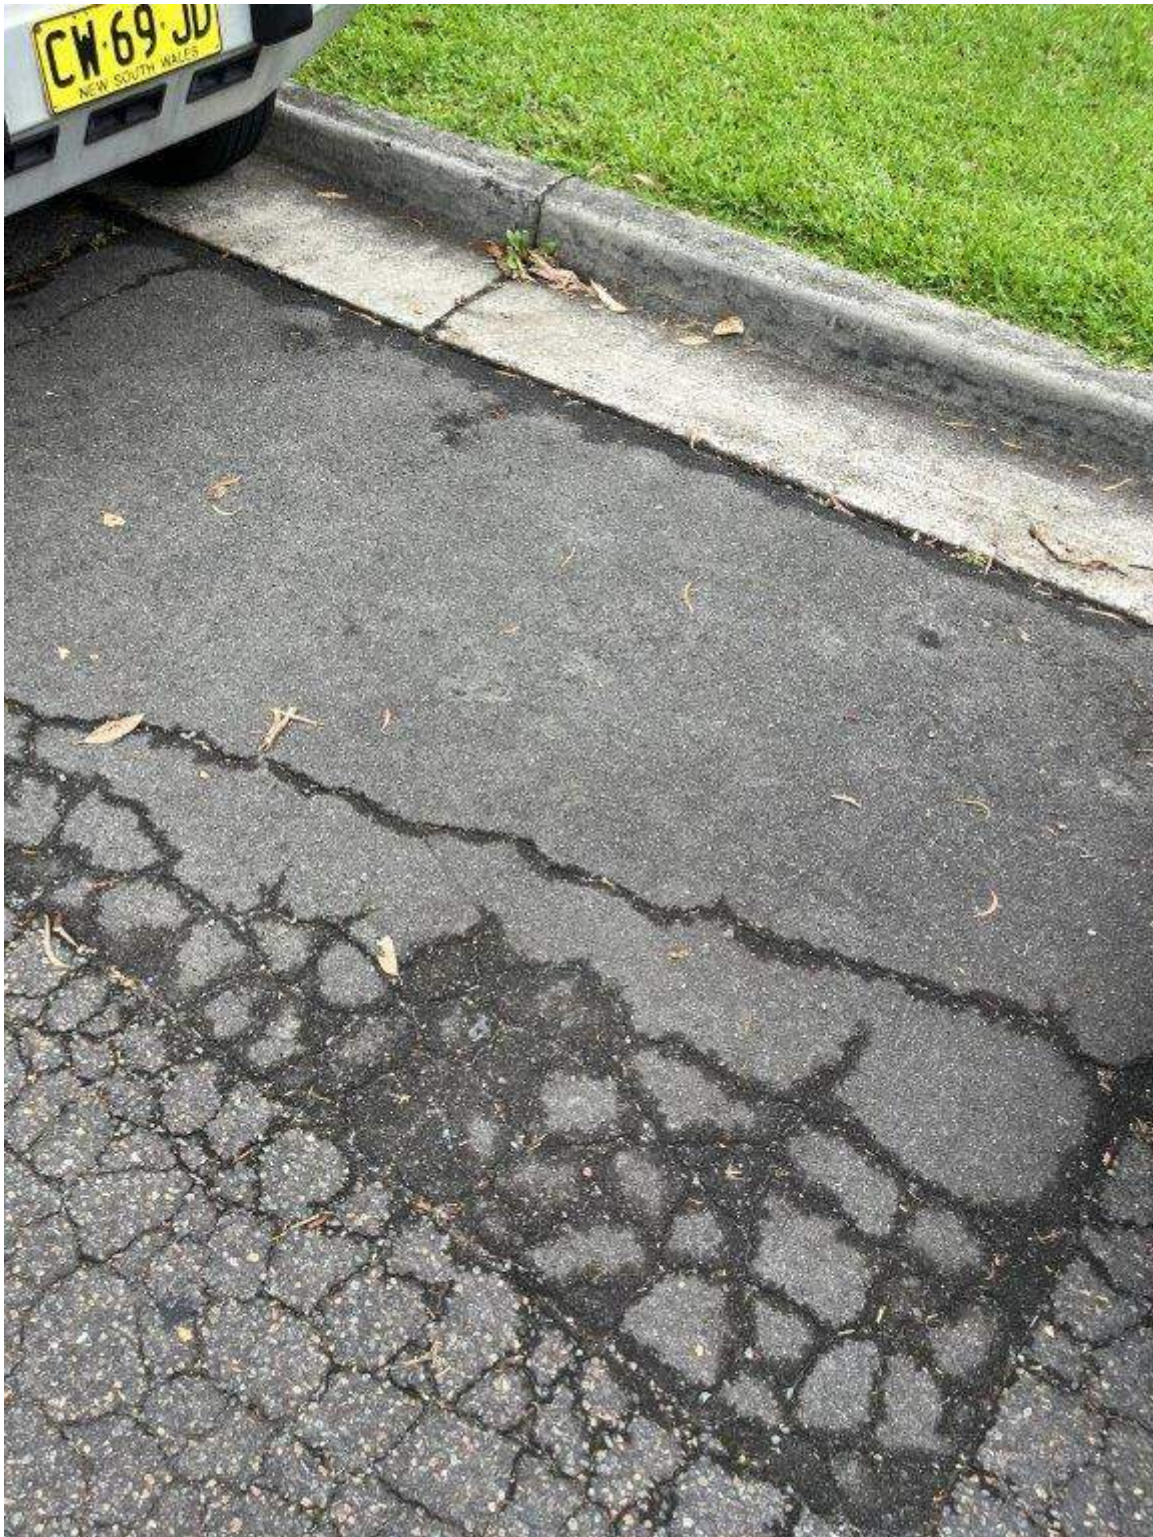
Photo 154 - Taren Point Road - Cracking of pavement

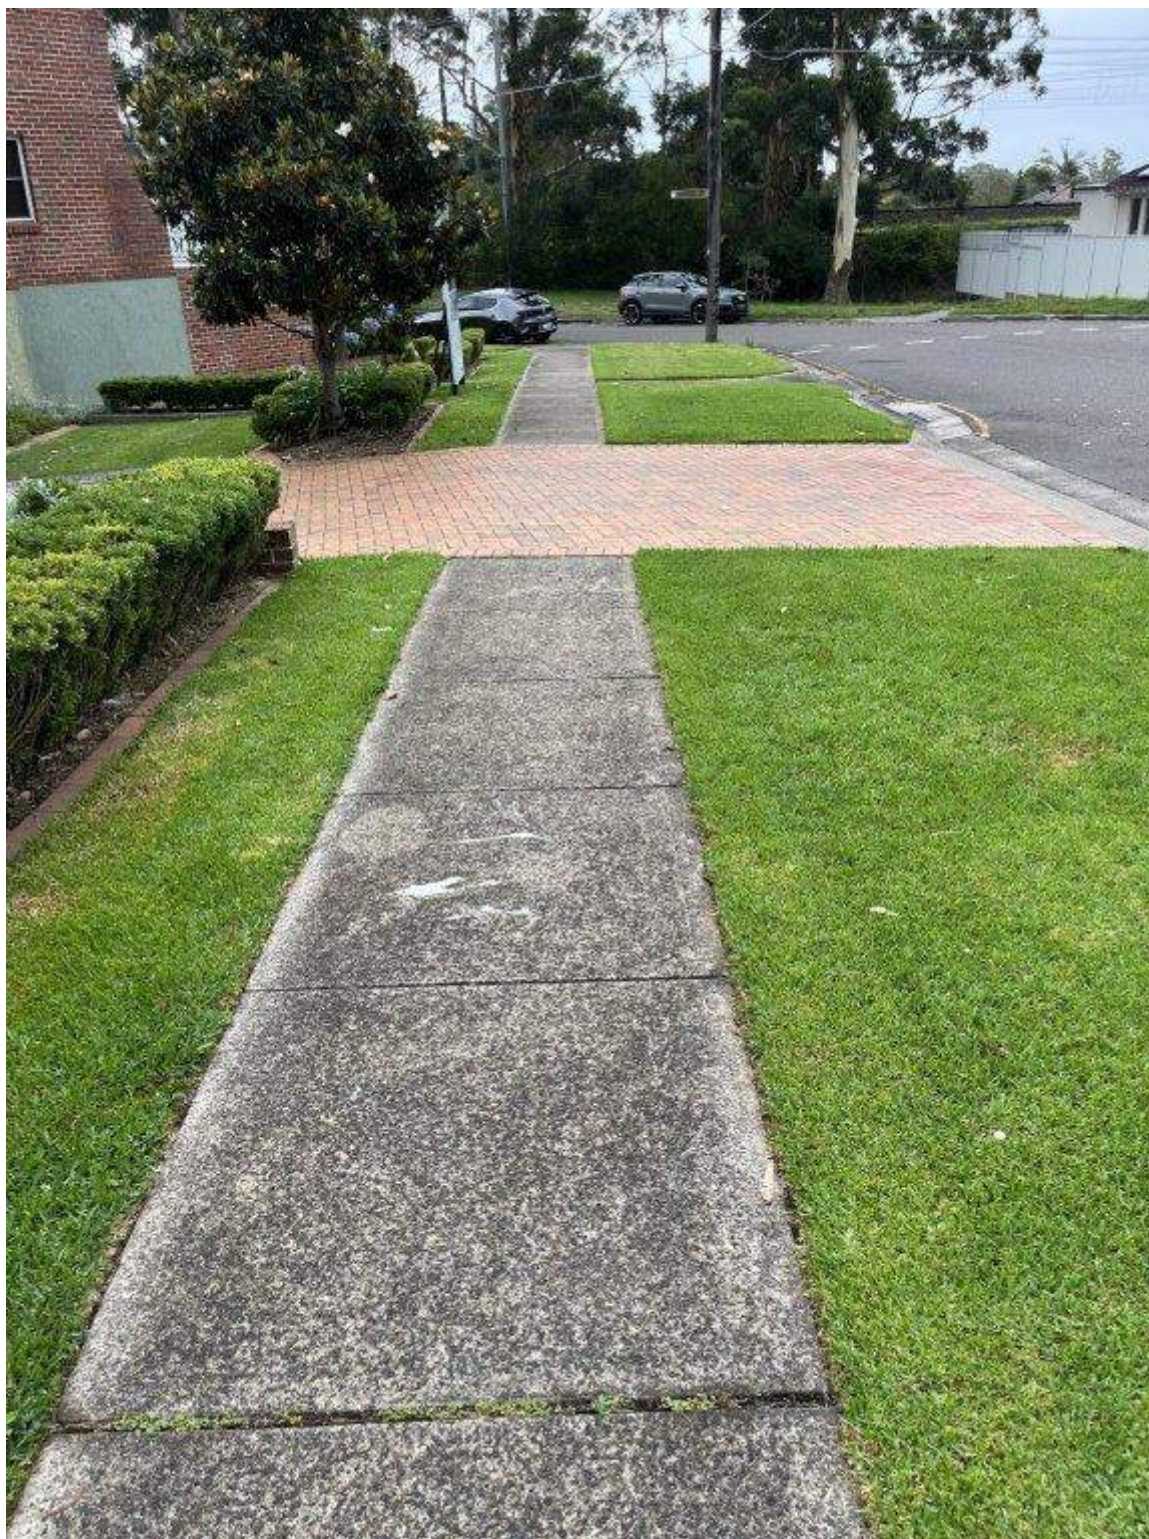
Photo 155 - Taren Point Road - Existing condition of pavement and vegetation
