## PRE-CONSTRUCTION DILAPIDATION REPORT

### 6-20 HINKLER AVENUE & 319-333 TAREN POINT ROAD, CARINGBAH

| PRE-CONSTRUCTION DILAPIDATION REPORT<br>6-20 Hinkler Avenue & 319-333 Taren Point Road,<br>Caringbah NSW 2229 | | | | | Project Number: 21039 |

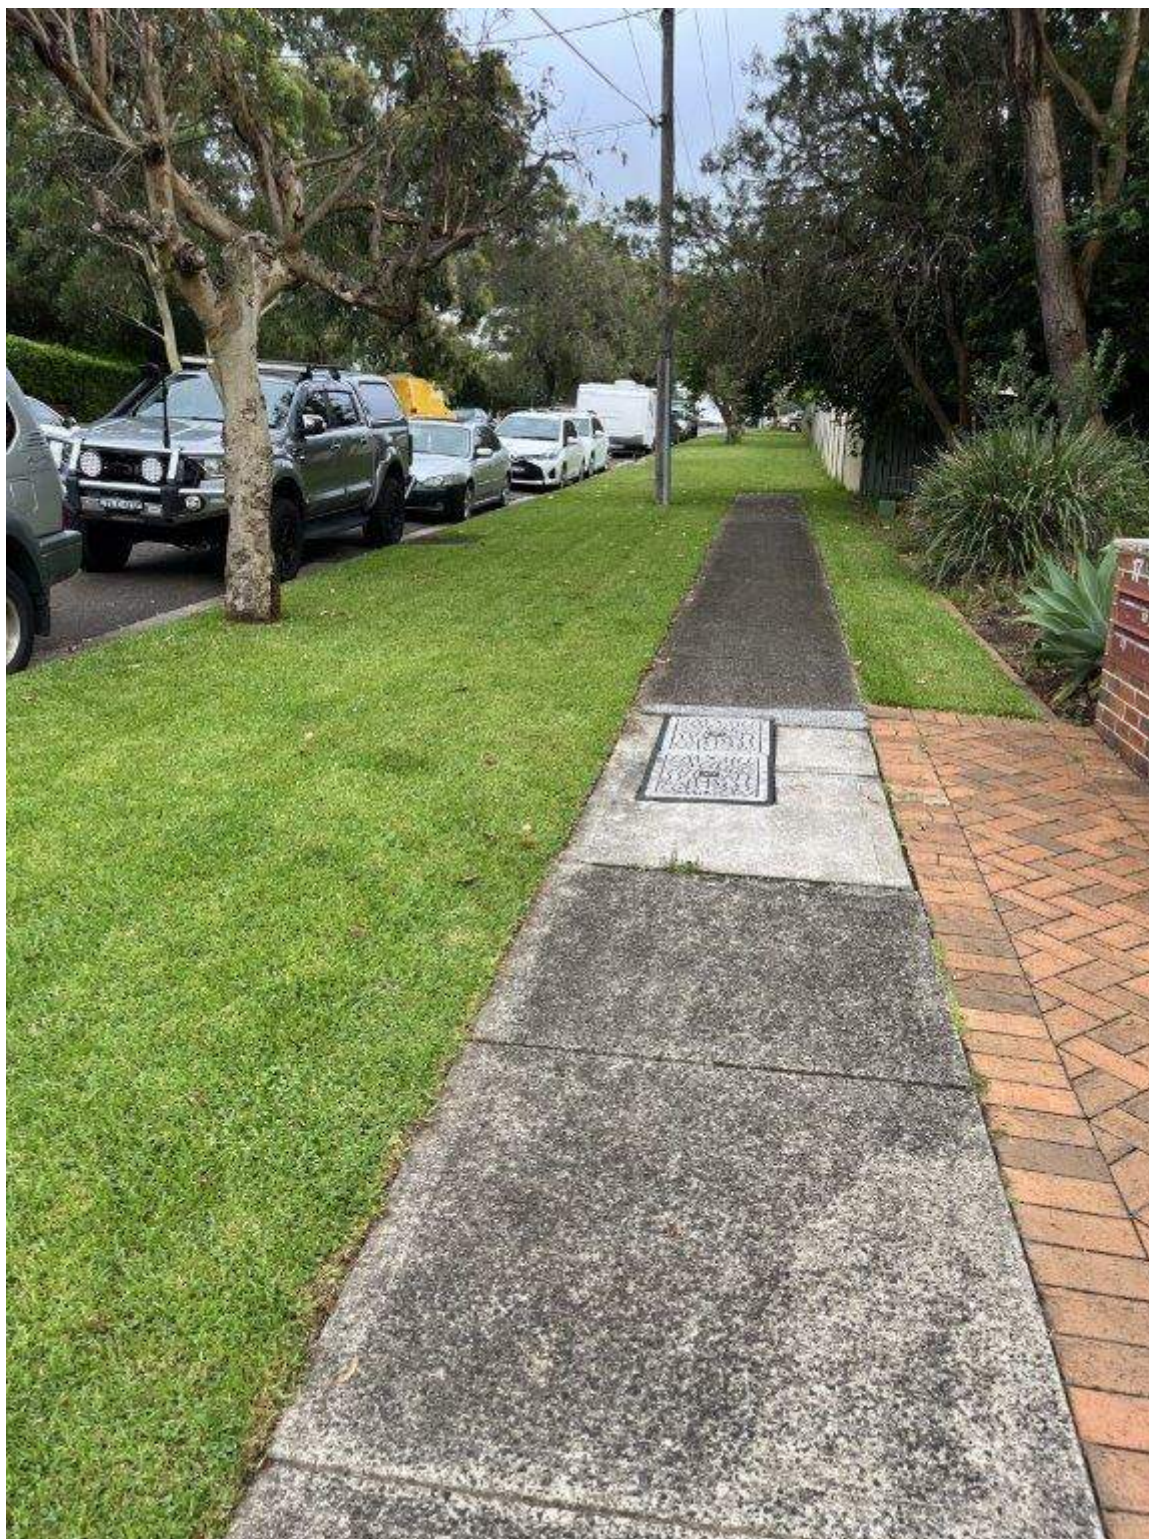
Photo 156 - Taren Point Road - Existing condition of pavement and vegetation

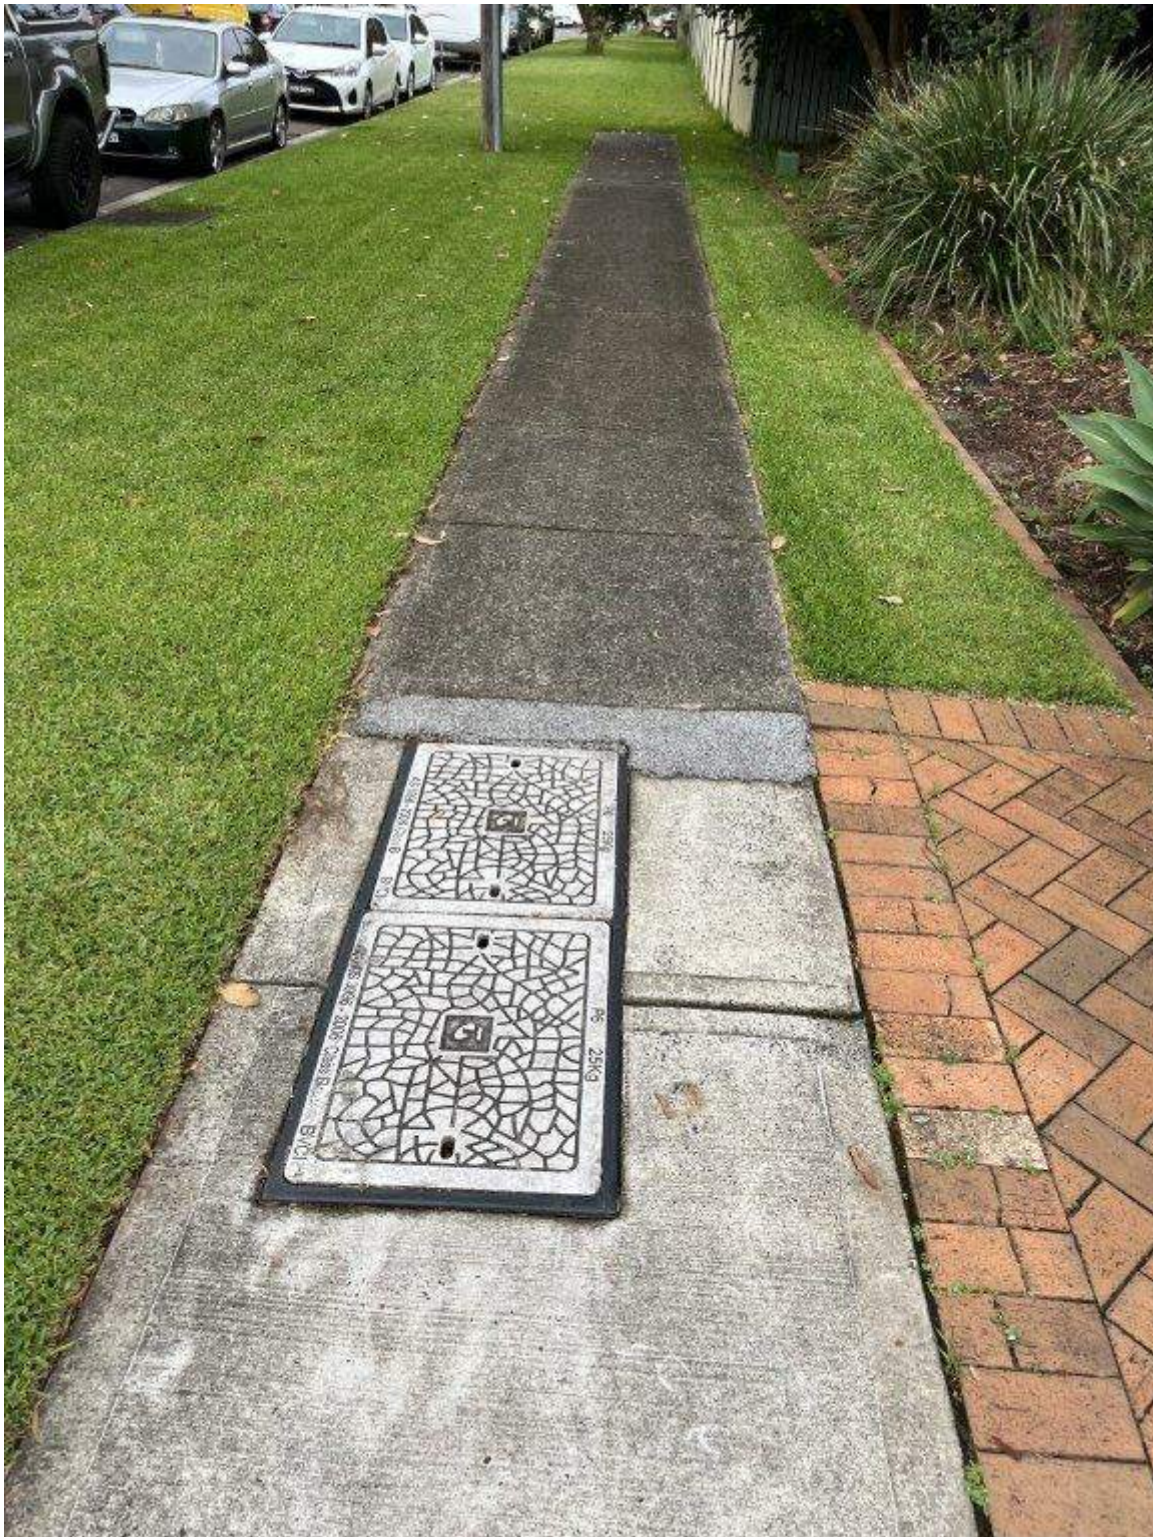
Photo 157 - Taren Point Road - Existing condition of pavement and service pit

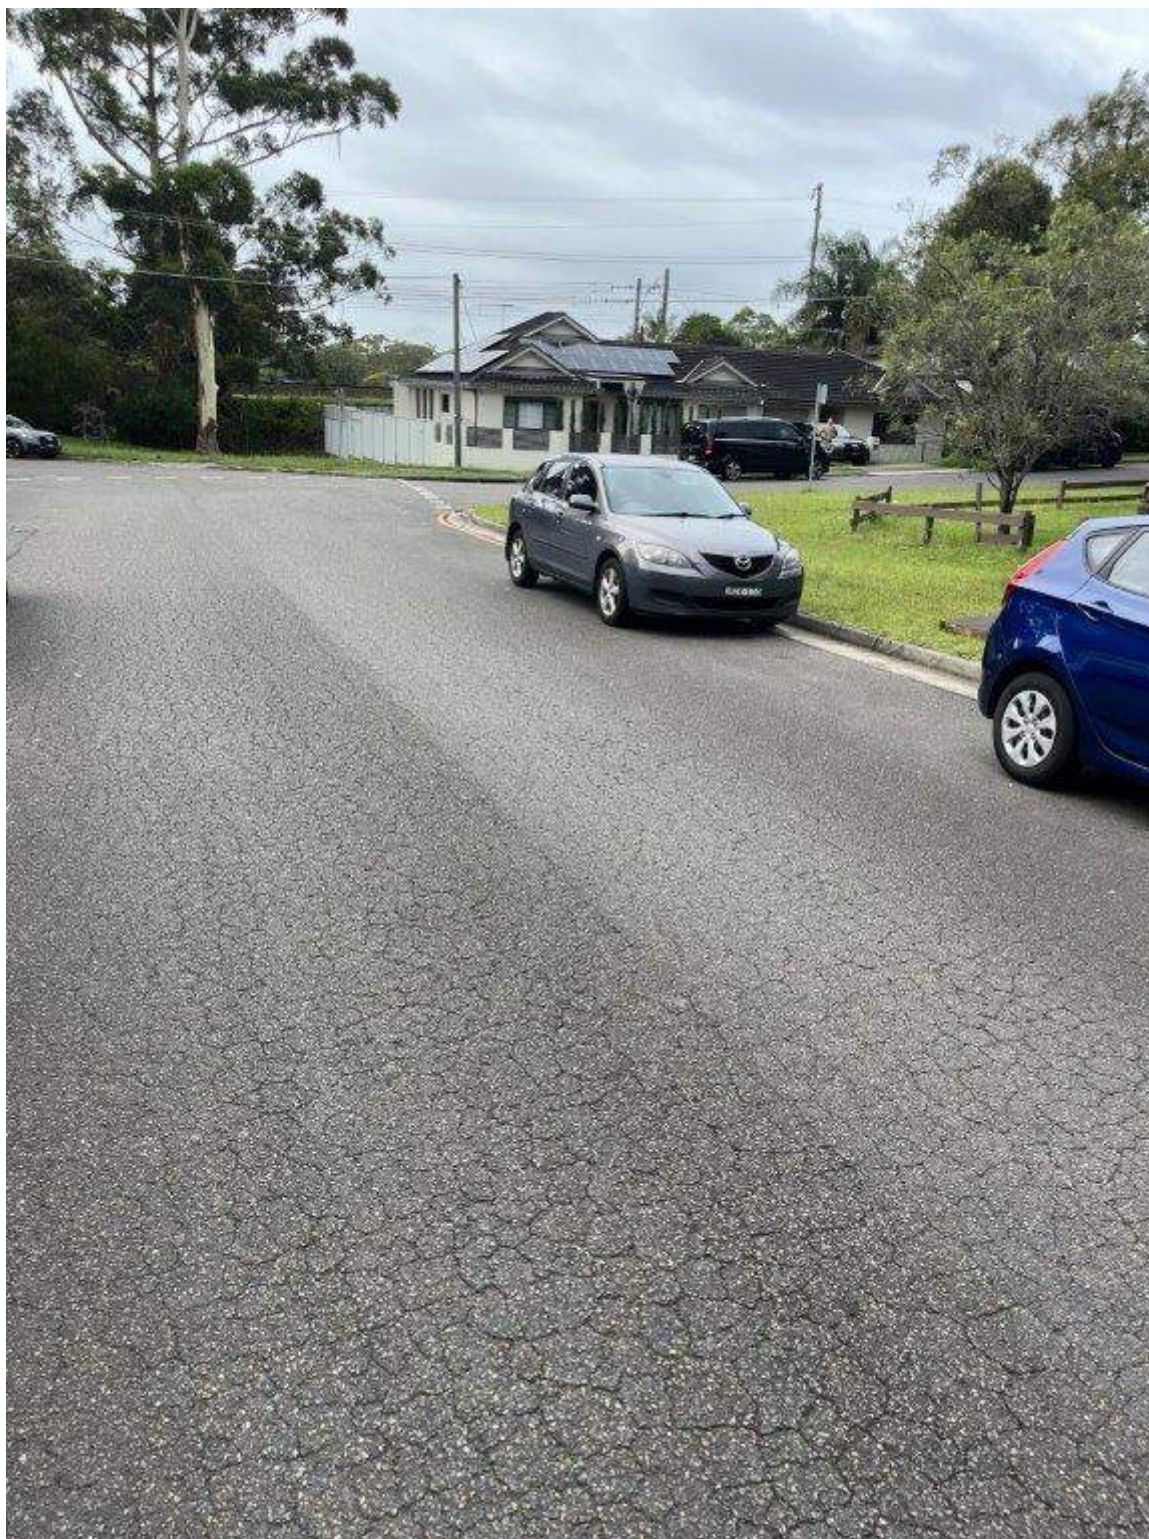
Photo 158 - Taren Point Road - Cracking of pavement

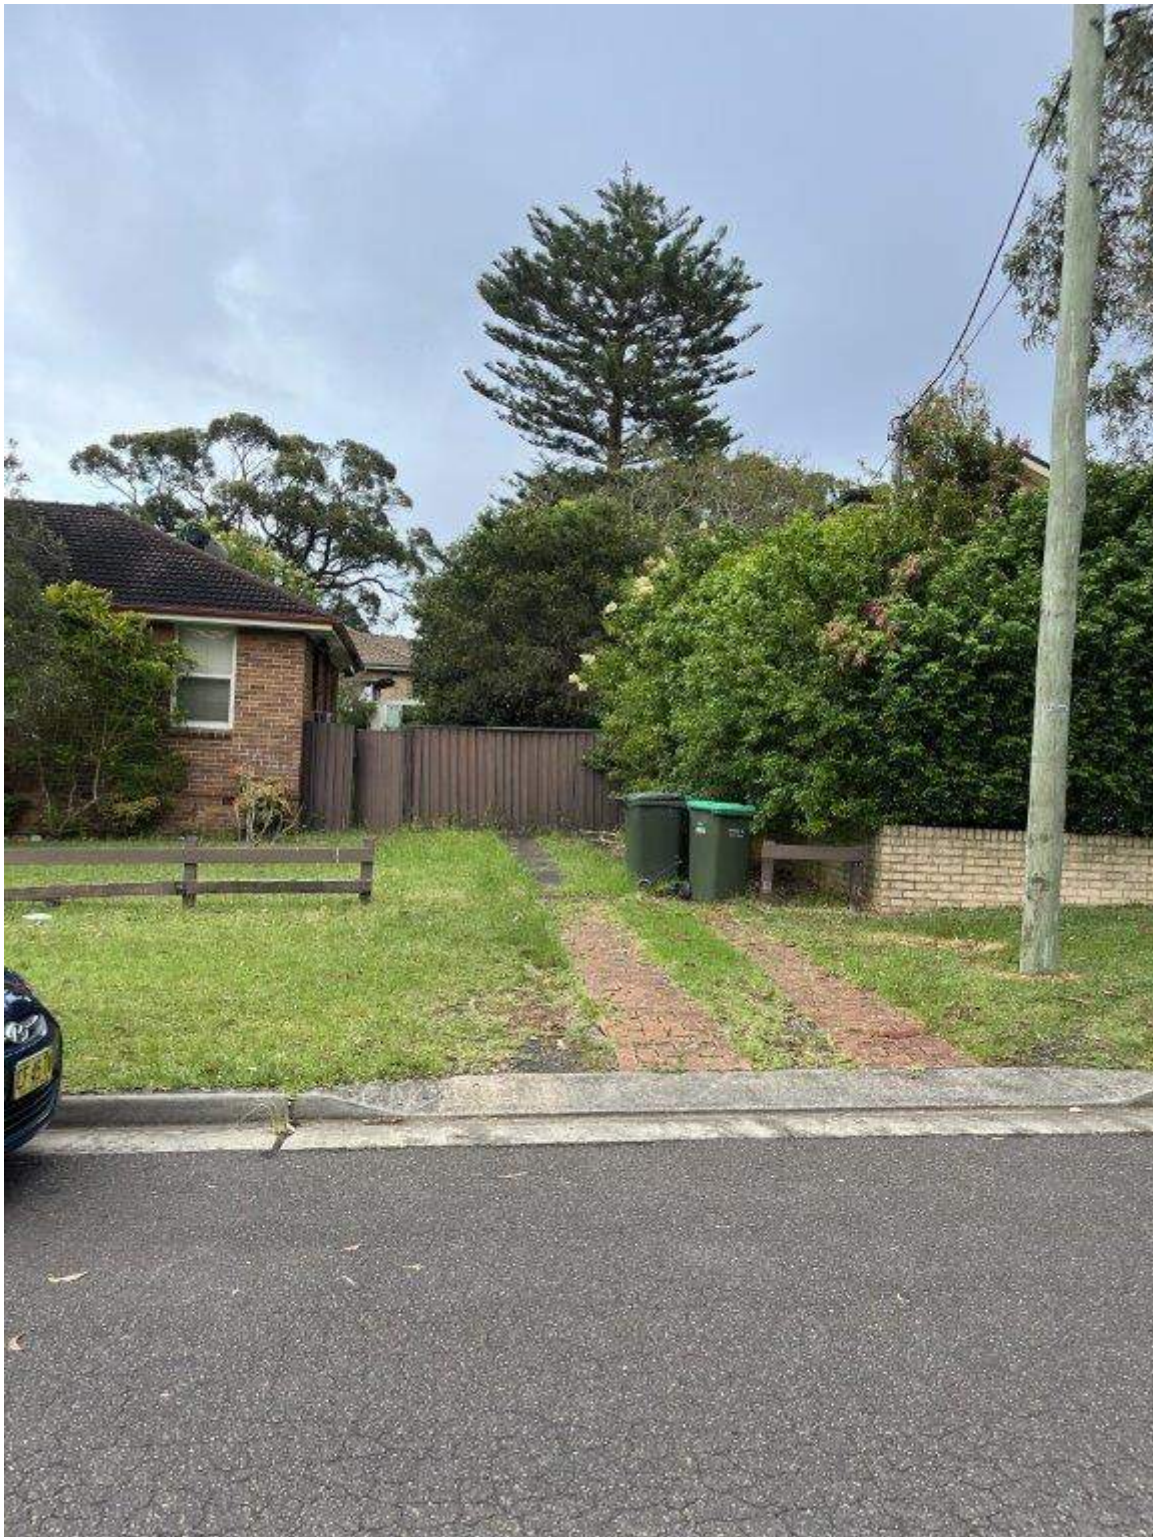
Photo 159 - Taren Point Road - Existing condition of pavement and vegetation

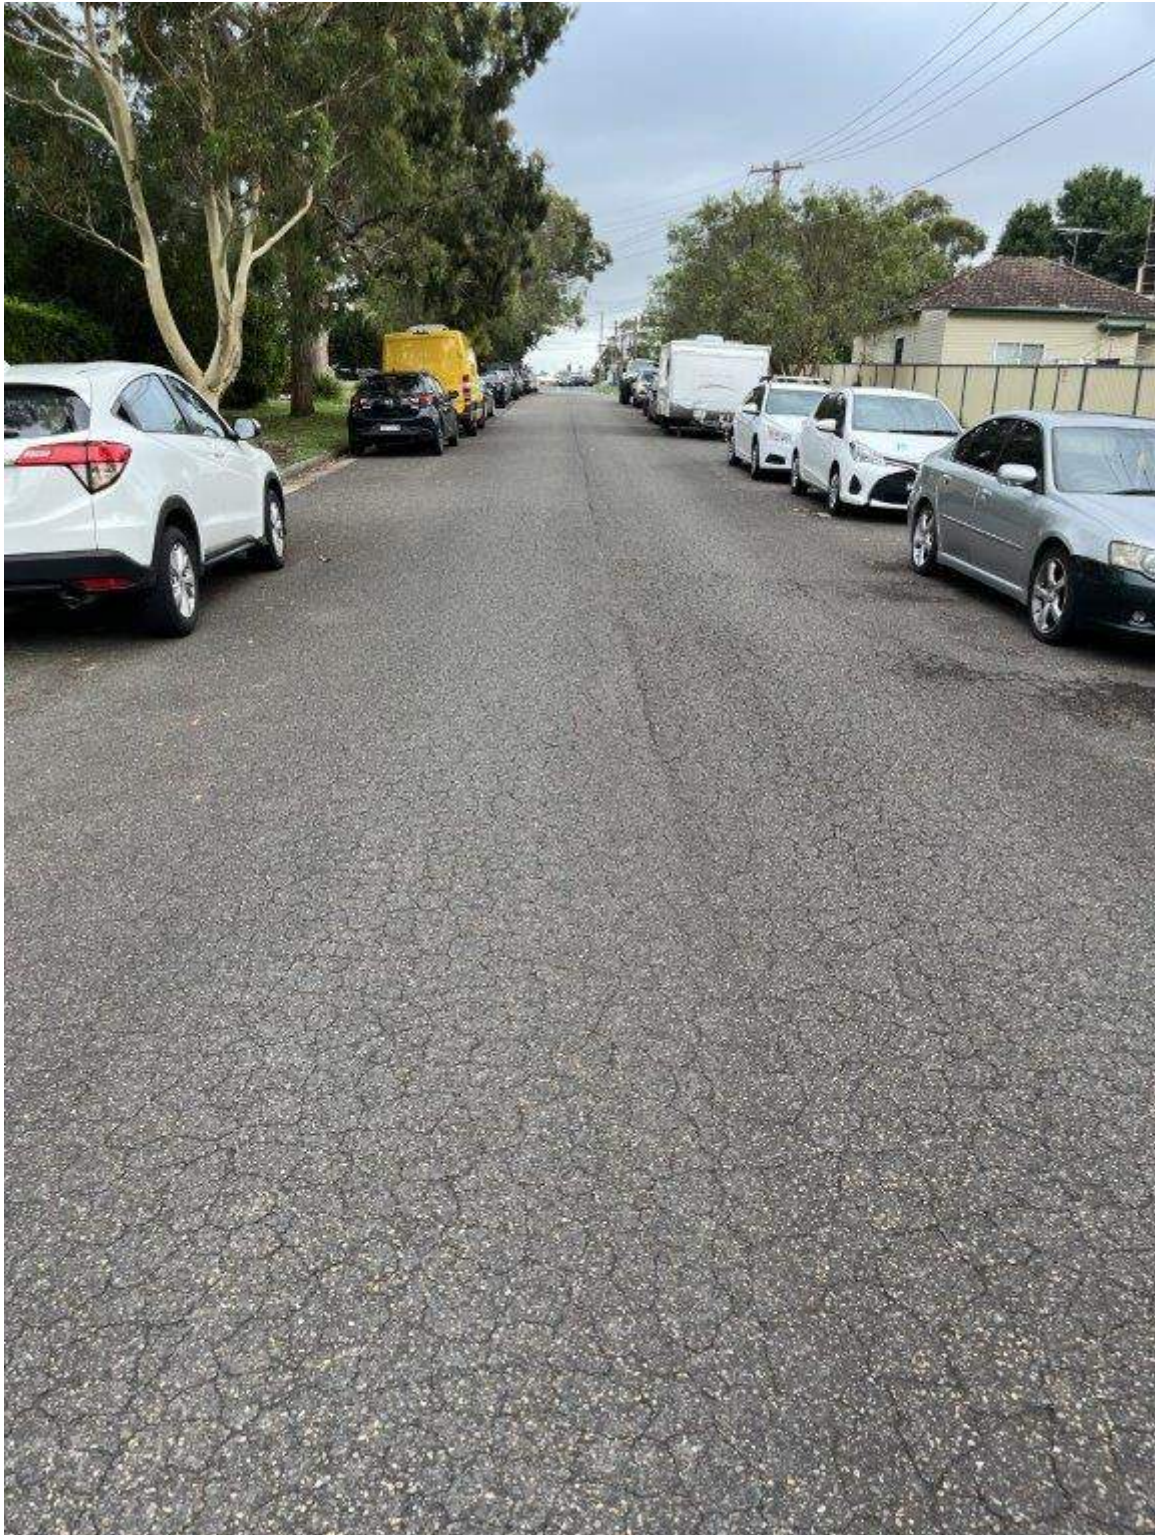
Photo 160 - Taren Point Road - Cracking of pavement

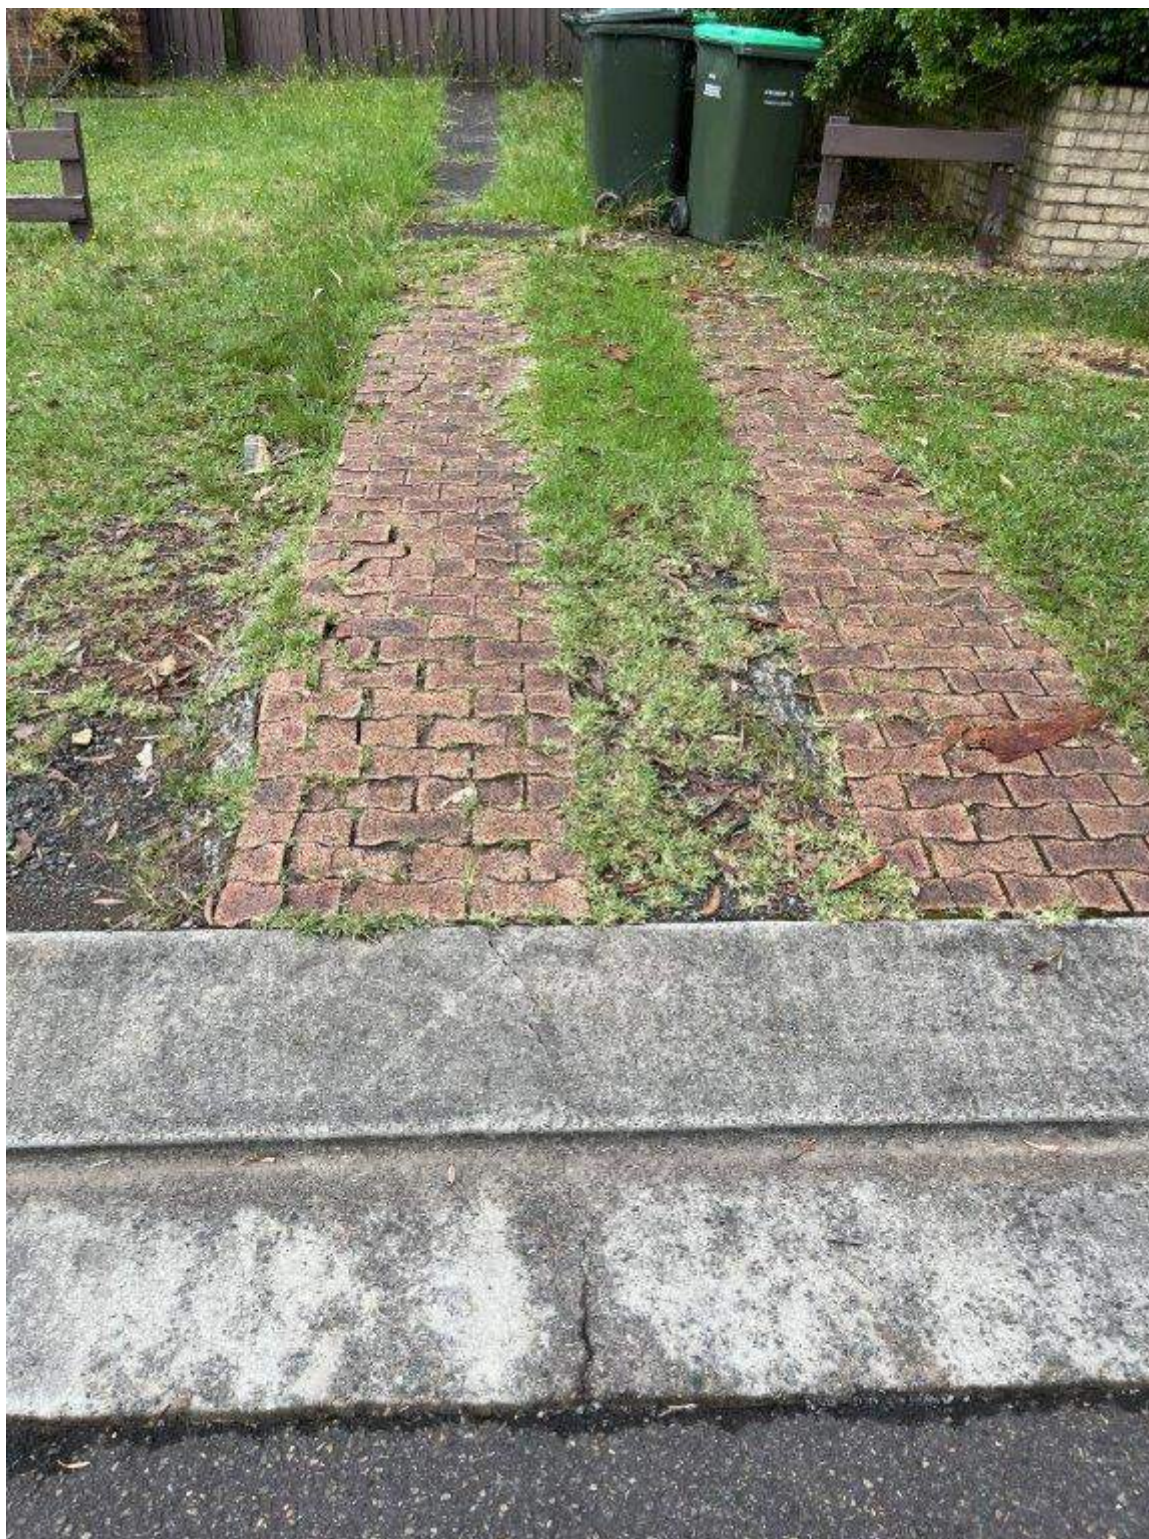
Photo 161 - Taren Point Road - Cracking of pavement

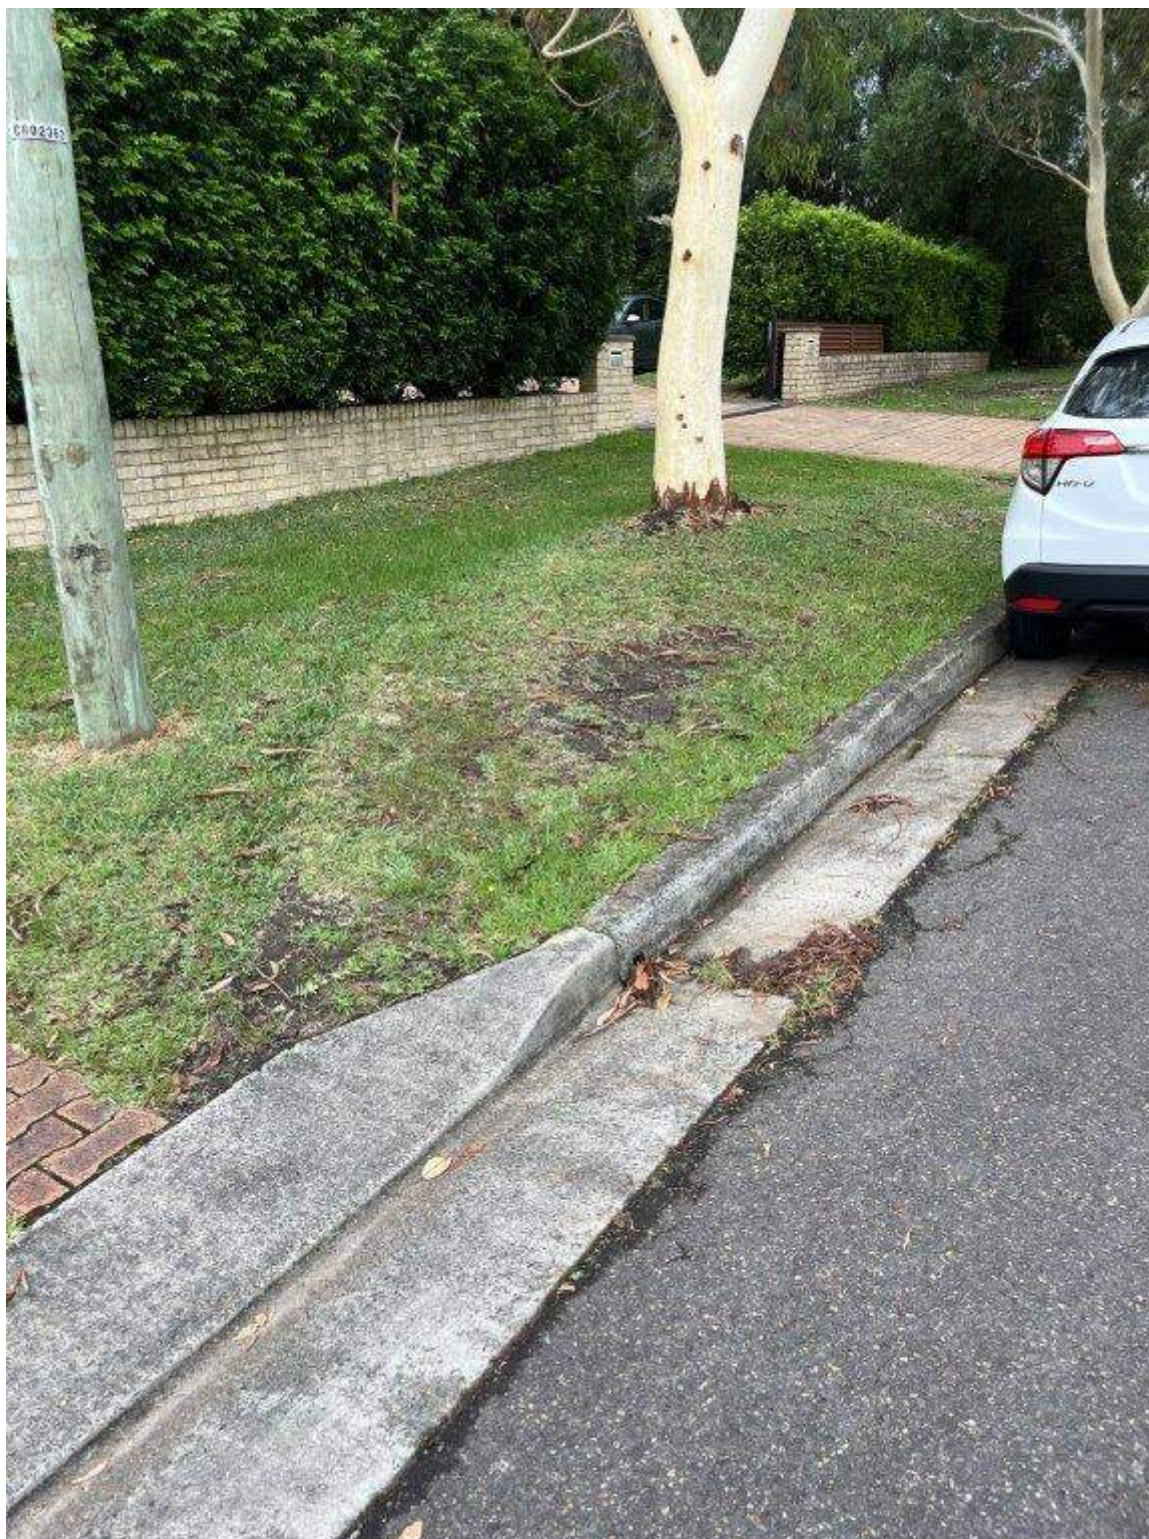
Photo 162 - Taren Point Road - Existing condition of pavement and vegetation

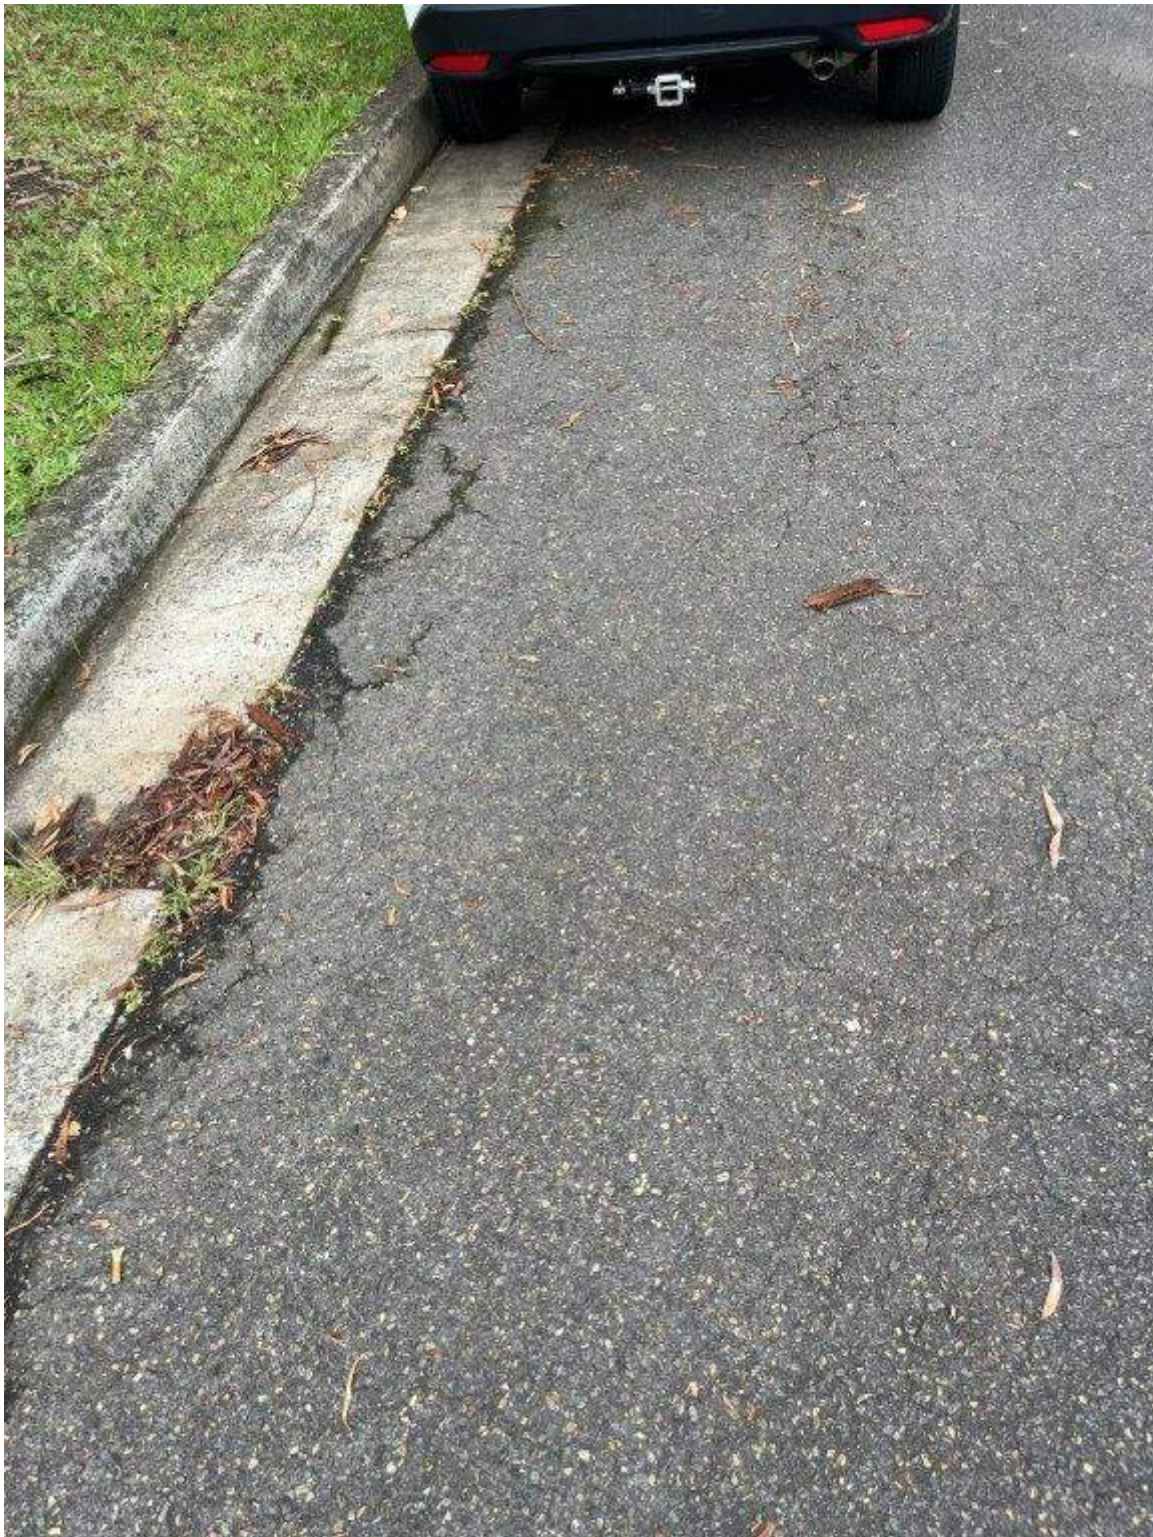
Photo 163 - Taren Point Road - Cracking of pavement

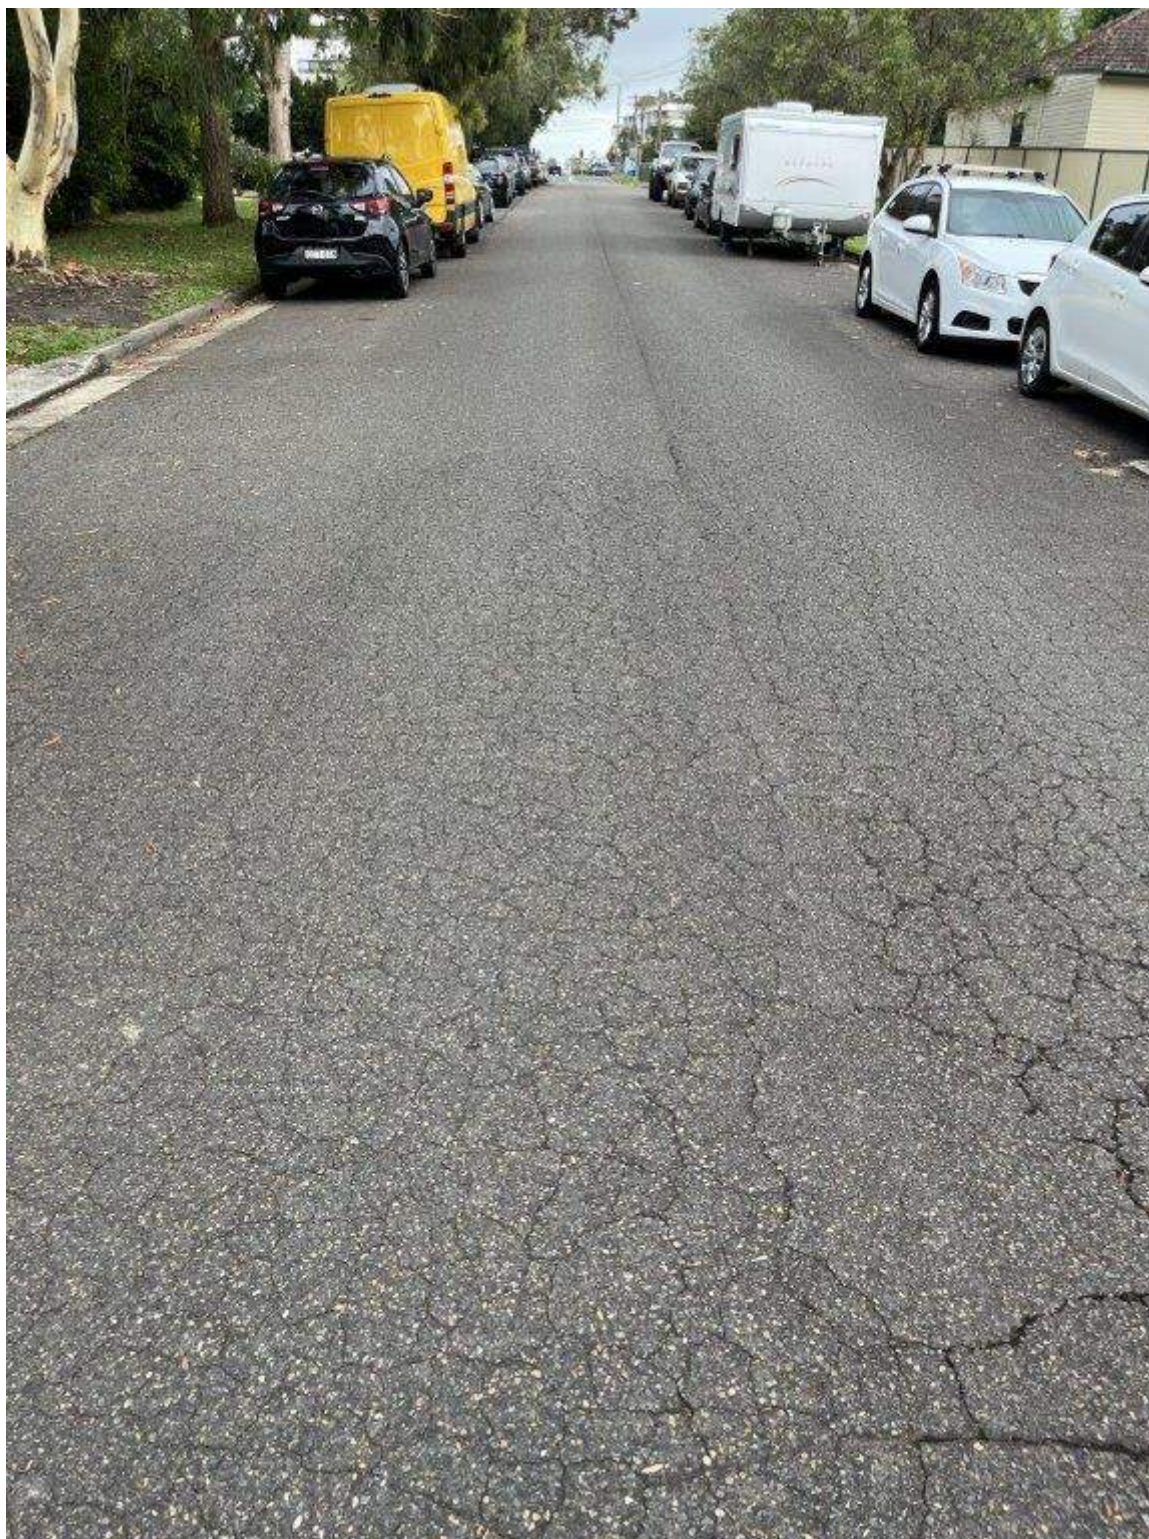
Photo 164 - Taren Point Road - Cracking of pavement

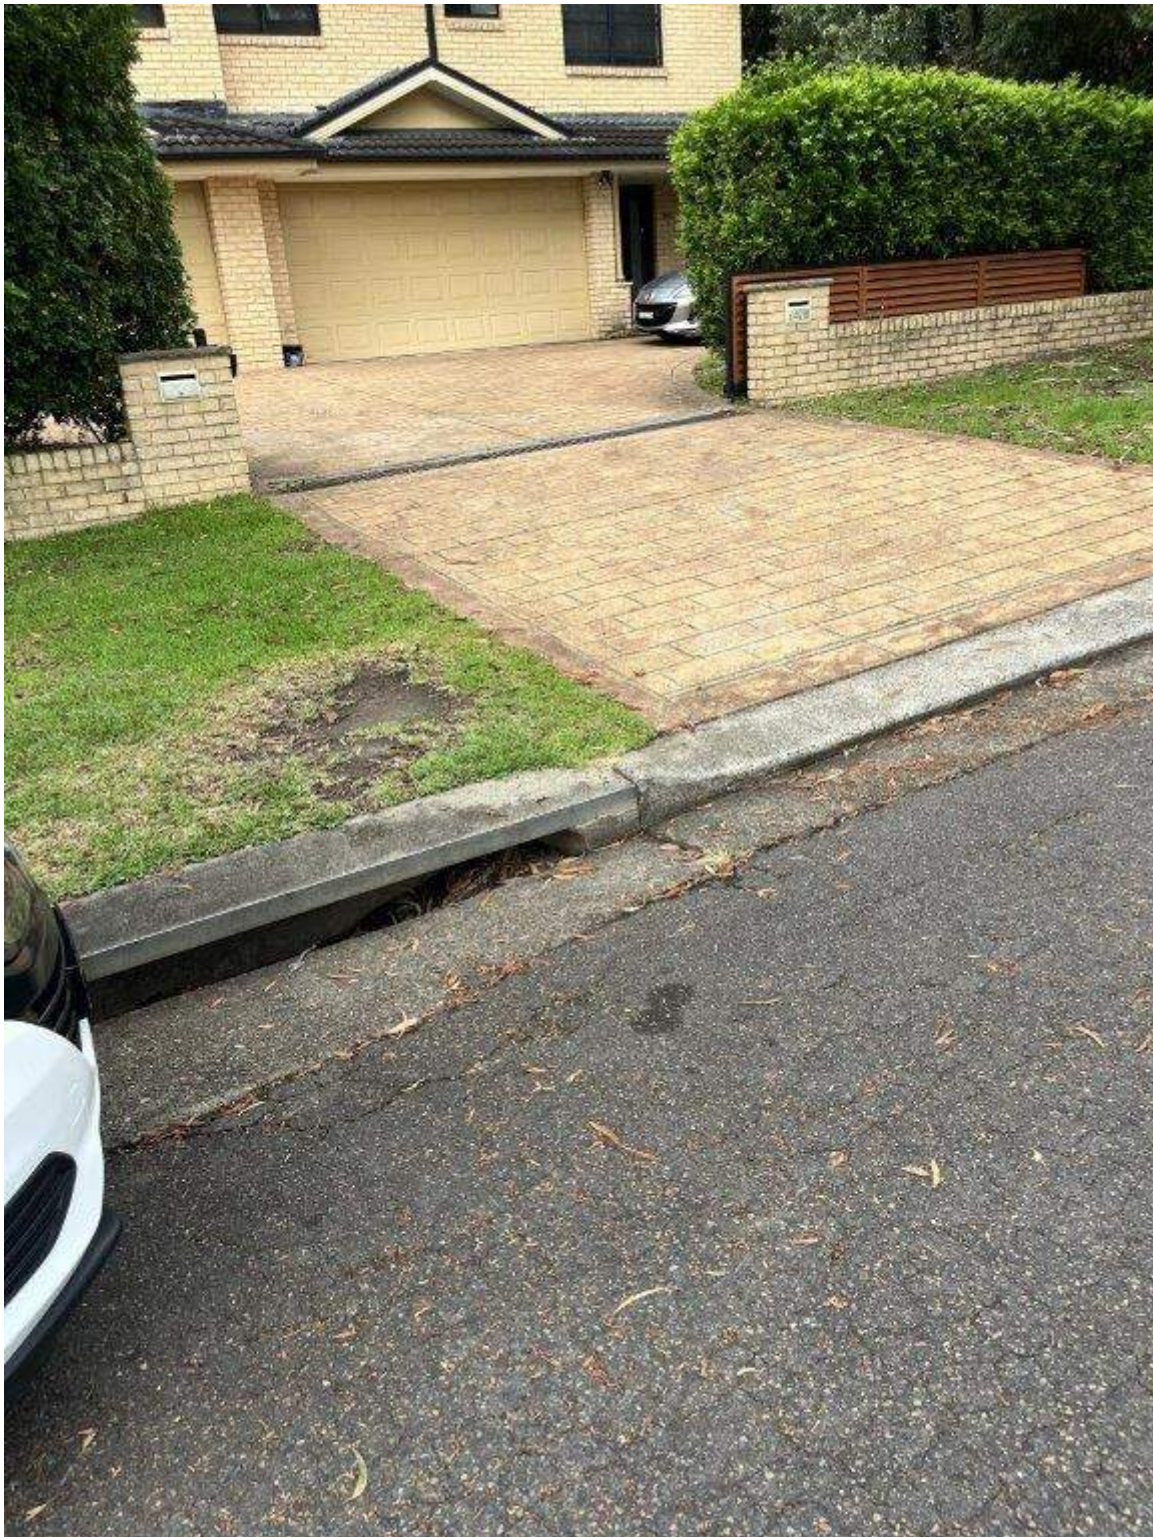
Photo 165 - Taren Point Road - Cracking of pavement

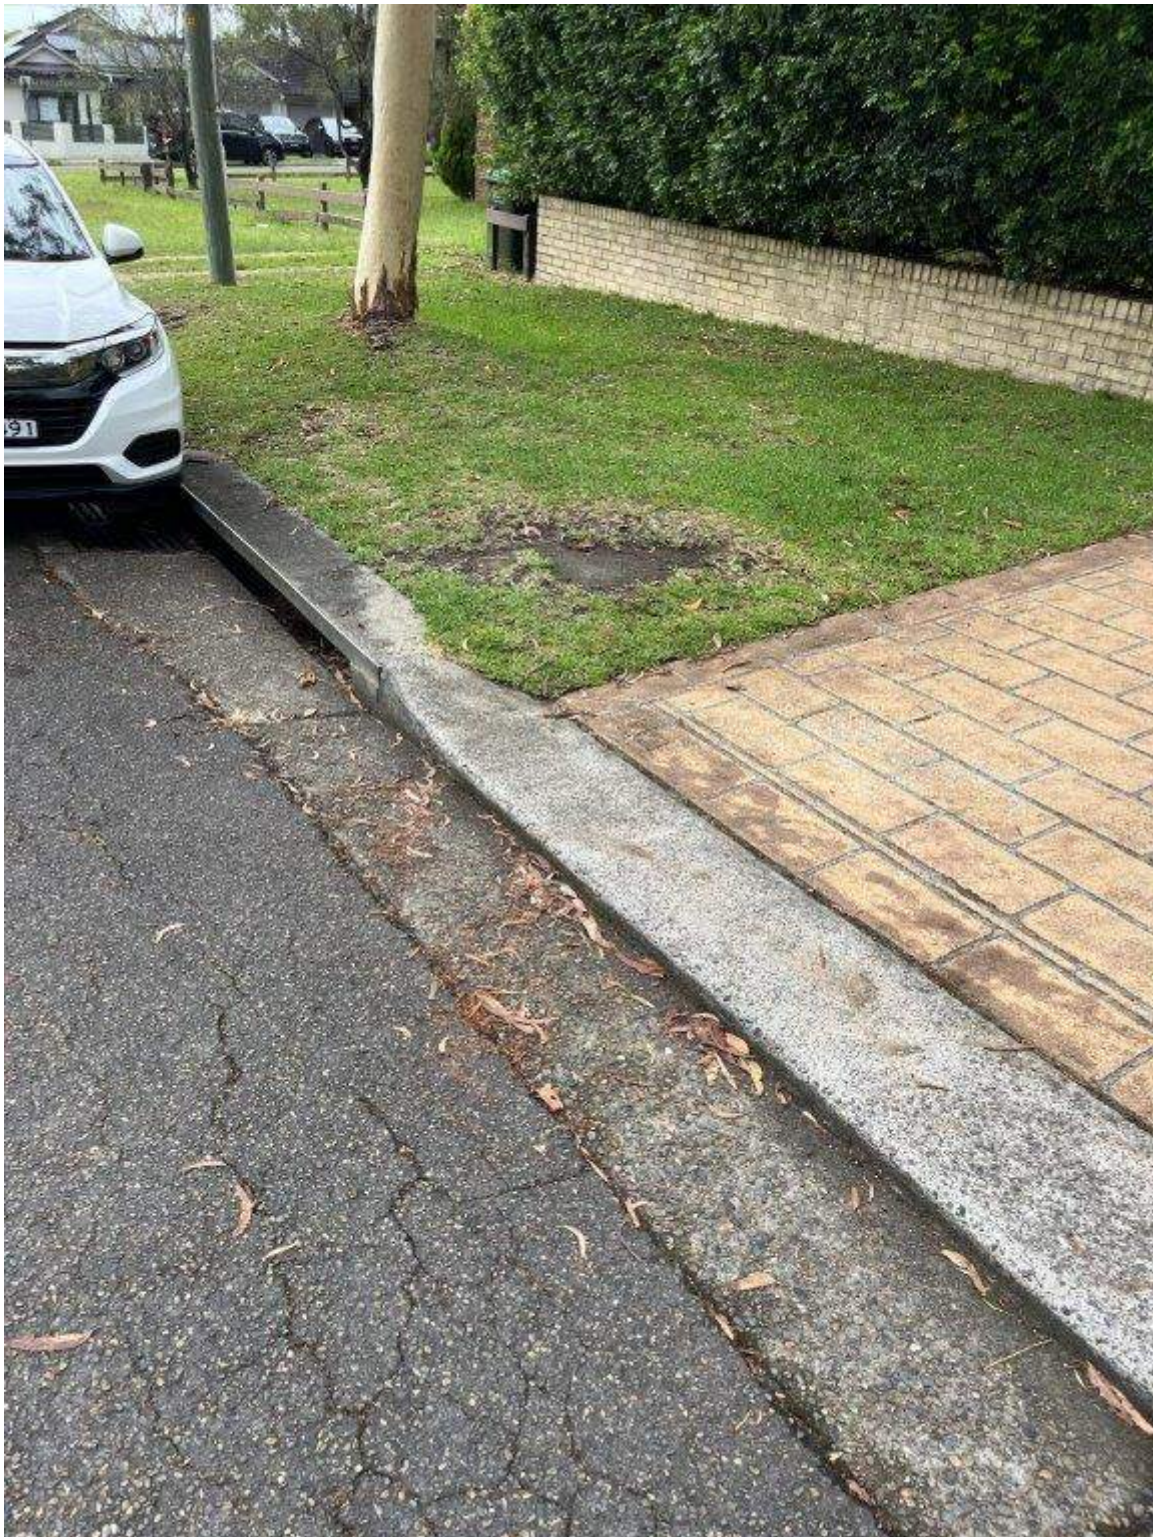
Photo 166 - Taren Point Road - Cracking of pavement

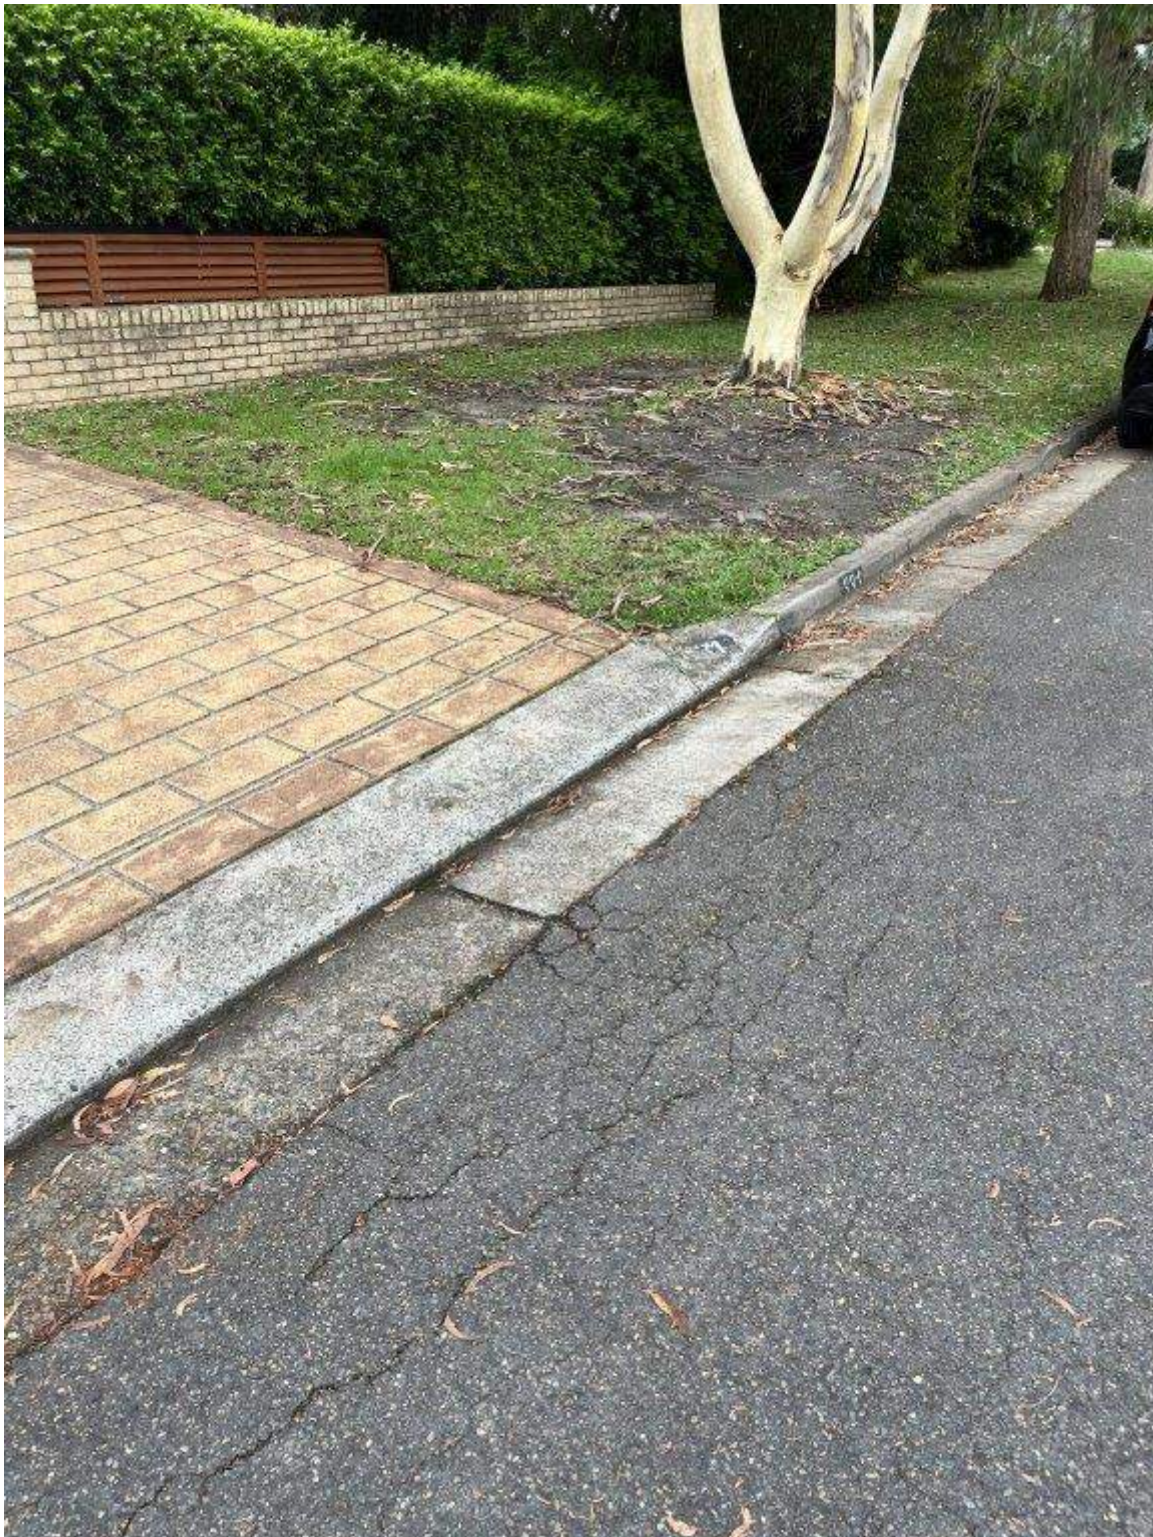
Photo 167 - Taren Point Road - Cracking of pavement

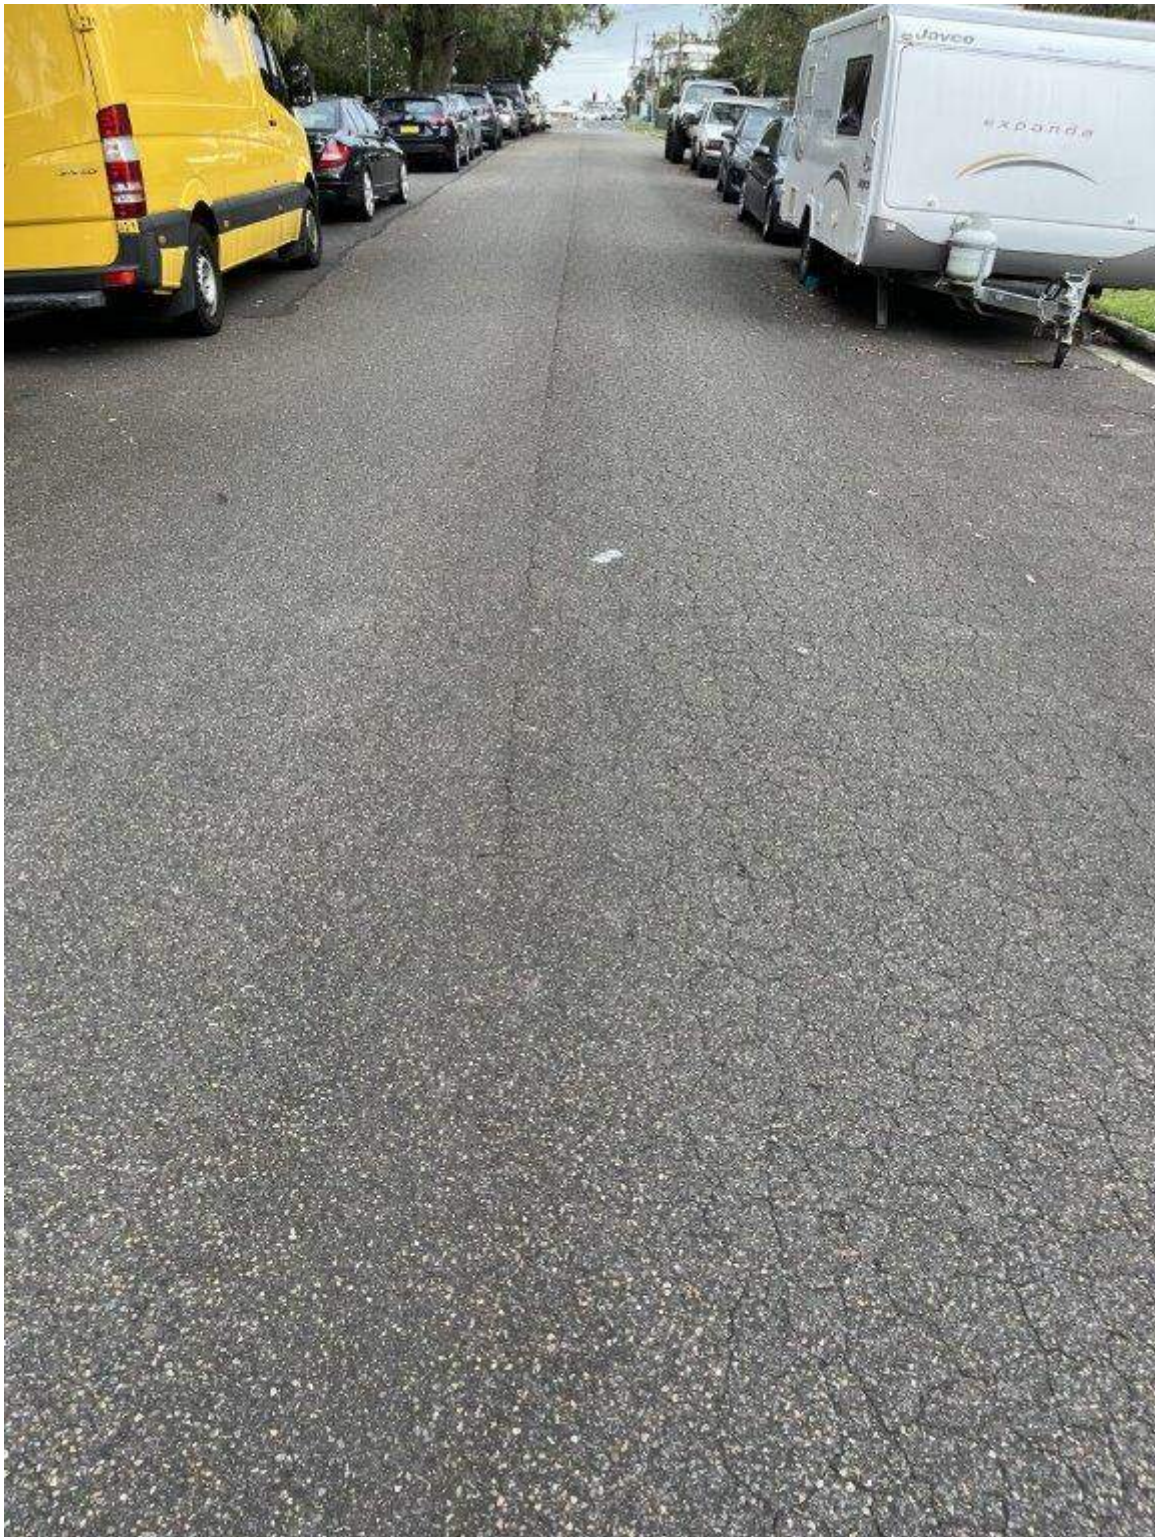
Photo 168 - Taren Point Road - Cracking of pavement
