## PRE-CONSTRUCTION DILAPIDATION REPORT

### 6-20 HINKLER AVENUE & 319-333 TAREN POINT ROAD, CARINGBAH

| PRE-CONSTRUCTION DILAPIDATION REPORT<br>6-20 Hinkler Avenue & 319-333 Taren Point Road,<br>Caringbah NSW 2229 | | | | | Project Number: 21039 |

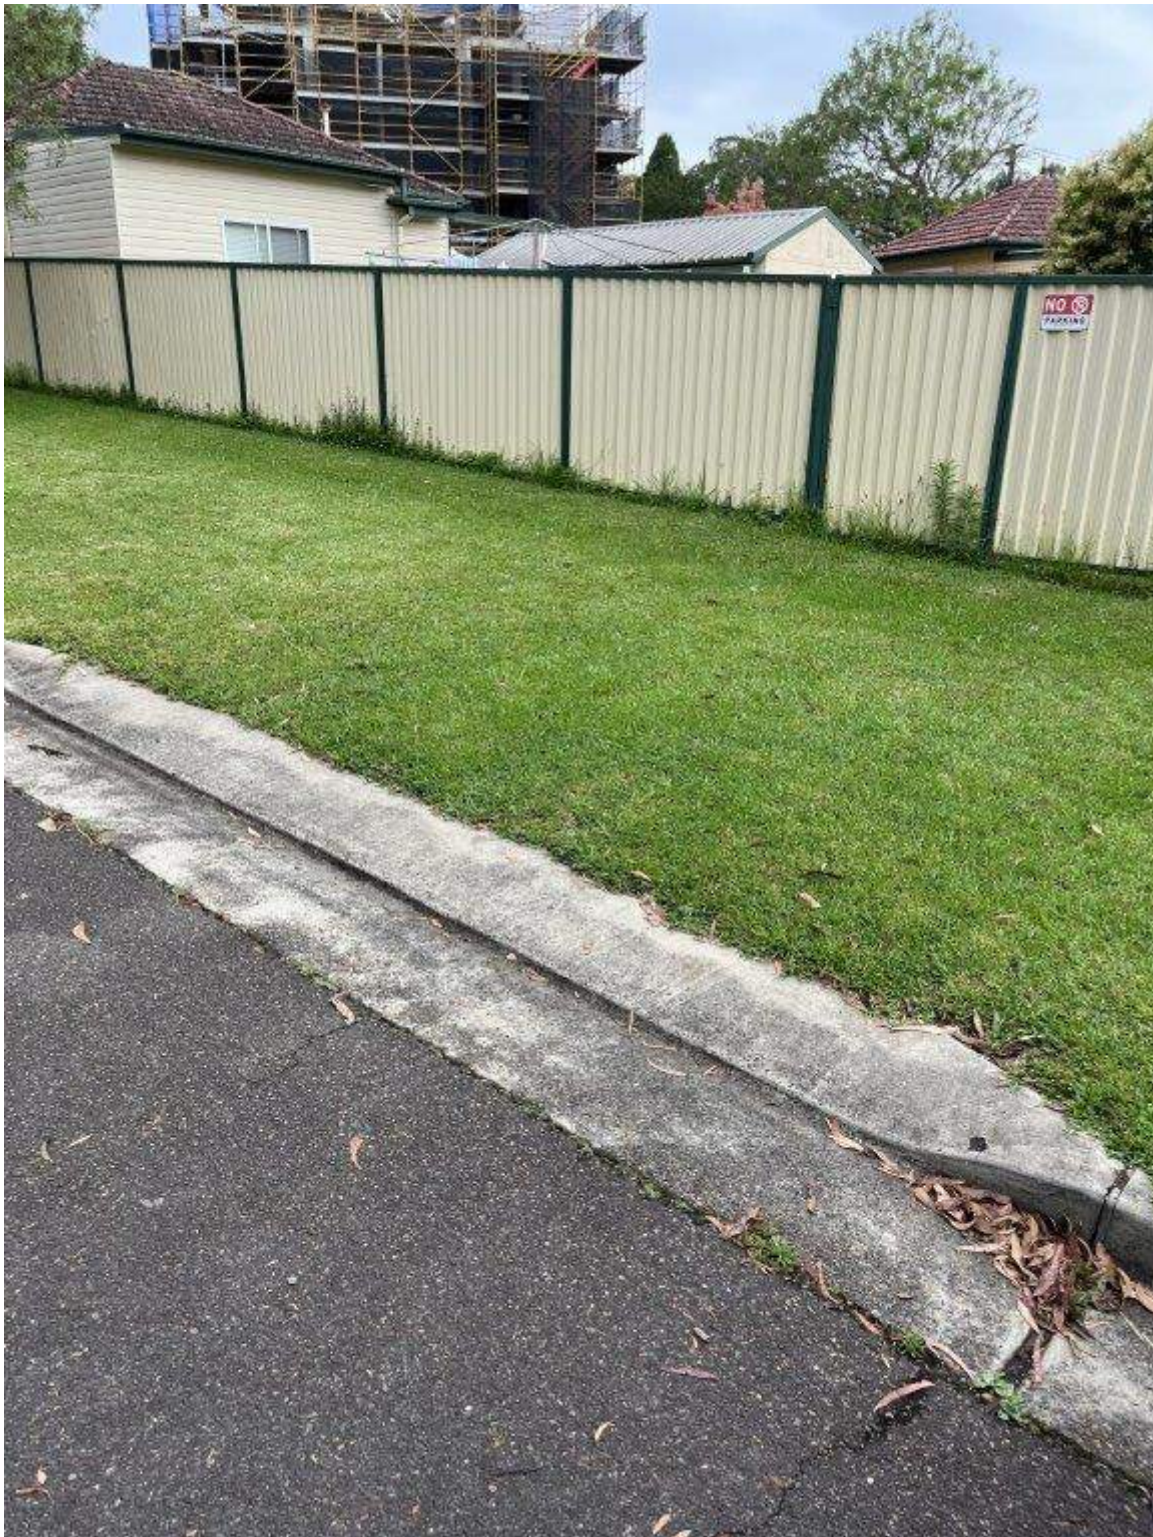
Photo 169 - Taren Point Road - Existing condition of pavement and vegetation

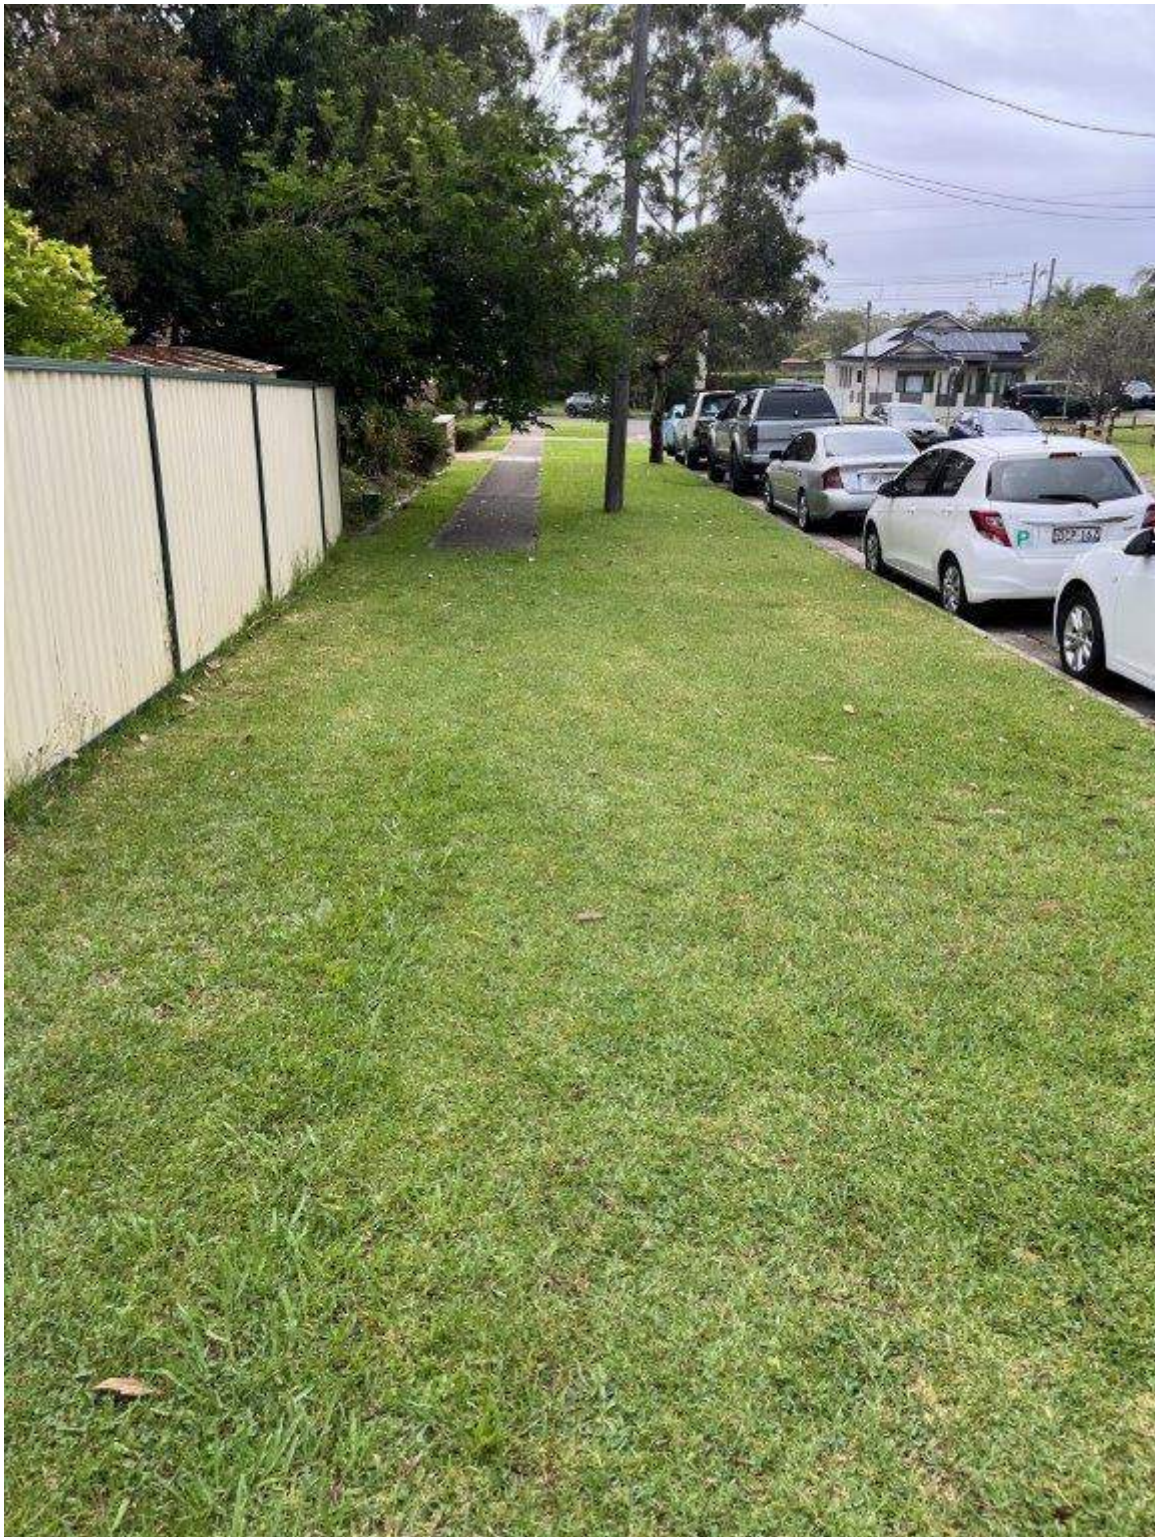
Photo 170 - Taren Point Road - Existing condition of vegetation

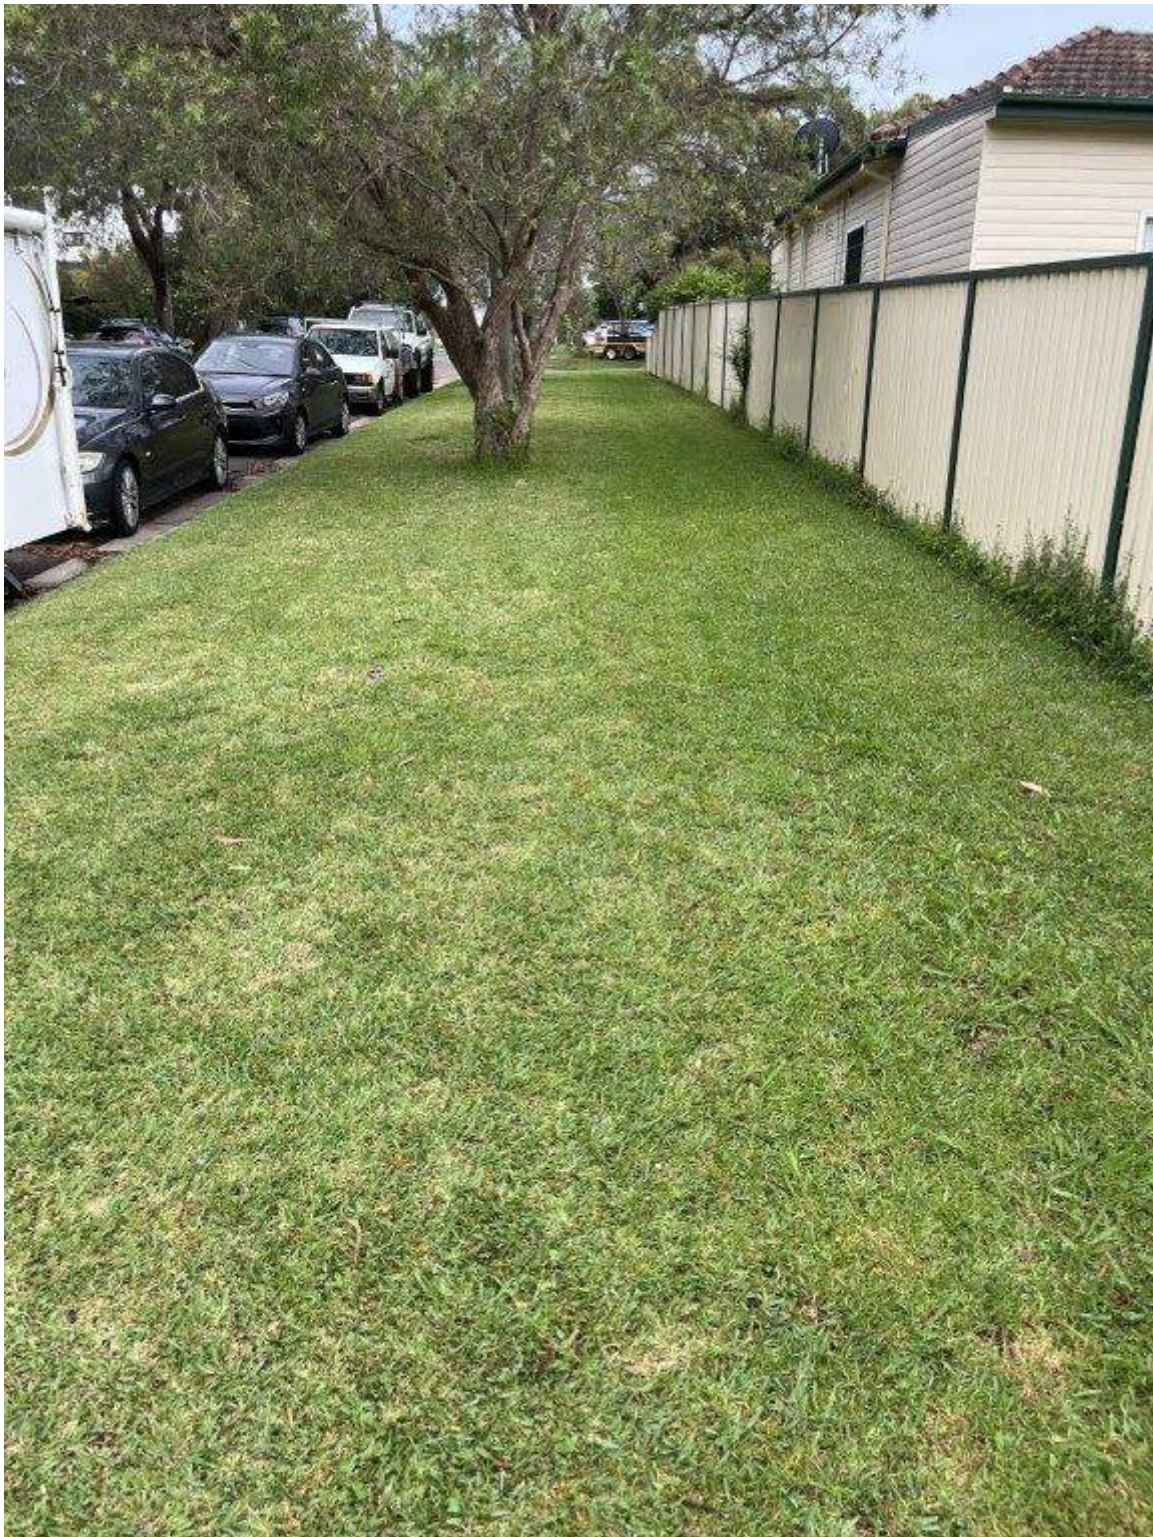
Photo 171 - Taren Point Road - Existing condition of vegetation

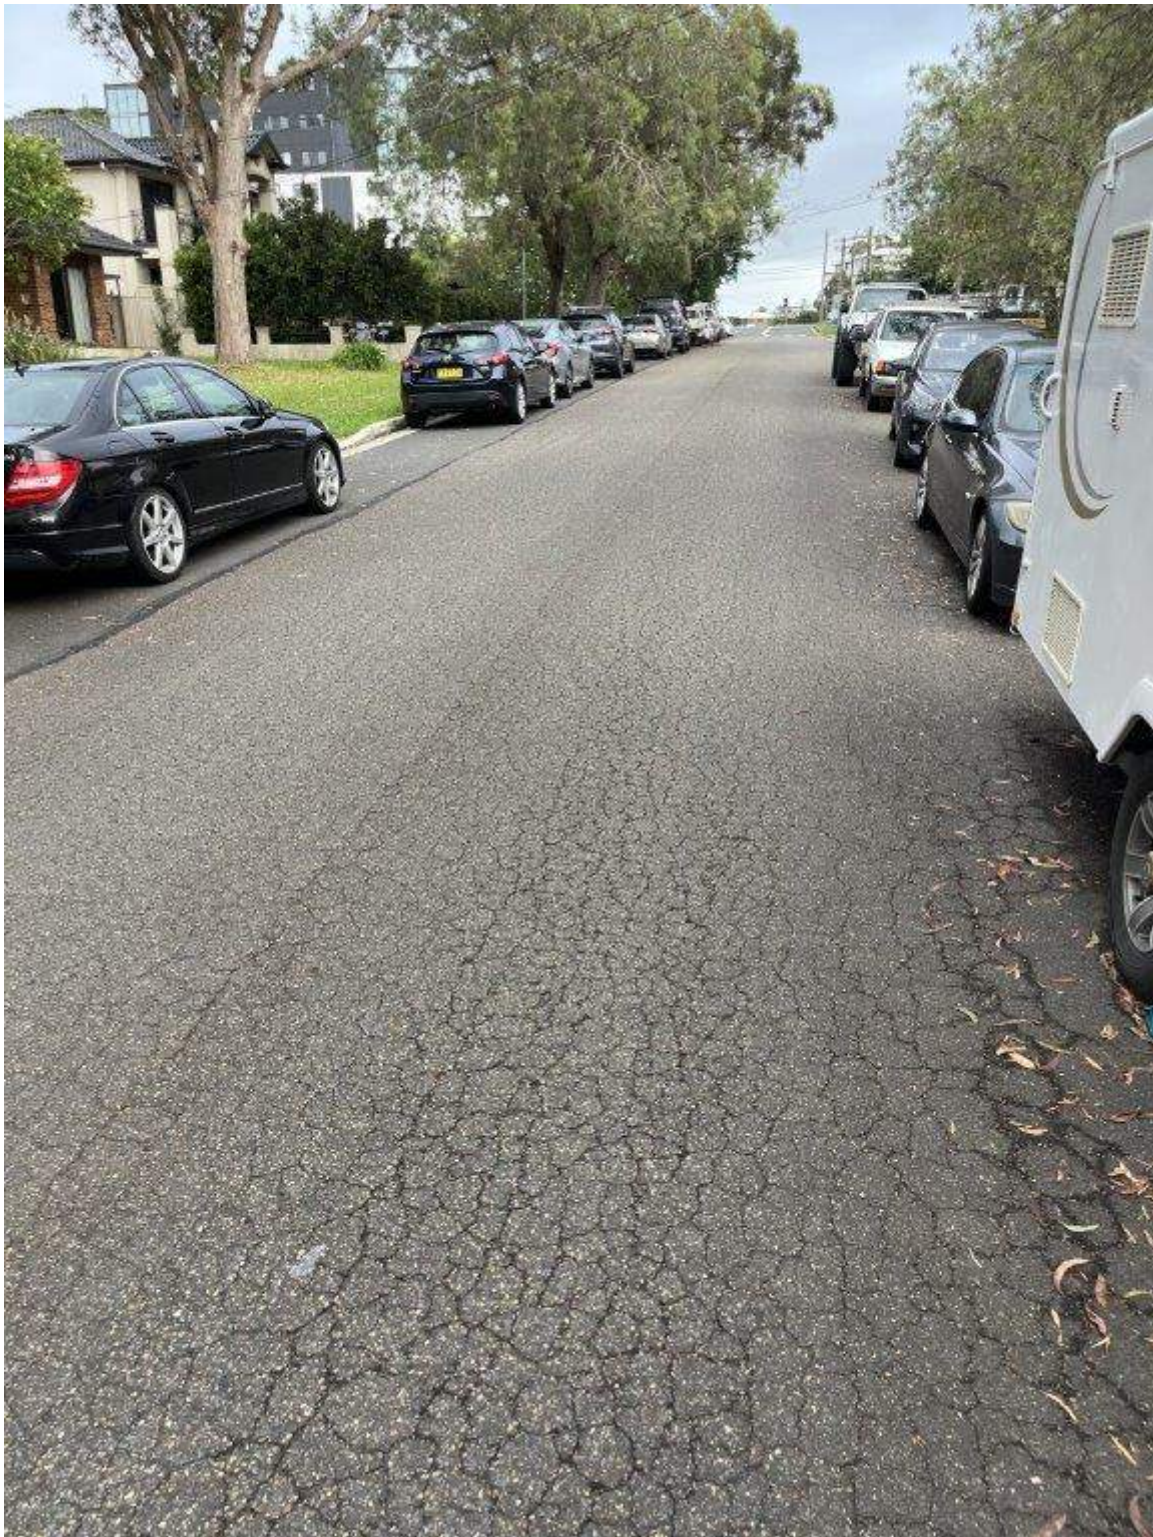
Photo 172 - Taren Point Road - Cracking of pavement

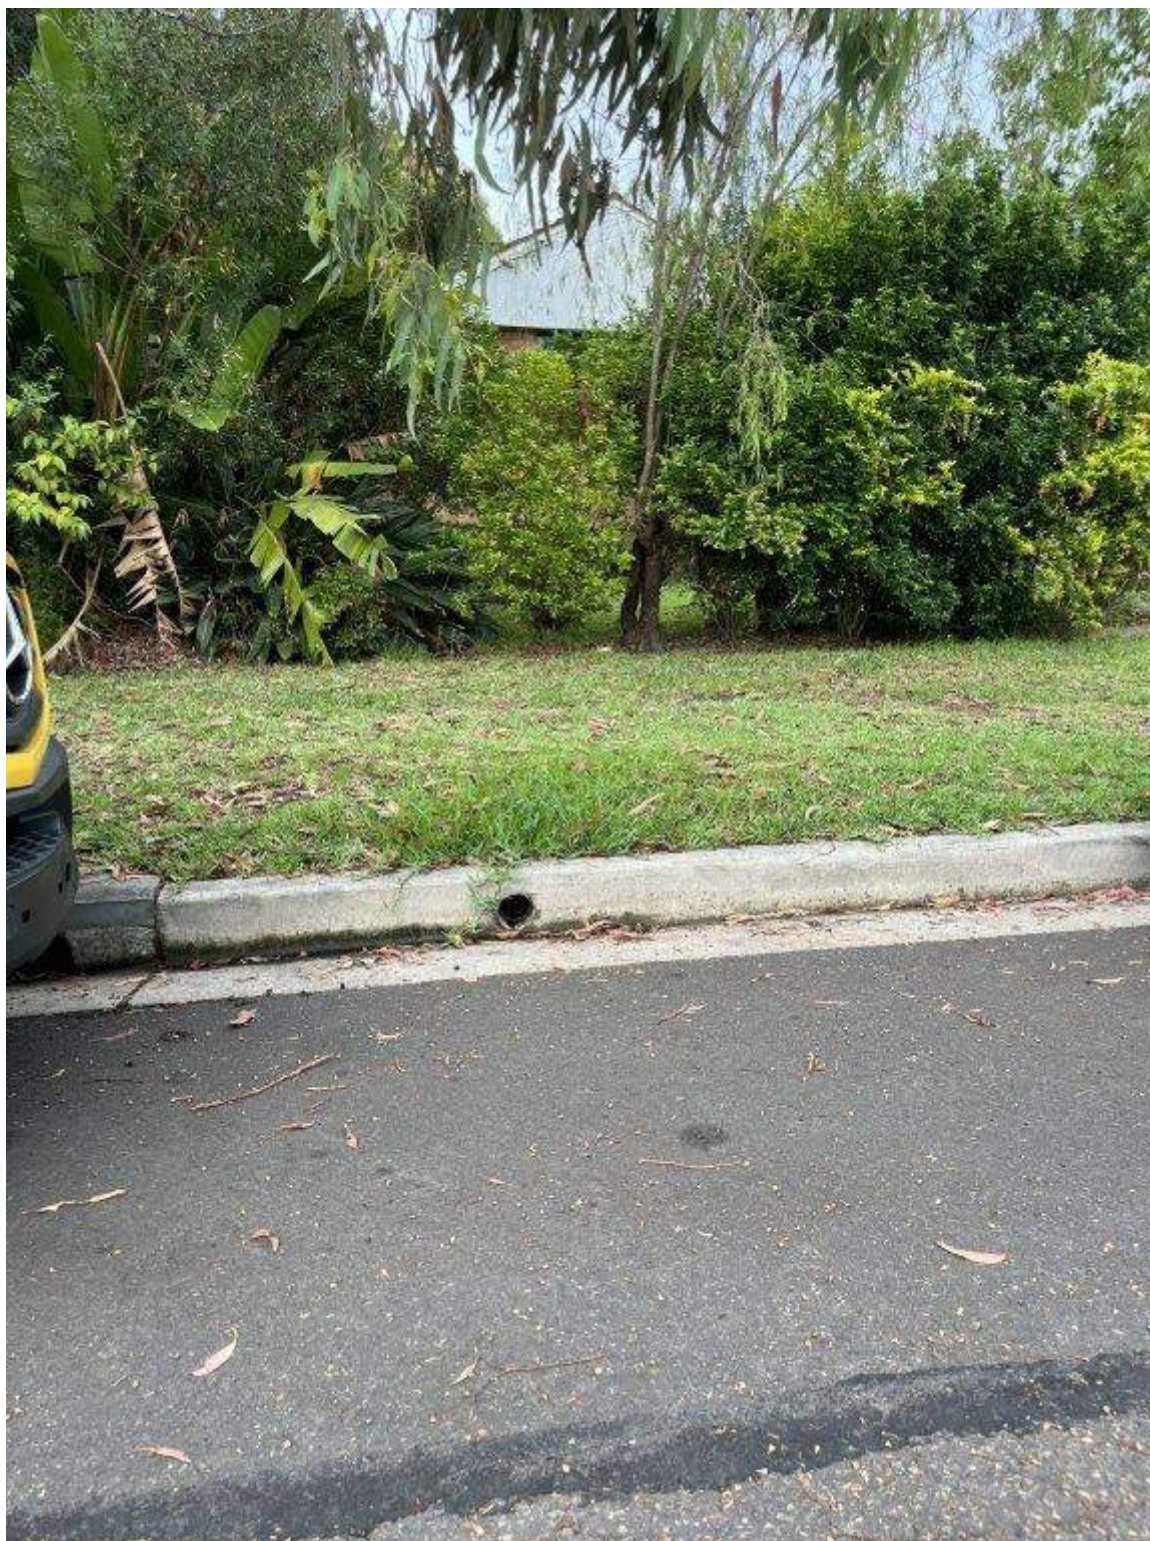
Photo 173 - Taren Point Road - Existing condition of pavement and vegetation

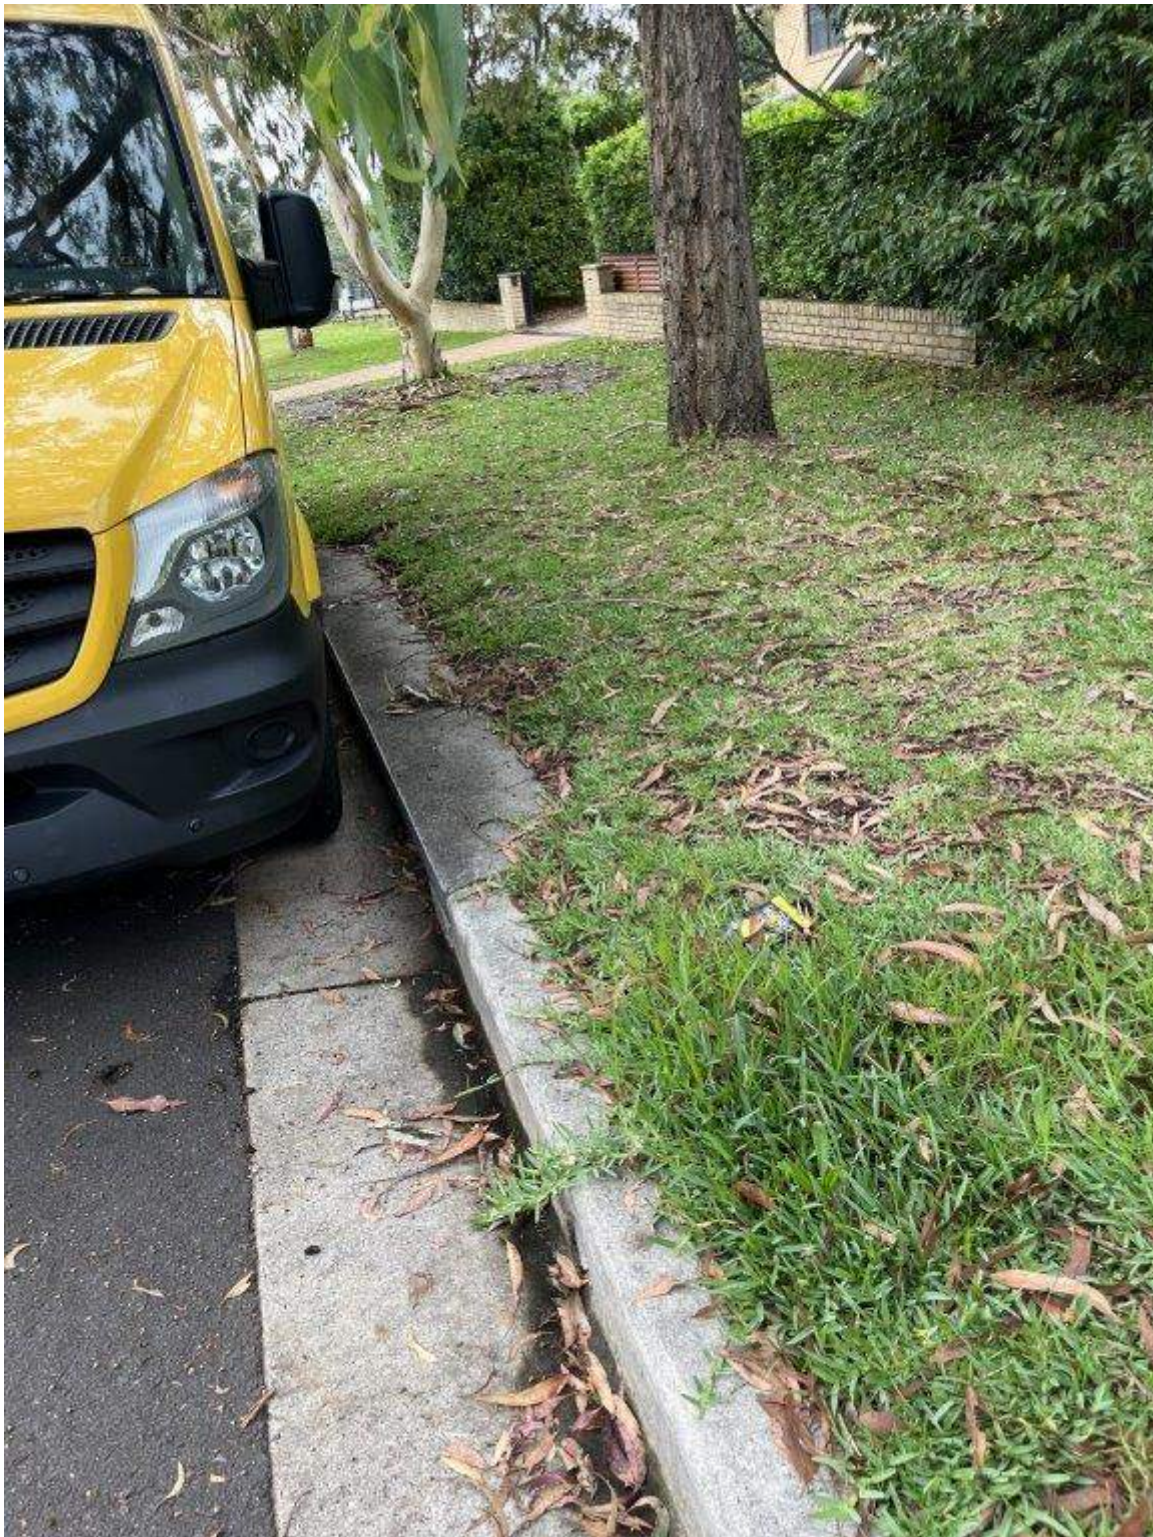
Photo 174 - Taren Point Road - Existing condition of pavement and vegetation

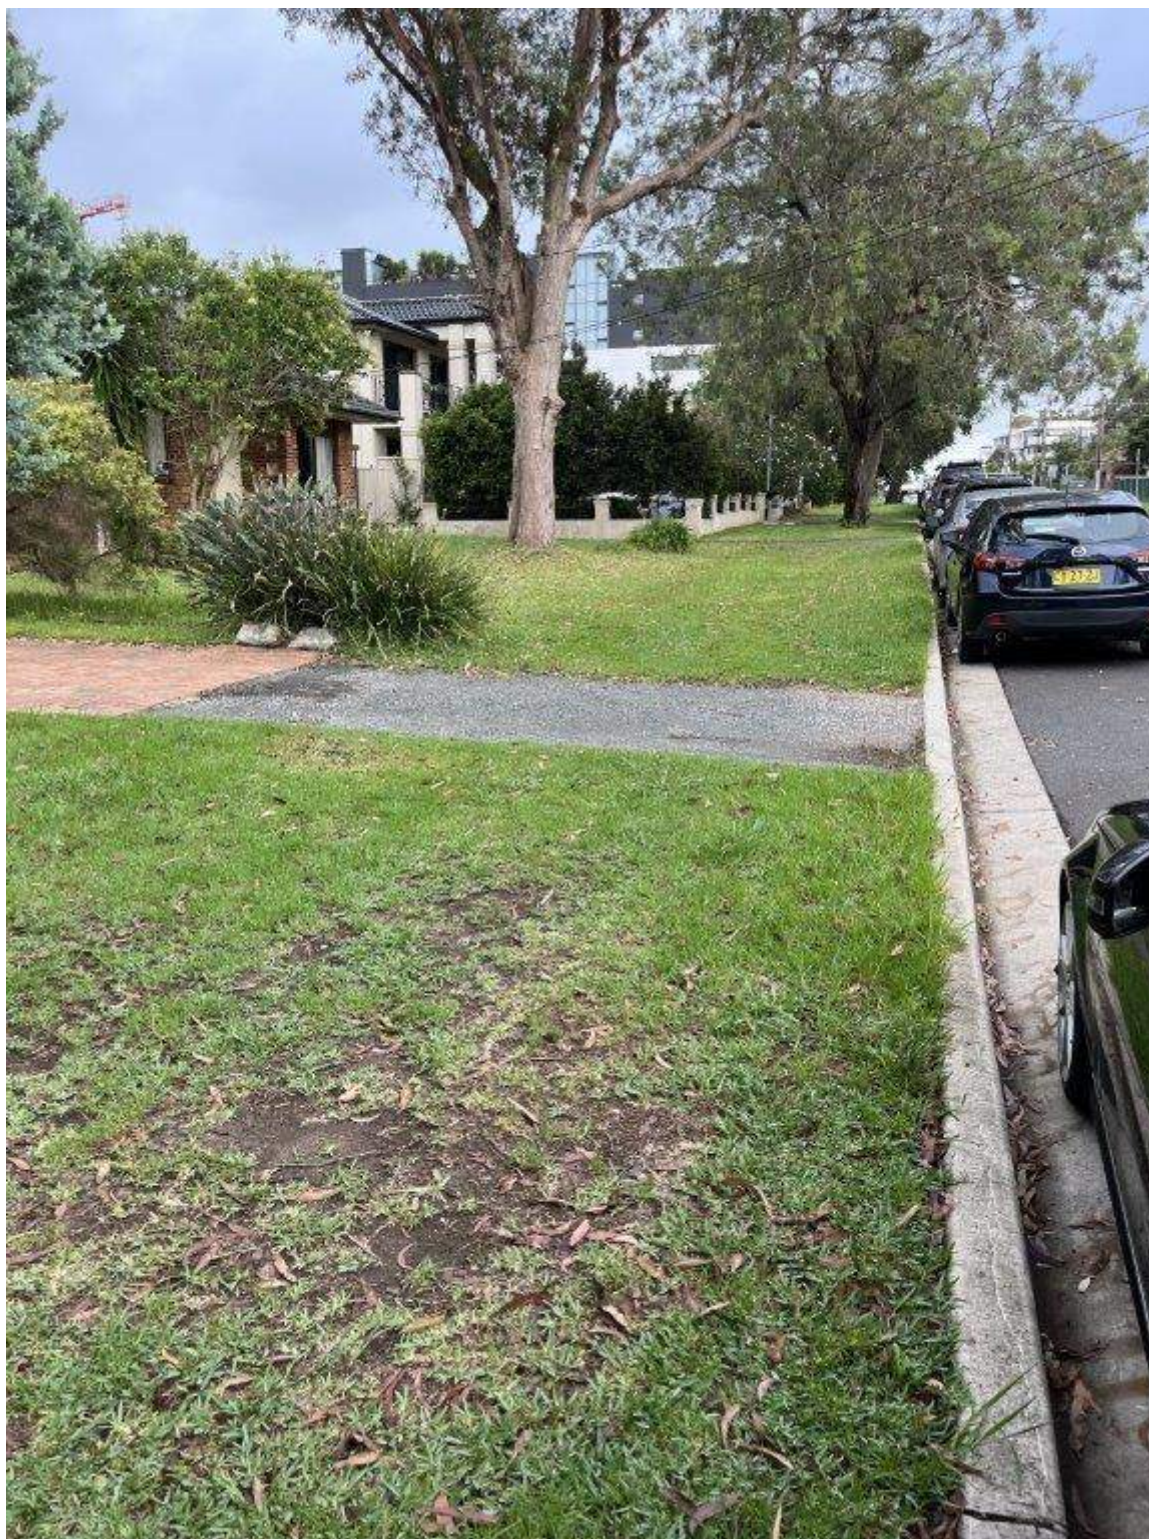
Photo 175 - Taren Point Road - Existing condition of pavement and vegetation

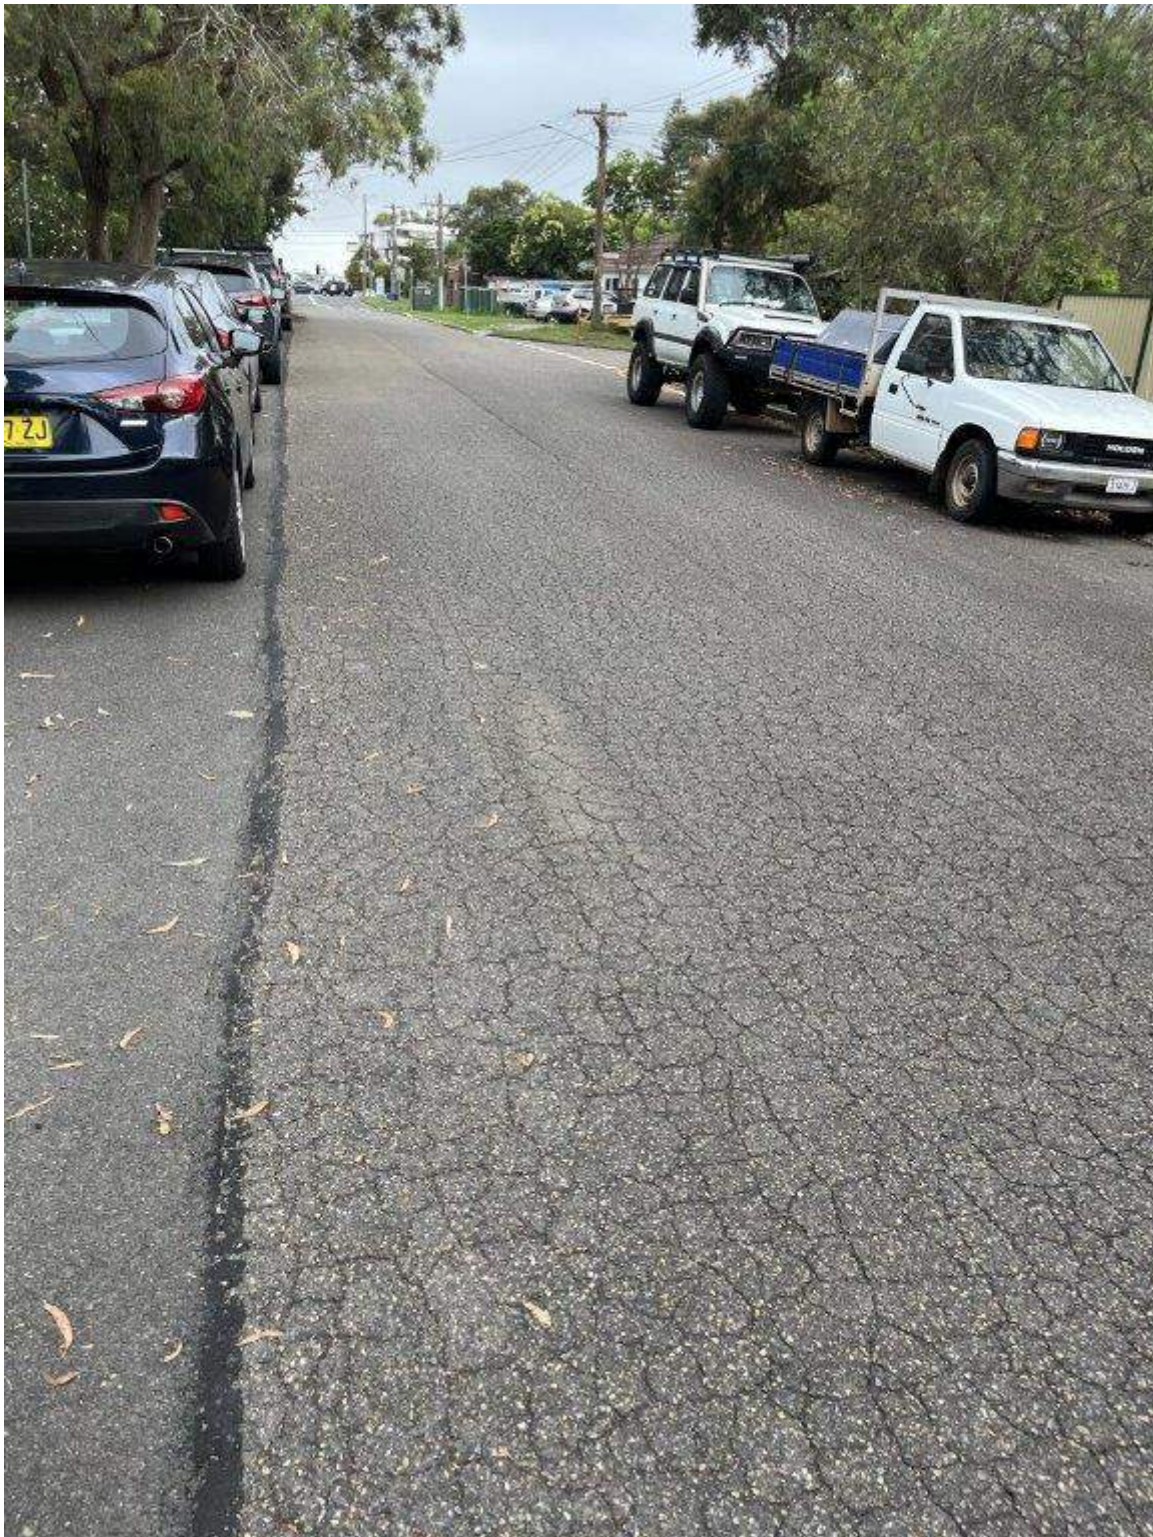
Photo 176 - Taren Point Road - Existing condition of pavement and vegetation

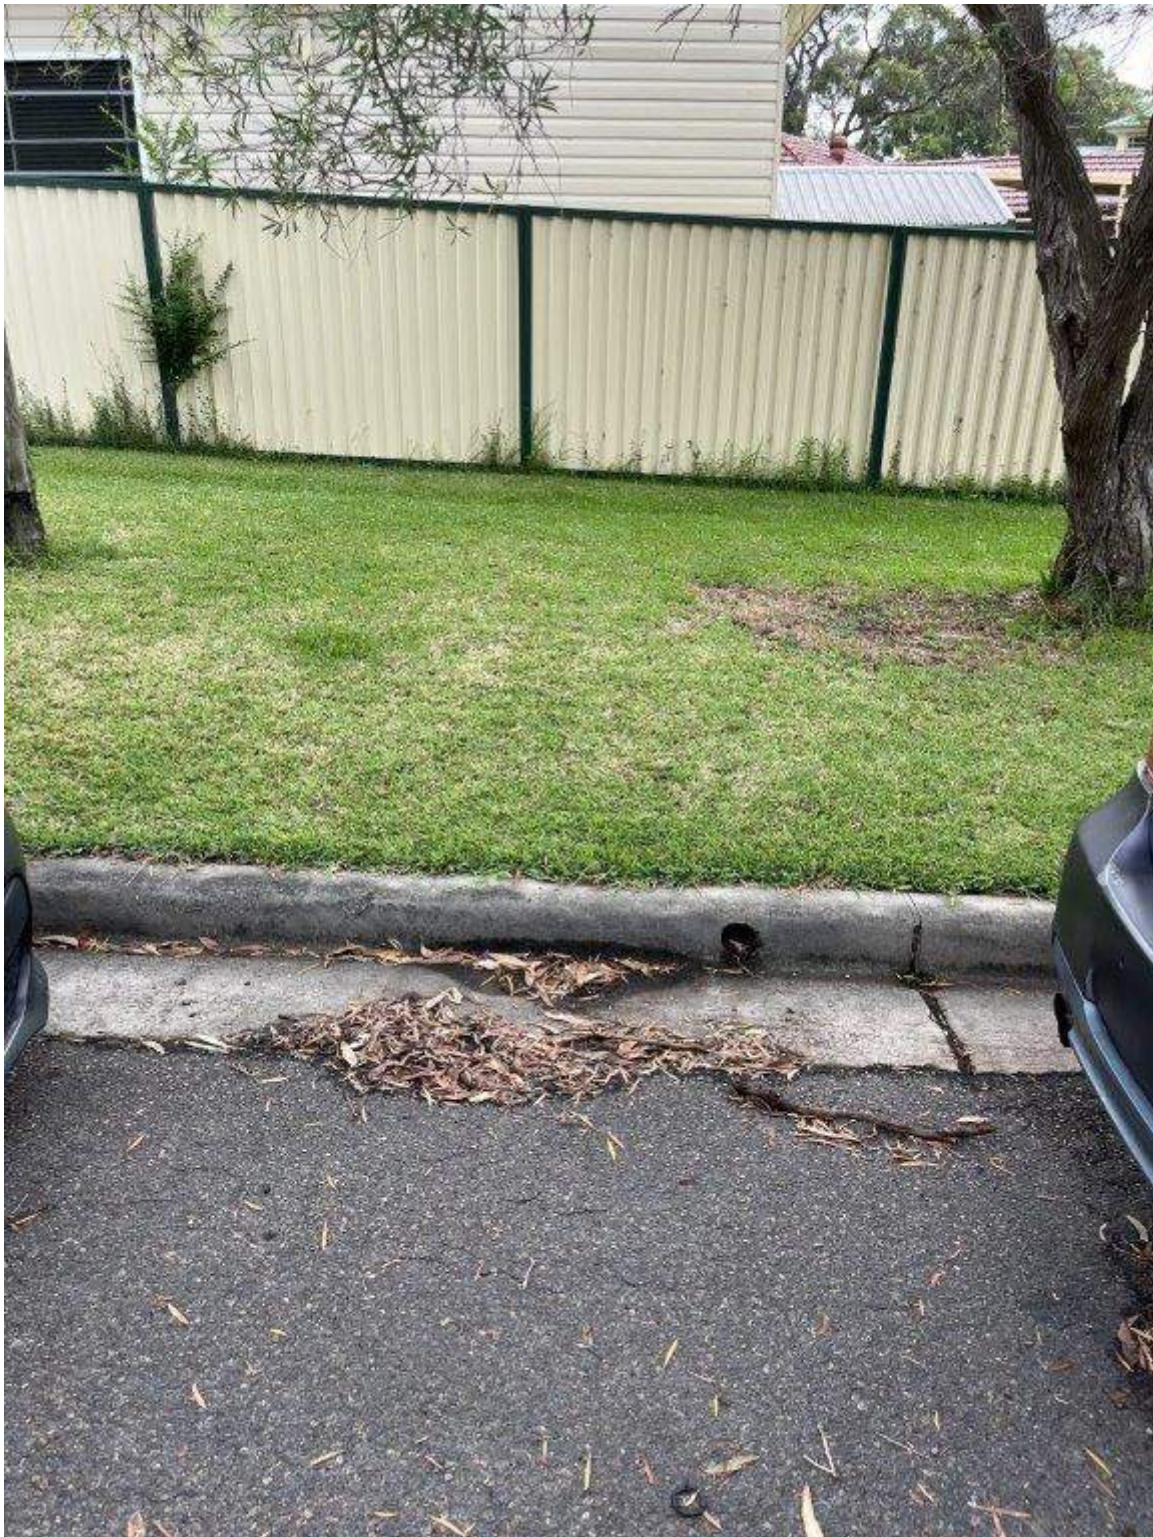
Photo 177 - Taren Point Road - Cracking of pavement

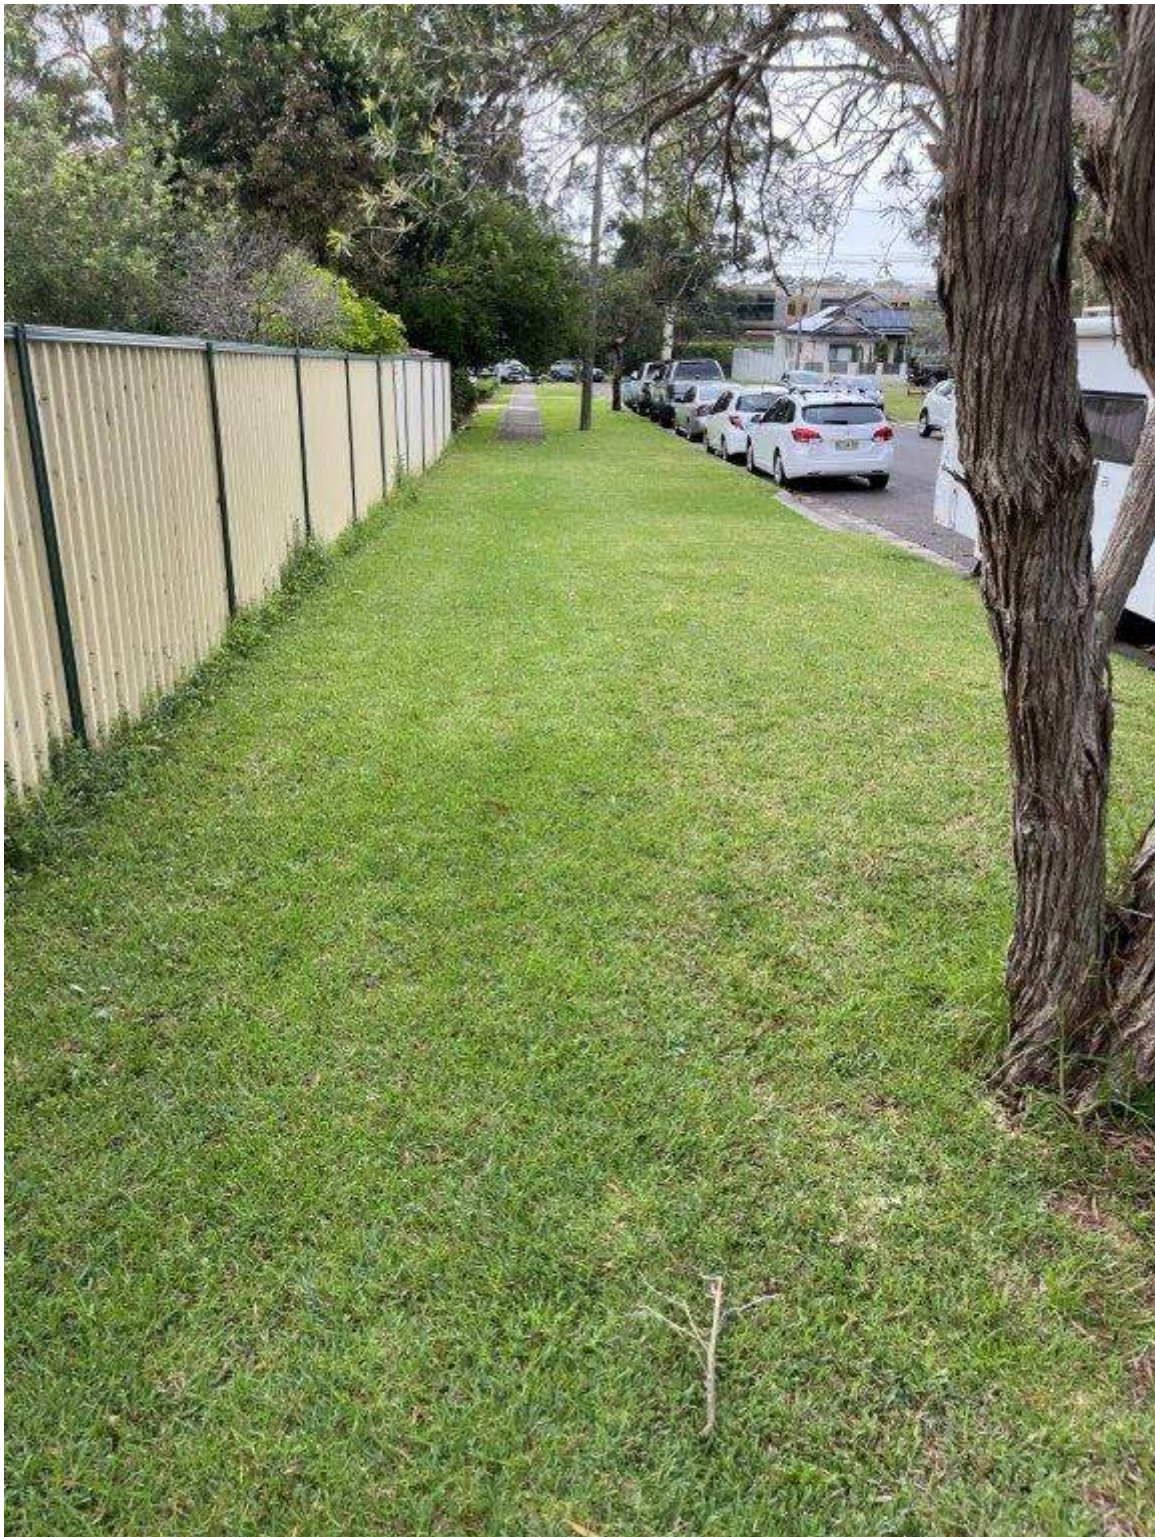
Photo 178 - Taren Point Road - Existing condition of pavement and vegetation

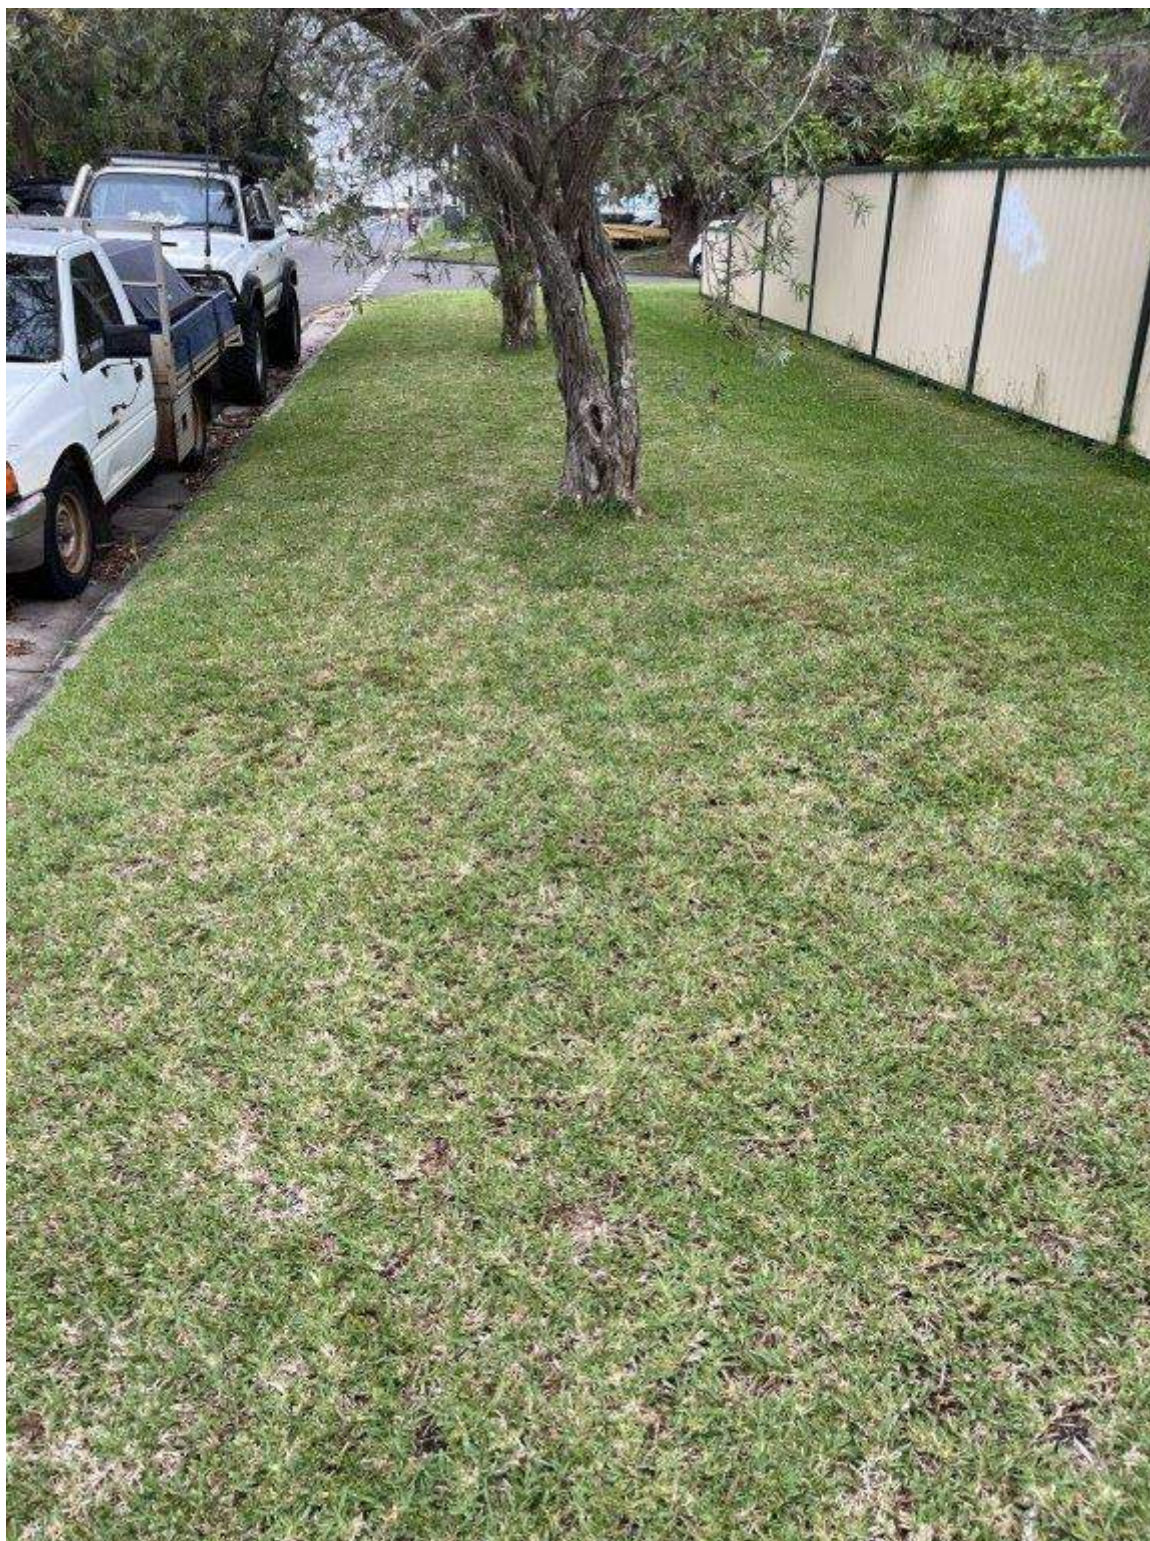
Photo 179 - Taren Point Road - Existing condition of vegetation

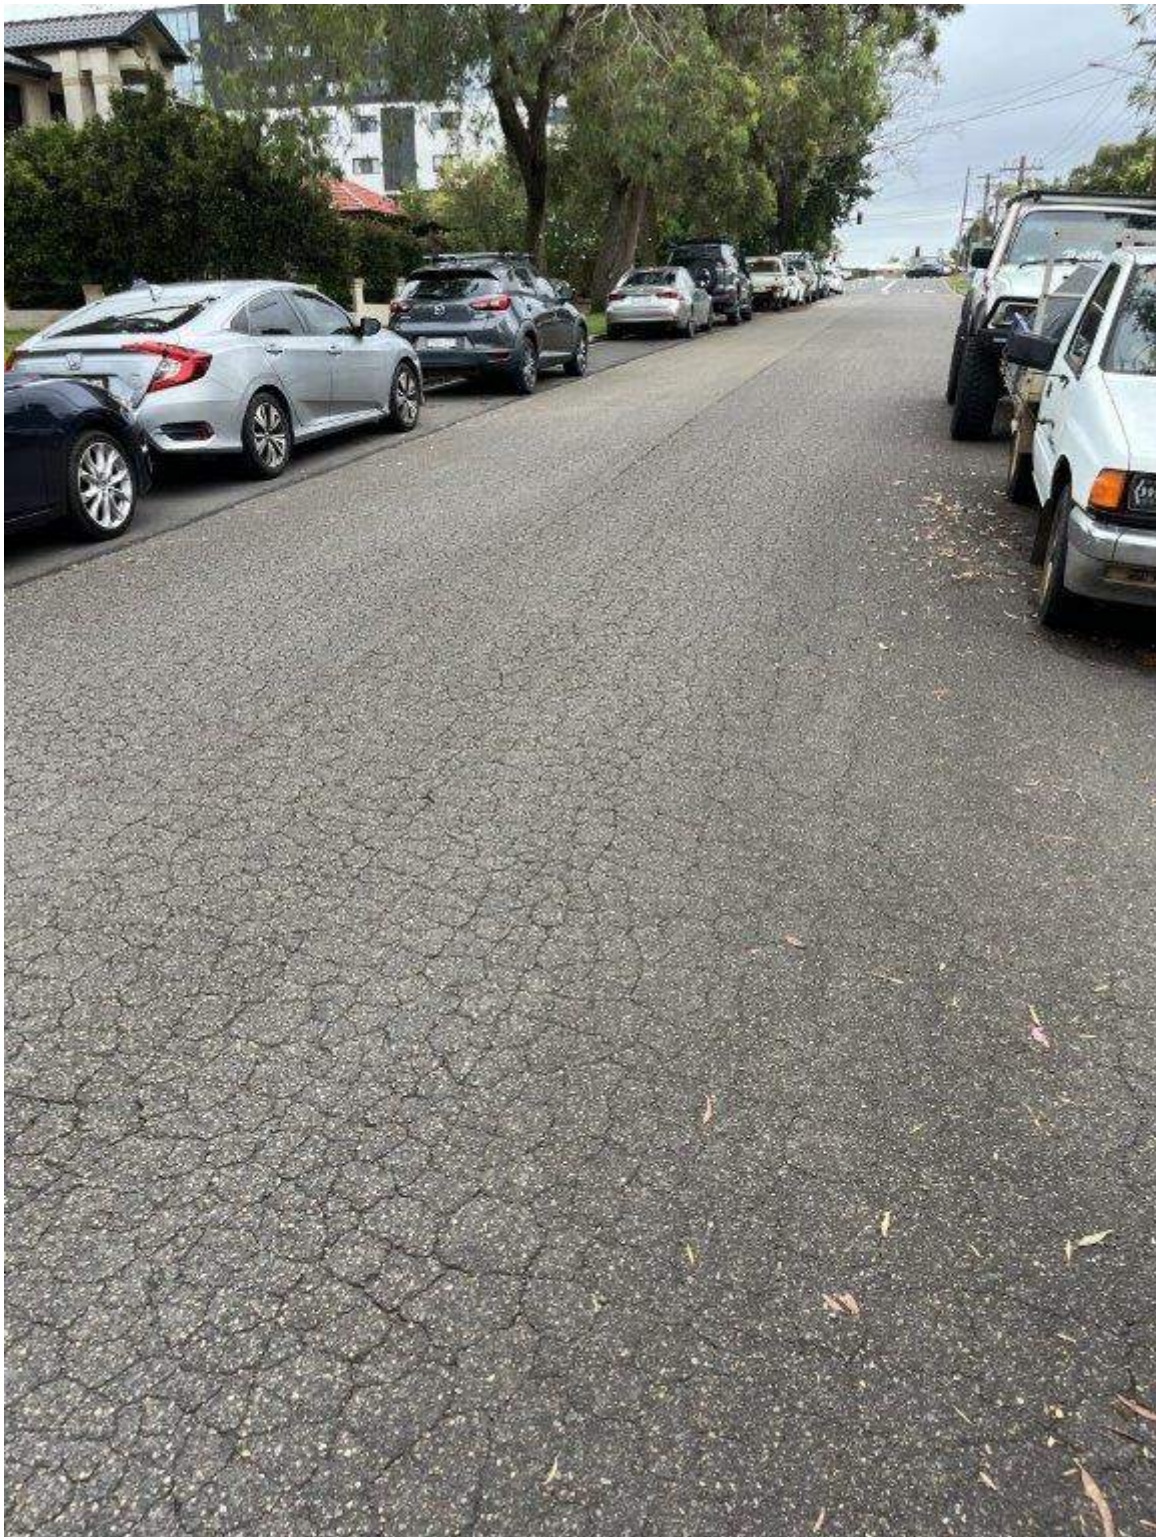
Photo 180 - Taren Point Road - Existing condition of vegetation

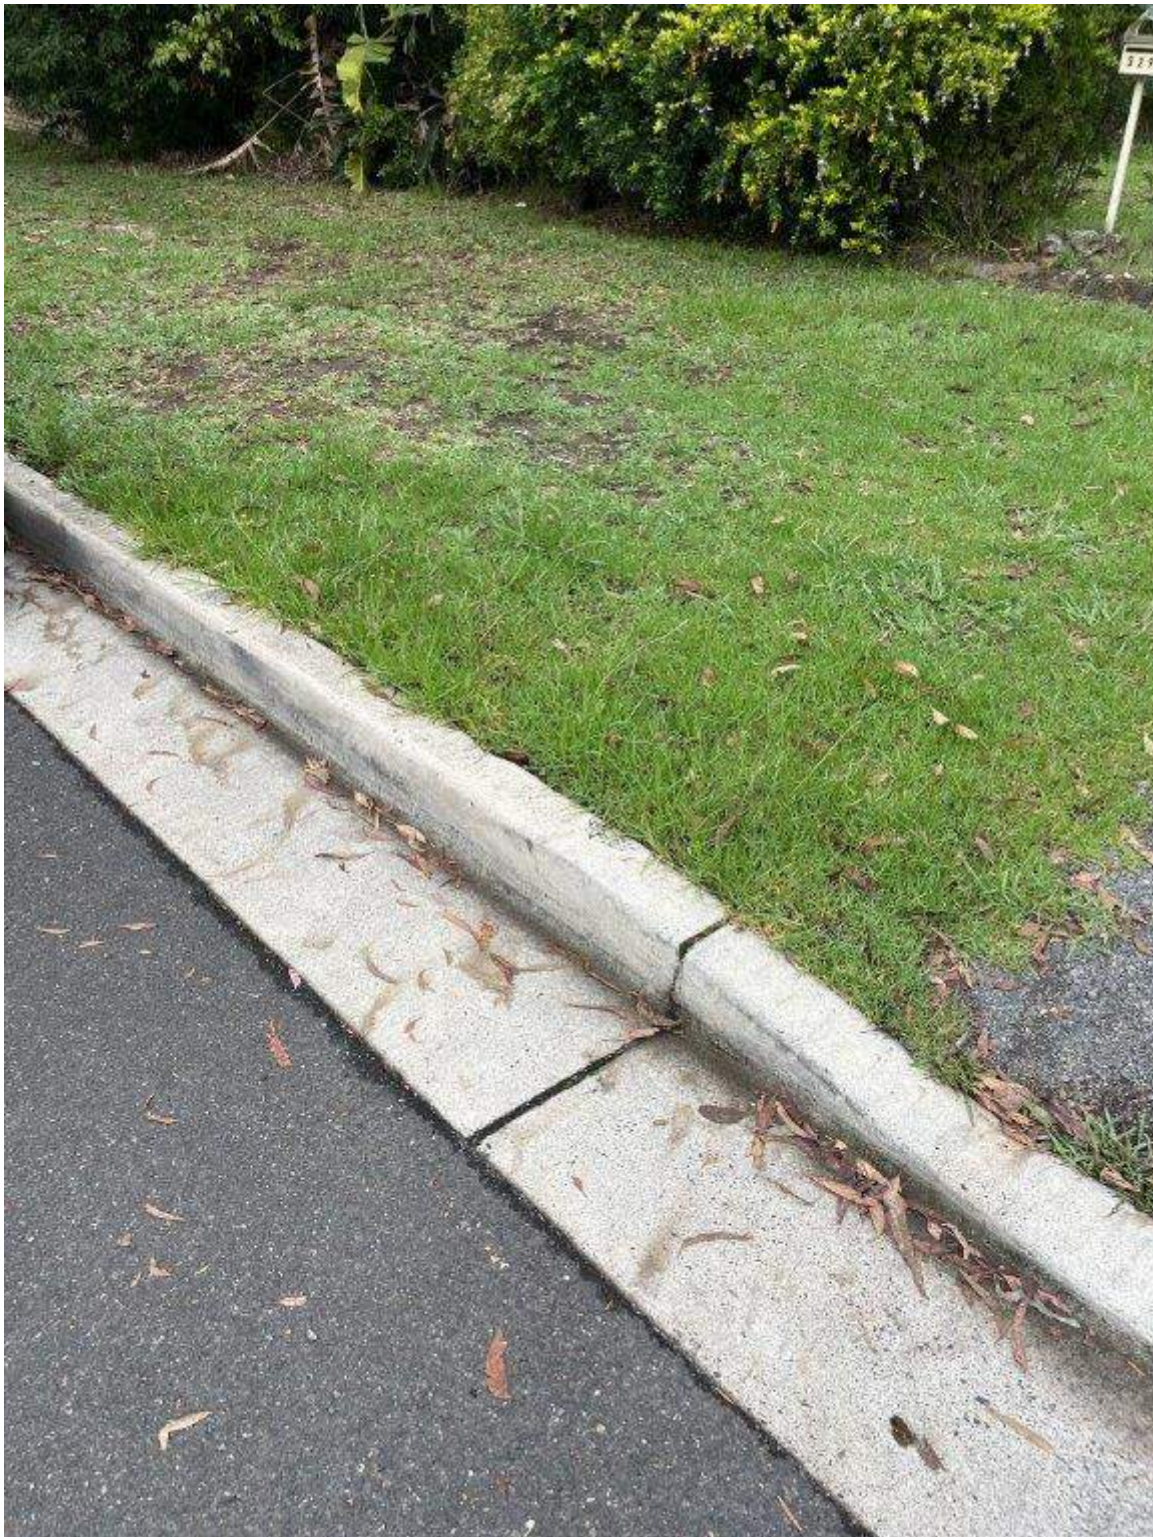
Photo 181 - Taren Point Road - Cracking of pavement
