## PRE-CONSTRUCTION DILAPIDATION REPORT

### 6-20 HINKLER AVENUE & 319-333 TAREN POINT ROAD, CARINGBAH

| PRE-CONSTRUCTION DILAPIDATION REPORT<br>6-20 Hinkler Avenue & 319-333 Taren Point Road,<br>Caringbah NSW 2229 | | | | | Project Number: 21039 |

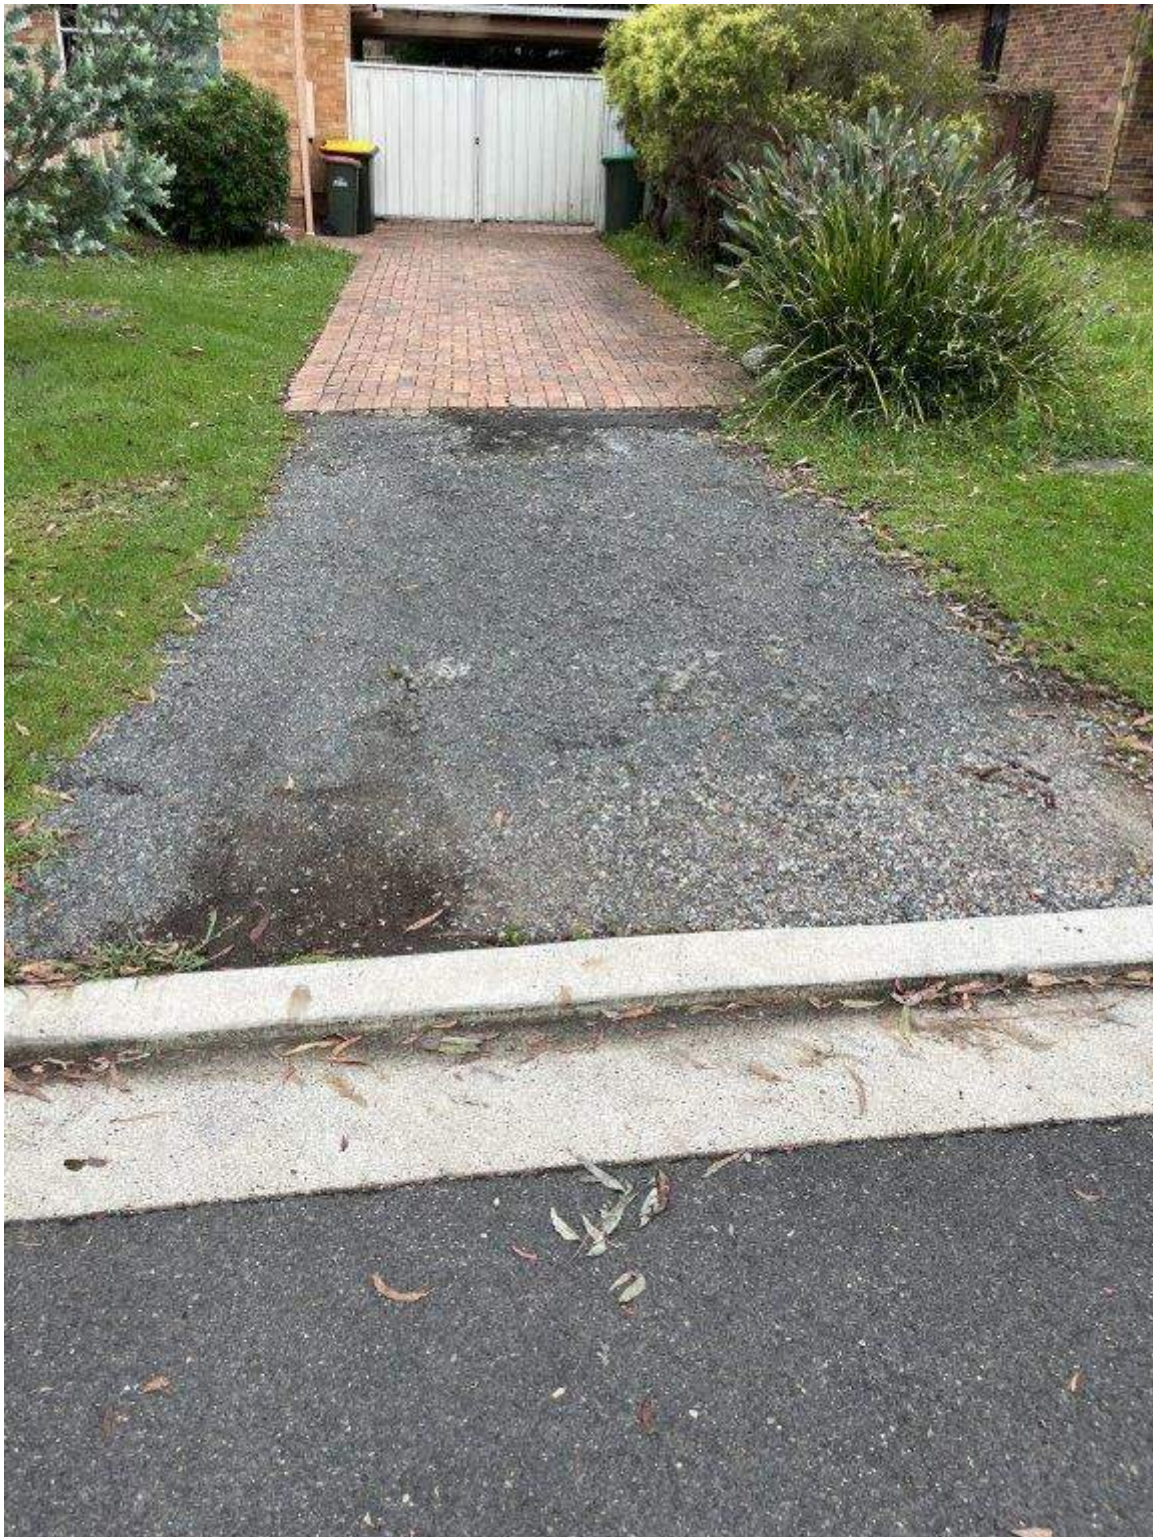
Photo 182 - Taren Point Road - Existing condition of pavement and vegetation

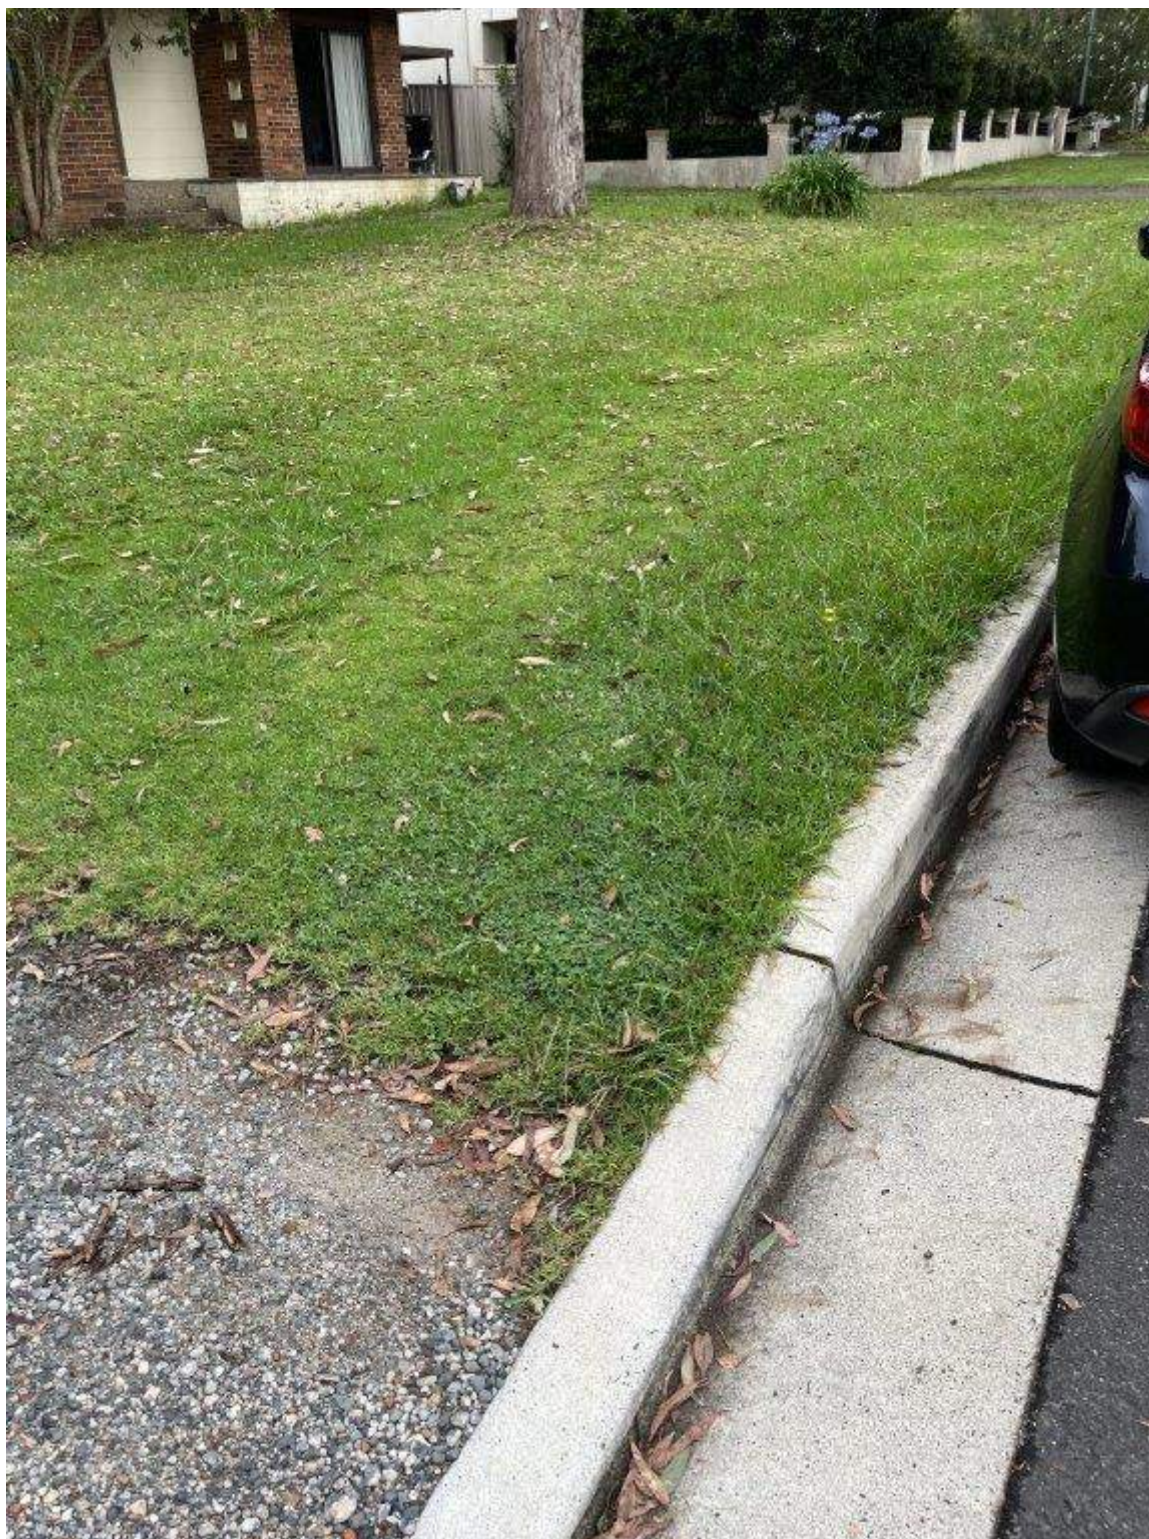
Photo 183 - Taren Point Road - Existing condition of pavement

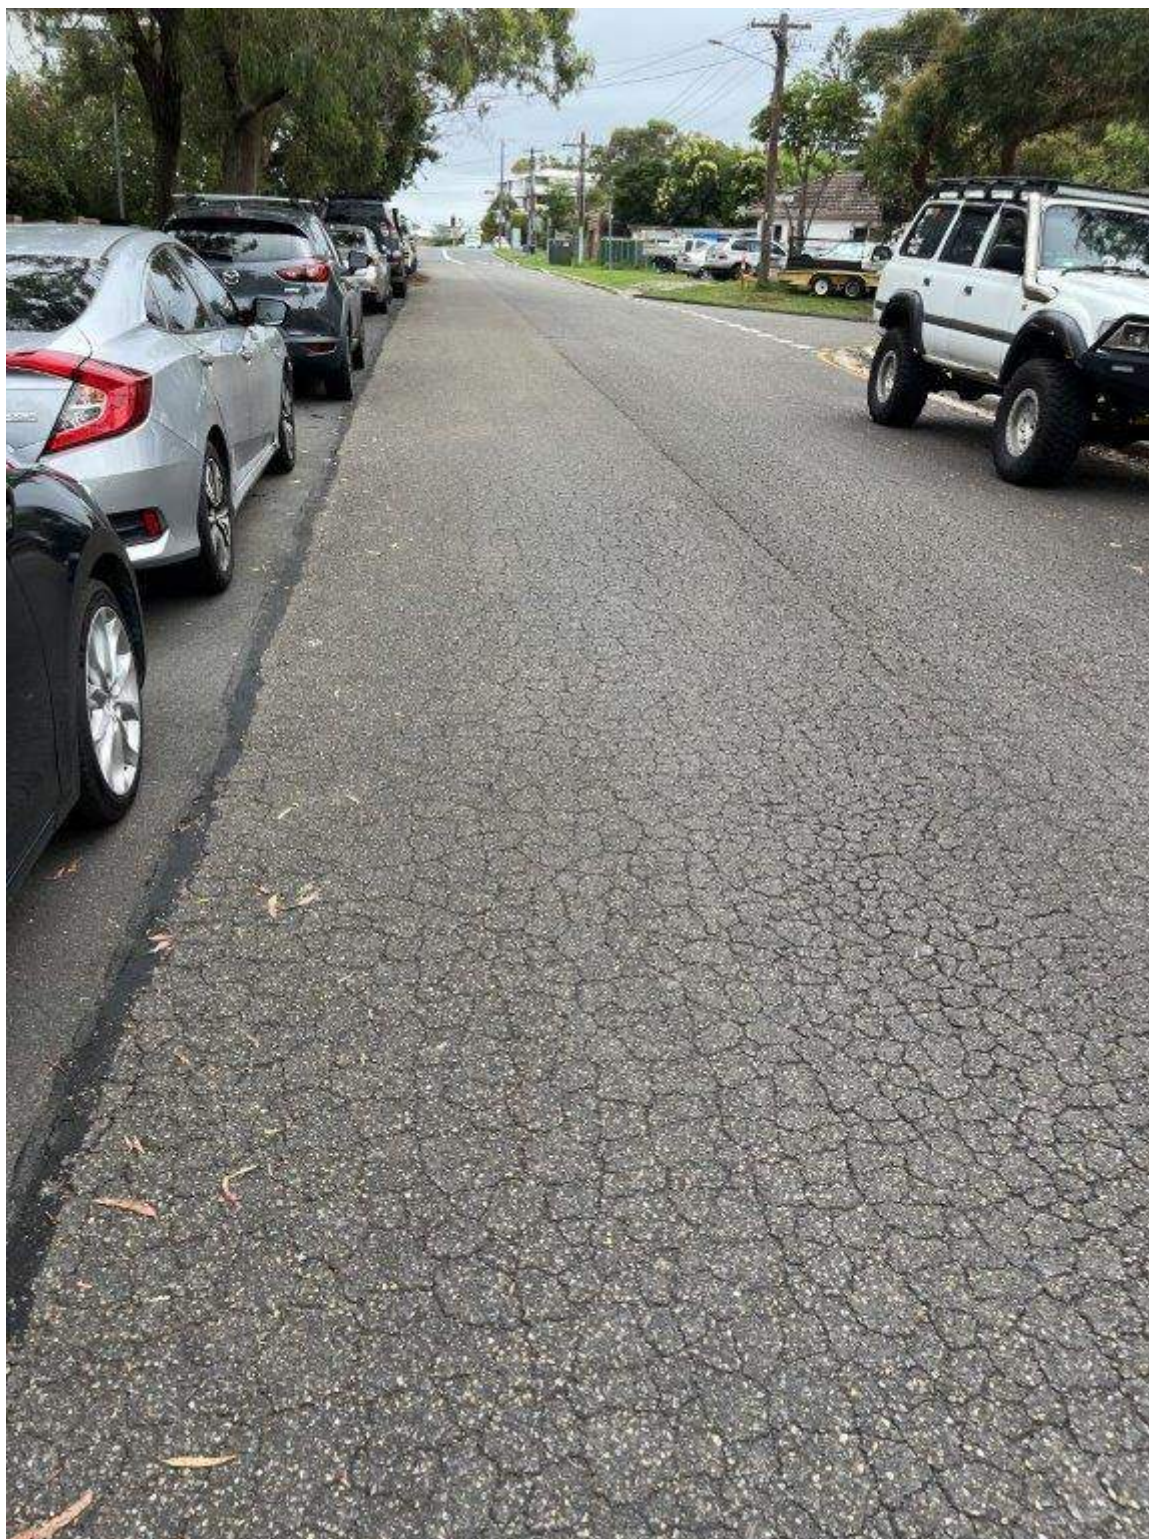
Photo 184 - Taren Point Road - Existing condition of pavement and vegetation

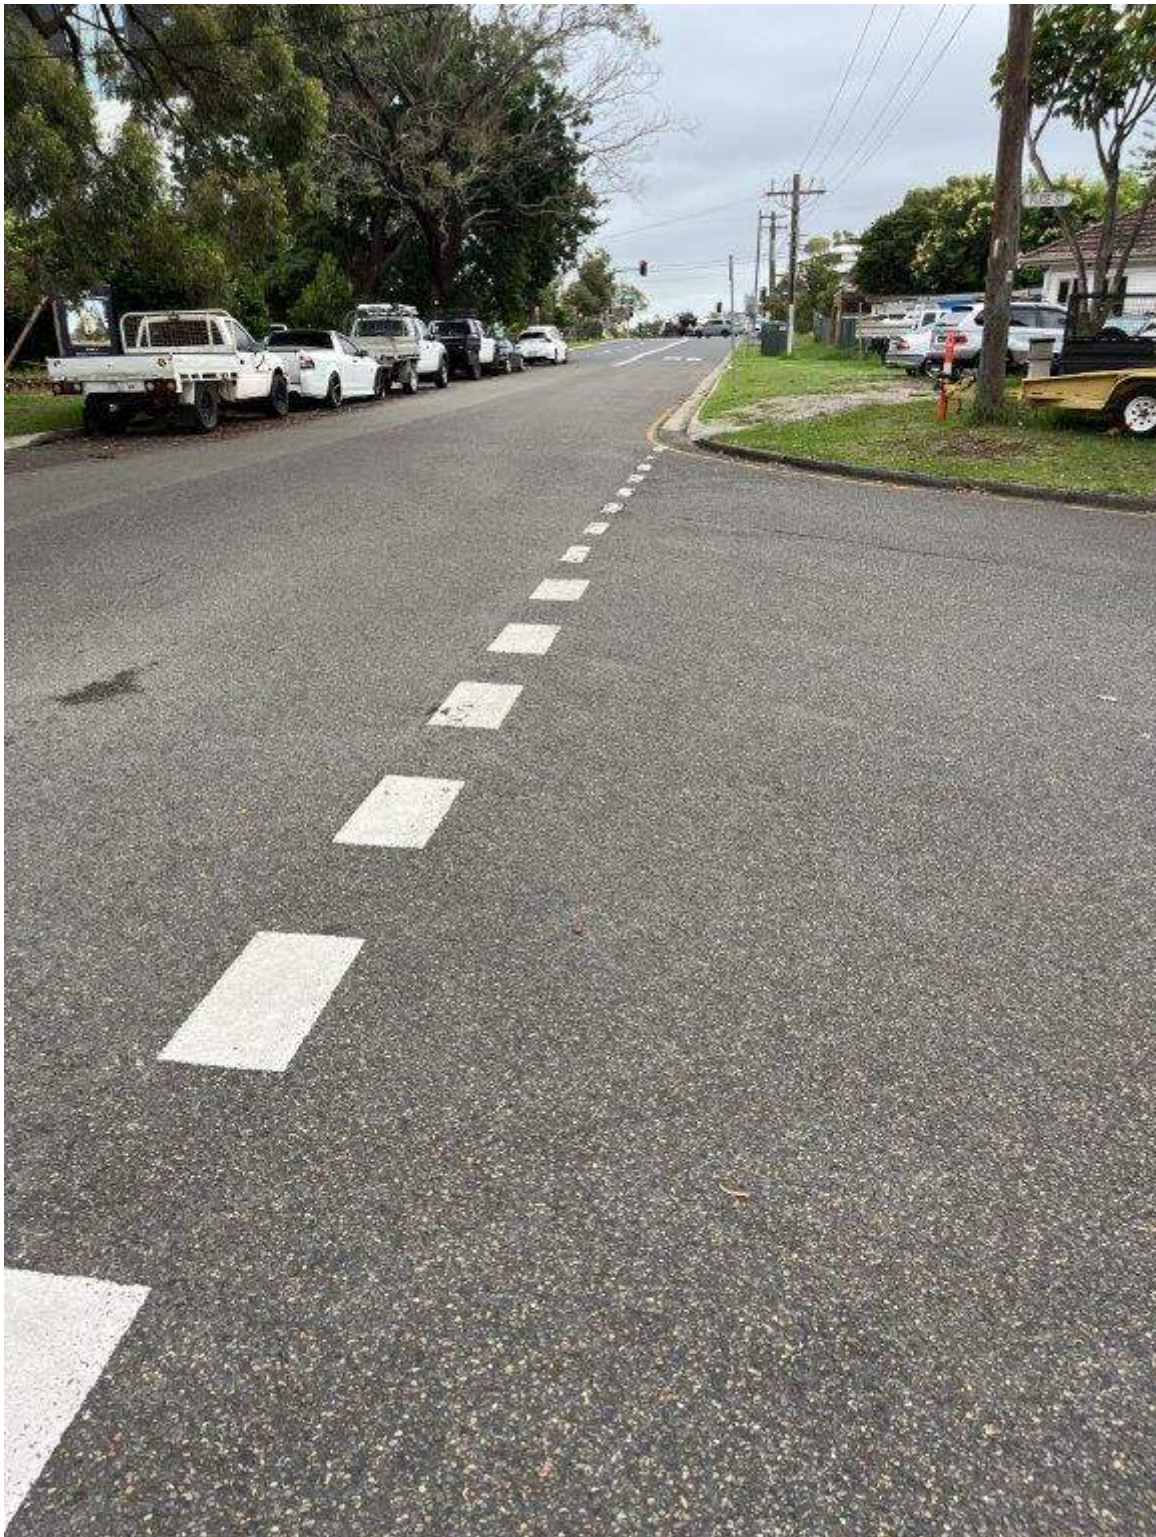
Photo 185 - Taren Point Road - Cracking of pavement

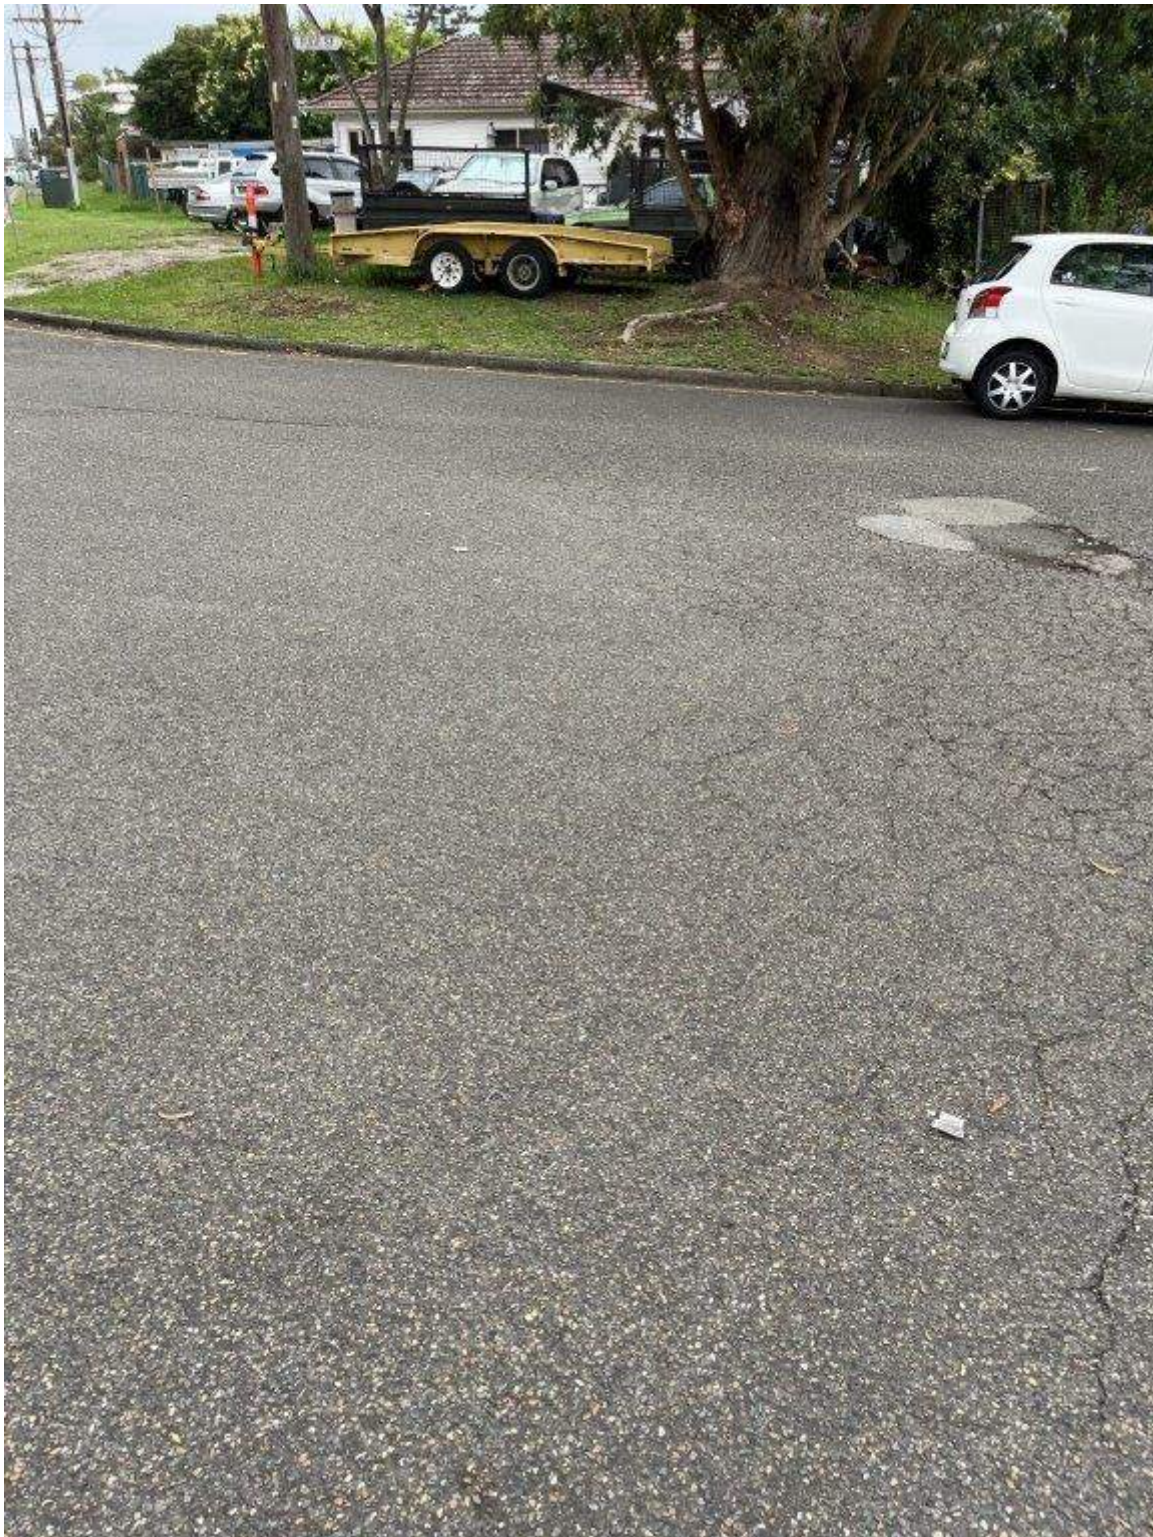
Photo 186 - Taren Point Road - Existing condition of pavement

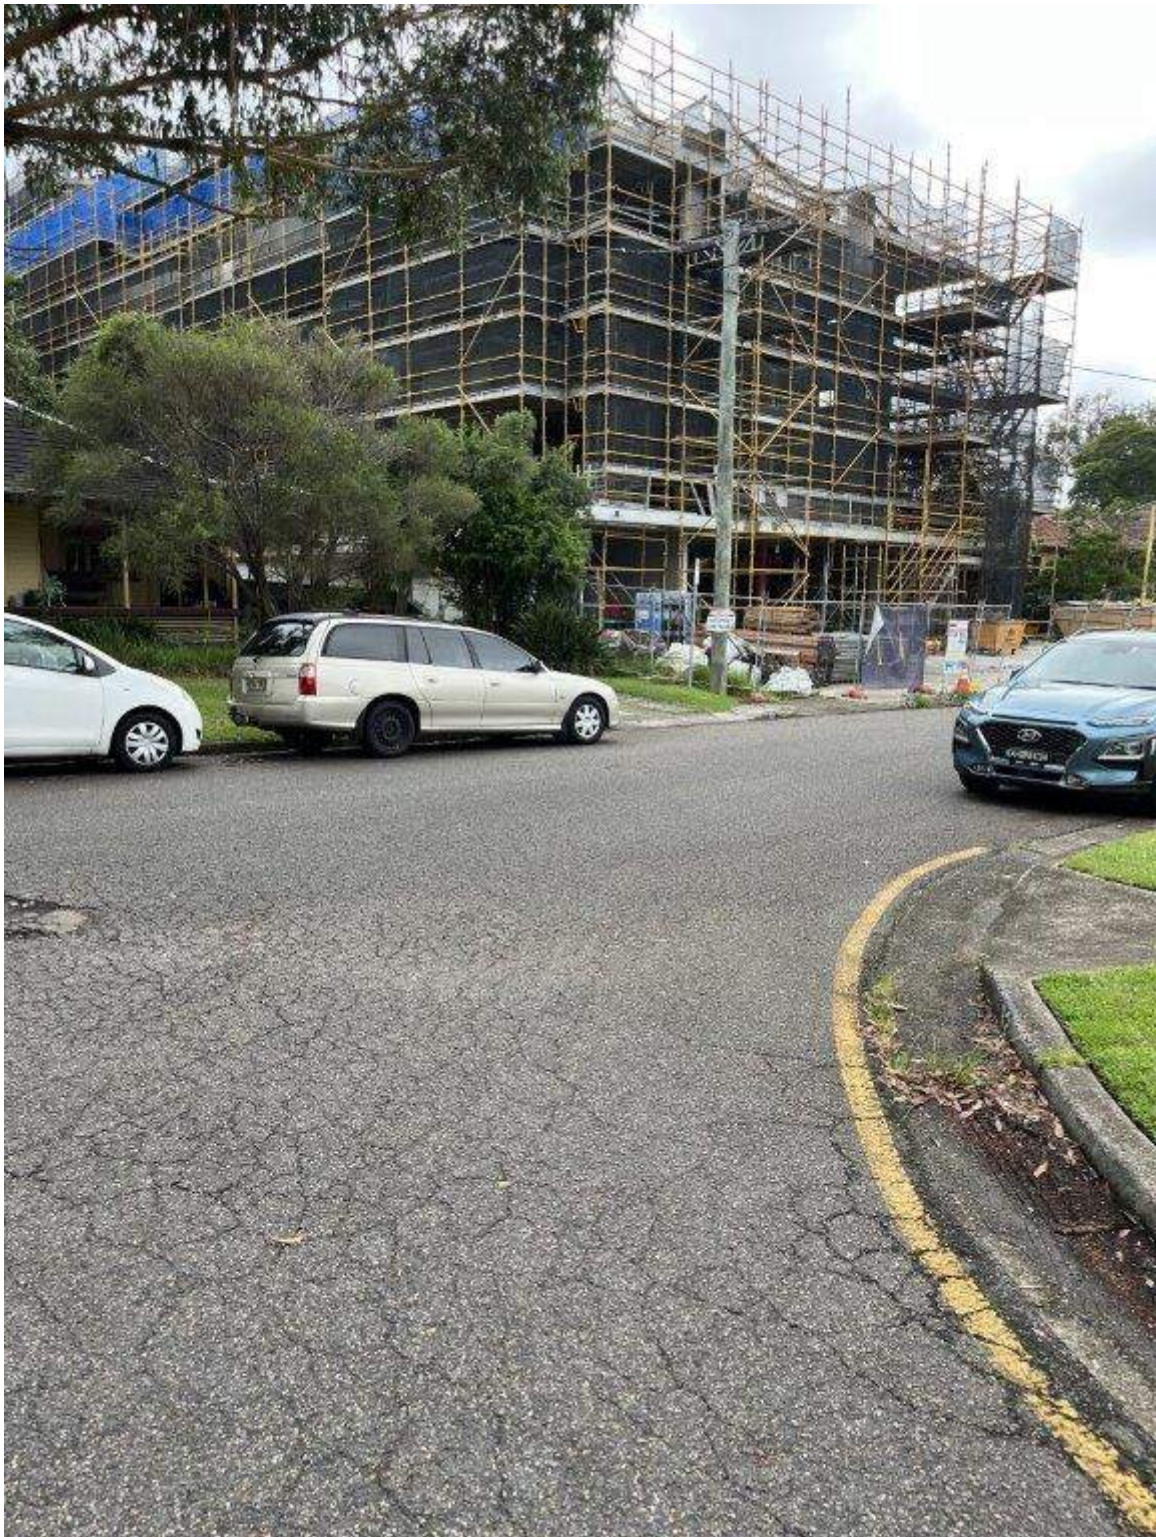
Photo 187 - Taren Point Road - Cracking of pavement

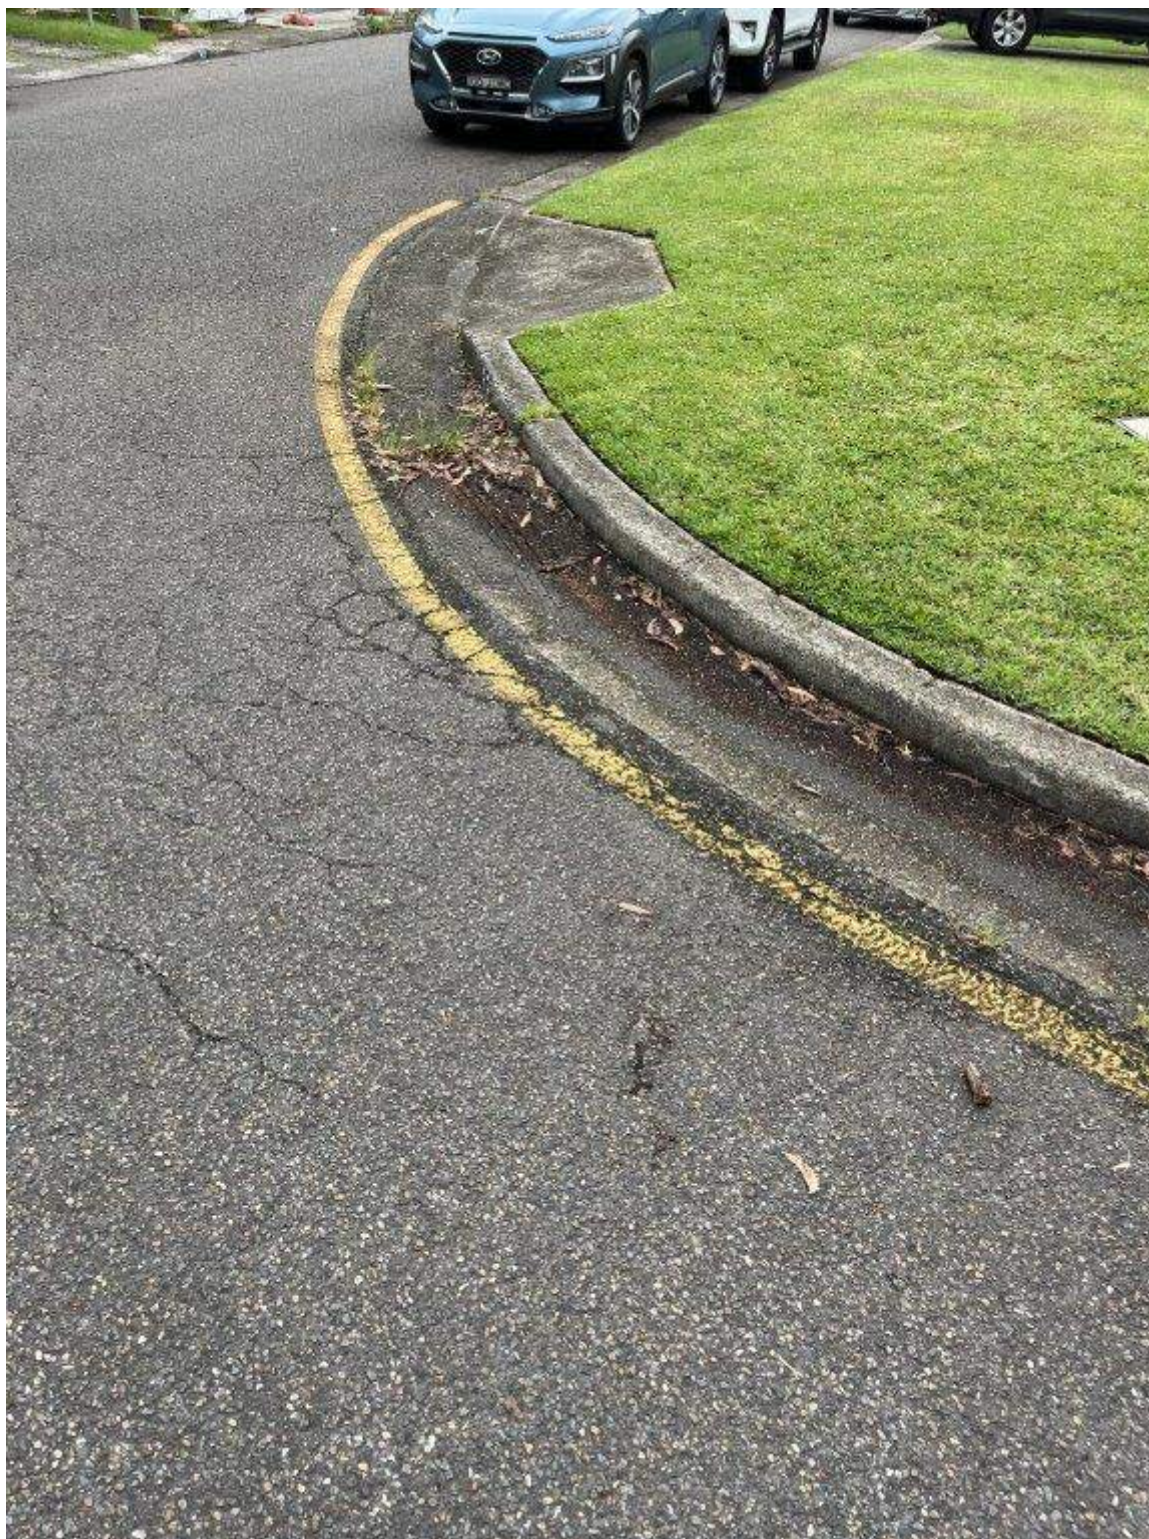
**Photo 188 - Taren Point Road - Cracking of pavement**

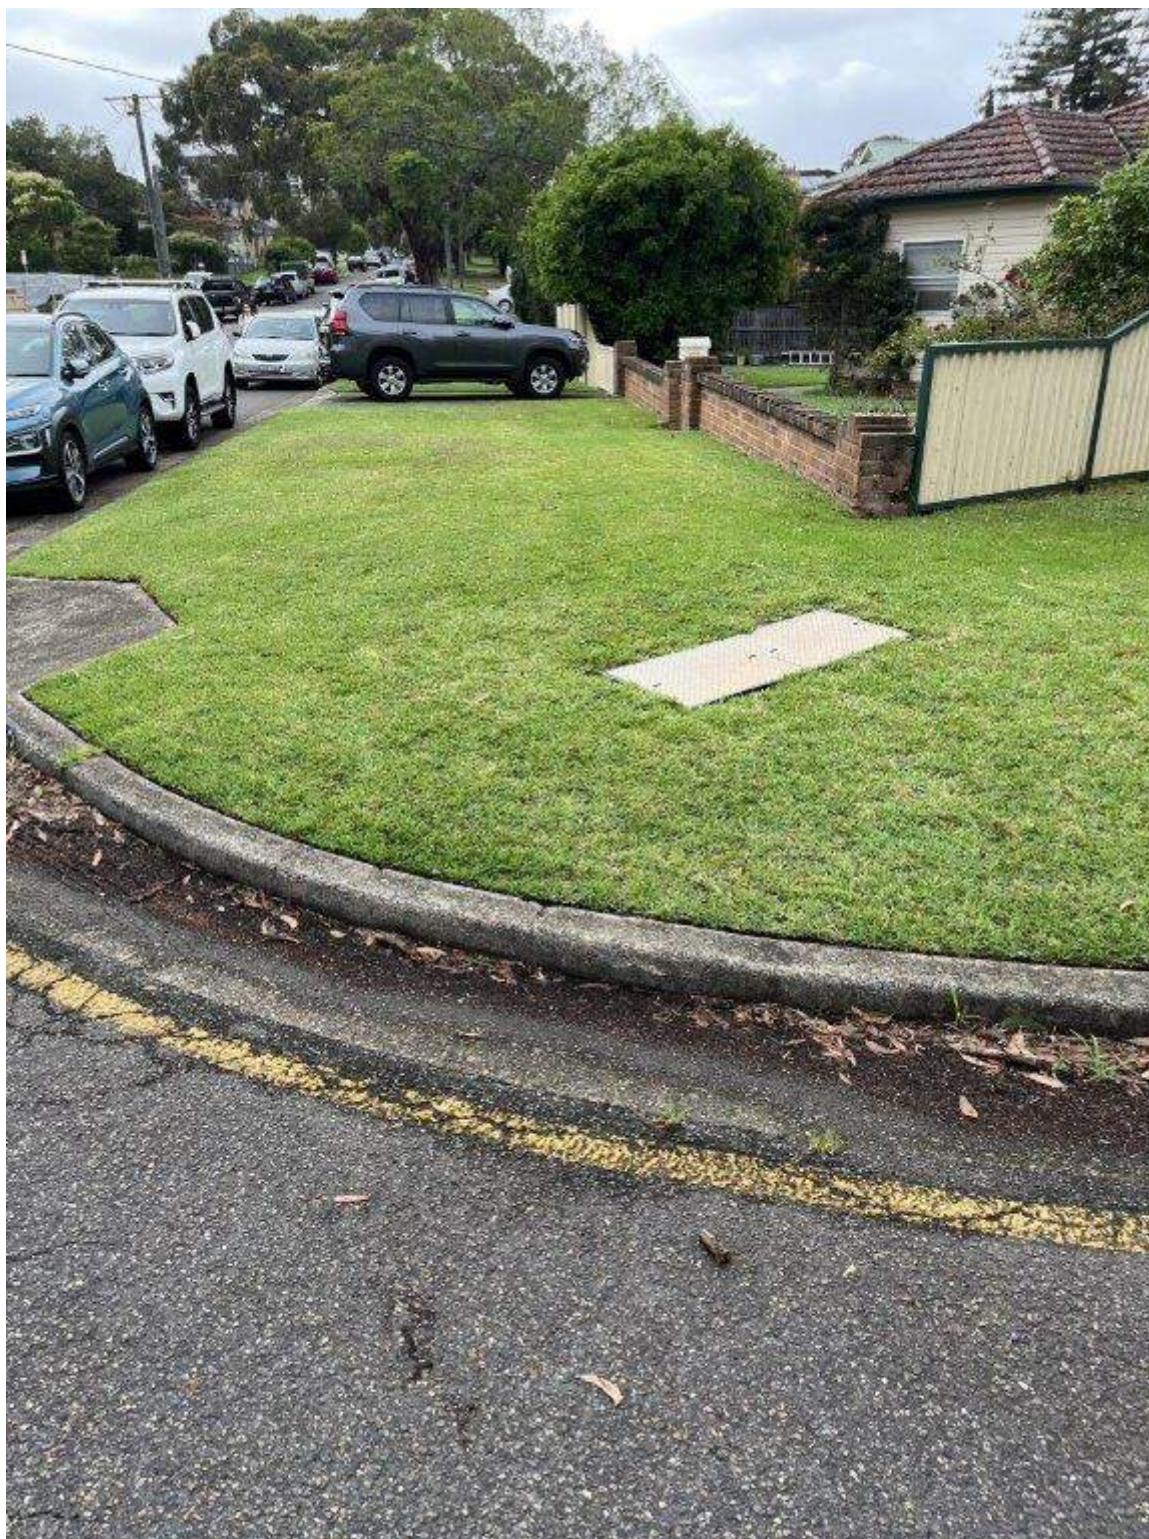
Photo 189 - Taren Point Road - Cracking of pavement

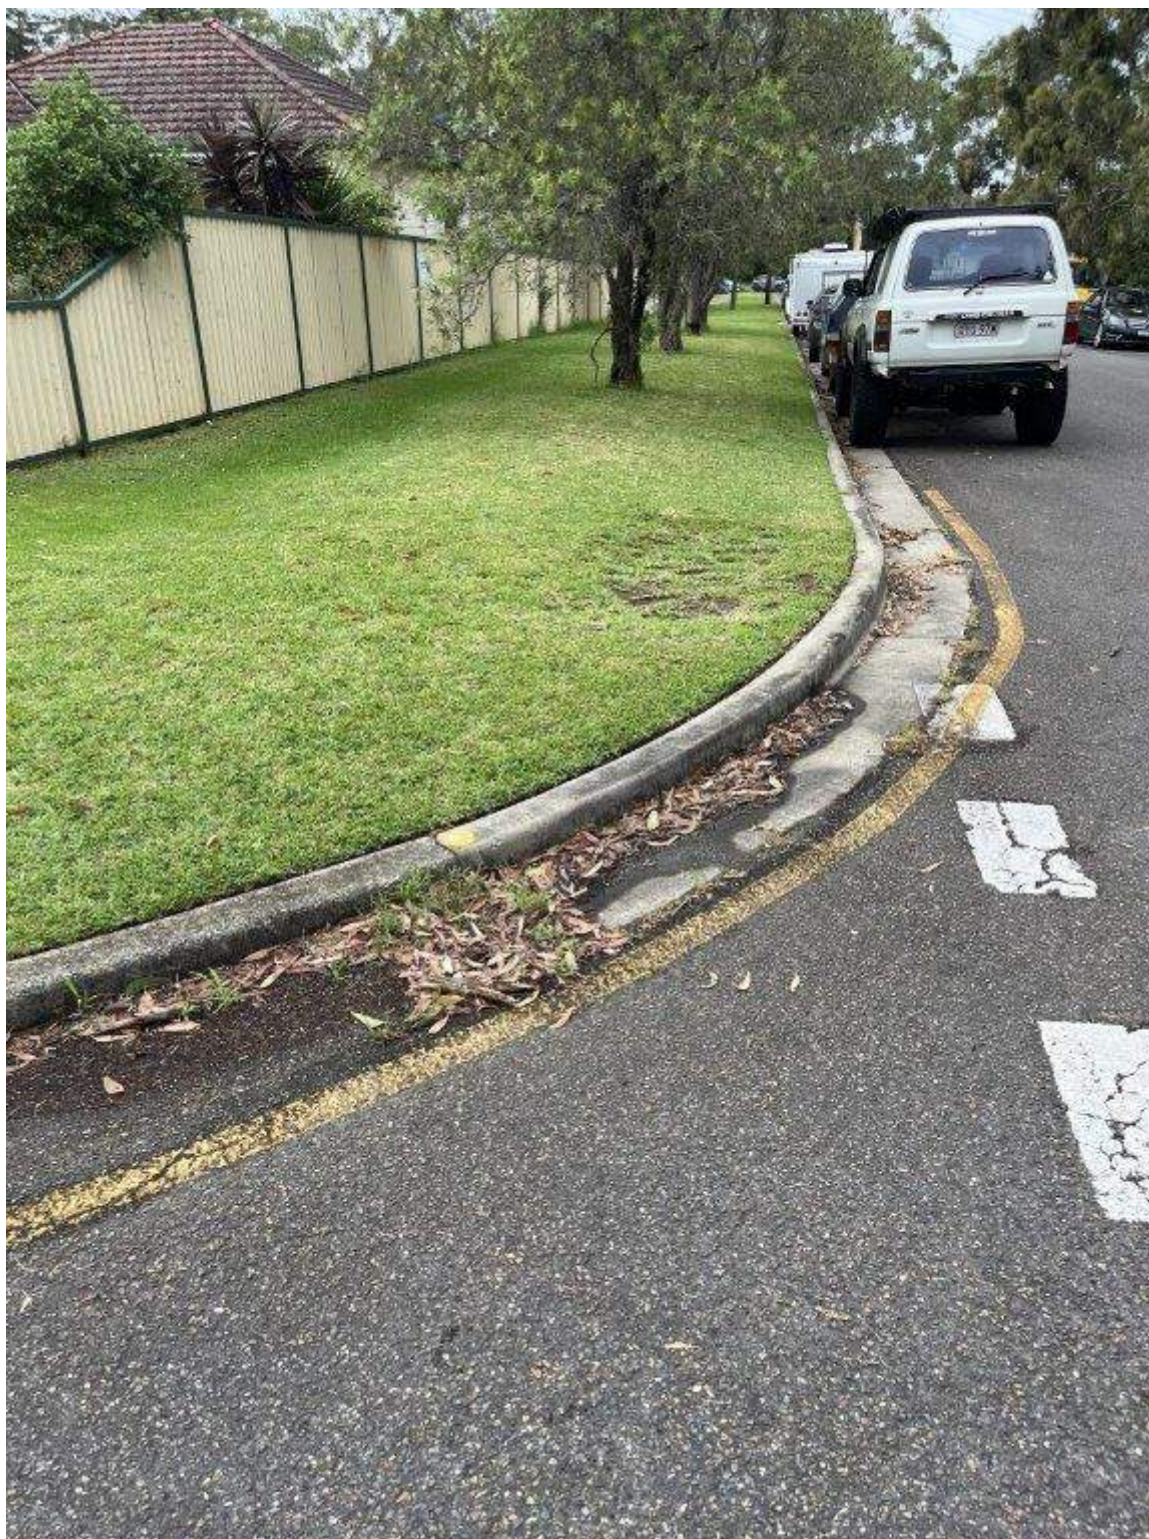
Photo 190 - Taren Point Road - Cracking of pavement

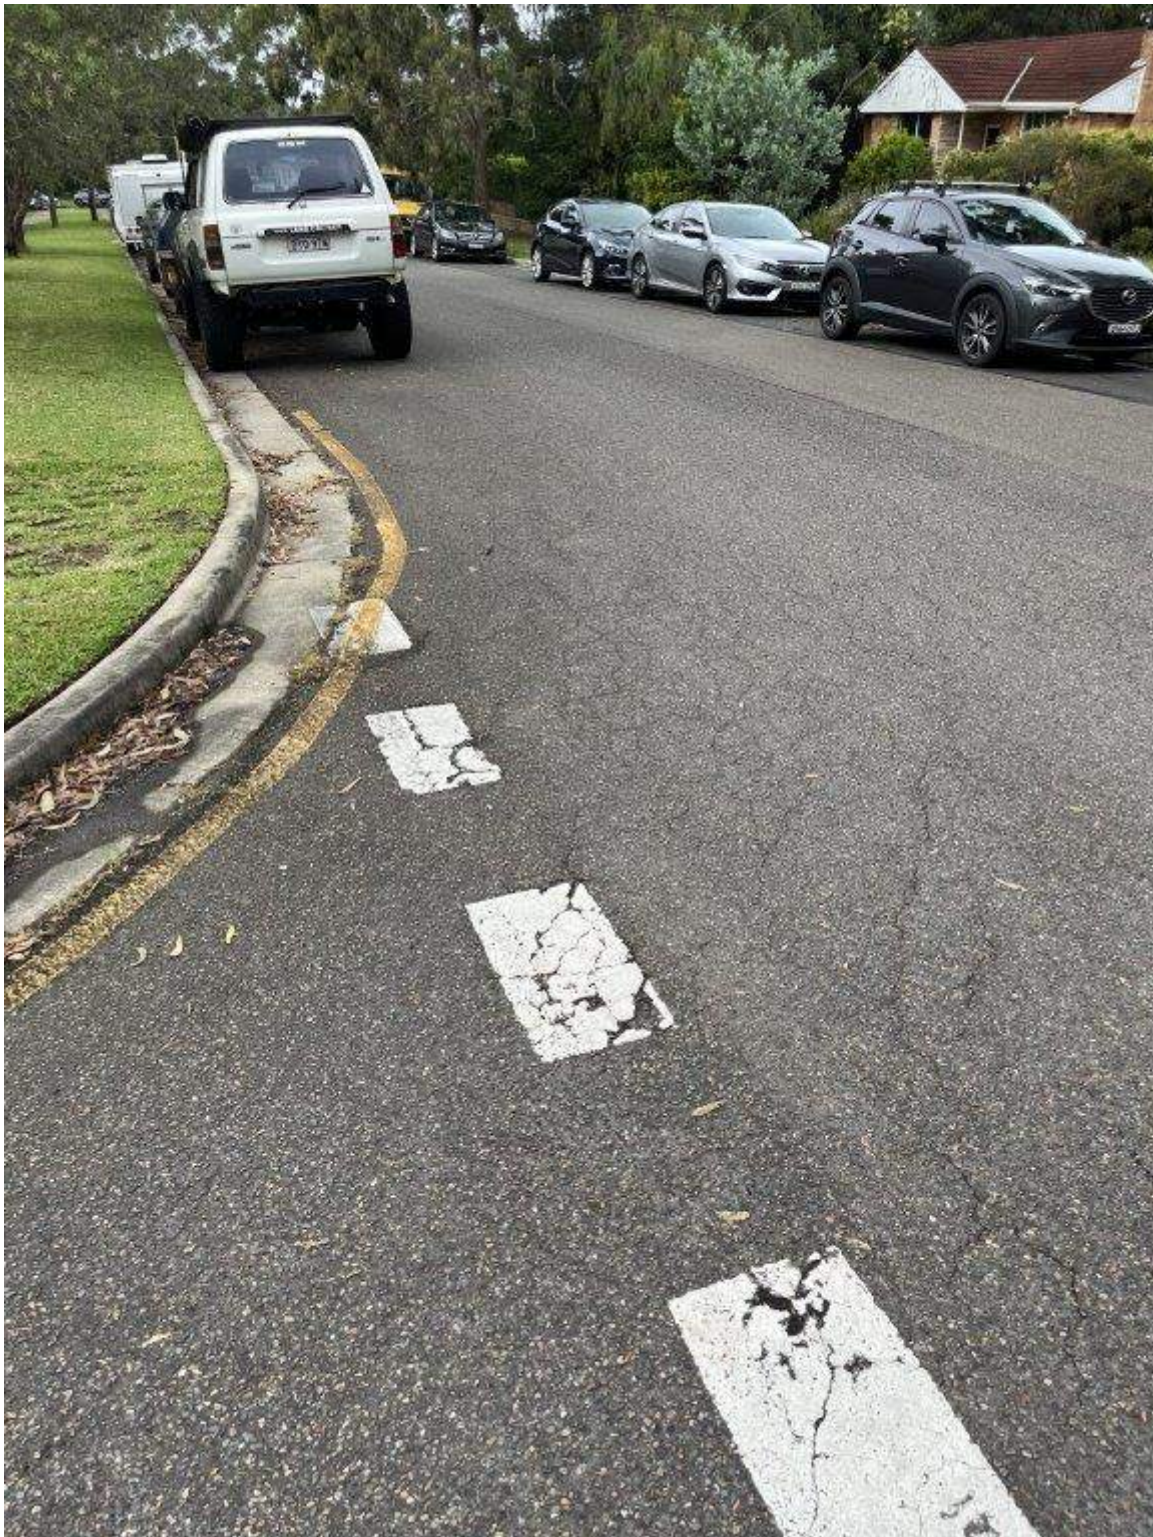
Photo 191 - Taren Point Road - Cracking of pavement

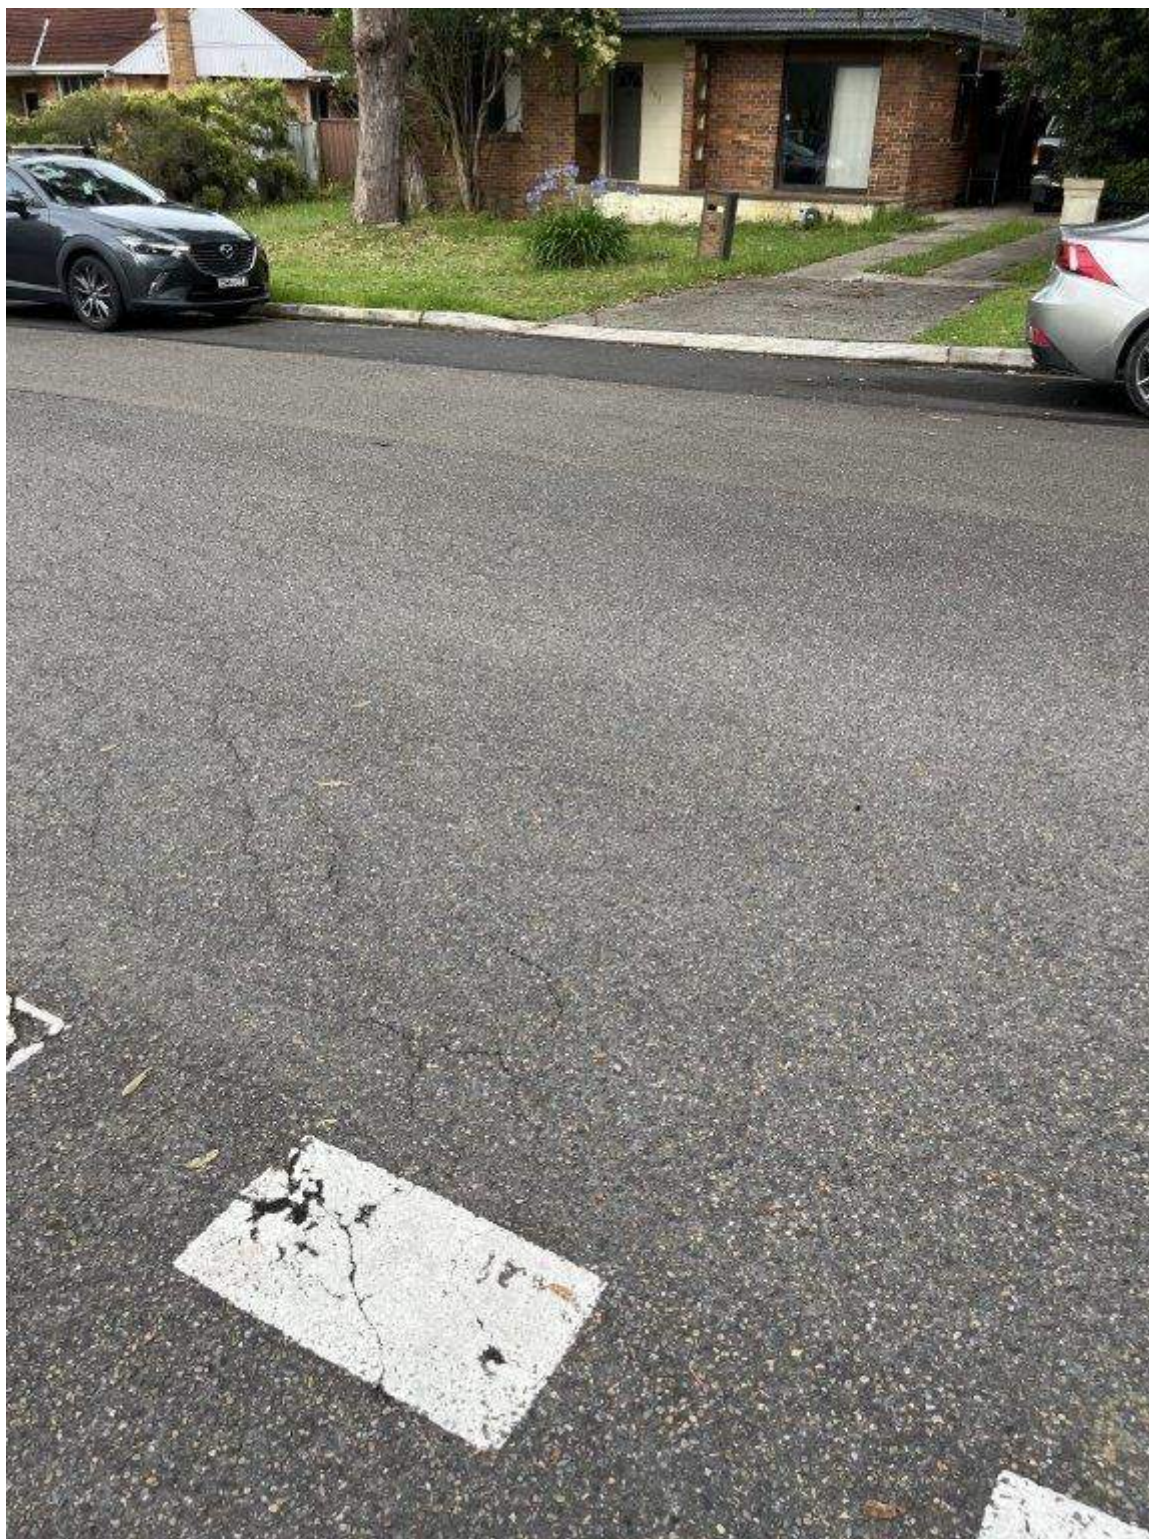
Photo 192 - Taren Point Road - Cracking of pavement

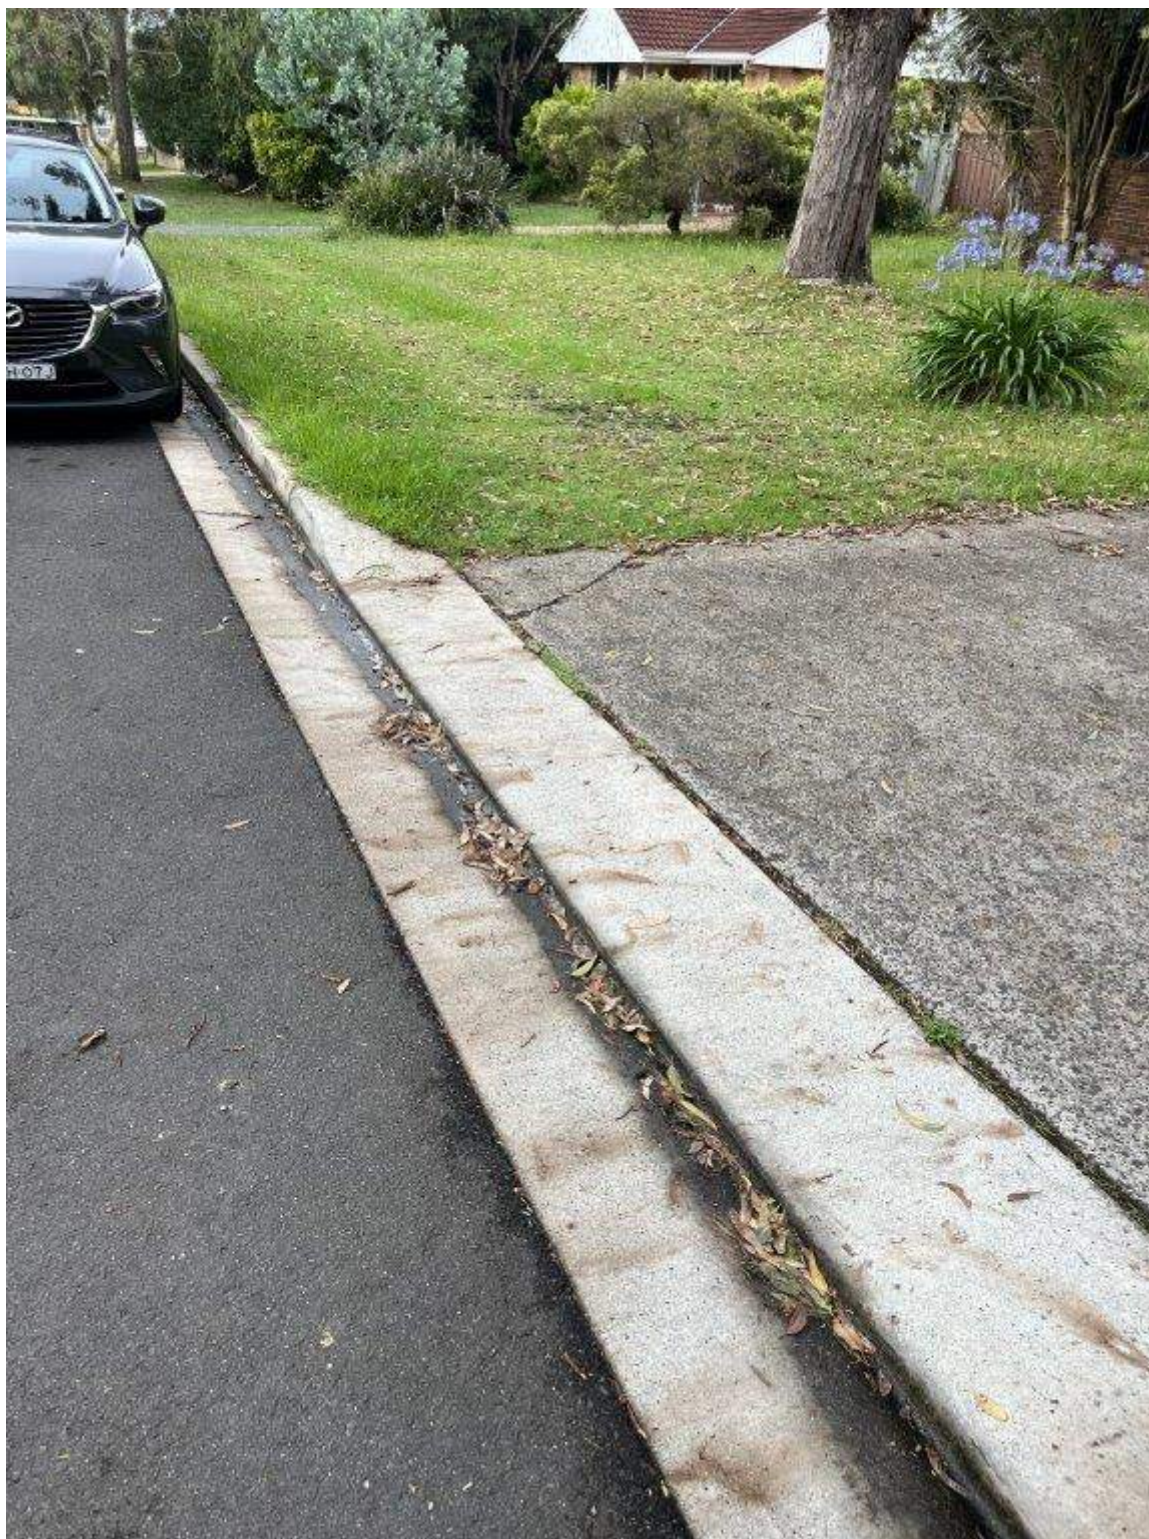
Photo 193 - Taren Point Road - Cracking of pavement

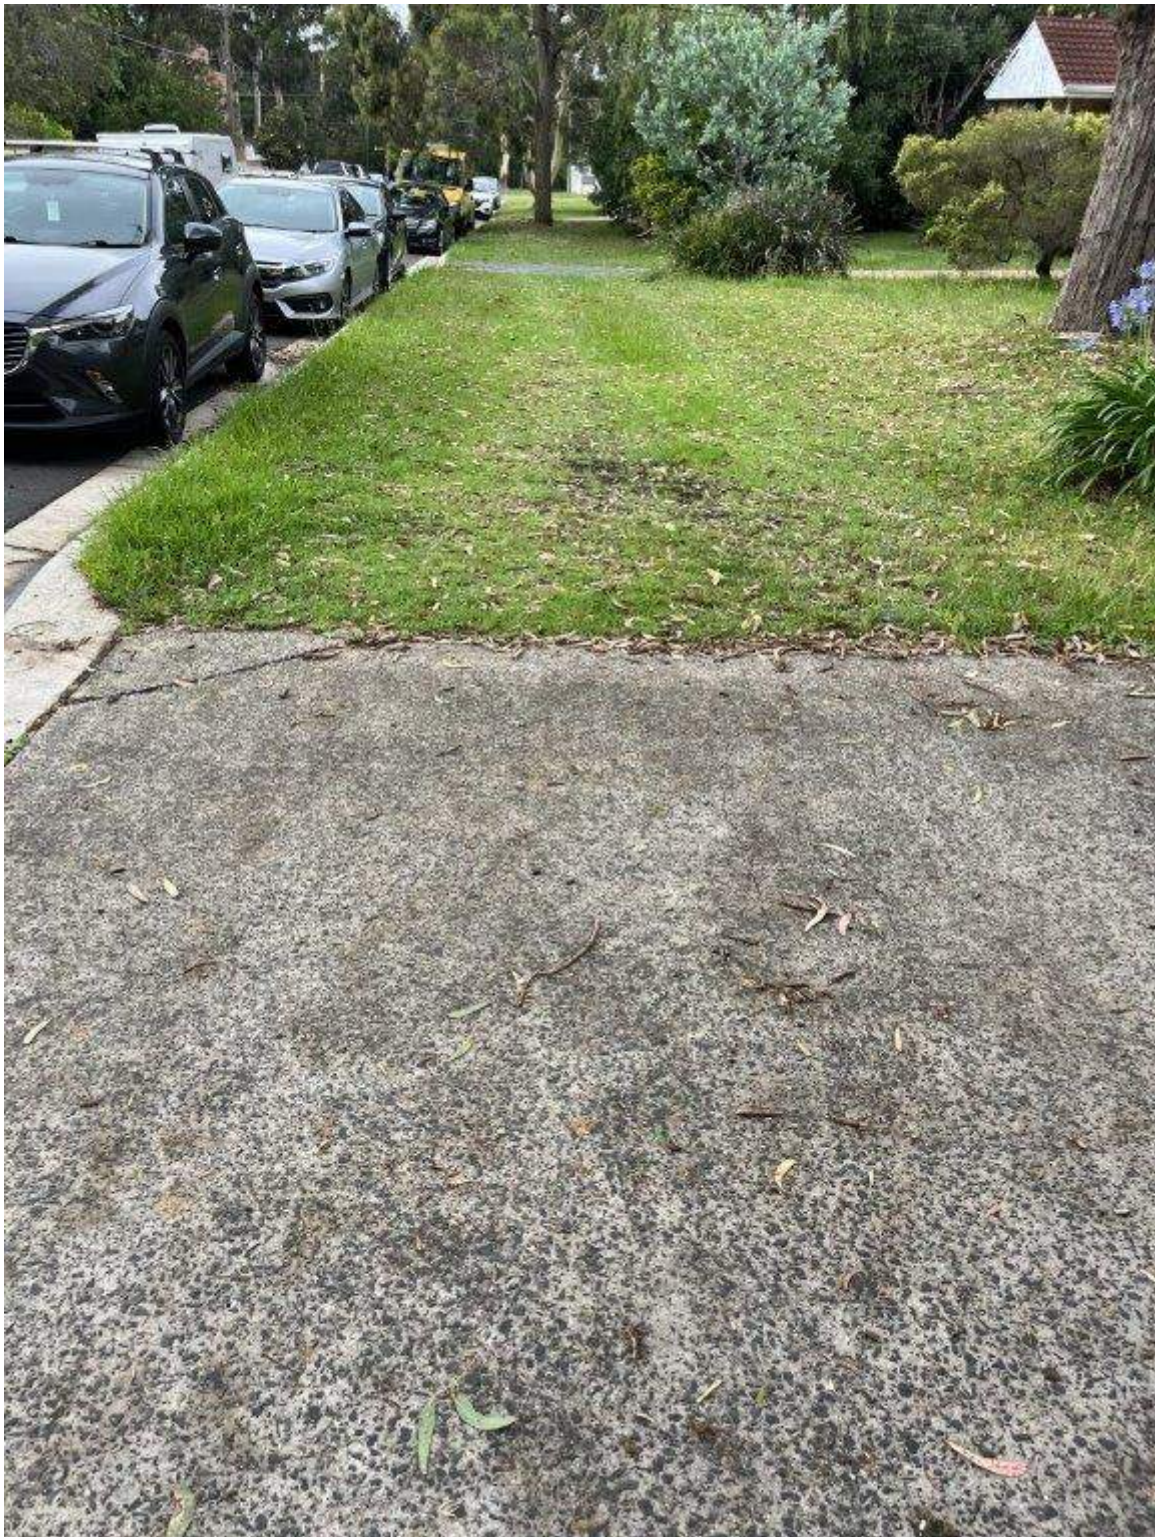
Photo 194 - Taren Point Road - Cracking of pavement
