## PRE-CONSTRUCTION DILAPIDATION REPORT

### 6-20 HINKLER AVENUE & 319-333 TAREN POINT ROAD, CARINGBAH

| PRE-CONSTRUCTION DILAPIDATION REPORT<br>6-20 Hinkler Avenue & 319-333 Taren Point Road,<br>Caringbah NSW 2229 | | | | | Project Number: 21039 |

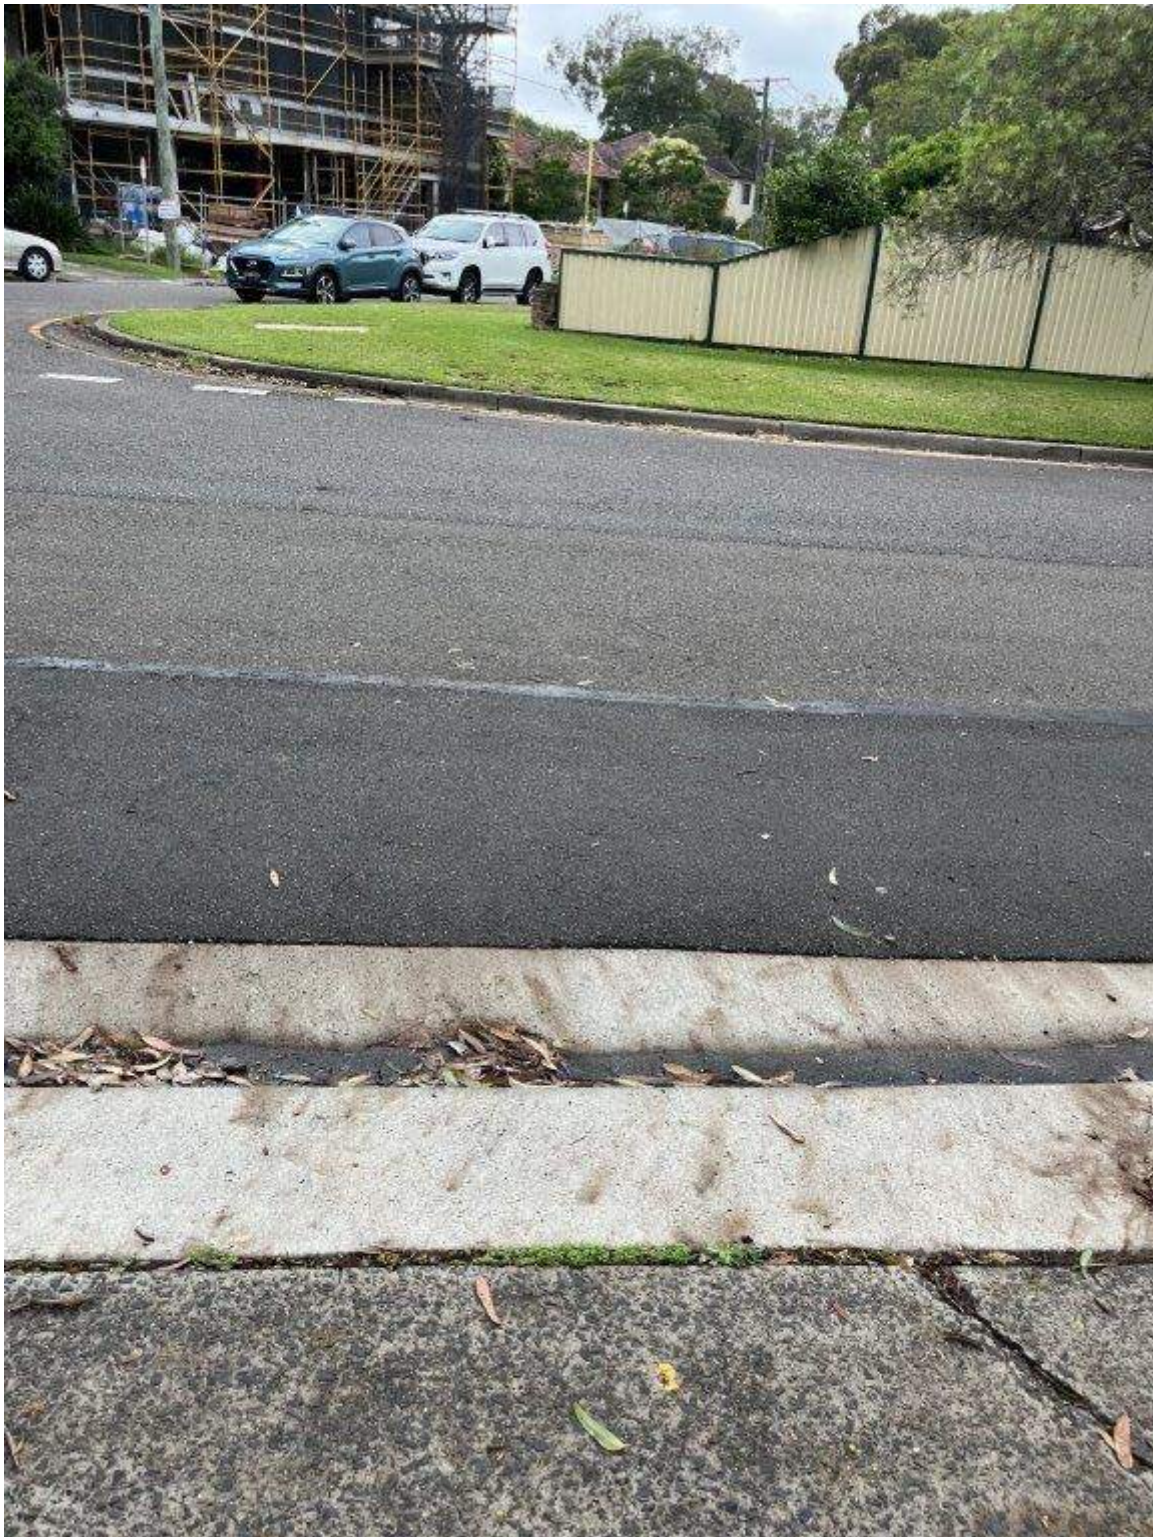
Photo 195 - Taren Point Road - Cracking of pavement

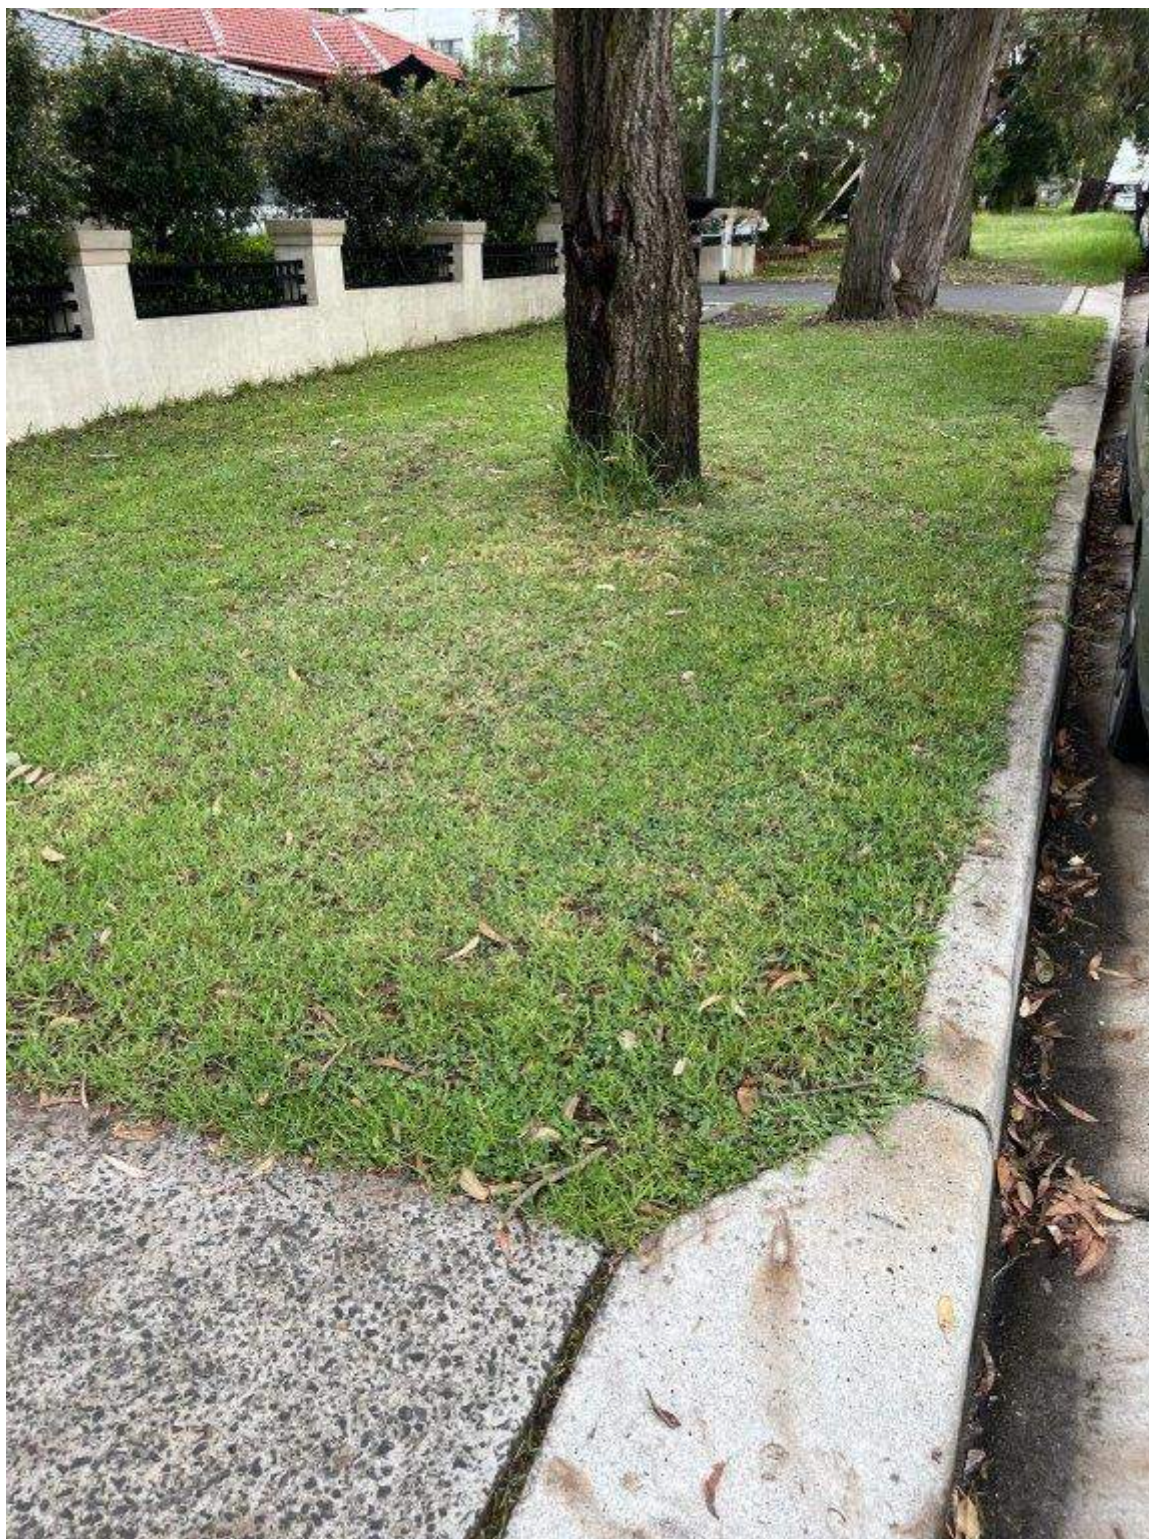
Photo 196 - Taren Point Road - Cracking of pavement

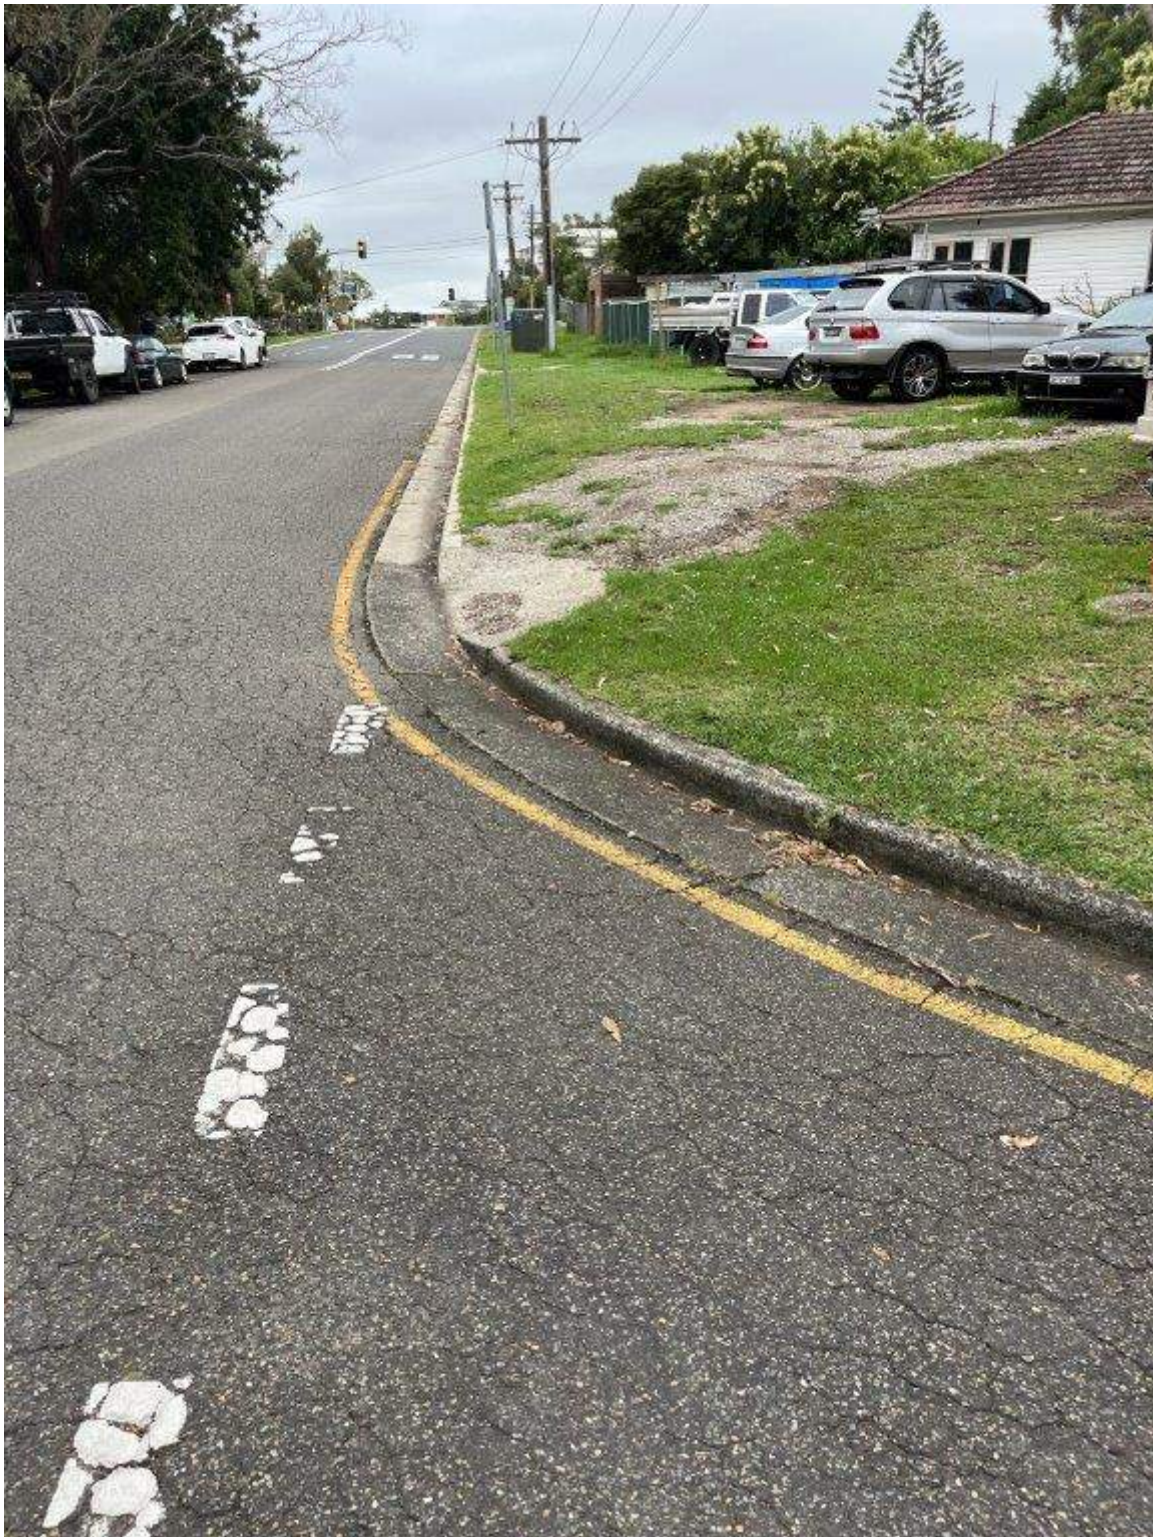
Photo 197 - Taren Point Road - Existing condition of pavement and vegetation

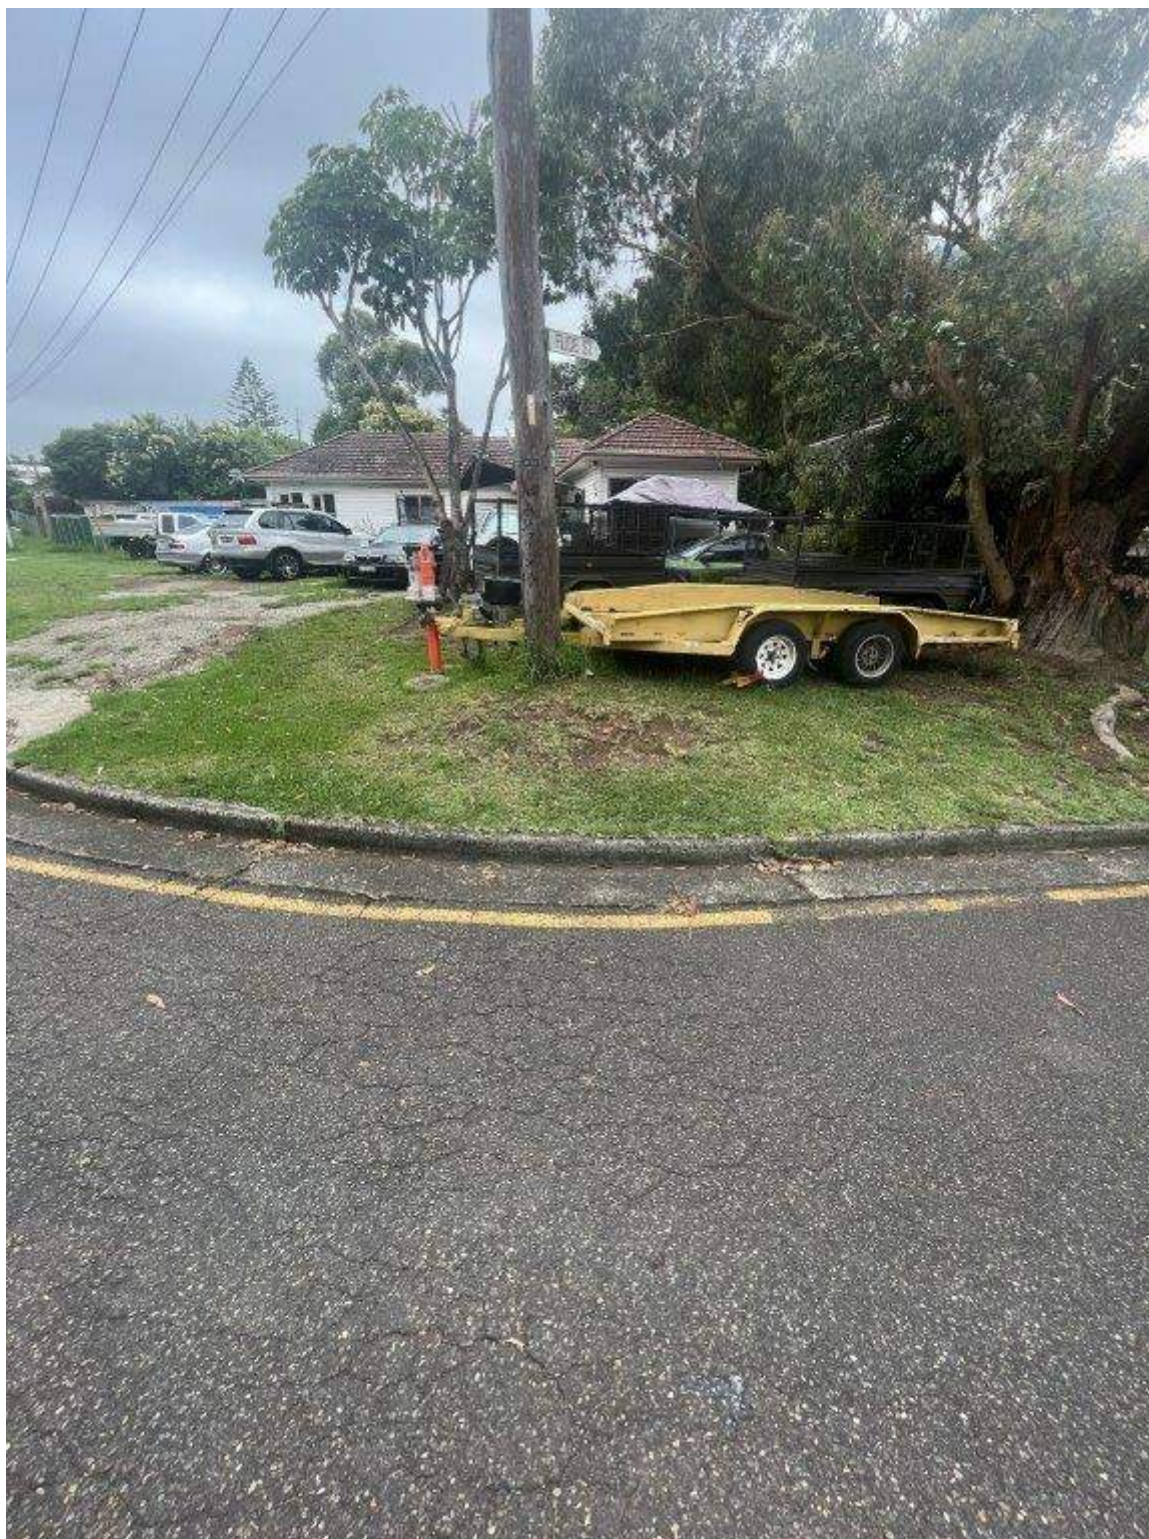
Photo 198 - Taren Point Road - Cracking of pavement

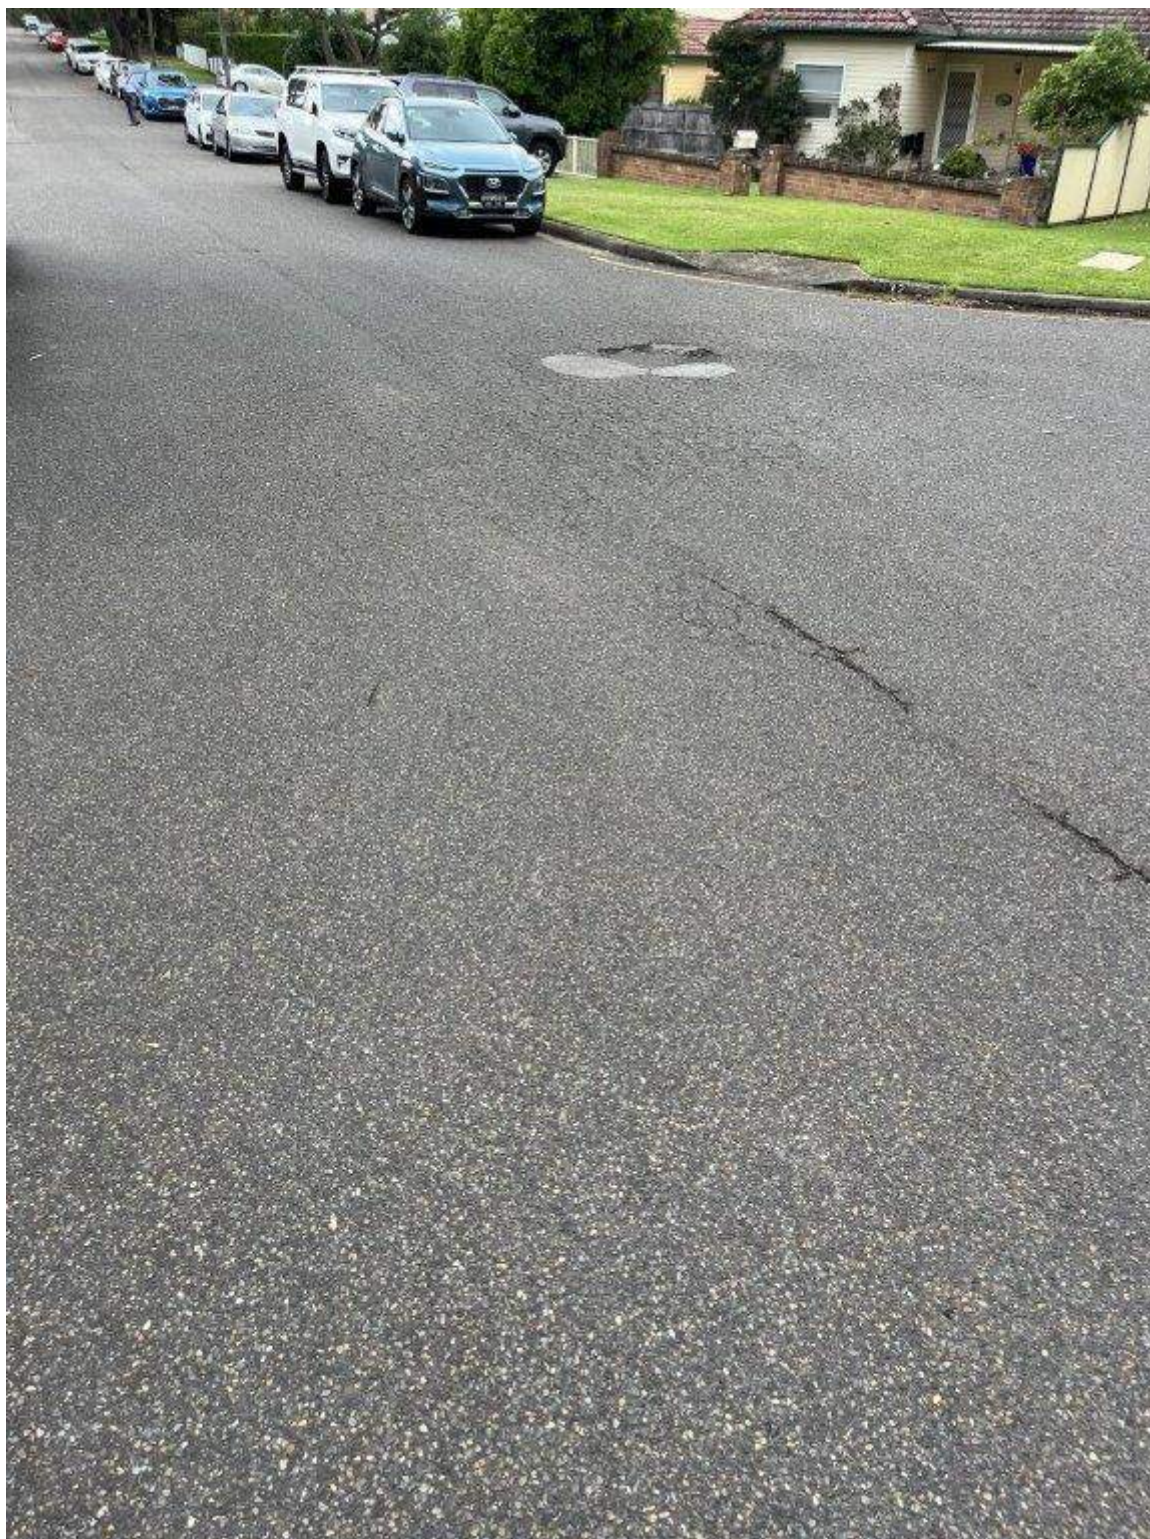
Photo 200 - Taren Point Road - Existing condition of pavement and vegetation

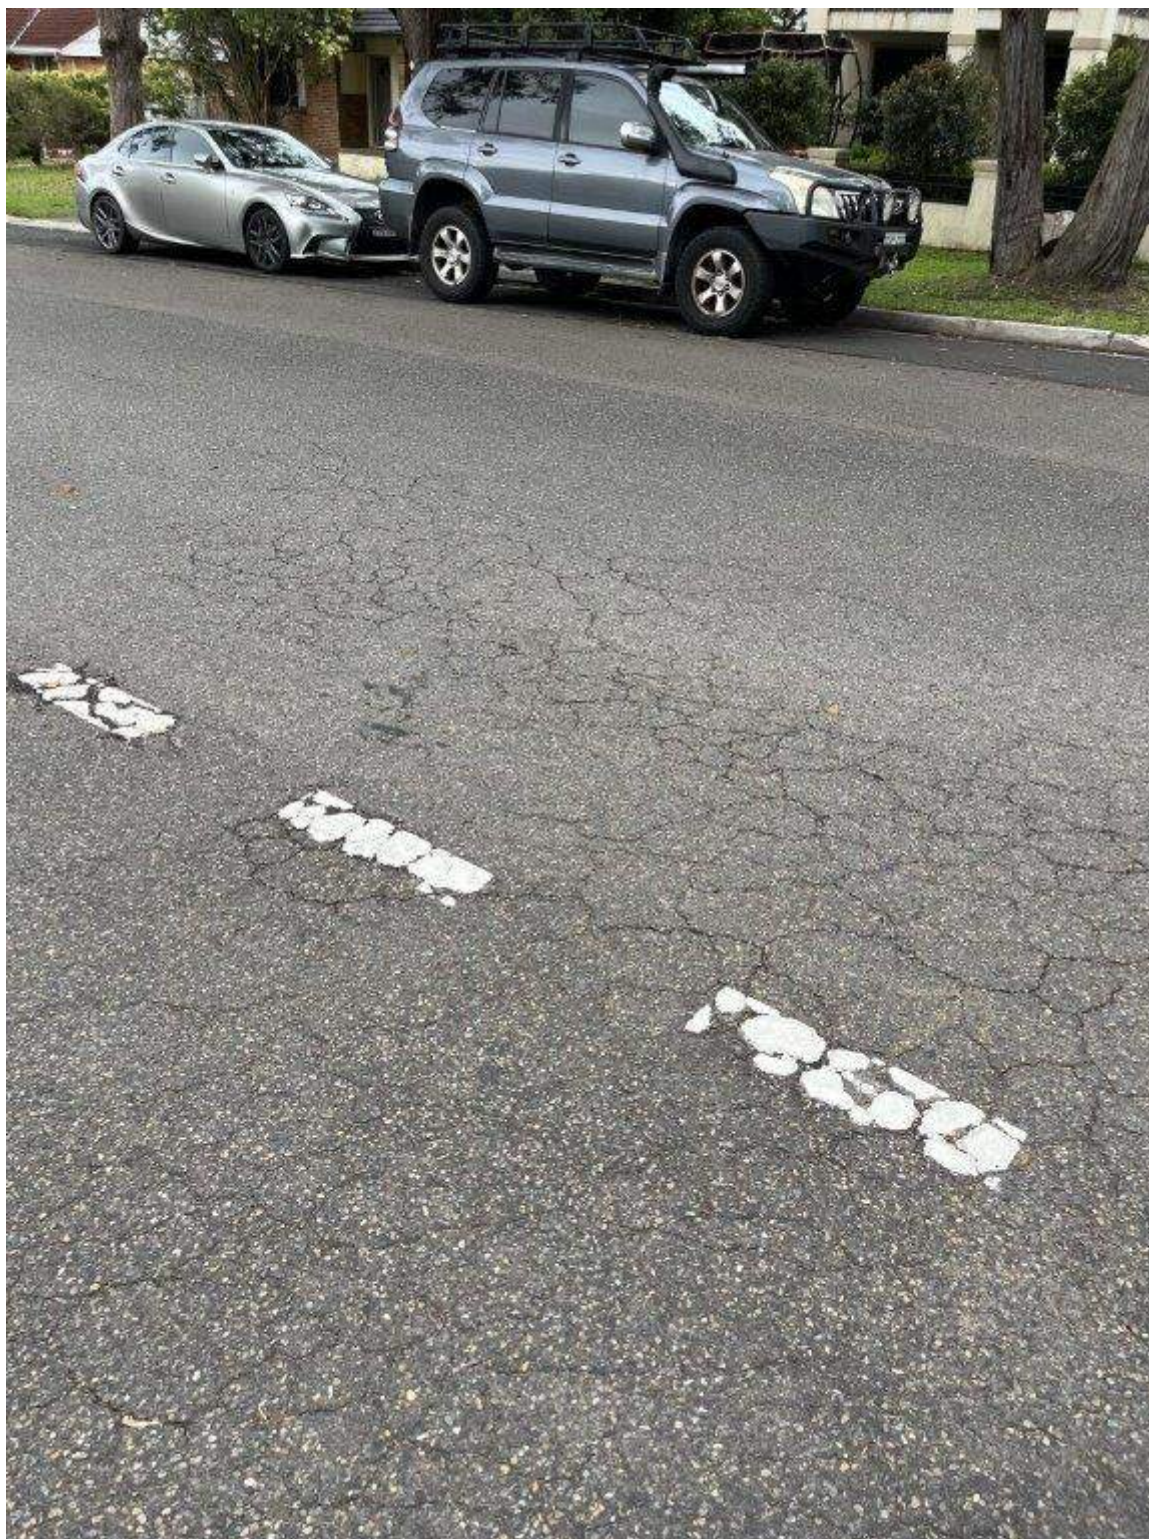
Photo 202 - Taren Point Road - Cracking of pavement

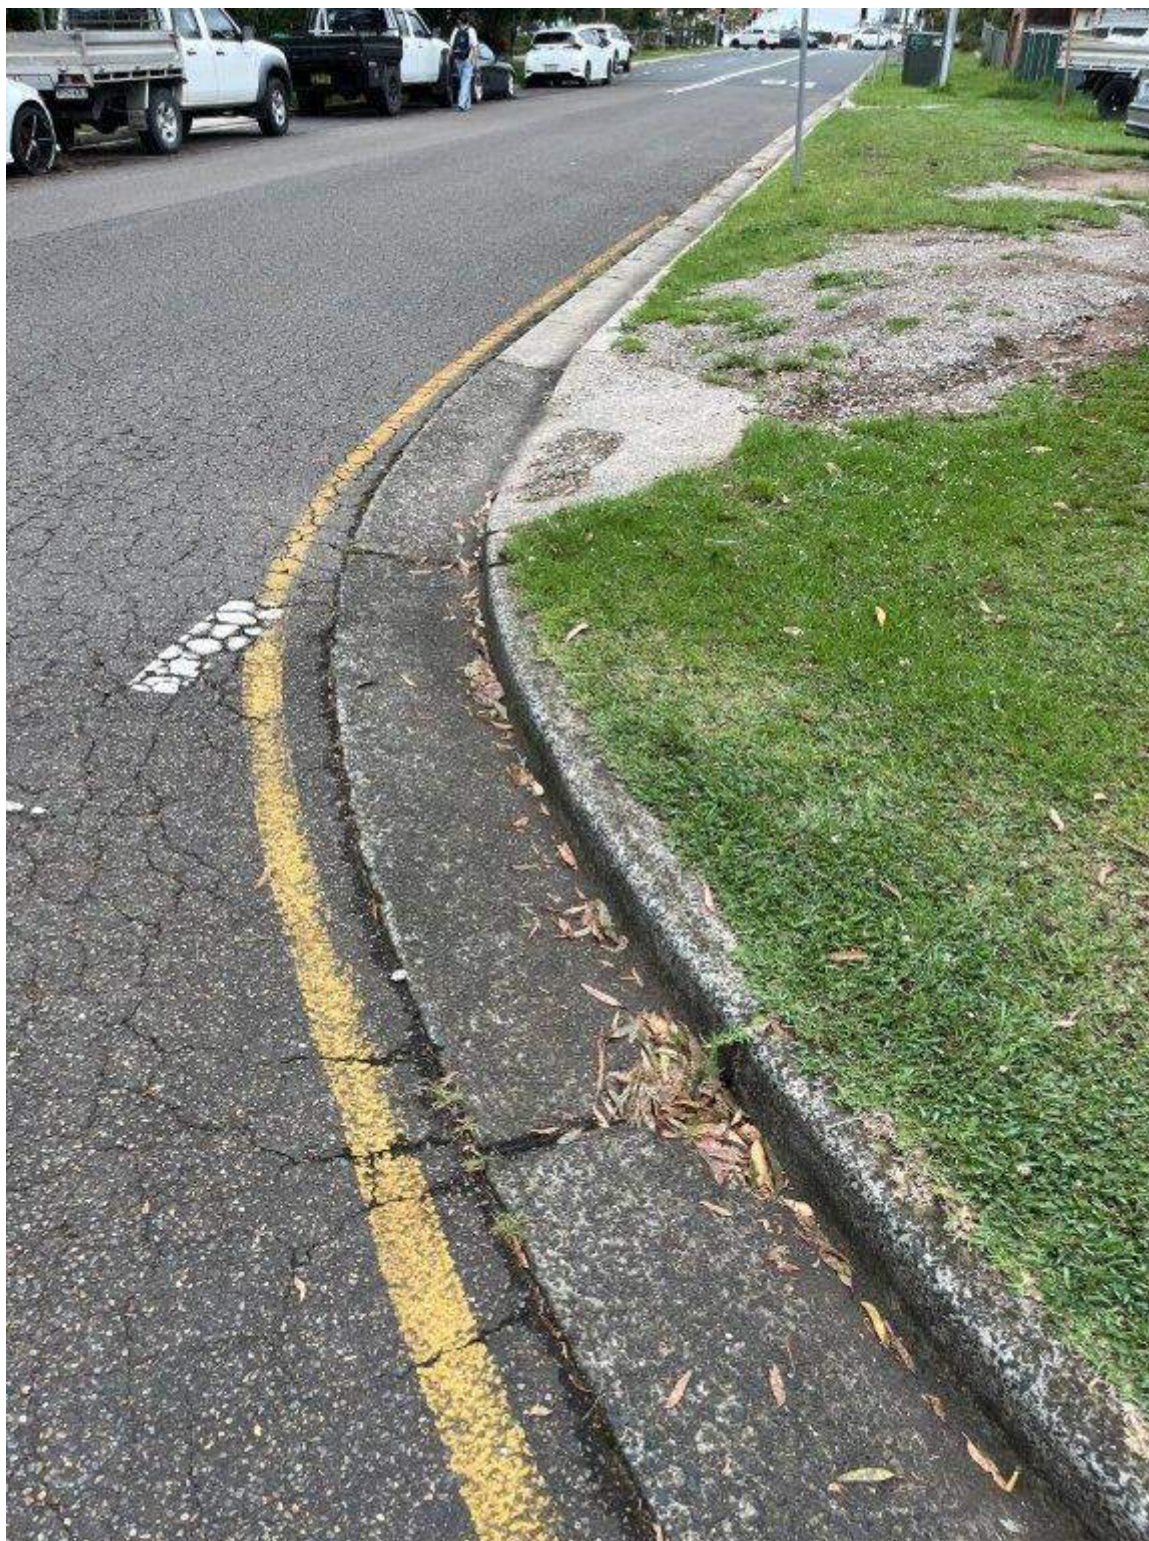
Photo 203 - Taren Point Road - Cracking of pavement

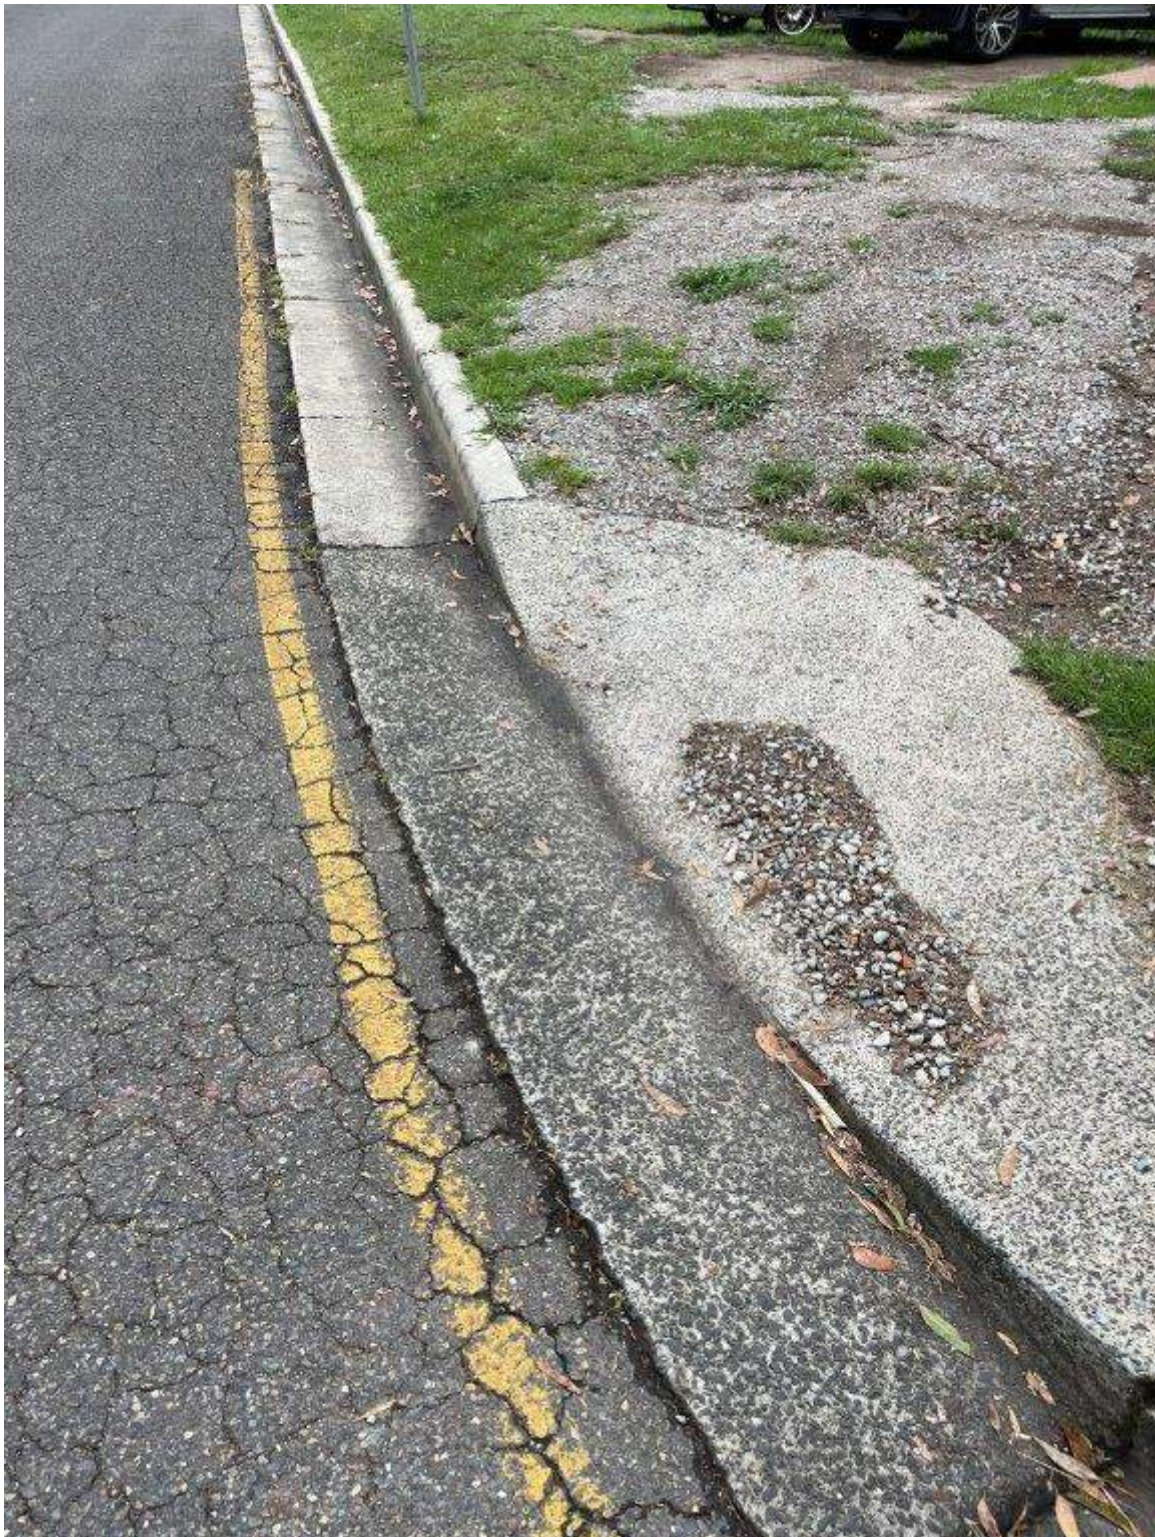
Photo 204 - Taren Point Road - Cracking of pavement

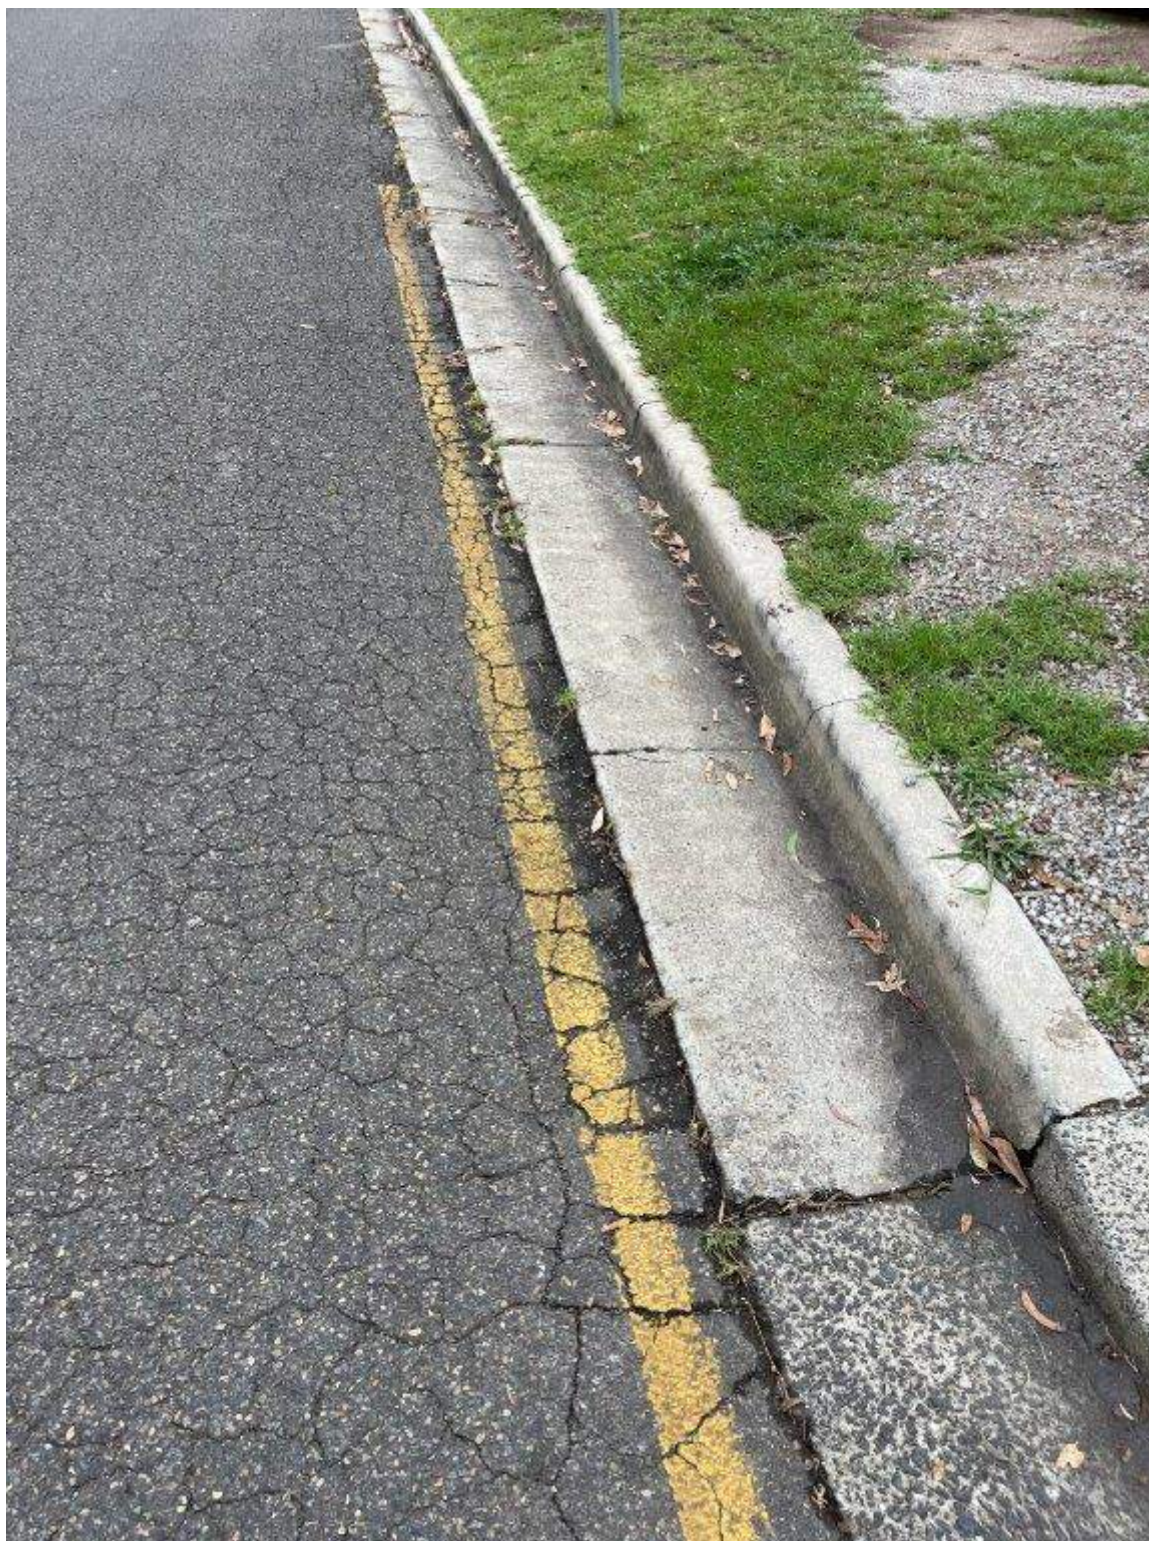
Photo 205 - Taren Point Road - Cracking of pavement

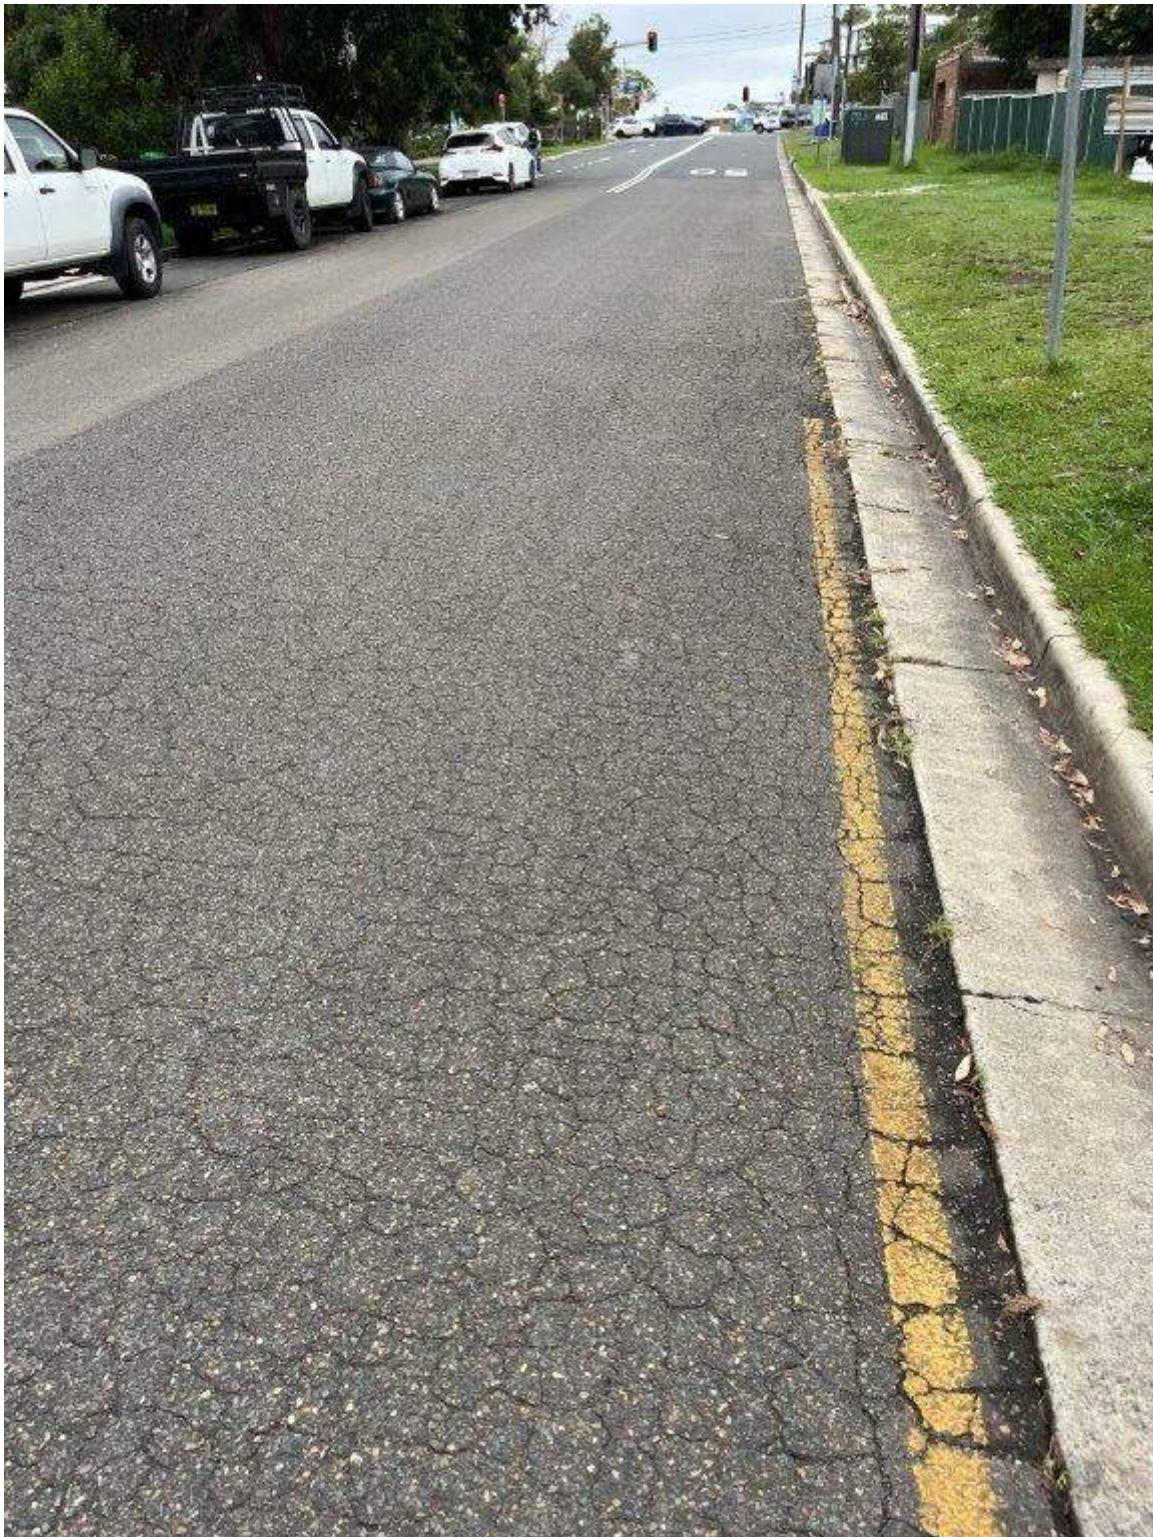
Photo 206 - Taren Point Road - Cracking of pavement

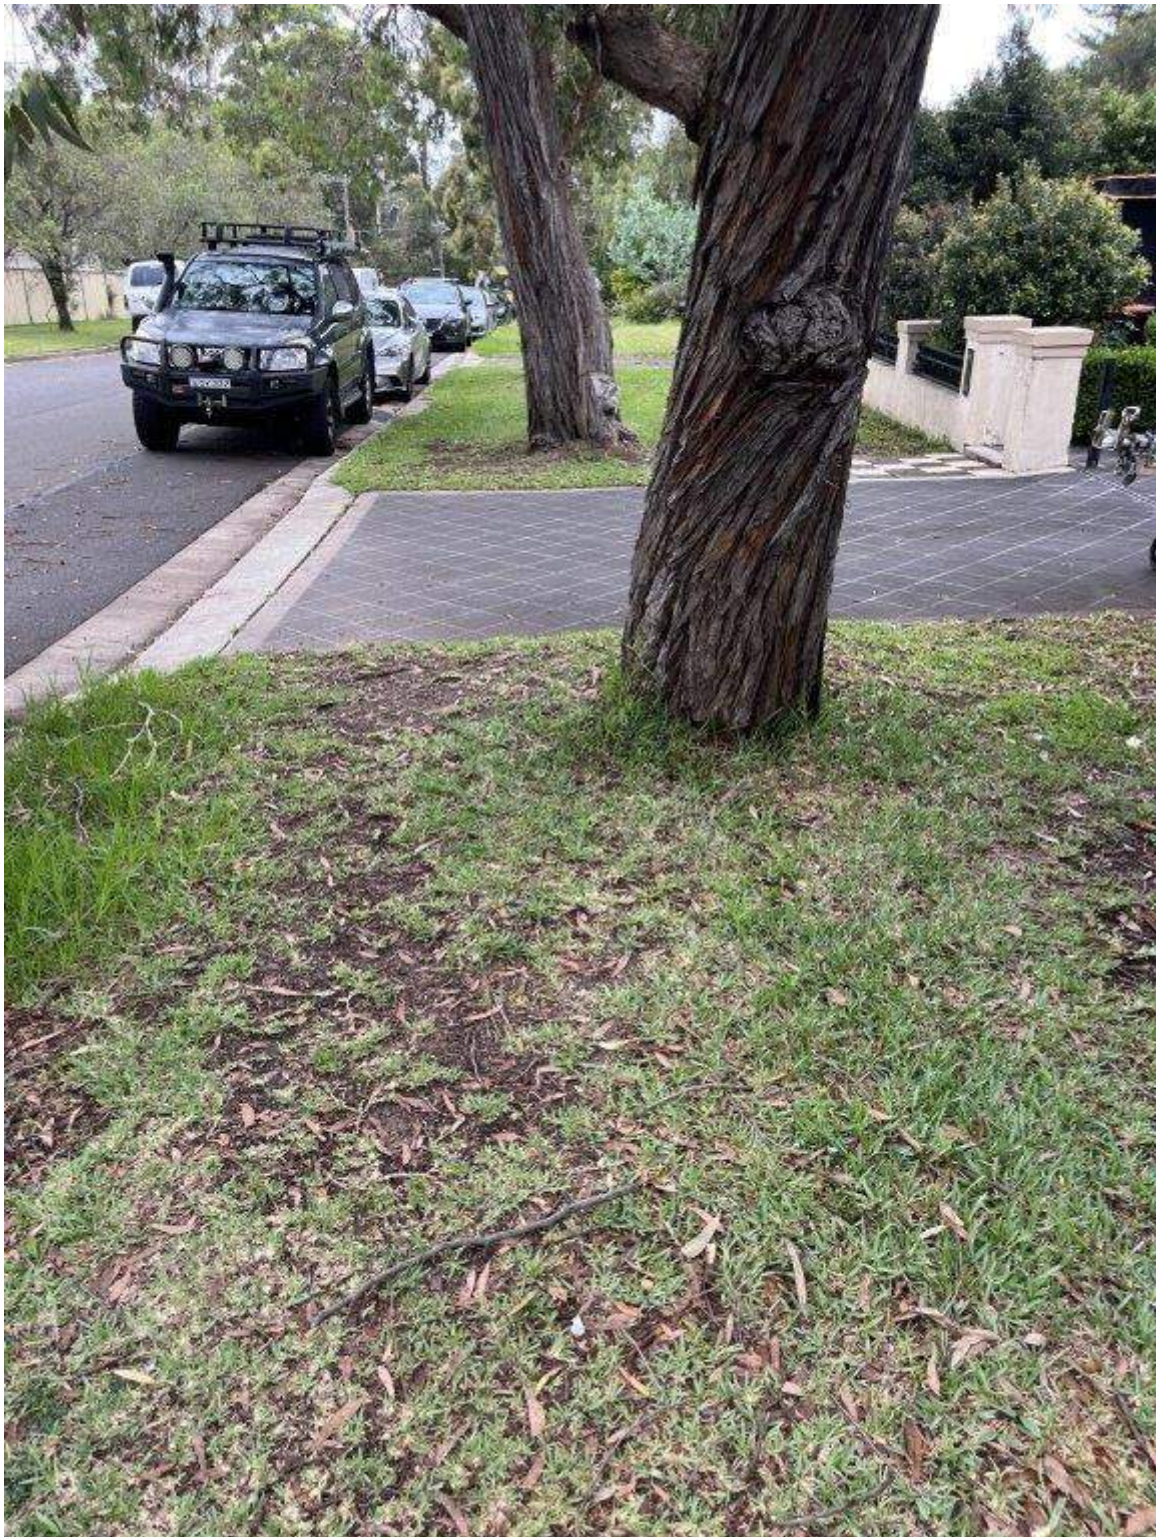
Photo 207 - Taren Point Road - Cracking of pavement

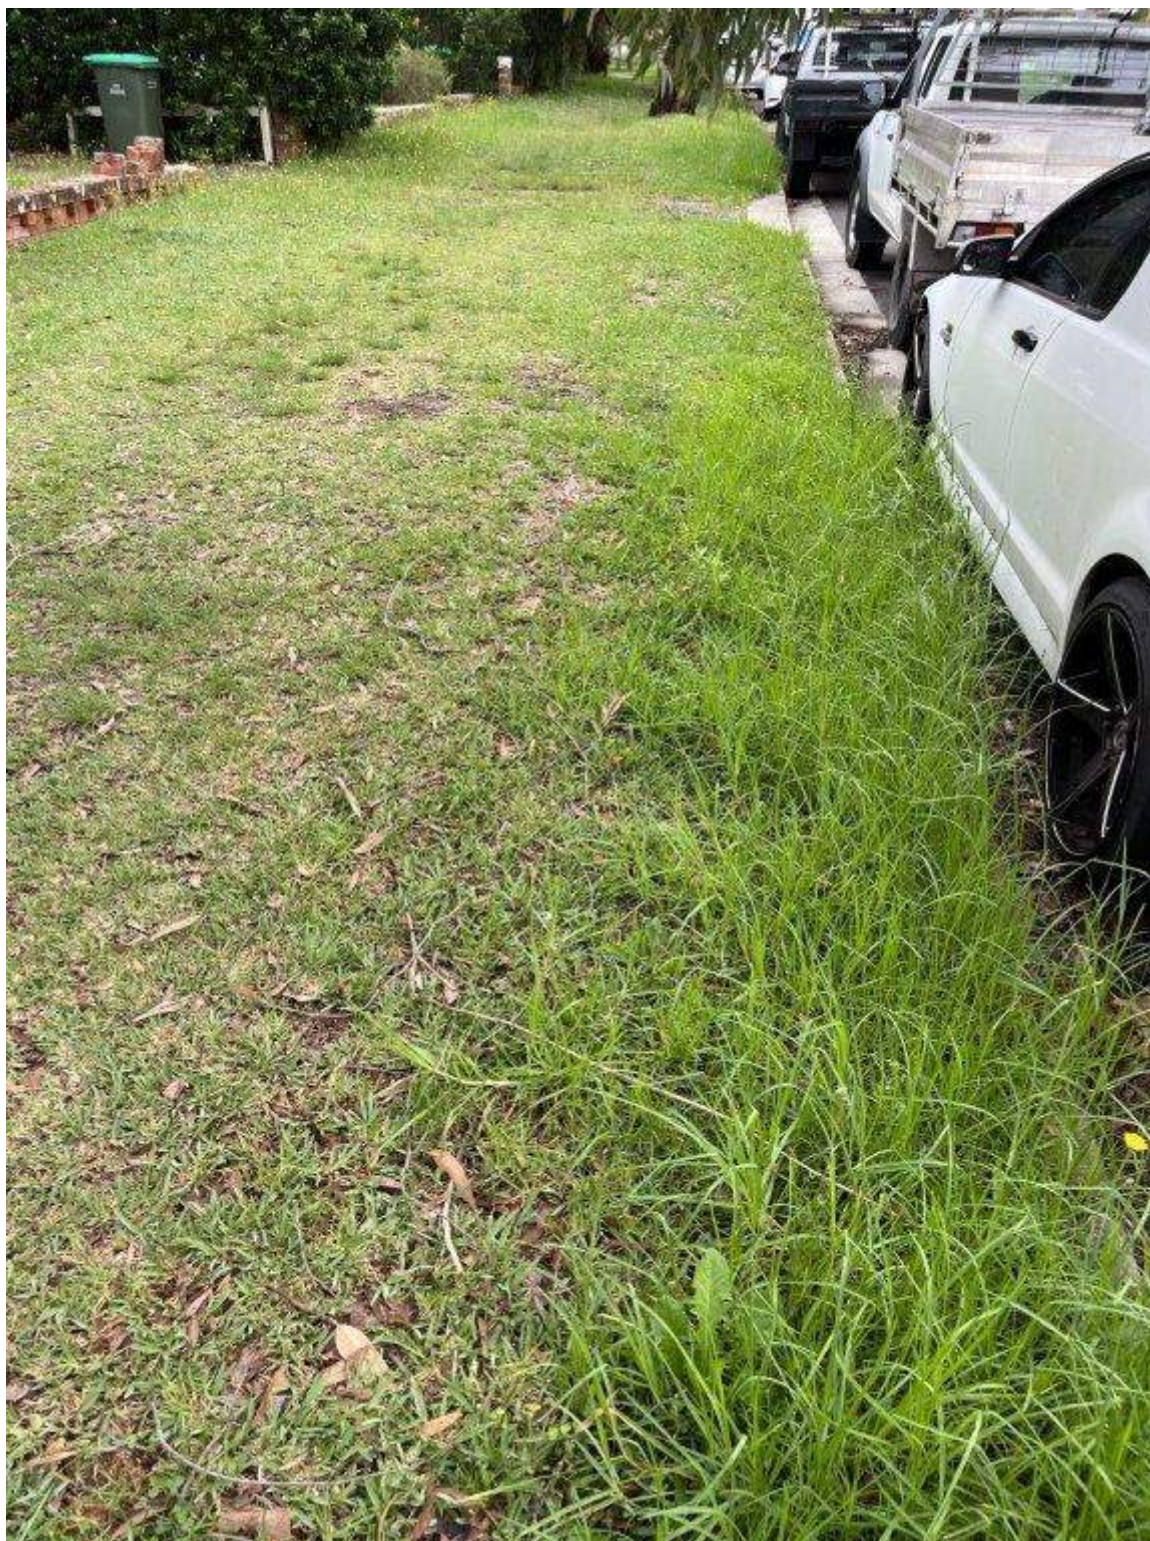
Photo 208 - Taren Point Road - Existing condition of pavement and vegetation

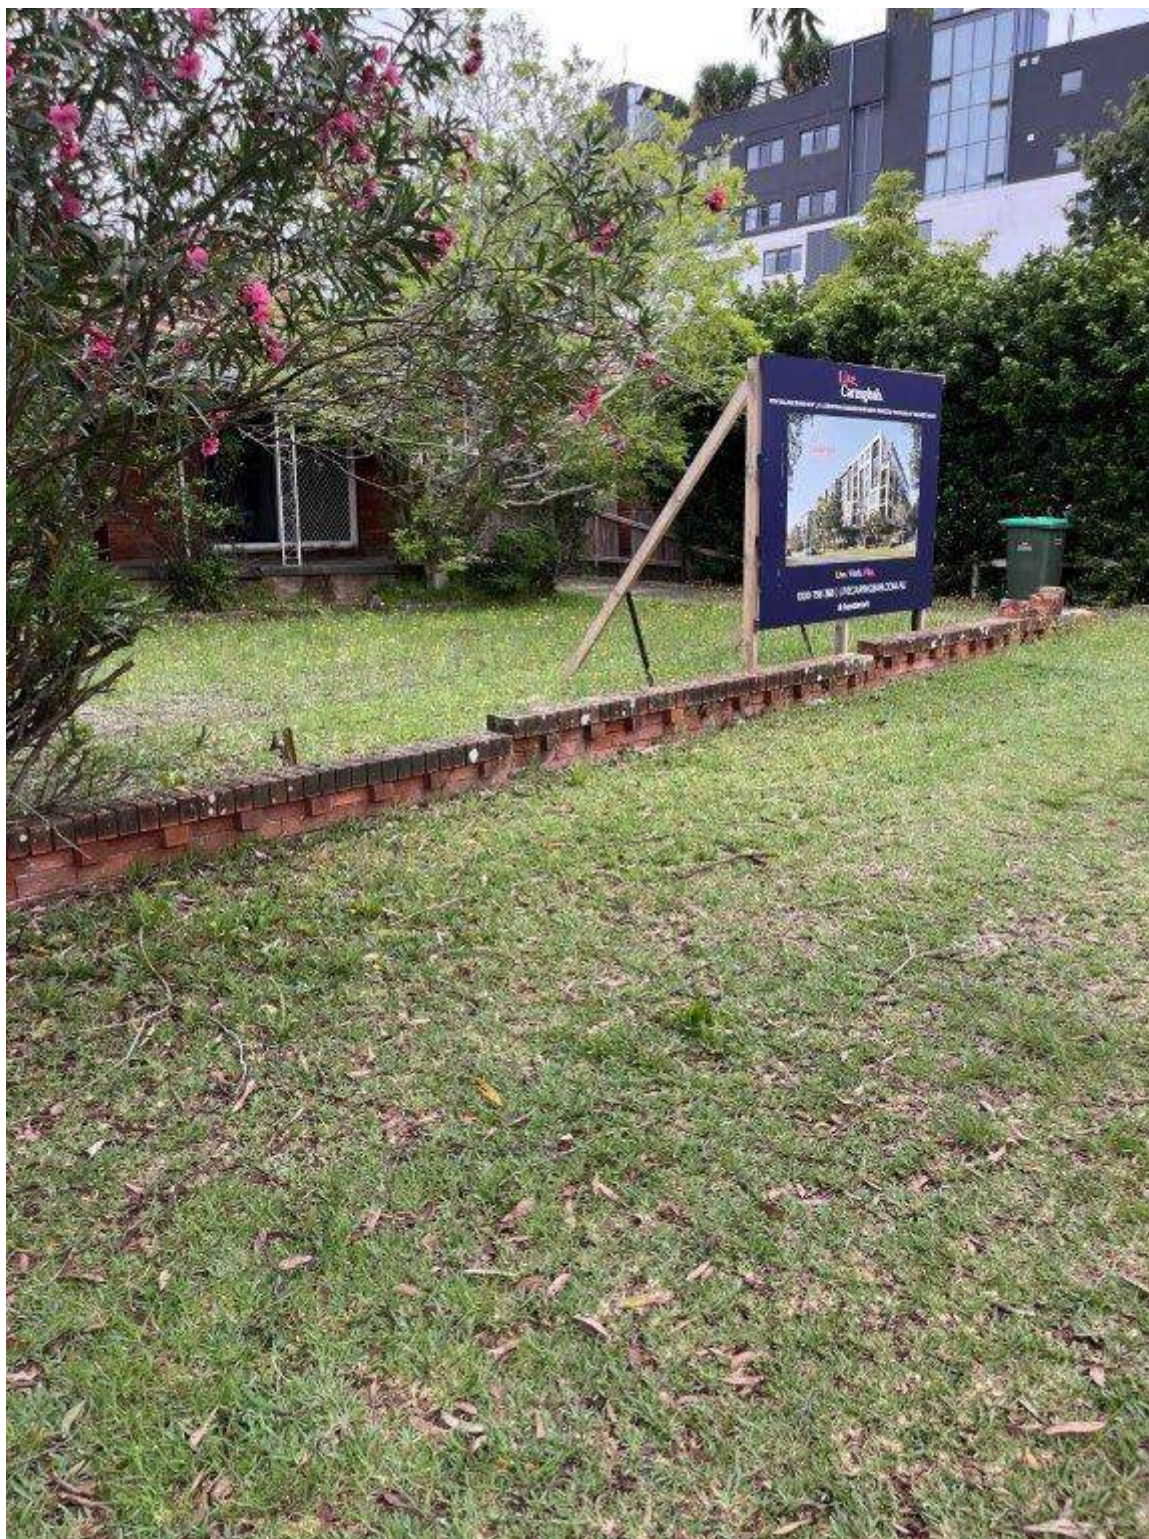
Photo 209 - Taren Point Road - Existing condition of vegetation
