## PRE-CONSTRUCTION DILAPIDATION REPORT

### 6-20 HINKLER AVENUE & 319-333 TAREN POINT ROAD, CARINGBAH

| PRE-CONSTRUCTION DILAPIDATION REPORT<br>6-20 Hinkler Avenue & 319-333 Taren Point Road,<br>Caringbah NSW 2229 | | | | | Project Number: 21039 |

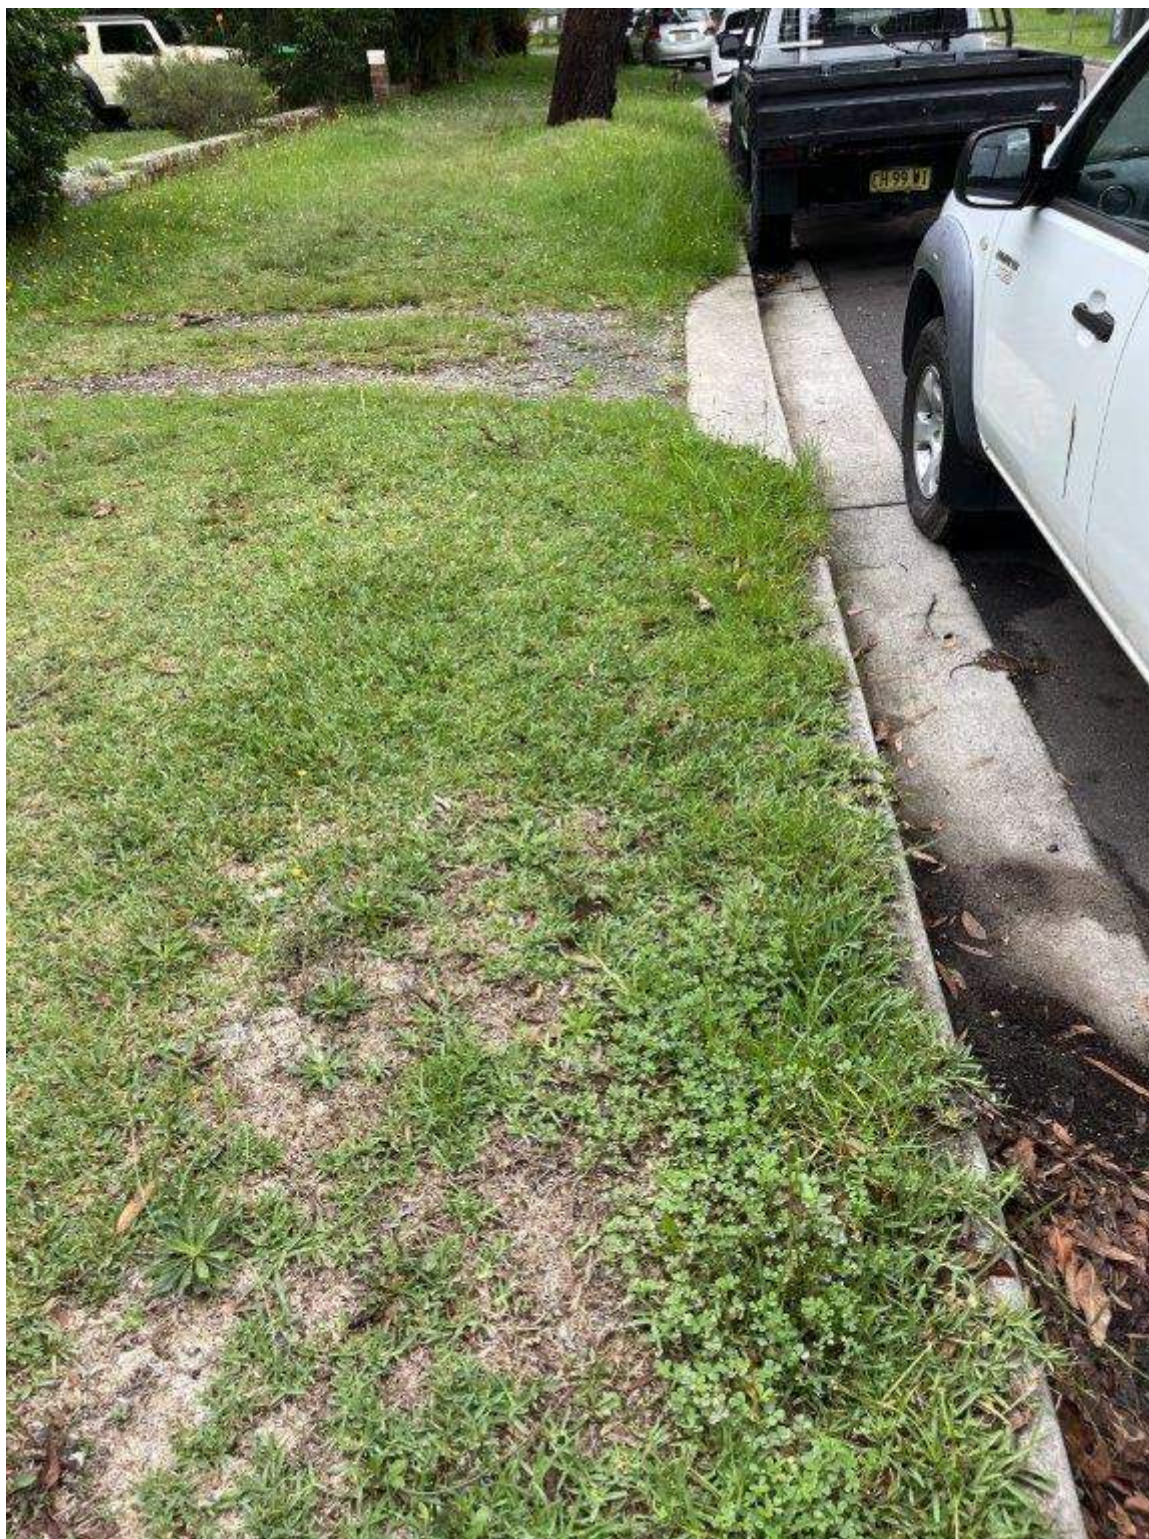
Photo 210 - Taren Point Road - Existing condition of vegetation

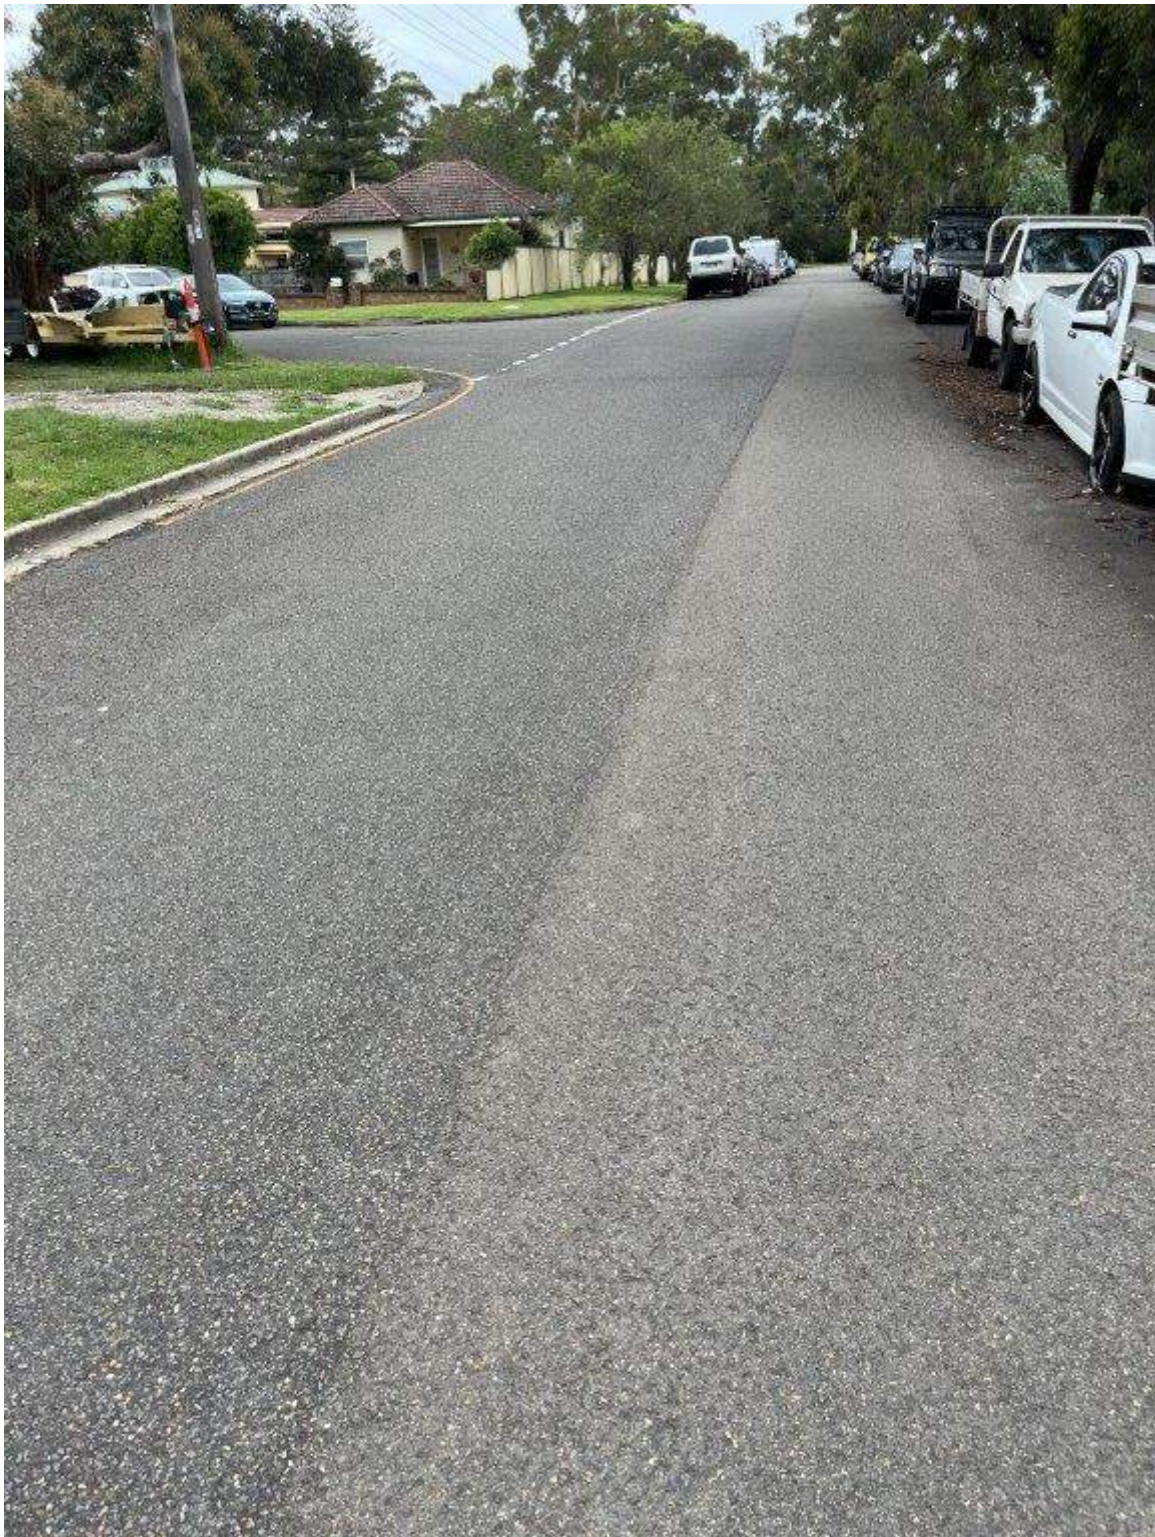
Photo 211 - Taren Point Road - Existing condition of pavement and vegetation

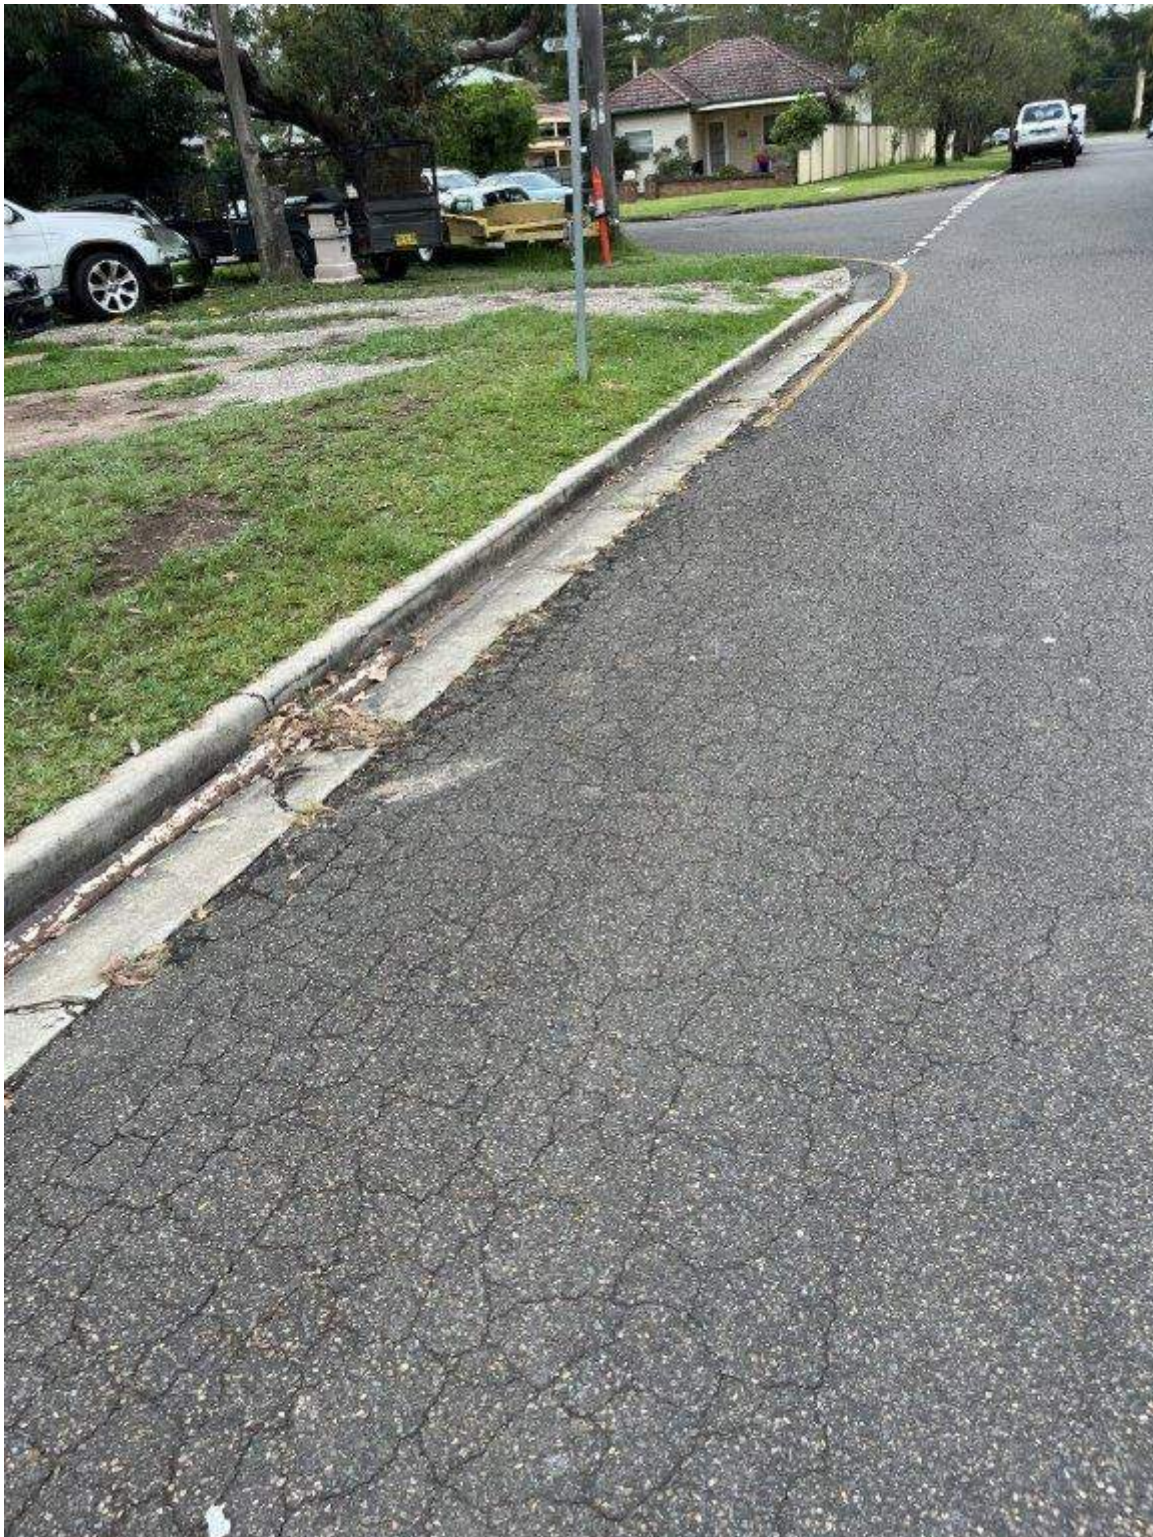
Photo 212 - Taren Point Road - Existing condition of pavement

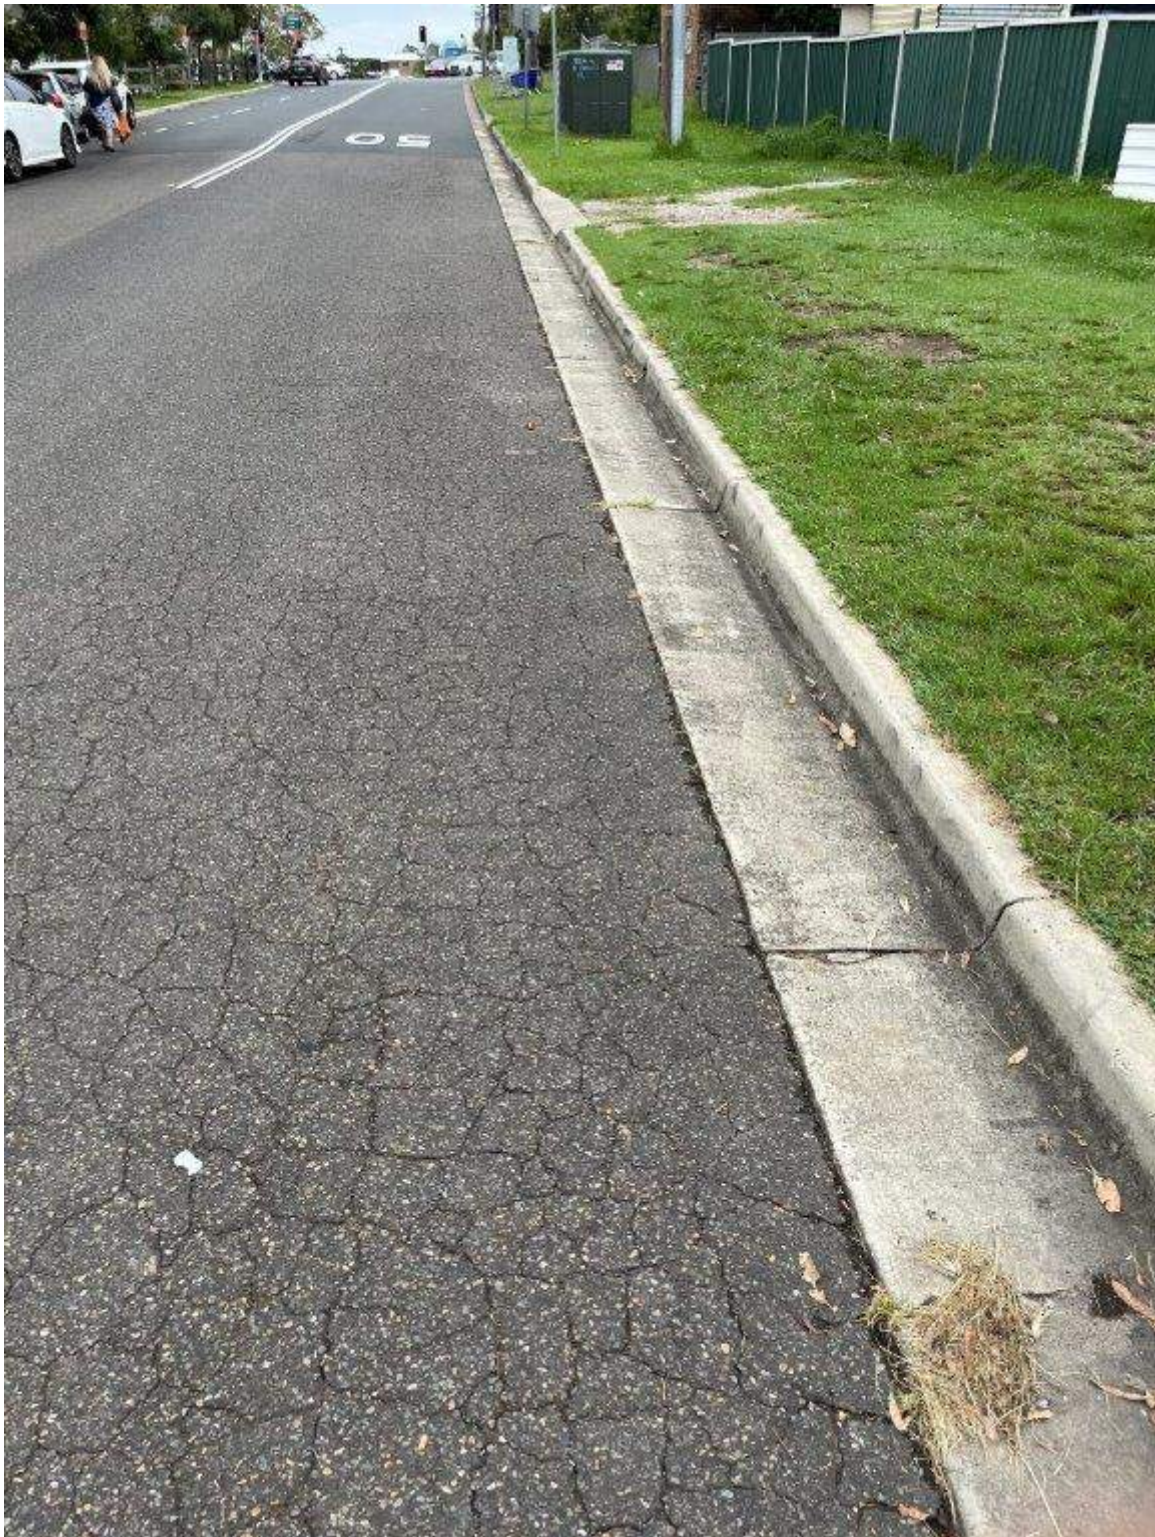
Photo 213 - Taren Point Road - Cracking of pavement

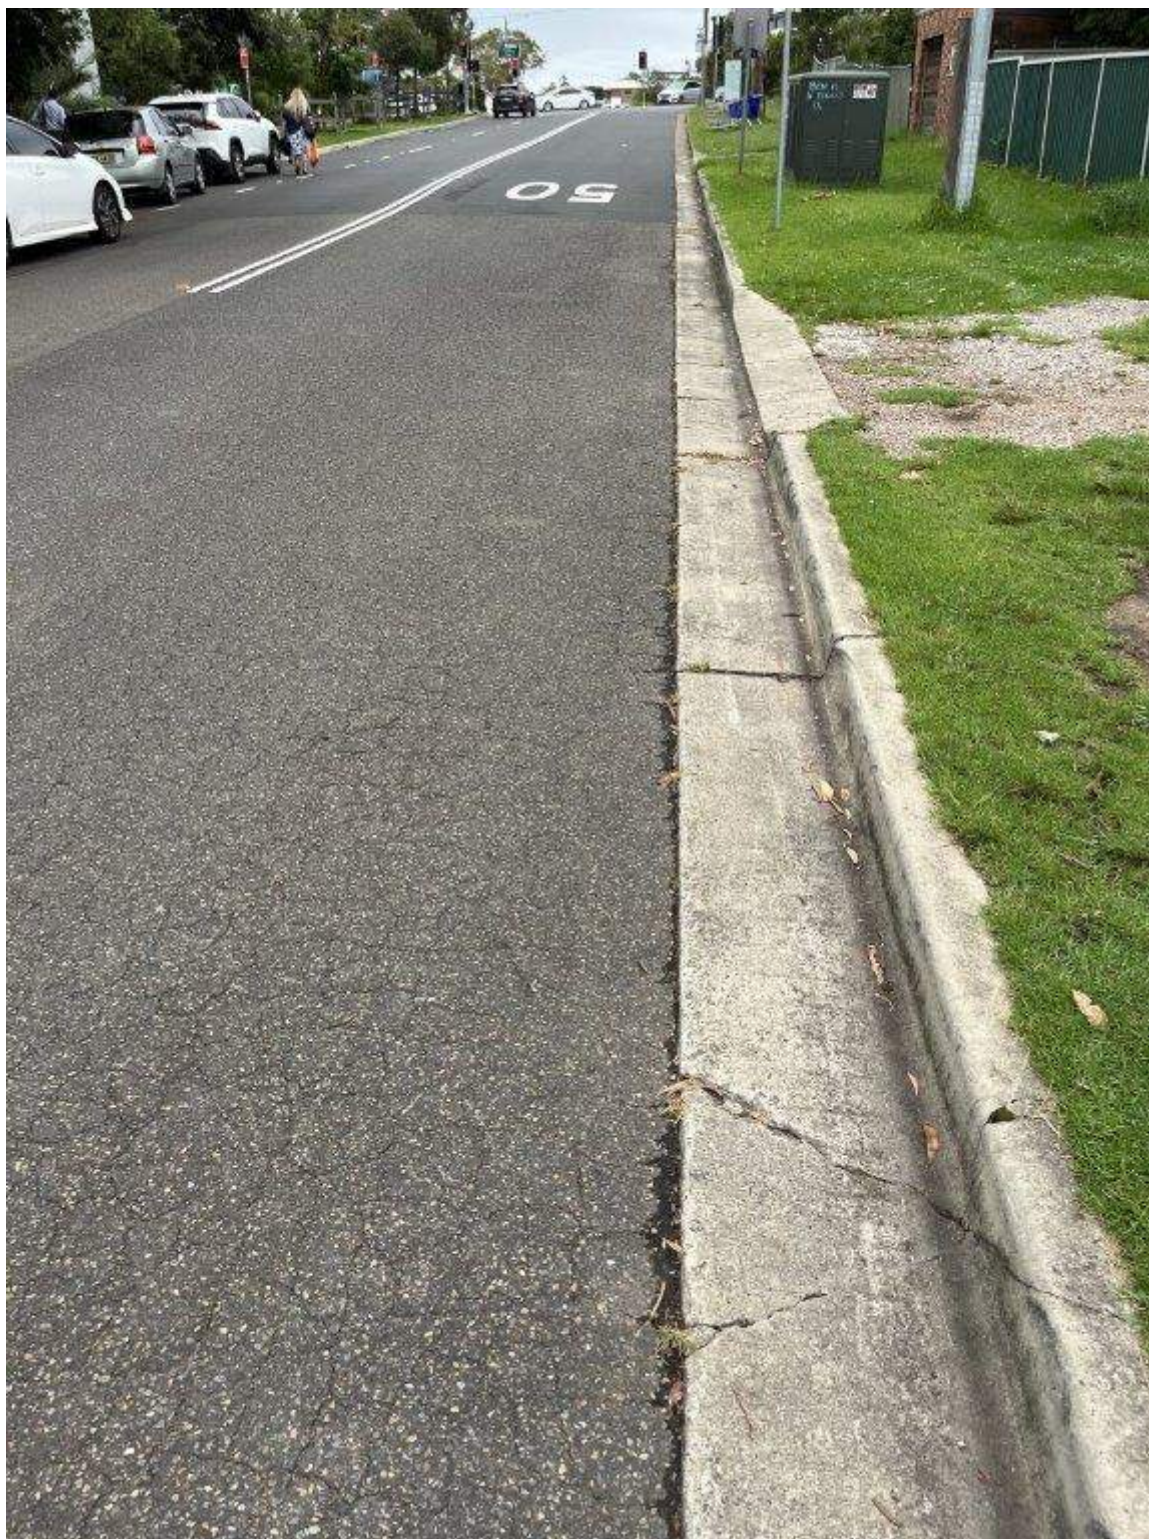
Photo 215 - Taren Point Road - Cracking of kerb and pavement

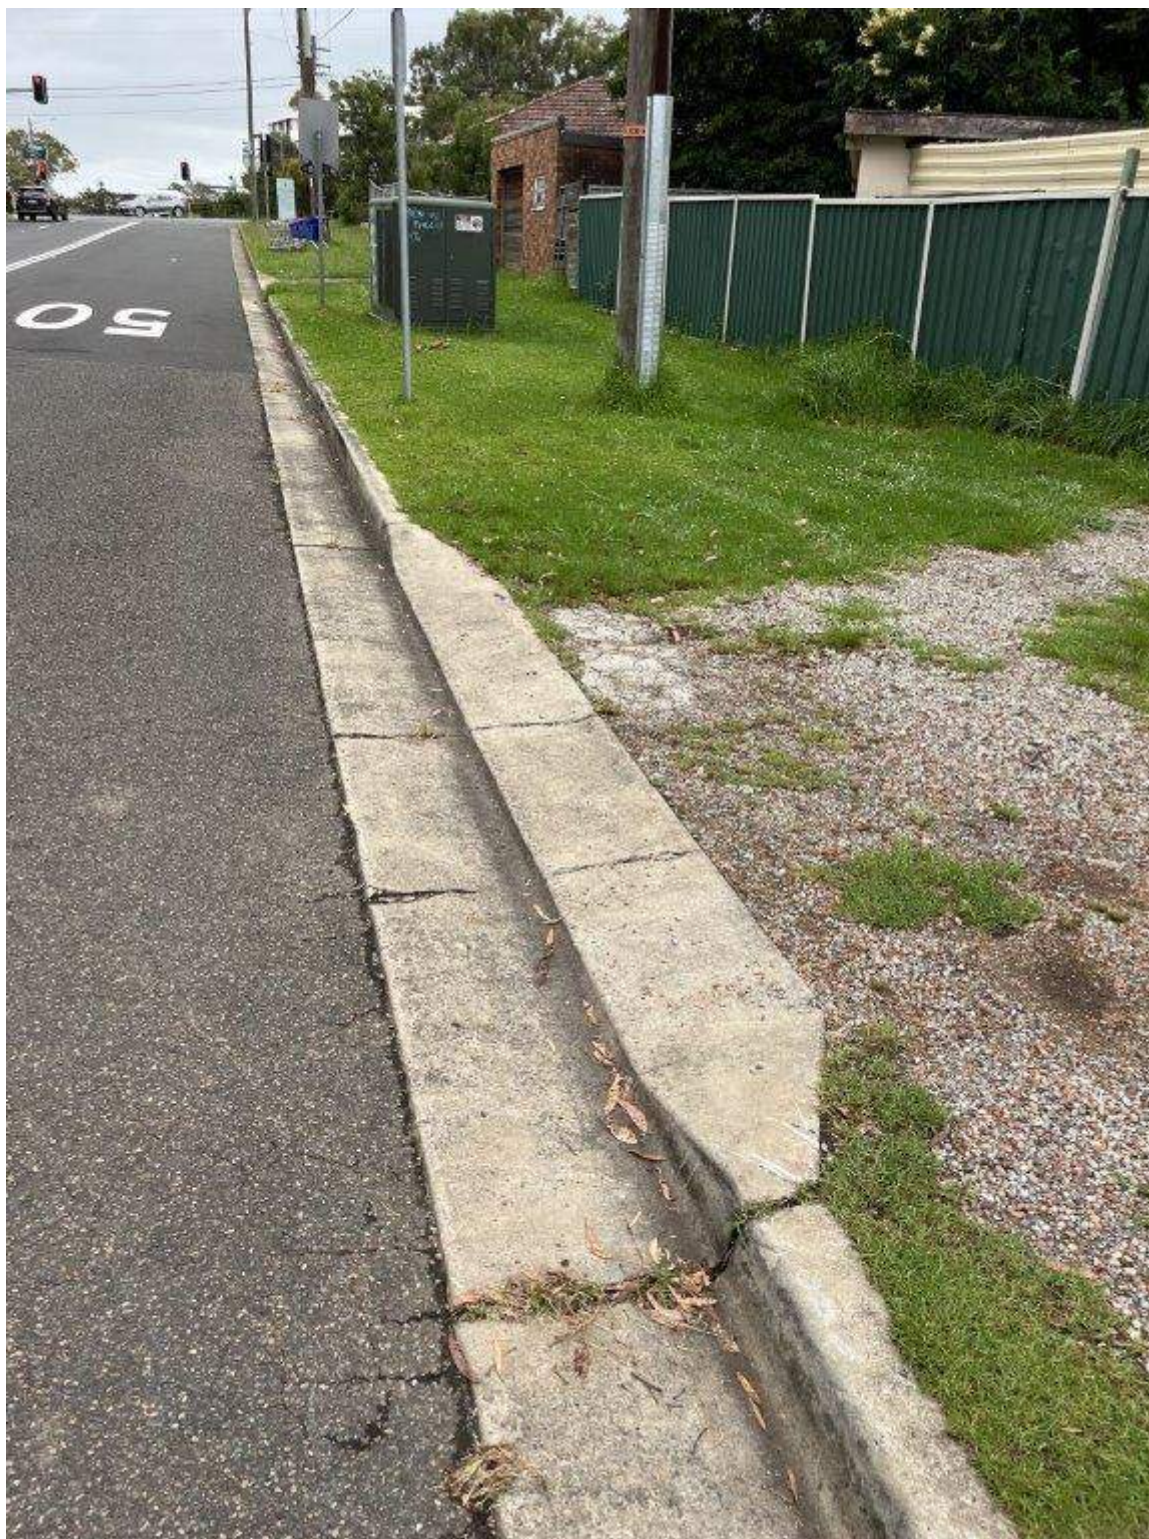
Photo 216 - Taren Point Road - Cracking of kerb and pavement

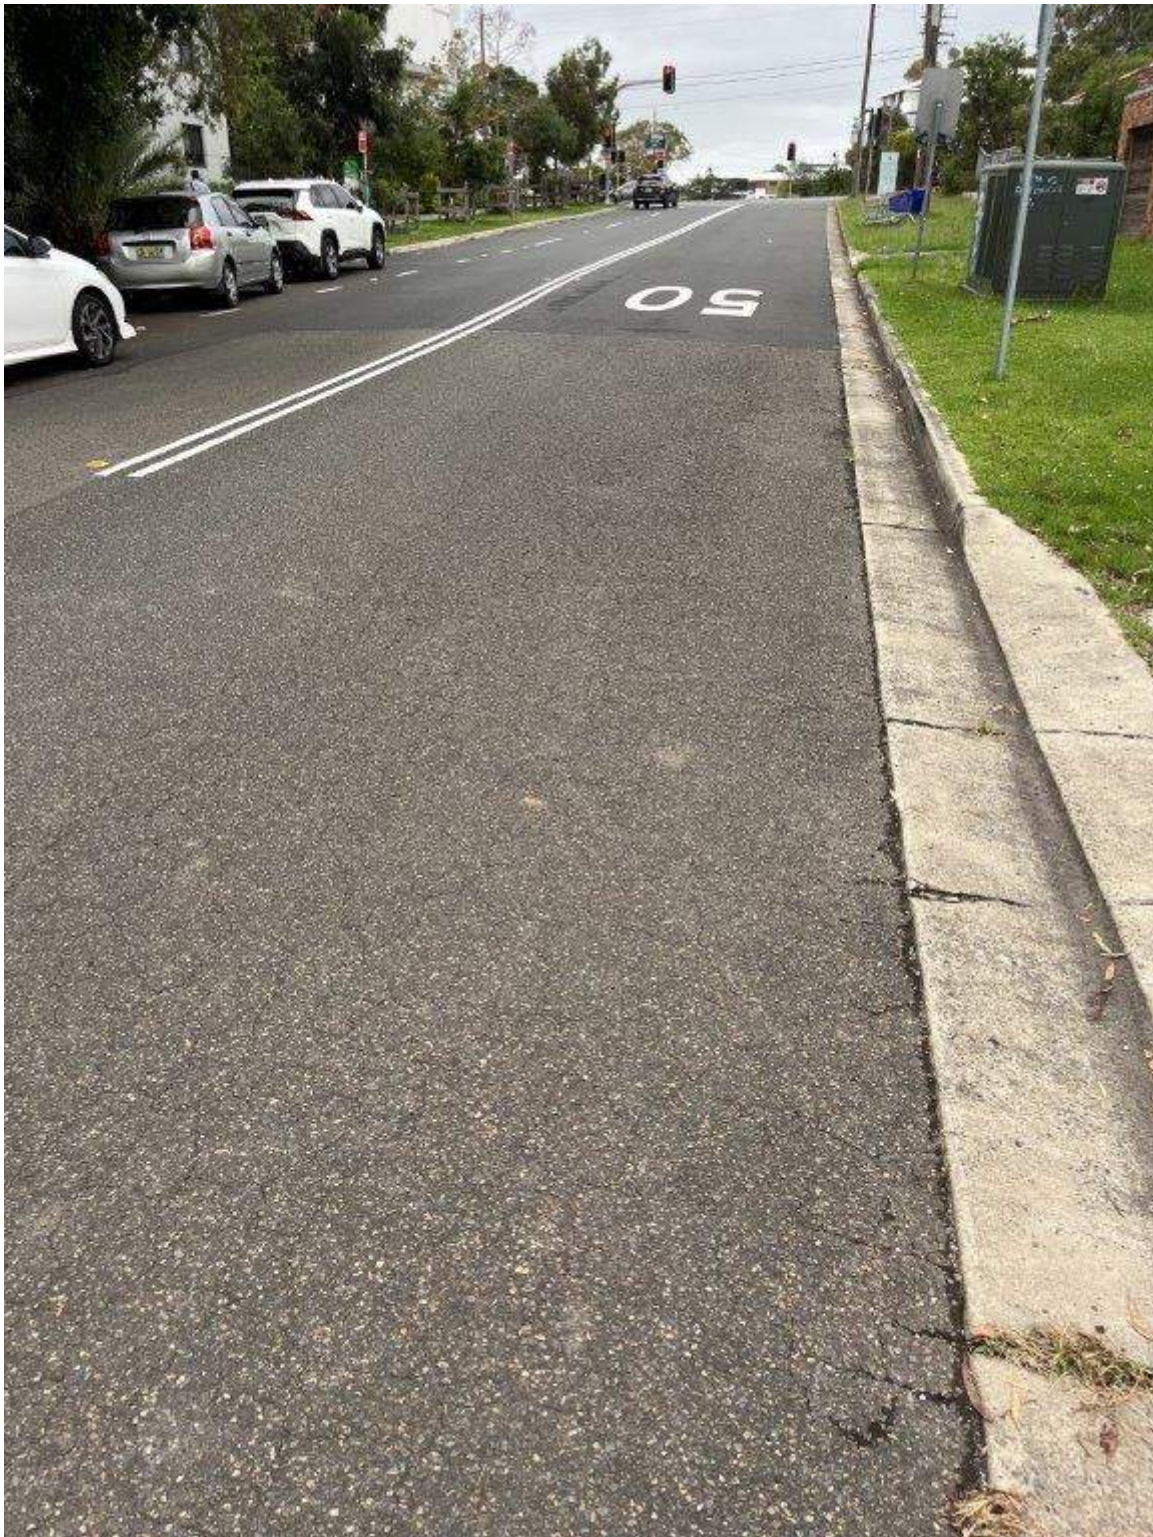
Photo 217 - Taren Point Road - Cracking of pavement

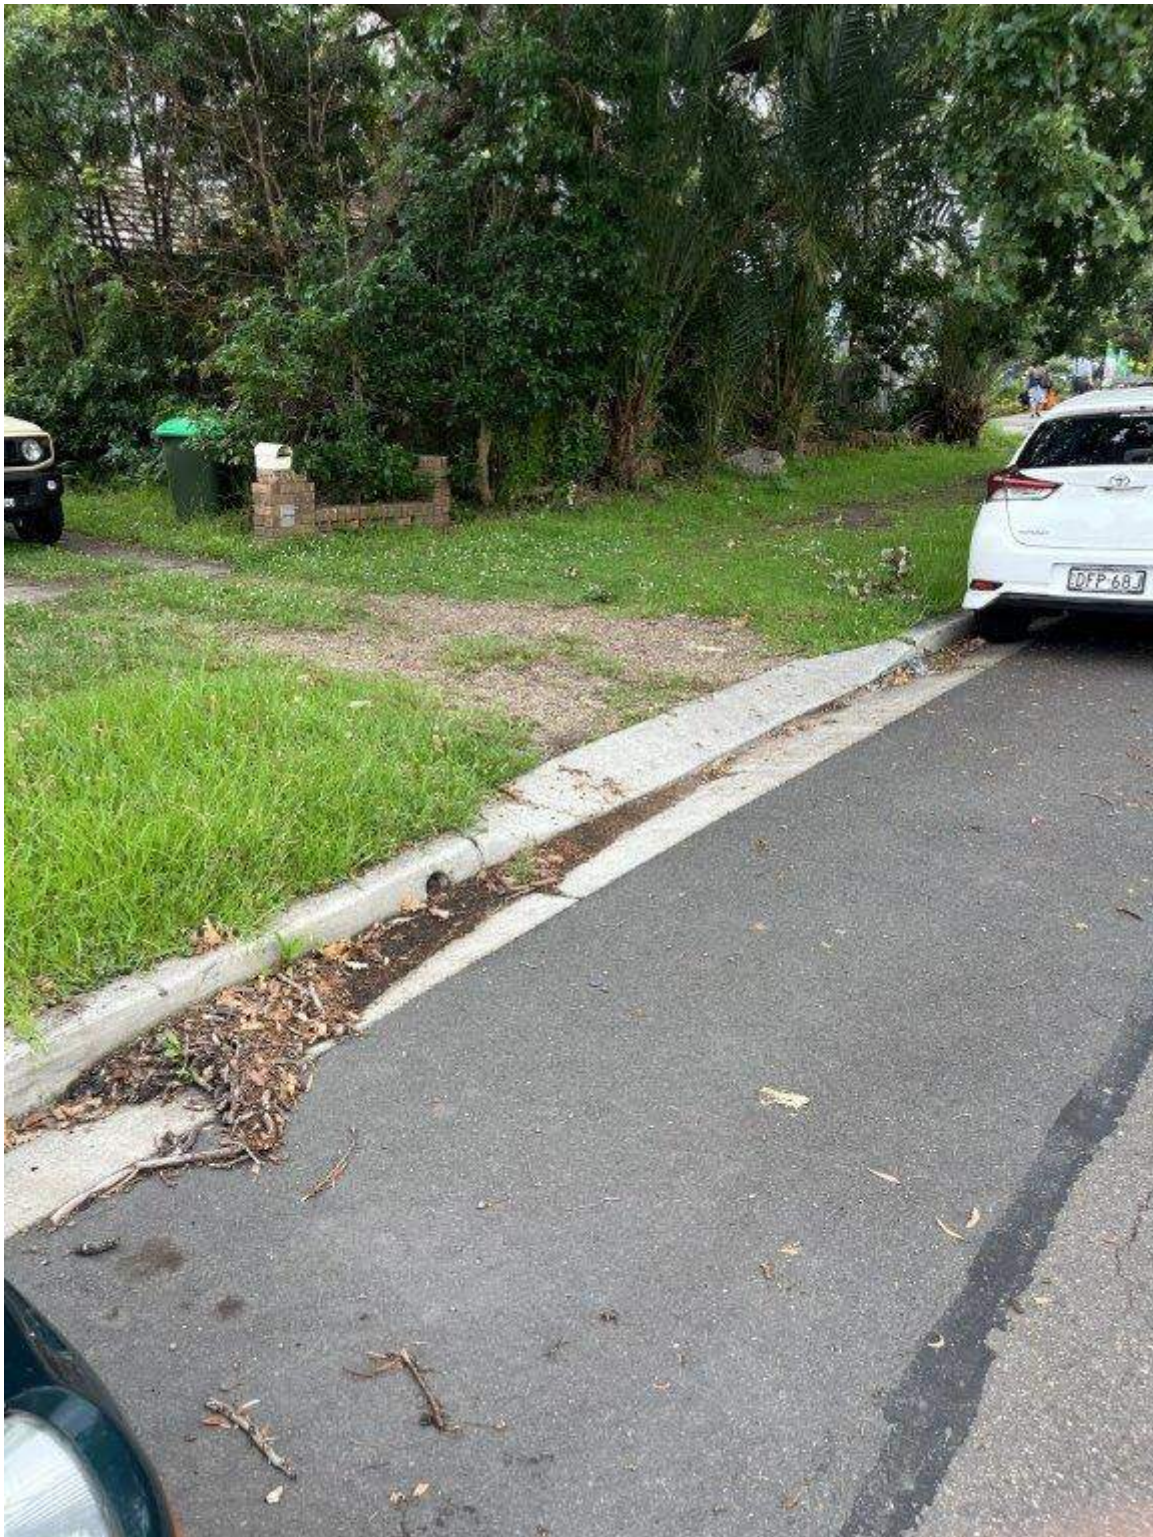
Photo 218 - Taren Point Road - Cracking of pavement

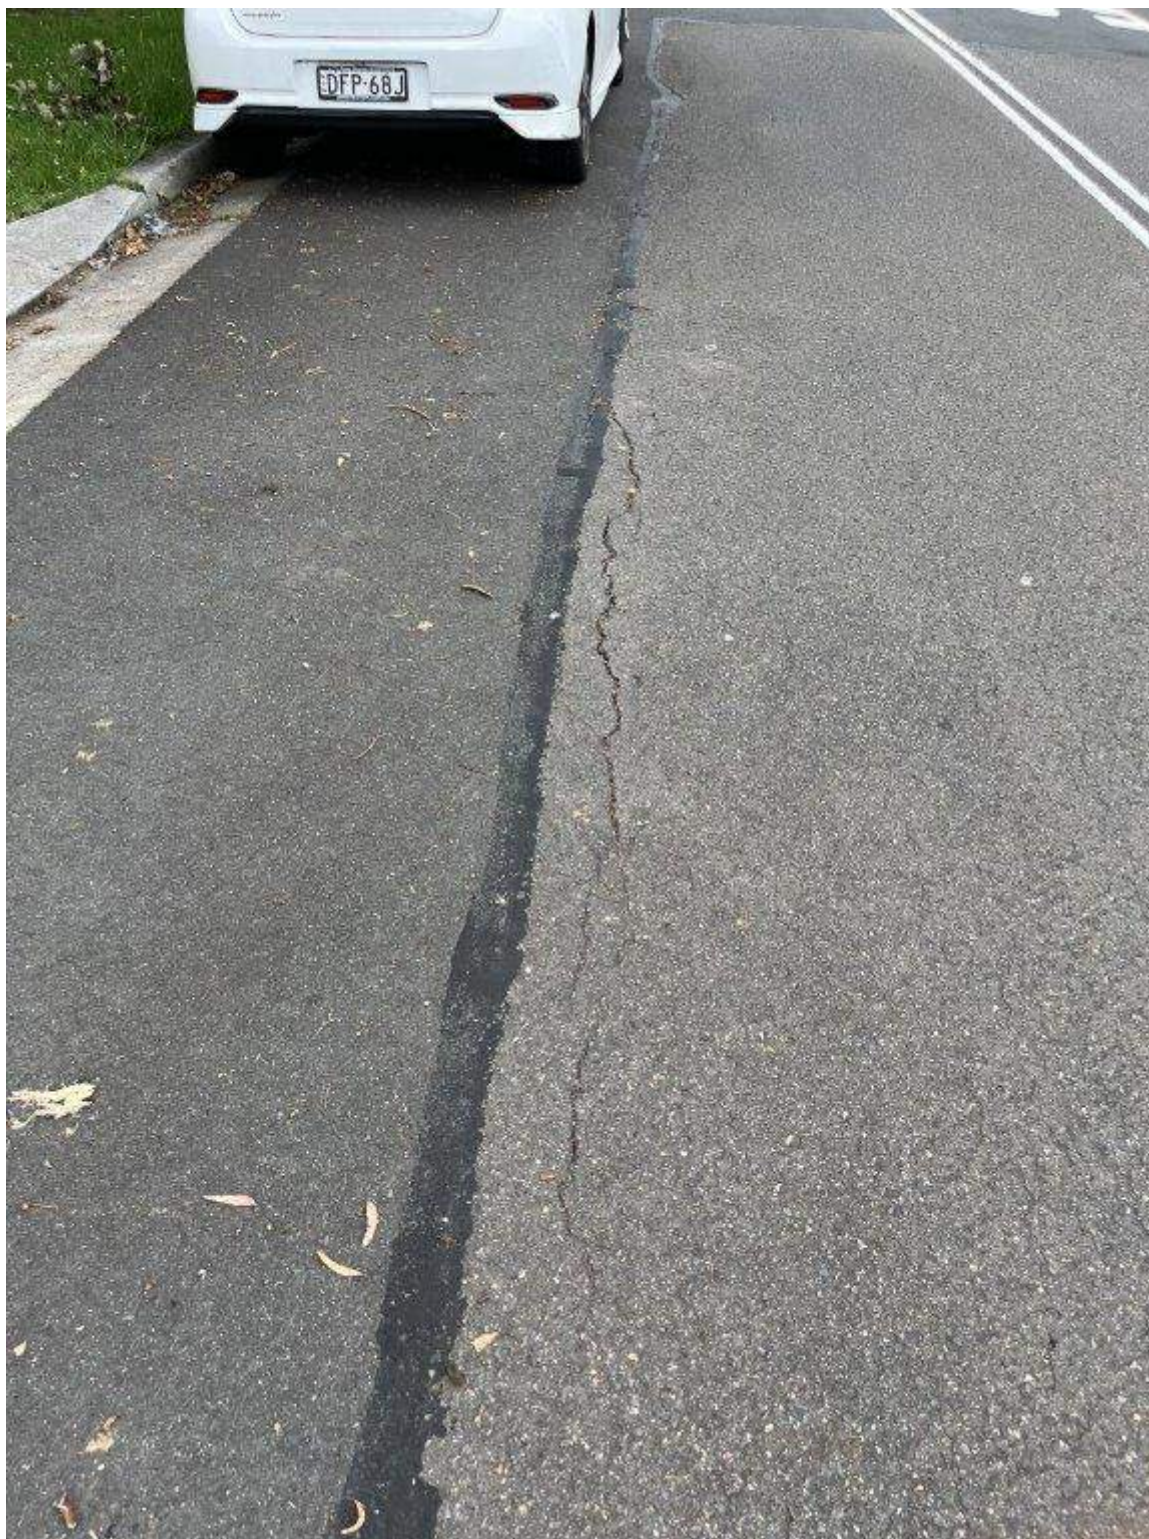
Photo 219 - Taren Point Road - Existing condition of pavement and vegetation

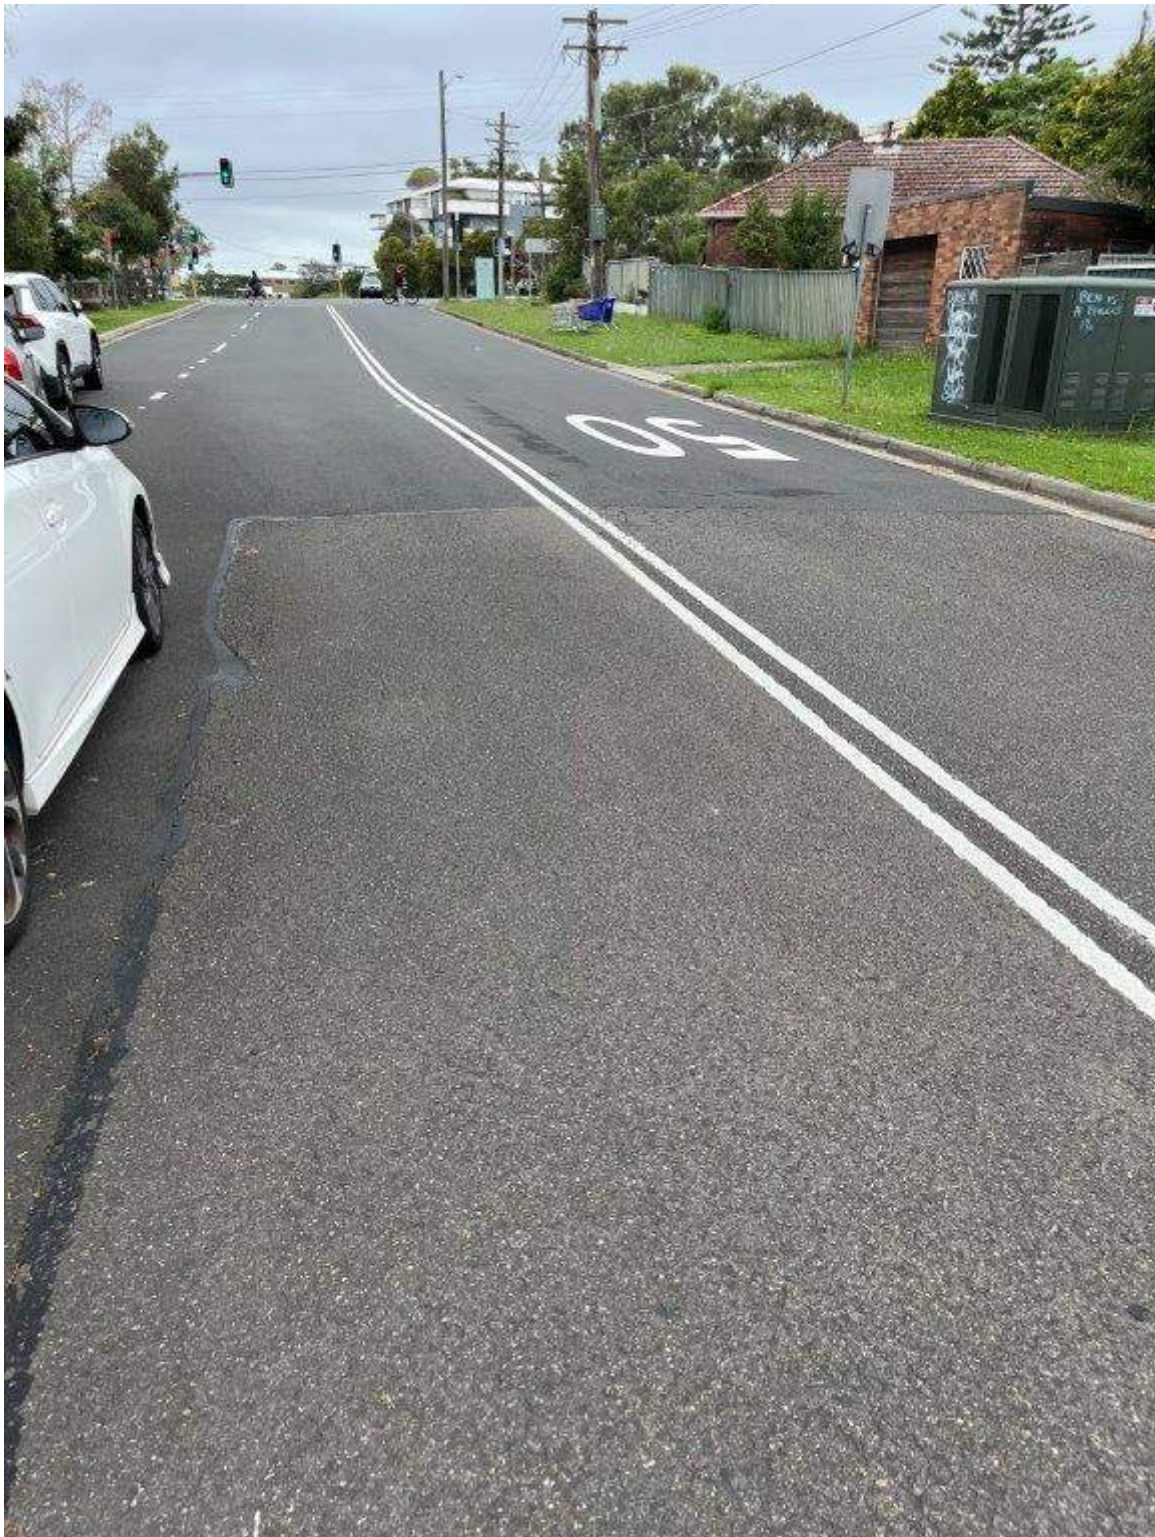
Photo 220 - Taren Point Road - Cracking of pavement

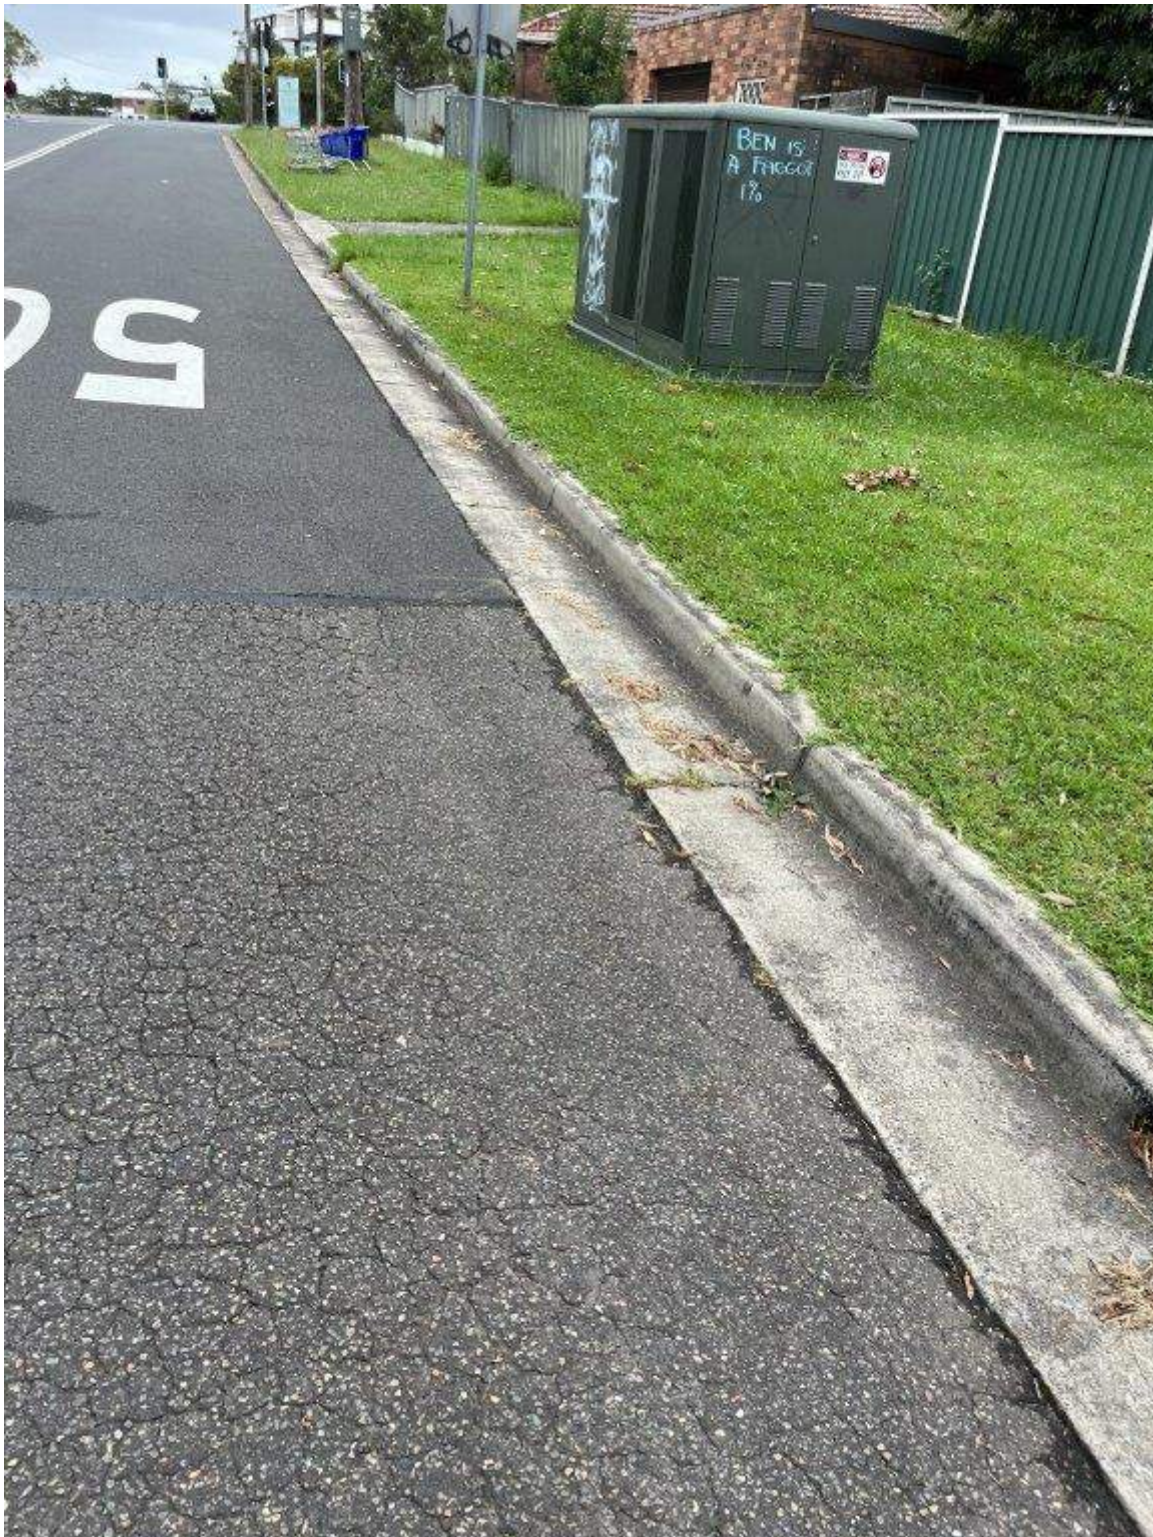
Photo 221 - Taren Point Road - Existing condition of pavement

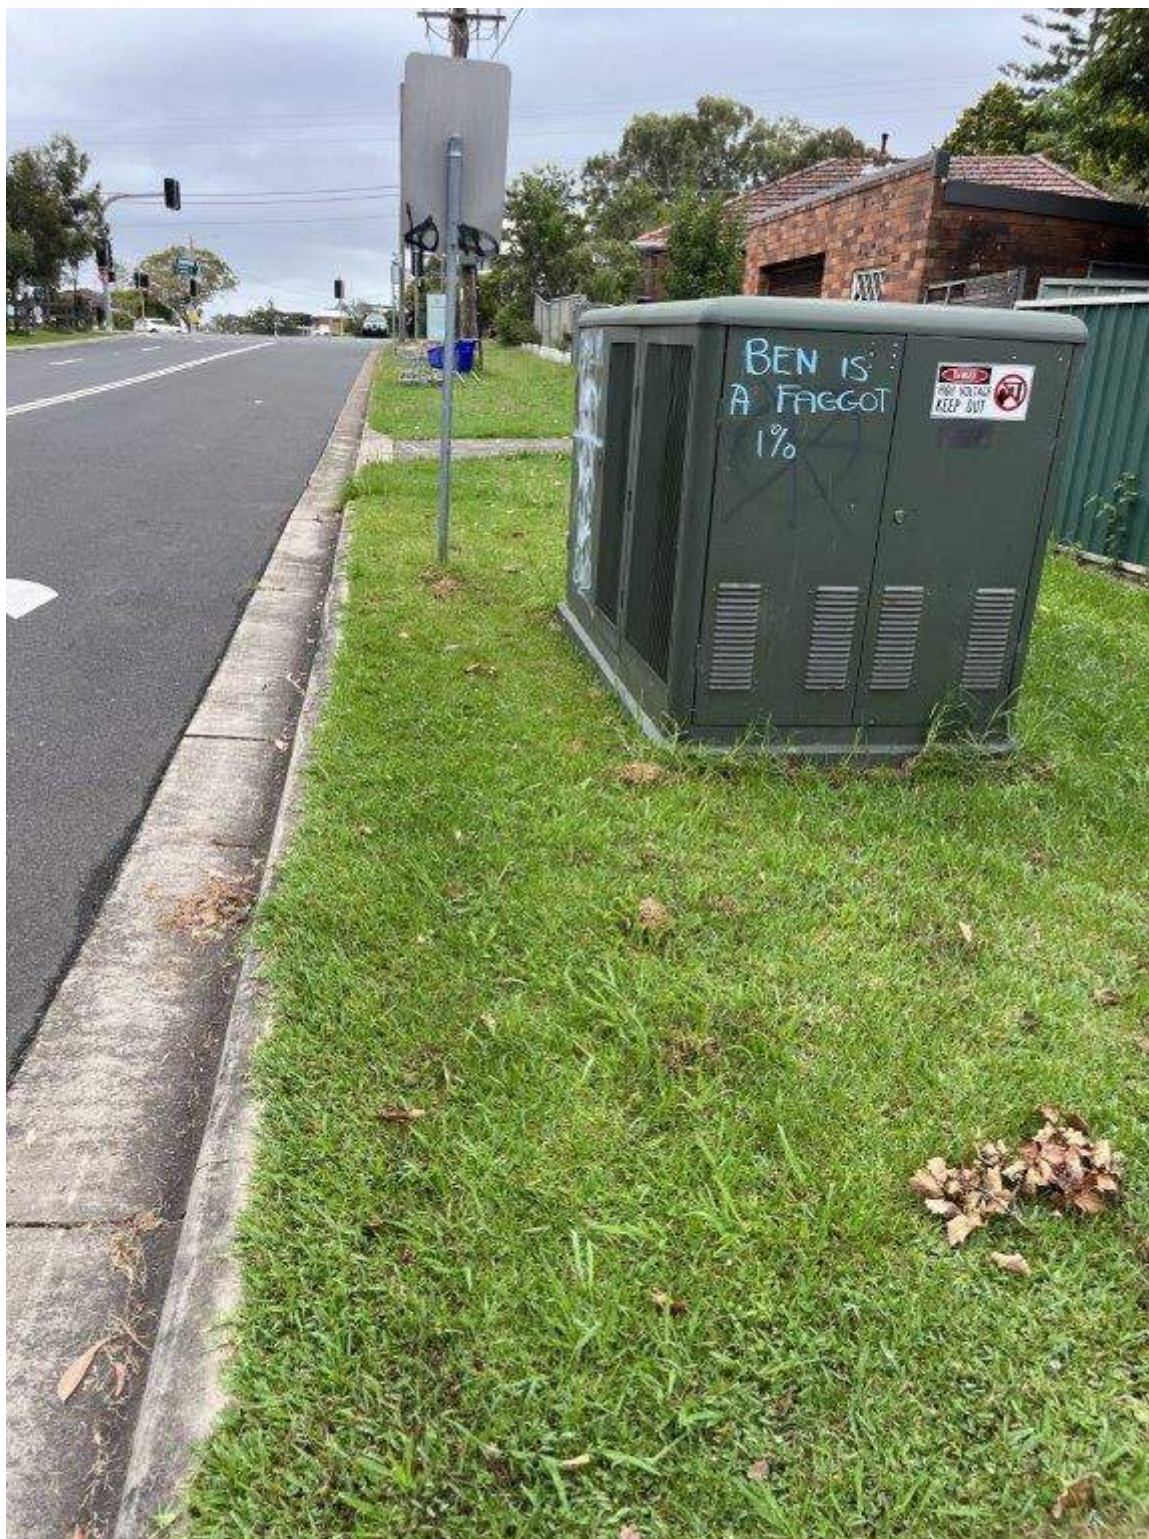
Photo 222 - Taren Point Road - Cracking of pavement

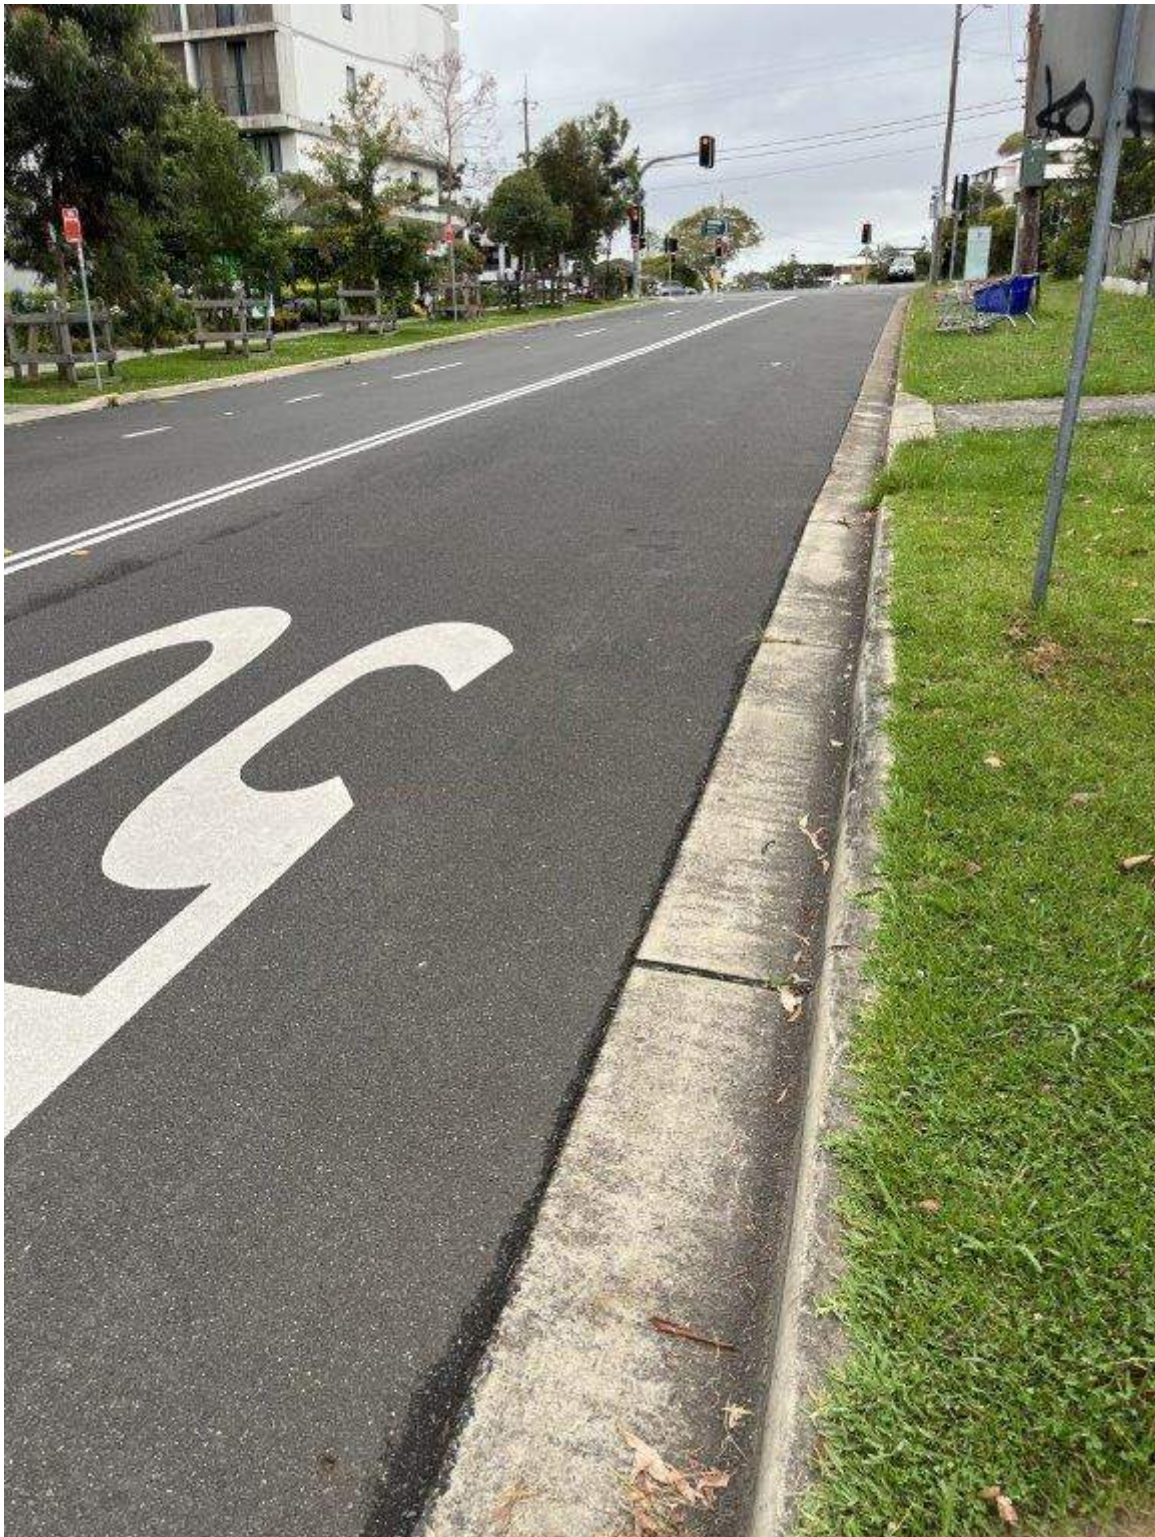
Photo 223 - Taren Point Road - Existing condition of pavement, signpost and vegetation
