## PRE-CONSTRUCTION DILAPIDATION REPORT

### 6-20 HINKLER AVENUE & 319-333 TAREN POINT ROAD, CARINGBAH

| PRE-CONSTRUCTION DILAPIDATION REPORT<br>6-20 Hinkler Avenue & 319-333 Taren Point Road,<br>Caringbah NSW 2229 | | | | | Project Number: 21039 |

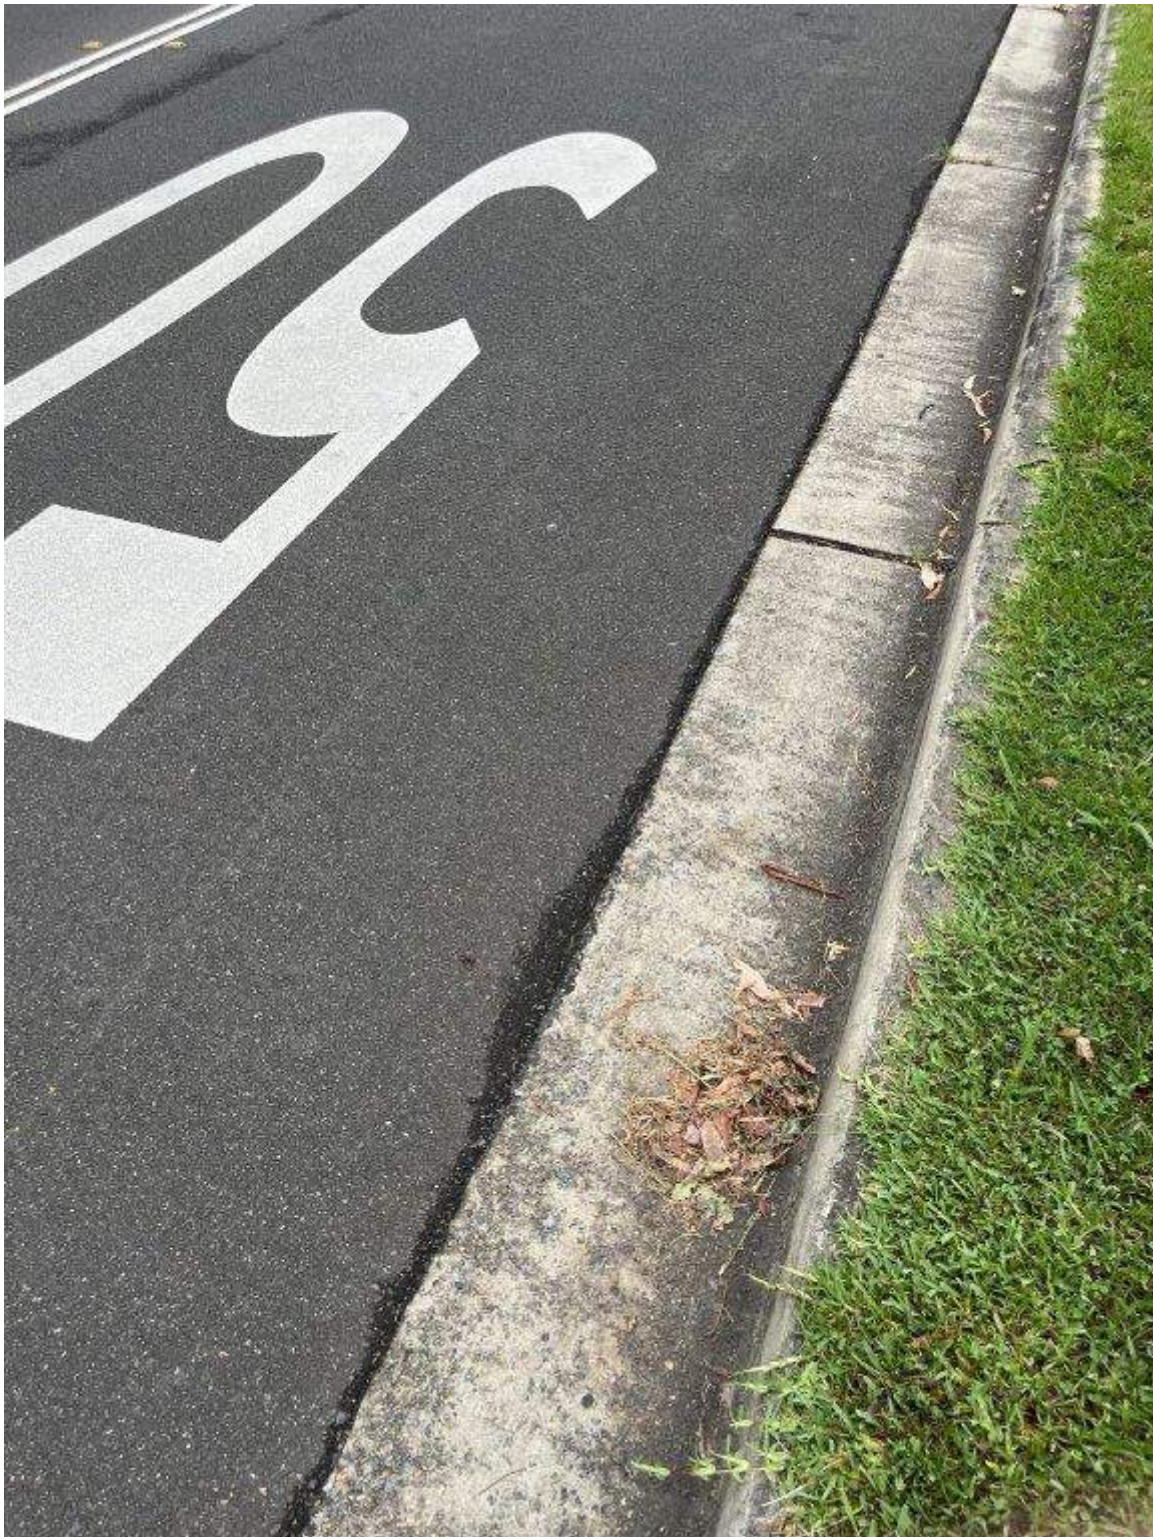
Photo 224 - Taren Point Road - Existing condition of pavement

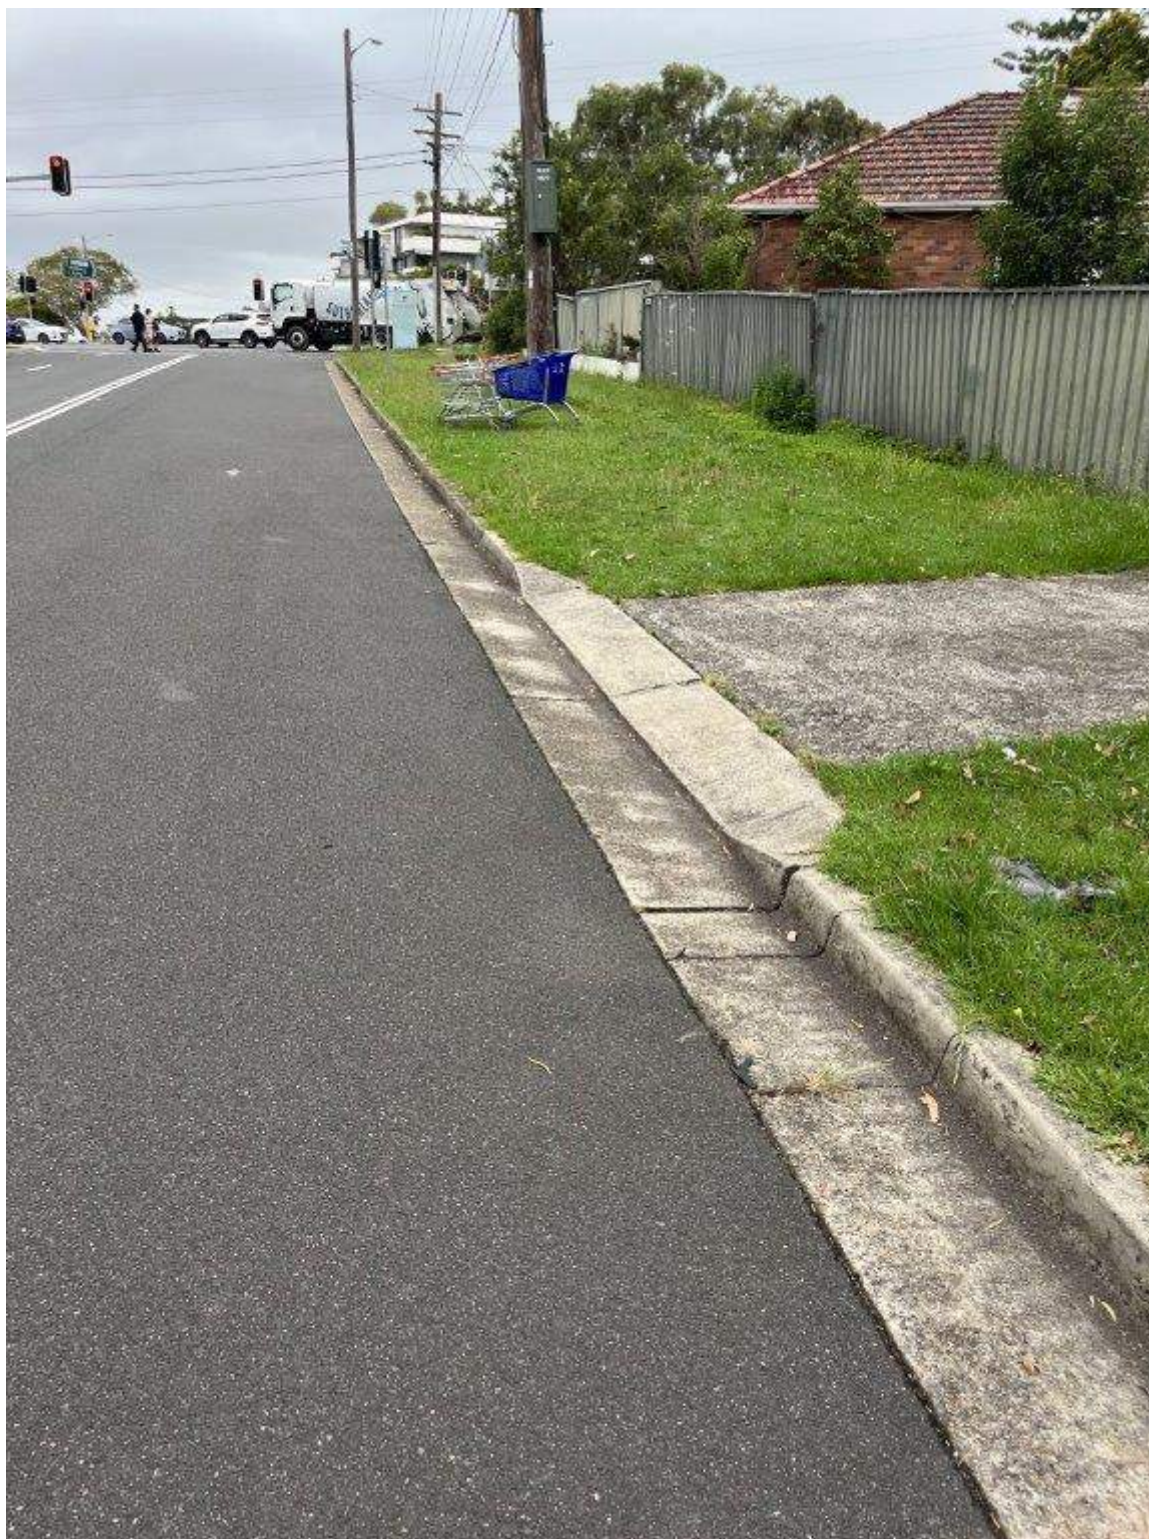
Photo 225 - Taren Point Road - Existing condition of pavement

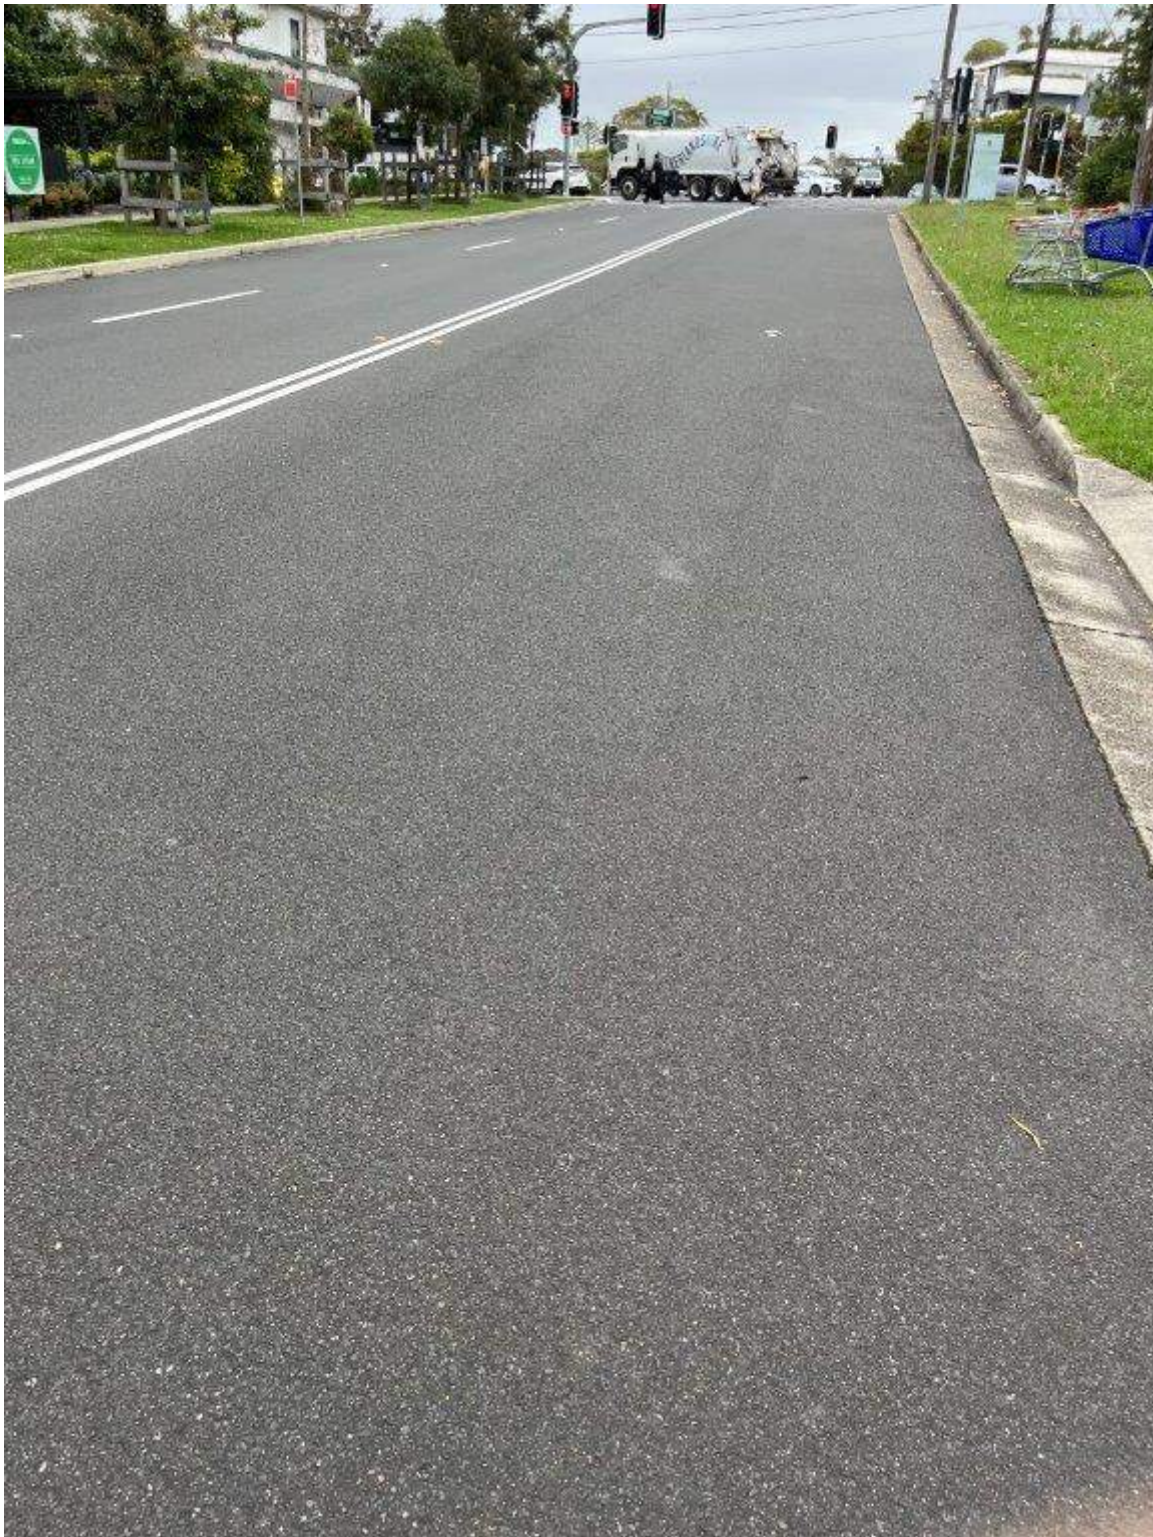
Photo 226 - Taren Point Road - Existing condition of pavement and vegetation

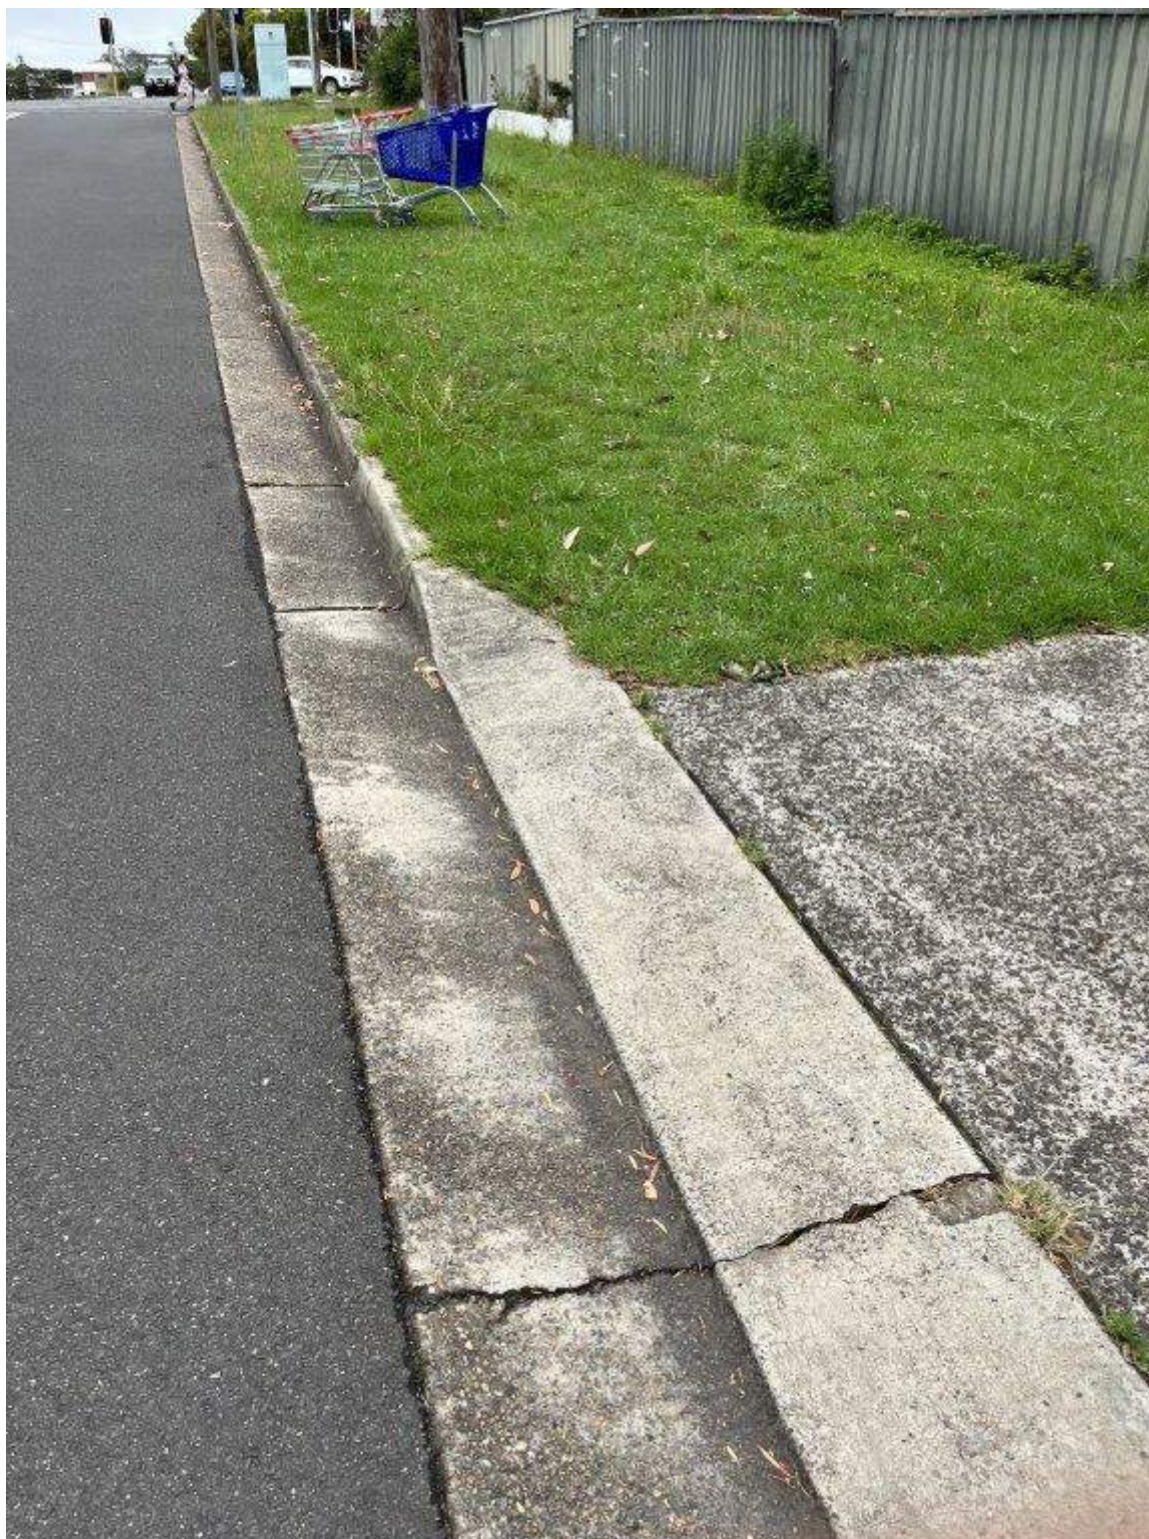
Photo 227 - Taren Point Road - Existing condition of pavement

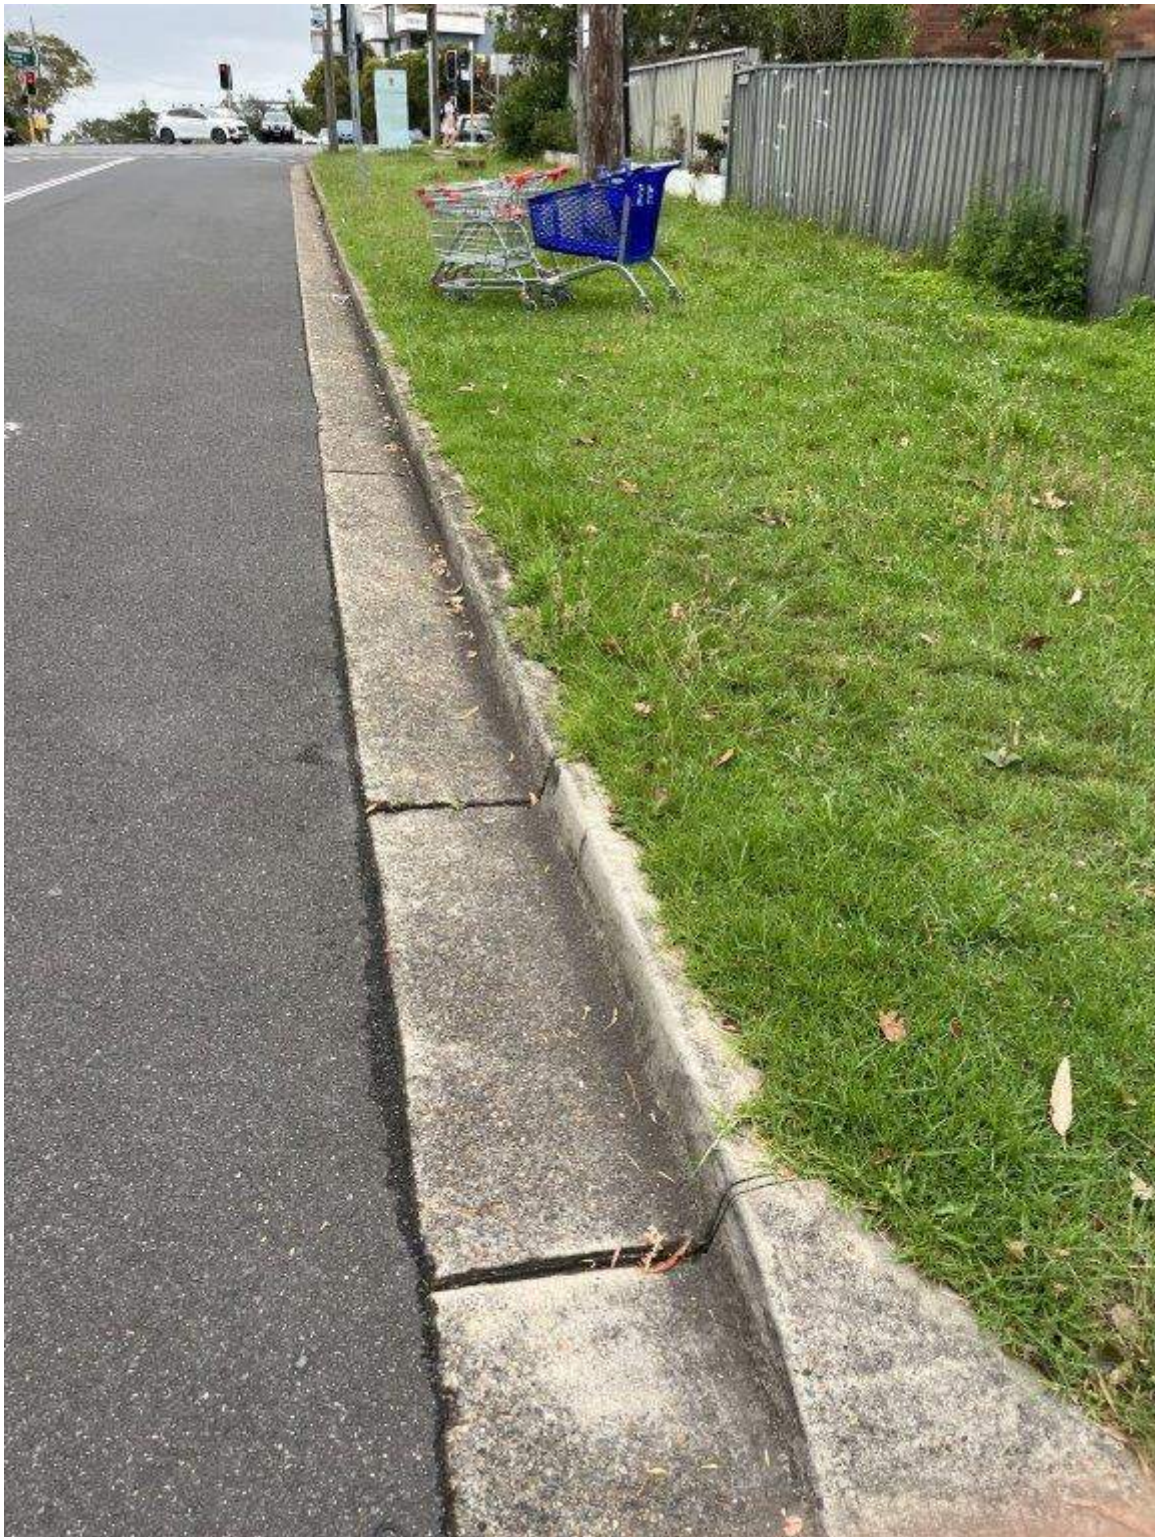
Photo 228 - Taren Point Road - Cracking of pavement

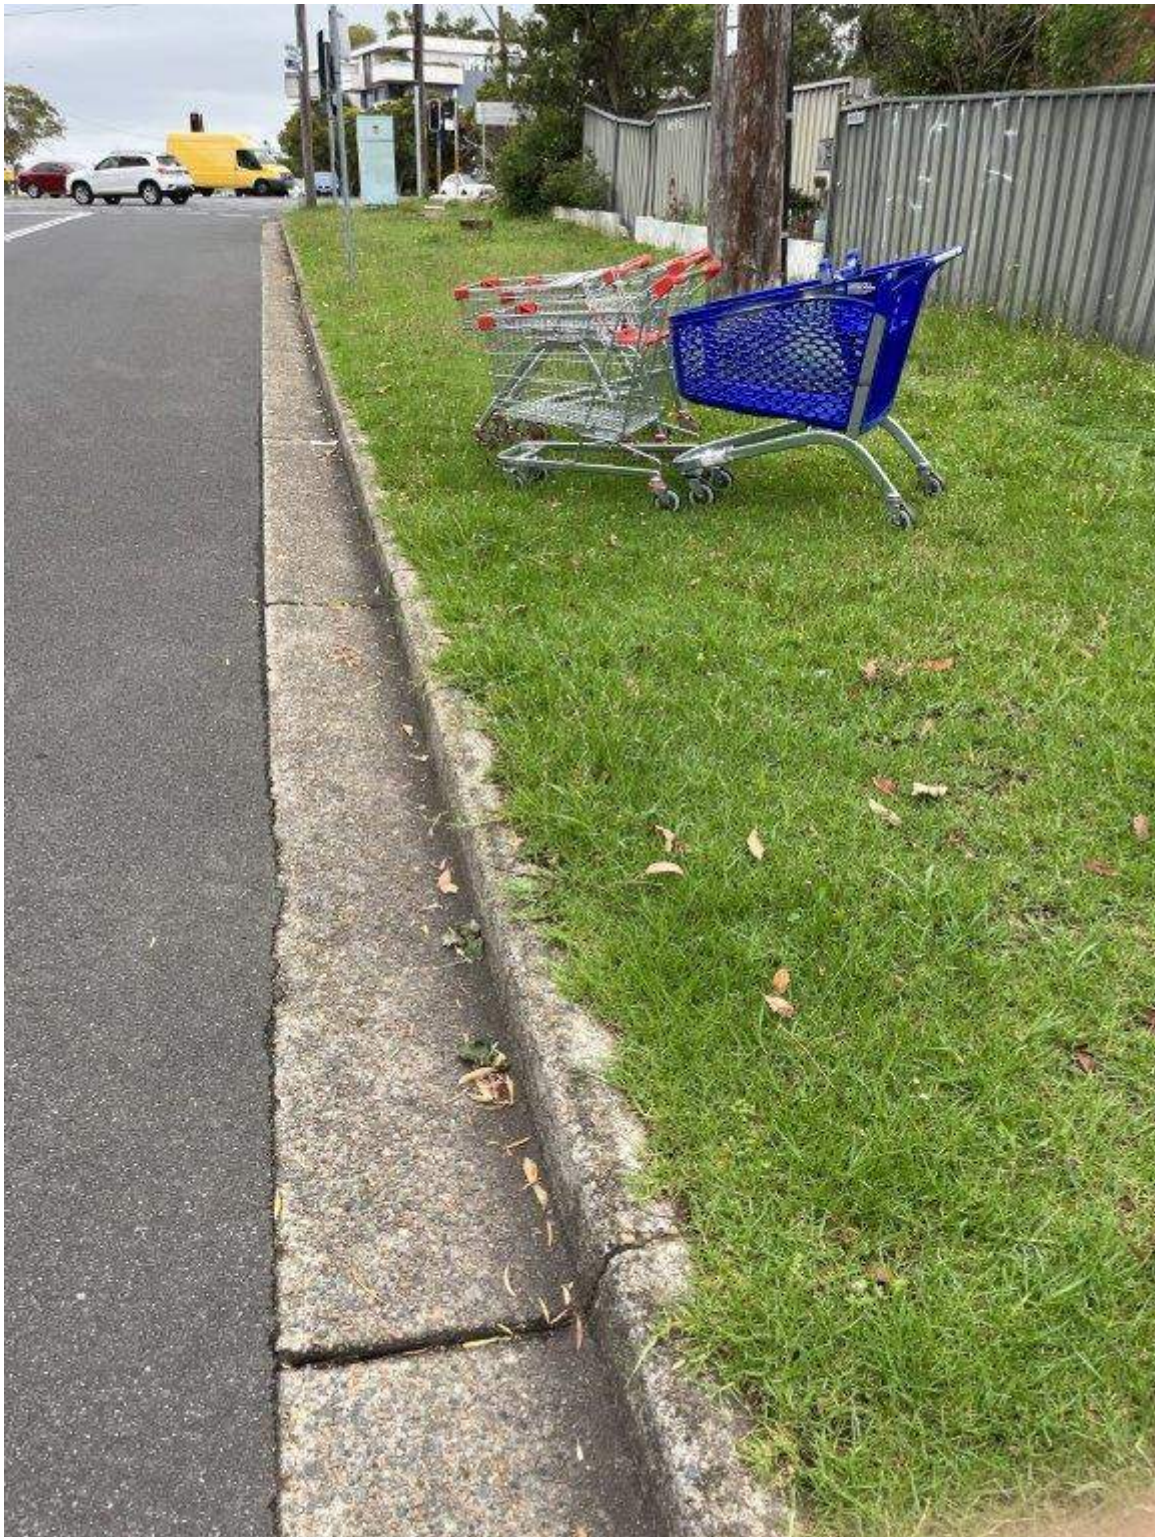
Photo 229 - Taren Point Road - Existing condition of pavement and vegetation

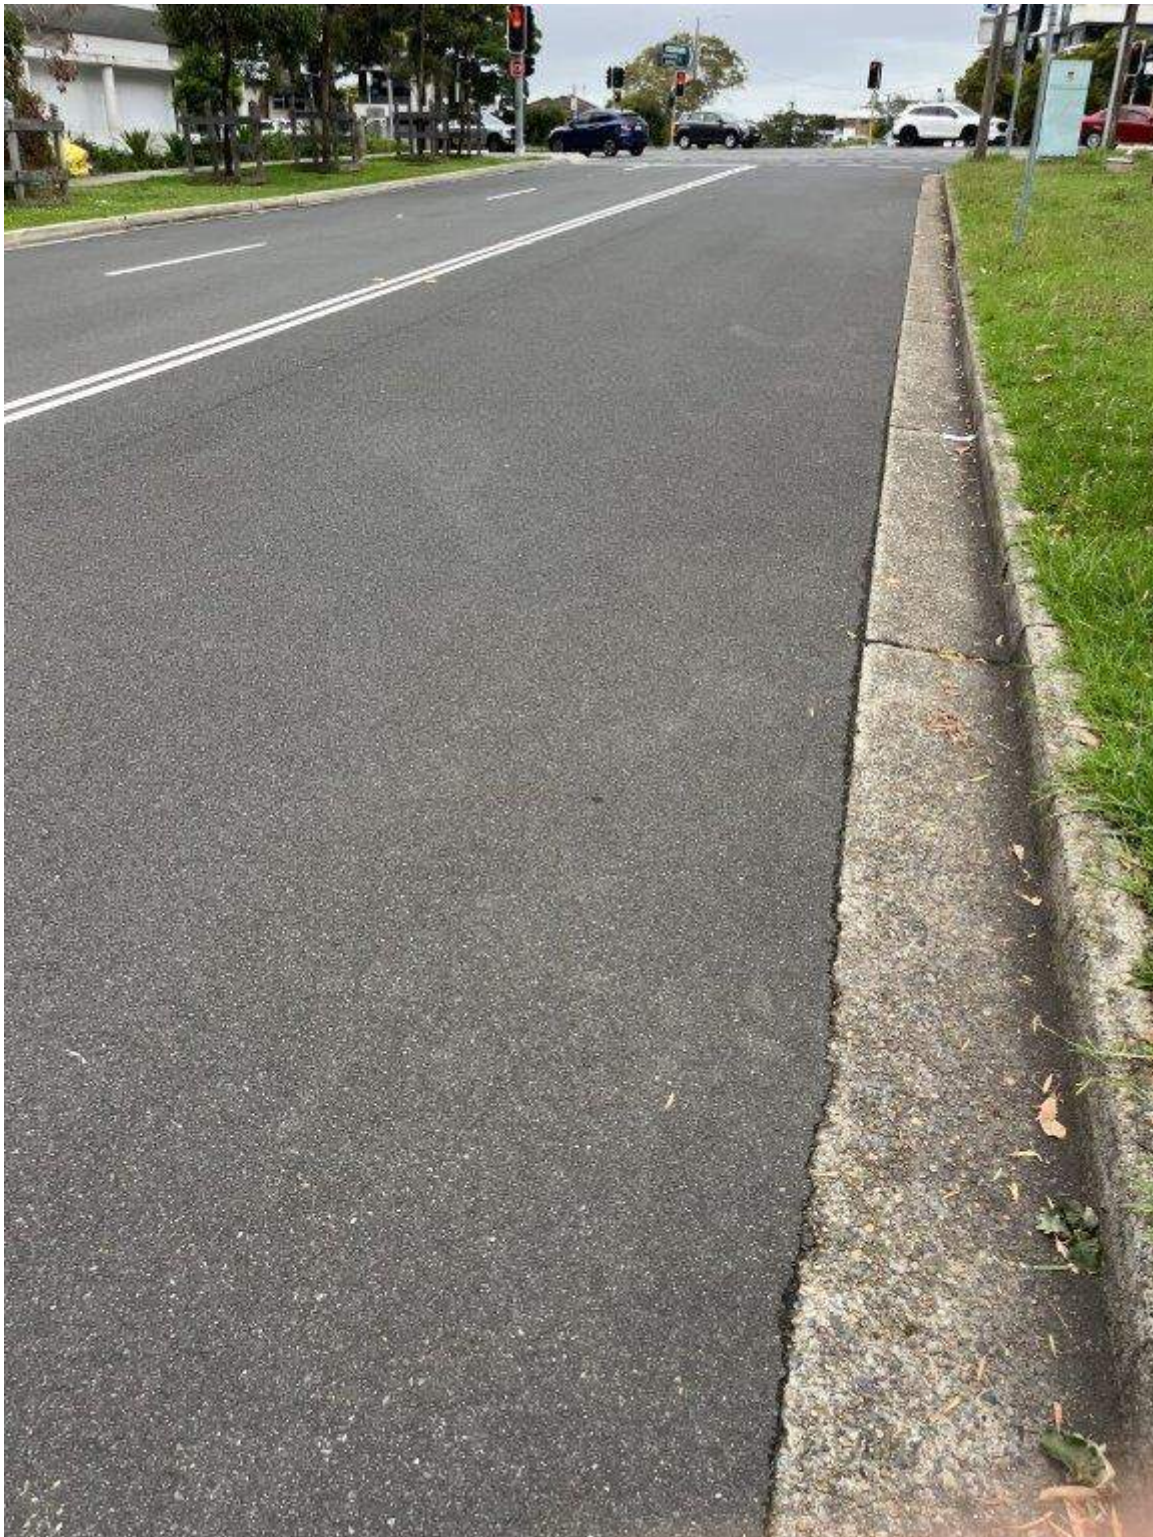
Photo 230 - Taren Point Road - Existing condition of pavement and vegetation

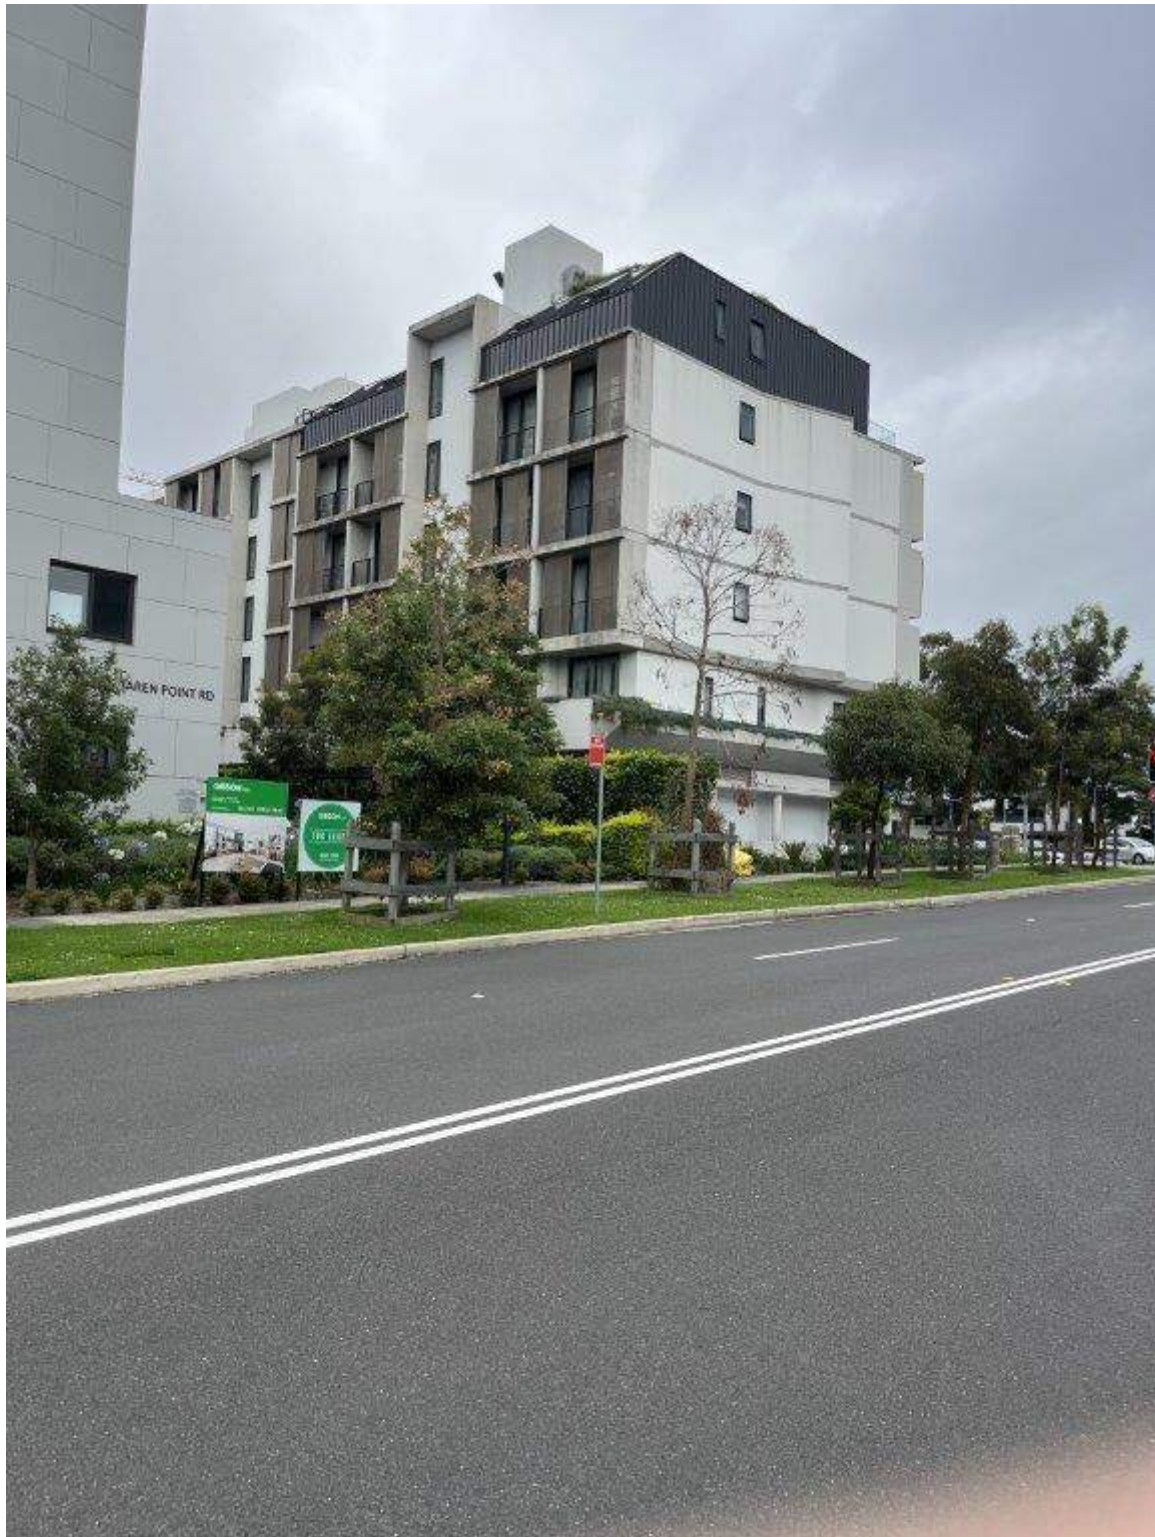
Photo 231 - Taren Point Road - Existing condition of pavement

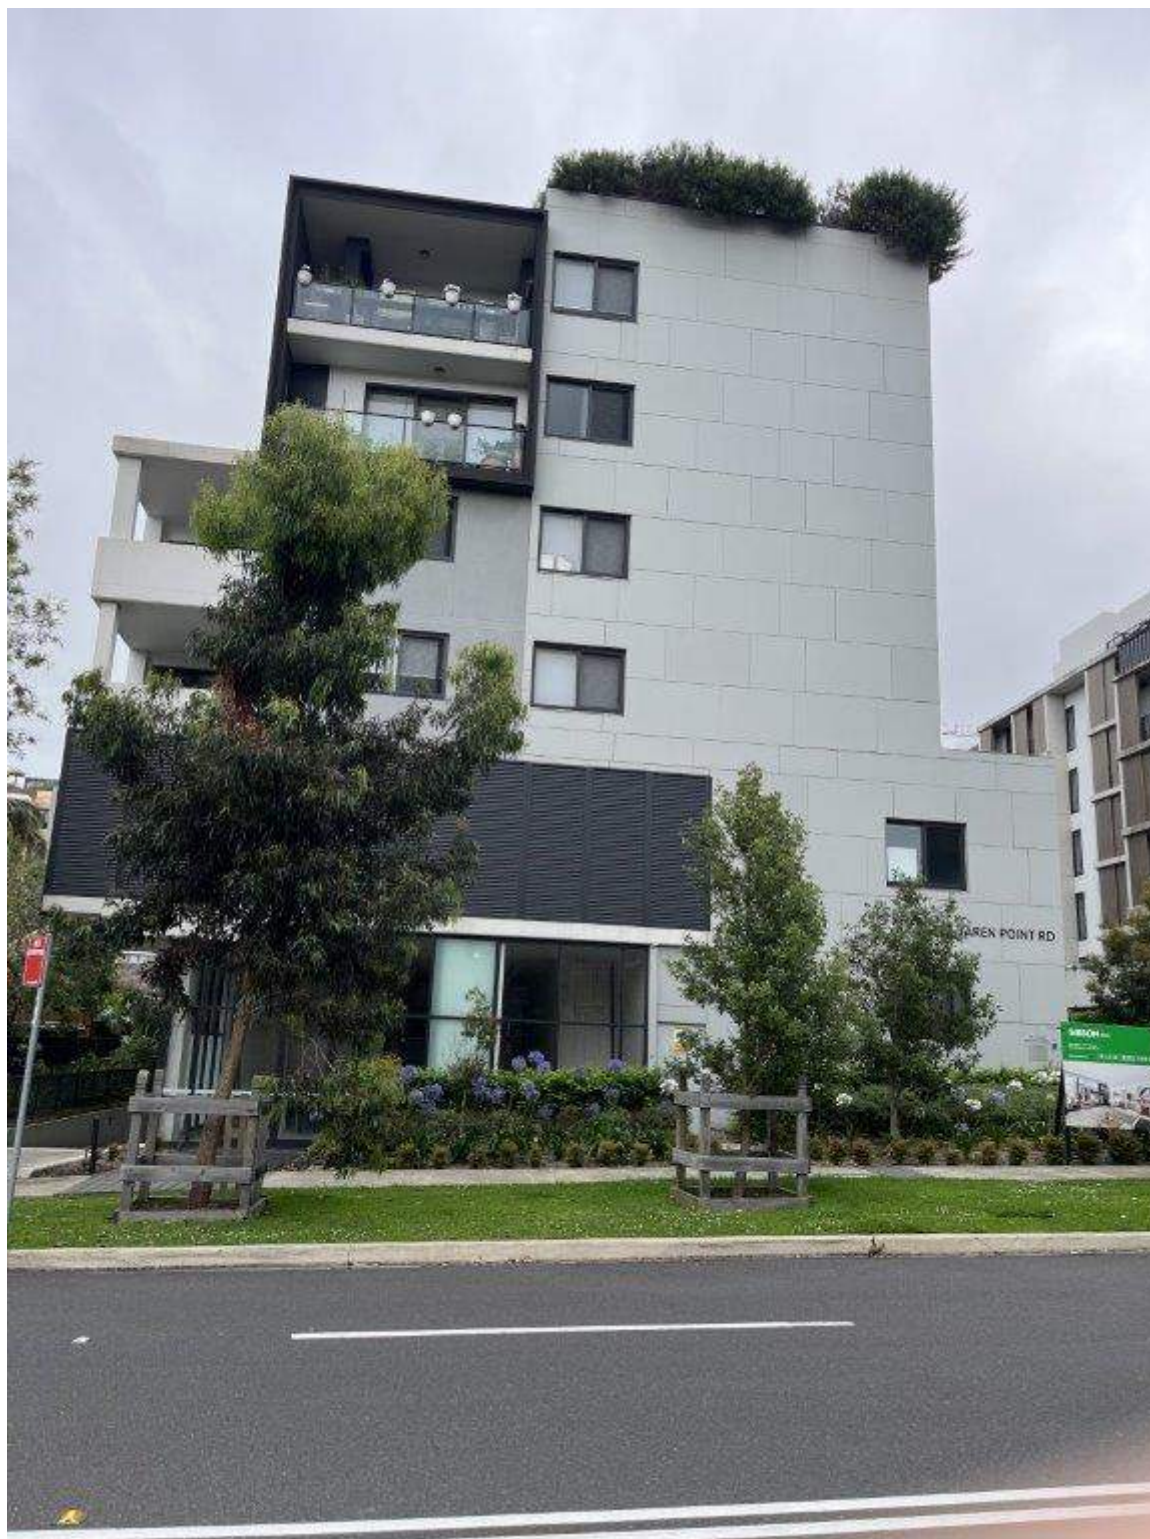
Photo 232 - Taren Point Road - Existing condition of external façade and pavement

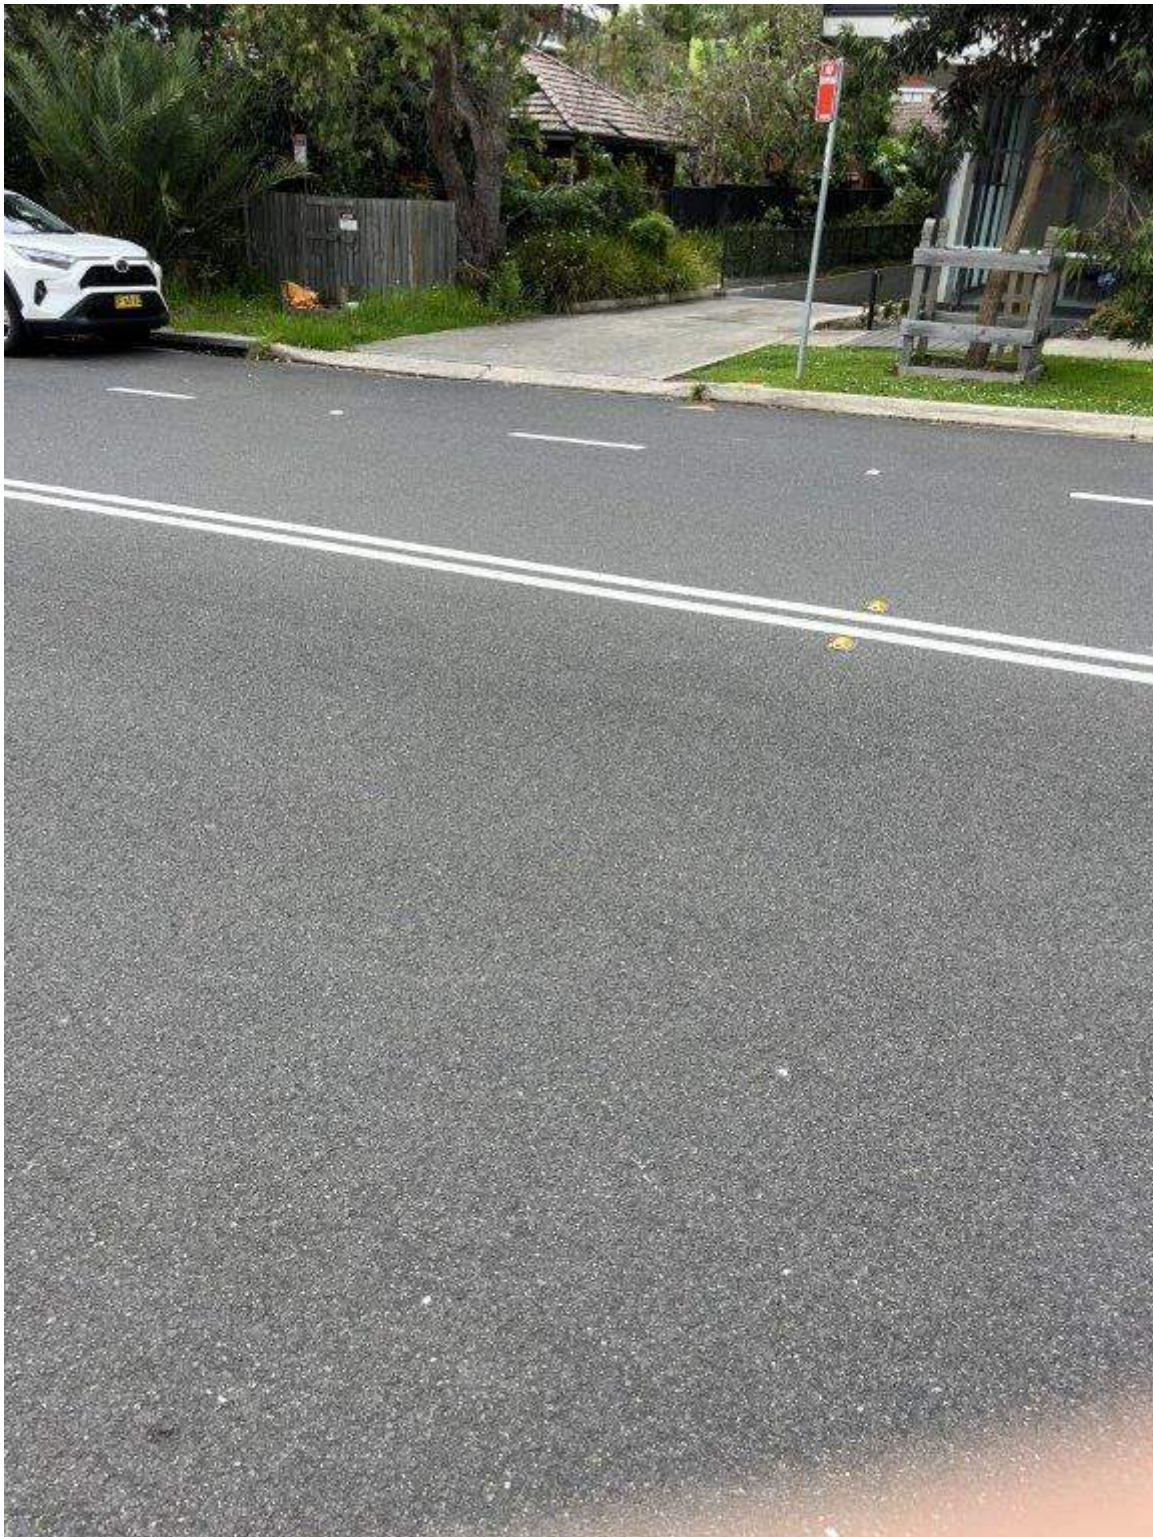
Photo 234 - Taren Point Road - Existing condition of pavement

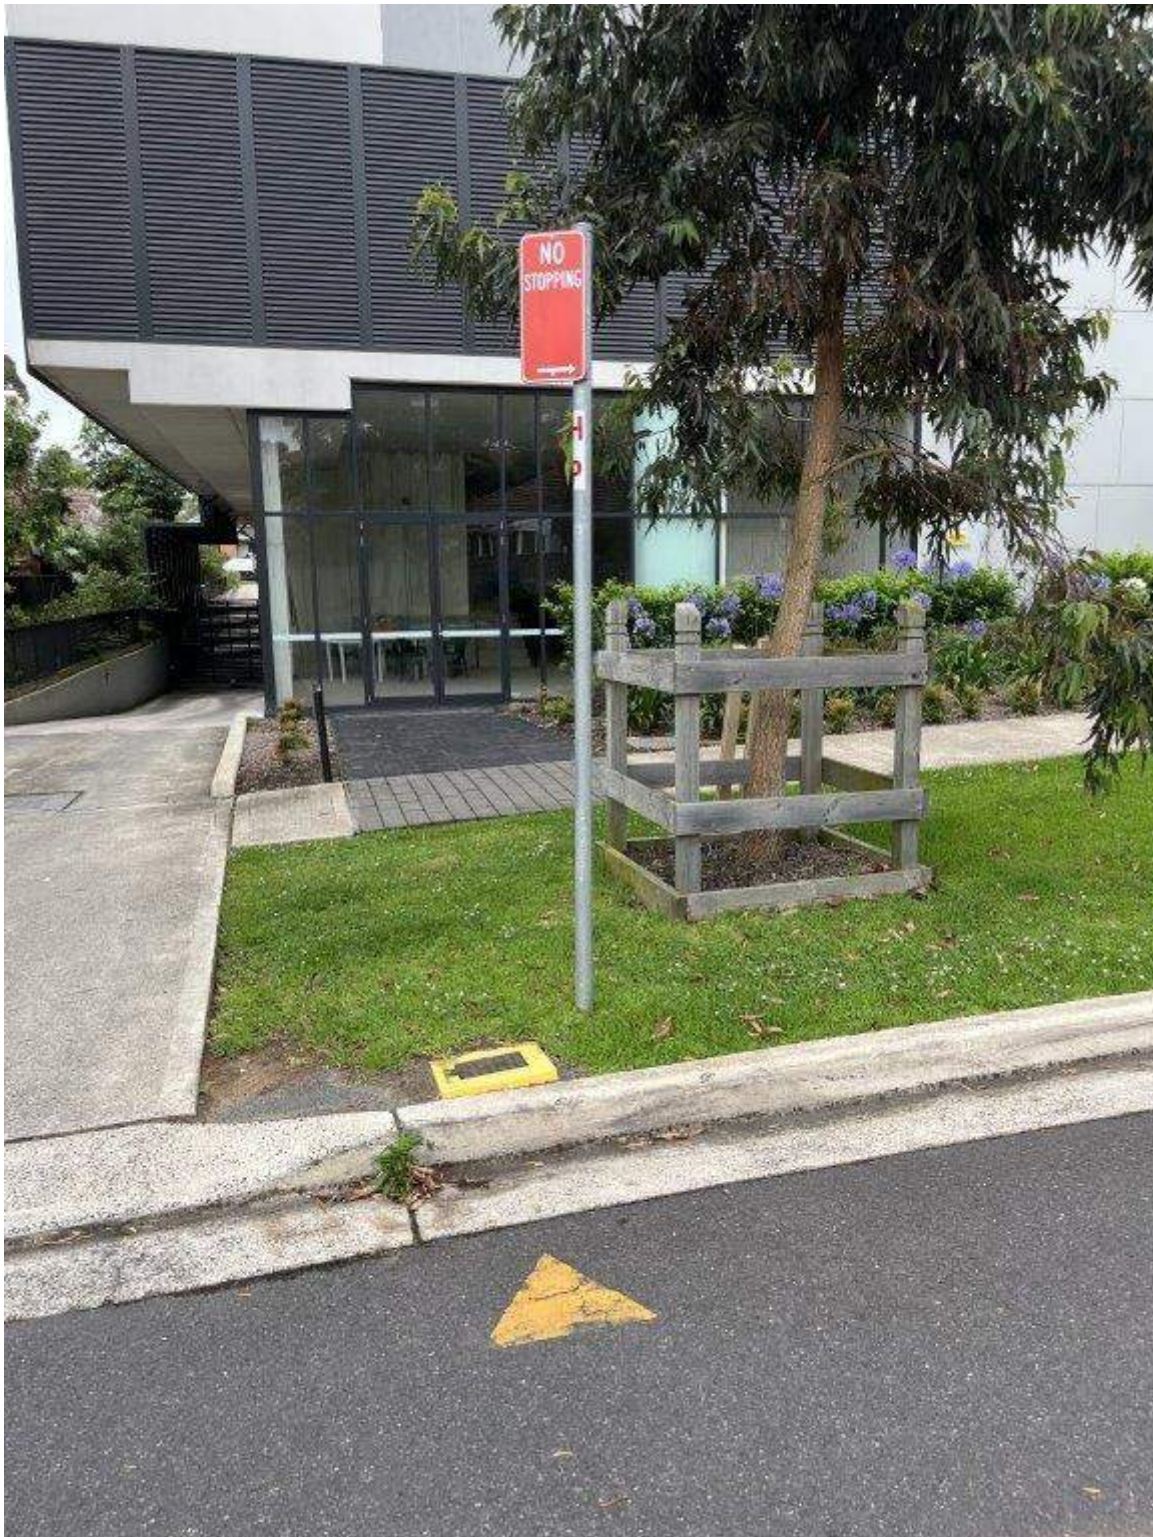
Photo 236 - Taren Point Road - Cracking of pavement

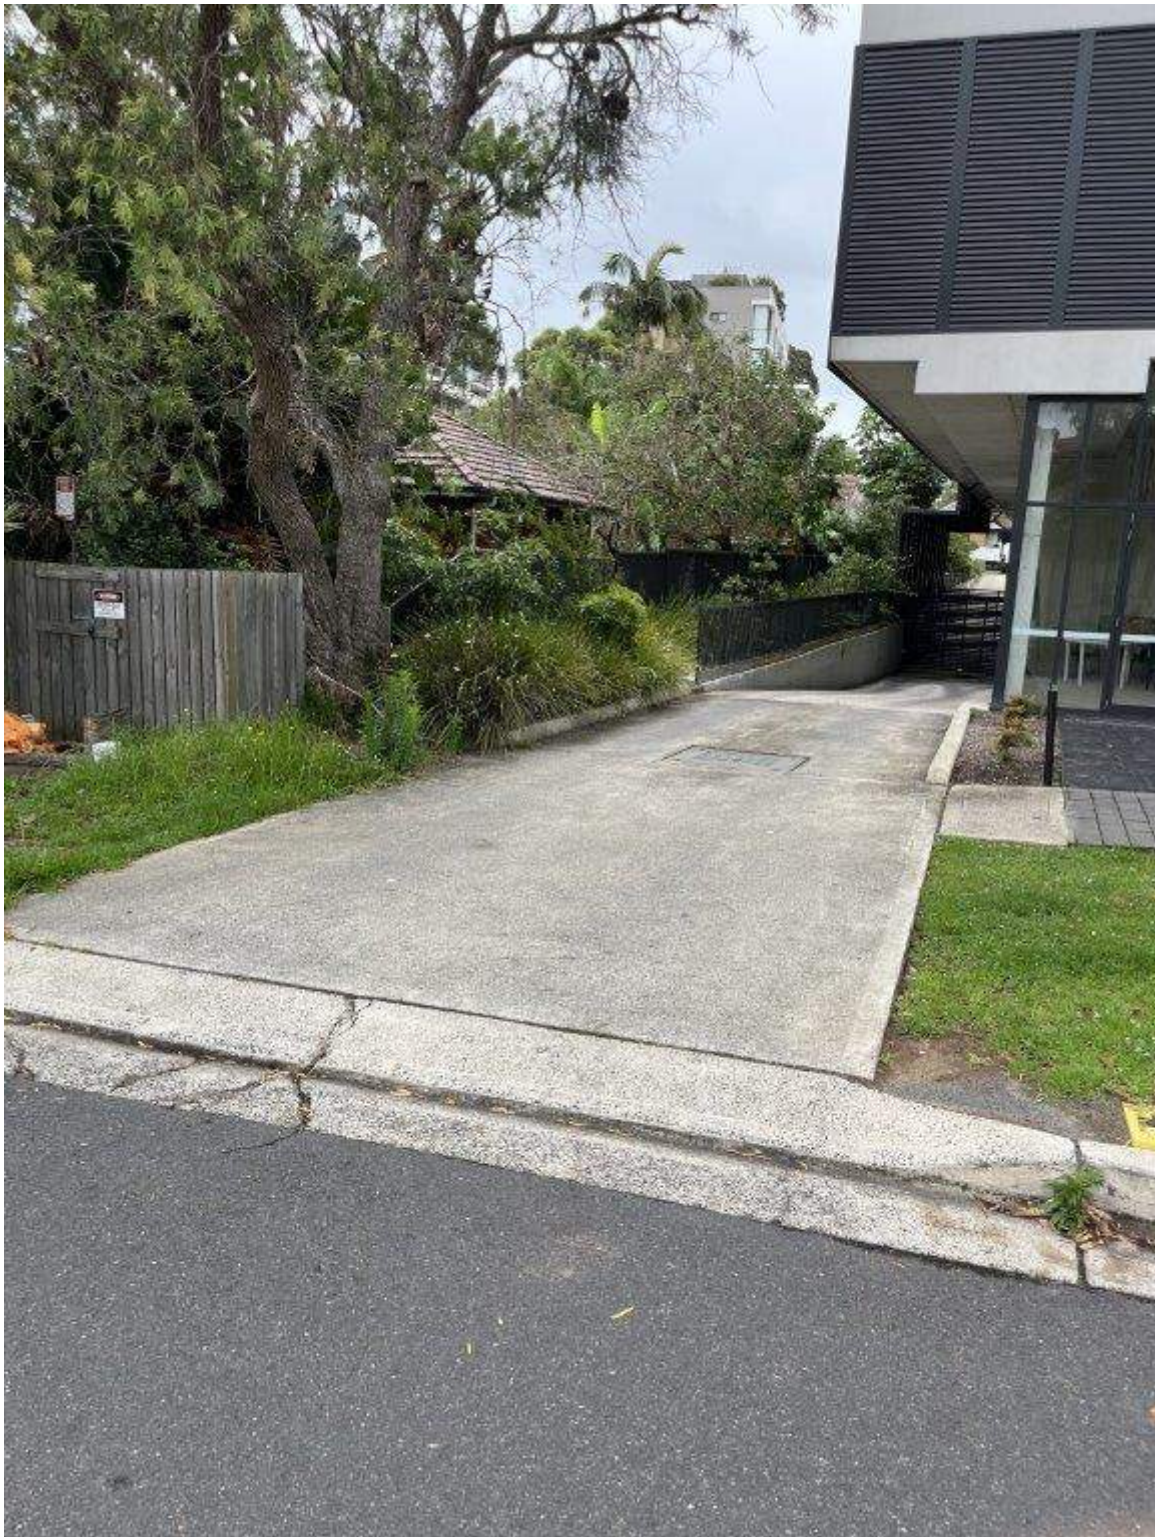
Photo 237 - Taren Point Road - Existing condition of pavement and vegetation

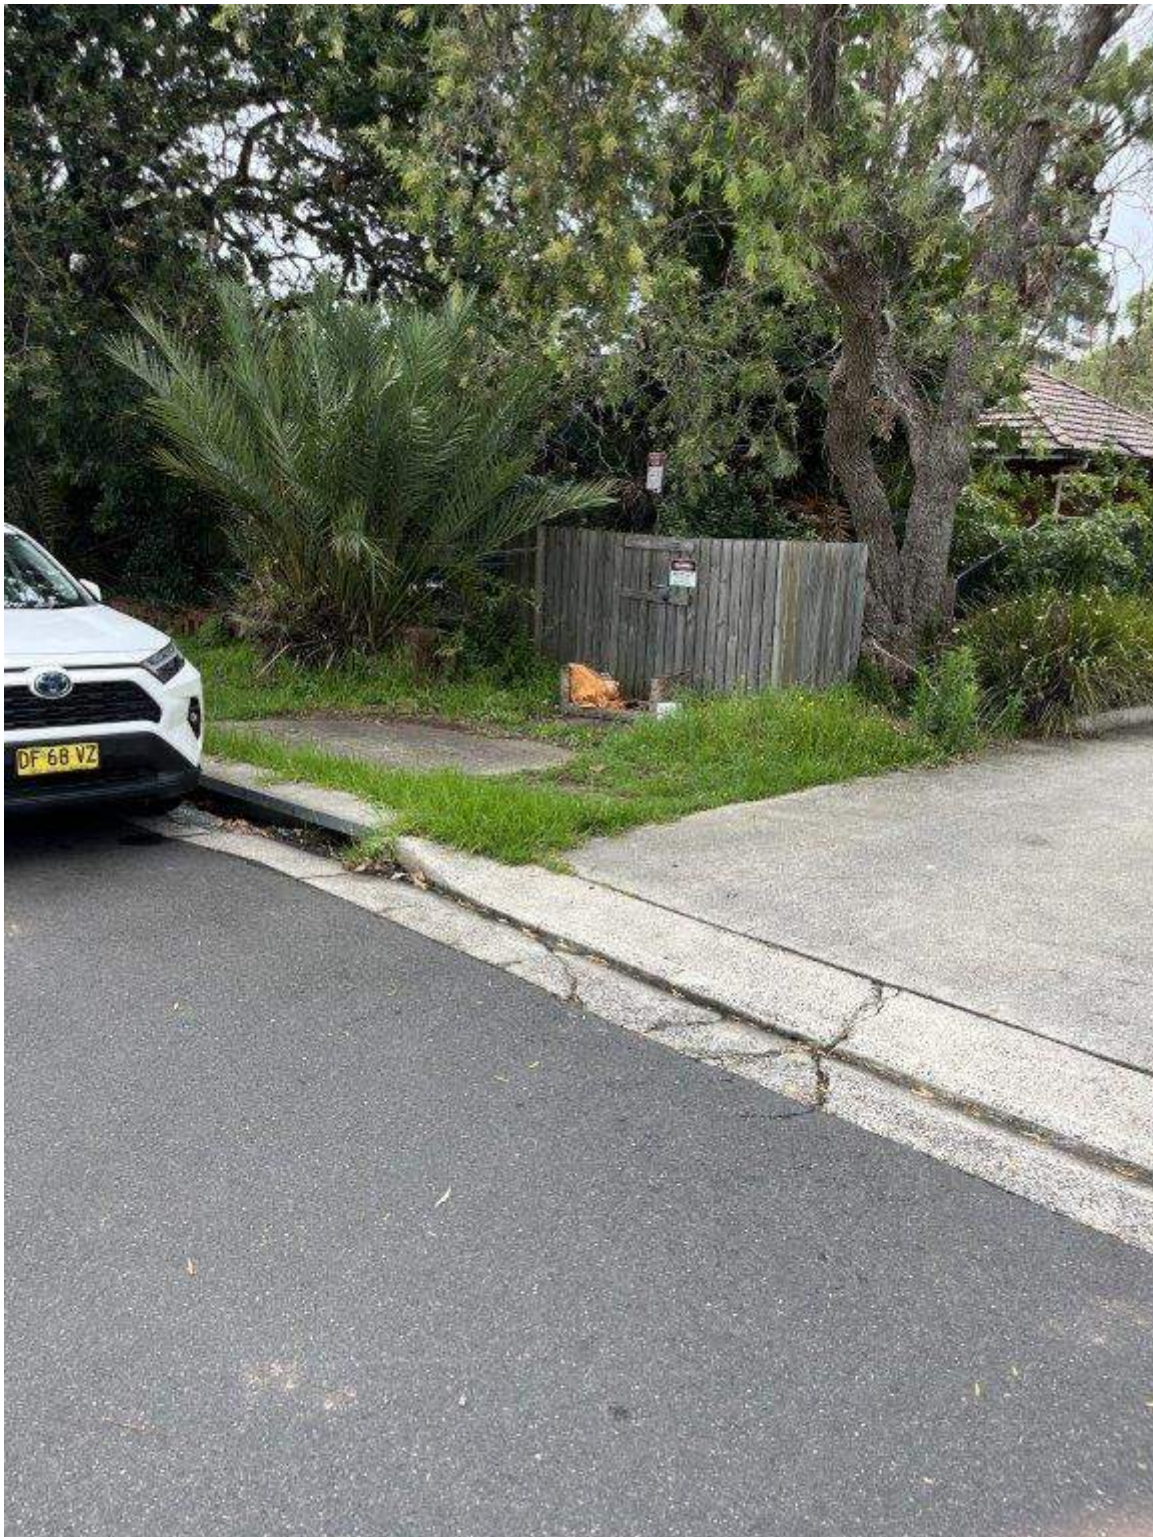
Photo 238 - Taren Point Road - Cracking of pavement
