## PRE-CONSTRUCTION DILAPIDATION REPORT

### 6-20 HINKLER AVENUE & 319-333 TAREN POINT ROAD, CARINGBAH

| PRE-CONSTRUCTION DILAPIDATION REPORT<br>6-20 Hinkler Avenue & 319-333 Taren Point Road,<br>Caringbah NSW 2229 | | | | | Project Number: 21039 |

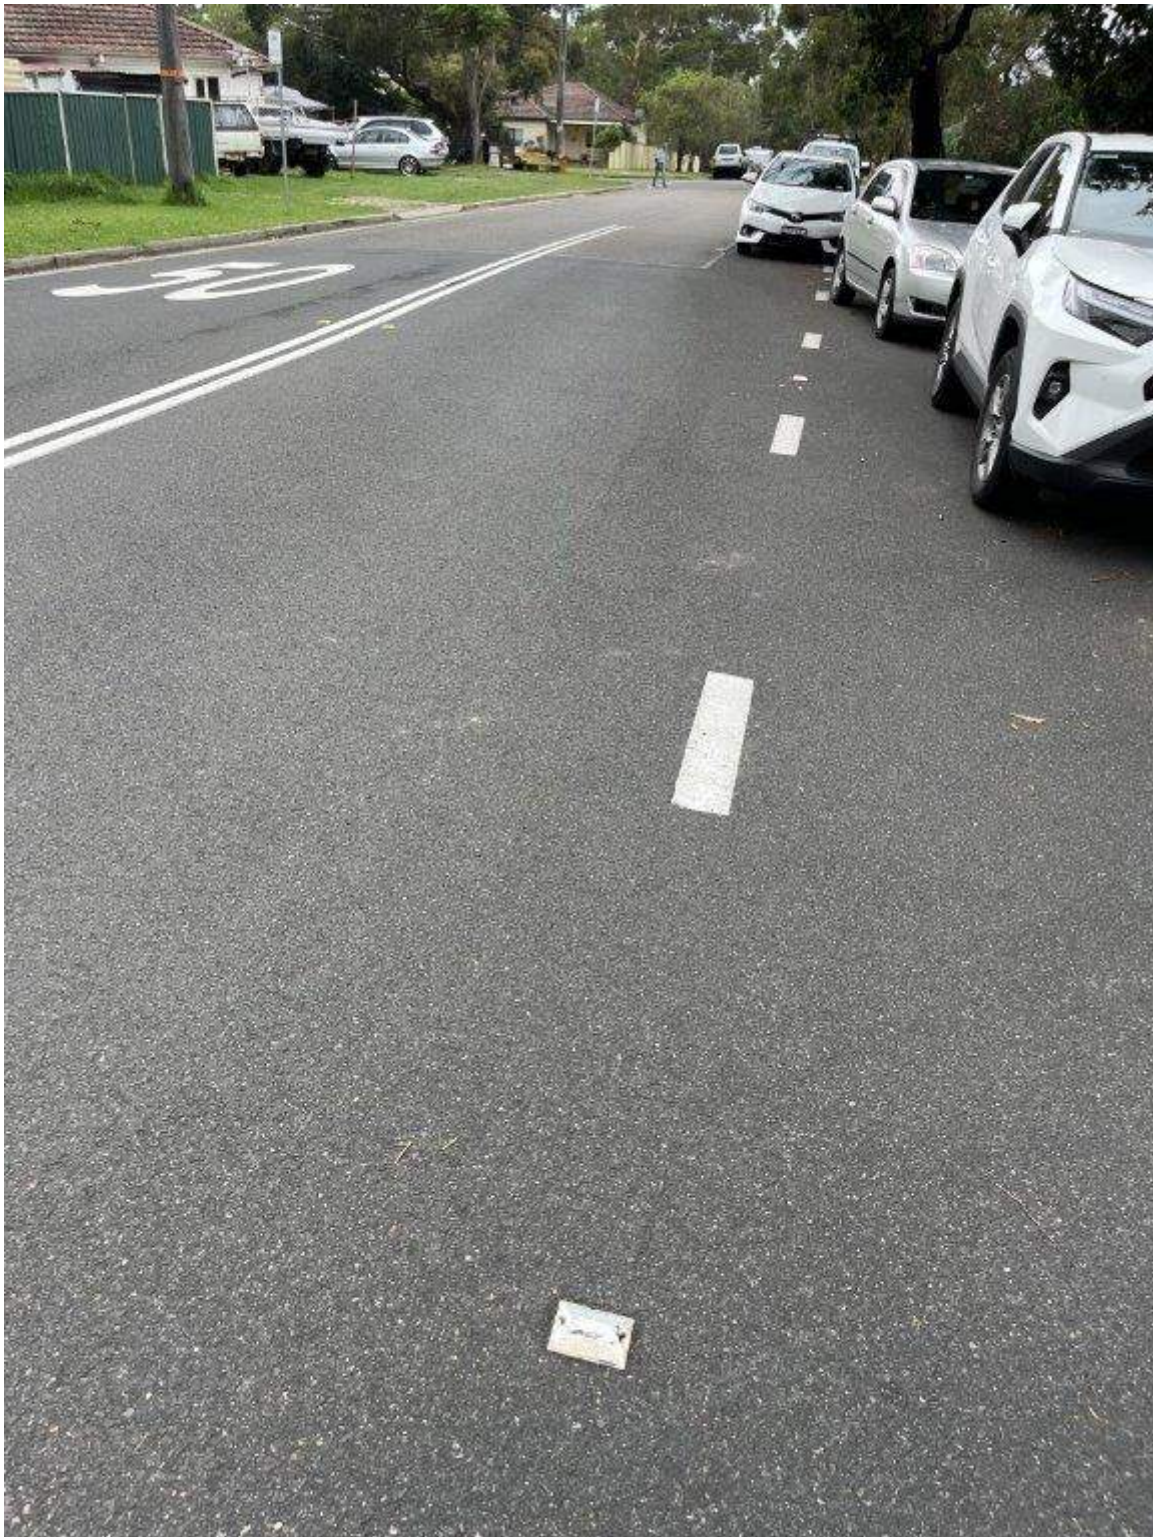
Photo 239 - Taren Point Road - Cracking of pavement

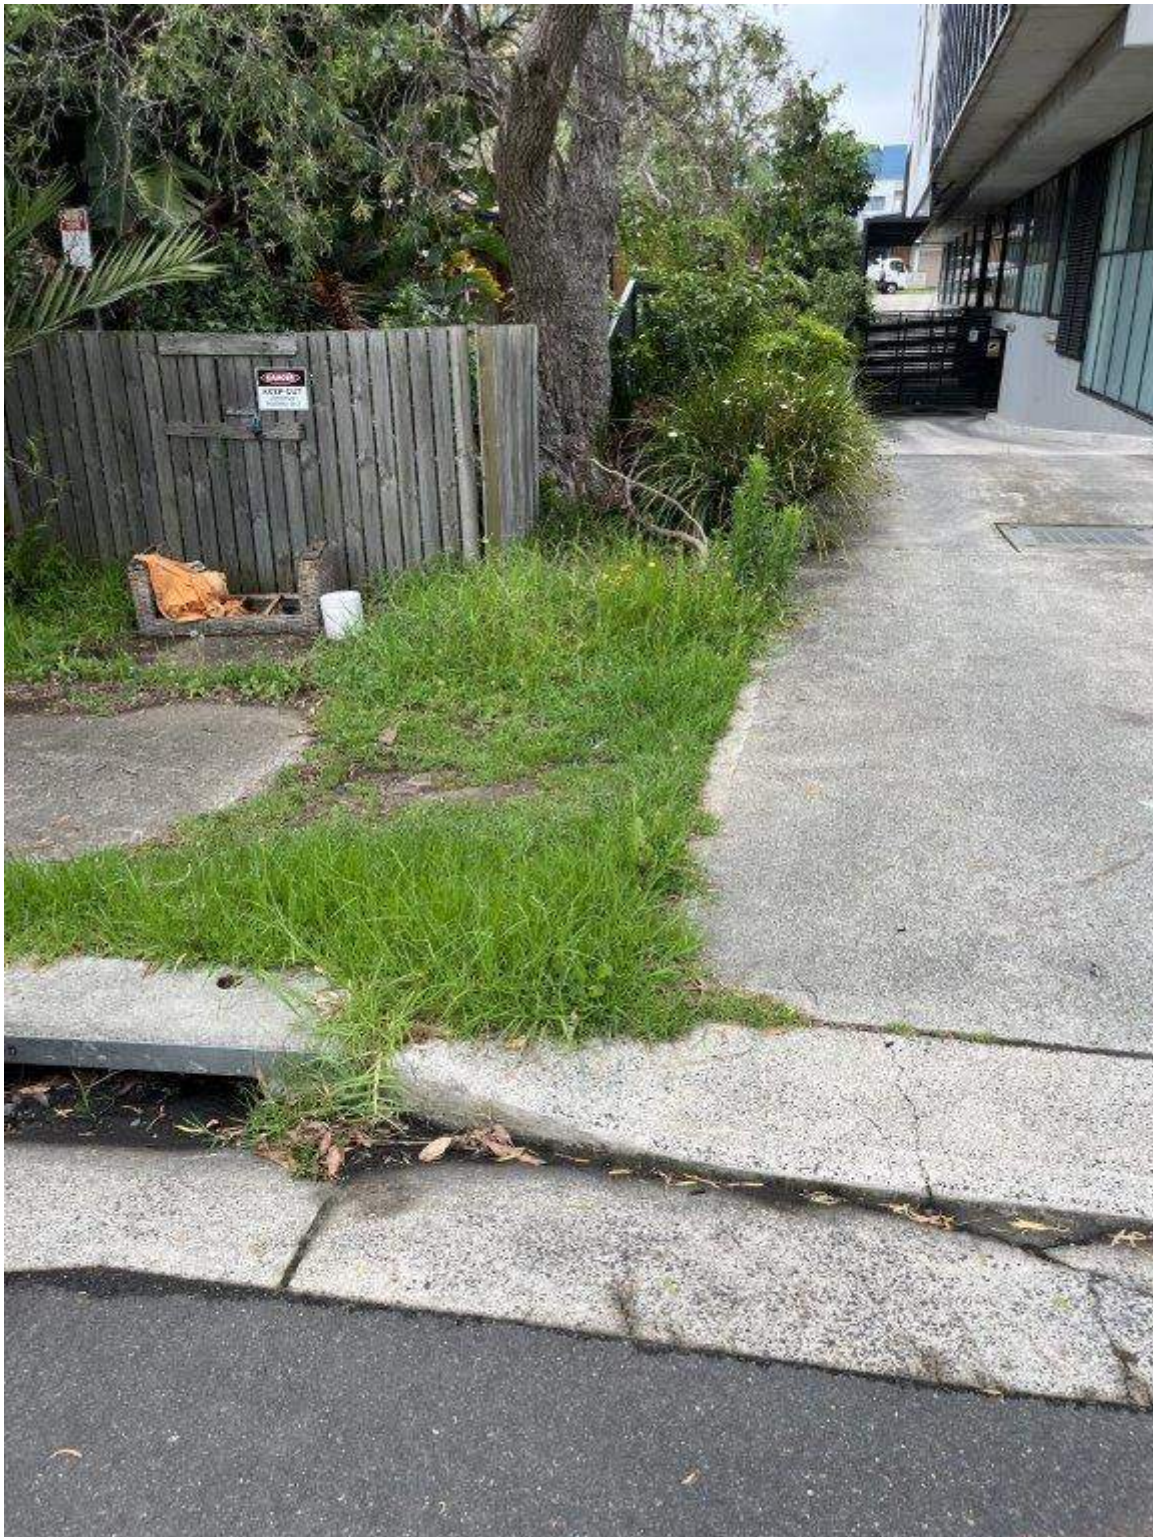
Photo 240 - Taren Point Road - Existing condition of pavement

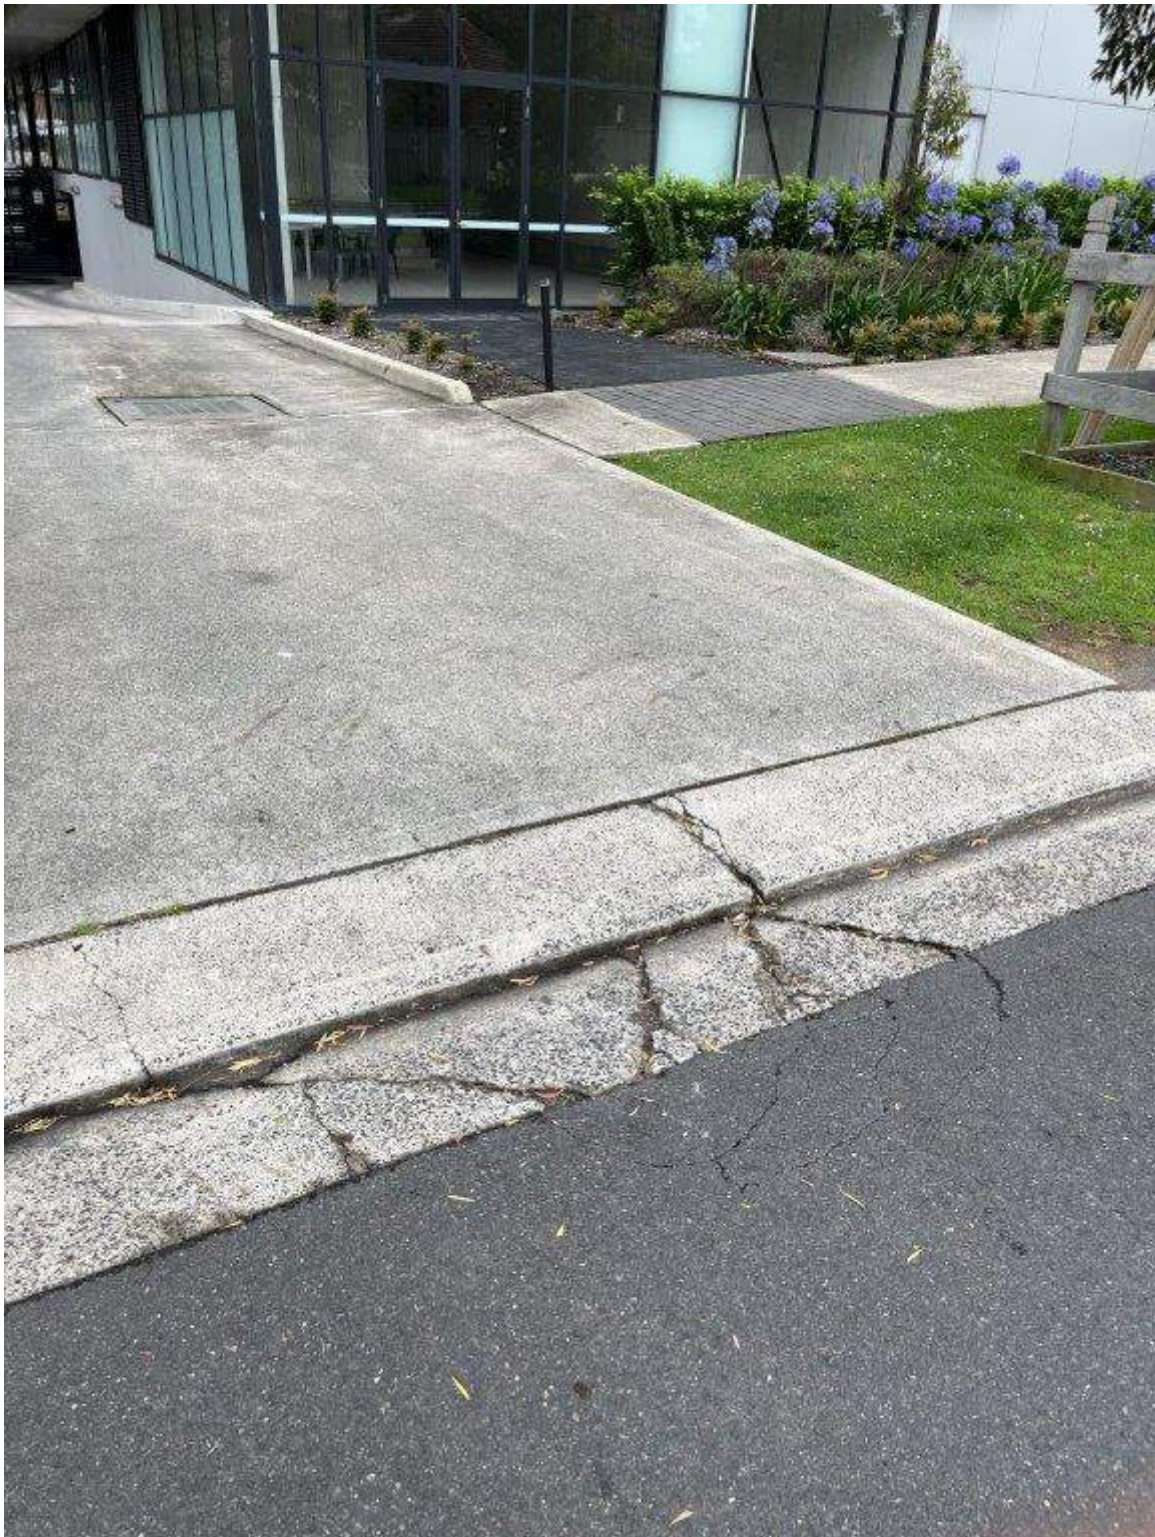
Photo 241 - Taren Point Road - Cracking of pavement

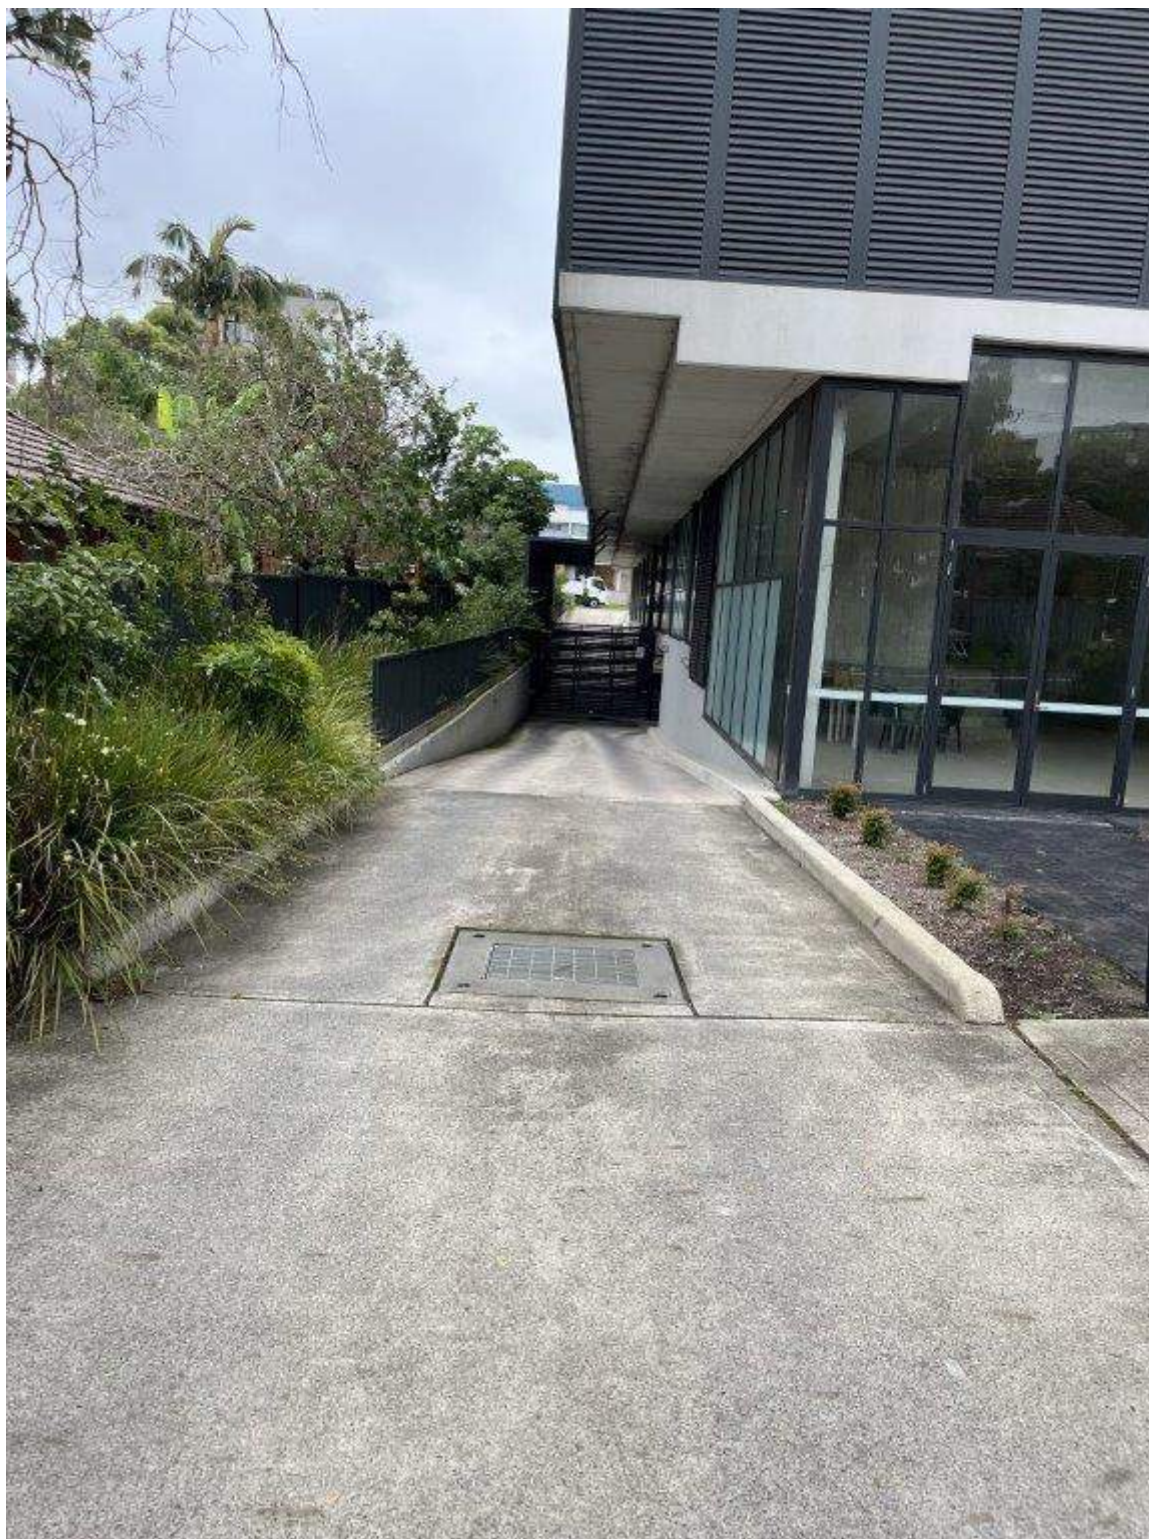
Photo 242 - Taren Point Road - Cracking of pavement

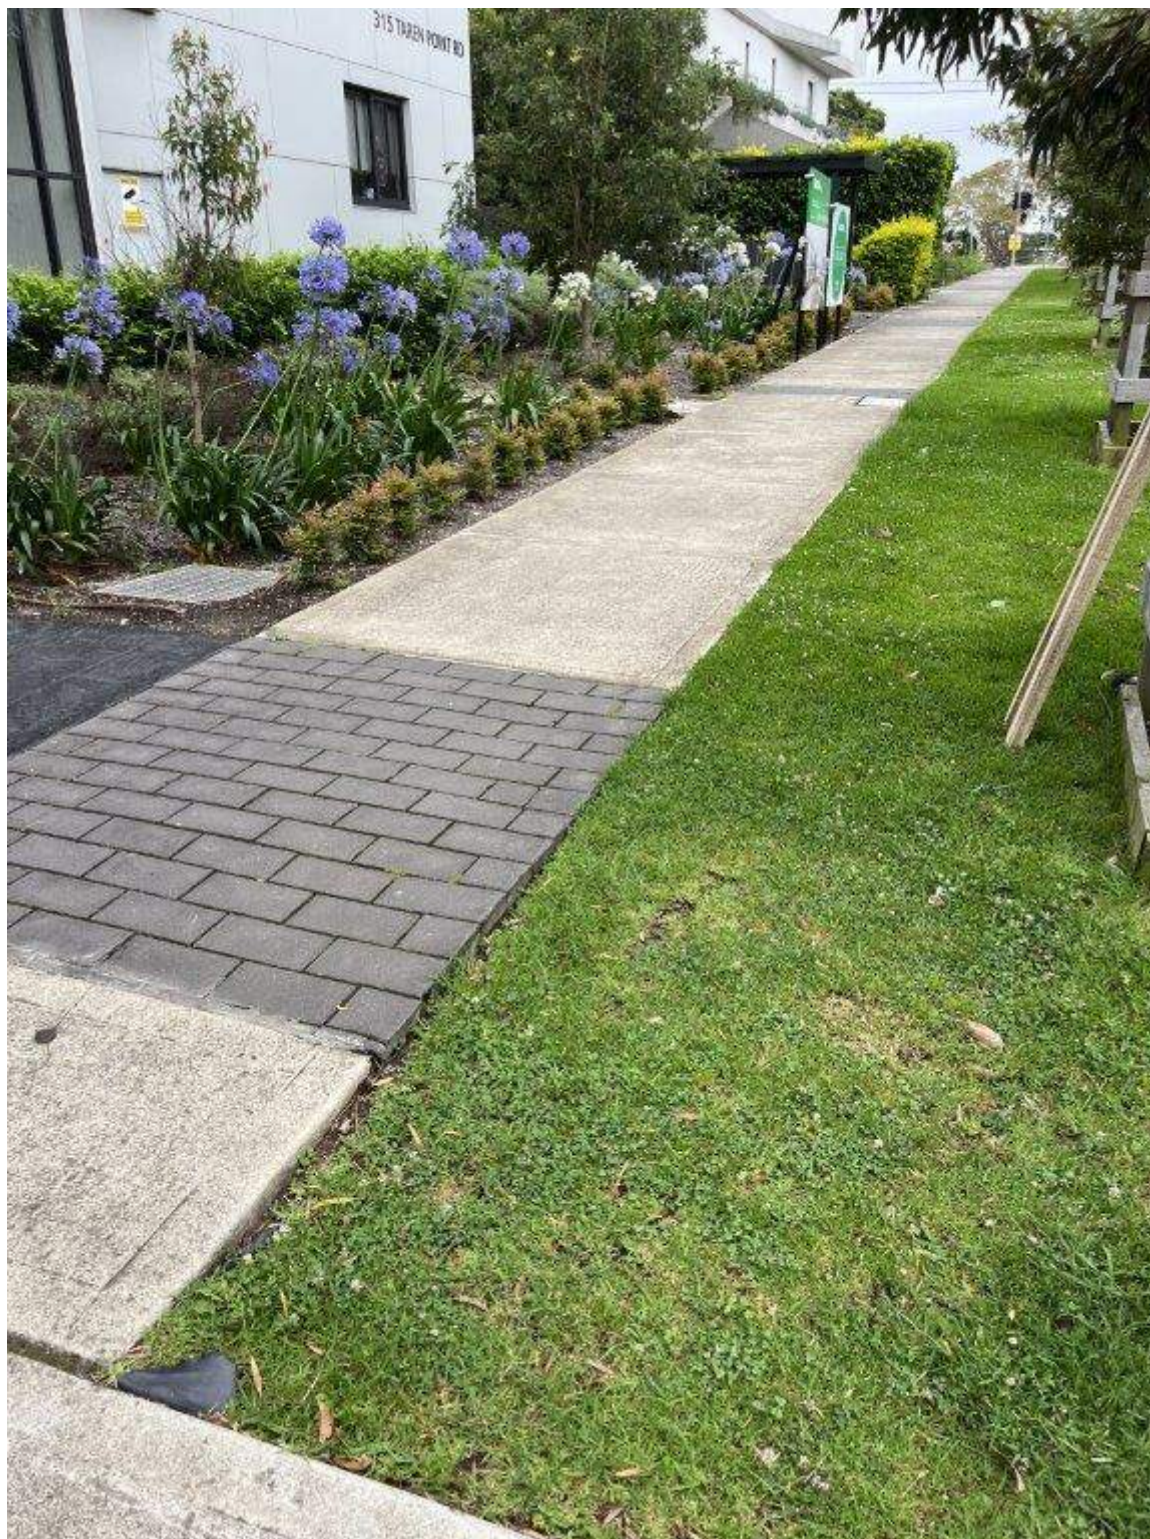
Photo 243 - Taren Point Road - Existing condition of pavement and steel grate

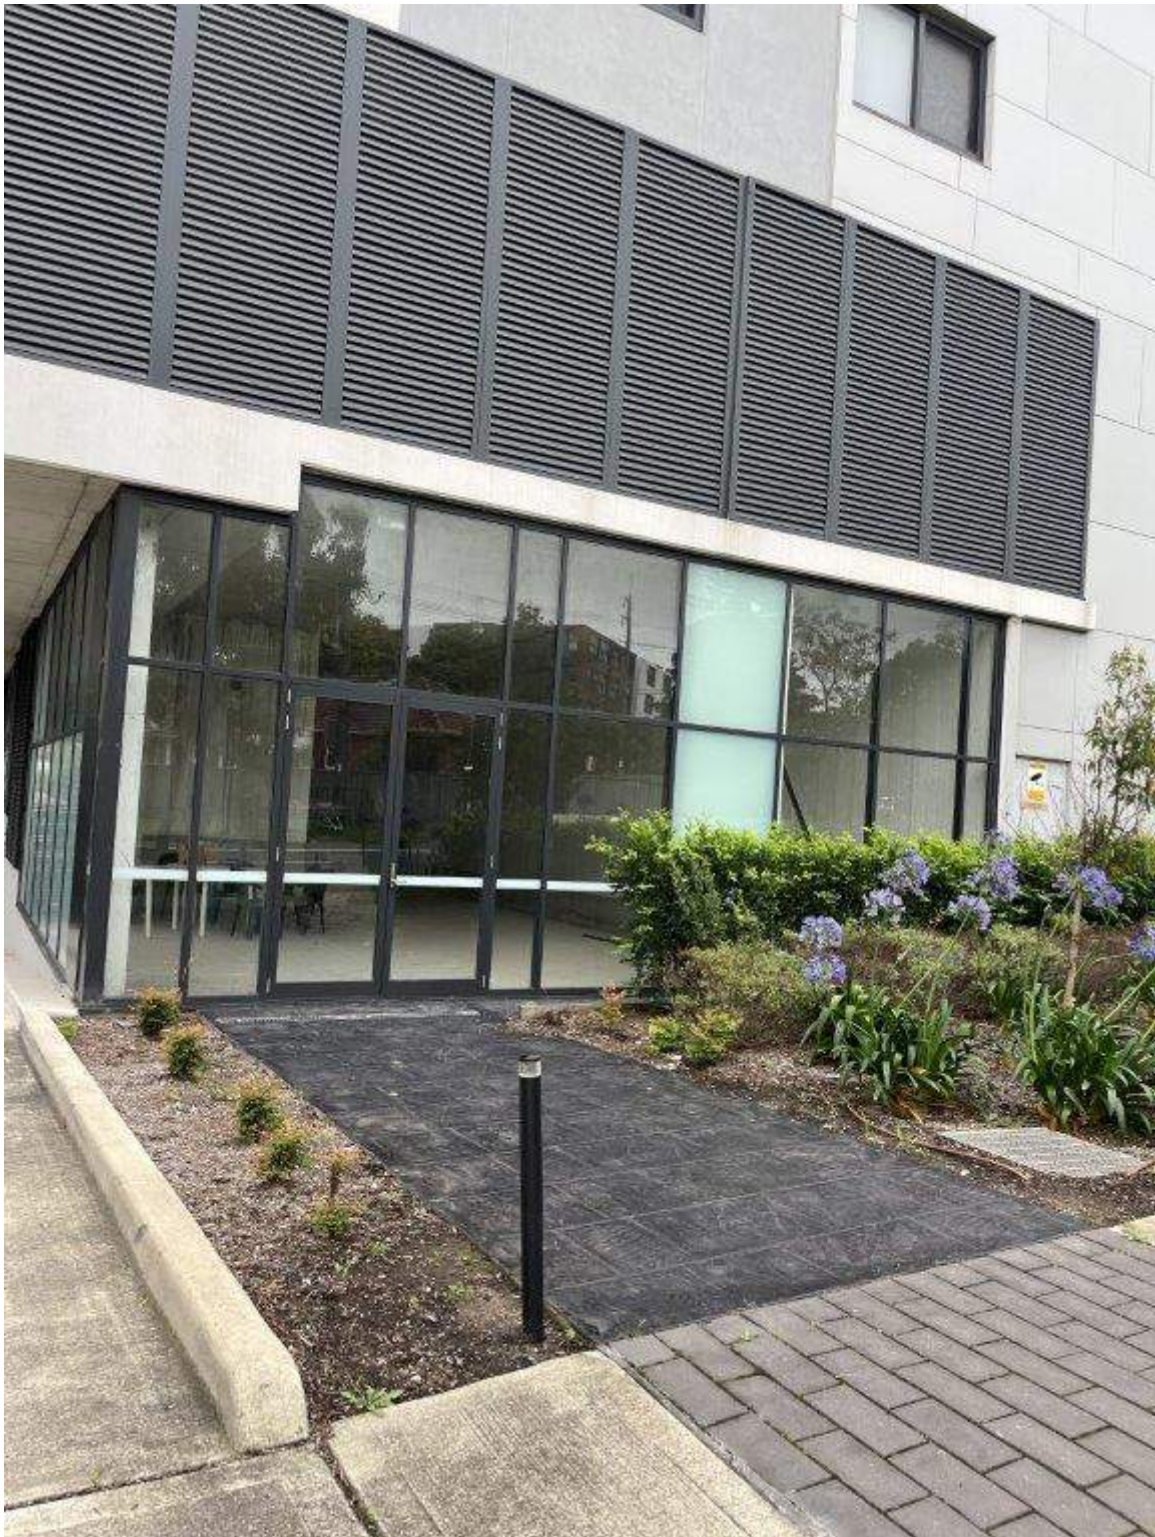
Photo 244 - Taren Point Road - Existing condition of pavement and vegetation

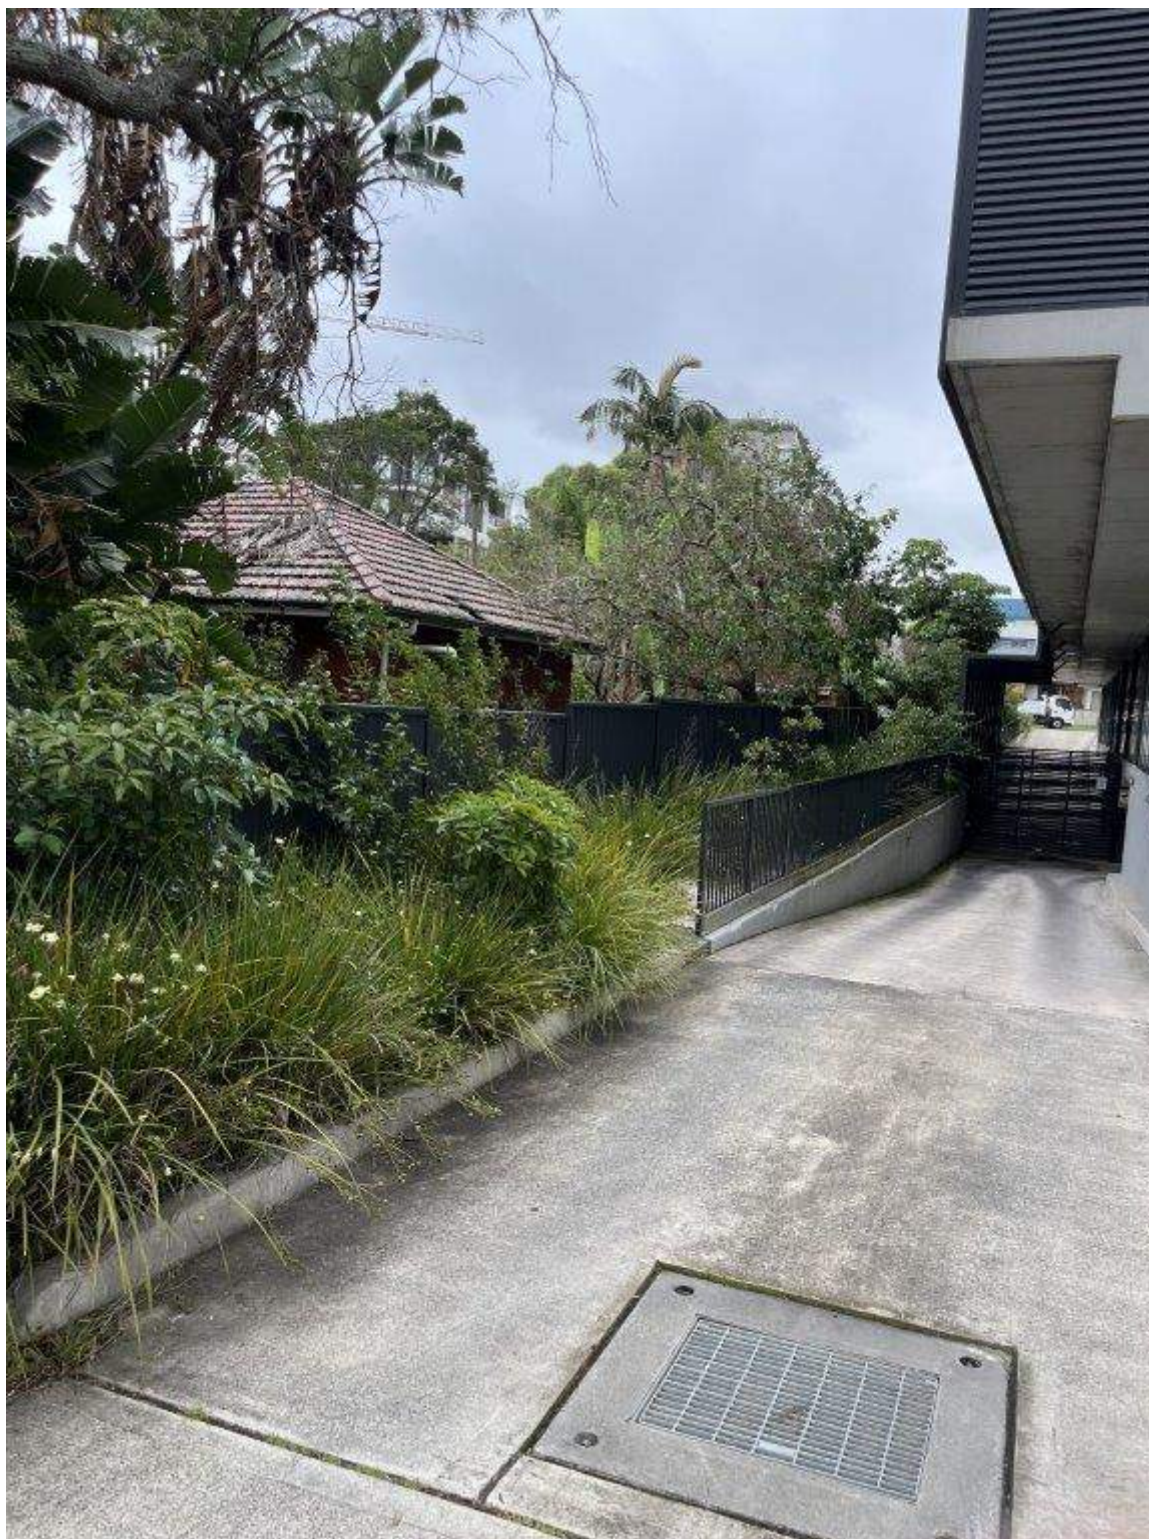
Photo 245 - Taren Point Road - Existing condition of external façade and pavement

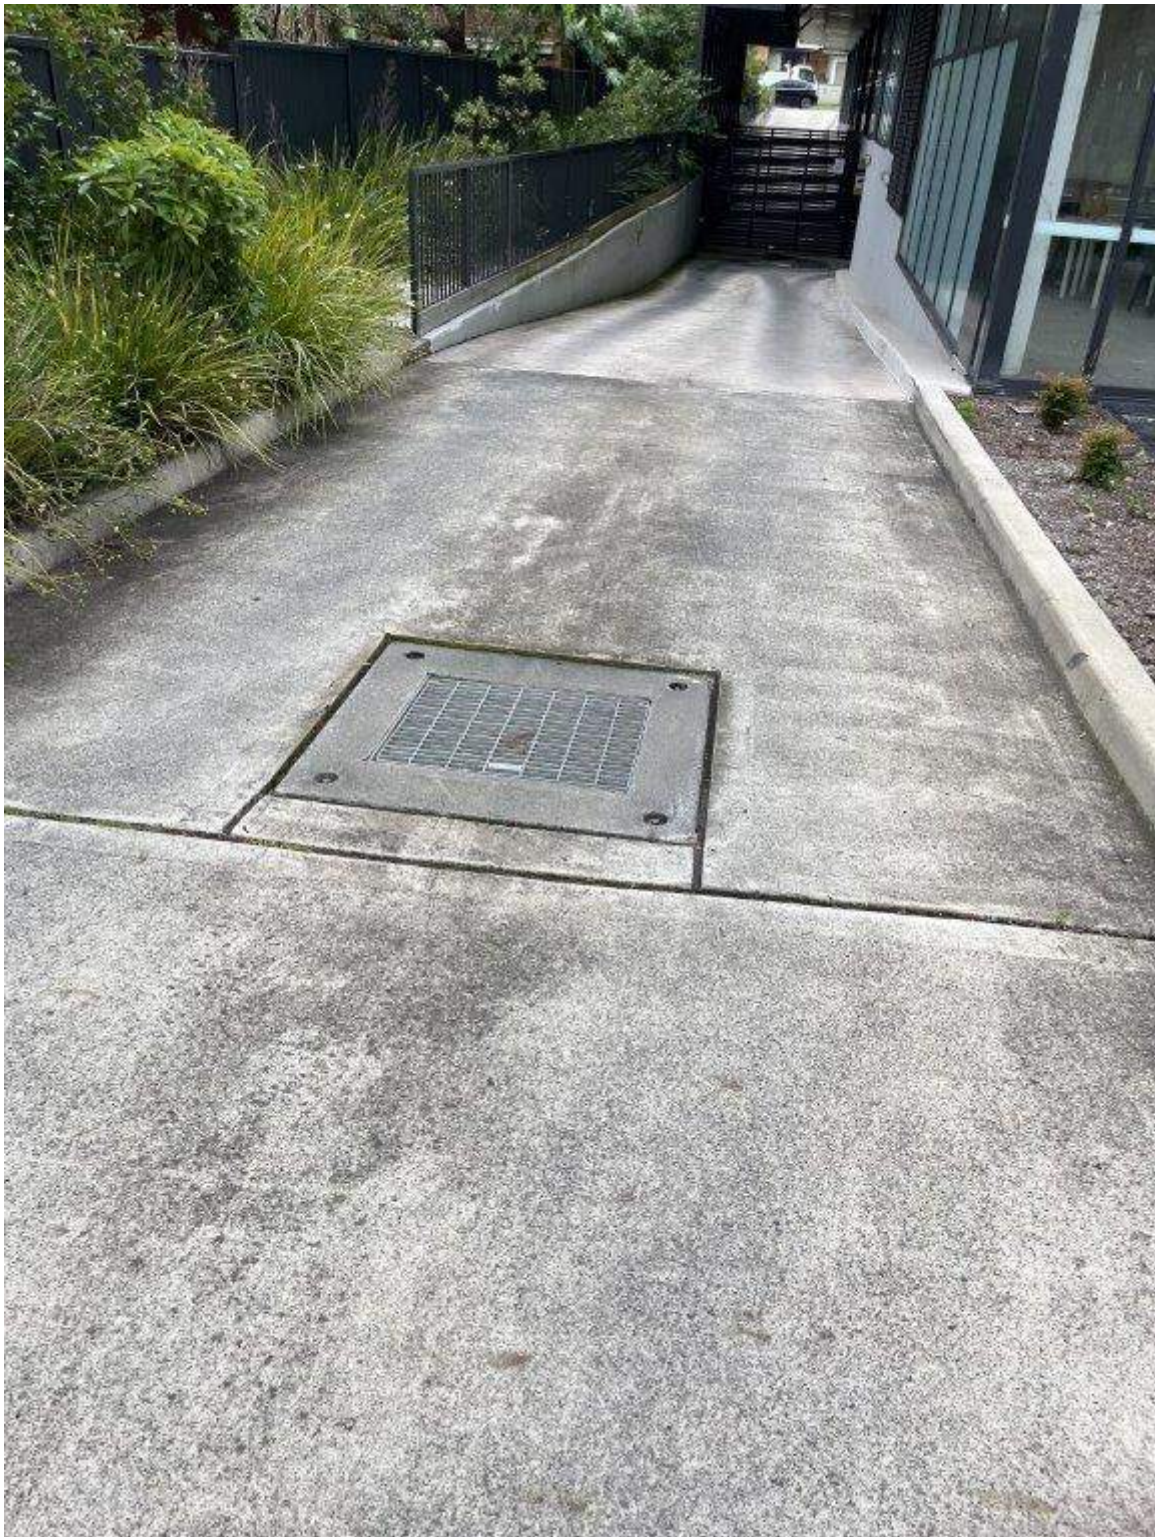
Photo 246 - Taren Point Road - Existing condition of pavement and steel grate

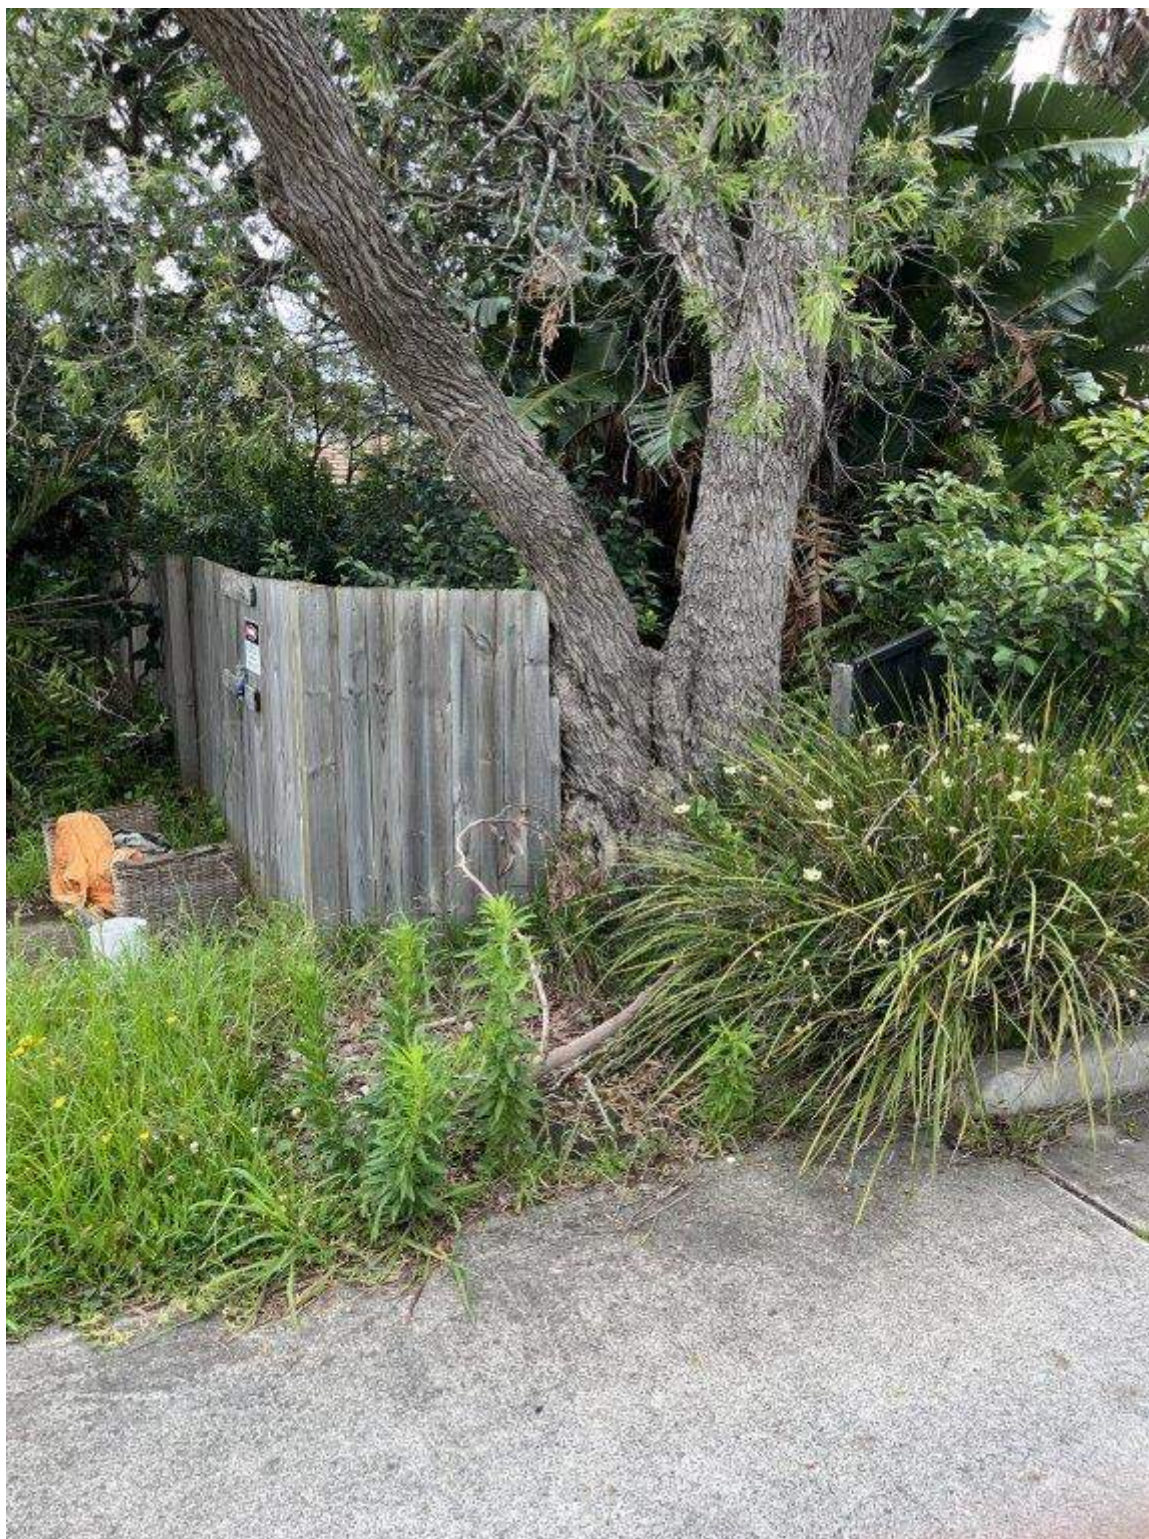
Photo 247 - Taren Point Road - Existing condition of pavement and steel grate

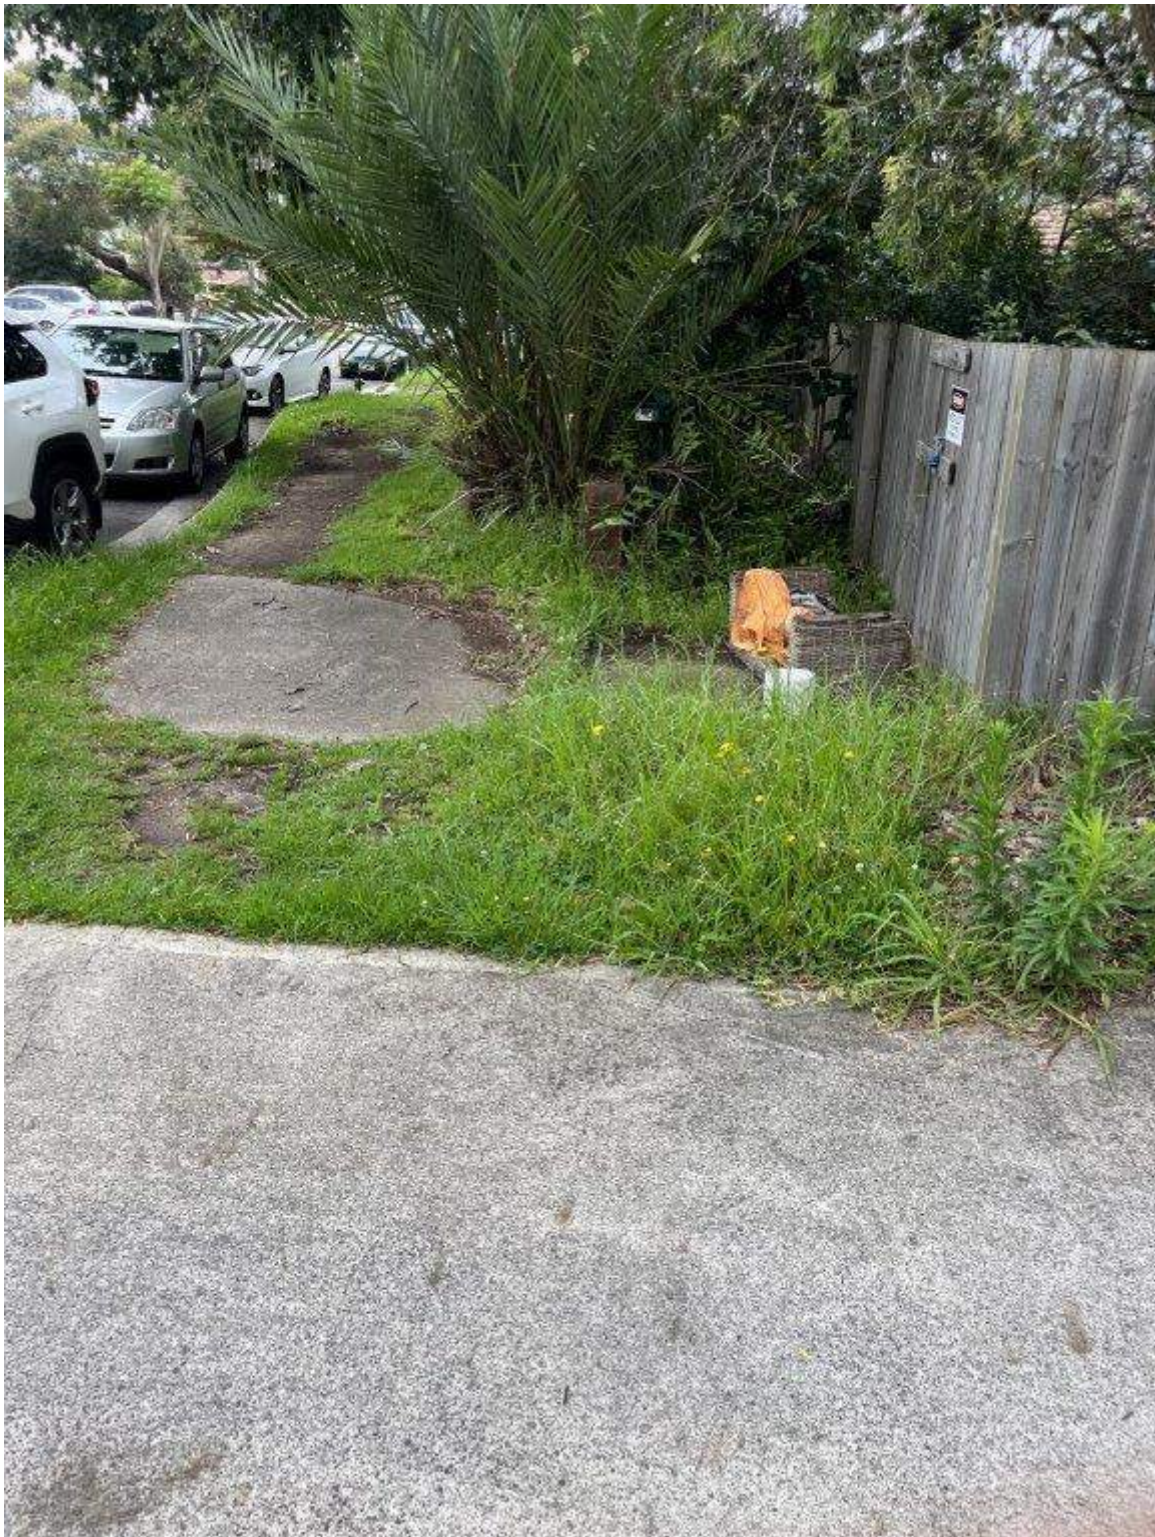
Photo 248 - Taren Point Road - Existing condition of pavement and vegetation

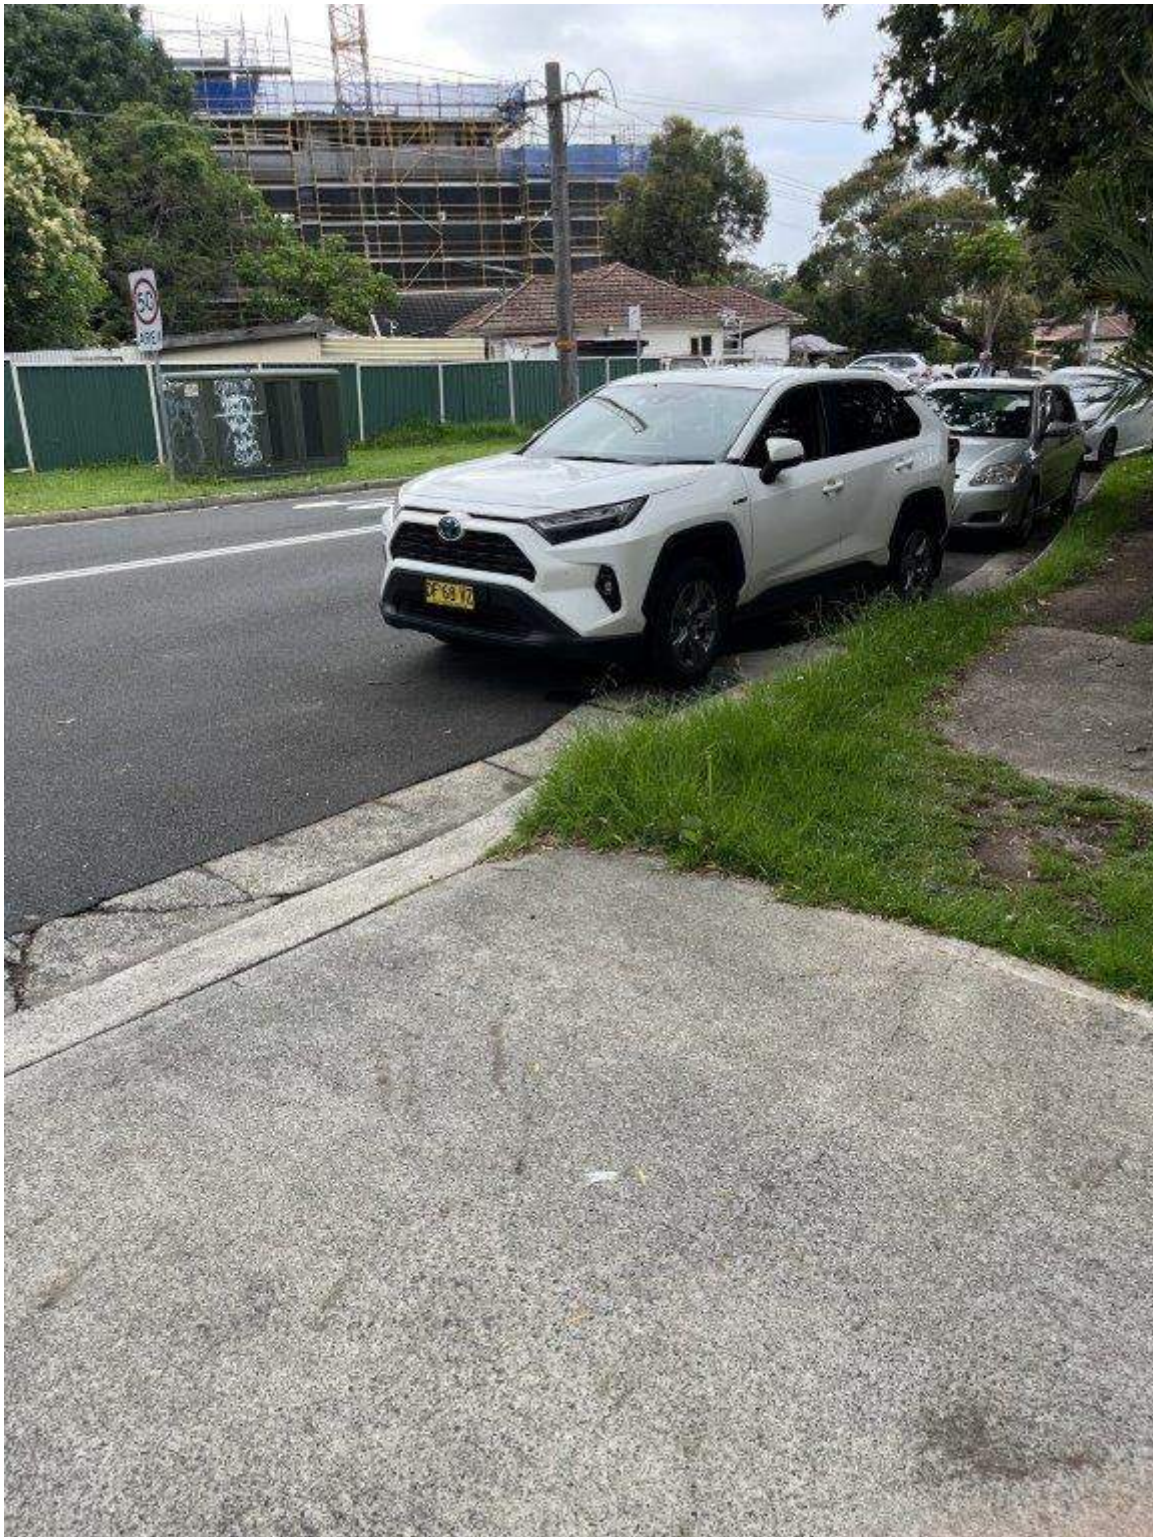
Photo 249 - Taren Point Road - Existing condition of pavement and vegetation

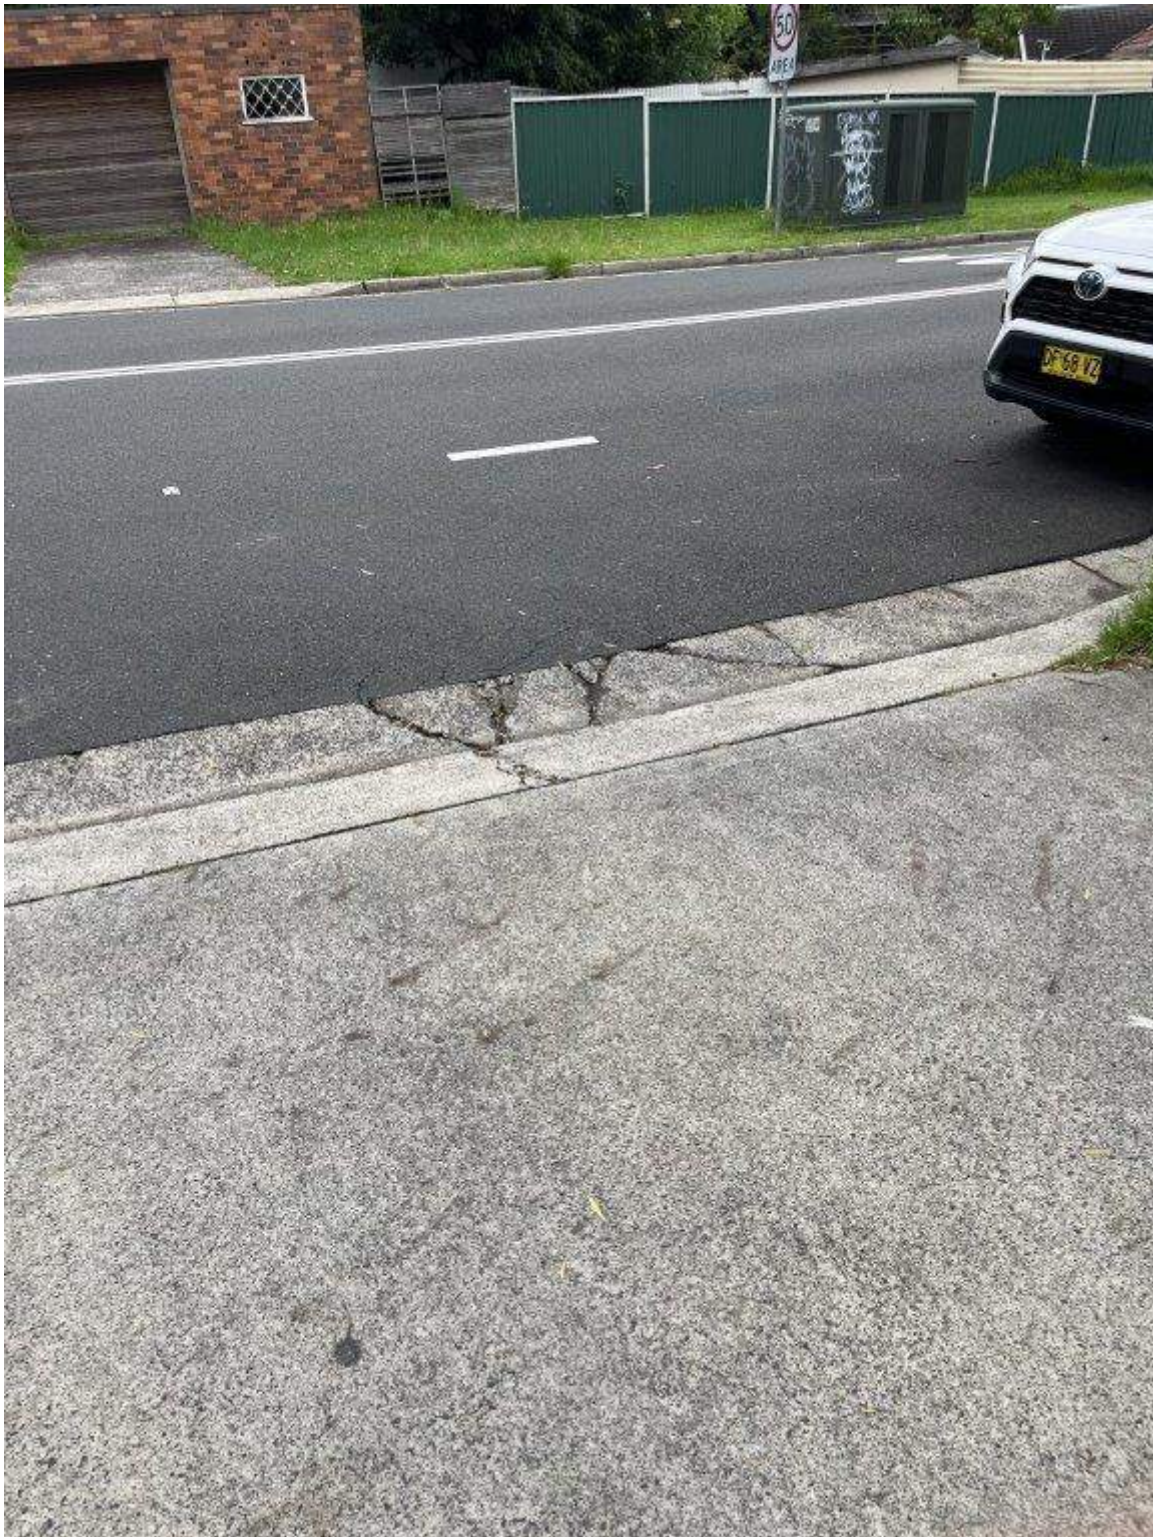
Photo 250 - Taren Point Road - Cracking of pavement

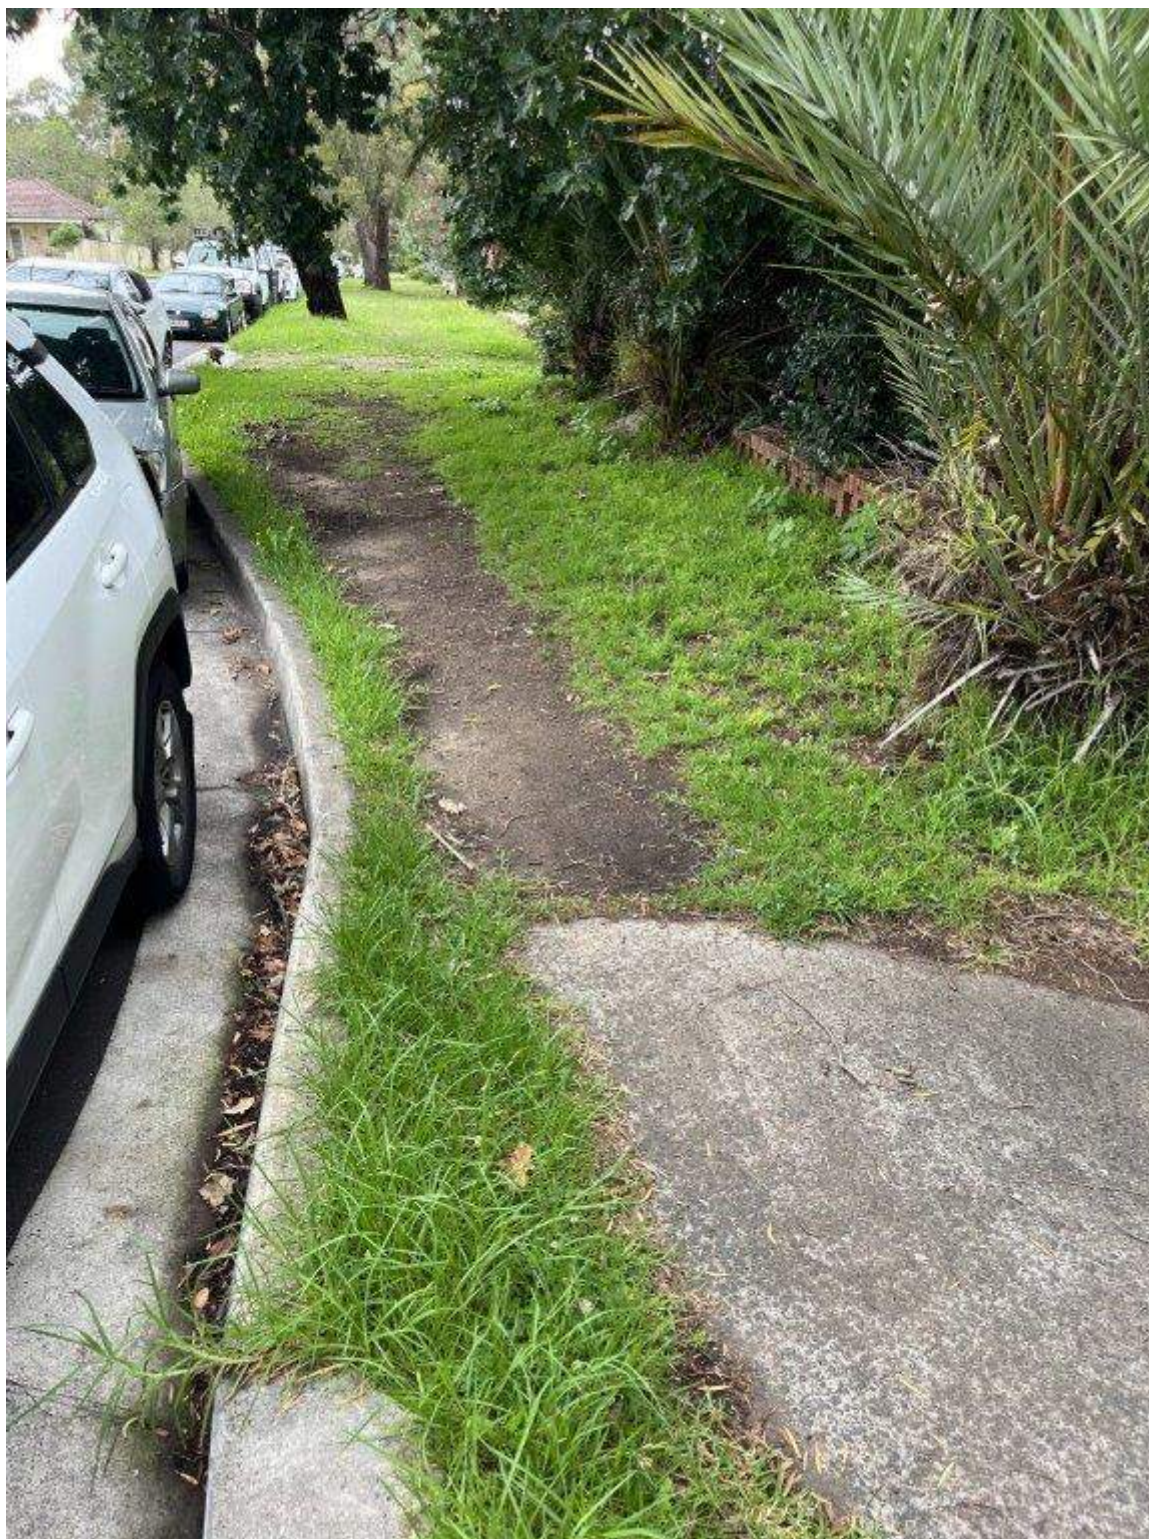
Photo 251 - Taren Point Road - Cracking of pavement
