## PRE-CONSTRUCTION DILAPIDATION REPORT

### 6-20 HINKLER AVENUE & 319-333 TAREN POINT ROAD, CARINGBAH

| PRE-CONSTRUCTION DILAPIDATION REPORT<br>6-20 Hinkler Avenue & 319-333 Taren Point Road,<br>Caringbah NSW 2229 | | | | | Project Number: 21039 |

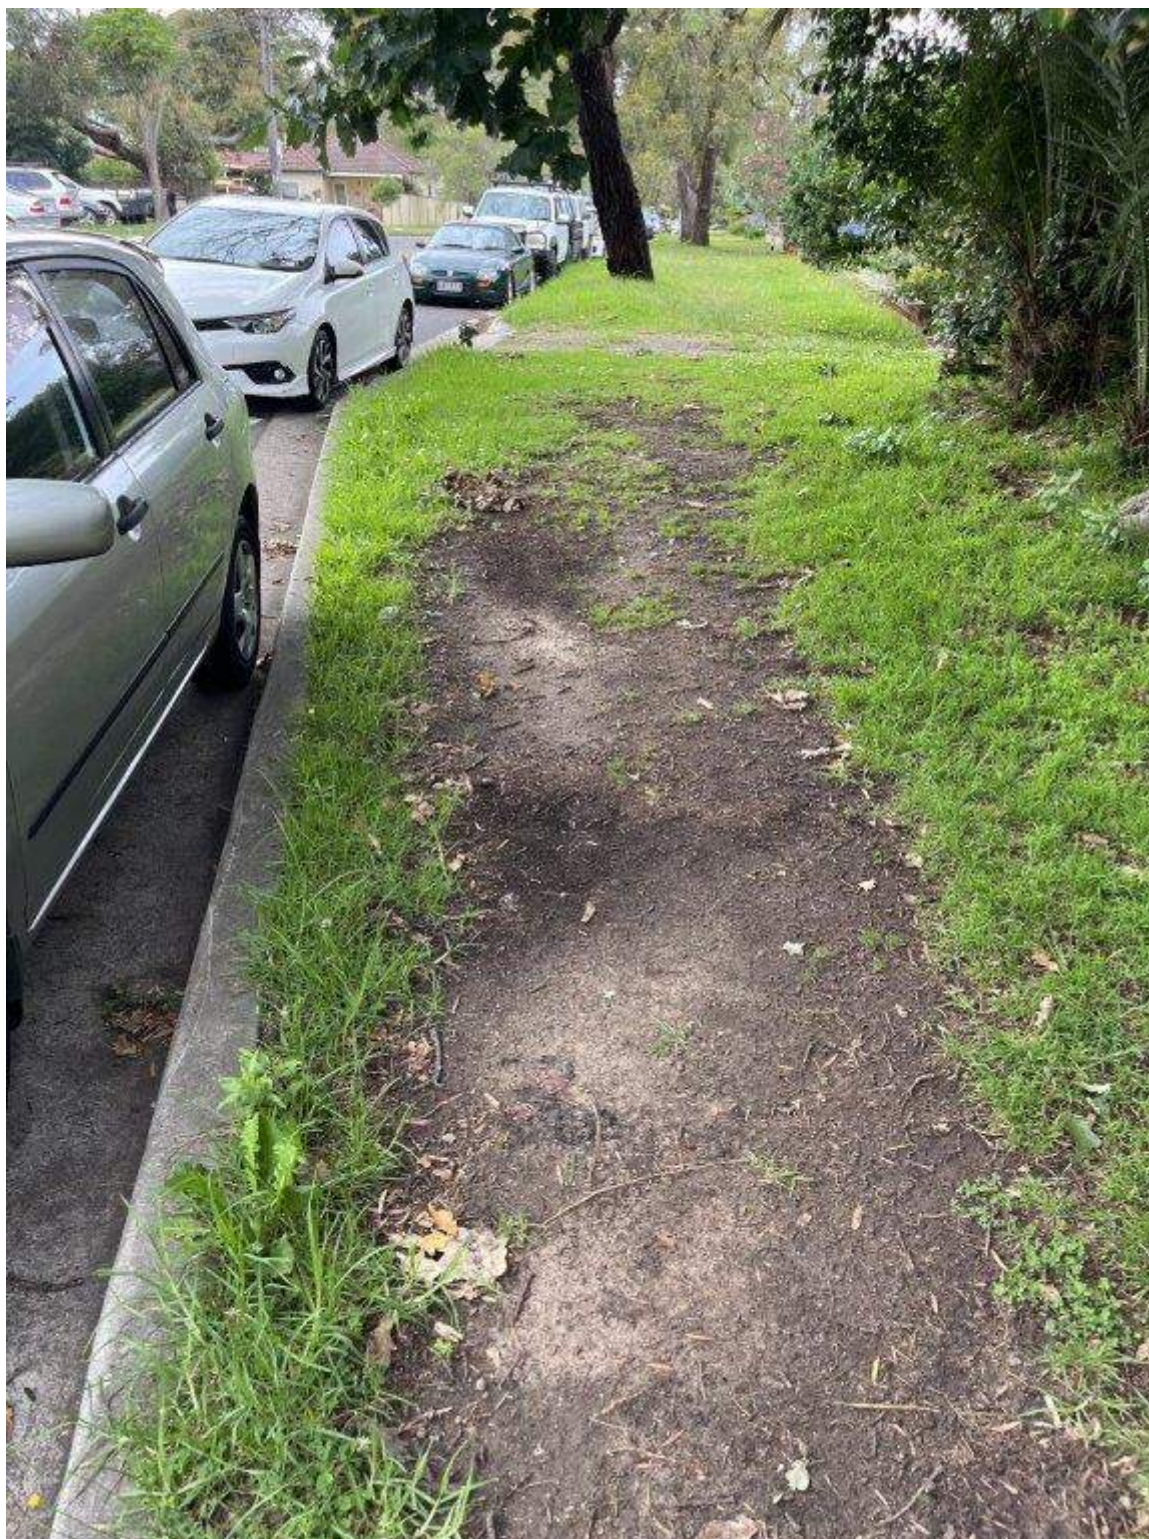
Photo 252 - Taren Point Road - Existing condition of pavement and vegetation

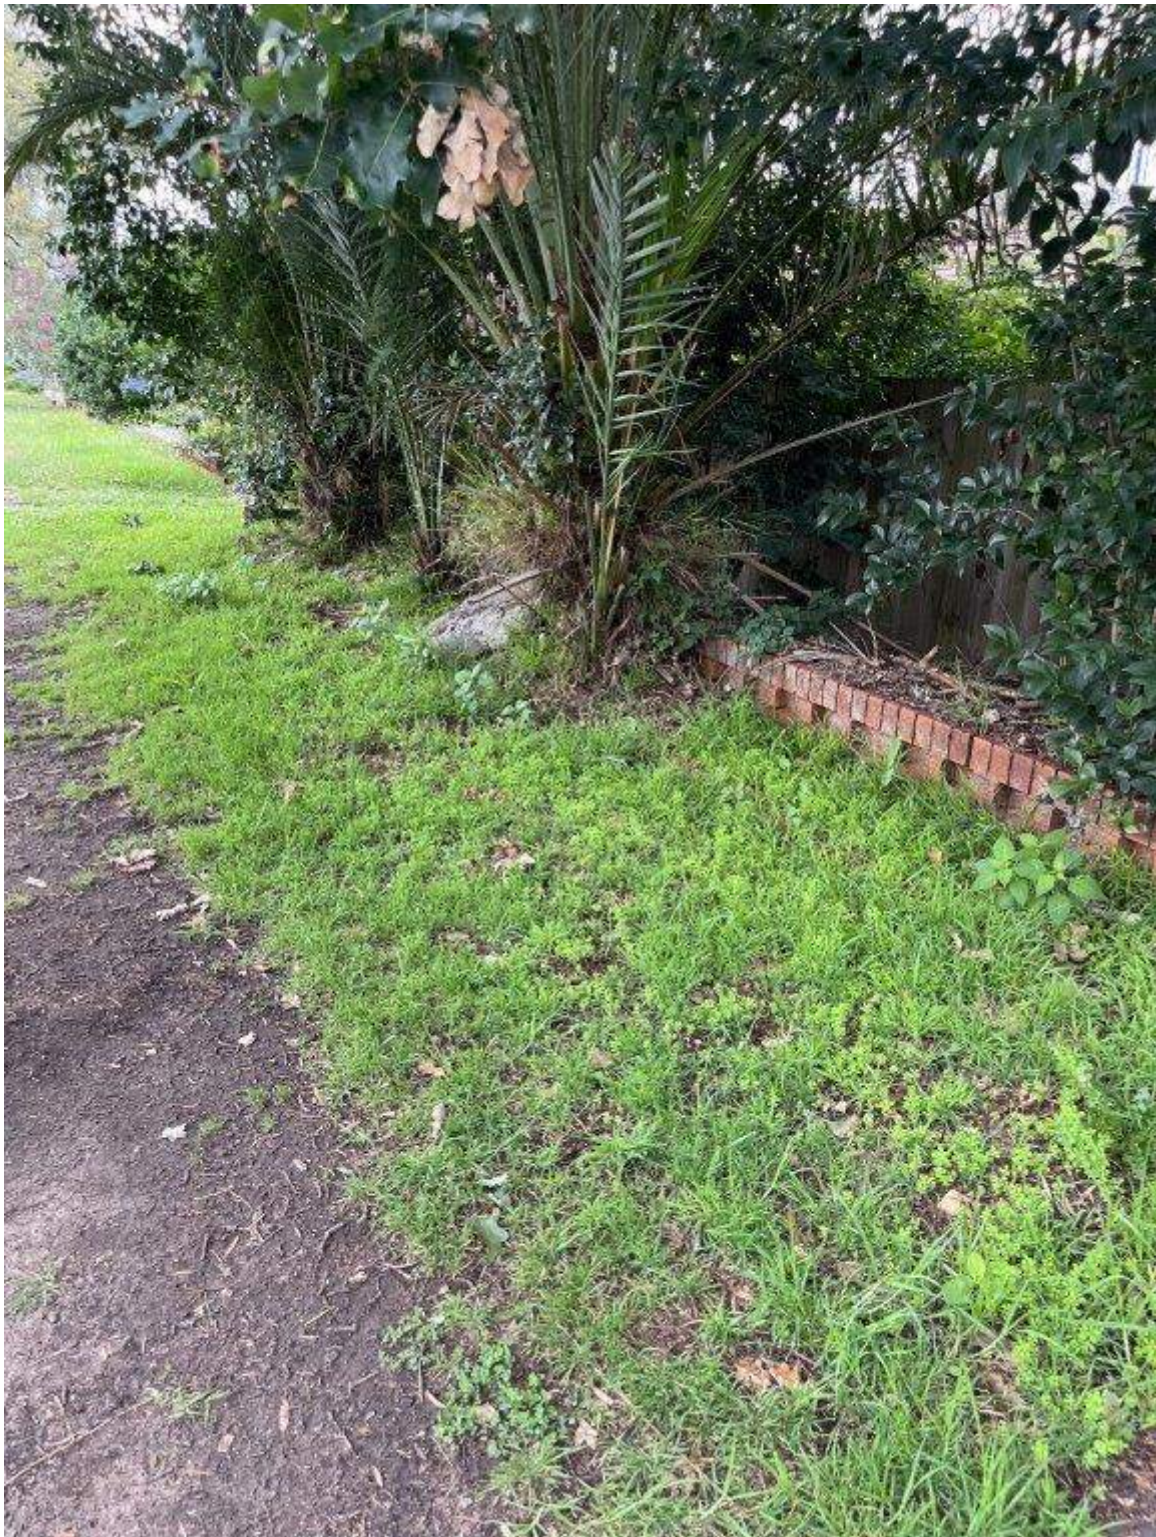
Photo 253 - Taren Point Road - Existing condition of vegetation

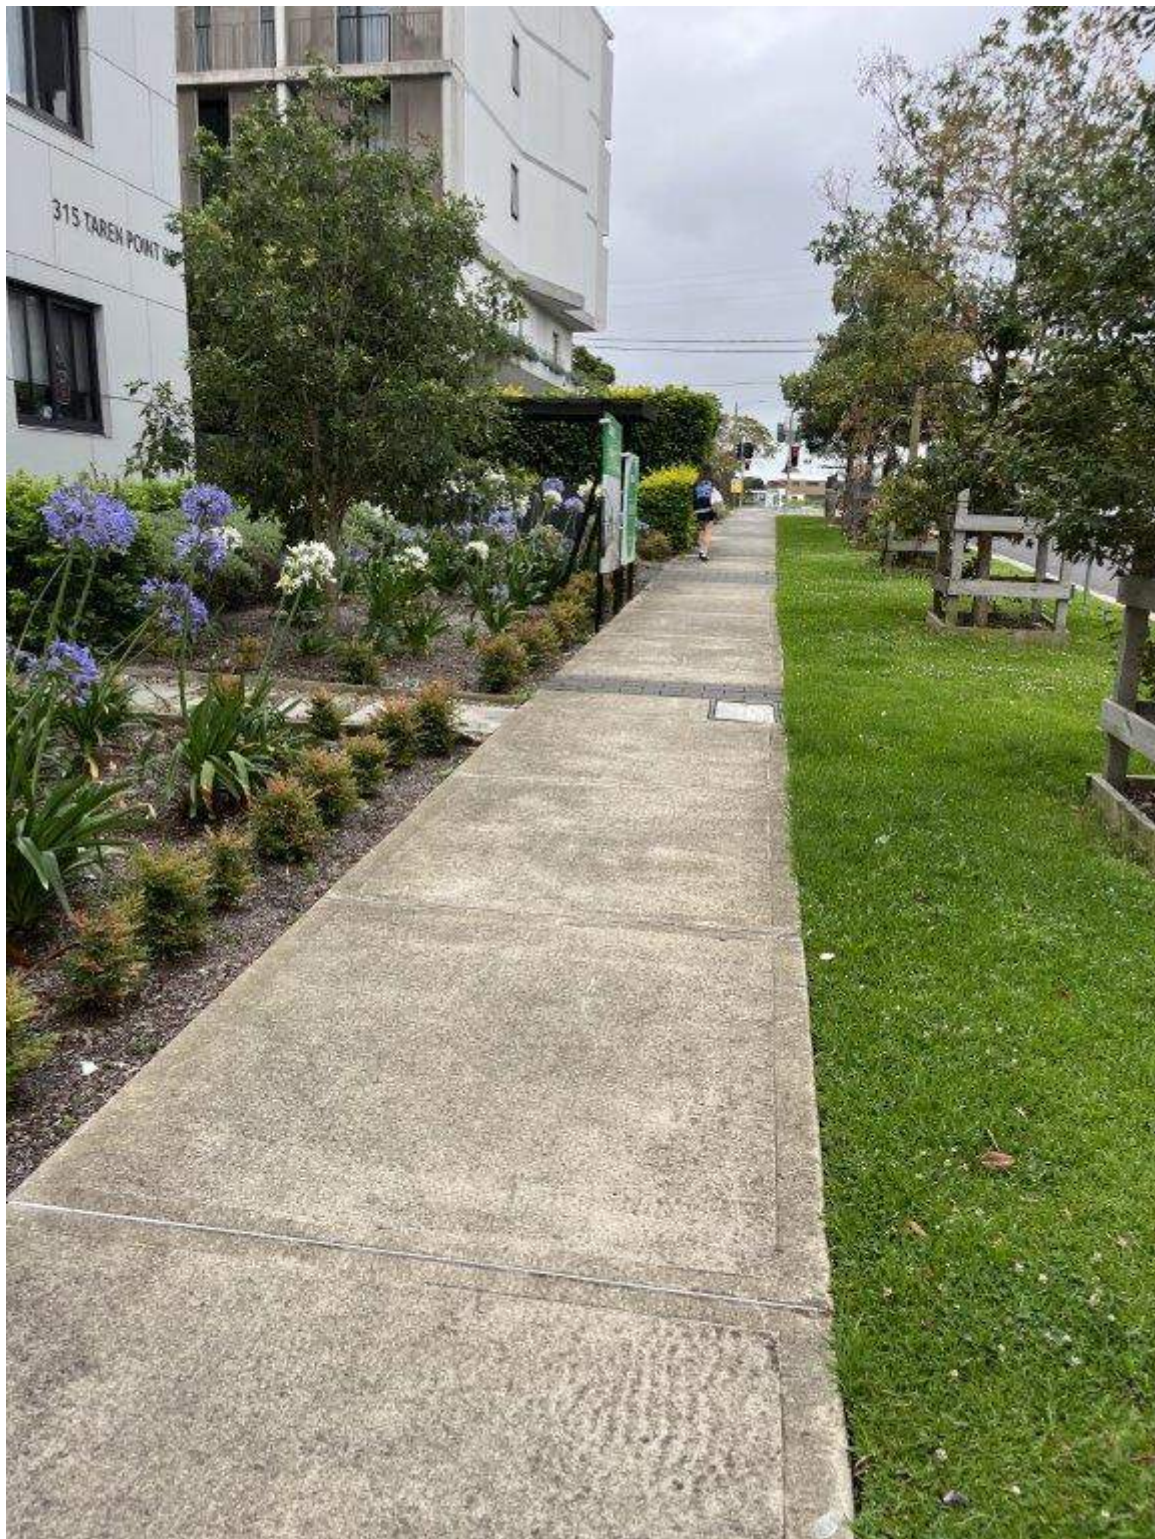
Photo 254 - Taren Point Road - Existing condition of vegetation

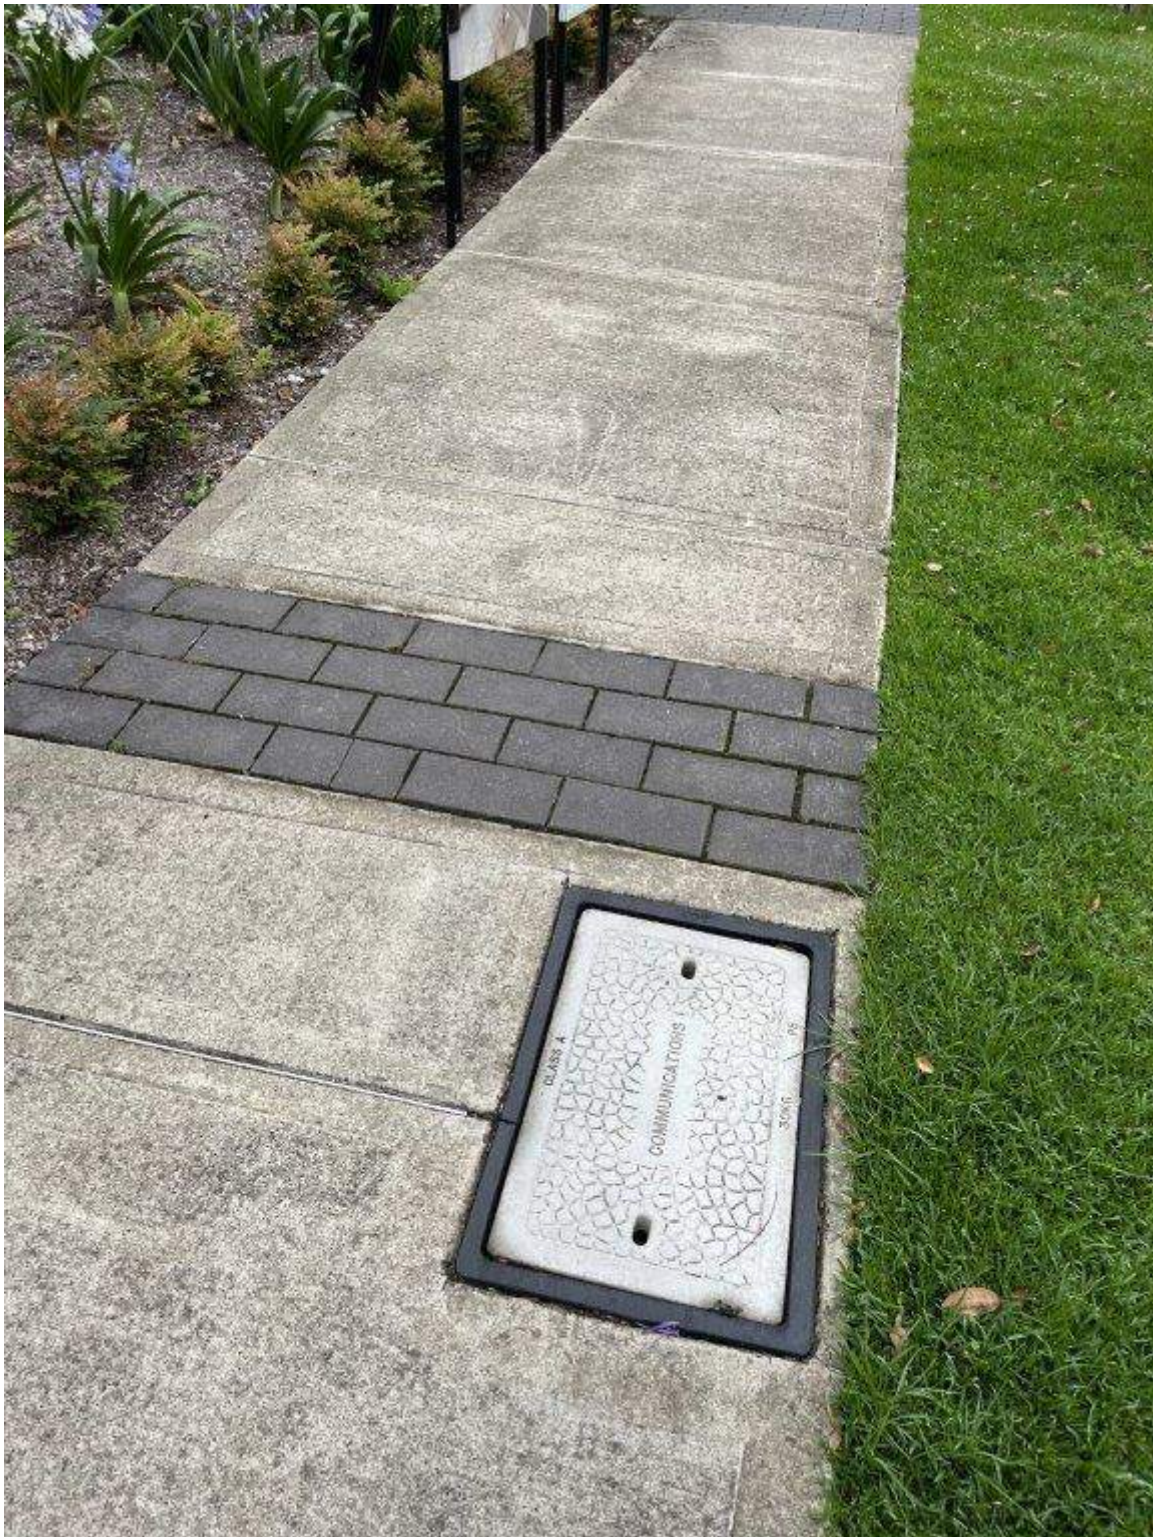
Photo 255 - Taren Point Road - Existing condition of pavement

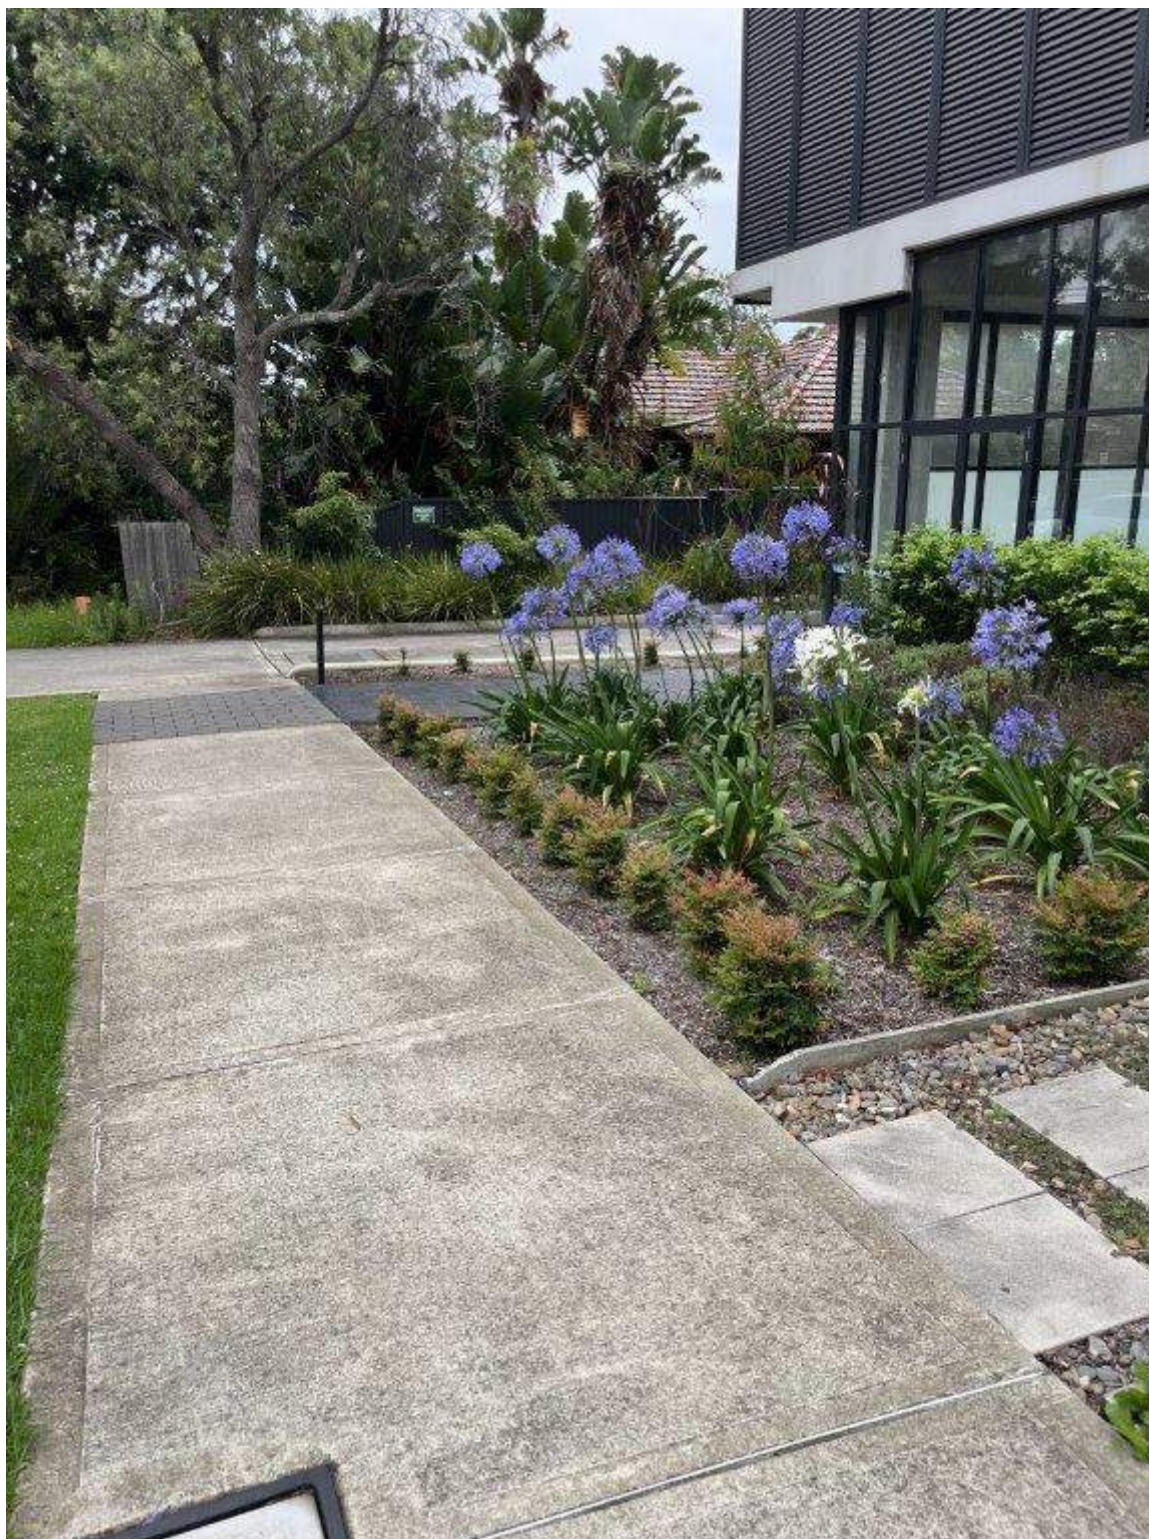
Photo 256 - Taren Point Road - Existing condition of pavement and service pit

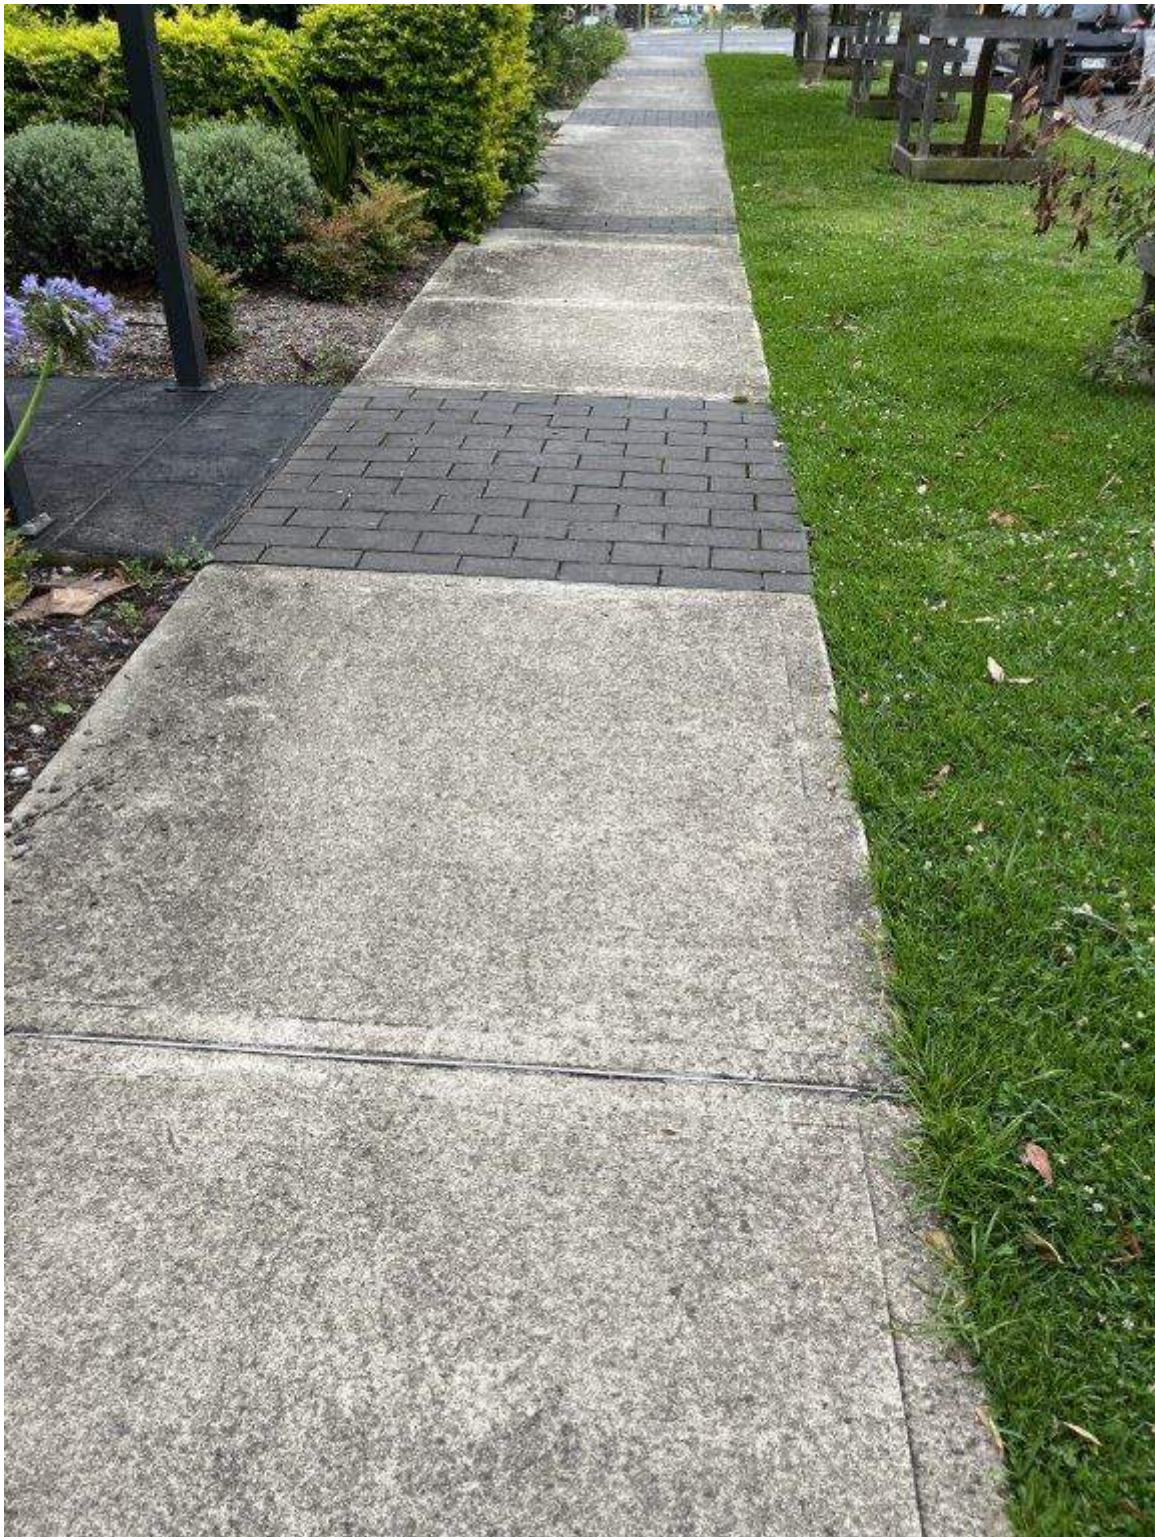
Photo 257 - Taren Point Road - Existing condition of pavement and vegetation
