# **Council Assets Dilapidation Report**

Address: 6-20 Hinkler Ave, Caringbah

Project No: 7235

DATE: 1<sup>st</sup> July, 2025

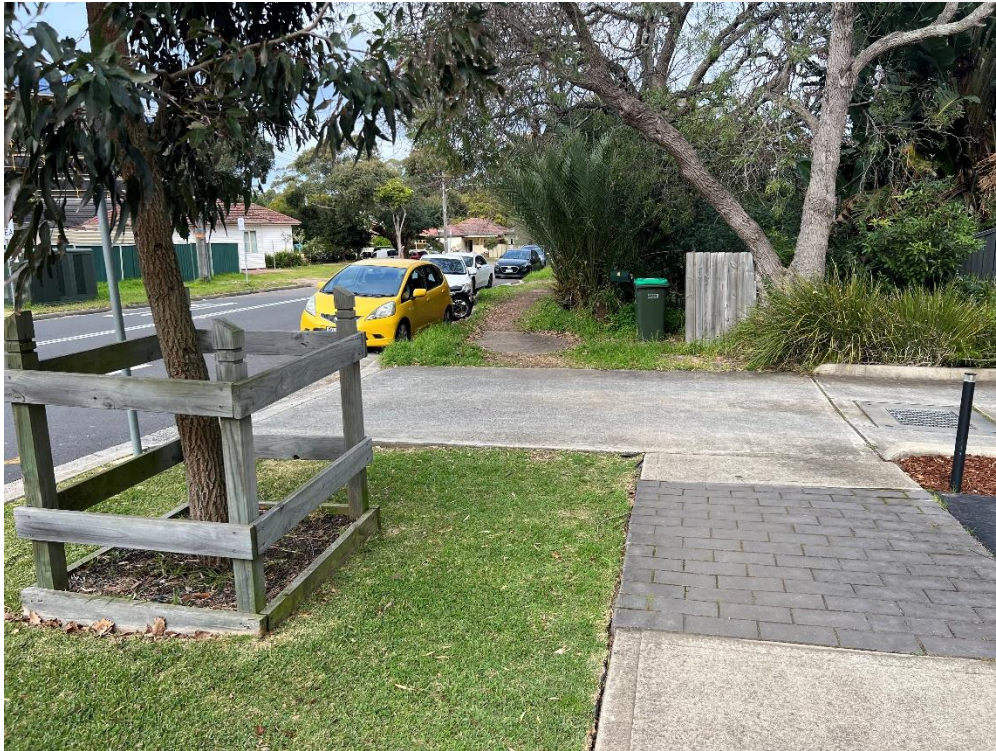
| 1 – 75 | <p>Existing condition of nature strip on Taren Point Road and Hinkler Avenue including footpaths, driveways, kerb ramps, trees and telegraph poles.</p> <p>Defects observed in:</p> <ul style="list-style-type: none"> <li>• Photos 13, 16, 17, 43, 46, 51, 59, 73 – Cracks in driveway</li> <li>• Photo 72 – Cracks in Footpath</li> </ul> |

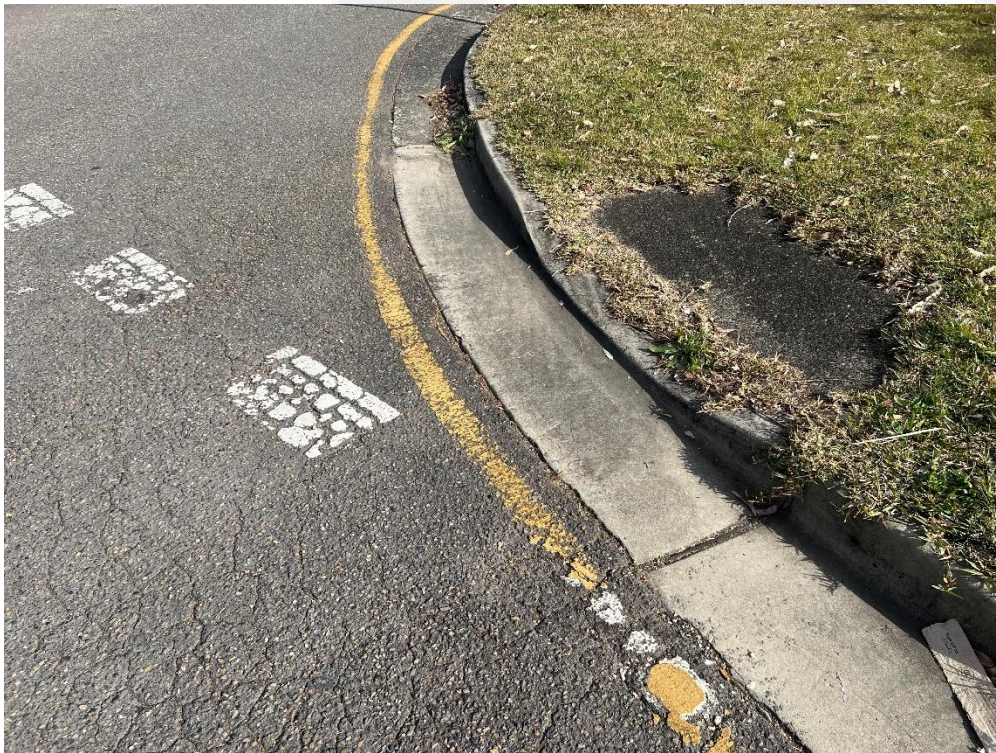
**123**

| 76 – 185 | <p>Existing condition of kerbs and gutters, laybacks and stormwater drains.</p> <p>Existing condition of asphalt on Taren Point Road and Hinkler Avenue.</p> <p>Defects observed in:</p> <ul style="list-style-type: none"> <li>• Photos 79, 81, 132, 146, 148, 152, 154, 158, 164, 166, 172, 176, 182 – Cracks in kerb and gutter</li> <li>• Photos 82, 91, 92, 101, 103, 105, 107, 109, 111, 113, 115, 117, 119, 121, 127, 129, 131, 137, 138, 139, 140, 141, 143, 145, 147, 149, 151, 153, 155, 157, 159, 161, 163, 165, 167, 169, 171, 173, 175, 177, 179, 181, 183, 185 – Cracks/Potholes in asphalt</li> <li>• Photos 123, 125, 135 – Gouges in asphalt</li> </ul> |
