Client Name Aurora Projects	Site Location Lismore Base Hospital Uralba Street, Lismore, NSW	Document Ref: CUS000/ 00006107F
---------------------------------------	--	--

Introduction

Hazardous Materials Survey Report

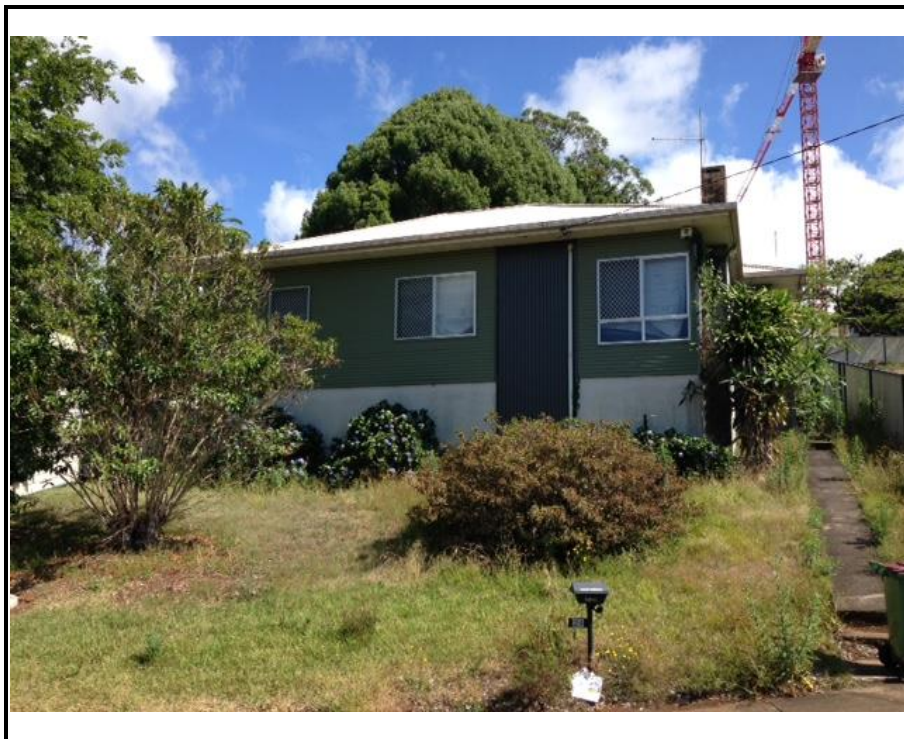
Photo No. 1	Date 19/11/2014
Location External – Soffit lining	
Sample Reference 00006107D-001	
ACM / NAD ACM	Nature of ACM Non-friable
Comments Soffit linings on all elevations of the house. In good condition and painted. Paint flaking in areas.

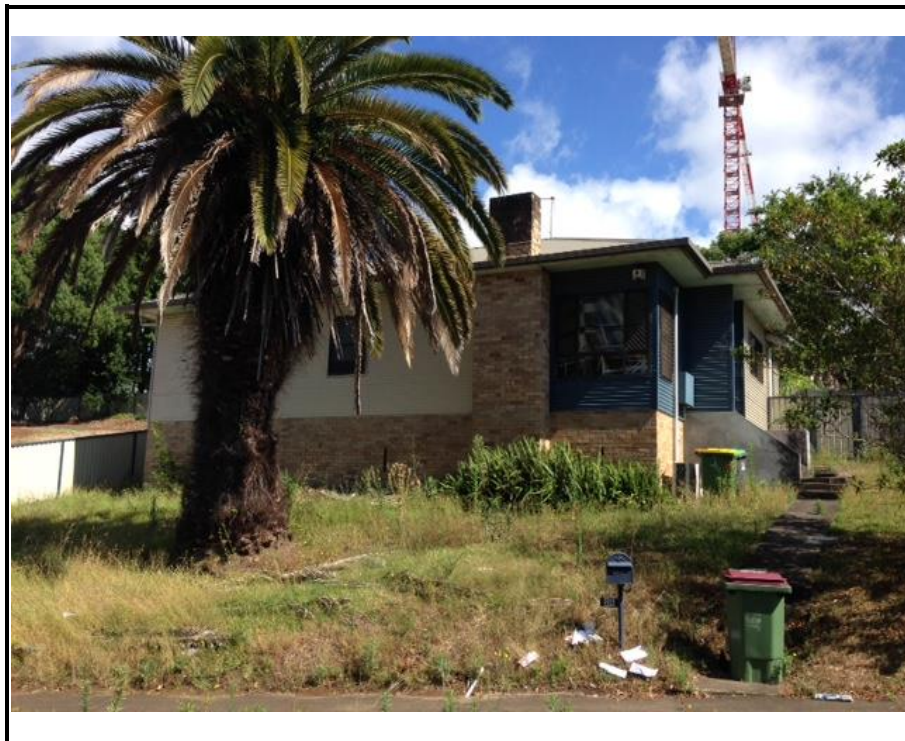
Photo No. 8	Date 19/11/2014
Location External – Soffit lining	
Sample Reference 00006107C-002	
ACM / NAD ACM	Nature of ACM Non-friable
Comments Soffit linings on all elevations of the house. In good condition and painted. Paint flaking in areas.
