# Hazardous Materials Management Survey and Register

## 366 Jamison Rd, Jamisontown NSW 2750

**JOB NUMBER:** JN05770

**ISSUED DATE:** 31 January 2025

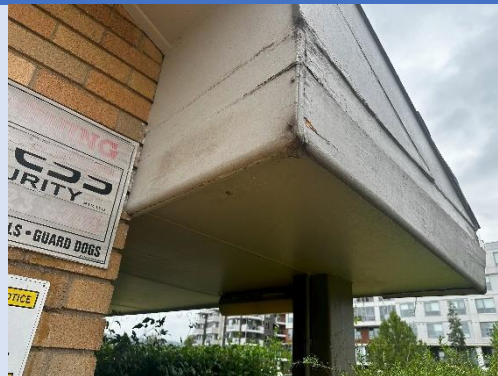
| Material Identification | | | Risk Assessment | | Risk Management & Corrective Actions | | | Photo |
|---|---|---|---|---|---|---|---|---|
| External, eave linings throughout | Off-white paint | LP01 | <0.1% Lead | TH | NA | - | Not lead-containing paint (≤0.1% w/w) as described in AS/NZS 4361.2:2017 Guide to hazardous paint management, Part 2: Lead paint in residential, public and commercial buildings. No further action required. | |

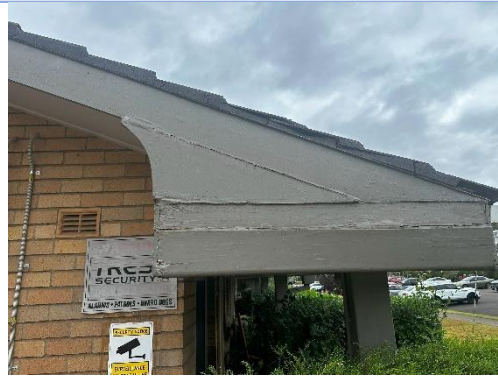
| Material Identification | | | Risk Assessment | | Risk Management & Corrective Actions | | | Photo |
|---|---|---|---|---|---|---|---|---|
| External, eaves and roof | Grey paint | LP02 | <0.1% Lead | TH | NA | - | Not lead-containing paint (≤0.1% w/w) as described in AS/NZS 4361.2:2017 Guide to hazardous paint management, Part 2: Lead paint in residential, public and commercial buildings. No further action required. | |

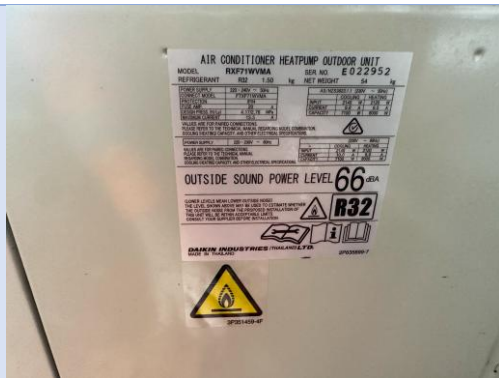
| Material Identification | | Risk Assessment | | | Risk Management & Corrective Actions | | Photo | |
|---|---|---|---|---|---|---|---|---|
| External, Zone 1, eastern courtyard units, Daikin | R32 refrigerant gas | ODS02 | Non-ODS | 2 units | NA | - | No ozone depleting gas identified. No further action required. | |

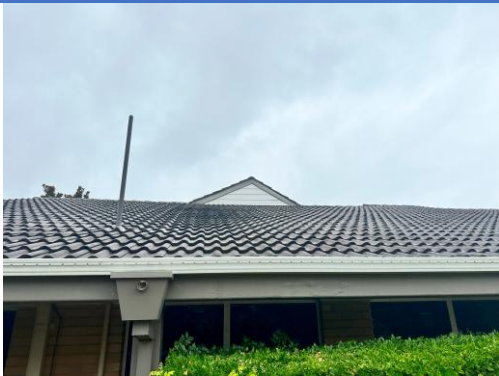
| Material Identification | | Risk Assessment | | | Risk Management & Corrective Actions | | | Photo |
|---|---|---|---|---|---|---|---|---|
| External, Zone 1, north facing weatherboard to gable | Unknown material | - | Unknown | - | NA | - | No access at the time of inspection. Gain access to confirm presence of hazmat. | |

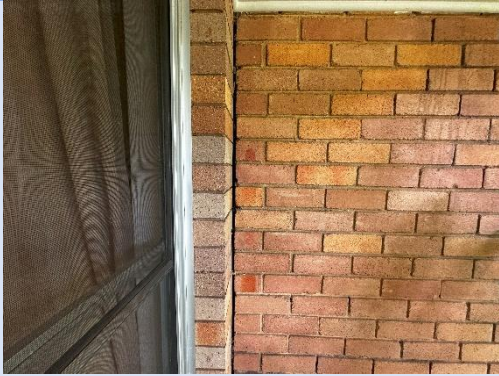
| Material Identification | | Risk Assessment | | | Risk Management & Corrective Actions | | | Photo |
|---|---|---|---|---|---|---|---|---|
| External, Zone 1, northeastern brick, expansion joint | Mastic | ASB03 | NAD | TH | NA | - | No asbestos detected. No further action required. | |

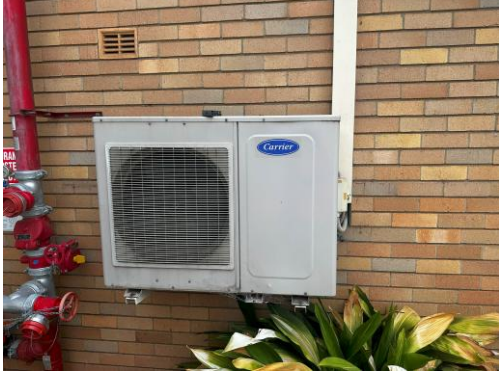
| Material Identification | | Risk Assessment | | | Risk Management & Corrective Actions | | | Photo |
|---|---|---|---|---|---|---|---|---|
| External, Zone 1, northern Carrier unit | R410a refrigerant gas | ODS03 | Non-ODS | 1 unit | NA | - | No ozone depleting gas identified. No further action required. | |

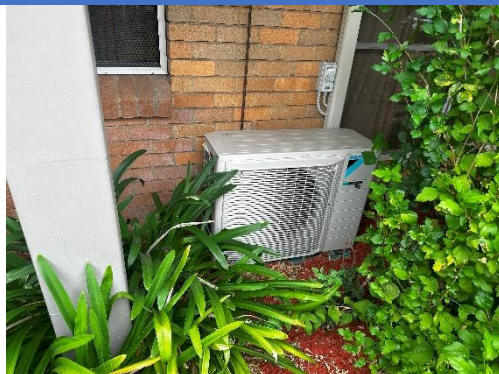
| Material Identification | | Risk Assessment | | | Risk Management & Corrective Actions | | | Photo |
|---|---|---|---|---|---|---|---|---|
| External, Zone 1, northern unit, Daikin inverter | R32 refrigerant gas, 1.5kg | ODS04 | Non-ODS | 7 units | NA | - | No ozone depleting gas identified. No further action required. | |

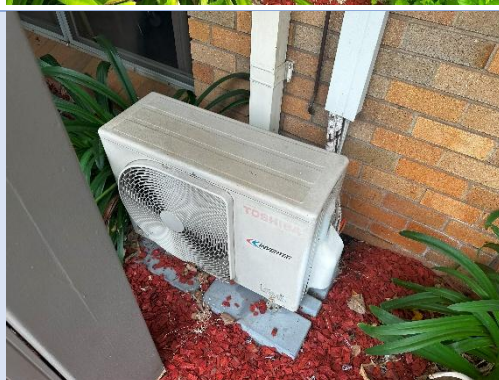
| Material Identification | | Risk Assessment | | | Risk Management & Corrective Actions | | | Photo |
|---|---|---|---|---|---|---|---|---|
| External, Zone 1, northern unit, Toshiba inverter | R410a refrigerant gas | ODS05 | Non-ODS | 1 unit | NA | - | No ozone depleting gas identified. No further action required. | |

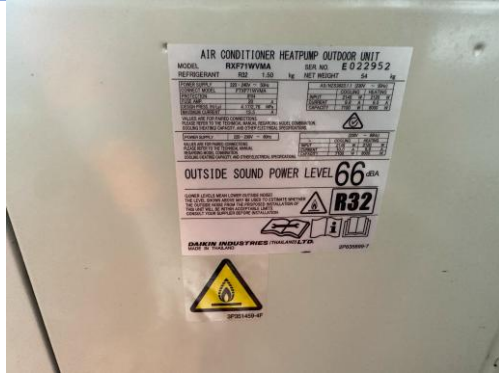
| Material Identification | | Risk Assessment | | | | Risk Management & Corrective Actions | | Photo |
|---|---|---|---|---|---|---|---|---|
| External, Zone 1, western section, south unit, Daikin | R32 refrigerant gas | ODS07 | Non-ODS | 4 units | NA | - | No ozone depleting gas identified. No further action required. | |

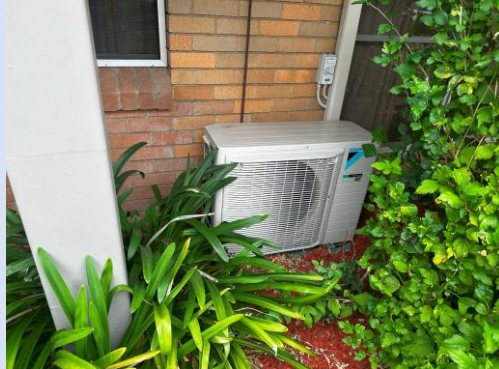
| Material Identification | | Risk Assessment | | | | Risk Management & Corrective Actions | | Photo |
|---|---|---|---|---|---|---|---|---|
| External, Zone 1, western unit, Daikin | R32 refrigerant gas | ODS08 | Non-ODS | 11 units | NA | - | No ozone depleting gas identified. No further action required. | |

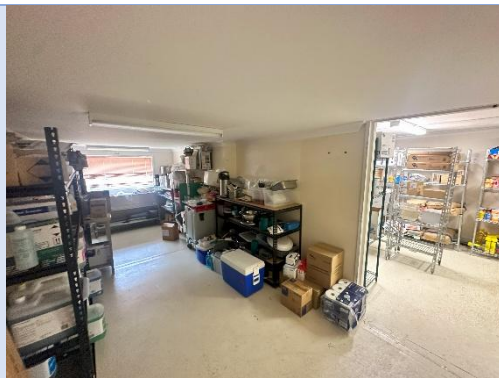
| Material Identification | | Risk Assessment | | | Risk Management & Corrective Actions | | Photo | |
|---|---|---|---|---|---|---|---|---|
| External, Zone 2, Food Storage room, walls | Fibre cement sheeting | ASB18 | NAD | 32 sqm | NA | - | No asbestos detected. No further action required. | |

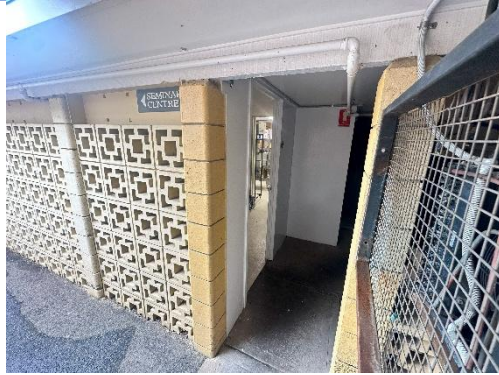
| Material Identification | | Risk Assessment | | | Risk Management & Corrective Actions | | Photo | |
|---|---|---|---|---|---|---|---|---|
| External, Zone 2, Food Storage, western and northern soffits | Fibre cement sheeting | ASB17 | NAD | 10 sqm | NA | - | No asbestos detected. No further action required. | |

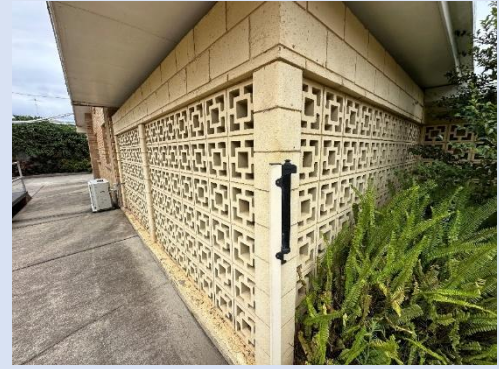
| Material Identification | | Risk Assessment | | | Risk Management & Corrective Actions | | Photo | |
|---|---|---|---|---|---|---|---|---|
| External, Zone 2, Seminar Room and food storage area | Soft yellow paint system | LP05 | <0.1% Lead | TH | NA | - | Not lead-containing paint (≤0.1% w/w) as described in AS/NZS 4361.2:2017 Guide to hazardous paint management, Part 2: Lead paint in residential, public and commercial buildings. No further action required. | |

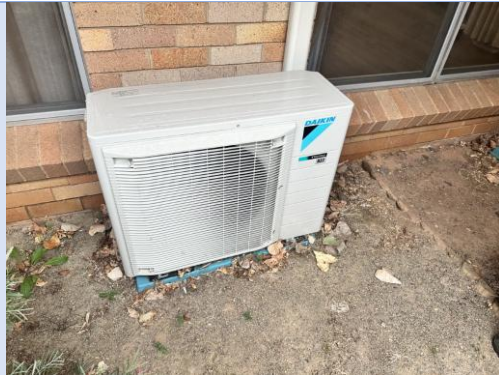
| Material Identification | | | Risk Assessment | | | Risk Management & Corrective Actions | | Photo |
|---|---|---|---|---|---|---|---|---|
| External, Zone 2, southern area, eastern unit, Daikin | R32 refrigerant gas | ODS10 | Non-ODS | 1 unit | NA | - | No ozone depleting gas identified. No further action required. | |

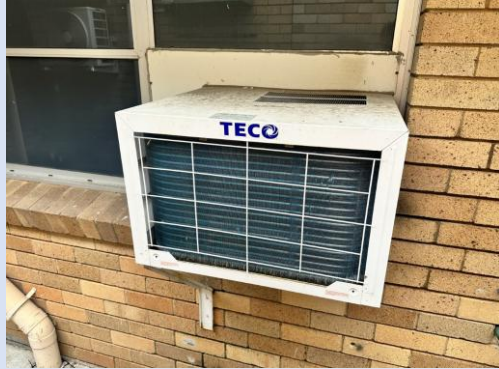
| Material Identification | | | Risk Assessment | | | Risk Management & Corrective Actions | | Photo |
|---|---|---|---|---|---|---|---|---|
| External, Zone 2, west, TECO unit | Refrigerant gas | ODS11 | Presumed ODS | 1 unit | NA | Negligible | Ozone depleting gas should be degassed by a licenced refrigerant tradesperson prior to demolition works and disposed of as per EPA requirements. | |

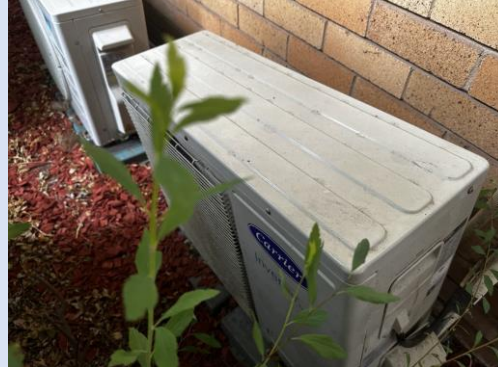
| Material Identification | | Risk Assessment | | | Risk Management & Corrective Actions | | Photo | |
|---|---|---|---|---|---|---|---|---|
| External, Zone 3, northern unit, Carrier inverter | R410a refrigerant gas | ODS12 | Non-ODS | 1 unit | NA | - | No ozone depleting gas identified. No further action required. | |

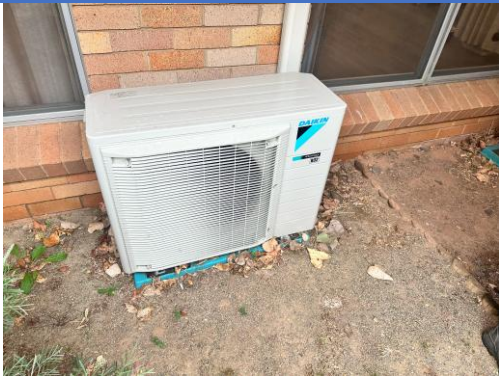
| Material Identification | | Risk Assessment | | | Risk Management & Corrective Actions | | | Photo |
|---|---|---|---|---|---|---|---|---|
| External, Zone 3, northern unit, Daikin | Refrigerant gas | ODS13 | Non-ODS | 1 unit | NA | - | No ozone depleting gas identified. No further action required. | |

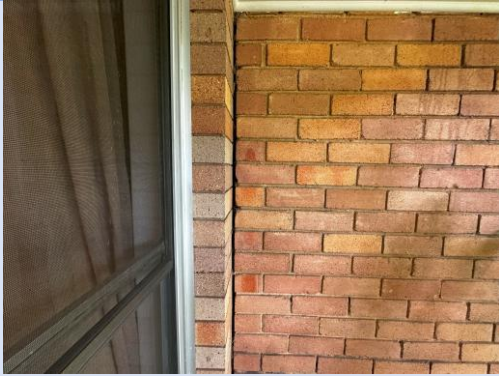
| Material Identification | | Risk Assessment | | | Risk Management & Corrective Actions | | | Photo |
|---|---|---|---|---|---|---|---|---|
| External, Zone 4, brick expansion joint | Bituminous Mastic | ASB03/R1 | NAD | TH | NA | - | No asbestos detected. No further action required. | |

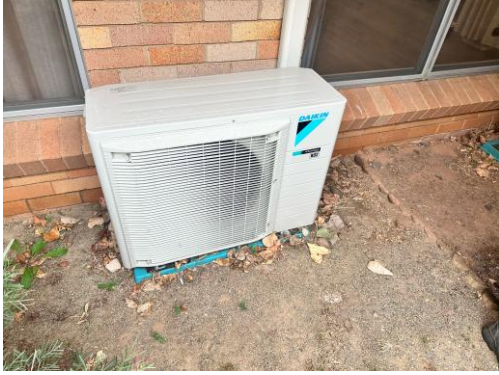
| Material Identification | | Risk Assessment | | | Risk Management & Corrective Actions | | | Photo |
|---|---|---|---|---|---|---|---|---|
| External, Zone 4, northern unit, Daikin | Refrigerant gas | ODS13 | Non-ODS | 1 unit | NA | - | No ozone depleting gas identified. No further action required. | |

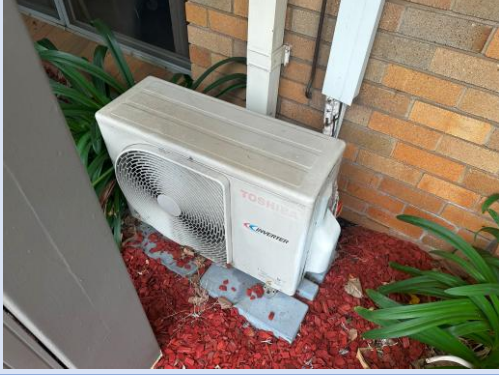
| Material Identification | | Risk Assessment | | | Risk Management & Corrective Actions | | | Photo |
|---|---|---|---|---|---|---|---|---|
| External, Zone 4, northern unit, Toshiba | R410a refrigerant gas | ODS15 | Non-ODS | 1 unit | NA | - | No ozone depleting gas identified. No further action required. | |

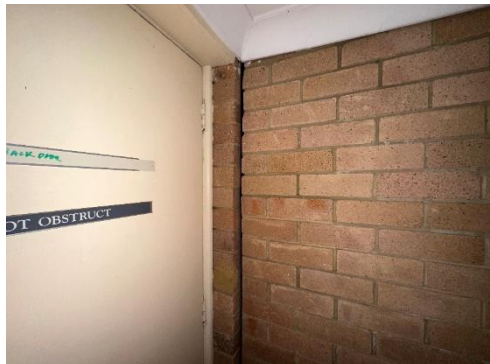
| Material Identification | | Risk Assessment | | | Risk Management & Corrective Actions | | | Photo |
|---|---|---|---|---|---|---|---|---|
| External, Zone 5, northern section of courtyard, expansion join to eastern bricks | Bituminous Mastic | ASB03/R2 | NAD | 7 Lm | NA | - | No asbestos detected. No further action required. | |

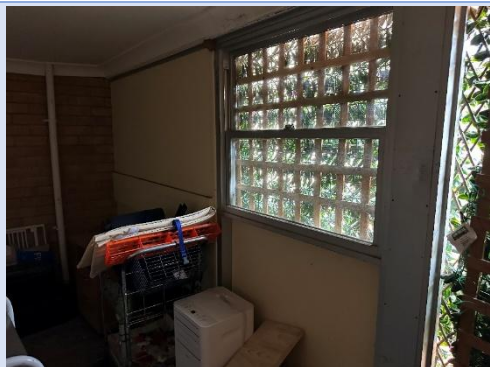
| Material Identification | | Risk Assessment | | | Risk Management & Corrective Actions | | | Photo |
|---|---|---|---|---|---|---|---|---|
| External, Zone 5, northern section of courtyard, southeastern wall panel | Fibre cement sheeting | ASB34/R1 | CH | 1 sqm | NF | Negligible | Prior to demolition works, this material must be removed by a Class A or B licensed asbestos removalist with a clearance certificate issued by a competent third party. Air monitoring is also recommended. | |

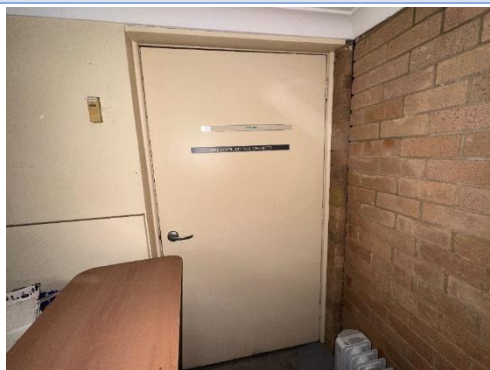
| Material Identification | | Risk Assessment | | | Risk Management & Corrective Actions | | | Photo |
|---|---|---|---|---|---|---|---|---|
| External, Zone 5, northern section of courtyard, western fire door, core material | Millboard | P1 | Presumed Asbestos | 1 unit | F | Negligible | 1989 tag. Remove item intact under controlled conditions prior to demolition works by a Class A asbestos removal contractor, with mandatory asbestos air monitoring and clearance certificate issued by a Licensed Asbestos Assessor (LAA). | |

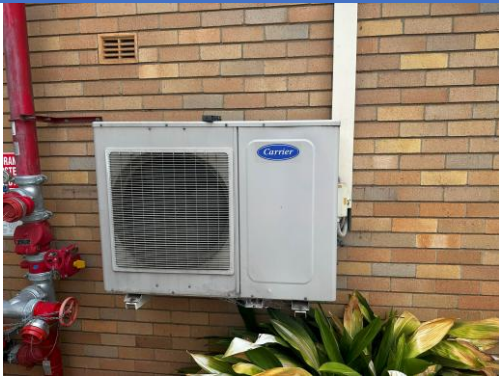
| Material Identification | | Risk Assessment | | | Risk Management & Corrective Actions | | | Photo |
|---|---|---|---|---|---|---|---|---|
| External, Zone 5, northwestern unit, Carrier inverter | Refrigerant gas | ODS16 | Non-ODS | 2 units | NA | - | No ozone depleting gas identified. No further action required. | |

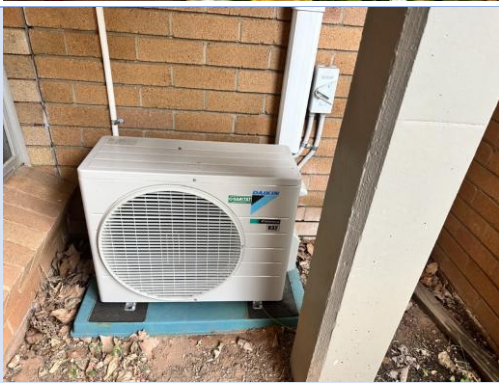
| Material Identification | | Risk Assessment | | | Risk Management & Corrective Actions | | | Photo |
|---|---|---|---|---|---|---|---|---|
| Internal, Zone 5, northwestern unit, Daikin inverter | R32 refrigerant gas, 1.5kg | ODS17 | Non-ODS | 2 units | NA | - | No ozone depleting gas identified. No further action required. | |

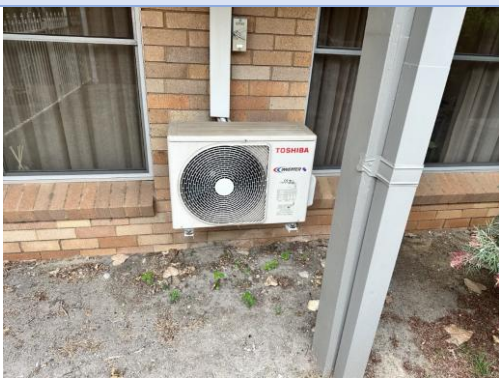
| Material Identification | | Risk Assessment | | | Risk Management & Corrective Actions | | | Photo |
|---|---|---|---|---|---|---|---|---|
| External, Zone 5, northwestern unit, Toshiba inverter | R410a refrigerant gas | ODS18 | Non-ODS | 2 units | NA | - | No ozone depleting gas identified. No further action required. | |

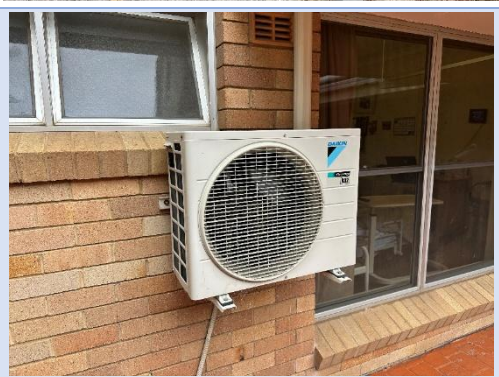
| Material Identification | | Risk Assessment | | | Risk Management & Corrective Actions | | | Photo |
|---|---|---|---|---|---|---|---|---|
| External, Zone 6 eastern courtyard unit, Daikin | R32 refrigerant gas | ODS19 | Non-ODS | 2 units | NA | - | No ozone depleting gas identified. No further action required. | |

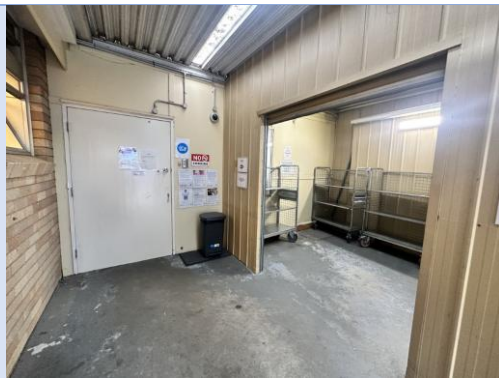
| Material Identification | | Risk Assessment | | | Risk Management & Corrective Actions | | | Photo |
|---|---|---|---|---|---|---|---|---|
| External, Zone 6, Delivery Dock southern wall | Fibre cement sheeting | ASB10 | NAD | 16 sqm | NA | - | No asbestos detected. No further action required. | |

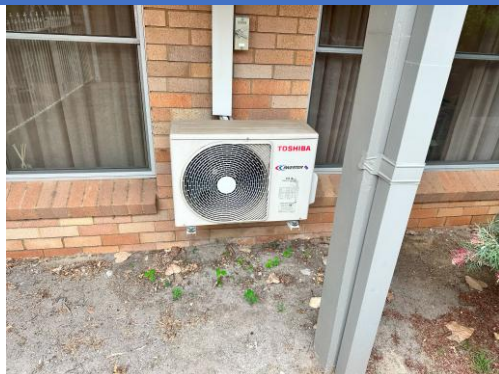
| Material Identification | | Risk Assessment | | | Risk Management & Corrective Actions | | | Photo |
|---|---|---|---|---|---|---|---|---|
| External, Zone 6, northwestern unit, Toshiba inverter | R410a refrigerant gas | ODS22 | Non-ODS | 1 unit | NA | - | No ozone depleting gas identified. No further action required. | |

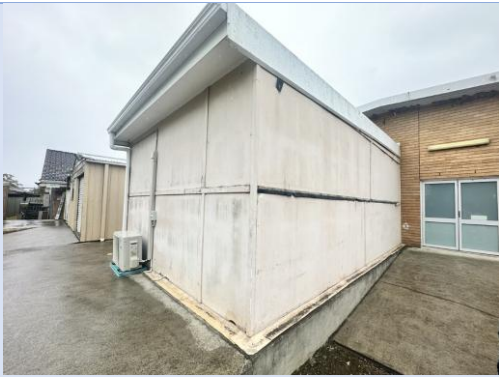
| Material Identification | | | Risk Assessment | | Risk Management & Corrective Actions | | | Photo |
|---|---|---|---|---|---|---|---|---|
| External, Zone 7, southern Store Room wall lining | Fibre cement sheeting | ASB12 | NAD | 40 sqm | NA | - | No asbestos detected. No further action required. | |

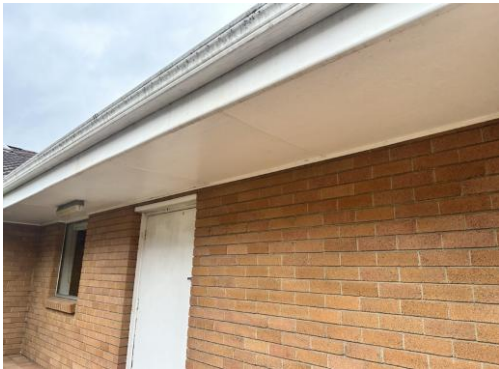
| Material Identification | | Risk Assessment | | | Risk Management & Corrective Actions | | | Photo |
|---|---|---|---|---|---|---|---|---|
| External, Zone 9, eaves throughout | White paint system | LP03 | <0.1% Lead | TH | NA | - | Not lead-containing paint ( $\leq 0.1\%$ w/w) as described in AS/NZS 4361.2:2017 Guide to hazardous paint management, Part 2: Lead paint in residential, public and commercial buildings. No further action required. | |

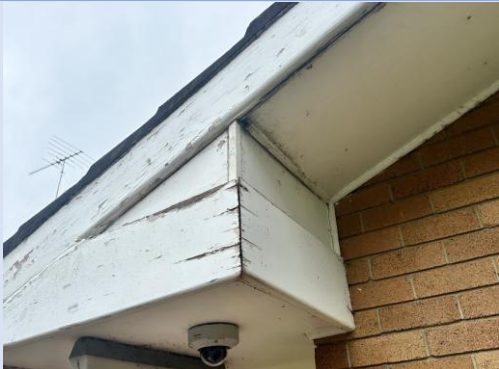
| Material Identification | | Risk Assessment | | | Risk Management & Corrective Actions | | | Photo |
|---|---|---|---|---|---|---|---|---|
| External, Zone 9, north facing infill panel and gable eaves | Fibre cement sheeting | ASB07 | NAD | 15 sqm | NA | - | No asbestos detected. No further action required. | |

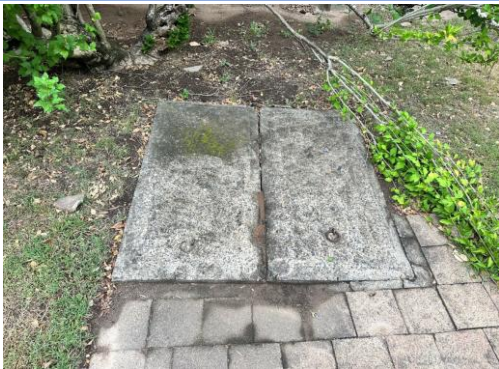
| Material Identification | | Risk Assessment | | | Risk Management & Corrective Actions | | | Photo |
|---|---|---|---|---|---|---|---|---|
| External, Zone 9, north side of building, inaccessible pit | Pit Wall linings | - | Unknown | Unknown | NA | - | No access at the time of inspection. Gain access to pit to identify any potential hazardous materials e.g. asbestos pit wall linings. | |

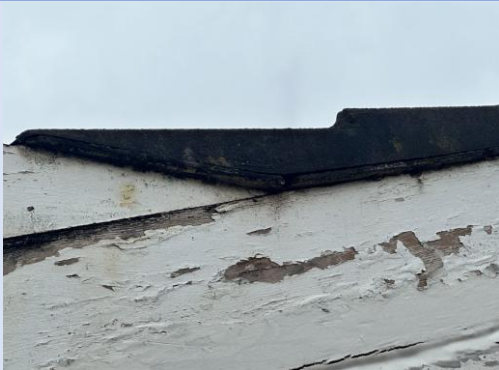
| Material Identification | | Risk Assessment | | | Risk Management & Corrective Actions | | | Photo |
|---|---|---|---|---|---|---|---|---|
| External, Zone 9, roof, edging strip | Fibre cement sheeting | ASB06 | NAD | TH | NA | - | No asbestos detected. No further action required. | |

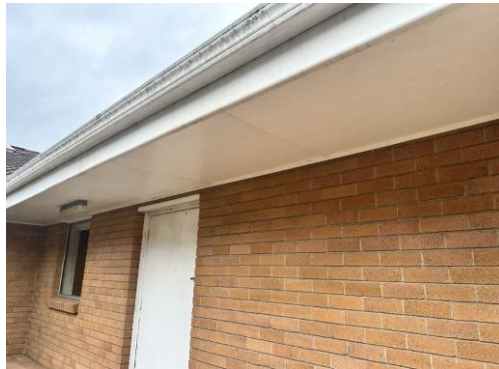
| Material Identification | | Risk Assessment | | | Risk Management & Corrective Actions | | | Photo |
|---|---|---|---|---|---|---|---|---|
| External, Zone 9, soffit | Fibre cement sheeting | ASB05 | NAD*<br><b>Presumed Asbestos</b> | TH | NF | Low | <p>*No asbestos detected by the laboratory. Asbestos has been detected in samples of eaves linings/soffits from other locations around the site.</p> <p>Due to no easily discernible visual difference between the full extents of asbestos and non-asbestos containing eaves linings/soffits ALL eaves linings/soffits at the site are to be managed as asbestos containing.</p> <p>Prior to demolition works, this material must be removed by a Class A or B licensed asbestos removalist with a clearance certificate issued by a competent third party. Air monitoring is also recommended.</p> | |

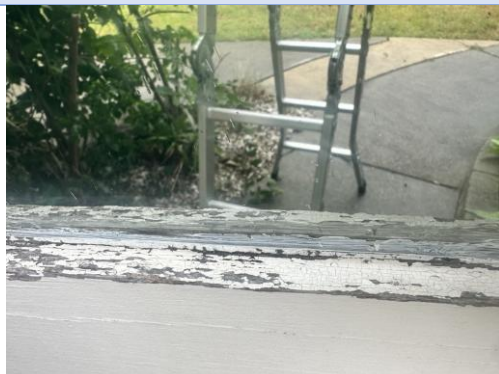
| Material Identification | | Risk Assessment | | | Risk Management & Corrective Actions | | | Photo |
|---|---|---|---|---|---|---|---|---|
| External, Zone 10, Activities Room, window putty | Mastic | ASB14 | NAD | TH | NA | - | No asbestos detected. No further action required. | |

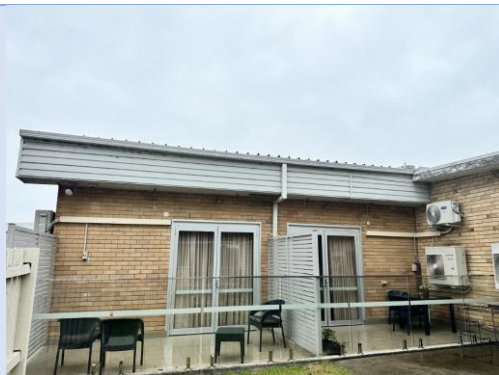
| Material Identification | | Risk Assessment | | | Risk Management & Corrective Actions | | | Photo |
|---|---|---|---|---|---|---|---|---|
| External, Zone 10, southeast corner, south and southeast infill panels | Fibre cement sheeting | ASB13/R1 | NAD | 10 Lm | NA | - | No asbestos detected. No further action required. | |

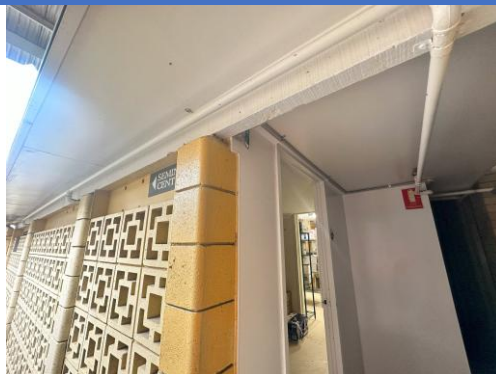
| Material Identification | | | Risk Assessment | | Risk Management & Corrective Actions | | | Photo |
|---|---|---|---|---|---|---|---|---|
| External, Zone 10, southeast corner, south eave soffit | Fibre cement sheeting | ASB13 | NAD | 8 Lm | NA | - | No asbestos detected. No further action required. | |

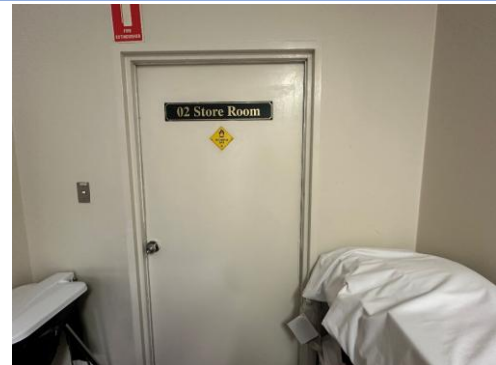
| Material Identification | | | Risk Assessment | | Risk Management & Corrective Actions | | | Photo |
|---|---|---|---|---|---|---|---|---|
| Internal, alarmed fire doors | Inaccessible | - | Unknown | TH | NA | - | No access at the time of inspection. Gain access to confirm presence of hazmat. | |

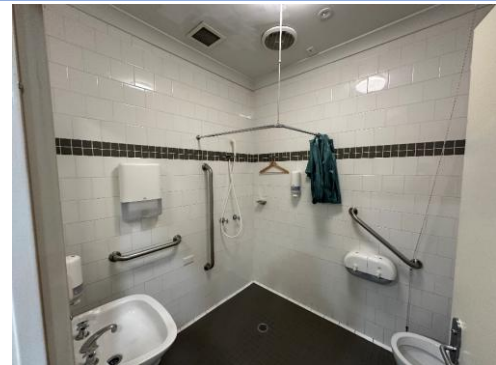
| Material Identification | | | Risk Assessment | | | Risk Management & Corrective Actions | | Photo |
|---|---|---|---|---|---|---|---|---|
| Internal, Zone 1, Staff Toilet, tiled walls | Fibre cement sheeting | P5 | Presumed Asbestos | 18 sqm | NF | Negligible | Prior to demolition works, this material must be removed by a Class A or B licensed asbestos removalist with a clearance certificate issued by a competent third party. Air monitoring is also recommended. | |

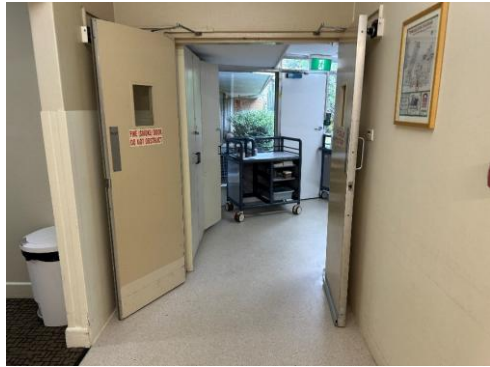
| Material Identification | | Risk Assessment | | | Risk Management & Corrective Actions | | Photo | |
|---|---|---|---|---|---|---|---|---|
| Internal, Zone 2, doorway north of Kitchen, fire door core material | Fire door core insulation | P6 | Presumed Asbestos | 1 unit | F | Negligible | 1905 tag. Remove item intact under controlled conditions prior to demolition works by a Class A asbestos removal contractor, with mandatory asbestos air monitoring and clearance certificate issued by a Licensed Asbestos Assessor (LAA). | |

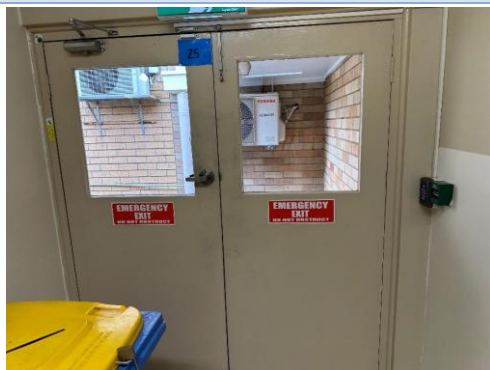
| Material Identification | | Risk Assessment | | | Risk Management & Corrective Actions | | Photo | |
|---|---|---|---|---|---|---|---|---|
| Internal, Zone 2, hallway east of Kitchen, fire door core material | Fire door core insulation | SP1 | Strongly Presumed Asbestos | 1 unit | F | Negligible | 1989 tag. Remove item intact under controlled conditions prior to demolition works by a Class A asbestos removal contractor, with mandatory asbestos air monitoring and clearance certificate issued by a Licensed Asbestos Assessor (LAA). | |

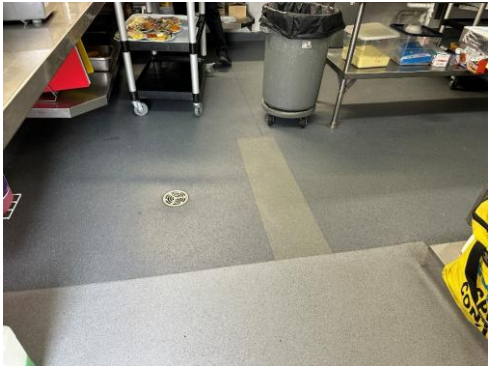
| Material Identification | | Risk Assessment | | | Risk Management & Corrective Actions | | | Photo |
|---|---|---|---|---|---|---|---|---|
| Internal, Zone 2, Kitchen | Vinyl sheeting - navy blue | ASB28/R1 | NAD | 65 sqm | NA | - | No asbestos detected. No further action required. | |

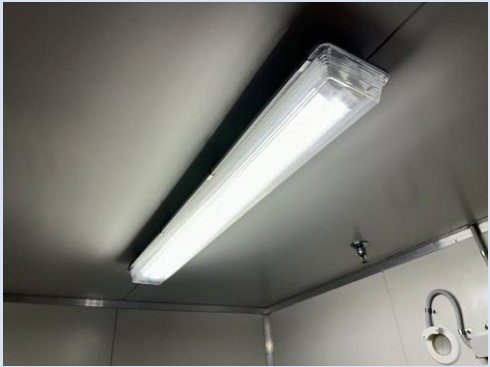
| Material Identification | | Risk Assessment | | | Risk Management & Corrective Actions | | | Photo |
|---|---|---|---|---|---|---|---|---|
| Internal, Zone 2, Kitchen cool room and freezer, light fitting | PCB-containing capacitors | PCB16 | <b>Presumed PCB</b> | 2 units | NA | Negligible | Inaccessible during survey due to live electrical hazard. Confirm presence of polychlorinated biphenyls prior to demolition. PCB-containing material should be removed prior to demolition works and disposed of as per EPA requirements. | |

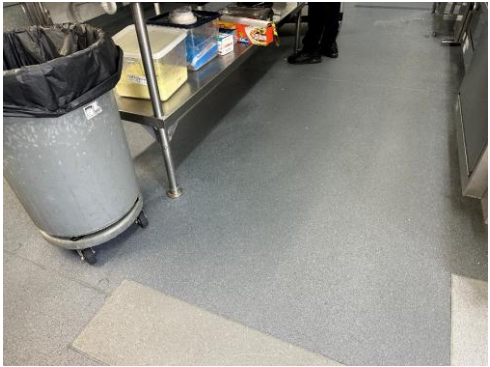
| Material Identification | | Risk Assessment | | | Risk Management & Corrective Actions | | | Photo |
|---|---|---|---|---|---|---|---|---|
| Internal, Zone 2, Kitchen, flooring | Vinyl flooring - speckled grey | ASB24/R1 | NAD | TH | NA | - | No asbestos detected. No further action required. | |

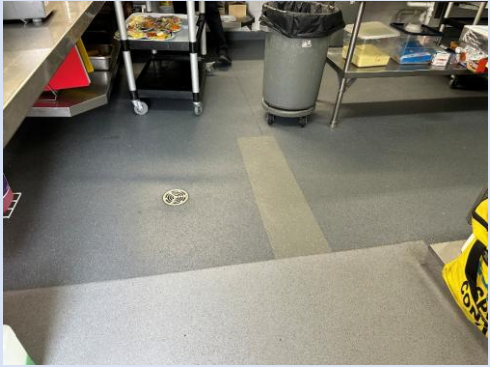
| Material Identification | | Risk Assessment | | | Risk Management & Corrective Actions | | | Photo |
|---|---|---|---|---|---|---|---|---|
| Internal, Zone 2, Kitchen, flooring | Vinyl flooring - light blue | ASB21/R2 | NAD | TH | NA | - | No asbestos detected. No further action required. | |

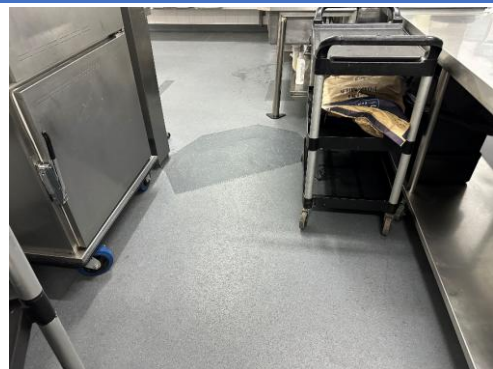
| Material Identification | | Risk Assessment | | | Risk Management & Corrective Actions | | | Photo |
|---|---|---|---|---|---|---|---|---|
| Internal, Zone 2, Kitchen, flooring | Vinyl flooring - dark speckled grey | ASB28/R2 | NAD | TH | NA | - | No asbestos detected. No further action required. | |

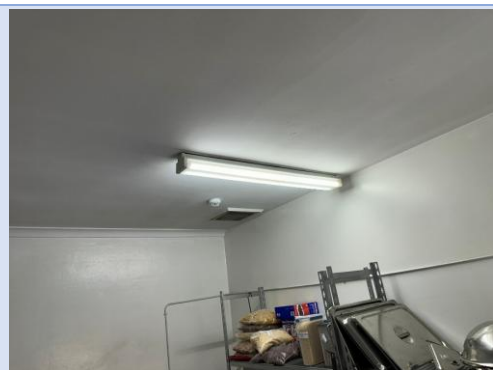
| Material Identification | | Risk Assessment | | | Risk Management & Corrective Actions | | | Photo |
|---|---|---|---|---|---|---|---|---|
| Internal, Zone 2, Kitchen, light fittings | PCB-containing capacitors | PCB17 | Presumed PCB | 9 units | NA | Negligible | Inaccessible during survey due to live electrical hazard. Confirm presence of polychlorinated biphenyls prior to demolition. PCB-containing material should be removed prior to demolition works and disposed of as per EPA requirements. | |

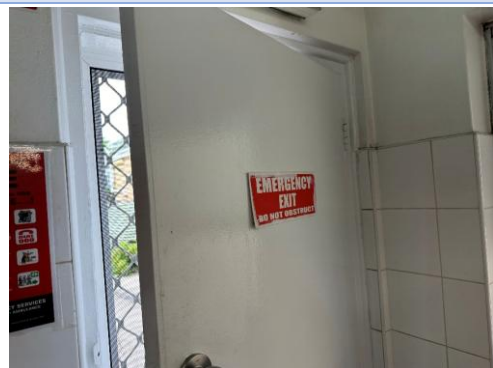
| Material Identification | | Risk Assessment | | | Risk Management & Corrective Actions | | | Photo |
|---|---|---|---|---|---|---|---|---|
| Internal, Zone 2, Kitchen, north entry fire door, core material | Fire door core insulation | SP2 | Strongly Presumed Asbestos | 1 unit | F | Negligible | 1980s tag. Remove item intact under controlled conditions prior to demolition works by a Class A asbestos removal contractor, with mandatory asbestos air monitoring and clearance certificate issued by a Licensed Asbestos Assessor (LAA). | |

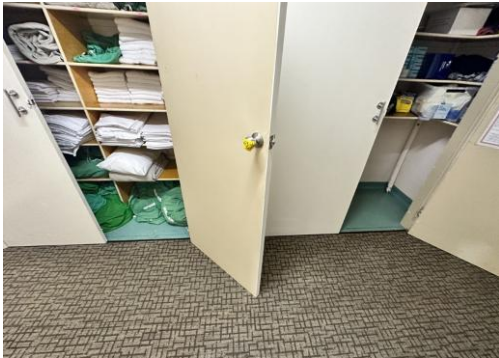
| Material Identification | | Risk Assessment | | | Risk Management & Corrective Actions | | | Photo |
|---|---|---|---|---|---|---|---|---|
| Internal, Zone 2, linen and supplies closet flooring | Vinyl sheeting - teal | ASB22/R1 | NAD | 4 sqm | NA | - | No asbestos detected. No further action required. | |

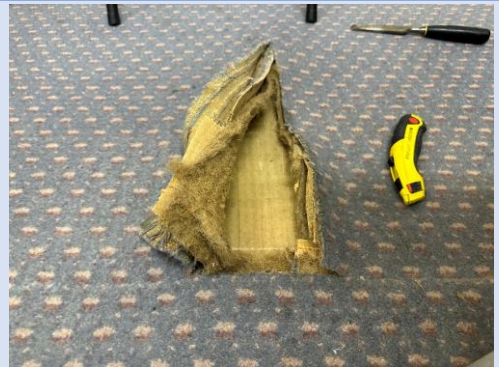
| Material Identification | | Risk Assessment | | | Risk Management & Corrective Actions | | | Photo |
|---|---|---|---|---|---|---|---|---|
| Internal, Zone 2, Quality Office, concealed vinyl flooring | Vinyl sheeting - beige | ASB29 | NAD | TH | NA | - | No asbestos detected. No further action required. | |

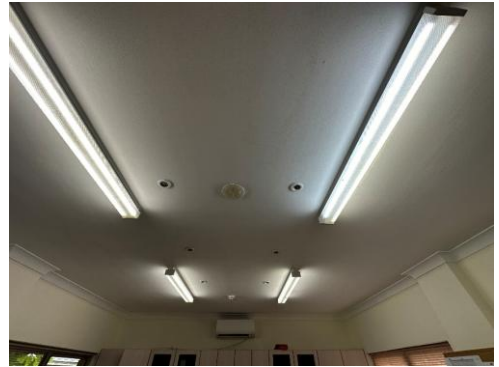
| Material Identification | | Risk Assessment | | | Risk Management & Corrective Actions | | | Photo |
|---|---|---|---|---|---|---|---|---|
| Internal, Zone 2, Quality Office, light fittings | PCB-containing capacitors | PCB19 | <b>Presumed PCB</b> | 4 units | NA | Negligible | Inaccessible during survey due to live electrical hazard. Confirm presence of polychlorinated biphenyls prior to demolition. PCB-containing material should be removed prior to demolition works and disposed of as per EPA requirements. | |

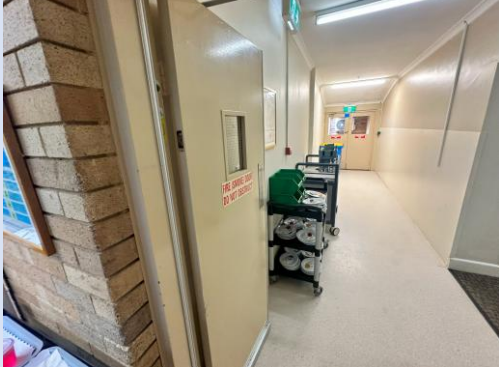
| Material Identification | | Risk Assessment | | | Risk Management & Corrective Actions | | | Photo |
|---|---|---|---|---|---|---|---|---|
| Internal, Zone 2, room and hallways adjacent Kitchen, flooring | Vinyl sheeting - Grey speckled | ASB24 | NAD | 20 sqm | NA | - | No asbestos detected. No further action required. | |

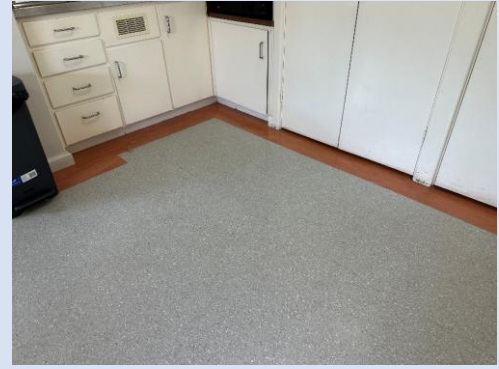
| Material Identification | | Risk Assessment | | | | Risk Management & Corrective Actions | | Photo |
|---|---|---|---|---|---|---|---|---|
| Internal, Zone 2, southern Staff Room, flooring | Vinyl flooring - grey speckled with red and white | ASB24/R2 | NAD | 30 sqm | NA | - | No asbestos detected. No further action required. | |

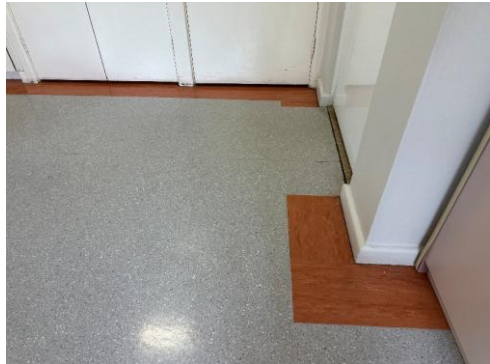
| Material Identification | | Risk Assessment | | | Risk Management & Corrective Actions | | | Photo |
|---|---|---|---|---|---|---|---|---|
| Internal, Zone 2, southern Staff Room, flooring | Vinyl flooring - rust red | ASB30 | NAD | 10 sqm | NA | - | No asbestos detected. No further action required. | |

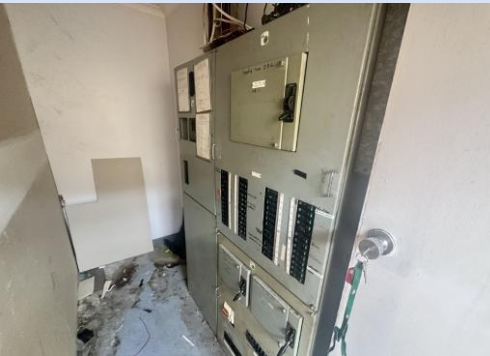
| Material Identification | | Risk Assessment | | | Risk Management & Corrective Actions | | | Photo |
|---|---|---|---|---|---|---|---|---|
| Internal, Zone 2, western electrical switch cabinet | Low voltage HRC fuses | P7 | Presumed Asbestos | 1 sqm | F | Negligible | Fuses of this type have been known to contain asbestos in the internal components of the use. Isolate the electrical supply and collect sample of fuses for laboratory analysis. This material must be removed by a Class A licensed asbestos removalist and air monitoring and a clearance certificate must be conducted by a licensed asbestos assessor. | |

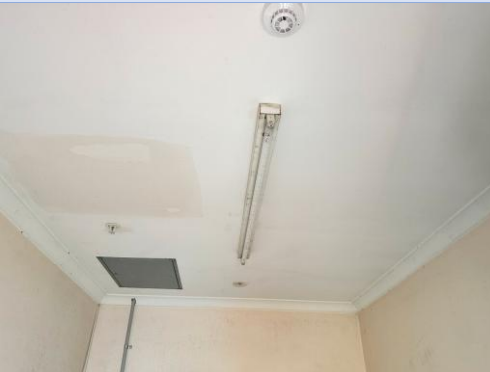
| Material Identification | | Risk Assessment | | | Risk Management & Corrective Actions | | | Photo |
|---|---|---|---|---|---|---|---|---|
| Internal, Zone 2, western Electrical Switch Room, ceiling | Horsehair plaster | ASB16 | NAD | 8 sqm | NA | - | No asbestos detected. No further action required. | |

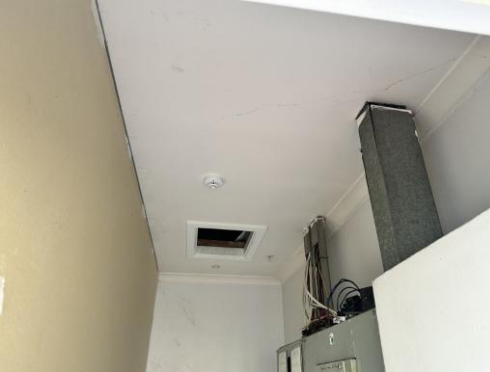
| Material Identification | | Risk Assessment | | | Risk Management & Corrective Actions | | | Photo |
|---|---|---|---|---|---|---|---|---|
| Internal, Zone 2, western Electrical Switch Room, ceiling space | Lead dust | LD02 | Lead Containing Dust (21mg/m2) | 12 sqm | NA | Low | Do not disturb, restrict access to ceiling cavity. Remove by competent hazardous materials removal contractor prior to demolition or refurbishment works, with clearance conducted by competent hazardous materials consultant. | |

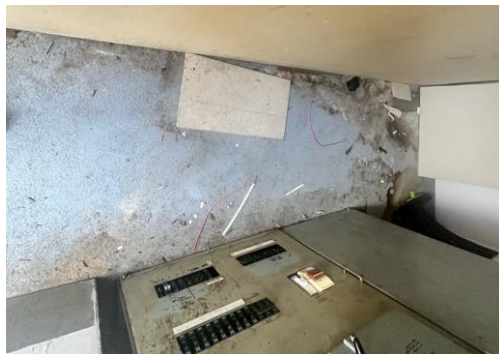
| Material Identification | | Risk Assessment | | | Risk Management & Corrective Actions | | | Photo |
|---|---|---|---|---|---|---|---|---|
| Internal, Zone 2, western Electrical Switch Room, debris on floor | Fibre cement sheet | ASB15 | NAD | 3 units | NA | - | No asbestos detected. No further action required. | |

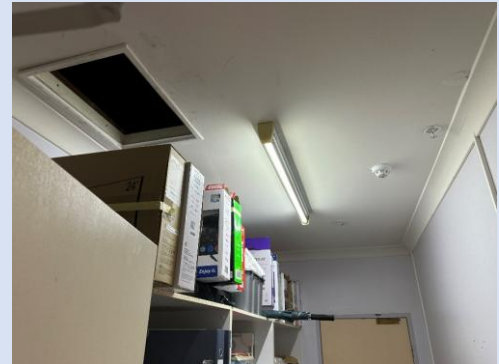
| Material Identification | | Risk Assessment | | | Risk Management & Corrective Actions | | | Photo |
|---|---|---|---|---|---|---|---|---|
| Internal, Zone 4, northern light fitting | PCB-containing capacitor | PCB23 | Presumed PCB | 1 unit | NF | Negligible | Inaccessible during survey due to live electrical hazard. Confirm presence of polychlorinated biphenyls prior to demolition. PCB-containing material should be removed prior to demolition works and disposed of as per EPA requirements. | |

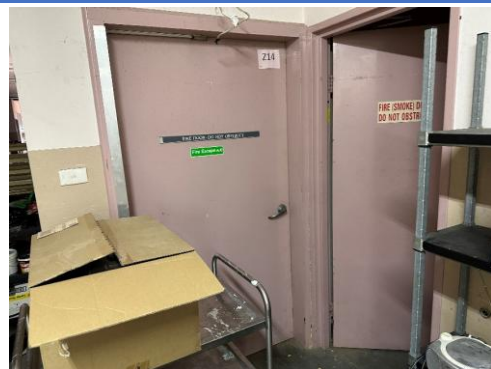
| Material Identification | | Risk Assessment | | | | Risk Management & Corrective Actions | | Photo |
|---|---|---|---|---|---|---|---|---|
| Internal, Zone 4, Plant Room hallway, west end fire door, core material | Fire door core insulation | P8 | Presumed Asbestos | 1 unit | F | Negligible | Unknown tag, material presumed to contain friable asbestos. Remove item intact under controlled conditions prior to demolition works by a Class A asbestos removal contractor, with mandatory asbestos air monitoring and clearance certificate issued by a Licensed Asbestos Assessor (LAA). | |

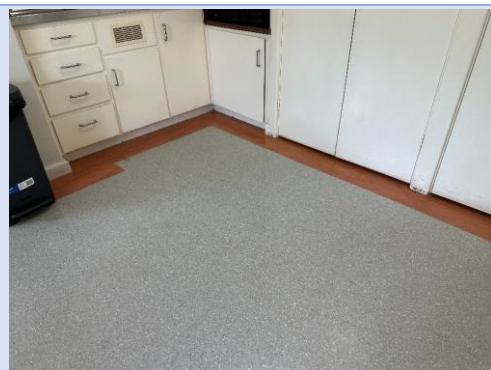
| Material Identification | | Risk Assessment | | | | Risk Management & Corrective Actions | | Photo |
|---|---|---|---|---|---|---|---|---|
| Internal, Zone 4, Plant Room, flooring | Paper composite | ASB32 | NAD | TH | NA | - | No asbestos detected. No further action required. | |

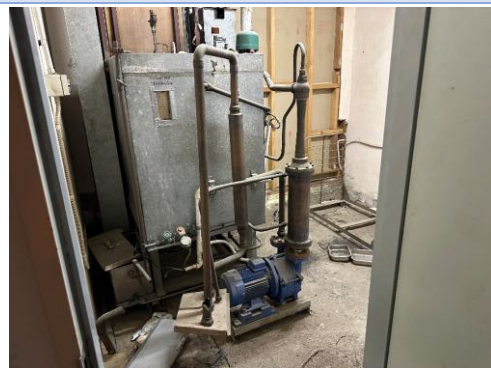
| Material Identification | | Risk Assessment | | | | Risk Management & Corrective Actions | | Photo |
|---|---|---|---|---|---|---|---|---|
| Internal, Zone 4, Plant Room, hot water piping insulation | SMF | SMF01 | SMF | 4 sqm | F | Negligible | Remove under controlled conditions. | |

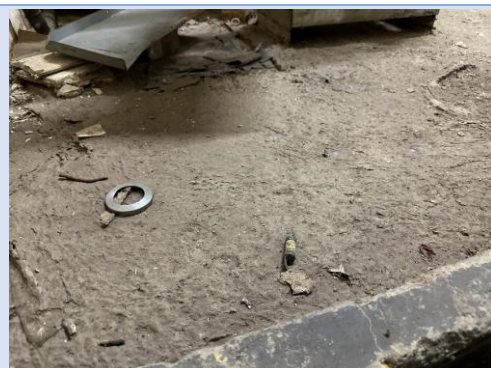
| Material Identification | | Risk Assessment | | | | Risk Management & Corrective Actions | | Photo |
|---|---|---|---|---|---|---|---|---|
| Internal, Zone 4, Plant Room, loose fuse | Low voltage HRC fuse | SP3 | Strongly Presumed Asbestos | 1 unit | F | Medium | Remove item intact under controlled conditions prior to demolition works by a Class A asbestos removal contractor, with mandatory asbestos air monitoring and clearance certificate issued by a Licensed Asbestos Assessor (LAA). | |

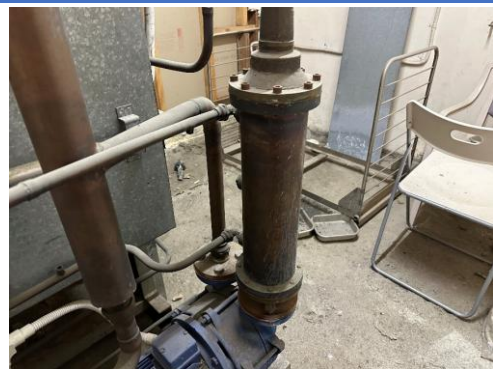
| Material Identification | | Risk Assessment | | | Risk Management & Corrective Actions | | Photo | |
|---|---|---|---|---|---|---|---|---|
| Internal, Zone 4, Plant Room, machinery | Gasket | ASB31 | CH | 1 unit | NF | Negligible | Prior to demolition works, this material must be removed by a Class A or B licensed asbestos removalist with a clearance certificate issued by a competent third party. Air monitoring is also recommended. | |

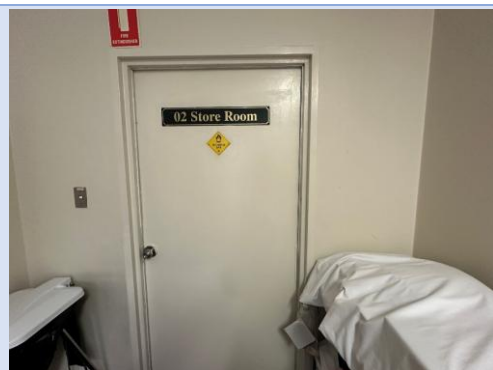
| Material Identification | | Risk Assessment | | | Risk Management & Corrective Actions | | Photo | |
|---|---|---|---|---|---|---|---|---|
| Internal, Zone 5, 02 Store Room fire door, core material | Fire door core insulation | P9 | Presumed Asbestos | 1 unit | F | Negligible | Remove item intact under controlled conditions prior to demolition works by a Class A asbestos removal contractor, with mandatory asbestos air monitoring and clearance certificate issued by a Licensed Asbestos Assessor (LAA). | |

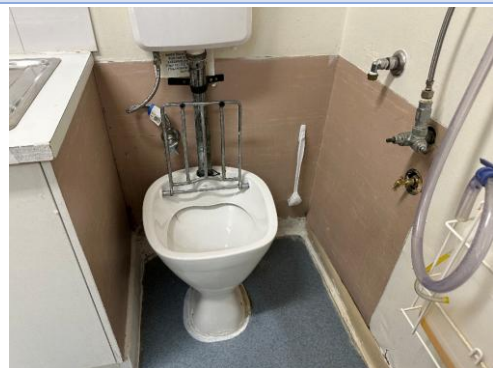
| Material Identification | | Risk Assessment | | | Risk Management & Corrective Actions | | Photo | |
|---|---|---|---|---|---|---|---|---|
| Internal, Zone 5, Dirty Utility | Light blue vinyl | ASB21/R3 | NAD | TH | NA | - | No asbestos detected. No further action required. | |

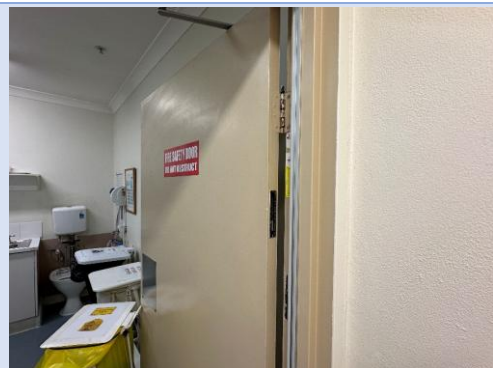
| Material Identification | | Risk Assessment | | | Risk Management & Corrective Actions | | Photo | |
|---|---|---|---|---|---|---|---|---|
| Internal, Zone 5, Dirty Utility, second fire door, core material | Fire door core insulation | P10 | Presumed Asbestos | 1 unit | F | Negligible | 1989 tag. Remove item intact under controlled conditions prior to demolition works by a Class A asbestos removal contractor, with mandatory asbestos air monitoring and clearance certificate issued by a Licensed Asbestos Assessor (LAA). | |

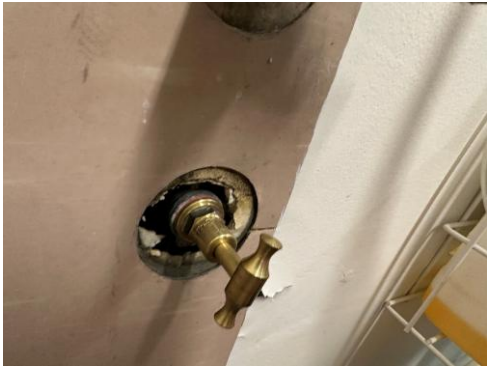
| Material Identification | | Risk Assessment | | | Risk Management & Corrective Actions | | | Photo |
|---|---|---|---|---|---|---|---|---|
| Internal, Zone 5, Dirty Utility, south wall lining behind rust red vinyl | Fibre cement sheeting | ASB36 | NAD | 2 sqm | NA | - | No asbestos detected. No further action required. | |

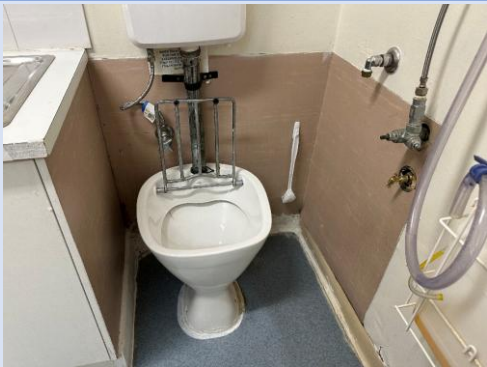
| Material Identification | | Risk Assessment | | | Risk Management & Corrective Actions | | | Photo |
|---|---|---|---|---|---|---|---|---|
| Internal, Zone 5, Dirty Utility, wall vinyl | Rust-red vinyl | ASB30/R1 | NAD | 2 sqm | NA | - | No asbestos detected. No further action required. | |

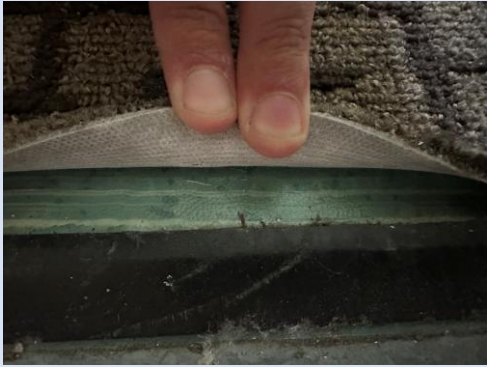
| Material Identification | | Risk Assessment | | | Risk Management & Corrective Actions | | | Photo |
|---|---|---|---|---|---|---|---|---|
| Internal, Zone 5, hallway throughout, under carpet | Teal vinyl | ASB22/R4 | NAD | TH | NA | - | No asbestos detected. No further action required. | |

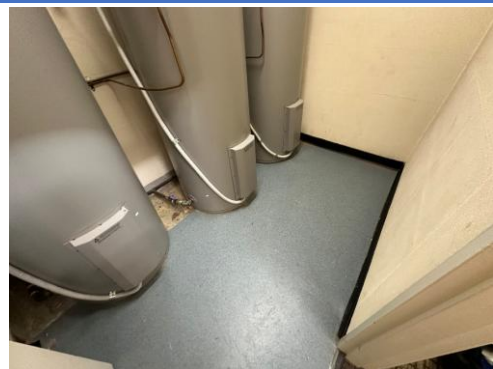
| Material Identification | | | Risk Assessment | | Risk Management & Corrective Actions | | | Photo |
|---|---|---|---|---|---|---|---|---|
| Internal, Zone 5, hot water system room | Light blue vinyl | ASB21/R4 | NAD | 4 sqm | NA | - | No asbestos detected. No further action required. | |

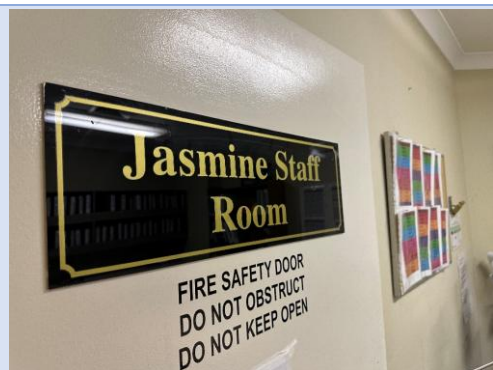
| Material Identification | | | Risk Assessment | | Risk Management & Corrective Actions | | | Photo |
|---|---|---|---|---|---|---|---|---|
| Internal, Zone 5, Jasmine Staff Room fire door, core material | Fire door core insulation | P12 | Presumed Asbestos | 1 unit | F | Negligible | Remove item intact under controlled conditions prior to demolition works by a Class A asbestos removal contractor, with mandatory asbestos air monitoring and clearance certificate issued by a Licensed Asbestos Assessor (LAA). | |

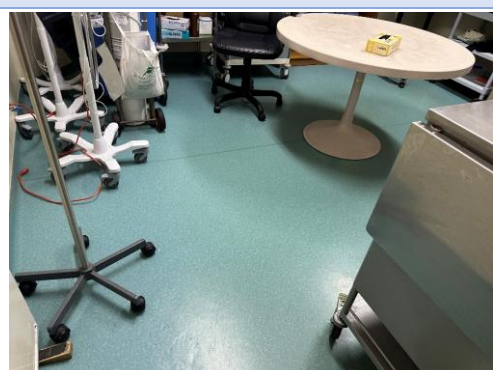
| Material Identification | | | Risk Assessment | | Risk Management & Corrective Actions | | | Photo |
|---|---|---|---|---|---|---|---|---|
| Internal, Zone 5, Jasmine Staff Room, flooring | Teal vinyl tile | ASB22/R2 | NAD | TH | NA | - | No asbestos detected. No further action required. | |

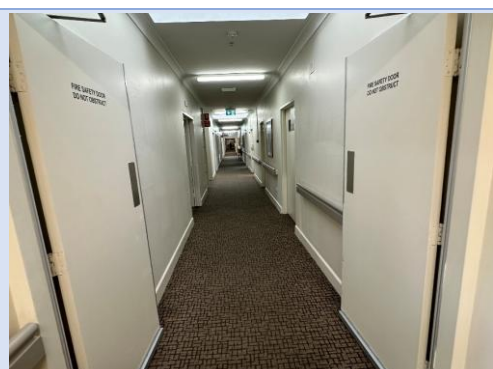
| Material Identification | | | Risk Assessment | | Risk Management & Corrective Actions | | | Photo |
|---|---|---|---|---|---|---|---|---|
| Internal, Zone 5, Jasmine Wing double fire doors, core material | Fire door core insulation | P13 | Presumed Asbestos | 2 units | F | Negligible | Remove item intact under controlled conditions prior to demolition works by a Class A asbestos removal contractor, with mandatory asbestos air monitoring and clearance certificate issued by a Licensed Asbestos Assessor (LAA). | |

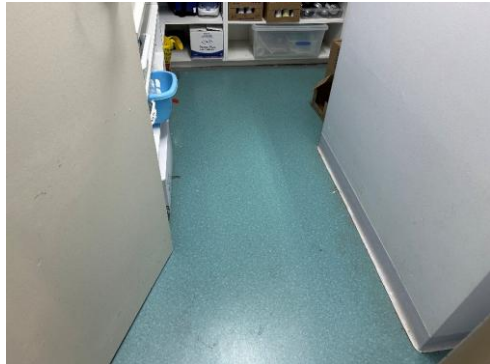
| Material Identification | | | Risk Assessment | | | Risk Management & Corrective Actions | | Photo |
|---|---|---|---|---|---|---|---|---|
| Internal, Zone 5, Medical Store | Teal vinyl tile | ASB22/R3 | NAD | TH | NA | - | No asbestos detected. No further action required. | |

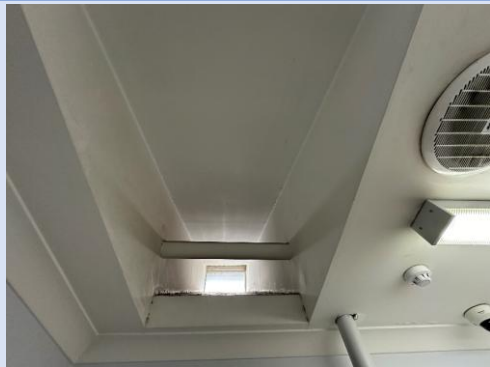
| Material Identification | | | Risk Assessment | | | Risk Management & Corrective Actions | | Photo |
|---|---|---|---|---|---|---|---|---|
| Internal, Zone 5, north facing skylight, walls | Fibre cement sheeting | ASB04/R2 | CH | TH | NF | Low | Prior to demolition works, this material must be removed by a Class A or B licensed asbestos removalist with a clearance certificate issued by a competent third party. Air monitoring is also recommended. | |
