# Hazardous Materials Management Survey and Register

## 366 Jamison Rd, Jamisontown NSW 2750

**JOB NUMBER:** JN05770

**ISSUED DATE:** 31 January 2025

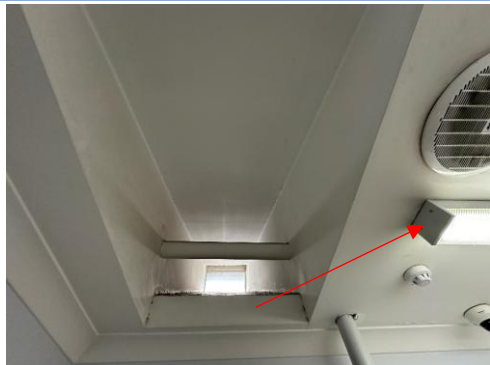
| Material Identification | | | Risk Assessment | | | Risk Management & Corrective Actions | | Photo |
|---|---|---|---|---|---|---|---|---|
| Internal, Zone 5, northern light fitting | PCB-containing capacitors | PCB24 | Presumed PCB | 4 units | NF | Negligible | Inaccessible during survey due to live electrical hazard. Confirm presence of polychlorinated biphenyls prior to demolition. PCB-containing material should be removed prior to demolition works and disposed of as per EPA requirements. | |

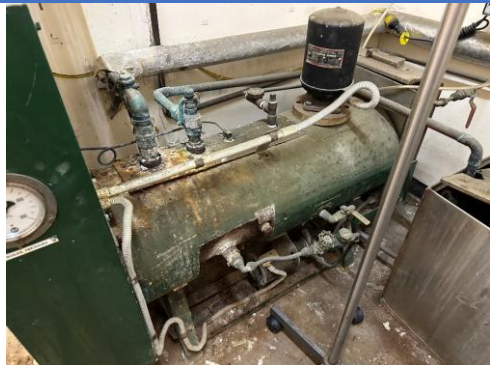
| Material Identification | | Risk Assessment | | | | Risk Management & Corrective Actions | | Photo |
|---|---|---|---|---|---|---|---|---|
| Internal, Zone 5, room adjacent west of Zone 4 Plant Room | Gasket | ASB31/R1 | CH | 2 sqm | NF | Negligible | Prior to demolition works, this material must be removed by a Class A or B licensed asbestos removalist with a clearance certificate issued by a competent third party. Air monitoring is also recommended. | |

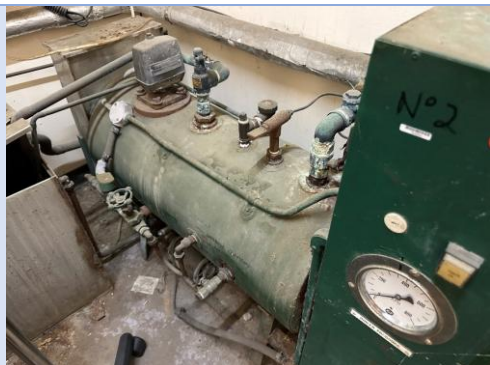
| Material Identification | | Risk Assessment | | | | Risk Management & Corrective Actions | | Photo |
|---|---|---|---|---|---|---|---|---|
| Internal, Zone 5, room adjacent west of Zone 4 Plant Room, boiler insulation | Insulation | ASB33 | NAD | 4 sqm | NA | - | No asbestos detected. No further action required. | |

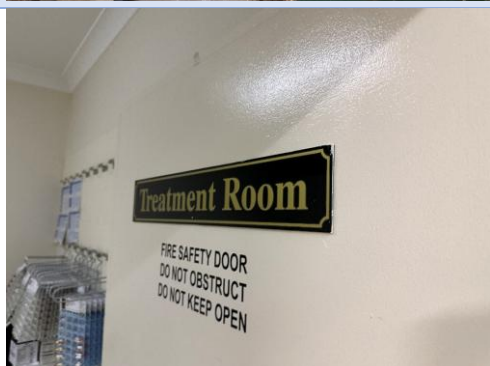
| Material Identification | | Risk Assessment | | | | Risk Management & Corrective Actions | | Photo |
|---|---|---|---|---|---|---|---|---|
| Internal, Zone 5, Treatment Room fire door, core material | Fire door core insulation | P14 | Presumed Asbestos | 1 unit | F | Negligible | 1989 tag. Remove item intact under controlled conditions prior to demolition works by a Class A asbestos removal contractor, with mandatory asbestos air monitoring and clearance certificate issued by a Licensed Asbestos Assessor (LAA). | |

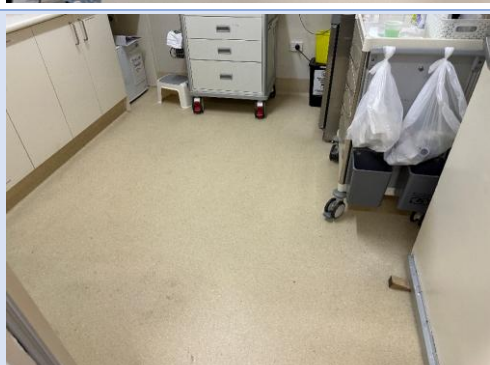
| Material Identification | | Risk Assessment | | | | Risk Management & Corrective Actions | | Photo |
|---|---|---|---|---|---|---|---|---|
| Internal, Zone 5, Treatment Room flooring | Beige speckled vinyl | ASB35 | NAD | TH | NA | - | No asbestos detected. No further action required. | |

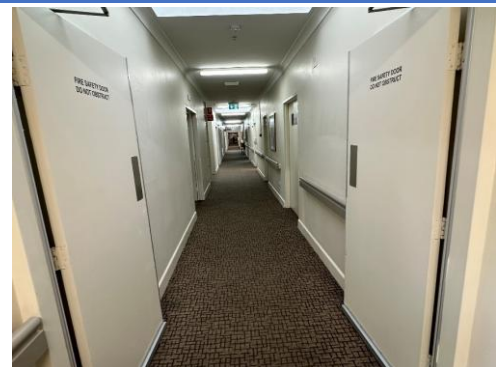
| Material Identification | | Risk Assessment | | | Risk Management & Corrective Actions | | Photo | |
|---|---|---|---|---|---|---|---|---|
| Internal, Zone 6, eastern double fire doors, core material | Fire door core insulation | SP4 | Strongly Presumed Asbestos | 2 units | F | Negligible | 1989 tag. Remove item intact under controlled conditions prior to demolition works by a Class A asbestos removal contractor, with mandatory asbestos air monitoring and clearance certificate issued by a Licensed Asbestos Assessor (LAA). | |

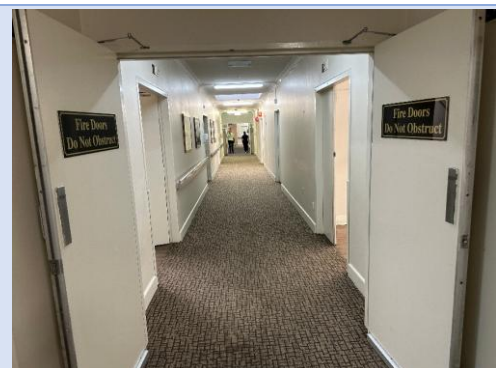
| Material Identification | | Risk Assessment | | | Risk Management & Corrective Actions | | Photo | |
|---|---|---|---|---|---|---|---|---|
| Internal, Zone 6, Jasmine Ward main hallway southern double fire doors, core material | Fire door core insulation | SP5 | Strongly Presumed Asbestos | 2 units | F | Negligible | 1985 tag. Remove item intact under controlled conditions prior to demolition works by a Class A asbestos removal contractor, with mandatory asbestos air monitoring and clearance certificate issued by a Licensed Asbestos Assessor (LAA). | |

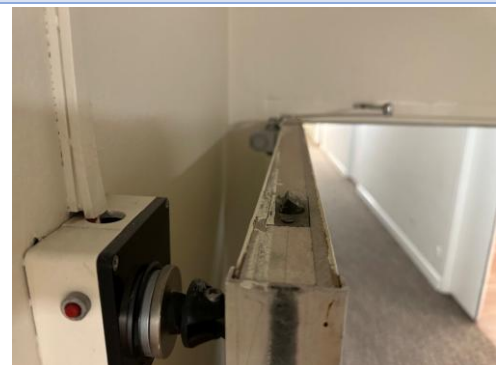
| Material Identification | | Risk Assessment | | | Risk Management & Corrective Actions | | Photo | |
|---|---|---|---|---|---|---|---|---|
| Internal, Zone 6, main hallway western double fire doors, core material | Fire door core insulation | SP6 | Strongly Presumed Asbestos | 2 units | F | Negligible | 1989 tag. Remove item intact under controlled conditions prior to demolition works by a Class A asbestos removal contractor, with mandatory asbestos air monitoring and clearance certificate issued by a Licensed Asbestos Assessor (LAA). | |

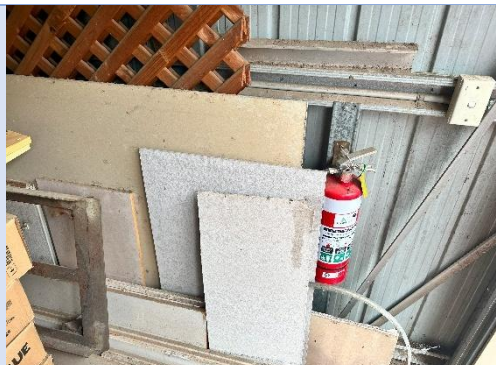
| Material Identification | | Risk Assessment | | | Risk Management & Corrective Actions | | Photo | |
|---|---|---|---|---|---|---|---|---|
| Internal, Zone 6, Maintenance Shed, loose sheeting | Fibre cement sheeting | ASB11 | NAD | 4 units | NA | - | No asbestos detected. No further action required. | |

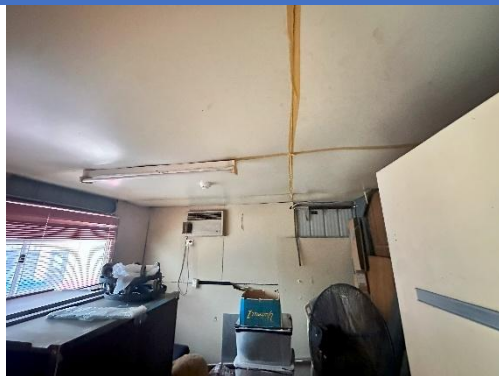
| Material Identification | | Risk Assessment | | | Risk Management & Corrective Actions | | | Photo |
|---|---|---|---|---|---|---|---|---|
| Internal, Zone 6, Maintenance Shed, store room western walls and ceiling | Masonite and plasterboard | - | NAI | TH | NA | - | No asbestos identified. No further action required. | |

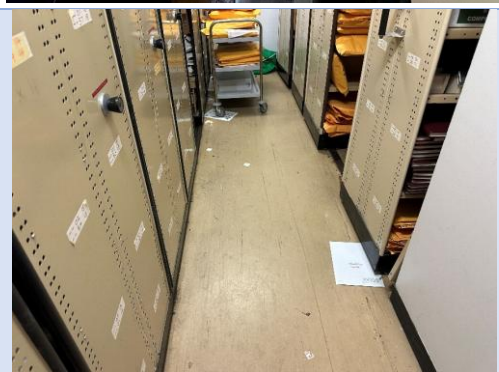
| Material Identification | | Risk Assessment | | | Risk Management & Corrective Actions | | | Photo |
|---|---|---|---|---|---|---|---|---|
| Internal, Zone 6, Medical Records Room, flooring | Light brown vinyl | ST-1838C-ASB4/R1 | NAD | 16 sqm | NA | - | No asbestos detected. No further action required. | |

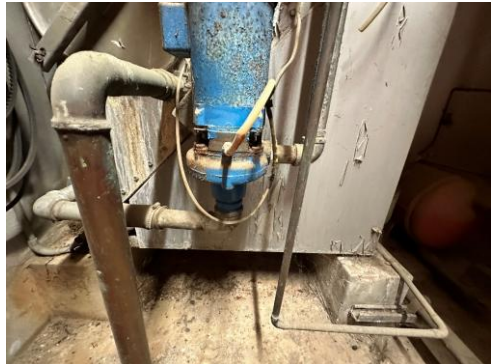
| Material Identification | | Risk Assessment | | | Risk Management & Corrective Actions | | | Photo |
|---|---|---|---|---|---|---|---|---|
| Internal, Zone 6, Power Board Plant Room, equipment | Gasket | ASB31/R2 | CH | 1 sqm | NF | Negligible | Prior to demolition works, this material must be removed by a Class A or B licensed asbestos removalist with a clearance certificate issued by a competent third party. Air monitoring is also recommended. | |

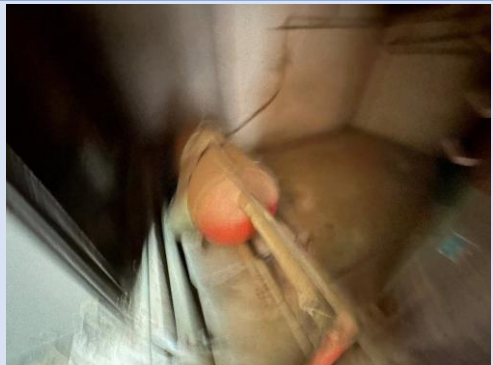
| Material Identification | | Risk Assessment | | | Risk Management & Corrective Actions | | | Photo |
|---|---|---|---|---|---|---|---|---|
| Internal, Zone 6, Power Board Plant Room, red boiler | Insulation | P15 | Presumed Asbestos | 4 sqm | F | Negligible | Remove item intact under controlled conditions prior to demolition works by a Class A asbestos removal contractor, with mandatory asbestos air monitoring and clearance certificate issued by a Licensed Asbestos Assessor (LAA). | |

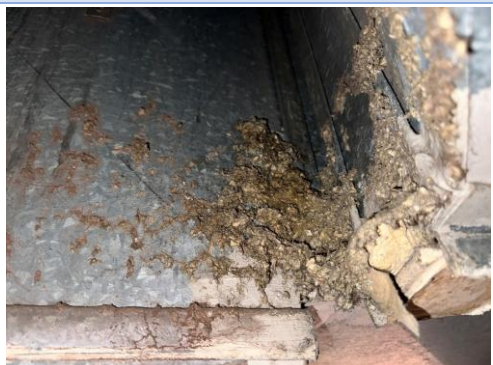
| Material Identification | | Risk Assessment | | | Risk Management & Corrective Actions | | | Photo |
|---|---|---|---|---|---|---|---|---|
| Internal, Zone 6, Power Board Plant Room, roof cavity | Insulation | ASB37 | NAD | 10 sqm | NA | - | No asbestos detected. No further action required. | |

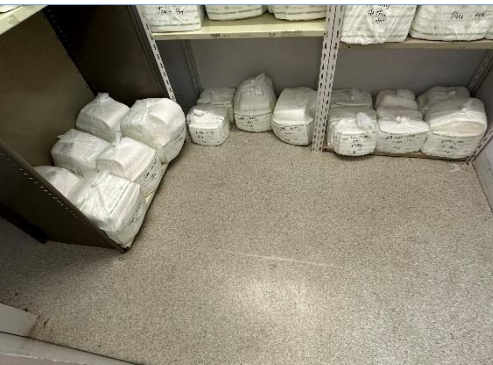
| Material Identification | | Risk Assessment | | | Risk Management & Corrective Actions | | | Photo |
|---|---|---|---|---|---|---|---|---|
| Internal, Zone 6, south of Room 70, store rooms, flooring | Grey speckled with red and white | ASB24/R4 | NAD | 6 sqm | NA | - | No asbestos detected. No further action required. | |

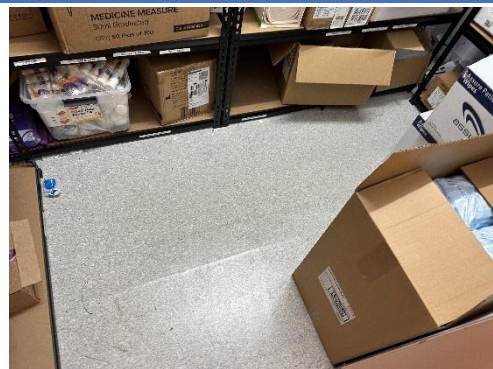
| Material Identification | | Risk Assessment | | | Risk Management & Corrective Actions | | | Photo |
|---|---|---|---|---|---|---|---|---|
| Internal, Zone 6, south visitors lounge, office adjacent south, flooring | Grey speckled with red and white | ASB24/R3 | NAD | 8 sqm | NA | - | No asbestos detected. No further action required. | |

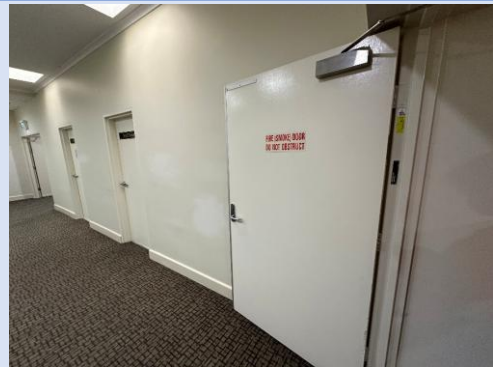
| Material Identification | | Risk Assessment | | | Risk Management & Corrective Actions | | | Photo |
|---|---|---|---|---|---|---|---|---|
| Internal, Zone 7, Dining Room northwestern entrance, larger door to double fire doors, core material | Fire door core insulation | P16 | Presumed Asbestos | 2 units | F | Negligible | 1990 tag. Remove item intact under controlled conditions prior to demolition works by a Class A asbestos removal contractor, with mandatory asbestos air monitoring and clearance certificate issued by a Licensed Asbestos Assessor (LAA). | |

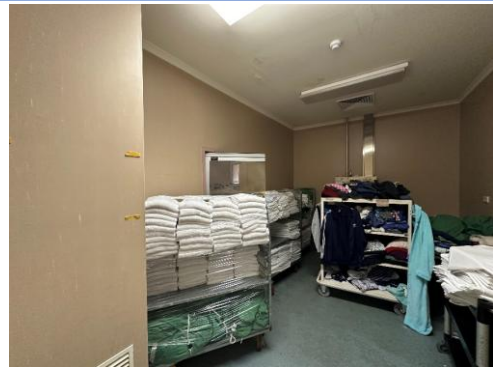
| Material Identification | | Risk Assessment | | | Risk Management & Corrective Actions | | | Photo |
|---|---|---|---|---|---|---|---|---|
| Internal, Zone 7, Laundry floor | Vinyl sheeting – blue | ASB28 | NAD | TH | NA | - | No asbestos detected. No further action required. | |

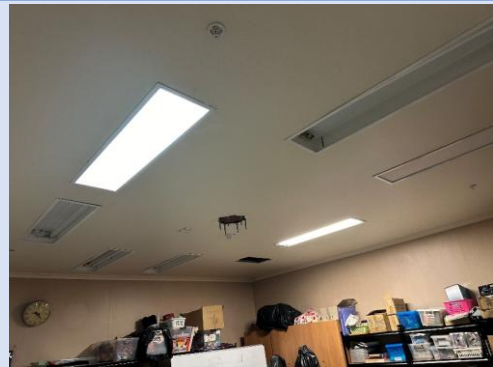
| Material Identification | | Risk Assessment | | | Risk Management & Corrective Actions | | | Photo |
|---|---|---|---|---|---|---|---|---|
| Internal, Zone 7, light fittings throughout | PCB-containing capacitors | PCB25 | Presumed PCB | TH | NA | Negligible | Inaccessible during survey due to live electrical hazard. Confirm presence of polychlorinated biphenyls prior to demolition. PCB-containing material should be removed prior to demolition works and disposed of as per EPA requirements. | |

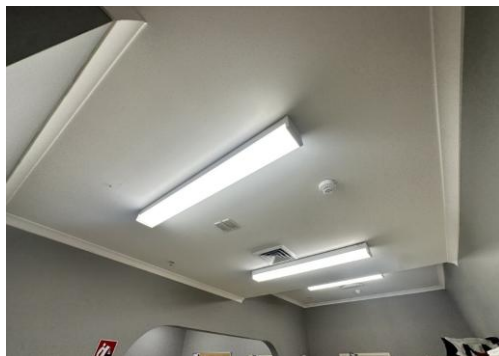
| Material Identification | | | Risk Assessment | | Risk Management & Corrective Actions | | | Photo |
|---|---|---|---|---|---|---|---|---|
| Internal, Zone 7, Staff Room light fittings | PCB-containing capacitors | PCB28 | Presumed PCB | 10 units | NA | Negligible | Inaccessible during survey due to live electrical hazard. Confirm presence of polychlorinated biphenyls prior to demolition. PCB-containing material should be removed prior to demolition works and disposed of as per EPA requirements. | |

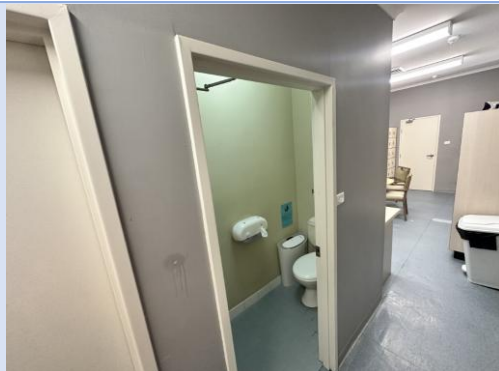
| Material Identification | | | Risk Assessment | | Risk Management & Corrective Actions | | | Photo |
|---|---|---|---|---|---|---|---|---|
| Internal, Zone 7, Staff Room, water closets and shower rooms | Fibre cement sheeting | ASB20 | NAD | 80 sqm | NA | - | No asbestos detected. No further action required. | |

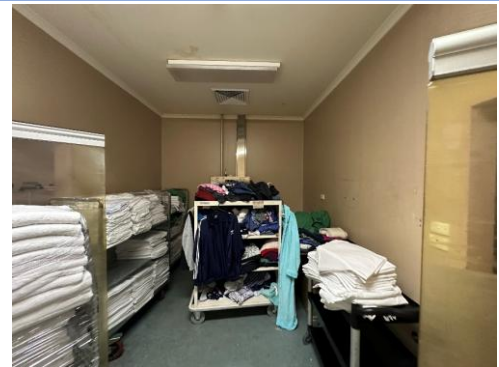
| Material Identification | | | Risk Assessment | | Risk Management & Corrective Actions | | | Photo |
|---|---|---|---|---|---|---|---|---|
| Internal, Zone 7, Storage Room and Linen Storage Room adjacent to Laundry, walls | Vinyl wall lining - salmon | ASB27 | NAD | TH | NA | - | No asbestos detected. No further action required. | |

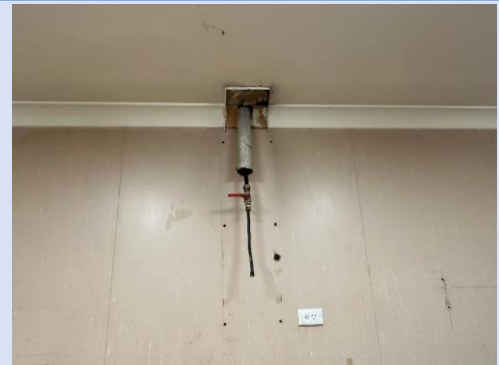
| Material Identification | | | Risk Assessment | | Risk Management & Corrective Actions | | | Photo |
|---|---|---|---|---|---|---|---|---|
| Internal, Zone 7, store room north of Theatre Room, hot water pipe | Insulation | SMF02 | SMF | 4 sqm | F | Negligible | Remove under controlled conditions. | |

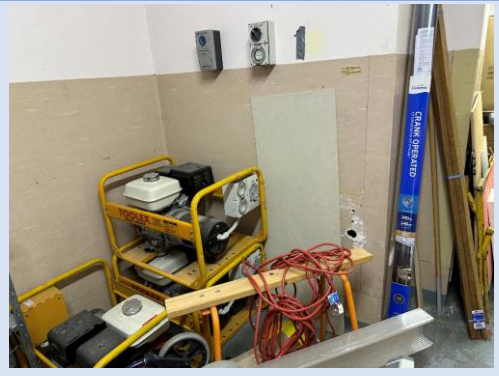
| Material Identification | | Risk Assessment | | | Risk Management & Corrective Actions | | | Photo |
|---|---|---|---|---|---|---|---|---|
| Internal, Zone 7, western hallway, northern section | Loose cement sheeting panel | ASB15/R1 | NAD | 2 sqm | NA | - | No asbestos detected. No further action required. | |

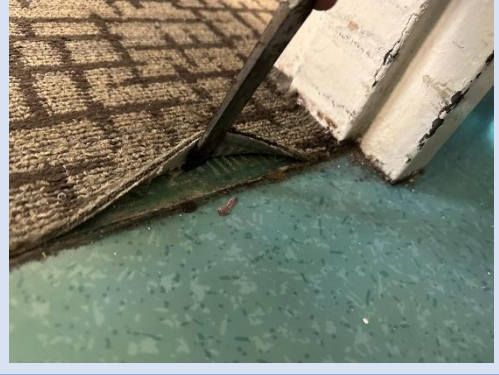
| Material Identification | | Risk Assessment | | | Risk Management & Corrective Actions | | | Photo |
|---|---|---|---|---|---|---|---|---|
| Internal, Zone 8, Aged Care Rooms, flooring, concealed vinyl | Teal vinyl | ASB22/R7 | NAD | TH | NA | - | No asbestos detected. No further action required. | |

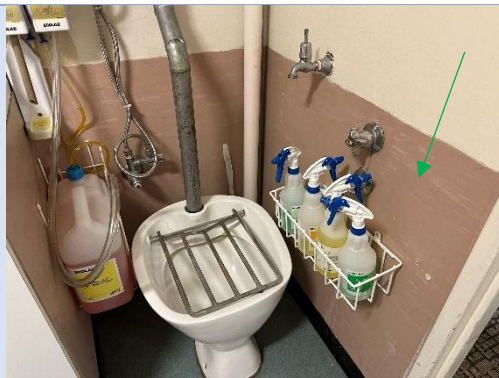
| Material Identification | | Risk Assessment | | | Risk Management & Corrective Actions | | Photo | |
|---|---|---|---|---|---|---|---|---|
| Internal, Zone 8, Dirty Utility, corner to toilet, vinyl wall lining | rust-red vinyl | ASB30/R2 | NAD | 2 sqm | NA | - | No asbestos detected. No further action required. | |

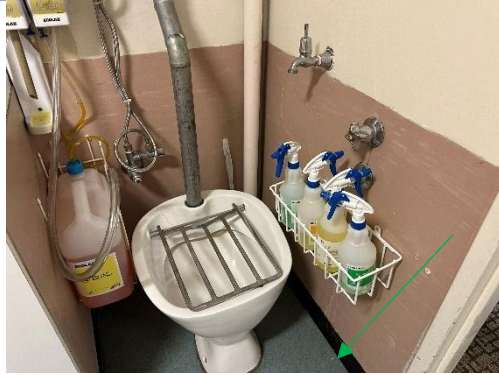
| Material Identification | | Risk Assessment | | | Risk Management & Corrective Actions | | Photo | |
|---|---|---|---|---|---|---|---|---|
| Internal, Zone 8, Dirty Utility, corner to toilet, vinyl wall lining | south wall lining behind rust red vinyl | ASB36/R1 | NAD | 2 sqm | NA | - | No asbestos detected. No further action required. | |

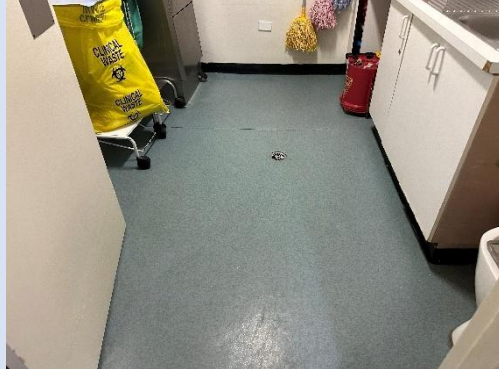
| Material Identification | | Risk Assessment | | | Risk Management & Corrective Actions | | Photo | |
|---|---|---|---|---|---|---|---|---|
| Internal, Zone 8, Dirty Utility, flooring | Light blue vinyl | ASB21/R5 | NAD | TH | NA | - | No asbestos detected. No further action required. | |

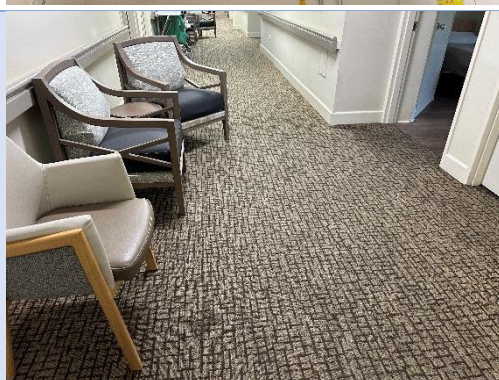
| Material Identification | | | Risk Assessment | | | Risk Management & Corrective Actions | | Photo |
|---|---|---|---|---|---|---|---|---|
| Internal, Zone 8, northwest office and hallway throughout, underneath carpet, flooring | Teal vinyl | ASB22/R6 | NAD | TH | NA | - | No asbestos detected. No further action required. | |

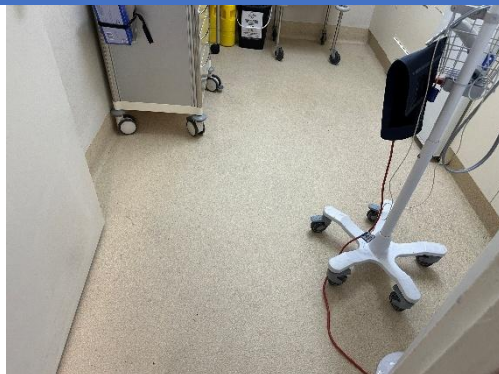
| Material Identification | | Risk Assessment | | | Risk Management & Corrective Actions | | | Photo |
|---|---|---|---|---|---|---|---|---|
| Internal, Zone 8, Treatment Room, flooring | Beige vinyl | ASB35/R1 | NAD | TH | NA | - | No asbestos detected. No further action required. | |

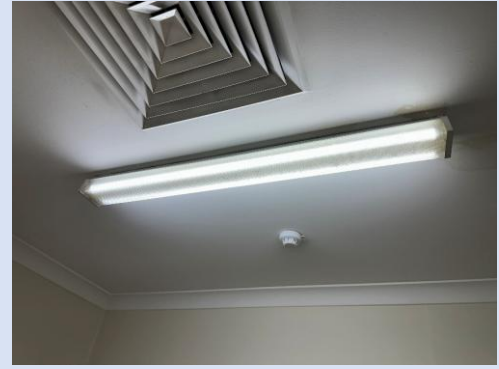
| Material Identification | | Risk Assessment | | | Risk Management & Corrective Actions | | | Photo |
|---|---|---|---|---|---|---|---|---|
| Internal, Zone 9, light fittings throughout | PCB-containing capacitors | PCB31 | Presumed PCB | TH | NA | Negligible | Inaccessible during survey due to live electrical hazard. Confirm presence of polychlorinated biphenyls prior to demolition. PCB-containing material should be removed prior to demolition works and disposed of as per EPA requirements. | |

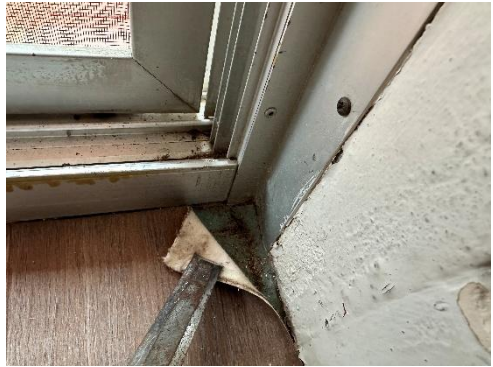
| Material Identification | | Risk Assessment | | | Risk Management & Corrective Actions | | | Photo |
|---|---|---|---|---|---|---|---|---|
| Internal, Zone 9, throughout flooring | Concealed teal vinyl | ASB22/R5 | NAD | TH | NA | - | No asbestos detected. No further action required. | |

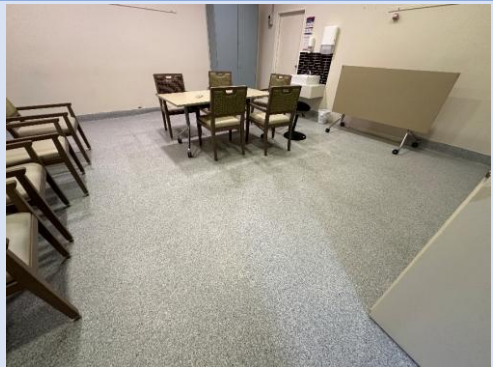
| Material Identification | | Risk Assessment | | | Risk Management & Corrective Actions | | | Photo |
|---|---|---|---|---|---|---|---|---|
| Internal, Zone 10, Craft Room | Vinyl sheeting - Blue - red and white speckle | ASB25/R1 | NAD | 35 sqm | NA | - | No asbestos detected. No further action required. | |

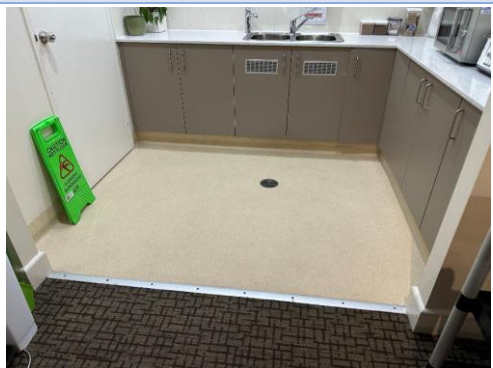
| Material Identification | | Risk Assessment | | | Risk Management & Corrective Actions | | | Photo |
|---|---|---|---|---|---|---|---|---|
| Internal, Zone 10, Kitchen, flooring | Vinyl sheeting - off-white/yellow | ASB26 | NAD | 8 sqm | NA | - | No asbestos detected. No further action required. | |

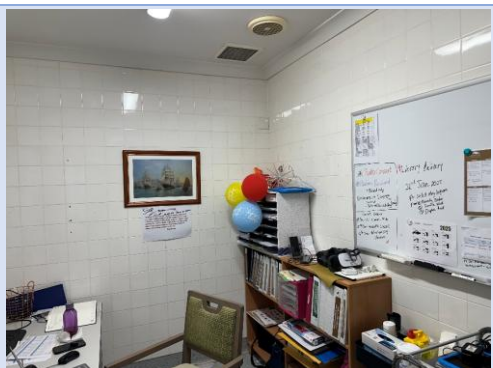
| Material Identification | | Risk Assessment | | | Risk Management & Corrective Actions | | | Photo |
|---|---|---|---|---|---|---|---|---|
| Internal, Zone 10, old toilet converted into office | Vinyl sheeting - Blue - red and white speckle | ASB25/R2 | NAD | 6 sqm | NA | - | No asbestos detected. No further action required. | |

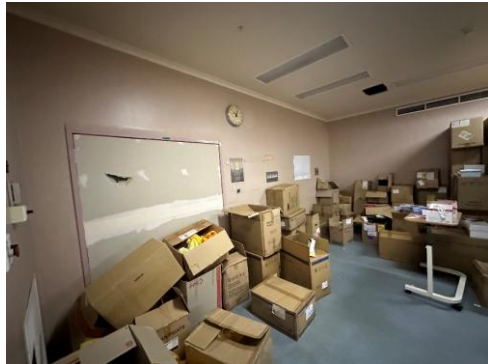
| Material Identification | | Risk Assessment | | | Risk Management & Corrective Actions | | Photo | |
|---|---|---|---|---|---|---|---|---|
| Internal, Zone 10, storage rooms and corridors adjacent, door frames | Lead paint - pink | LP04 | <0.01% Lead | TH | NA | - | Not lead-containing paint (≤0.1% w/w) as described in AS/NZS 4361.2:2017 Guide to hazardous paint management, Part 2: Lead paint in residential, public and commercial buildings. No further action required. | |

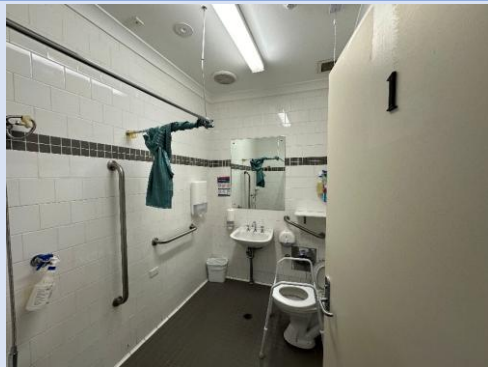
| Material Identification | | Risk Assessment | | | Risk Management & Corrective Actions | | Photo | |
|---|---|---|---|---|---|---|---|---|
| Internal, Zone 10, Toilet 1, tiles walls | Fibre cement sheeting | P22 | Presumed Asbestos | 18 sqm | NF | Negligible | Prior to demolition works, this material must be removed by a Class A or B licensed asbestos removalist with a clearance certificate issued by a competent third party. Air monitoring is also recommended. | |

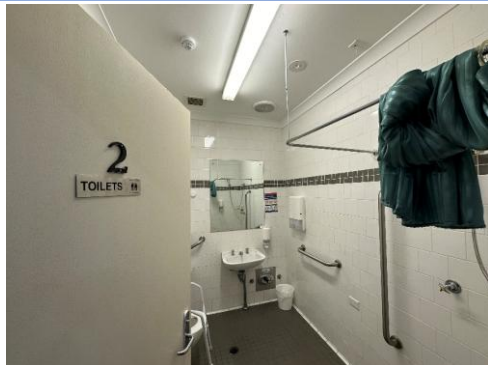
| Material Identification | | Risk Assessment | | | Risk Management & Corrective Actions | | Photo | |
|---|---|---|---|---|---|---|---|---|
| Internal, Zone 10, Toilet 2, tiles walls | Fibre cement sheeting | P23 | Presumed Asbestos | 18 sqm | NF | Negligible | Prior to demolition works, this material must be removed by a Class A or B licensed asbestos removalist with a clearance certificate issued by a competent third party. Air monitoring is also recommended. | |

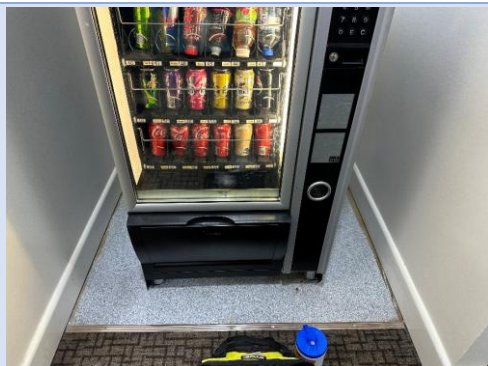
| Material Identification | | Risk Assessment | | | Risk Management & Corrective Actions | | Photo | |
|---|---|---|---|---|---|---|---|---|
| Internal, Zone 10, vending machine area, flooring | Vinyl sheeting Blue - red and white speckle | ASB25 | NAD | 4 sqm | NA | - | No asbestos detected. No further action required. | |

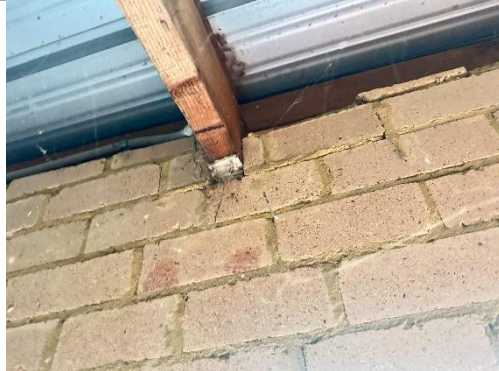
| Material Identification | | Risk Assessment | | | Risk Management & Corrective Actions | | Photo | |
|---|---|---|---|---|---|---|---|---|
| Internal, Zone 11, Main Power Board Room, packers | Fibre cement sheet | ASB08 | NAD | - | NA | - | <p>No asbestos detected. No further action required.</p> | |
