# Hazardous Materials Register

## Education Centre

| Site Details | | Building Details | | | | | | Audit Details | |
|---|---|---|---|--|--|---|---|---|---|
| Full Address: | Holden Street Gosford NSW 2250 | Building Name: | Education Centre | | | Number of Levels: | 3 | Survey Date: | 04-11-2014 |
| Client Name: | Gosford Hospital | Roof Type: | Metal | | | Construction Type: | Brick | Company: | GreencapNAA |

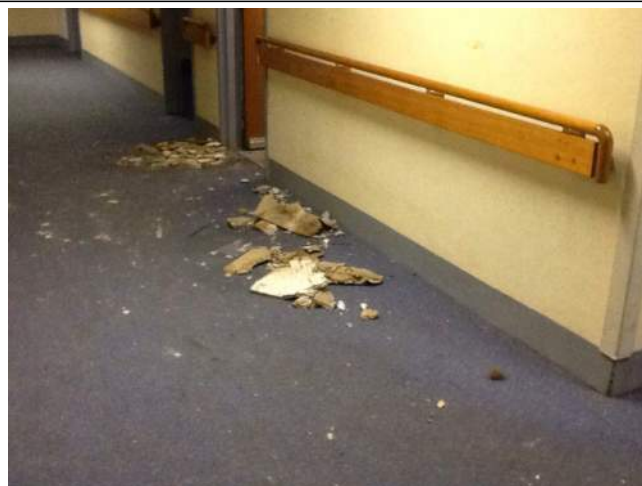
Photo No: J128740-001-MAND-Photo012  
Result: SMF - Positive  
Building/Level: Main Building-Levels One & Two  
Room/Location: Various Rooms-Throughout  
Feature/Material: On Ground-Compressed Ceiling Tiles

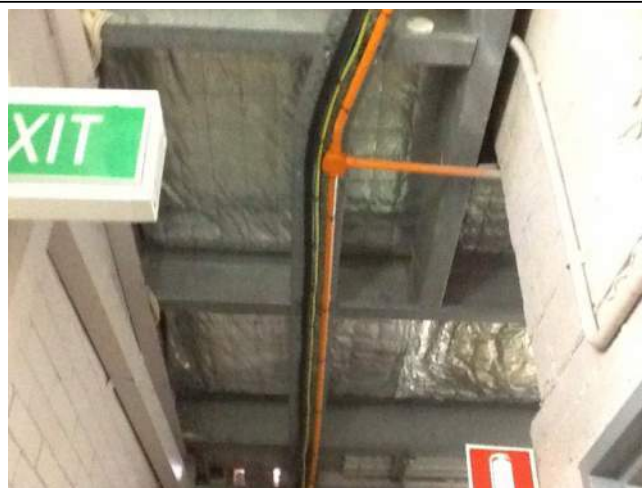
Photo No: J128740-001-MAND-Photo006  
Result: SMF - Positive  
Building/Level: Main Building-Level Three  
Room/Location: All areas-Throughout  
Feature/Material: Roof Lining-Sarking Insulation

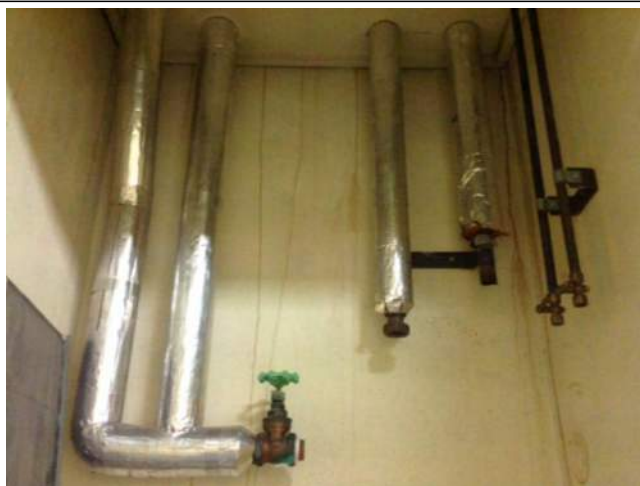
Photo No: J128740-003-HEAL-Photo002  
Result: SMF - Presumed Positive  
Building/Level: Health Services Building-Level One  
Room/Location: Corridor between Dentist and Library-Header Cupboard  
Feature/Material: Pipework Insulation-Insulation Material

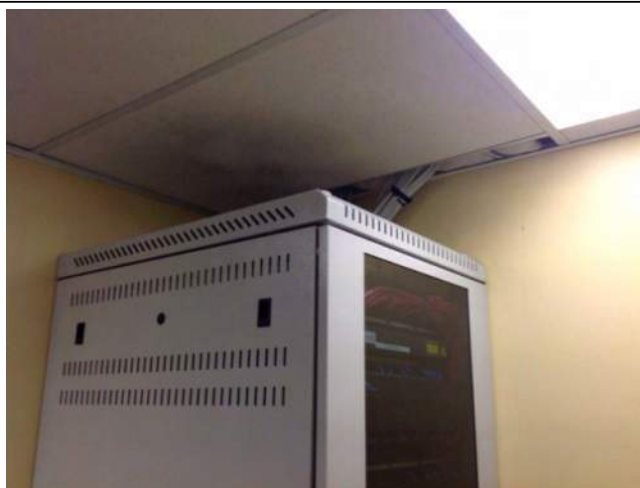
Photo No: J128740-003-HEAL-Photo015  
Result: SMF - Presumed Positive  
Building/Level: Health Services Building-Level One  
Room/Location: Library Stack Area-West, Above Comms Unit  
Feature/Material: Penetrations-Pillow Insulation

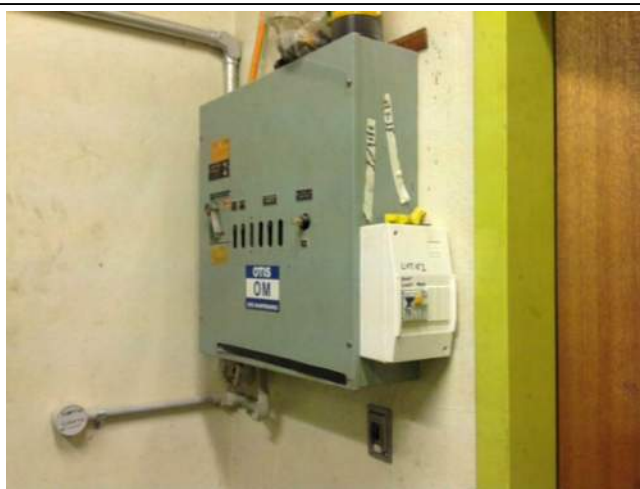
Photo No: J128740-003-HEAL-Photo003  
Result: Asbestos - Presumed Positive  
Building/Level: Health Services Building-Level One  
Room/Location: Lift Motor Room-East Wall  
Feature/Material: Electrical Distribution Board-Compressed Bituminous Electrical Panel

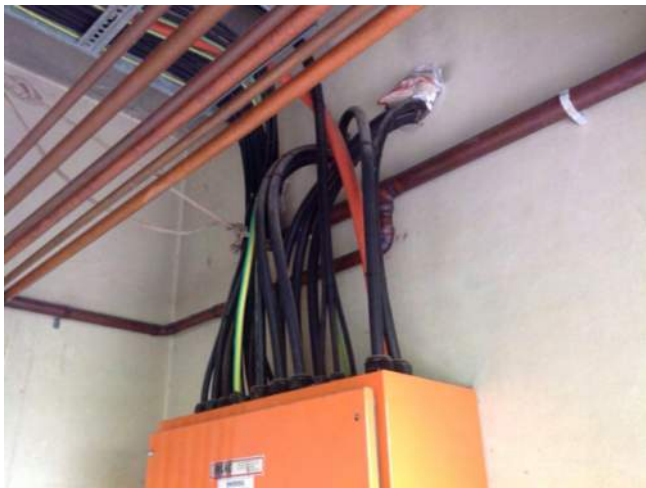
Photo No: J128740-003-HEAL-Photo011  
Result: SMF - Presumed Positive  
Building/Level: Health Services Building-Level One  
Room/Location: Plant Room-Southeast  
Feature/Material: Penetrations-Pillow Insulation

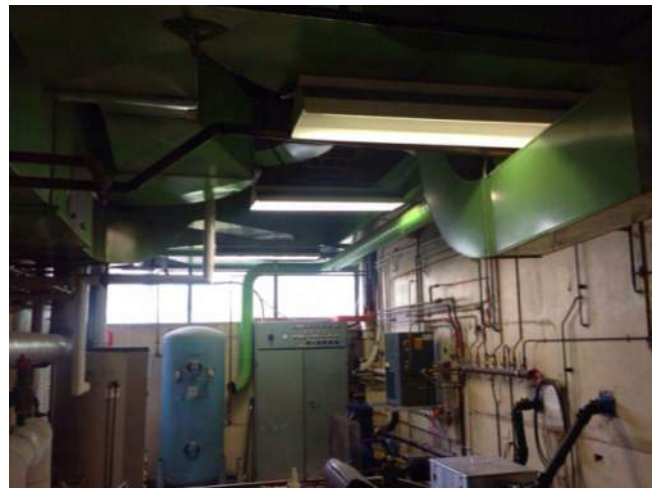
Photo No: J128740-003-HEAL-Photo013  
Result: PCB - Presumed Positive  
Building/Level: Health Services Building-Level One  
Room/Location: Plant Room-Throughout  
Feature/Material: Fluorescent Light Fitting-Capacitor

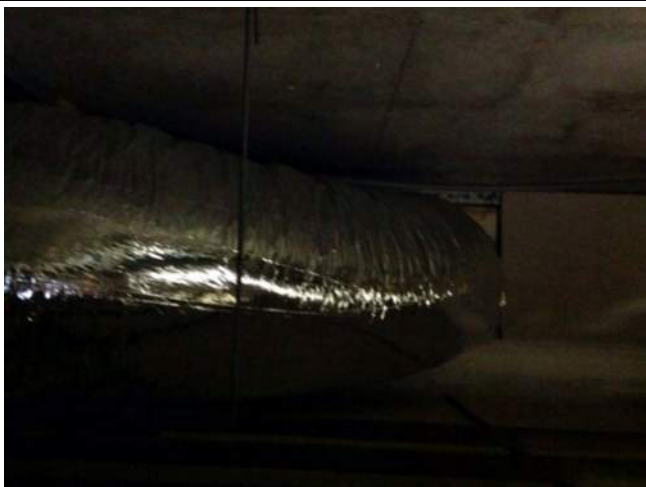
Photo No: J128740-003-HEAL-Photo045  
Result: SMF - Presumed Positive  
Building/Level: Health Services Building-Level One  
Room/Location: Throughout Level-Ceiling Space  
Feature/Material: Flexible Ductwork Insulation-Insulation Material

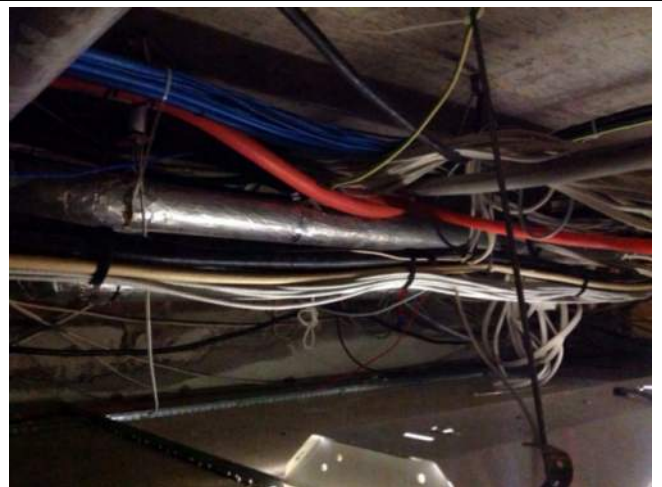
Photo No: J128740-003-HEAL-Photo044  
Result: SMF - Presumed Positive  
Building/Level: Health Services Building-Level One  
Room/Location: Throughout Level-Ceiling Space  
Feature/Material: Pipework Insulation-Insulation Material

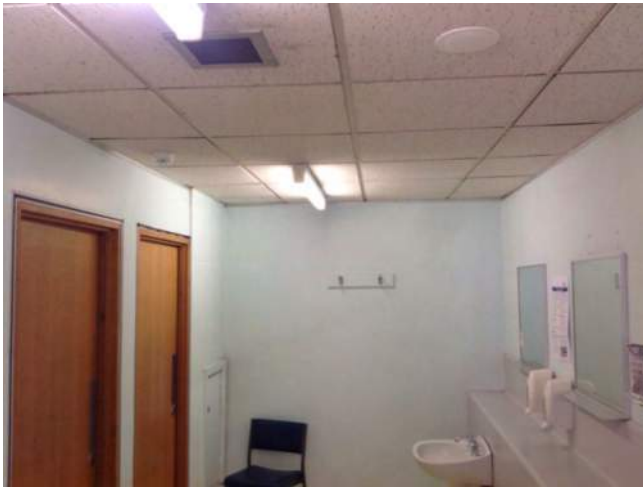
Photo No: J128740-003-HEAL-Photo034  
Result: SMF - Presumed Positive  
Building/Level: Health Services Building-Level One  
Room/Location: Women's Health, Nurses Clinic and Toilets-Throughout  
Feature/Material: Ceiling Tiles-Insulation Material

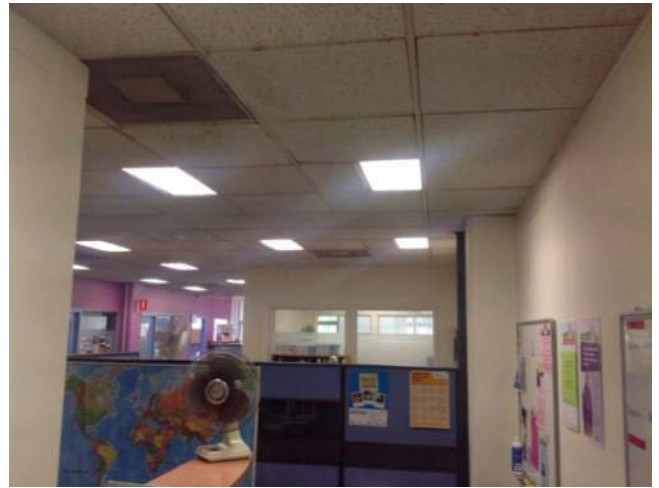
Photo No: J128740-003-HEAL-Photo033  
Result: SMF - Presumed Positive  
Building/Level: Health Services Building-Level Two  
Room/Location: Mid-Southern Offices-Throughout  
Feature/Material: Ceiling Tiles-Insulation Material

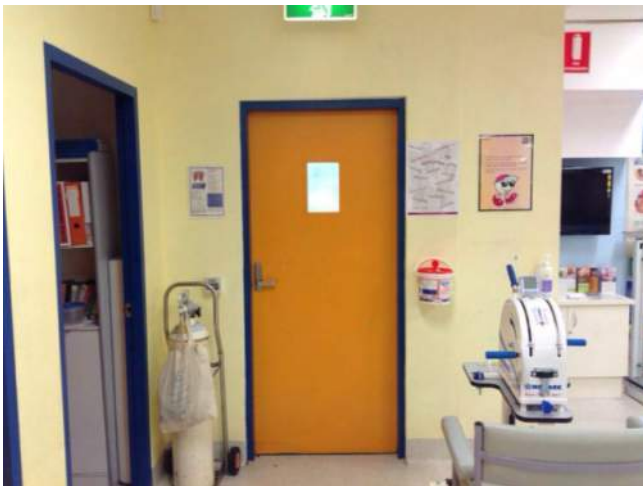
Photo No: J128740-003-HEAL-Photo032  
Result: Asbestos - Presumed Positive  
Building/Level: Health Services Building-Level Two  
Room/Location: Physio and OT Treatment Area-Northwest  
Feature/Material: Fire Door-Fire Door Core

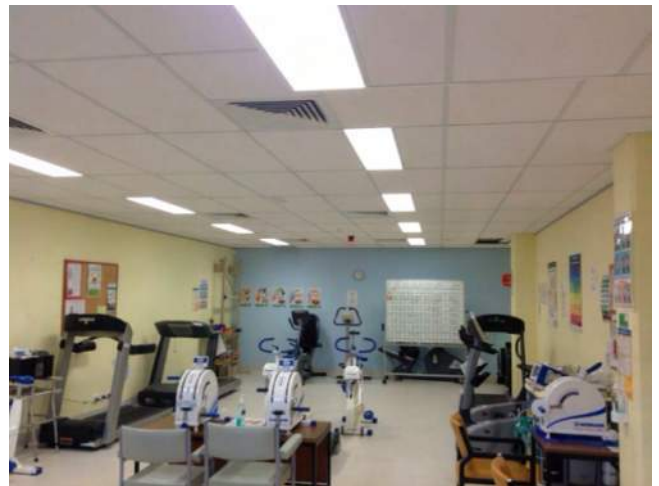
Photo No: J128740-003-HEAL-Photo031  
Result: SMF - Presumed Positive  
Building/Level: Health Services Building-Level Two  
Room/Location: Physio and OT Treatment Area-Throughout  
Feature/Material: Ceiling Tiles-Insulation Material

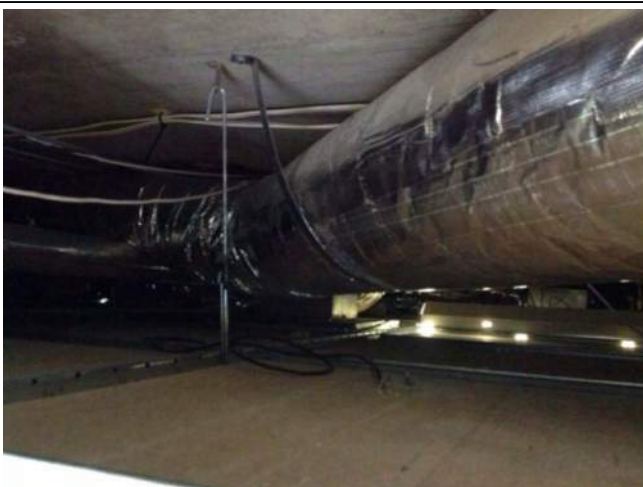
Photo No: J128740-003-HEAL-Photo046  
Result: SMF - Presumed Positive  
Building/Level: Health Services Building-Level Two  
Room/Location: Throughout Level-Ceiling Space  
Feature/Material: Flexible Ductwork Insulation-Insulation Material

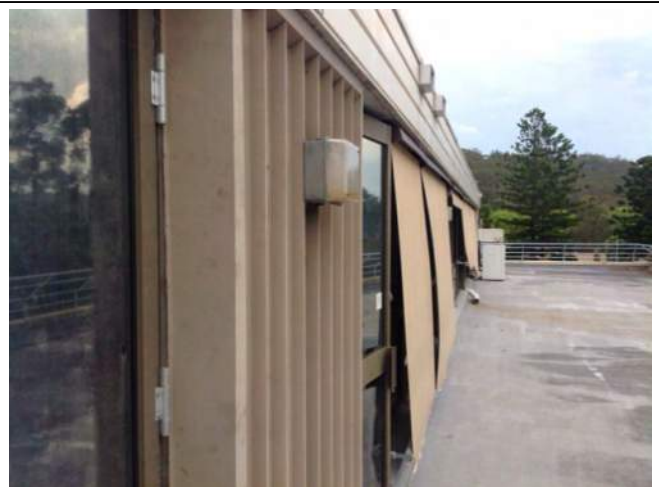
Photo No: J128740-003-HEAL-Photo029  
Result: Asbestos - Previously Sampled Positive  
Building/Level: Health Services Building-Level Three  
Room/Location: Surrounding-  
Feature/Material: Eaves-Fibre Cement Sheetting

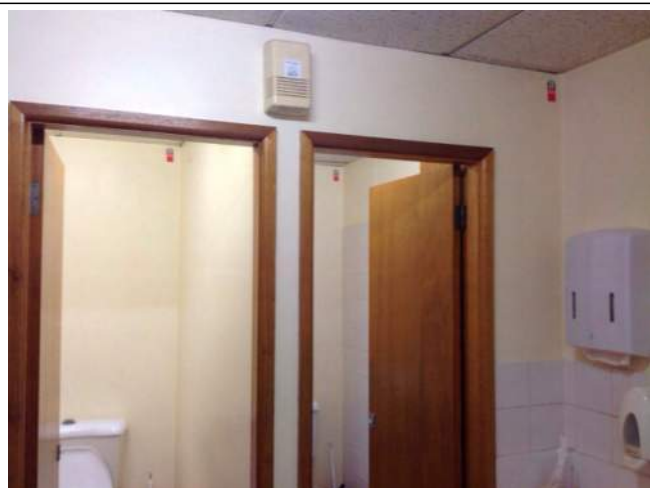
Photo No: J128740-003-HEAL-Photo027  
Result: Asbestos - Previously Sampled Positive  
Building/Level: Health Services Building-Level Three  
Room/Location: Female Toilets-Throughout  
Feature/Material: Wall-Fibre Cement Sheetting

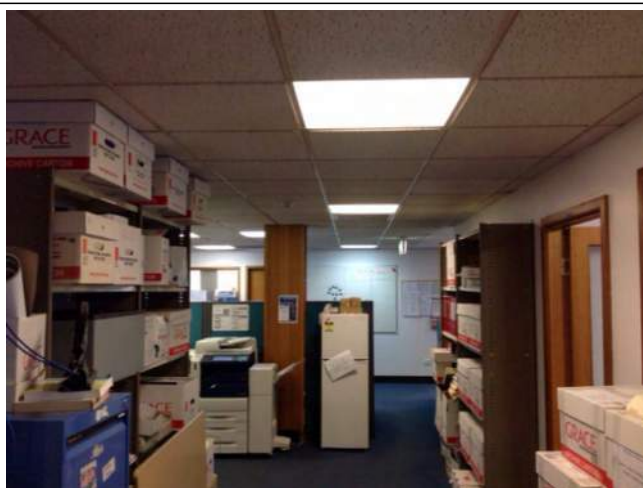
Photo No: J128740-003-HEAL-Photo022  
Result: SMF - Presumed Positive  
Building/Level: Health Services Building-Level Three  
Room/Location: Finance Offices including Toilet-Throughout  
Feature/Material: Ceiling Tiles-Insulation Material

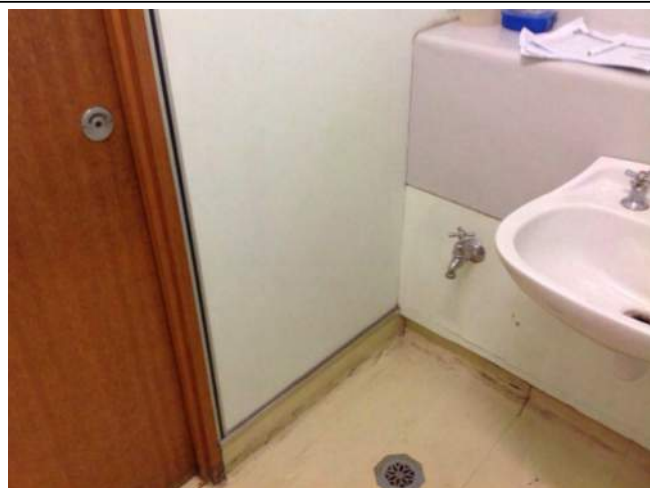
Photo No: J128740-003-HEAL-Photo021  
Result: Asbestos - Positive  
Building/Level: Health Services Building-Level Three  
Room/Location: Finance Toilet-North and East  
Feature/Material: Wall-Fibre Cement Sheetting

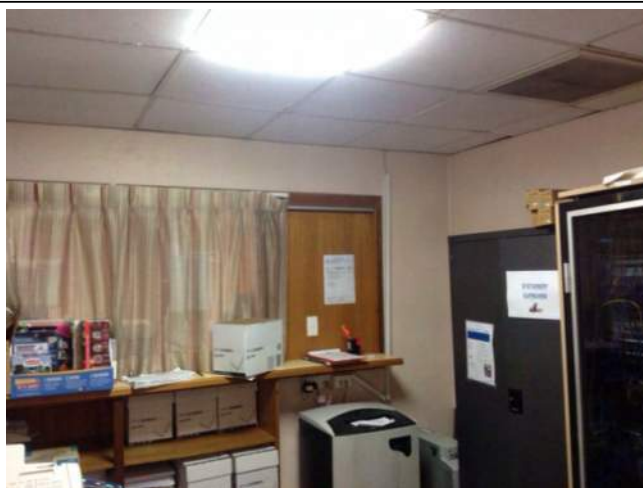
Photo No: J128740-003-HEAL-Photo018  
Result: SMF - Presumed Positive  
Building/Level: Health Services Building-Level Three  
Room/Location: Human Resources-Photocopy Room  
Feature/Material: Ceiling Tiles-Insulation Material

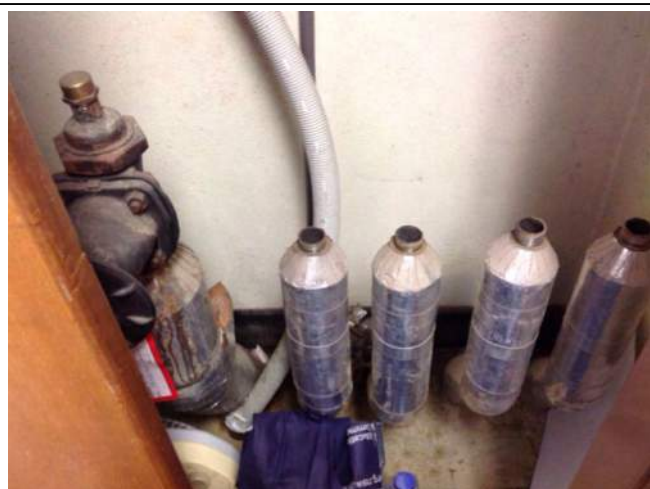
Photo No: J128740-003-HEAL-Photo017  
Result: SMF - Presumed Positive  
Building/Level: Health Services Building-Level Three  
Room/Location: Human Resources-Reception Desk, Header Cupboard  
Feature/Material: Pipework Insulation-Insulation Material

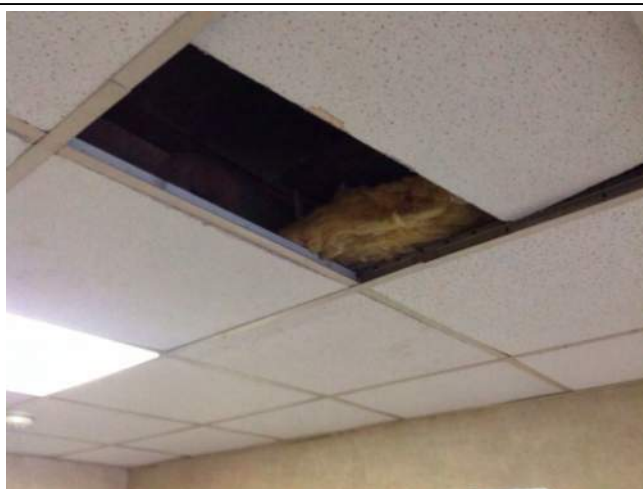
Photo No: J128740-003-HEAL-Photo041  
Result: SMF - Presumed Positive  
Building/Level: Health Services Building-Level Three  
Room/Location: Main Corridor-Ceiling Space  
Feature/Material: Insulation Batts-Insulation Material
