# Hazardous Materials Survey Report - Administration Building

132 McCredie Road, Smithfield NSW 2161

11-Feb-2025

Doc No. 60635909\_Hazmat\_Rpt\_132 McCredie Rd\_20250211\_0

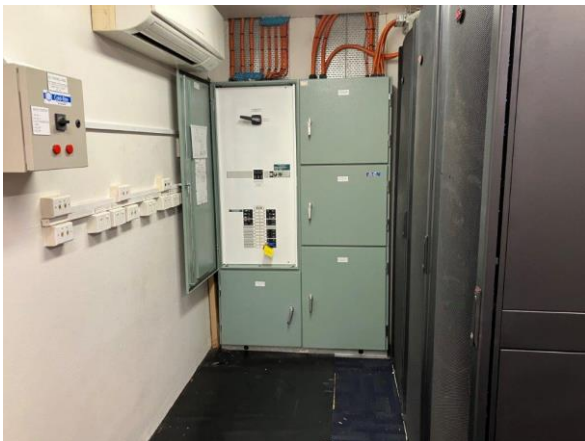
Photo 65

| No. | Location | | | Material Description | | | | | | | | Risk Assessment | | | | | | Recommendation |
|---|---|---|---|---|---|---|---|---|---|---|---|---|---|---|---|---|---|---|
| 95 | Central area | Communication room | Electrical distribution cabinet | Inaccessible area - electrical hazard | 65 | 1 | Item | - | - | - | - | - | - | - | - | - | - | Non-accessed area, Electrical hazard. Item should be assumed to contain hazmat until surveyed and proved otherwise by a competent person. |
