# **Pre-Dilapidation Report**

**19 GEORGE STREET**

**REAR BUILDING (UNITS 20-29)**

Project Reference: 20250047.19G.3

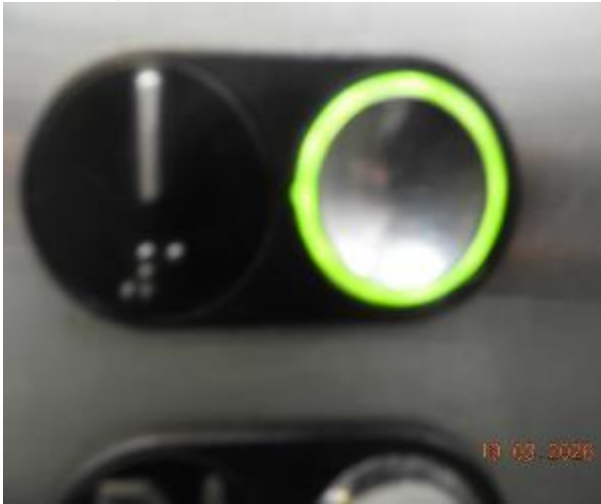
Figure 1 - The following images display the condition of Level 1 Common Area

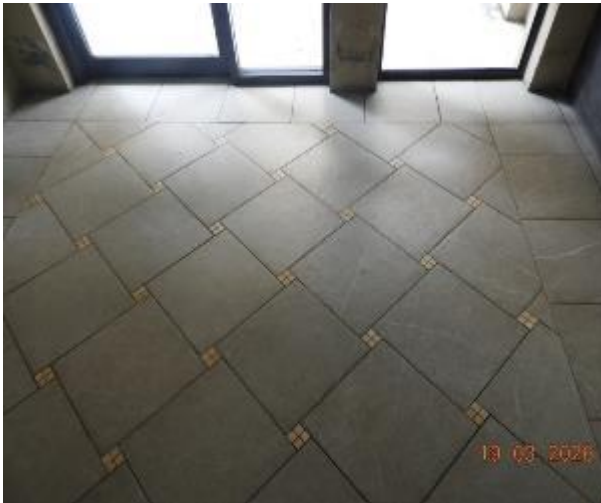
Figure 3 - General condition of level 1 common area floor tiles

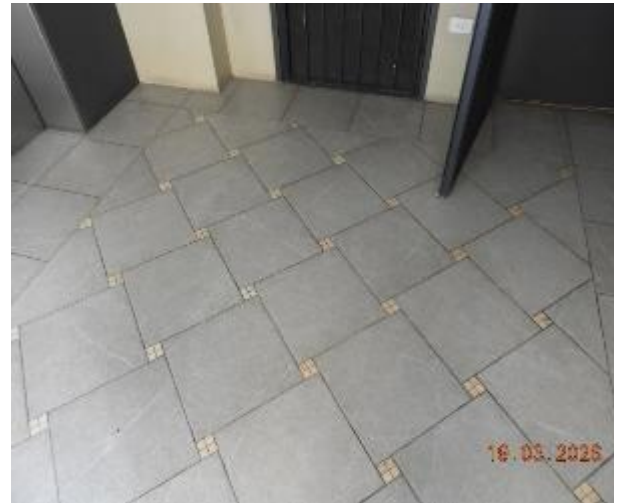
Figure 4 - General condition of level 1 common area floor tiles

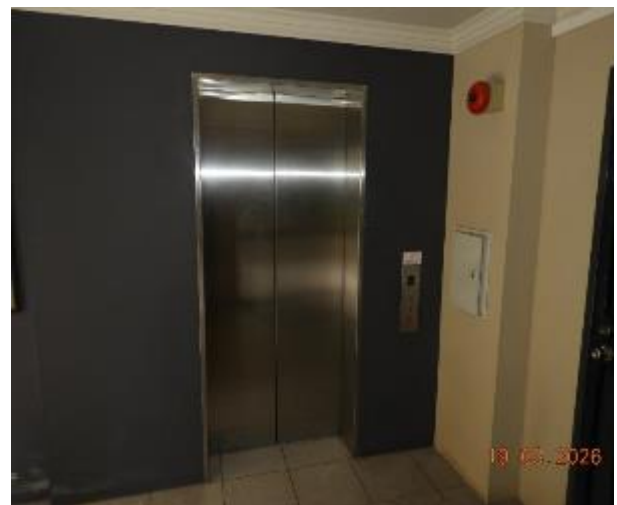
Figure 6 - General condition of level 1 common area internal wall

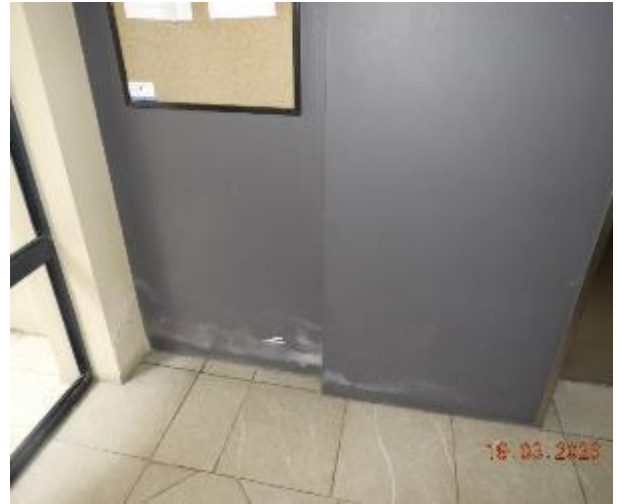
Figure 8 - General condition of level 1 common area internal wall

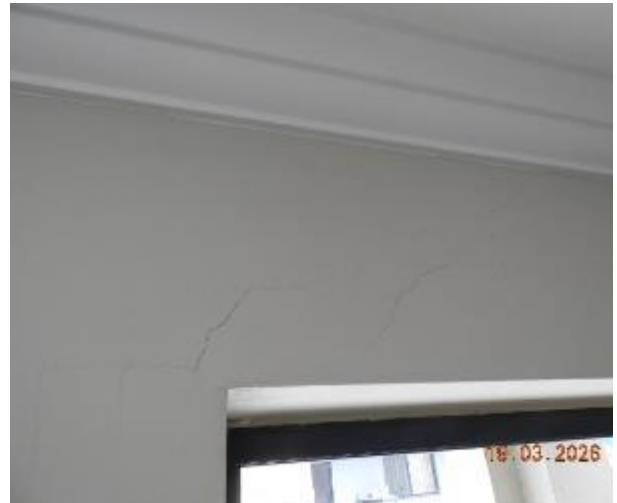
Figure 10 - Crack propagation through level 1 common area internal wall

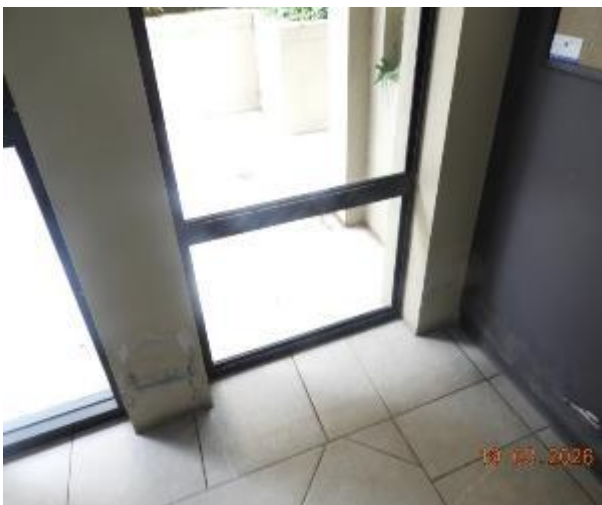
Figure 11 - General condition of level 1 common area internal wall

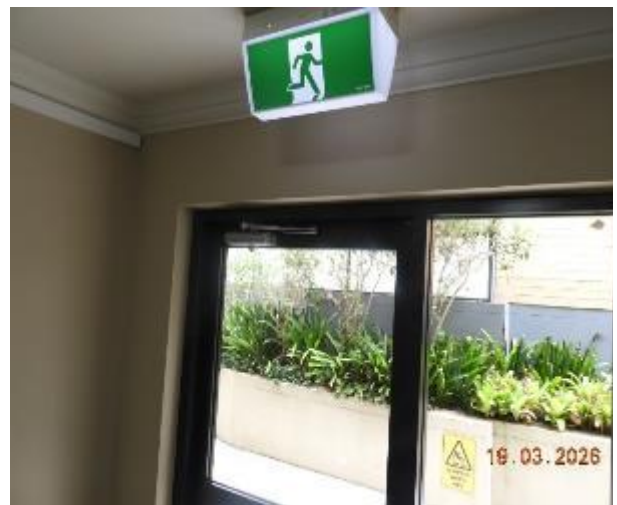
Figure 12 - General condition of level 1 common area internal wall

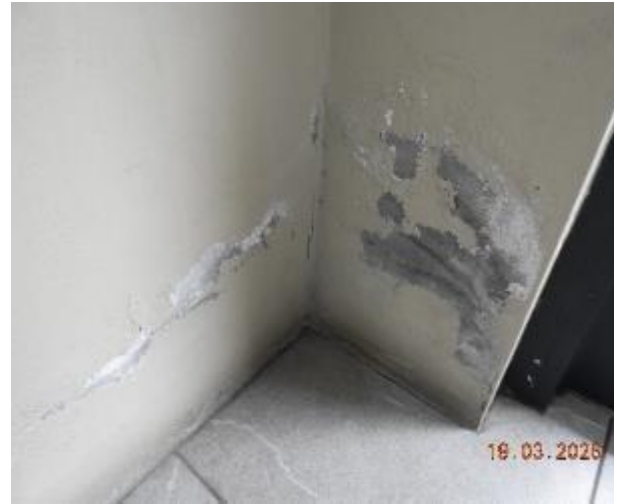
Figure 14 - Paint flaking through level 1 common area internal wall

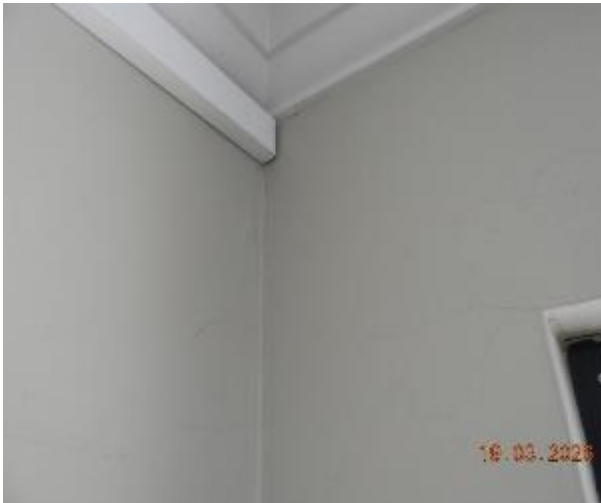
Figure 15 - General condition of level 1 common area internal wall

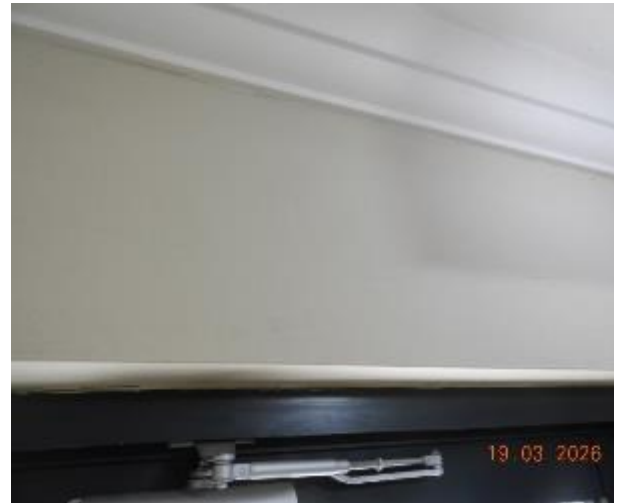
Figure 16 - General condition of level 1 common area internal wall

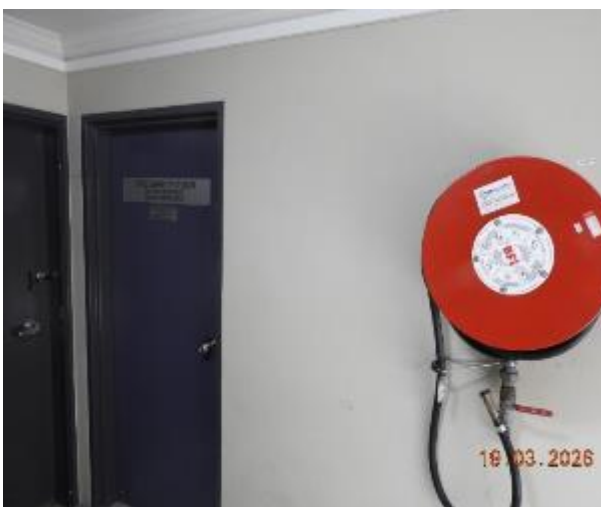
Figure 17 - General condition of level 1 common area internal wall

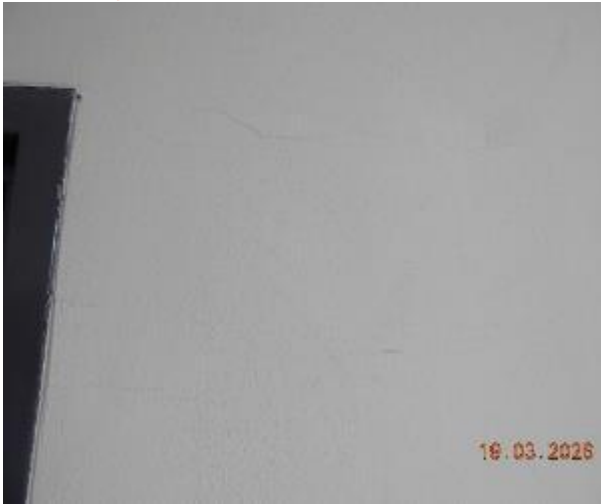
Figure 19 - Crack propagation through level 1 common area internal wall

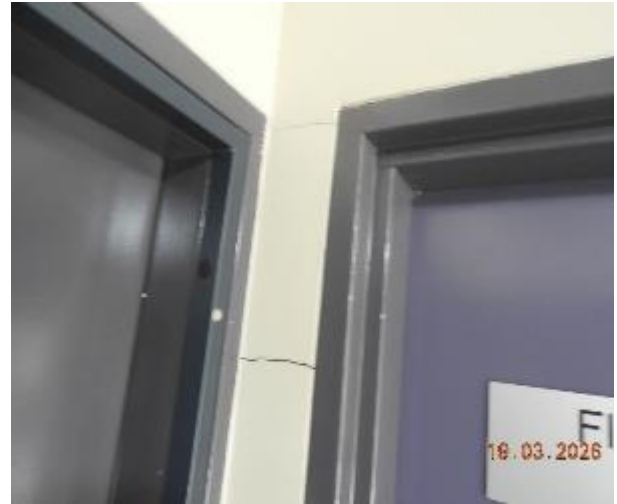
Figure 20 - Crack propagation through level 1 common area internal wall

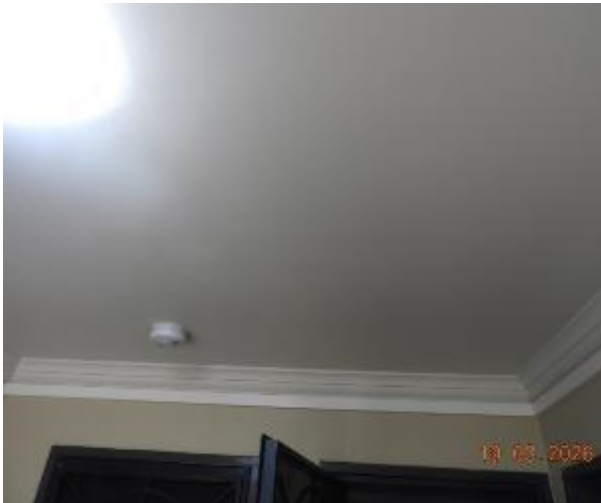
Figure 21 - General condition of level 1 common area ceiling

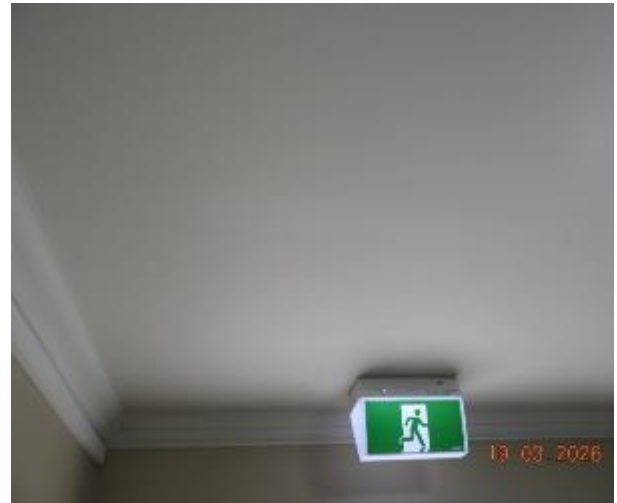
Figure 22 - General condition of level 1 common area ceiling

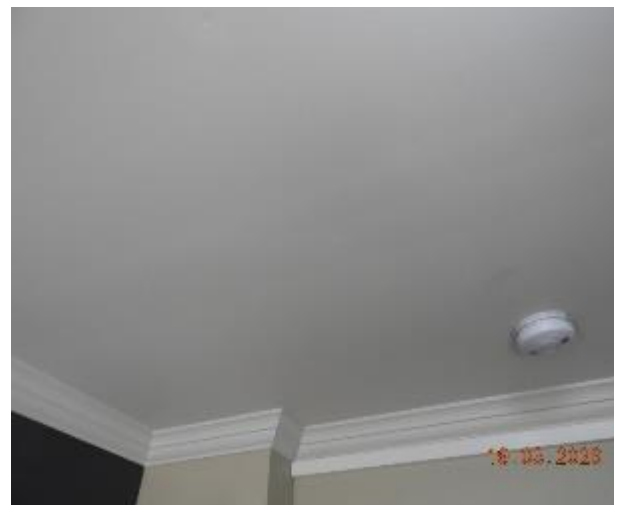
Figure 24 - General condition of level 1 common area ceiling

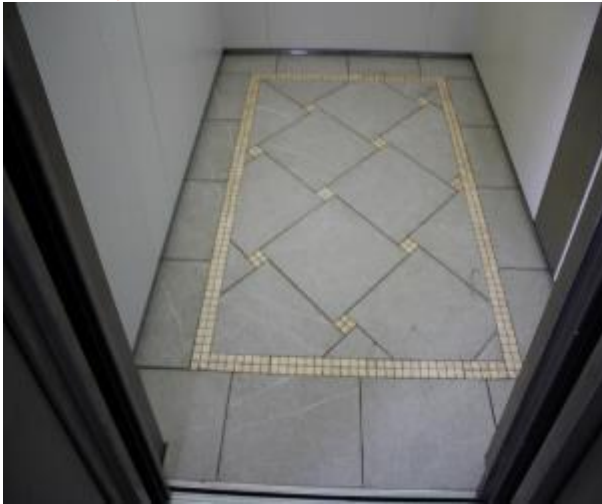
Figure 25 - General condition of level 1 common area floor tiles

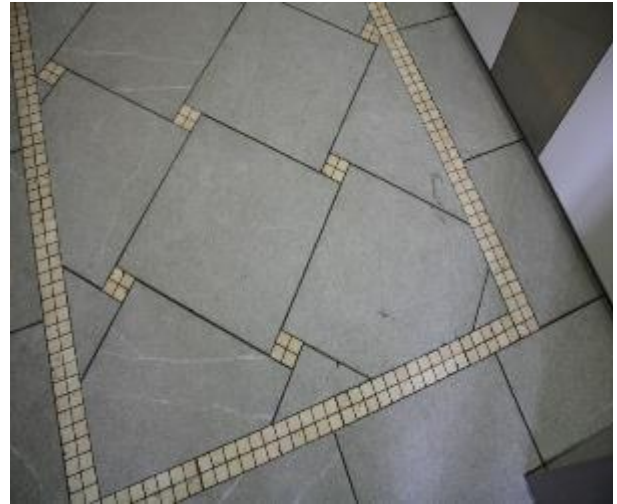
Figure 26 - General condition of level 1 common area floor tiles

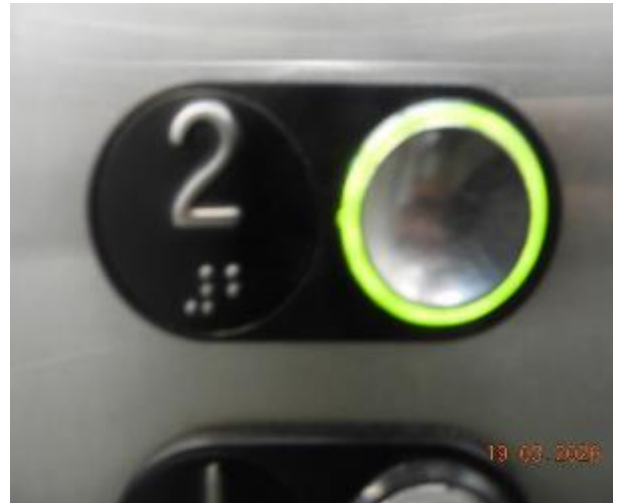
Figure 28 -The following images display the condition of level 2 Common Area

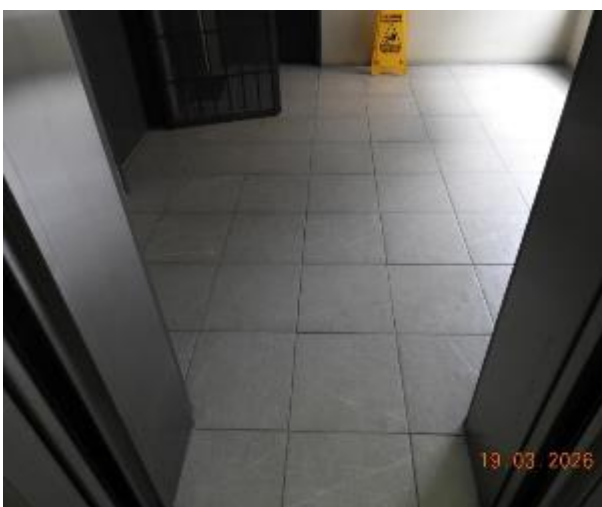
Figure 29 - General condition of level 2 common area floor tiles

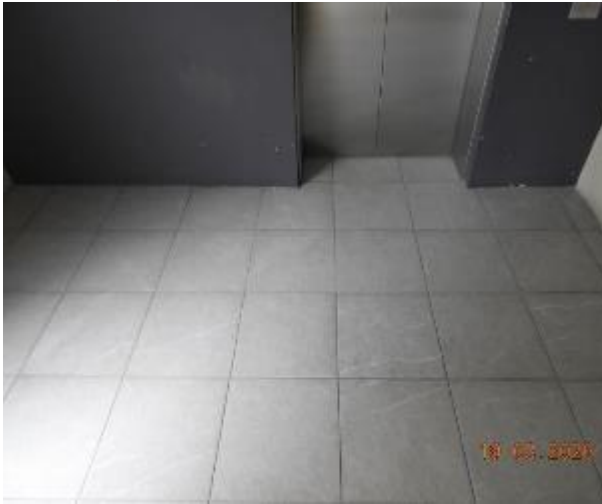
Figure 31 - General condition of level 2 common area floor tiles

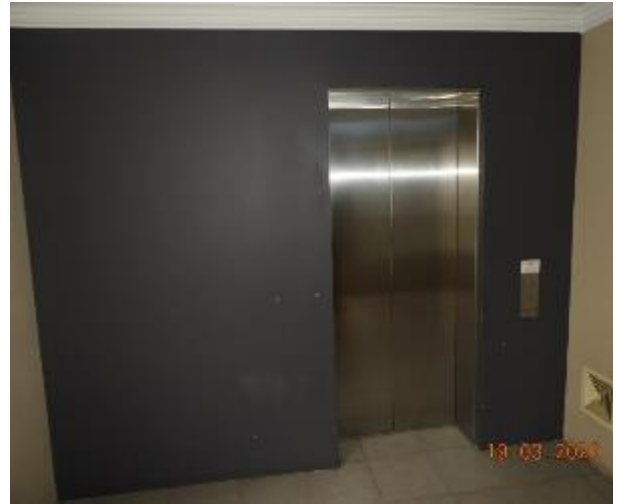
Figure 32 - General condition of level 2 common area internal wall

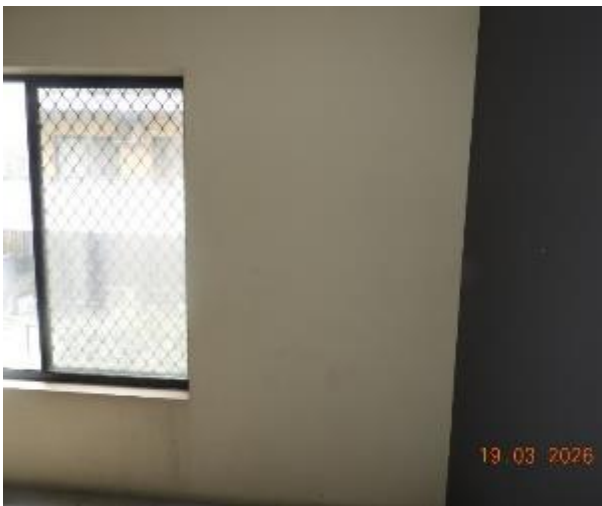
Figure 33 - General condition of level 2 common area internal wall

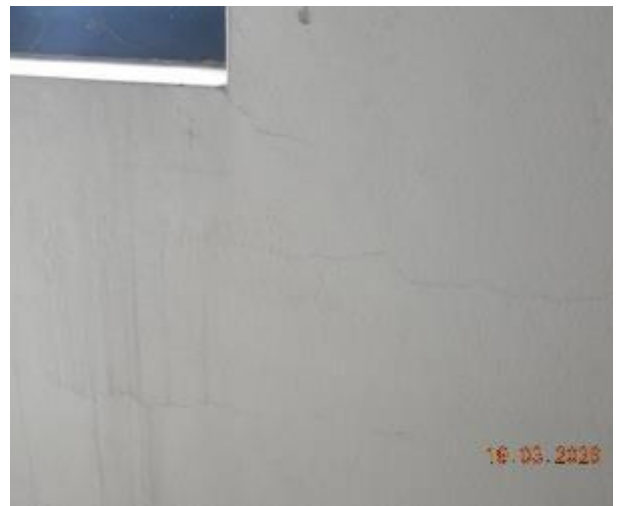
Figure 34 - Crack propagation through level 2 common area internal wall

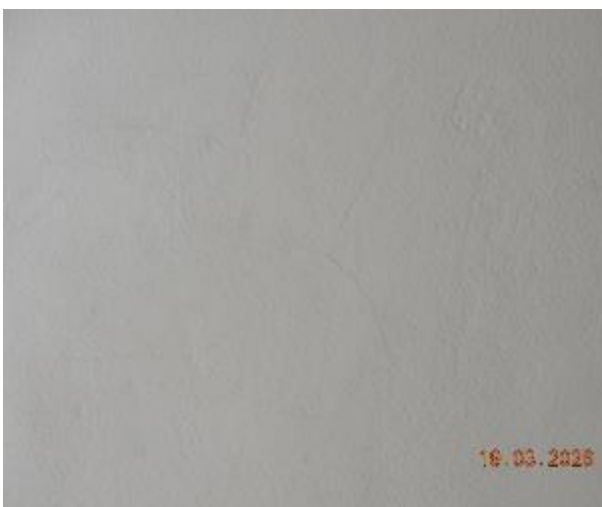
Figure 35 - Crack propagation through level 2 common area internal wall

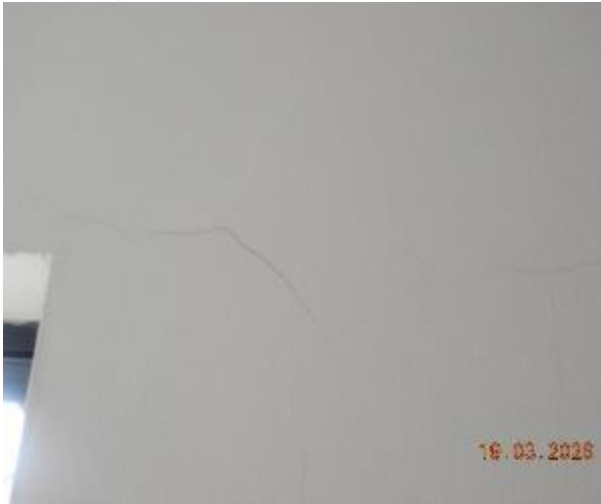
Figure 37 - Crack propagation through level 2 common area internal wall

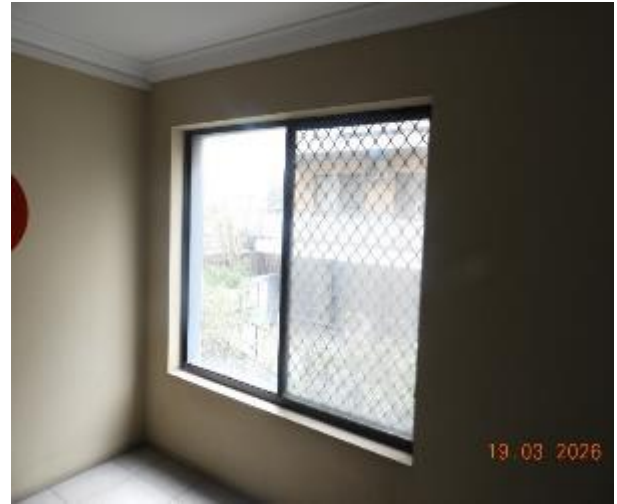
Figure 38 - General condition of level 2 common area internal wall

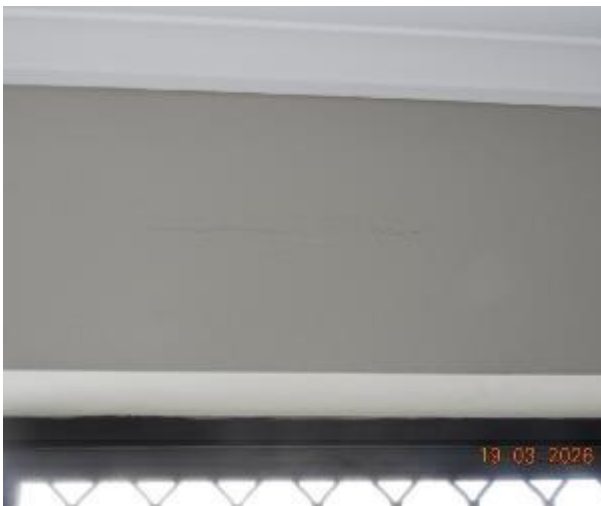
Figure 39 - Crack propagation through level 2 common area internal wall

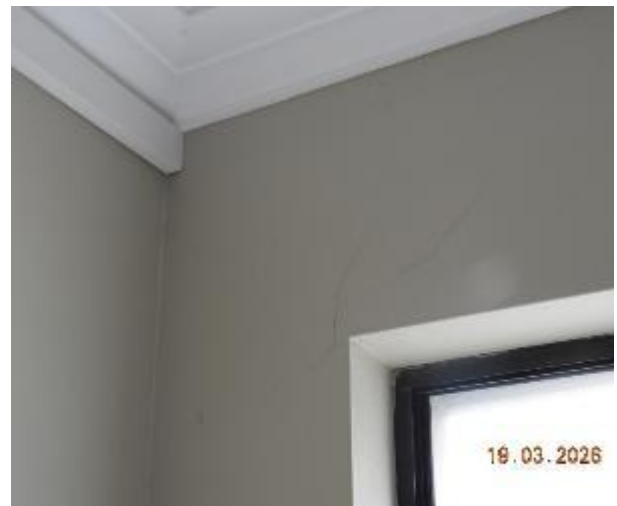
Figure 40 - Crack propagation through level 2 common area internal wall

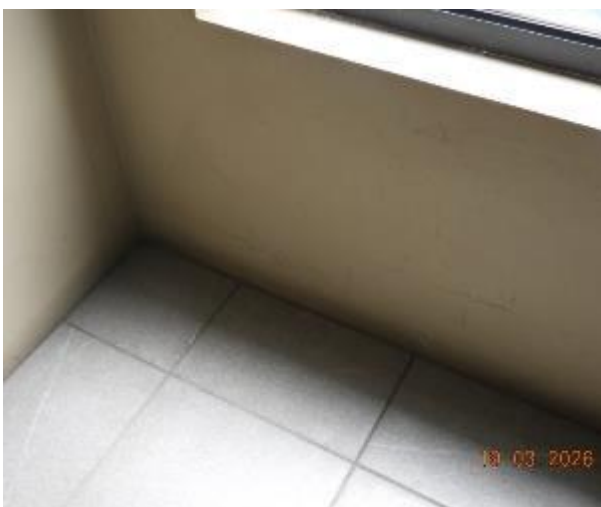
Figure 41 - Crack propagation through level 2 common area internal wall

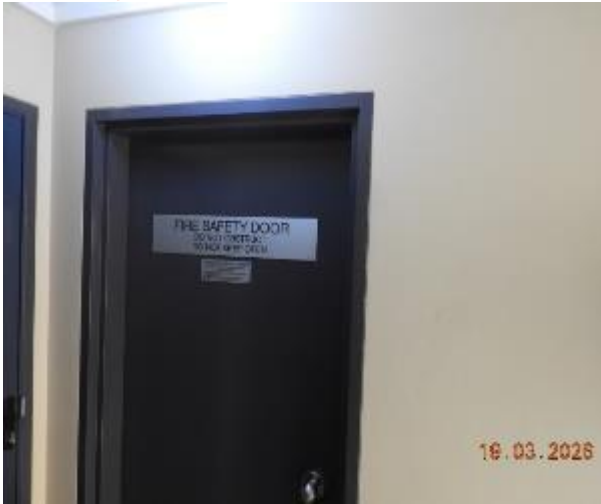
Figure 43 - General condition of level 2 common area internal wall

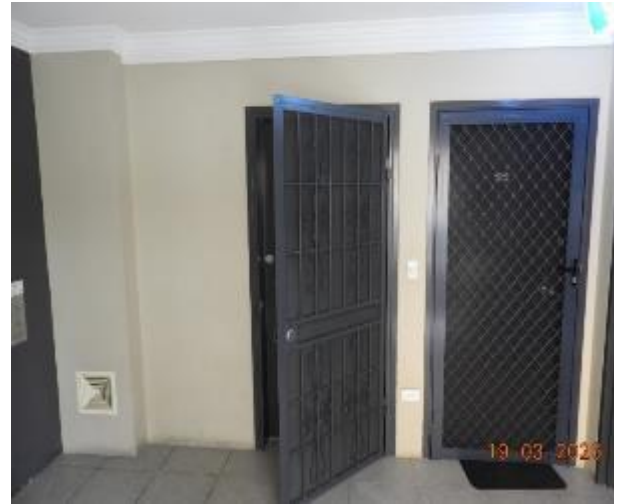
Figure 44 - General condition of level 2 common area internal wall

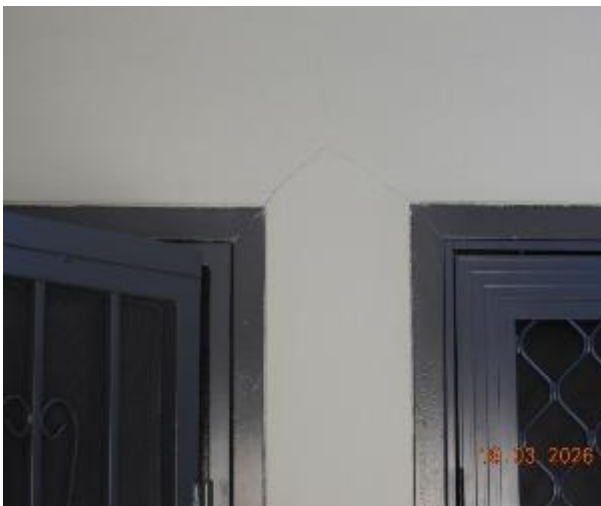
Figure 45 - Crack propagation through level 2 common area internal wall

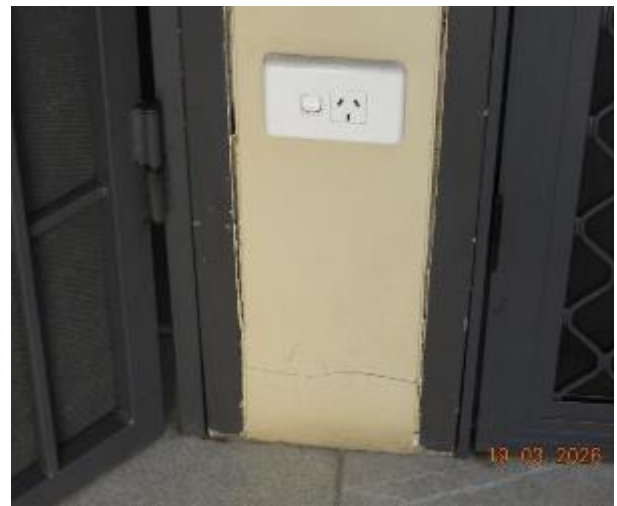
Figure 46 - Crack propagation through level 2 common area internal wall

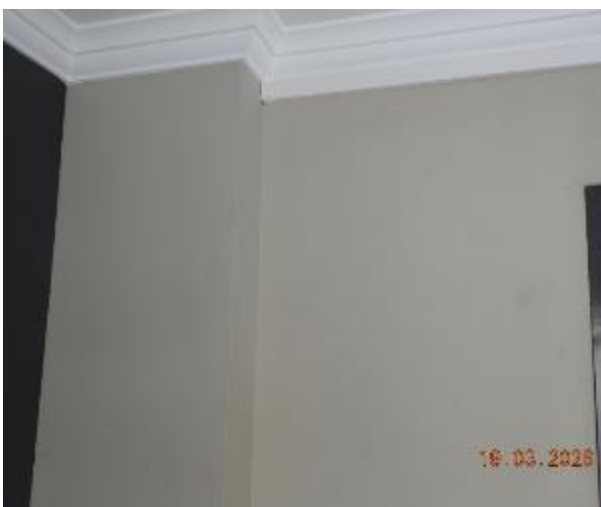
Figure 47 - General condition of level 2 common area internal wall

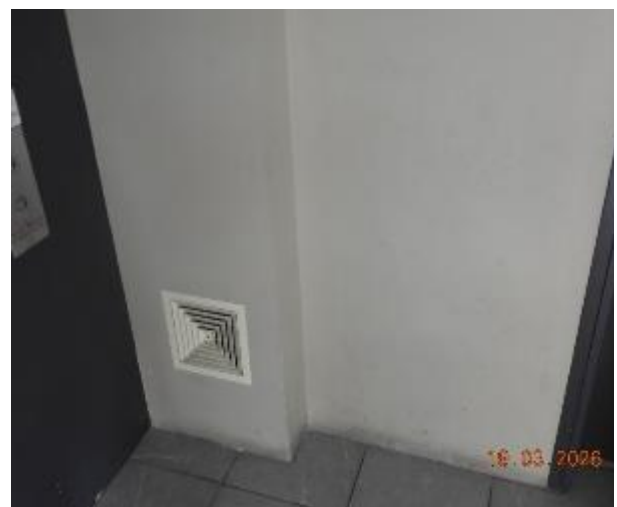
Figure 48 - General condition of level 2 common area internal wall

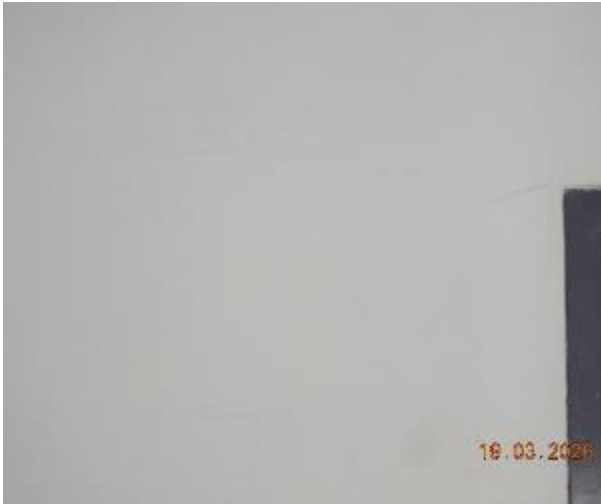
Figure 49 - Crack propagation through level 2 common area internal wall

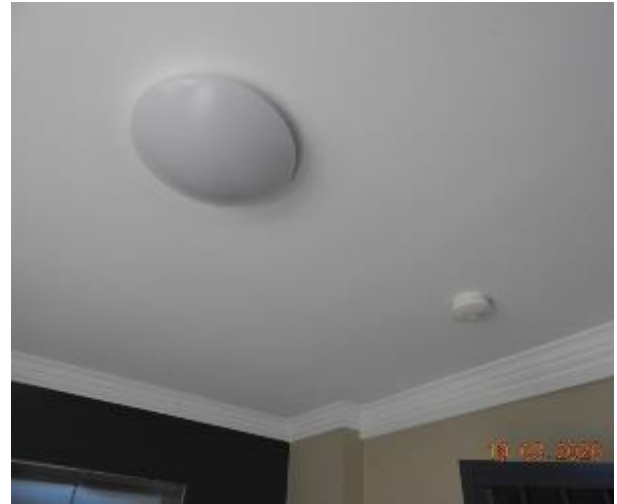
Figure 50 - General condition of level 2 common area ceiling

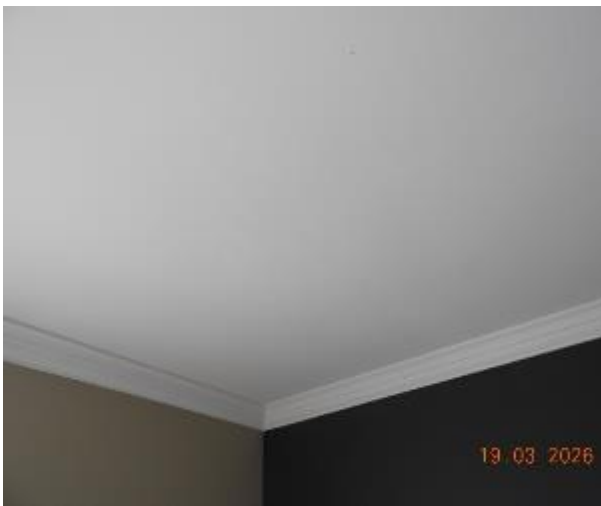
Figure 51 - General condition of level 2 common area ceiling

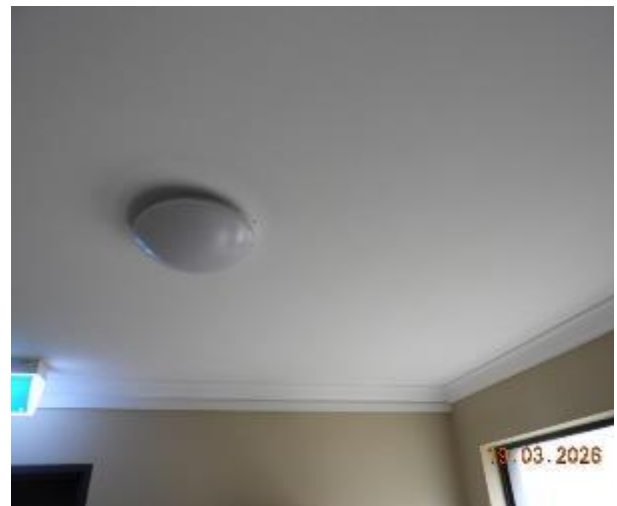
Figure 52 - General condition of level 2 common area ceiling

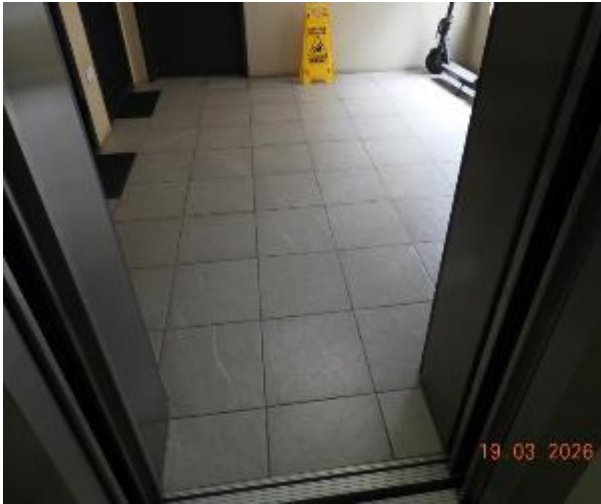
Figure 55 - General condition of level 3 common area floor tiles

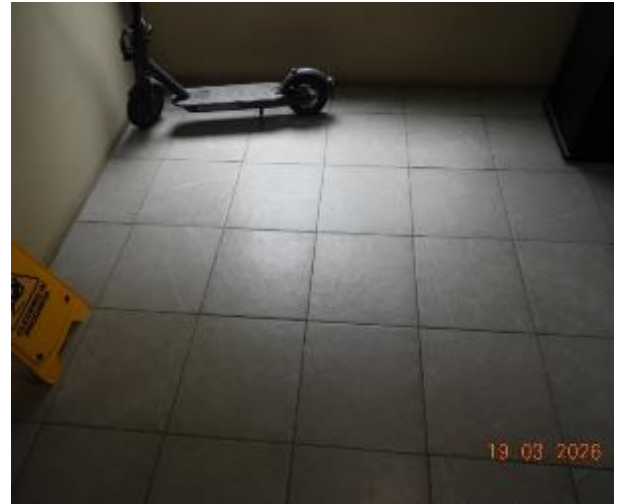
Figure 56 - General condition of level 3 common area floor tiles

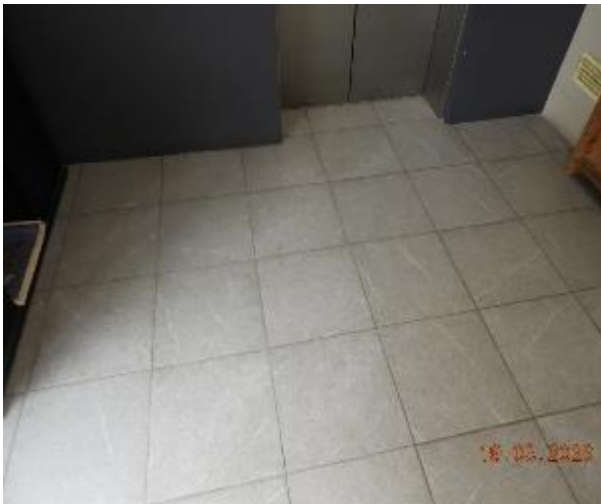
Figure 57 - General condition of level 3 common area floor tiles

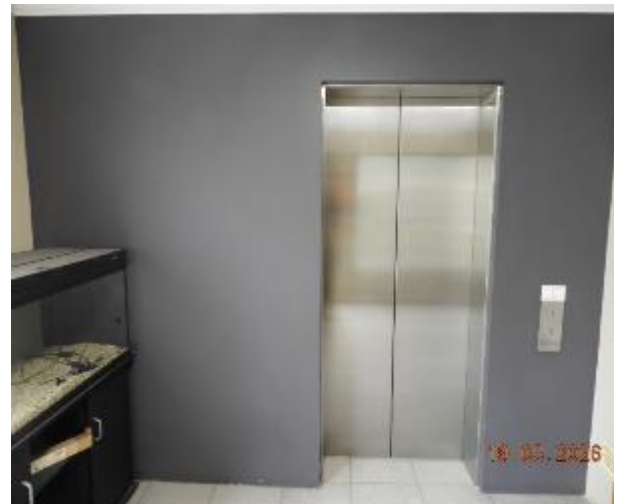
Figure 58 - General condition of level 3 common area internal wall

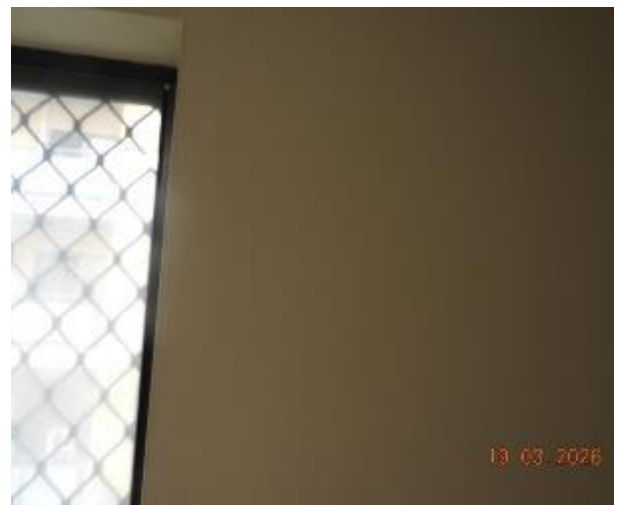
Figure 60 - Crack propagation through level 3 common area internal wall

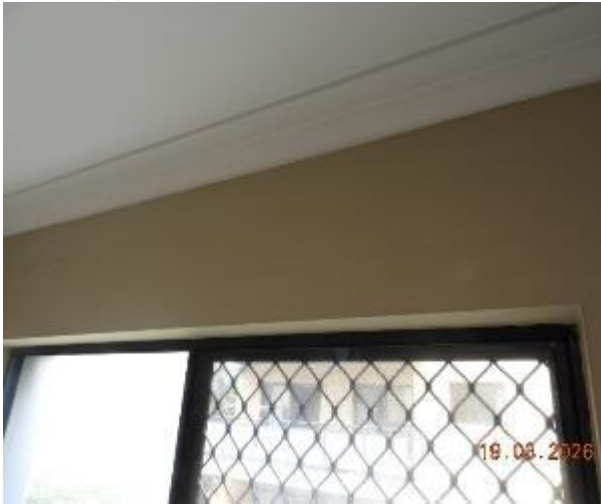
Figure 61 - General condition of level 3 common area internal wall

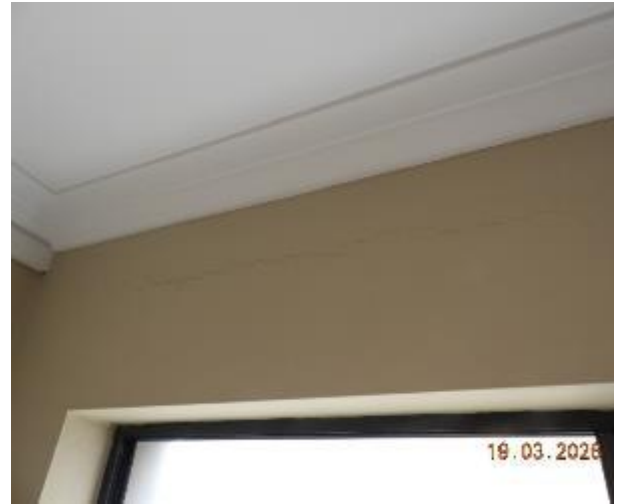
Figure 62 - Crack propagation through level 3 common area internal wall

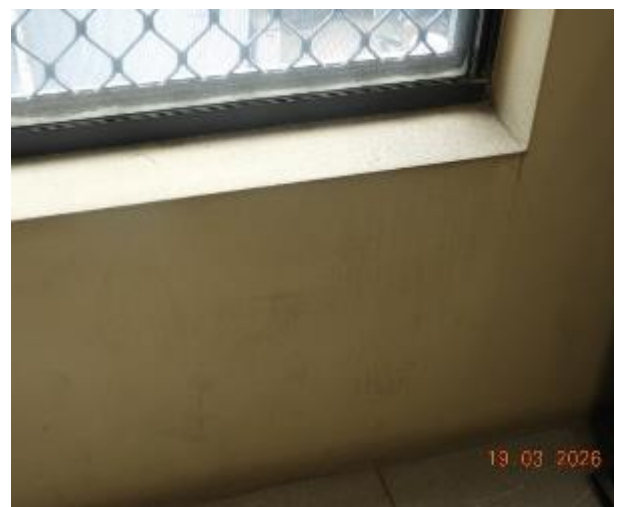
Figure 66 - Crack propagation through level 3 common area internal wall

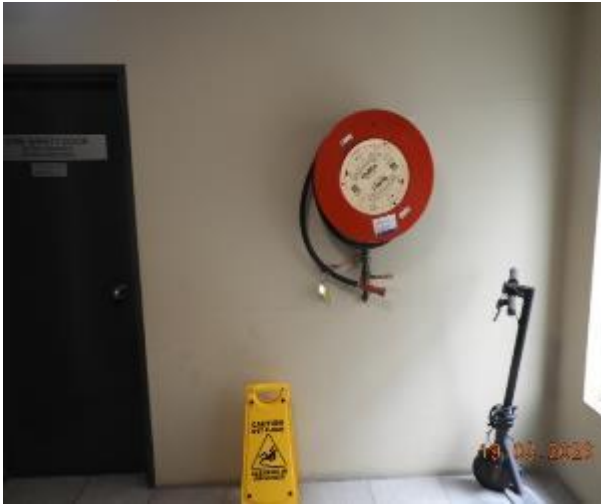
Figure 67 - General condition of level 3 common area internal wall

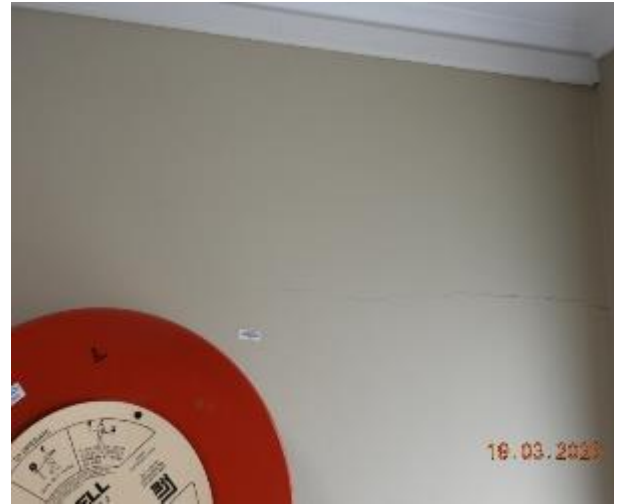
Figure 68 - Crack propagation through level 3 common area internal wall

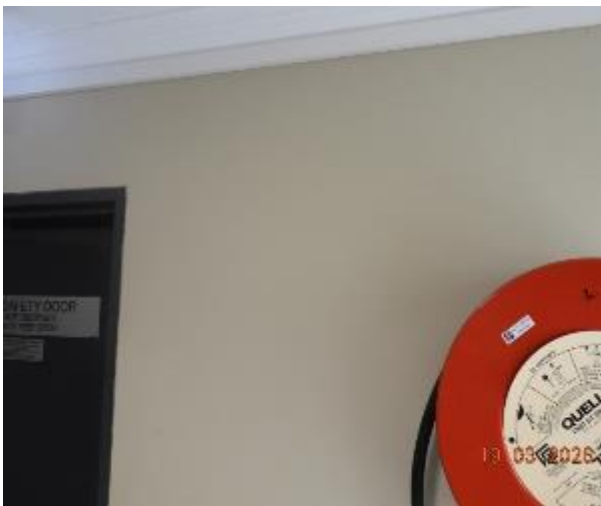
Figure 69 - General condition of level 3 common area internal wall

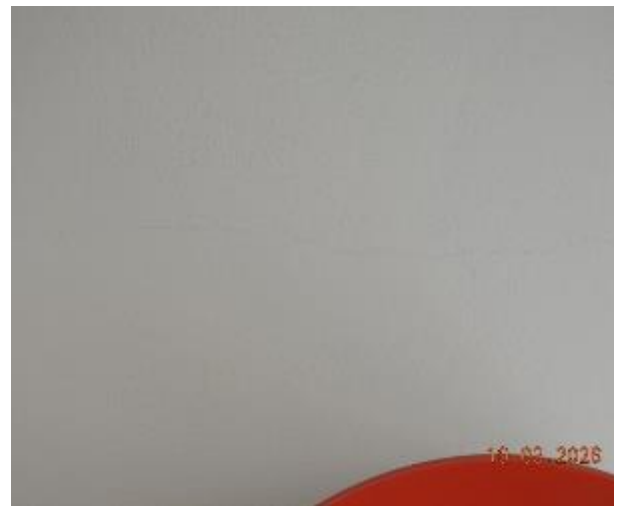
Figure 70 - Crack propagation through level 3 common area internal wall

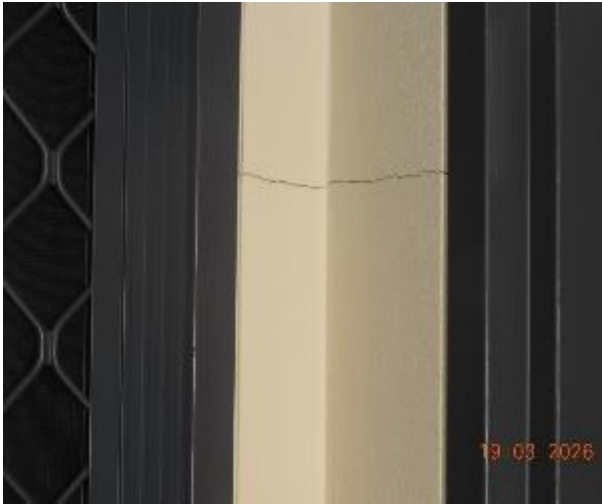
Figure 73 - Crack propagation through level 3 common area internal wall

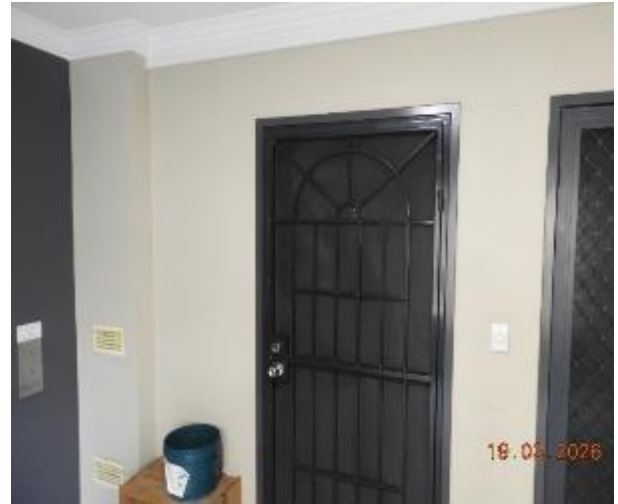
Figure 74 - General condition of level 3 common area internal wall

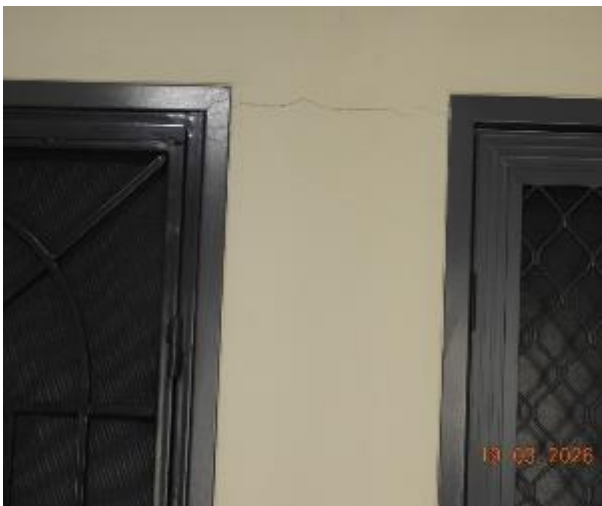
Figure 75 - Crack propagation through level 3 common area internal wall

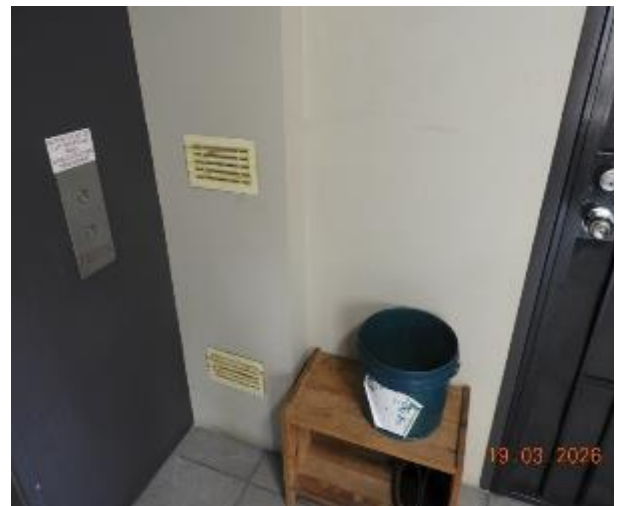
Figure 76 - General condition of level 3 common area internal wall

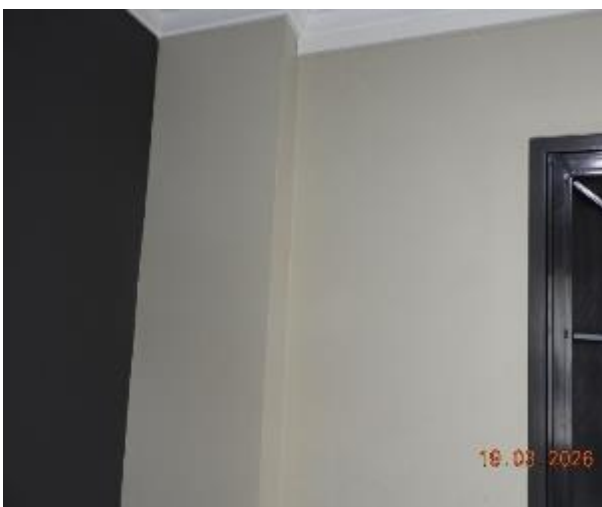
Figure 77 - General condition of level 3 common area internal wall

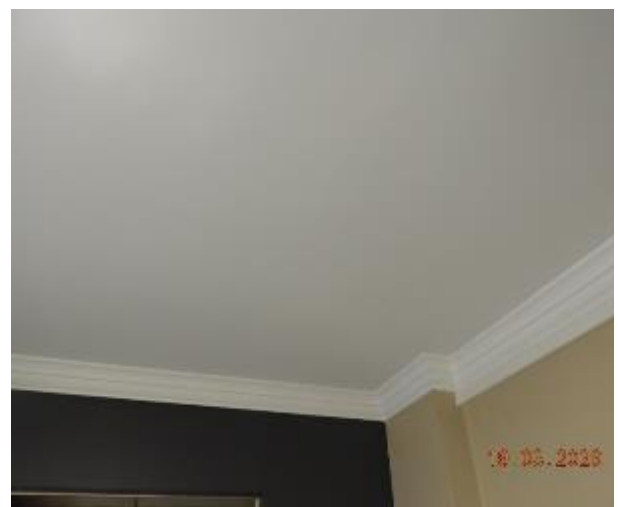
Figure 78 - General condition of level 3 common area ceiling

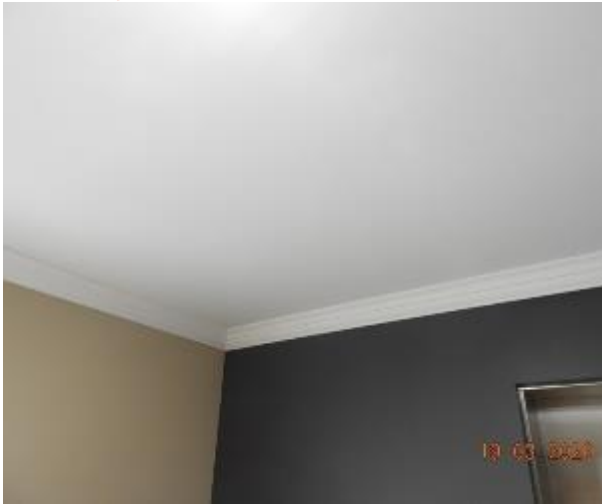
Figure 79 - General condition of level 3 common area ceiling

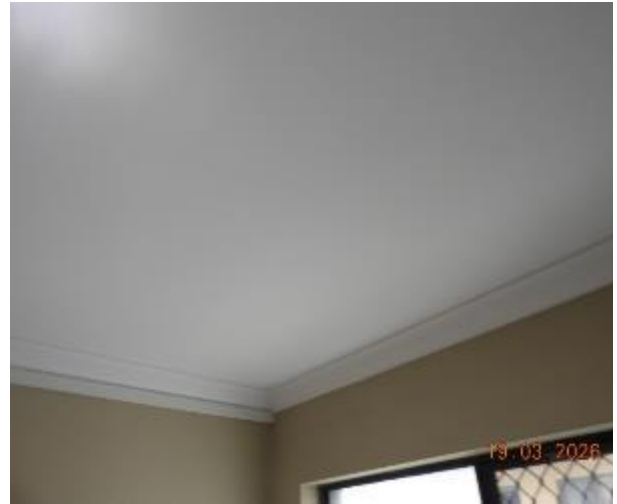
Figure 80 - General condition of level 3 common area ceiling

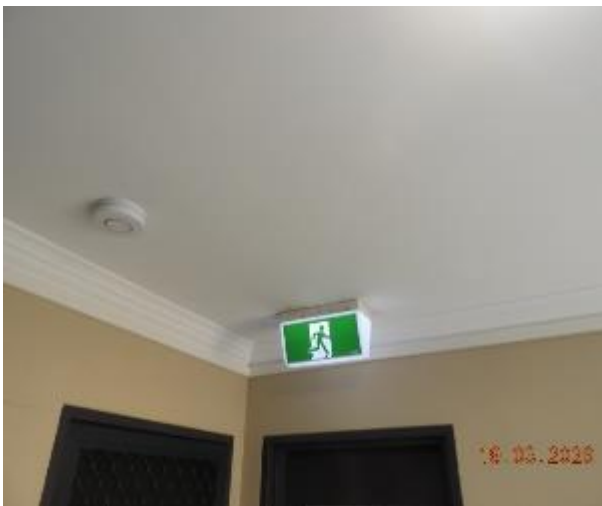
Figure 81 - General condition of level 3 common area ceiling

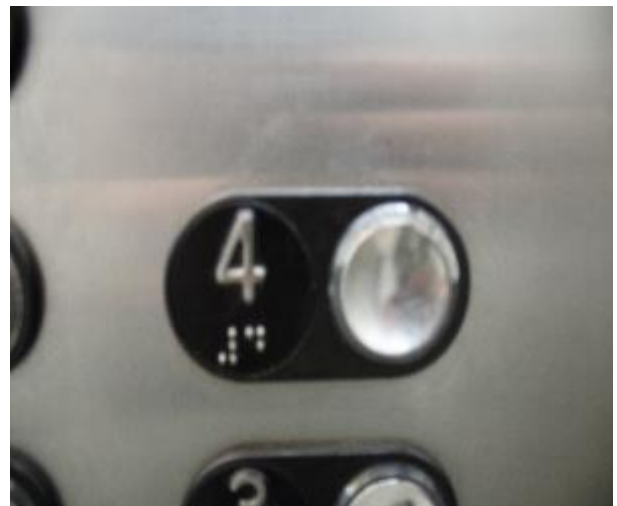
Figure 82 -The following images display the condition of Level 4 & 5 Common Area

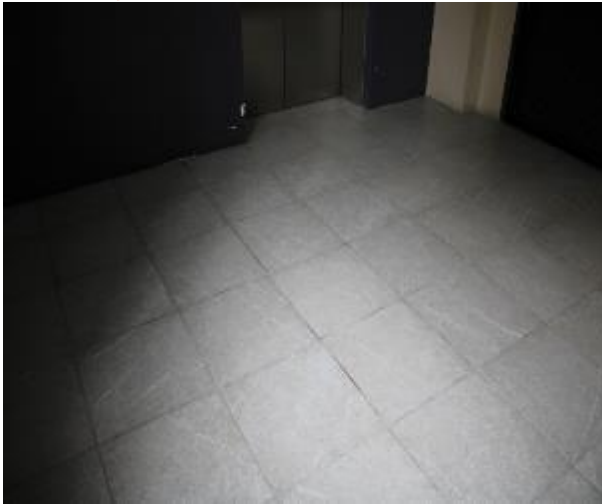
Figure 85 - General condition of level 4 common area floor tiles

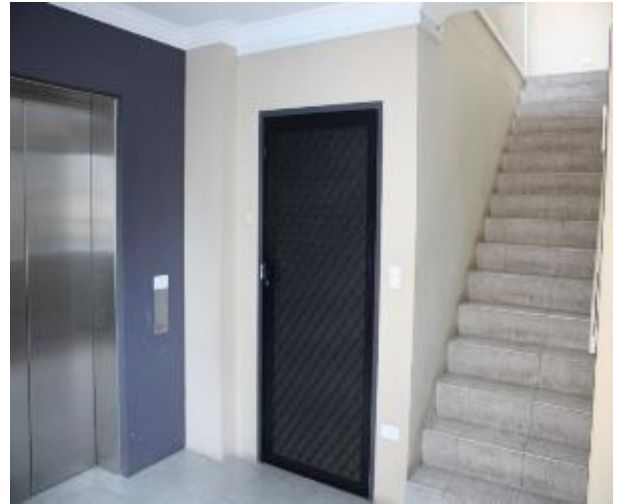
Figure 86 - General condition of level 4 common area internal wall

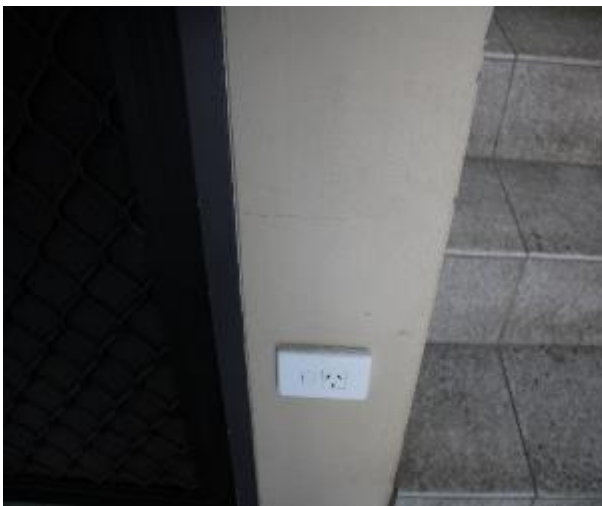
Figure 87 - Crack propagation through level 4 common area internal wall

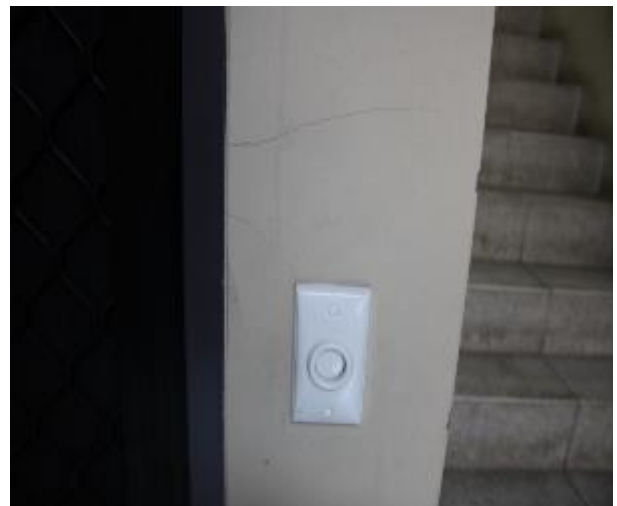
Figure 88 - Crack propagation through level 4 common area internal wall

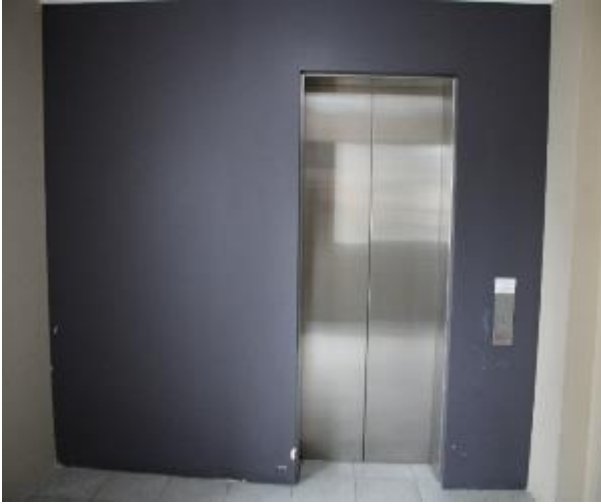
Figure 91 - General condition of level 4 common area internal wall

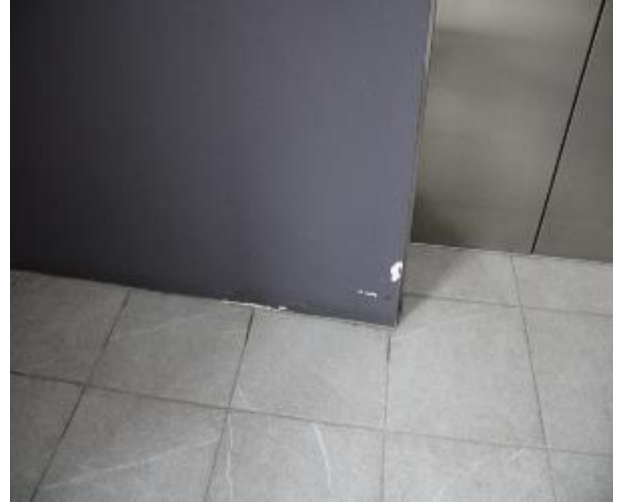
Figure 92 - Paint flaking through level 4 common area internal wall

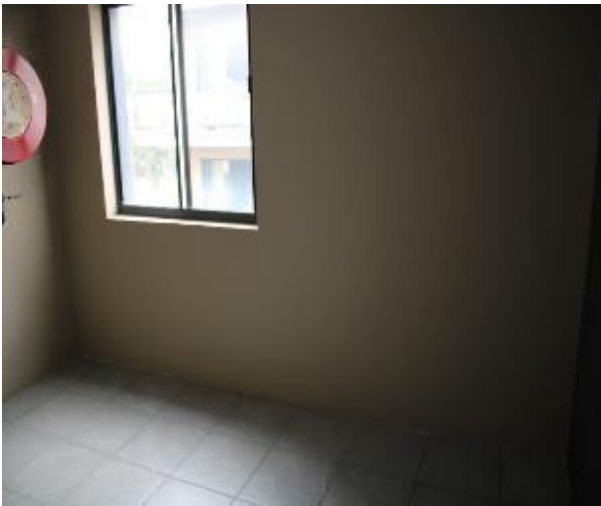
Figure 93 - General condition of level 4 common area internal wall

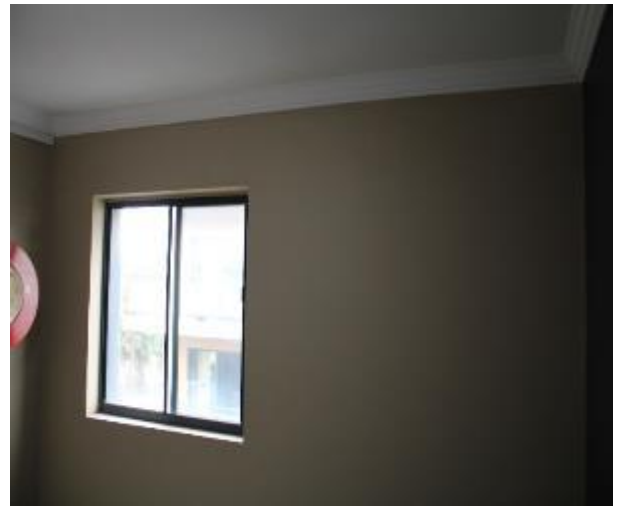
Figure 94 - General condition of level 4 common area internal wall
