# **Pre-Dilapidation Report**

**19 GEORGE STREET**

**REAR BUILDING (UNITS 20-29)**

Project Reference: 20250047.19G.3

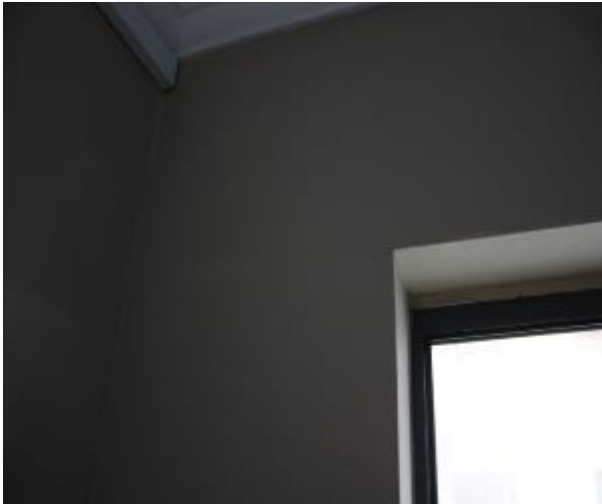
Figure 97 - Crack propagation through level 4 common area internal wall

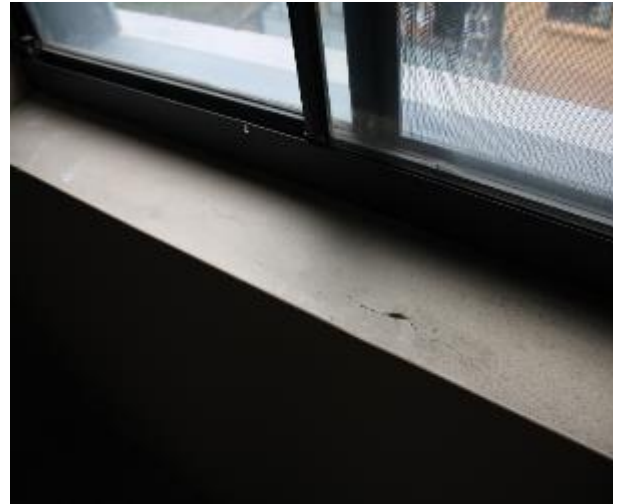
Figure 98 - Crack propagation through level 4 common area internal wall

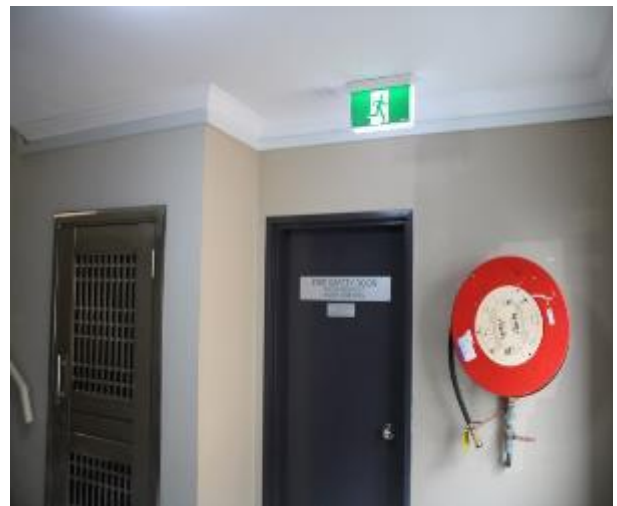
Figure 100 - General condition of level 4 common area internal wall

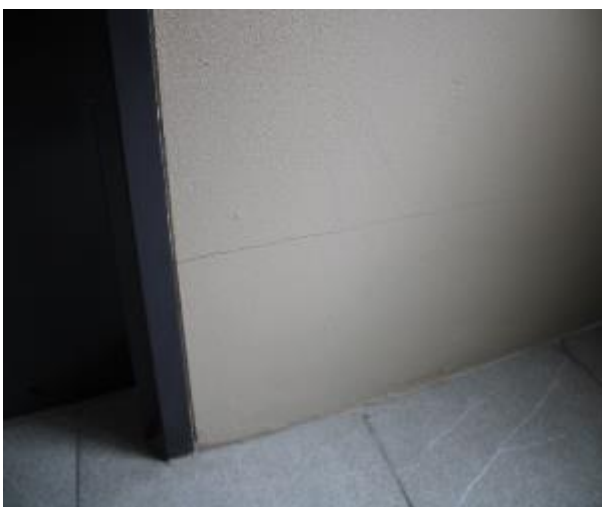
Figure 101 - Crack propagation through level 4 common area internal wall

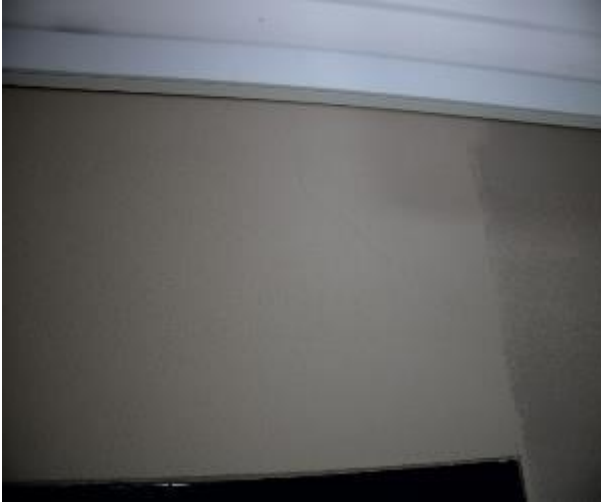
Figure 103 - Crack propagation through level 4 common area internal wall

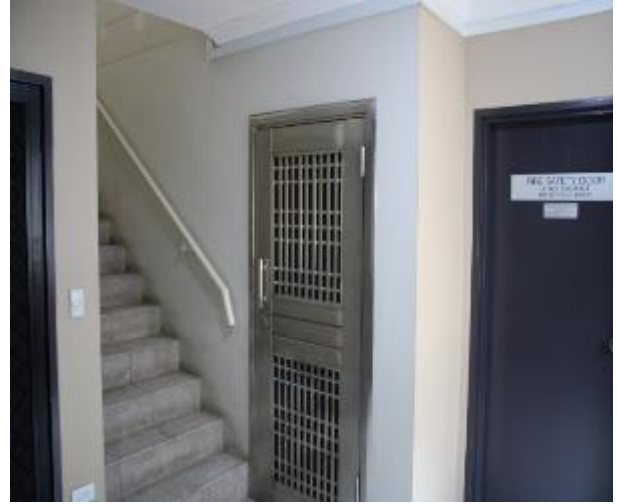
Figure 104 - General condition of level 4 common area internal wall

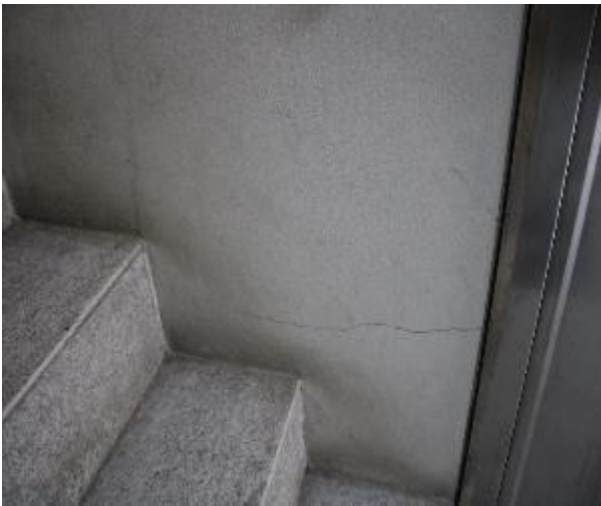
Figure 105 - Crack propagation through level 4 common area internal wall

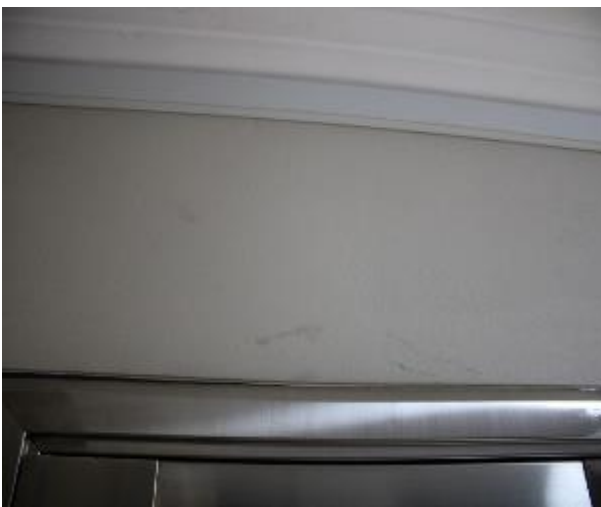
Figure 107 - Crack propagation through level 4 common area internal wall

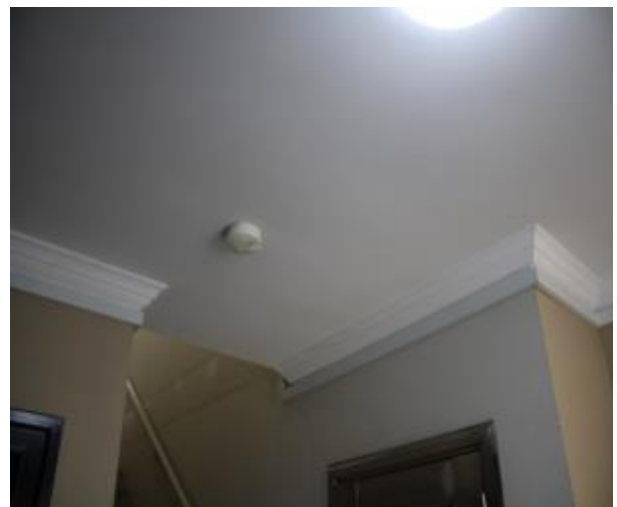
Figure 108 - General condition of level 4 common area ceiling

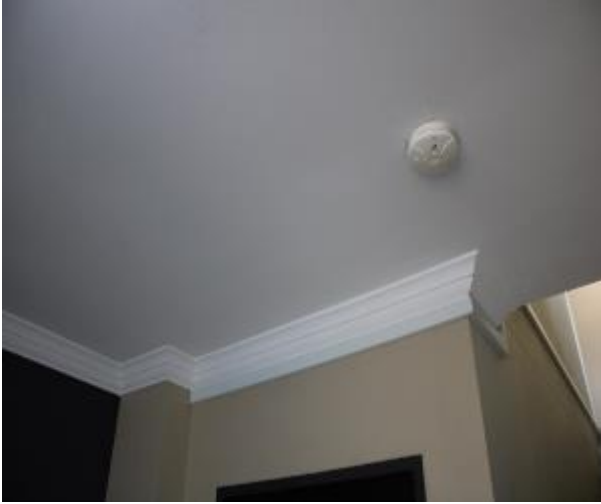
Figure 109 - General condition of level 4 common area ceiling

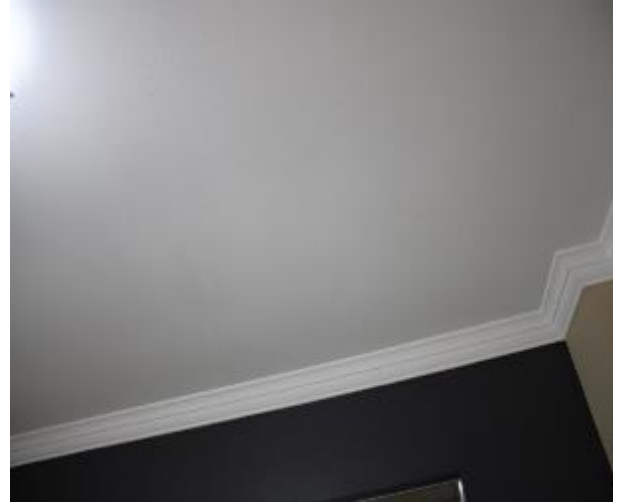
Figure 110 - General condition of level 4 common area ceiling

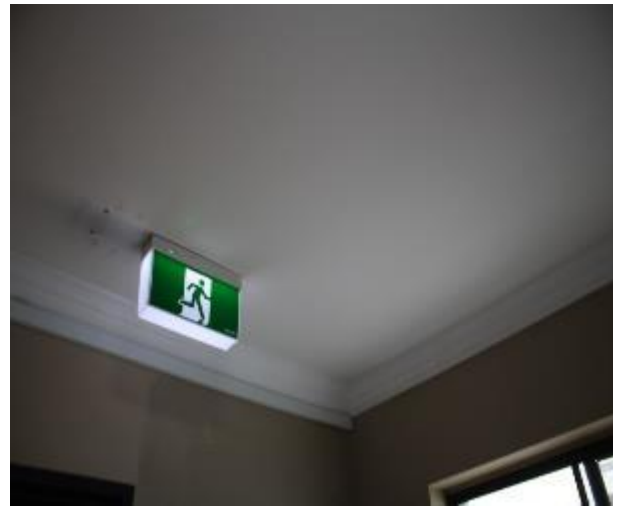
Figure 112 - General condition of level 4 common area ceiling

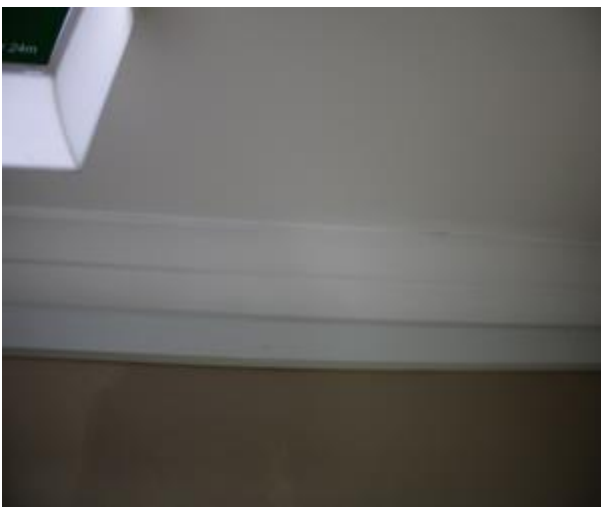
Figure 113 - Crack propagation through level 4 common area ceiling

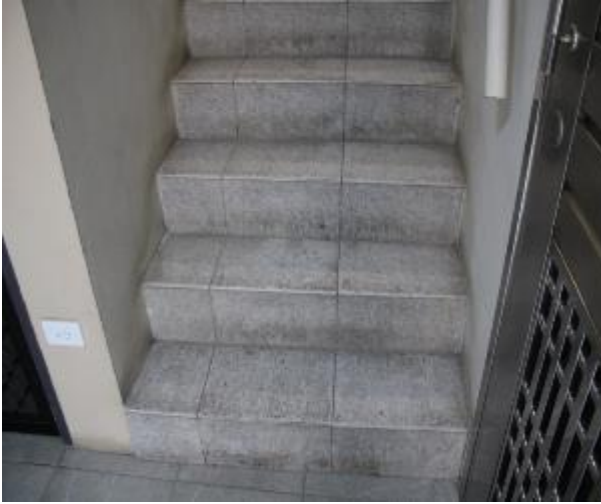
Figure 115 - General condition of staircase to level 5 common area

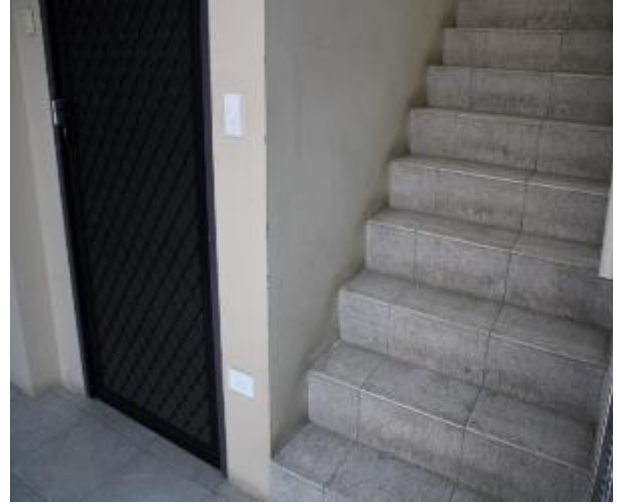
Figure 116 - General condition of staircase to level 5 common area internal wall

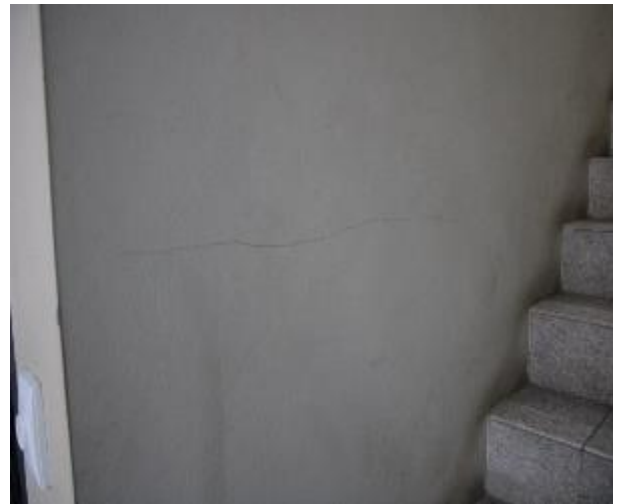
Figure 118 - Crack propagation through staircase to level 5 common area internal wall

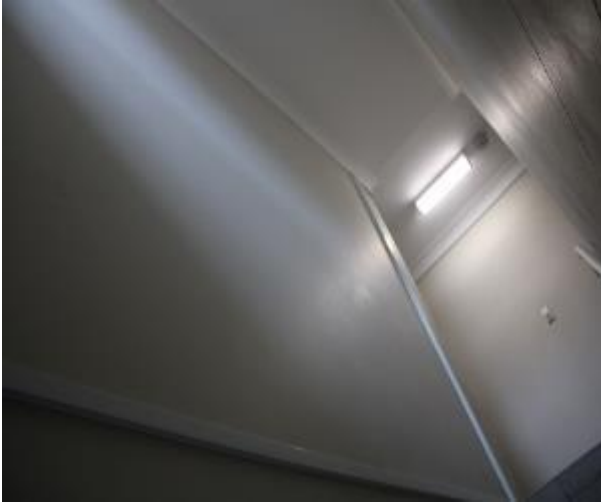
Figure 121 - General condition of staircase to level 5 common area internal wall

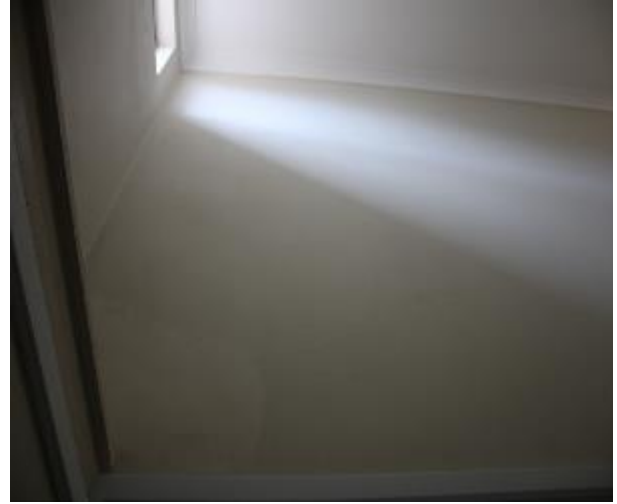
Figure 122 - General condition of staircase to level 5 common area internal wall

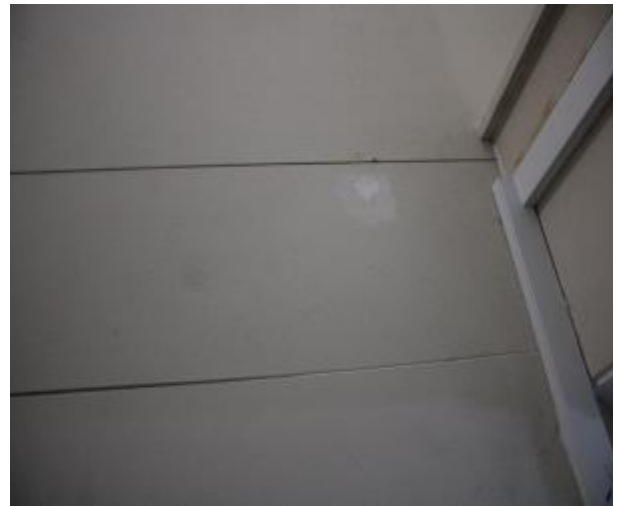
Figure 124 - Crack propagation through staircase to level 5 common area internal wall

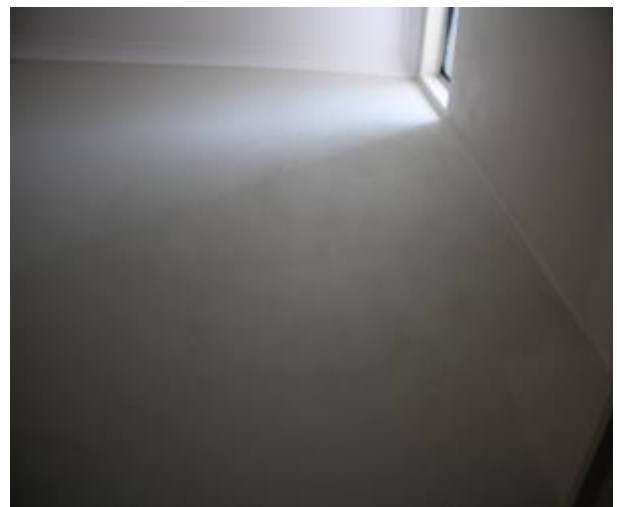
Figure 126 - General condition of staircase to level 5 common area internal wall

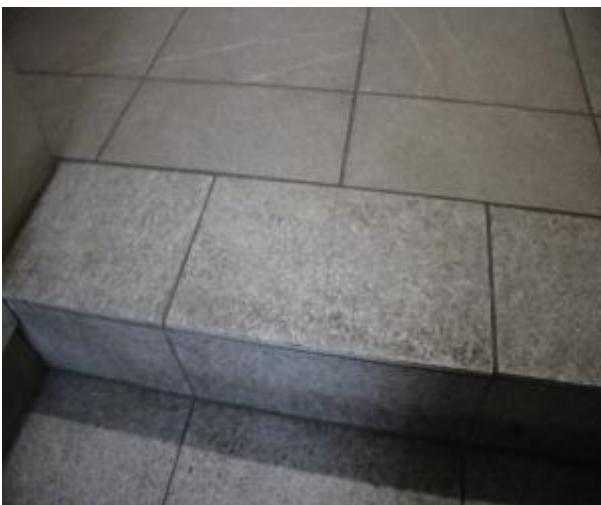
Figure 137 - Crack propagation through level 5 common area floor tiles

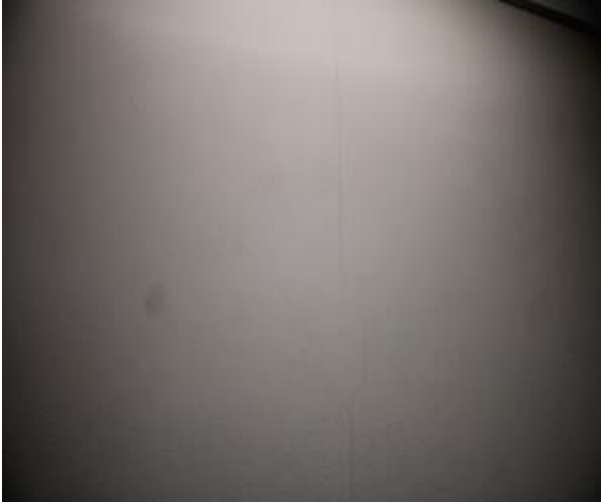
Figure 145 - Crack propagation through level 5 common area internal wall

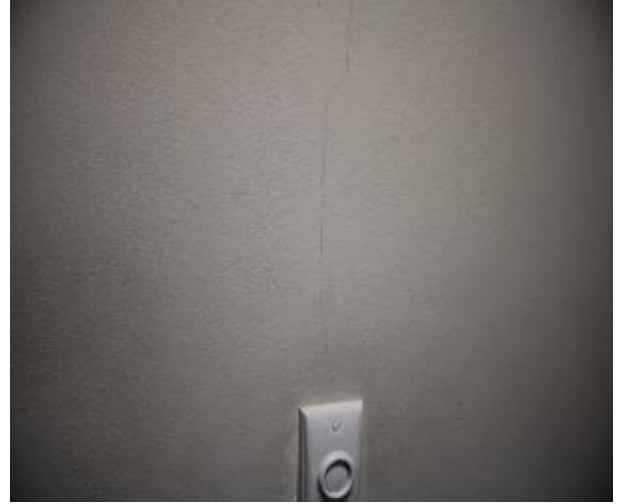
Figure 146 - Crack propagation through level 5 common area internal wall

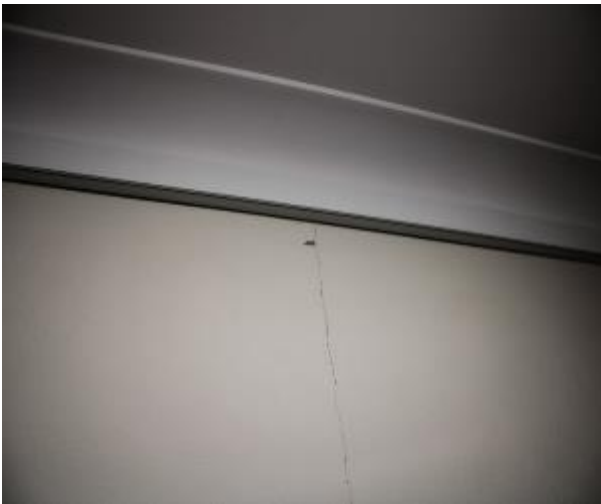
Figure 147 - Crack propagation through level 5 common area internal wall

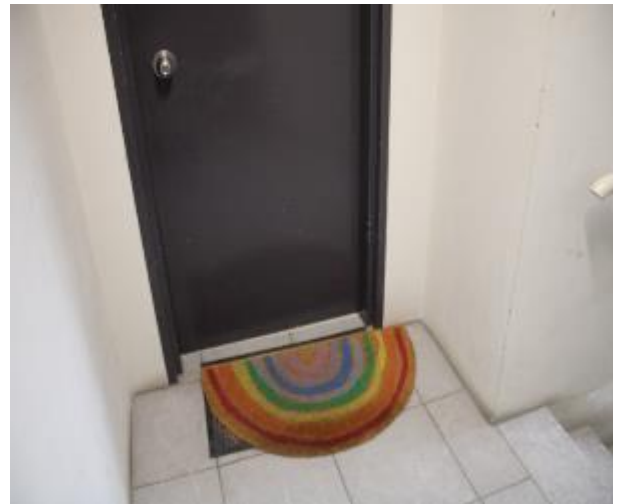
Figure 148 - General condition of level 5 common area internal wall

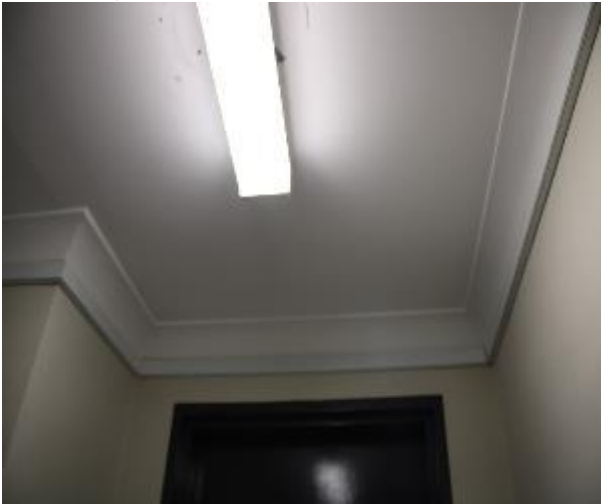
Figure 151 - General condition of level 5 common area ceiling

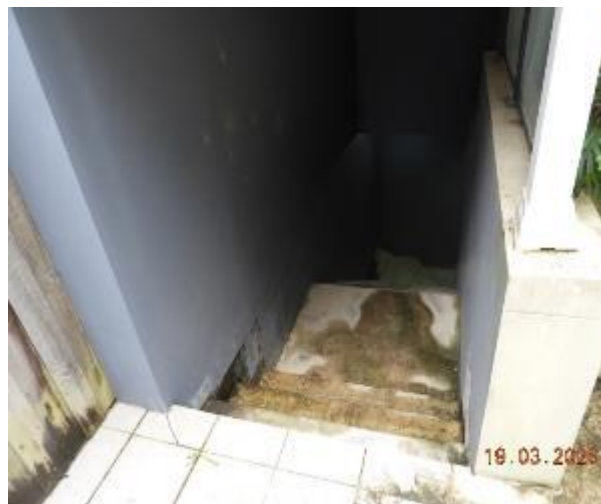
Figure 156 - General condition of B2 to Level 1 fire stairs

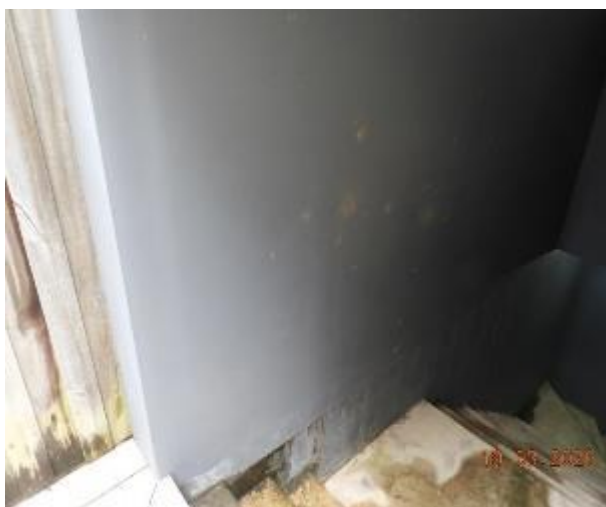
Figure 159 - General condition of B2 to Level 1 fire stairs internal wall

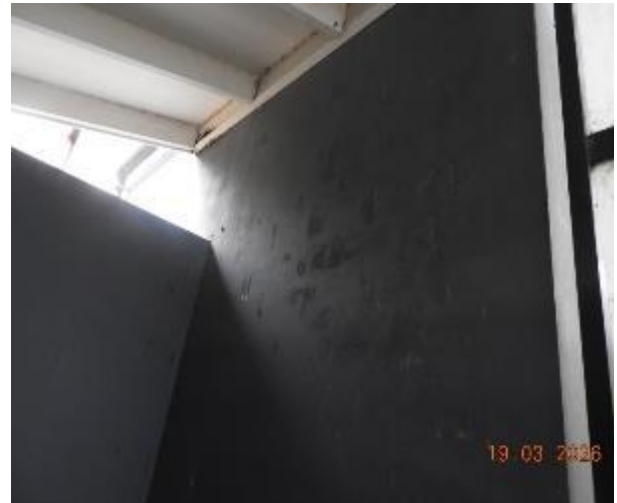
Figure 164 - General condition of B2 to Level 1 fire stairs internal wall

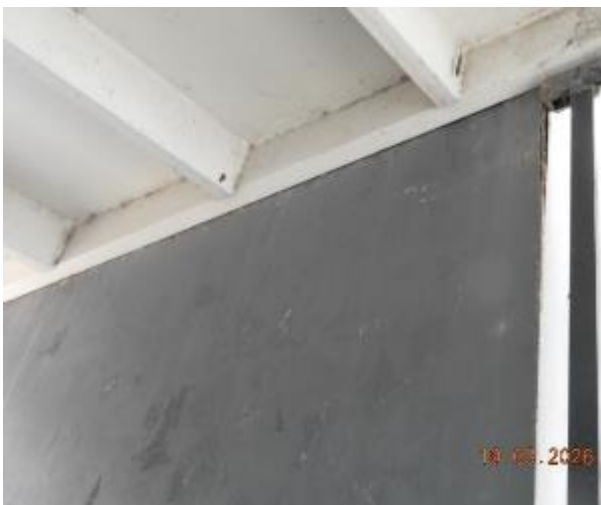
Figure 165 - General condition of B2 to Level 1 fire stairs internal wall

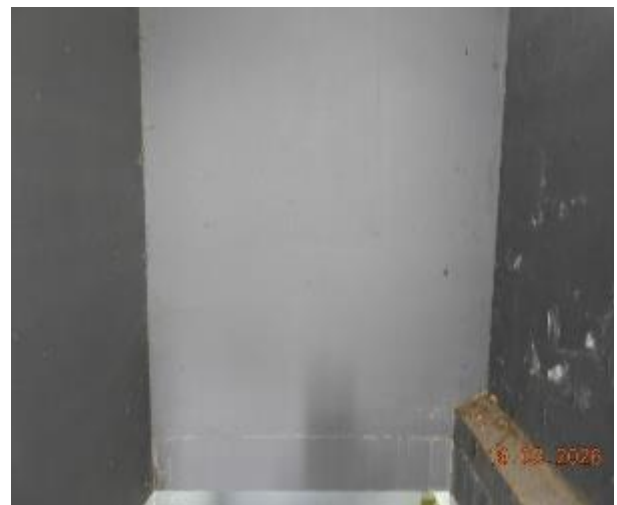
Figure 166 - General condition of B2 to Level 1 fire stairs internal wall

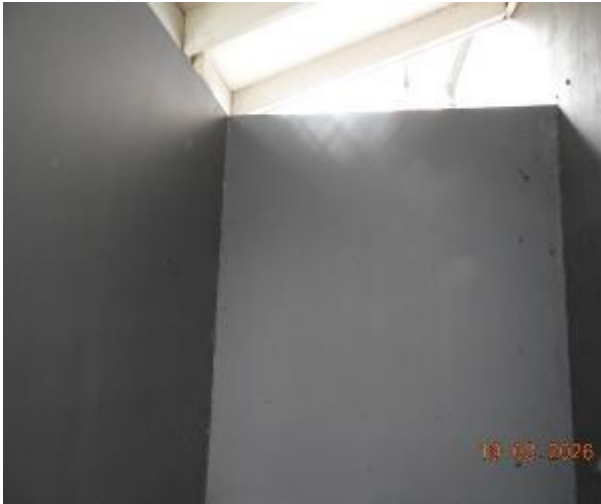
Figure 167 - General condition of B2 to Level 1 fire stairs internal wall

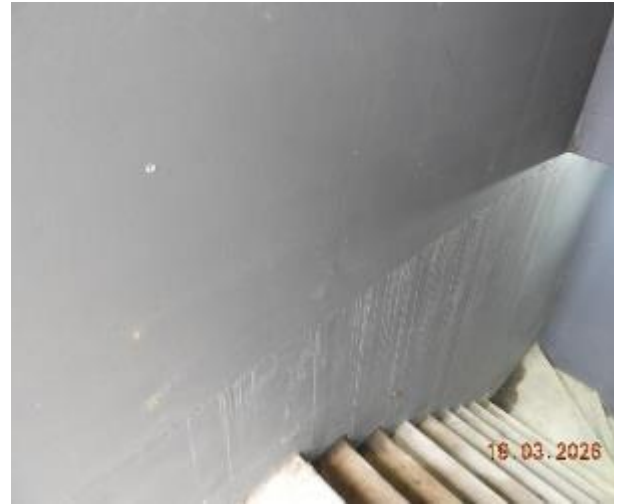
Figure 168 - General condition of B2 to Level 1 fire stairs internal wall

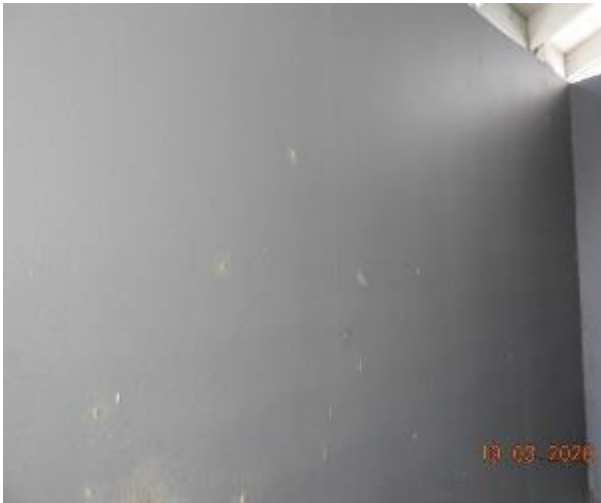
Figure 169 - General condition of B2 to Level 1 fire stairs internal wall

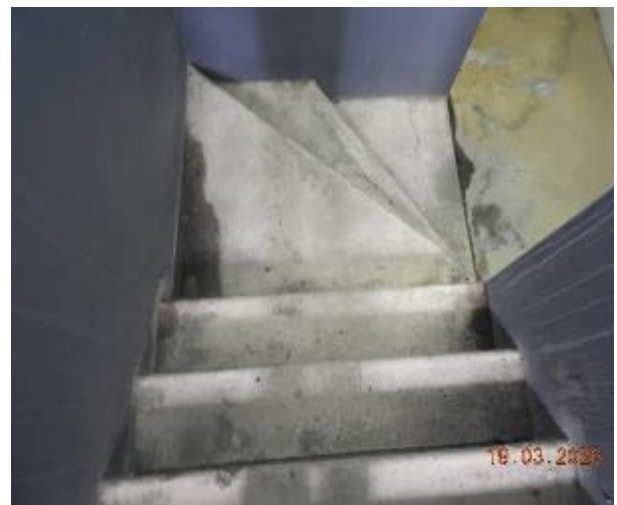
Figure 172 - General condition of B2 to Level 1 fire stairs

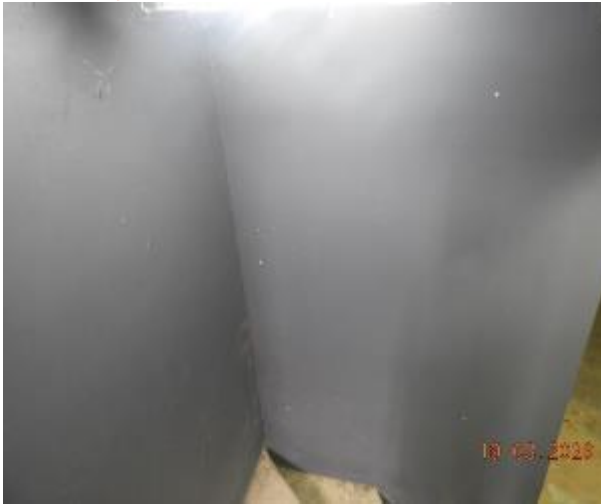
Figure 173 - General condition of B2 to Level 1 fire stairs internal wall

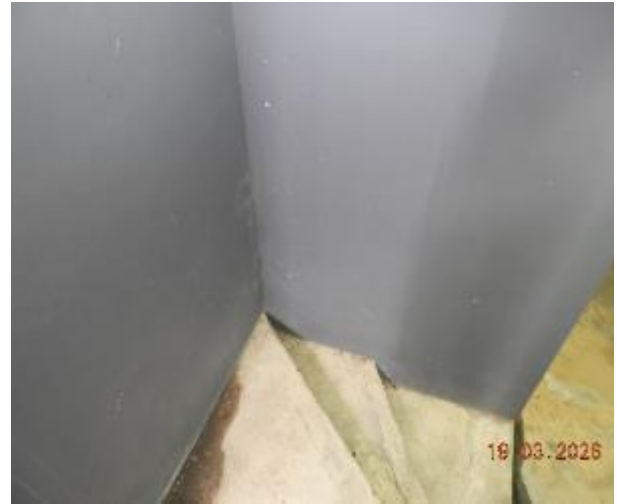
Figure 174 - General condition of B2 to Level 1 fire stairs internal wall

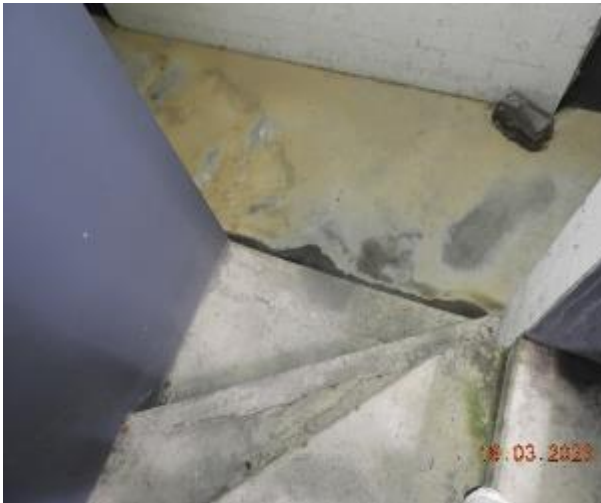
Figure 175 - General condition of B2 to Level 1 fire stairs pavement slab

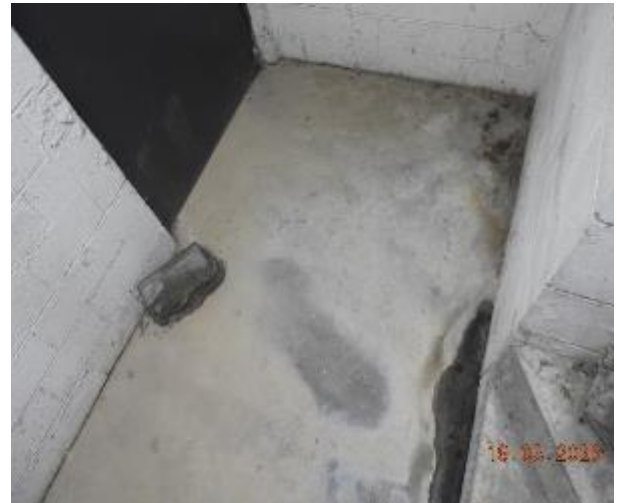
Figure 176 - General condition of B2 to Level 1 fire stairs pavement slab

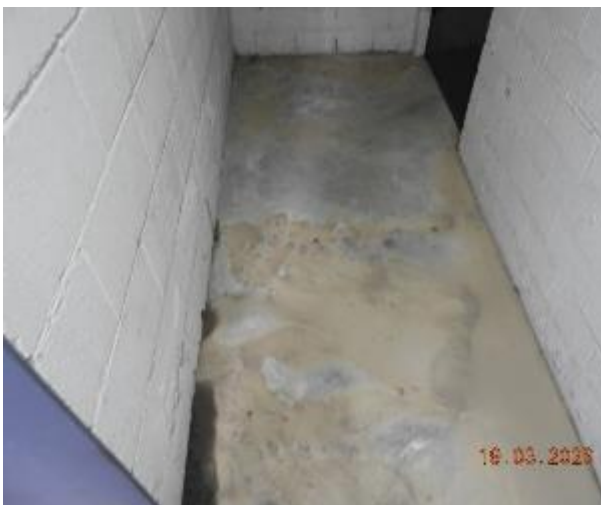
Figure 177 - General condition of B2 to Level 1 fire stairs pavement slab

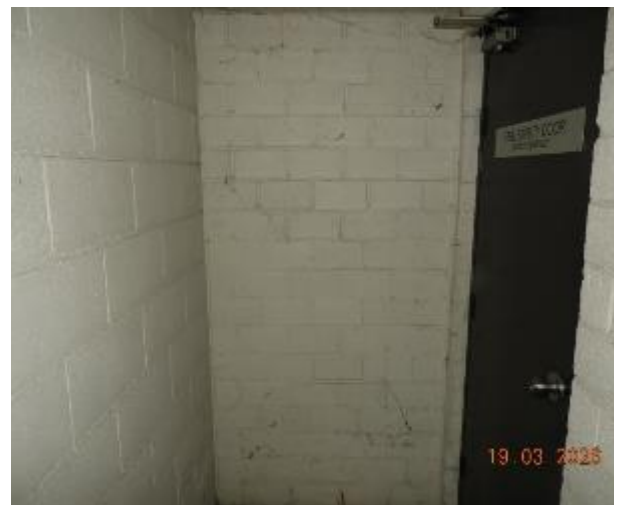
Figure 178 - General condition of B2 to Level 1 fire stairs internal wall

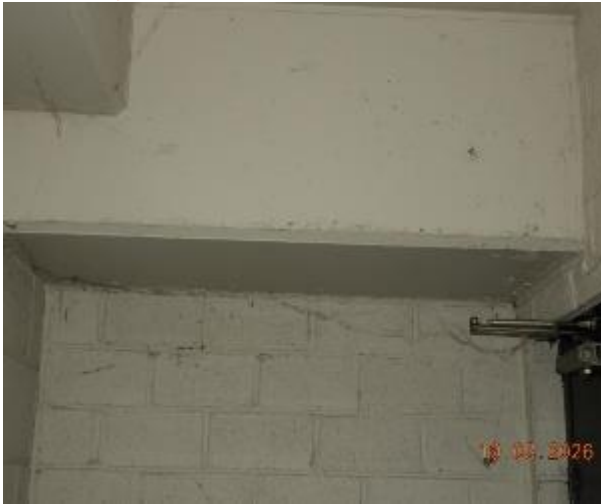
Figure 179 - General condition of B2 to Level 1 fire stairs internal wall

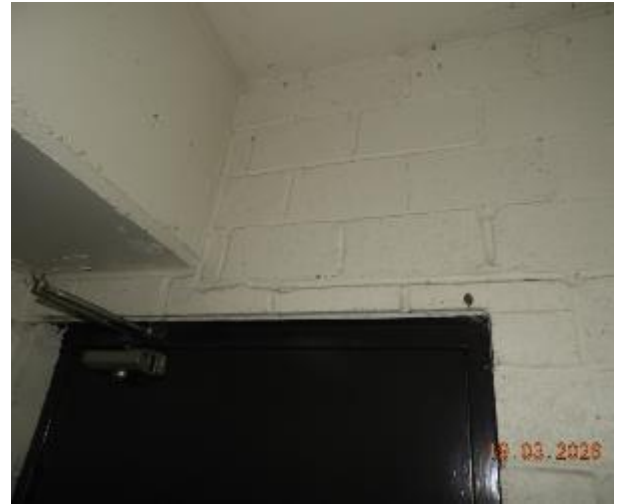
Figure 180 - General condition of B2 to Level 1 fire stairs internal wall

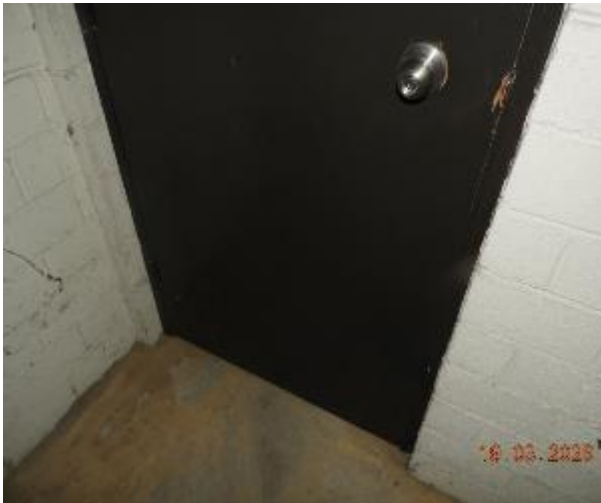
Figure 181 - General condition of B2 to Level 1 fire stairs internal wall

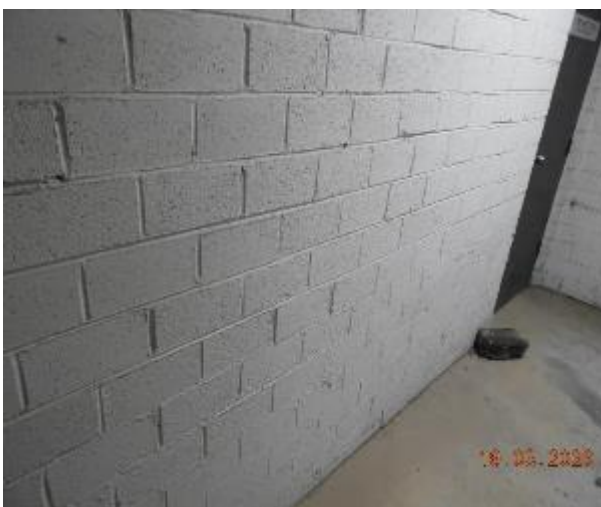
Figure 183 - General condition of B2 to Level 1 fire stairs internal wall

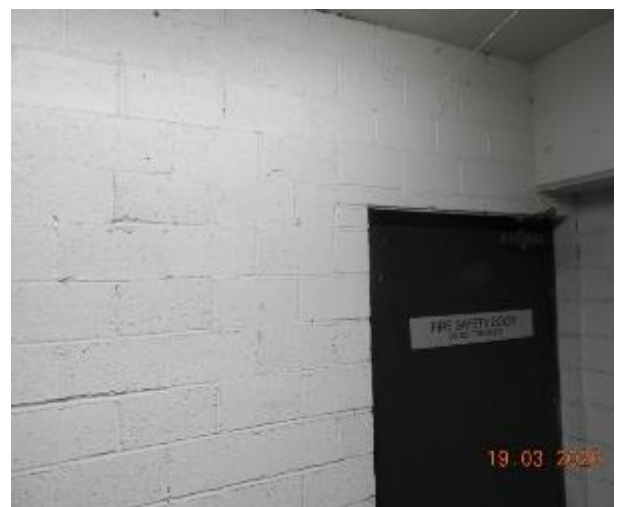
Figure 184 - General condition of B2 to Level 1 fire stairs internal wall

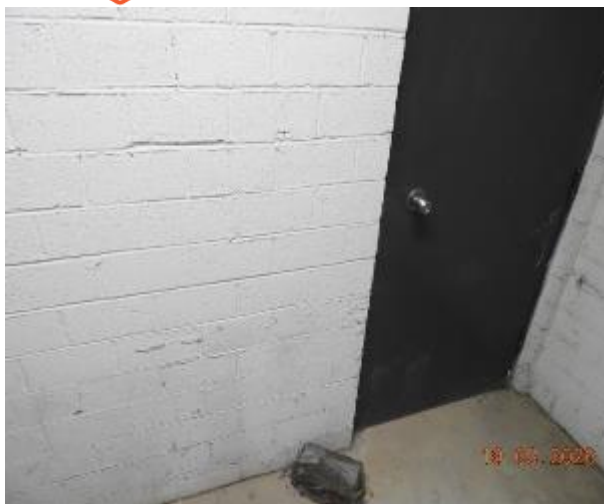
Figure 185 - General condition of B2 to Level 1 fire stairs internal wall

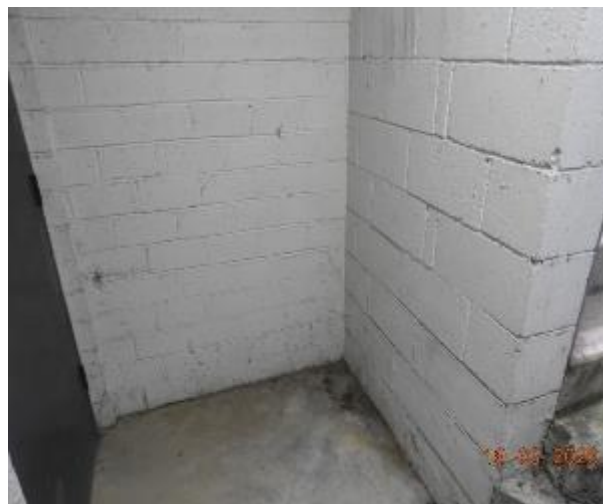
Figure 186 - General condition of B2 to Level 1 fire stairs internal wall

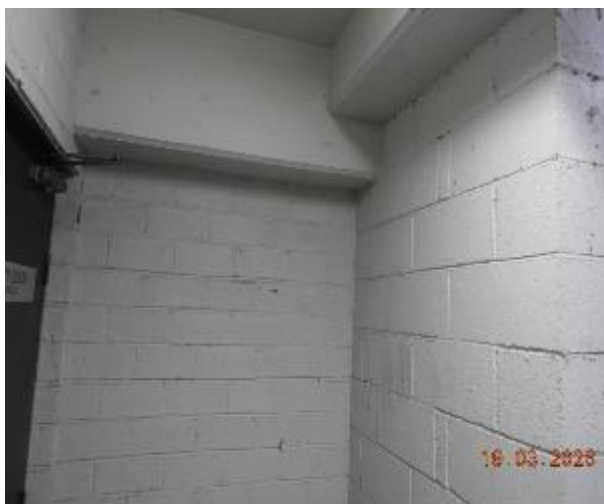
Figure 187 - General condition of B2 to Level 1 fire stairs internal wall

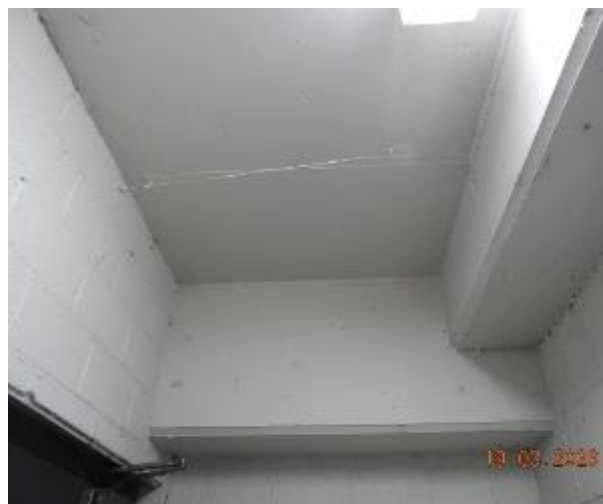
Figure 188 - General condition of B2 to Level 1 fire stairs underside slab

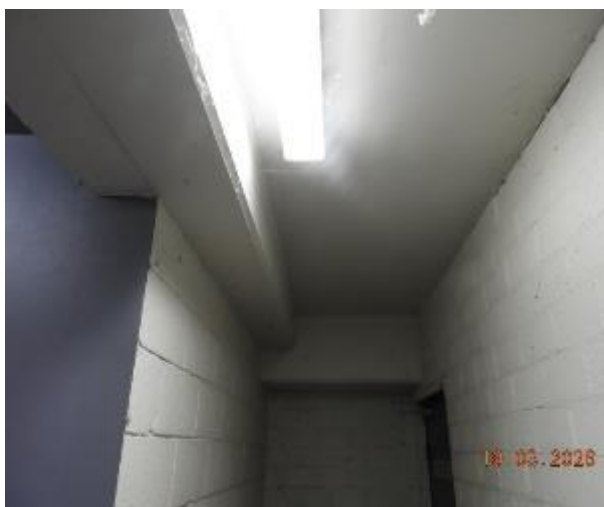
Figure 189 - General condition of B2 to Level 1 fire stairs underside slab

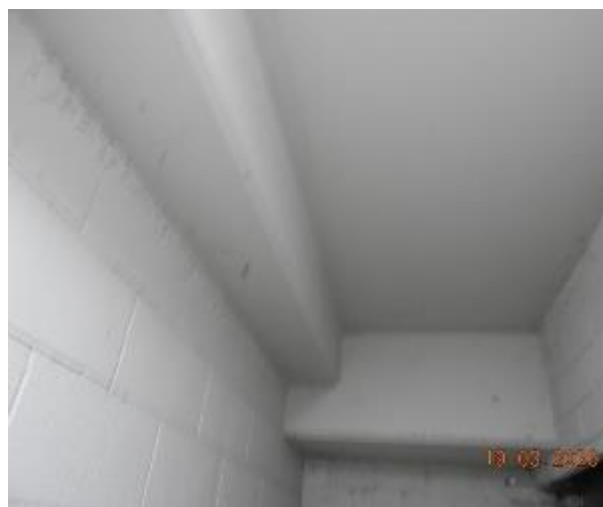
Figure 190 - General condition of B2 to Level 1 fire stairs underside slab

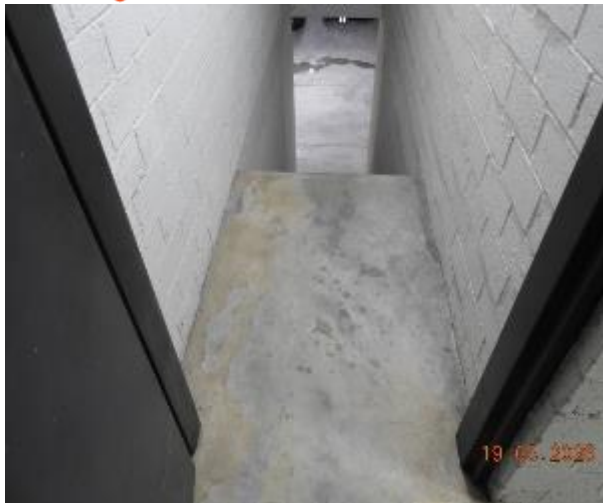
Figure 191 - General condition of B2 to Level 1 fire stairs pavement slab

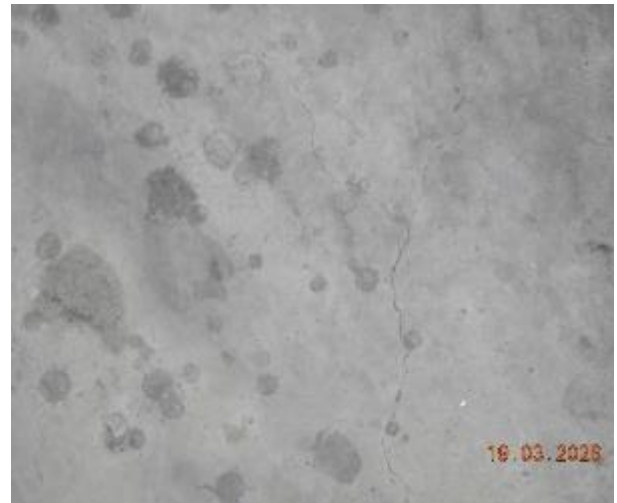
Figure 192 - Crack propagation through B2 to Level 1 fire stairs pavement slab

The fire stairs from Basement B2 to Level 1 were inspected and determined to be in reasonable condition with cases of cracking through the pavement slab.

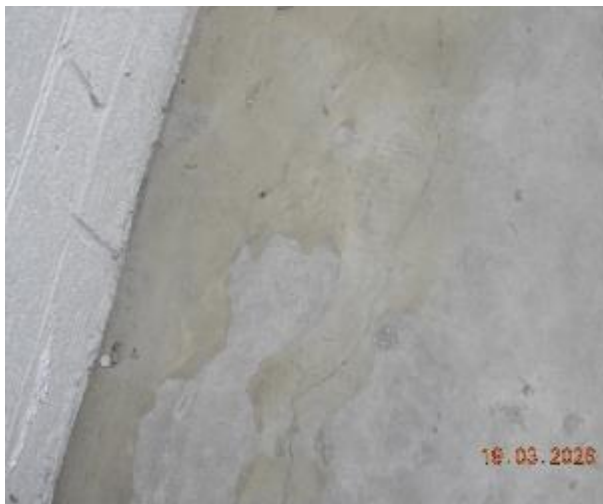
Figure 193 - Crack propagation through B2 to Level 1 fire stairs pavement slab

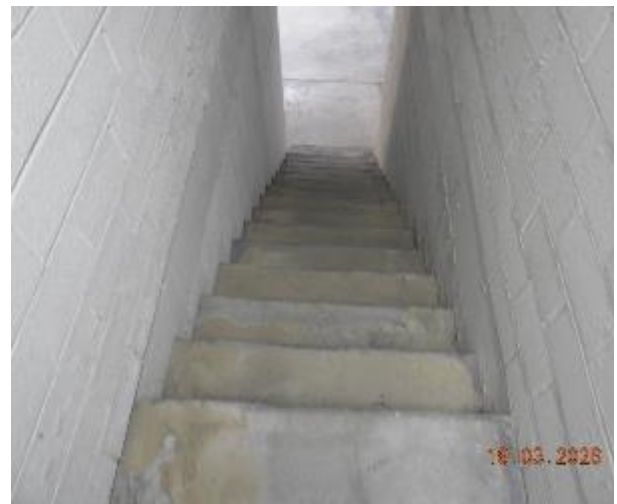
Figure 194 - General condition of B2 to Level 1 fire stairs

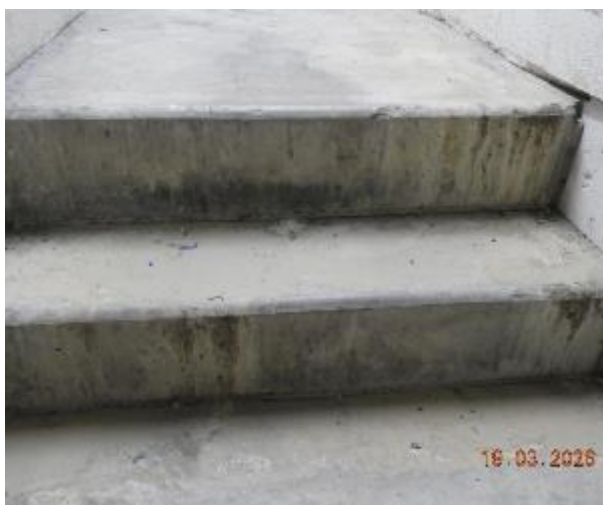
Figure 195 - General condition of B2 to Level 1 fire stairs

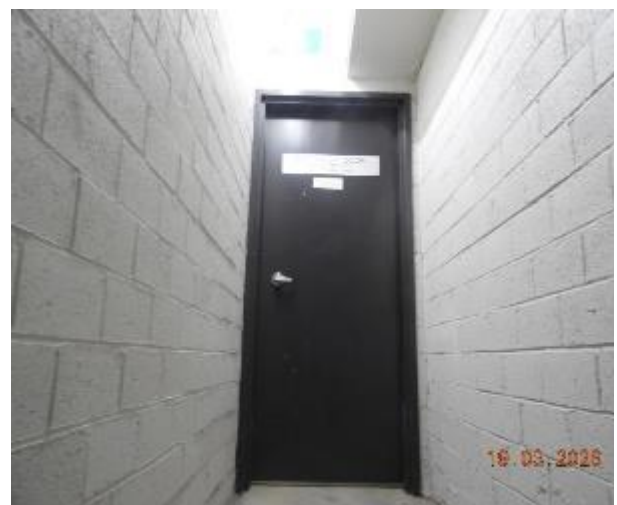
Figure 196 - General condition of B2 to Level 1 fire stairs internal wall

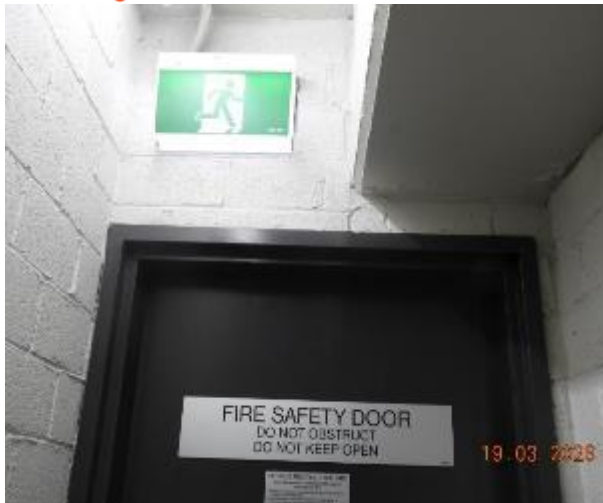
Figure 197 - General condition of B2 to Level 1 fire stairs internal wall

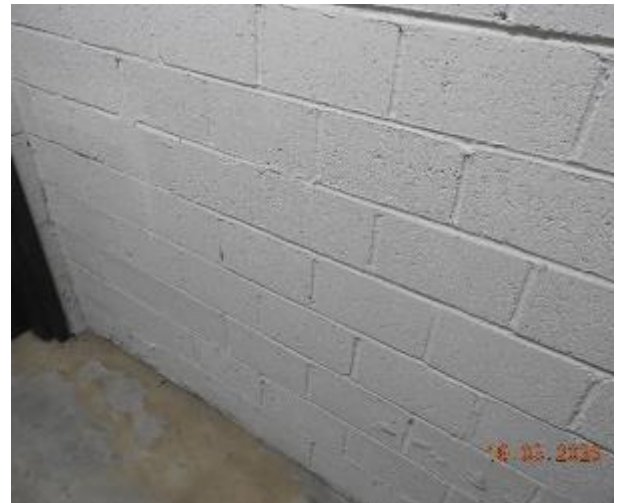
Figure 198 - General condition of B2 to Level 1 fire stairs internal wall

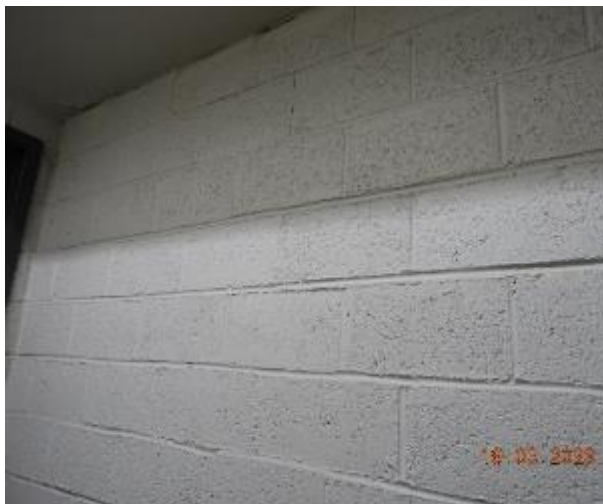
Figure 199 - General condition of B2 to Level 1 fire stairs internal wall

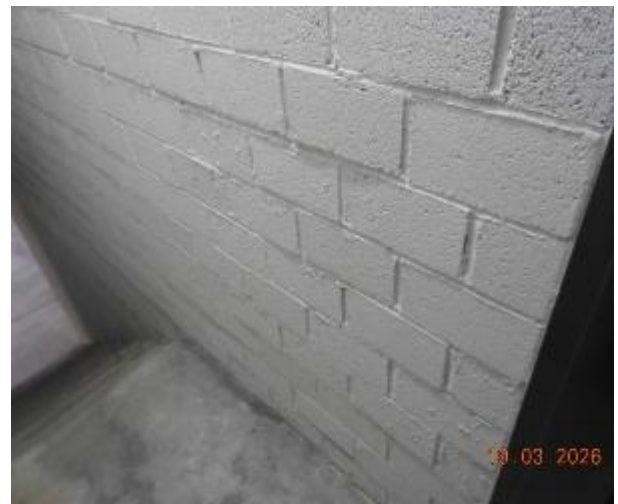
Figure 200 - General condition of B2 to Level 1 fire stairs internal wall

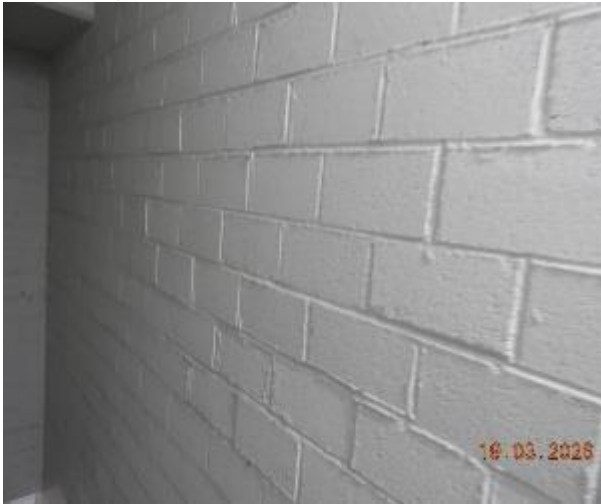
Figure 203 - General condition of B2 to Level 1 fire stairs internal wall

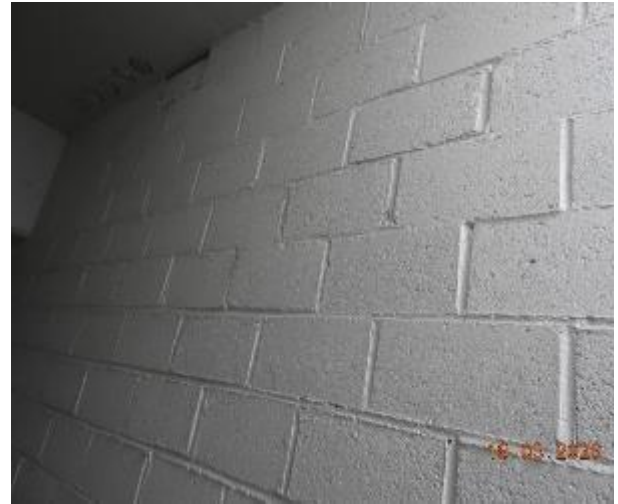
Figure 204 - General condition of B2 to Level 1 fire stairs internal wall

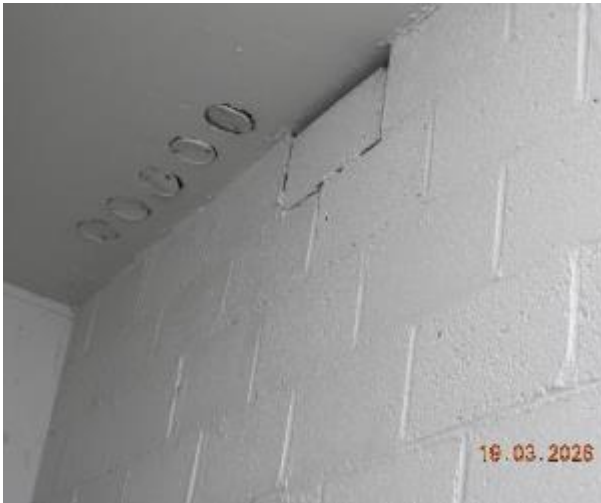
Figure 205 - General condition of B2 to Level 1 fire stairs internal wall

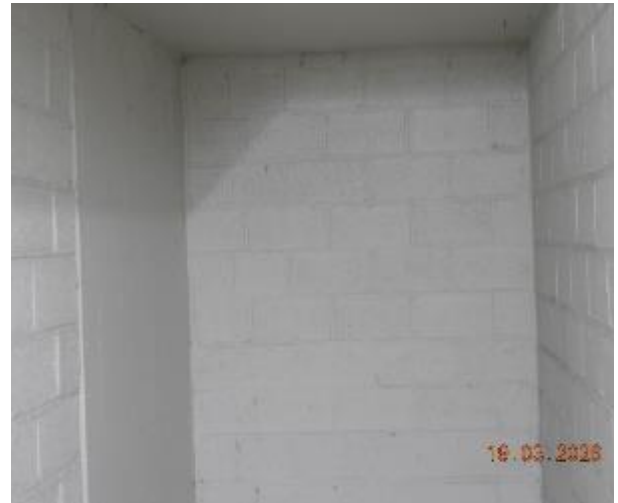
Figure 206 - General condition of B2 to Level 1 fire stairs internal wall

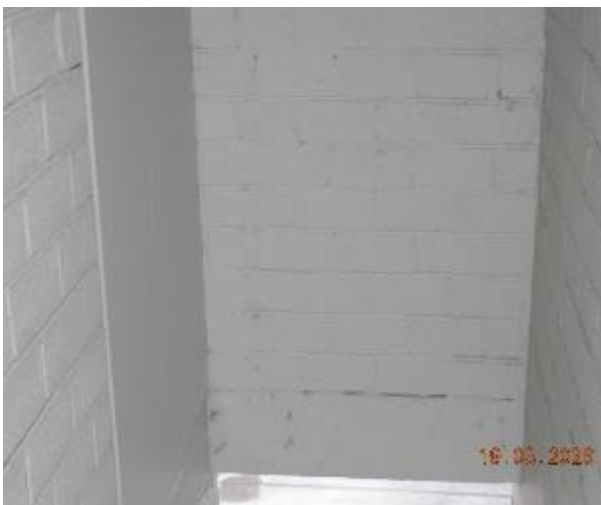
Figure 207 - General condition of B2 to Level 1 fire stairs internal wall

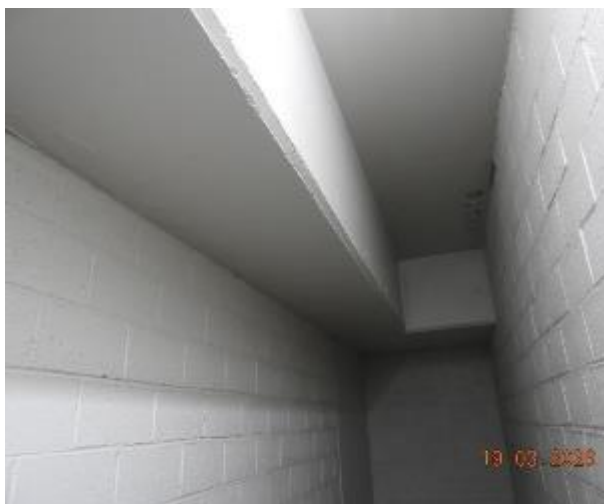
Figure 211 - General condition of B2 to Level 1 fire stairs underside slab

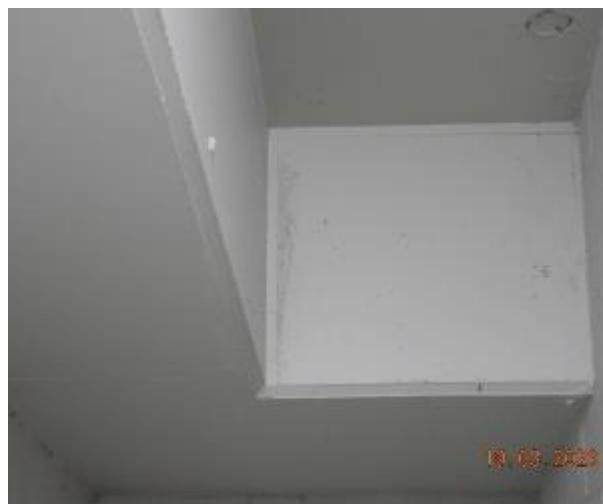
Figure 212 - General condition of B2 to Level 1 fire stairs underside slab

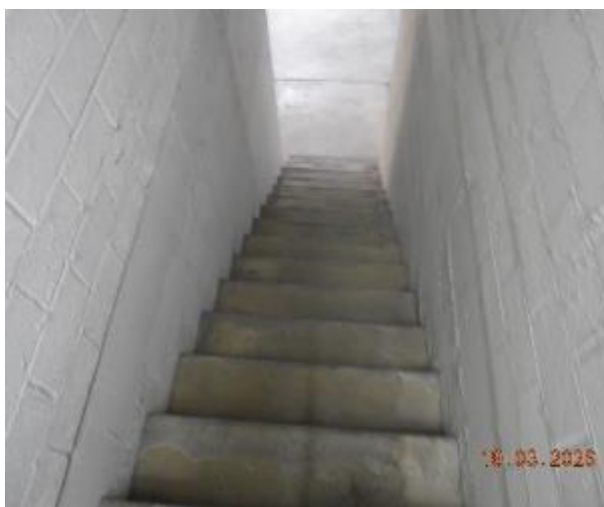
Figure 213 - General condition of B2 to Level 1 fire stairs
