# **Pre-Dilapidation Report**

**19 GEORGE STREET**

**REAR BUILDING (UNITS 20-29)**

Project Reference: 20250047.19G.3

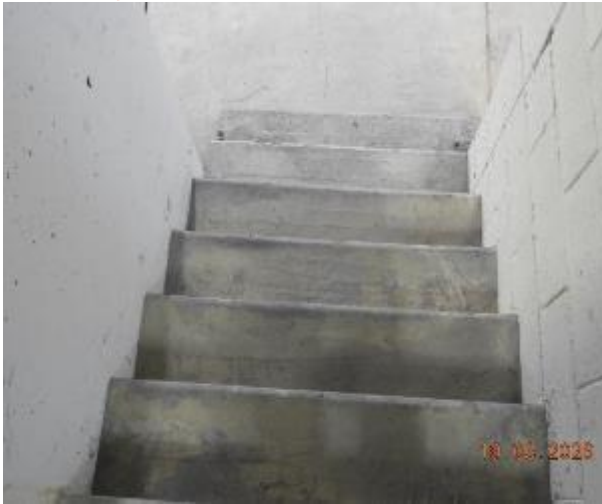
Figure 215 - General condition of B2 to Level 1 fire stairs

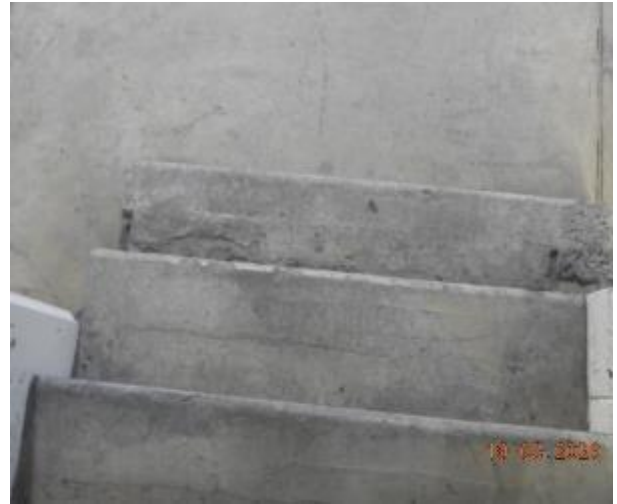
Figure 216 - General condition of B2 to Level 1 fire stairs

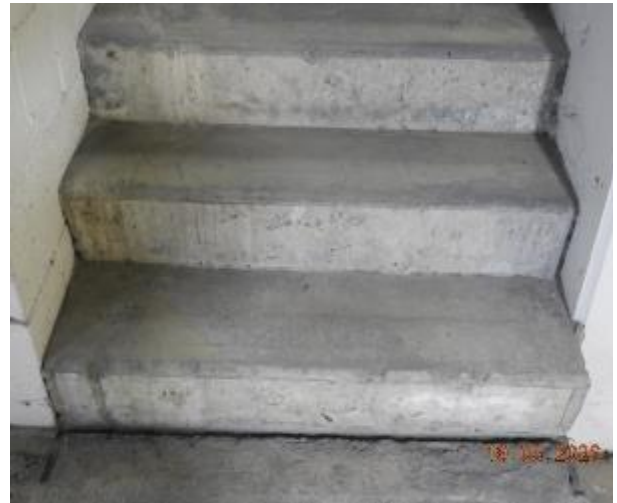
Figure 218 - General condition of B2 to Level 1 fire stairs

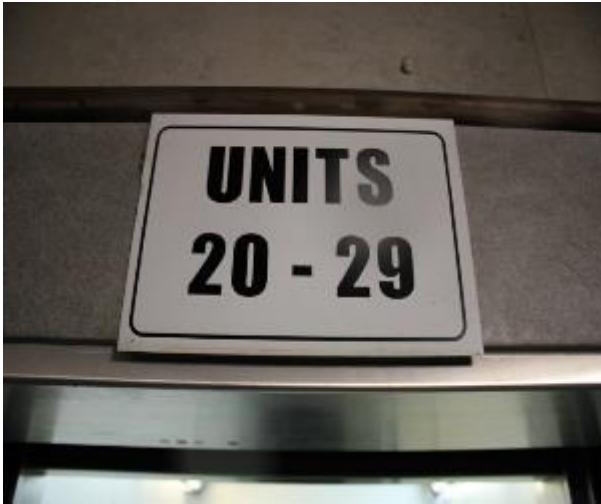
Figure 220 - The following images display the condition of the fire stairs from Level 5 to Basement B2

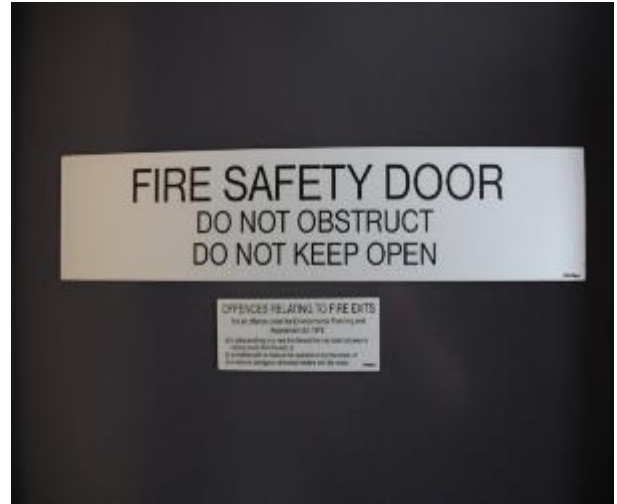
Figure 221 - General condition of level 5 to basement B2 fire stairs

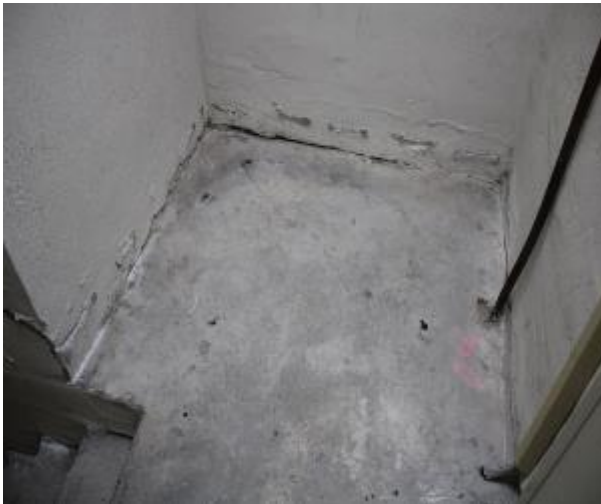
Figure 222 - General condition of level 5 to basement B2 fire stairs

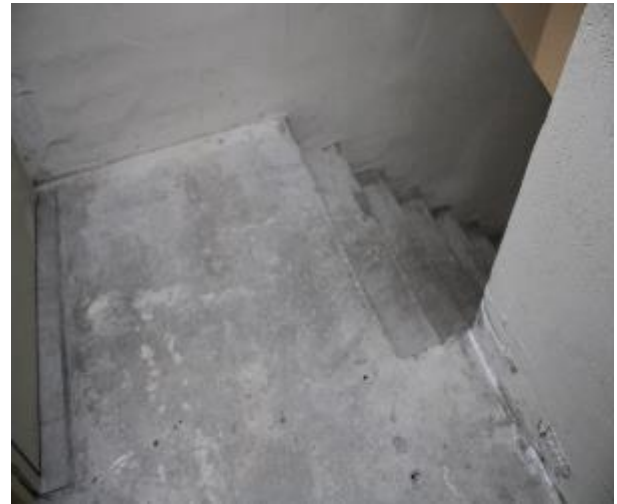
Figure 223 - General condition of level 5 to basement B2 fire stairs

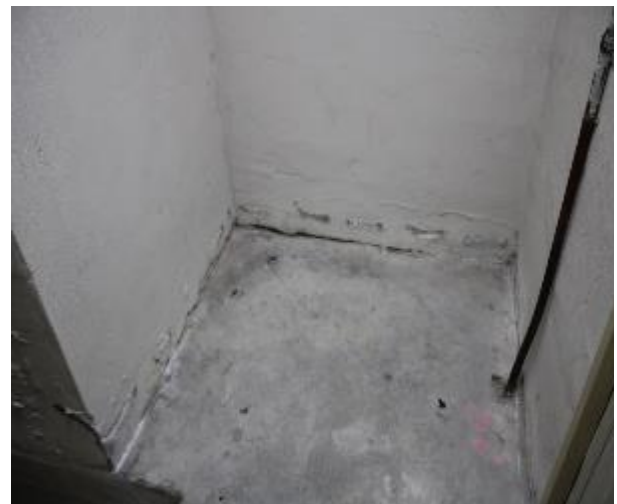
Figure 225 - General condition of level 5 to basement B2 fire stairs internal wall

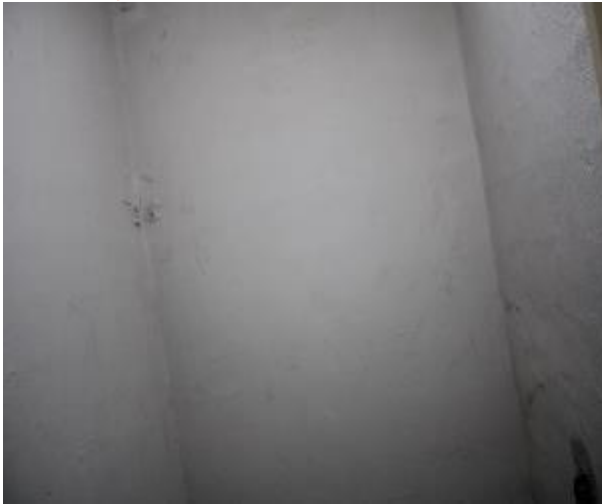
Figure 226 - General condition of level 5 to basement B2 fire stairs internal wall

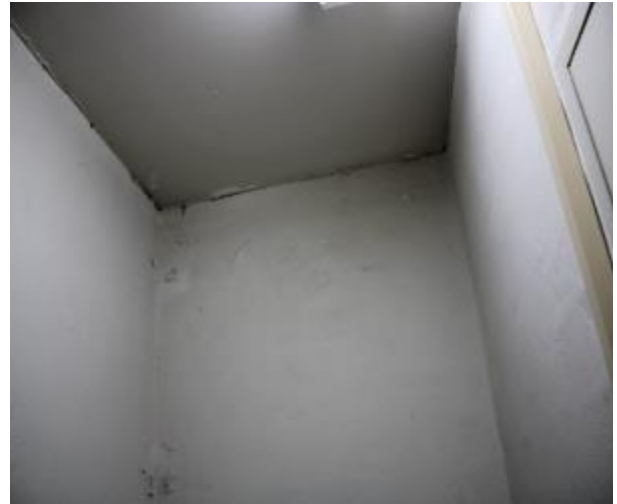
Figure 227 - Paint flaking through level 5 to basement B2 fire stairs internal wall

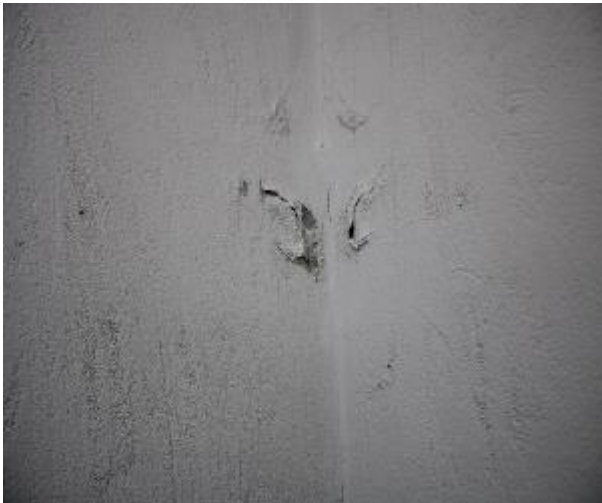
Figure 228 - Paint flaking through level 5 to basement B2 fire stairs internal wall

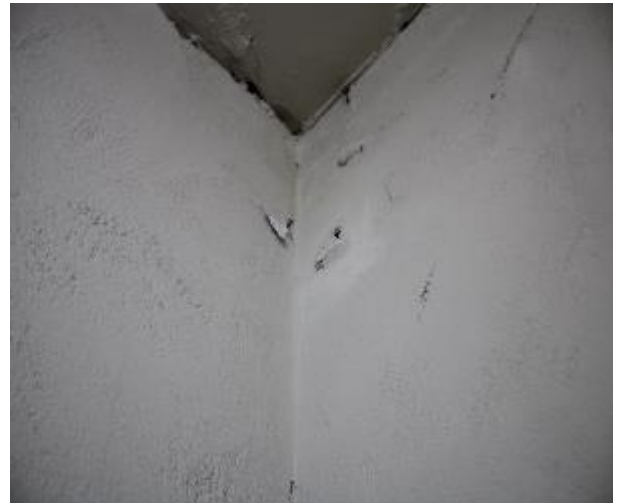
Figure 229 - General condition of level 5 to basement B2 fire stairs internal wall

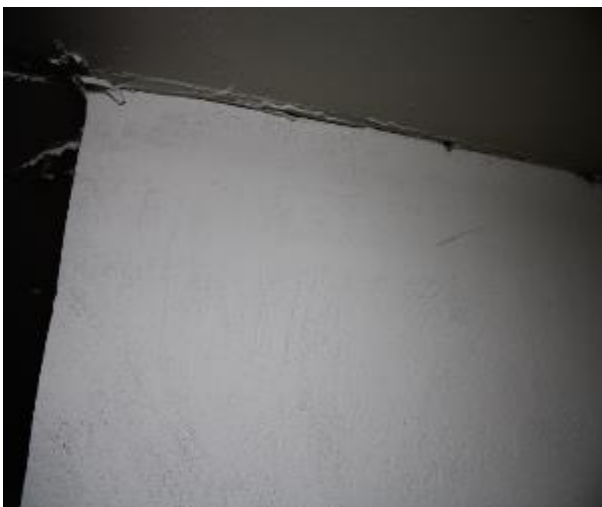
Figure 230 - Crack propagation through level 5 to basement B2 fire stairs internal wall

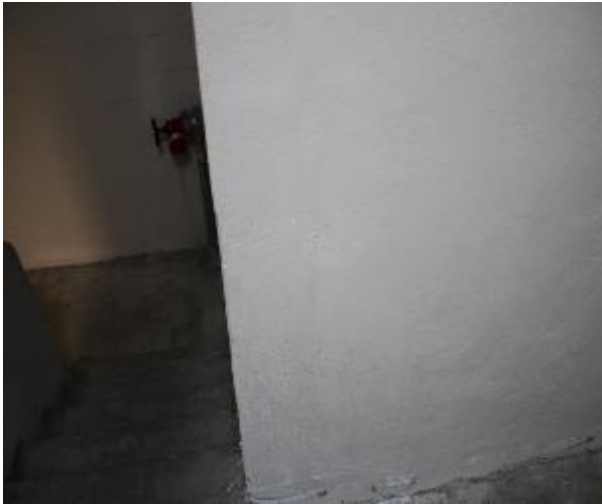
Figure 232 - General condition of level 5 to basement B2 fire stairs internal wall

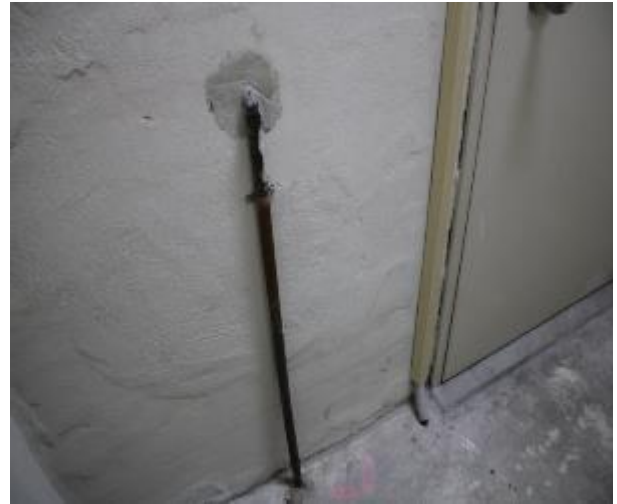
Figure 233 - General condition of level 5 to basement B2 fire stairs internal wall

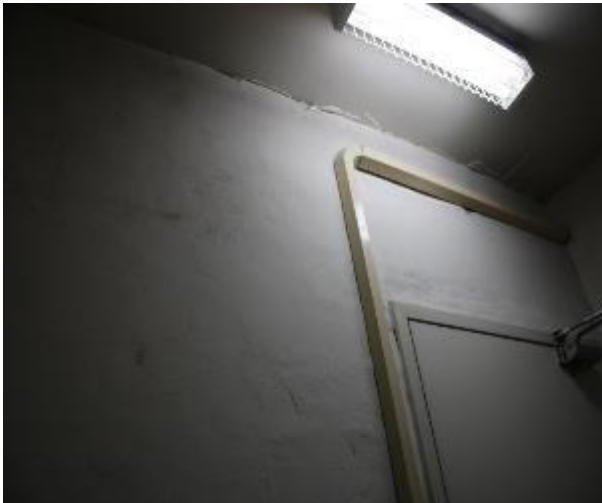
Figure 234 - Crack propagation through level 5 to basement B2 fire stairs internal wall

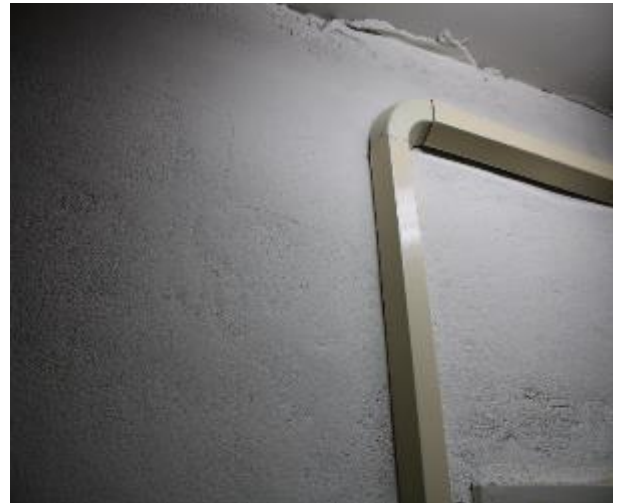
Figure 235 - General condition of level 5 to basement B2 fire stairs internal wall

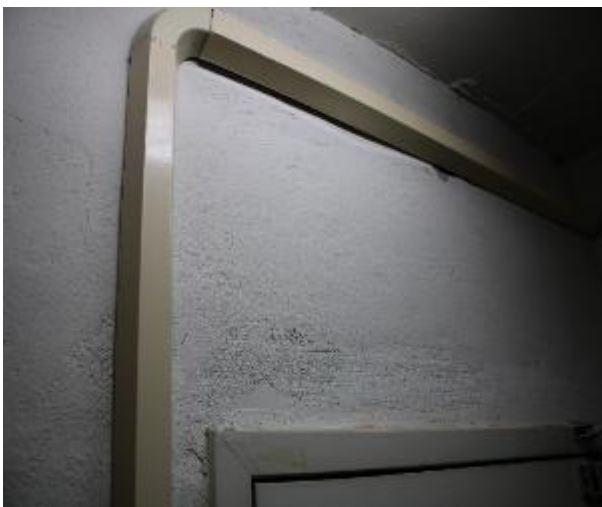
Figure 236 - General condition of level 5 to basement B2 fire stairs internal wall

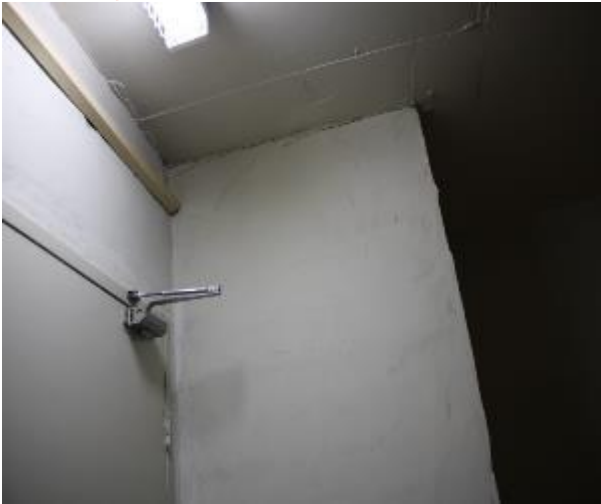
Figure 238 - Crack propagation through level 5 to basement B2 fire stairs internal wall

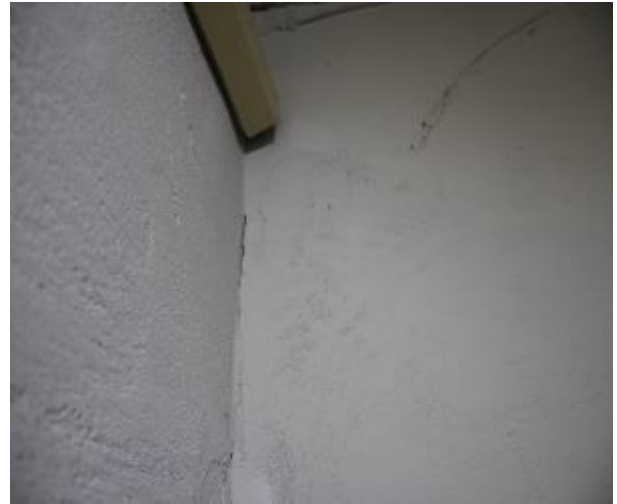
Figure 239 - Crack propagation through level 5 to basement B2 fire stairs internal wall

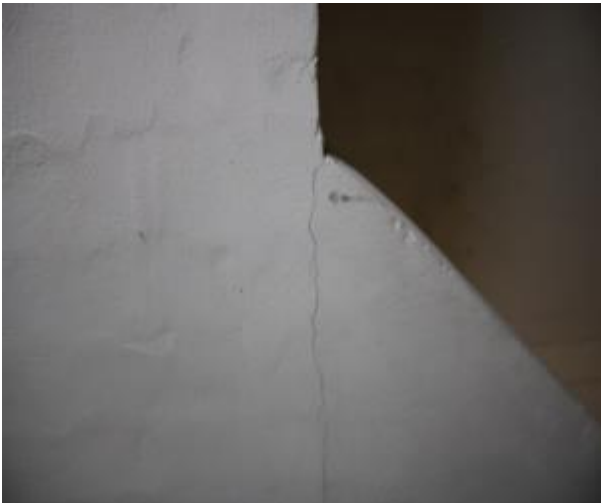
Figure 240 - Crack propagation through level 5 to basement B2 fire stairs internal wall

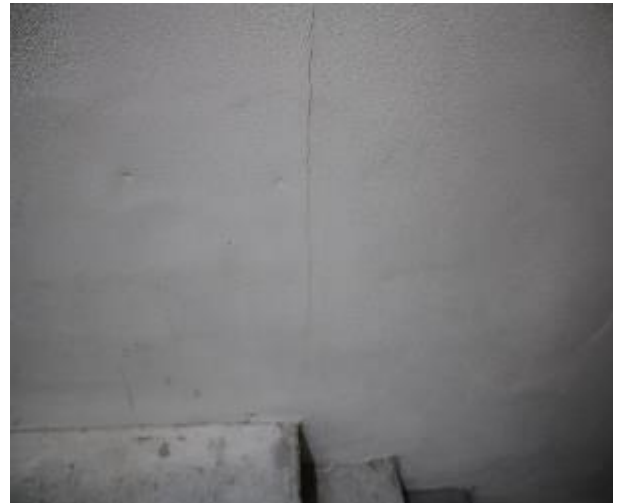
Figure 241 - General condition of level 5 to basement B2 fire stairs internal wall

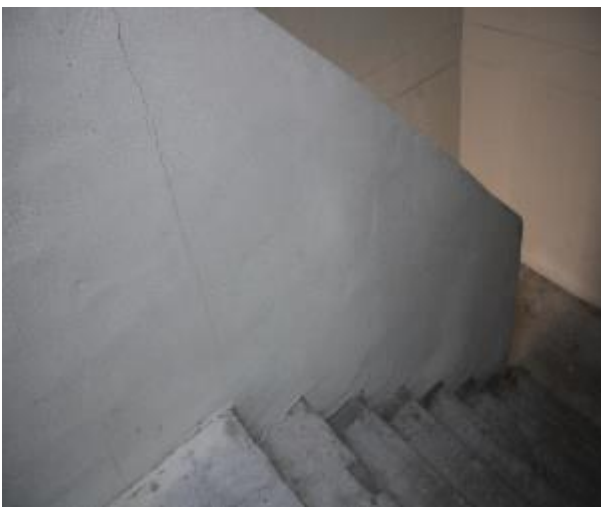
Figure 242 - General condition of level 5 to basement B2 fire stairs internal wall

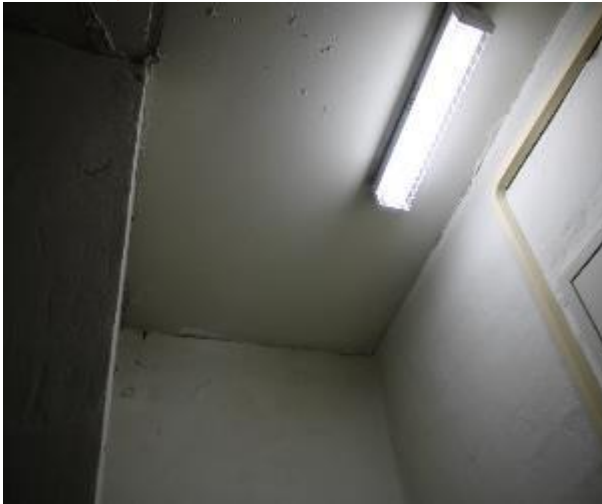
Figure 244 - General condition of level 5 to basement B2 fire stairs underside slab

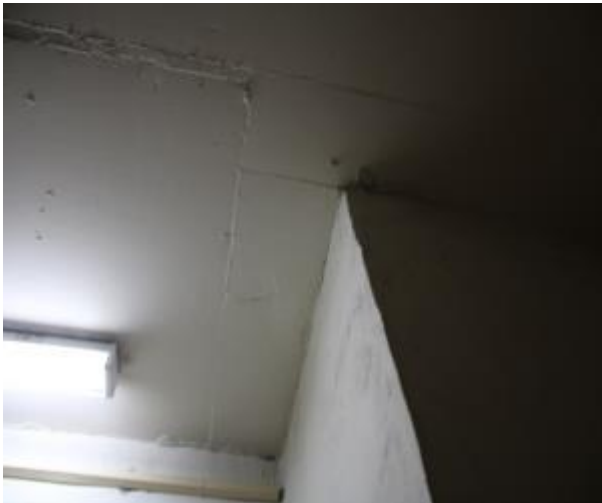
Figure 245 - General condition of level 5 to basement B2 fire stairs underside slab

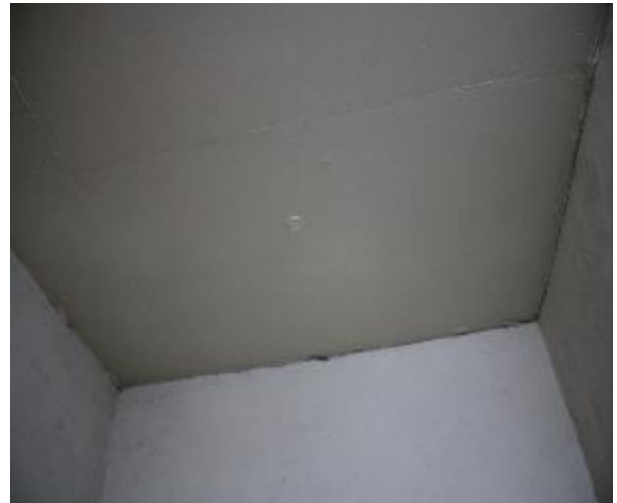
Figure 246 - General condition of level 5 to basement B2 fire stairs underside slab

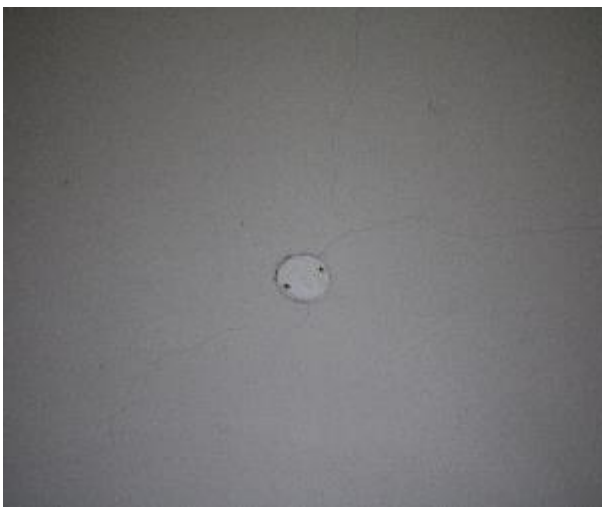
Figure 247 - Crack propagation through level 5 to basement B2 fire stairs underside slab

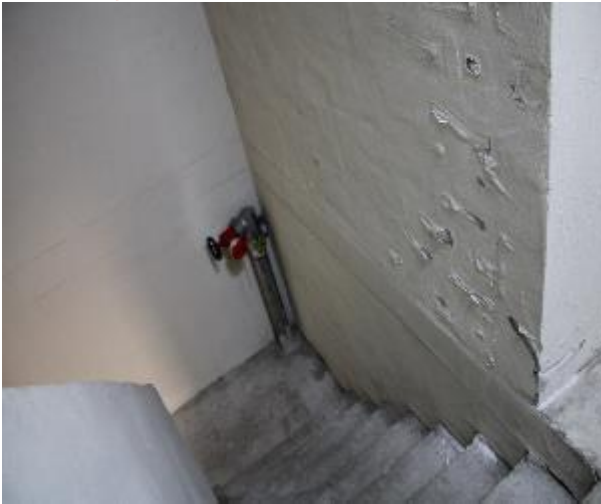
Figure 249 - General condition of level 5 to basement B2 fire stairs internal wall

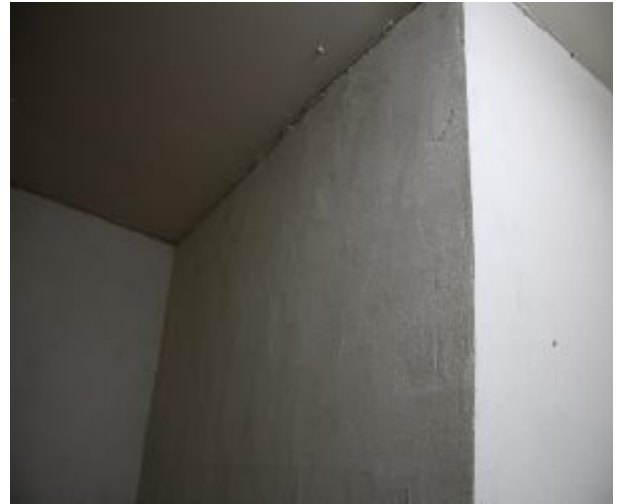
Figure 250 - General condition of level 5 to basement B2 fire stairs internal wall

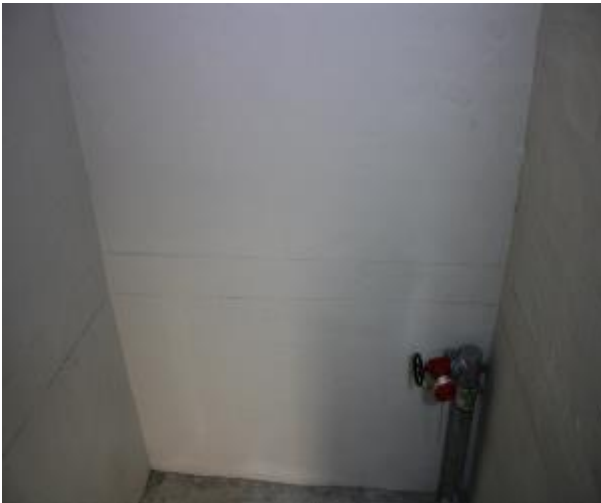
Figure 251 - General condition of level 5 to basement B2 fire stairs internal wall

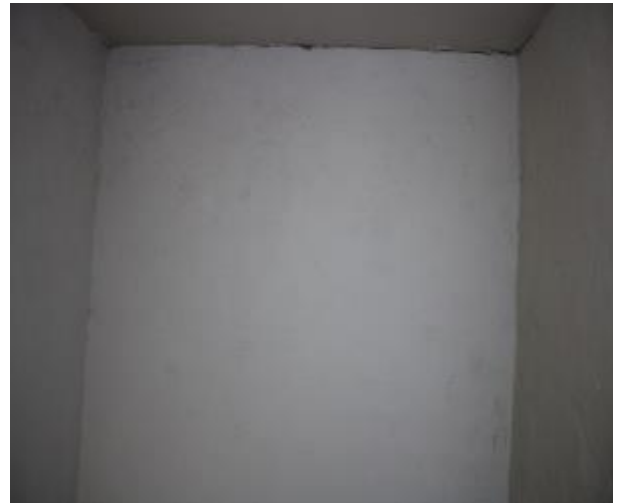
Figure 252 - General condition of level 5 to basement B2 fire stairs internal wall

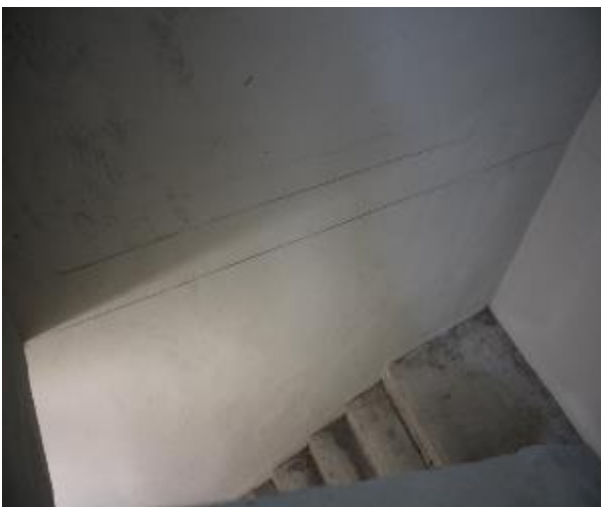
Figure 253 - General condition of level 5 to basement B2 fire stairs internal wall

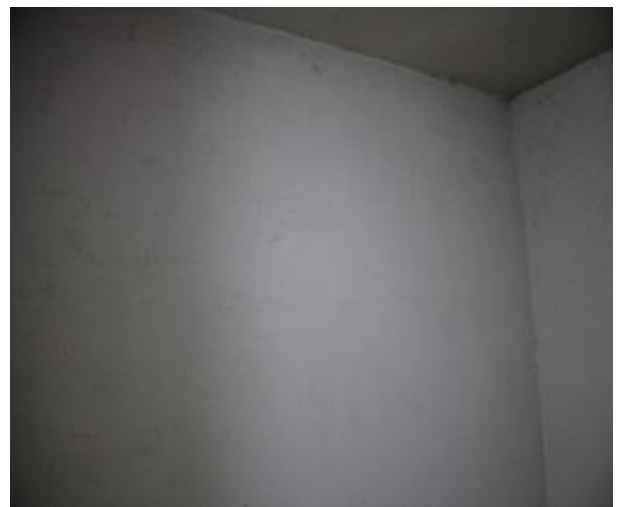
Figure 254 - General condition of level 5 to basement B2 fire stairs internal wall

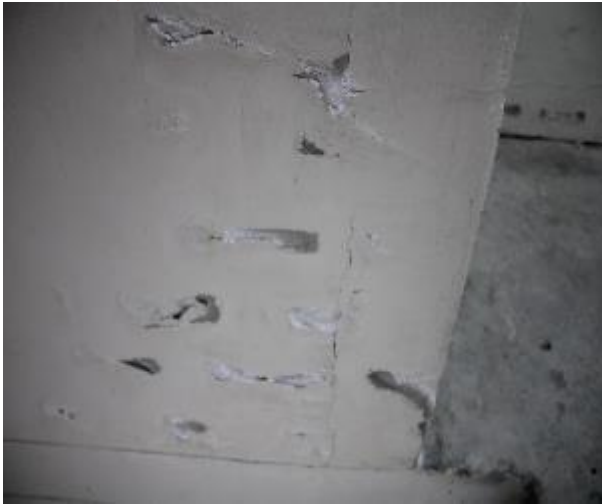
Figure 255 - Crack propagation and paint flaking through level 5 to basement B2 fire stairs internal wall

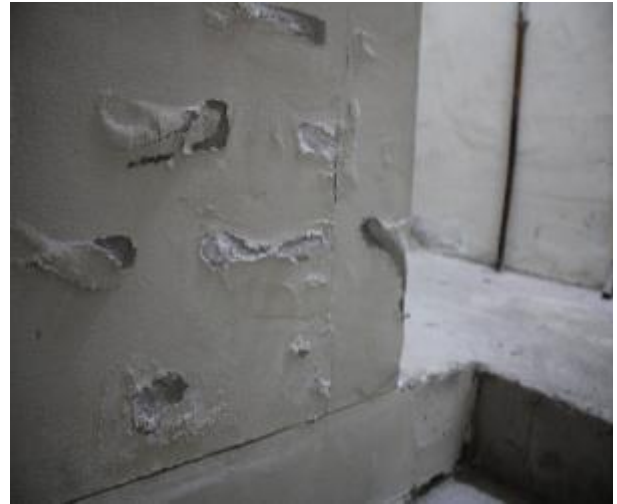
Figure 256 - Crack propagation and paint flaking through level 5 to basement B2 fire stairs internal wall

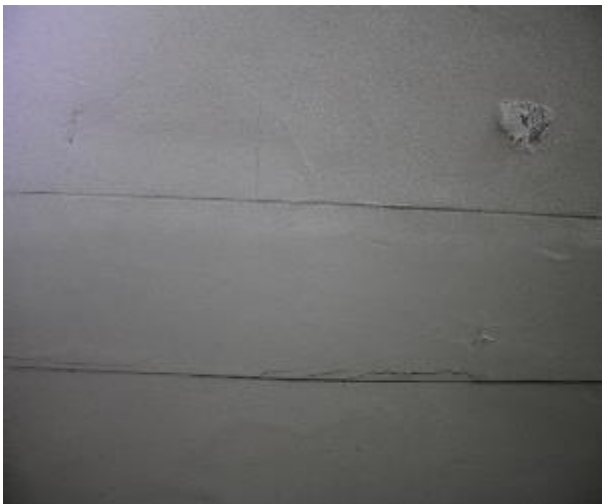
Figure 257 - Crack propagation through level 5 to basement B2 fire stairs internal wall

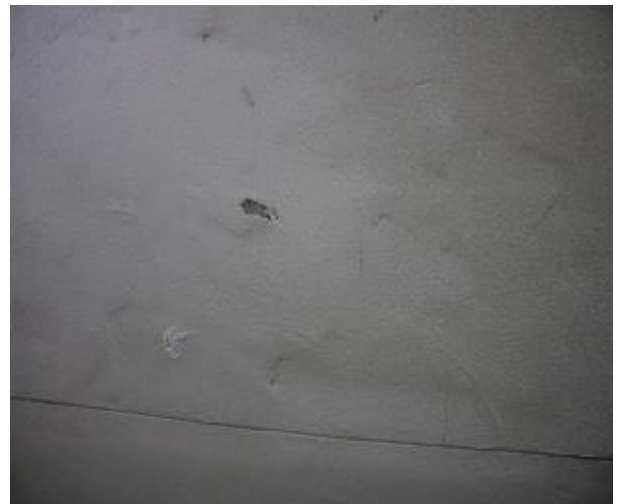
Figure 258 - Crack propagation through level 5 to basement B2 fire stairs internal wall

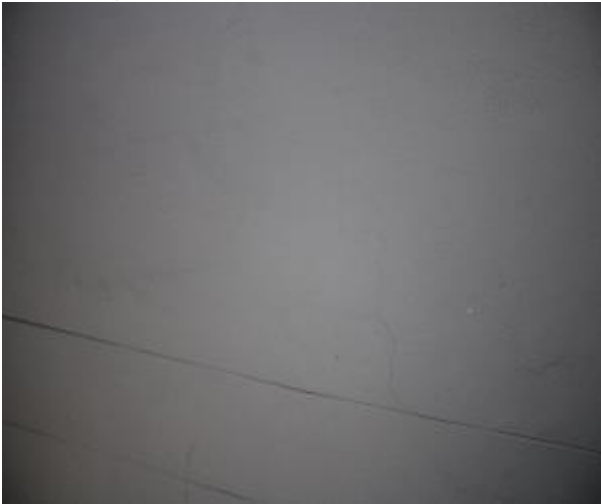
Figure 261 - Crack propagation through level 5 to basement B2 fire stairs internal wall

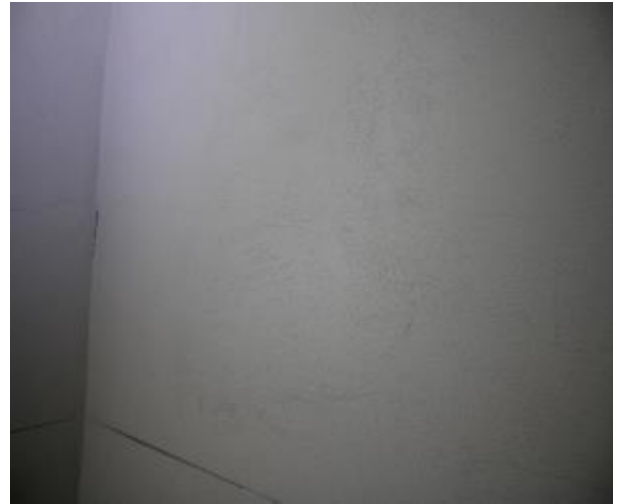
Figure 262 - General condition of level 5 to basement B2 fire stairs internal wall

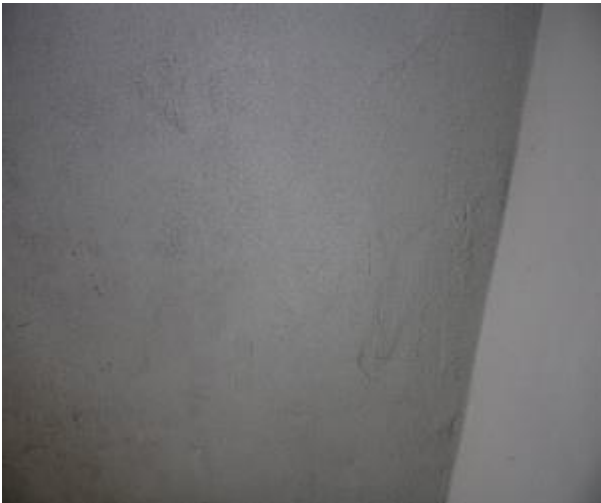
Figure 263 - General condition of level 5 to basement B2 fire stairs internal wall

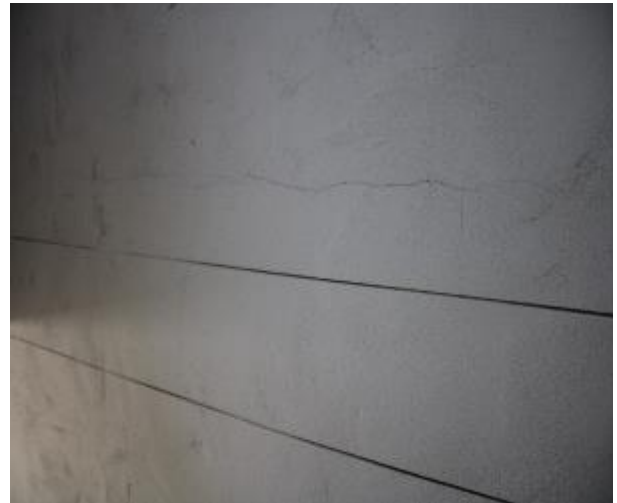
Figure 264 - Crack propagation through level 5 to basement B2 fire stairs internal wall

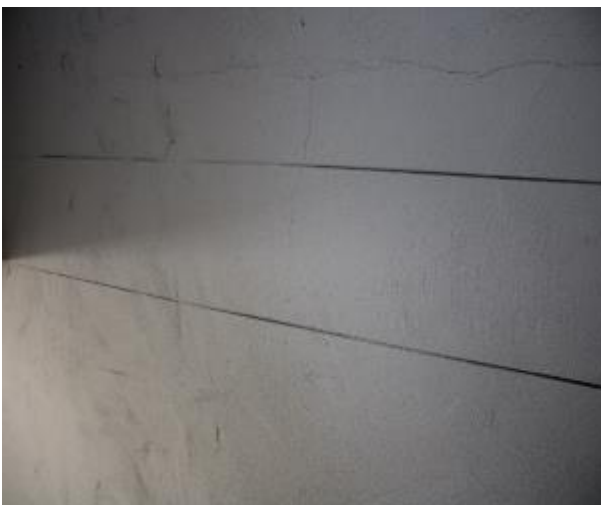
Figure 265 - Crack propagation through level 5 to basement B2 fire stairs internal wall

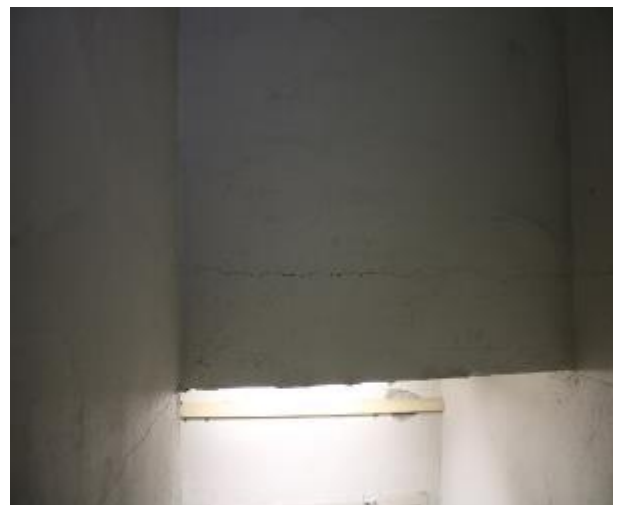
Figure 266 - Crack propagation through level 5 to basement B2 fire stairs internal wall

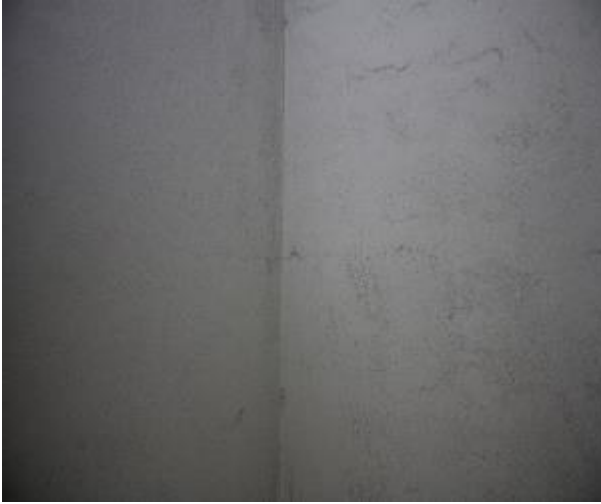
Figure 267 - Crack propagation through level 5 to basement B2 fire stairs internal wall

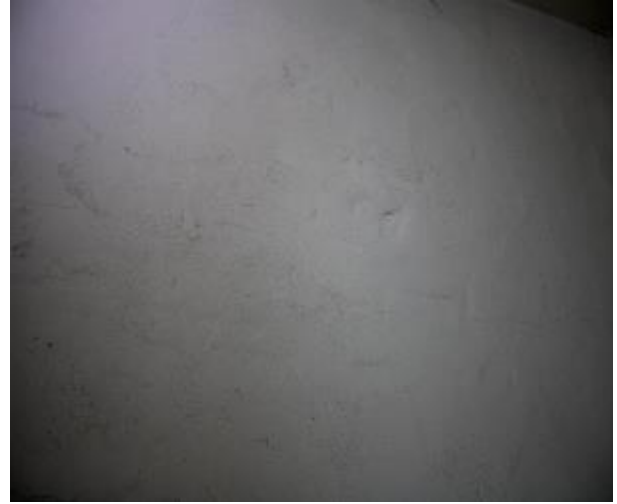
Figure 268 - Crack propagation through level 5 to basement B2 fire stairs internal wall

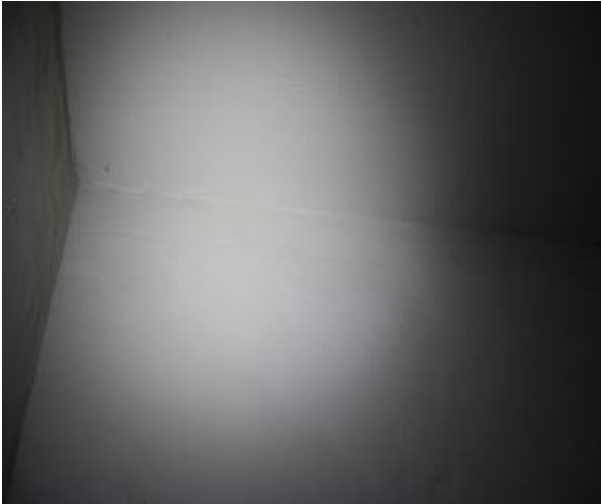
Figure 269 - General condition of level 5 to basement B2 fire stairs internal wall

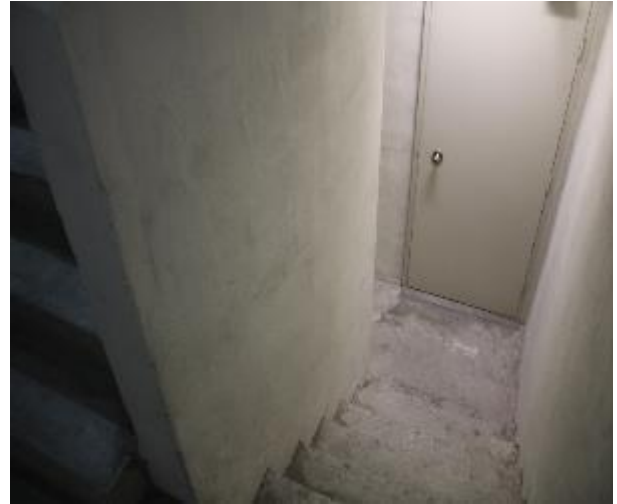
Figure 270 - General condition of level 5 to basement B2 fire stairs internal wall

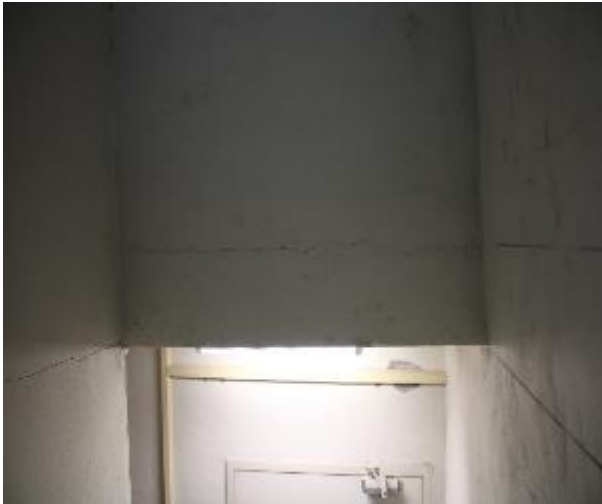
Figure 273 - Crack propagation through level 5 to basement B2 fire stairs internal wall

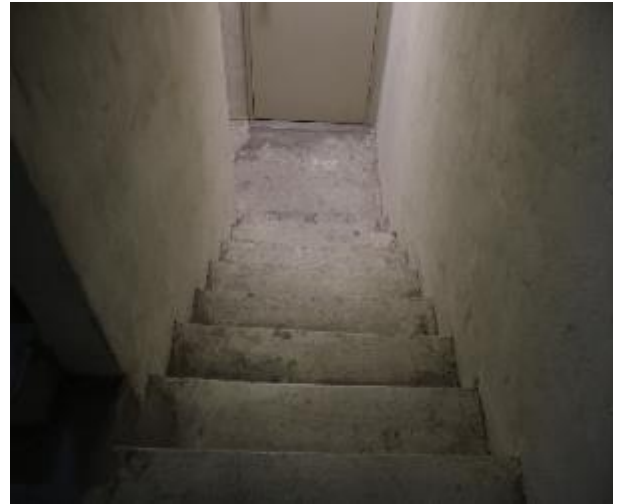
Figure 274 - General condition of level 5 to basement B2 fire stairs

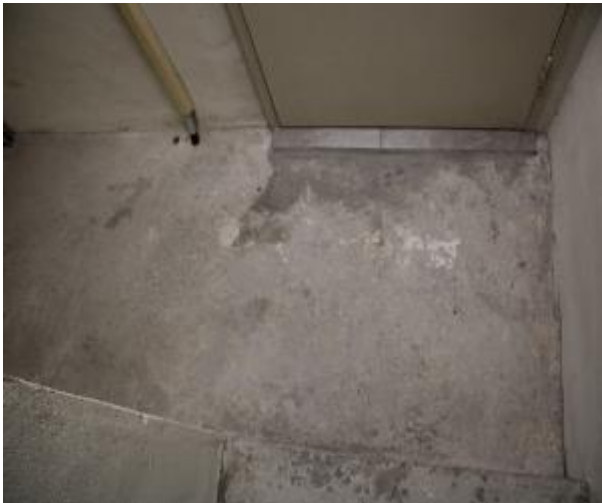
Figure 275 - General condition of level 5 to basement B2 fire stairs

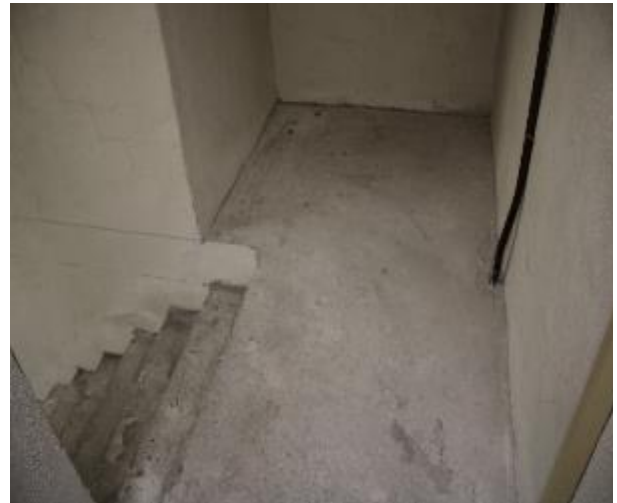
Figure 276 - General condition of level 5 to basement B2 fire stairs

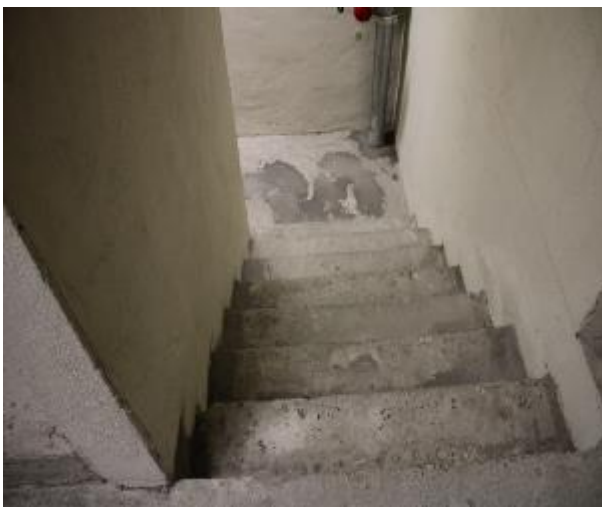
Figure 277 - General condition of level 5 to basement B2 fire stairs

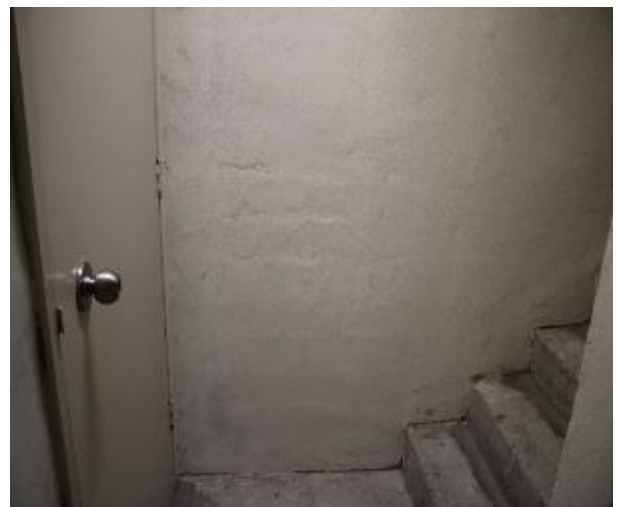
Figure 278 - General condition of level 5 to basement B2 fire stairs internal wall

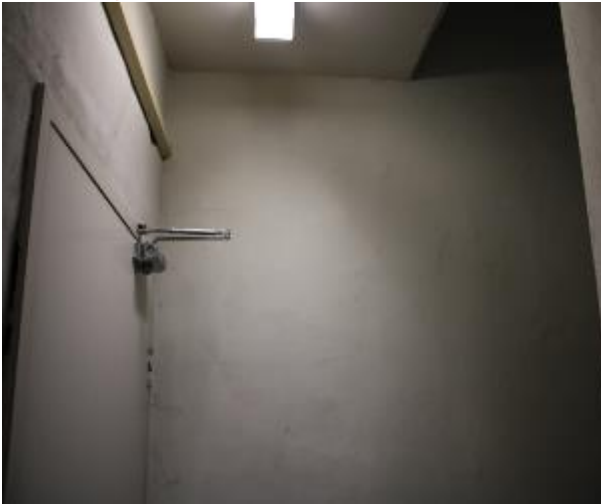
Figure 279 - General condition of level 5 to basement B2 fire stairs internal wall

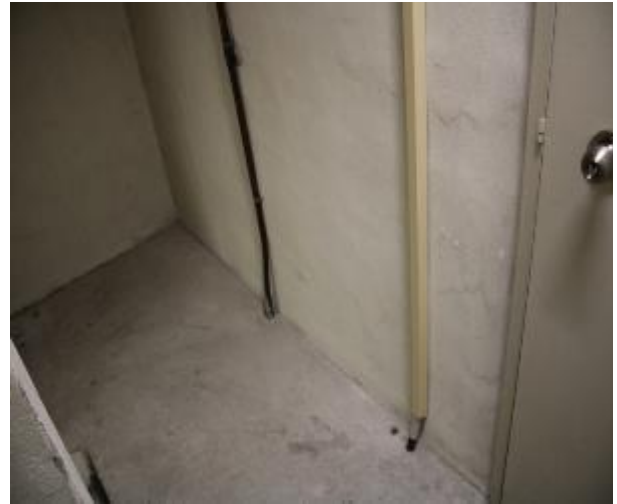
Figure 280 - General condition of level 5 to basement B2 fire stairs internal wall

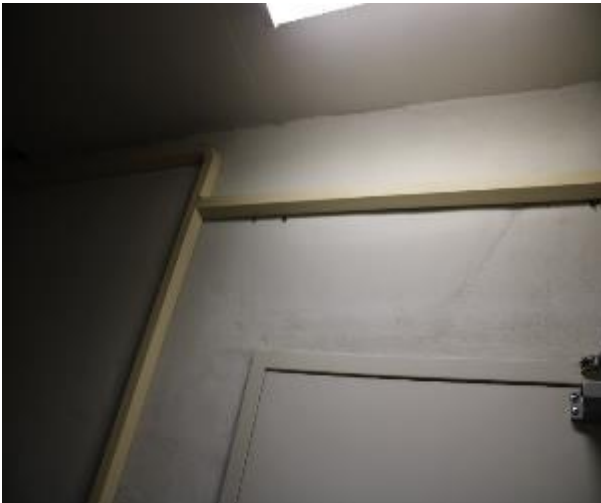
Figure 281 - General condition of level 5 to basement B2 fire stairs internal wall

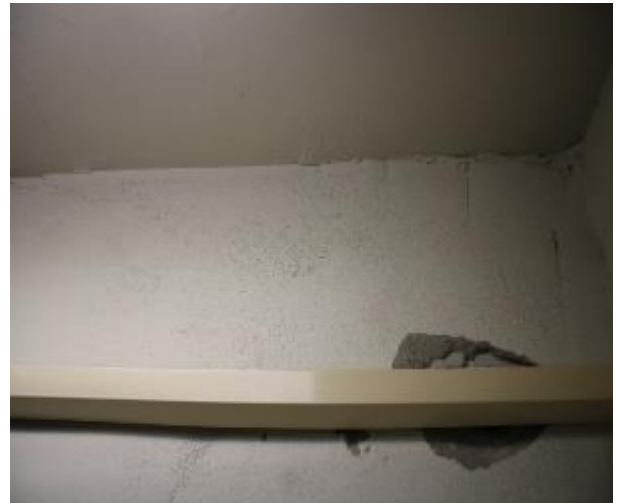
Figure 282 - General condition of level 5 to basement B2 fire stairs internal wall

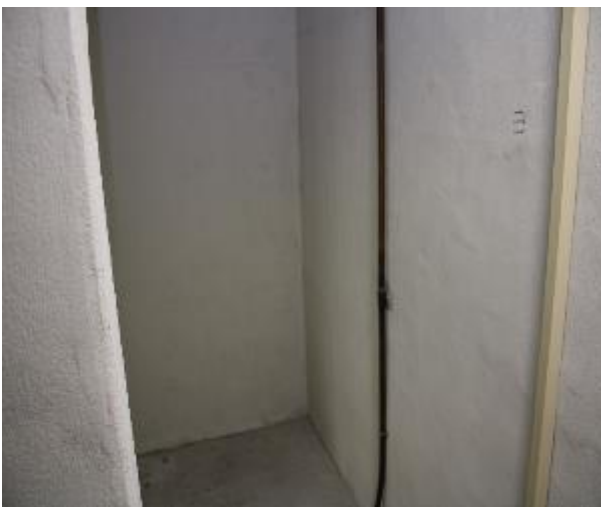
Figure 283 - General condition of level 5 to basement B2 fire stairs internal wall

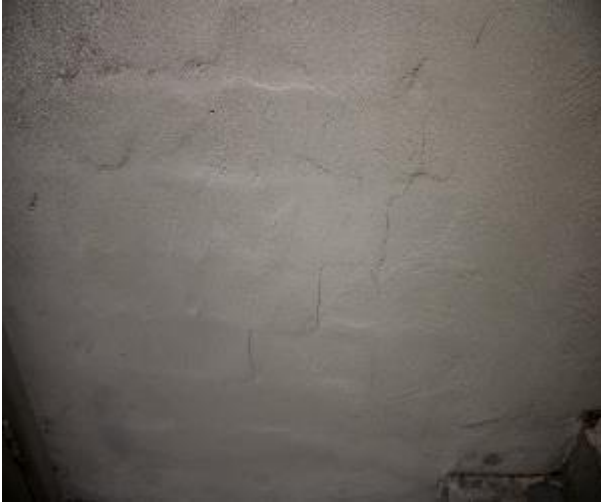
Figure 285 - Crack propagation through level 5 to basement B2 fire stairs internal wall

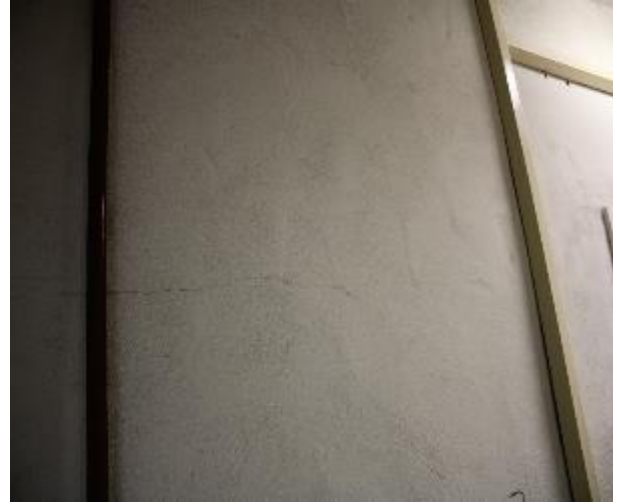
Figure 286 - Crack propagation through level 5 to basement B2 fire stairs internal wall

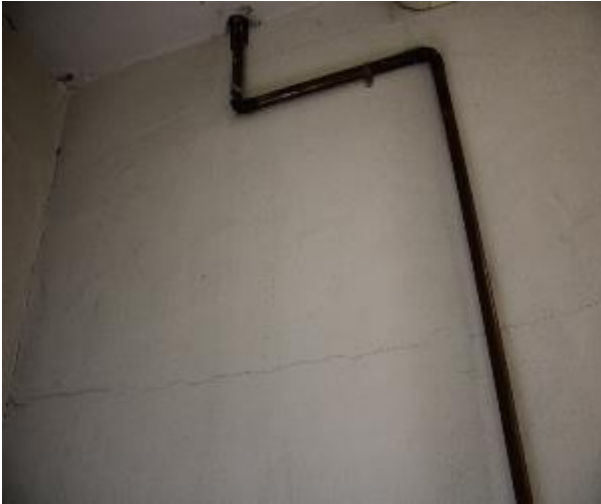
Figure 287 - General condition of level 5 to basement B2 fire stairs internal wall

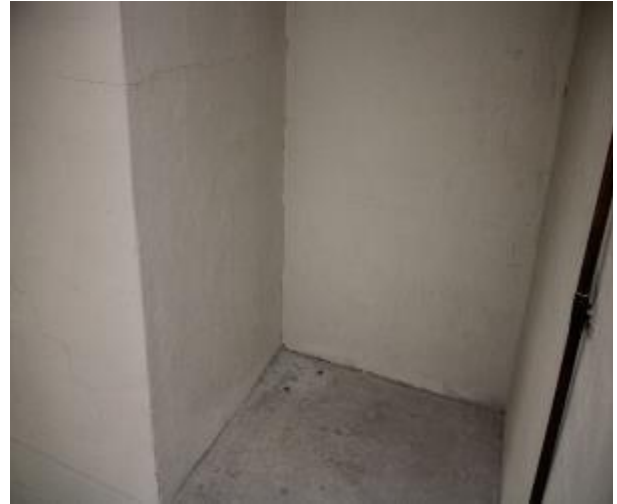
Figure 288 - General condition of level 5 to basement B2 fire stairs internal wall

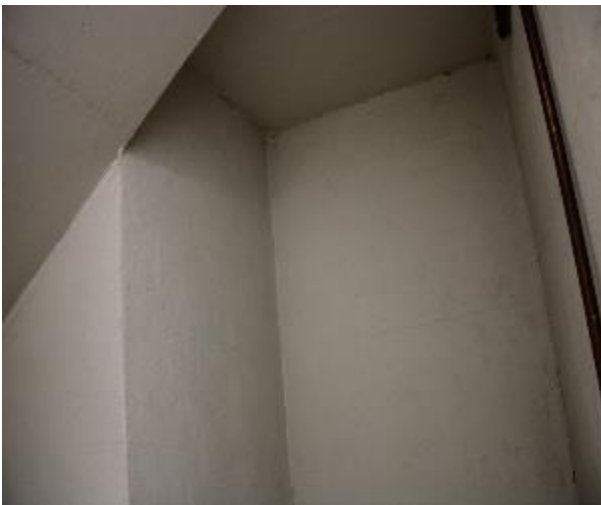
Figure 289 - General condition of level 5 to basement B2 fire stairs internal wall

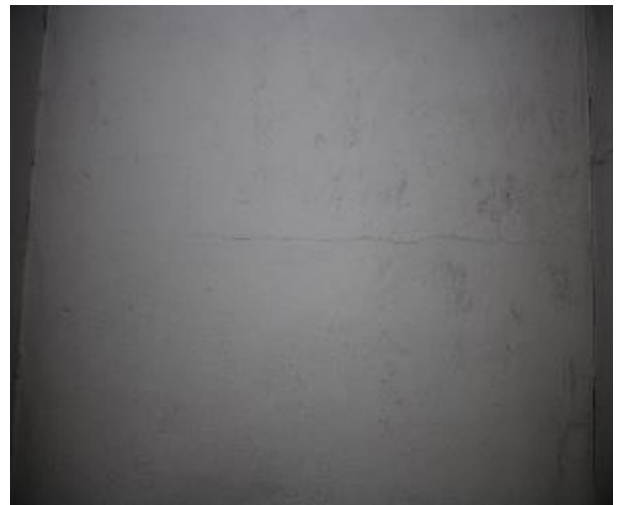
Figure 290 - Crack propagation through level 5 to basement B2 fire stairs internal wall

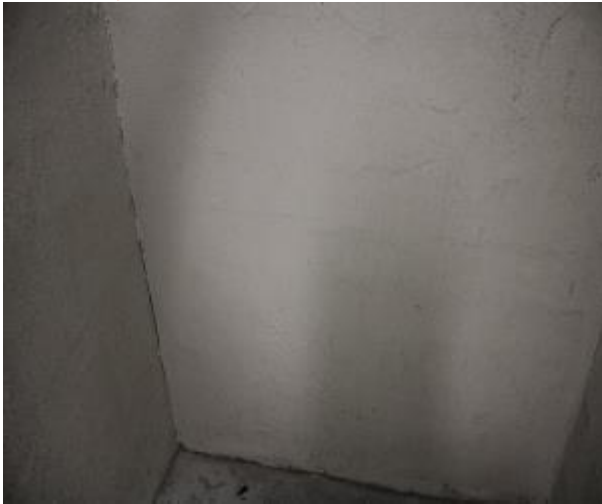
Figure 291 - General condition of level 5 to basement B2 fire stairs internal wall

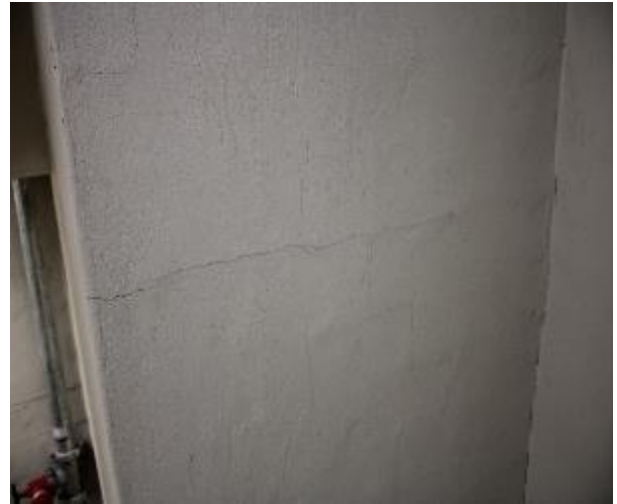
Figure 292 - Crack propagation through level 5 to basement B2 fire stairs internal wall

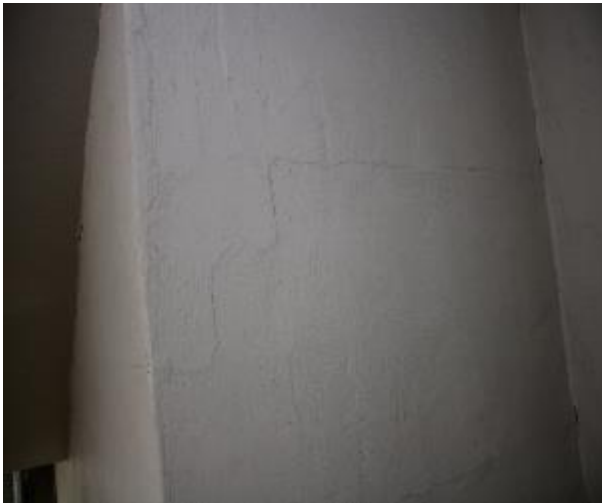
Figure 293 - Crack propagation through level 5 to basement B2 fire stairs internal wall

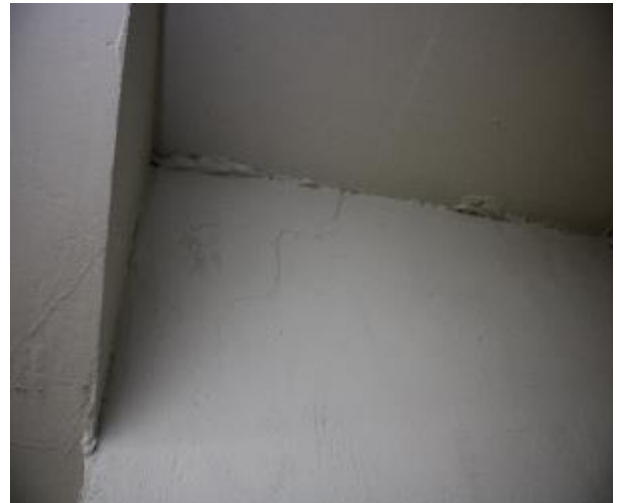
Figure 294 - Crack propagation through level 5 to basement B2 fire stairs internal wall

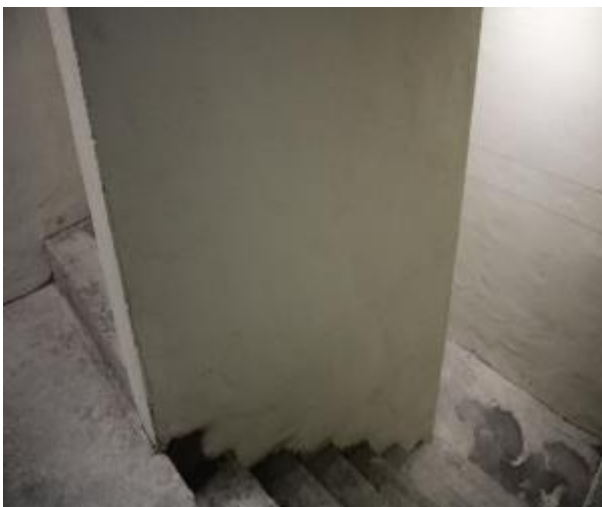
Figure 295 - General condition of level 5 to basement B2 fire stairs internal wall

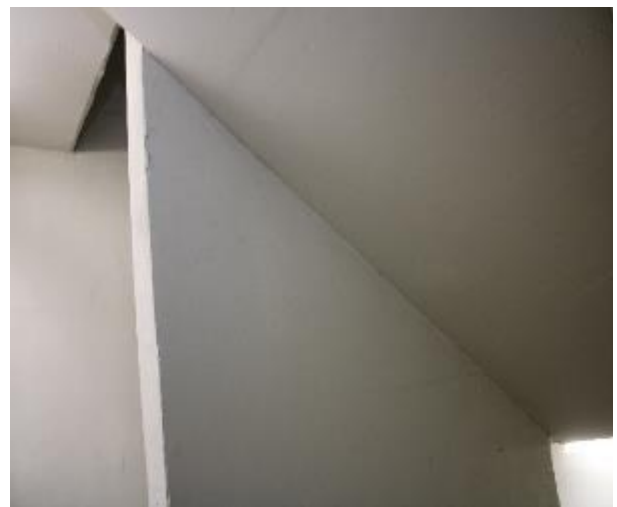
Figure 296 - General condition of level 5 to basement B2 fire stairs internal wall
