# **Pre-Dilapidation Report**

**19 GEORGE STREET**

**REAR BUILDING (UNITS 20-29)**

Project Reference: 20250047.19G.3

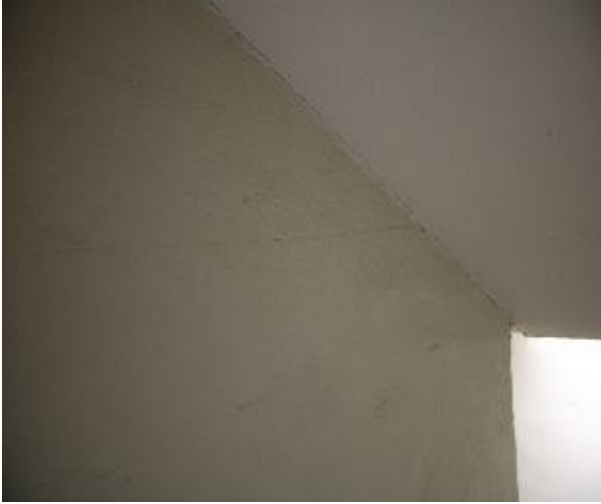
Figure 297 - Crack propagation through level 5 to basement B2 fire stairs internal wall

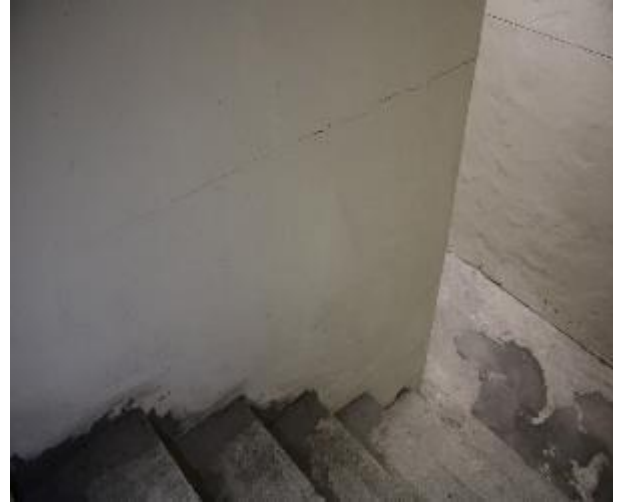
Figure 298 - Crack propagation through level 5 to basement B2 fire stairs internal wall

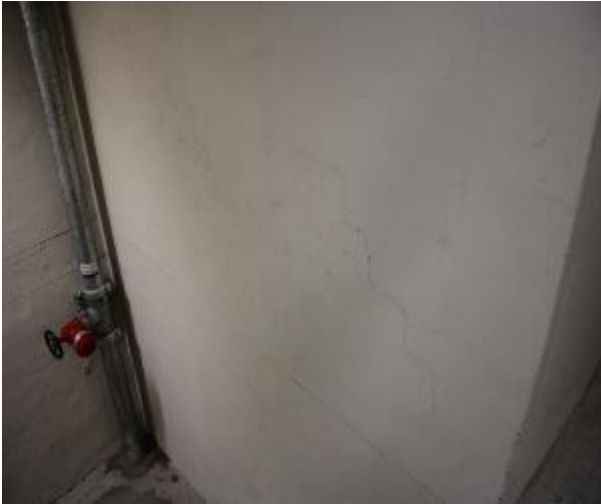
Figure 299 - Crack propagation through level 5 to basement B2 fire stairs internal wall

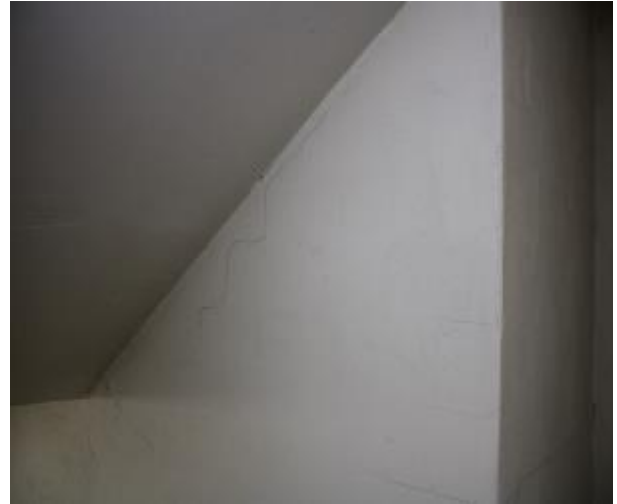
Figure 300 - General condition of level 5 to basement B2 fire stairs internal wall

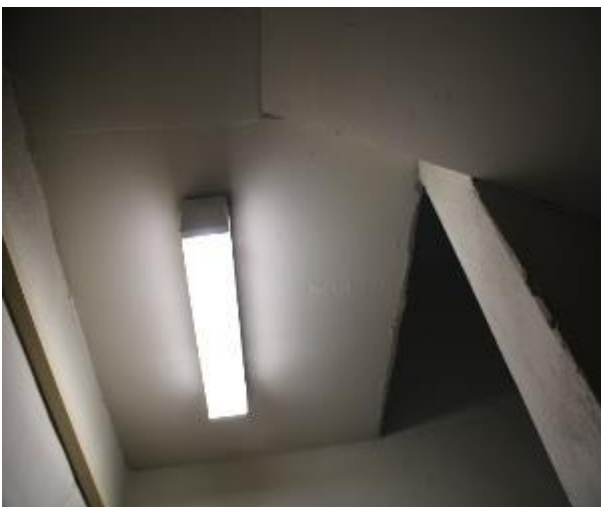
Figure 301 - General condition of level 5 to basement B2 fire stairs underside stairs

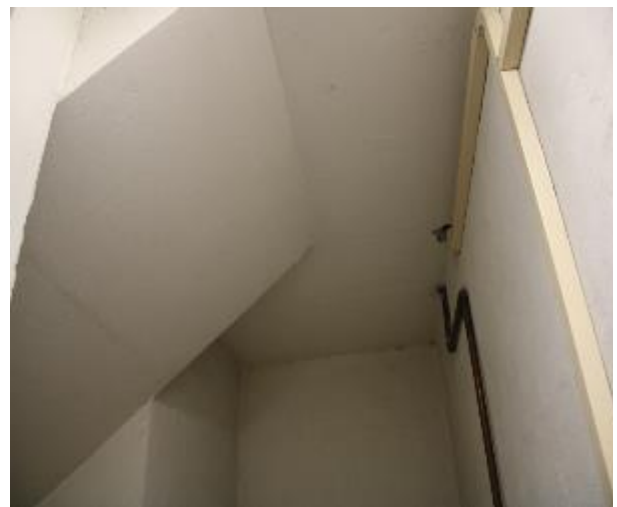
Figure 302 - General condition of level 5 to basement B2 fire stairs underside stairs

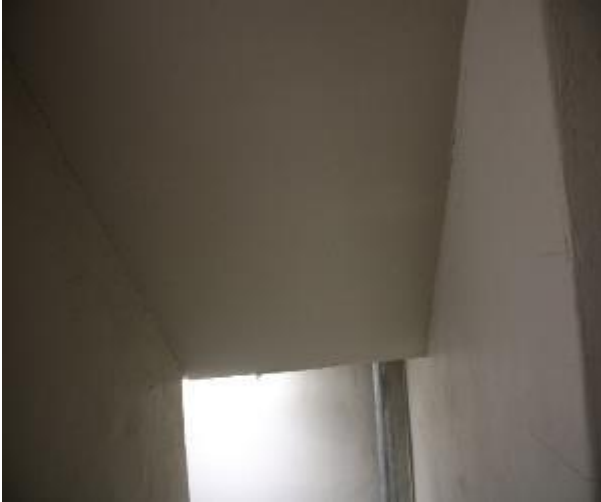
Figure 303 - General condition of level 5 to basement B2 fire stairs underside stairs

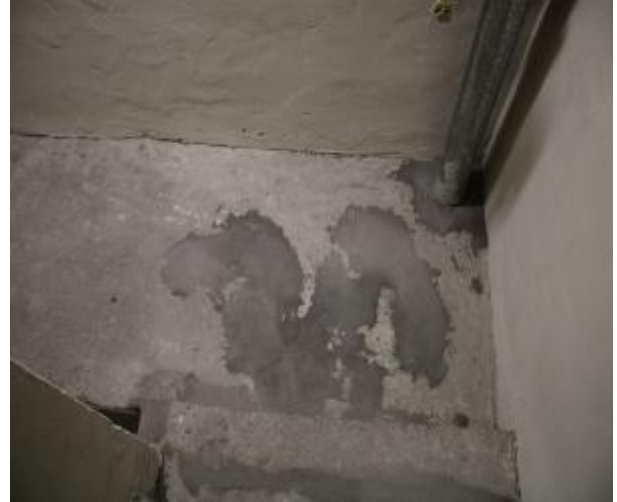
Figure 304 - General condition of level 5 to basement B2 fire stairs concrete floor

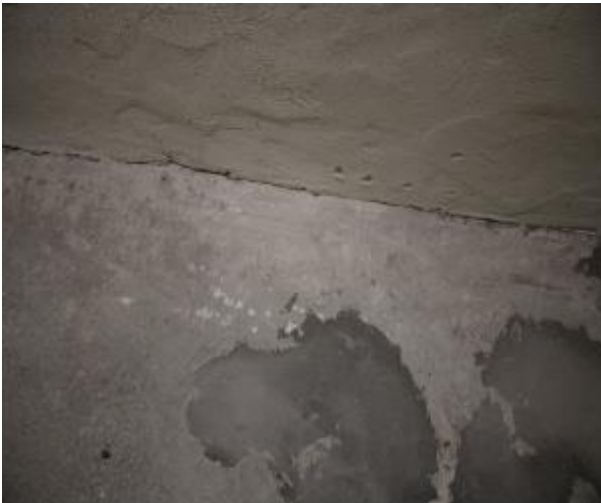
Figure 305 - Crack propagation through level 5 to basement B2 fire stairs concrete floor

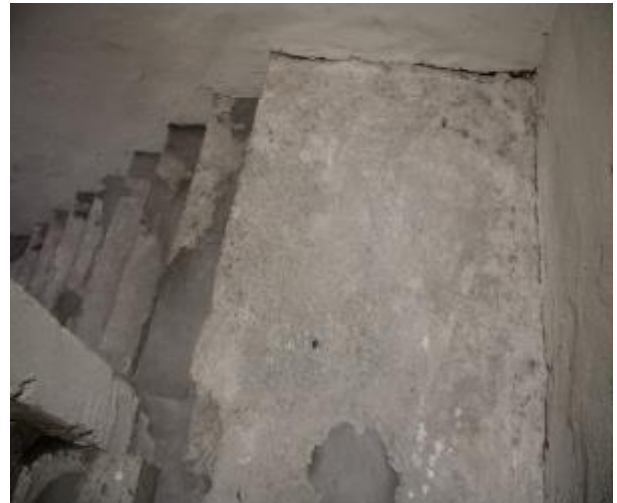
Figure 306 - General condition of level 5 to basement B2 fire stairs concrete floor

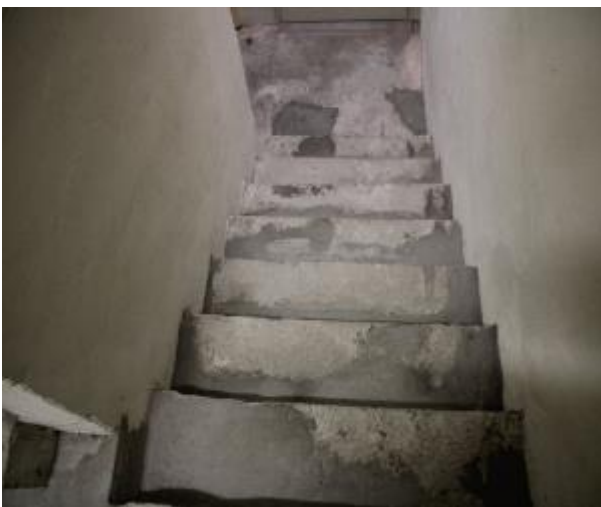
Figure 307 - General condition of level 5 to basement B2 fire stairs concrete floor

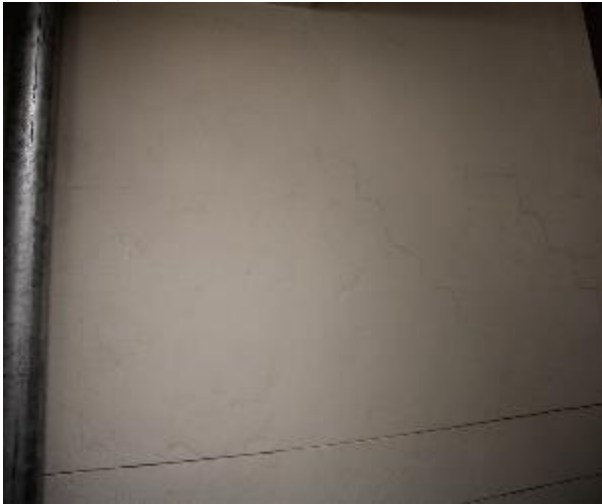
Figure 309 - General condition of level 5 to basement B2 fire stairs internal wall

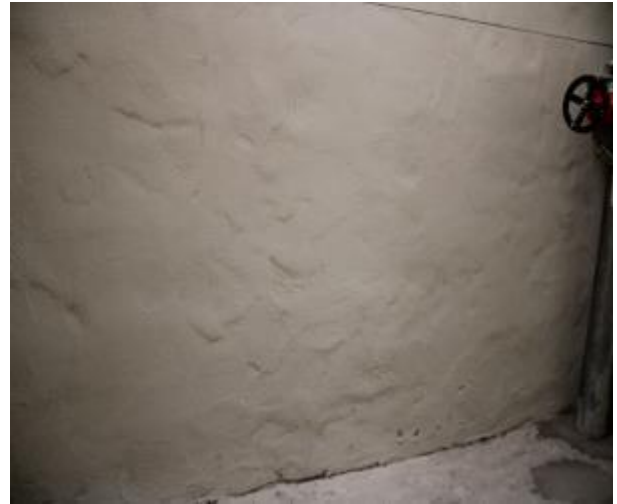
Figure 310 - General condition of level 5 to basement B2 fire stairs internal wall

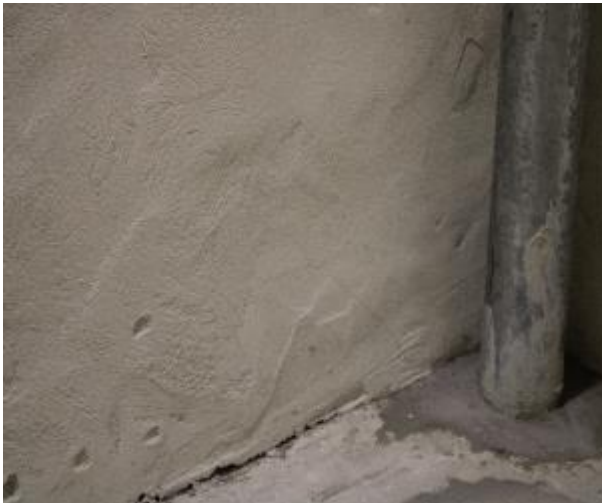
Figure 311 - Crack propagation through level 5 to basement B2 fire stairs internal wall

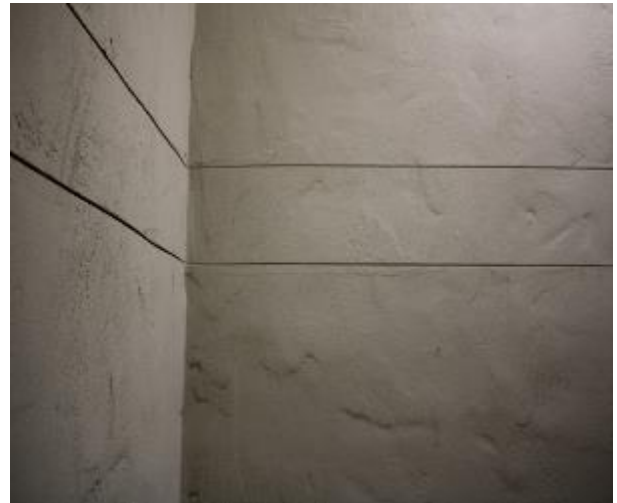
Figure 312 - General condition of level 5 to basement B2 fire stairs internal wall

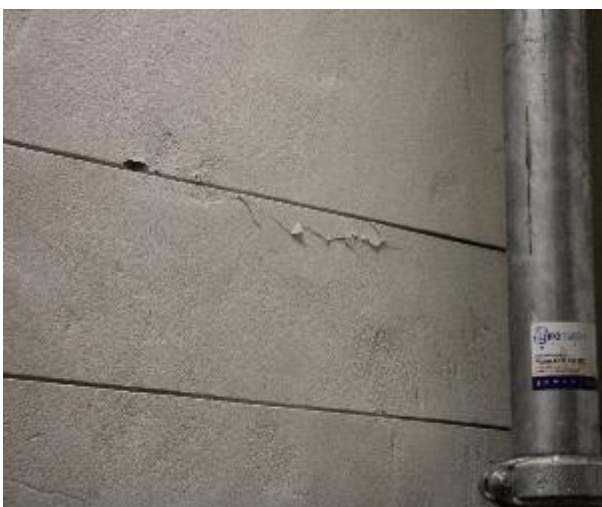
Figure 313 - Crack propagation through level 5 to basement B2 fire stairs internal wall

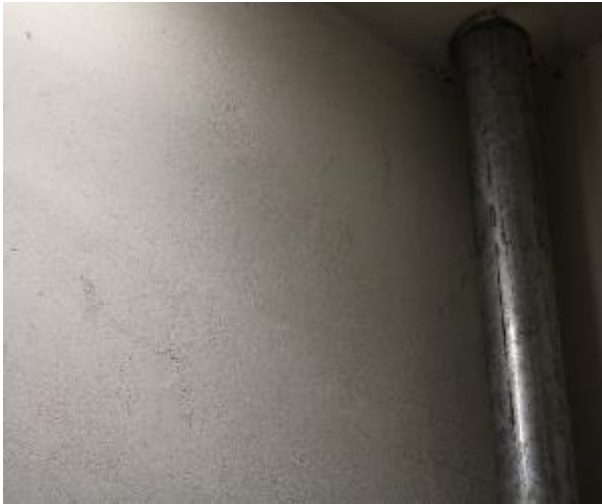
Figure 315 - General condition of level 5 to basement B2 fire stairs internal wall

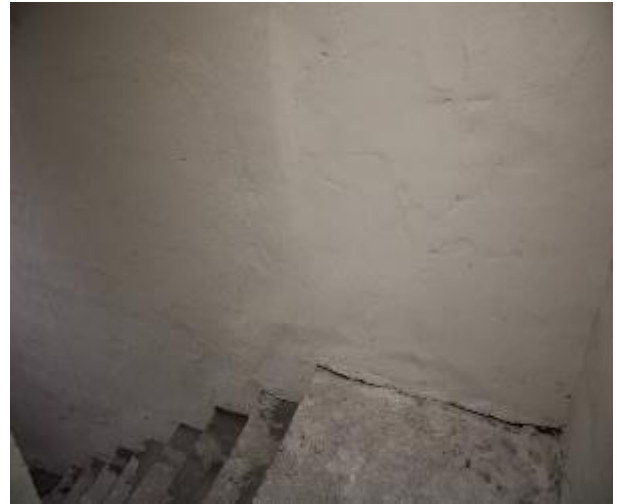
Figure 316 - General condition of level 5 to basement B2 fire stairs internal wall

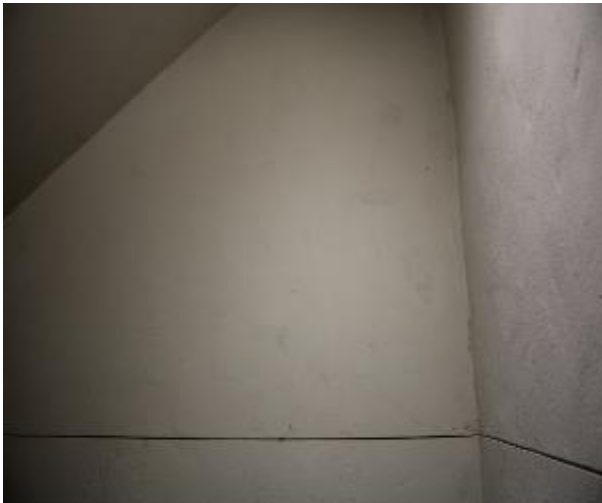
Figure 317 - General condition of level 5 to basement B2 fire stairs internal wall

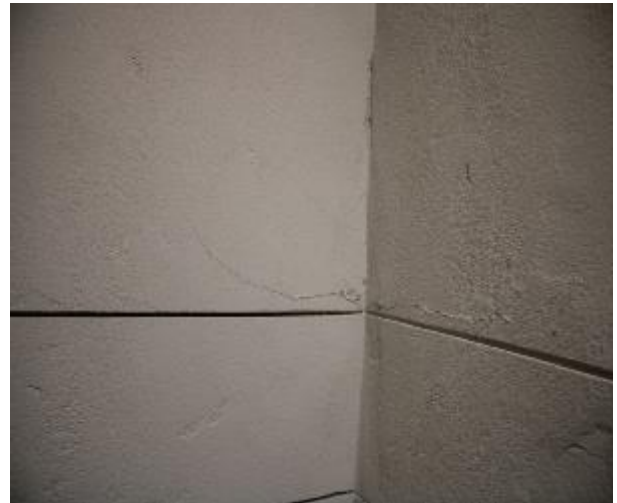
Figure 318 - Crack propagation through level 5 to basement B2 fire stairs internal wall

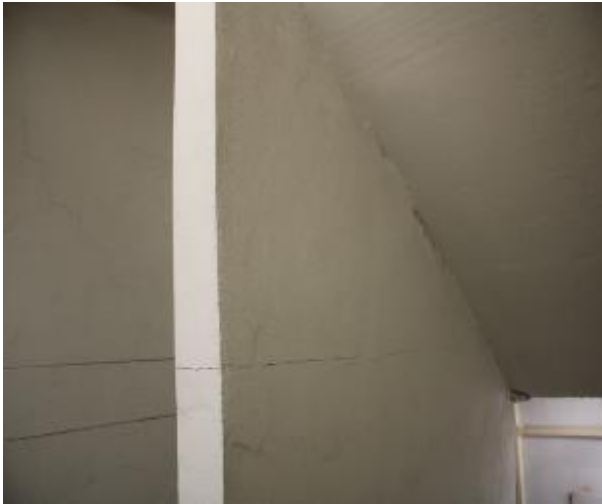
Figure 321 - Crack propagation through level 5 to basement B2 fire stairs internal wall

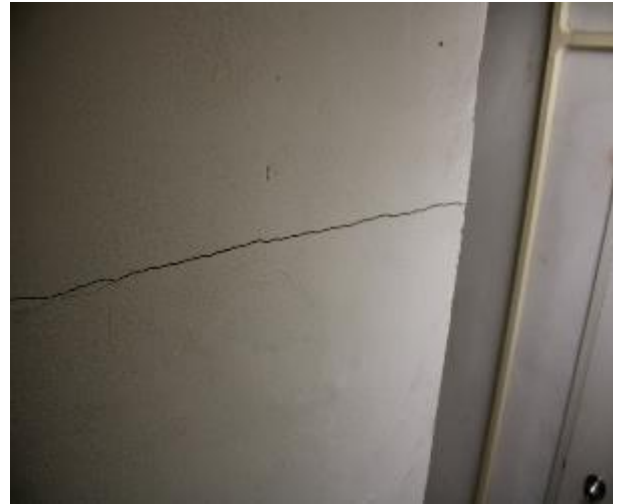
Figure 322 - Crack propagation through level 5 to basement B2 fire stairs internal wall

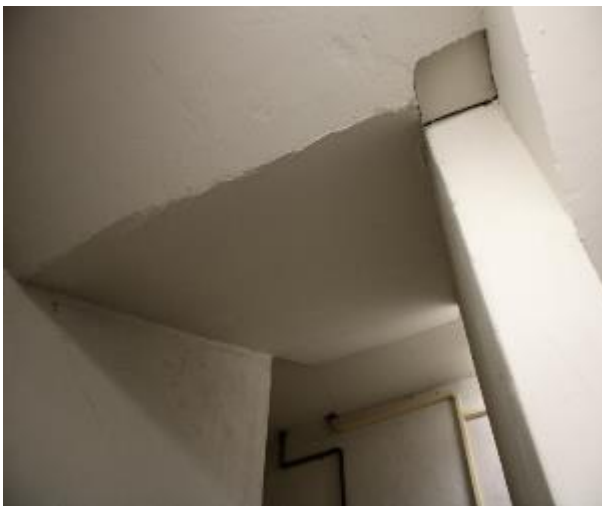
Figure 323 - General condition of level 5 to basement B2 fire stairs underside stairs

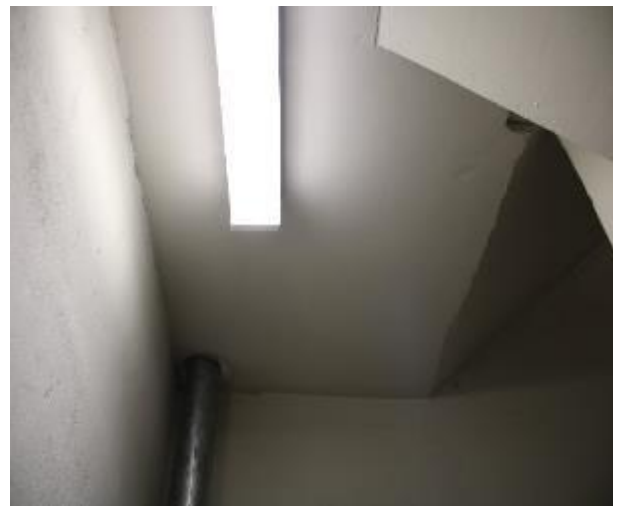
Figure 324 - General condition of level 5 to basement B2 fire stairs underside stairs

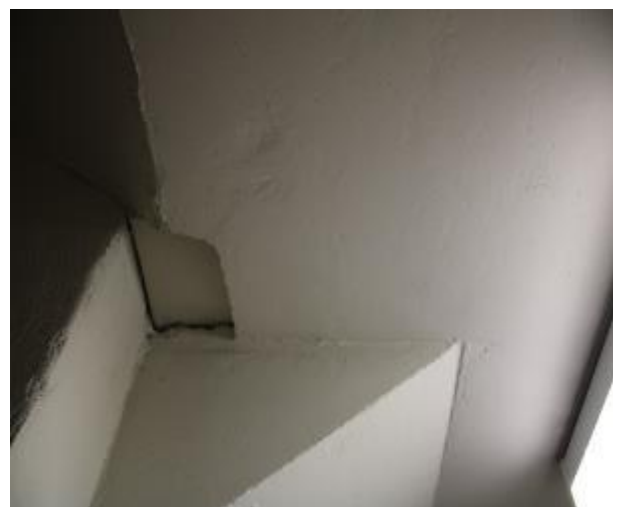
Figure 326 - General condition of level 5 to basement B2 fire stairs underside stairs

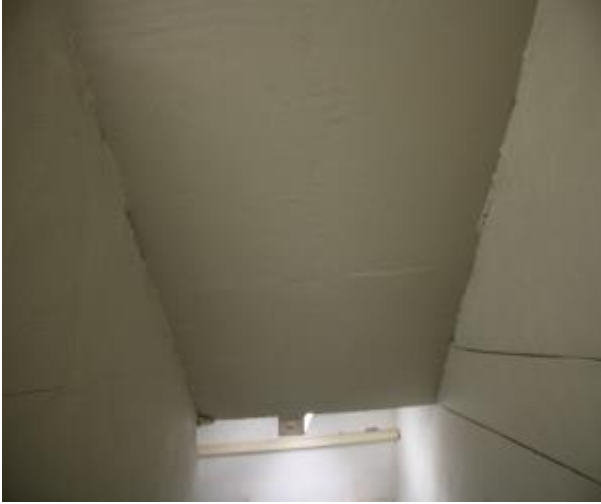
Figure 327 - General condition of level 5 to basement B2 fire stairs underside stairs

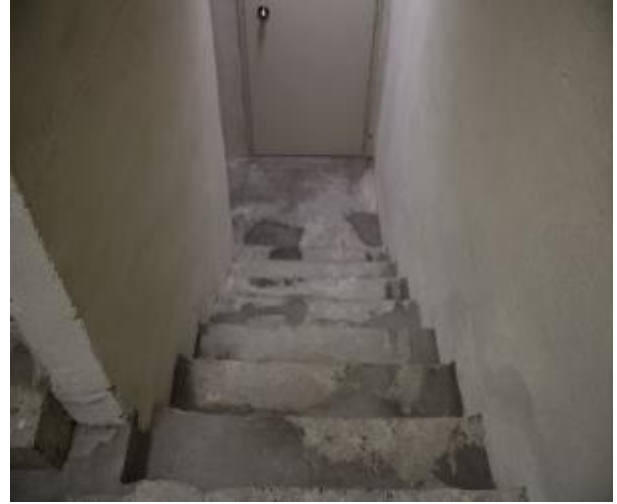
Figure 328 - General condition of level 5 to basement B2 fire stairs

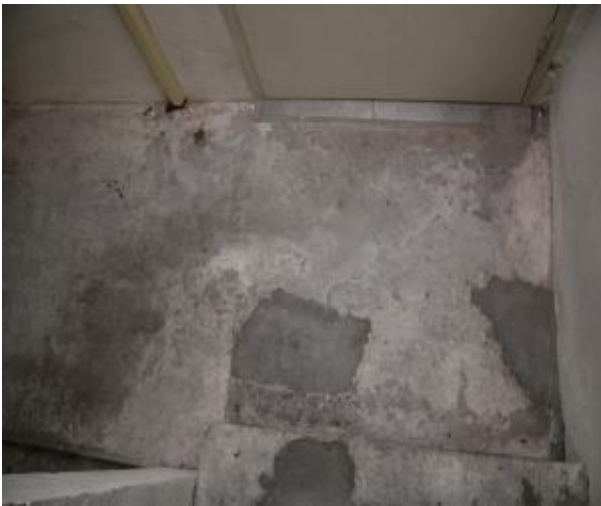
Figure 329 - General condition of level 5 to basement B2 fire stairs

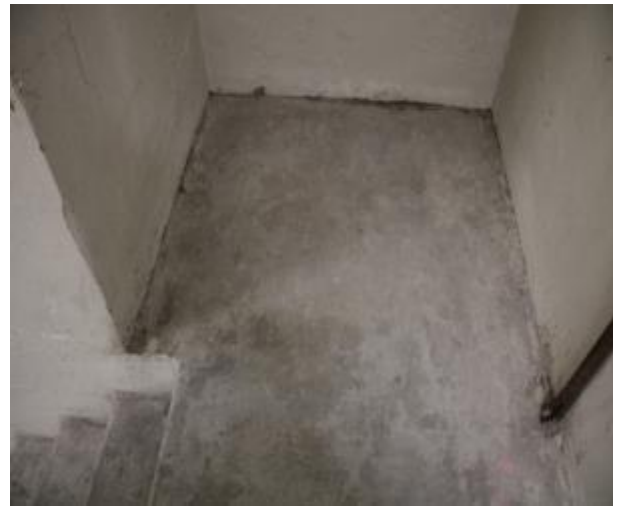
Figure 330 - General condition of level 5 to basement B2 fire stairs

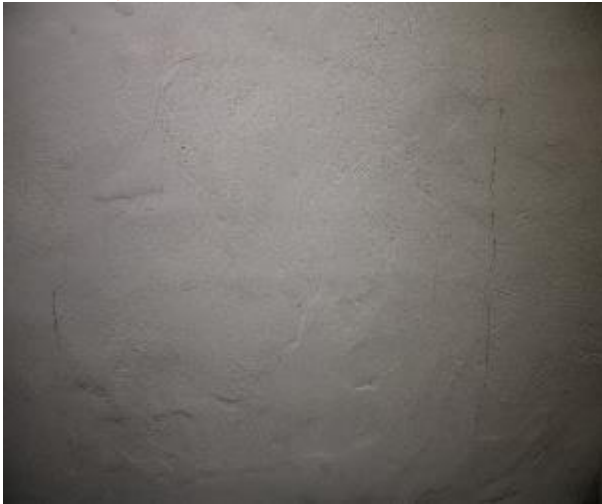
Figure 333 - Crack propagation through level 5 to basement B2 fire stairs internal wall

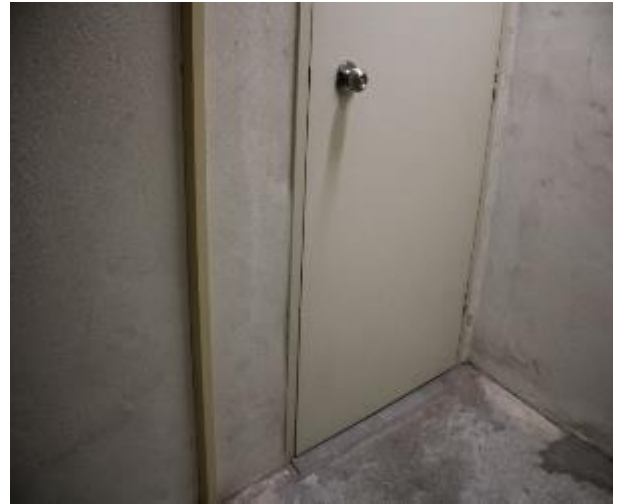
Figure 334 - General condition of level 5 to basement B2 fire stairs internal wall

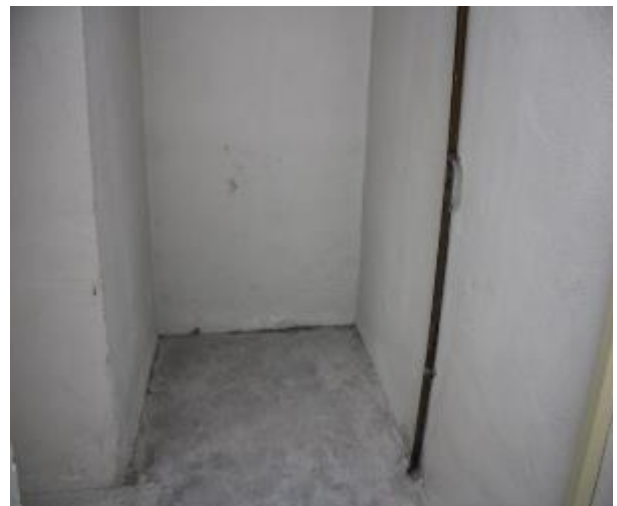
Figure 336 - General condition of level 5 to basement B2 fire stairs internal wall

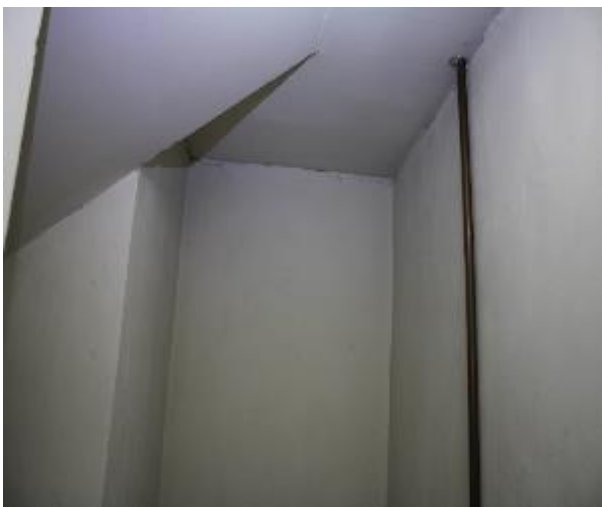
Figure 337 - General condition of level 5 to basement B2 fire stairs internal wall

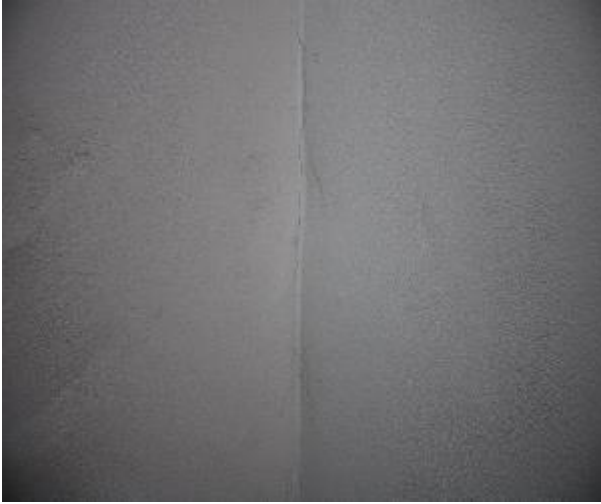
Figure 339 - Crack propagation through level 5 to basement B2 fire stairs internal wall

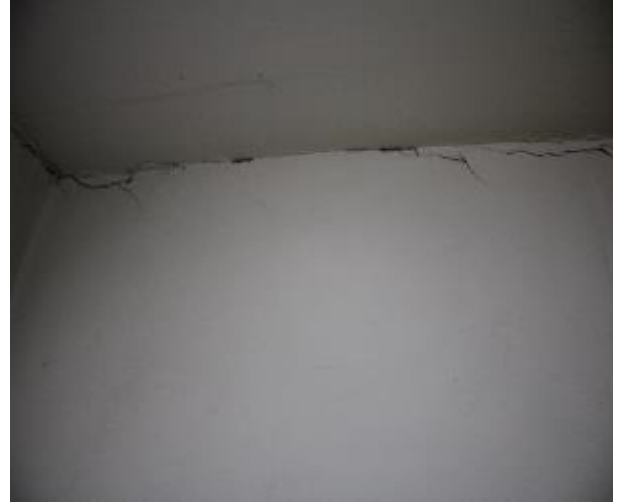
Figure 340 - Crack propagation through level 5 to basement B2 fire stairs internal wall

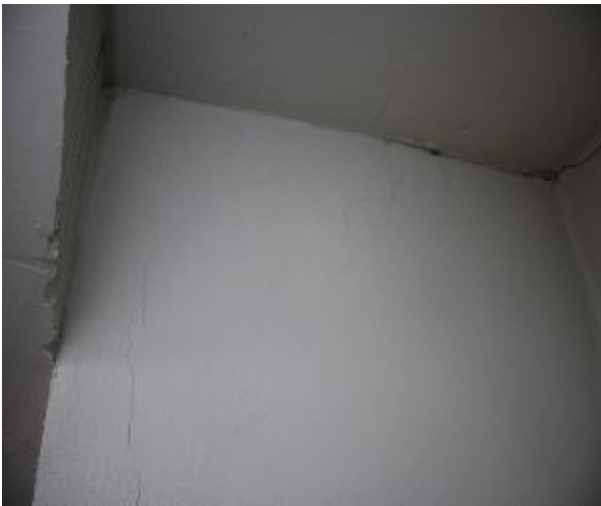
Figure 341 - Crack propagation through level 5 to basement B2 fire stairs internal wall

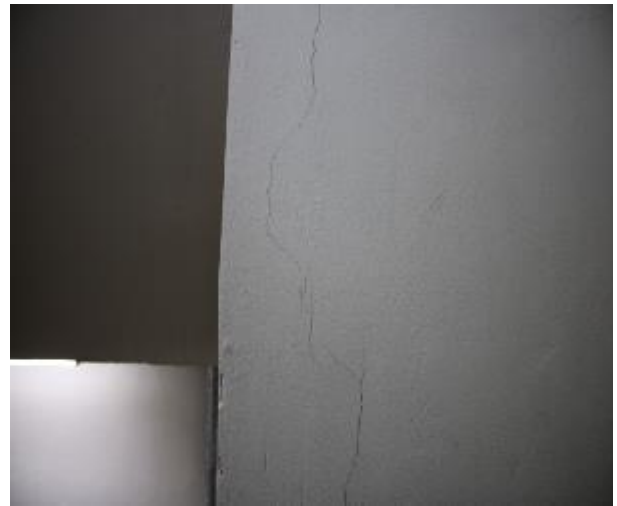
Figure 342 - Crack propagation through level 5 to basement B2 fire stairs internal wall

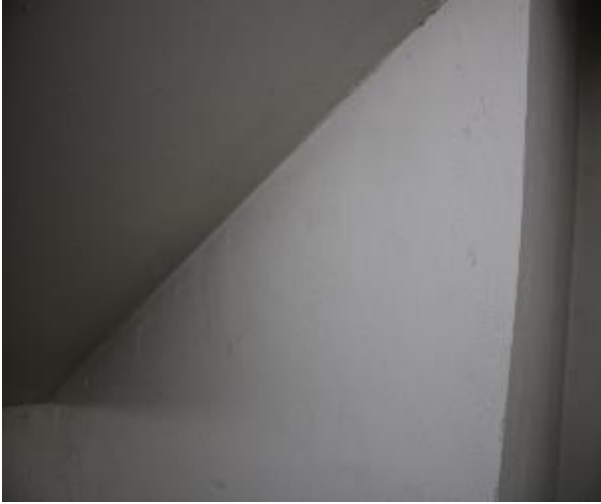
Figure 345 - General condition of level 5 to basement B2 fire stairs internal wall

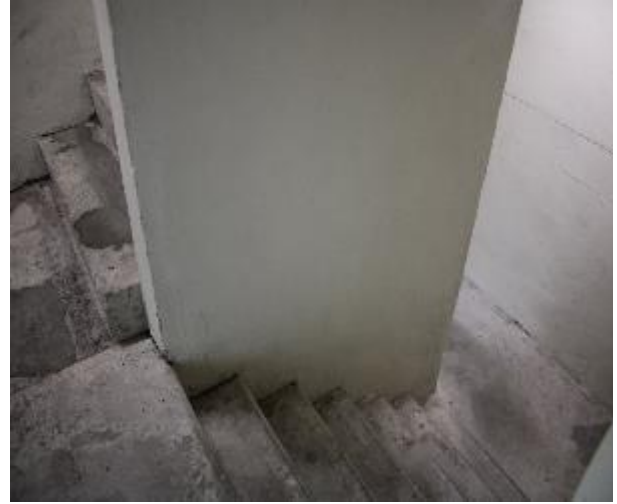
Figure 346 - General condition of level 5 to basement B2 fire stairs internal wall

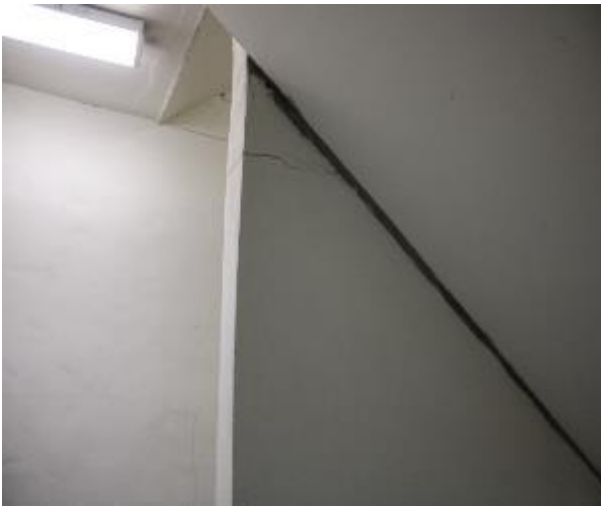
Figure 347 - Crack propagation through level 5 to basement B2 fire stairs internal wall

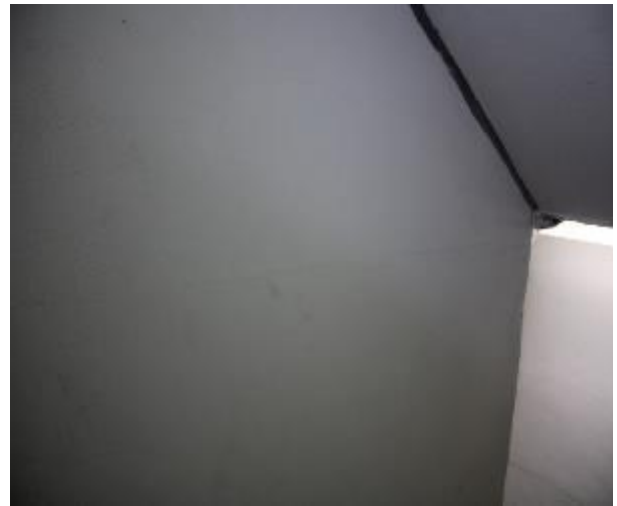
Figure 348 - Crack propagation through level 5 to basement B2 fire stairs internal wall

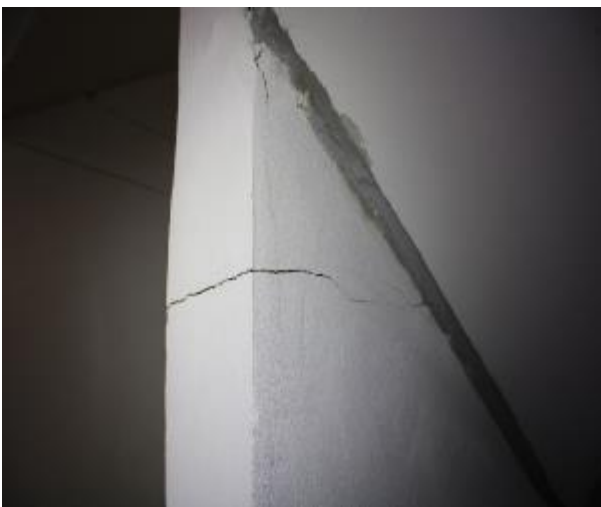
Figure 349 - Crack propagation through level 5 to basement B2 fire stairs internal wall

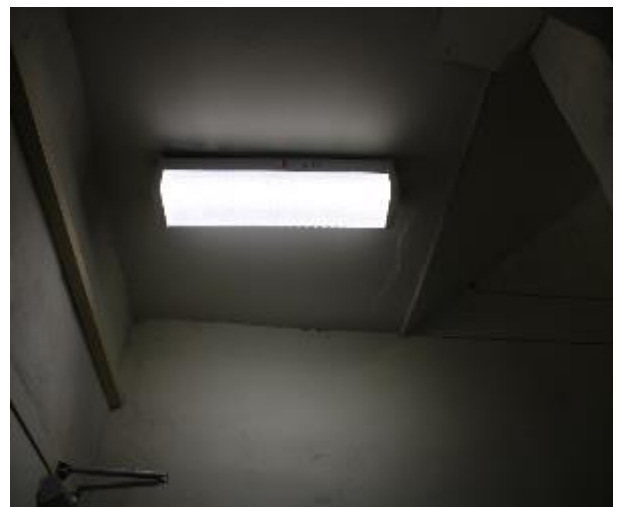
Figure 350 - General condition of level 5 to basement B2 fire stairs underside stairs

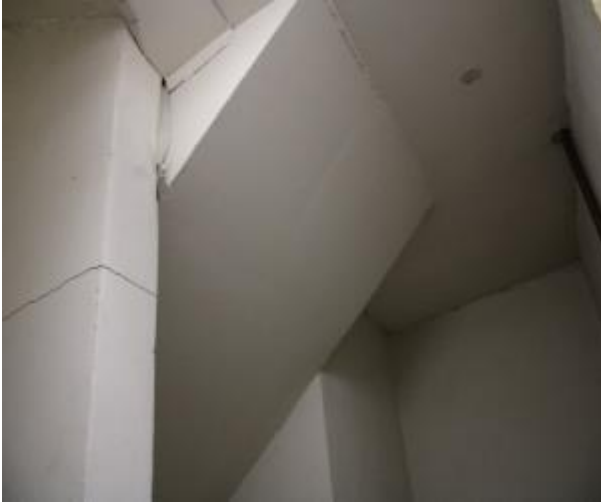
Figure 351 - General condition of level 5 to basement B2 fire stairs underside stairs

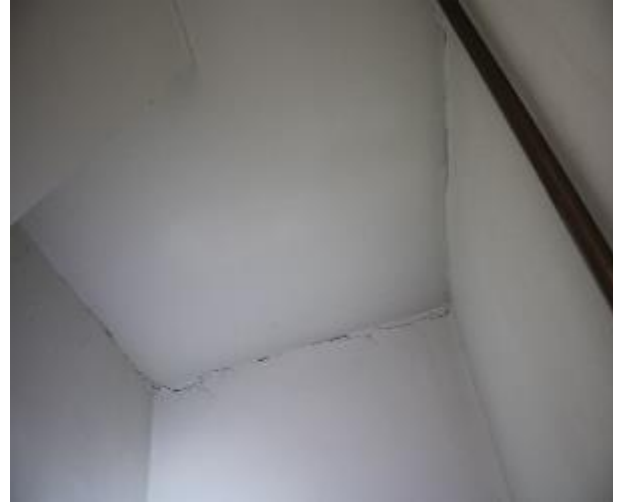
Figure 352 - General condition of level 5 to basement B2 fire stairs underside stairs

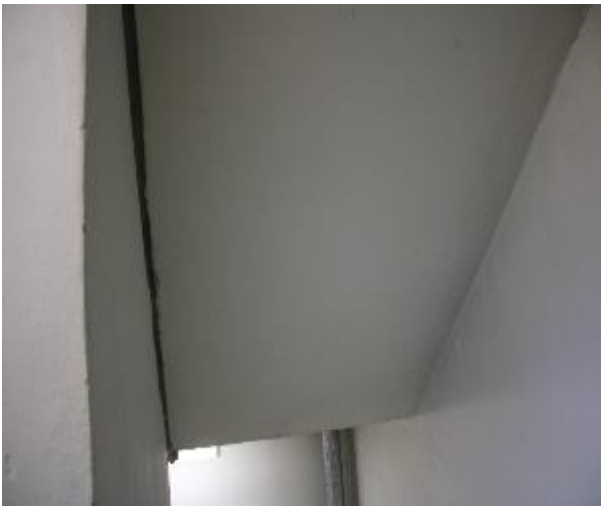
Figure 353 - General condition of level 5 to basement B2 fire stairs underside stairs

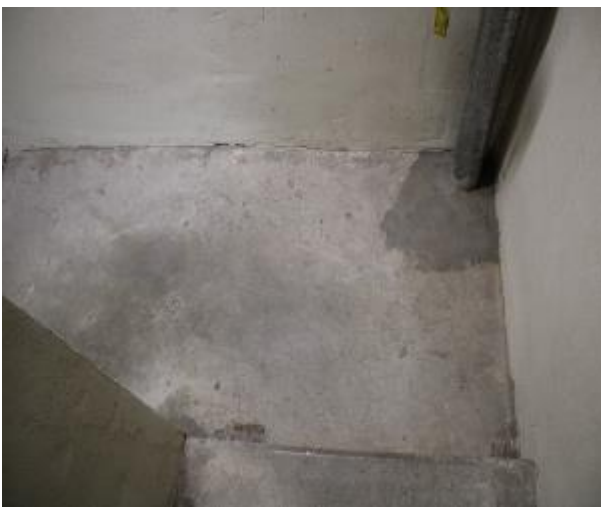
Figure 355 - General condition of level 5 to basement B2 fire stairs

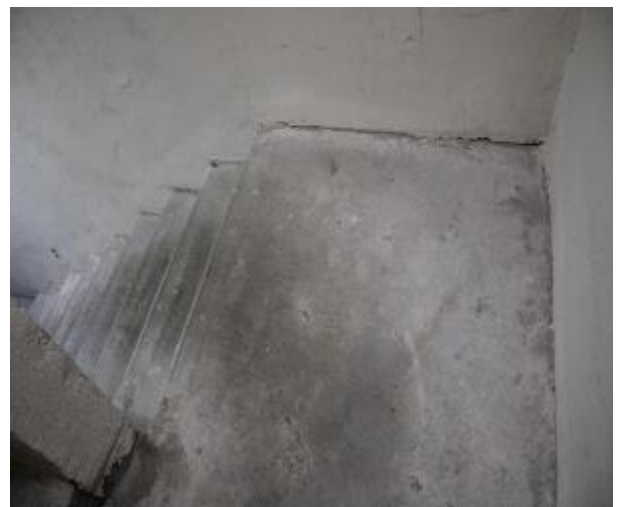
Figure 356 - General condition of level 5 to basement B2 fire stairs

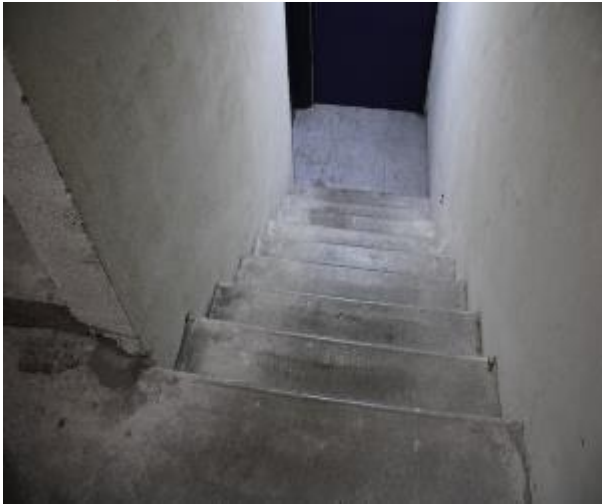
Figure 357 - General condition of level 5 to basement B2 fire stairs

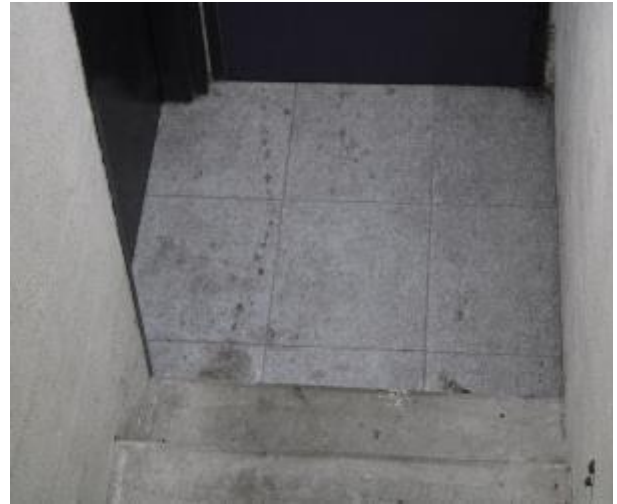
Figure 358 - General condition of level 5 to basement B2 fire stairs

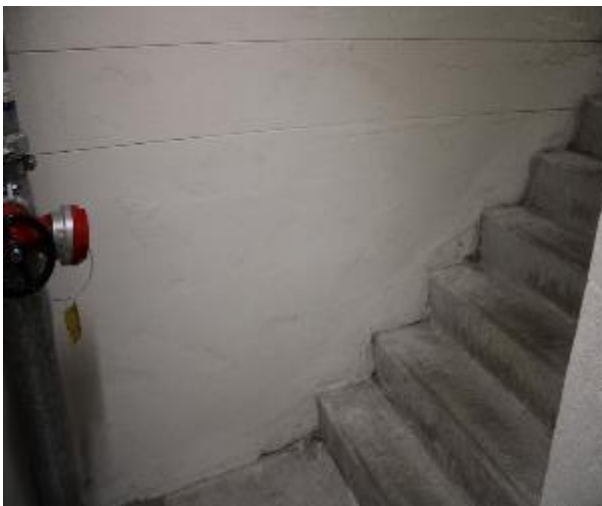
Figure 359 - General condition of level 5 to basement B2 fire stairs internal wall

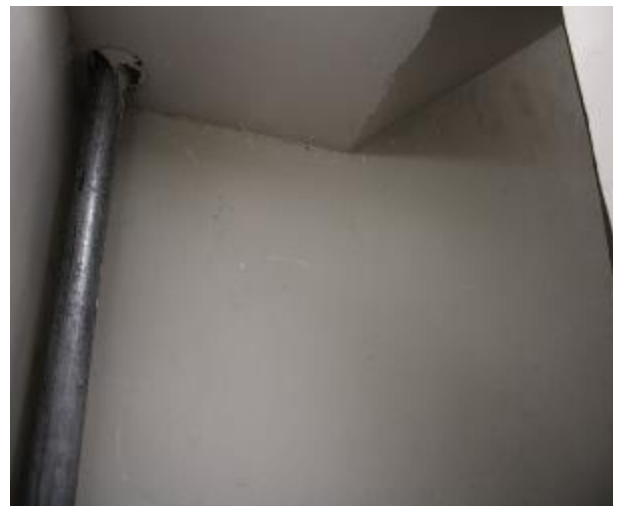
Figure 360 - General condition of level 5 to basement B2 fire stairs internal wall

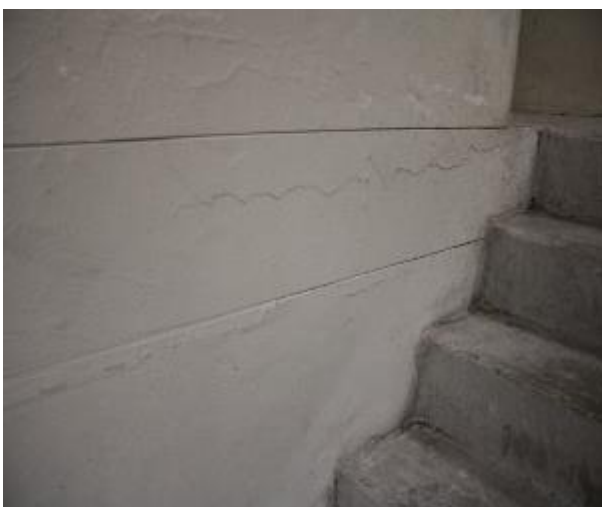
Figure 361 - Crack propagation through level 5 to basement B2 fire stairs internal wall

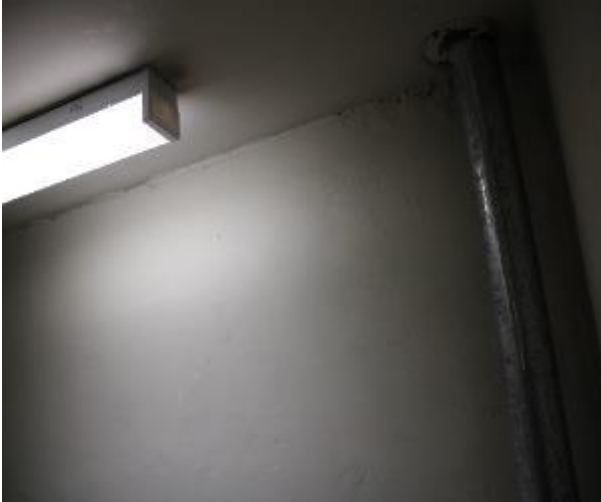
Figure 363 - General condition of level 5 to basement B2 fire stairs internal wall

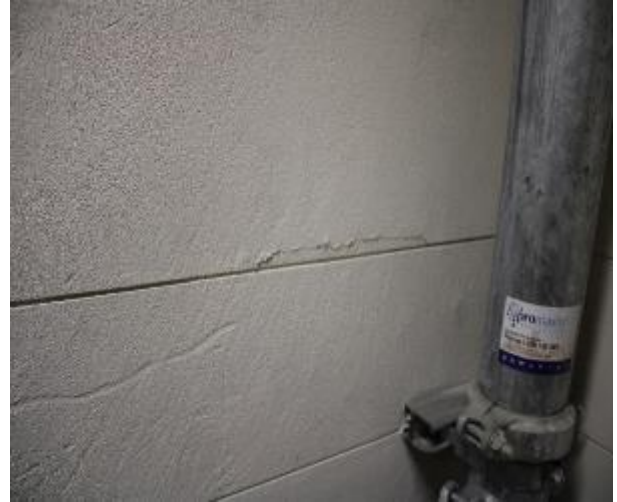
Figure 364 - Crack propagation through level 5 to basement B2 fire stairs internal wall

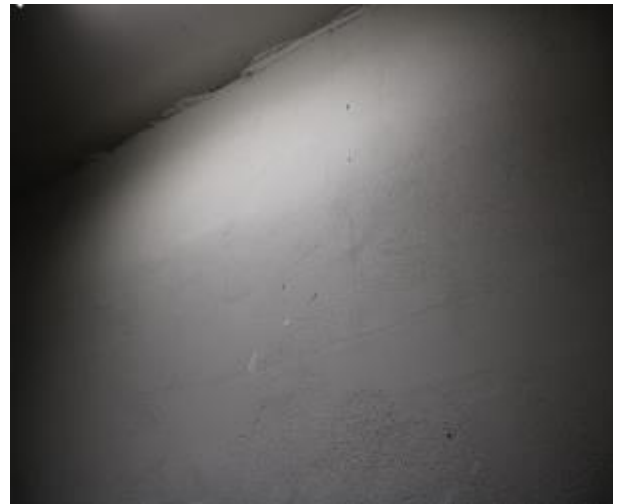
Figure 366 - General condition of level 5 to basement B2 fire stairs internal wall

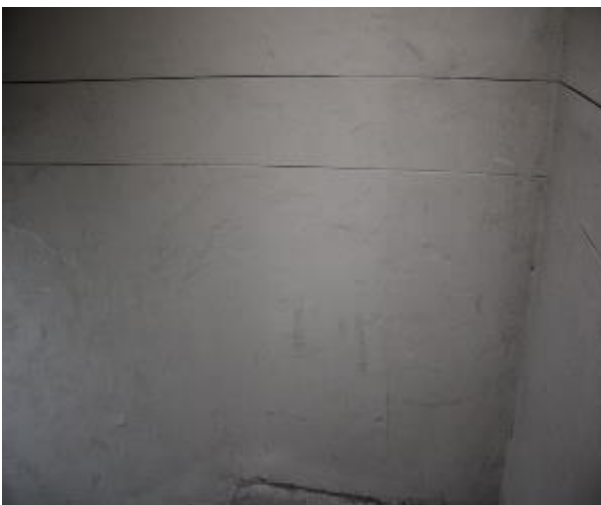
Figure 367 - General condition of level 5 to basement B2 fire stairs internal wall

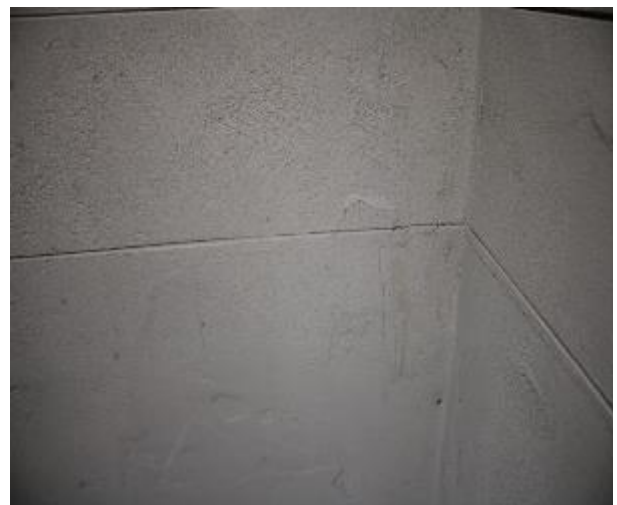
Figure 368 - Crack propagation through level 5 to basement B2 fire stairs internal wall

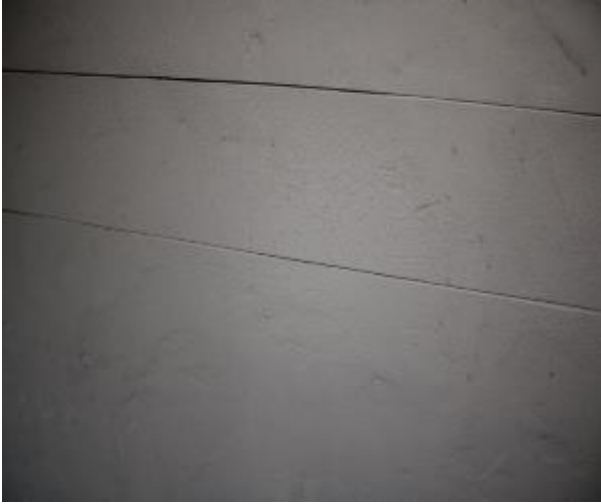
Figure 369 - Crack propagation through level 5 to basement B2 fire stairs internal wall

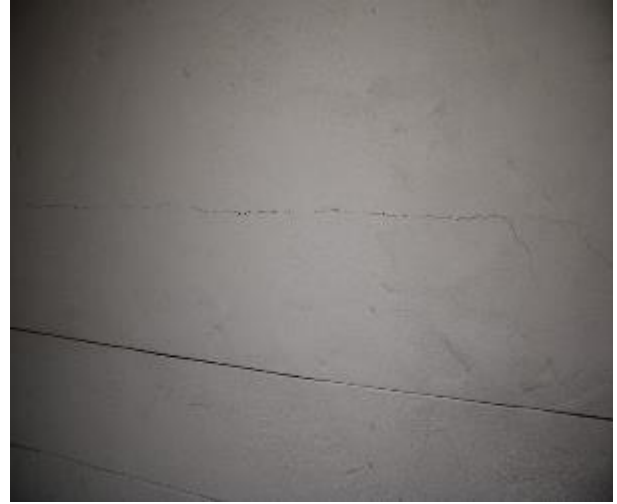
Figure 370 - Crack propagation through level 5 to basement B2 fire stairs internal wall

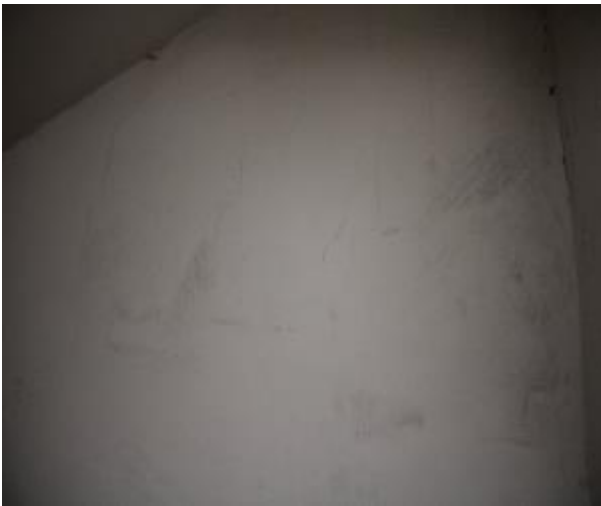
Figure 371 - General condition of level 5 to basement B2 fire stairs internal wall

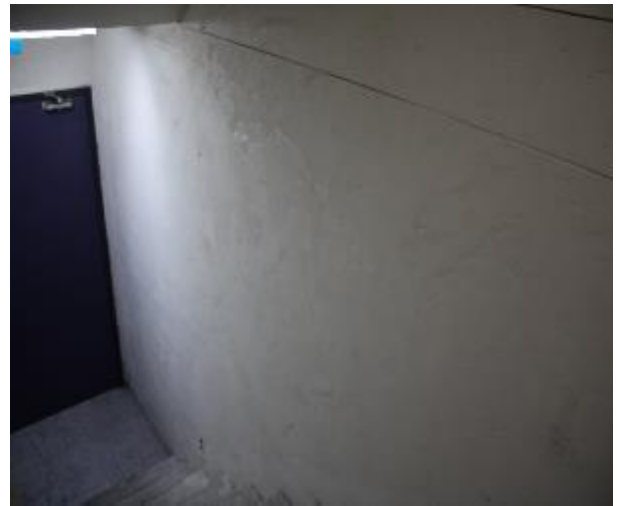
Figure 372 - General condition of level 5 to basement B2 fire stairs internal wall

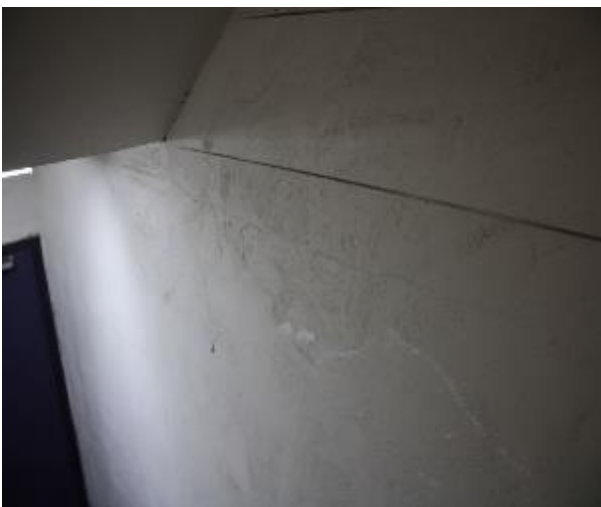
Figure 373 - Crack propagation through level 5 to basement B2 fire stairs internal wall

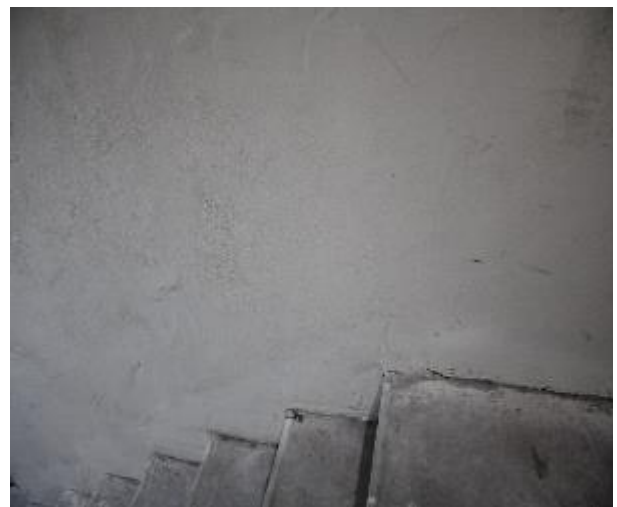
Figure 374 - General condition of level 5 to basement B2 fire stairs internal wall

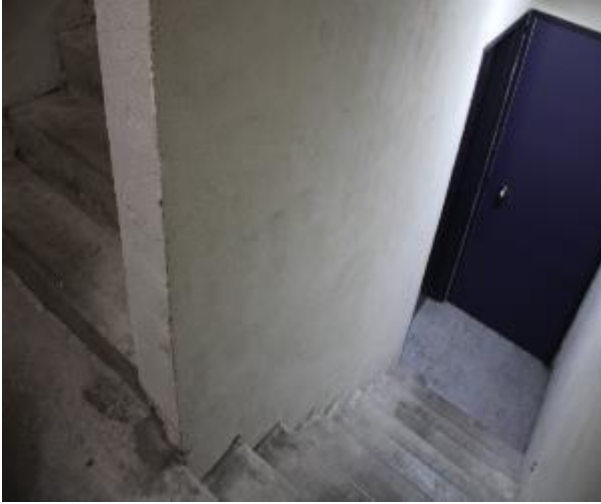
Figure 375 - General condition of level 5 to basement B2 fire stairs internal wall

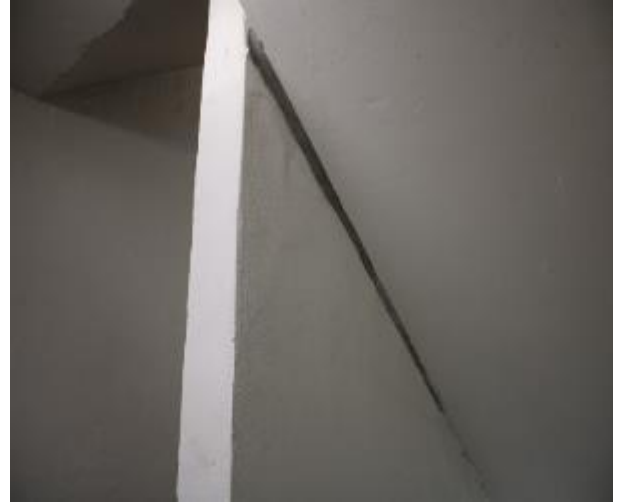
Figure 376 - General condition of level 5 to basement B2 fire stairs internal wall

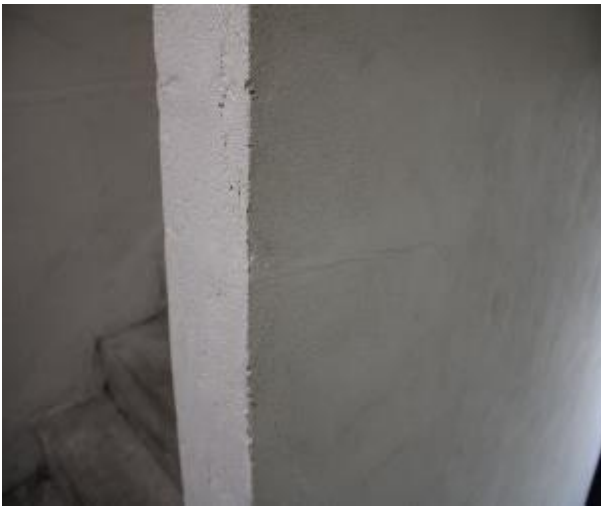
Figure 377 - Crack propagation through level 5 to basement B2 fire stairs internal wall

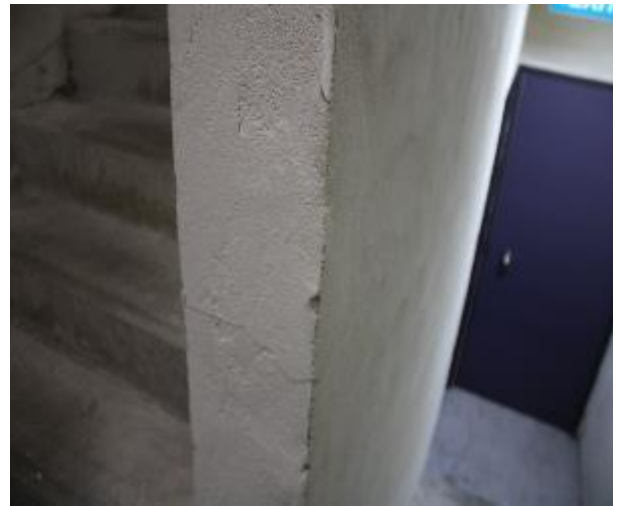
Figure 378 - Crack propagation through level 5 to basement B2 fire stairs internal wall

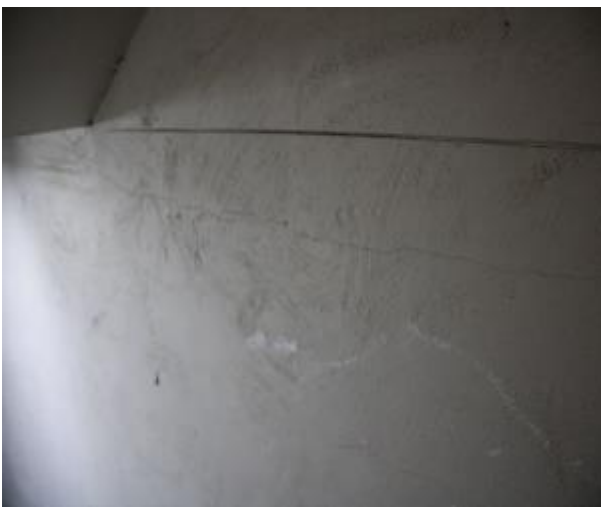
Figure 379 - Crack propagation through level 5 to basement B2 fire stairs internal wall

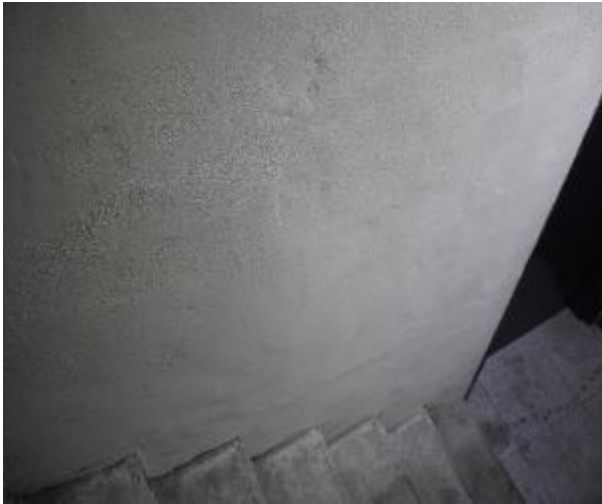
Figure 381 - General condition of level 5 to basement B2 fire stairs internal wall
