# **Pre-Dilapidation Report**

**19 GEORGE STREET**

**REAR BUILDING (UNITS 20-29)**

Project Reference: 20250047.19G.3

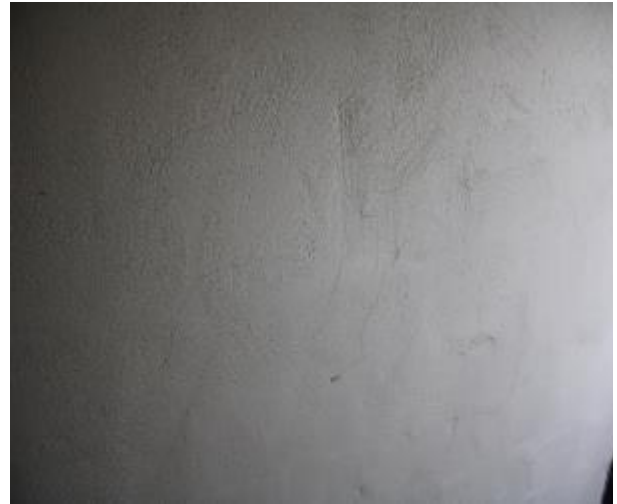
Figure 382 - Crack propagation through level 5 to basement B2 fire stairs internal wall

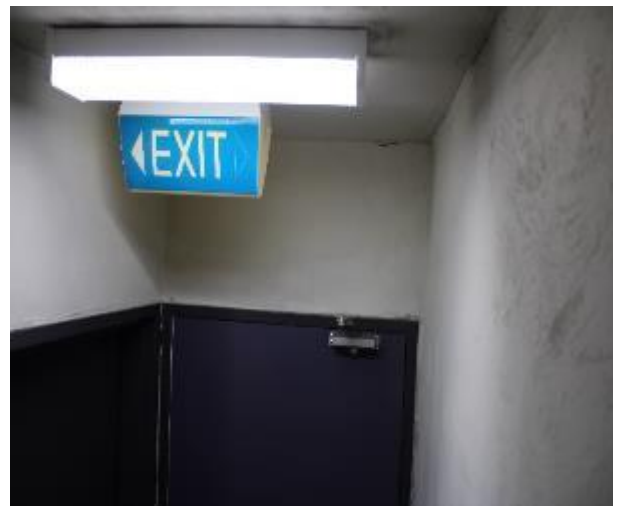
Figure 384 - General condition of level 5 to basement B2 fire stairs internal wall

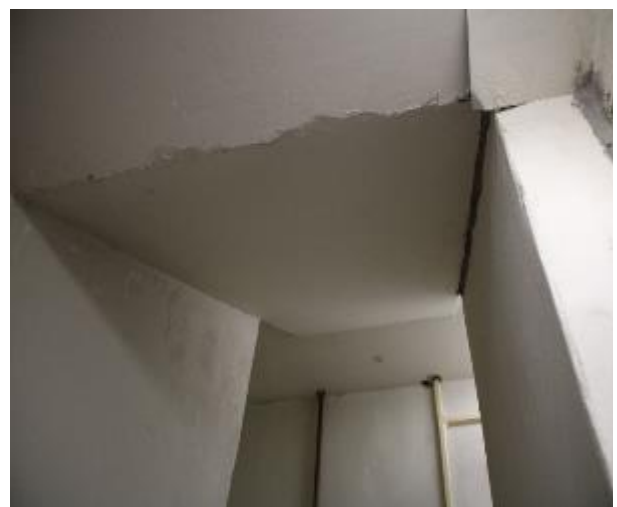
Figure 386 - General condition of level 5 to basement B2 fire stairs underside stairs

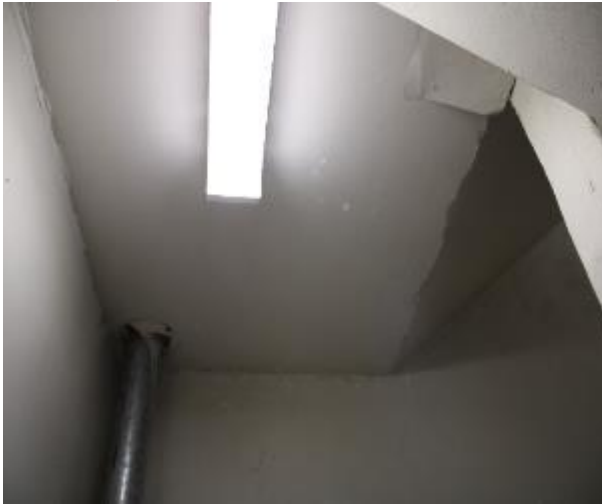
Figure 387 - General condition of level 5 to basement B2 fire stairs underside stairs

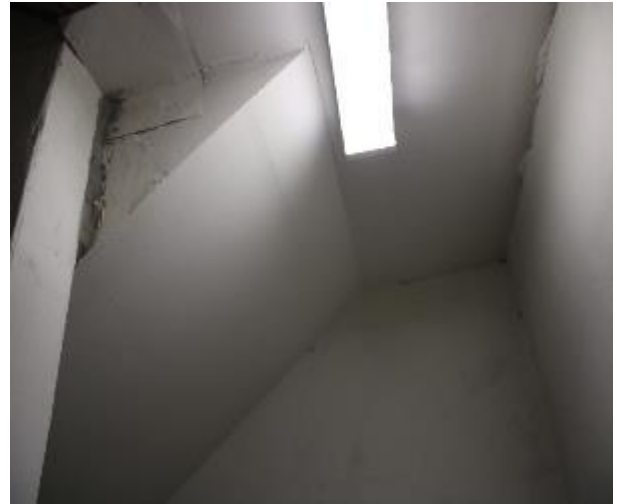
Figure 388 - General condition of level 5 to basement B2 fire stairs underside stairs

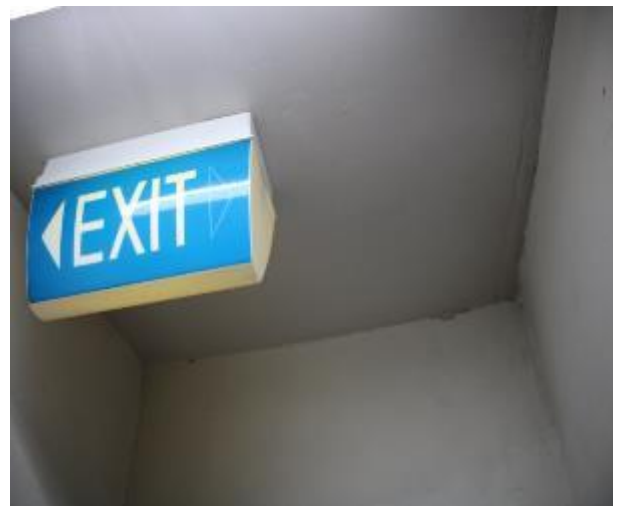
Figure 390 - General condition of level 5 to basement B2 fire stairs underside stairs

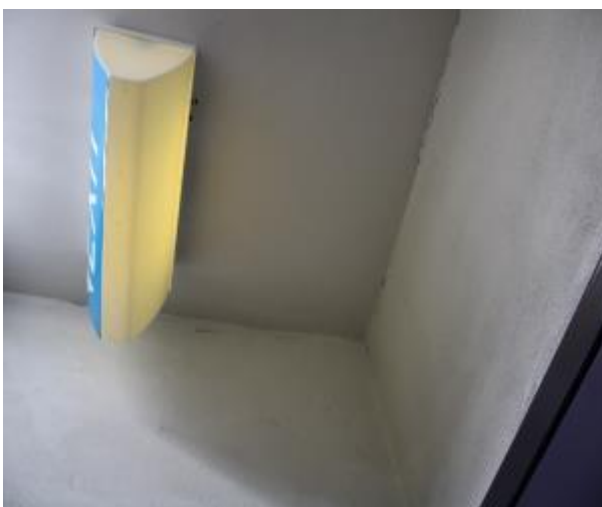
Figure 391 - General condition of level 5 to basement B2 fire stairs underside stairs

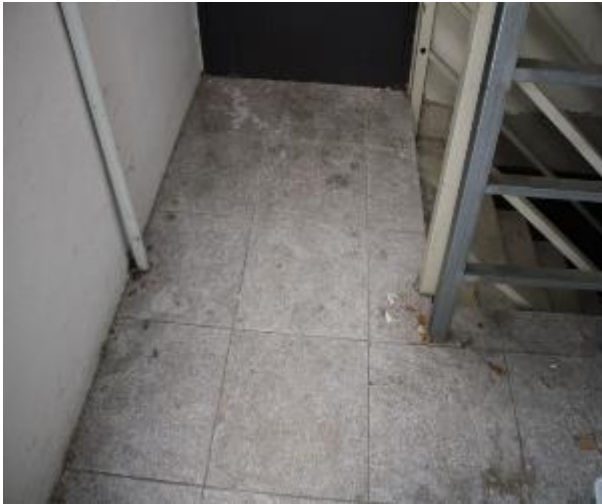
Figure 393 - General condition of level 5 to basement B2 fire stairs

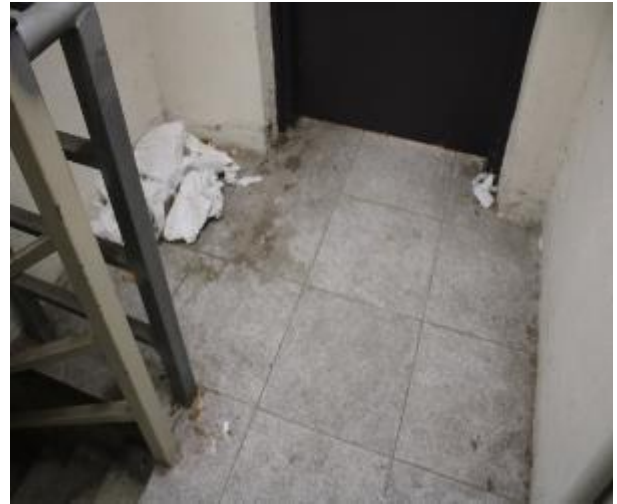
Figure 394 - General condition of level 5 to basement B2 fire stairs

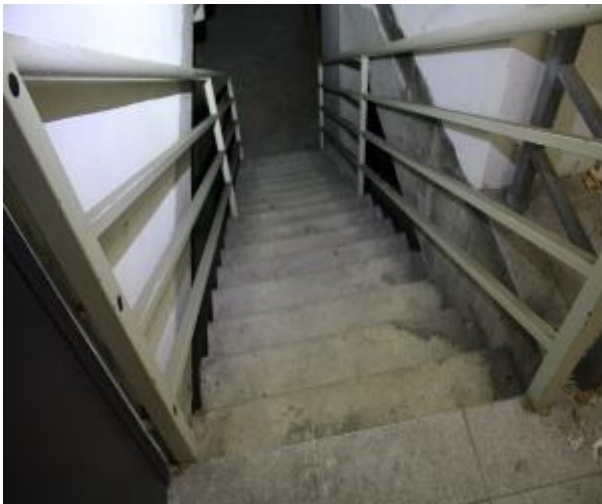
Figure 395 - General condition of level 5 to basement B2 fire stairs

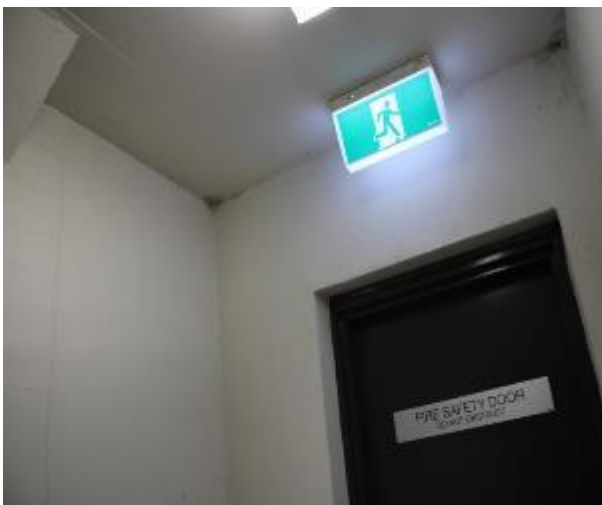
Figure 397 - General condition of level 5 to basement B2 fire stairs internal wall

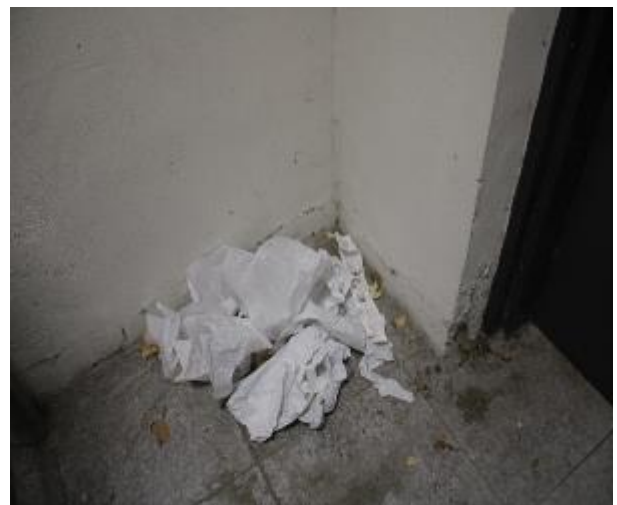
Figure 398 - General condition of level 5 to basement B2 fire stairs internal wall

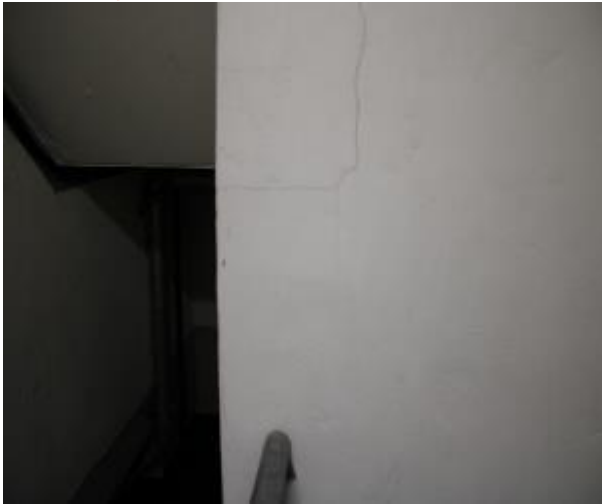
Figure 399 - Crack propagation through level 5 to basement B2 fire stairs internal wall

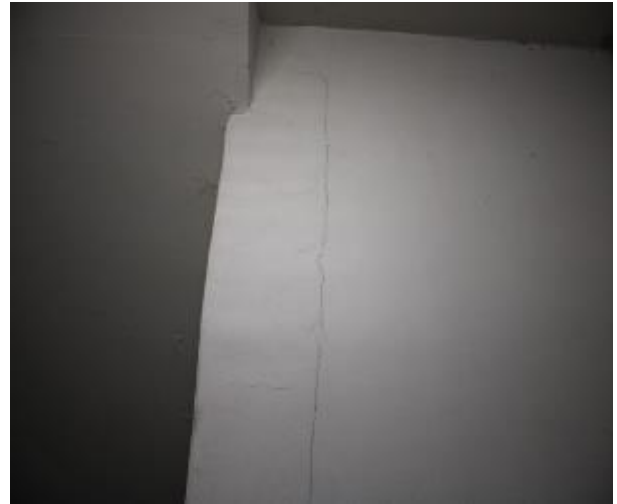
Figure 400 - Crack propagation through level 5 to basement B2 fire stairs internal wall

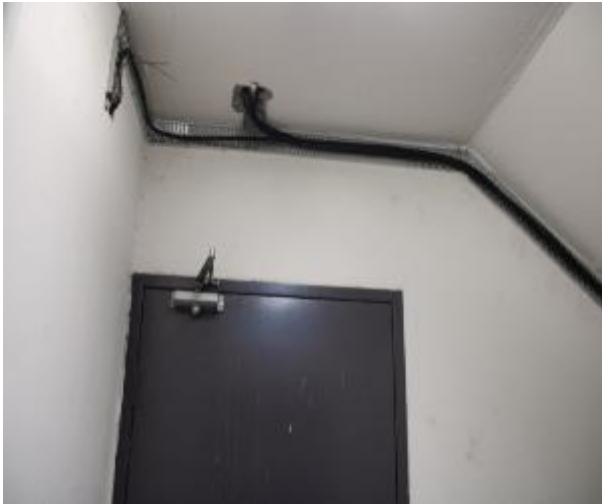
Figure 405 - General condition of level 5 to basement B2 fire stairs internal wall

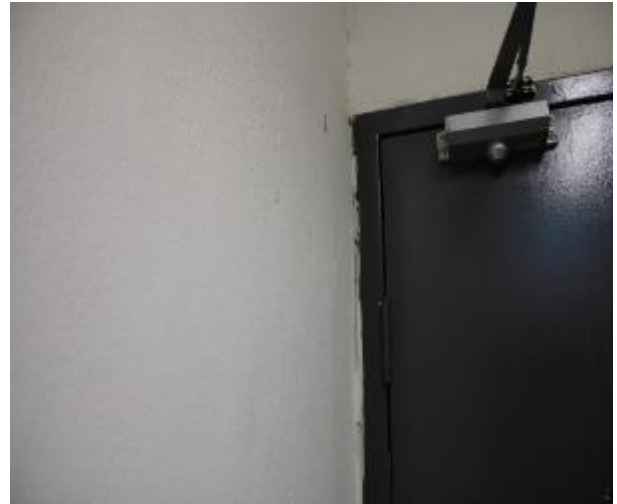
Figure 406 - General condition of level 5 to basement B2 fire stairs internal wall

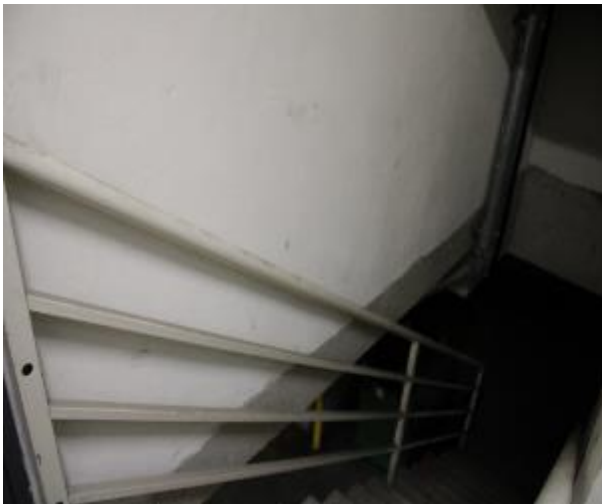
Figure 407 - General condition of level 5 to basement B2 fire stairs internal wall

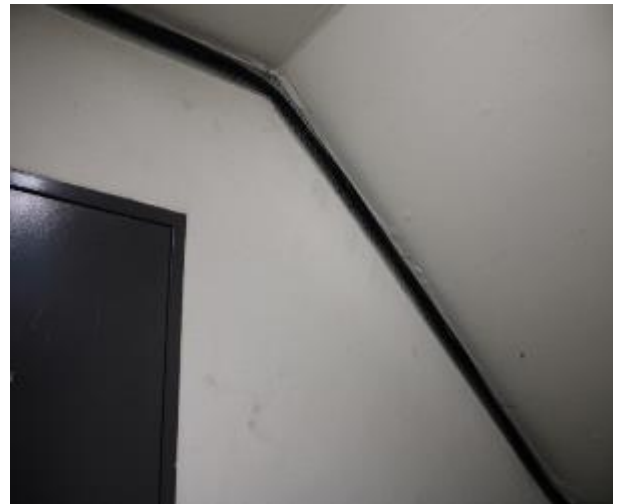
Figure 408 - General condition of level 5 to basement B2 fire stairs internal wall

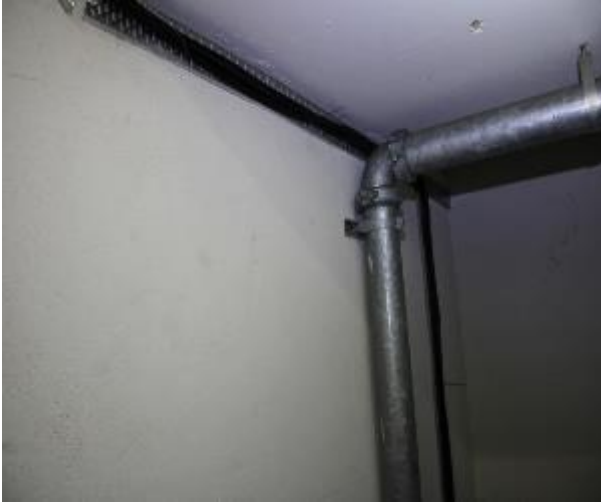
Figure 411 - General condition of level 5 to basement B2 fire stairs internal wall

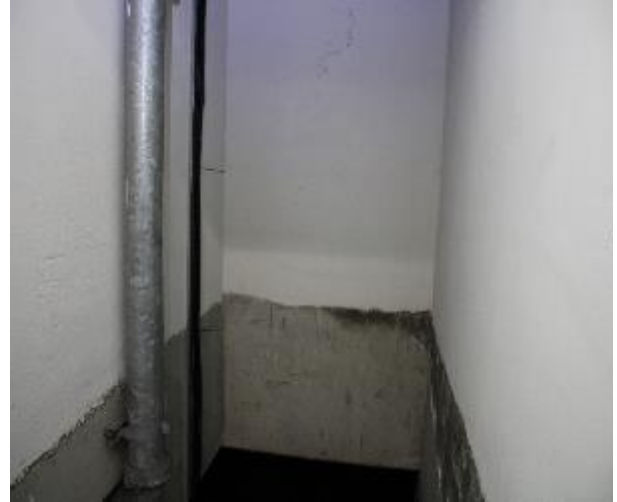
Figure 412 - General condition of level 5 to basement B2 fire stairs internal wall

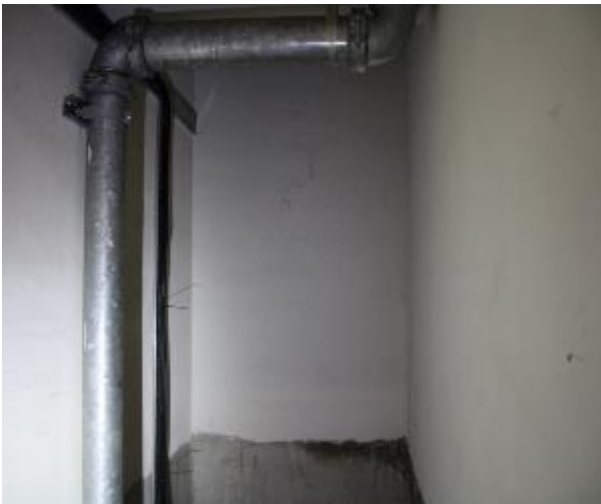
Figure 413 - General condition of level 5 to basement B2 fire stairs internal wall

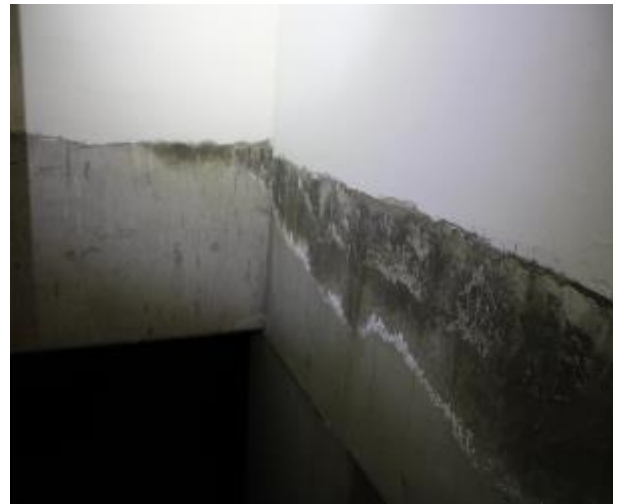
Figure 414 - General condition of level 5 to basement B2 fire stairs internal wall

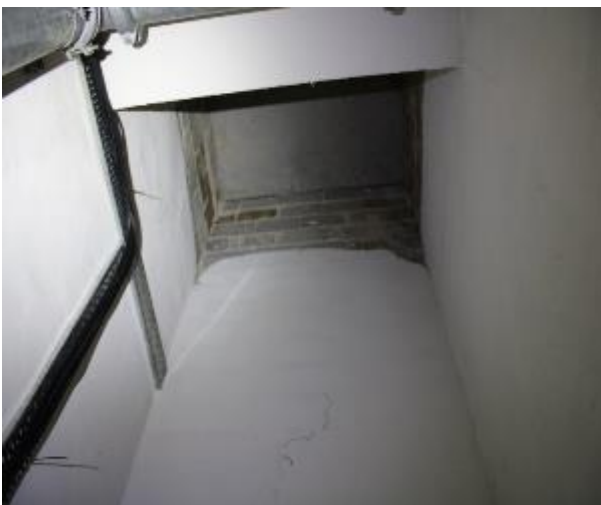
Figure 415 - General condition of level 5 to basement B2 fire stairs internal wall

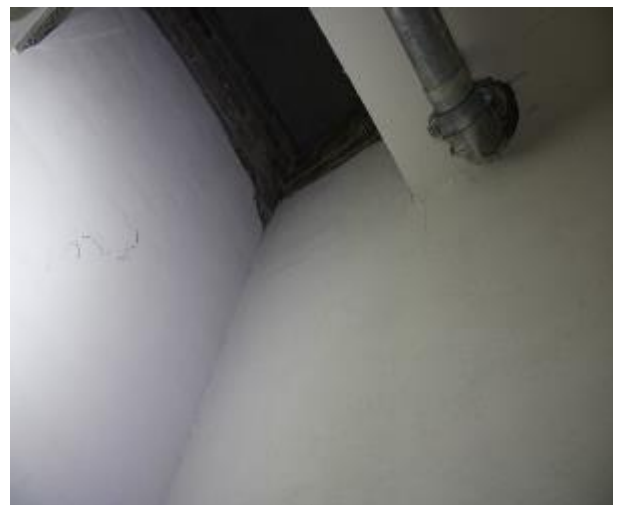
Figure 416 - General condition of level 5 to basement B2 fire stairs internal wall

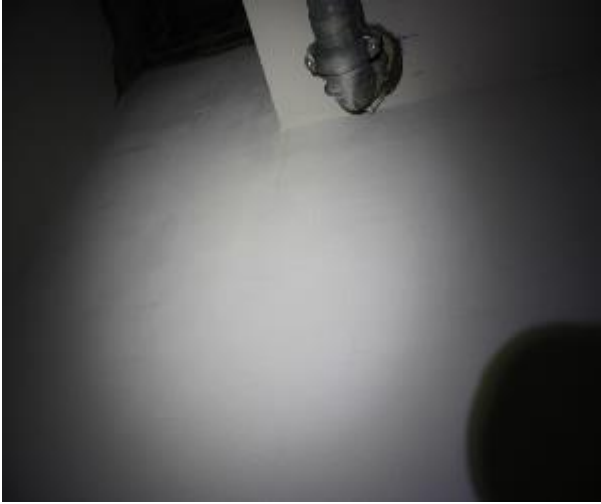
Figure 417 - Crack propagation through level 5 to basement B2 fire stairs internal wall

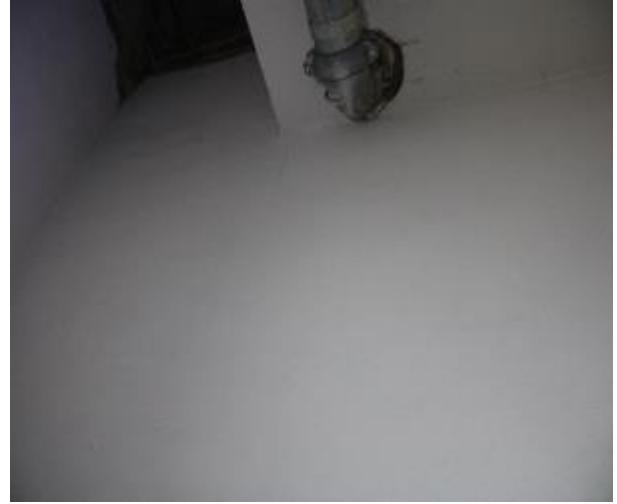
Figure 418 - Crack propagation through level 5 to basement B2 fire stairs internal wall

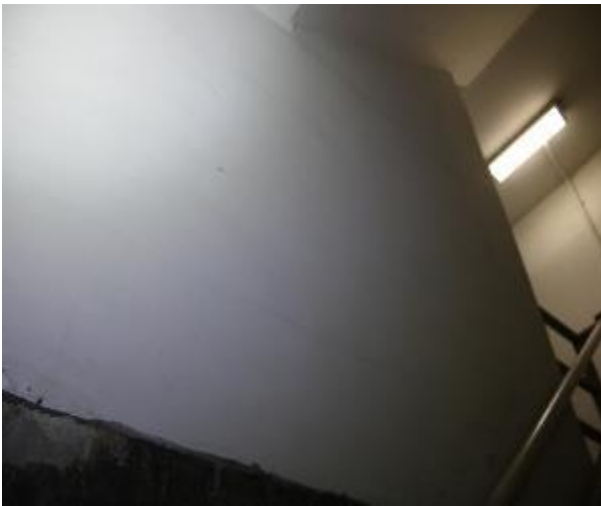
Figure 419 - General condition of level 5 to basement B2 fire stairs internal wall

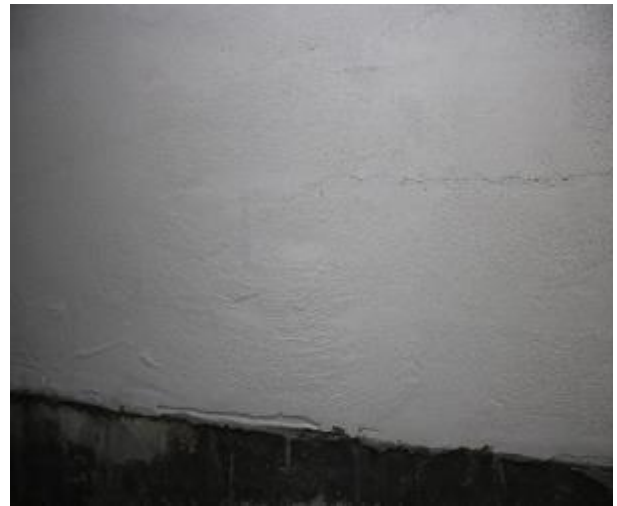
Figure 420 - Crack propagation through level 5 to basement B2 fire stairs internal wall

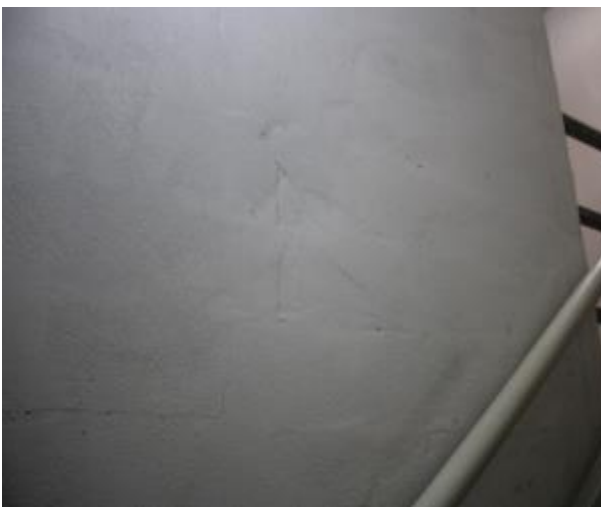
Figure 421 - Crack propagation through level 5 to basement B2 fire stairs internal wall

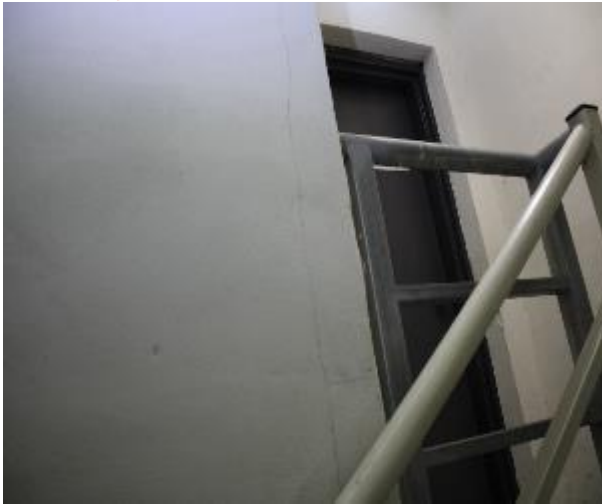
Figure 423 - Crack propagation through level 5 to basement B2 fire stairs internal wall

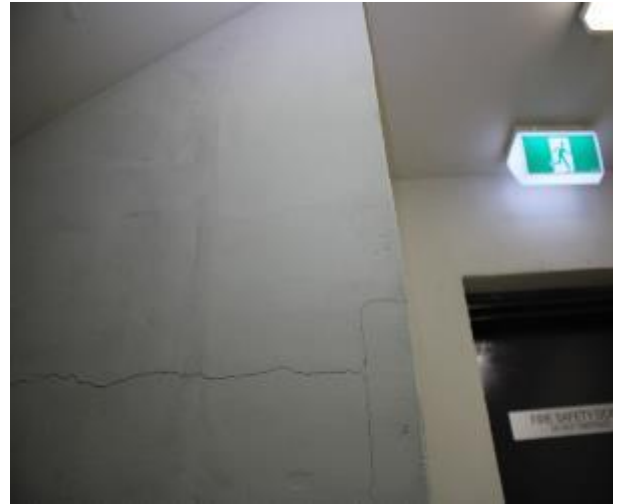
Figure 424 - Crack propagation through level 5 to basement B2 fire stairs internal wall

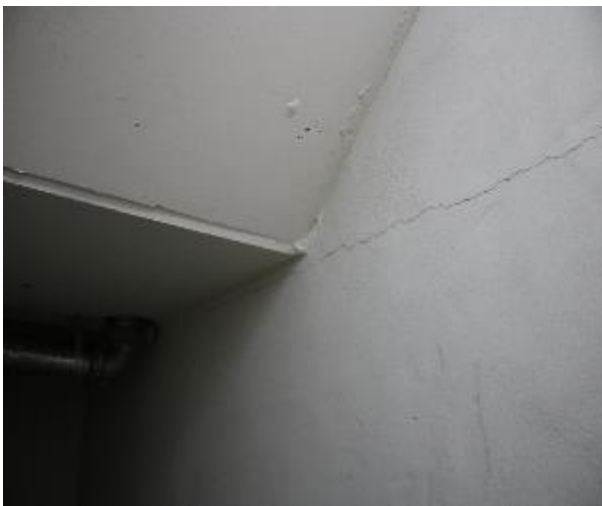
Figure 425 - Crack propagation through level 5 to basement B2 fire stairs internal wall

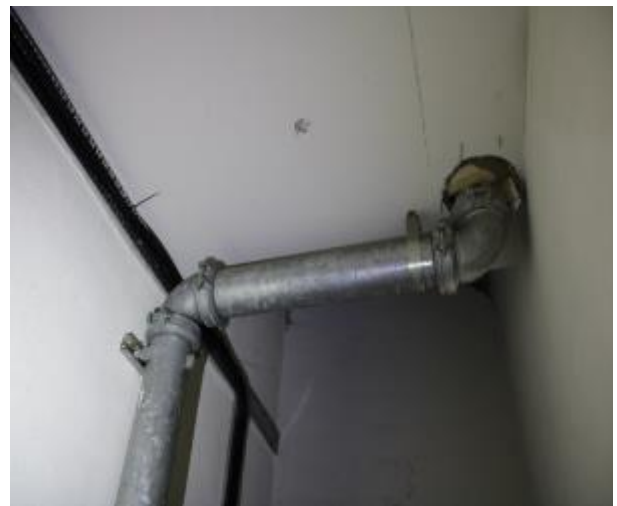
Figure 426 - General condition of level 5 to basement B2 fire stairs underside stairs

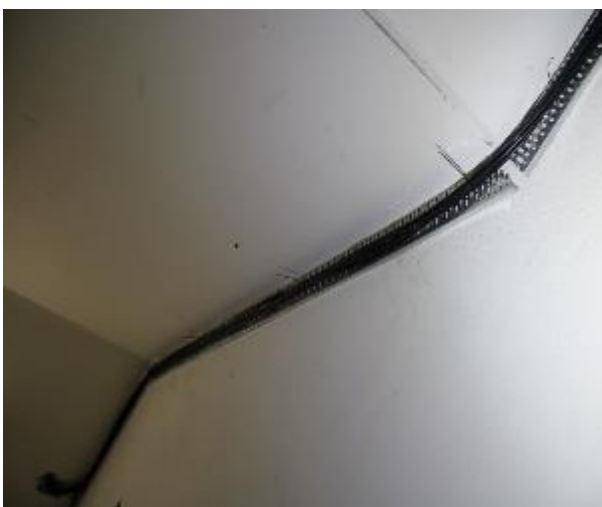
Figure 427 - General condition of level 5 to basement B2 fire stairs underside stairs

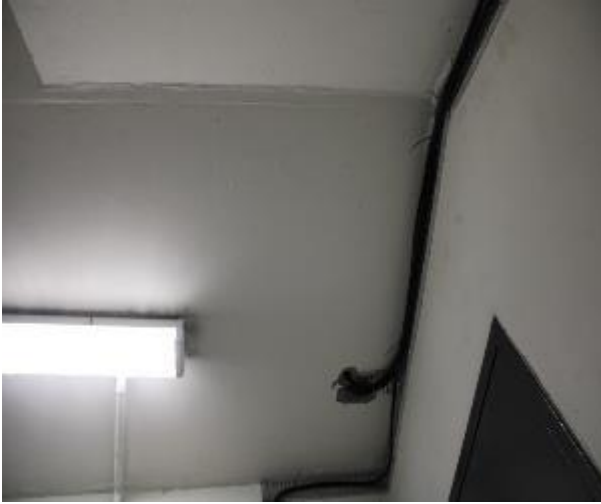
Figure 429 - General condition of level 5 to basement B2 fire stairs underside stairs

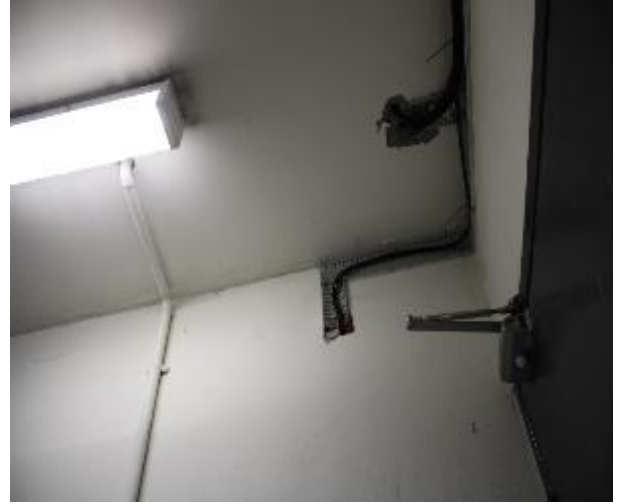
Figure 430 - General condition of level 5 to basement B2 fire stairs underside stairs

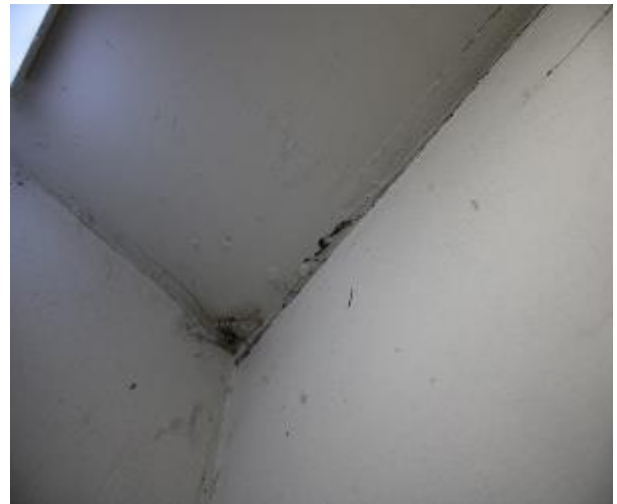
Figure 432 - Crack propagation through level 5 to basement B2 fire stairs underside stairs

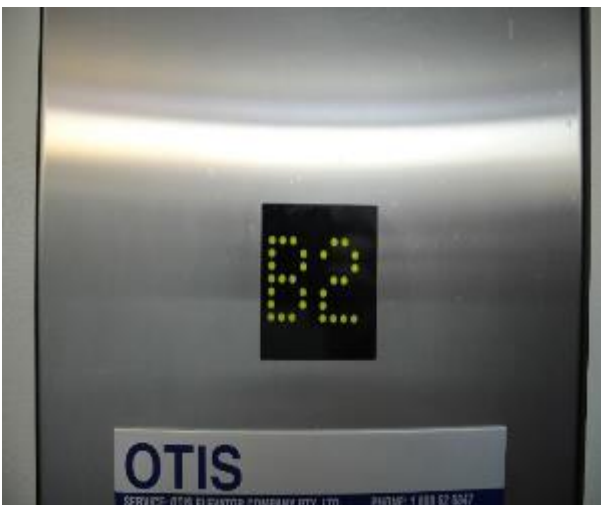
Figure 433 - The following images display the condition of basement B2 fire stairs

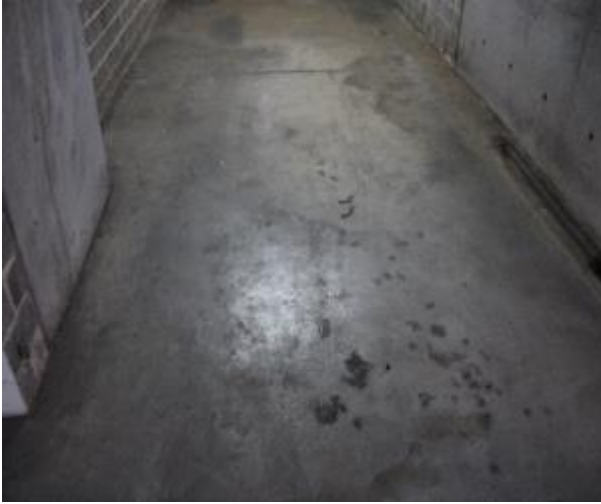
Figure 435 - General condition of basement B2 fire stairs pavement slab

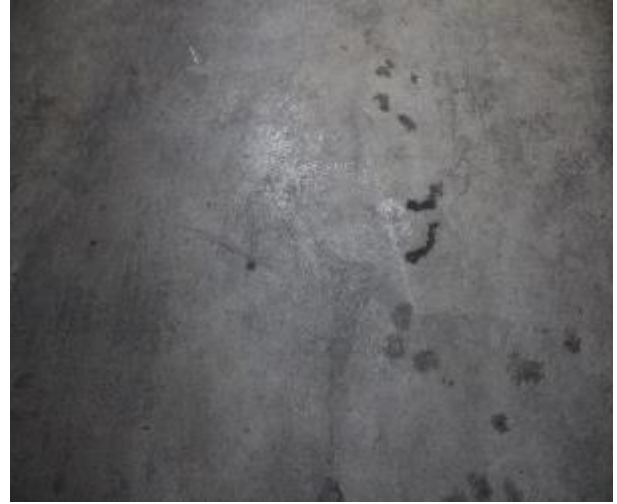
Figure 436 - Crack propagation through basement B2 fire stairs pavement slab

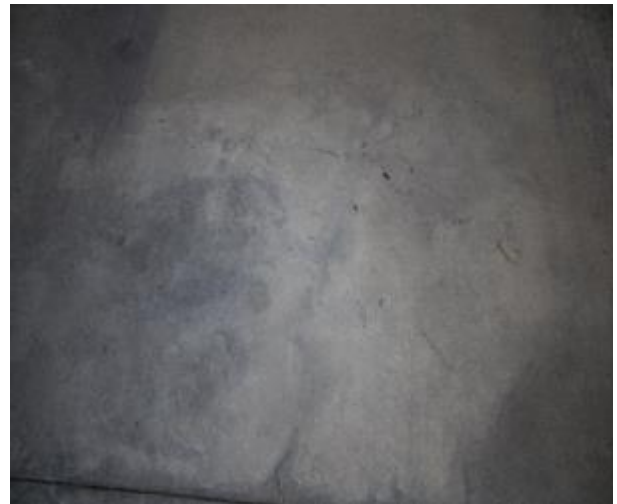
Figure 438 - General condition of basement B2 fire stairs pavement slab

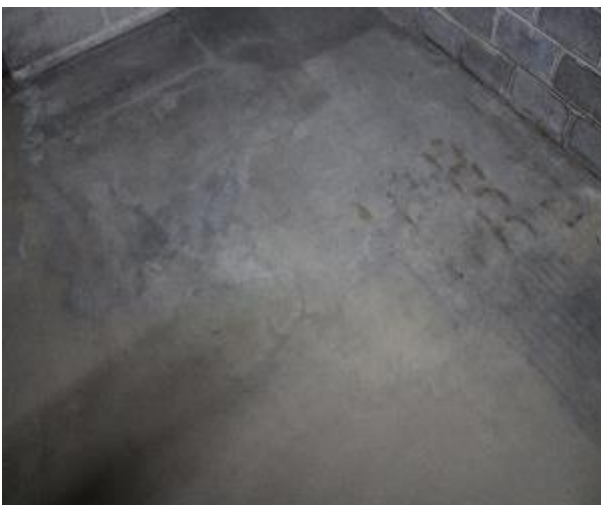
Figure 439 - General condition of basement B2 fire stairs pavement slab

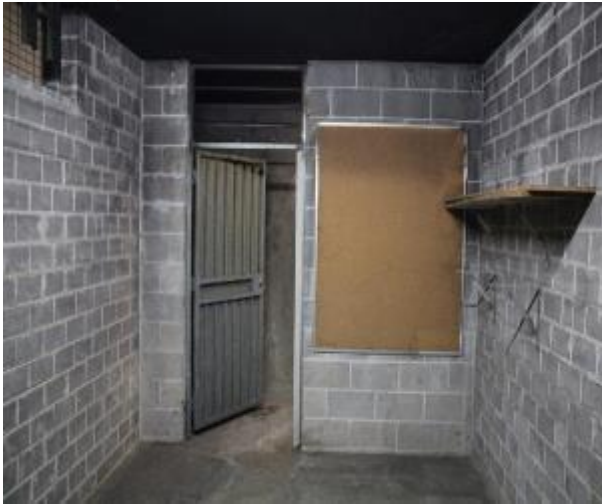
Figure 441 - General condition of basement B2 fire stairs internal wall

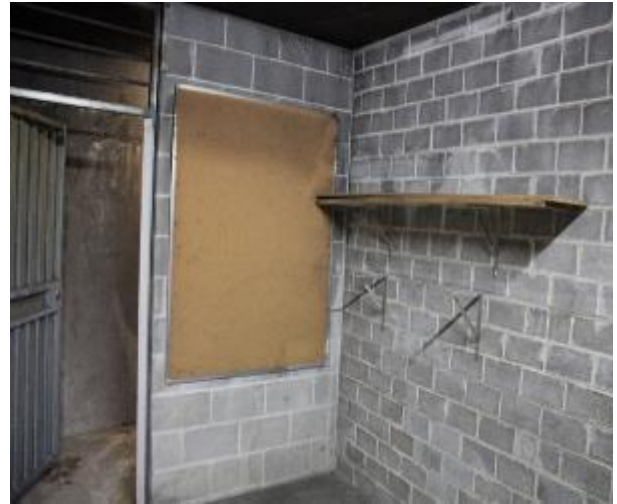
Figure 442 - General condition of basement B2 fire stairs internal wall

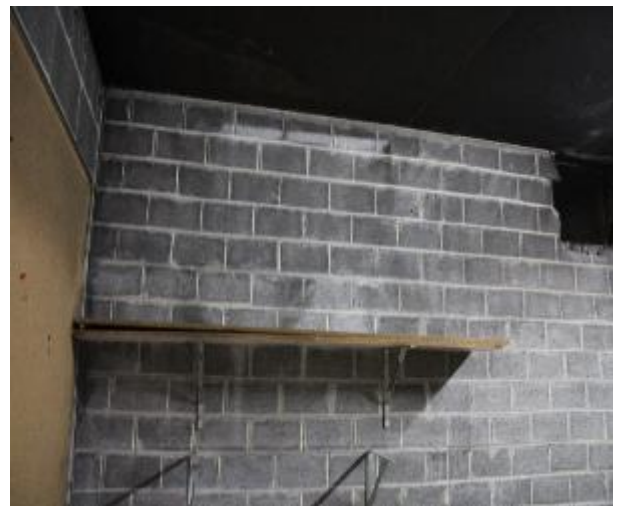
Figure 444 - General condition of basement B2 fire stairs internal wall

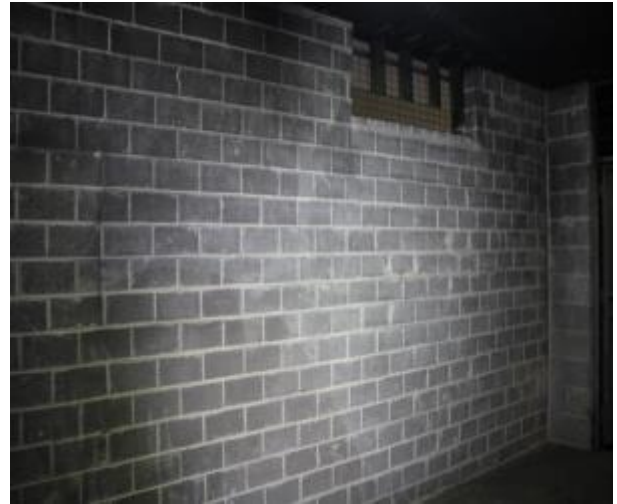
Figure 448 - General condition of basement B2 fire stairs internal wall

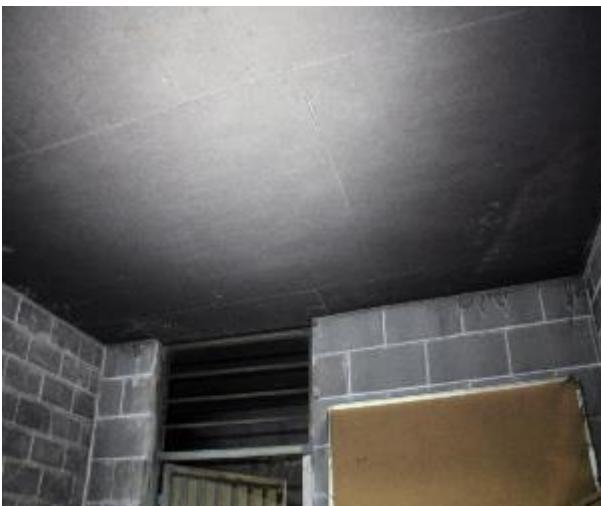
Figure 449 - General condition of basement B2 fire stairs underside slab

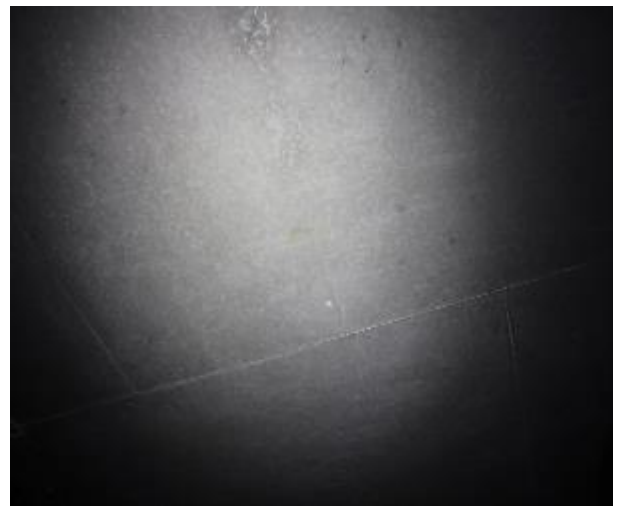
Figure 450 - Crack propagation through basement B2 fire stairs underside slab

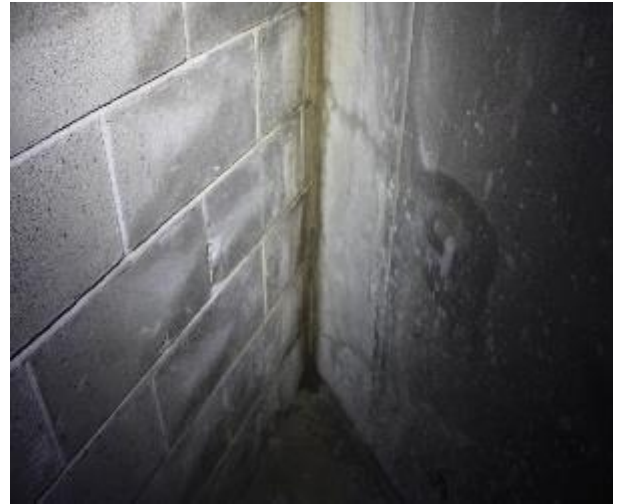
Figure 460 - Water damage evident through basement B2 fire stairs internal wall

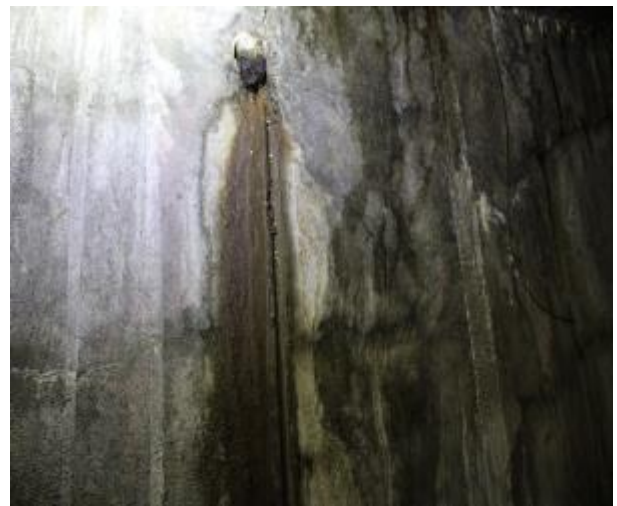
Figure 467 - Water damage evident through basement B2 fire stairs internal wall

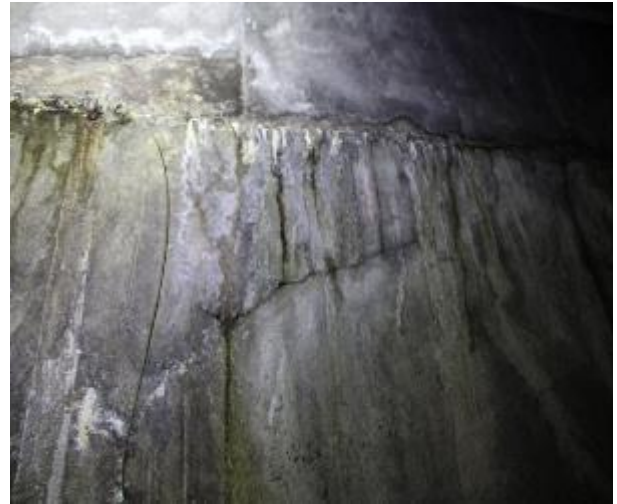
Figure 472 - Crack propagation and water damage through basement B2 fire stairs internal wall

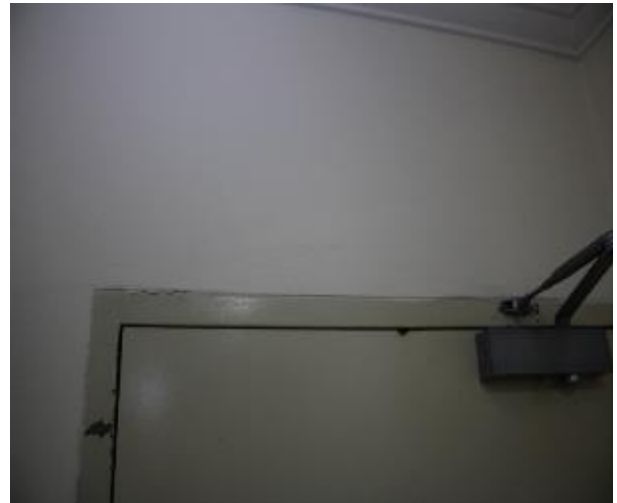
Figure 487 - Crack propagation through open kitchen/ lounge room internal wall

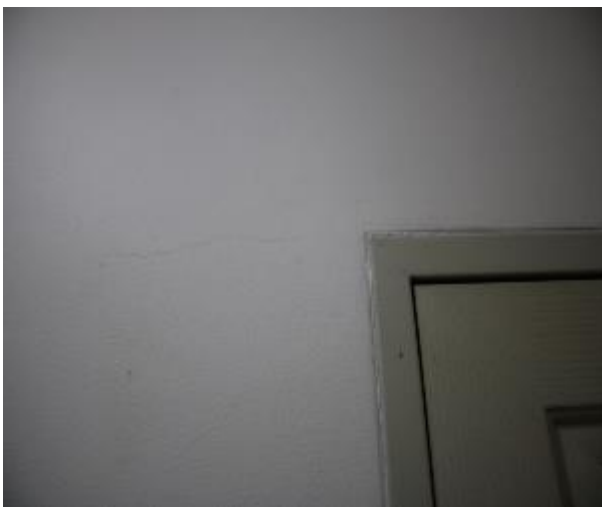
Figure 488 - Crack propagation through open kitchen/ lounge room internal wall

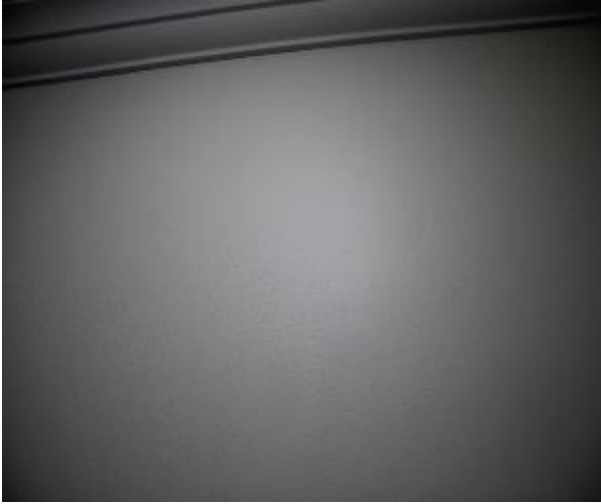
Figure 490 - Crack propagation through open kitchen/ lounge room internal wall

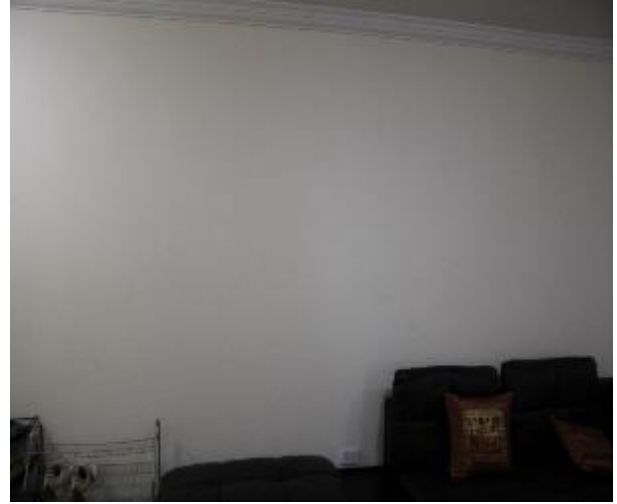
Figure 491 - General condition of open kitchen/ lounge room internal wall

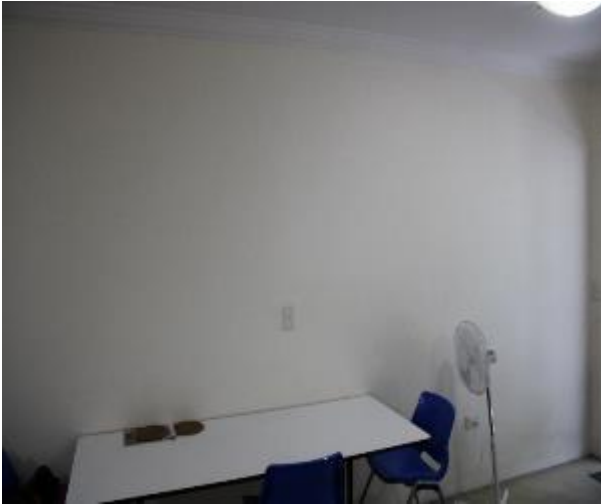
Figure 492 - General condition of open kitchen/ lounge room internal wall

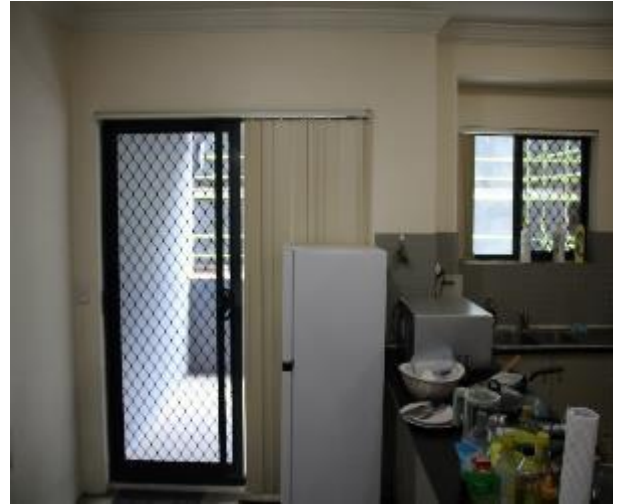
Figure 493 - General condition of open kitchen/ lounge room internal wall

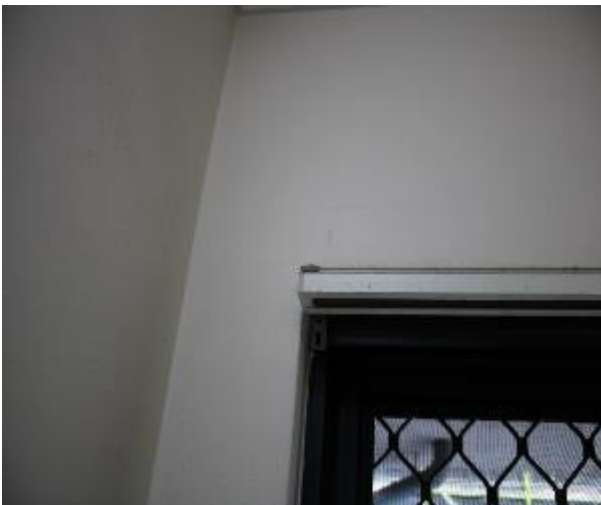
Figure 494 - Crack propagation through open kitchen/ lounge room internal wall

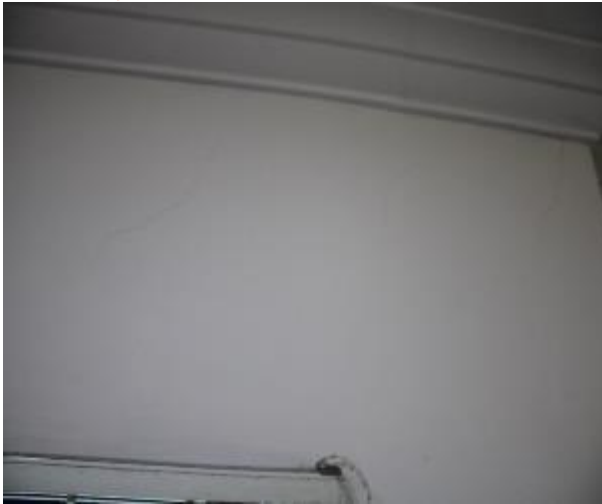
Figure 496 - Crack propagation through open kitchen/ lounge room internal wall

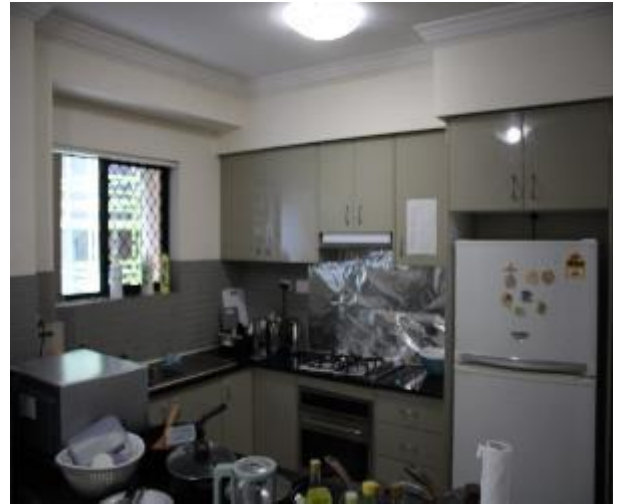
Figure 497 - General condition of open kitchen/ lounge room internal wall

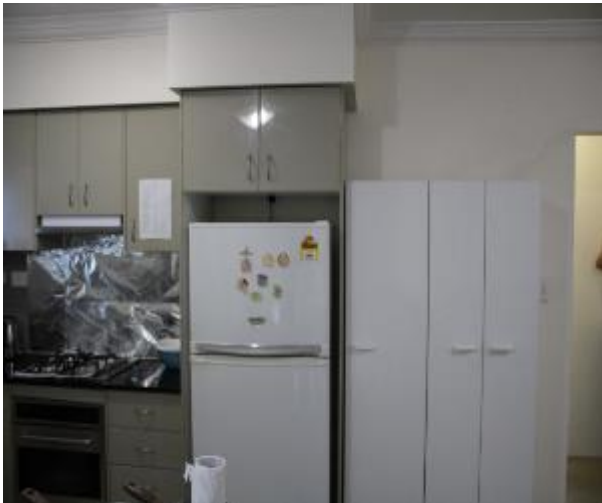
Figure 498 - General condition of open kitchen/ lounge room internal wall

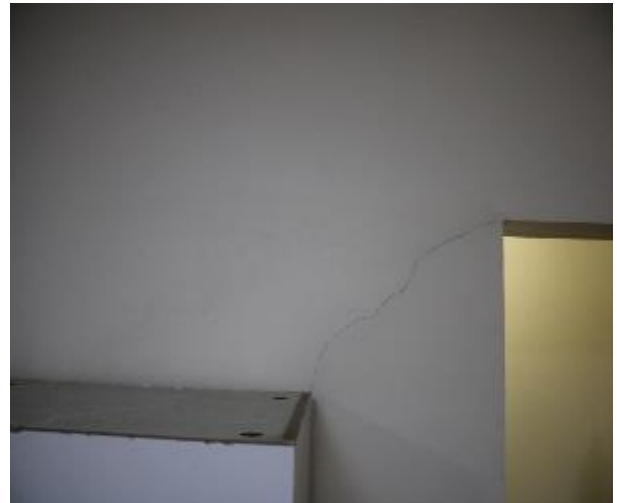
Figure 499 - Crack propagation through open kitchen/ lounge room internal wall

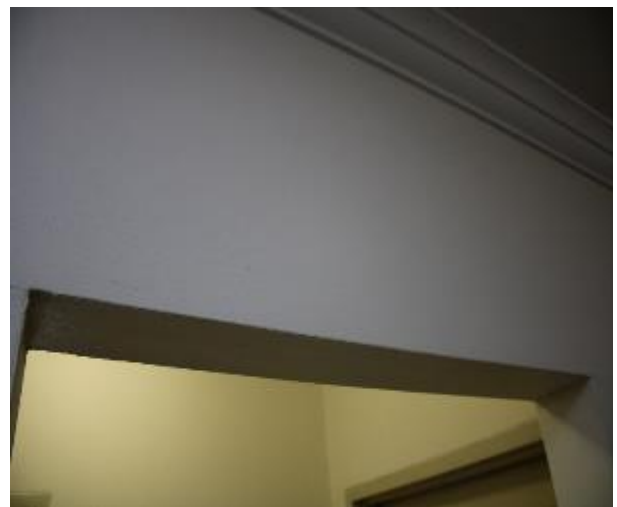
Figure 501 - General condition of open kitchen/ lounge room internal wall

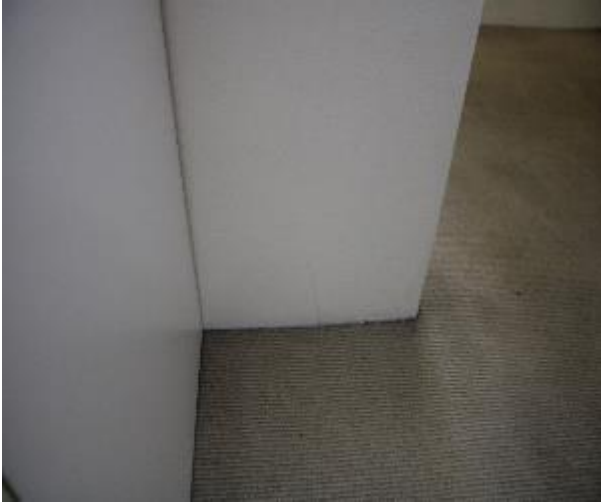
Figure 502 - Crack propagation through open kitchen/ lounge room internal wall

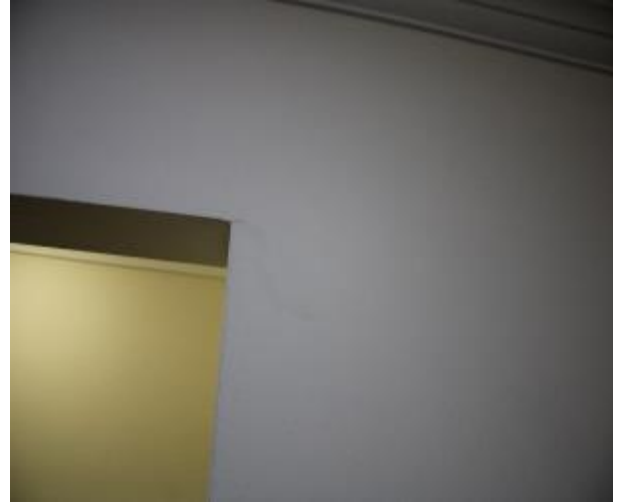
Figure 503 - Crack propagation through open kitchen/ lounge room internal wall

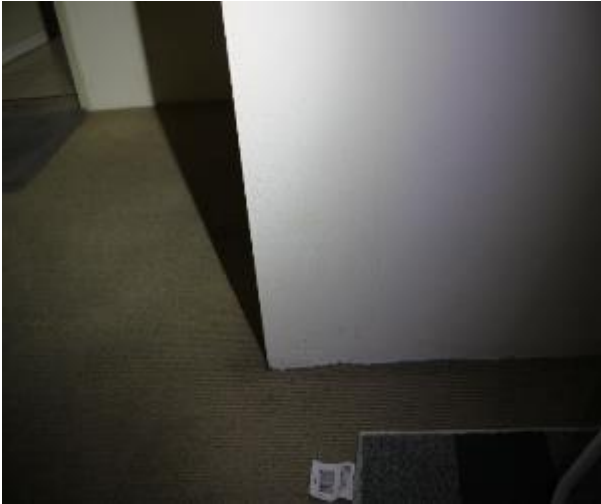
Figure 504 - General condition of open kitchen/ lounge room internal wall

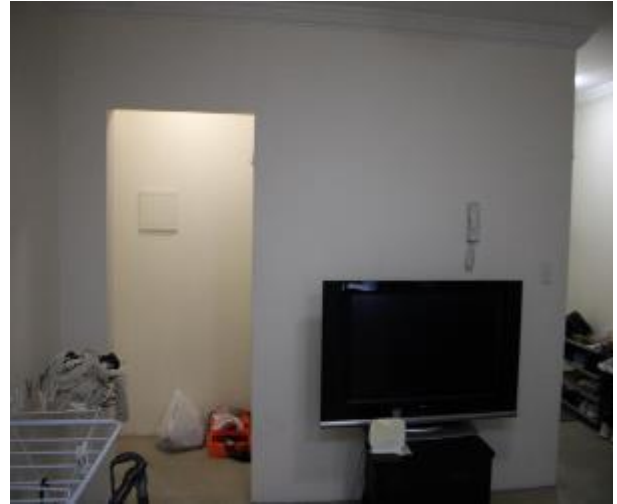
Figure 505 - General condition of open kitchen/ lounge room internal wall

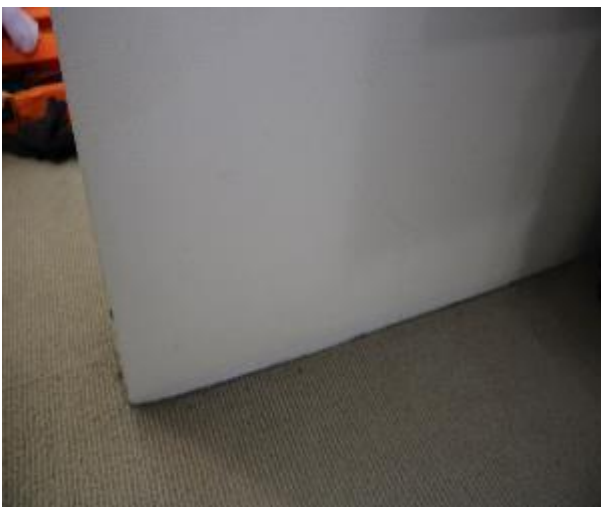
Figure 506 - Crack propagation through open kitchen/ lounge room internal wall

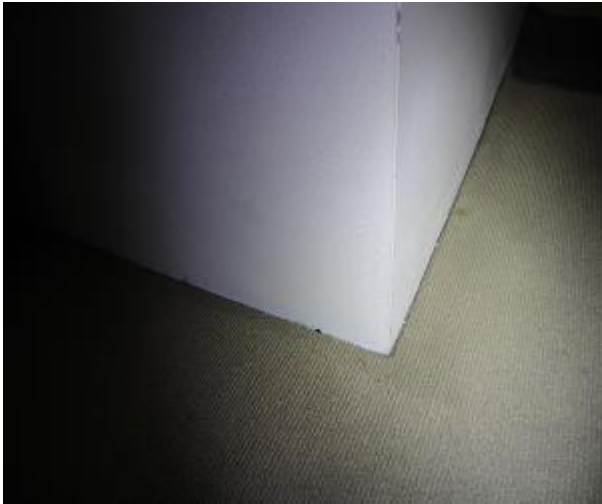
Figure 508 - General condition of open kitchen/ lounge room internal wall

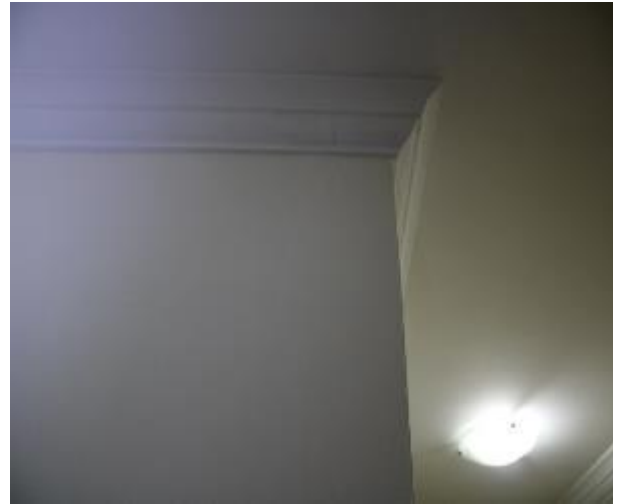
Figure 509 - Crack propagation through open kitchen/ lounge room internal wall
