# **Pre-Dilapidation Report**

**19 GEORGE STREET**

**REAR BUILDING (UNITS 20-29)**

Project Reference: 20250047.19G.3

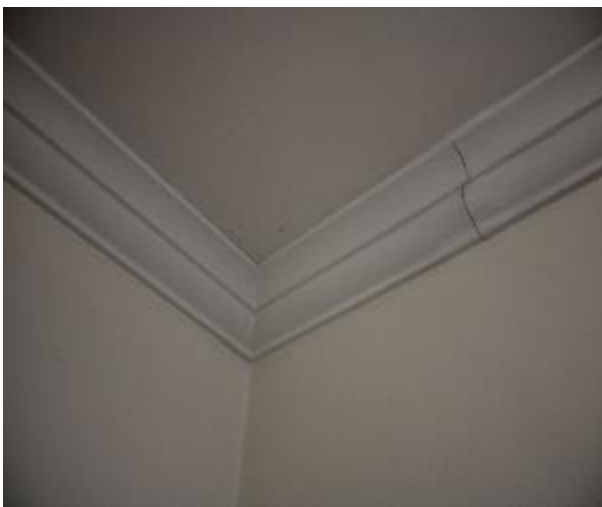
Figure 512 - Crack propagation through open kitchen/ lounge room ceiling

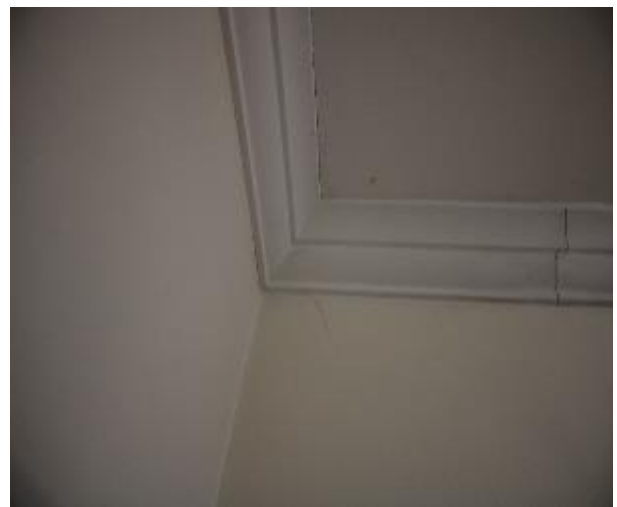
Figure 513 - Crack propagation through open kitchen/ lounge room ceiling

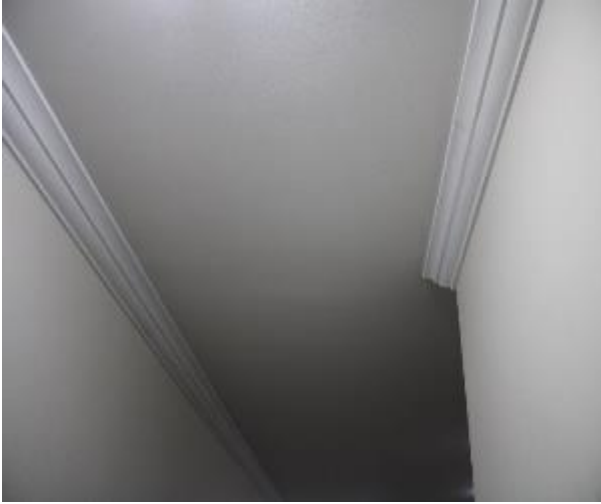
Figure 514 - General condition of open kitchen/  
lounge room ceiling

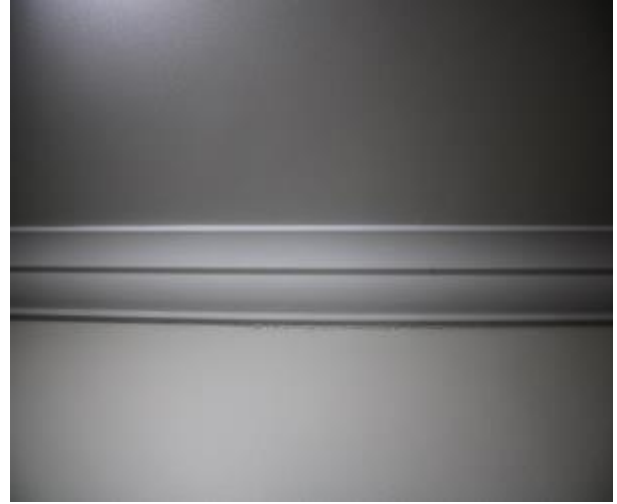
Figure 515 - Crack propagation through open  
kitchen/ lounge room ceiling

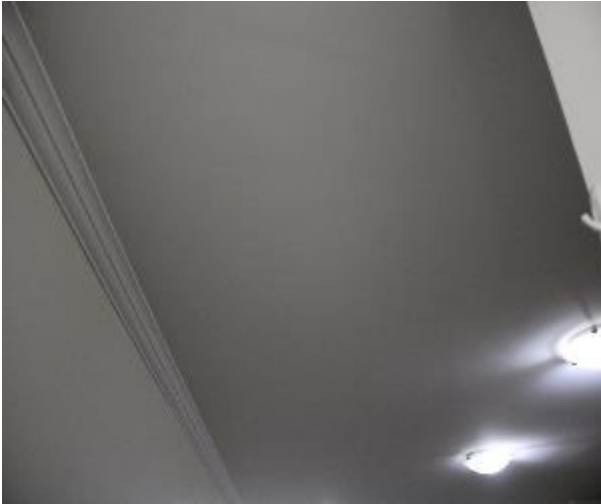
Figure 516 - General condition of open kitchen/  
lounge room ceiling

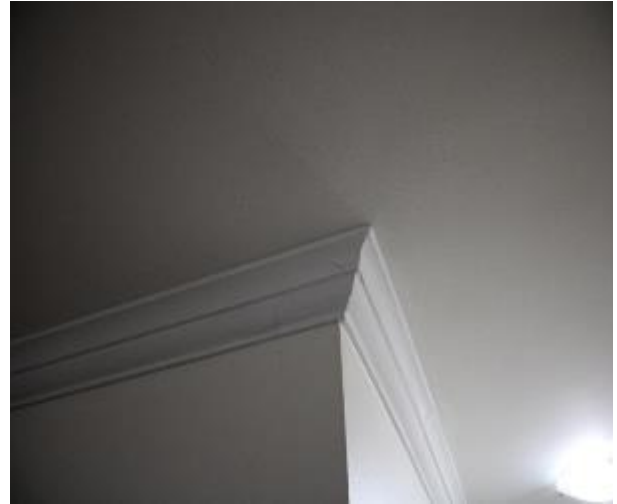
Figure 517 - Crack propagation through open  
kitchen/ lounge room ceiling

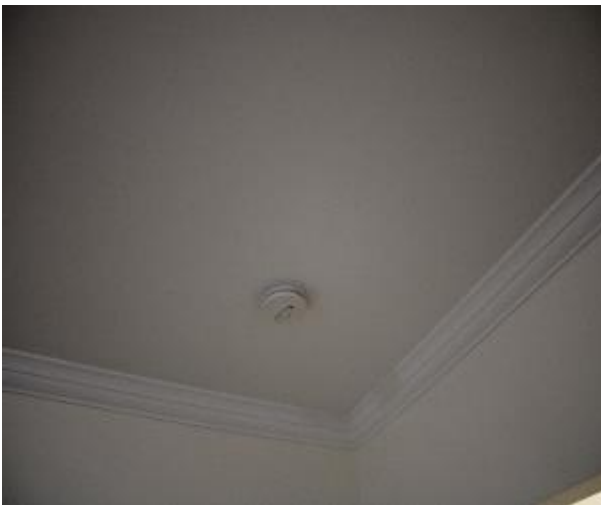
Figure 518 - General condition of open kitchen/  
lounge room ceiling

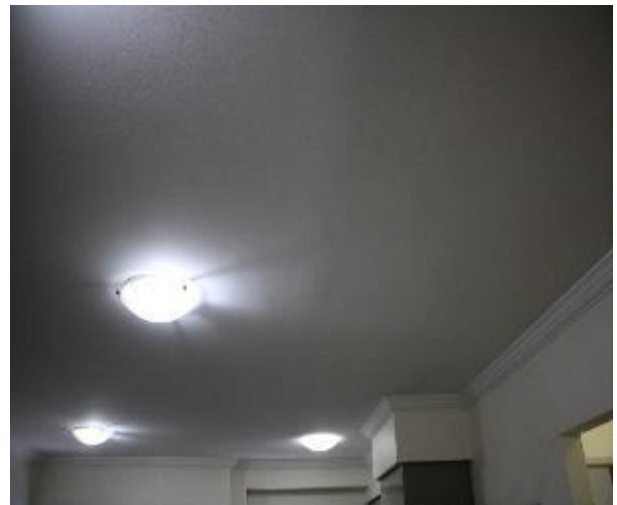
Figure 519 - General condition of open kitchen/  
lounge room ceiling

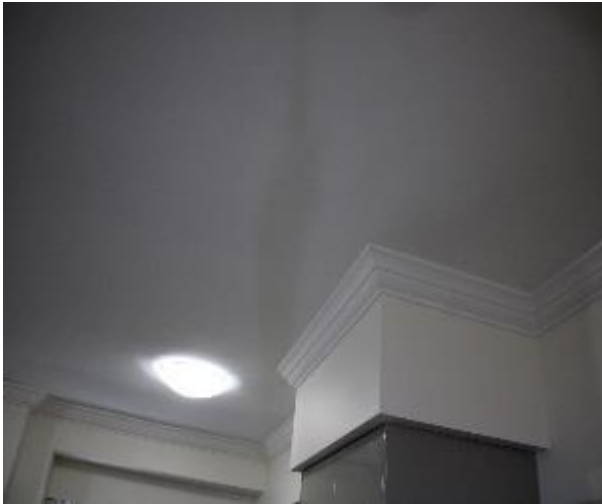
Figure 520 - General condition of open kitchen/  
lounge room ceiling

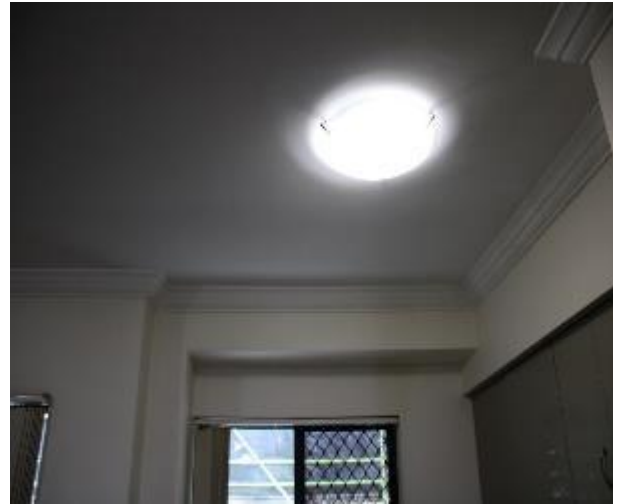
Figure 521 - General condition of open kitchen/  
lounge room ceiling

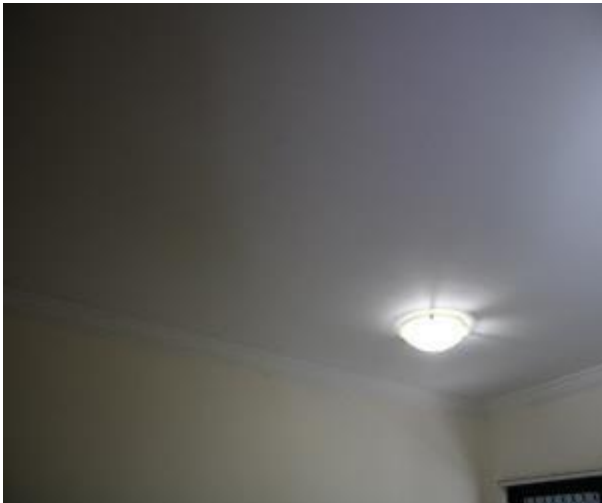
Figure 522 - General condition of open kitchen/  
lounge room ceiling

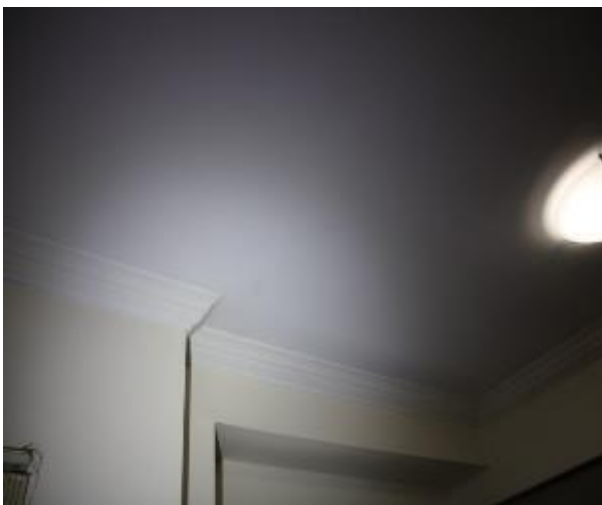
Figure 524 - General condition of open kitchen/  
lounge room ceiling

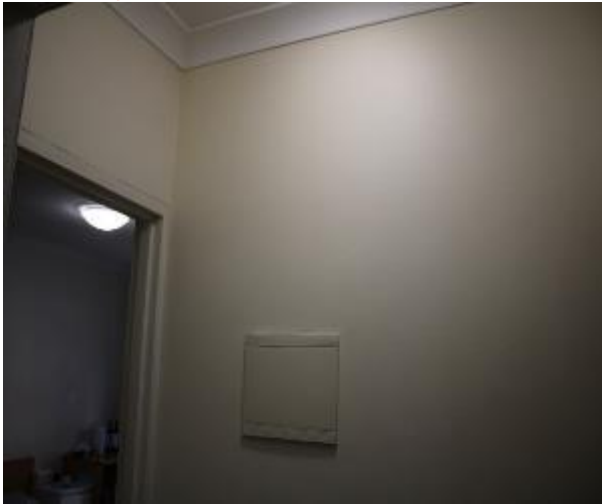
Figure 526 - General condition of corridor internal wall

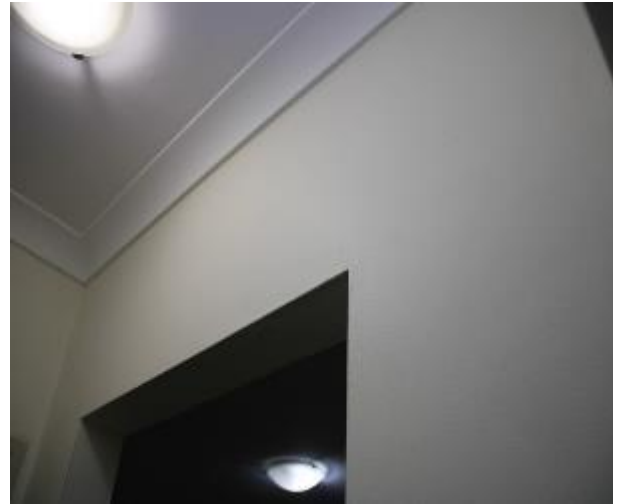
Figure 527 - General condition of corridor internal wall

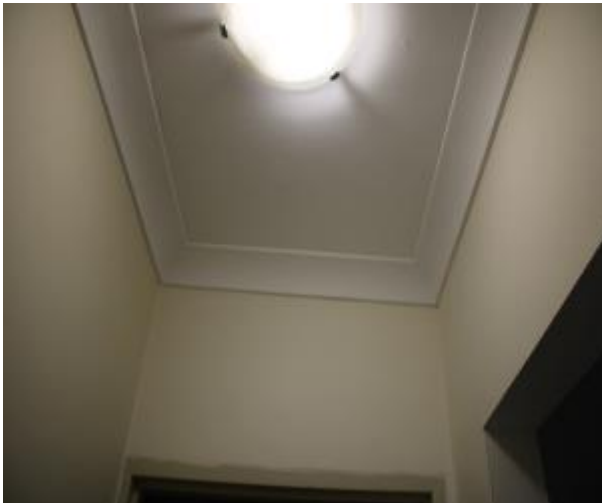
Figure 528 - General condition of corridor ceiling

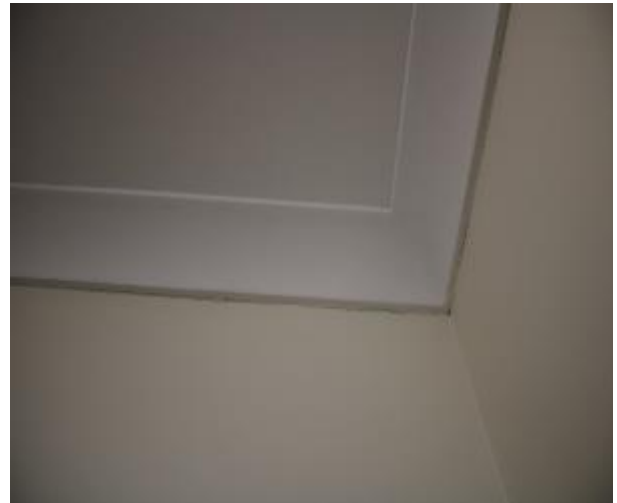
Figure 529 - Crack propagation through corridor ceiling

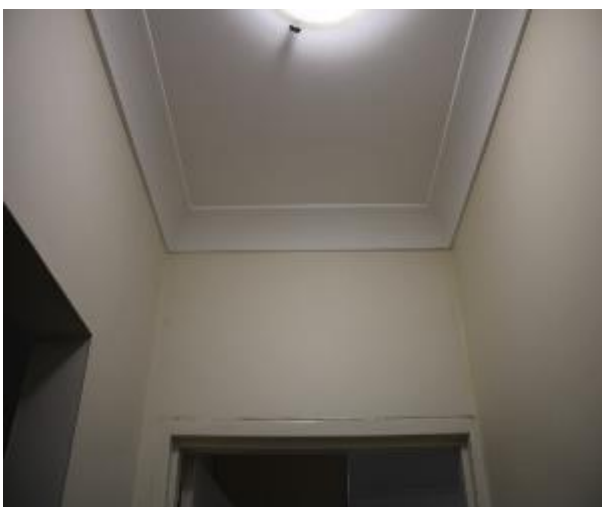
Figure 530 - General condition of corridor ceiling

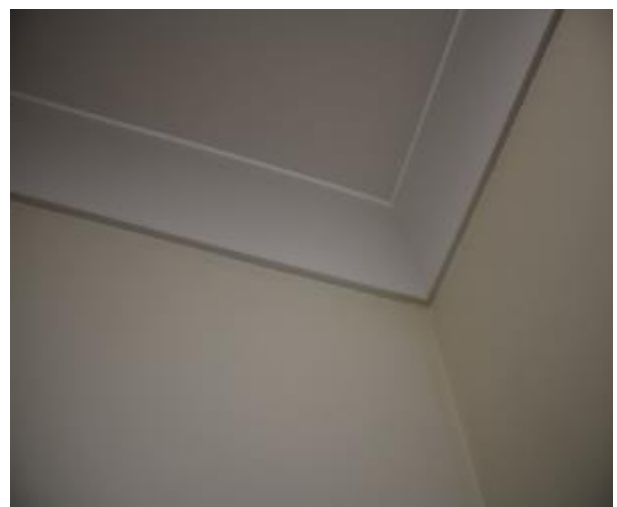
Figure 531 - Crack propagation through corridor ceiling

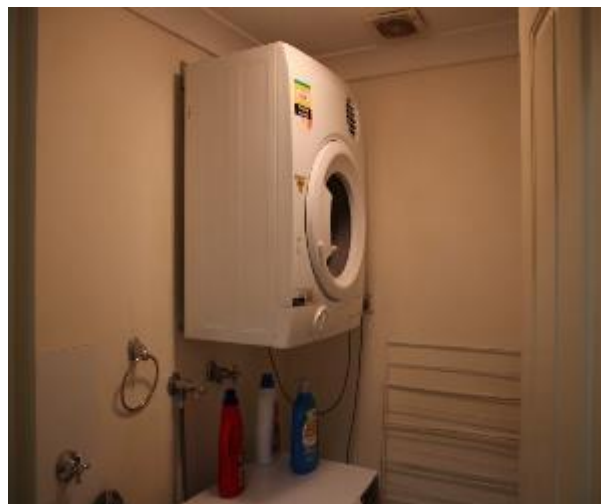
Figure 533 - General condition of laundry internal wall

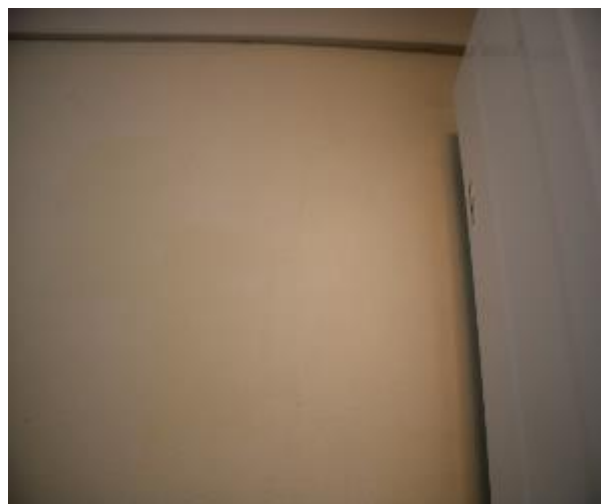
Figure 535 - Crack propagation through laundry internal wall

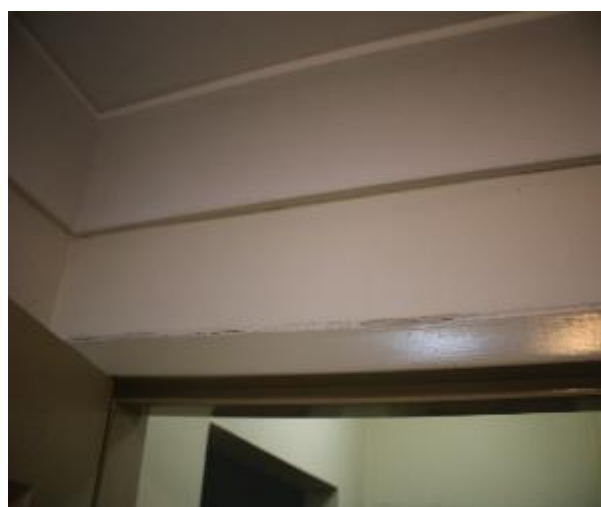
Figure 537 - Crack propagation through laundry internal wall

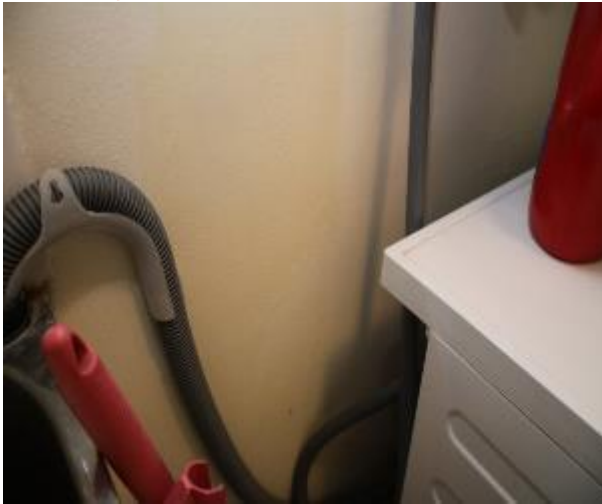
Figure 538 - General condition of laundry internal wall

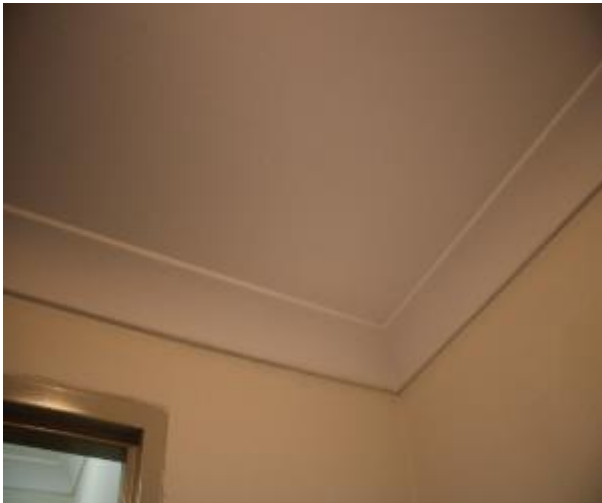
Figure 540 - General condition of laundry ceiling

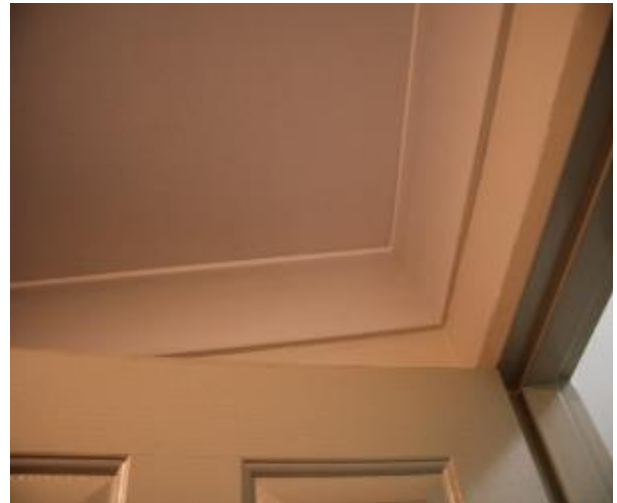
Figure 541 - General condition of laundry ceiling

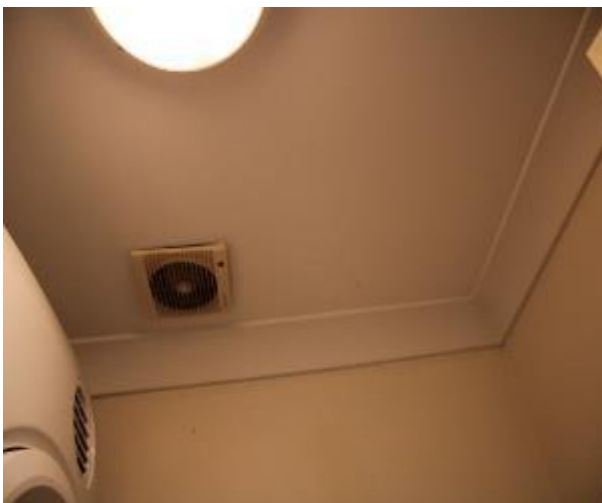
Figure 542 - General condition of laundry ceiling

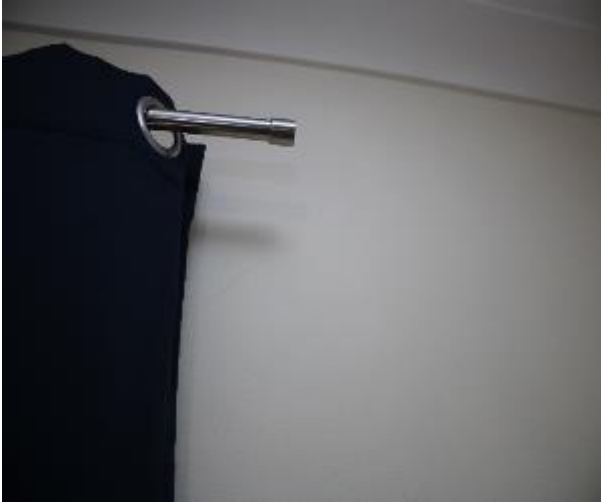
Figure 544 - Crack propagation through bedroom 1 internal wall

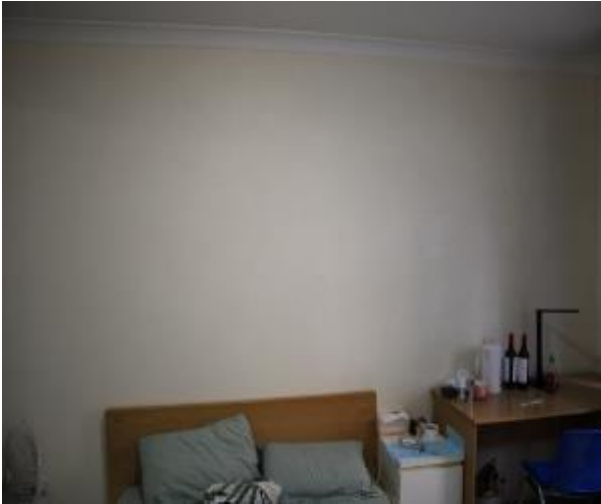
Figure 546 - General condition of bedroom 1 internal wall

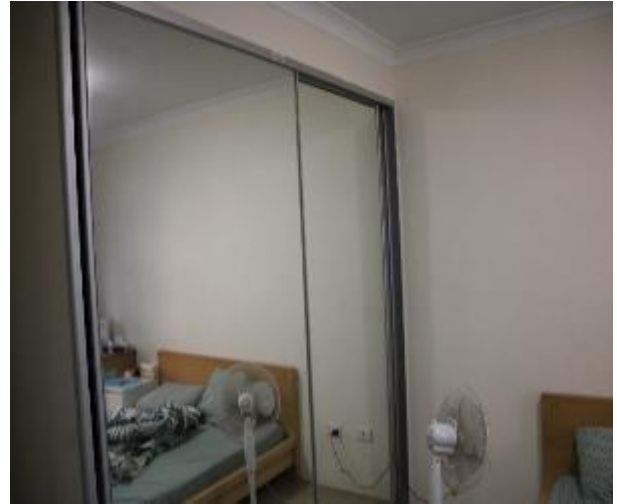
Figure 547 - General condition of bedroom 1 internal wall

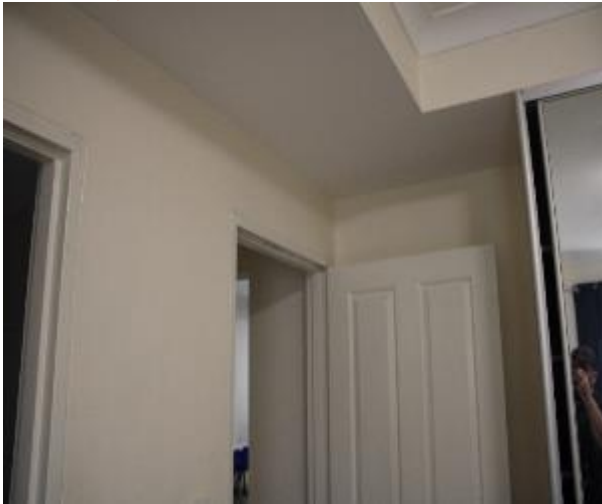
Figure 550 - General condition of bedroom 1 internal wall

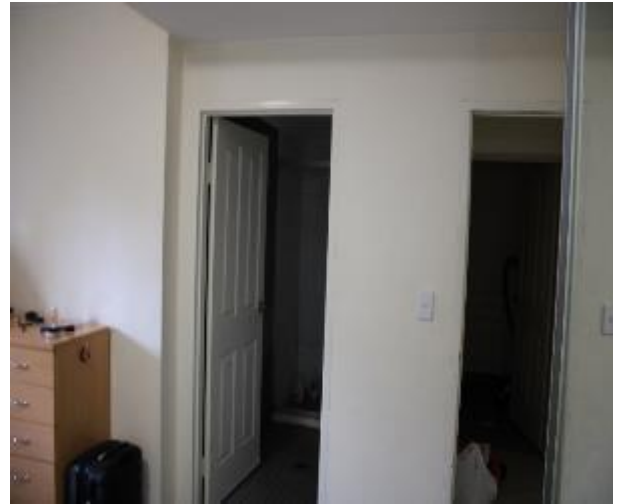
Figure 551 - General condition of bedroom 1 internal wall

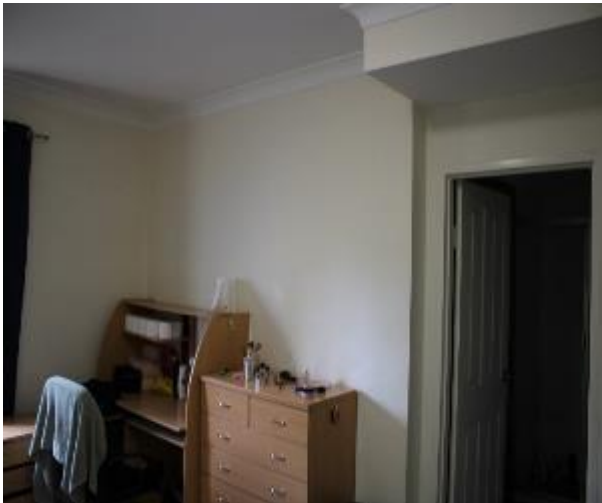
Figure 552 - General condition of bedroom 1 internal wall

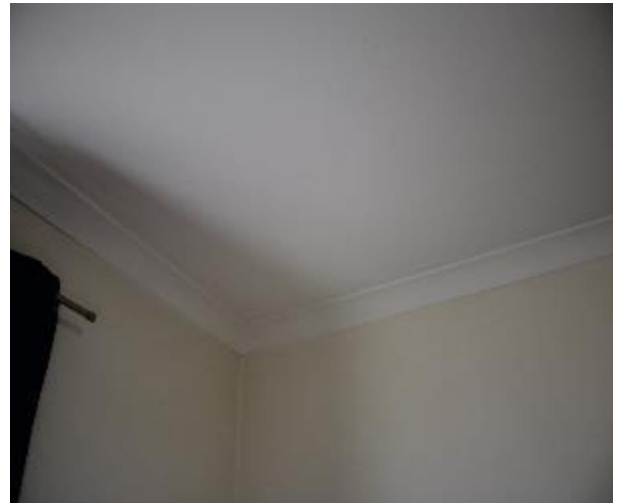
Figure 553 - General condition of bedroom 1 ceiling

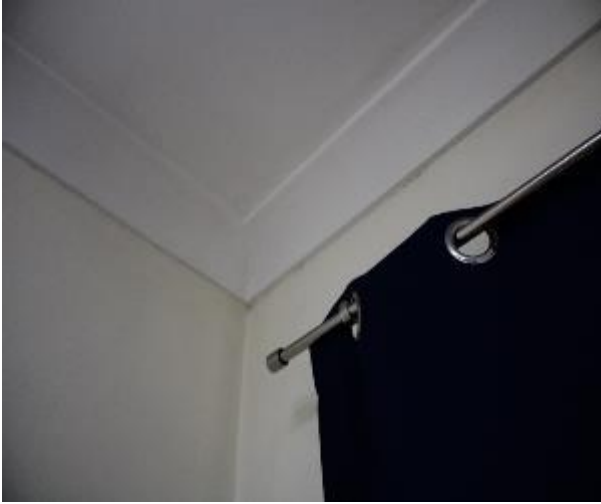
Figure 556 - Crack propagation through bedroom 1 ceiling

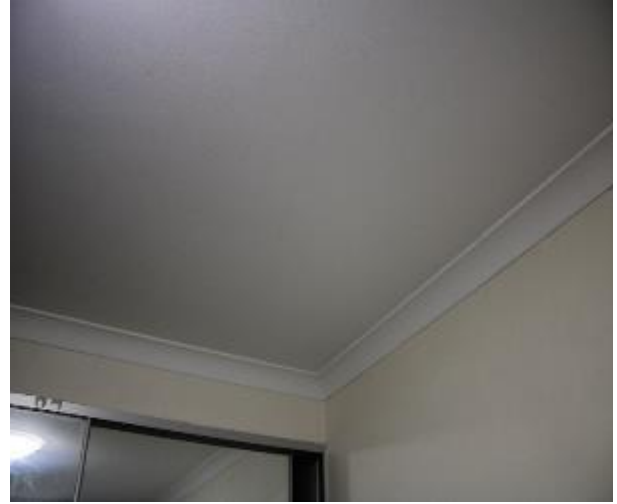
Figure 557 - General condition of bedroom 1 ceiling

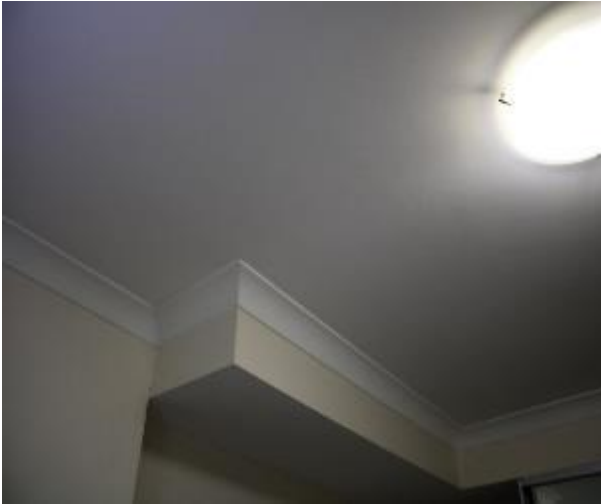
Figure 558 - General condition of bedroom 1 ceiling

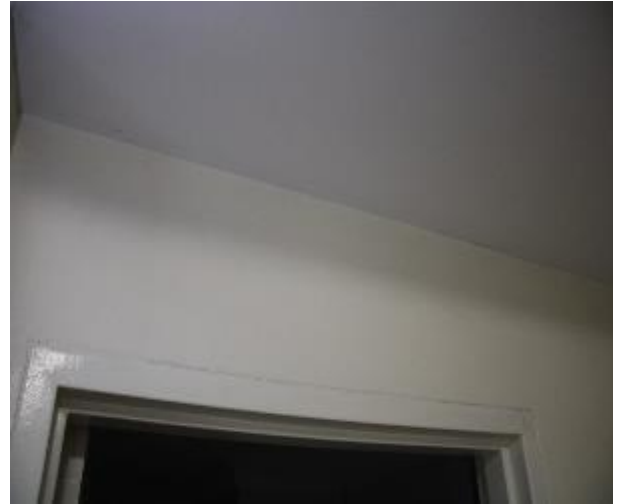
Figure 559 - General condition of bedroom 1 ceiling

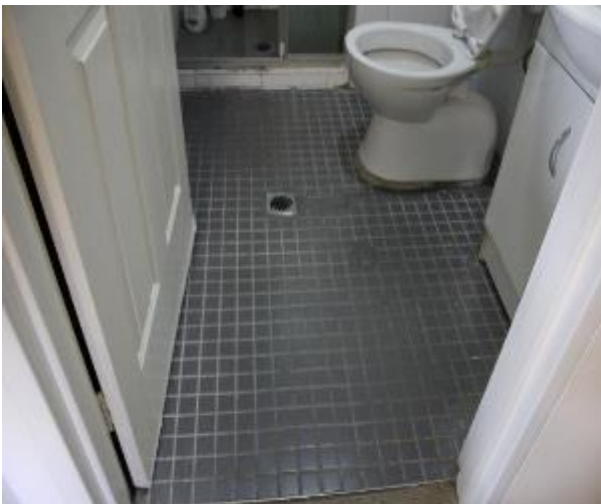
Figure 560 - General condition of ensuite bathroom floor tiles

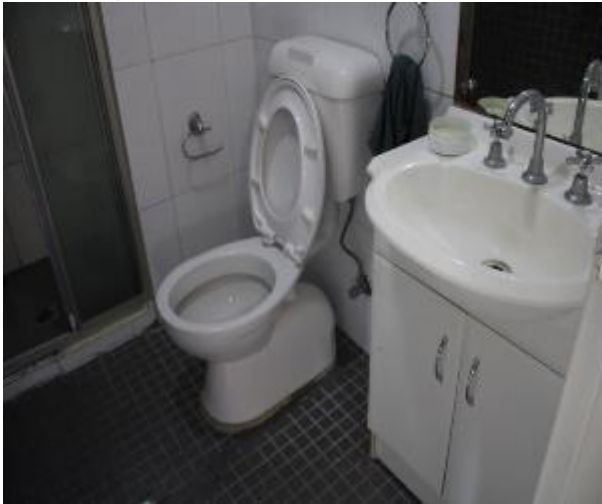
Figure 562 - General condition of ensuite bathroom internal wall

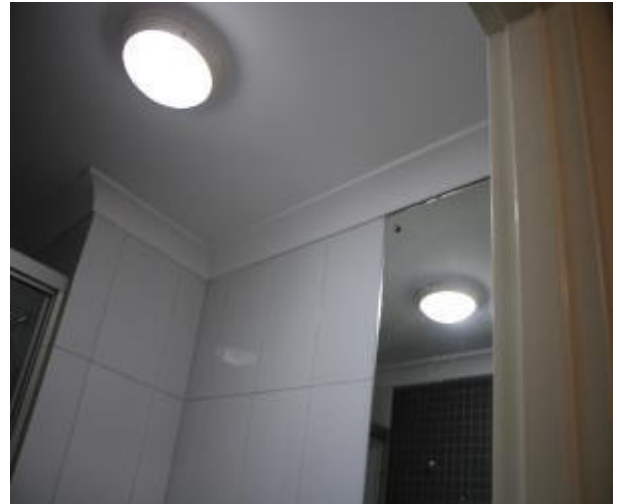
Figure 563 - General condition of ensuite bathroom internal wall

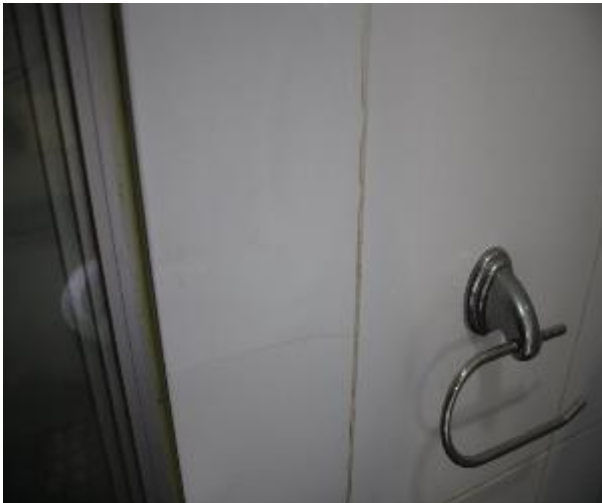
Figure 564 - Crack propagation through ensuite bathroom internal wall

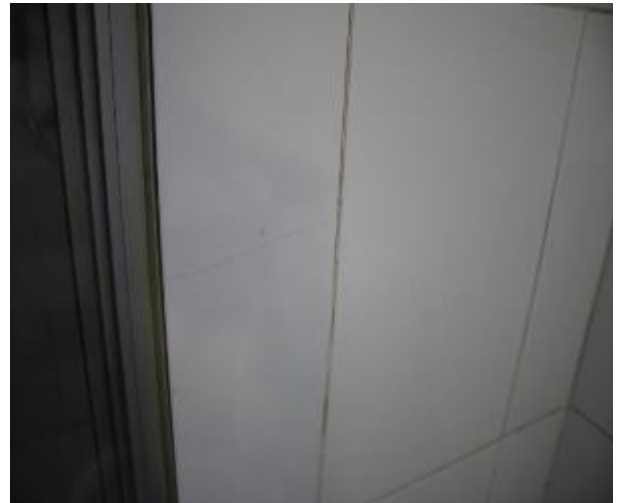
Figure 565 - Crack propagation through ensuite bathroom internal wall

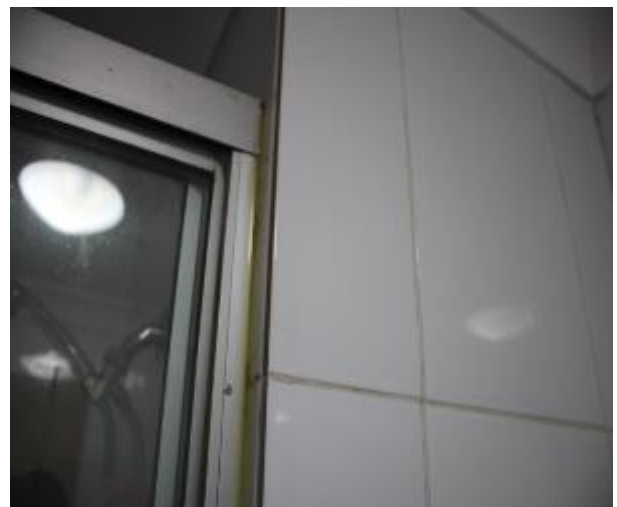
Figure 567 - Crack propagation through ensuite bathroom internal wall

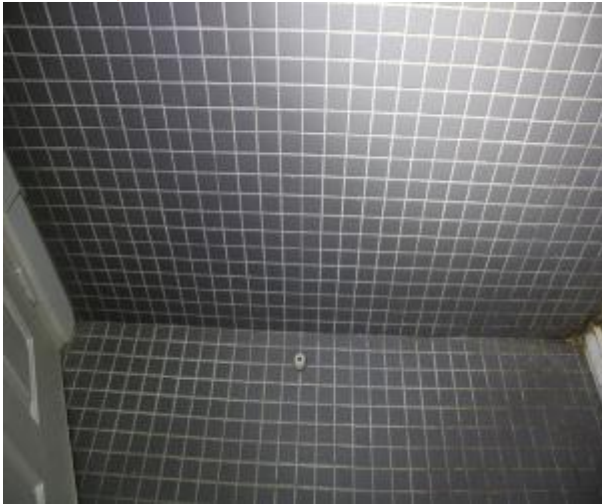
Figure 568 - General condition of ensuite bathroom internal wall

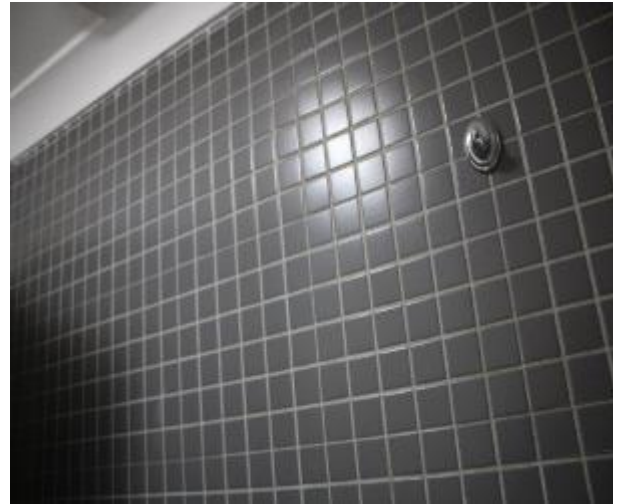
Figure 569 - General condition of ensuite bathroom internal wall

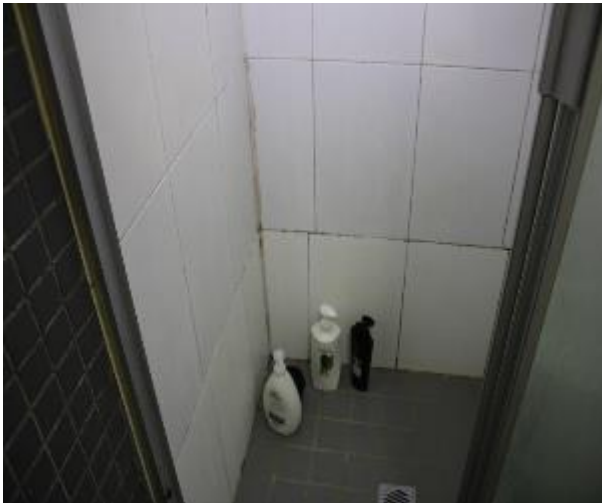
Figure 570 - General condition of ensuite bathroom internal wall

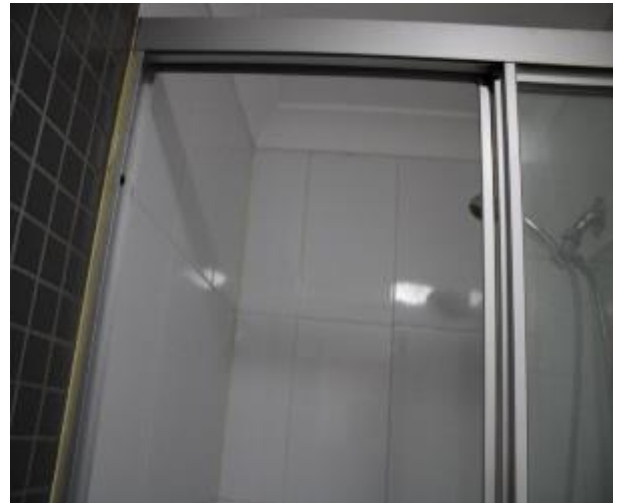
Figure 571 - General condition of ensuite bathroom internal wall

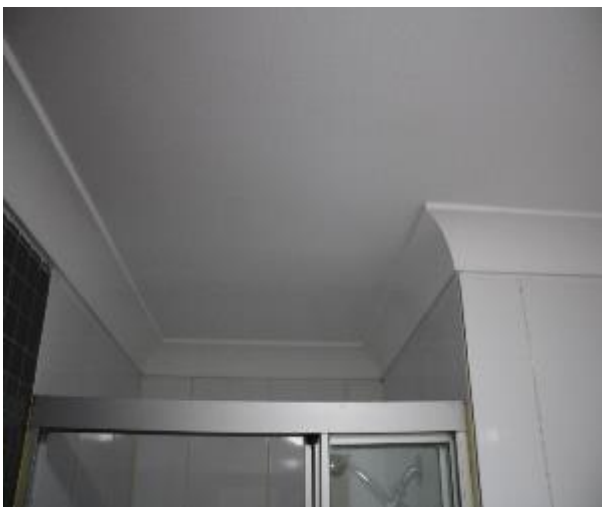
Figure 572 - General condition of ensuite bathroom ceiling

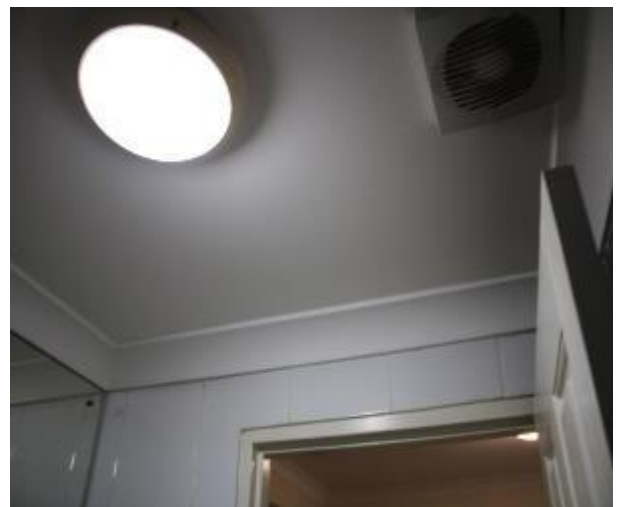
Figure 573 - General condition of ensuite bathroom ceiling

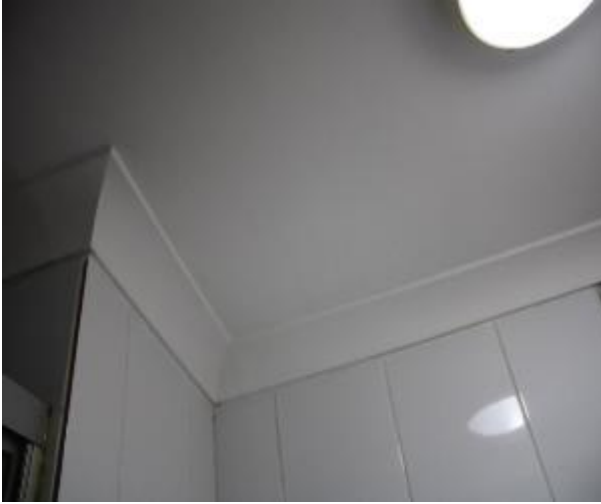
Figure 574 - General condition of ensuite bathroom ceiling

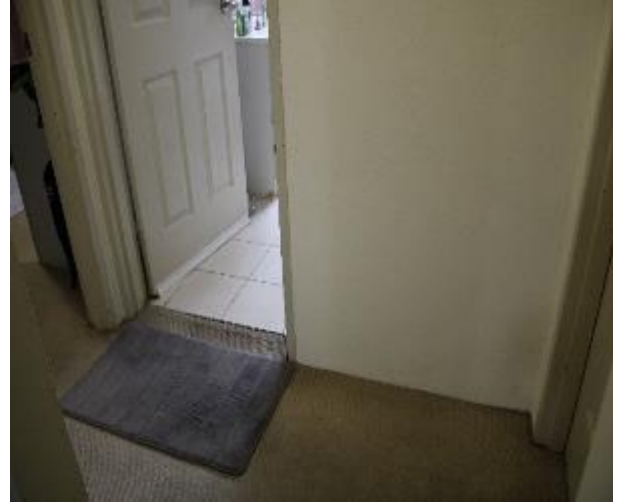
Figure 575 - General condition of corridor internal wall

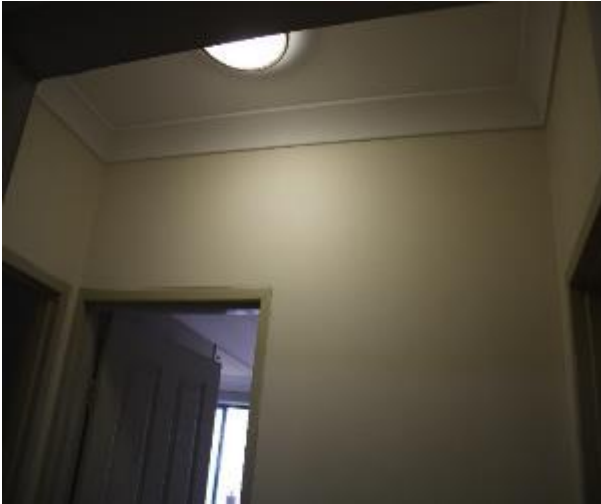
Figure 576 - General condition of corridor internal wall

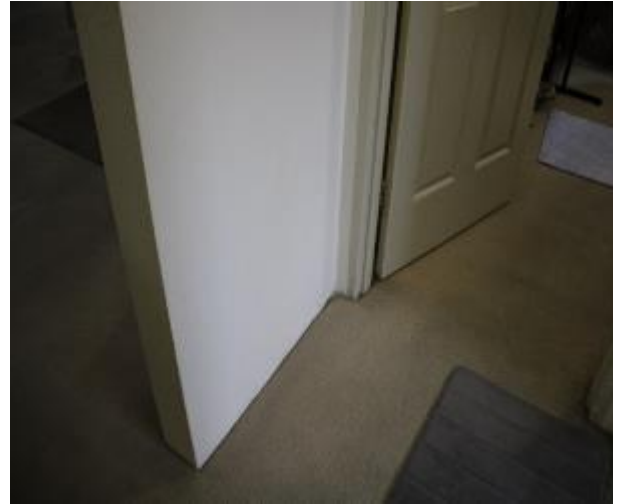
Figure 577 - General condition of corridor internal wall

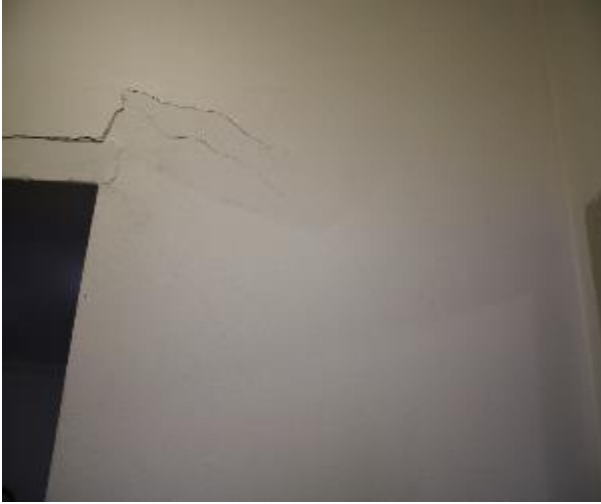
Figure 580 - Crack propagation through corridor internal wall

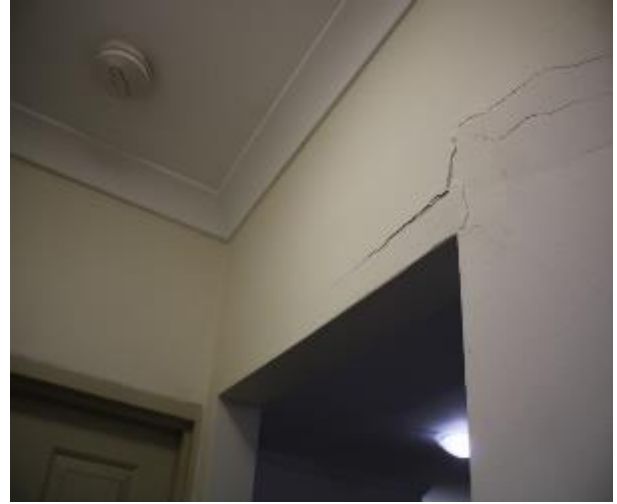
Figure 581 - Crack propagation through corridor internal wall

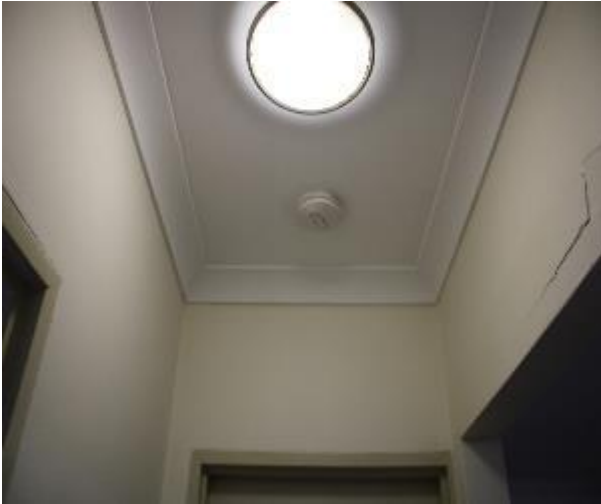
Figure 582 - General condition of corridor ceiling

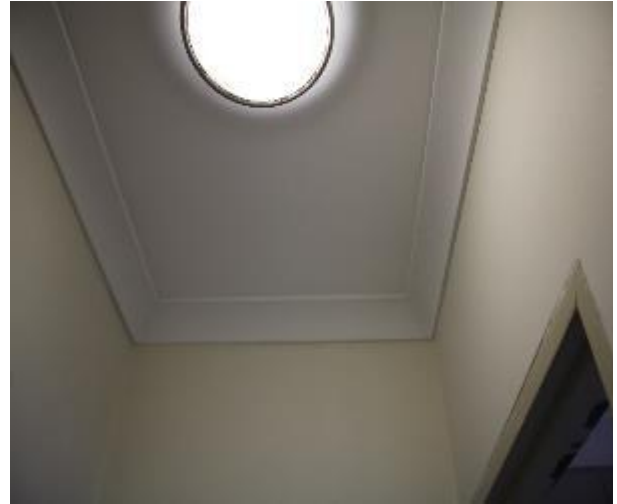
Figure 583 - General condition of corridor ceiling

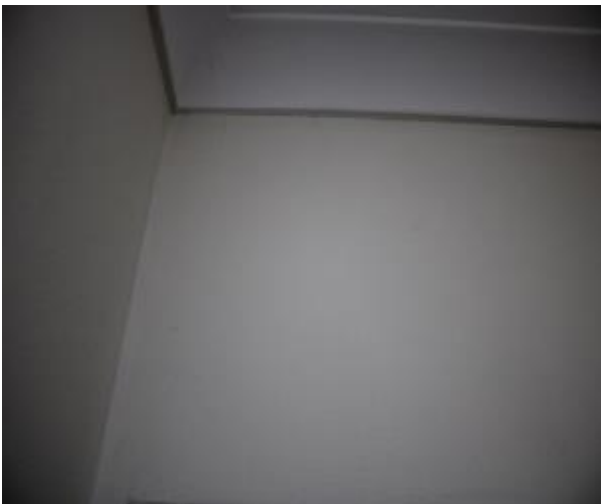
Figure 584 - Crack propagation through corridor internal wall

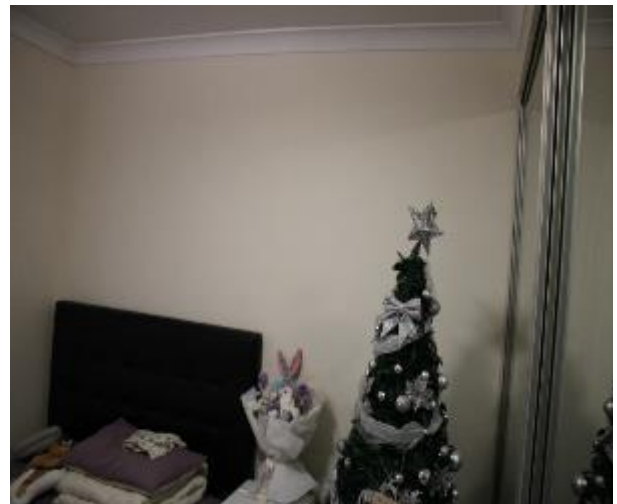
Figure 585 - General condition of bedroom 2 internal wall

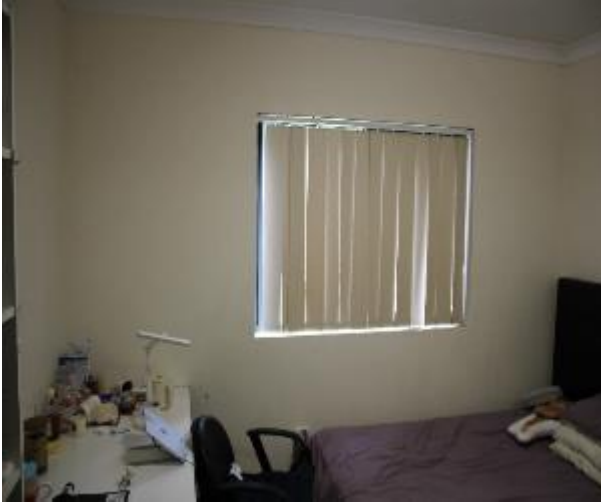
Figure 586 - General condition of bedroom 2 internal wall

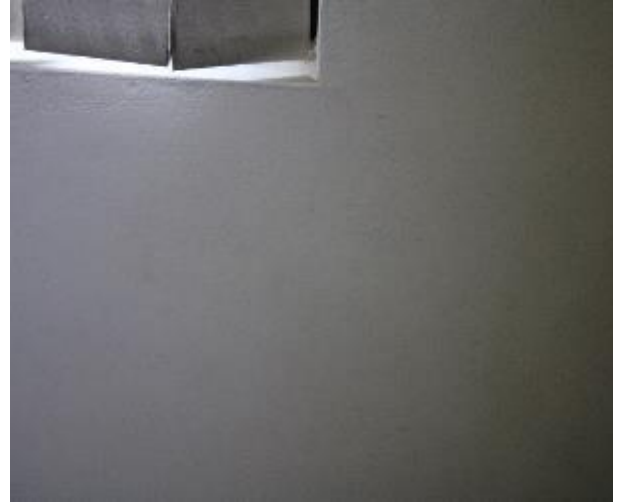
Figure 587 - Crack propagation through bedroom 2 internal wall

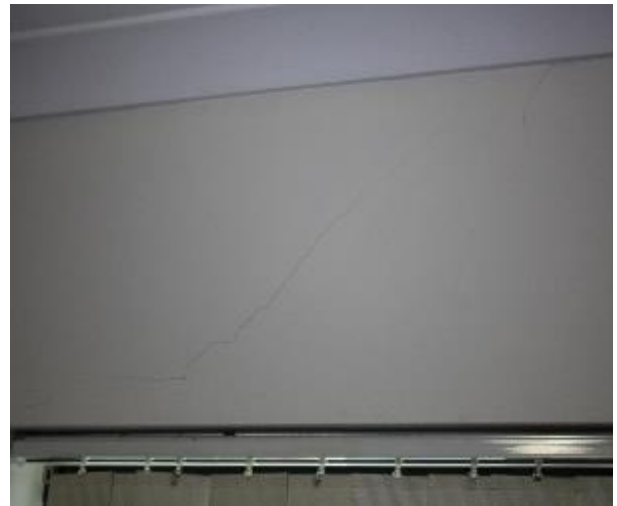
Figure 589 - Crack propagation through bedroom 2 internal wall

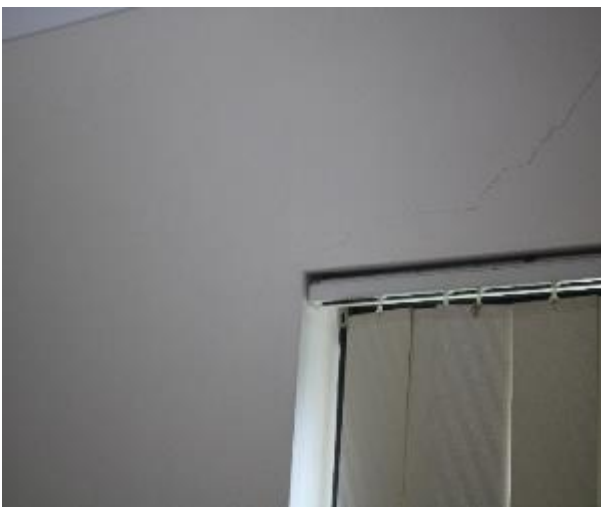
Figure 590 - Crack propagation through bedroom 2 internal wall

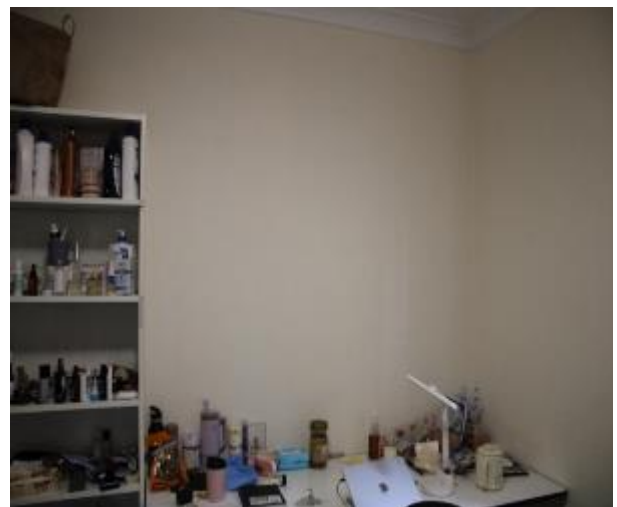
Figure 591 - General condition of bedroom 2 internal wall

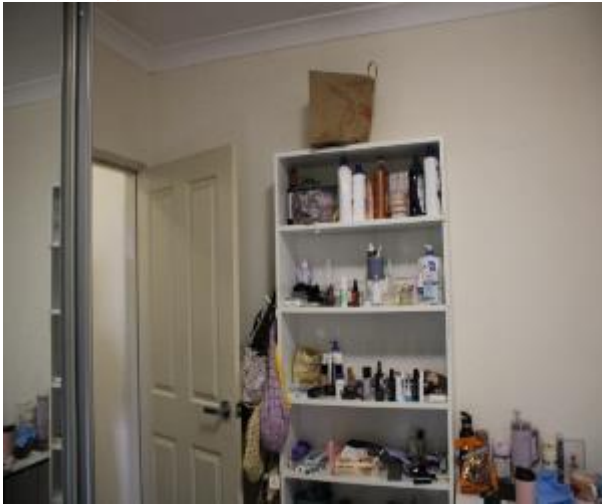
Figure 592 - General condition of bedroom 2 internal wall

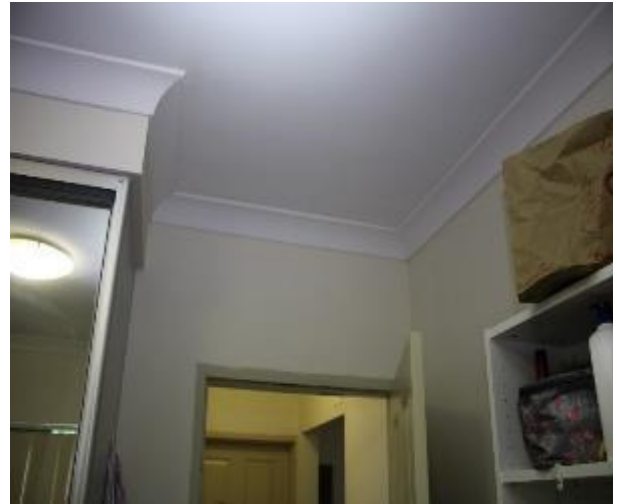
Figure 593 - General condition of bedroom 2 internal wall

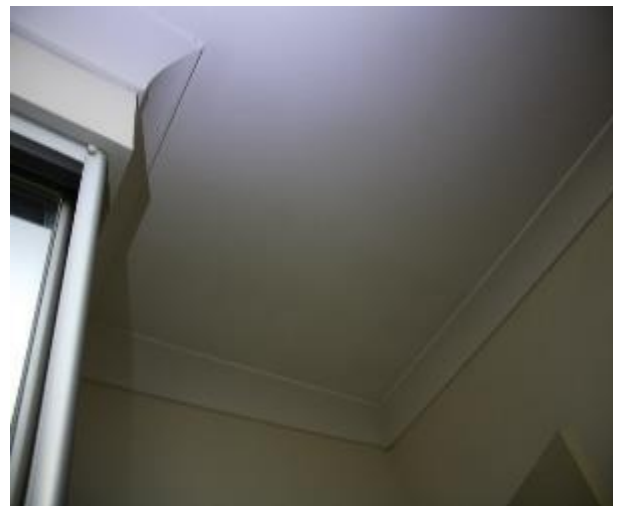
Figure 595 - General condition of bedroom 2 ceiling

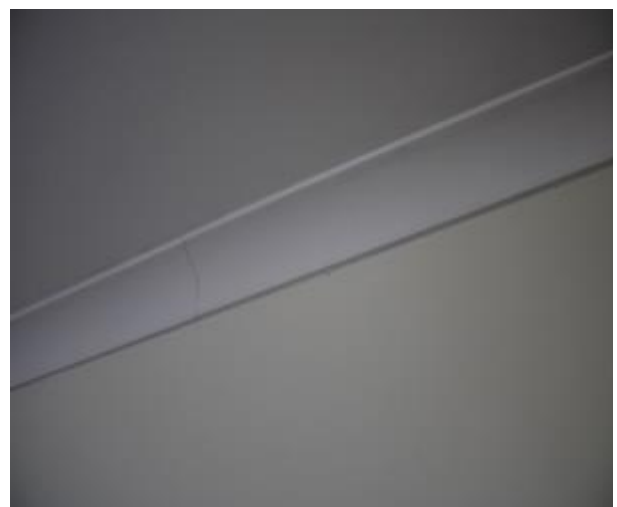
Figure 597 - Crack propagation through bedroom 2 ceiling

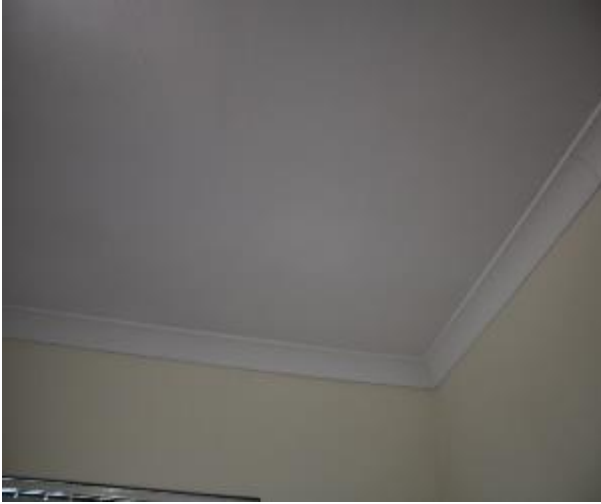
Figure 598 - General condition of bedroom 2 ceiling

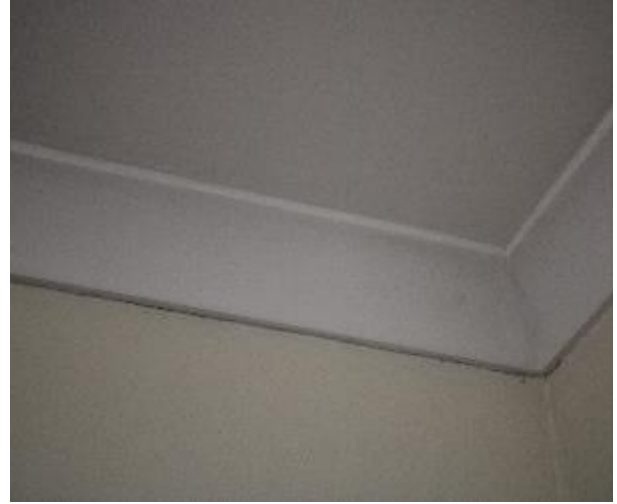
Figure 599 - Crack propagation through bedroom 2 ceiling

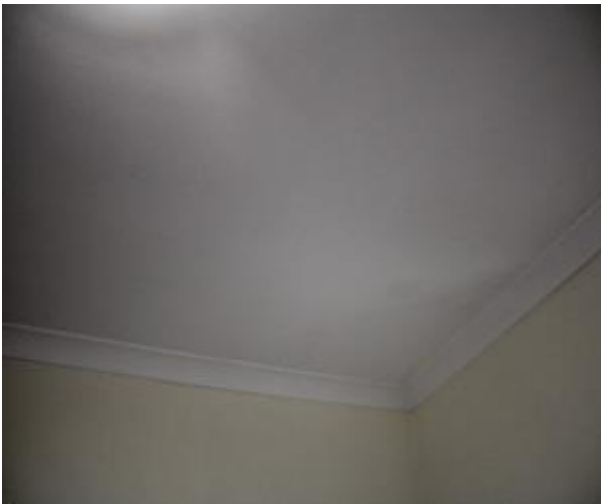
Figure 600 - General condition of bedroom 2 ceiling

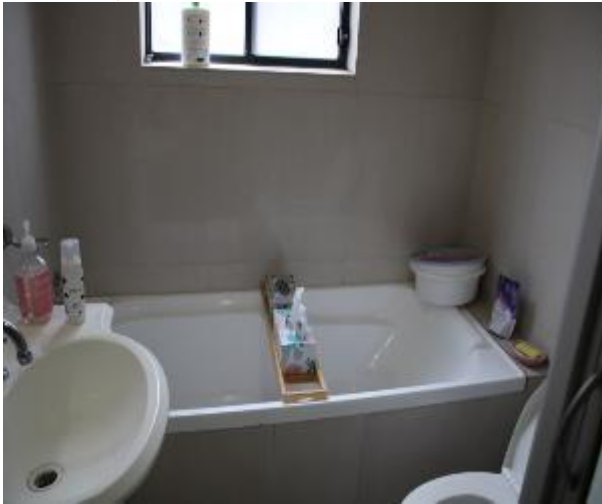
Figure 604 - General condition of bathroom 1 internal wall
