# **Pre-Dilapidation Report**

**19 GEORGE STREET**

**REAR BUILDING (UNITS 20-29)**

Project Reference: 20250047.19G.3

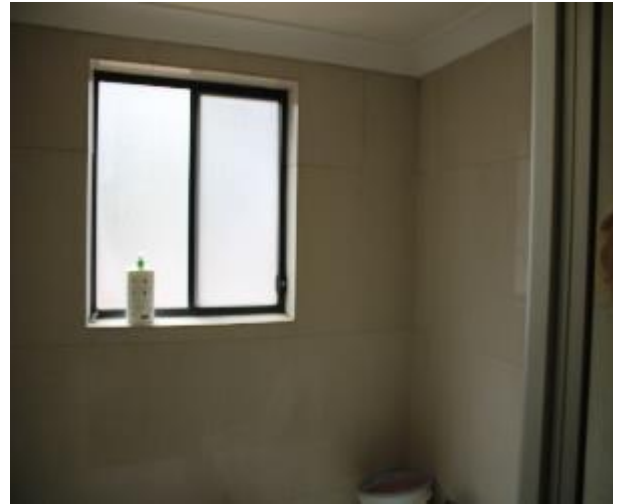
Figure 605 - General condition of bathroom 1 internal wall

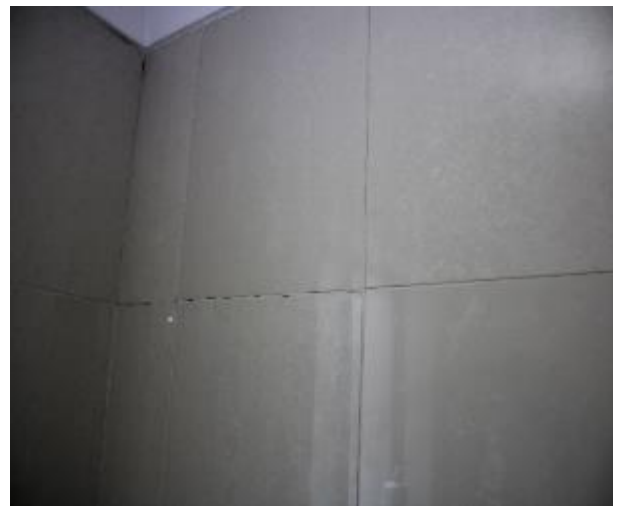
Figure 607 - Crack propagation through bathroom 1 internal wall

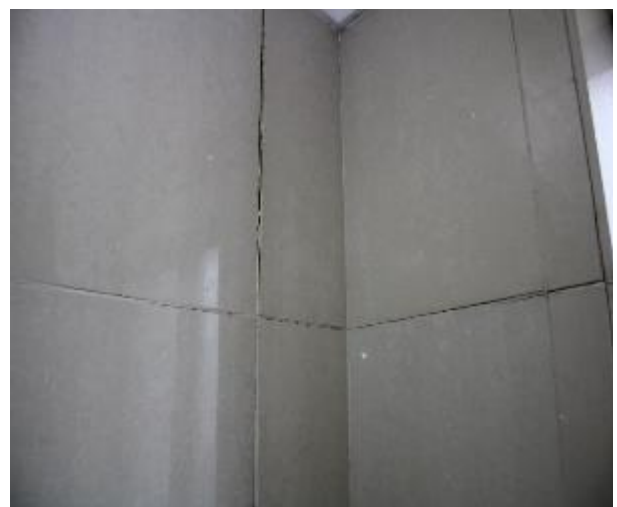
Figure 608 - Crack propagation through bathroom 1 internal wall

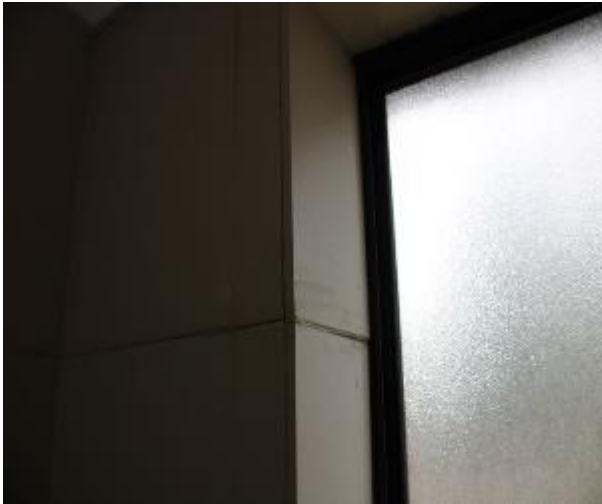
Figure 609 - Crack propagation through bathroom 1 internal wall

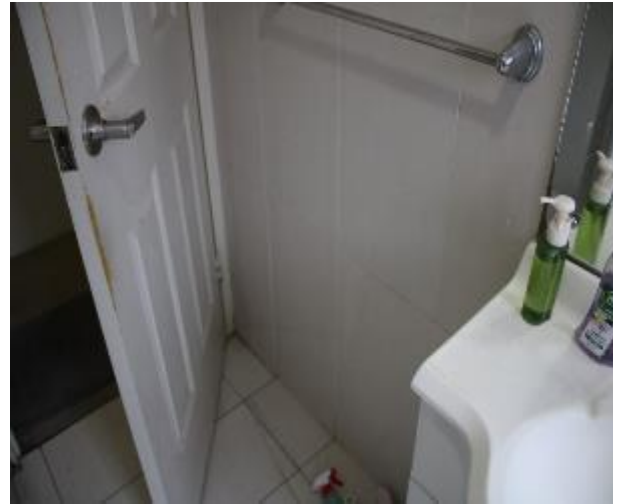
Figure 610 - Crack propagation through bathroom 1 internal wall

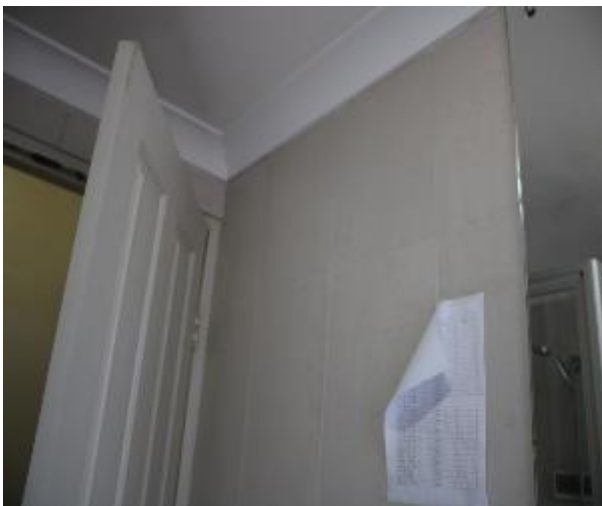
Figure 611 - General condition of bathroom 1 internal wall

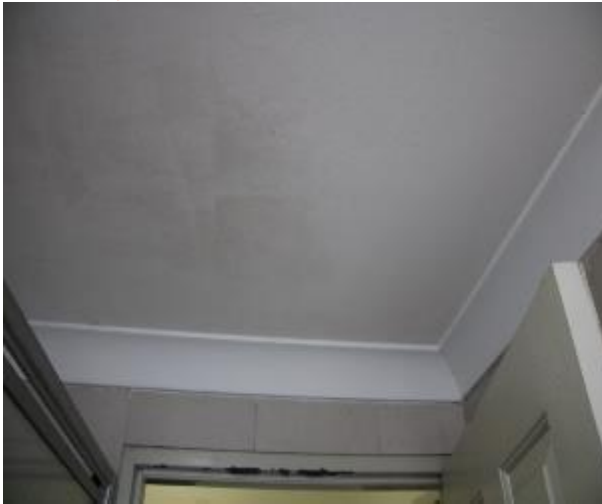
Figure 615 - General condition of bathroom 1 internal wall

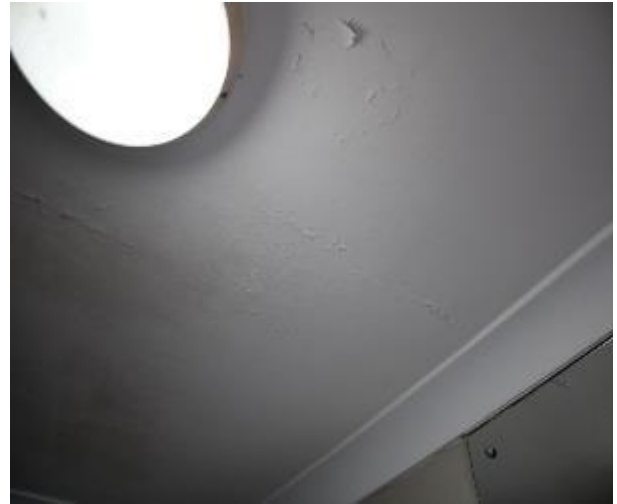
Figure 616 - General condition of bathroom 1 ceiling

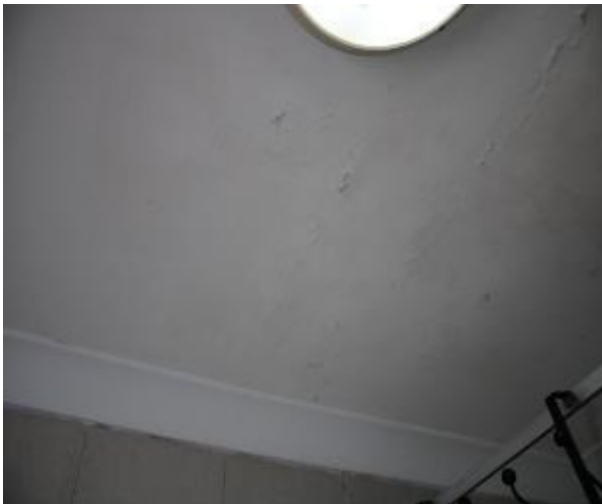
Figure 617 - Paint flaking through bathroom 1 ceiling

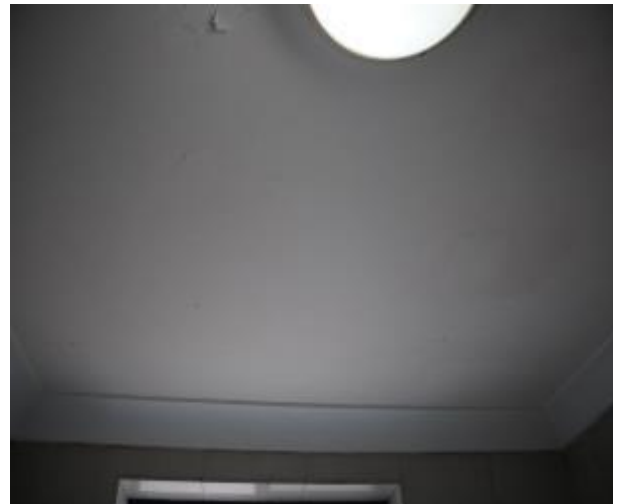
Figure 618 - Paint flaking through bathroom 1 ceiling

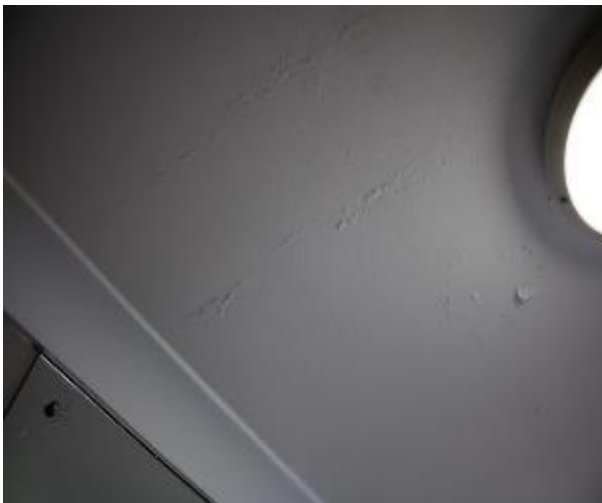
Figure 619 - General condition of bathroom 1 ceiling

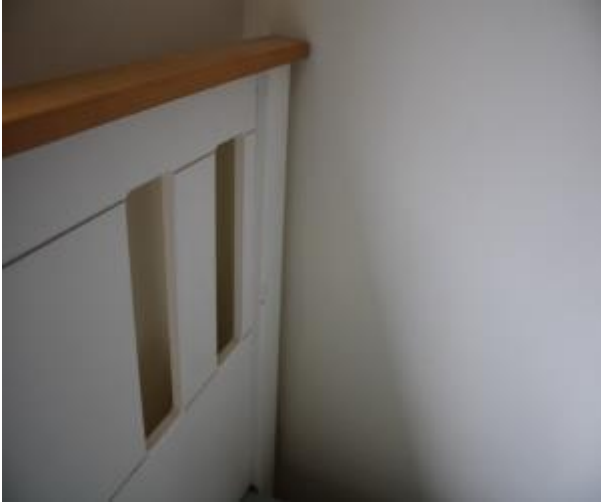
Figure 621 - General condition of bedroom 3 internal wall

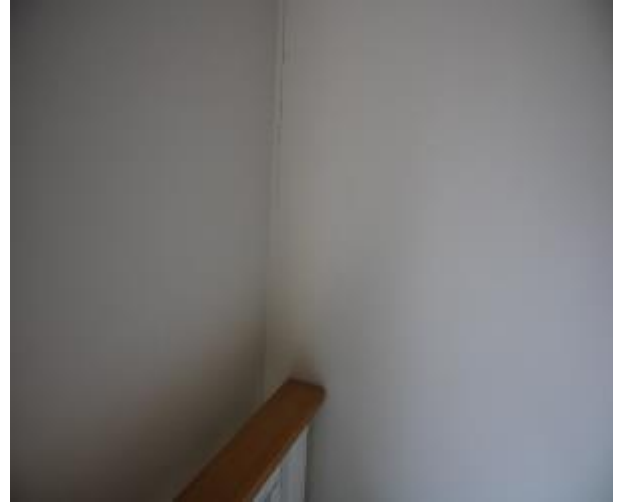
Figure 622 - Crack propagation through bedroom 3 internal wall

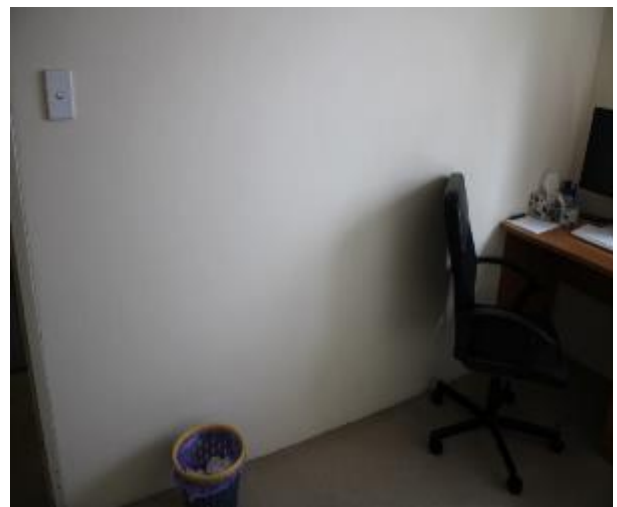
Figure 626 - General condition of bedroom 3 internal wall

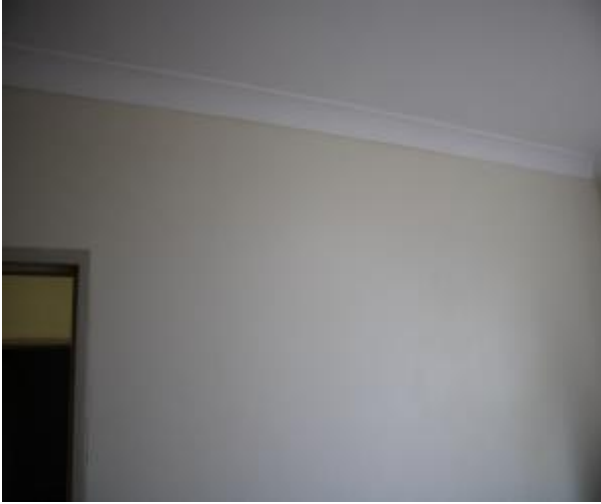
Figure 627 - General condition of bedroom 3 internal wall

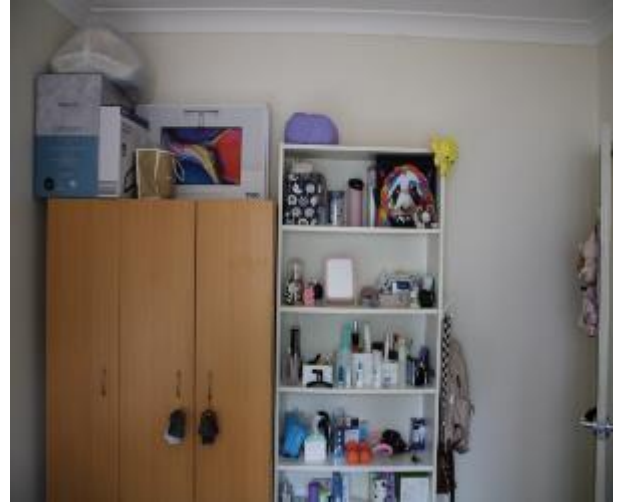
Figure 628 - General condition of bedroom 3 internal wall

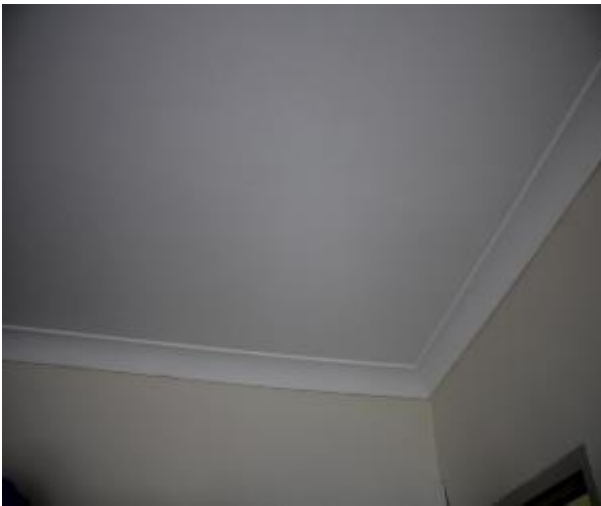
Figure 629 - General condition of bedroom 3 internal wall

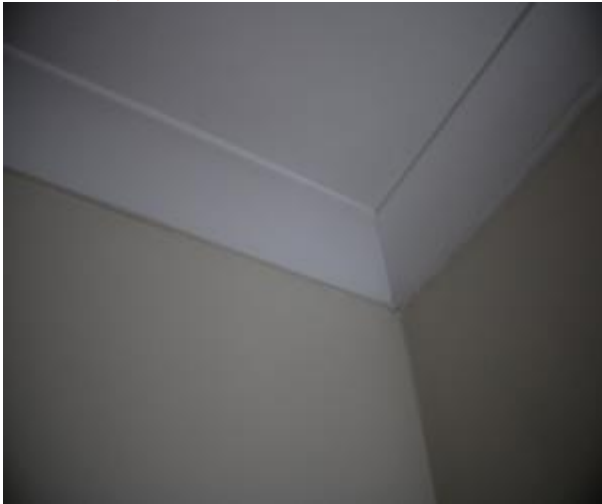
Figure 633 - General condition of bedroom 3 ceiling

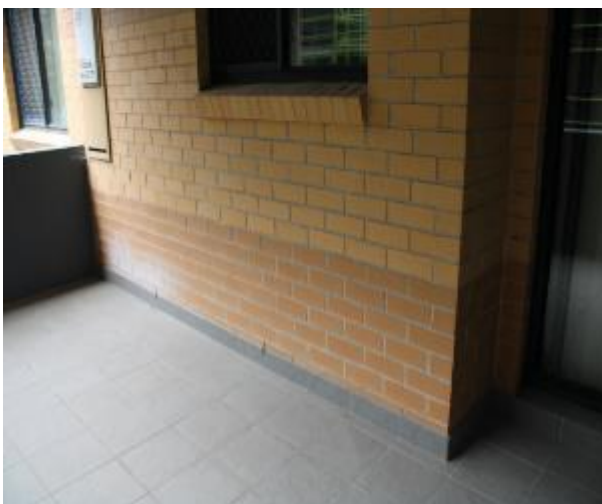
Figure 637 - General condition of balcony floor tiles

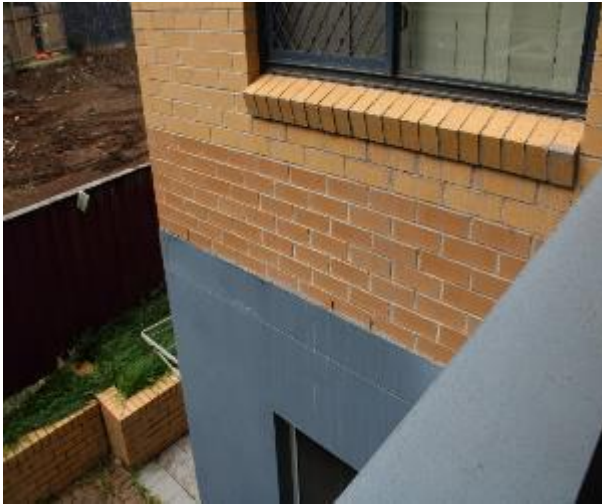
Figure 639 - General condition of external wall

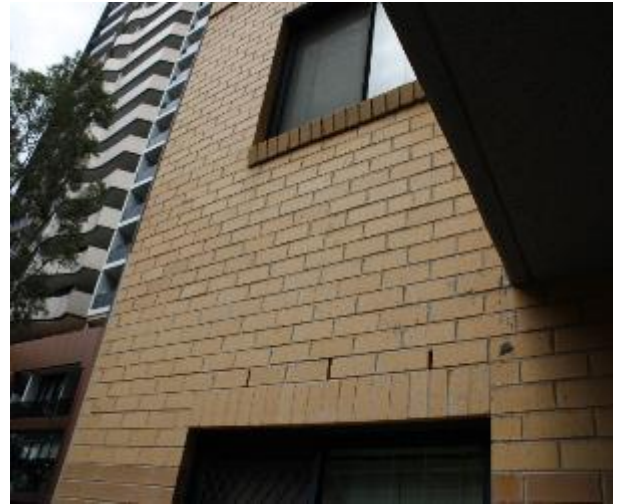
Figure 640 - General condition of external wall

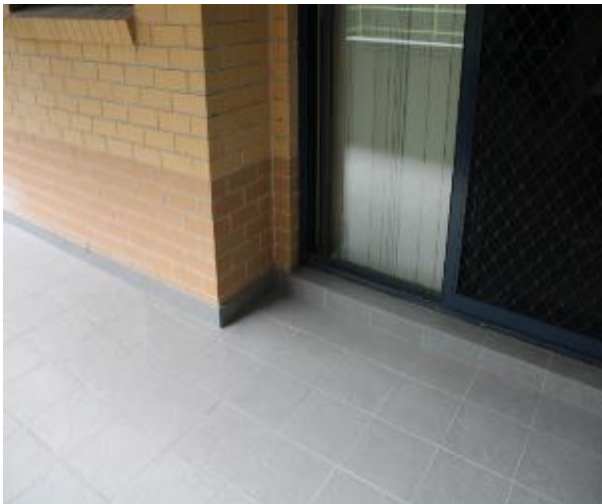
Figure 641 - General condition of external wall

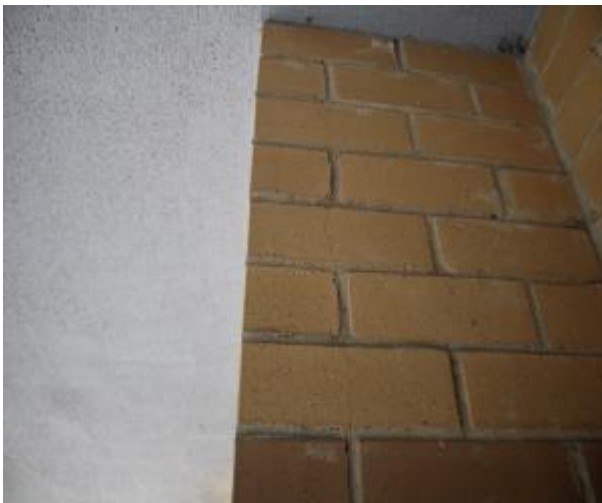
Figure 643 - General condition of external wall

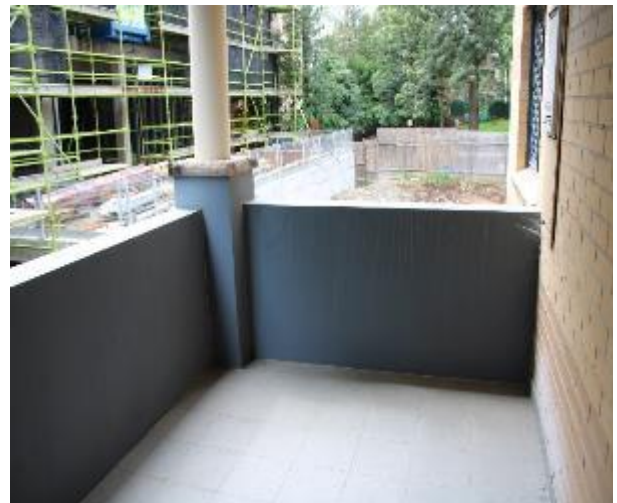
Figure 644 - Crack propagation through external wall

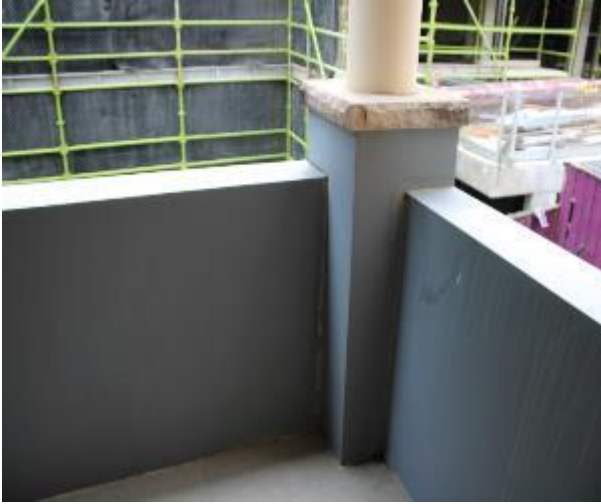
Figure 645 - General condition of external wall

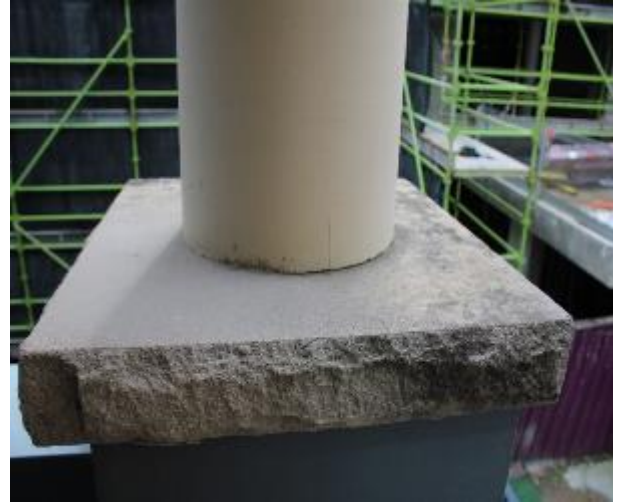
Figure 646 - General condition of external wall

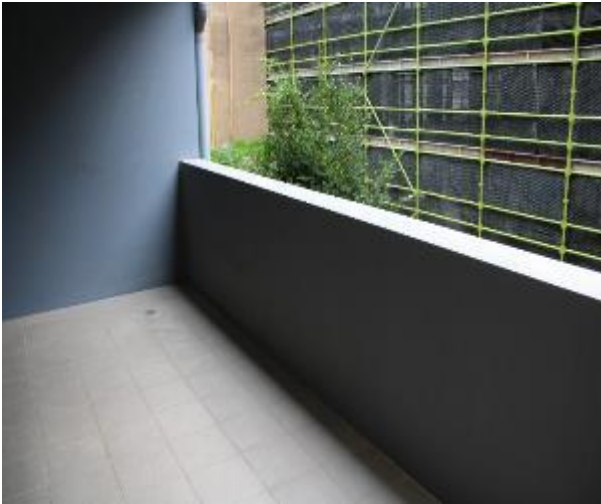
Figure 647 - General condition of external wall

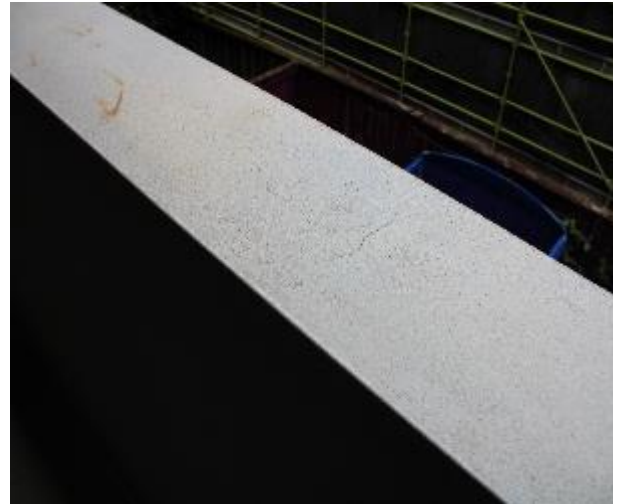
Figure 649 - Crack propagation through external wall

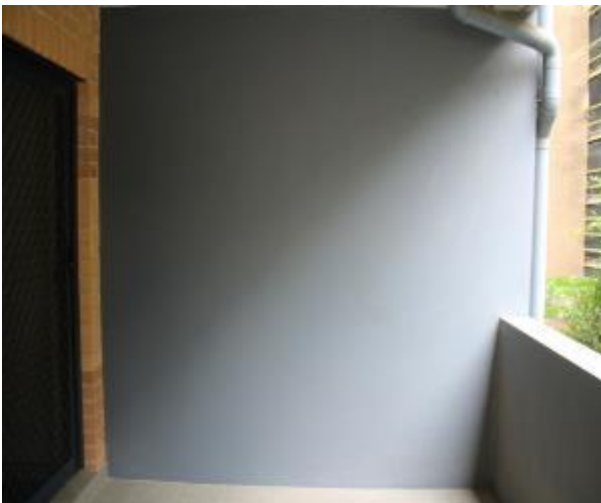
Figure 650 - General condition of external wall

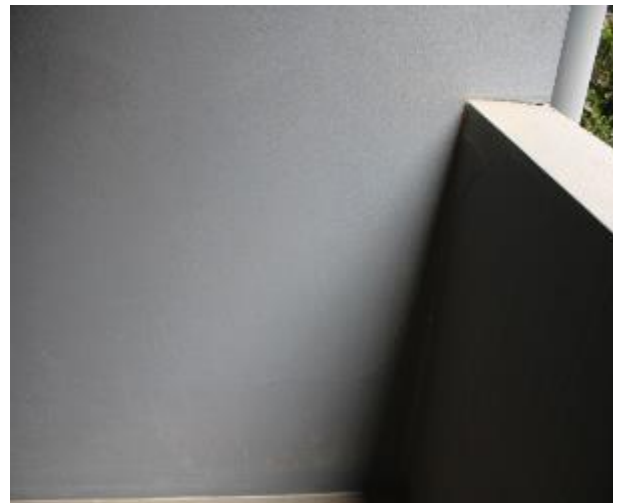
Figure 651 - General condition of external wall

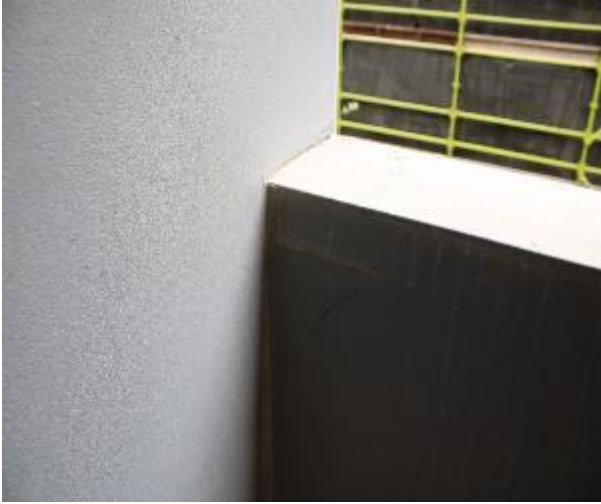
Figure 652 - General condition of external wall

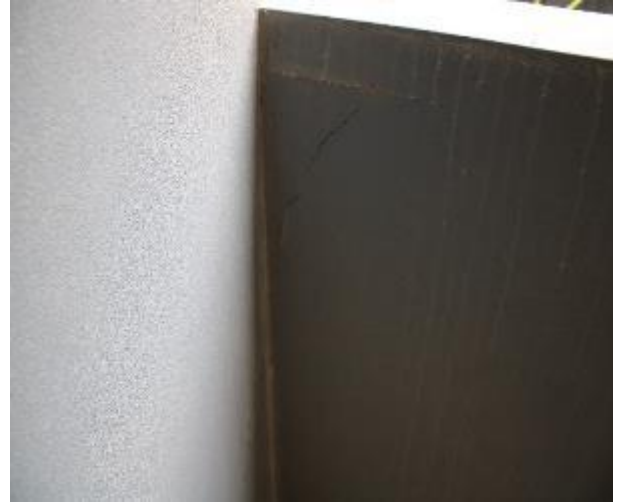
Figure 653 - Crack propagation through external wall

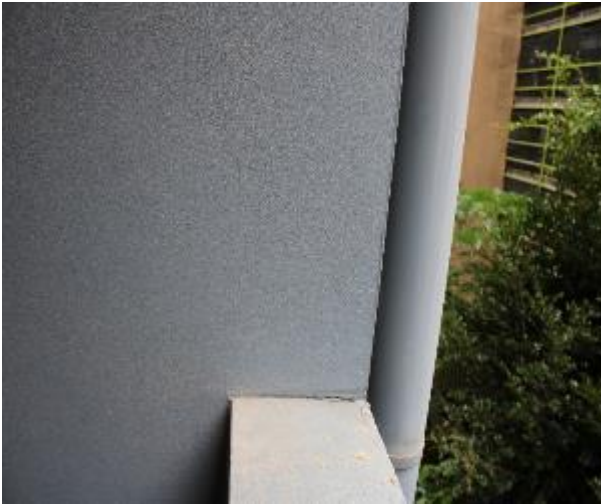
Figure 654 - General condition of external wall

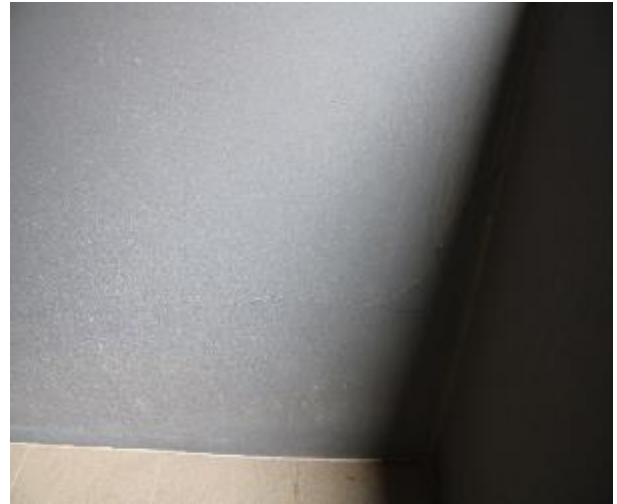
Figure 655 - Crack propagation through external wall

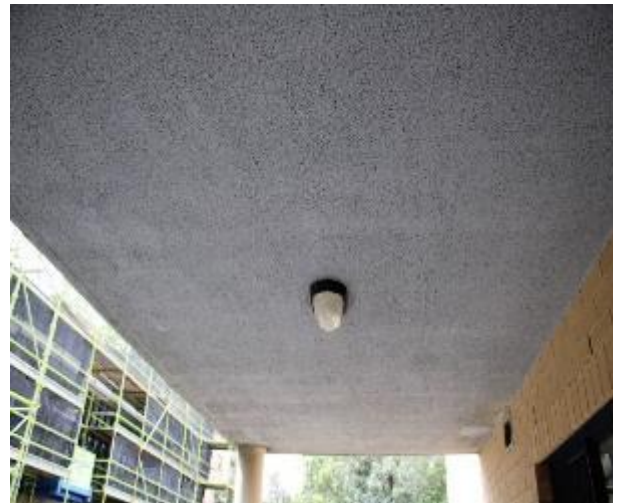
Figure 659 - General condition of balcony underside slab

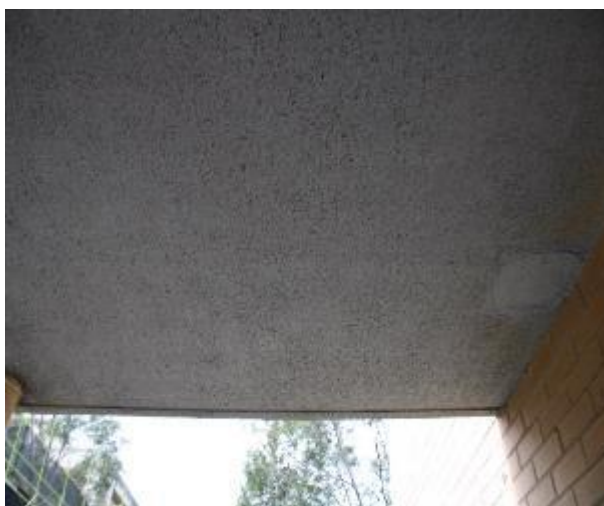
Figure 660 - General condition of balcony underside slab

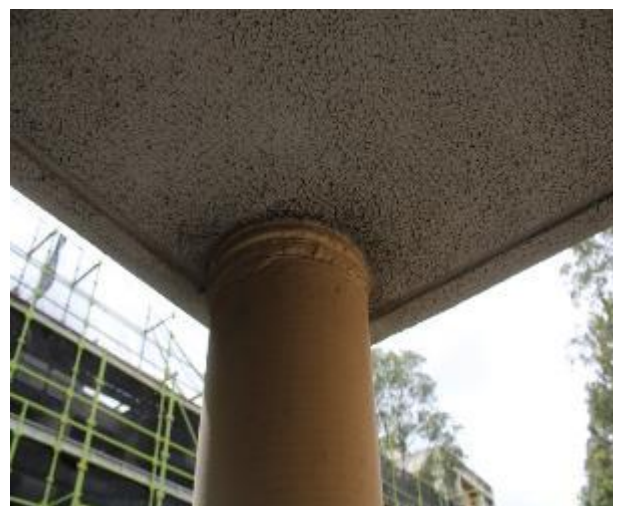
Figure 661 - General condition of balcony underside slab

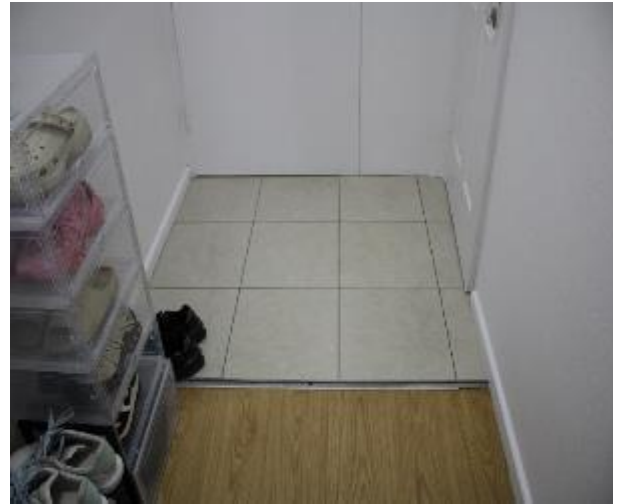
Figure 663 - General condition of entry floor tiles

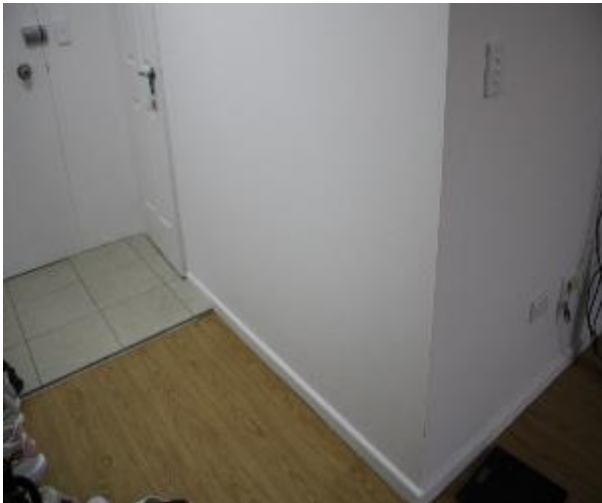
Figure 664 - General condition of kitchen internal wall

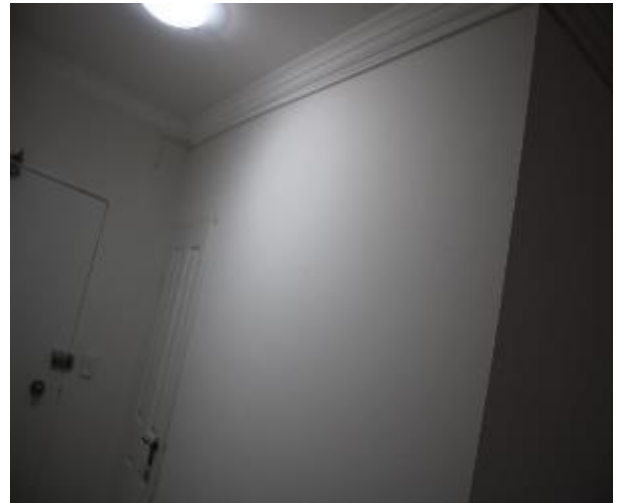
Figure 665 - General condition of kitchen internal wall

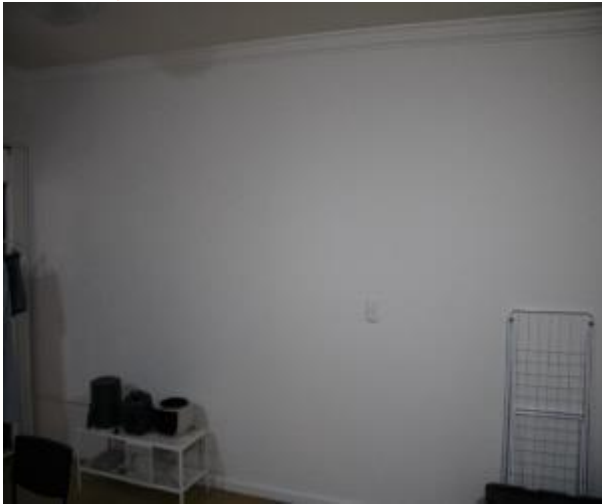
Figure 668 - General condition of kitchen internal wall

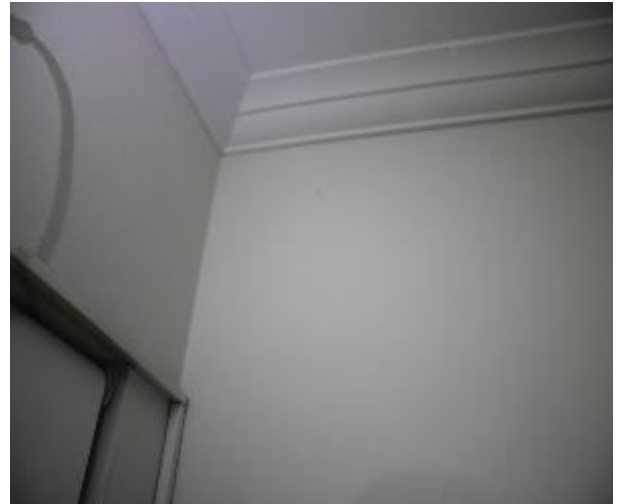
Figure 669 - General condition of kitchen internal wall

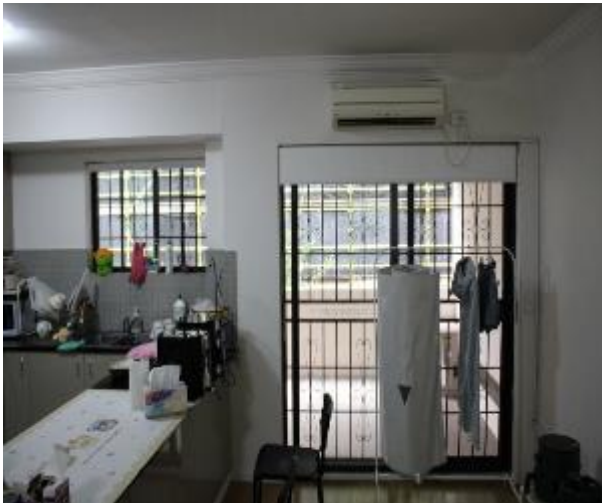
Figure 670 - General condition of kitchen internal wall

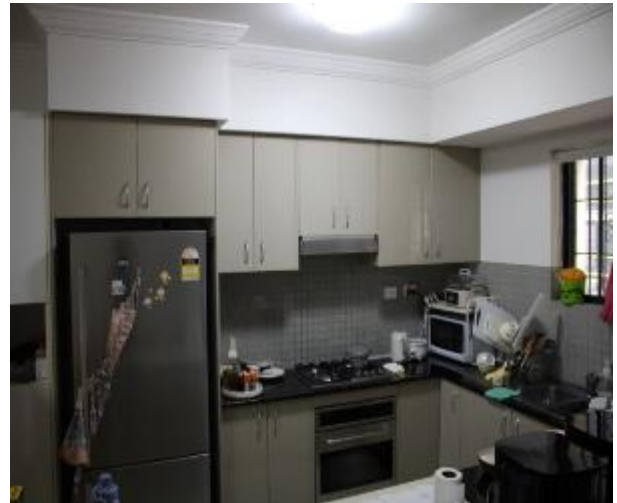
Figure 671 - General condition of kitchen internal wall

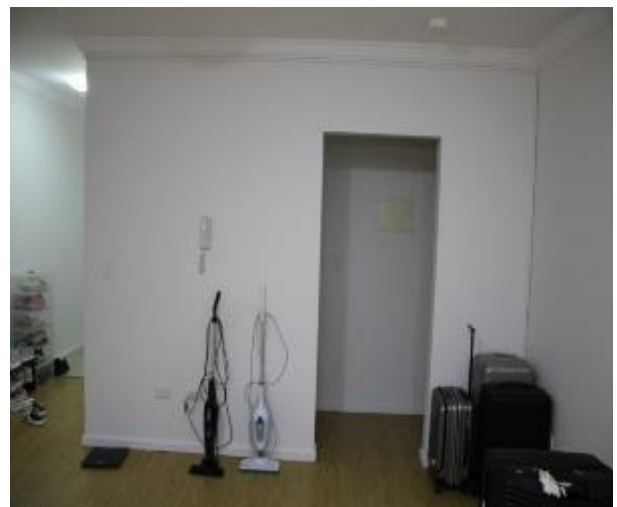
Figure 673 - General condition of kitchen internal wall

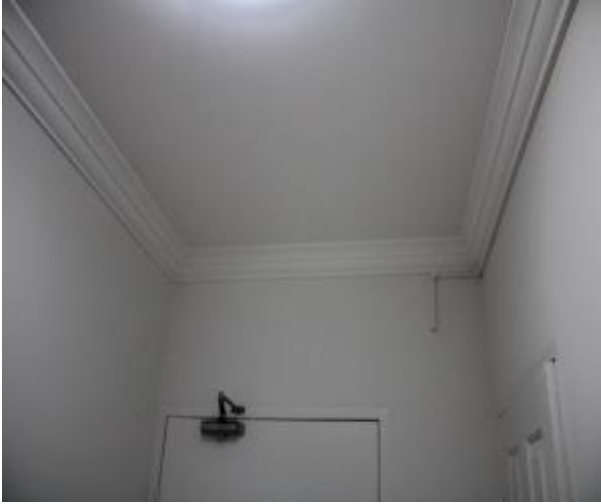
Figure 674 - General condition of kitchen ceiling

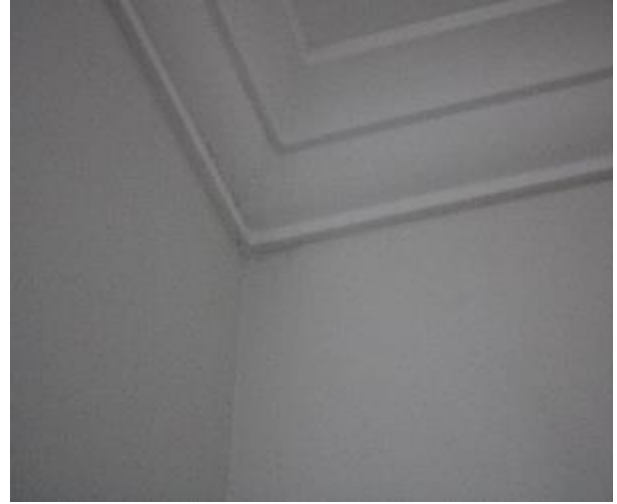
Figure 675 - Crack propagation through kitchen ceiling

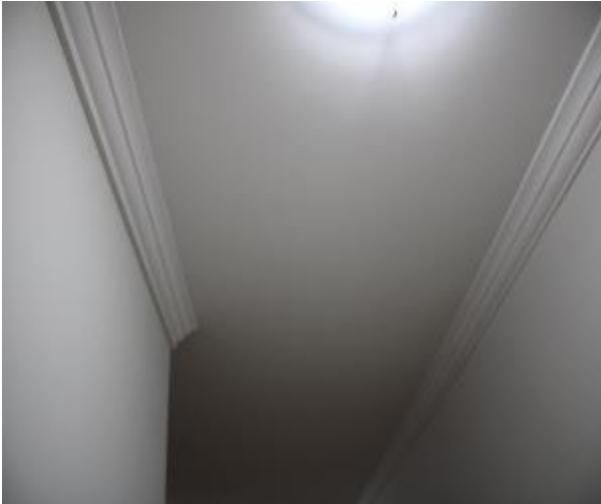
Figure 676 - General condition of kitchen ceiling

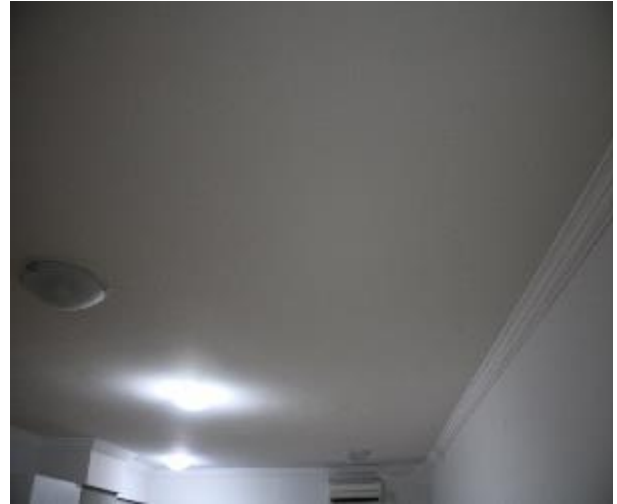
Figure 677 - General condition of kitchen ceiling

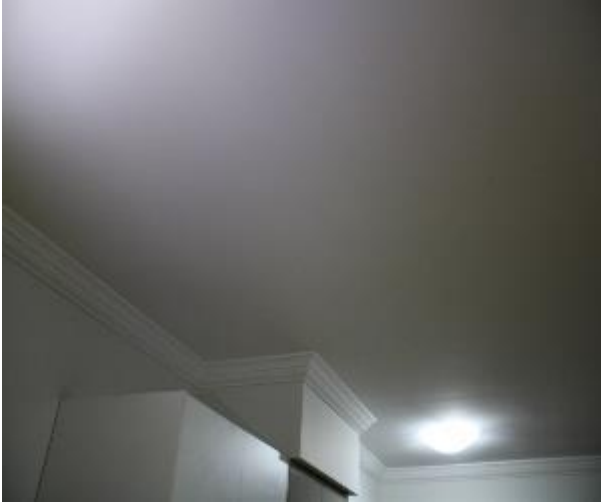
Figure 680 - General condition of kitchen ceiling

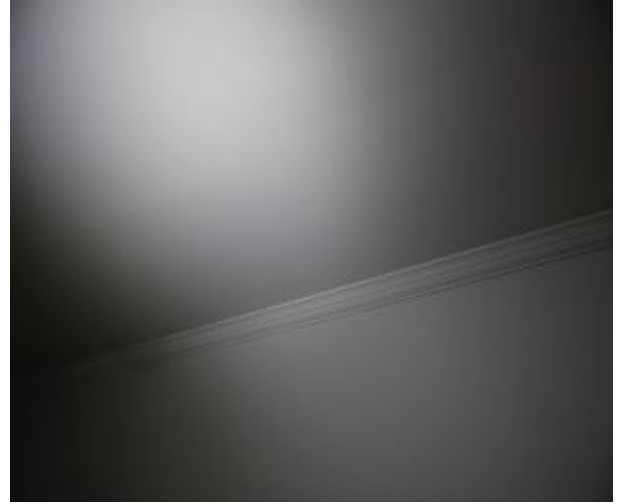
Figure 681 - General condition of kitchen ceiling

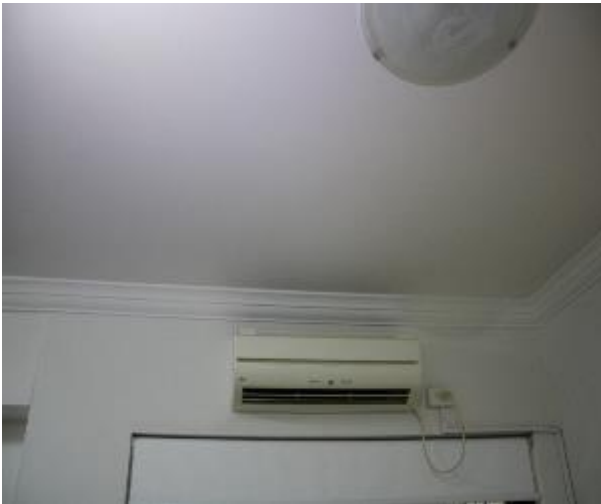
Figure 682 - General condition of kitchen ceiling

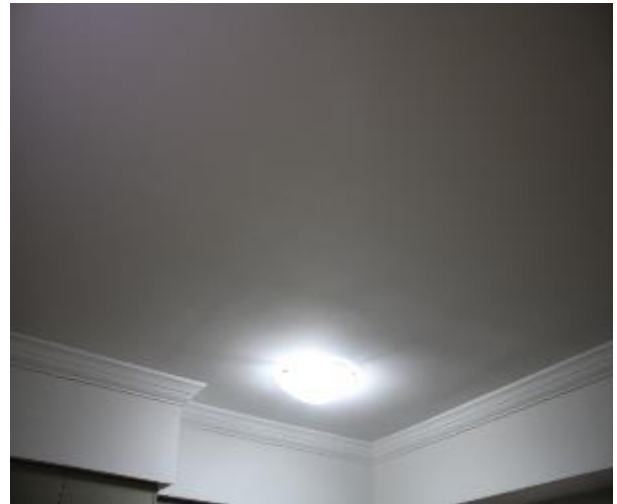
Figure 683 - General condition of kitchen ceiling

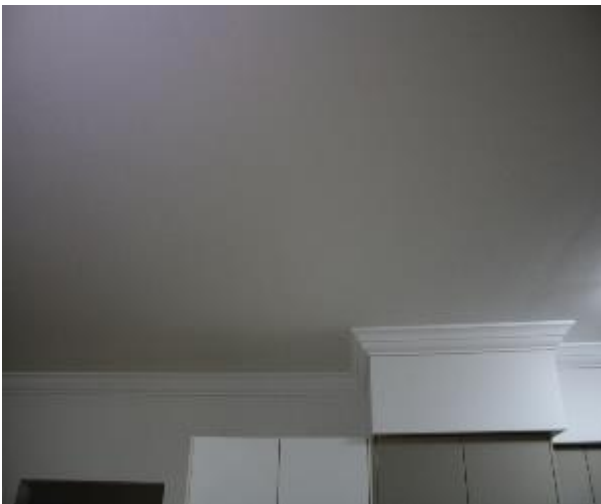
Figure 684 - General condition of kitchen ceiling

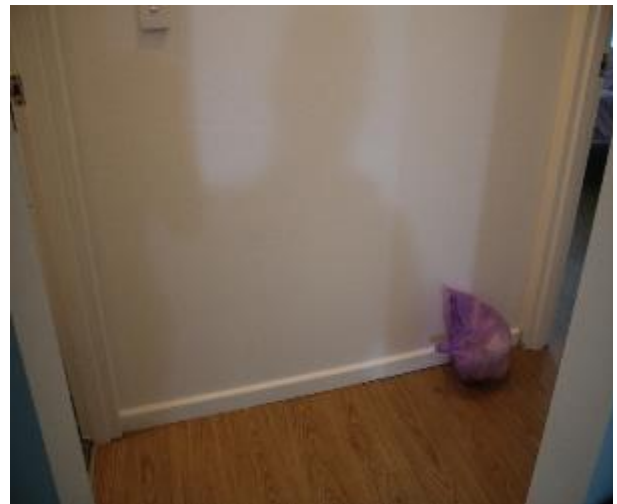
Figure 685 - General condition of corridor internal wall

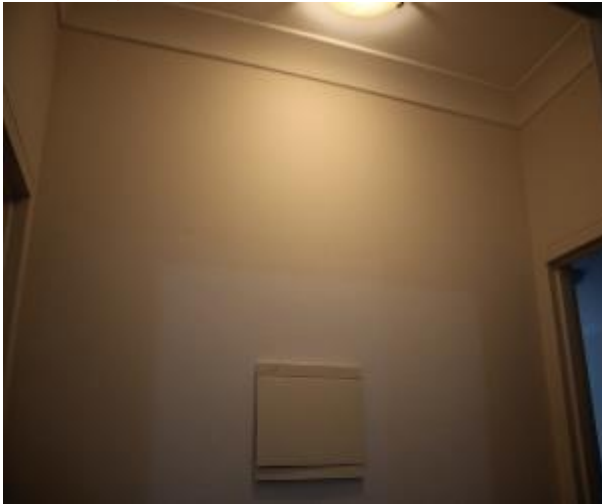
Figure 686 - General condition of corridor internal wall

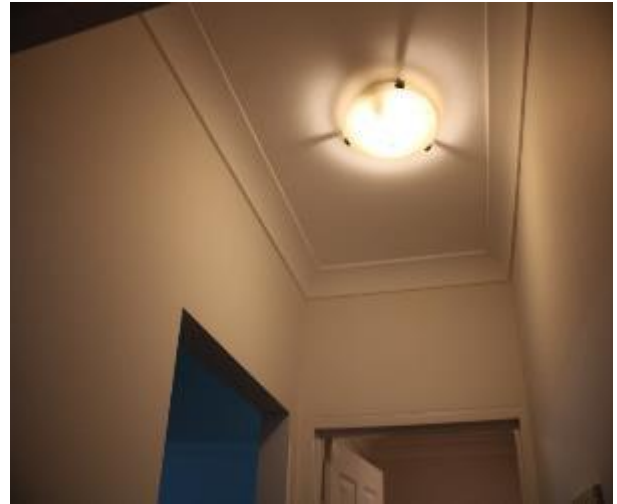
Figure 687 - General condition of corridor ceiling

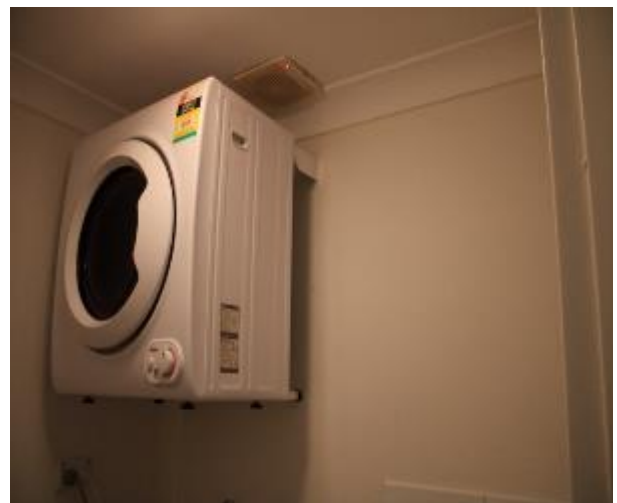
Figure 690 - General condition of laundry internal wall

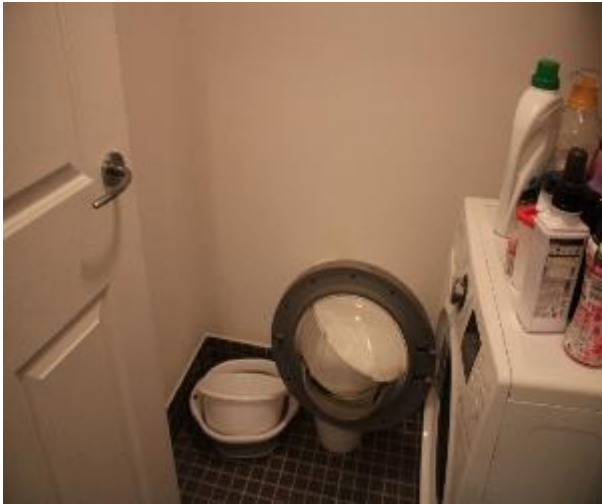
Figure 691 - General condition of laundry internal wall

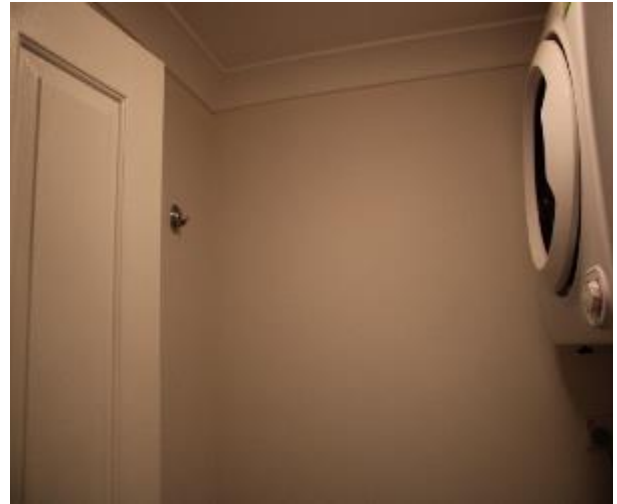
Figure 692 - General condition of laundry internal wall

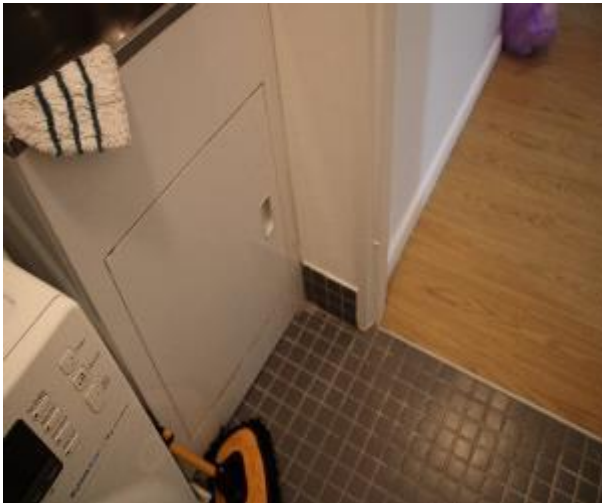
Figure 693 - General condition of laundry internal wall

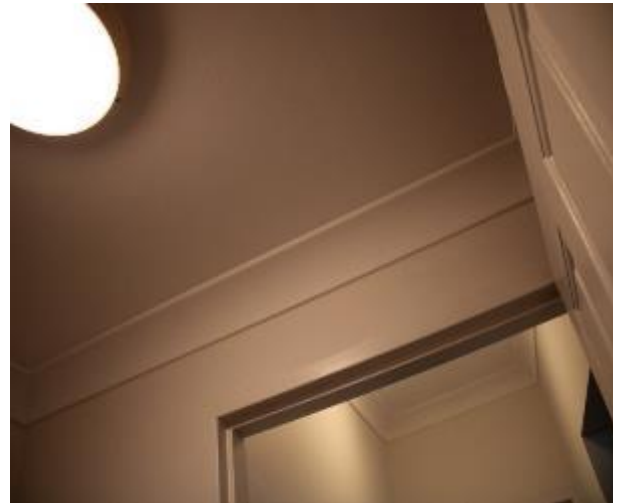
Figure 694 - General condition of laundry internal wall

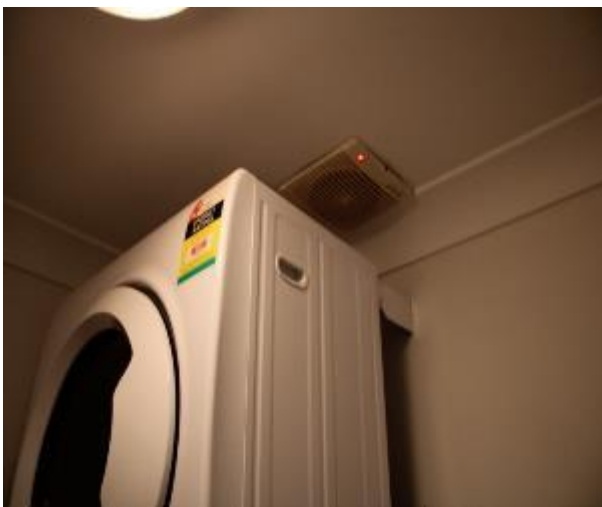
Figure 695 - General condition of laundry internal wall

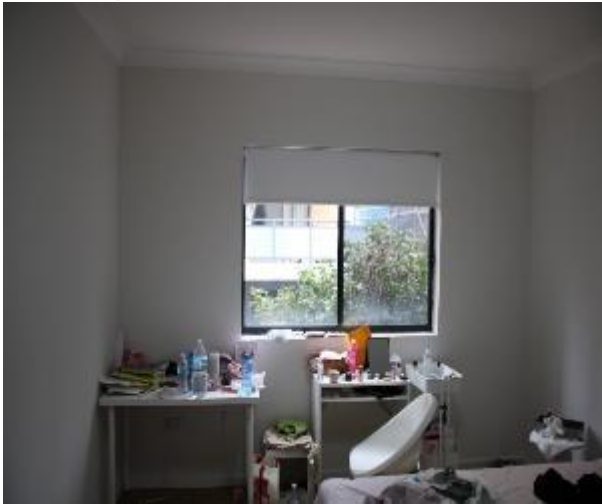
Figure 697 - General condition of bedroom 1 internal wall

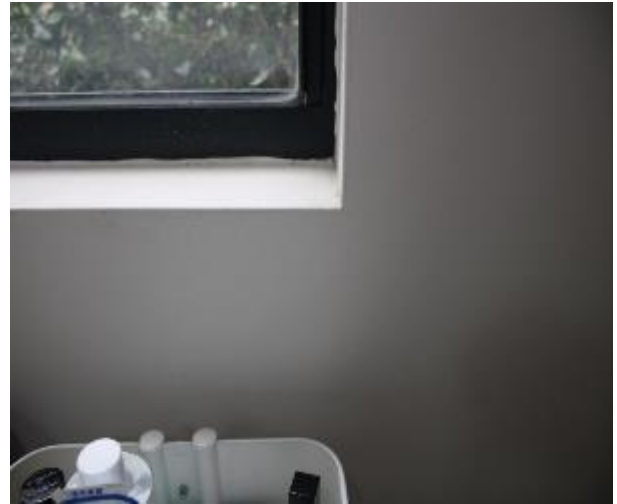
Figure 698 - General condition of bedroom 1 internal wall

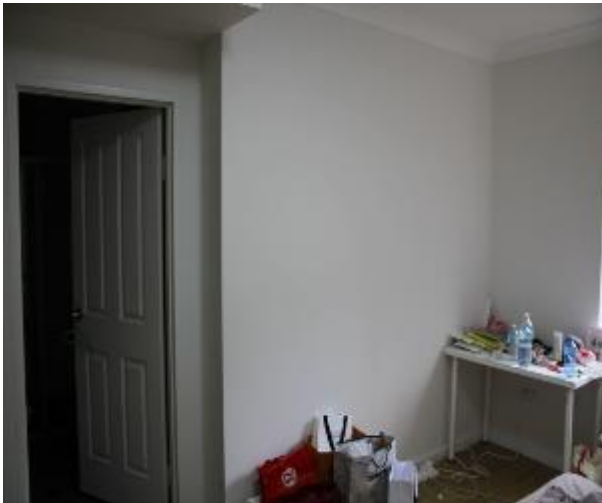
Figure 699 - Crack propagation through bedroom 1 internal wall

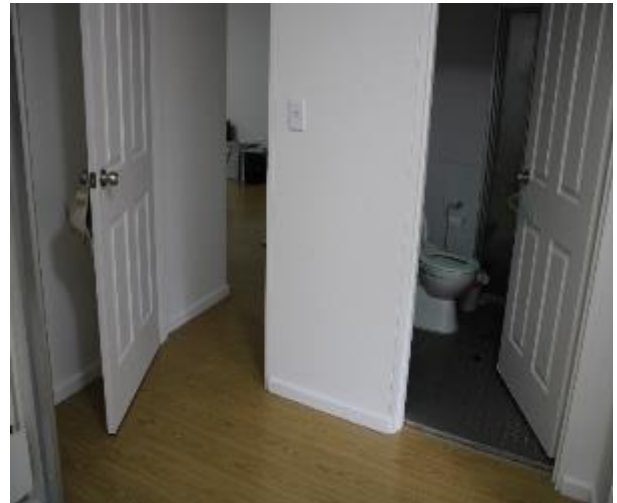
Figure 700 - General condition of bedroom 1 internal wall

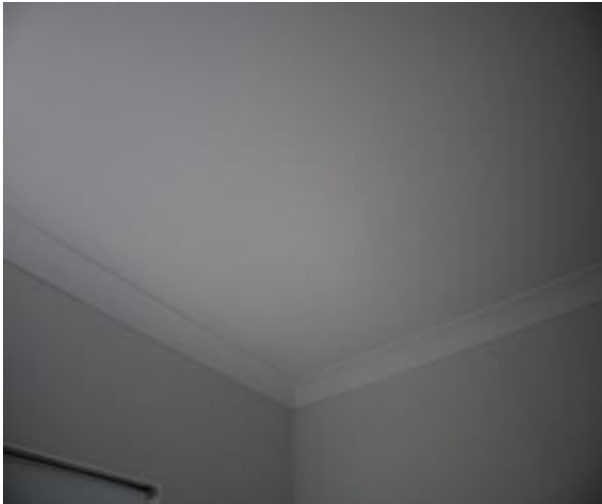
Figure 703 - General condition of bedroom 1 ceiling

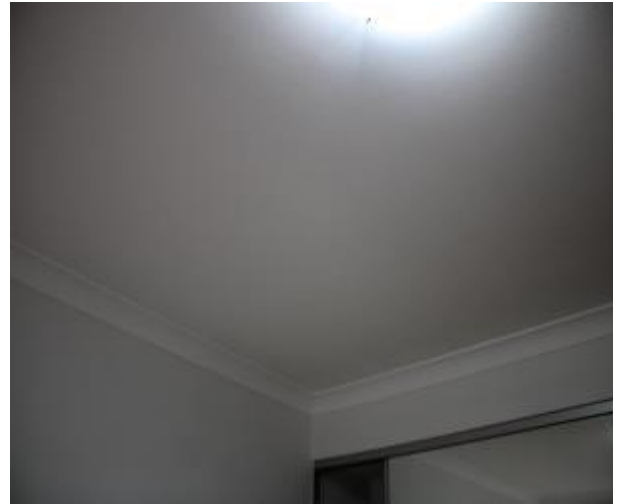
Figure 704 - General condition of bedroom 1 ceiling

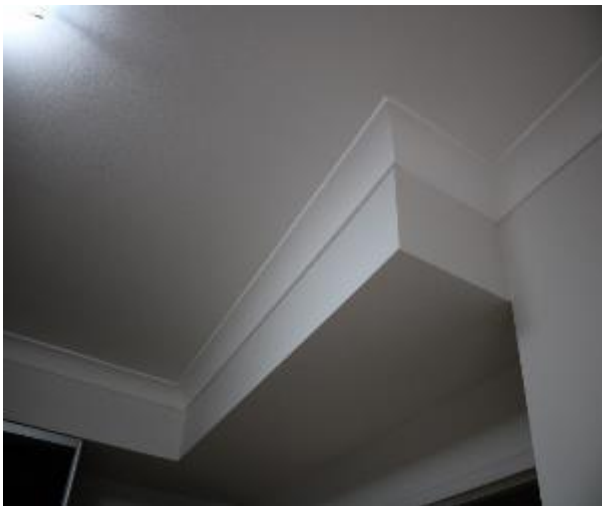
Figure 705 - General condition of bedroom 1 ceiling

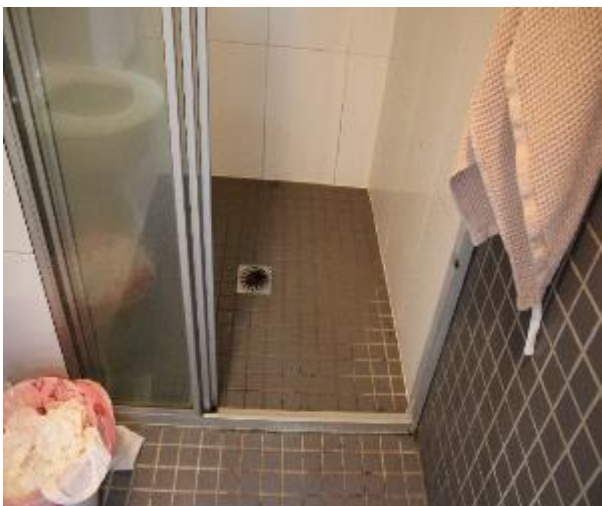
Figure 707 - General condition of ensuite bathroom floor tiles

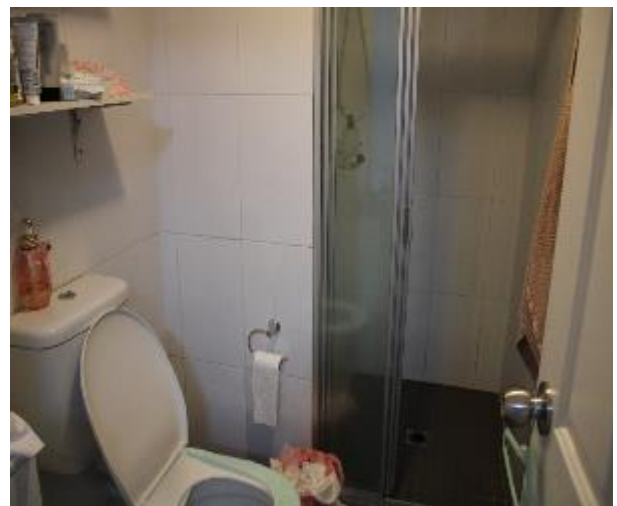
Figure 708 - General condition of ensuite bathroom floor tiles
