# **Pre-Dilapidation Report**

**19 GEORGE STREET**

**REAR BUILDING (UNITS 20-29)**

Project Reference: 20250047.19G.3

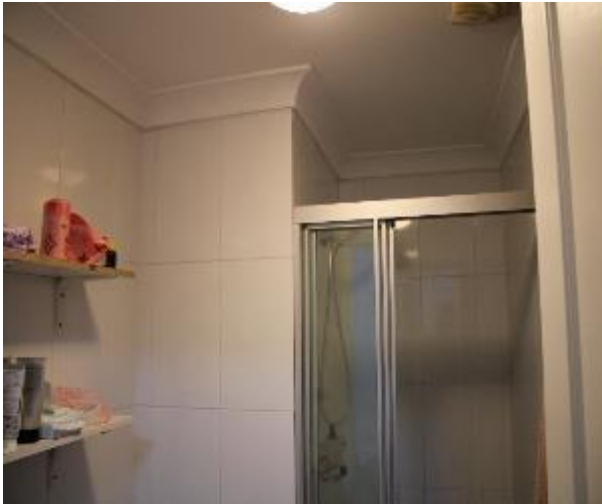
Figure 709 - General condition of ensuite bathroom internal wall

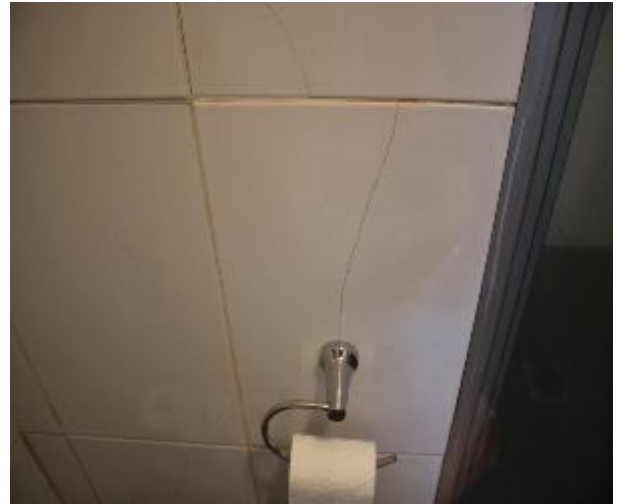
Figure 710 - General condition of ensuite bathroom internal wall

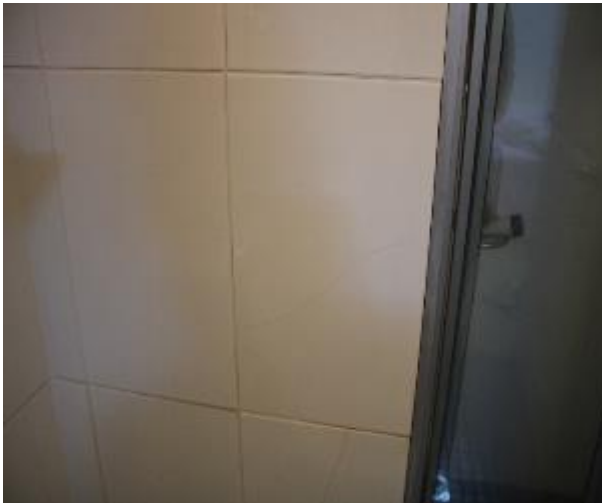
Figure 711 - Crack propagation through ensuite bathroom internal wall

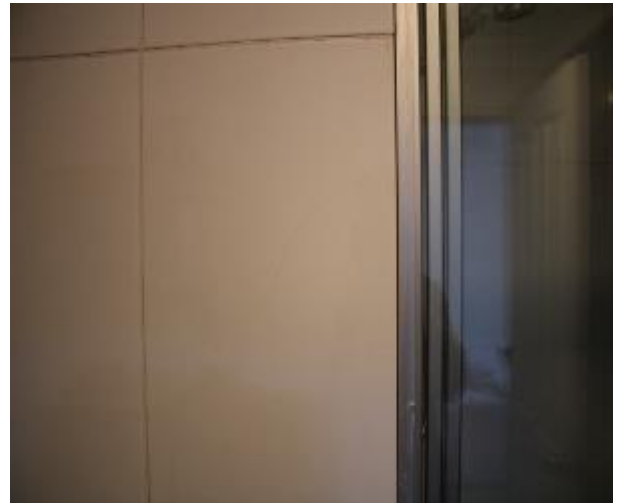
Figure 712 - Crack propagation through ensuite bathroom internal wall

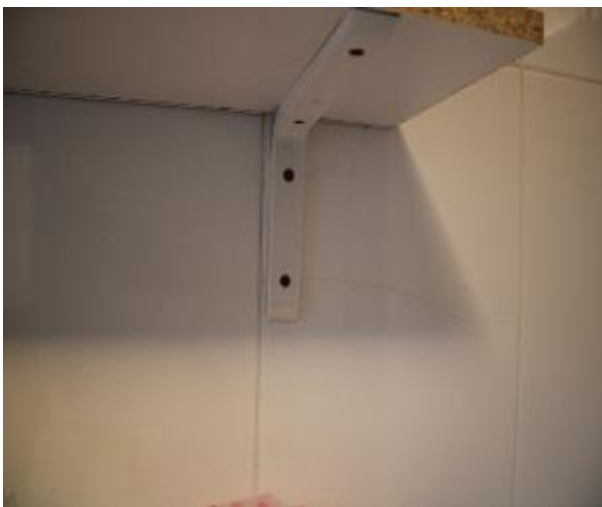
Figure 713 - Crack propagation through ensuite bathroom internal wall

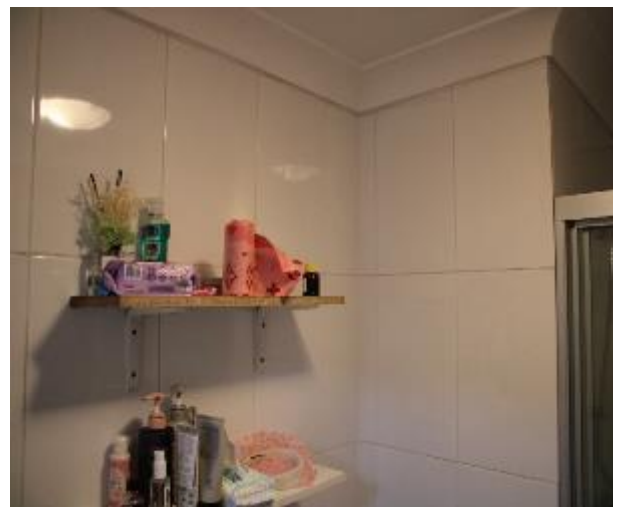
Figure 714 - Crack propagation through ensuite bathroom internal wall

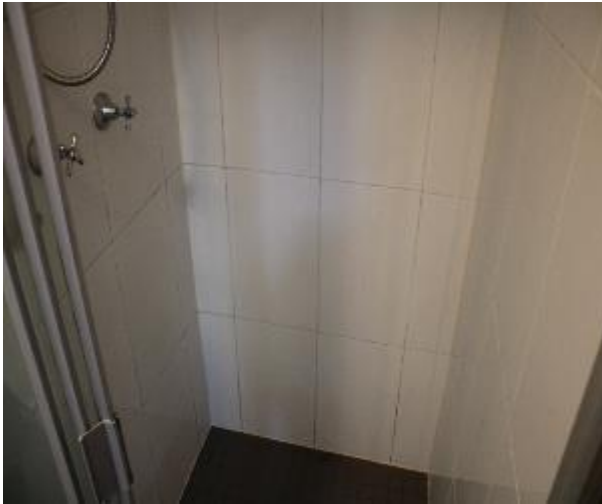
Figure 715 - General condition of ensuite bathroom internal wall

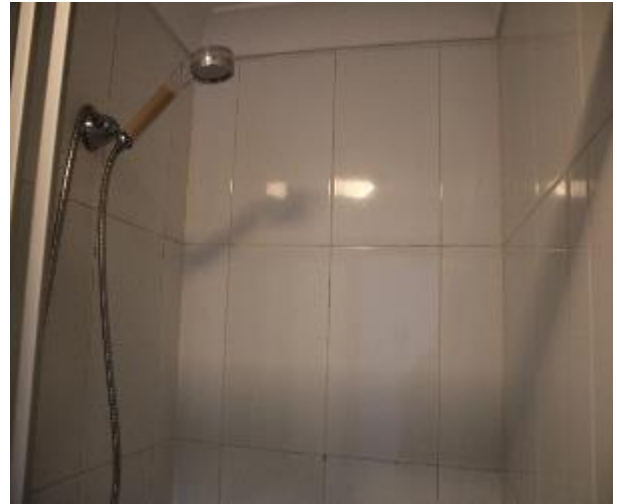
Figure 716 - General condition of ensuite bathroom internal wall

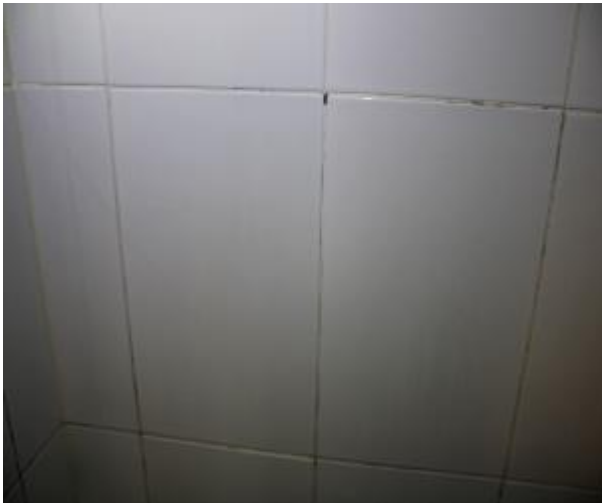
Figure 717 - General condition of ensuite bathroom internal wall

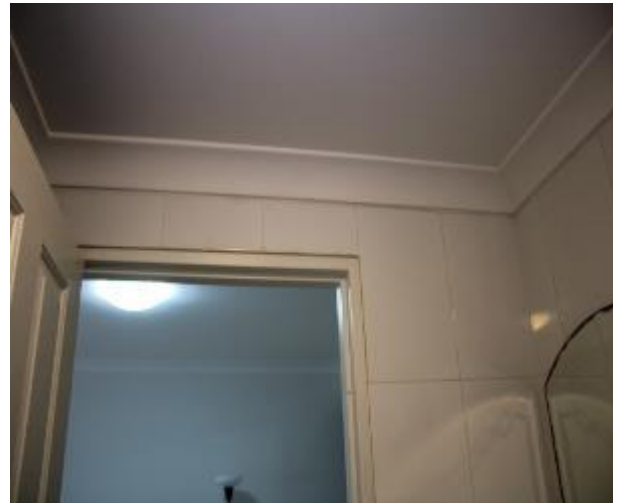
Figure 718 - Crack propagation through ensuite bathroom internal wall

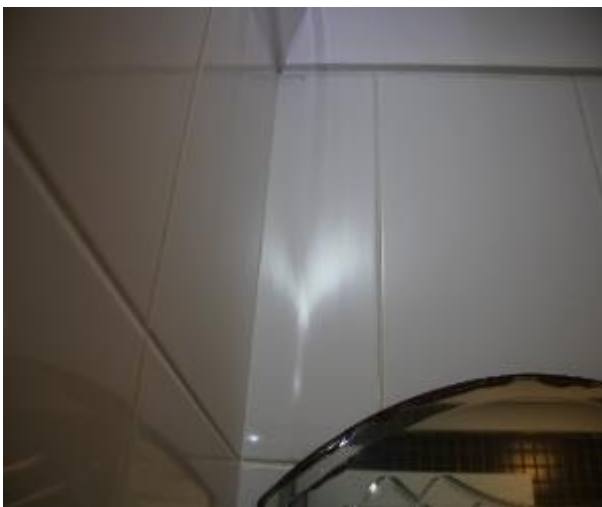
Figure 719 - General condition of ensuite bathroom internal wall

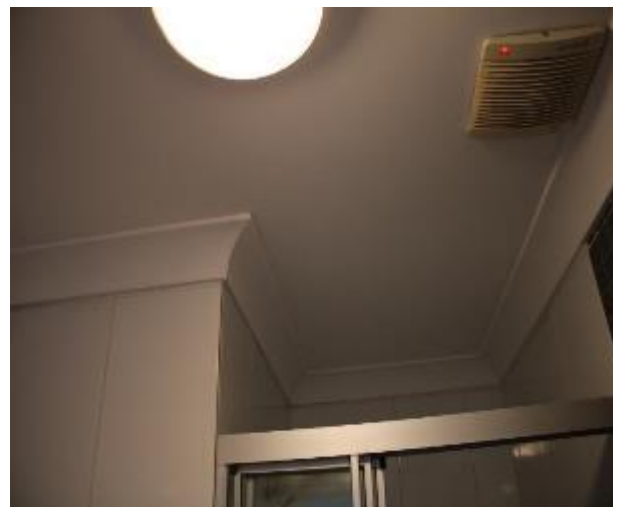
Figure 720 - Crack propagation through ensuite bathroom internal wall

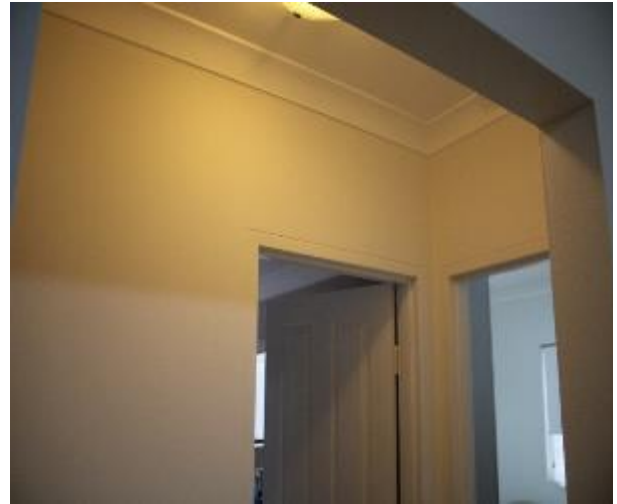
Figure 722 - General condition of corridor internal wall

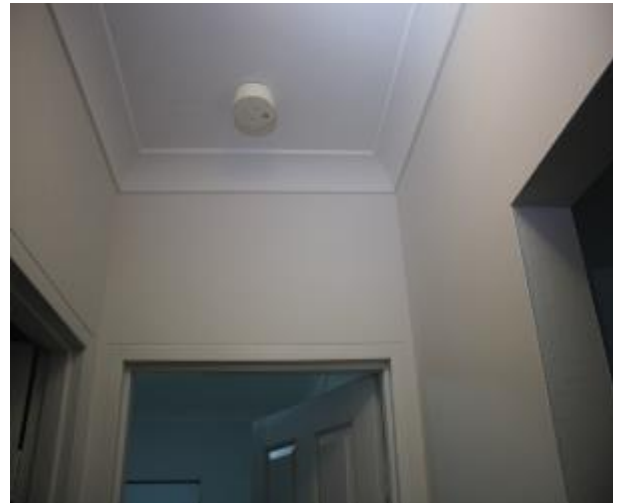
Figure 724 - General condition of corridor internal wall

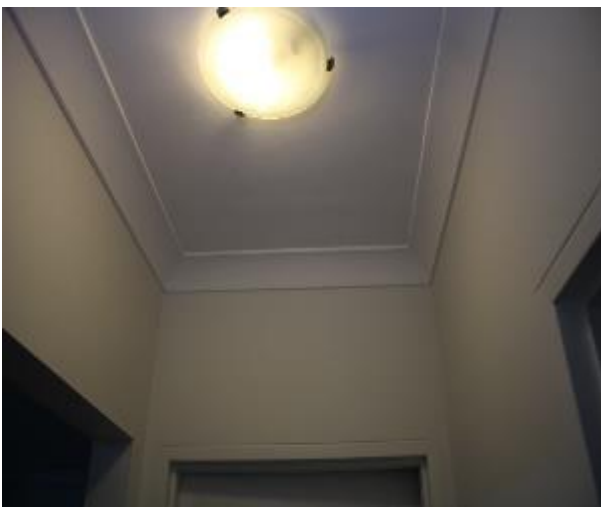
Figure 725 - General condition of corridor internal wall

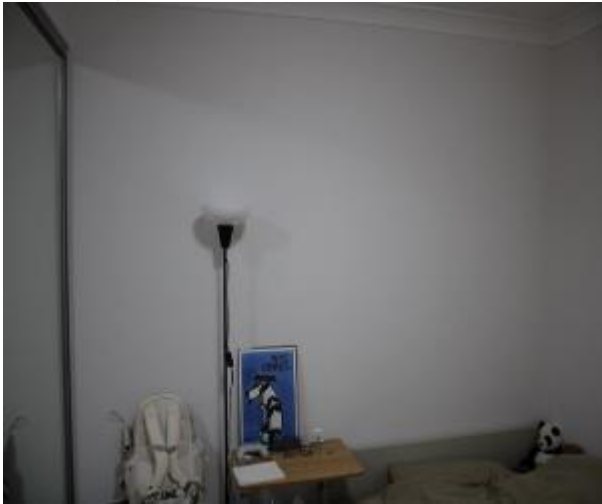
Figure 727 - General condition of bedroom 2 internal wall

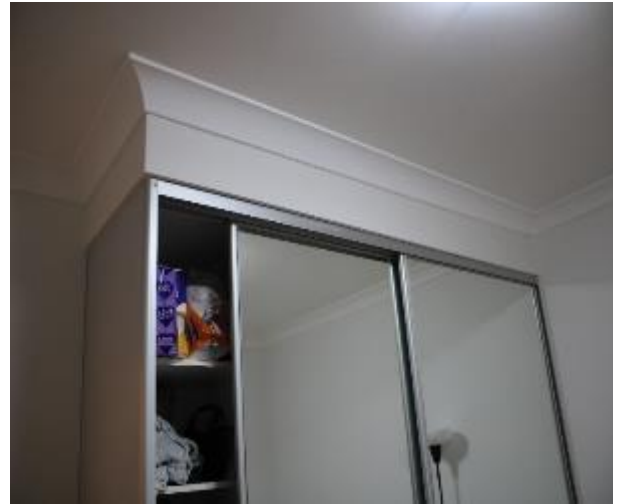
Figure 728 - General condition of bedroom 2 internal wall

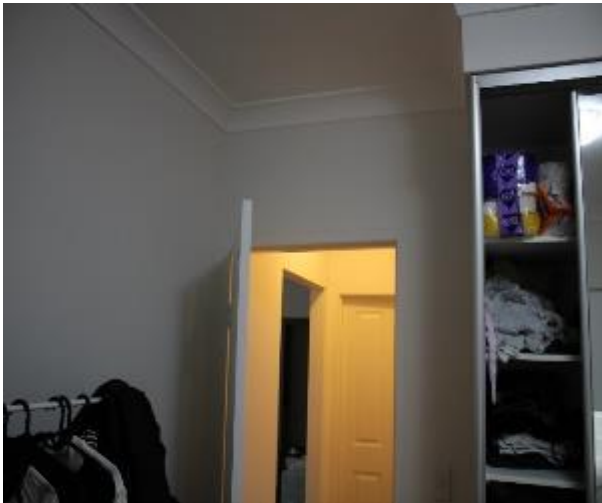
Figure 729 - General condition of bedroom 2 internal wall

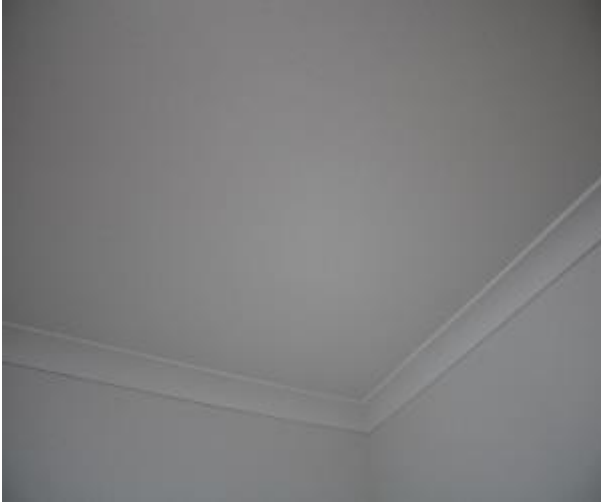
Figure 733 - General condition of bedroom 2 ceiling

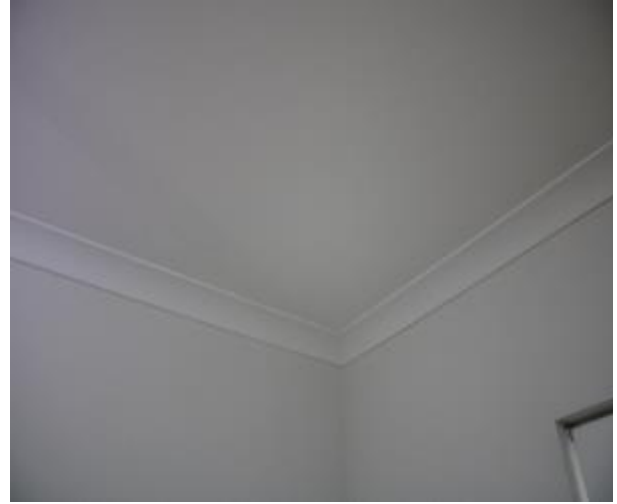
Figure 734 - General condition of bedroom 2 ceiling

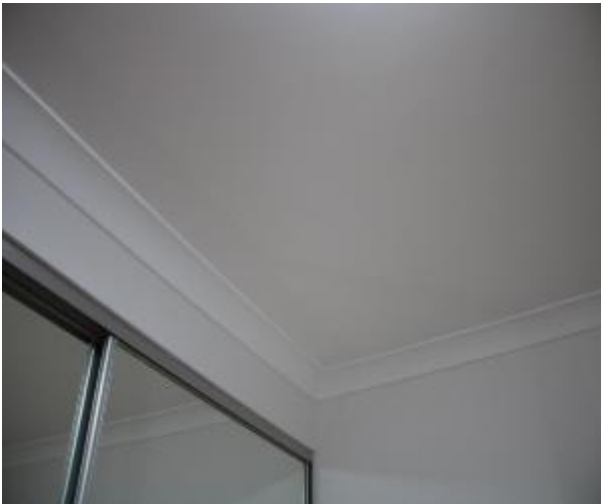
Figure 735 - General condition of bedroom 2 ceiling

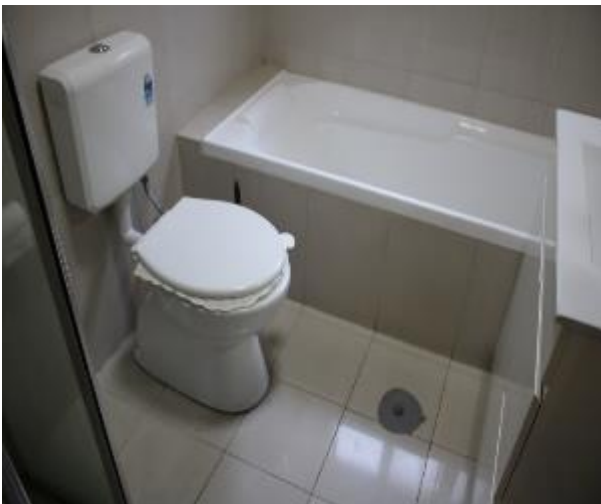
Figure 737 - General condition of bathroom 1 floor tiles

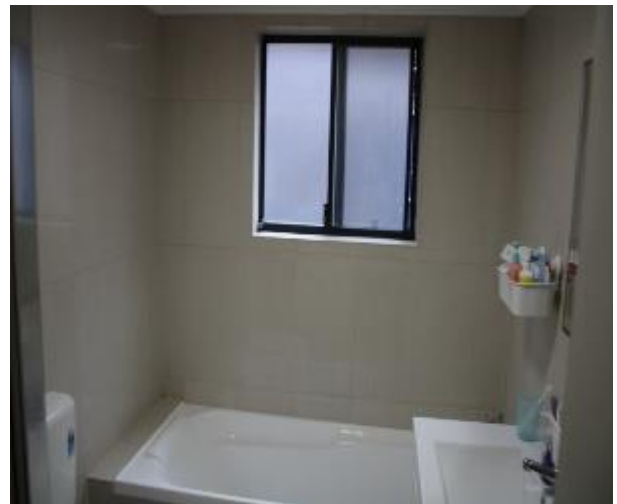
Figure 738 - General condition of bathroom 1 floor tiles

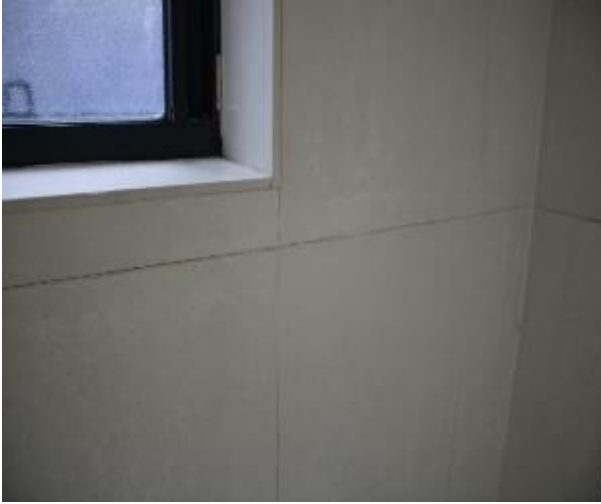
Figure 739 - General condition of bathroom 1 internal wall

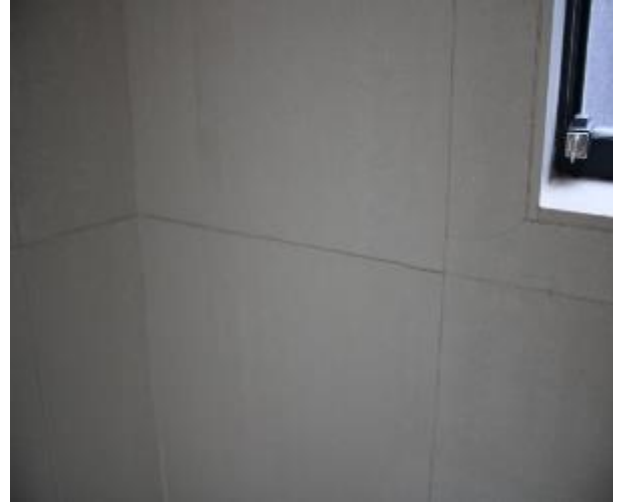
Figure 740 - Crack propagation through bathroom 1 internal wall

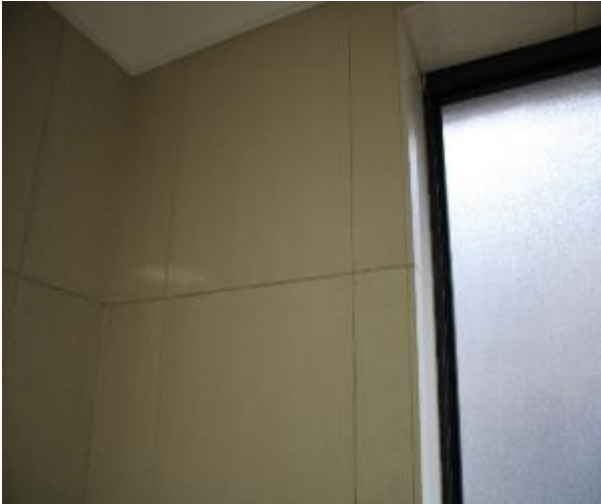
Figure 741 - Crack propagation through bathroom 1 internal wall

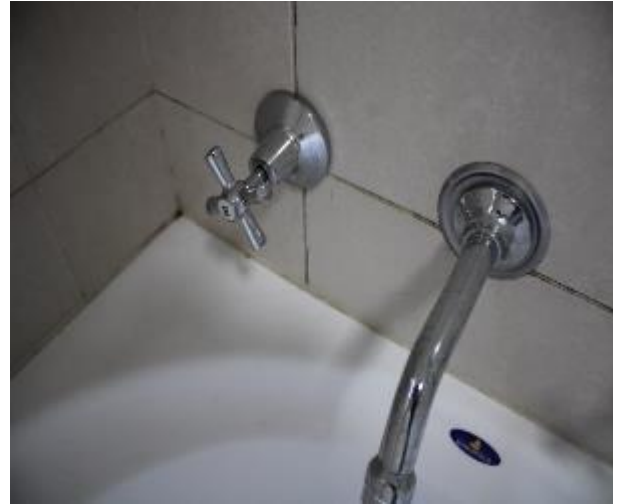
Figure 742 - General condition of bathroom 1 internal wall

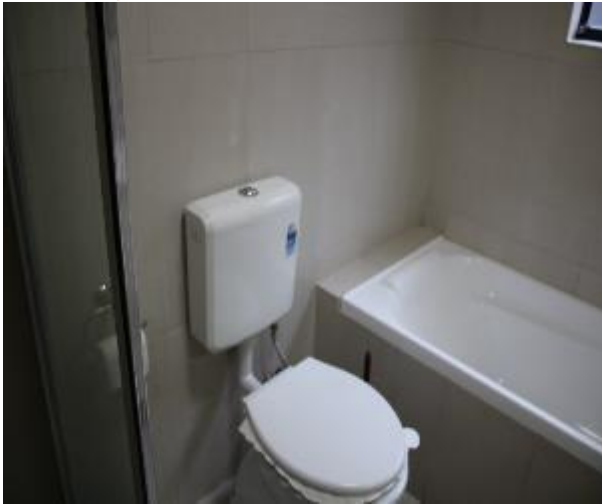
Figure 745 - General condition of bathroom 1 internal wall

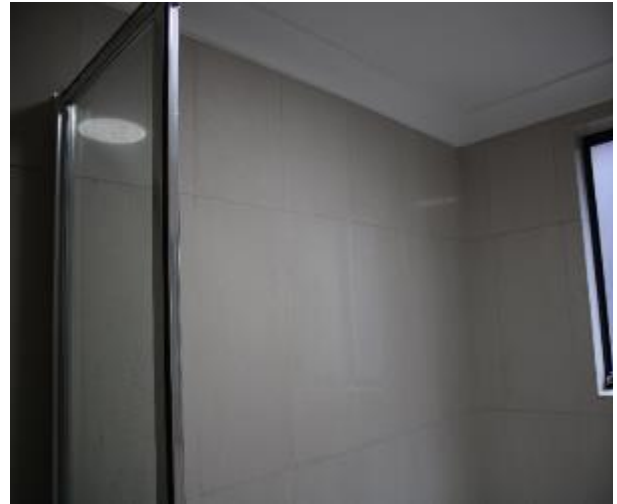
Figure 746 - General condition of bathroom 1 internal wall

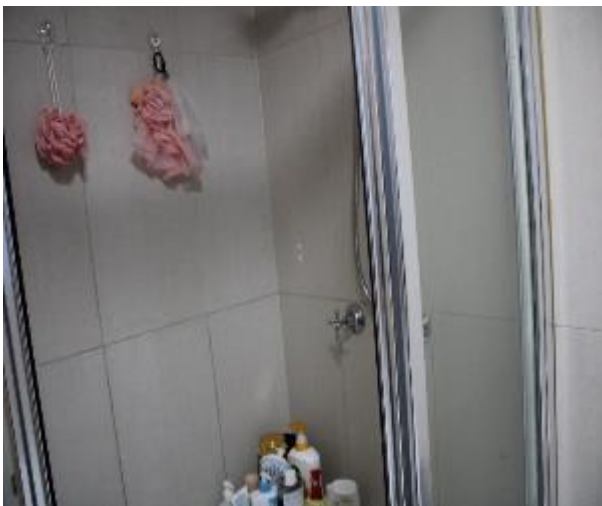
Figure 747 - General condition of bathroom 1 internal wall

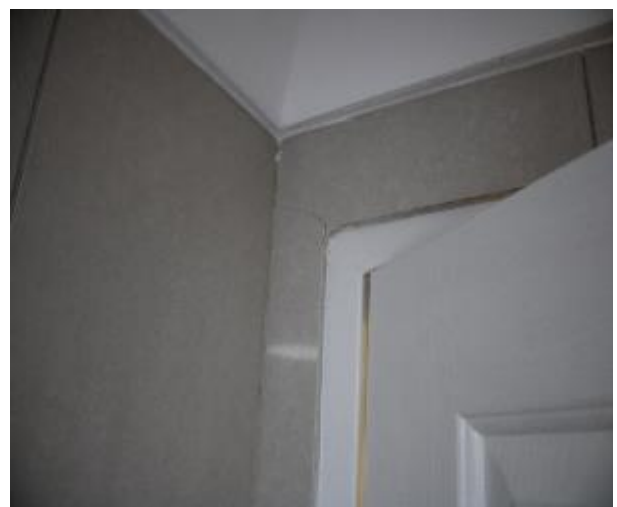
Figure 750 - Crack propagation through bathroom 1 internal wall

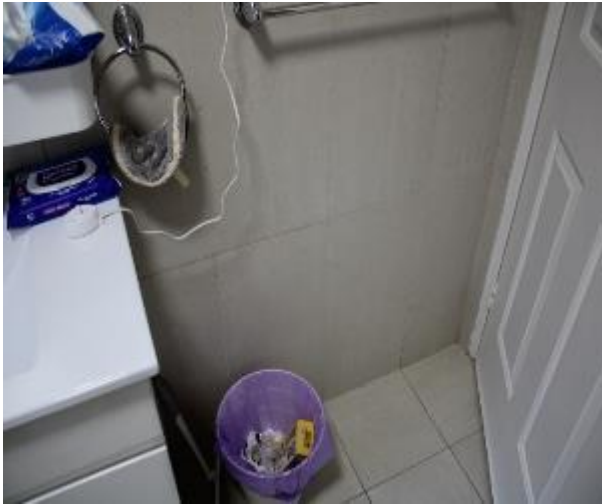
Figure 751 - Crack propagation through bathroom 1 internal wall

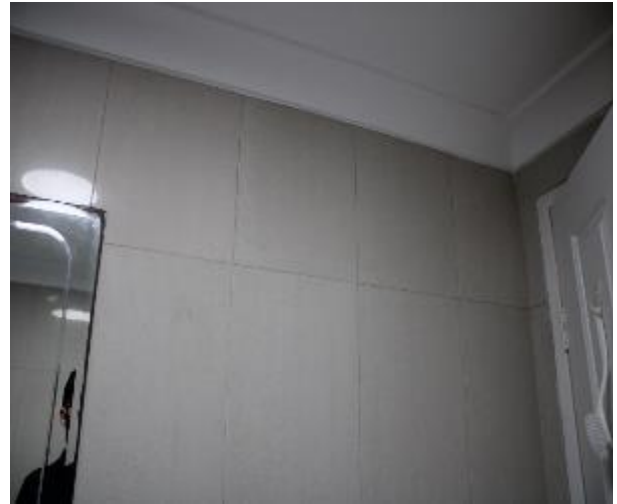
Figure 752 - General condition of bathroom 1 internal wall

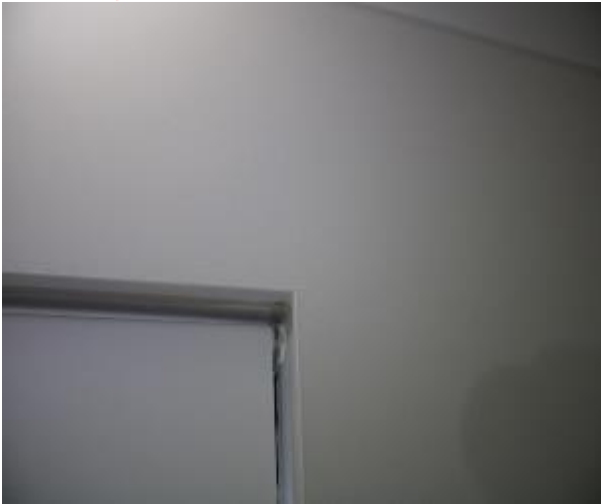
Figure 757 - General condition of bedroom 3 internal wall

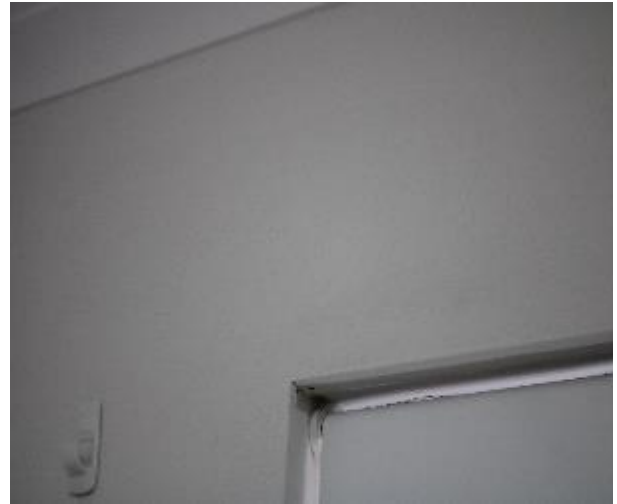
Figure 758 - Crack propagation through bedroom 3 internal wall

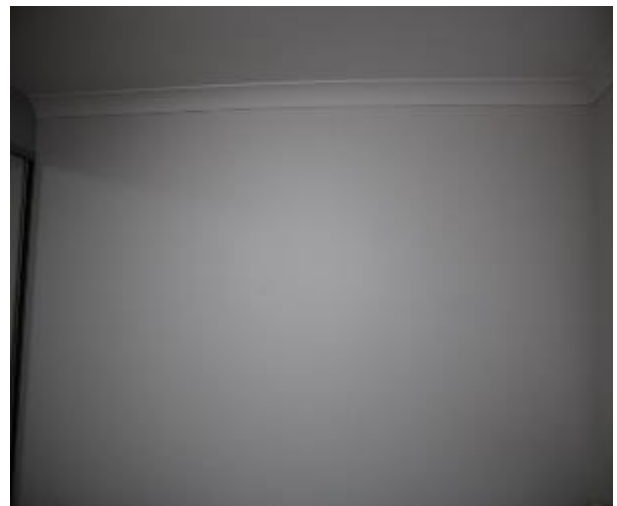
Figure 760 - General condition of bedroom 3 internal wall

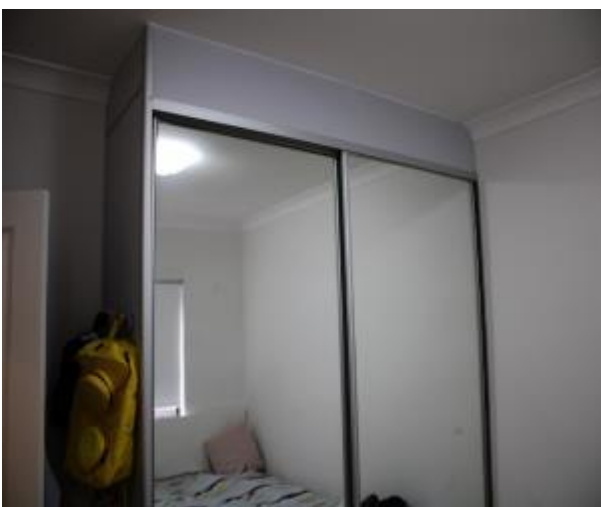
Figure 761 - General condition of bedroom 3 internal wall

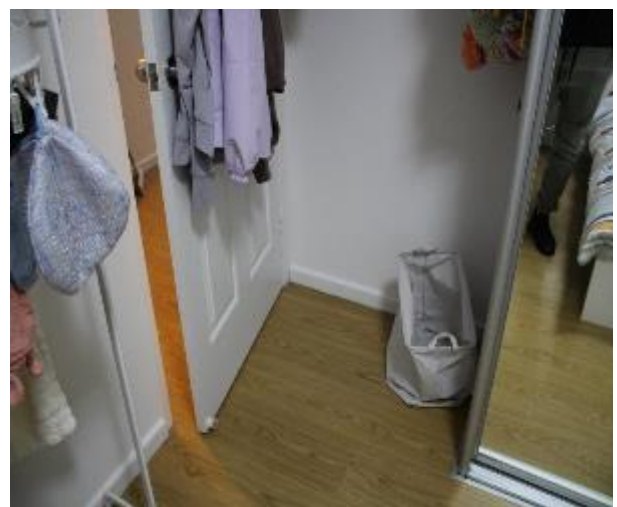
Figure 762 - General condition of bedroom 3 internal wall

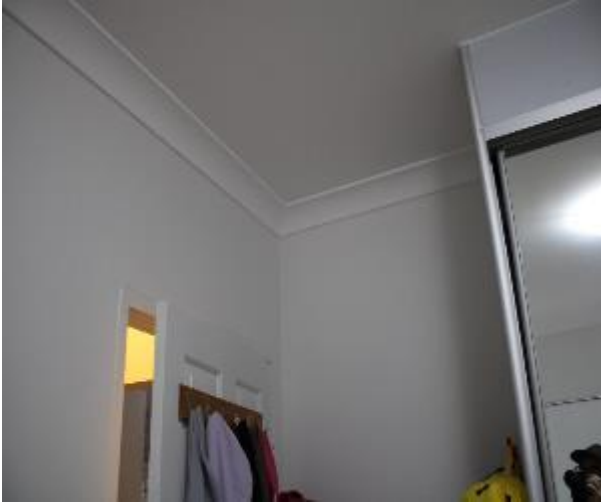
Figure 763 - General condition of bedroom 3 internal wall

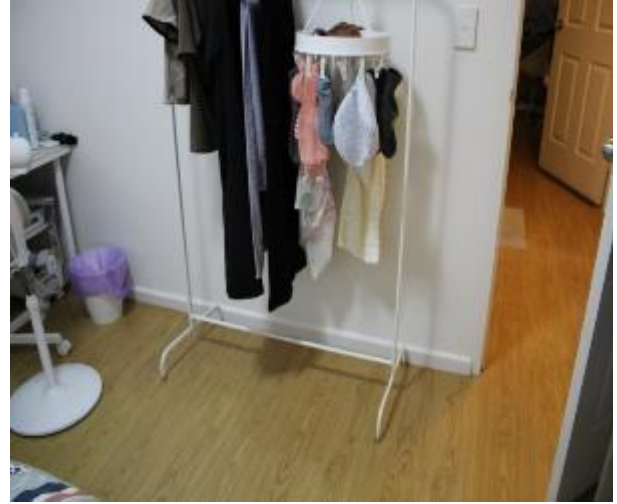
Figure 764 - General condition of bedroom 3 internal wall

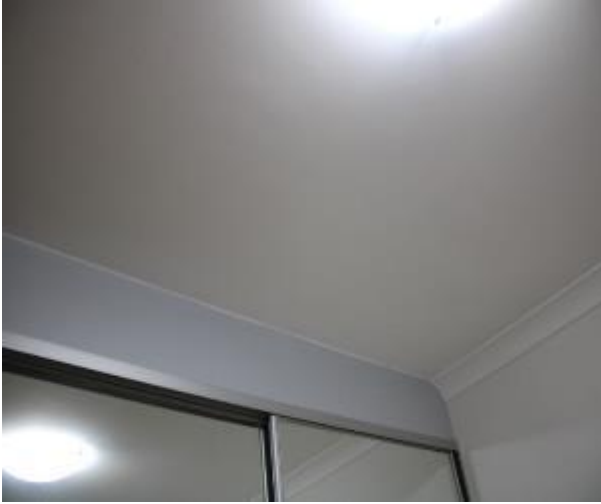
Figure 770 - General condition of bedroom 3 ceiling

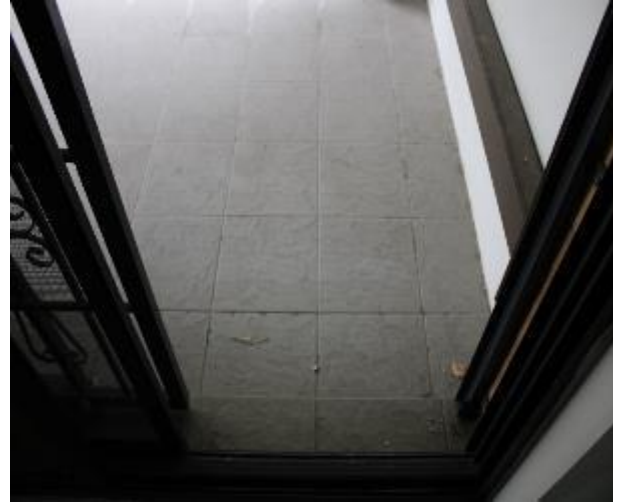
Figure 771 - General condition of balcony floor tiles

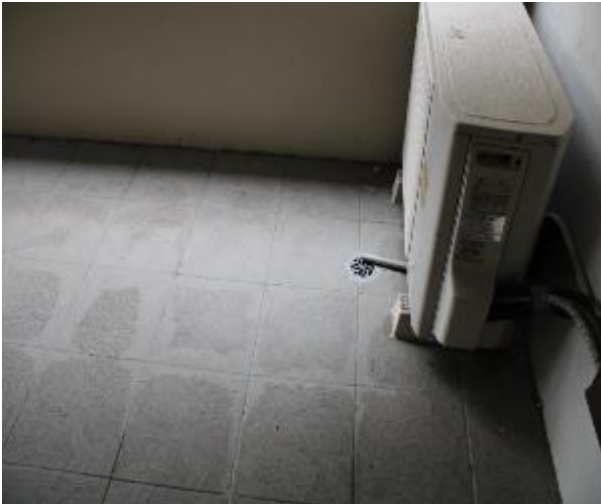
Figure 772 - General condition of balcony floor tiles

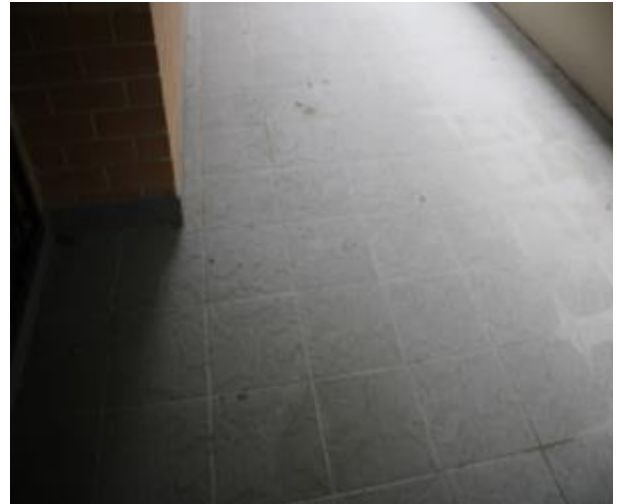
Figure 773 - General condition of balcony floor tiles

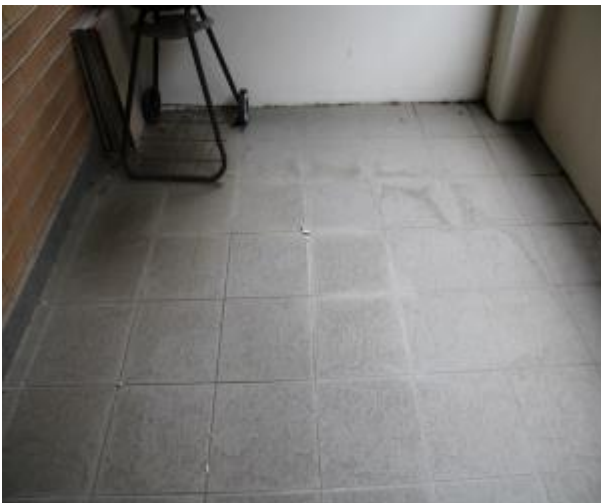
Figure 774 - General condition of balcony floor tiles

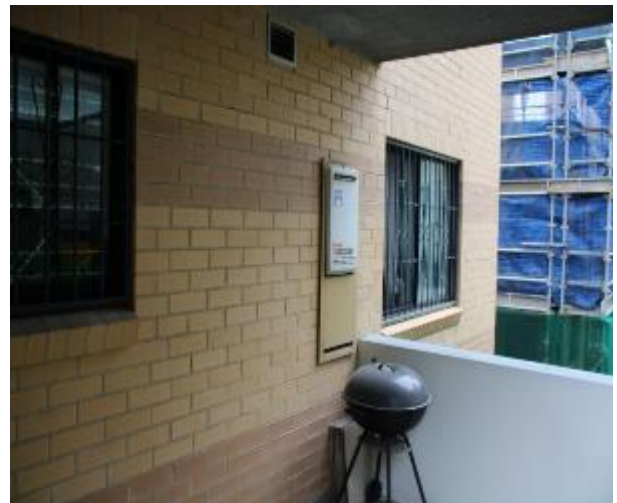
Figure 775 - General condition of external wall

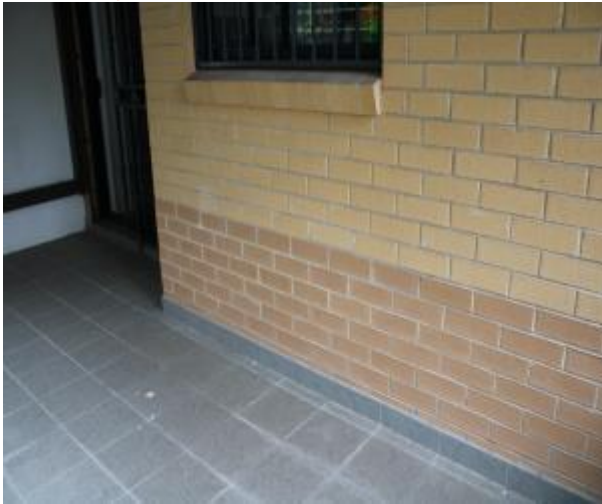
Figure 776 - General condition of external wall

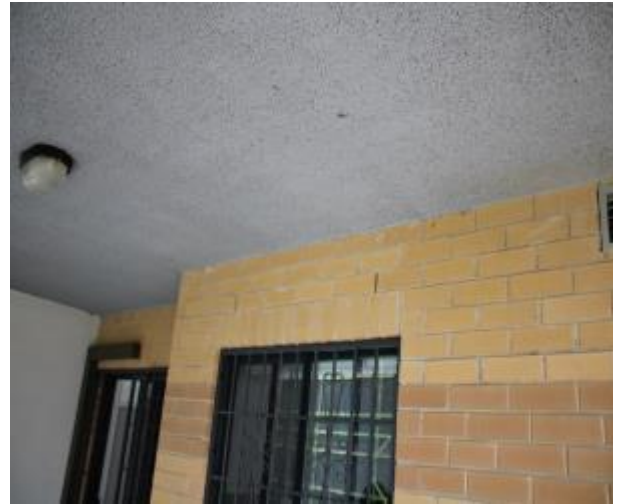
Figure 777 - General condition of external wall

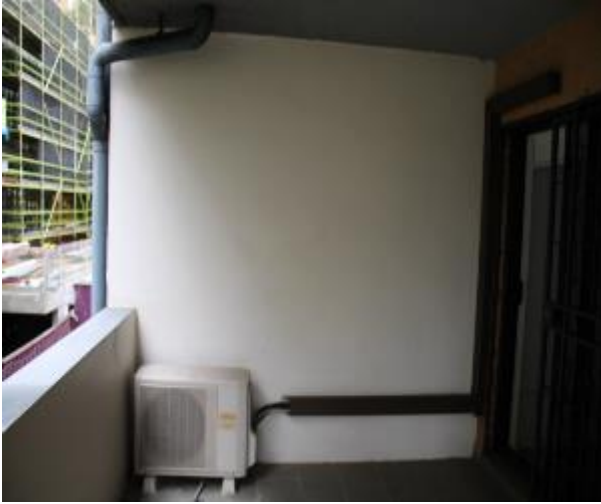
Figure 782 - General condition of external wall

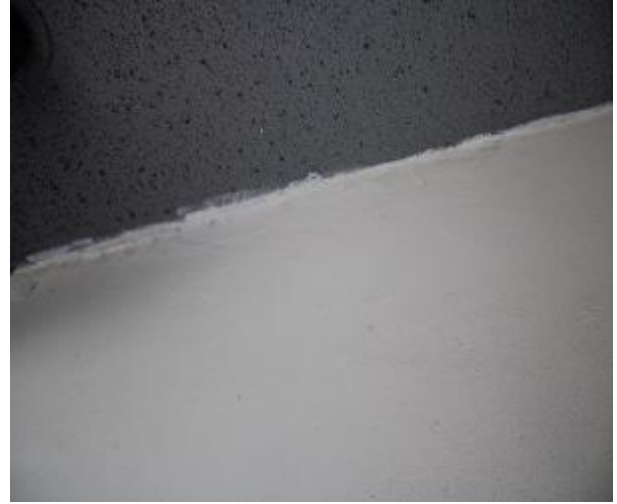
Figure 783 - Crack propagation through external wall

Unit 23 was inspected and found to be in reasonable condition with cases of cracking evident through the internal and external walls and ceilings.

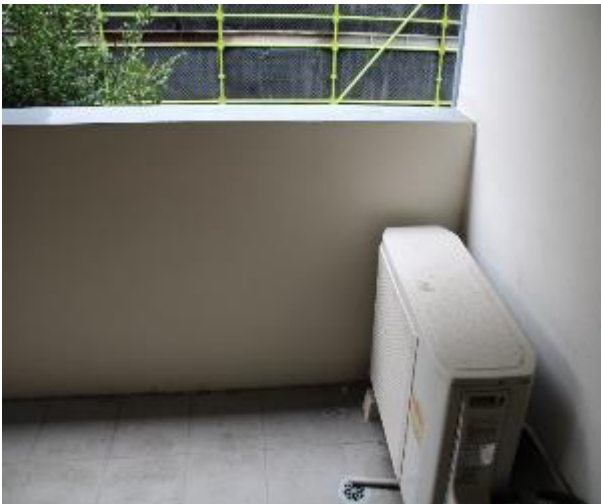
Figure 784 - General condition of external wall

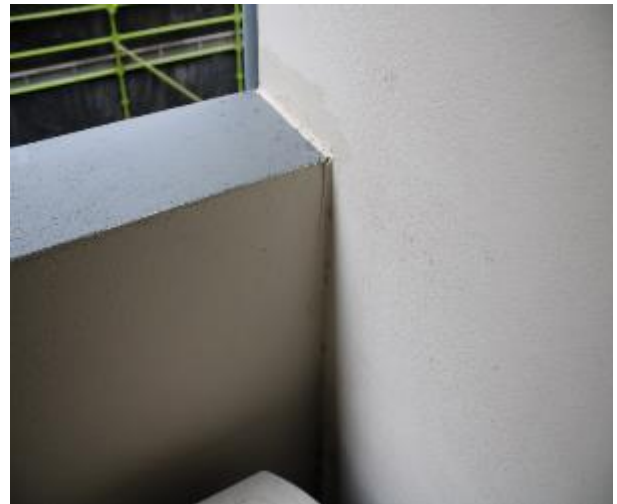
Figure 785 - Crack propagation through external wall

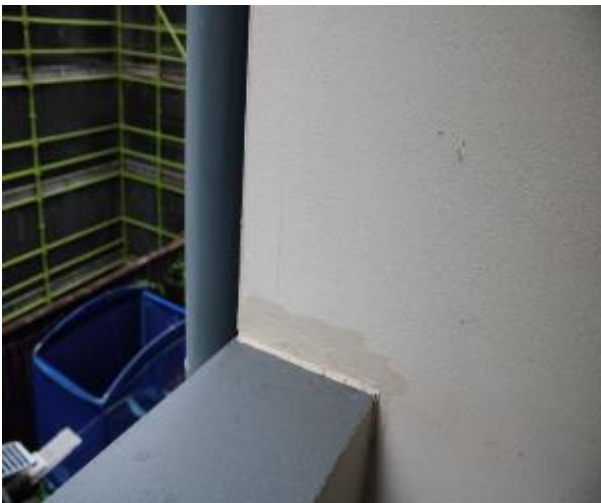
Figure 786 - Crack propagation through external wall

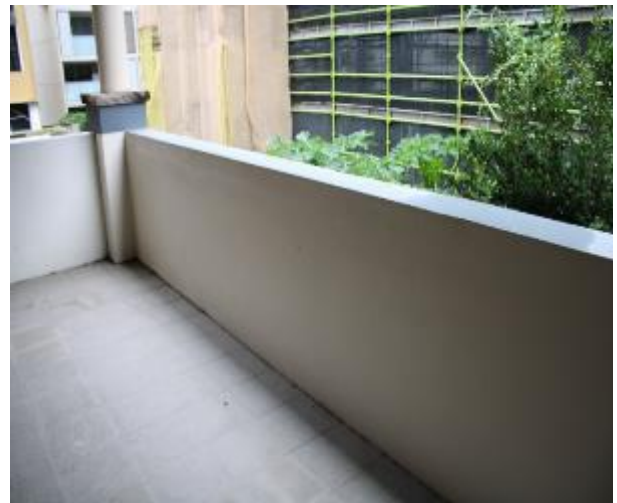
Figure 787 - General condition of external wall

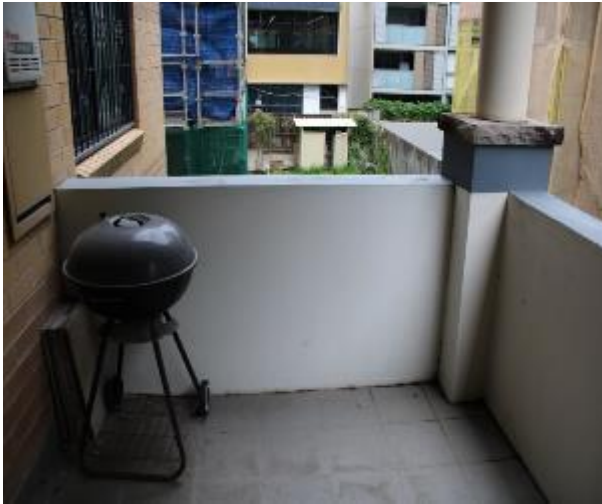
Figure 788 - General condition of external wall

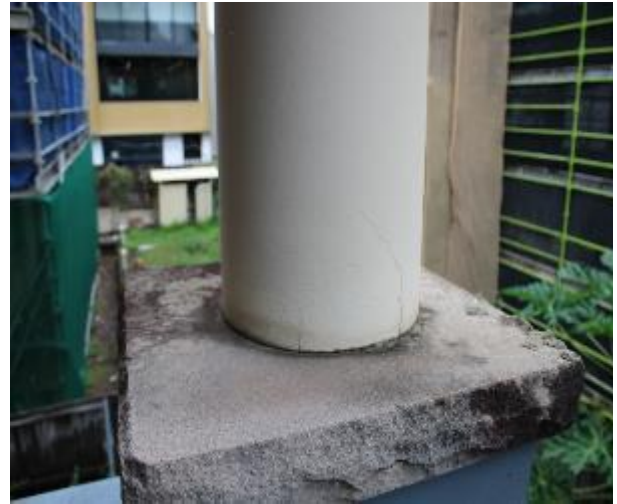
Figure 789 - Crack propagation through external wall

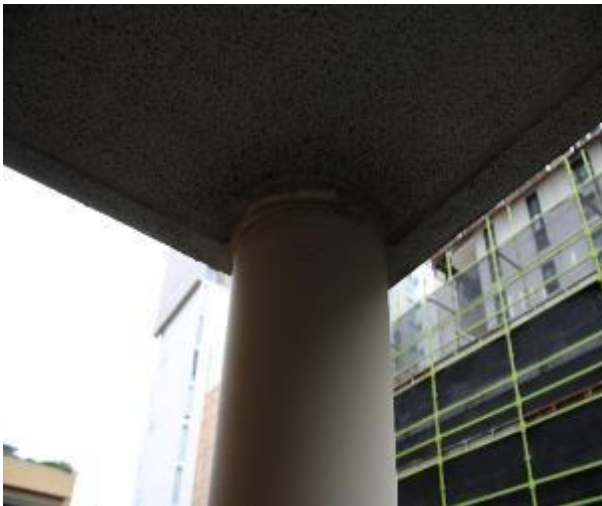
Figure 790 - General condition of external wall

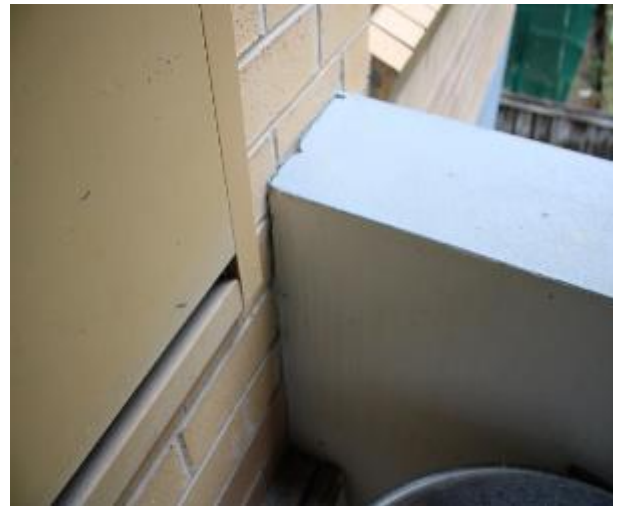
Figure 791 - General condition of external wall

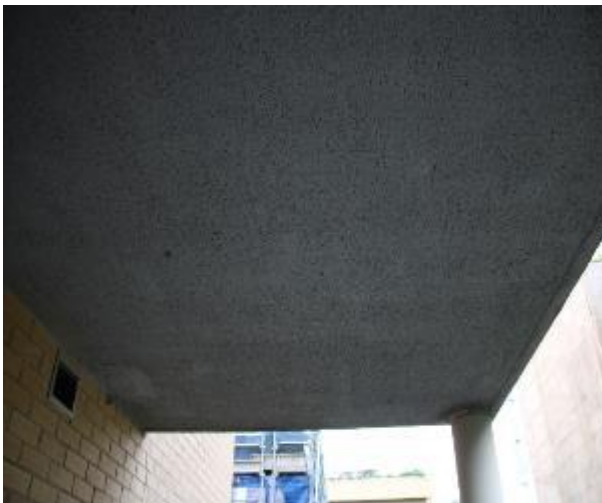
Figure 792 - General condition of balcony underside slab

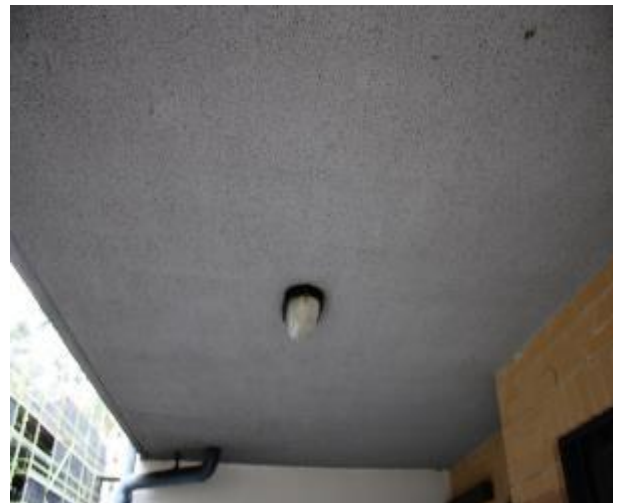
Figure 793 - General condition of balcony underside slab

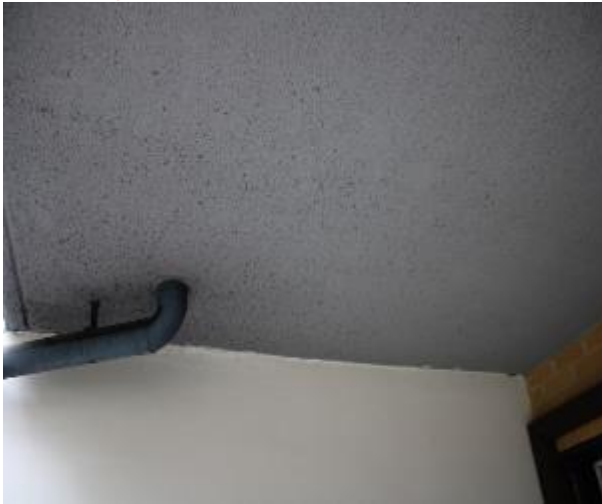
Figure 794 - General condition of balcony underside slab

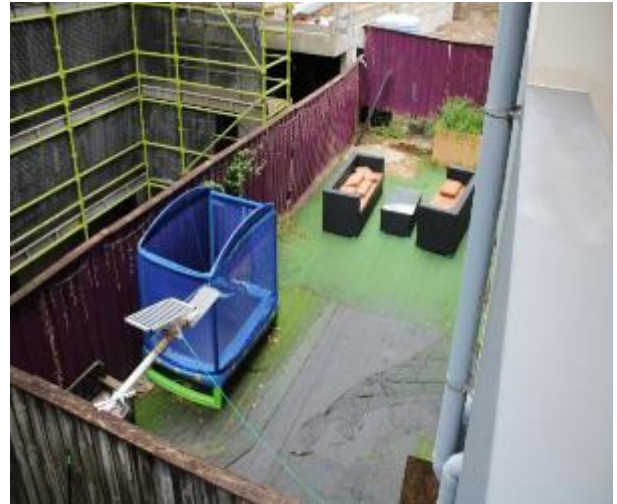
Figure 795 - General condition of boundary fence as seen from Unit 23 balcony

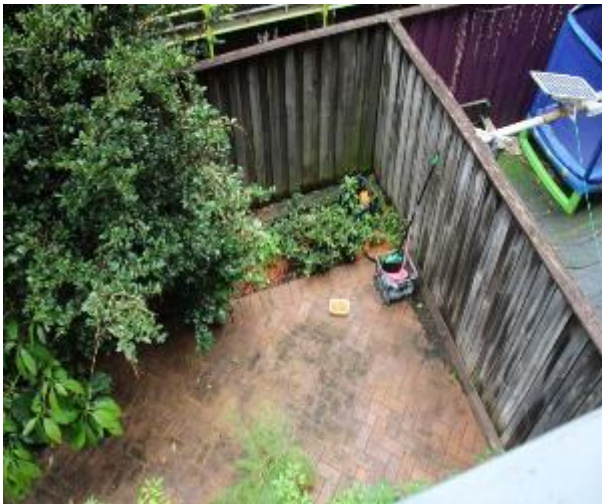
Figure 796 - General condition of boundary fence as seen from Unit 23 balcony

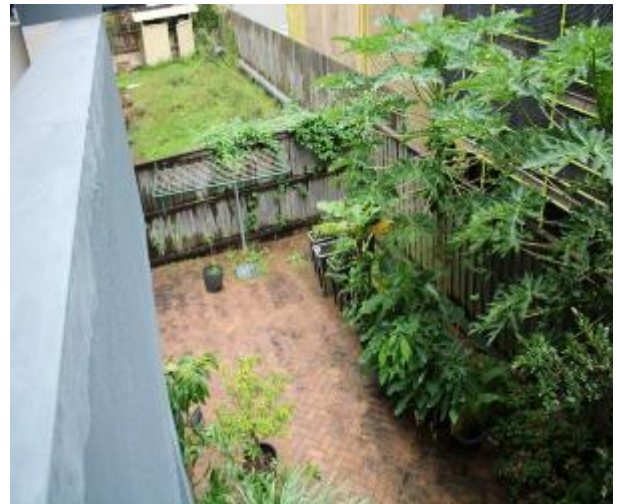
Figure 797 - General condition of boundary fence as seen from Unit 23 balcony

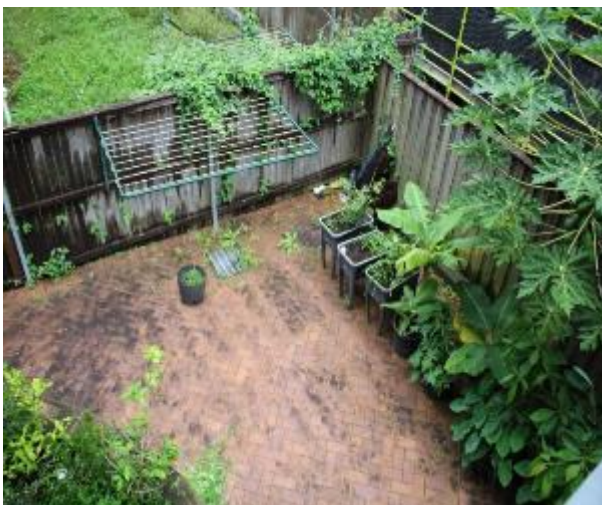
Figure 798 - General condition of boundary fence as seen from Unit 23 balcony

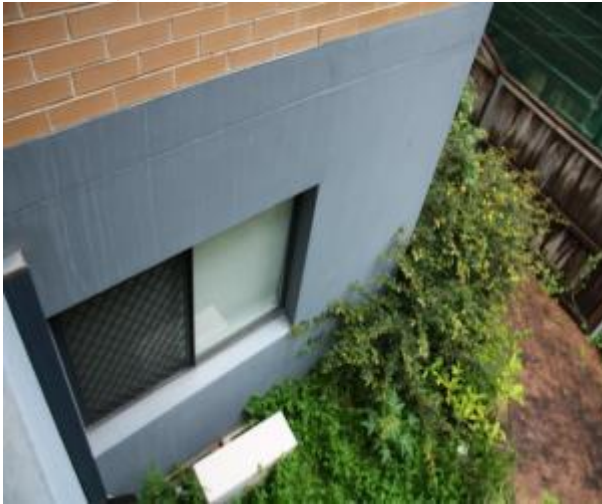
Figure 800 - General condition of external wall

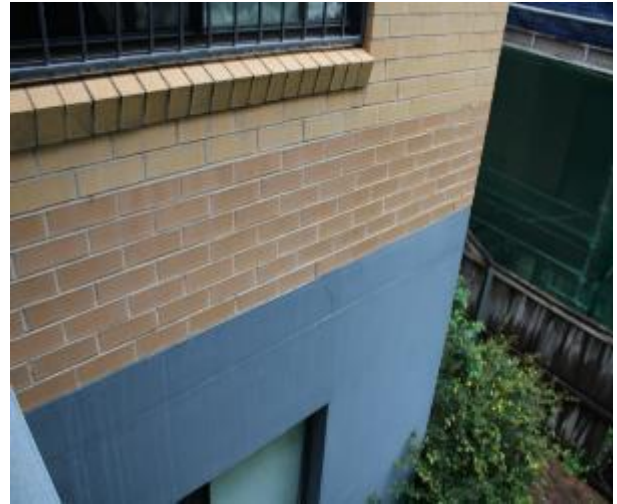
Figure 801 - General condition of external wall

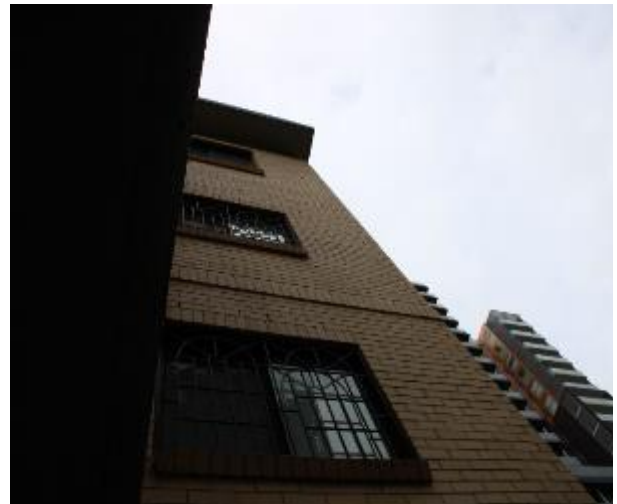
Figure 803 - General condition of external wall

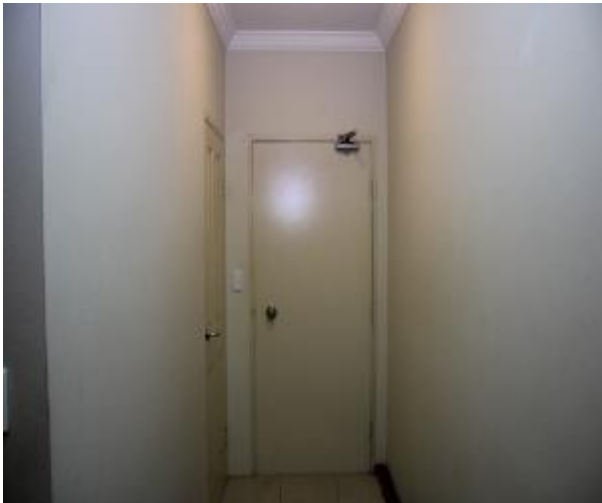
Figure 806 - General condition of open kitchen/ lounge room internal wall

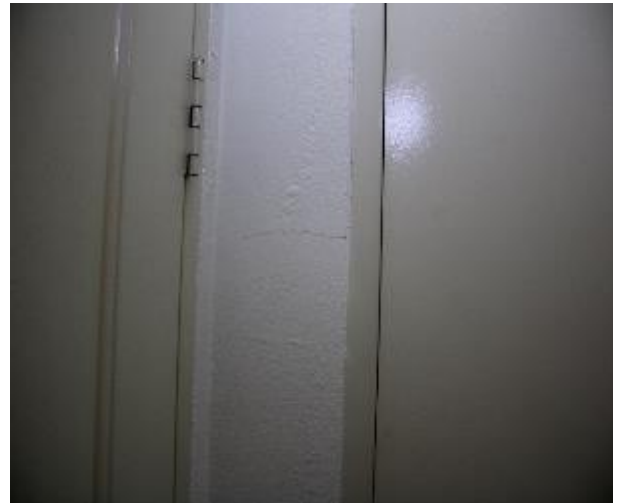
Figure 807 - Crack propagation through open kitchen/ lounge room internal wall

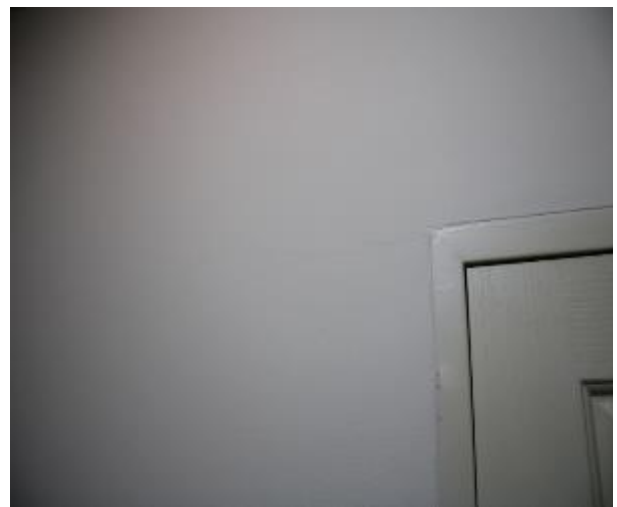
Figure 809 - Crack propagation through open kitchen/ lounge room internal wall
