# **Pre-Dilapidation Report**

**19 GEORGE STREET**

**REAR BUILDING (UNITS 20-29)**

Project Reference: 20250047.19G.3

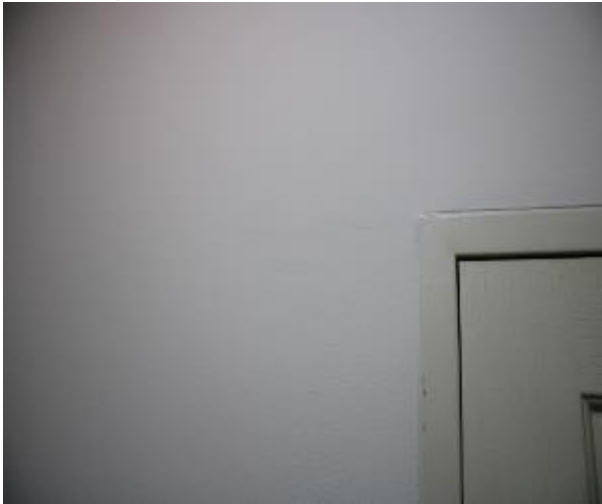
Figure 810 - Crack propagation through open kitchen/ lounge room internal wall

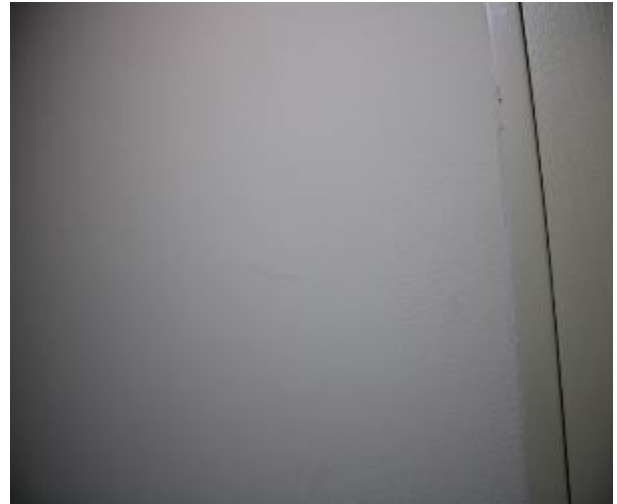
Figure 811 - Crack propagation through open kitchen/ lounge room internal wall

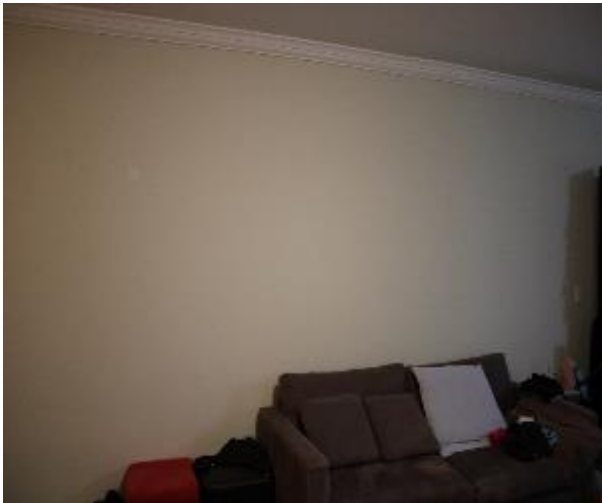
Figure 812 - General condition of open kitchen/ lounge room internal wall

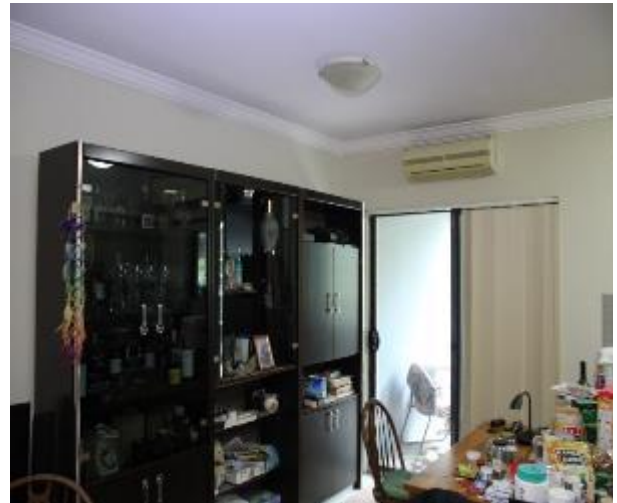
Figure 813 - General condition of open kitchen/ lounge room internal wall

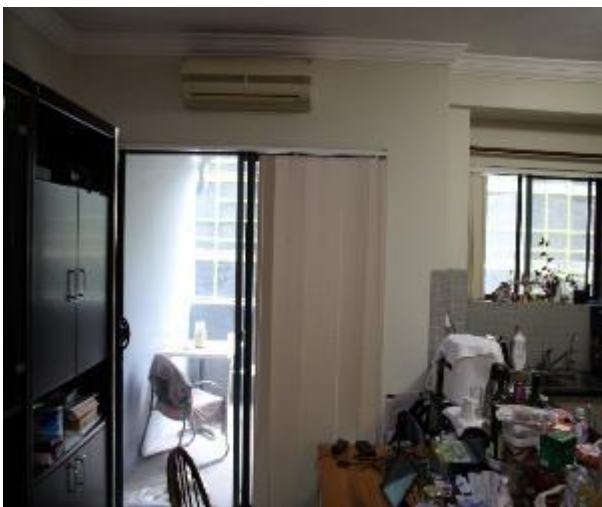
Figure 814 - General condition of open kitchen/ lounge room internal wall

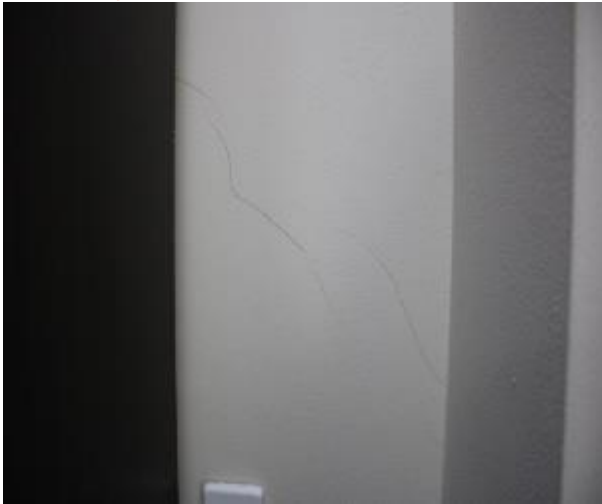
Figure 816 - Crack propagation through open kitchen/ lounge room internal wall

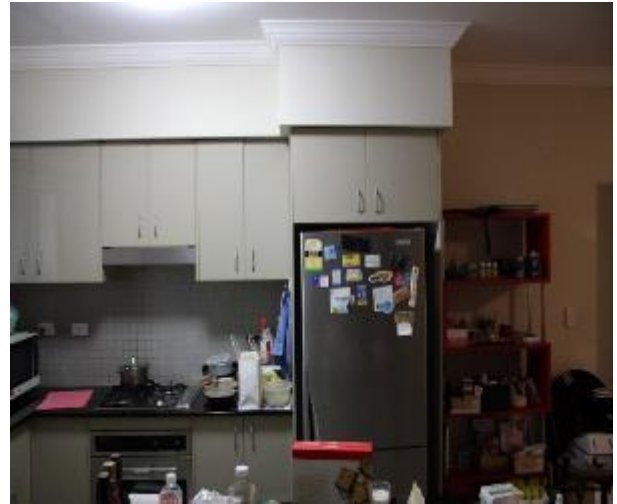
Figure 817 - General condition of open kitchen/ lounge room internal wall

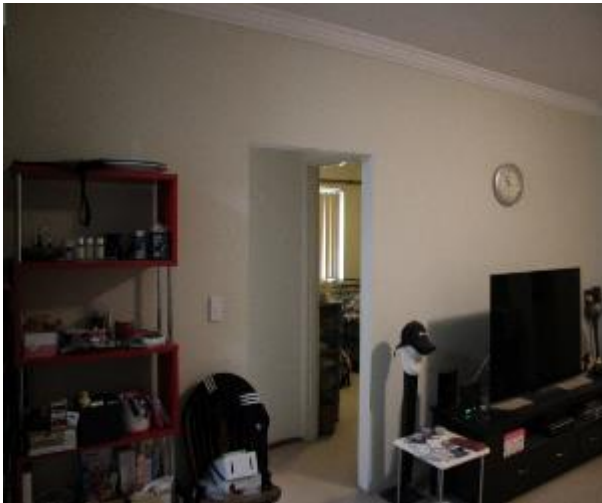
Figure 818 - General condition of open kitchen/ lounge room internal wall

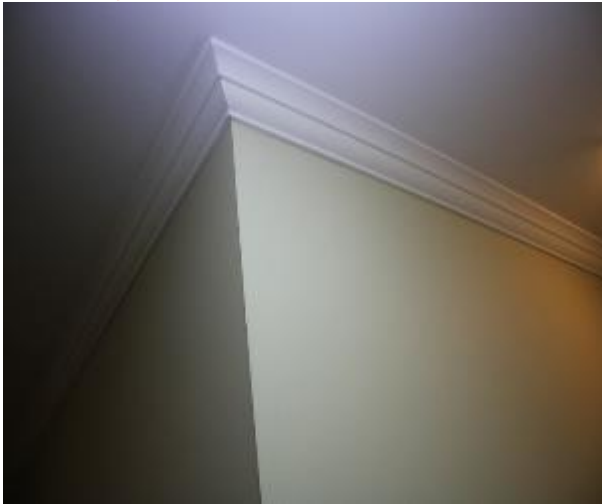
Figure 822 - General condition of open kitchen/  
lounge room internal wall

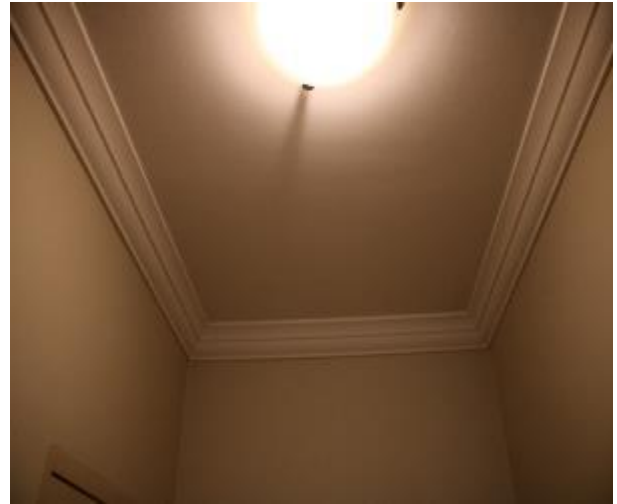
Figure 823 - General condition of open kitchen/  
lounge room ceiling

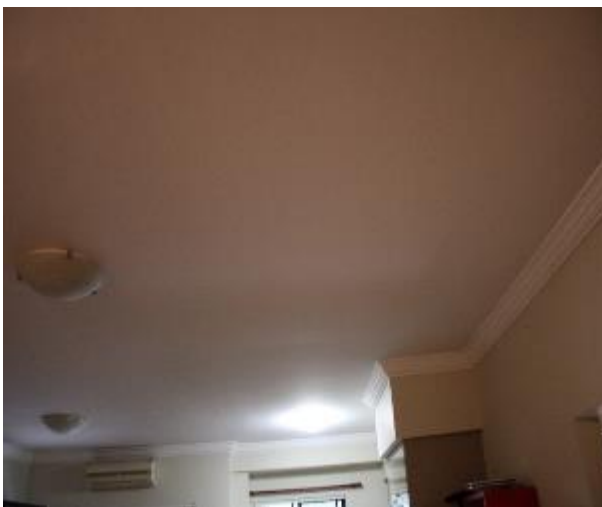
Figure 826 - General condition of open kitchen/  
lounge room ceiling

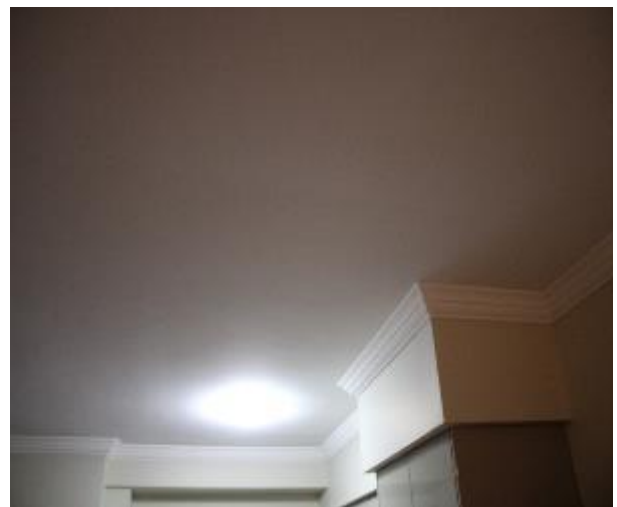
Figure 827 - General condition of open kitchen/  
lounge room ceiling

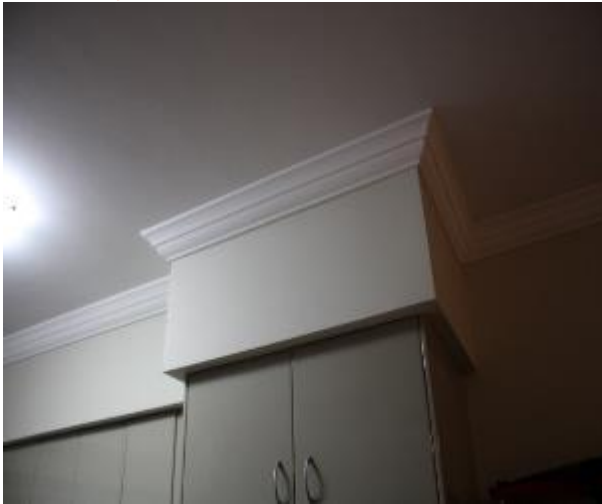
Figure 828 - General condition of open kitchen/  
lounge room ceiling

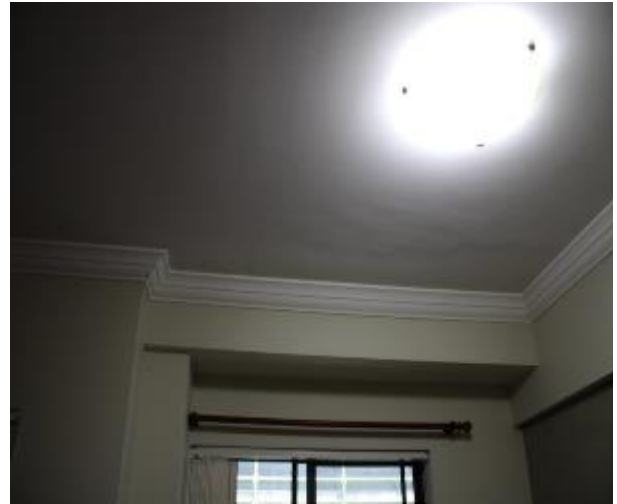
Figure 829 - General condition of open kitchen/  
lounge room ceiling

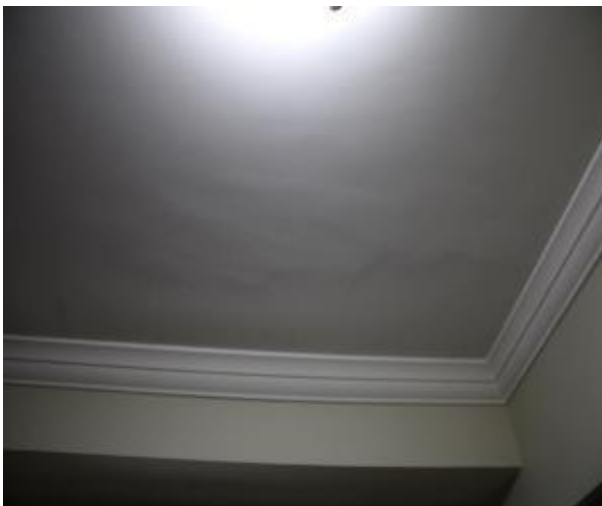
Figure 830 - General condition of open kitchen/  
lounge room ceiling

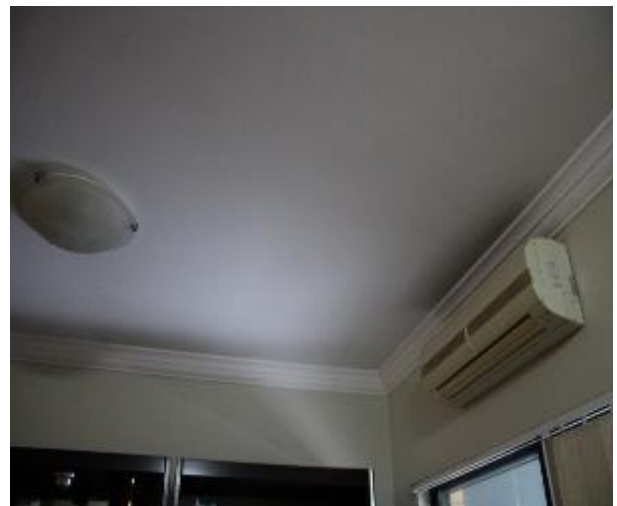
Figure 831 - General condition of open kitchen/  
lounge room ceiling

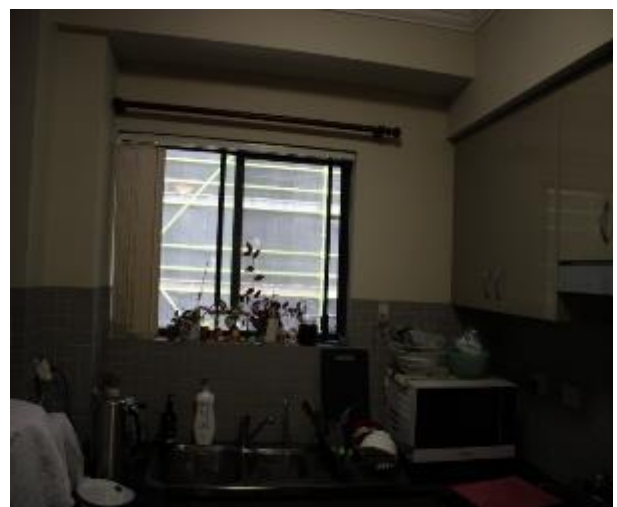
Figure 833 - General condition of kitchen internal  
wall

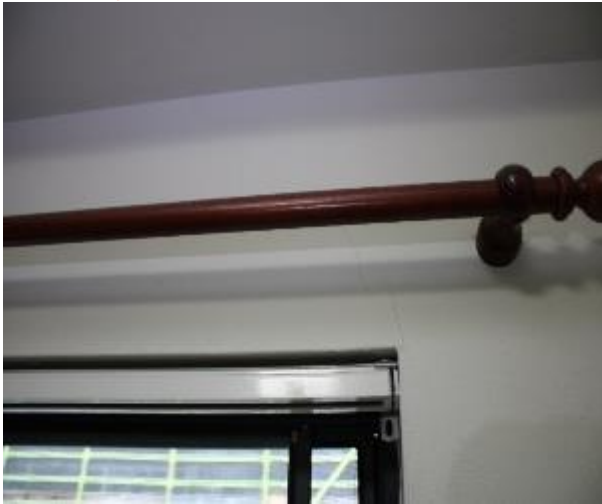
Figure 834 - Crack propagation through kitchen internal wall

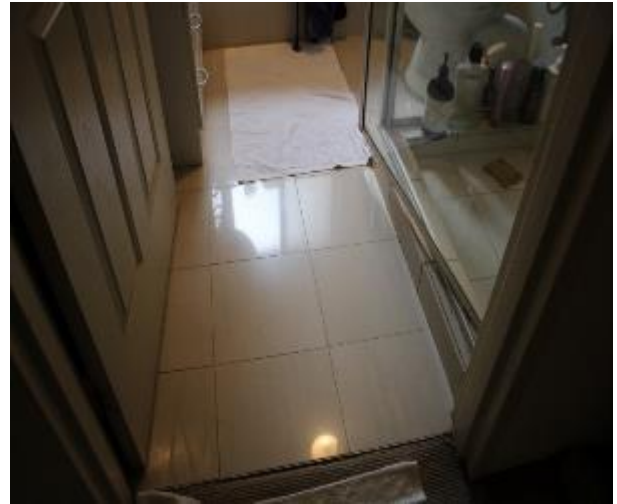
Figure 835 - General condition of bathroom 1 floor tiles

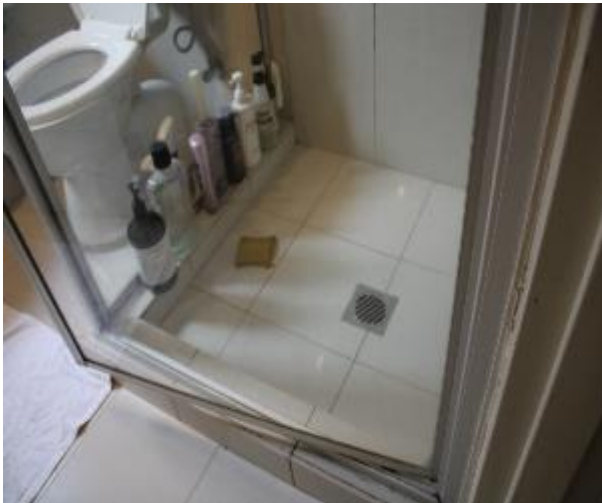
Figure 836 - General condition of bathroom 1 floor tiles

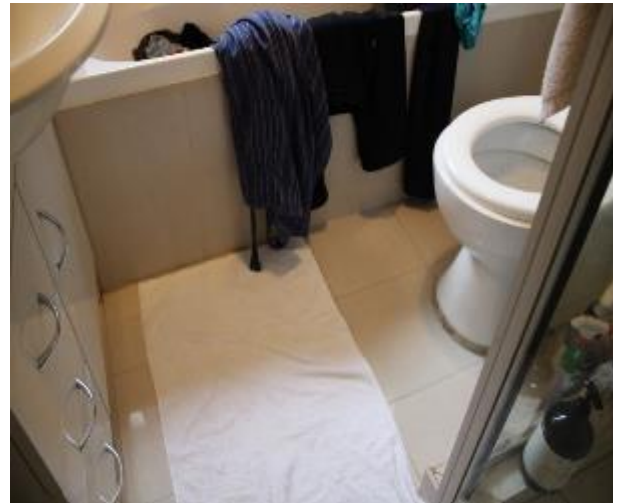
Figure 837 - General condition of bathroom 1 floor tiles

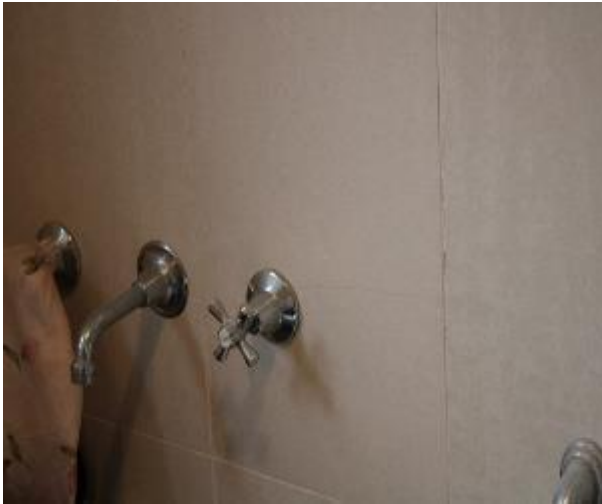
Figure 840 - Crack propagation through bathroom 1 internal wall

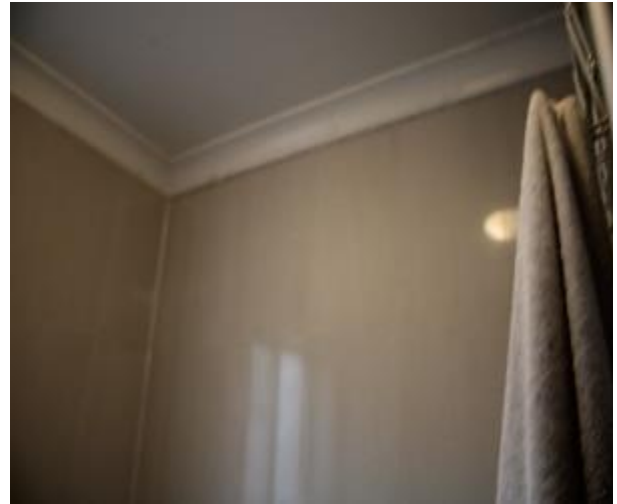
Figure 841 - General condition of bathroom 1 internal wall

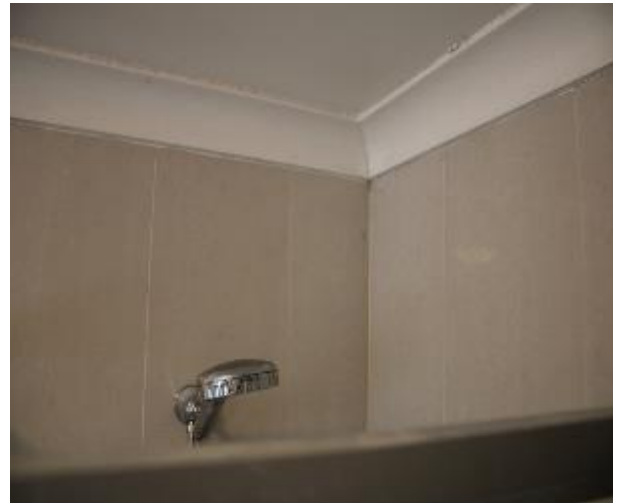
Figure 843 - General condition of bathroom 1 internal wall

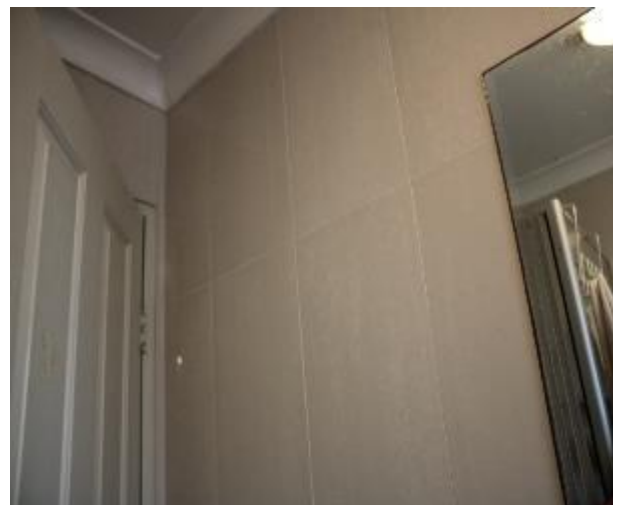
Figure 845 - General condition of bathroom 1 internal wall

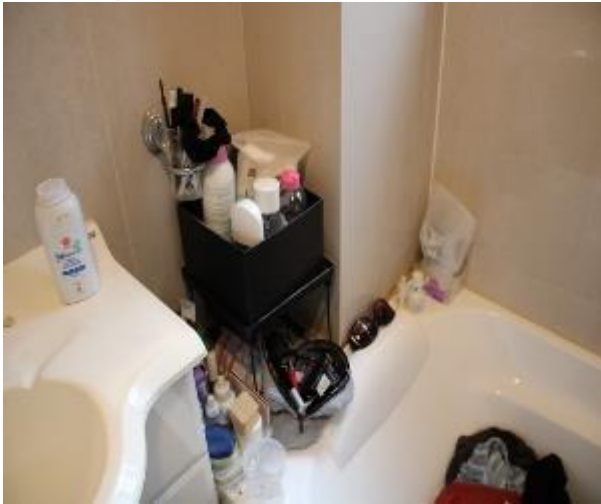
Figure 846 - General condition of bathroom 1 internal wall

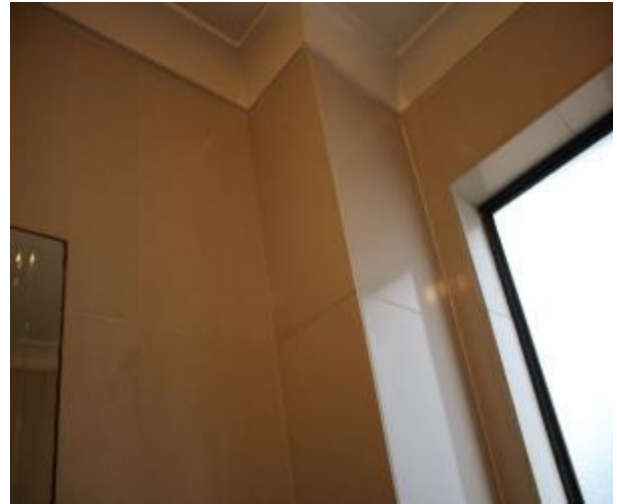
Figure 847 - General condition of bathroom 1 internal wall

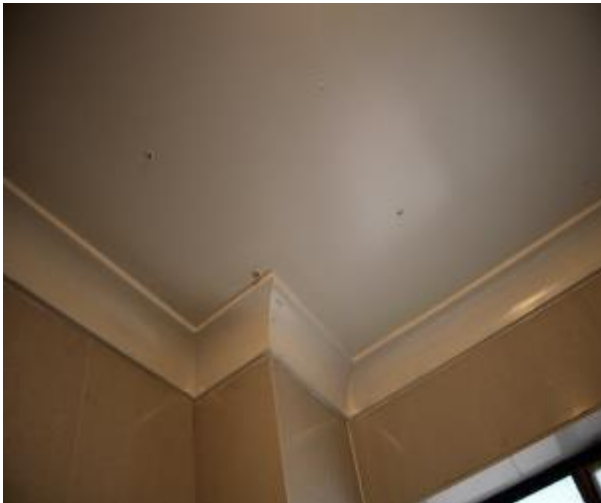
Figure 848 - General condition of bathroom 1 ceiling

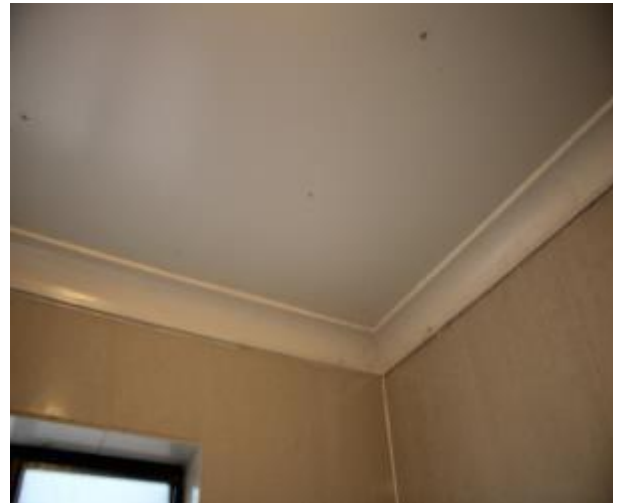
Figure 849 - General condition of bathroom 1 ceiling

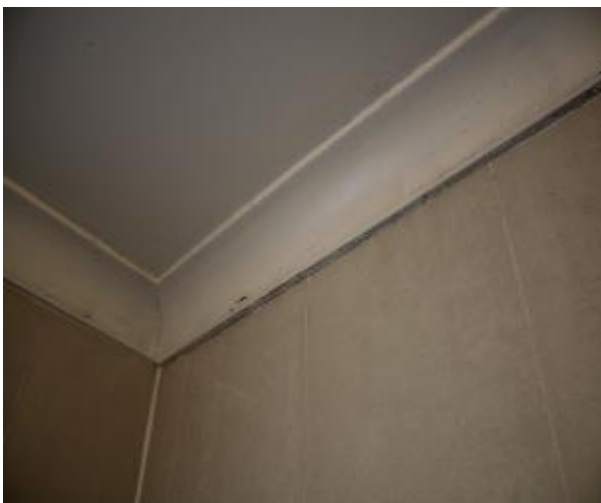
Figure 850 - Crack propagation through bathroom 1 ceiling

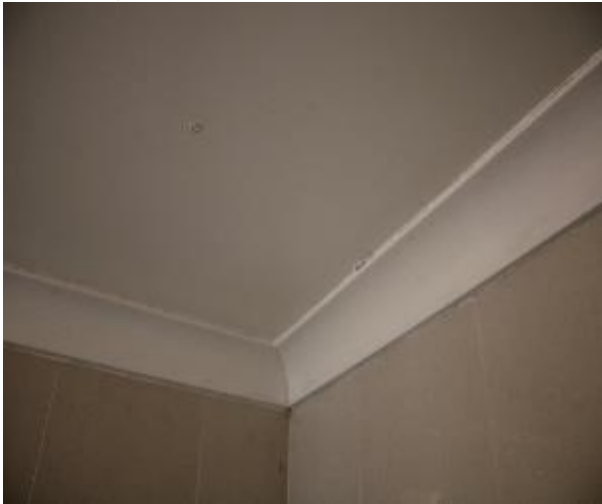
Figure 852 - General condition of bathroom 1 ceiling

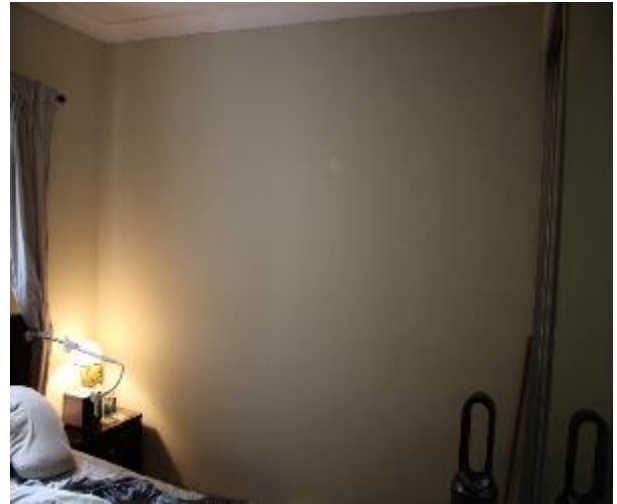
Figure 853 - General condition of bedroom 1 internal wall

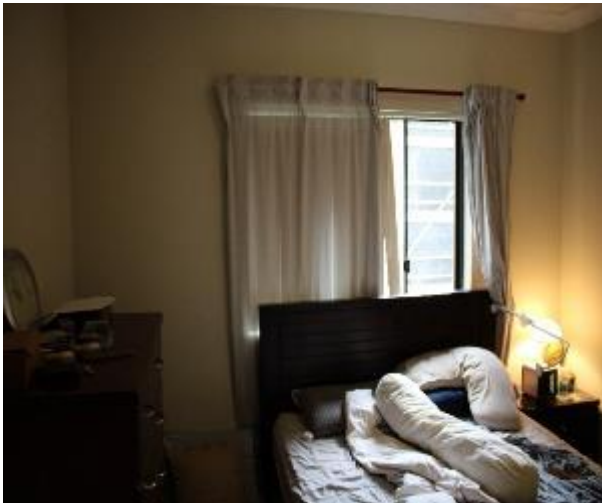
Figure 854 - General condition of bedroom 1 internal wall

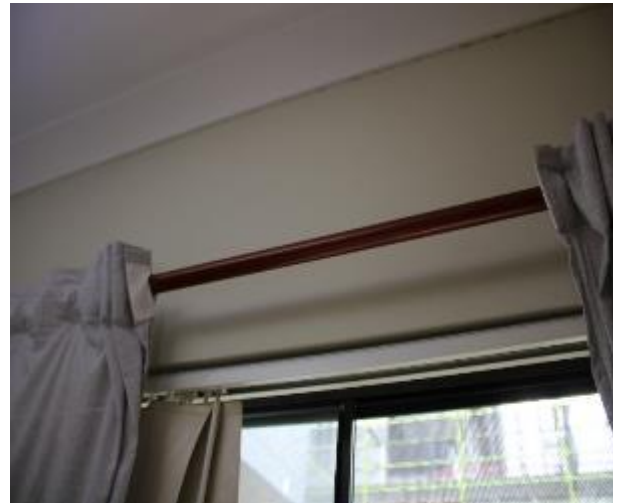
Figure 855 - General condition of bedroom 1 internal wall

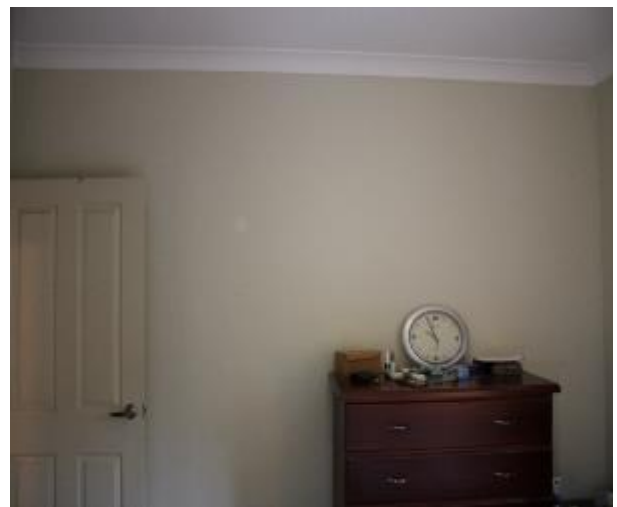
Figure 857 - General condition of bedroom 1 internal wall

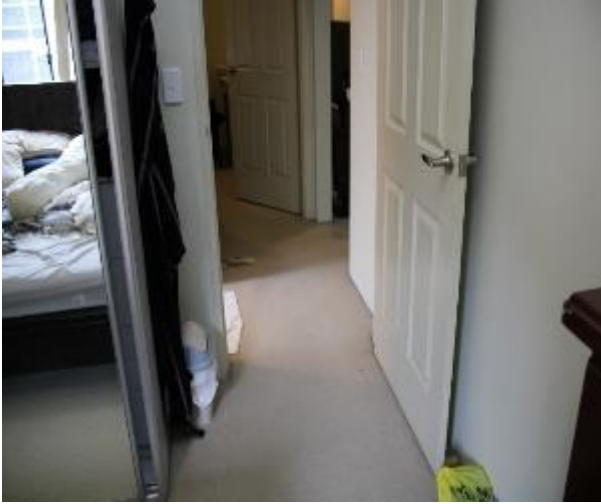
Figure 858 - General condition of bedroom 1 internal wall

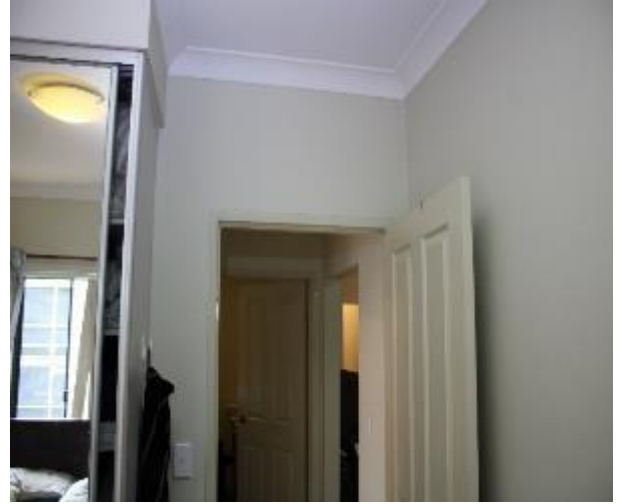
Figure 859 - General condition of bedroom 1 internal wall

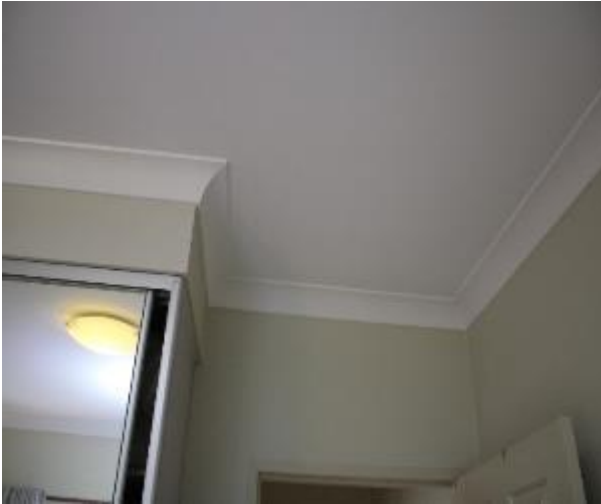
Figure 860 - General condition of bedroom 1 ceiling

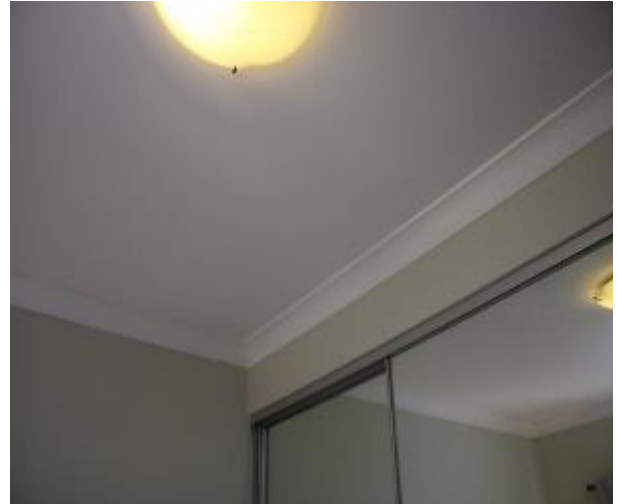
Figure 861 - General condition of bedroom 1 ceiling

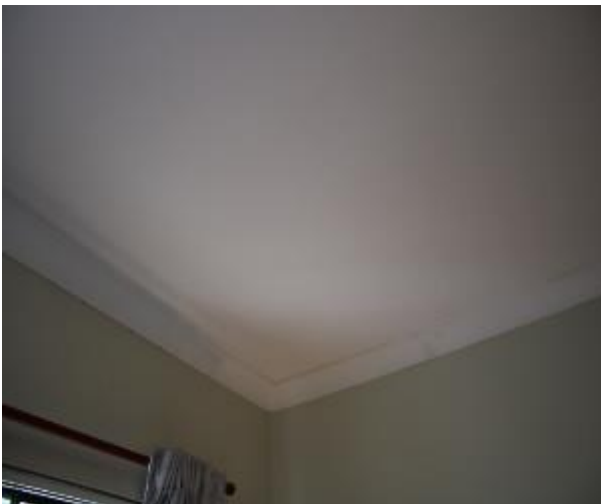
Figure 862 - General condition of bedroom 1 ceiling

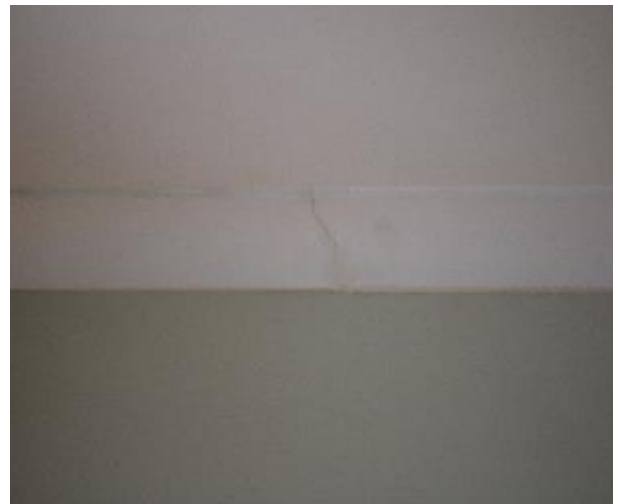
Figure 863 - Crack propagation through bedroom 1 ceiling

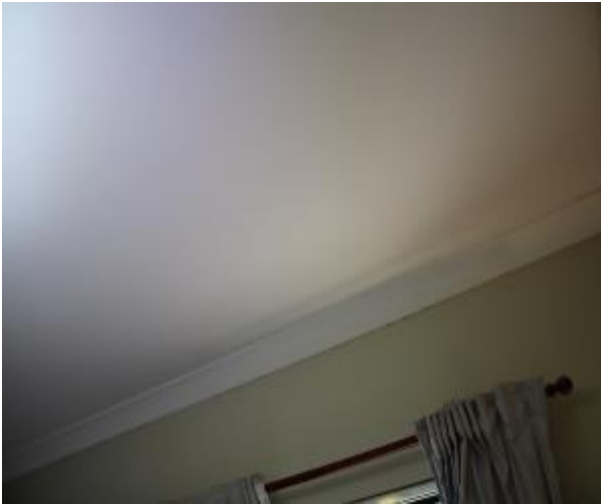
Figure 864 - General condition of bedroom 1 ceiling

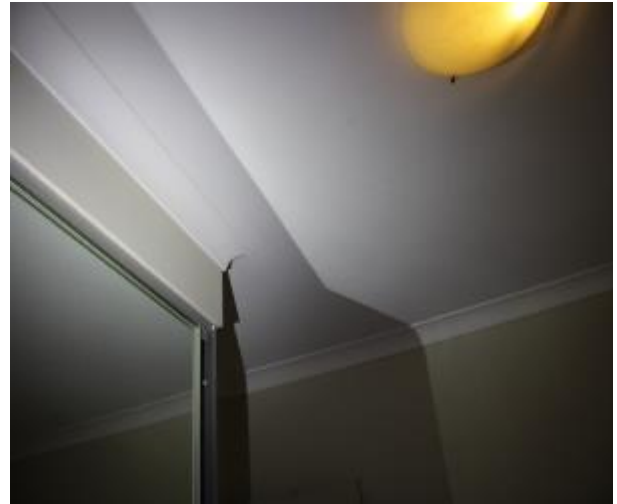
Figure 865 - General condition of bedroom 1 ceiling

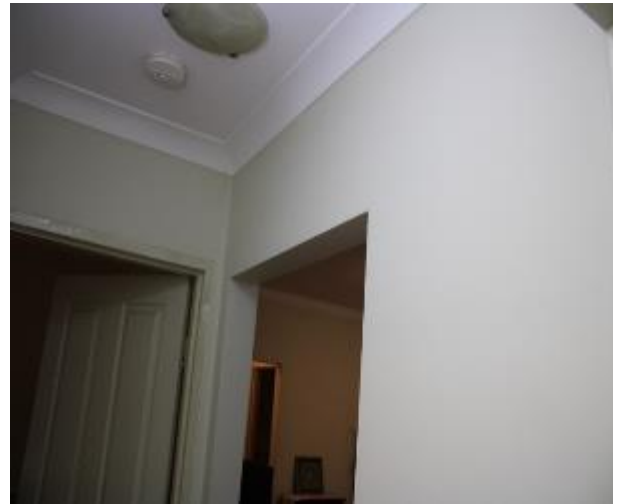
Figure 867 - General condition of corridor internal wall

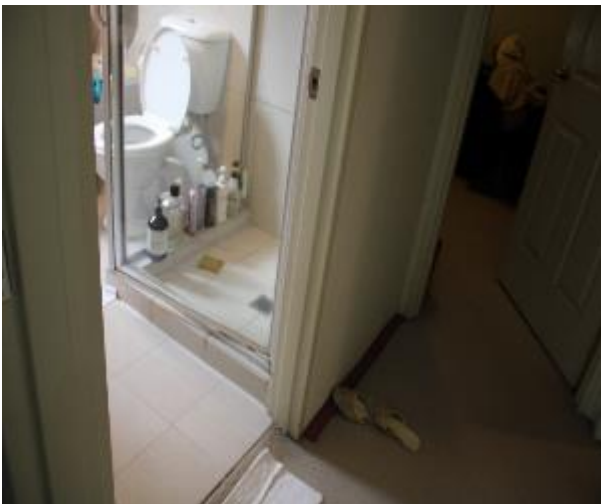
Figure 868 - General condition of corridor internal wall

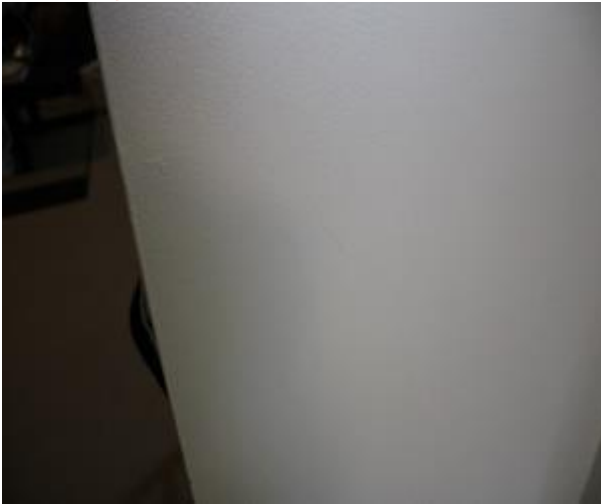
Figure 870 - Crack propagation through corridor internal wall

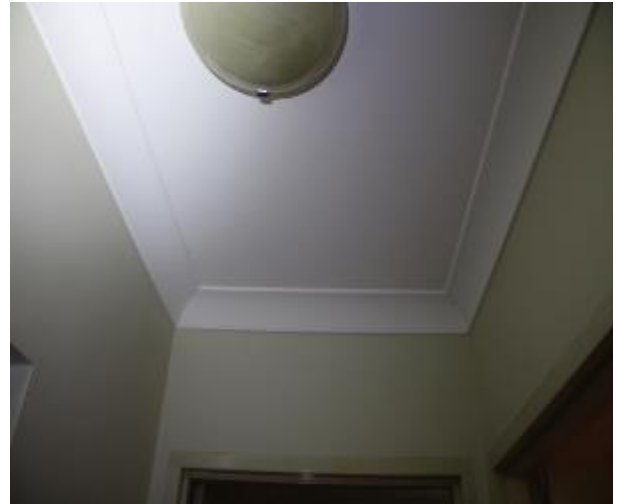
Figure 871 - General condition of corridor ceiling

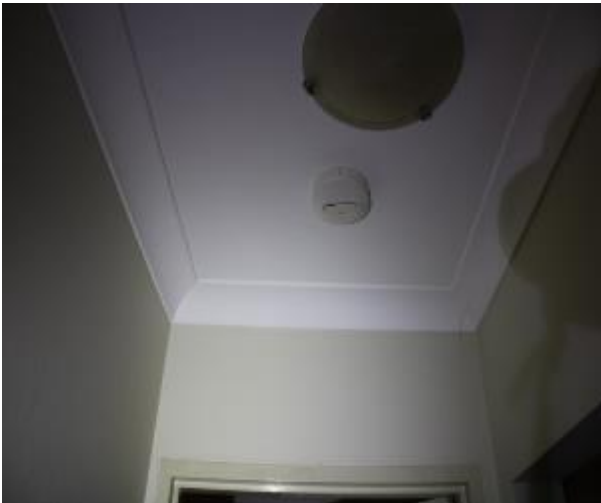
Figure 872 - General condition of corridor ceiling

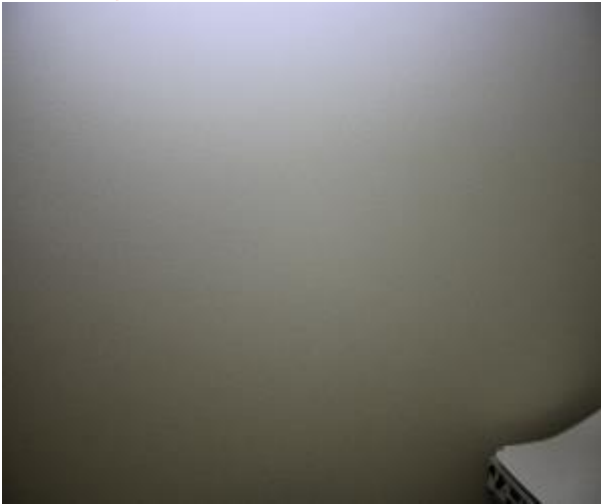
Figure 876 - Crack propagation through bedroom 2 internal wall

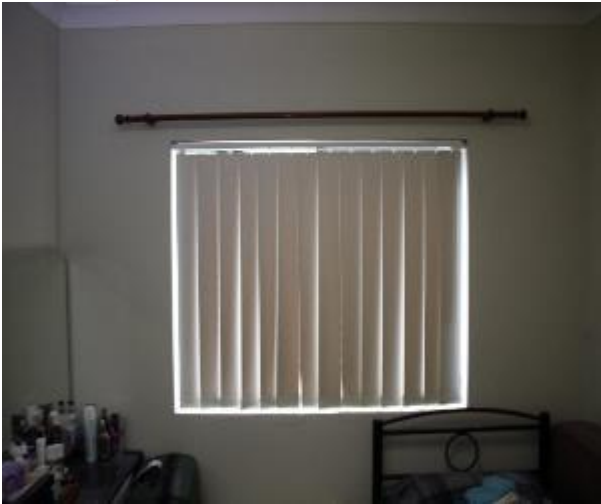
Figure 882 - General condition of bedroom 2 internal wall

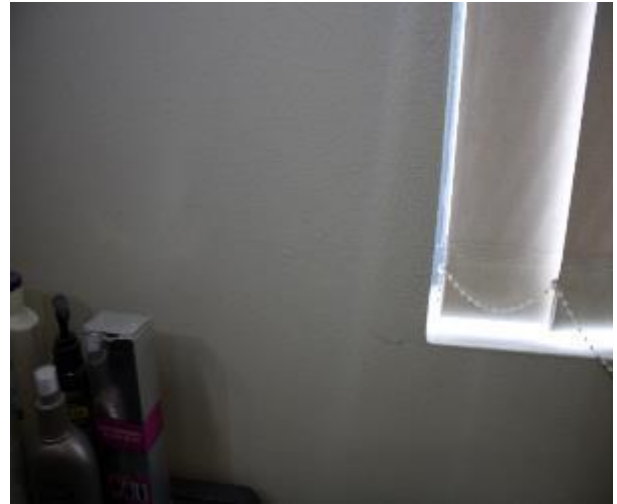
Figure 883 - Crack propagation through bedroom 2 internal wall

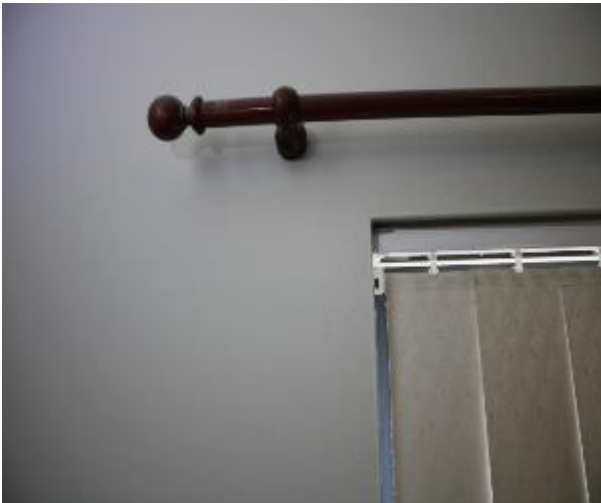
Figure 884 - Crack propagation through bedroom 2 internal wall

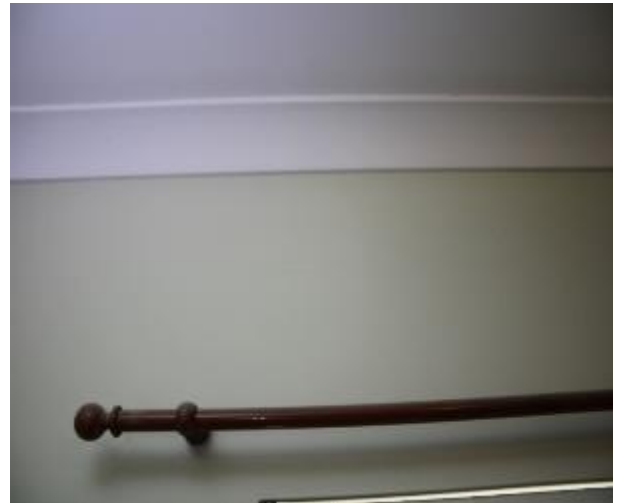
Figure 885 - Crack propagation through bedroom 2 internal wall

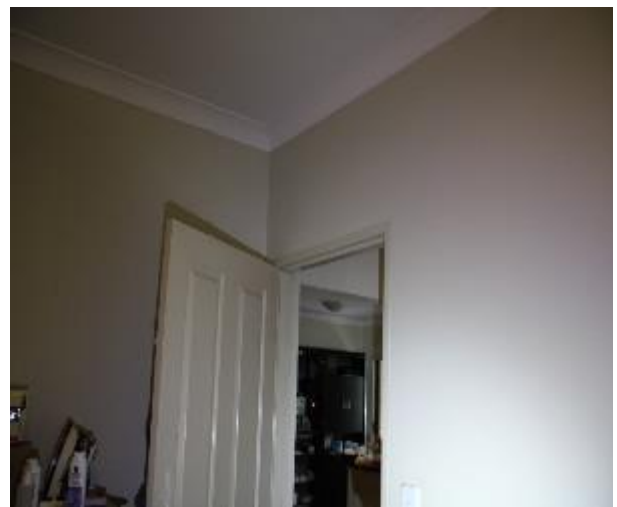
Figure 887 - General condition of bedroom 2 internal wall

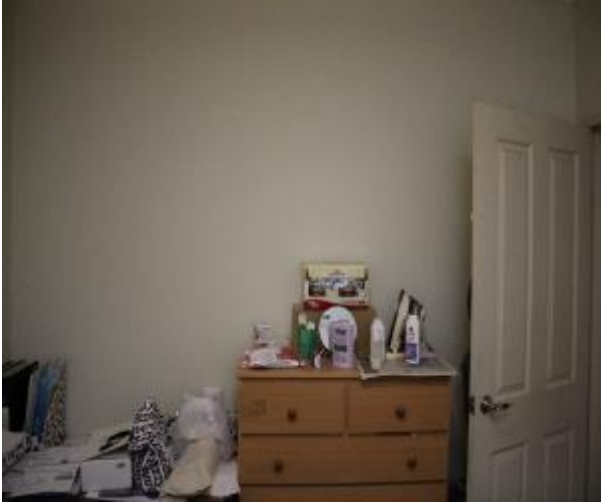
Figure 888 - General condition of bedroom 2 internal wall

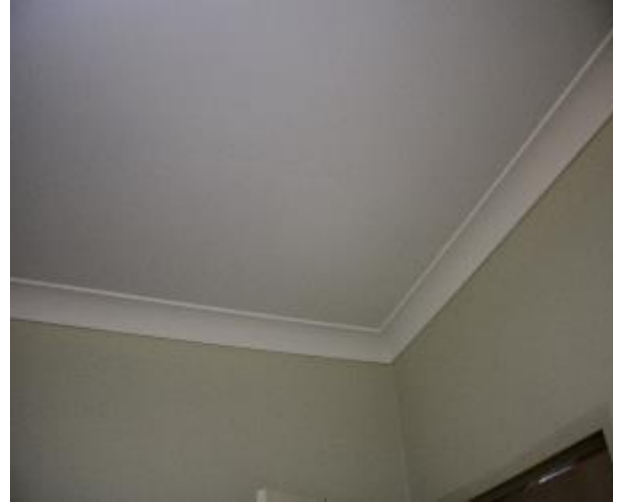
Figure 889 - General condition of bedroom 2 ceiling

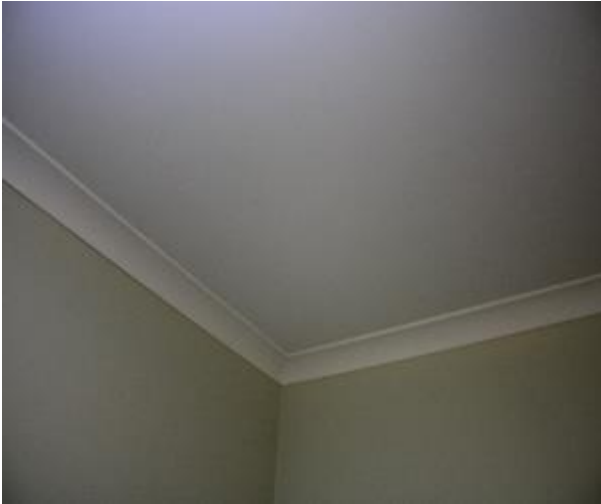
Figure 890 - General condition of bedroom 2 ceiling

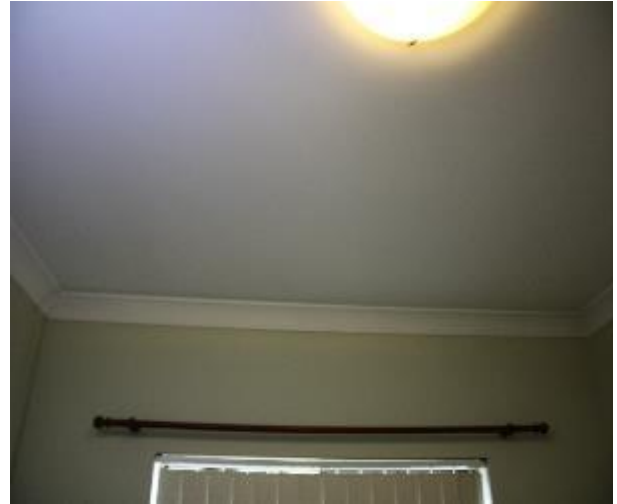
Figure 891 - General condition of bedroom 2 ceiling

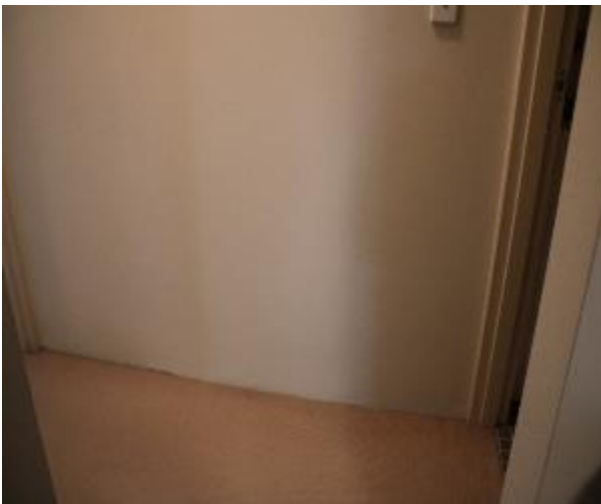
Figure 892 - General condition of corridor internal wall

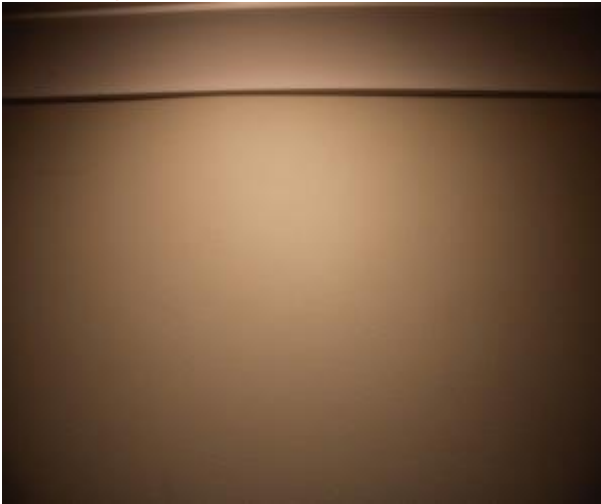
Figure 894 - Crack propagation through corridor internal wall

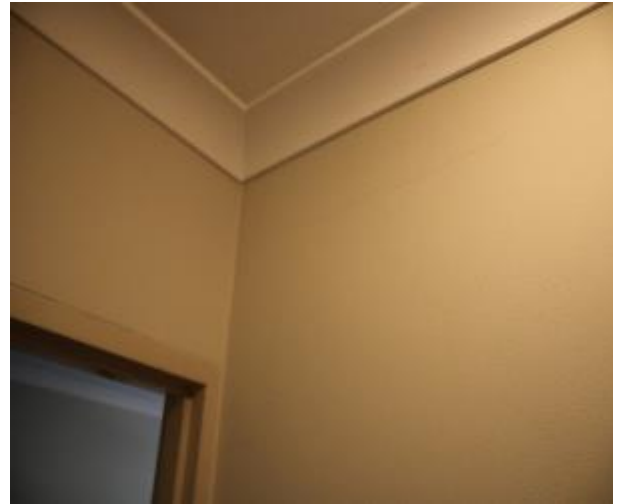
Figure 895 - General condition of corridor internal wall

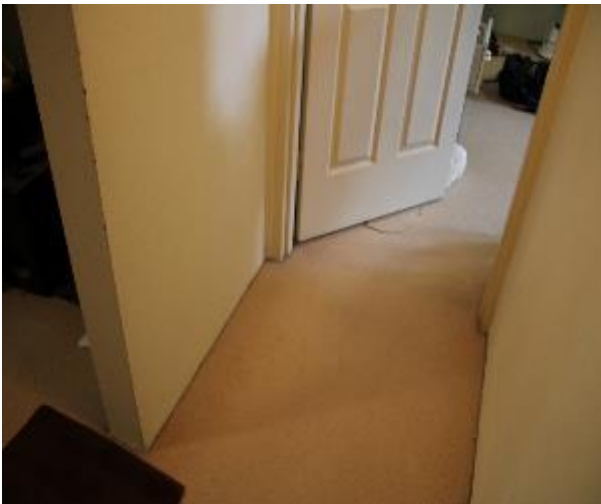
Figure 896 - General condition of corridor internal wall

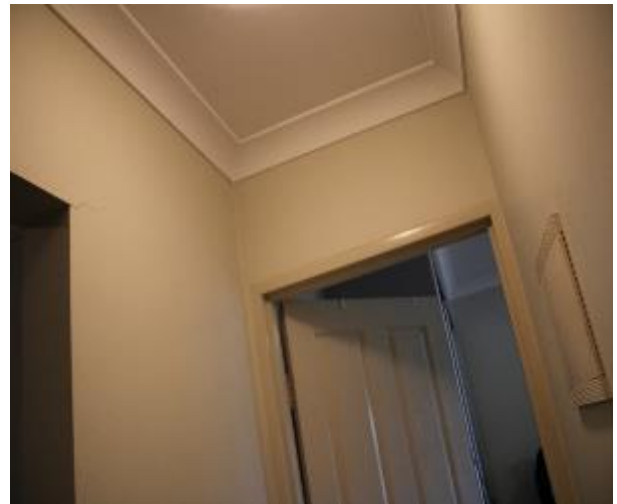
Figure 897 - General condition of corridor internal wall

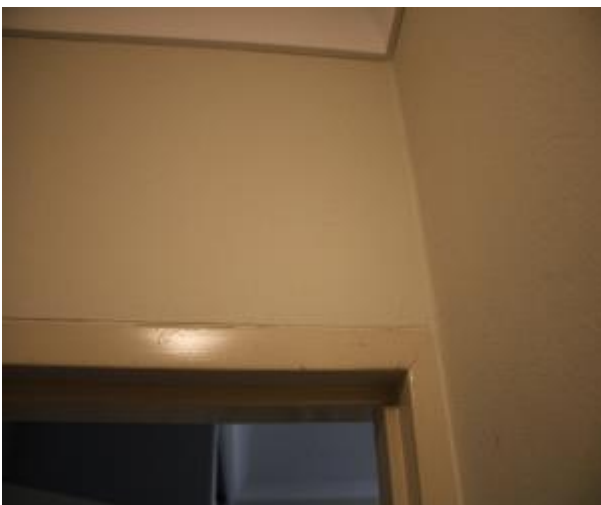
Figure 898 - Crack propagation through corridor internal wall

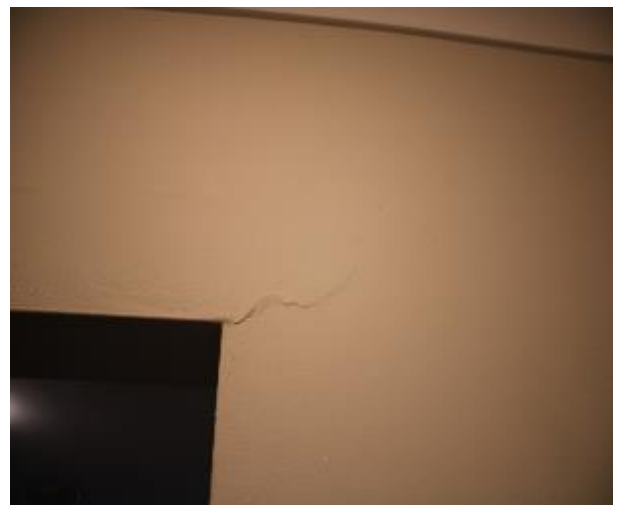
Figure 899 - Crack propagation through corridor internal wall

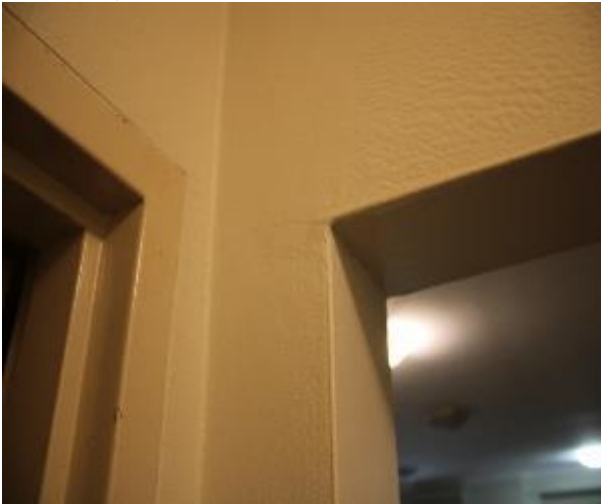
Figure 900 - Crack propagation through corridor internal wall

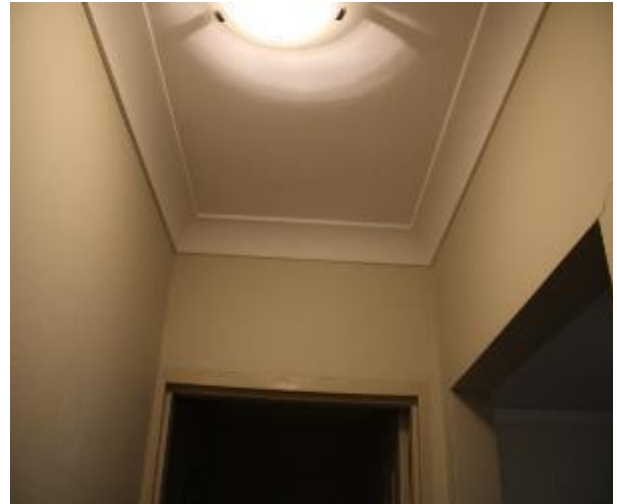
Figure 901 - General condition of corridor internal wall

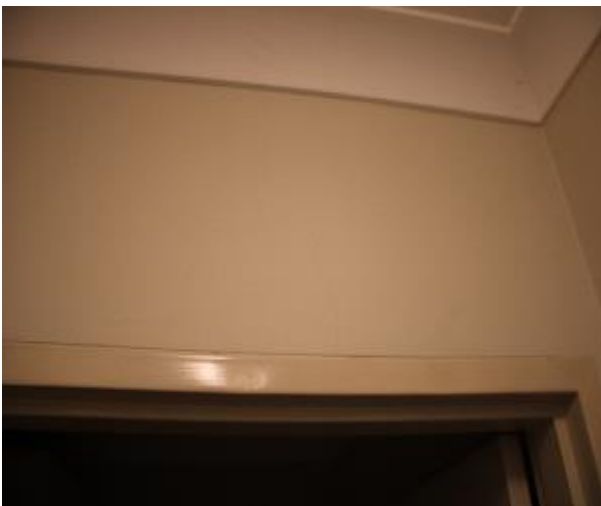
Figure 902 - Crack propagation through corridor internal wall

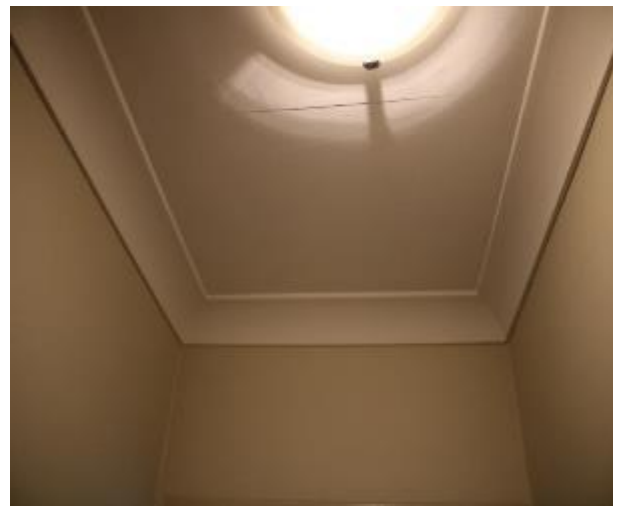
Figure 903 - General condition of corridor ceiling

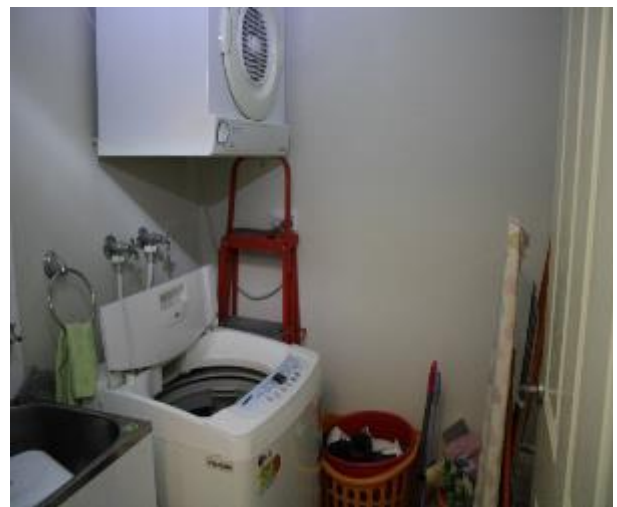
Figure 905 - General condition of laundry internal wall

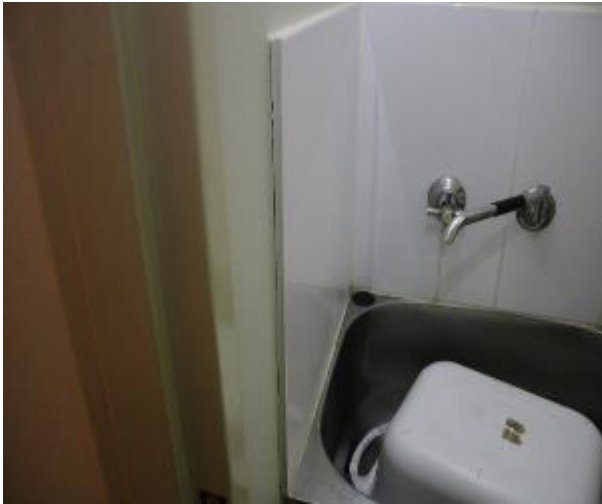
Figure 906 - Crack propagation through laundry internal wall
