# **Pre-Dilapidation Report**

**19 GEORGE STREET**

**REAR BUILDING (UNITS 20-29)**

Project Reference: 20250047.19G.3

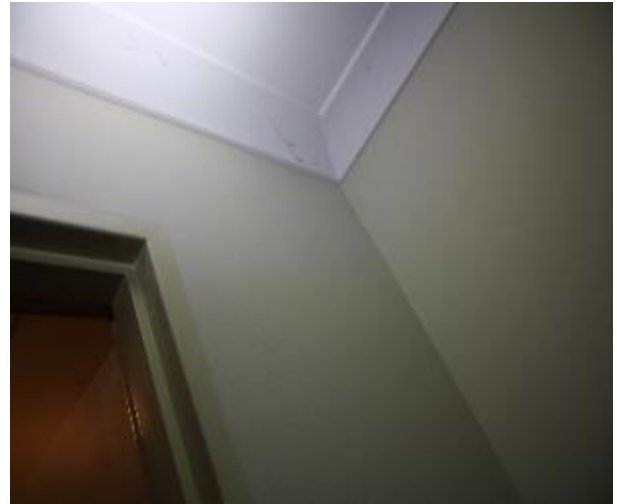
Figure 907 - General condition of laundry internal wall

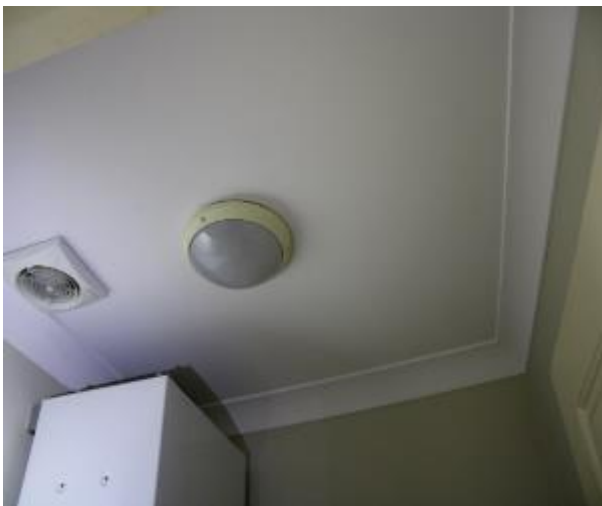
Figure 908 - General condition of laundry ceiling

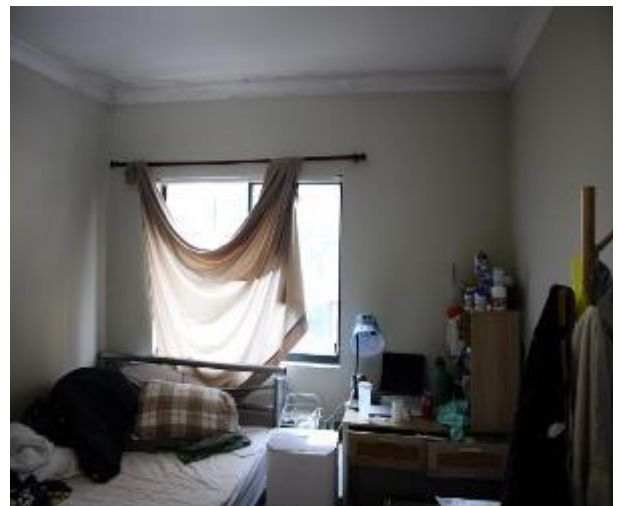
Figure 909 - General condition of bedroom 3 internal wall

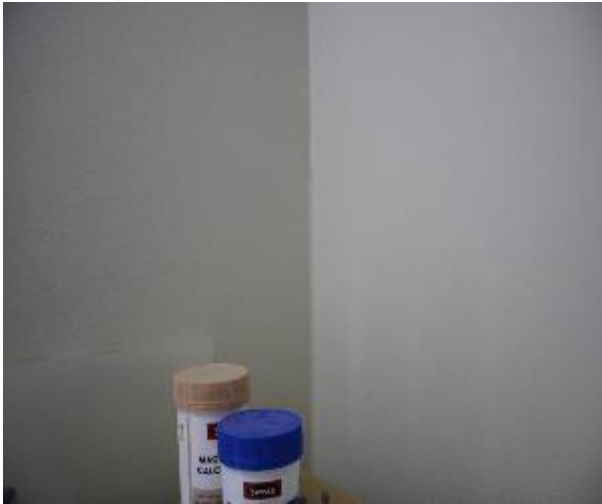
Figure 912 - Crack propagation through bedroom 3 internal wall

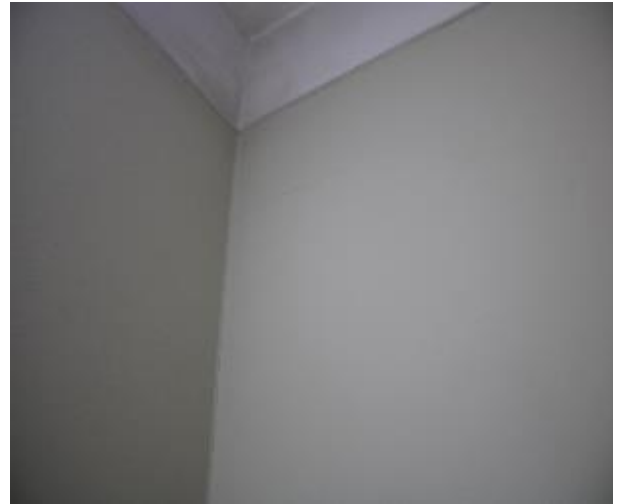
Figure 913 - Crack propagation through bedroom 3 internal wall

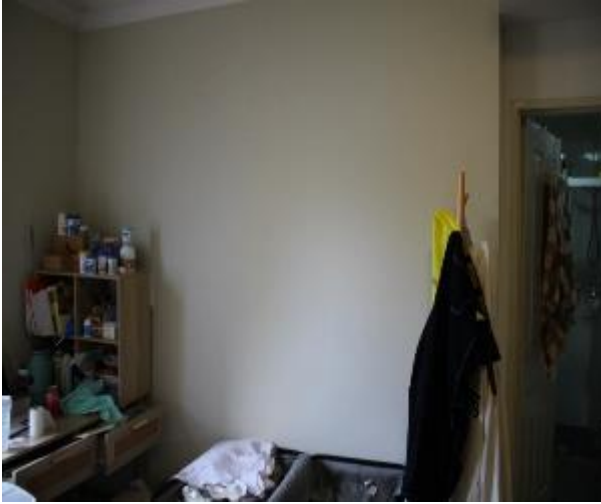
Figure 918 - General condition of bedroom 3 internal wall

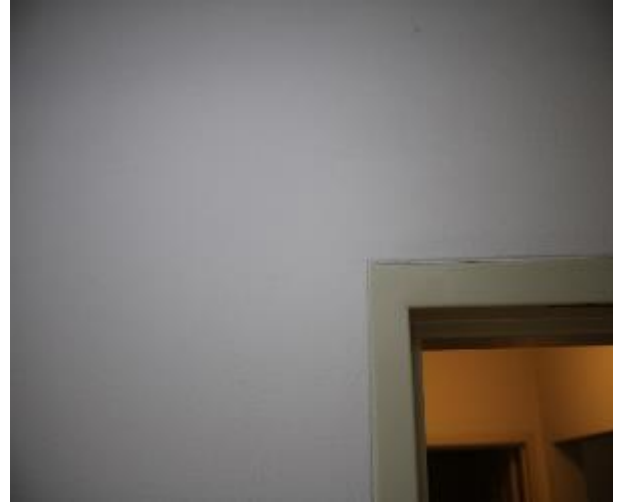
Figure 919 - Crack propagation through bedroom 3 internal wall

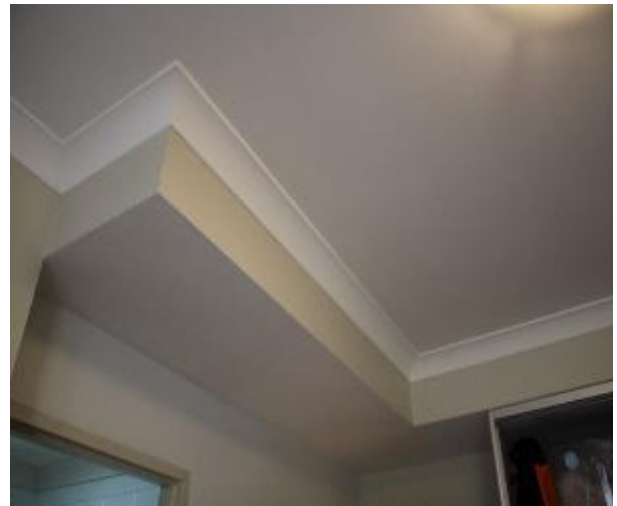
Figure 921 - General condition of bedroom 3 ceiling

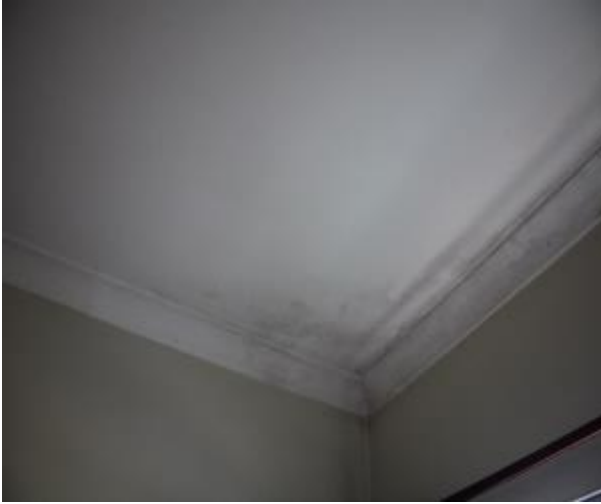
Figure 924 - Water damage evident through bedroom 3 ceiling

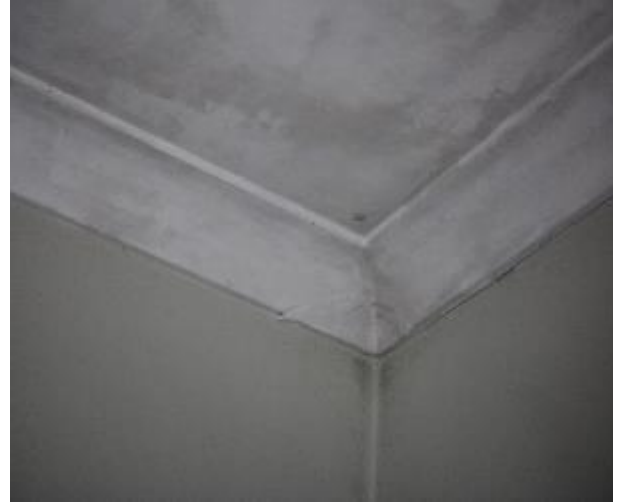
Figure 925 - Crack propagation through bedroom 3 ceiling

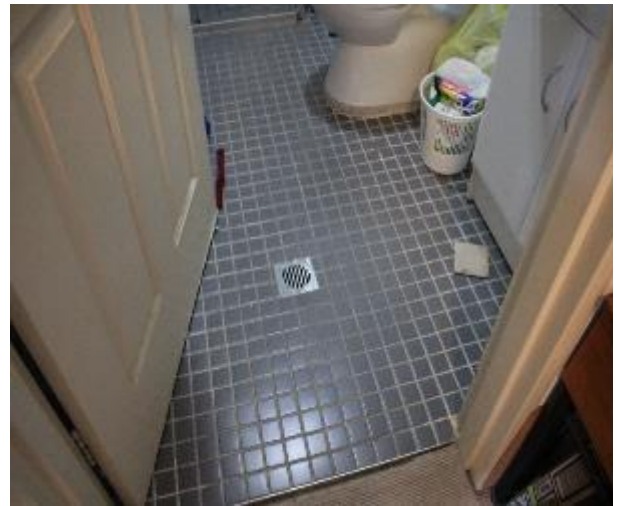
Figure 927 - General condition of ensuite bathroom floor tiles

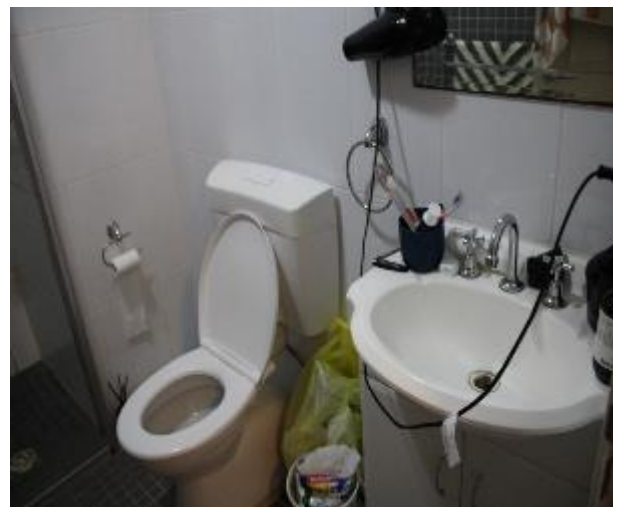
Figure 929 - General condition of ensuite bathroom internal wall

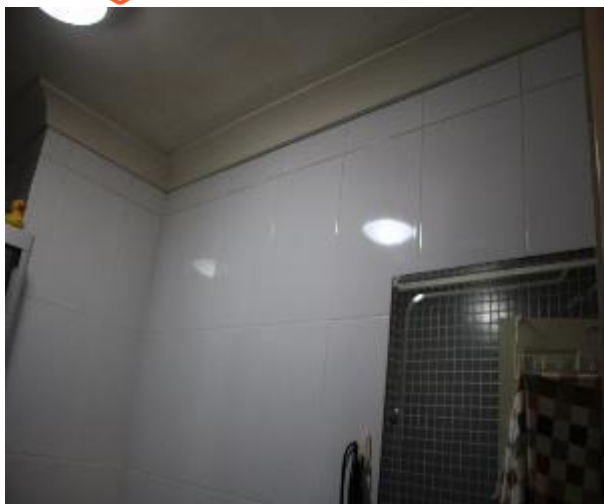
Figure 930 - General condition of ensuite bathroom internal wall

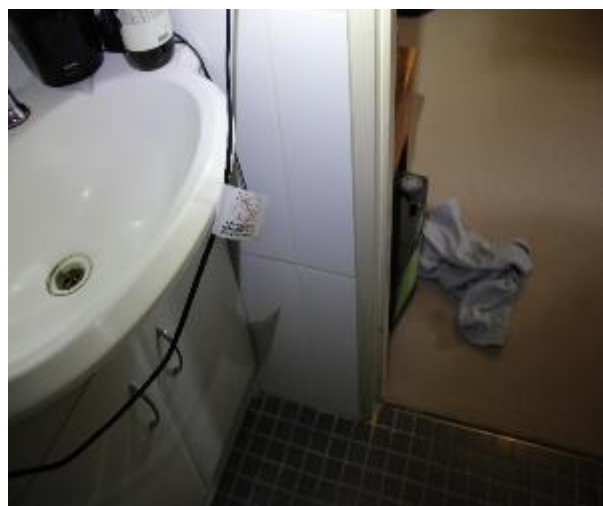
Figure 933 - General condition of ensuite bathroom internal wall

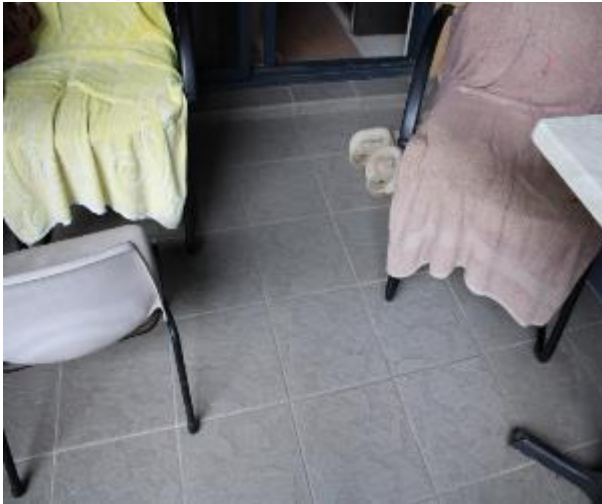
Figure 936 - General condition of balcony floor tiles

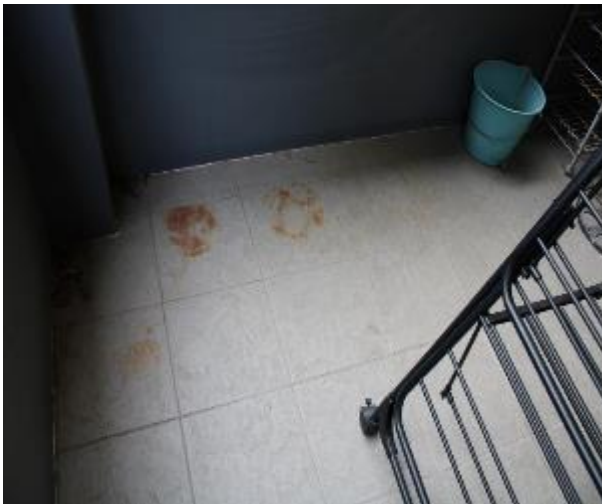
Figure 938 - General condition of balcony floor tiles

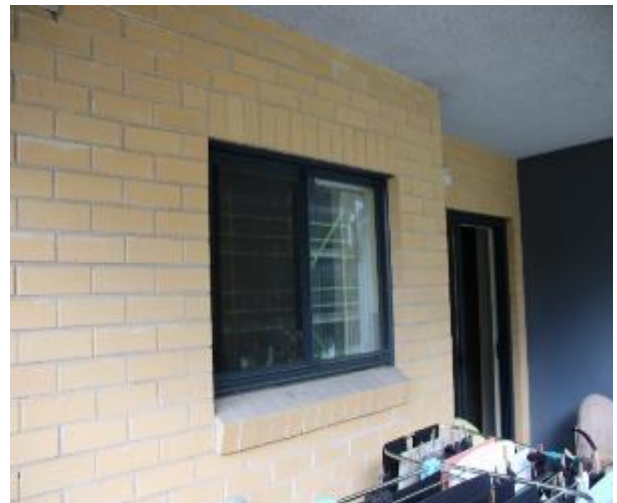
Figure 941 - General condition of external wall

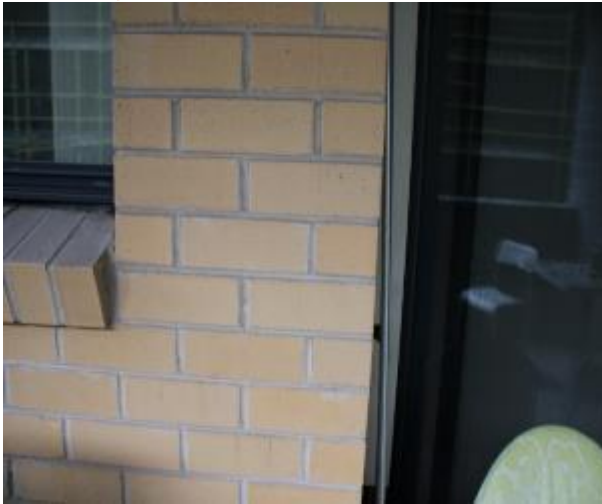
Figure 942 - Crack propagation through external wall

Unit 24 was also inspected and found to be in reasonable condition. There was evidence of cracking through the internal and external walls and ceilings, as well as some water damage through the ceiling.

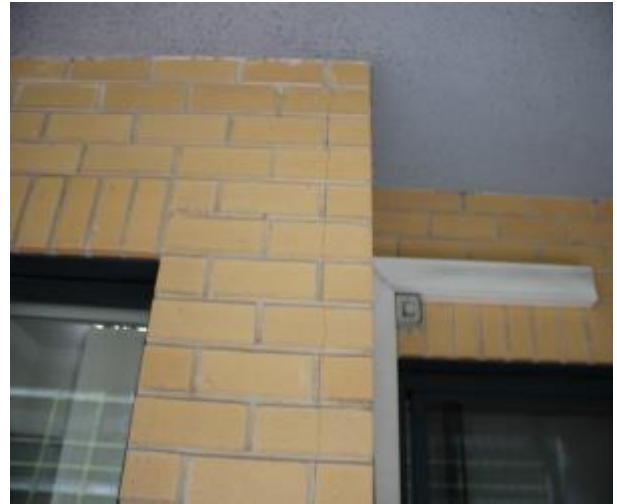
Figure 943 - Crack propagation through external wall

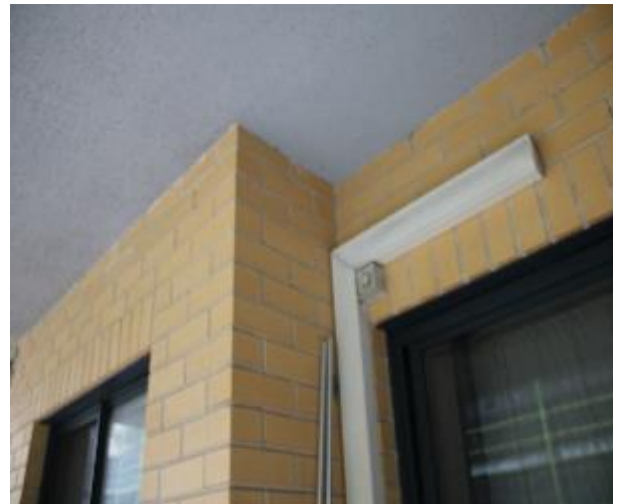
Figure 945 - General condition of external wall

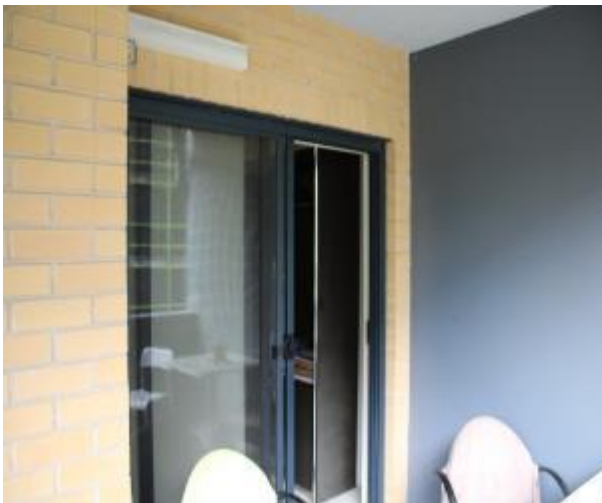
Figure 946 - General condition of external wall

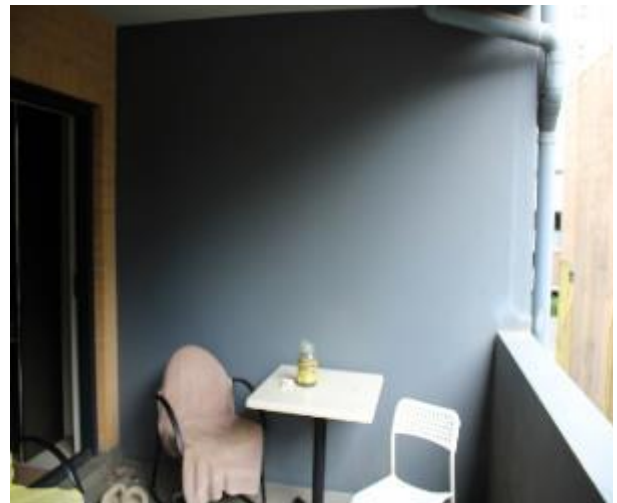
Figure 947 - General condition of external wall

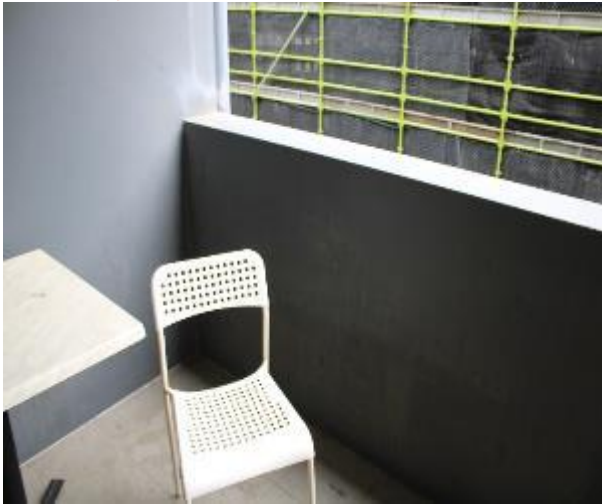
Figure 948 - General condition of external wall

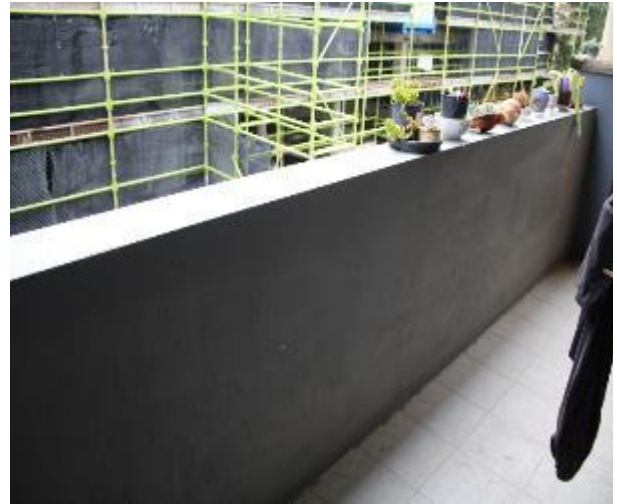
Figure 949 - General condition of external wall

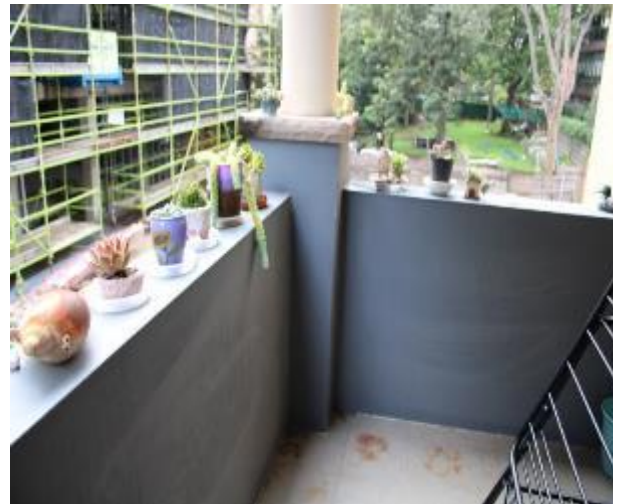
Figure 951 - General condition of external wall

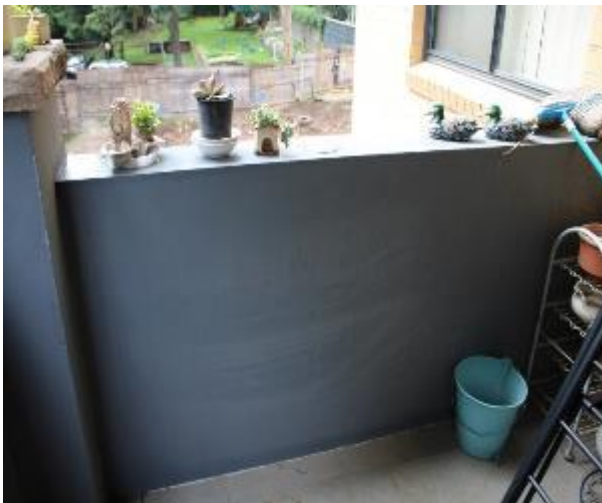
Figure 952 - General condition of external wall

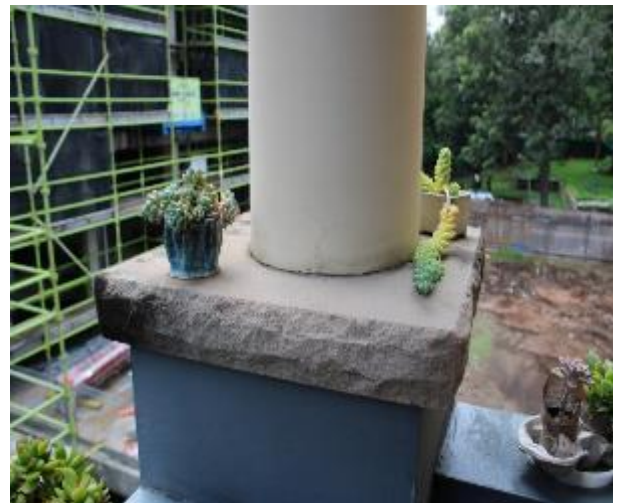
Figure 953 - Crack propagation through external wall

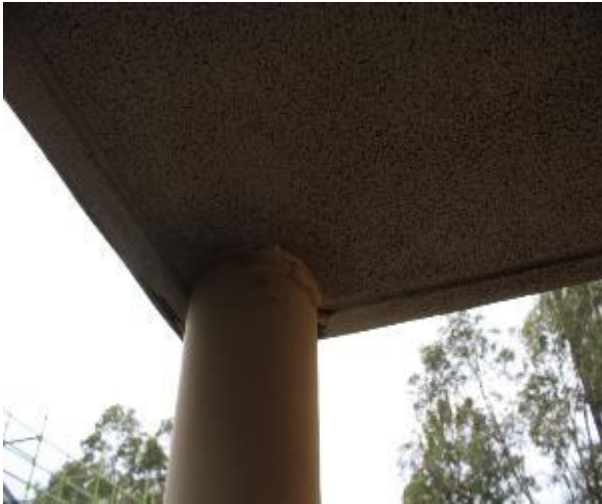
Figure 954 - General condition of balcony underside slab

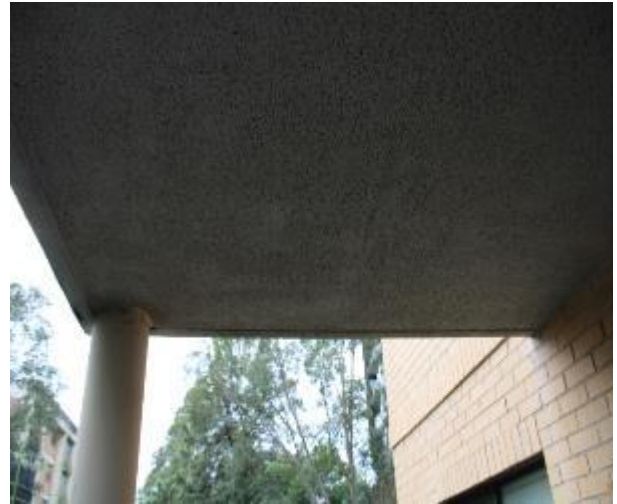
Figure 955 - General condition of balcony underside slab

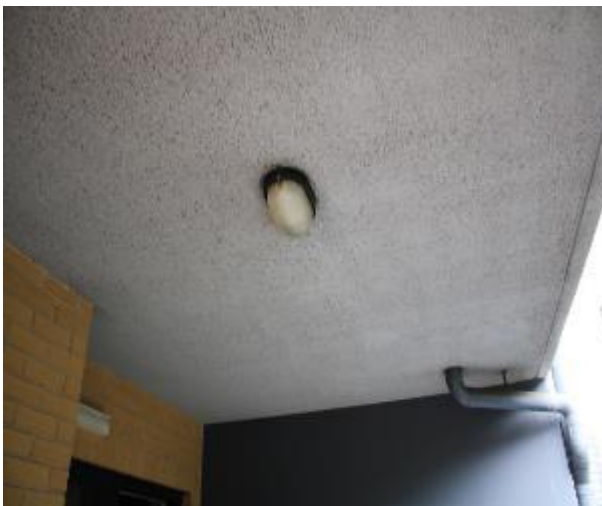
Figure 956 - General condition of balcony underside slab

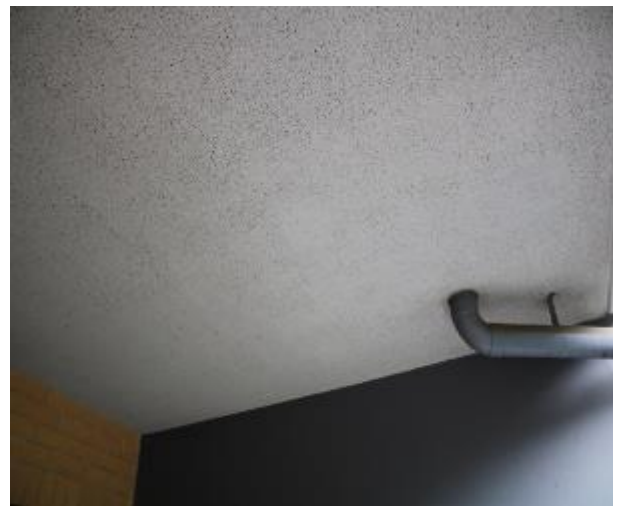
Figure 957 - General condition of balcony underside slab

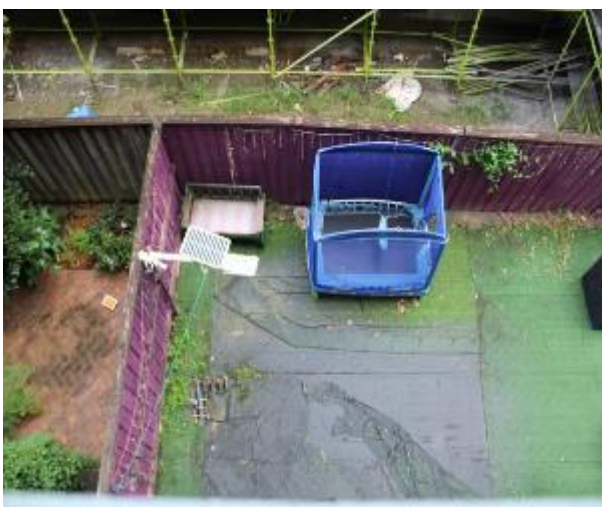
Figure 958 - General condition of boundary fence as seen from Unit 24 balcony

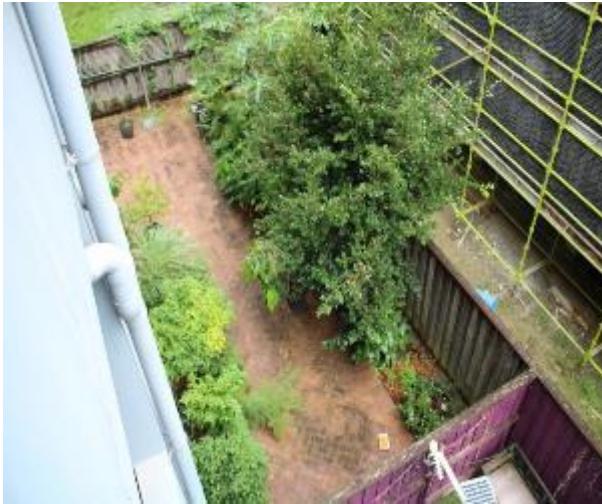
Figure 960 - General condition of boundary fence as seen from Unit 24 balcony

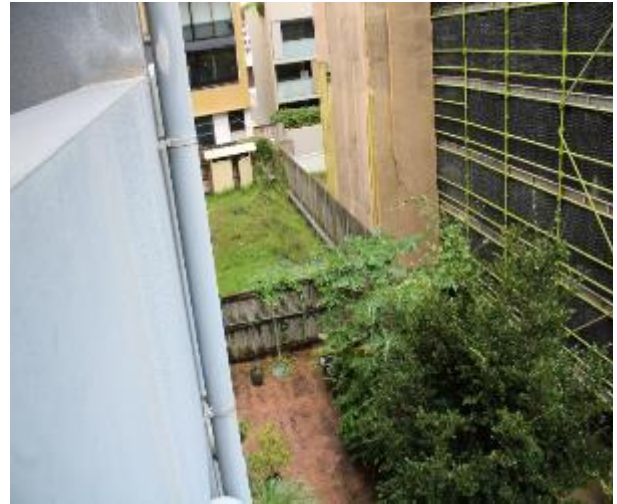
Figure 961 - General condition of boundary fence as seen from Unit 24 balcony

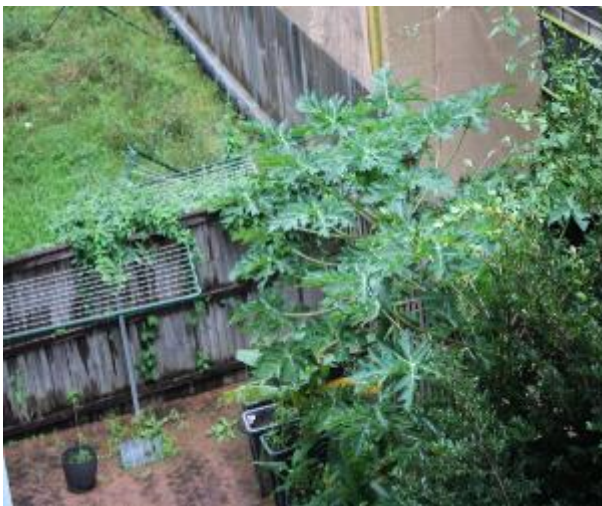
Figure 962 - General condition of boundary fence as seen from Unit 24 balcony

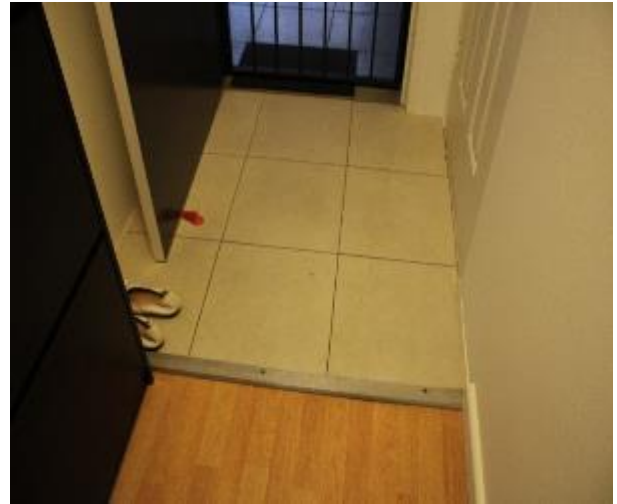
Figure 964 - General condition of entry floor tiles

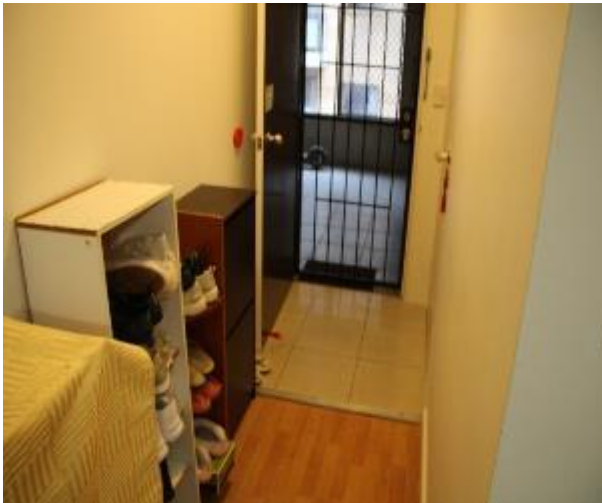
Figure 965 - General condition of lounge room internal wall

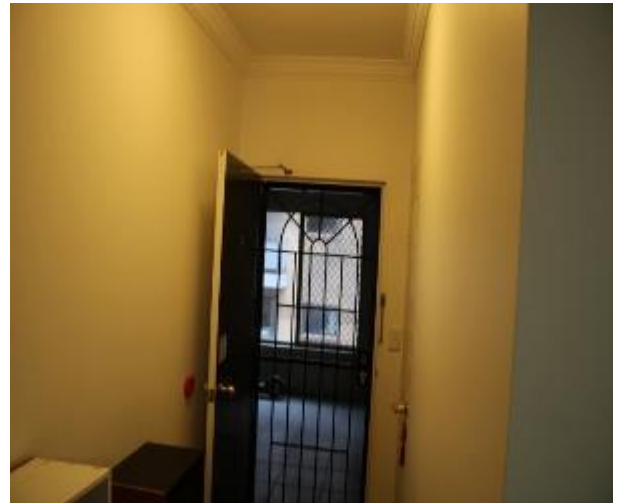
Figure 966 - General condition of lounge room internal wall

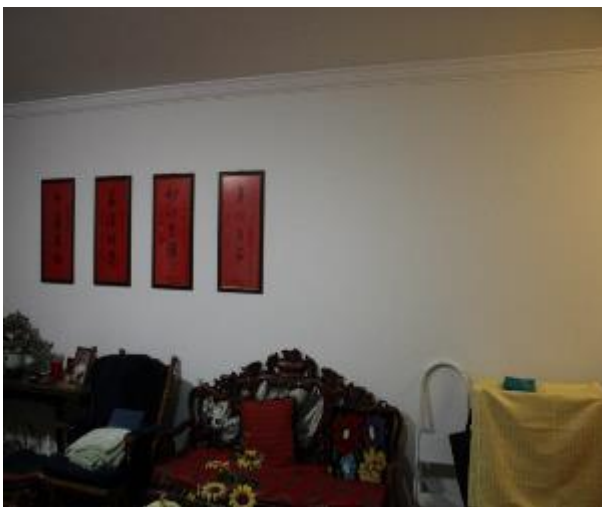
Figure 967 - General condition of lounge room internal wall

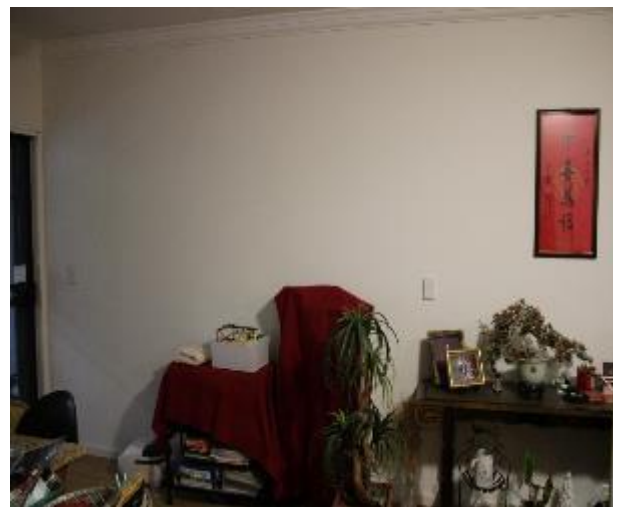
Figure 968 - General condition of lounge room internal wall

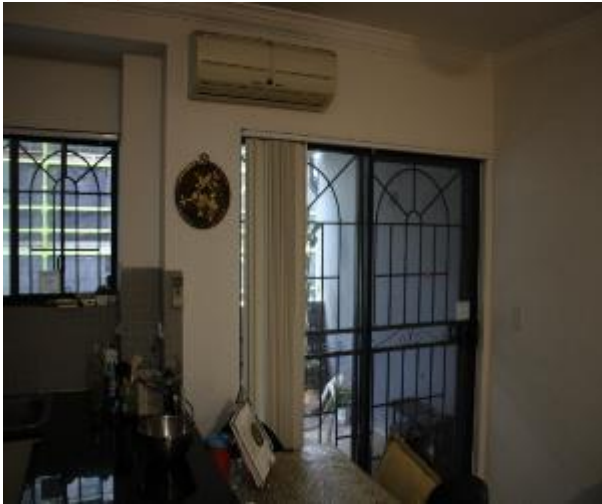
Figure 969 - General condition of lounge room internal wall

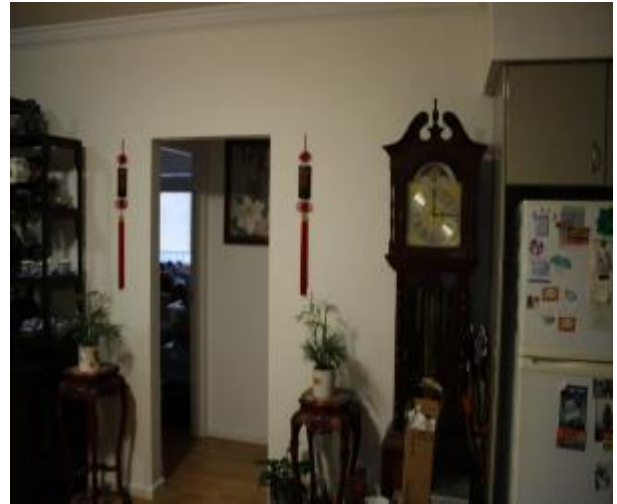
Figure 970 - General condition of lounge room internal wall

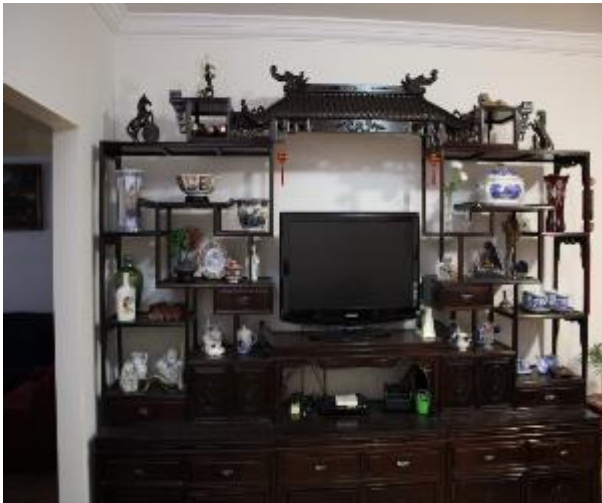
Figure 971 - General condition of lounge room internal wall

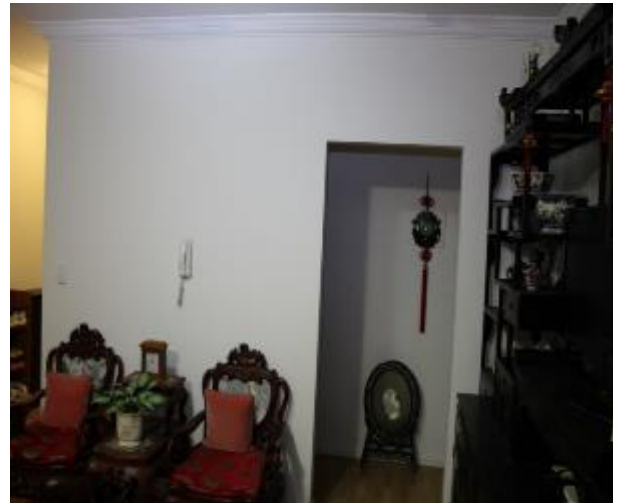
Figure 972 - General condition of lounge room internal wall

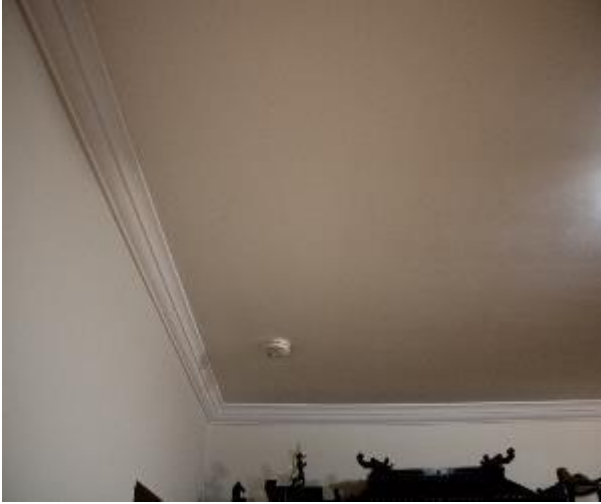
Figure 975 - General condition of lounge room ceiling

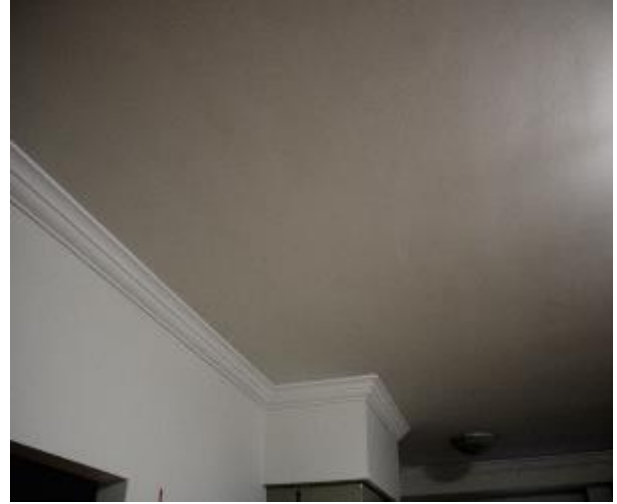
Figure 976 - General condition of lounge room ceiling

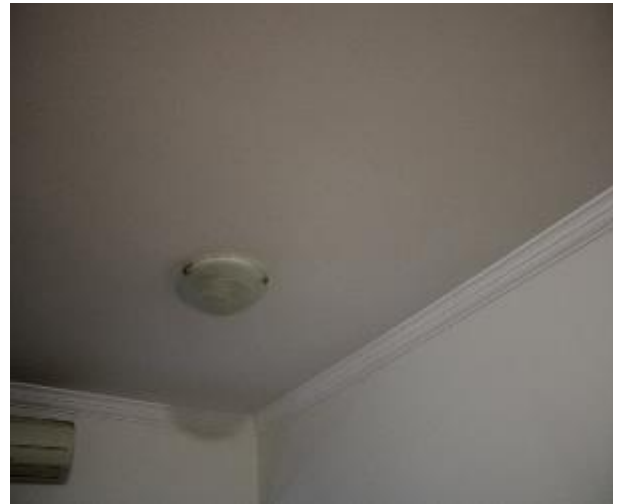
Figure 978 - General condition of lounge room ceiling

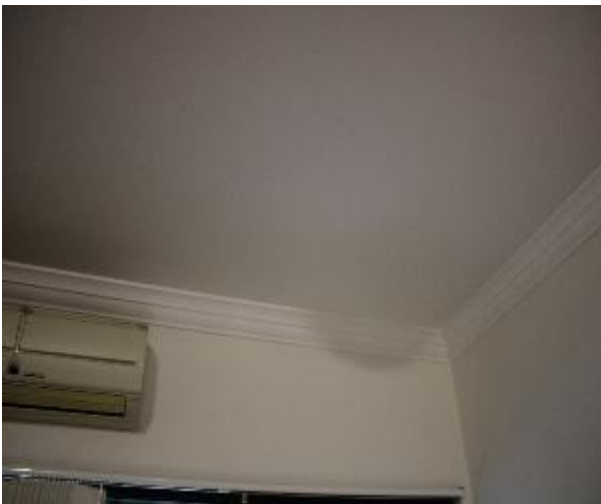
Figure 979 - General condition of lounge room ceiling

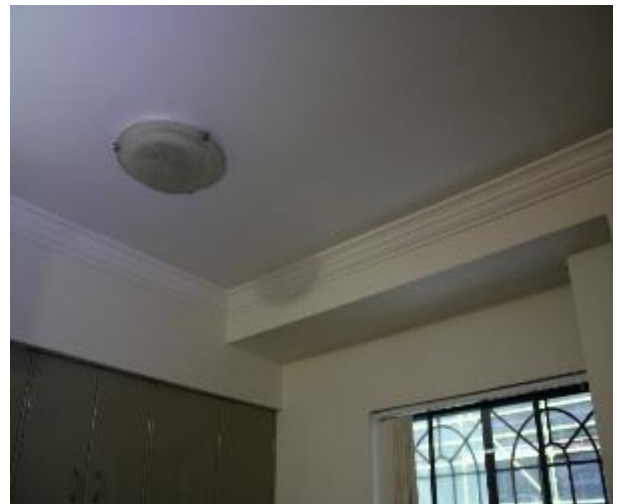
Figure 980 - General condition of lounge room ceiling

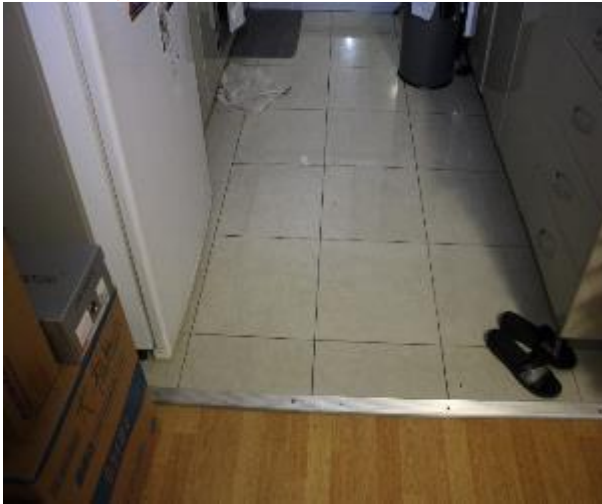
Figure 981 - General condition of kitchen floor tiles

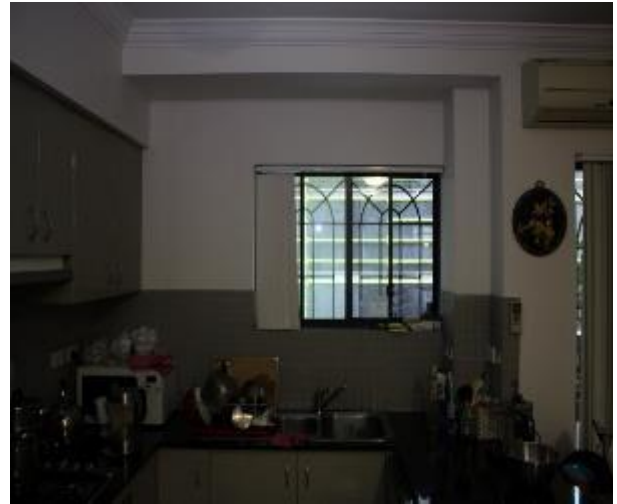
Figure 982 - General condition of kitchen internal wall

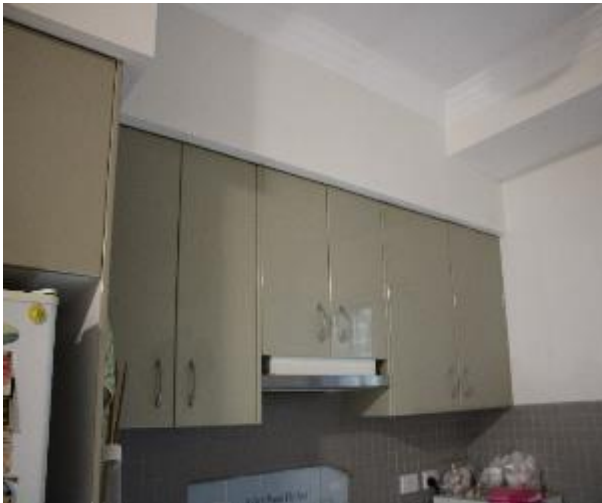
Figure 983 - General condition of kitchen internal wall

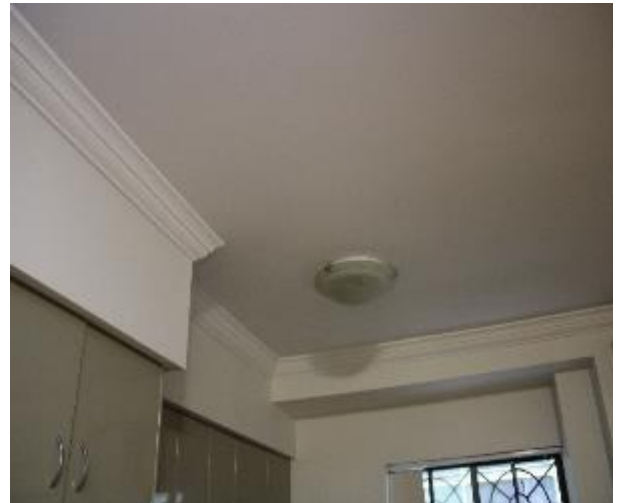
Figure 984 - General condition of kitchen ceiling

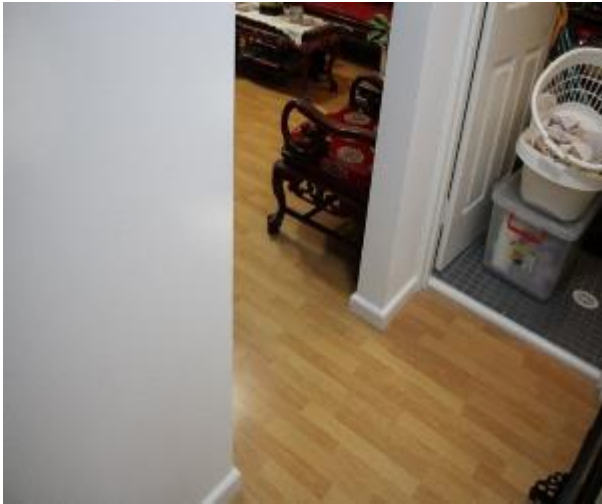
Figure 987 - General condition of corridor internal wall

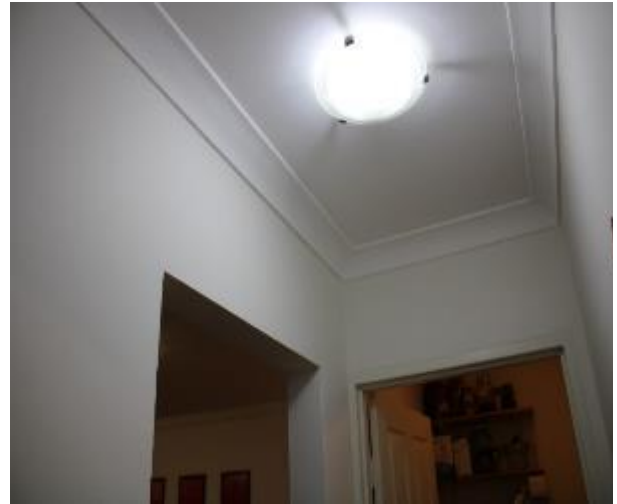
Figure 988 - General condition of corridor internal wall

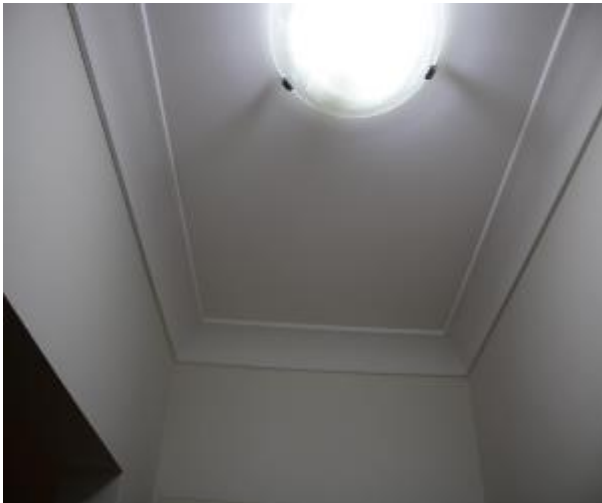
Figure 989 - General condition of corridor ceiling

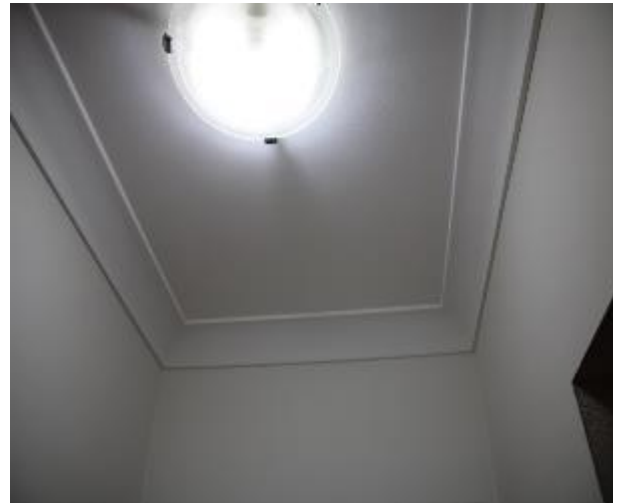
Figure 990 - General condition of corridor ceiling

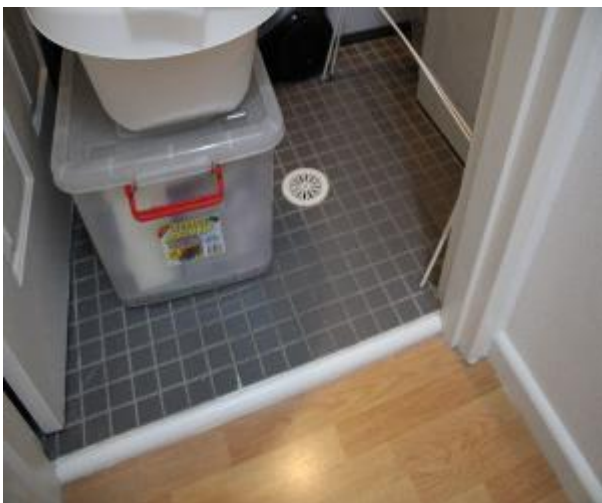
Figure 991 - General condition of laundry floor tiles

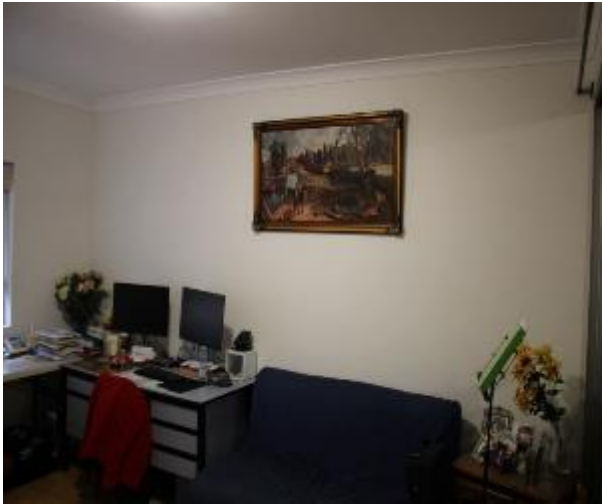
Figure 993 - General condition of study internal wall

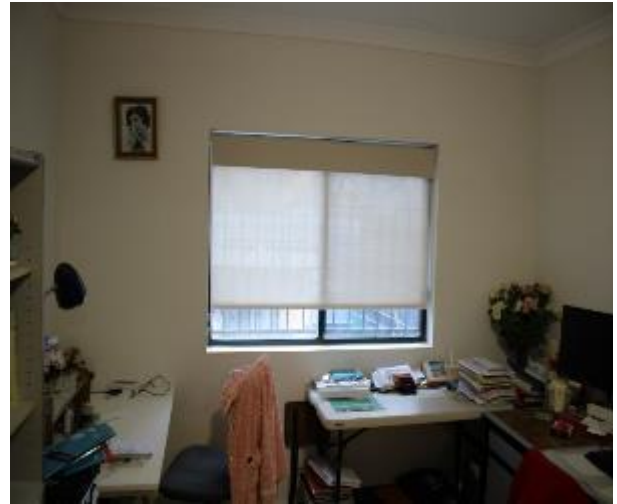
Figure 994 - General condition of study internal wall

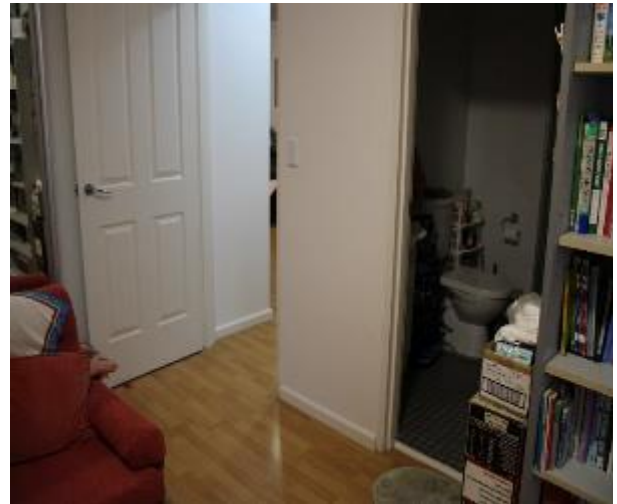
Figure 996 - General condition of study internal wall

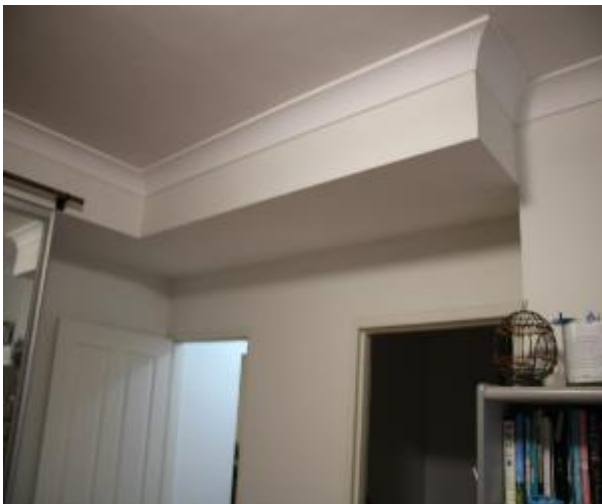
Figure 997 - General condition of study internal wall

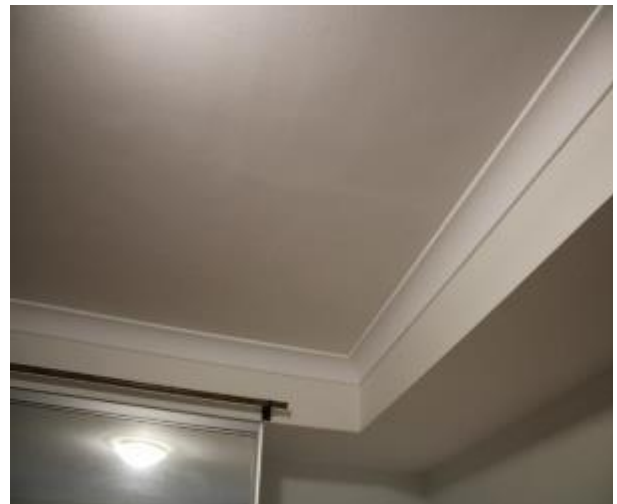
Figure 998 - General condition of study ceiling

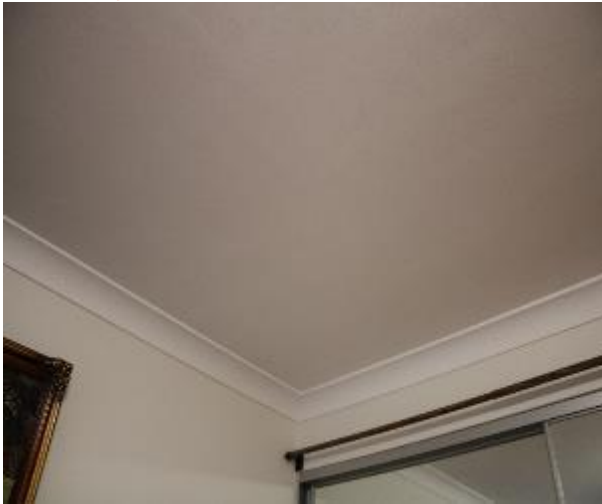
Figure 999 - General condition of study ceiling

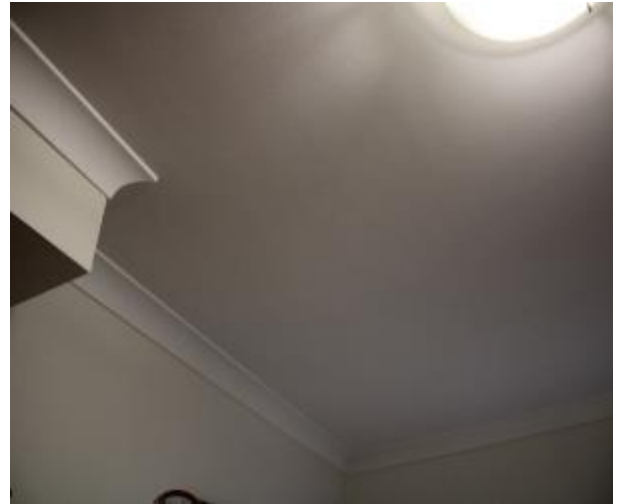
Figure 1000 - General condition of study ceiling

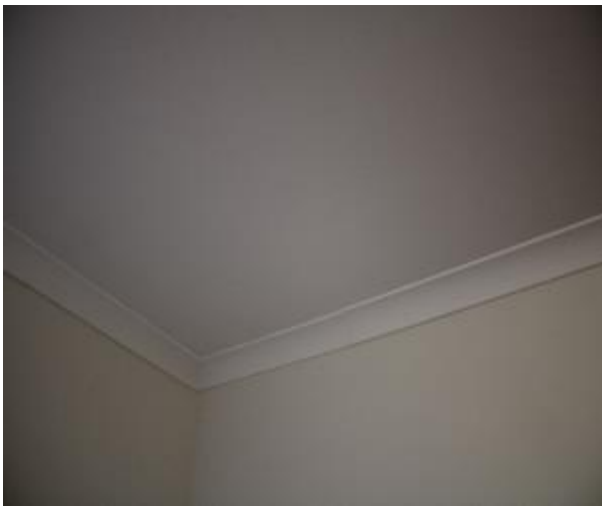
Figure 1001 - General condition of study ceiling

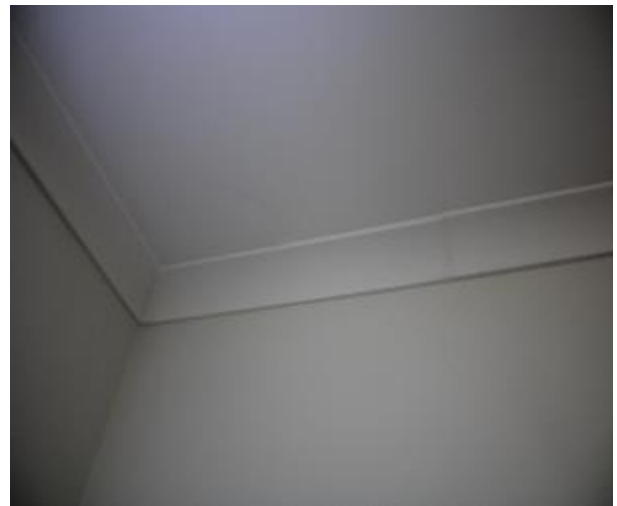
Figure 1002 - Crack propagation through study ceiling

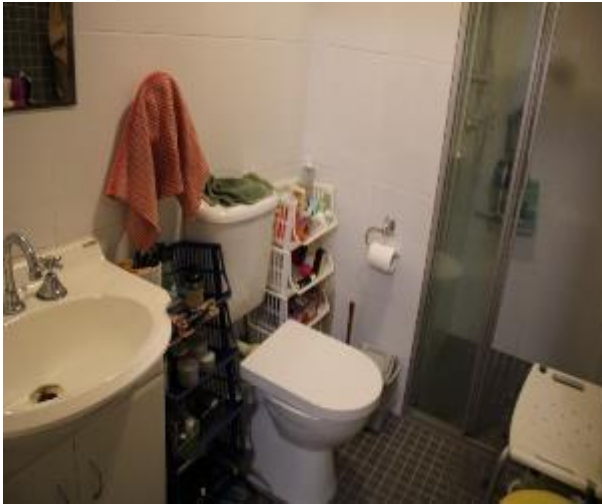
Figure 1005 - General condition of ensuite bathroom internal wall

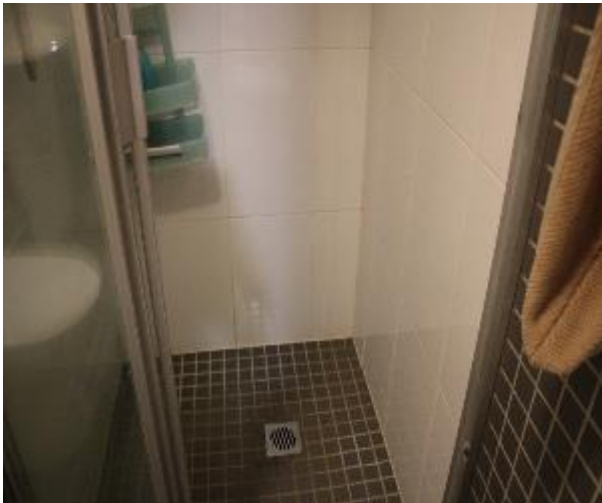
Figure 1006 - General condition of ensuite bathroom internal wall

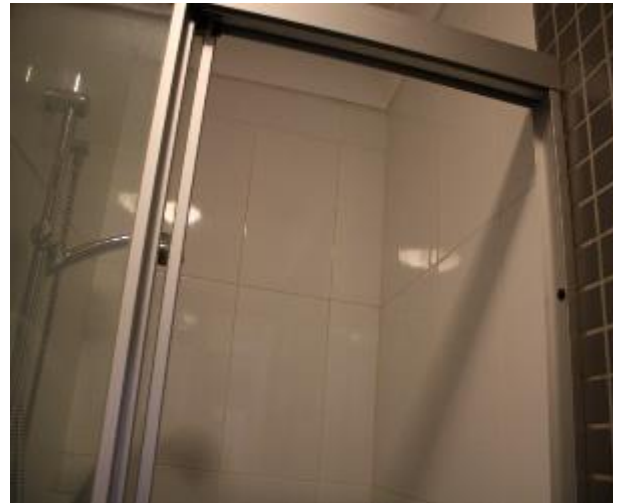
Figure 1007 - General condition of ensuite bathroom internal wall

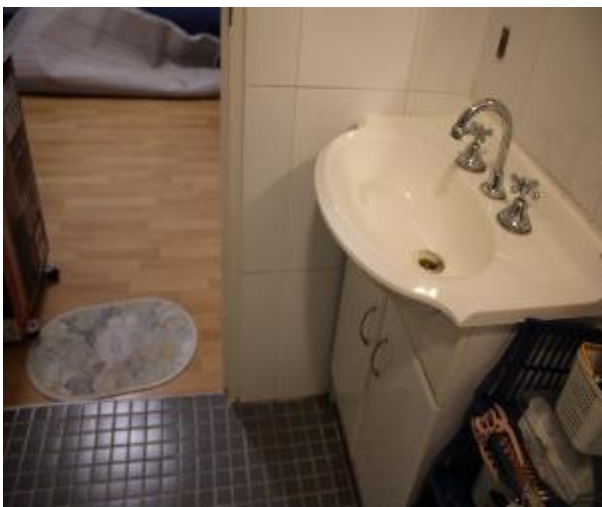
Figure 1008 - General condition of ensuite bathroom internal wall
