# **Pre-Dilapidation Report**

**19 GEORGE STREET**

**REAR BUILDING (UNITS 20-29)**

Project Reference: 20250047.19G.3

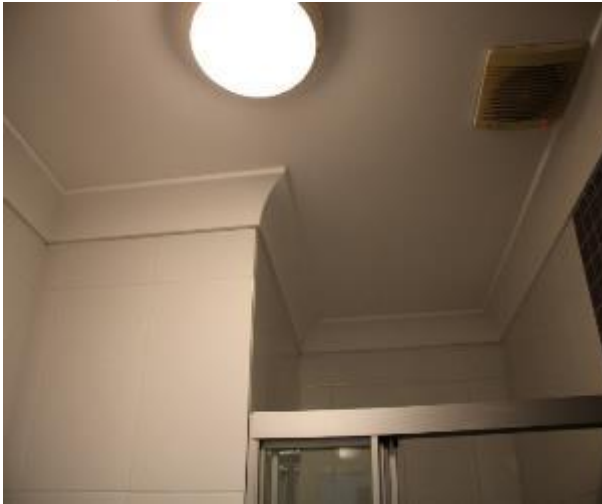
Figure 1010 - General condition of ensuite bathroom internal wall

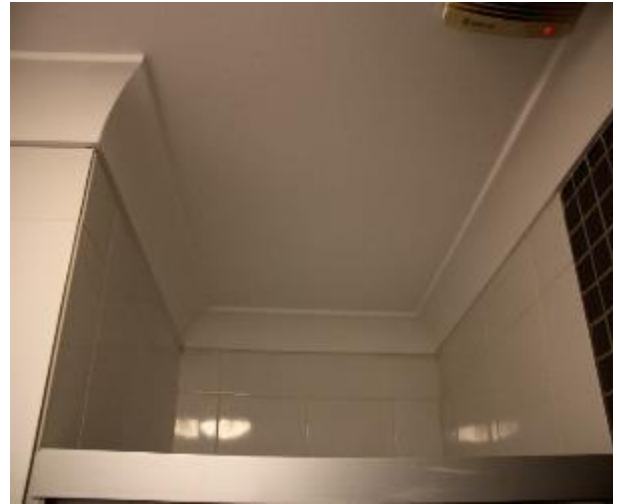
Figure 1011 - General condition of ensuite bathroom ceiling

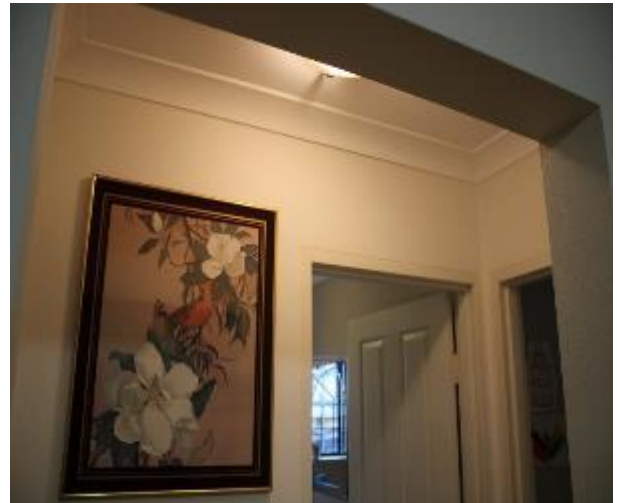
Figure 1013 - General condition of corridor internal wall

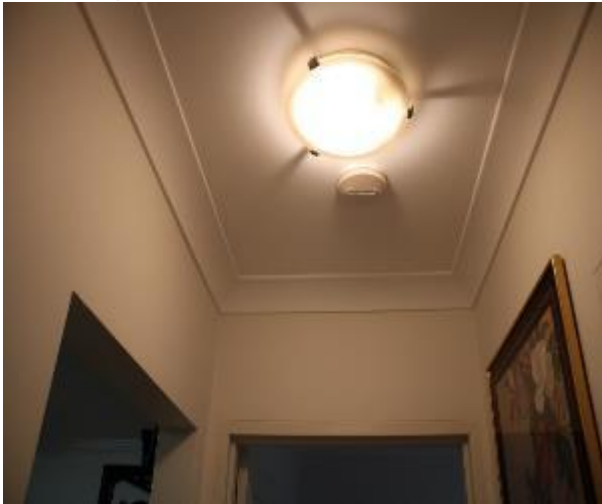
Figure 1016 - General condition of corridor internal wall

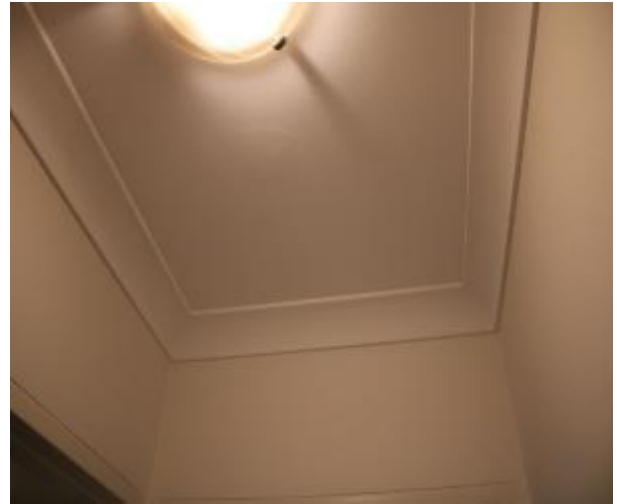
Figure 1017 - General condition of corridor ceiling

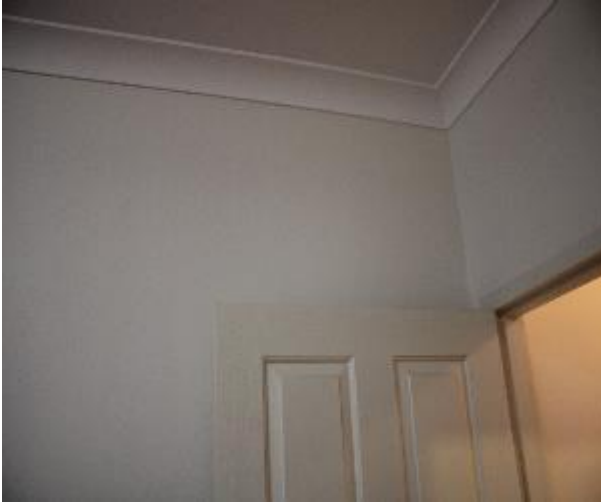
Figure 1022 - General condition of bedroom 1 internal wall

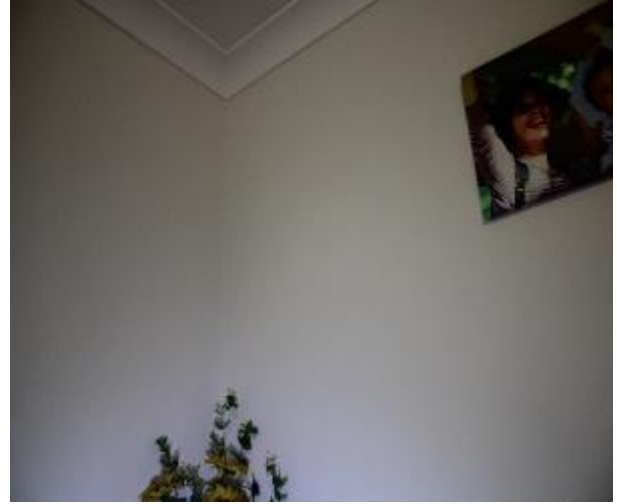
Figure 1023 - General condition of bedroom 1 internal wall

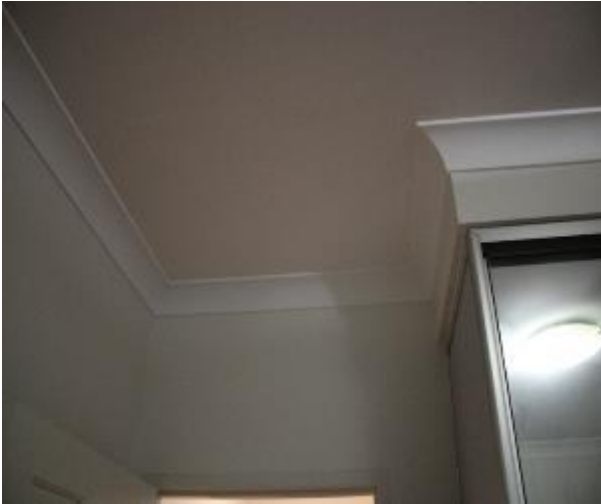
Figure 1024 - General condition of bedroom 1 internal wall

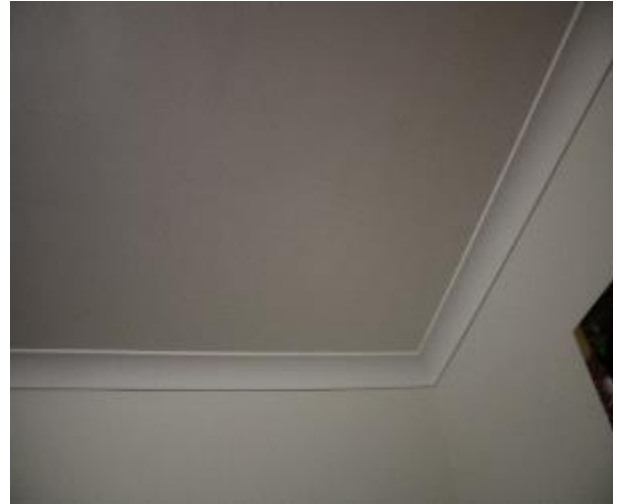
Figure 1025 - General condition of bedroom 1 ceiling

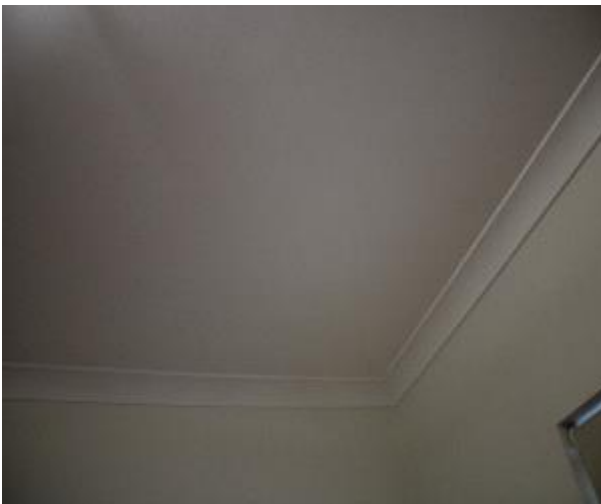
Figure 1026 - General condition of bedroom 1 ceiling

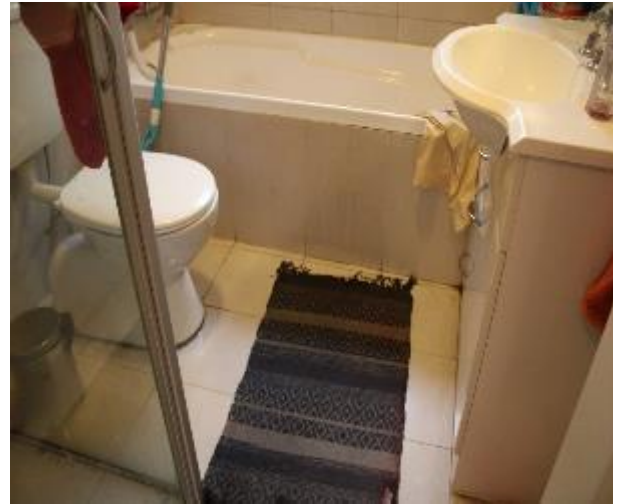
Figure 1029 - General condition of bathroom 1 floor tiles

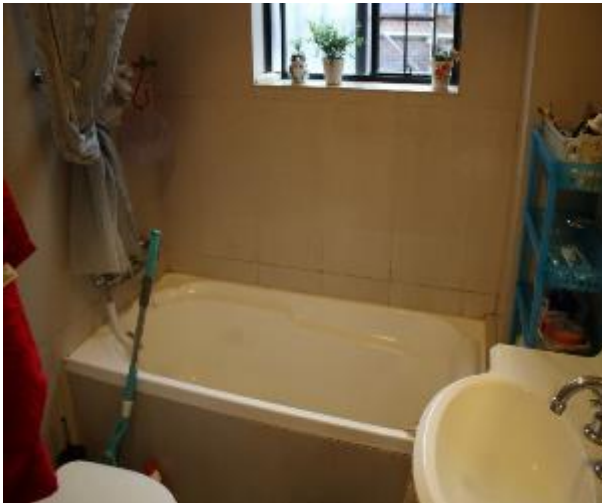
Figure 1030 - General condition of bathroom 1 floor tiles

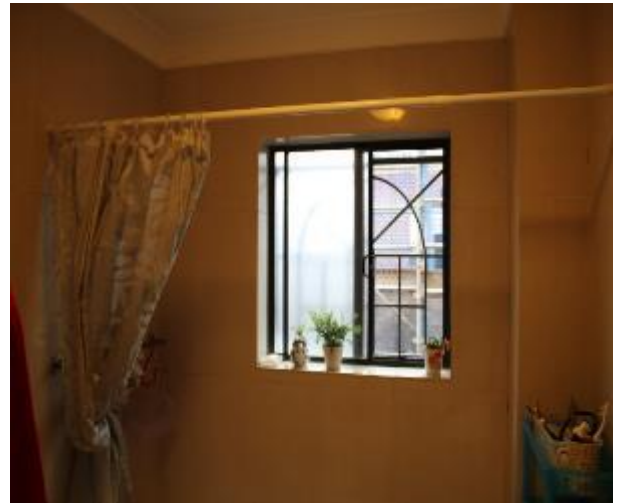
Figure 1031 - General condition of bathroom 1 internal wall

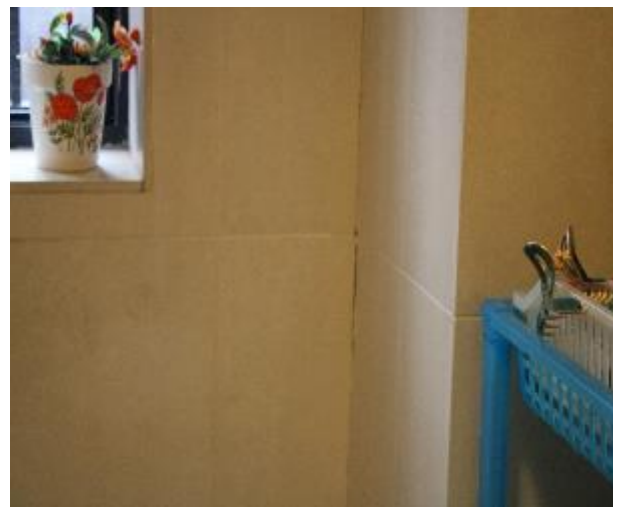
Figure 1033 - Crack propagation through bathroom 1 internal wall

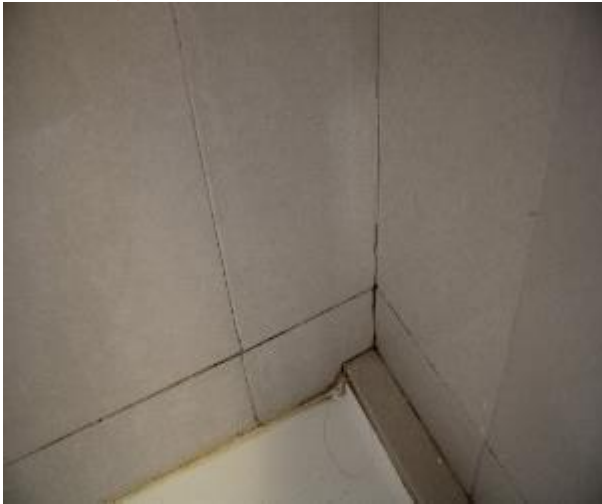
Figure 1034 - Crack propagation through bathroom 1 internal wall

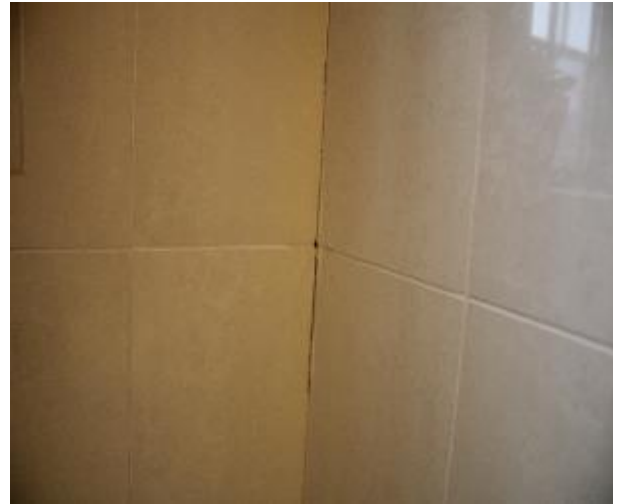
Figure 1035 - Crack propagation through bathroom 1 internal wall

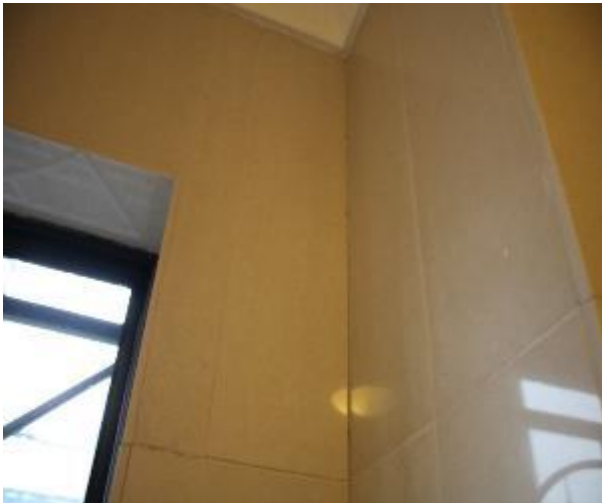
Figure 1036 - Crack propagation through bathroom 1 internal wall

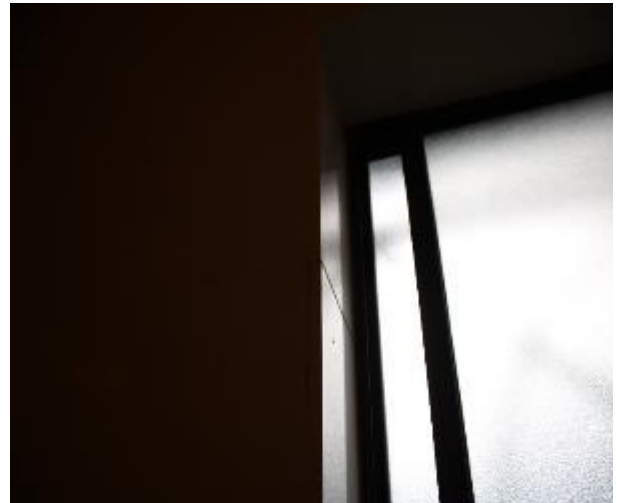
Figure 1037 - Crack propagation through bathroom 1 internal wall

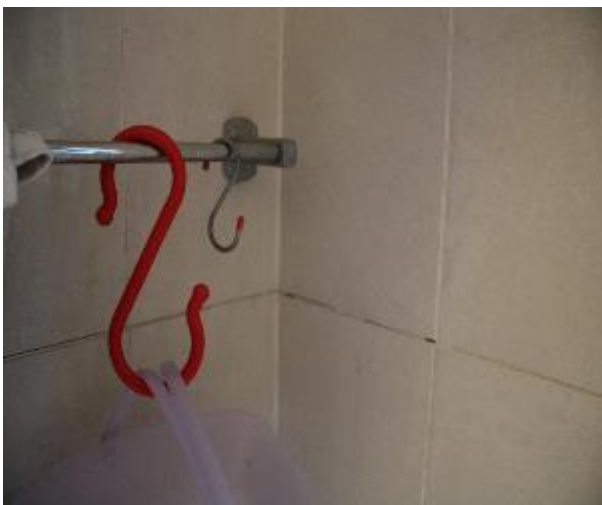
Figure 1038 - Crack propagation through bathroom 1 internal wall

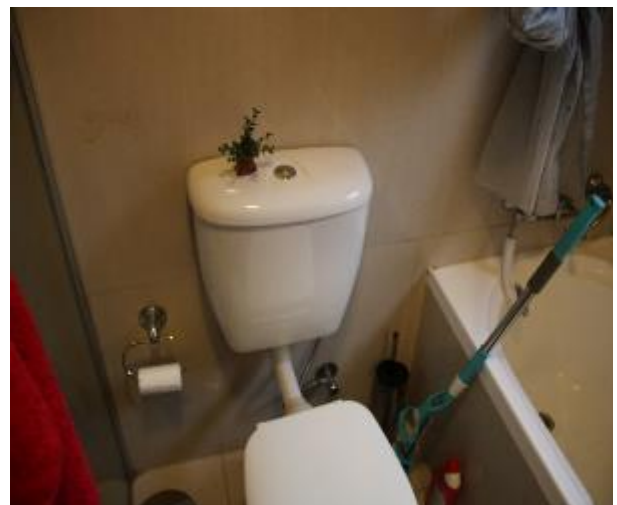
Figure 1039 - Crack propagation through bathroom 1 internal wall

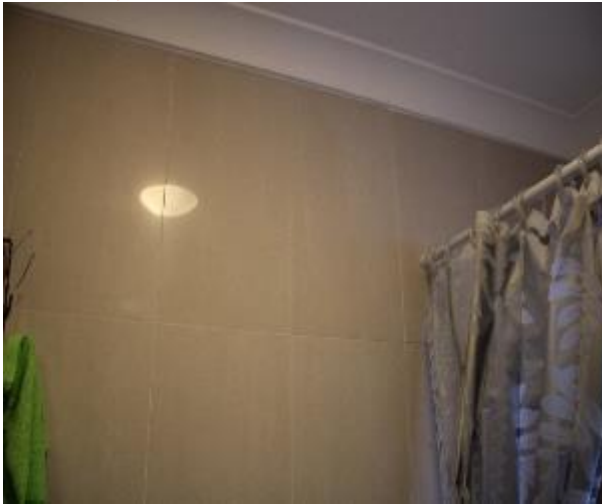
Figure 1040 - General condition of bathroom 1 internal wall

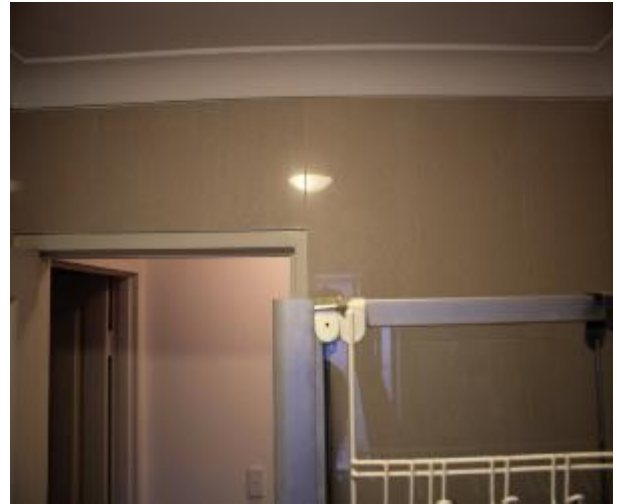
Figure 1041 - General condition of bathroom 1 internal wall

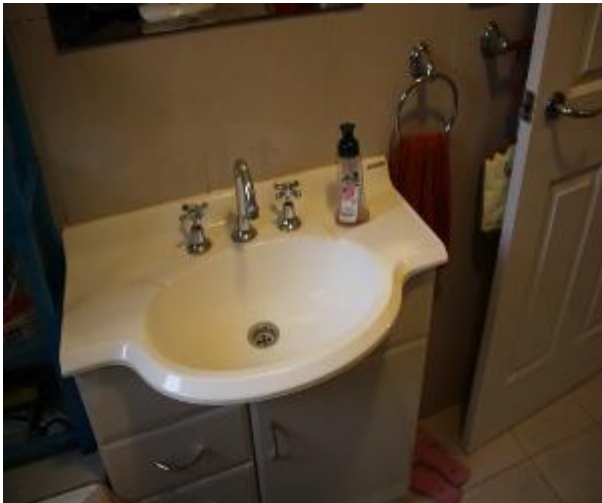
Figure 1042 - General condition of bathroom 1 internal wall

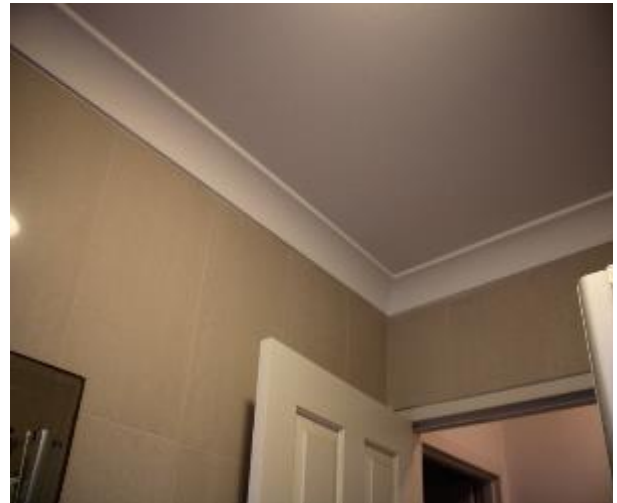
Figure 1043 - General condition of bathroom 1 internal wall

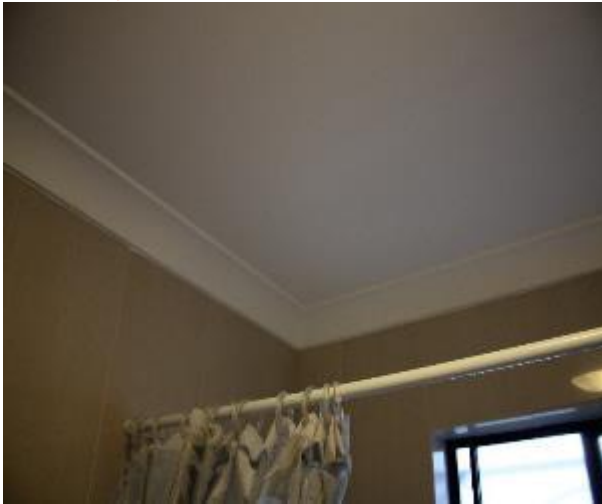
Figure 1047 - General condition of bathroom 1 ceiling

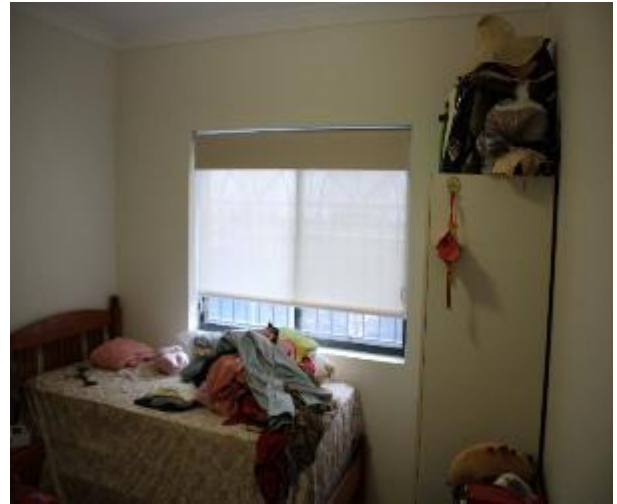
Figure 1048 - General condition of bedroom 2 internal wall

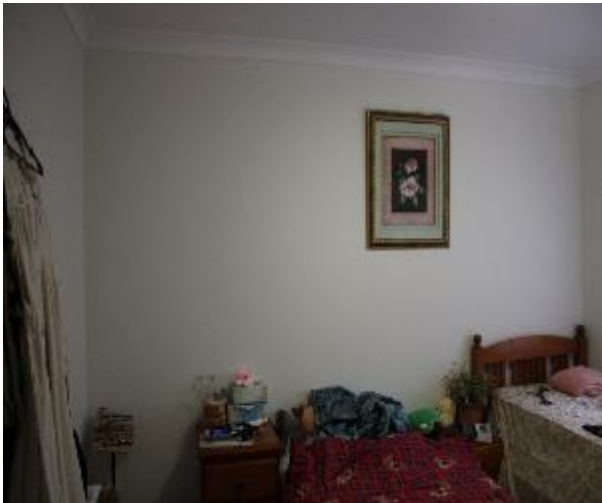
Figure 1049 - General condition of bedroom 2 internal wall

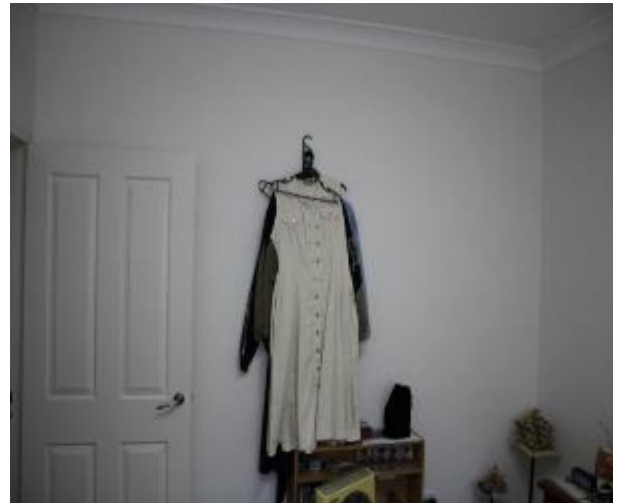
Figure 1050 - General condition of bedroom 2 internal wall

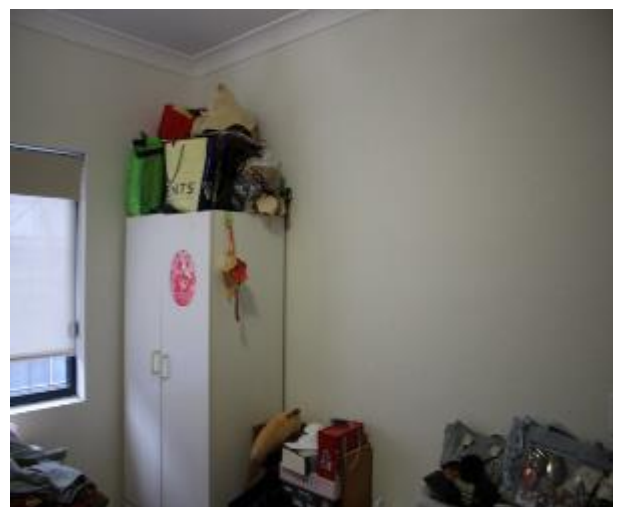
Figure 1052 - General condition of bedroom 2 internal wall

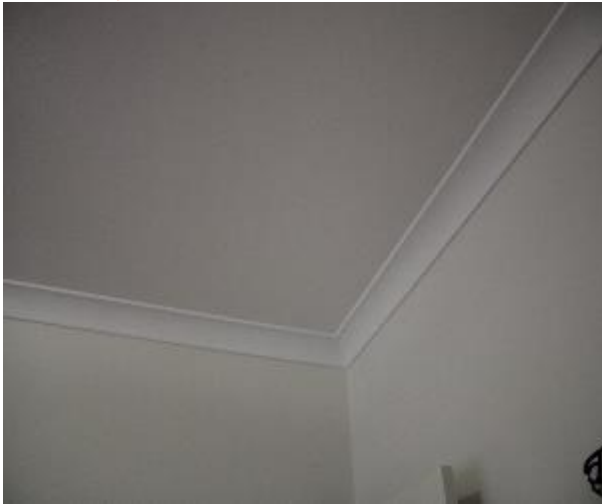
Figure 1053 - General condition of bedroom 2 ceiling

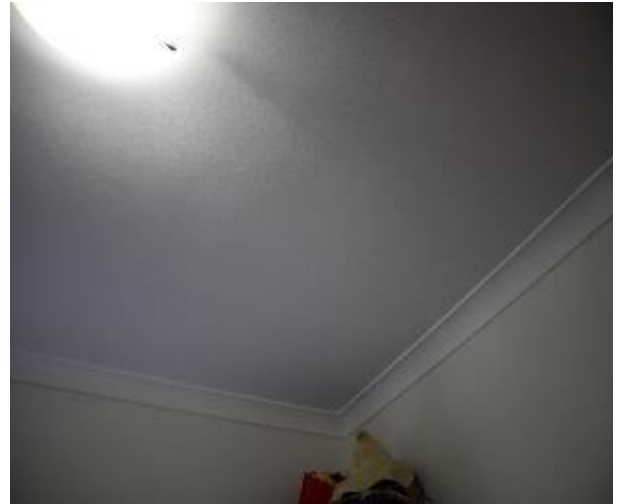
Figure 1054 - General condition of bedroom 2 ceiling

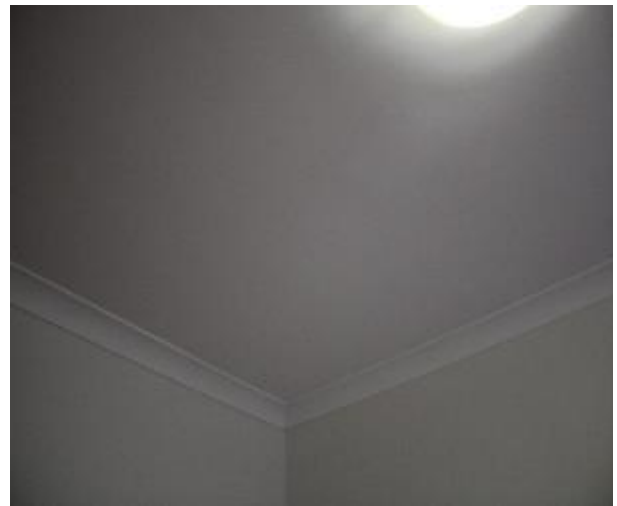
Figure 1056 - General condition of bedroom 2 ceiling

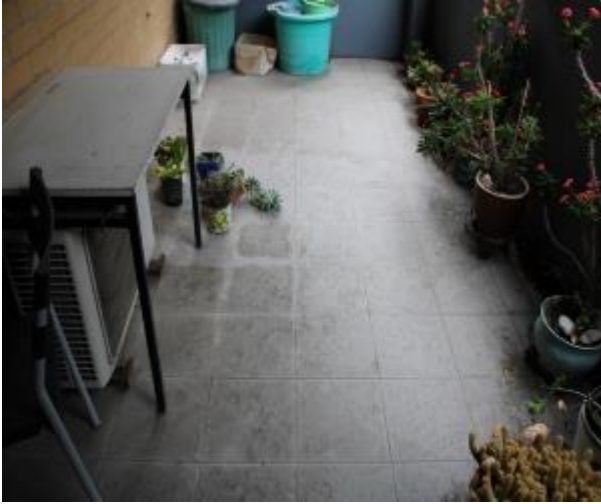
Figure 1059 - General condition of balcony floor tiles

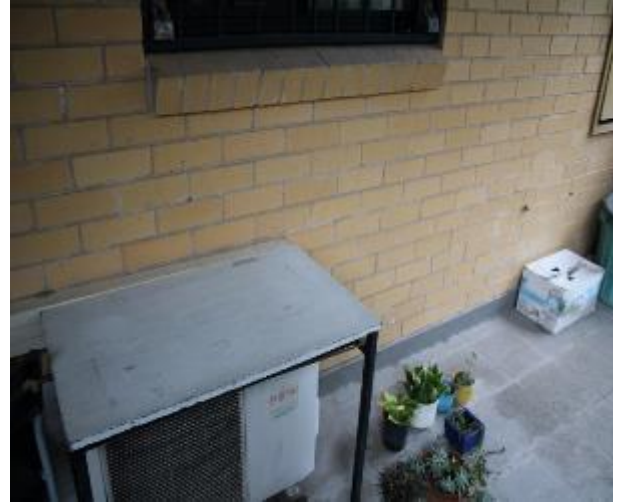
Figure 1060 - General condition of external wall

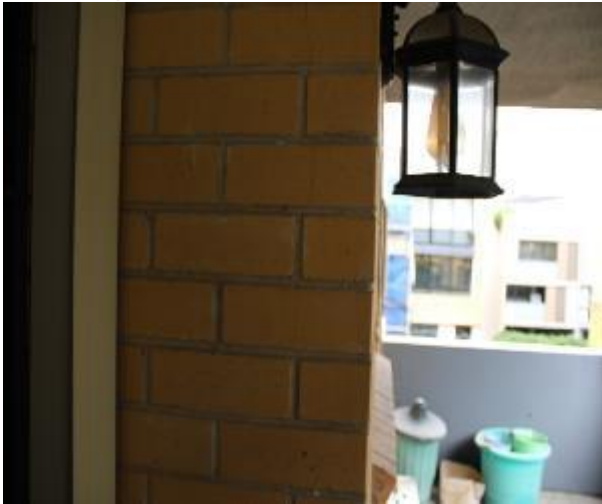
Figure 1065 - Crack propagation through external wall

Unit 25 was also inspected and found to be in reasonable condition. There were cases of cracking through the internal and external walls and ceilings.

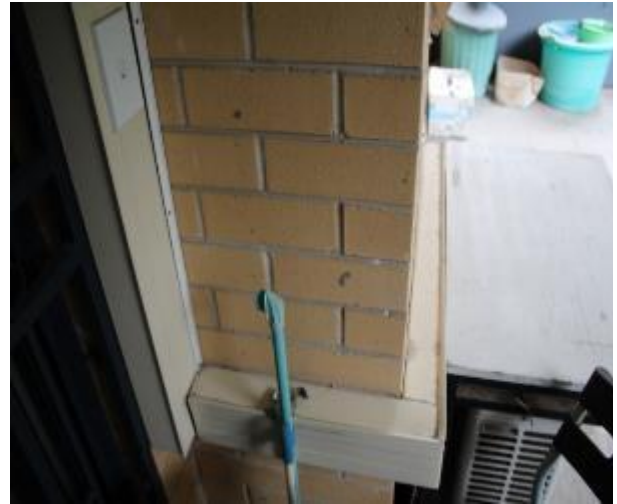
Figure 1066 - General condition of external wall

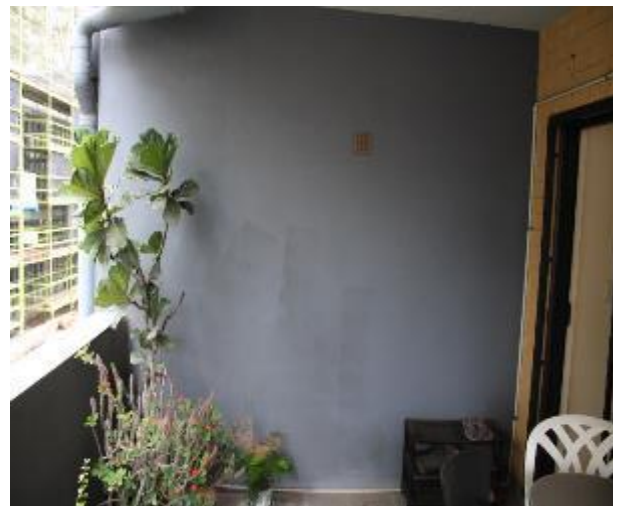
Figure 1068 - General condition of external wall

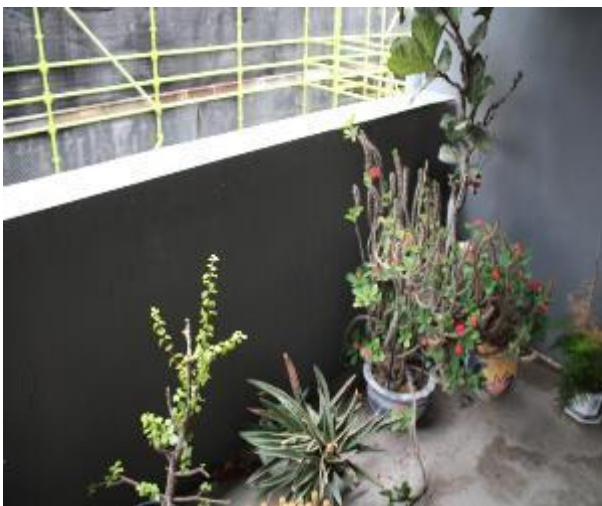
Figure 1069 - General condition of external wall

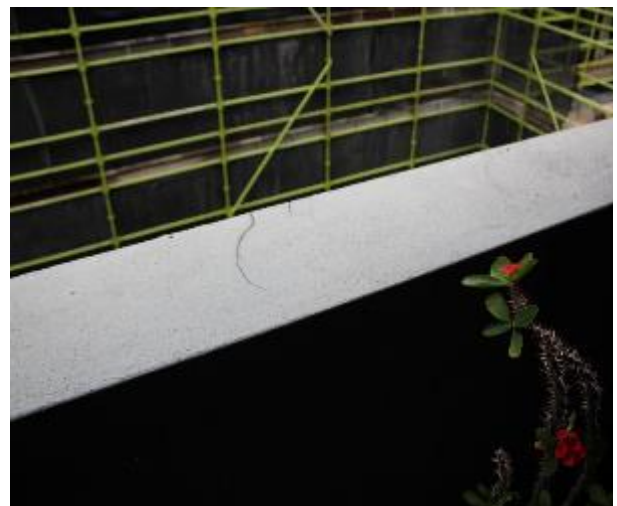
Figure 1070 - Crack propagation through external wall

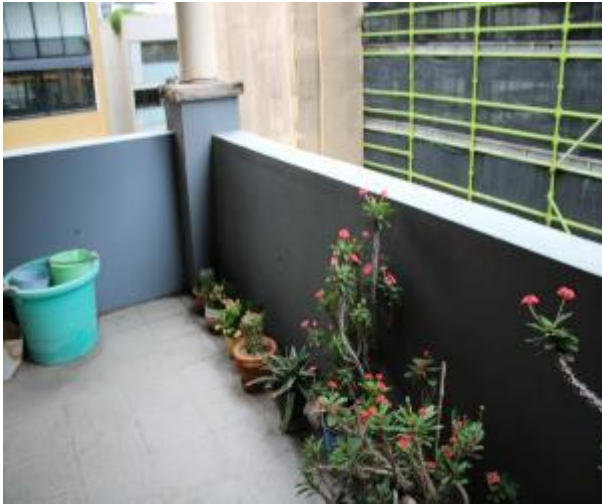
Figure 1071 - General condition of external wall

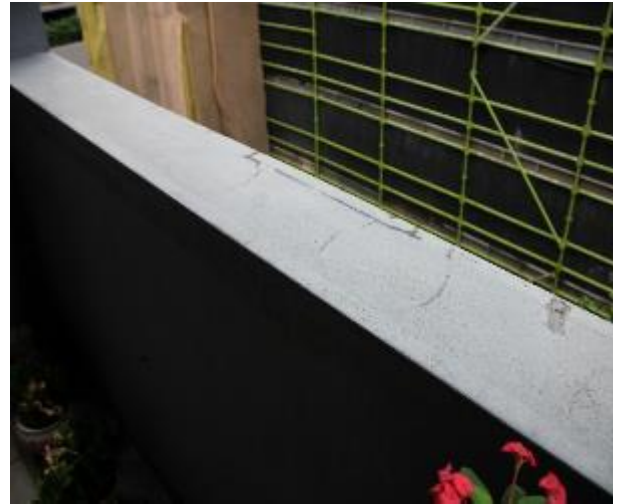
Figure 1072 - Crack propagation through external wall

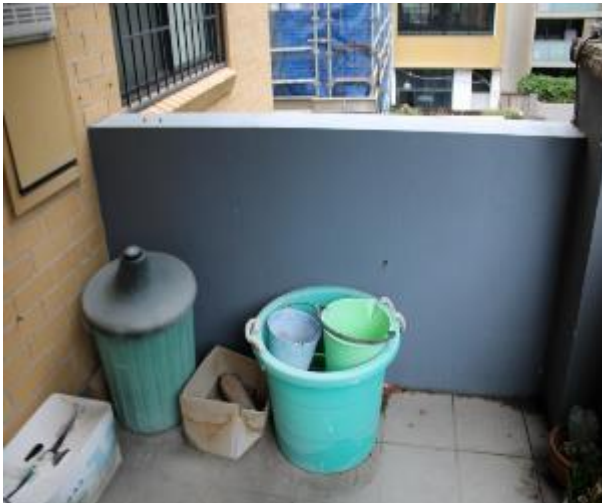
Figure 1073 - General condition of external wall

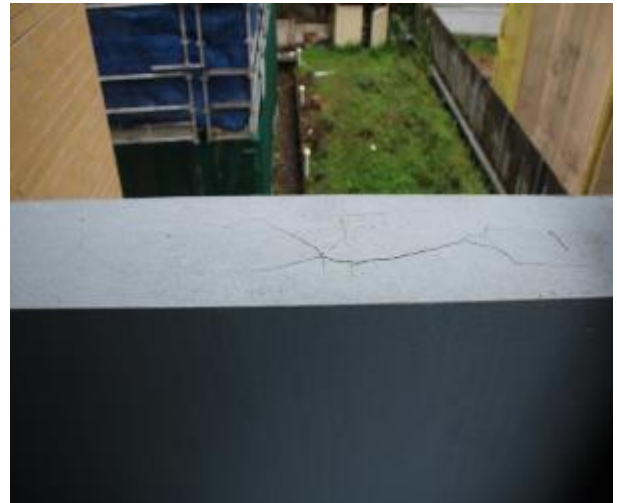
Figure 1074 - Crack propagation through external wall

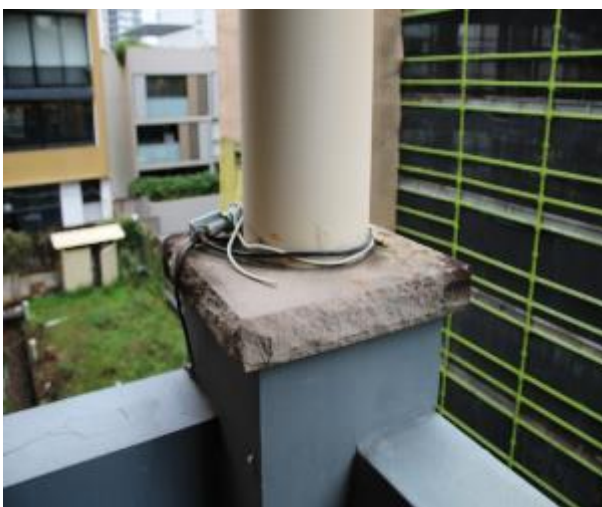
Figure 1075 - General condition of external wall

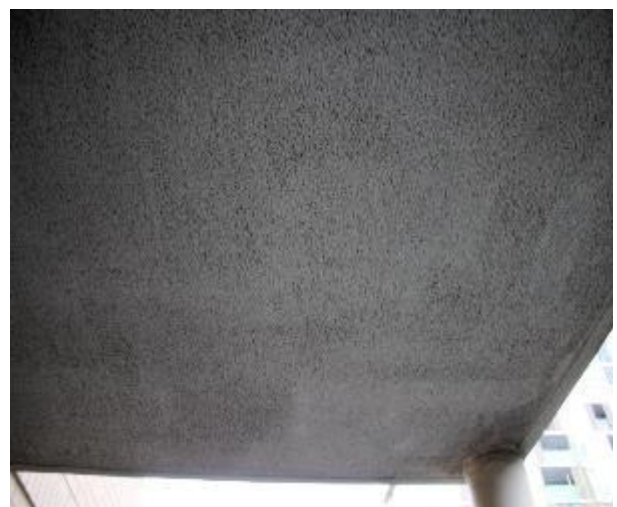
Figure 1076 - General condition of balcony underside slab

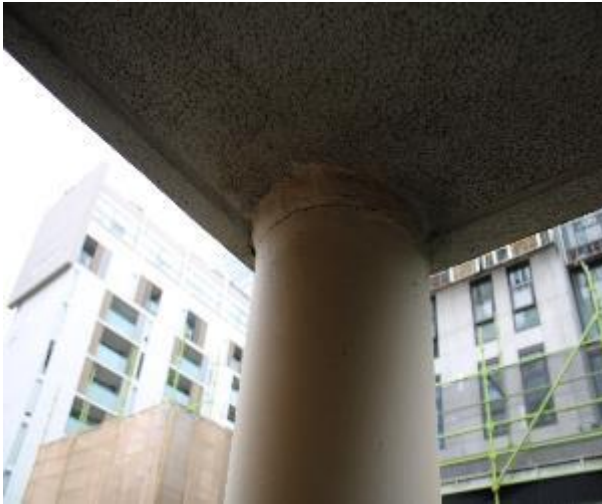
Figure 1077 - General condition of balcony underside slab

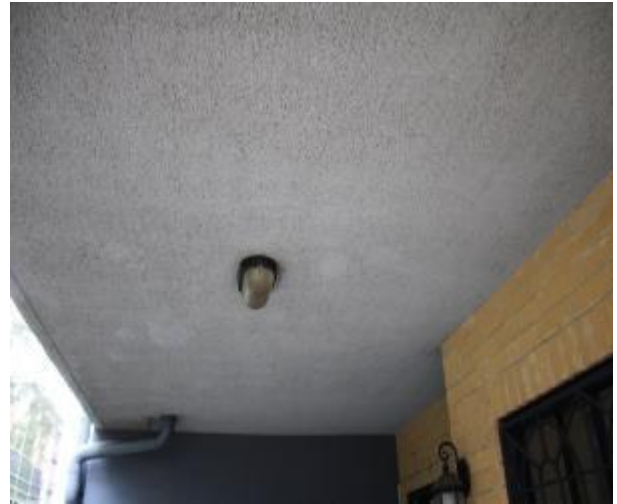
Figure 1078 - General condition of balcony underside slab

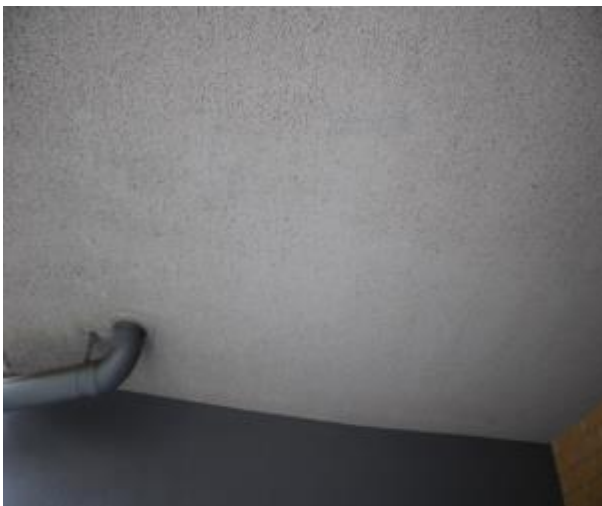
Figure 1079 - General condition of balcony underside slab

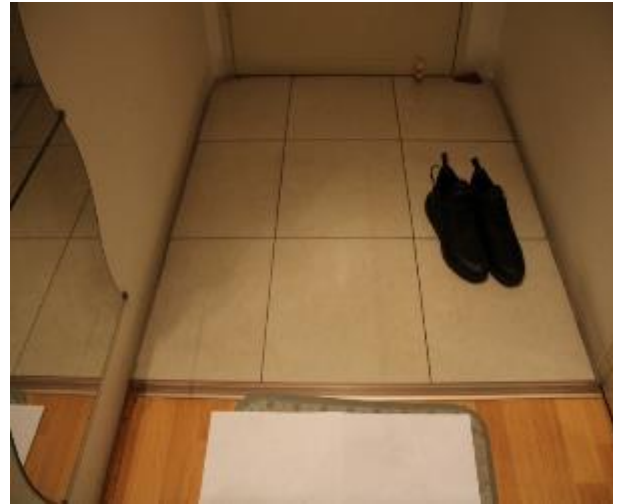
Figure 1081 - General condition of entry floor tiles

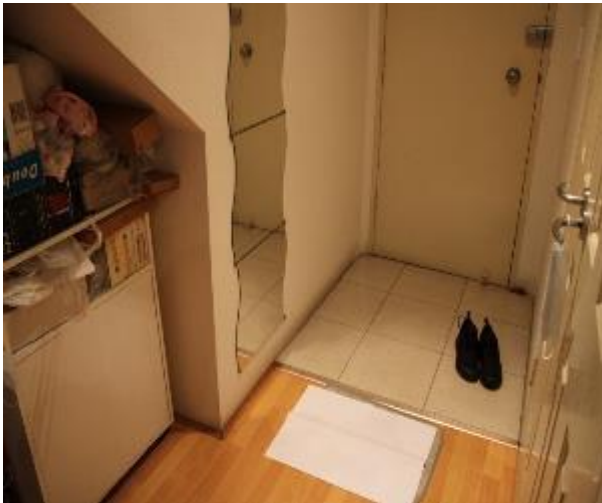
Figure 1082 - General condition of lounge room internal wall

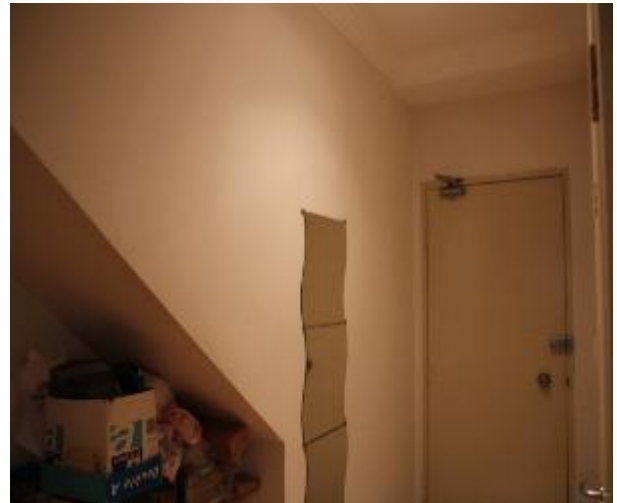
Figure 1083 - General condition of lounge room internal wall

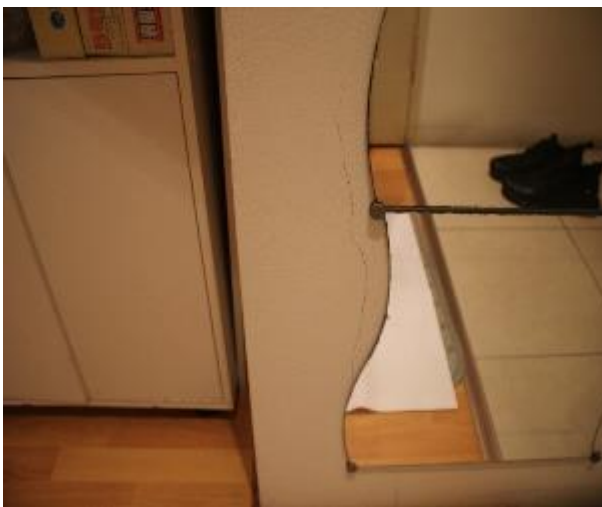
Figure 1084 - Crack propagation through lounge room internal wall

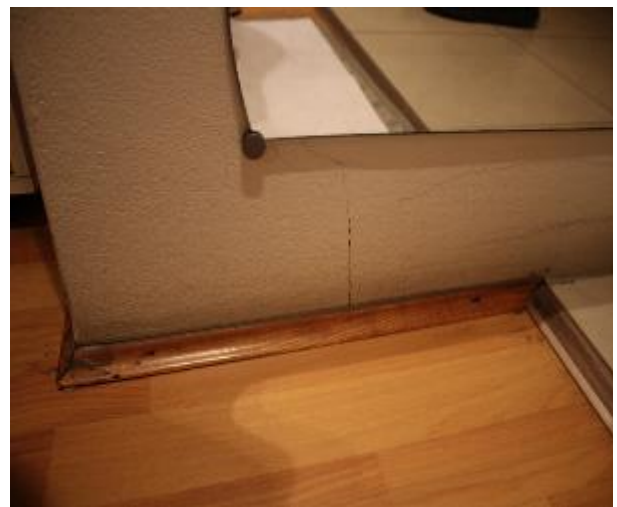
Figure 1085 - Crack propagation through lounge room internal wall

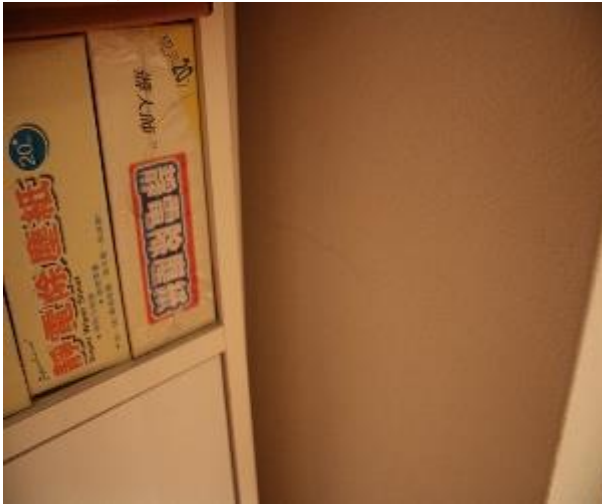
Figure 1086 - Crack propagation through lounge room internal wall

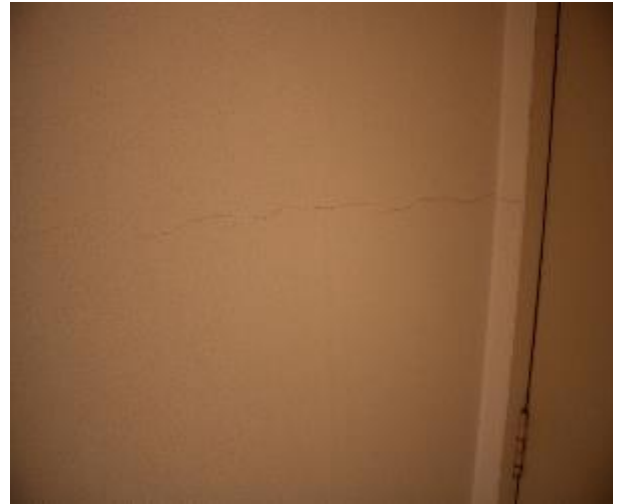
Figure 1087 - Crack propagation through lounge room internal wall

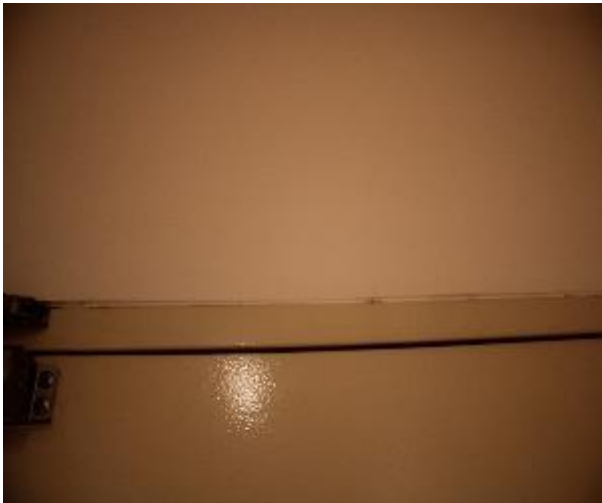
Figure 1088 - Crack propagation through lounge room internal wall

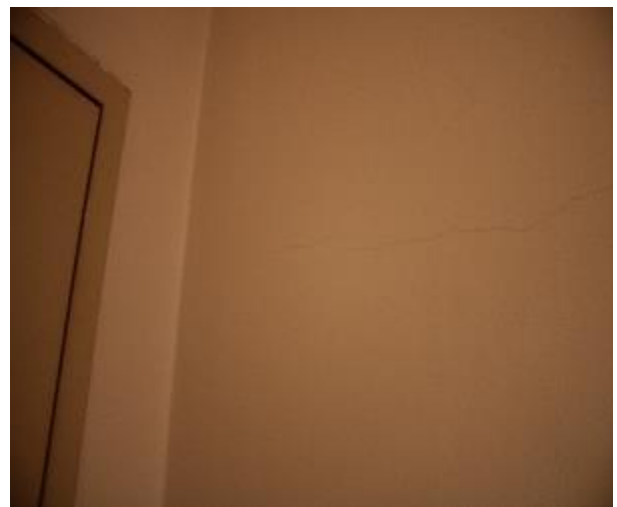
Figure 1091 - Crack propagation through lounge room internal wall

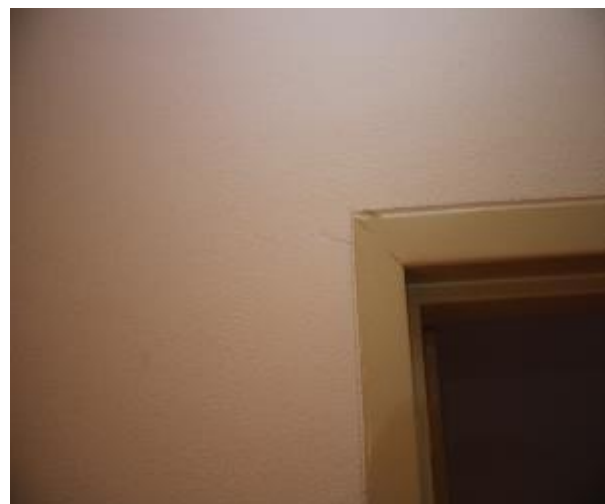
Figure 1095 - Crack propagation through lounge room internal wall

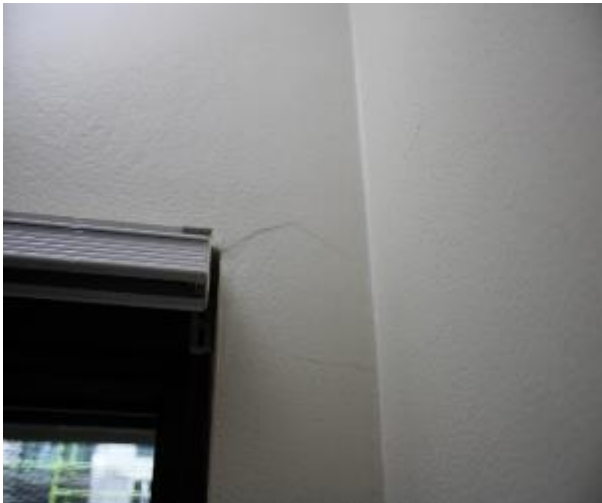
Figure 1100 - Crack propagation through lounge room internal wall

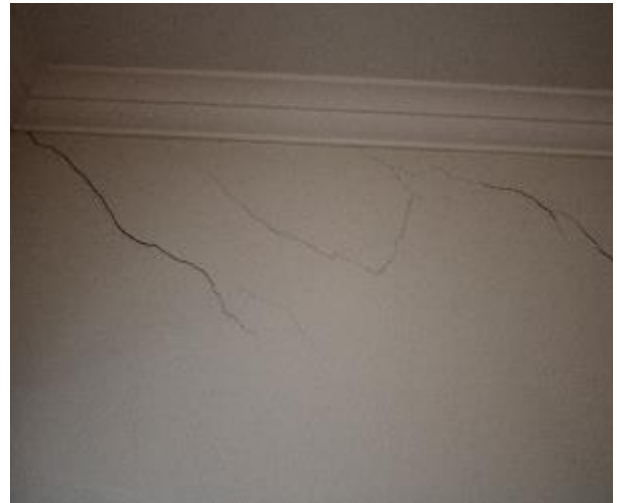
Figure 1101 - Crack propagation through lounge room internal wall

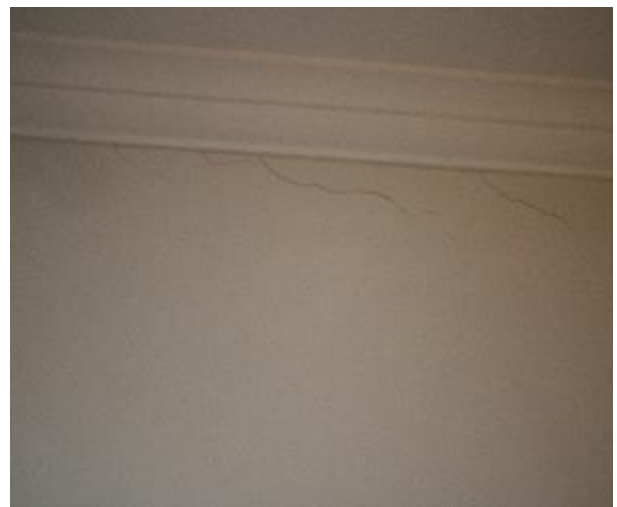
Figure 1103 - Crack propagation through lounge room internal wall

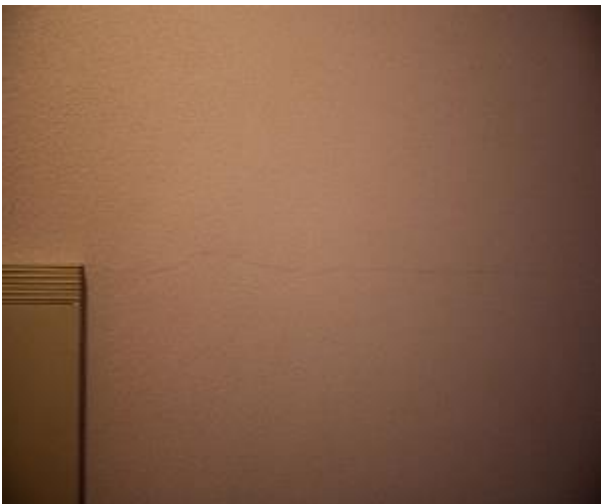
Figure 1120 - Crack propagation through bedroom 1 internal wall

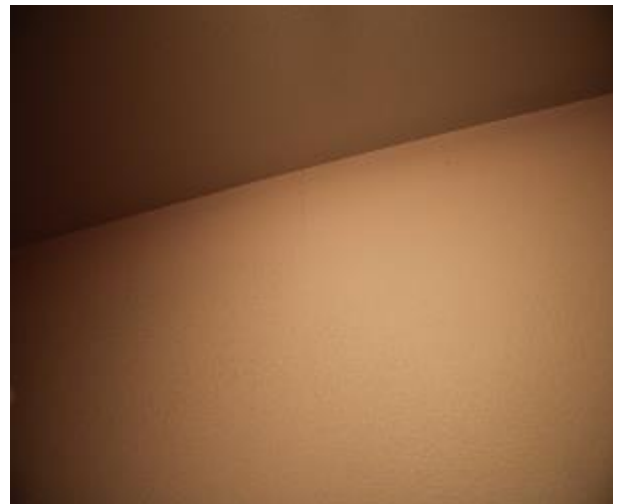
Figure 1121 - Crack propagation through bedroom 1 internal wall

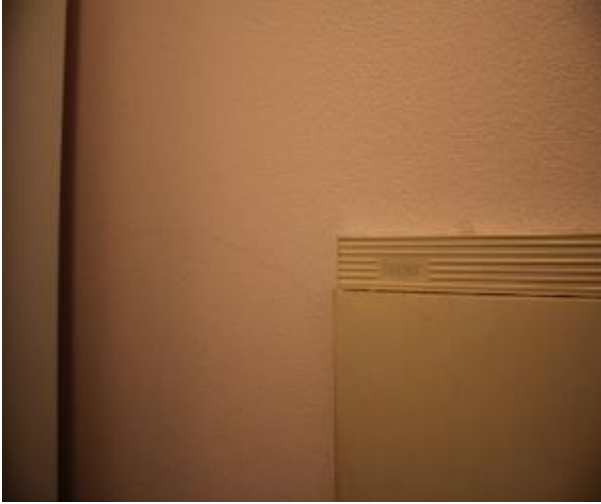
Figure 1122 - Crack propagation through bedroom 1 internal wall

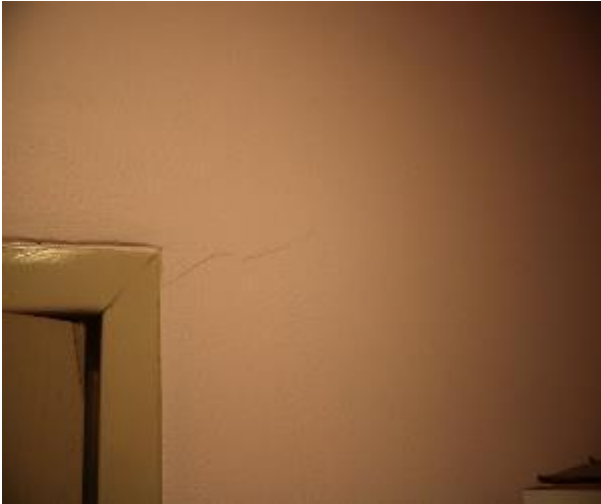
Figure 1124 - Crack propagation through bedroom 1 internal wall

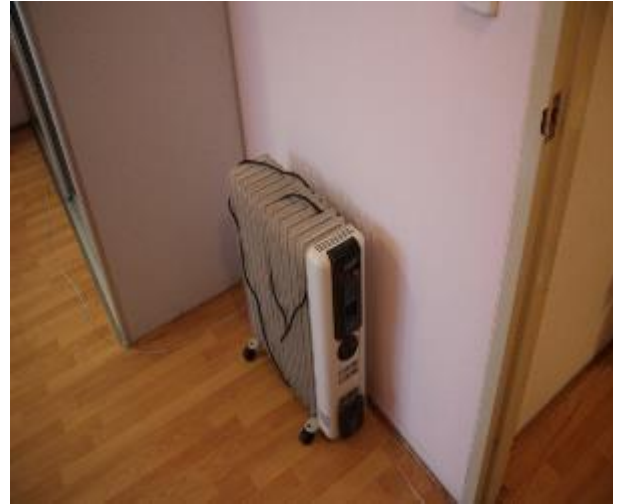
Figure 1125 - General condition of bedroom 1 internal wall

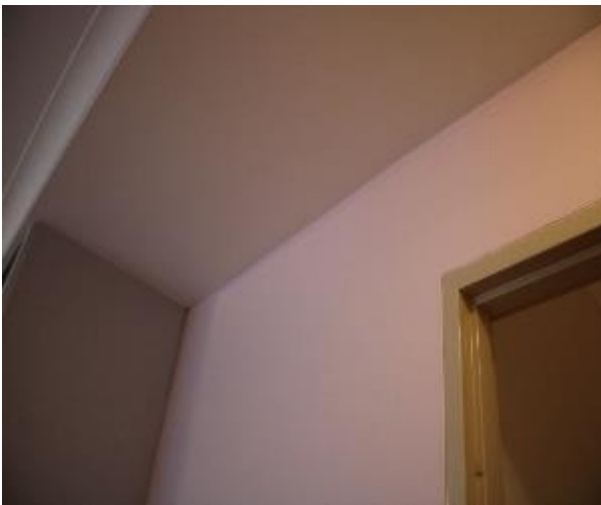
Figure 1126 - General condition of bedroom 1 internal wall

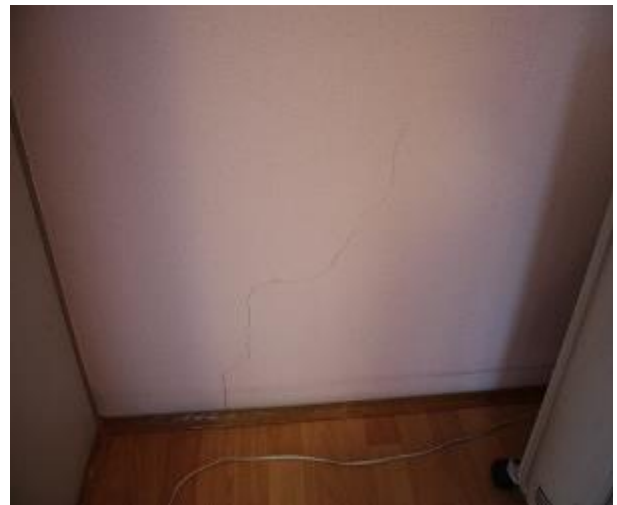
Figure 1127 - Crack propagation through bedroom 1 internal wall

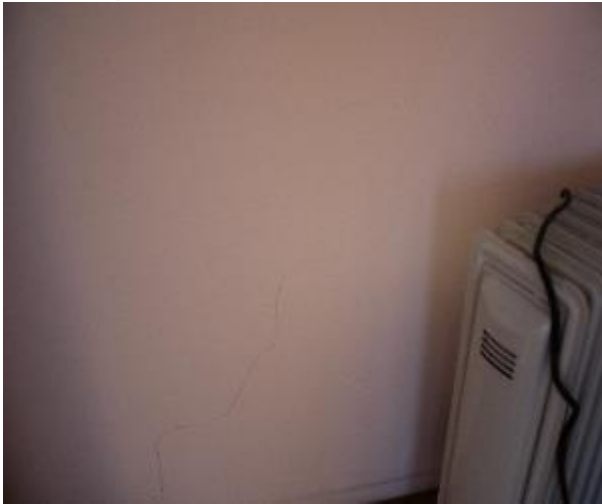
Figure 1128 - Crack propagation through bedroom 1 internal wall

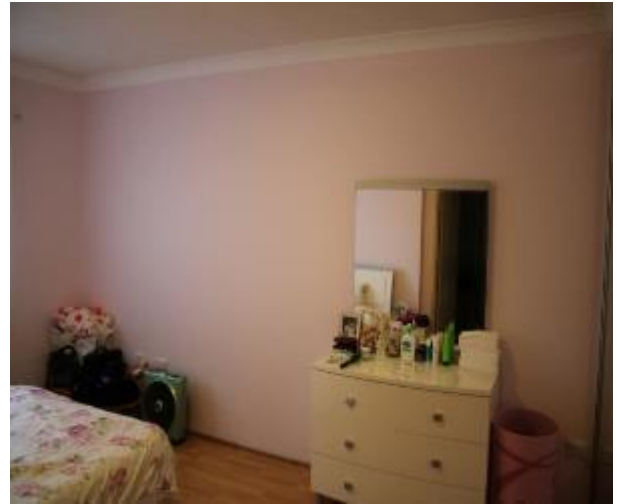
Figure 1129 - General condition of bedroom 1 internal wall

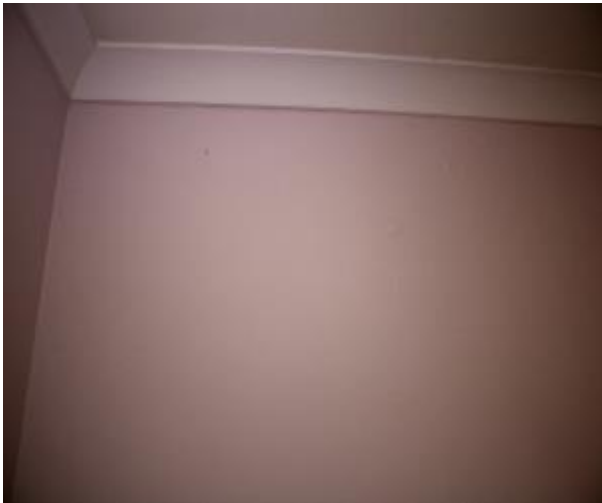
Figure 1130 - General condition of bedroom 1 internal wall
