# **Pre-Dilapidation Report**

**19 GEORGE STREET**

**REAR BUILDING (UNITS 20-29)**

Project Reference: 20250047.19G.3

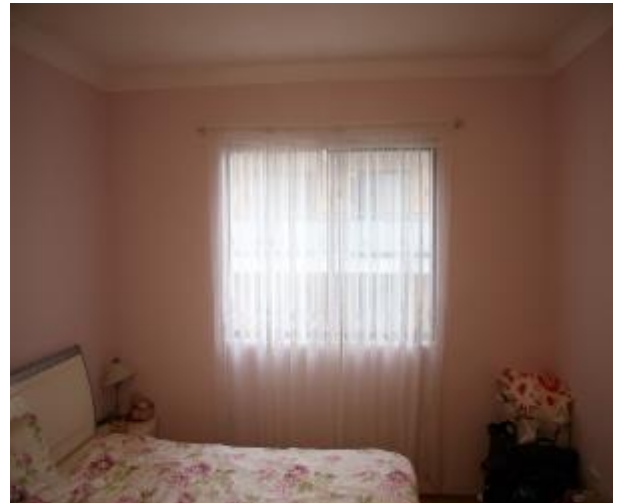
Figure 1131 - General condition of bedroom 1 internal wall

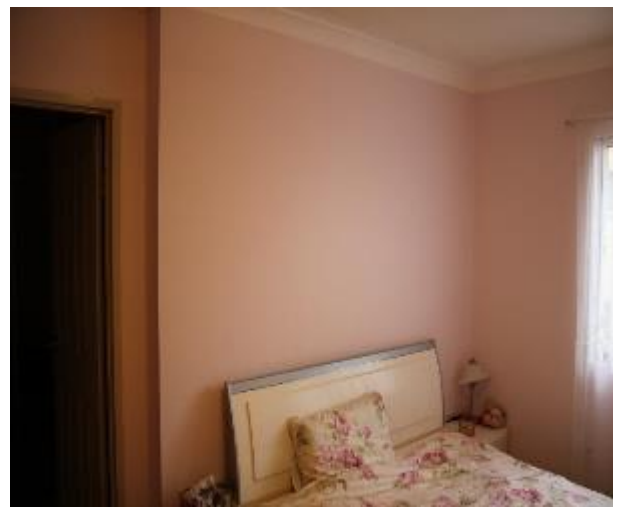
Figure 1133 - General condition of bedroom 1 internal wall

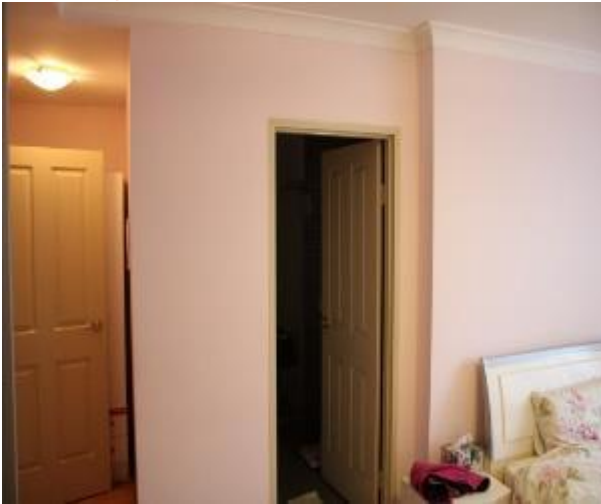
Figure 1134 - General condition of bedroom 1 internal wall

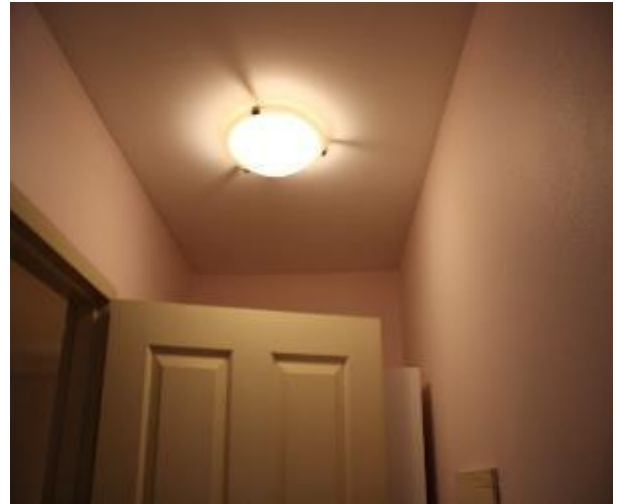
Figure 1135 - General condition of bedroom 1 ceiling

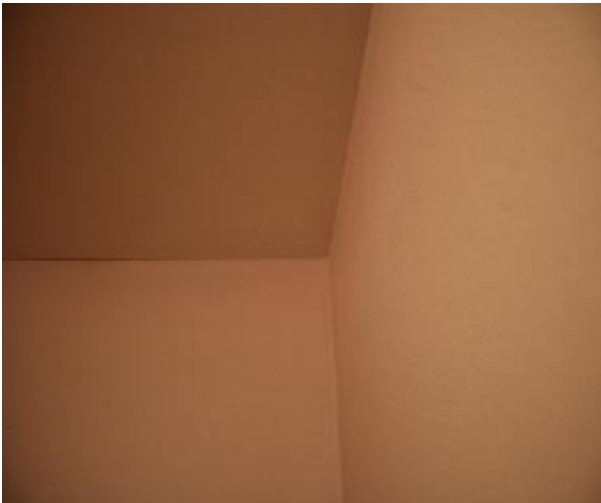
Figure 1136 - General condition of bedroom 1 ceiling

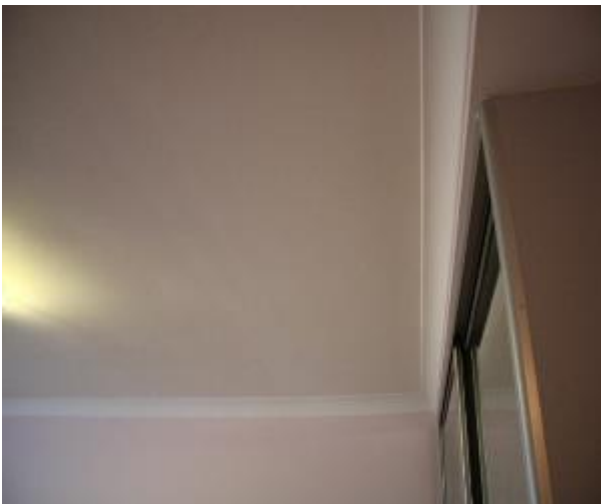
Figure 1138 - General condition of bedroom 1 ceiling

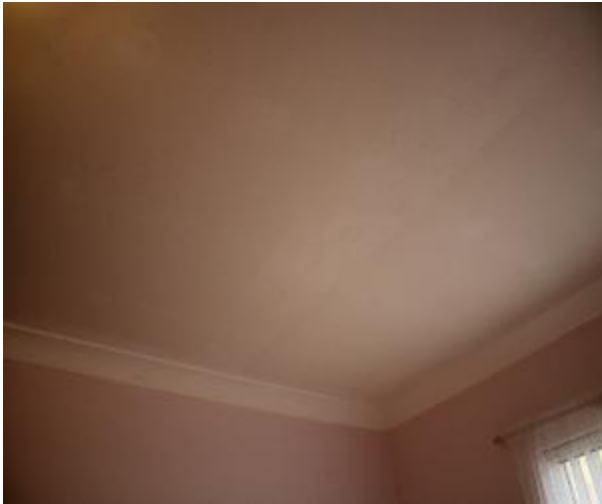
Figure 1140 - General condition of bedroom 1 ceiling

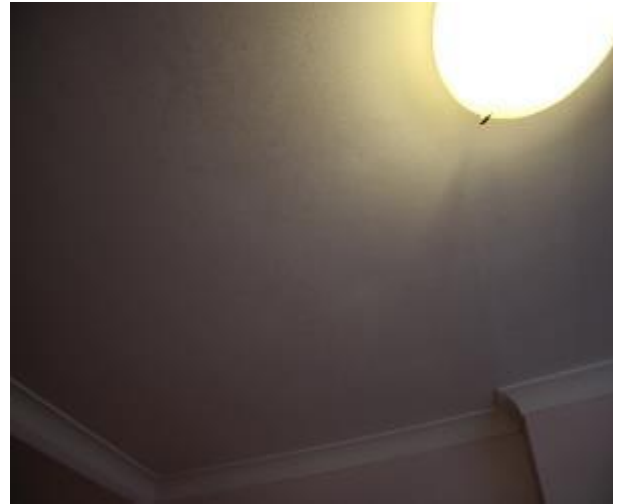
Figure 1141 - General condition of bedroom 1 ceiling

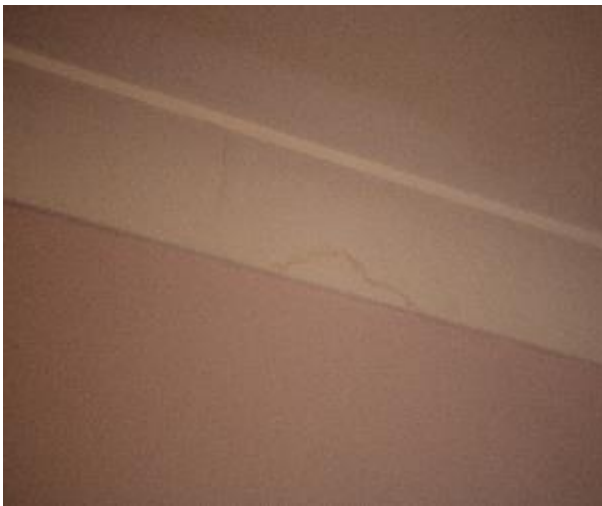
Figure 1142 - Crack propagation through bedroom 1 ceiling

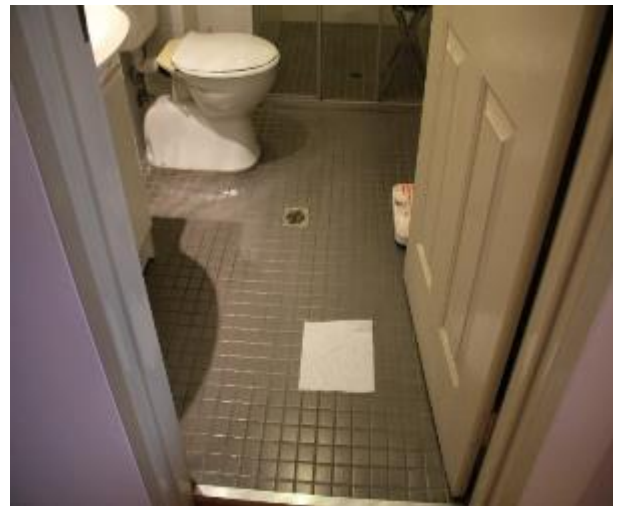
Figure 1143 - General condition of ensuite bathroom floor tiles

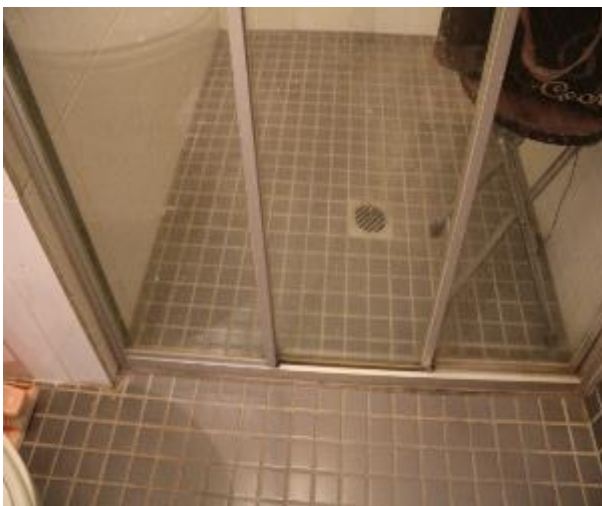
Figure 1144 - General condition of ensuite bathroom floor tiles

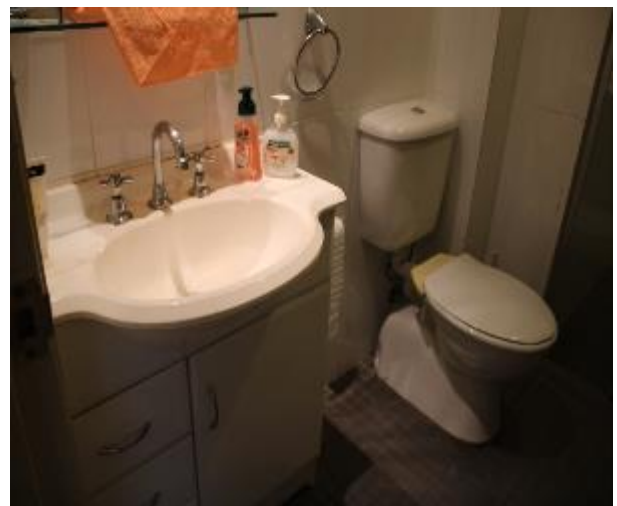
Figure 1145 - General condition of ensuite bathroom internal wall

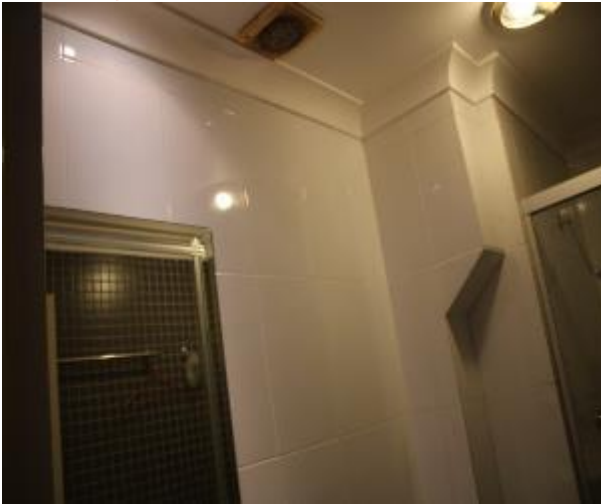
Figure 1146 - General condition of ensuite bathroom internal wall

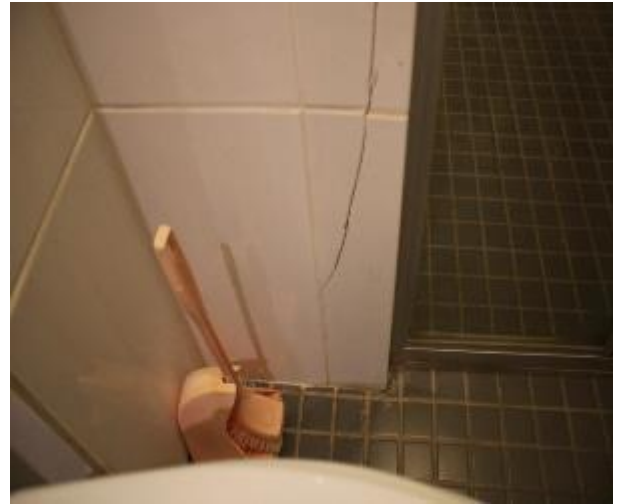
Figure 1147 - Crack propagation through ensuite bathroom internal wall

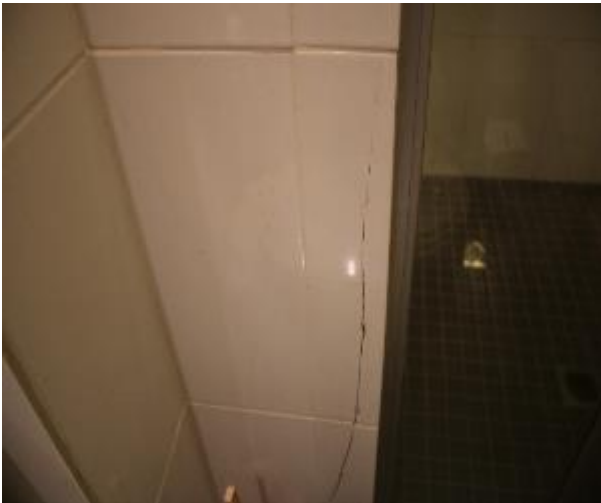
Figure 1148 - Crack propagation through ensuite bathroom internal wall

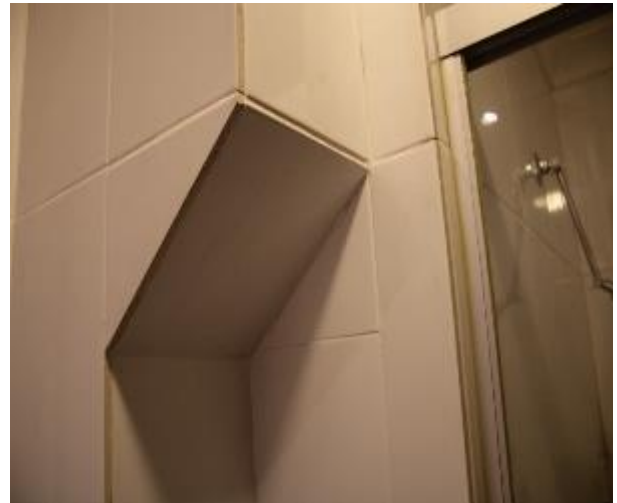
Figure 1149 - Crack propagation through ensuite bathroom internal wall

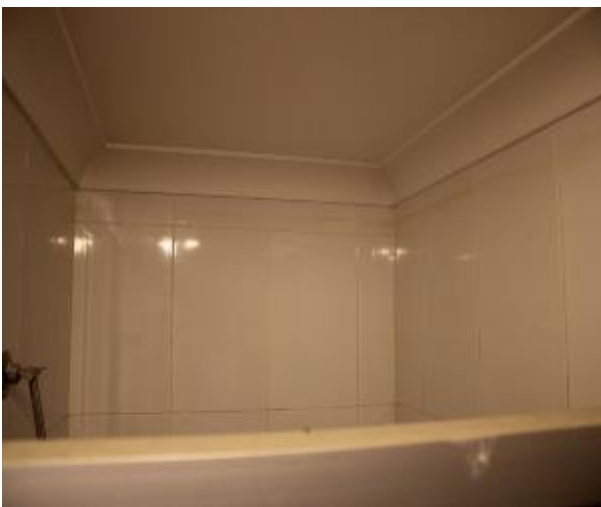
Figure 1150 - General condition of ensuite bathroom internal wall

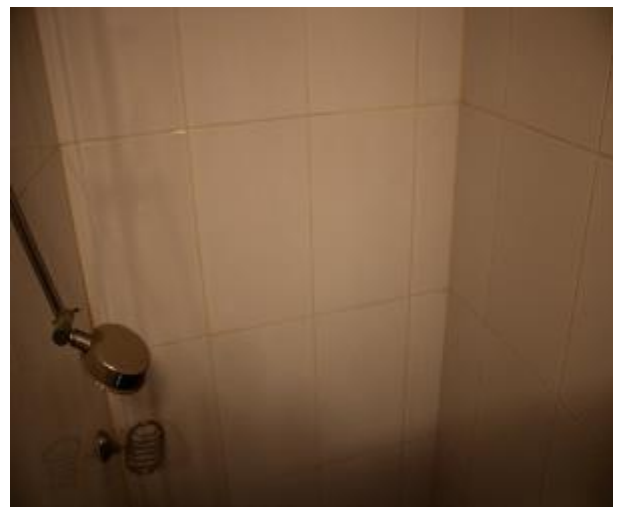
Figure 1151 - General condition of ensuite bathroom internal wall

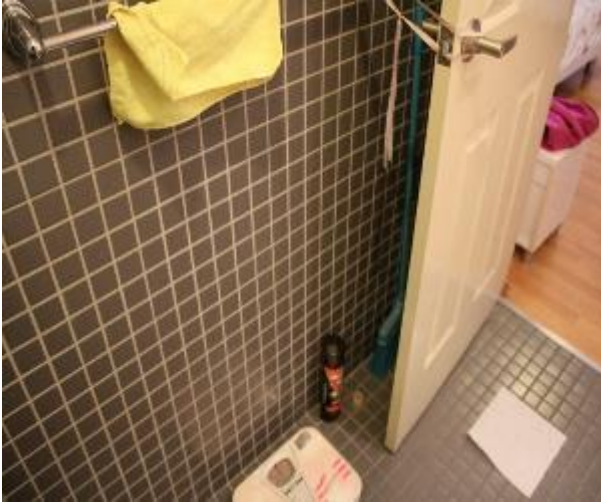
Figure 1152 - General condition of ensuite bathroom internal wall

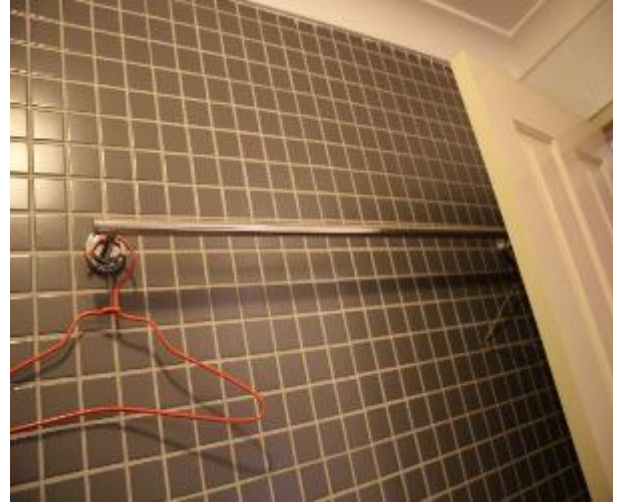
Figure 1153 - General condition of ensuite bathroom internal wall

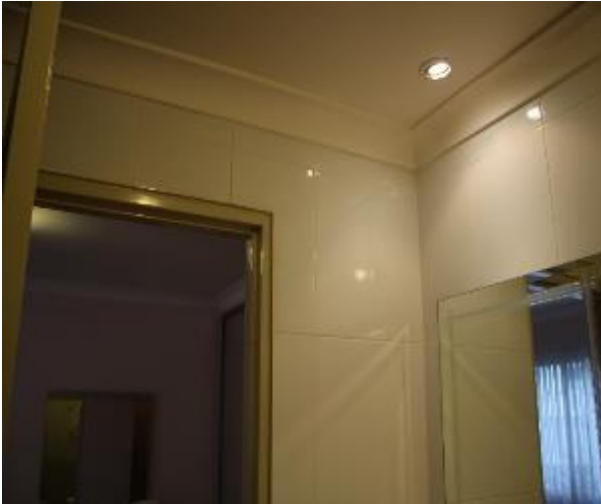
Figure 1154 - General condition of ensuite bathroom internal wall

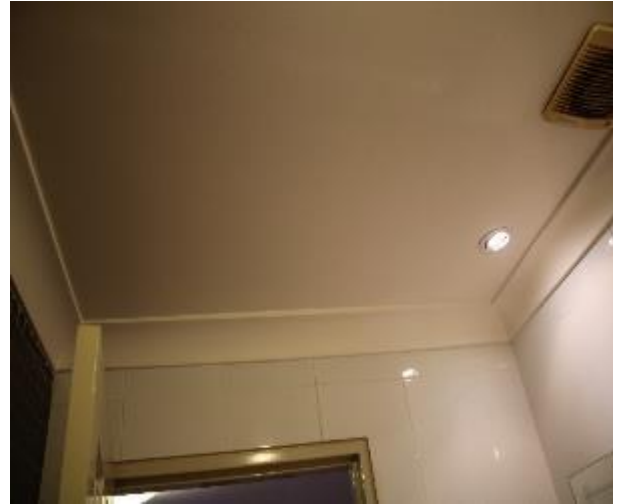
Figure 1155 - General condition of ensuite bathroom ceiling

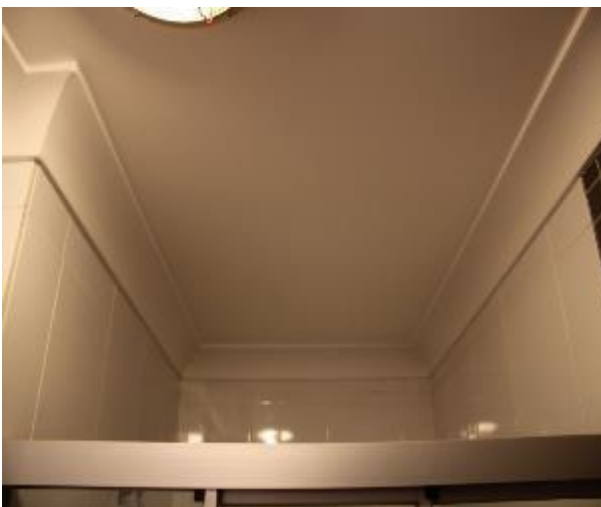
Figure 1156 - General condition of ensuite bathroom ceiling

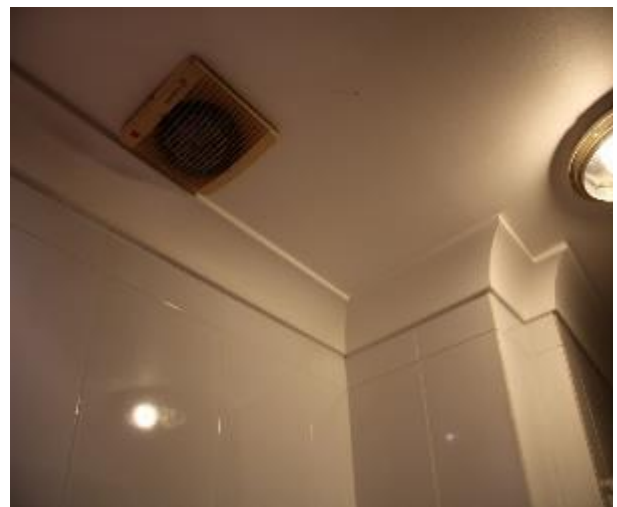
Figure 1157 - General condition of ensuite bathroom ceiling

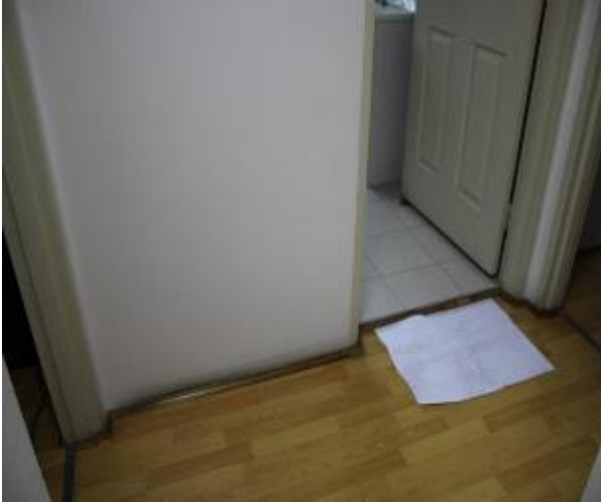
Figure 1158 - General condition of corridor internal wall

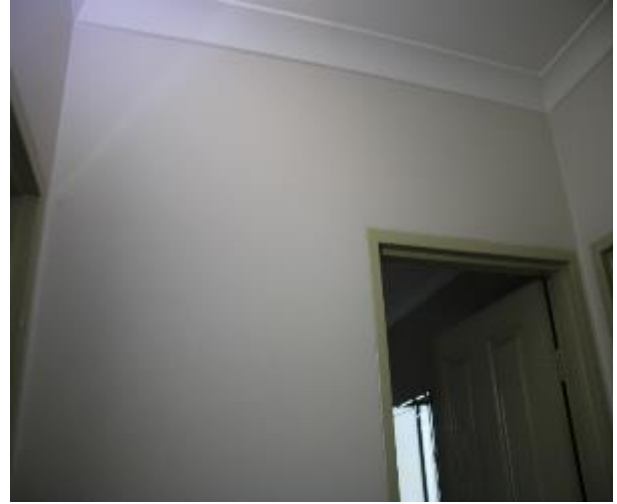
Figure 1159 - General condition of corridor internal wall

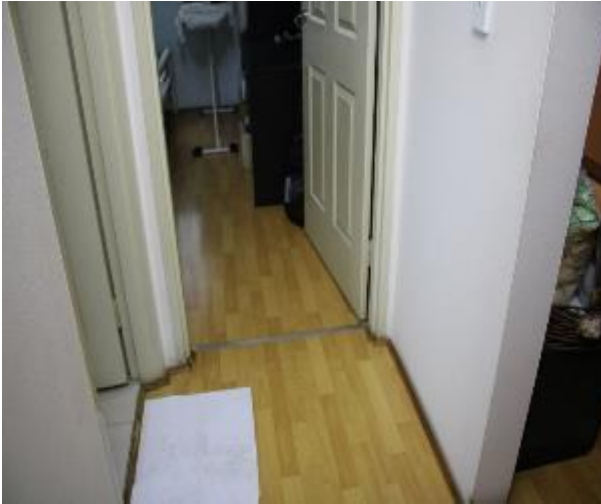
Figure 1160 - General condition of corridor internal wall

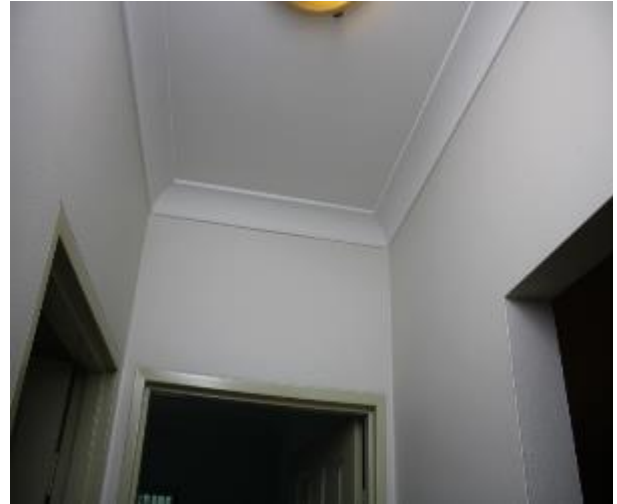
Figure 1161 - General condition of corridor internal wall

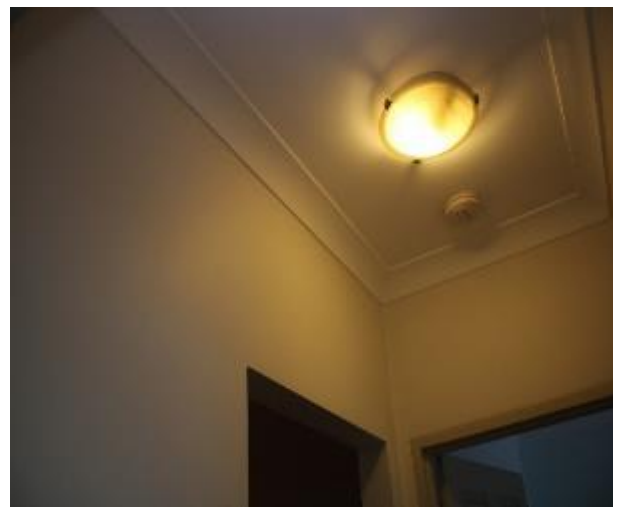
Figure 1163 - General condition of corridor internal wall

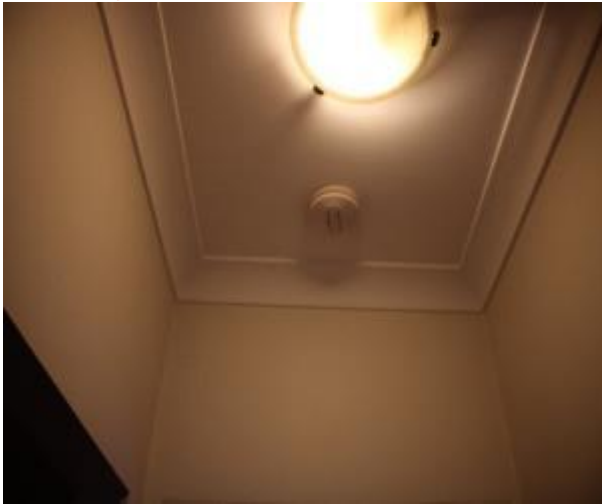
Figure 1164 - General condition of corridor ceiling

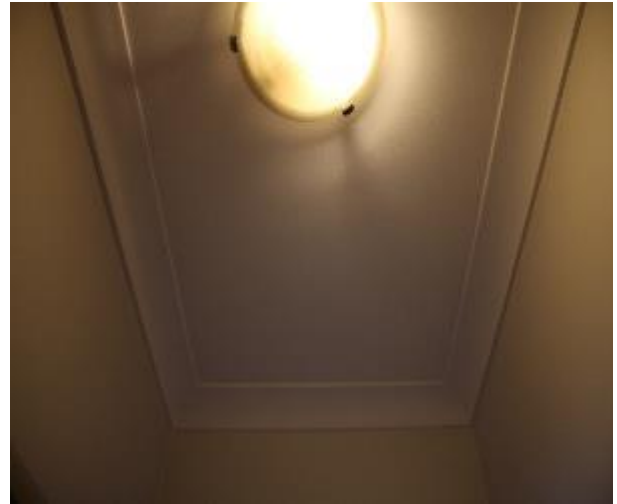
Figure 1165 - General condition of corridor ceiling

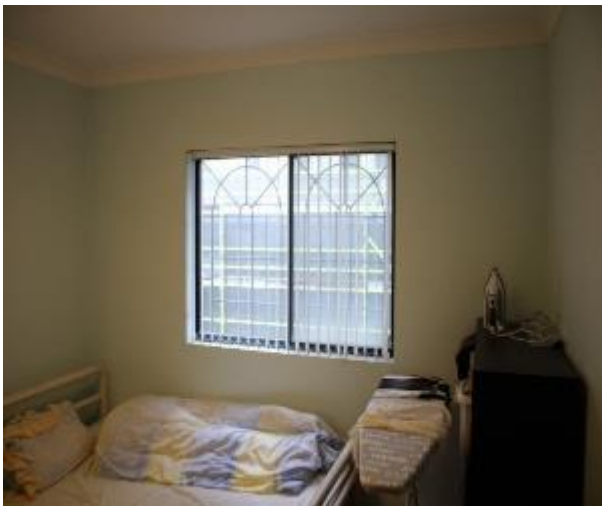
Figure 1166 - General condition of bedroom 2 internal wall

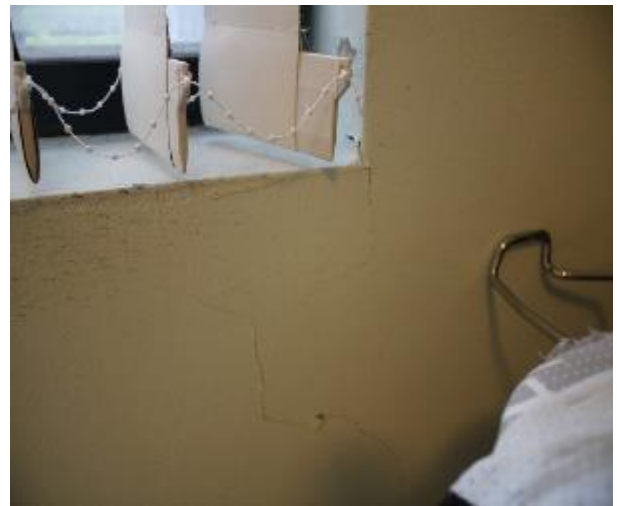
Figure 1167 - Crack propagation through bedroom 2 internal wall

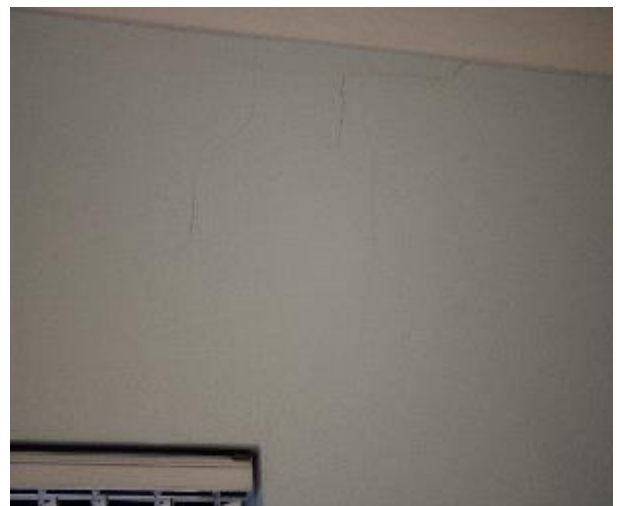
Figure 1169 - Crack propagation through bedroom 2 internal wall

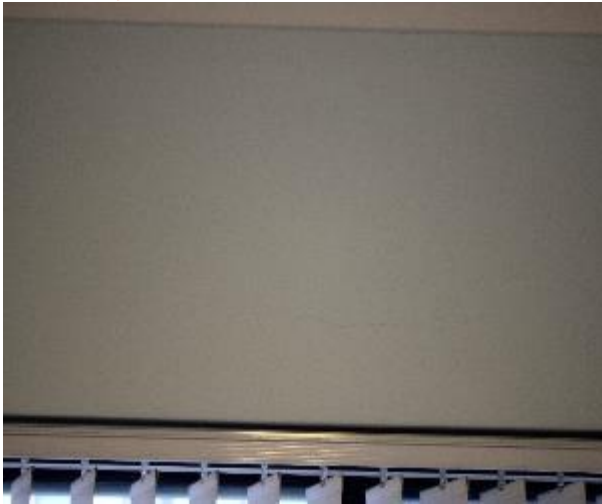
Figure 1170 - Crack propagation through bedroom 2 internal wall

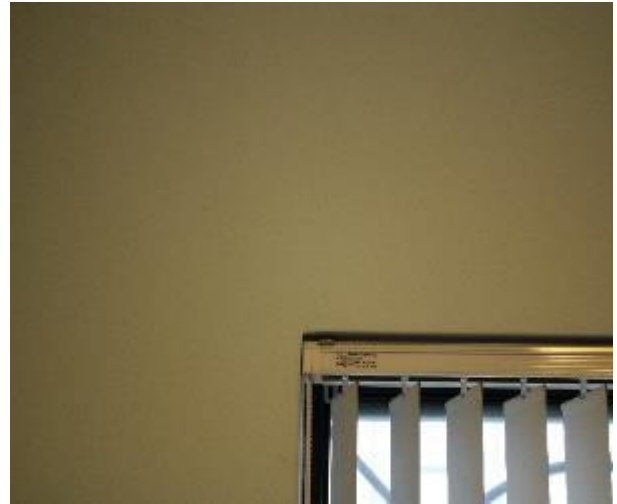
Figure 1171 - Crack propagation through bedroom 2 internal wall

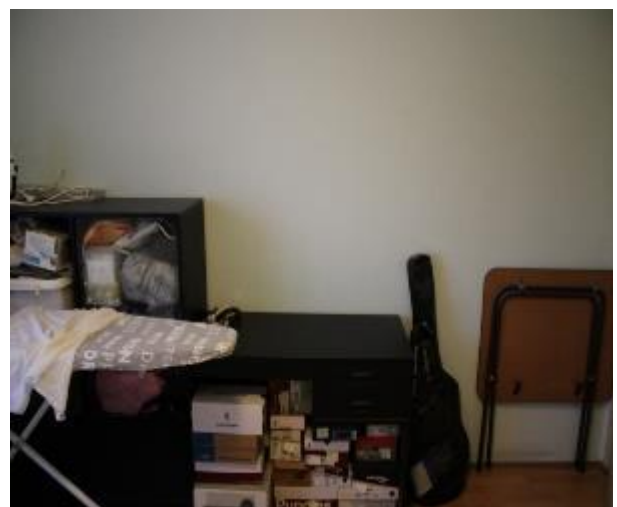
Figure 1175 - General condition of bedroom 2 internal wall

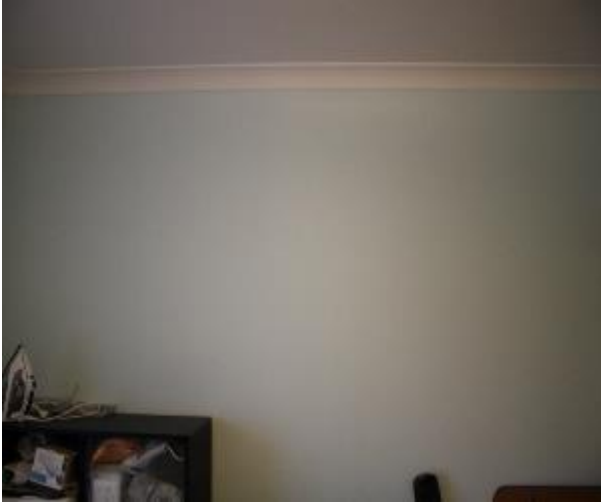
Figure 1176 - General condition of bedroom 2 internal wall

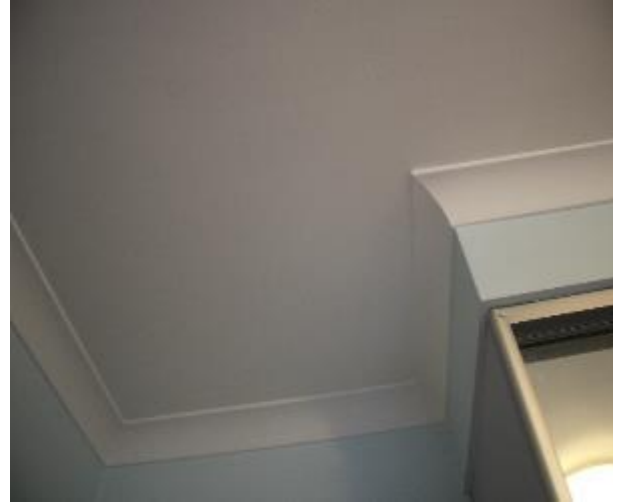
Figure 1177 - General condition of bedroom 2 ceiling

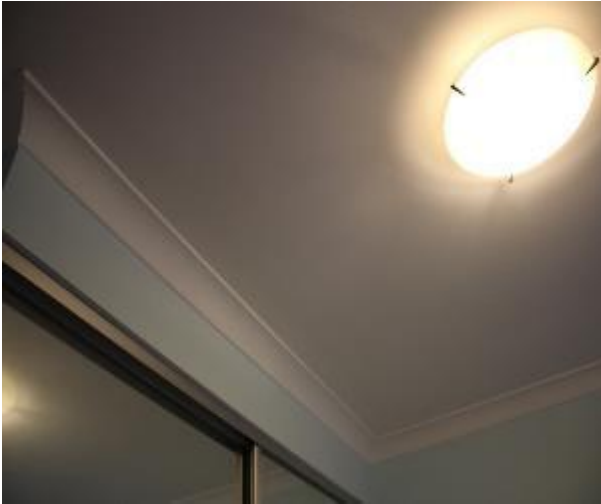
Figure 1178 - General condition of bedroom 2 ceiling

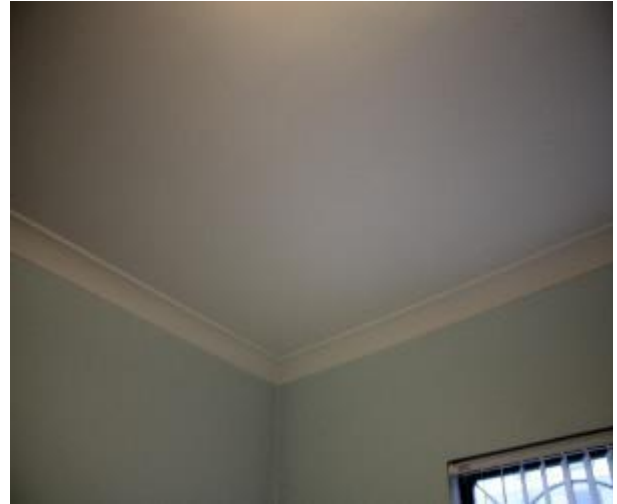
Figure 1179 - General condition of bedroom 2 ceiling

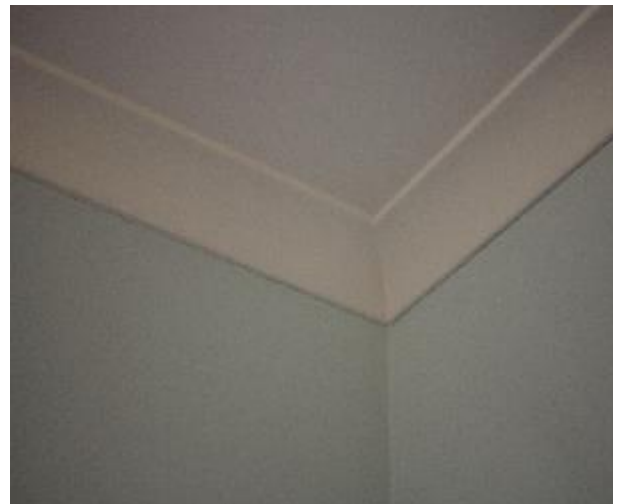
Figure 1181 - Crack propagation through bedroom 2 ceiling

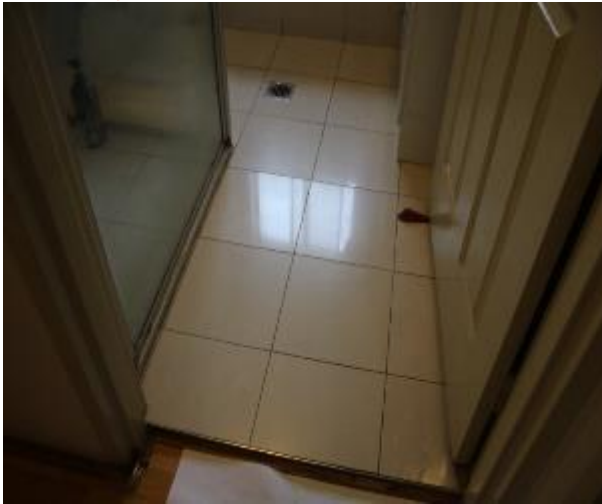
Figure 1182 - General condition of bathroom 1 floor tiles

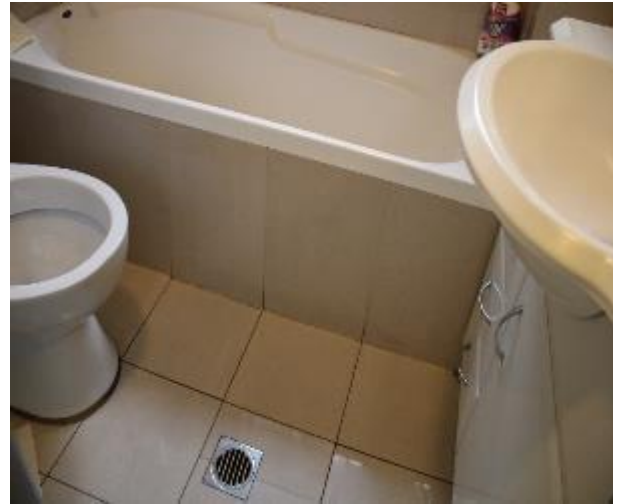
Figure 1183 - General condition of bathroom 1 floor tiles

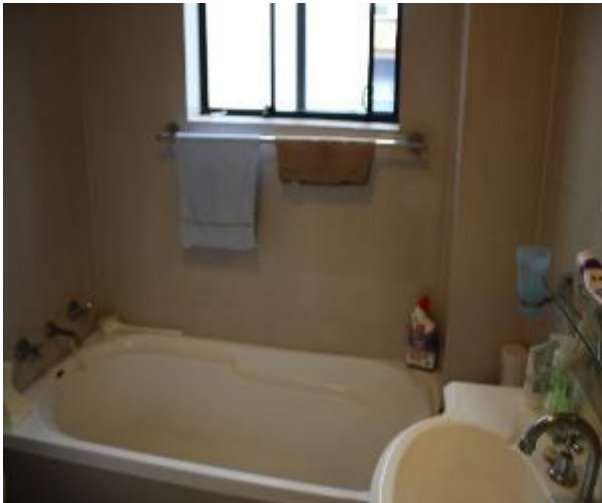
Figure 1184 - General condition of bathroom 1 internal wall

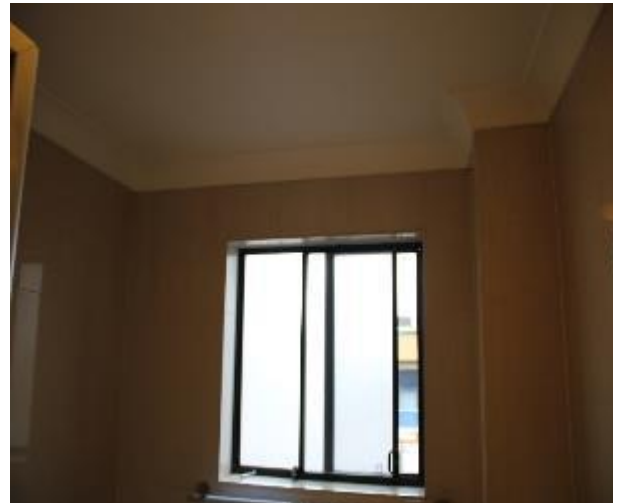
Figure 1185 - General condition of bathroom 1 internal wall

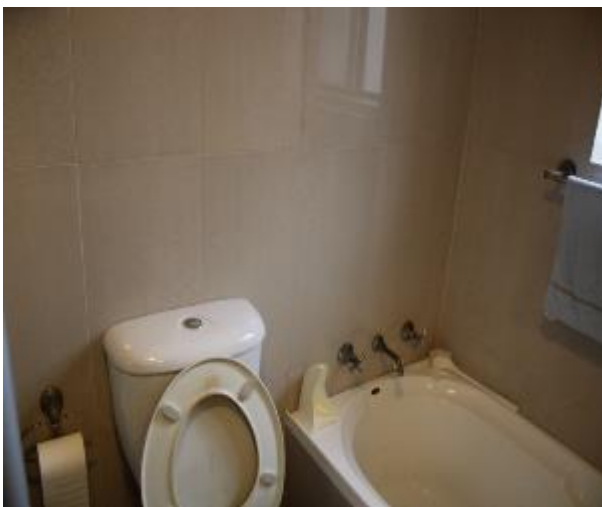
Figure 1186 - General condition of bathroom 1 internal wall

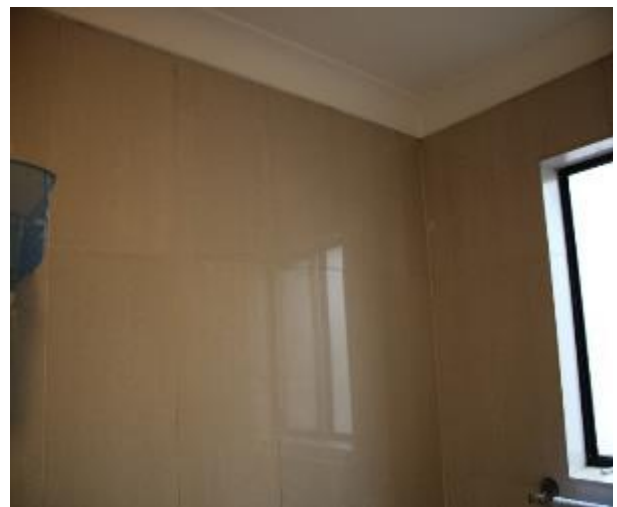
Figure 1187 - General condition of bathroom 1 internal wall

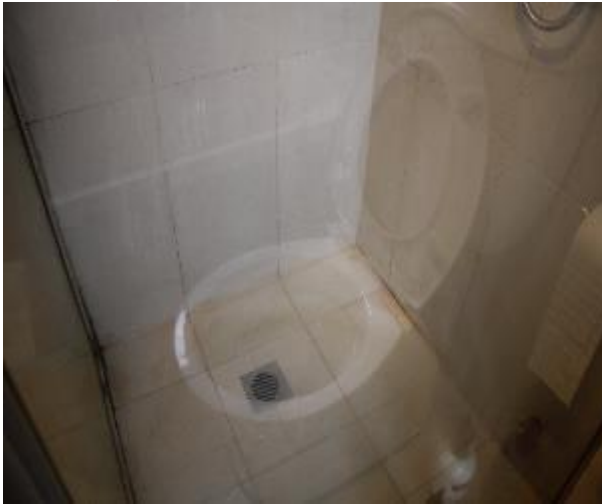
Figure 1188 - General condition of bathroom 1 internal wall

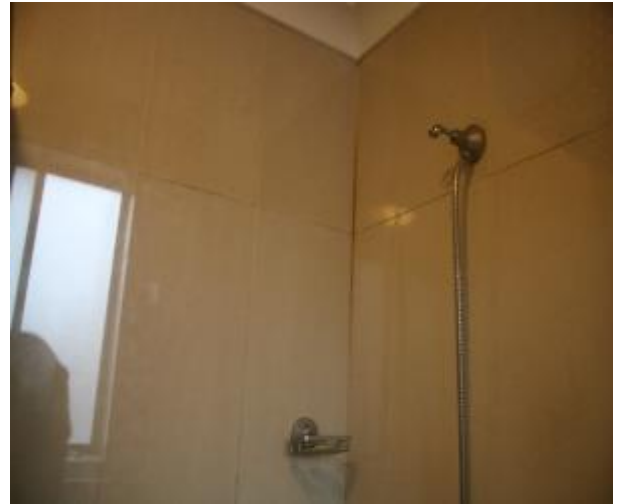
Figure 1189 - General condition of bathroom 1 internal wall

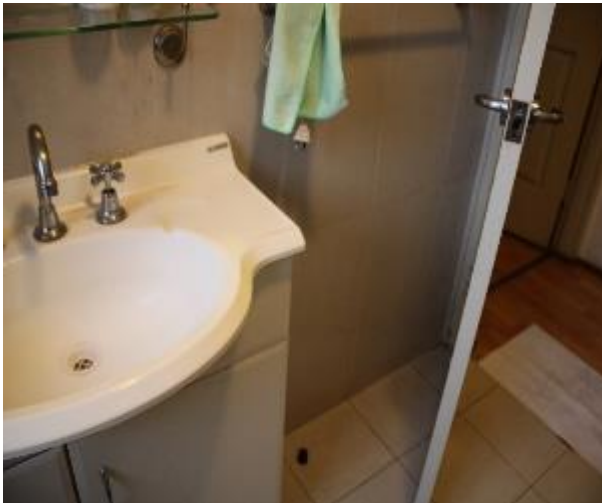
Figure 1190 - General condition of bathroom 1 internal wall

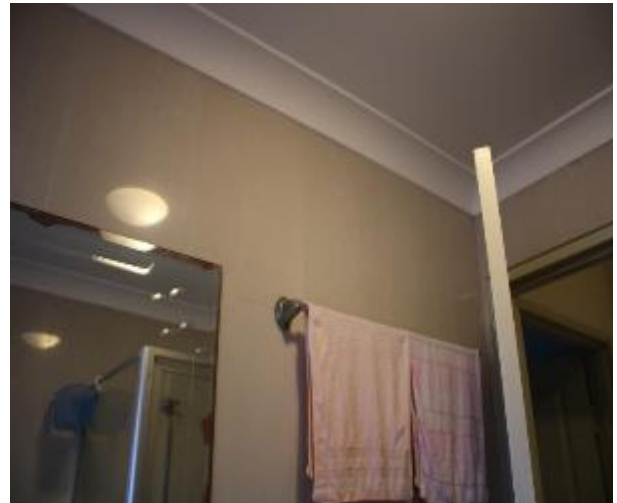
Figure 1191 - General condition of bathroom 1 internal wall

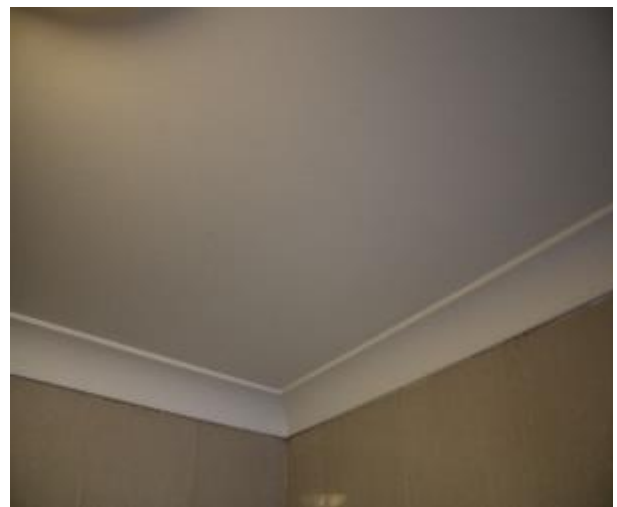
Figure 1193 - General condition of bathroom 1 ceiling

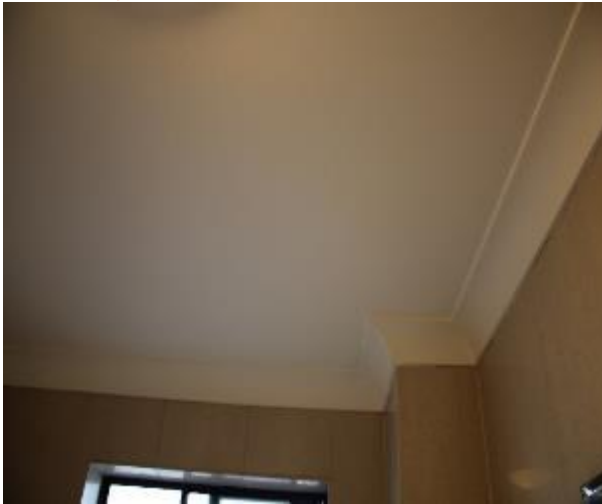
Figure 1194 - General condition of bathroom 1 ceiling

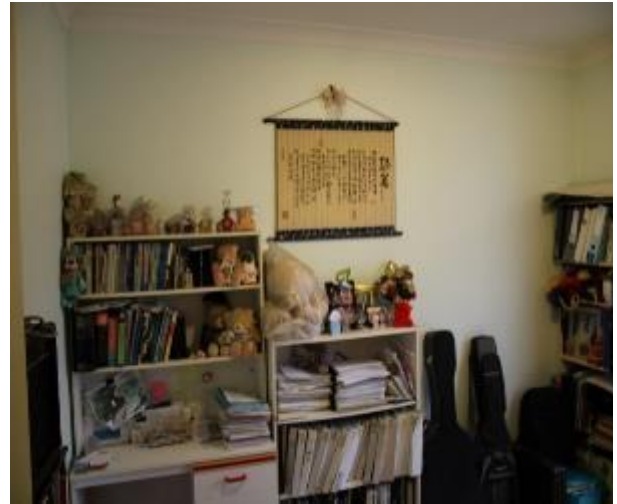
Figure 1195 - General condition of study internal wall

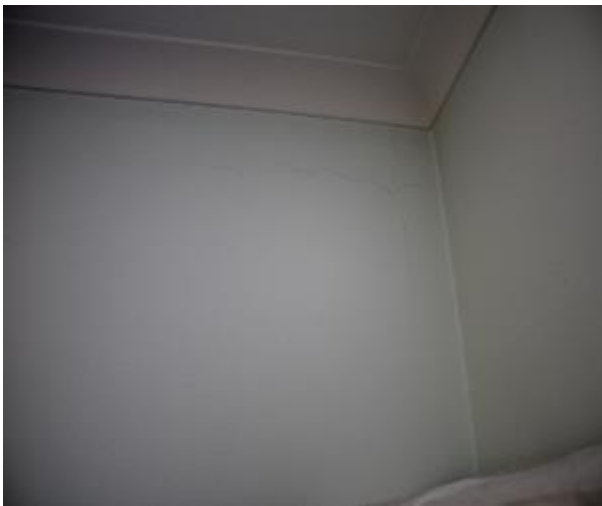
Figure 1196 - Crack propagation through study internal wall

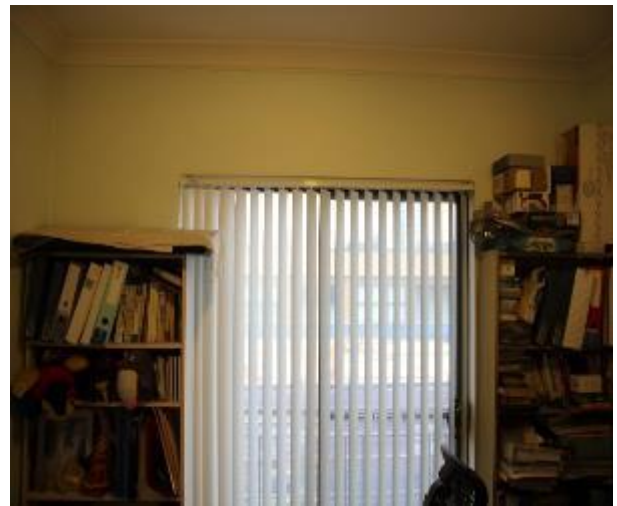
Figure 1197 - General condition of study internal wall

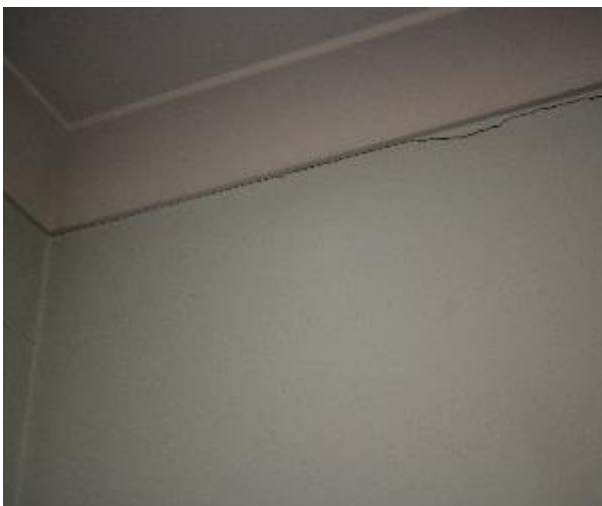
Figure 1198 - Crack propagation through study internal wall

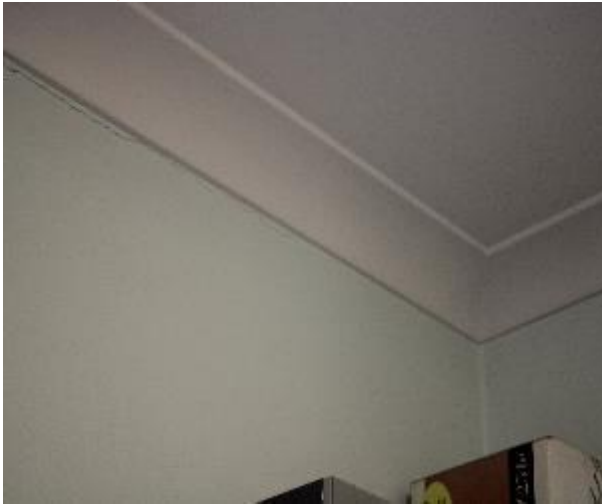
Figure 1200 - General condition of study internal wall

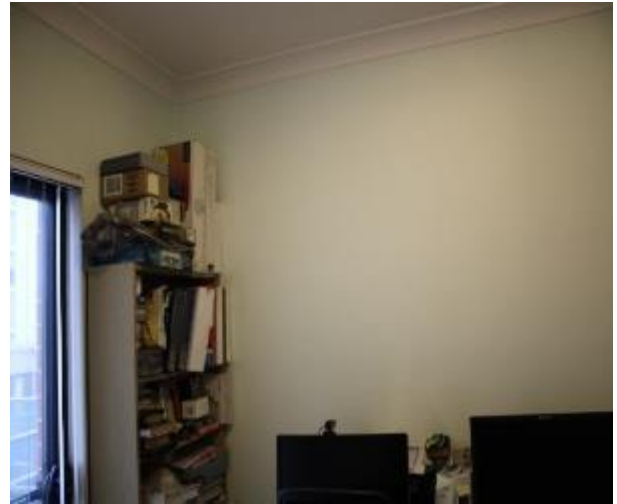
Figure 1201 - General condition of study internal wall

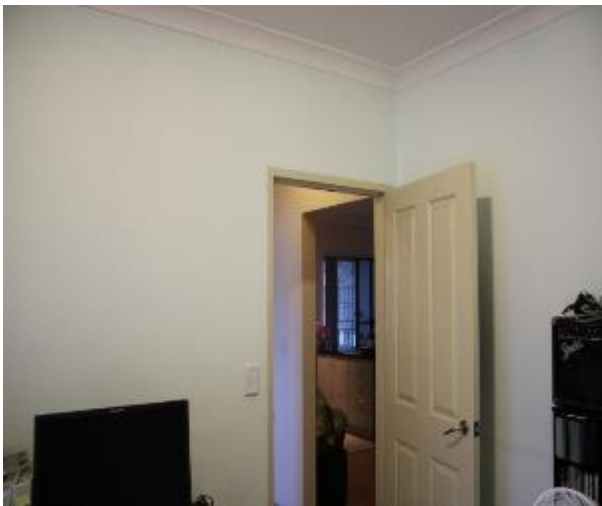
Figure 1202 - General condition of study internal wall

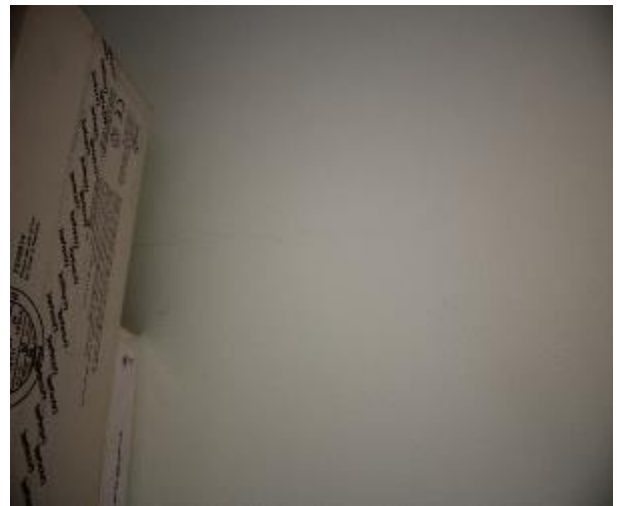
Figure 1203 - Crack propagation through study internal wall

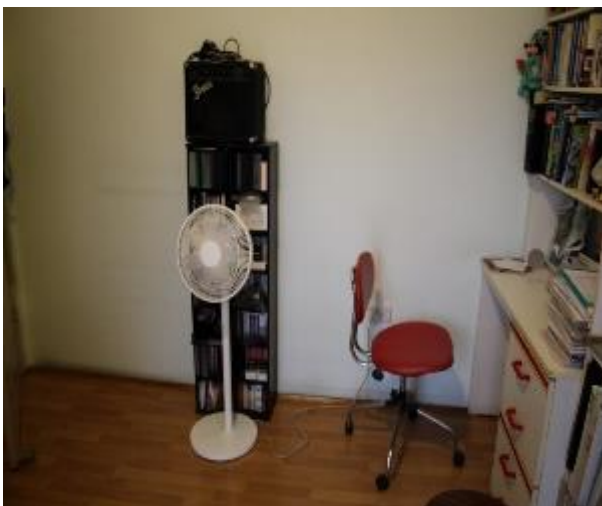
Figure 1204 - General condition of study internal wall

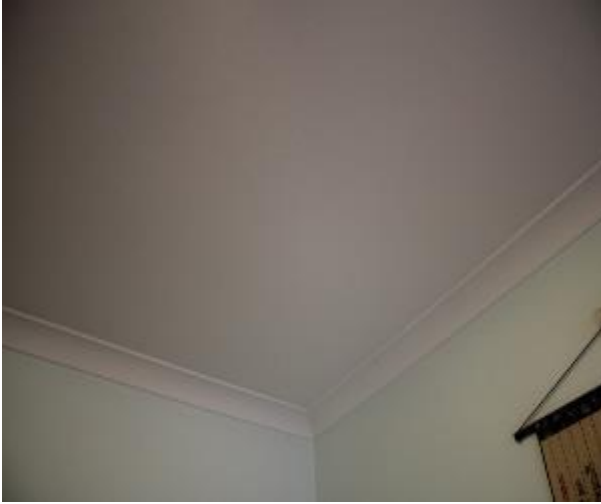
Figure 1206 - General condition of study ceiling

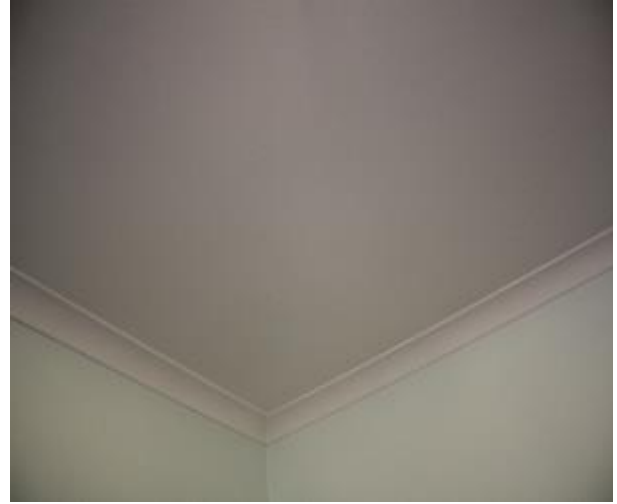
Figure 1207 - General condition of study ceiling

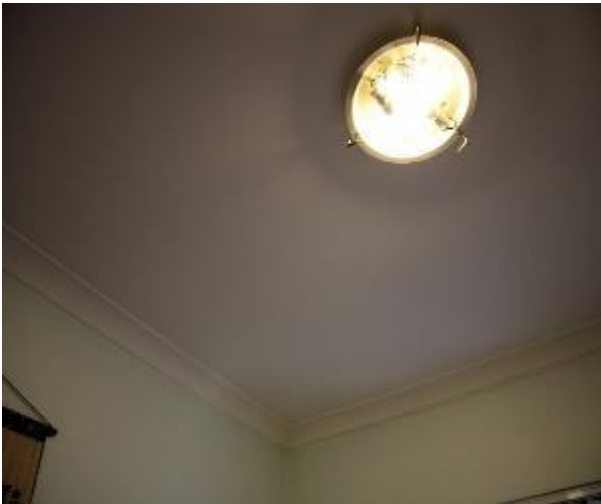
Figure 1208 - General condition of study ceiling

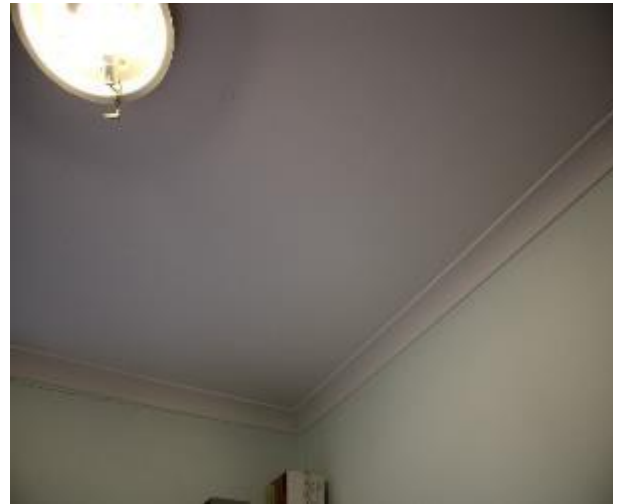
Figure 1209 - General condition of study ceiling

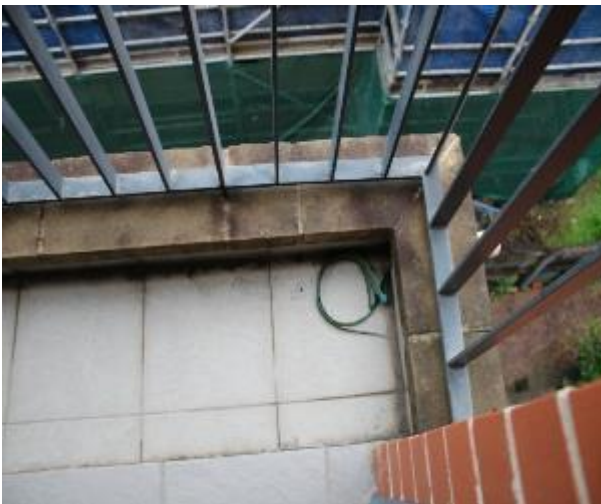
Figure 1210 - General condition of balcony floor tiles

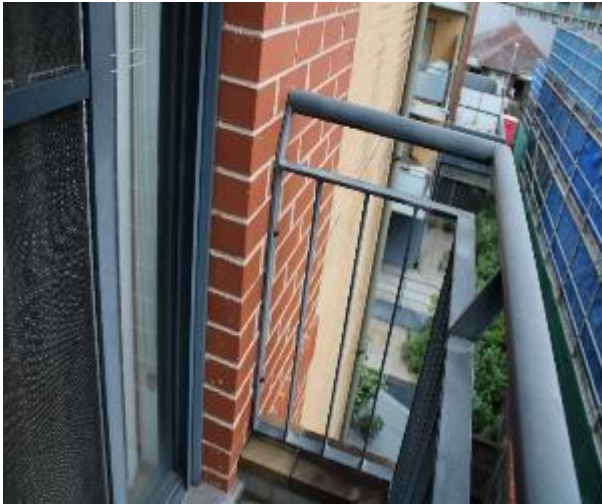
Figure 1212 - General condition of external wall

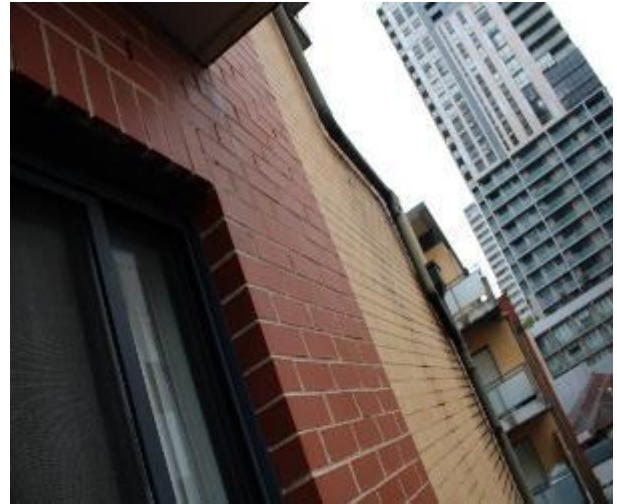
Figure 1213 - General condition of external wall

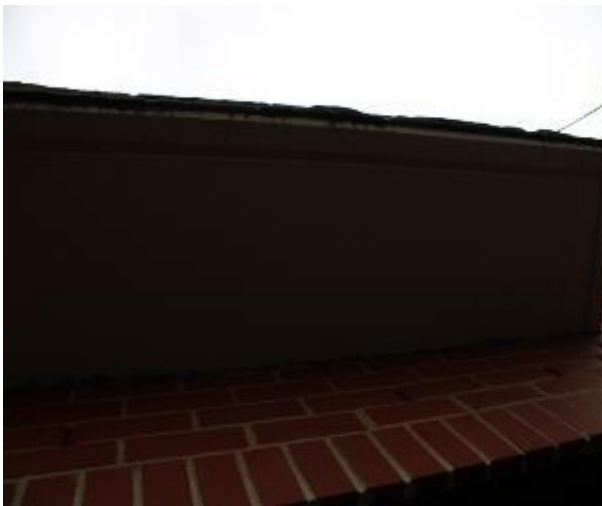
Figure 1214 - General condition of external wall
