# **Pre-Dilapidation Report**

**19 GEORGE STREET**

**REAR BUILDING (UNITS 20-29)**

Project Reference: 20250047.19G.3

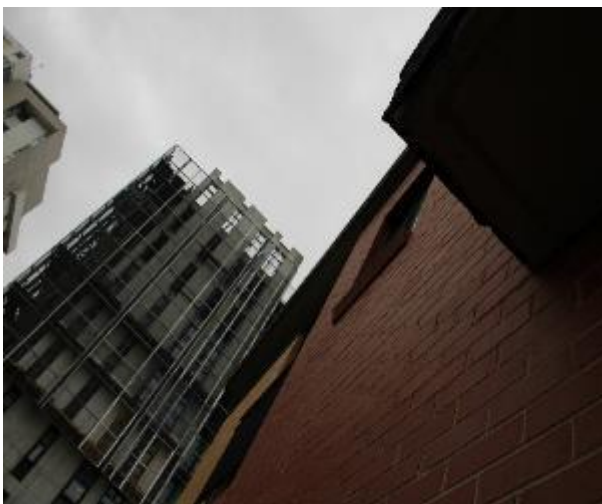
Figure 1216 - General condition of external wall

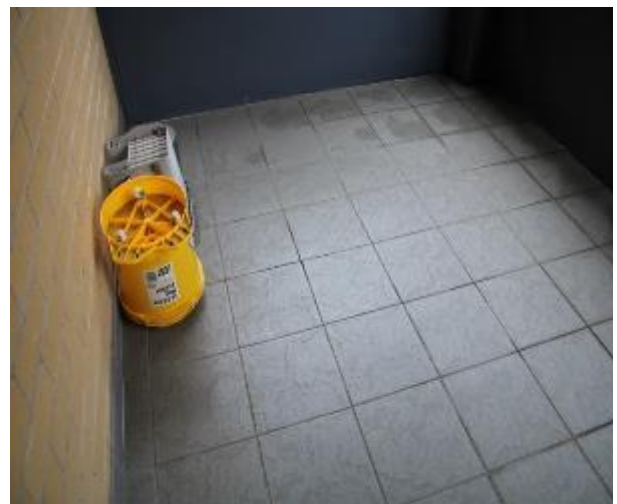
Figure 1217 - General condition of balcony 2 floor tiles

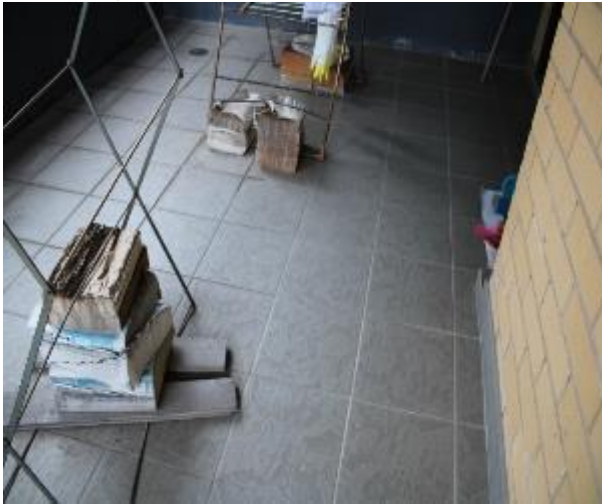
Figure 1218 - General condition of balcony 2 floor tiles

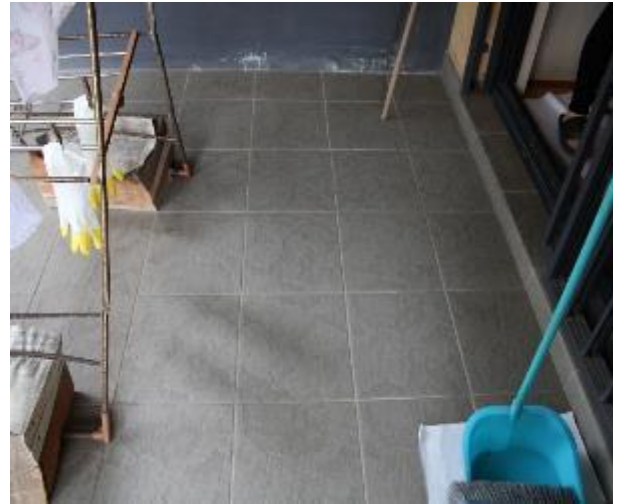
Figure 1219 - General condition of balcony 2 floor tiles

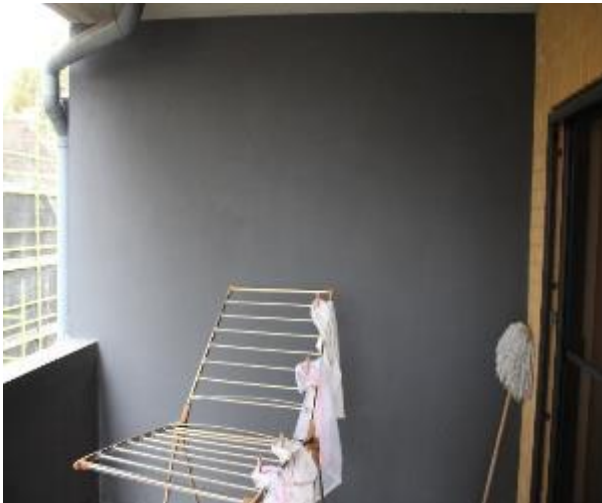
Figure 1220 - General condition of external wall

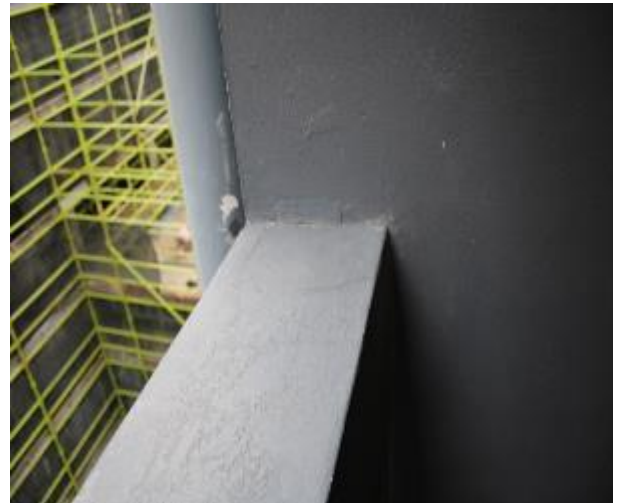
Figure 1221 - Crack propagation through external wall

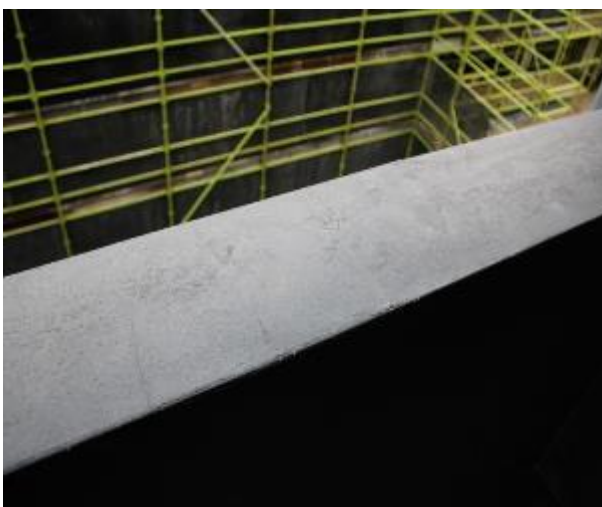
Figure 1222 - Crack propagation through external wall

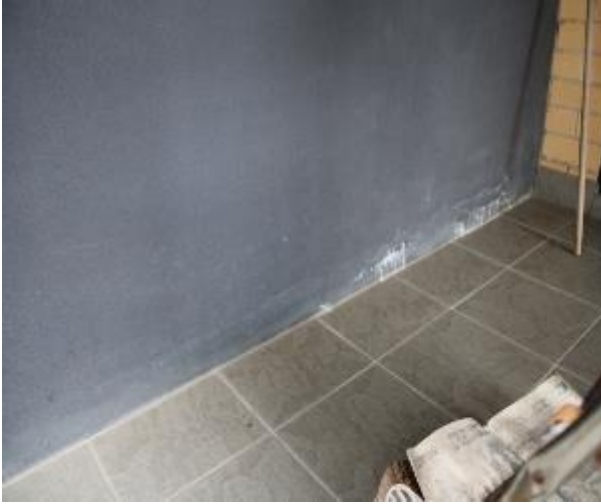
Figure 1224 - General condition of external wall

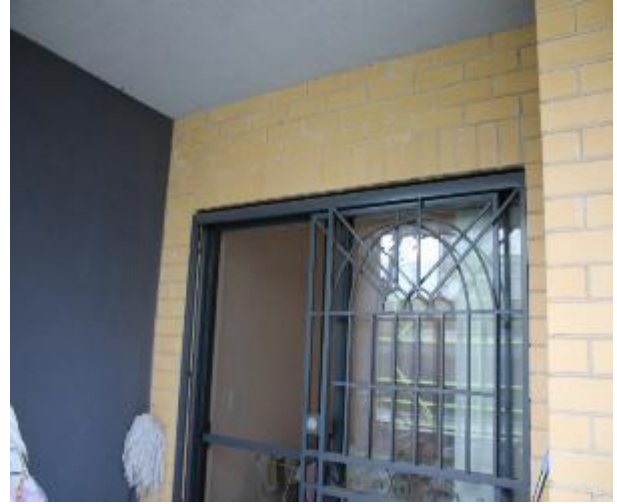
Figure 1225 - General condition of external wall

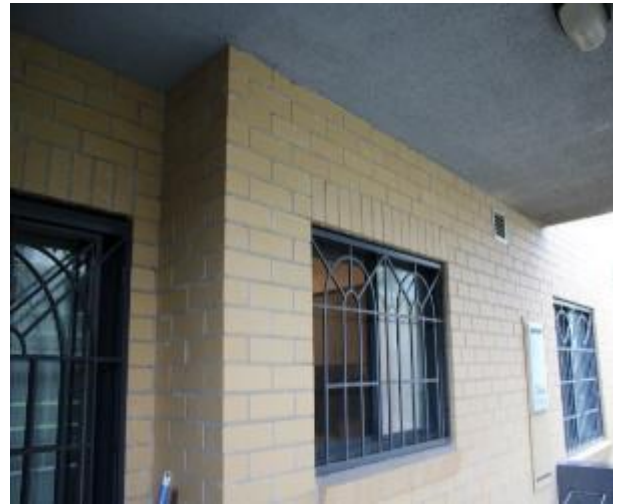
Figure 1227 - General condition of external wall

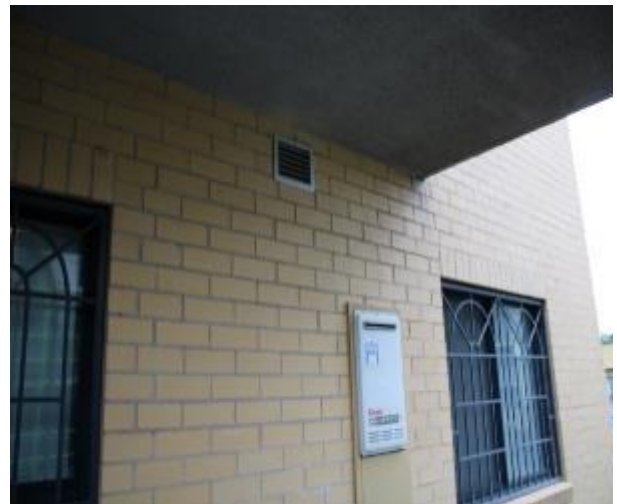
Figure 1229 - General condition of external wall

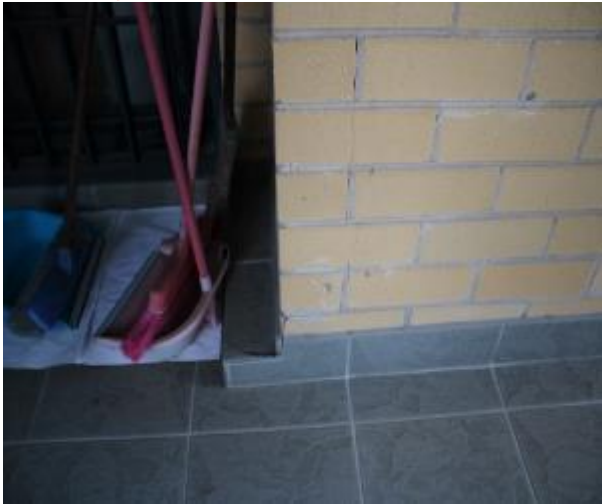
Figure 1230 - Crack propagation through external wall

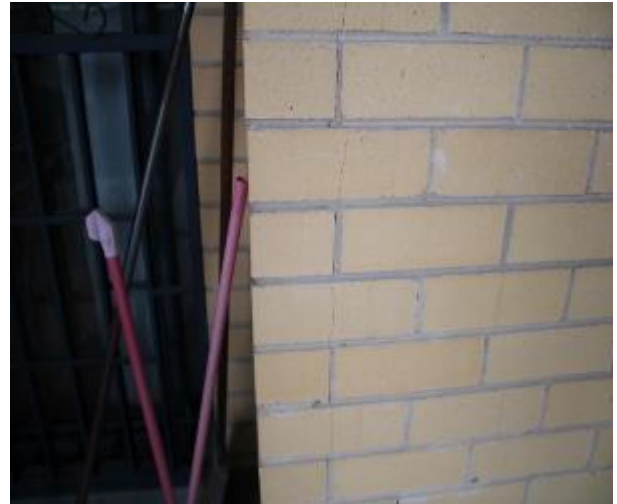
Figure 1231 - Crack propagation through external wall

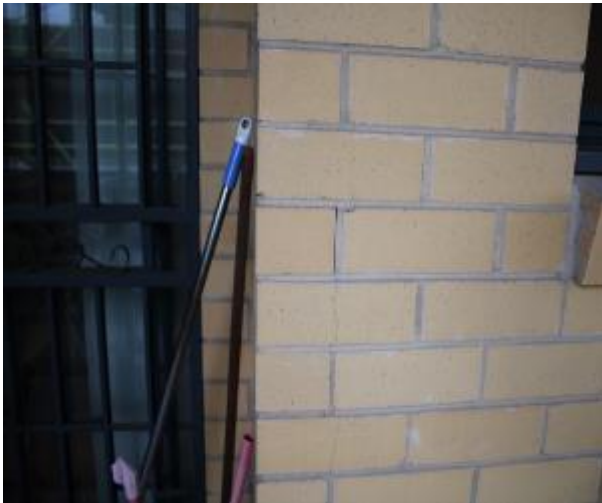
Figure 1232 - Crack propagation through external wall

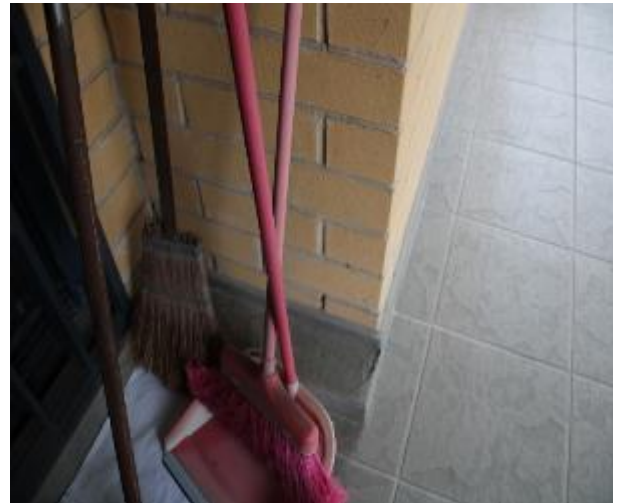
Figure 1233 - General condition of external wall

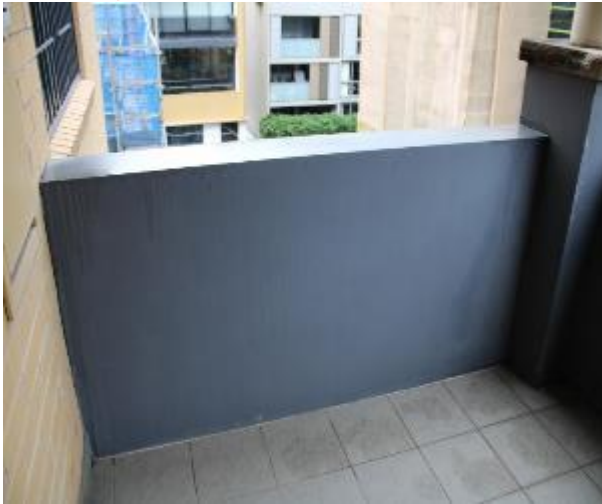
Figure 1236 - General condition of external wall

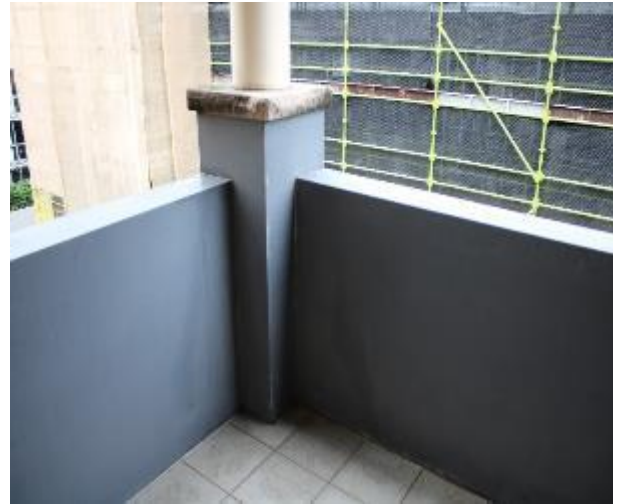
Figure 1237 - General condition of external wall

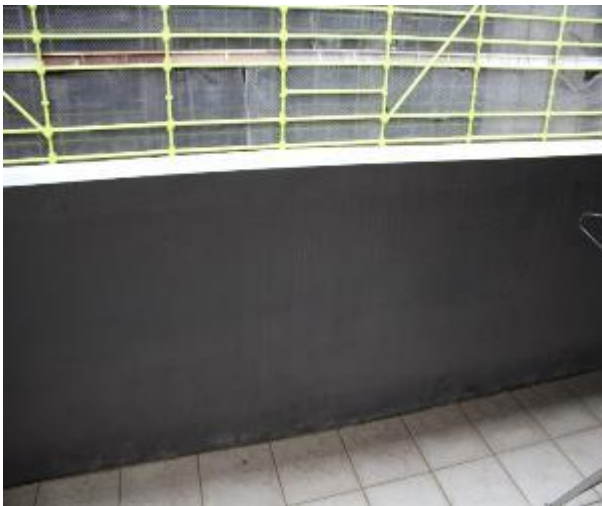
Figure 1238 - General condition of external wall

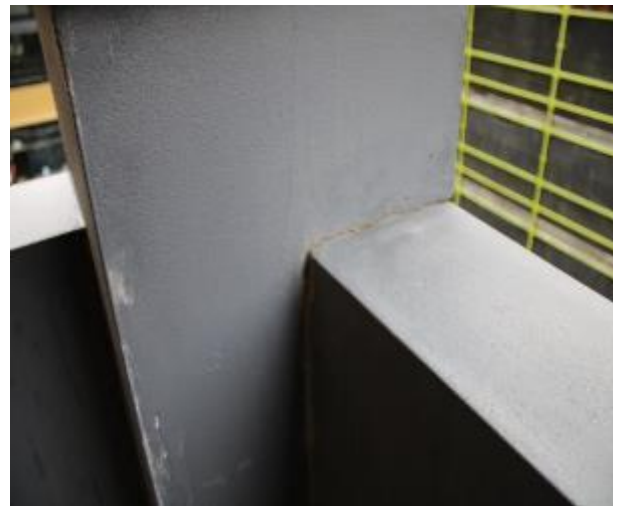
Figure 1239 - Crack propagation through external wall

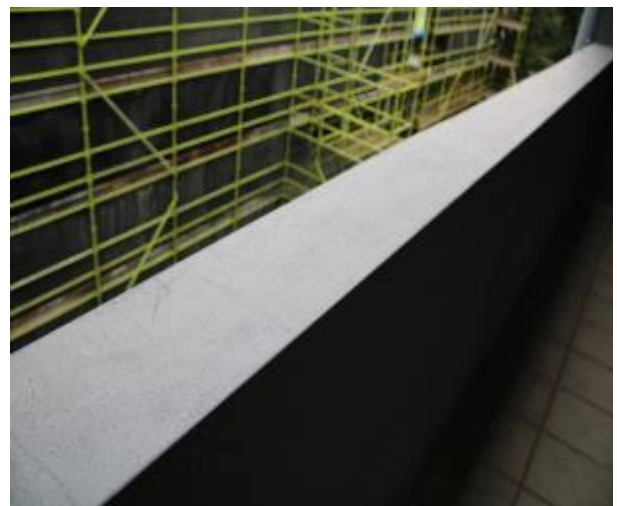
Figure 1241 - General condition of external wall

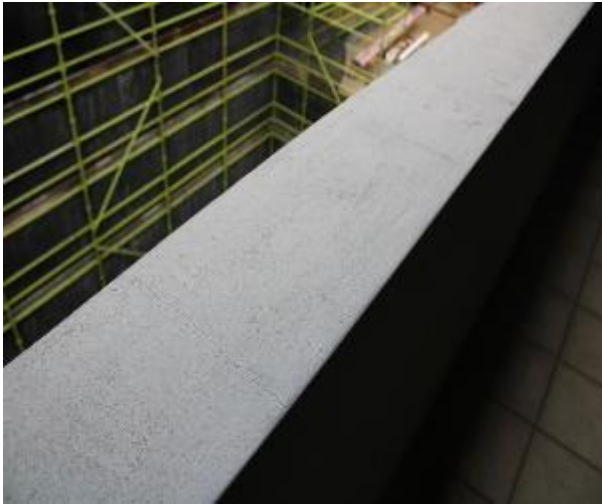
Figure 1242 - Crack propagation through external wall

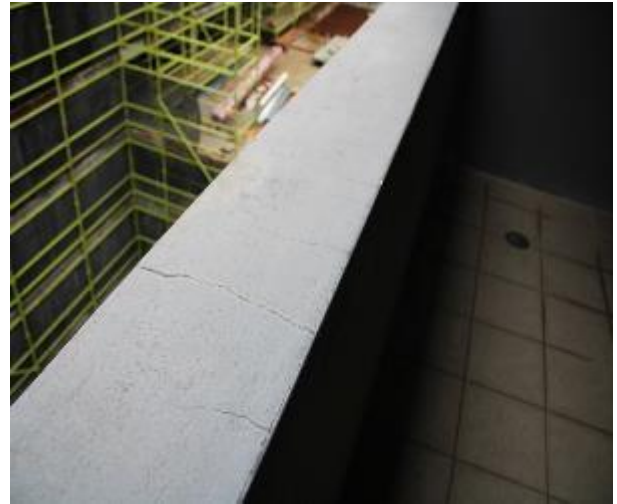
Figure 1243 - Crack propagation through external wall

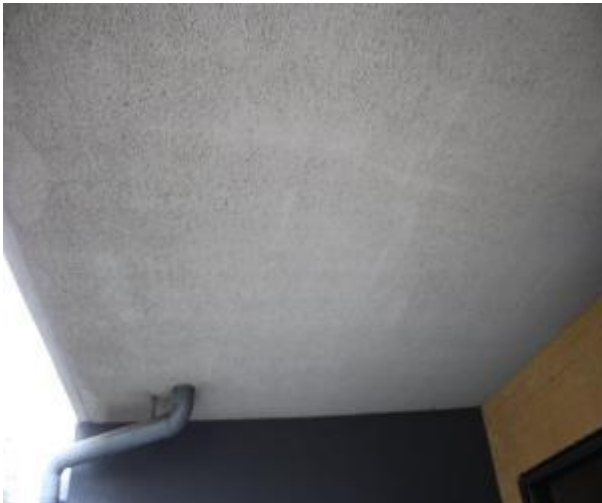
Figure 1244 - General condition of balcony underside slab

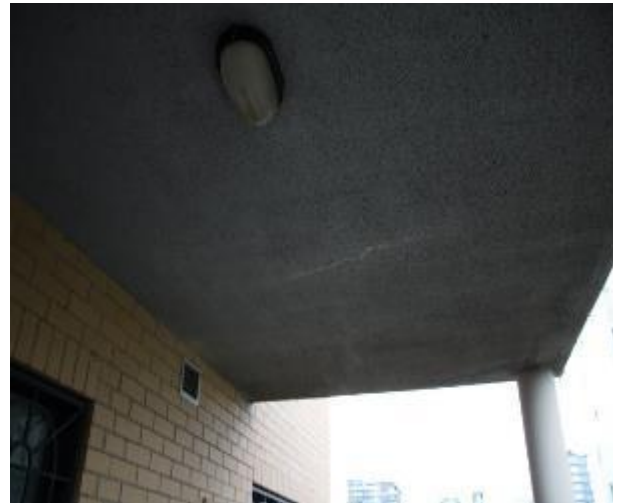
Figure 1245 - General condition of balcony underside slab

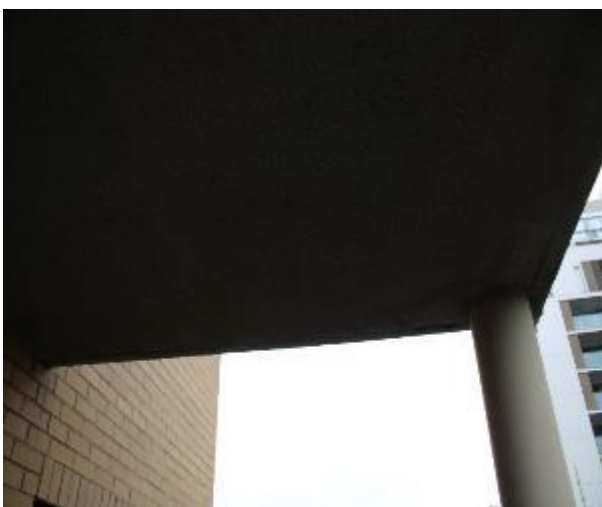
Figure 1246 - General condition of balcony underside slab

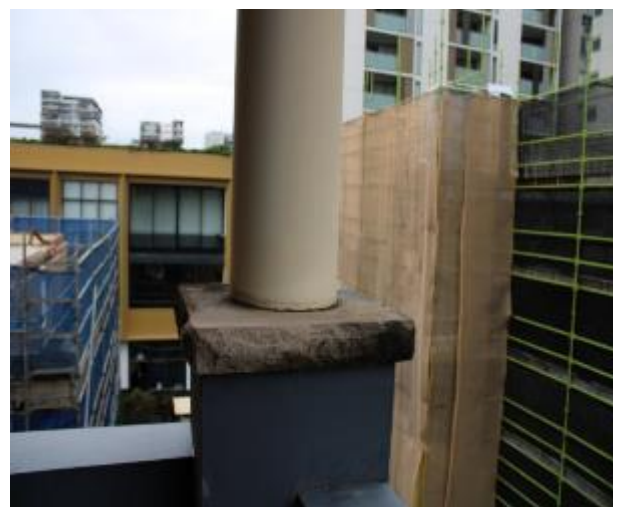
Figure 1247 - General condition of external wall

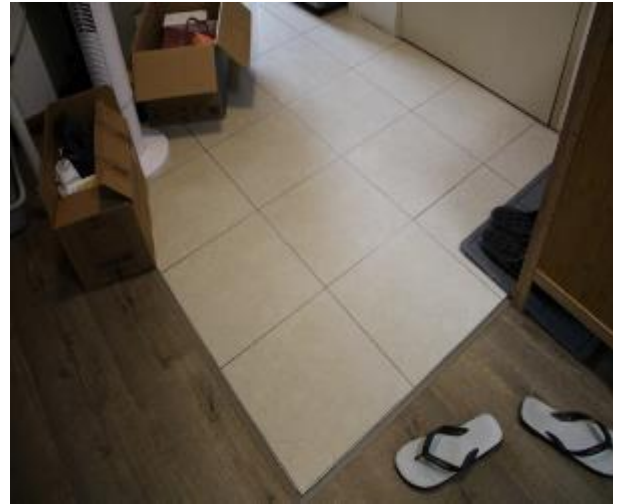
Figure 1249 - General condition of kitchen floor tiles

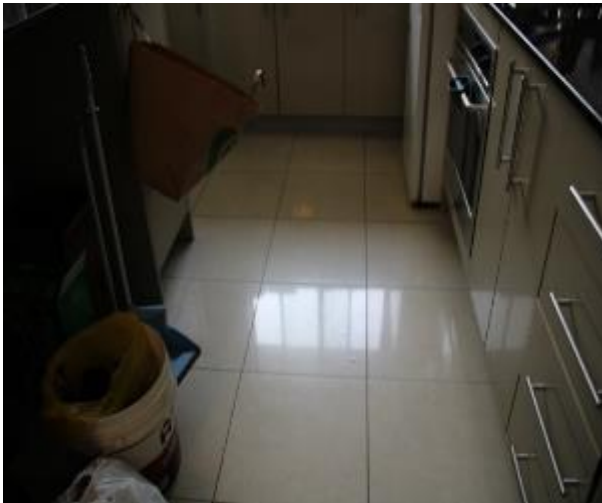
Figure 1250 - General condition of kitchen floor tiles

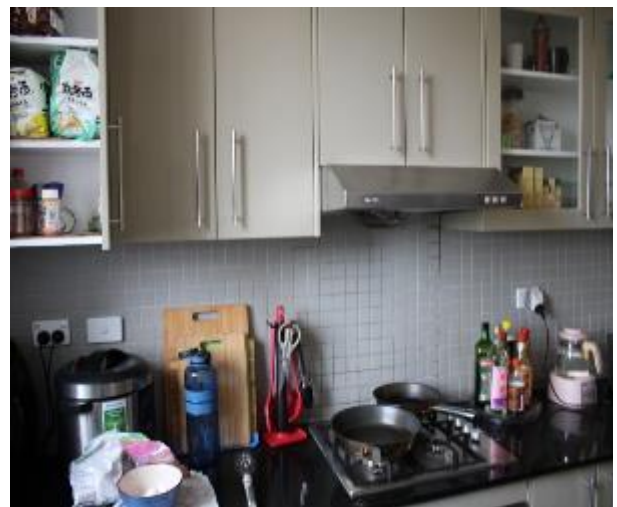
Figure 1253 - General condition of kitchen internal wall

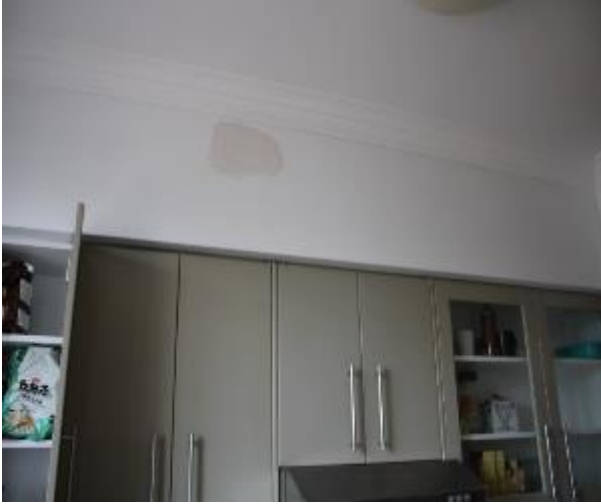
Figure 1254 - General condition of kitchen internal wall

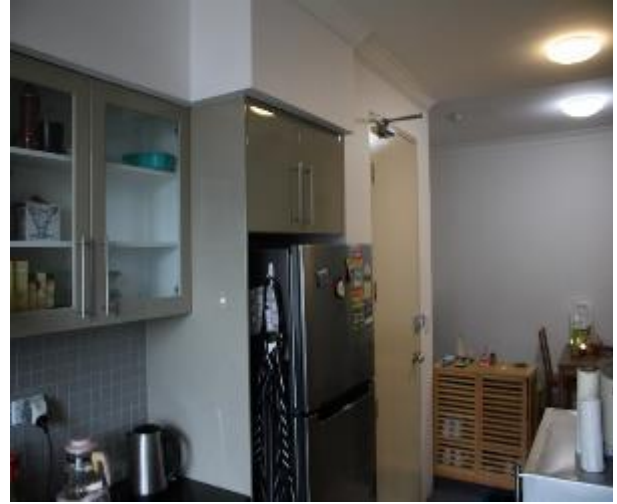
Figure 1255 - General condition of kitchen internal wall

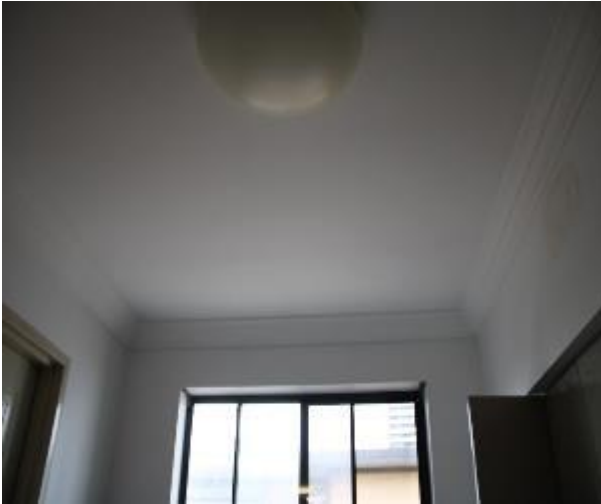
Figure 1256 - General condition of kitchen ceiling

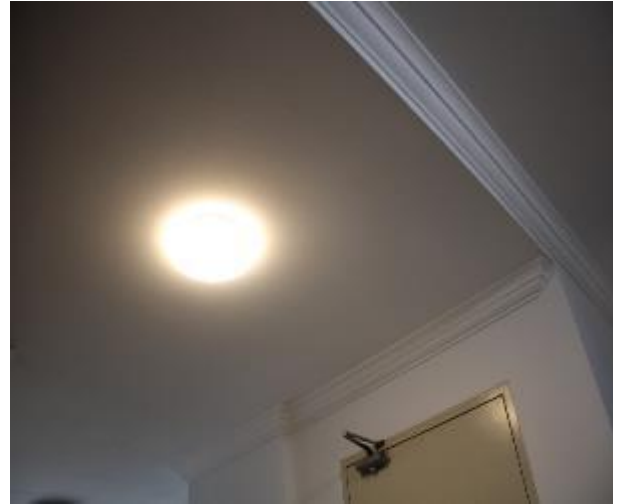
Figure 1257 - General condition of kitchen ceiling

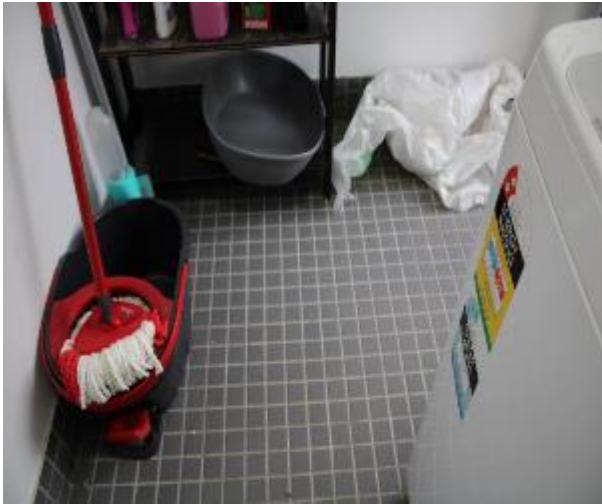
Figure 1260 - General condition of laundry floor tiles

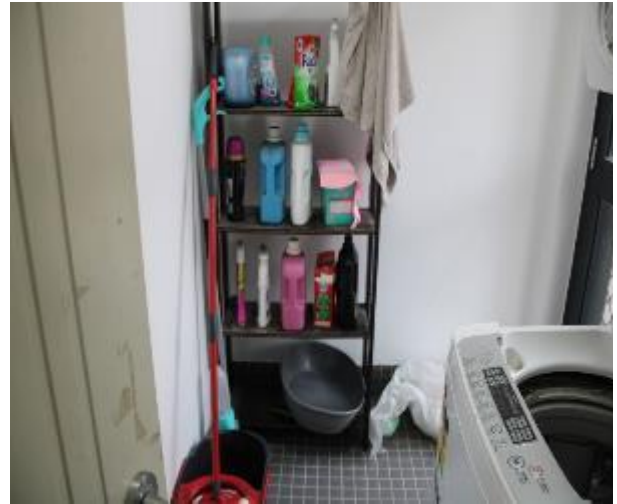
Figure 1261 - General condition of laundry internal wall

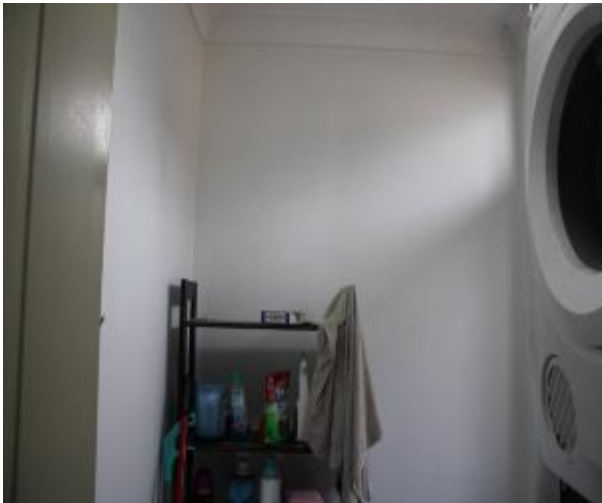
Figure 1262 - General condition of laundry internal wall

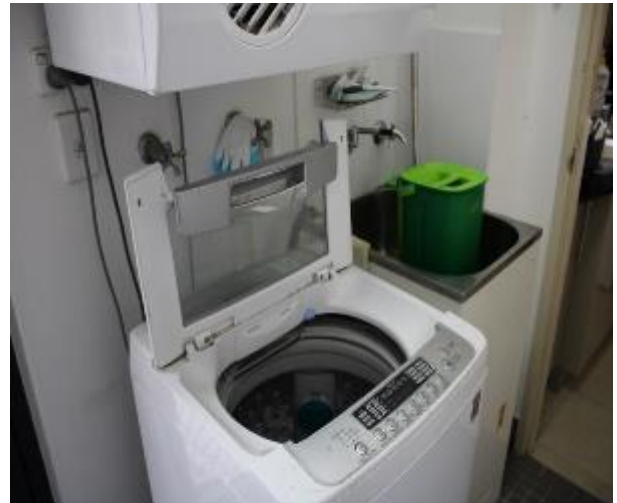
Figure 1263 - General condition of laundry internal wall

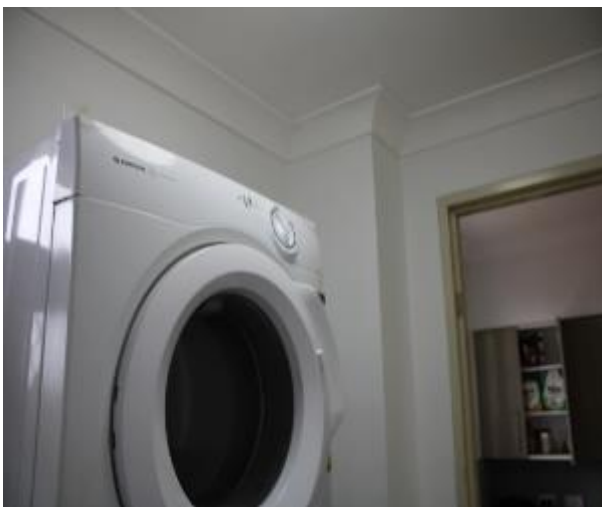
Figure 1264 - General condition of laundry internal wall

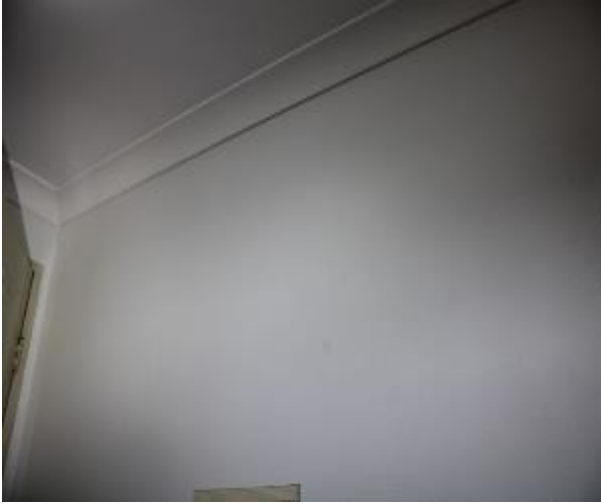
Figure 1266 - General condition of laundry internal wall

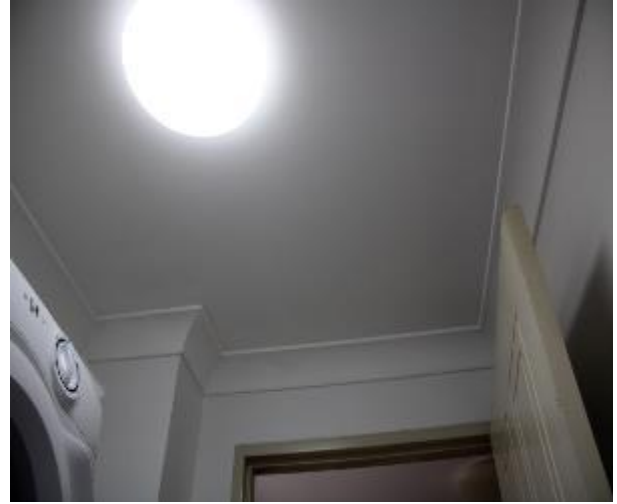
Figure 1267 - General condition of laundry ceiling

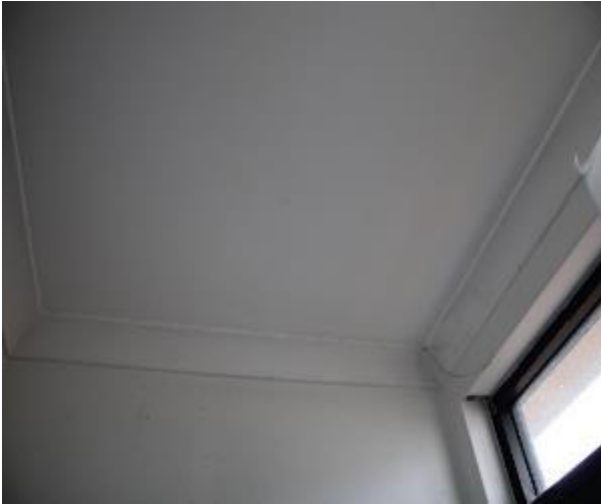
Figure 1268 - General condition of laundry ceiling

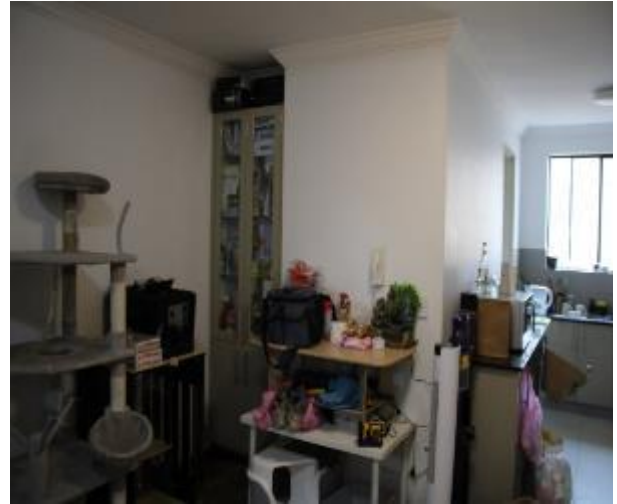
Figure 1269 - General condition of dining room internal wall

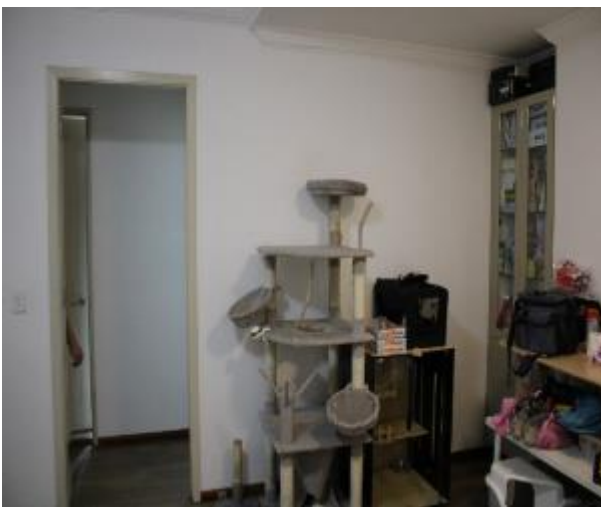
Figure 1270 - General condition of dining room internal wall

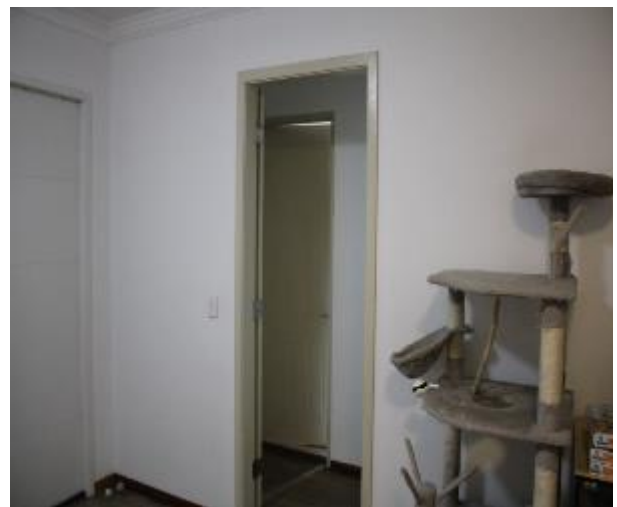
Figure 1271 - General condition of dining room internal wall

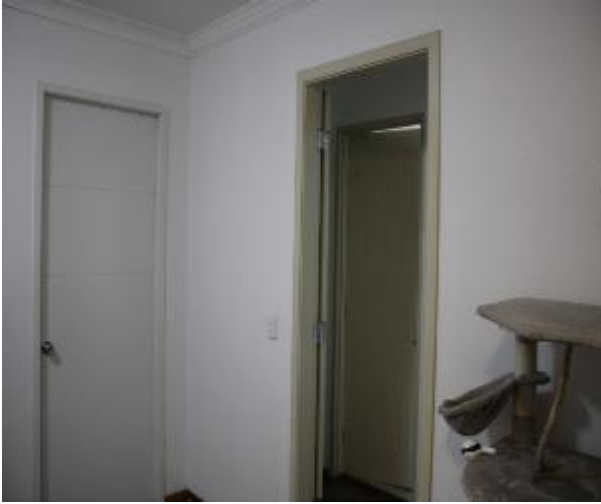
Figure 1272 - General condition of dining room internal wall

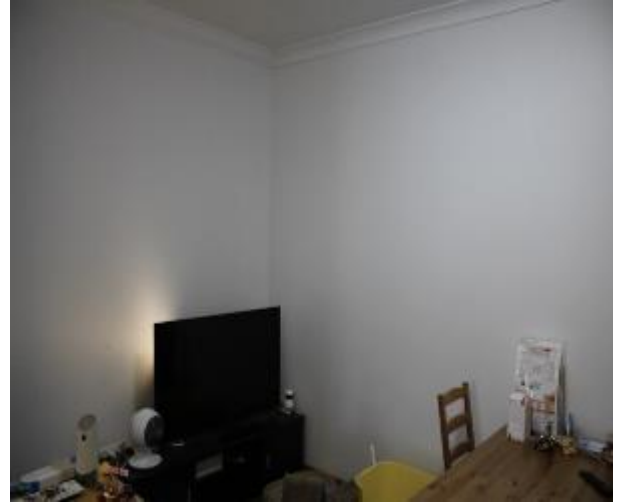
Figure 1273 - General condition of dining room internal wall

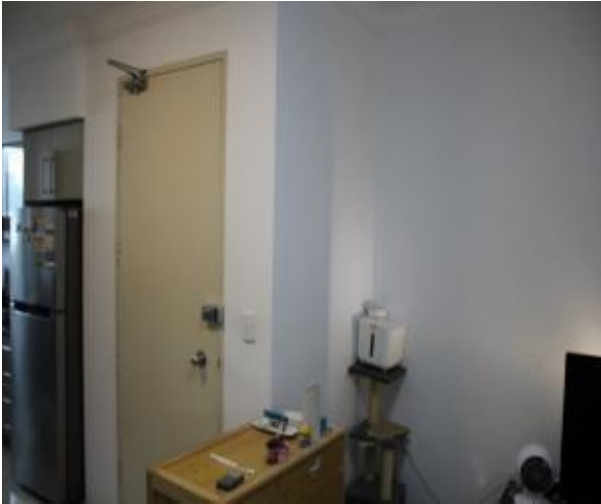
Figure 1274 - General condition of dining room internal wall

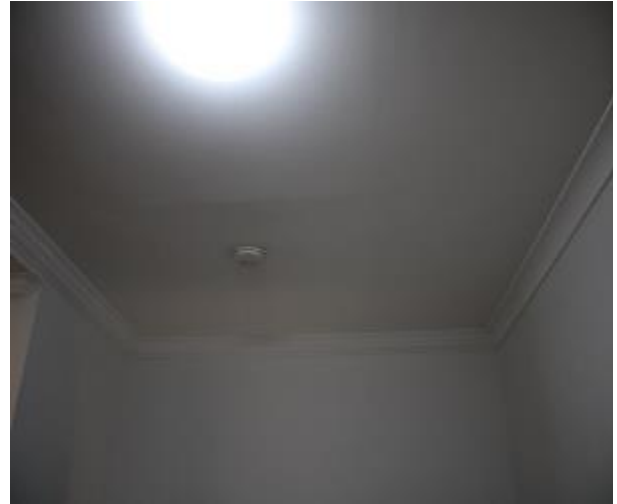
Figure 1275 - General condition of dining room ceiling

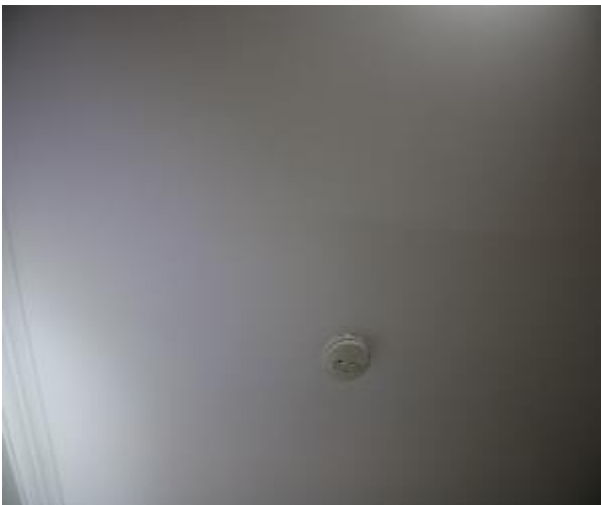
Figure 1276 - General condition of dining room ceiling

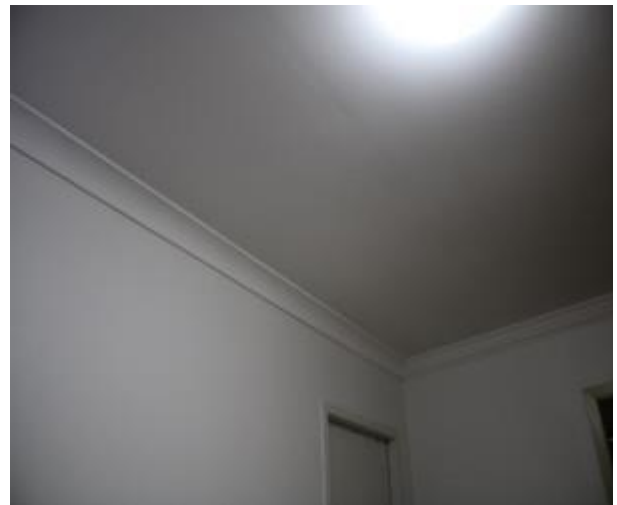
Figure 1277 - General condition of dining room ceiling

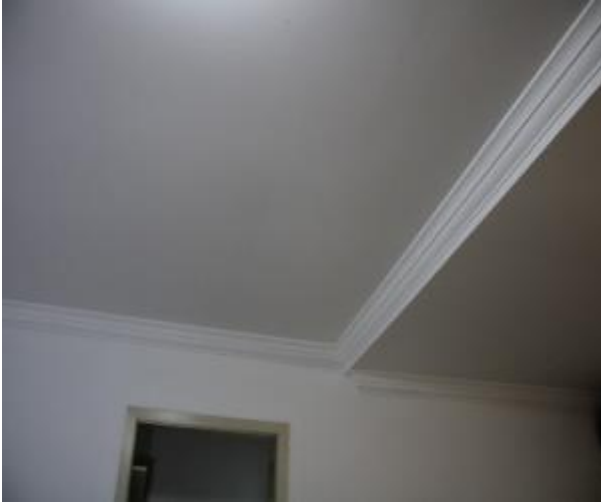
Figure 1278 - General condition of dining room ceiling

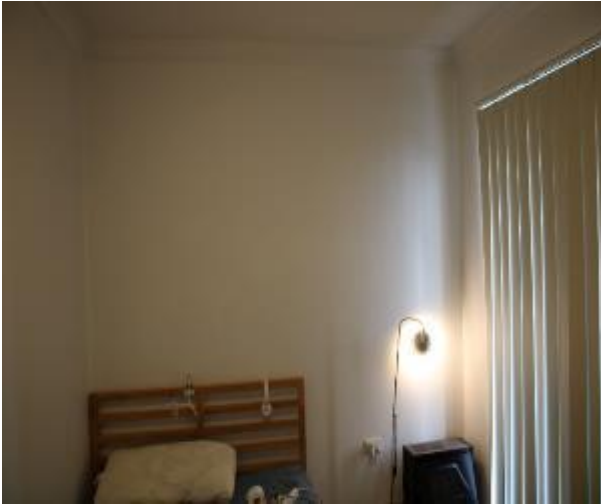
Figure 1280 - General condition of bedroom 1 internal wall

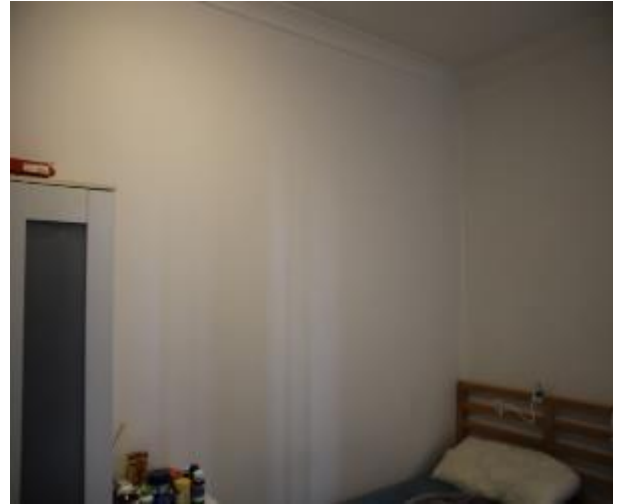
Figure 1281 - General condition of bedroom 1 internal wall

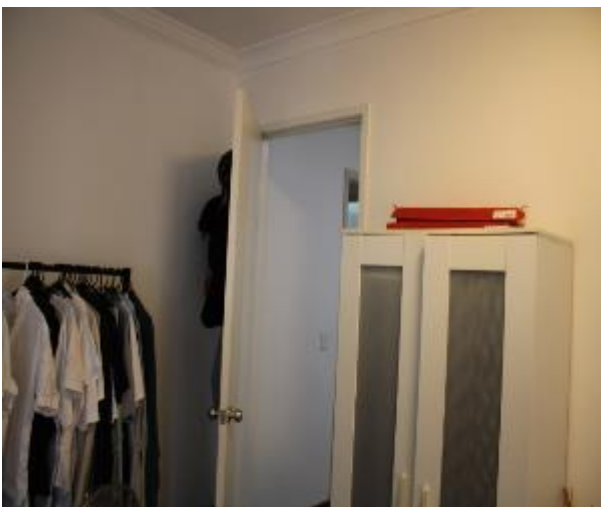
Figure 1282 - General condition of bedroom 1 internal wall

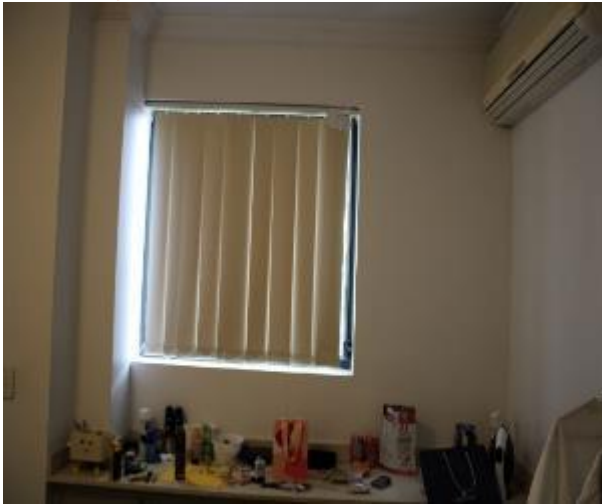
Figure 1283 - General condition of bedroom 1 internal wall

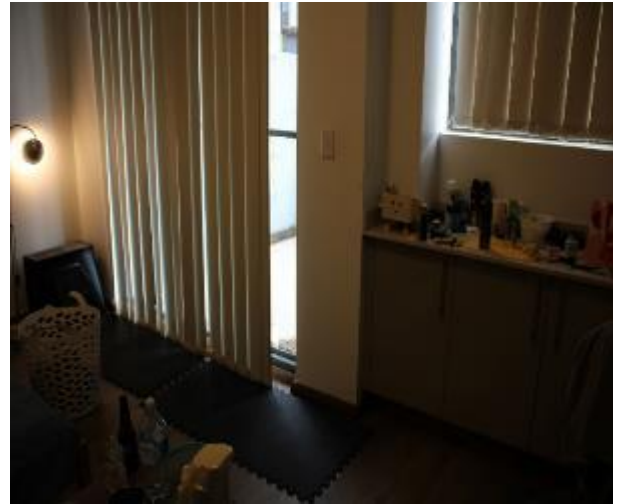
Figure 1284 - General condition of bedroom 1 internal wall

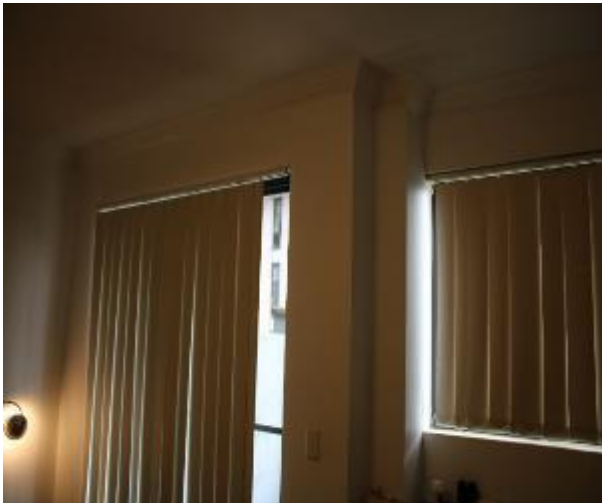
Figure 1285 - General condition of bedroom 1 internal wall

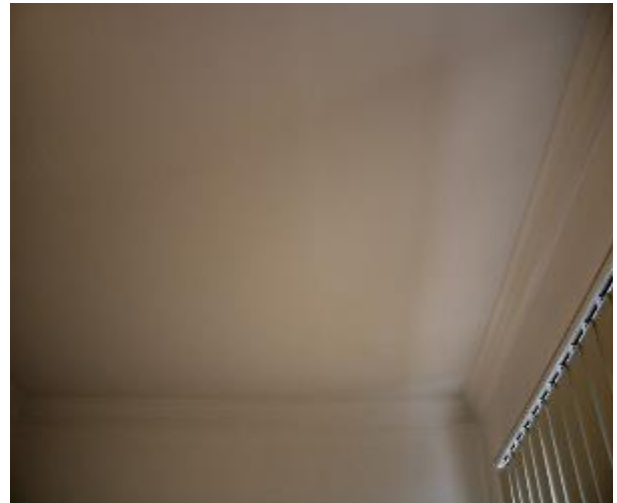
Figure 1286 - General condition of bedroom 1 internal wall

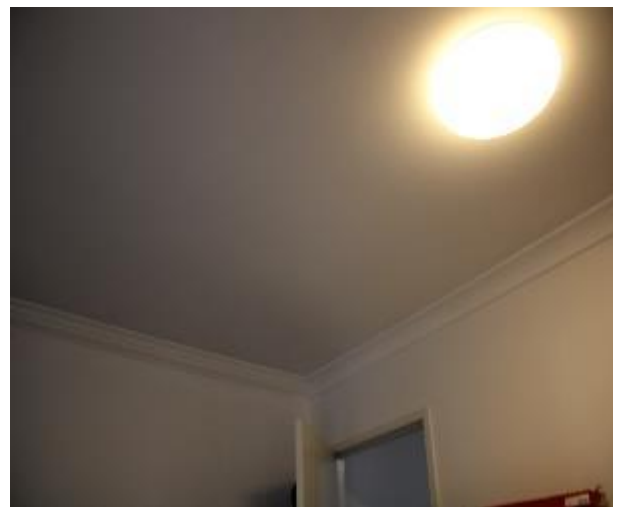
Figure 1288 - General condition of bedroom 1 ceiling

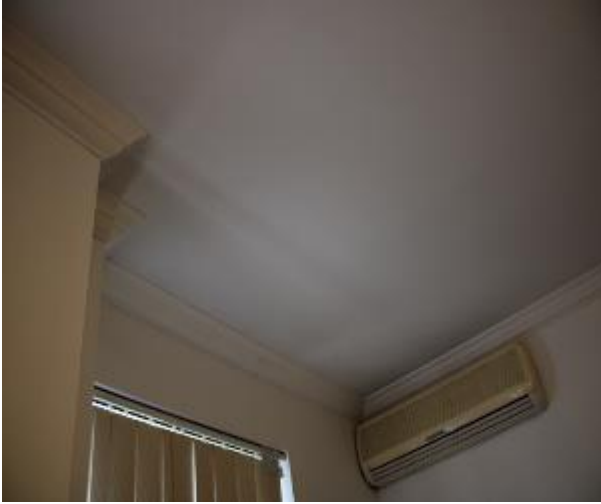
Figure 1289 - General condition of bedroom 1 ceiling

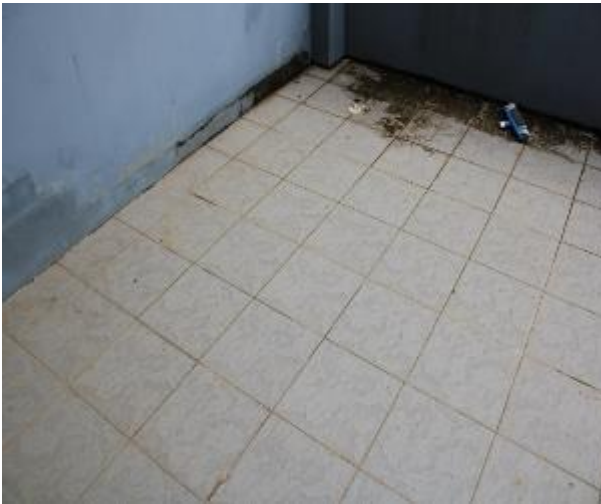
Figure 1291 - General condition of balcony floor tiles

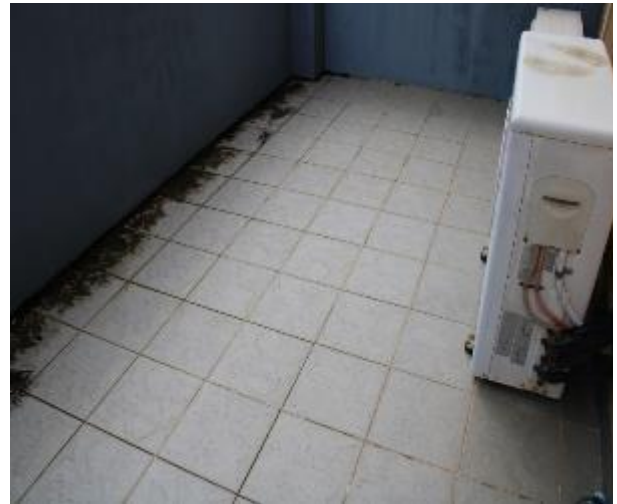
Figure 1292 - General condition of balcony floor tiles

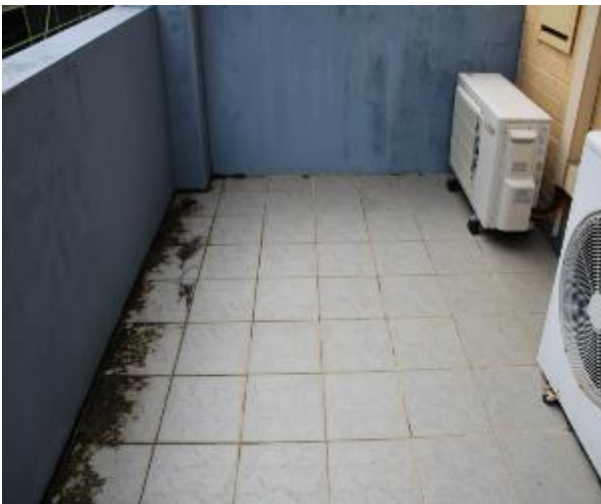
Figure 1293 - General condition of balcony floor tiles

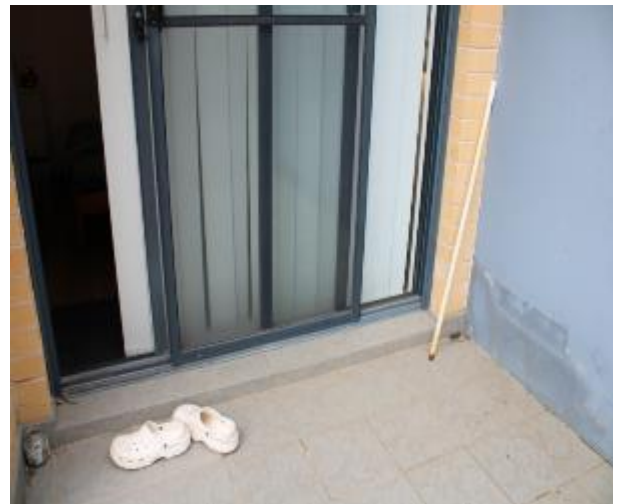
Figure 1294 - General condition of balcony floor tiles

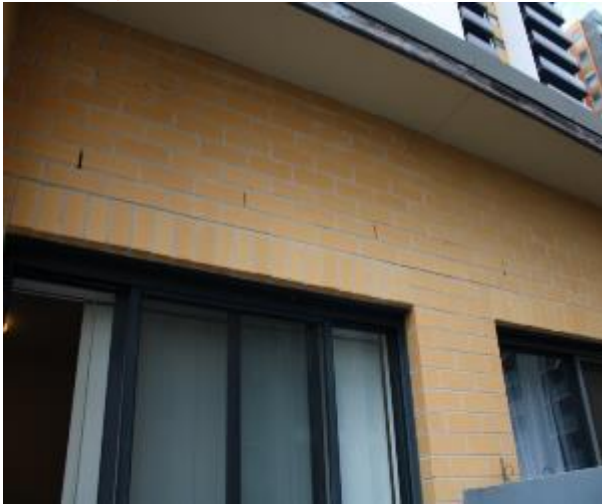
Figure 1295 - General condition of external wall

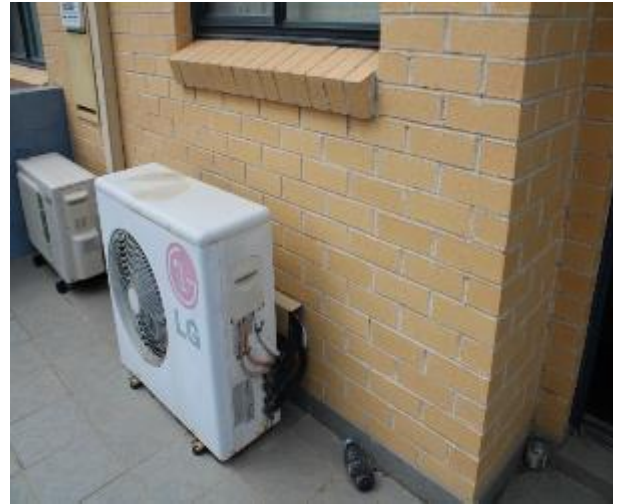
Figure 1296 - General condition of external wall

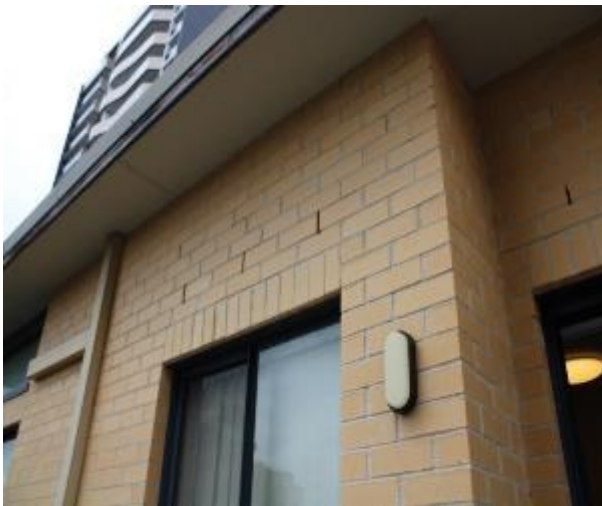
Figure 1297 - General condition of external wall

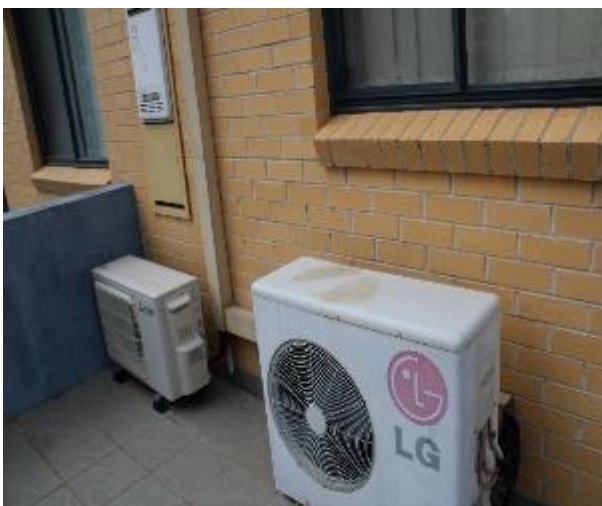
Figure 1299 - Crack propagation through external wall

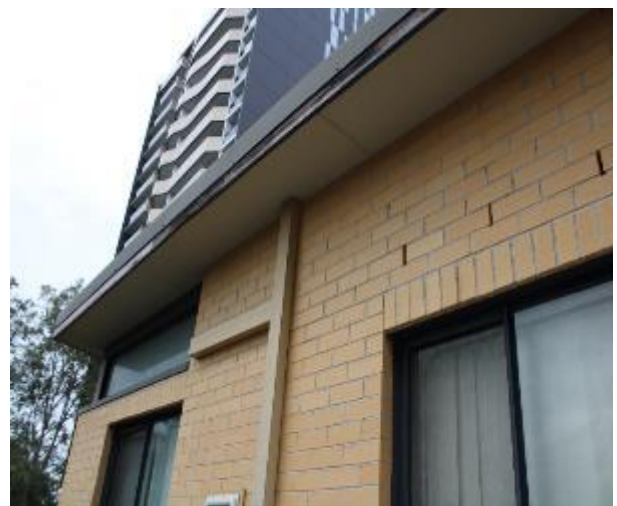
Figure 1300 - General condition of external wall

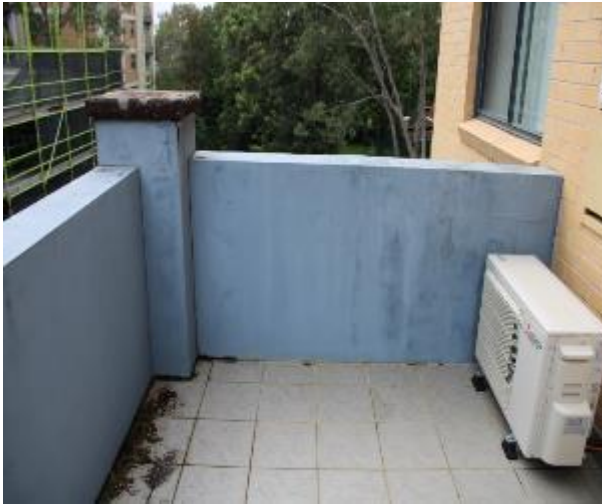
Figure 1301 - General condition of external wall

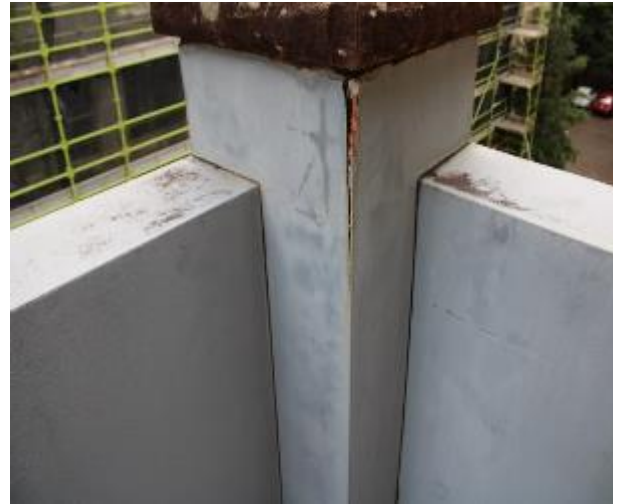
Figure 1302 - General condition of external wall

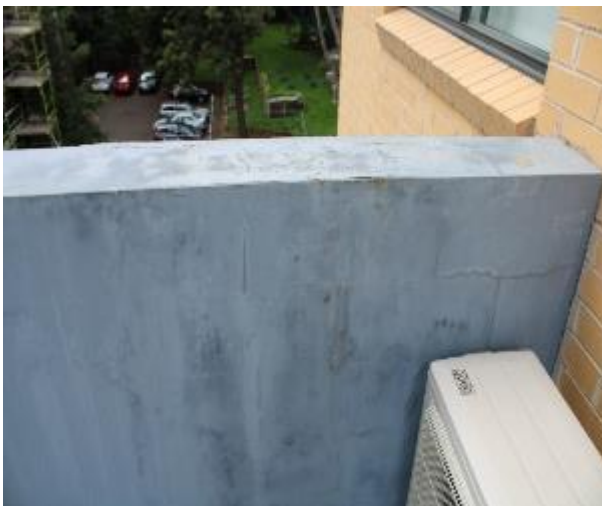
Figure 1303 - Crack propagation through external wall
