# **Pre-Dilapidation Report**

**19 GEORGE STREET**

**REAR BUILDING (UNITS 20-29)**

Project Reference: 20250047.19G.3

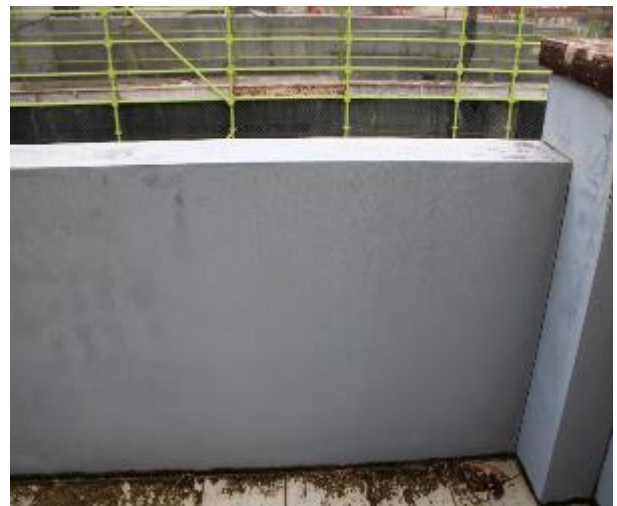
Figure 1304 - Crack propagation through external wall

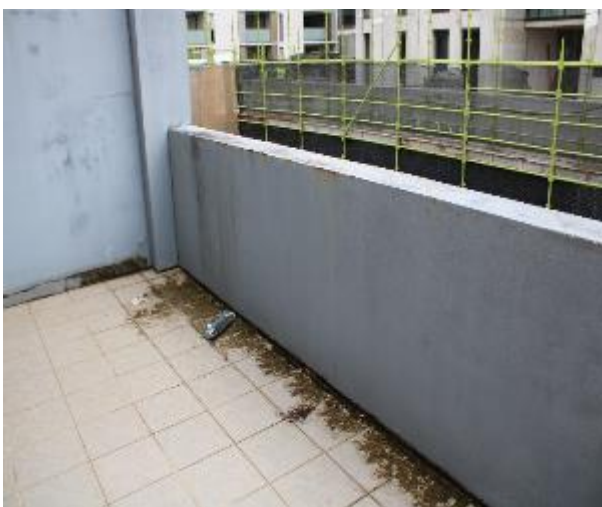
Figure 1305 - General condition of external wall

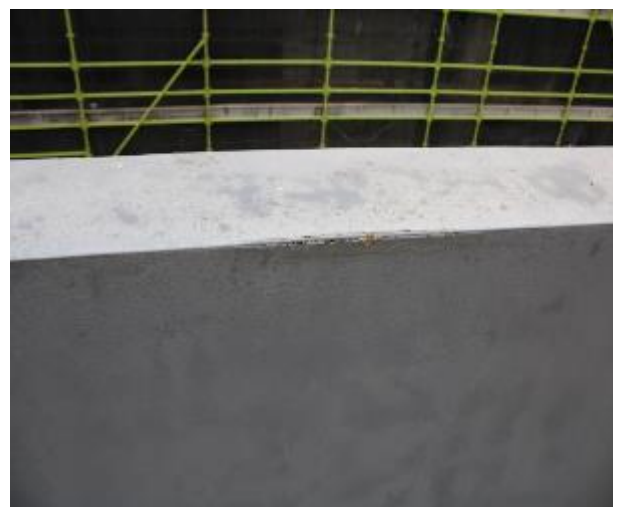
Figure 1306 - General condition of external wall

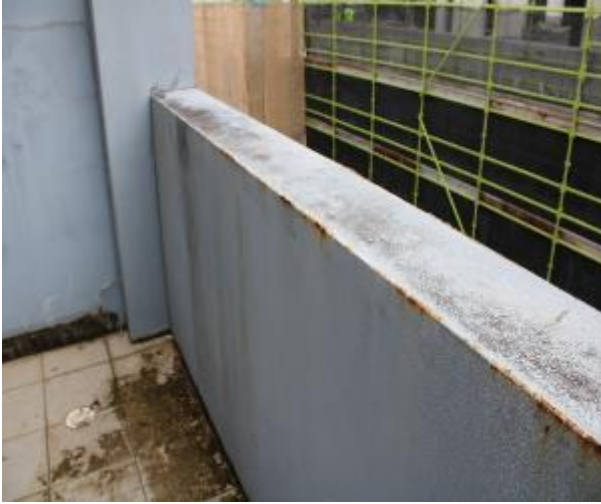
Figure 1307 - Crack propagation through external wall

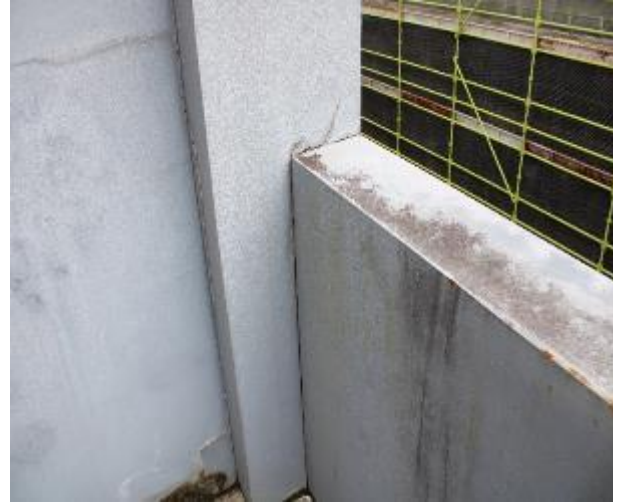
Figure 1308 - General condition of external wall

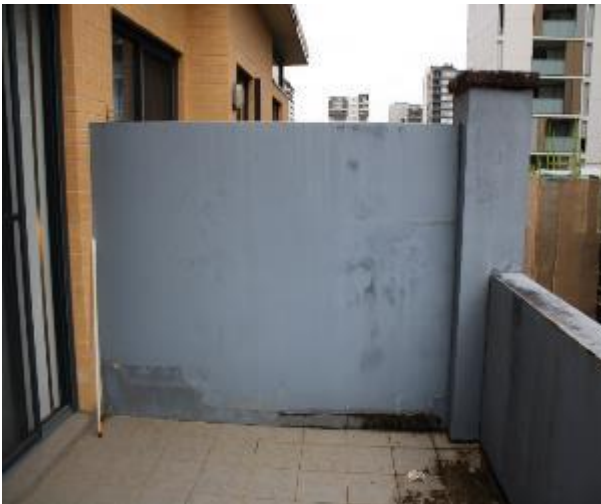
Figure 1309 - Crack propagation through external wall

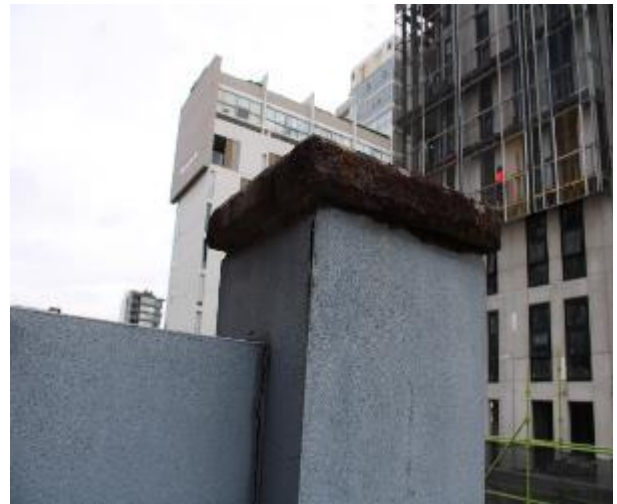
Figure 1310 - General condition of external wall

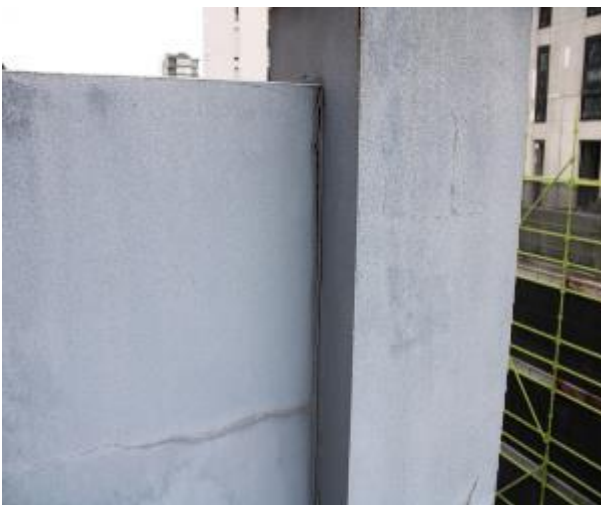
Figure 1311 - General condition of external wall

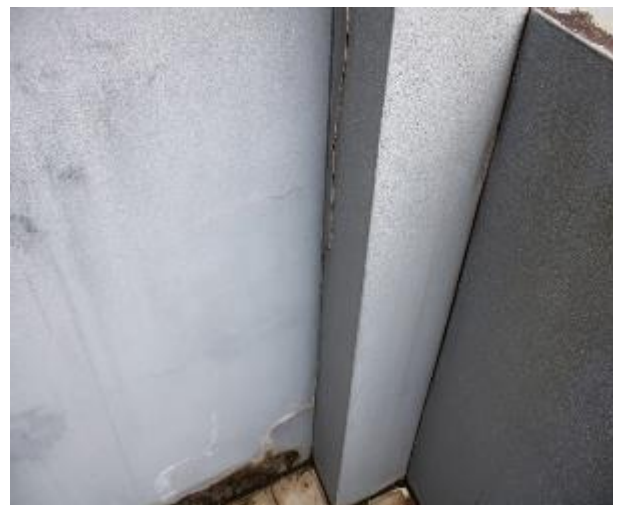
Figure 1312 - Crack propagation through external wall

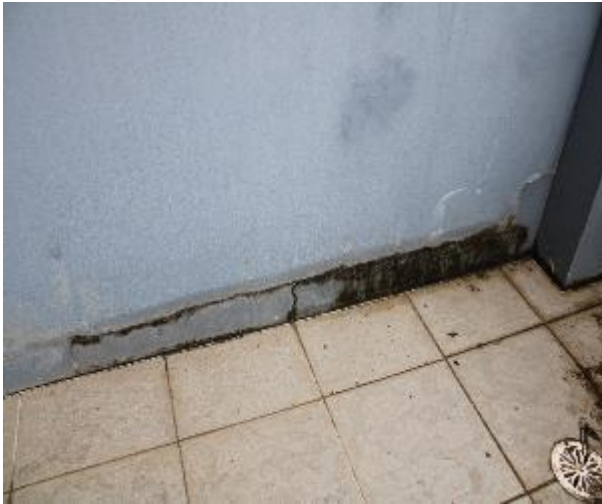
Figure 1313 - Crack propagation through external wall

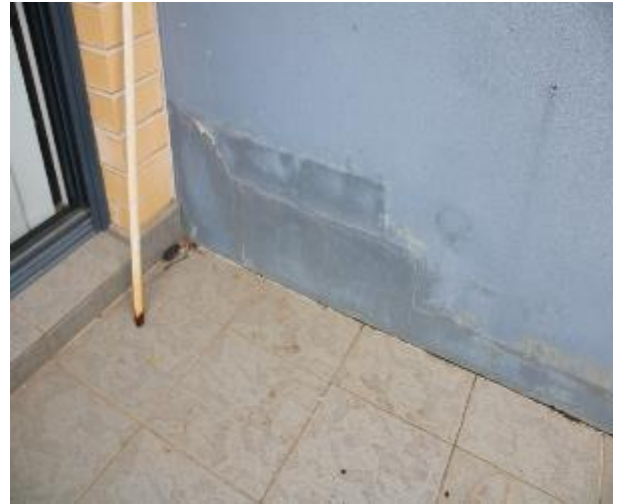
Figure 1314 - Crack propagation through external wall

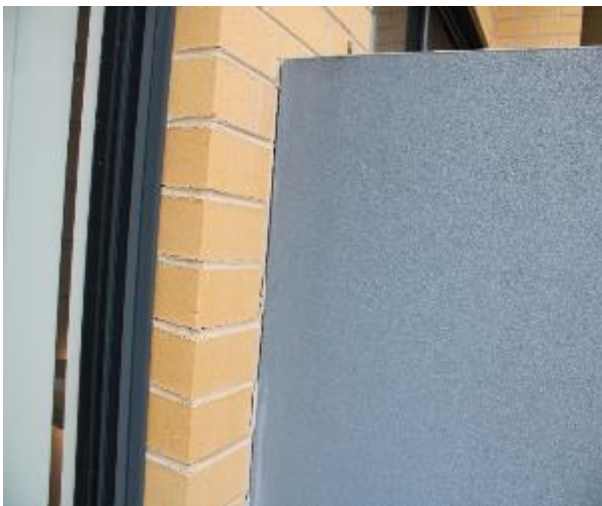
Figure 1315 - Crack propagation through external wall

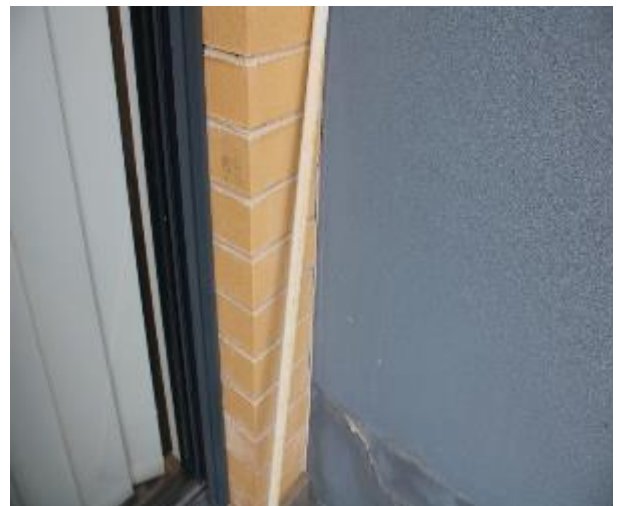
Figure 1316 - Crack propagation through external wall

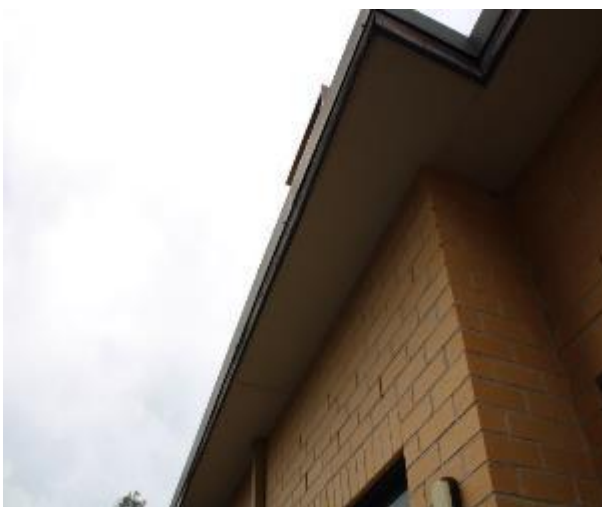
Figure 1317 - Crack propagation through external wall

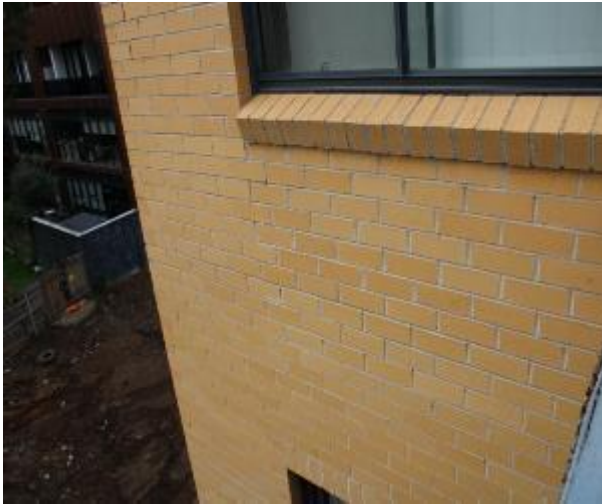
Figure 1319 - General condition of external wall

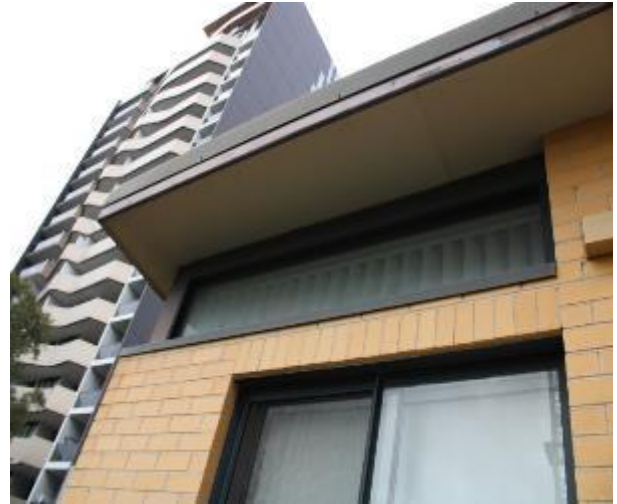
Figure 1320 - General condition of external wall

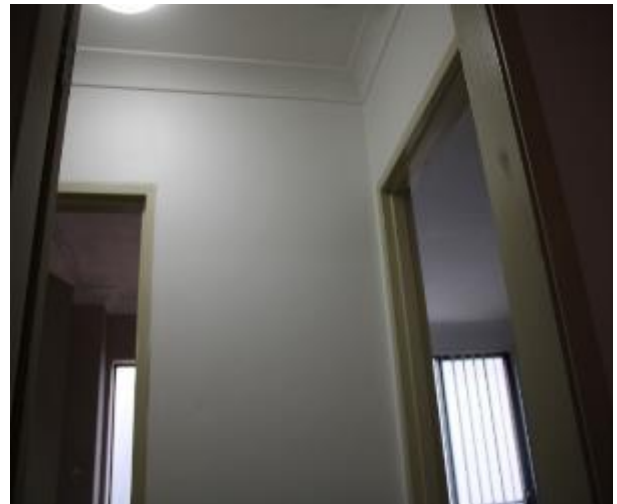
Figure 1323 - General condition of corridor internal wall

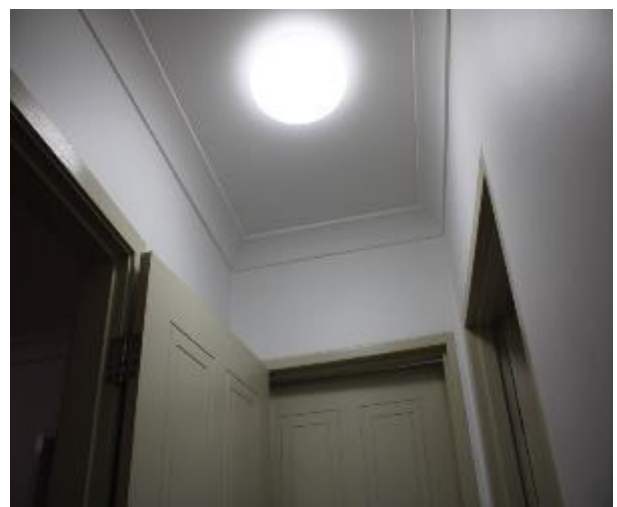
Figure 1325 - General condition of corridor ceiling

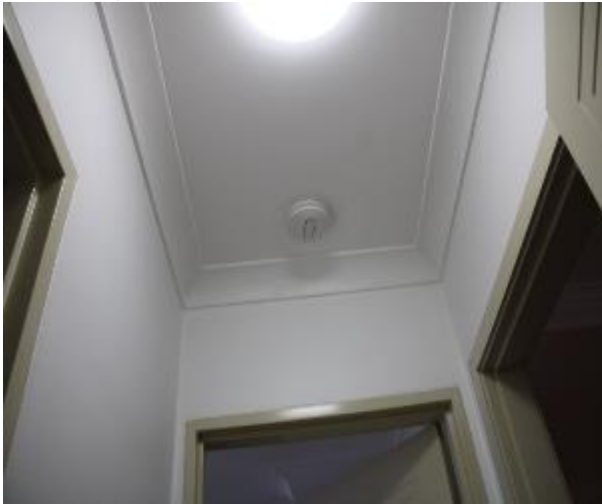
Figure 1326 - General condition of corridor ceiling

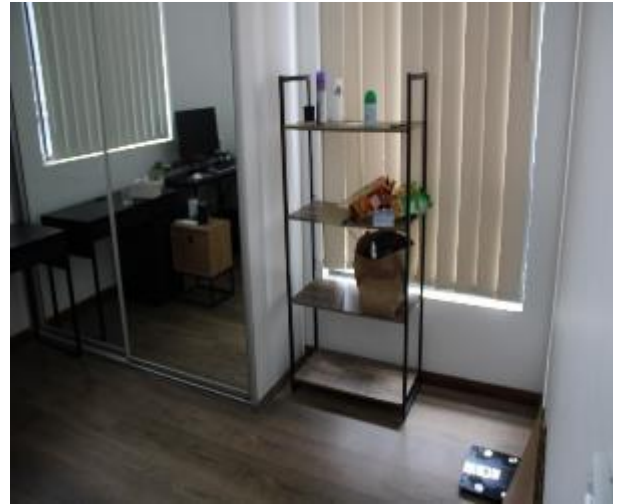
Figure 1327 - General condition of study internal wall

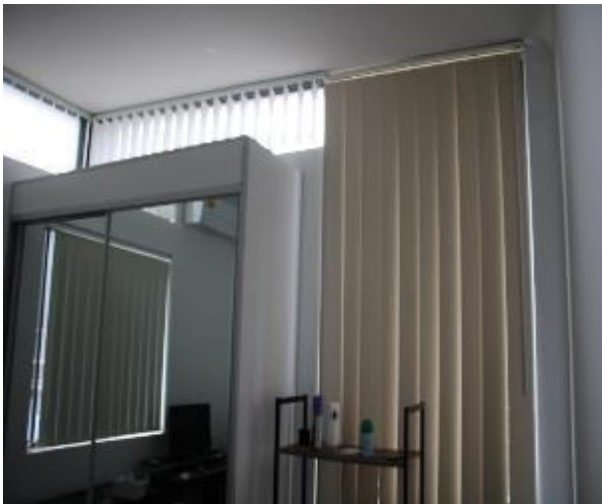
Figure 1328 - General condition of study internal wall

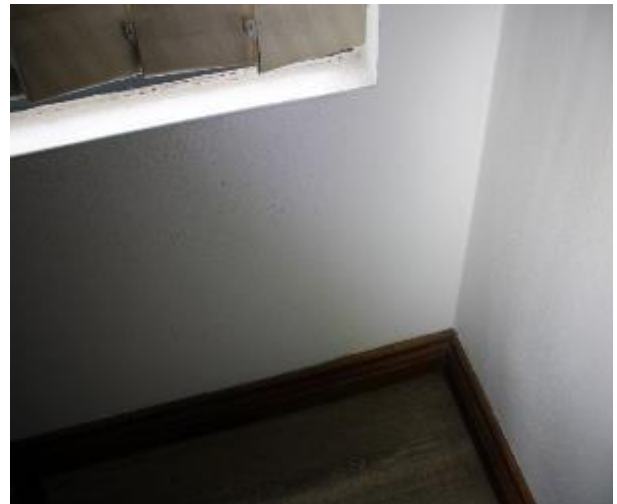
Figure 1329 - Crack propagation through study internal wall

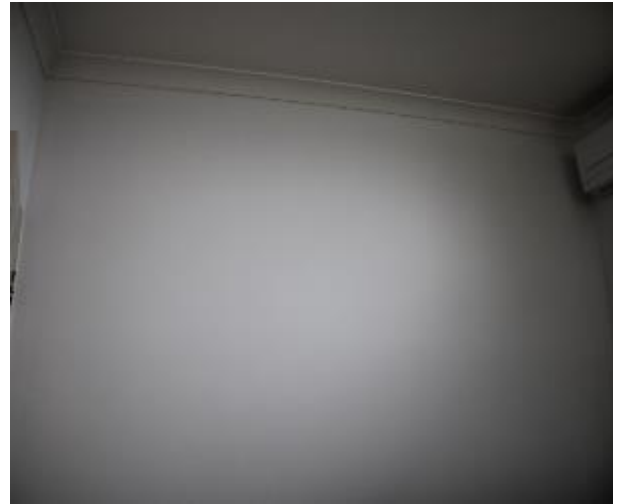
Figure 1333 - General condition of study internal wall

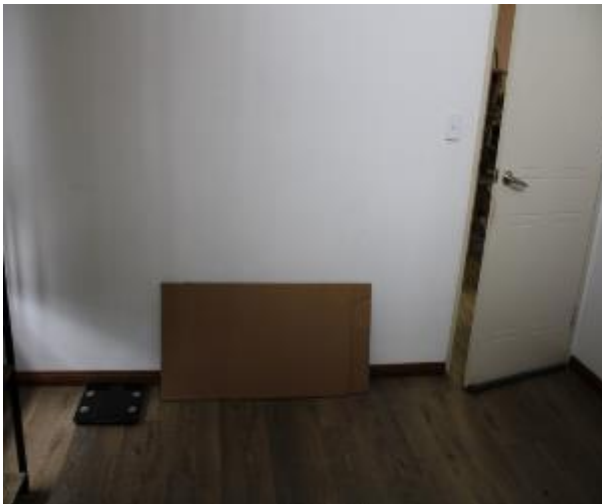
Figure 1334 - General condition of study internal wall

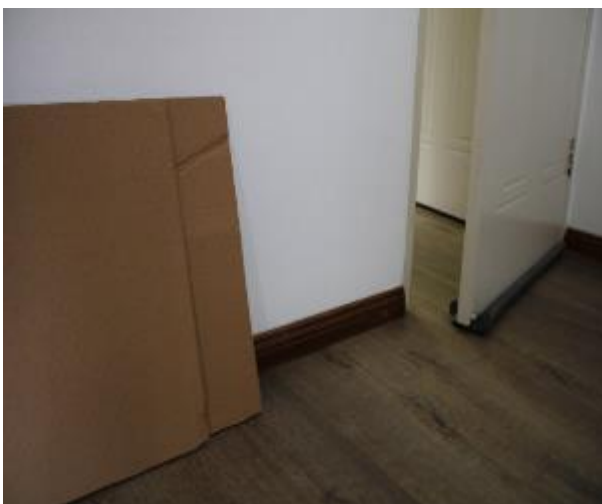
Figure 1336 - General condition of study internal wall

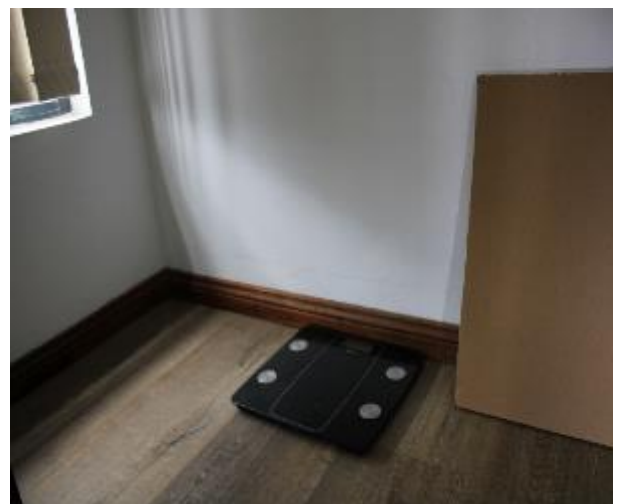
Figure 1337 - General condition of study internal wall

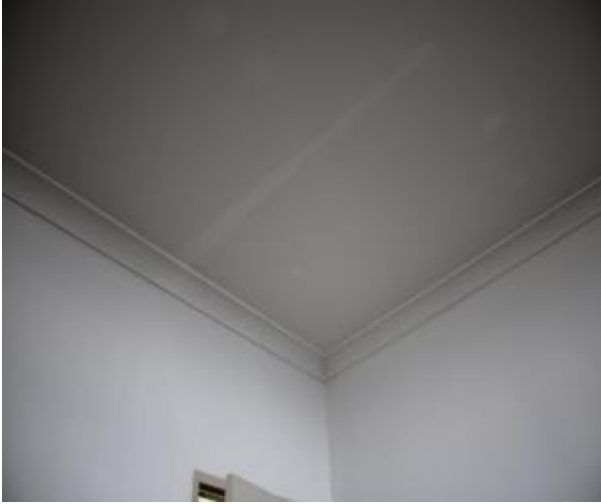
Figure 1338 - General condition of study ceiling

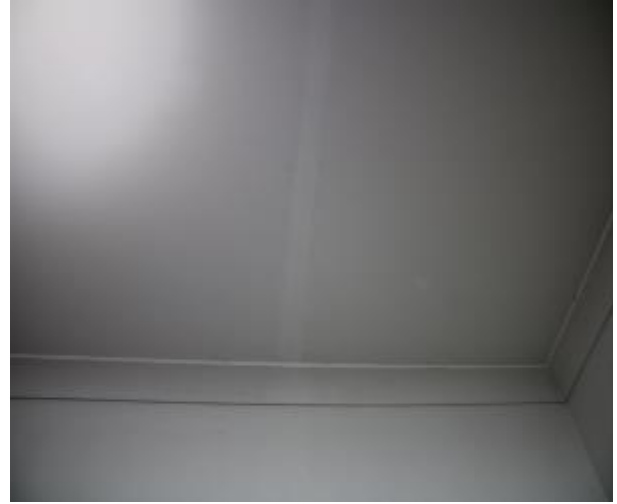
Figure 1339 - General condition of study ceiling

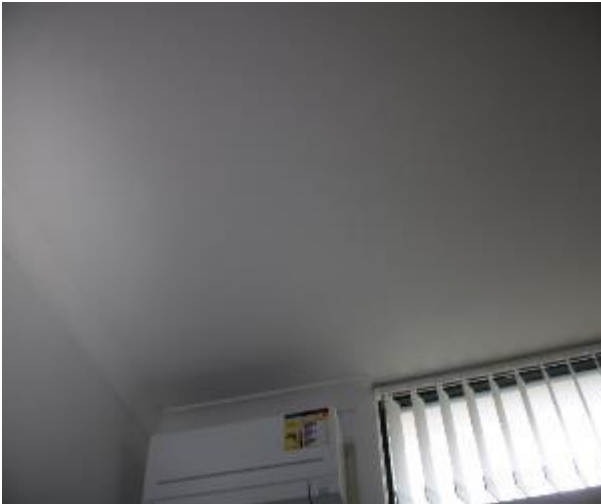
Figure 1340 - General condition of study ceiling

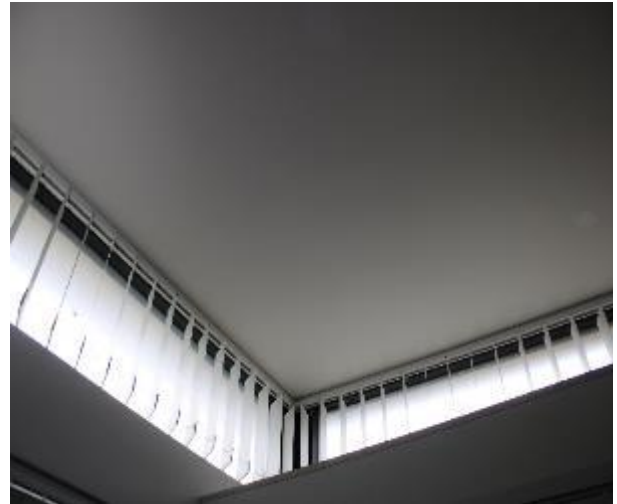
Figure 1341 - General condition of study ceiling

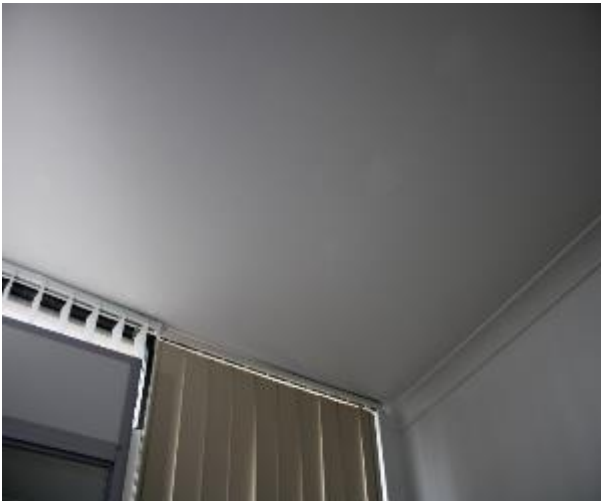
Figure 1342 - General condition of study ceiling

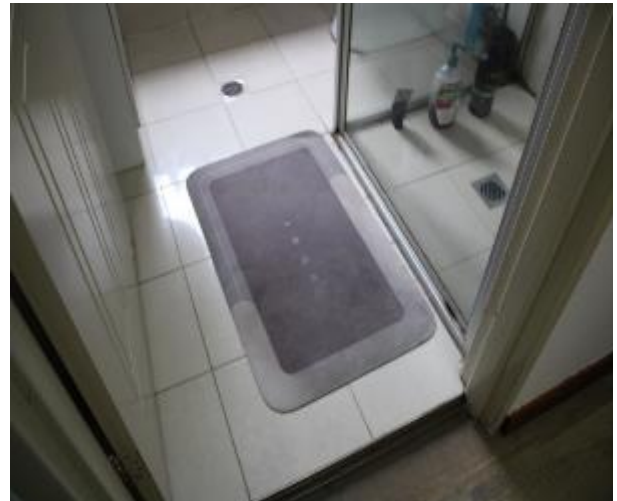
Figure 1343 - General condition of bathroom 1 floor tiles

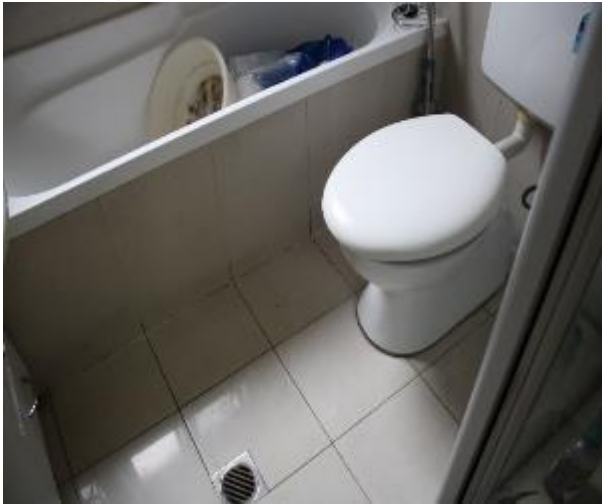
Figure 1344 - General condition of bathroom 1 floor tiles

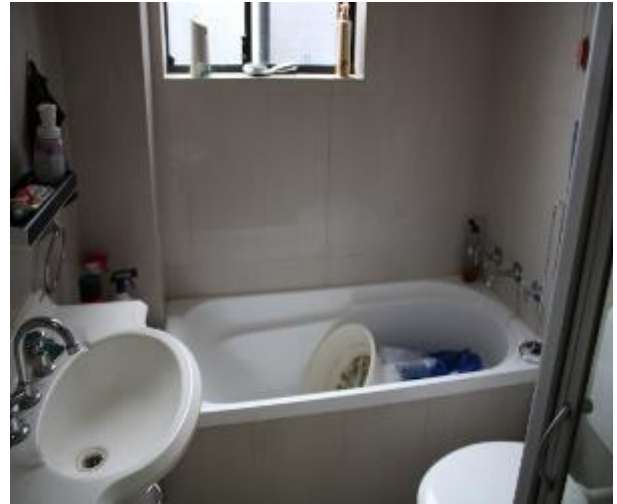
Figure 1345 - General condition of bathroom 1 internal wall

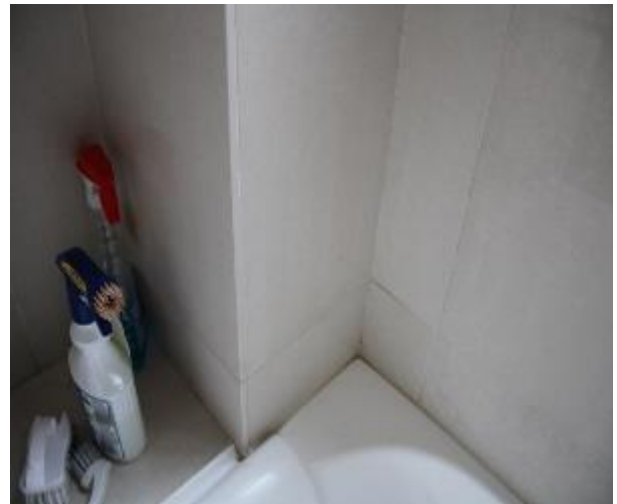
Figure 1347 - Crack propagation through bathroom 1 internal wall

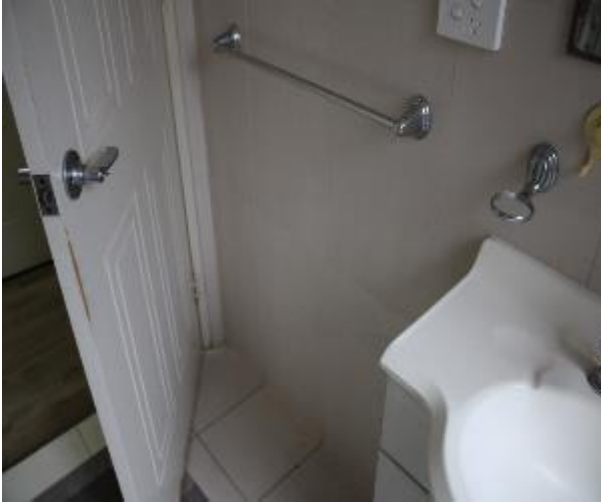
Figure 1350 - General condition of bathroom 1 internal wall

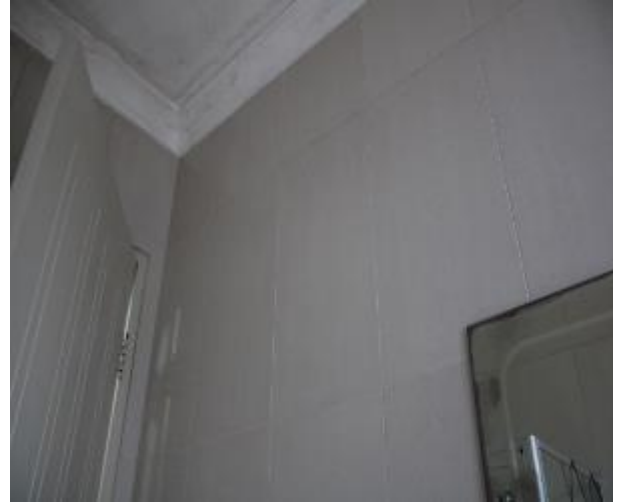
Figure 1351 - General condition of bathroom 1 internal wall

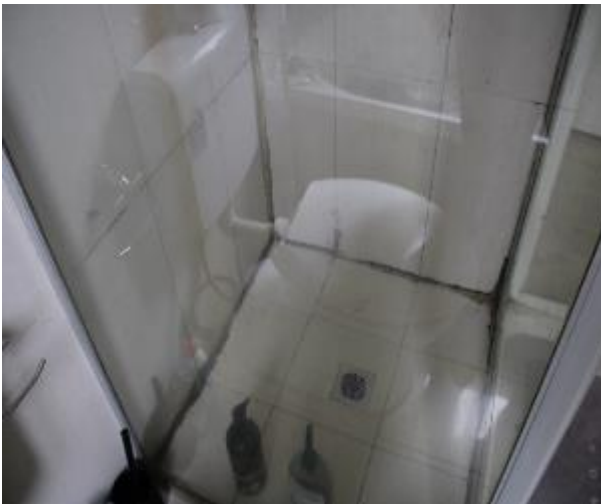
Figure 1352 - General condition of bathroom 1 internal wall

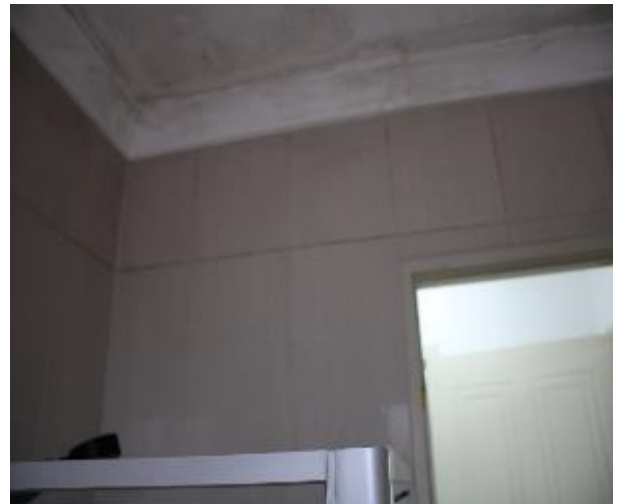
Figure 1353 - General condition of bathroom 1 internal wall

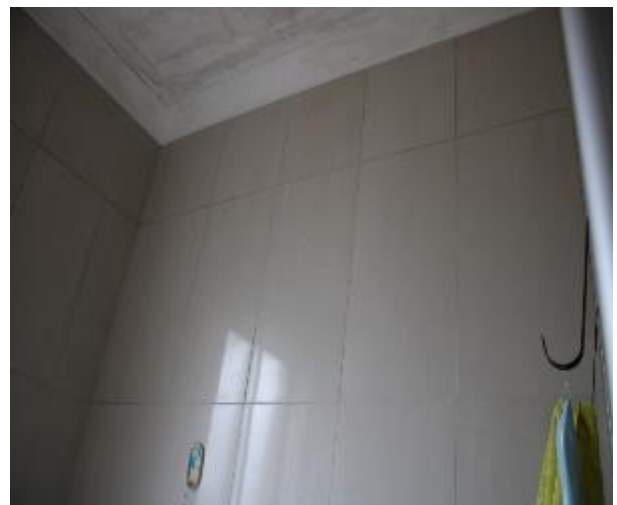
Figure 1355 - General condition of bathroom 1 internal wall

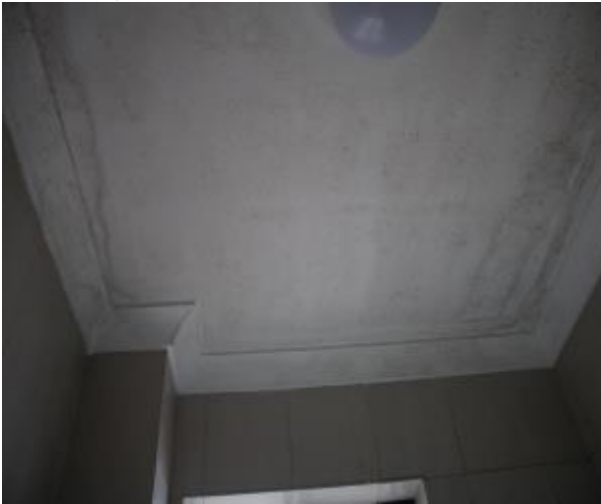
Figure 1356 - Water damage evident through bathroom 1 ceiling

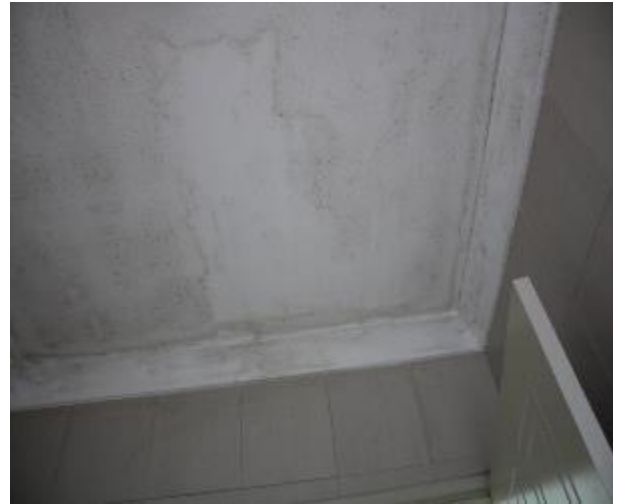
Figure 1357 - Water damage evident through bathroom 1 ceiling

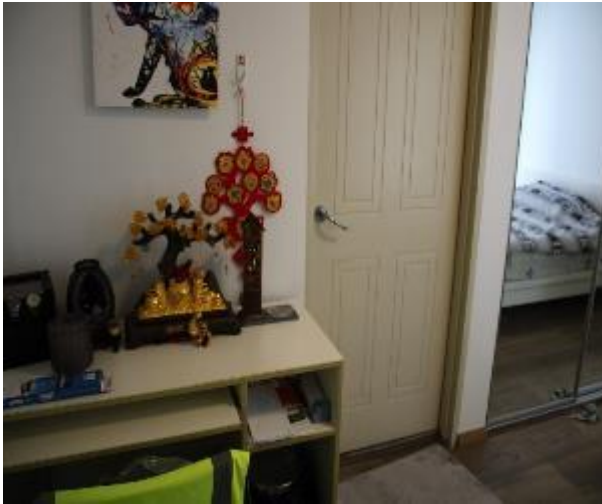
Figure 1362 - General condition of bedroom 2 internal wall

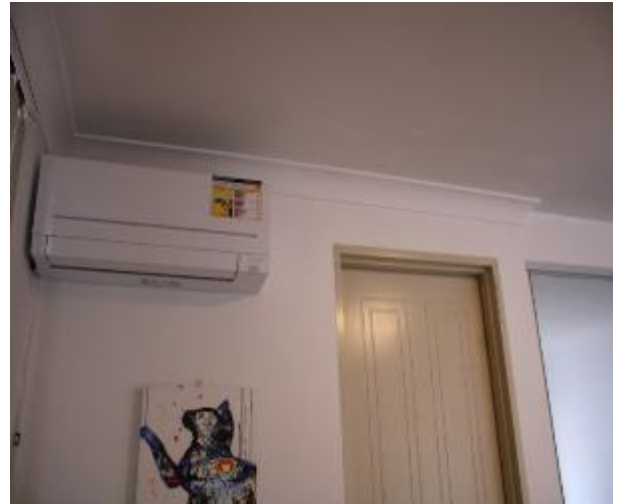
Figure 1363 - General condition of bedroom 2 internal wall

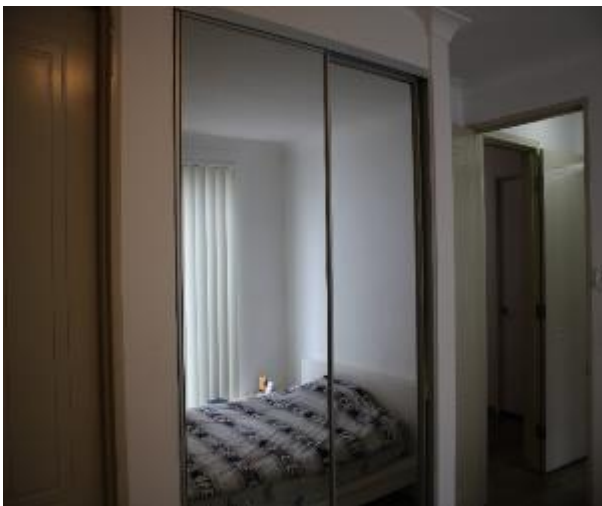
Figure 1364 - General condition of bedroom 2 internal wall

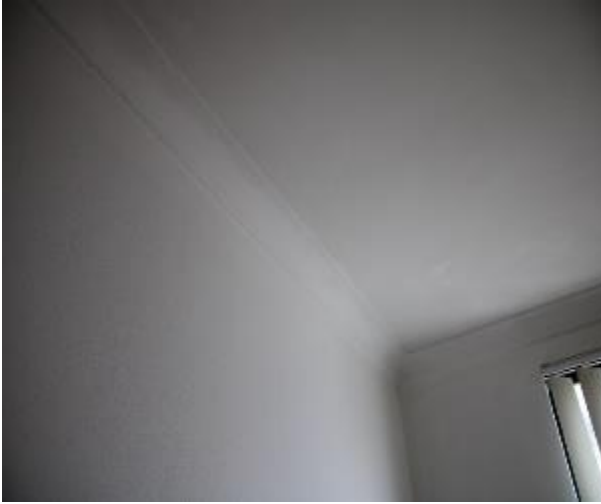
Figure 1368 - General condition of bedroom 2 ceiling

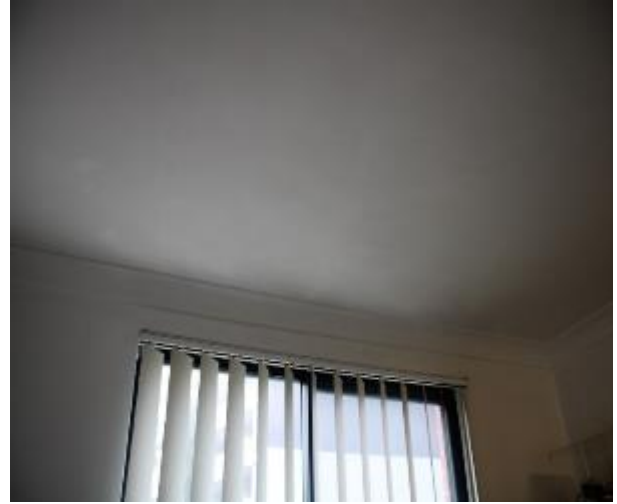
Figure 1369 - General condition of bedroom 2 ceiling

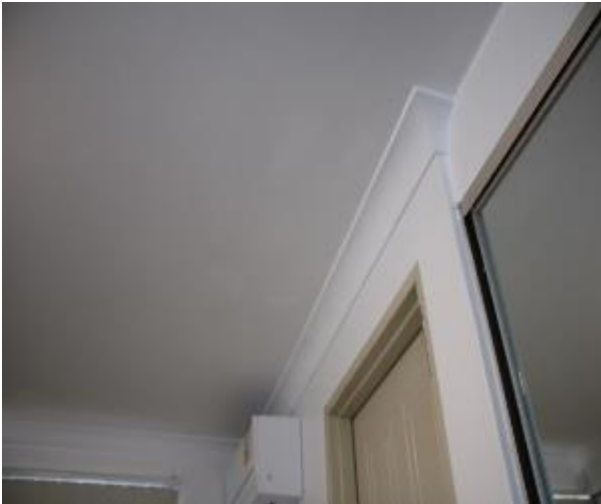
Figure 1370 - General condition of bedroom 2 ceiling

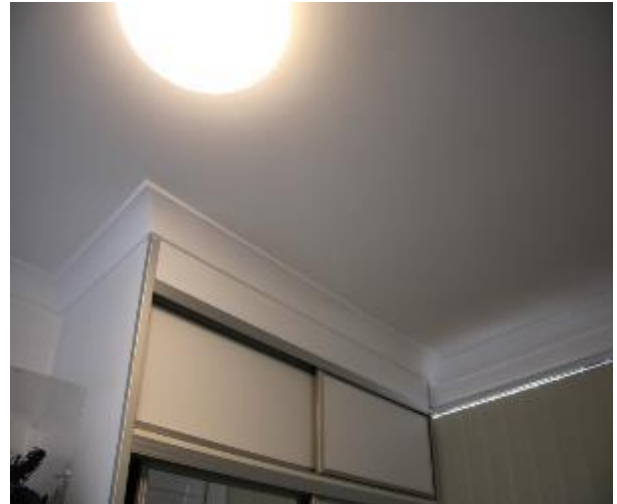
Figure 1371 - General condition of bedroom 2 ceiling

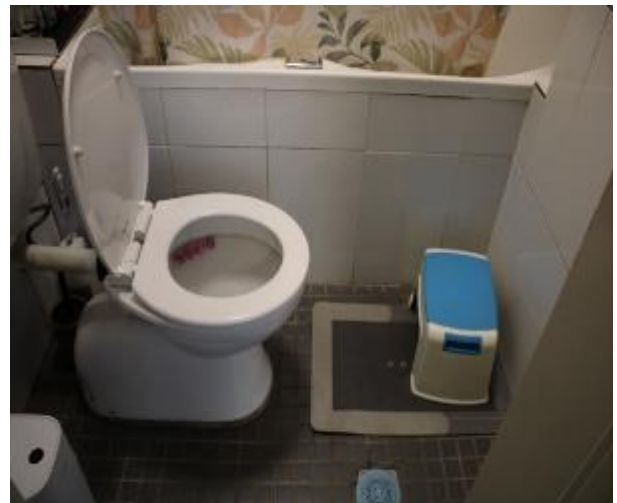
Figure 1373 - General condition of ensuite bathroom floor tiles

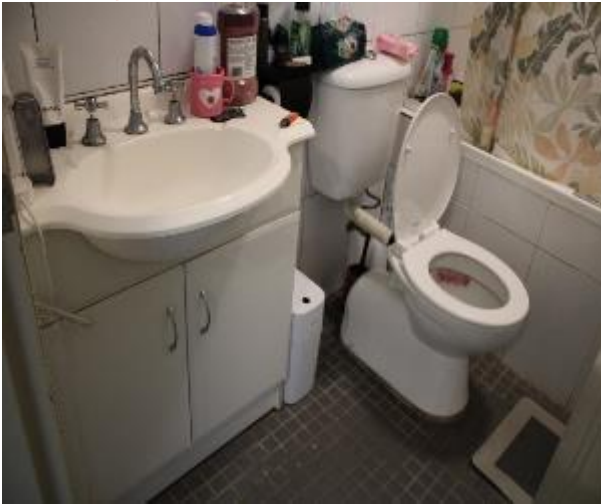
Figure 1374 - General condition of ensuite bathroom internal wall

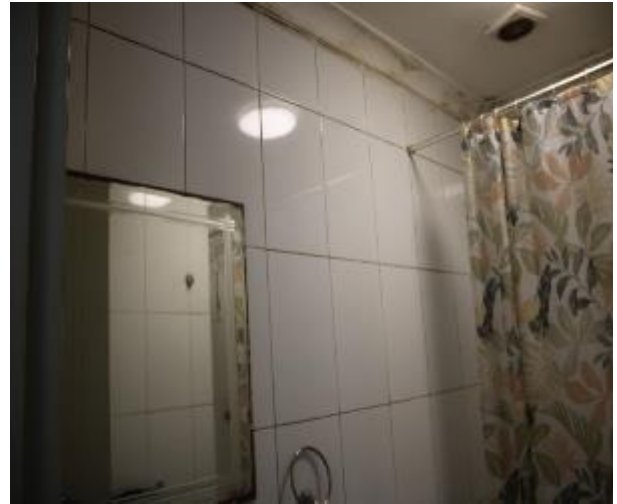
Figure 1375 - General condition of ensuite bathroom internal wall

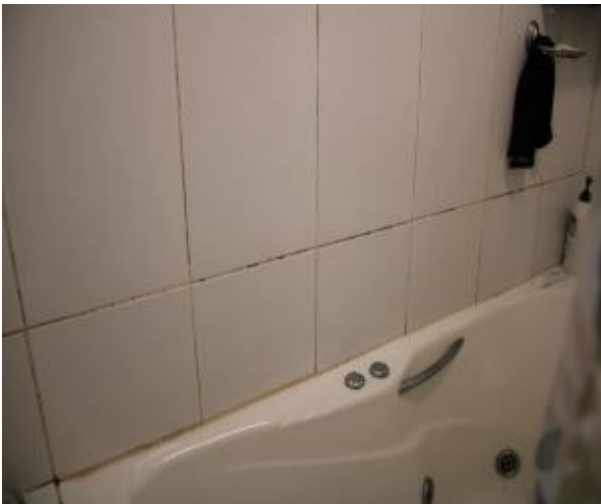
Figure 1376 - General condition of ensuite bathroom internal wall

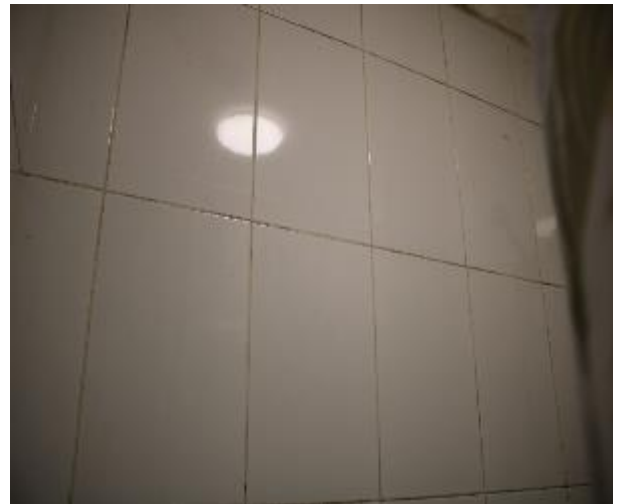
Figure 1377 - General condition of ensuite bathroom internal wall

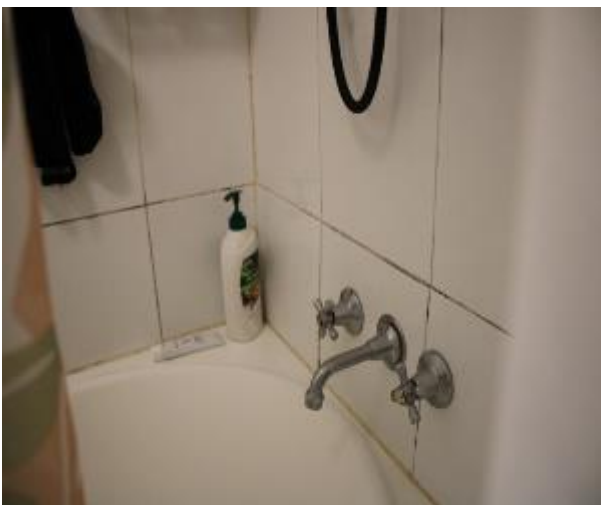
Figure 1378 - Crack propagation through ensuite bathroom internal wall

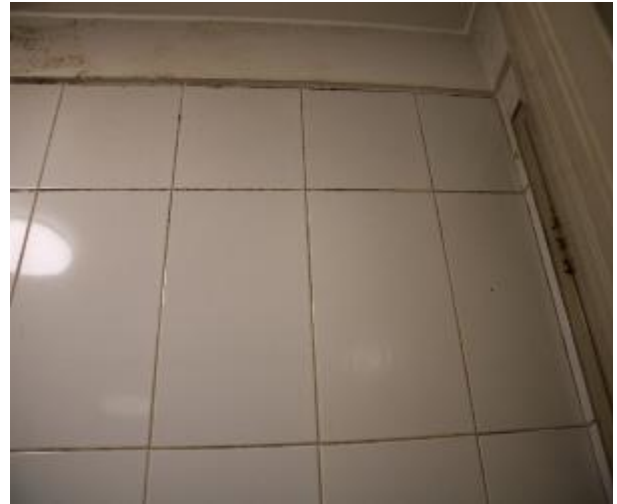
Figure 1381 - General condition of ensuite bathroom internal wall

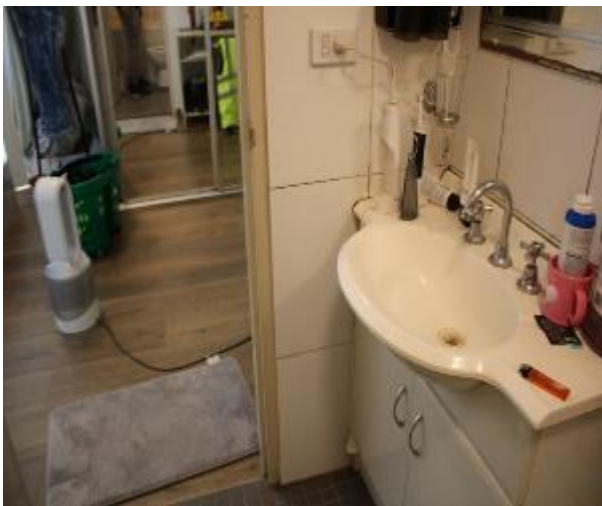
Figure 1382 - General condition of ensuite bathroom internal wall

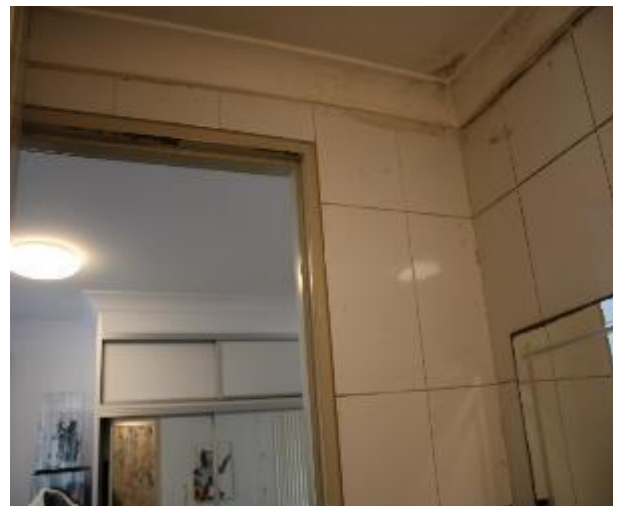
Figure 1383 - General condition of ensuite bathroom internal wall

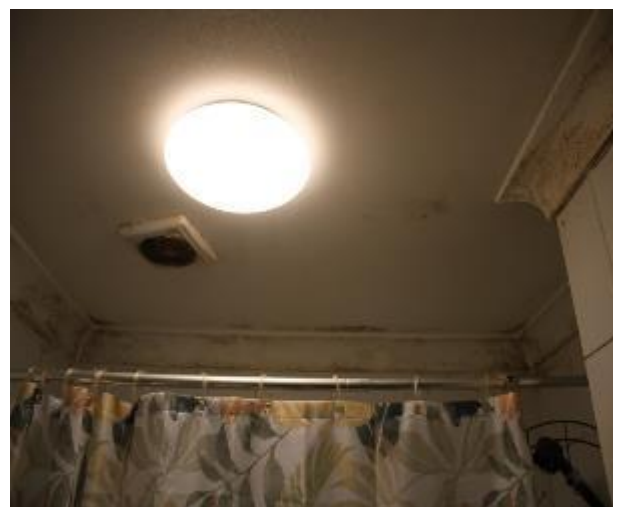
Figure 1385 - Water damage evident through ensuite bathroom ceiling

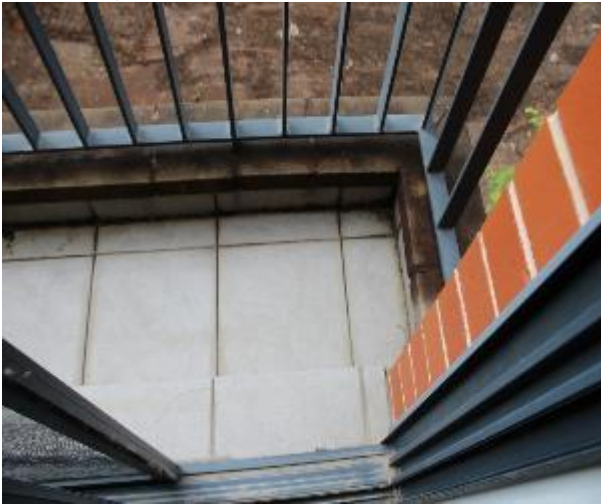
Figure 1386 - General condition of balcony 2 floor tiles

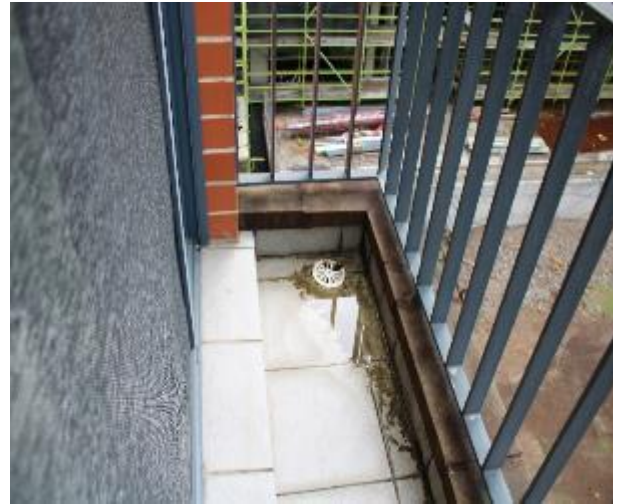
Figure 1387 - General condition of balcony 2 floor tiles

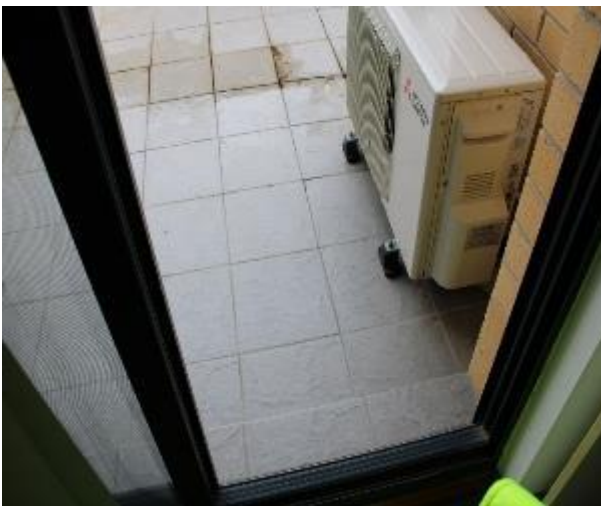
Figure 1388 - General condition of balcony 3 floor tiles

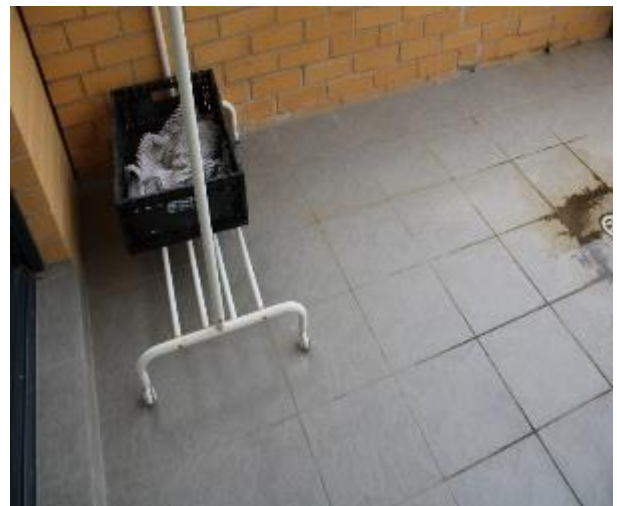
Figure 1389 - General condition of balcony 3 floor tiles

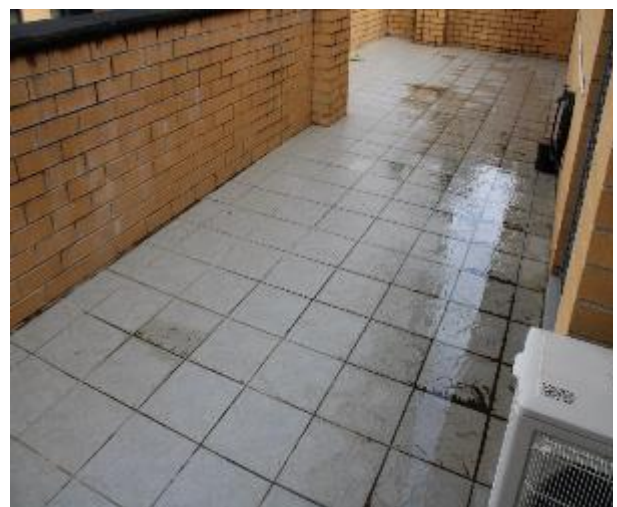
Figure 1391 - General condition of balcony 3 floor tiles

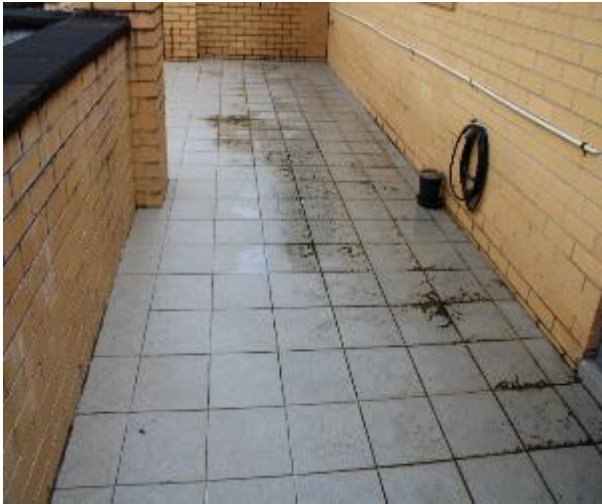
Figure 1392 - General condition of balcony 3 floor tiles

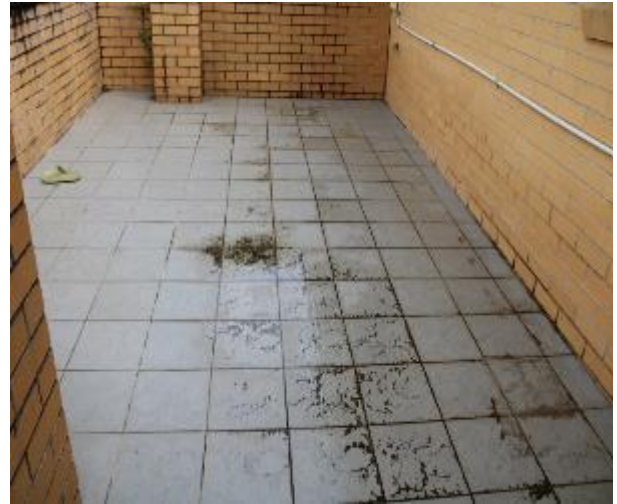
Figure 1393 - General condition of balcony 3 floor tiles

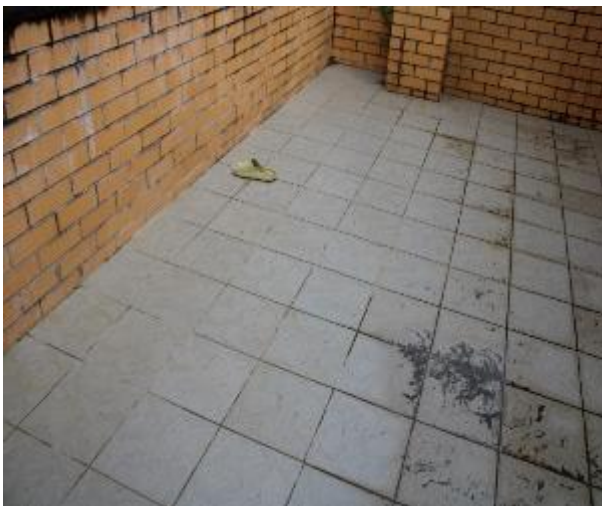
Figure 1394 - General condition of balcony 3 floor tiles

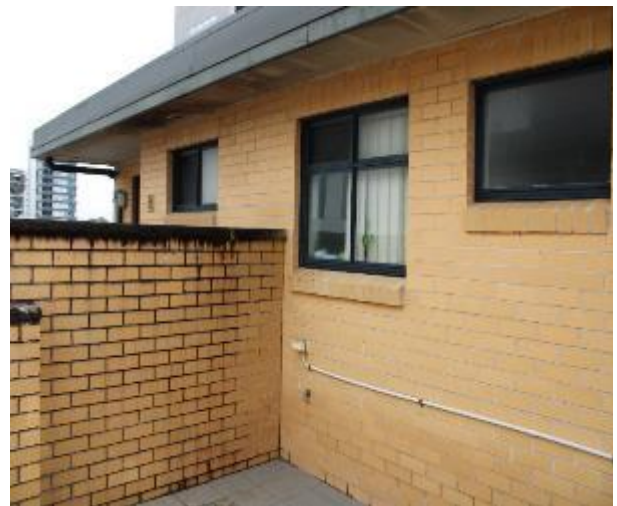
Figure 1395 - General condition of external wall

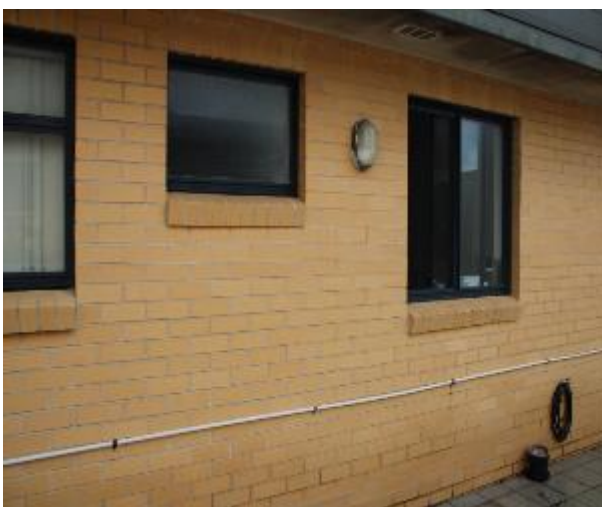
Figure 1396 - General condition of external wall

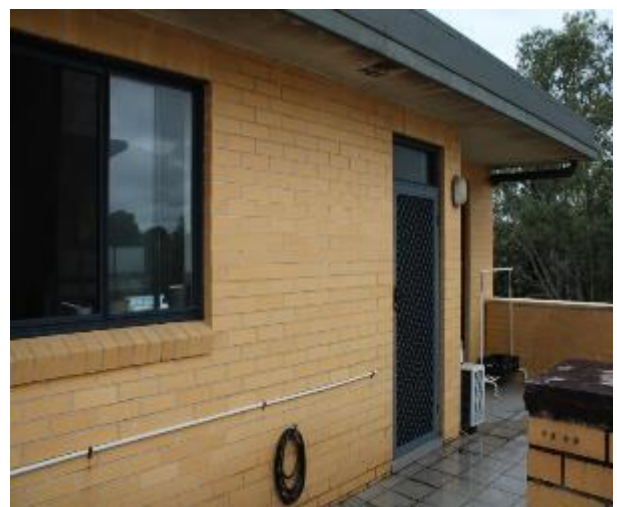
Figure 1397 - General condition of external wall

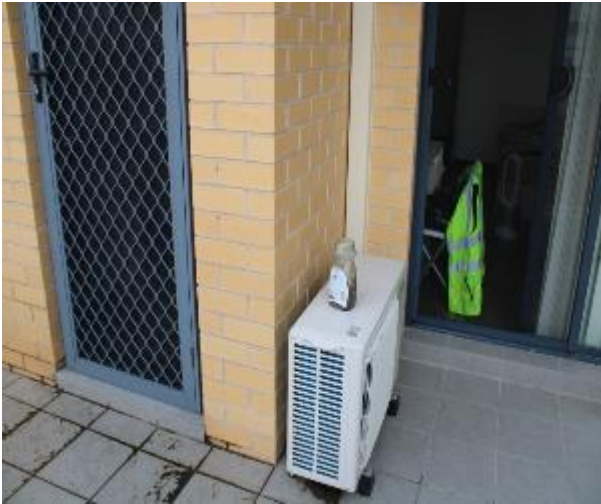
Figure 1398 - General condition of external wall

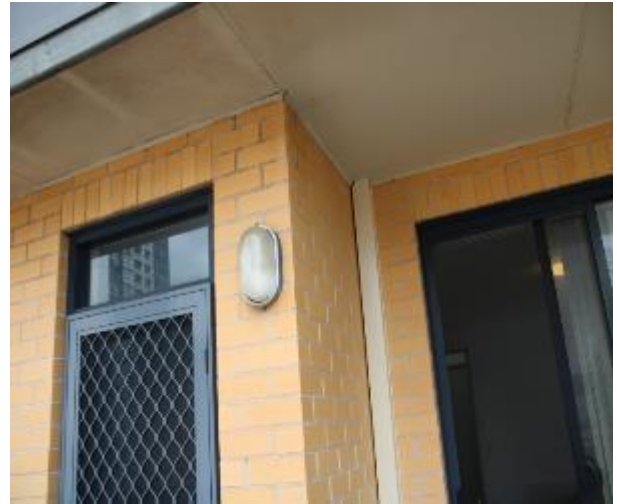
Figure 1399 - General condition of external wall
