# **Pre-Dilapidation Report**

**19 GEORGE STREET**

**REAR BUILDING (UNITS 20-29)**

Project Reference: 20250047.19G.3

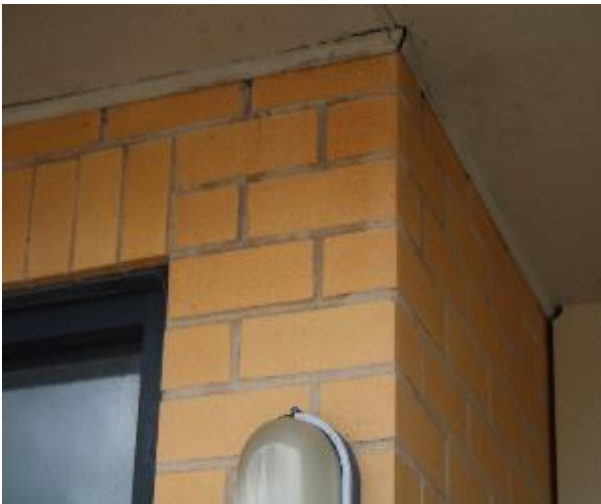
Figure 1400 - Crack propagation through external wall

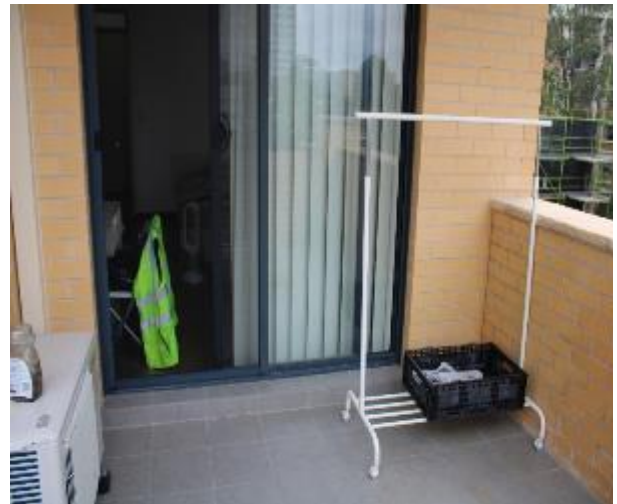
Figure 1401 - General condition of external wall

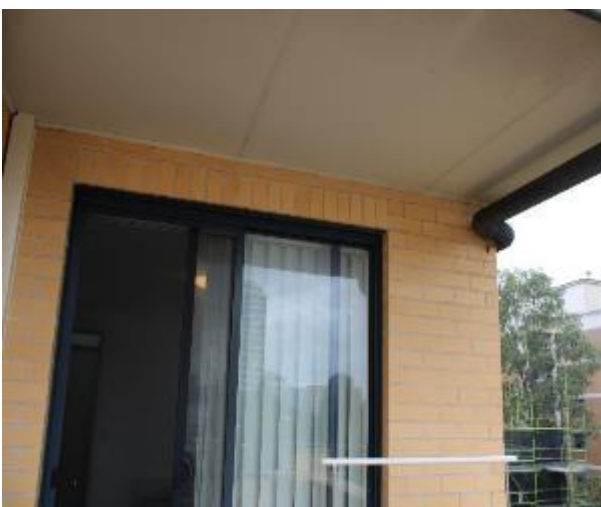
Figure 1402 - General condition of external wall

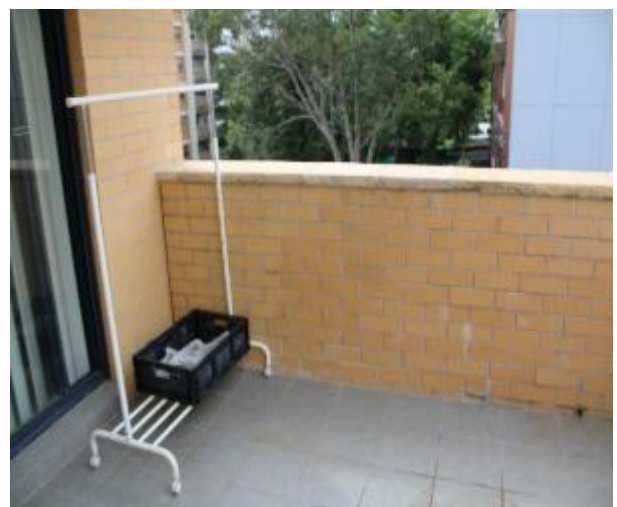
Figure 1403 - General condition of external wall

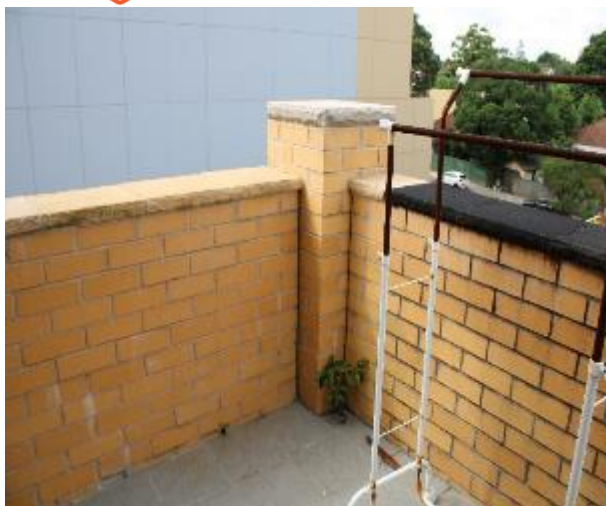
Figure 1404 - General condition of external wall

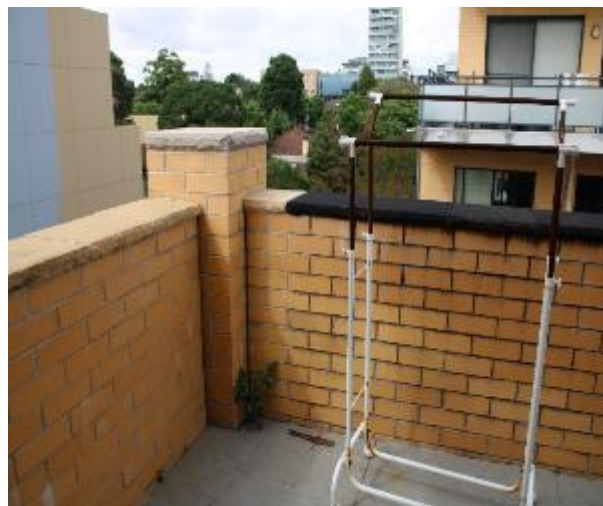
Figure 1405 - General condition of external wall

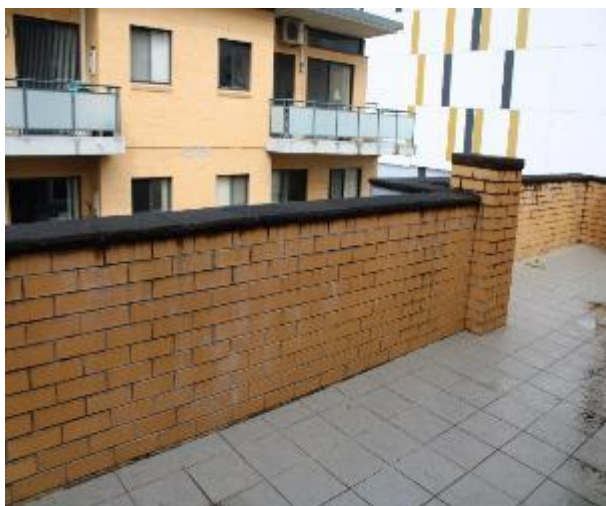
Figure 1406 - General condition of external wall

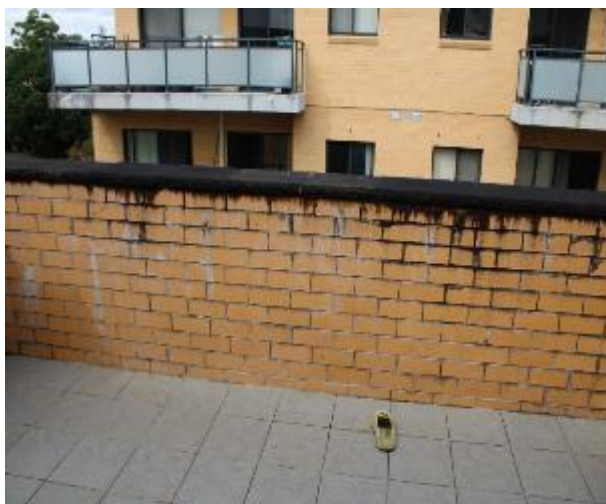
Figure 1408 - General condition of external wall

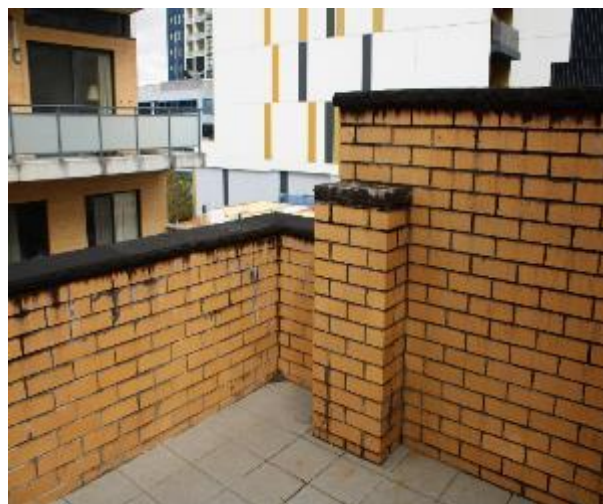
Figure 1409 - General condition of external wall

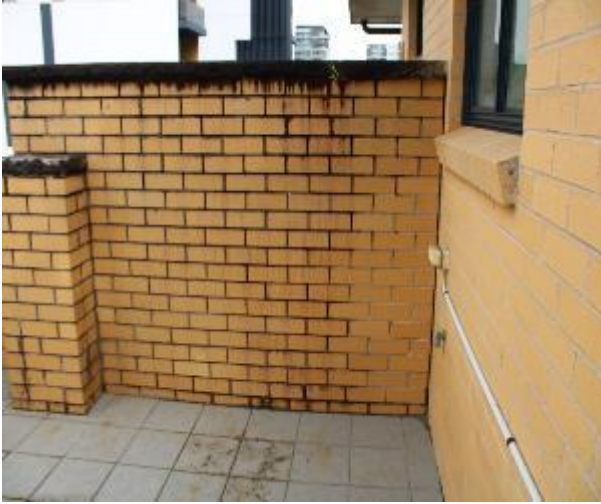
Figure 1410 - General condition of external wall

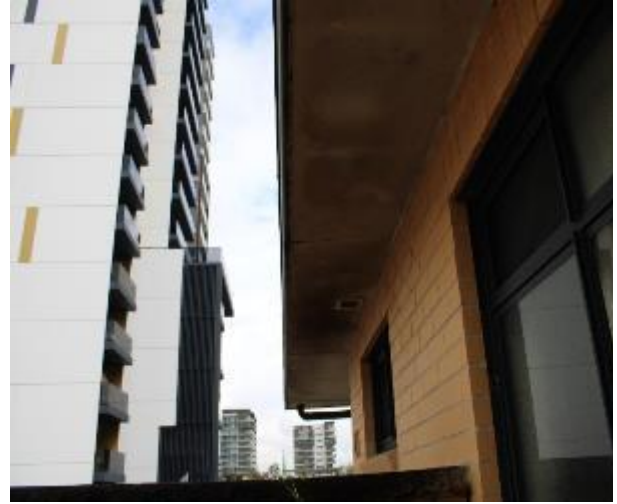
Figure 1411 - General condition of balcony underside slab

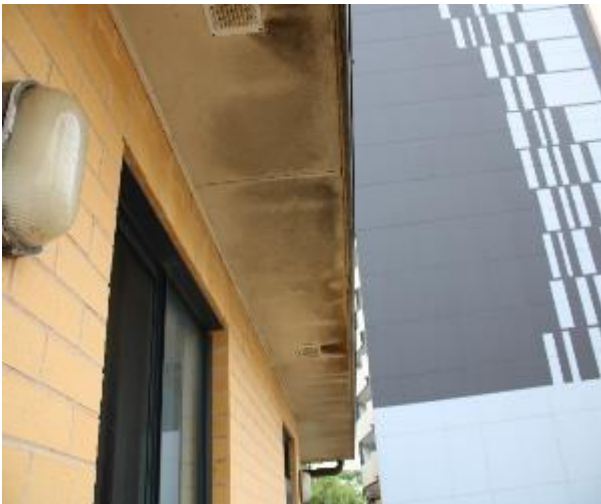
Figure 1412 - General condition of balcony underside slab

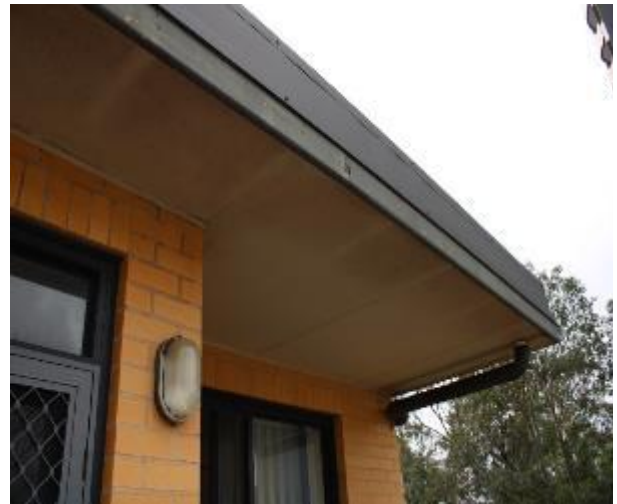
Figure 1413 - General condition of balcony underside slab

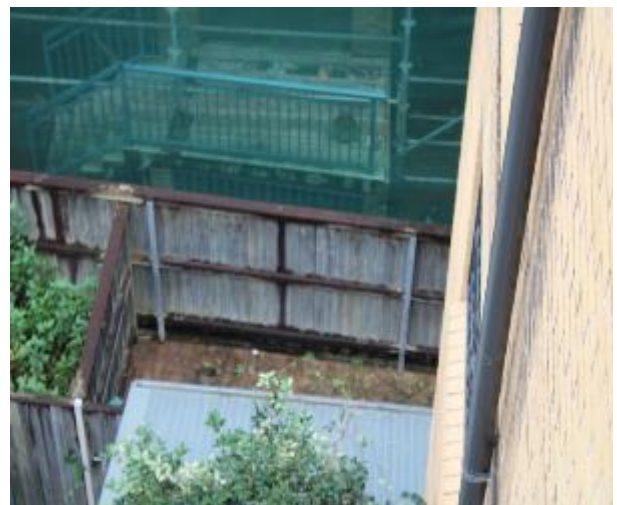
Figure 1415 - General condition of boundary as seen from Unit 28 balcony

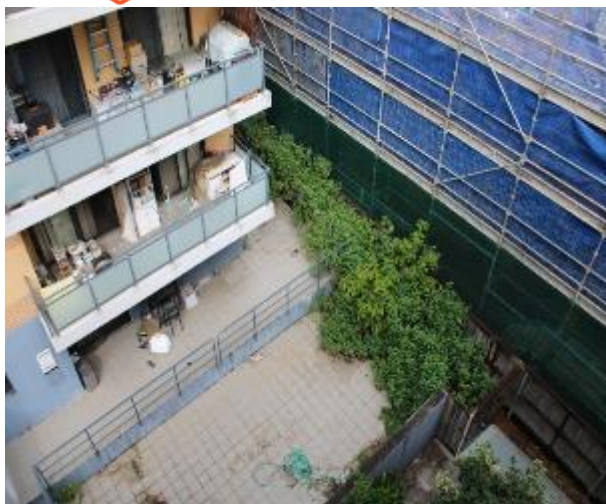
Figure 1416 - General condition of boundary as seen from Unit 28 balcony

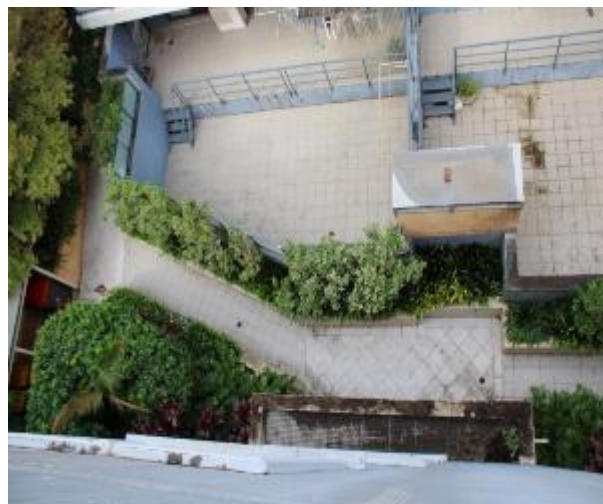
Figure 1417 - General condition of boundary as seen from Unit 28 balcony

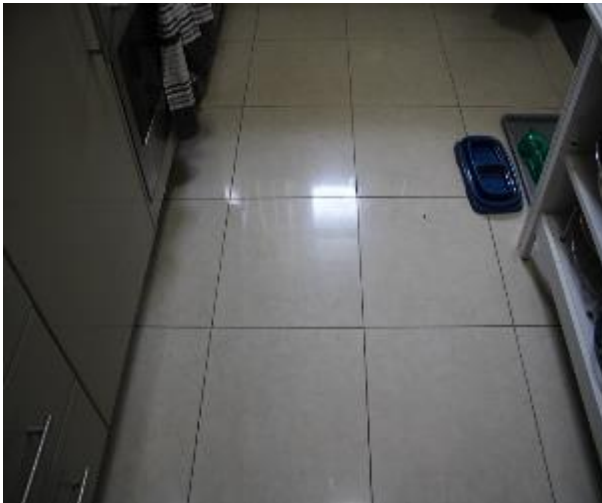
Figure 1420 - General condition of kitchen floor tiles

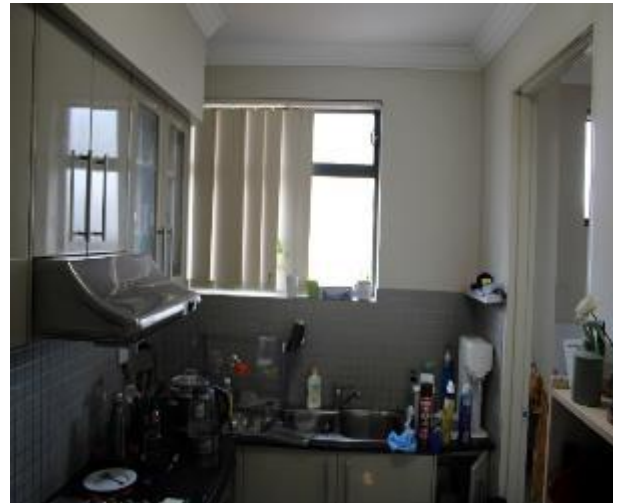
Figure 1421 - General condition of kitchen internal wall

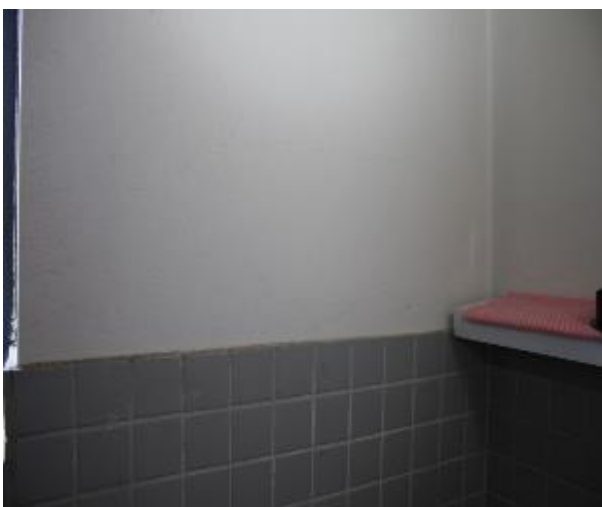
Figure 1422 - General condition of kitchen internal wall

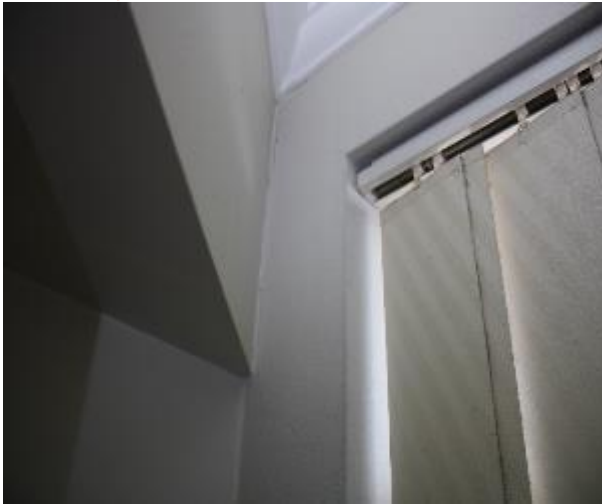
Figure 1424 - Crack propagation through kitchen internal wall

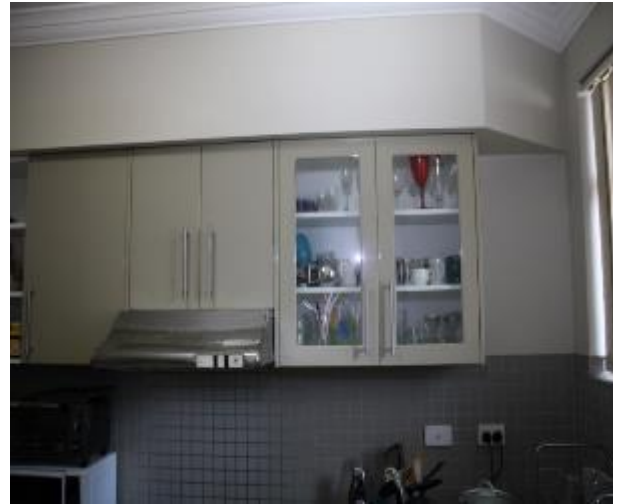
Figure 1425 - General condition of kitchen internal wall

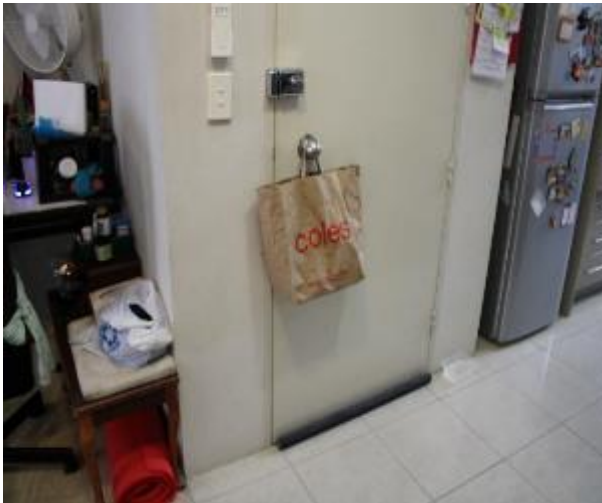
Figure 1426 - General condition of kitchen internal wall

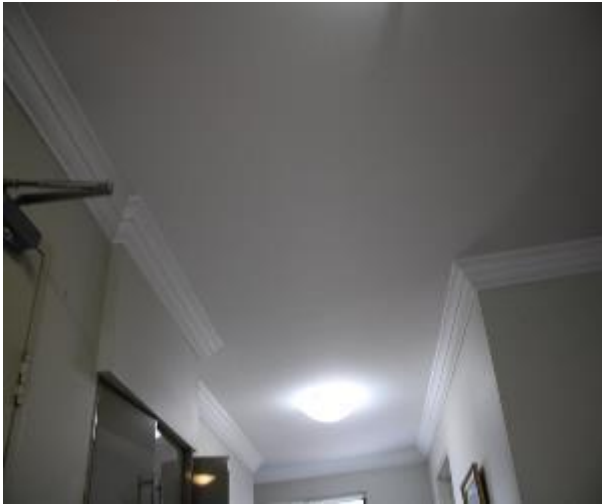
Figure 1430 - General condition of kitchen ceiling

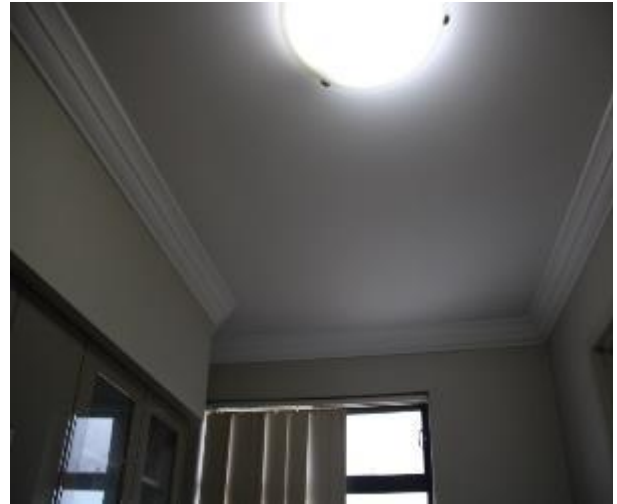
Figure 1431 - General condition of kitchen ceiling

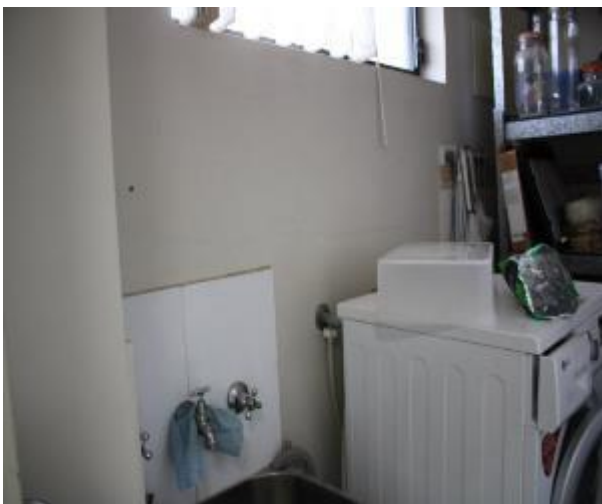
Figure 1434 - General condition of laundry internal wall

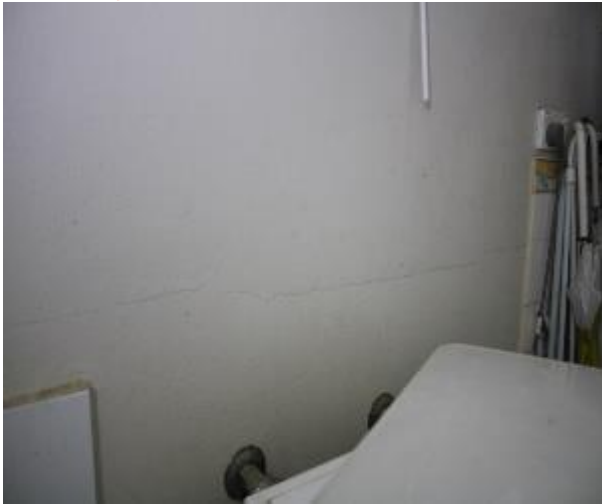
Figure 1436 - Crack propagation through laundry internal wall

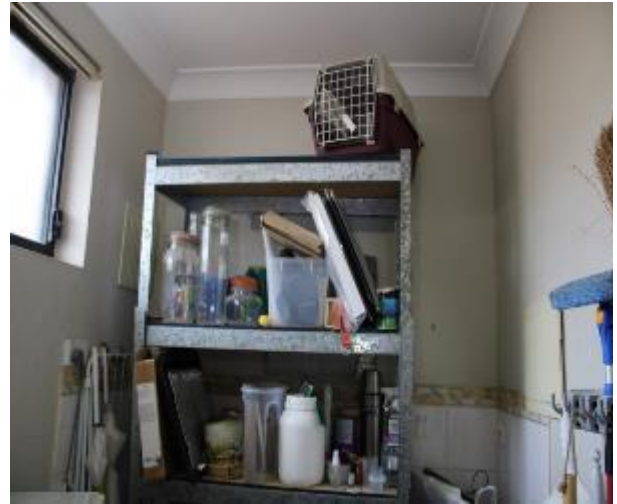
Figure 1437 - General condition of laundry internal wall

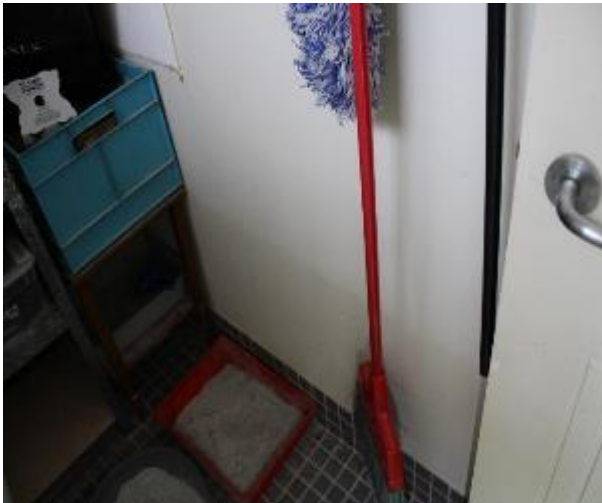
Figure 1438 - General condition of laundry internal wall

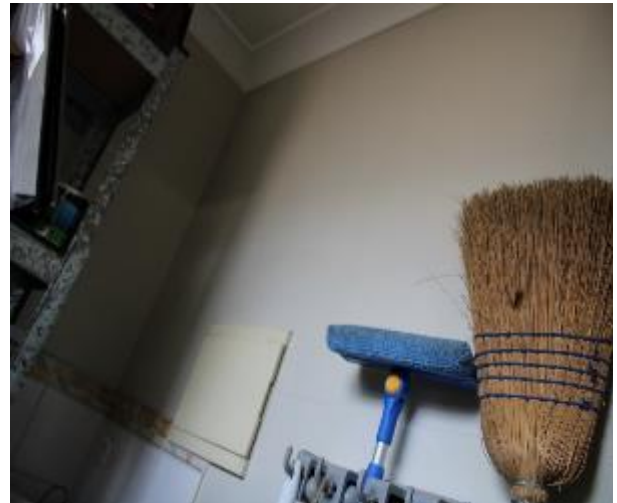
Figure 1439 - General condition of laundry internal wall

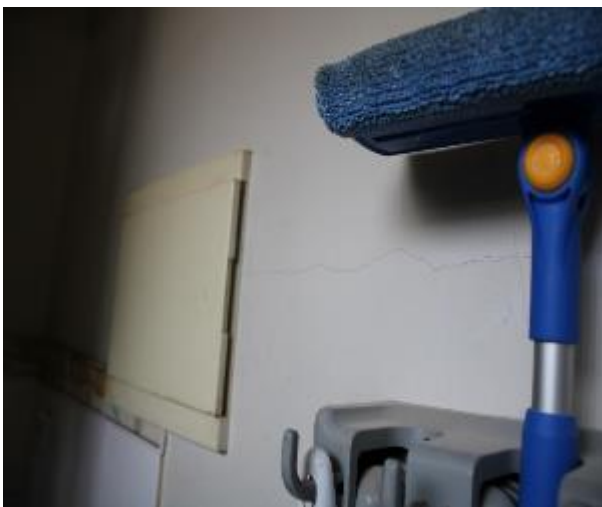
Figure 1440 - Crack propagation through laundry internal wall

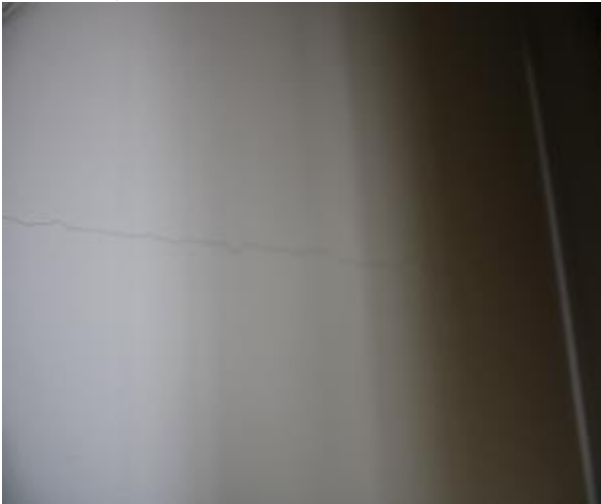
Figure 1442 - Crack propagation through laundry internal wall

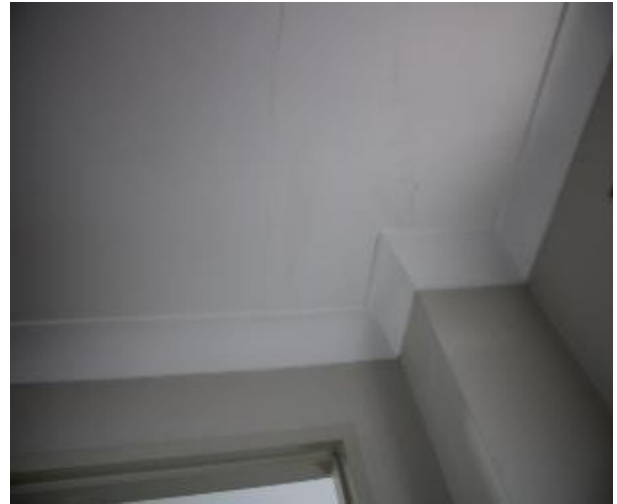
Figure 1443 - General condition of laundry ceiling

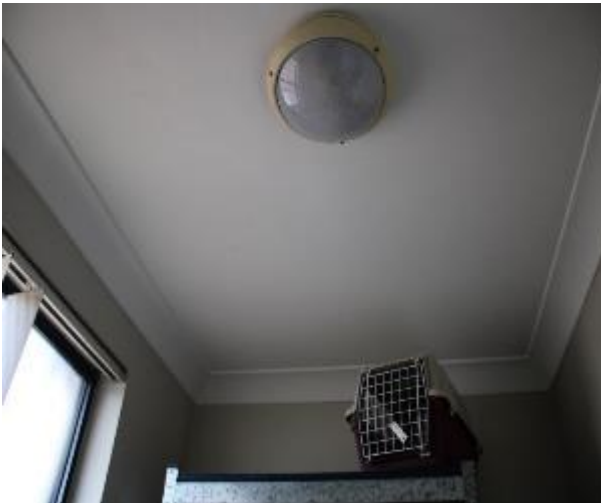
Figure 1444 - General condition of laundry ceiling

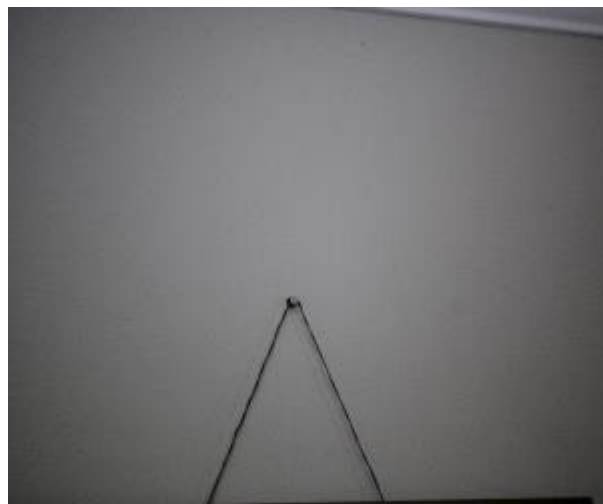
Figure 1449 - Crack propagation through lounge room internal wall

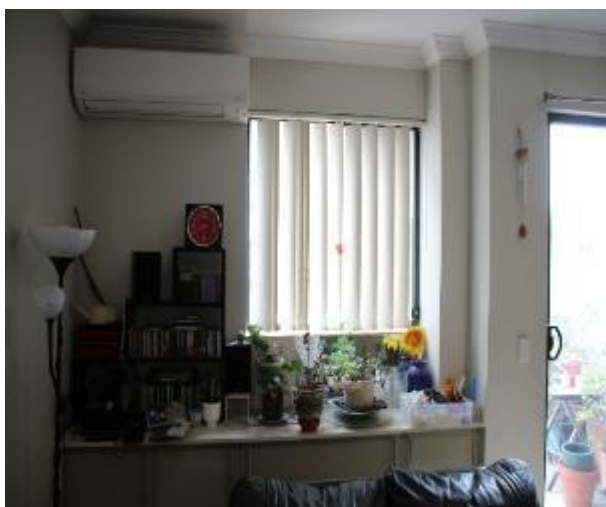
Figure 1452 - General condition of lounge room internal wall

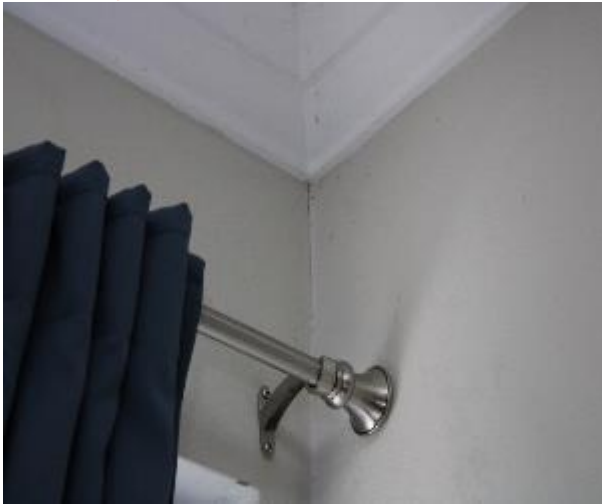
Figure 1454 - Crack propagation through lounge room internal wall

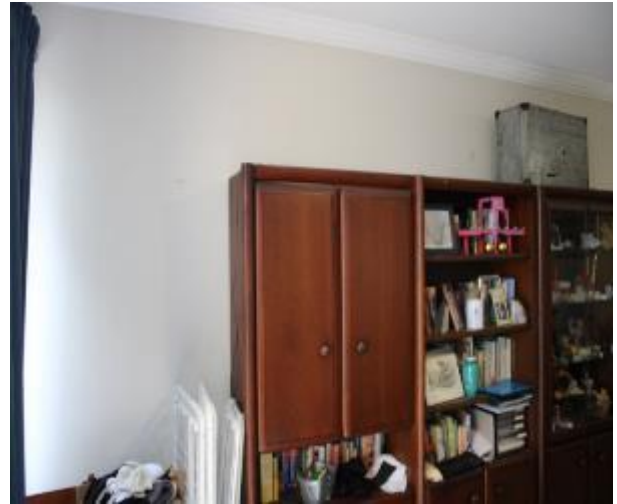
Figure 1455 - General condition of lounge room internal wall

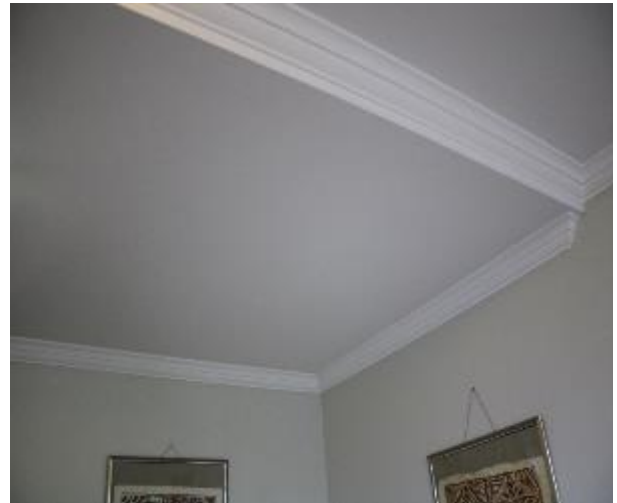
Figure 1457 - General condition of lounge room ceiling

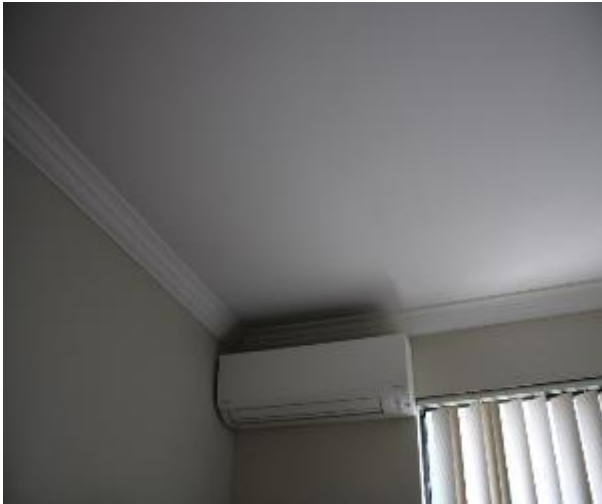
Figure 1460 - General condition of lounge room ceiling

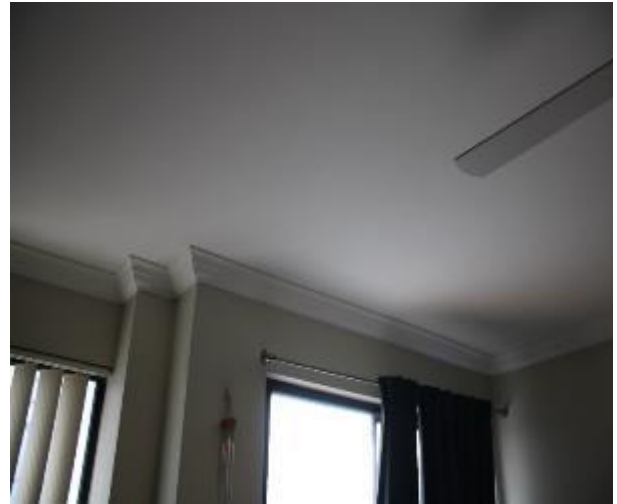
Figure 1461 - General condition of lounge room ceiling

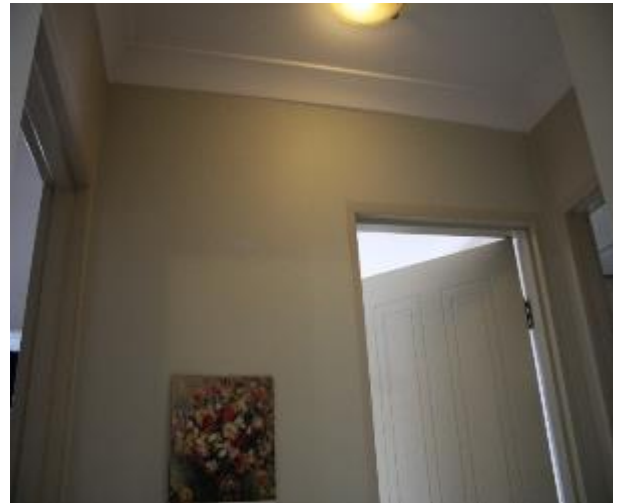
Figure 1463 - General condition of corridor internal wall

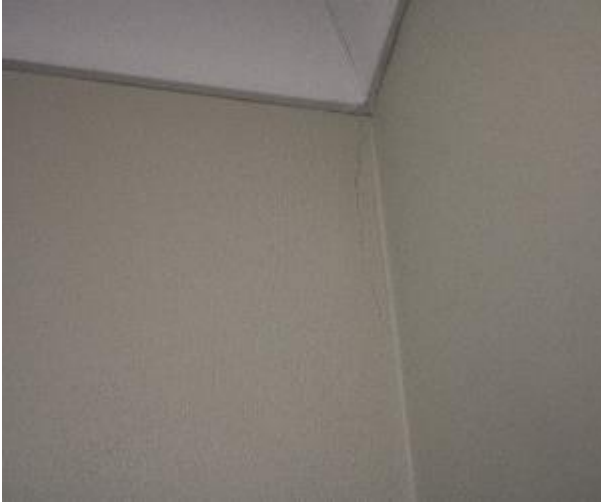
Figure 1466 - Crack propagation through corridor internal wall

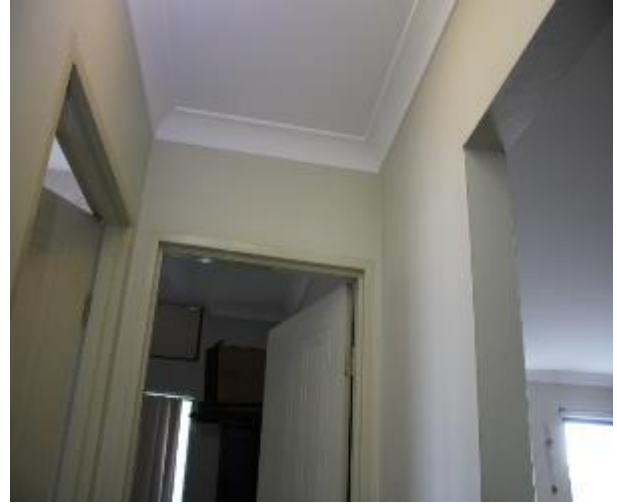
Figure 1467 - General condition of corridor internal wall

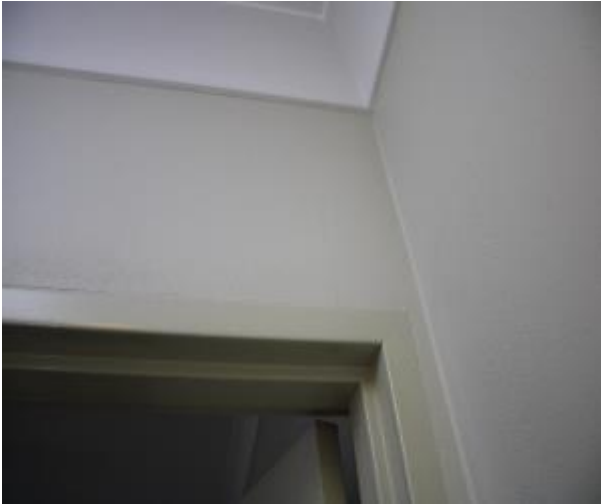
Figure 1468 - Crack propagation through corridor internal wall

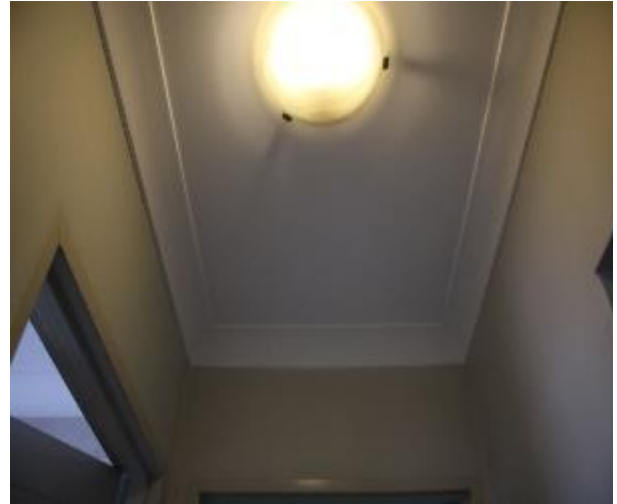
Figure 1469 - General condition of corridor ceiling

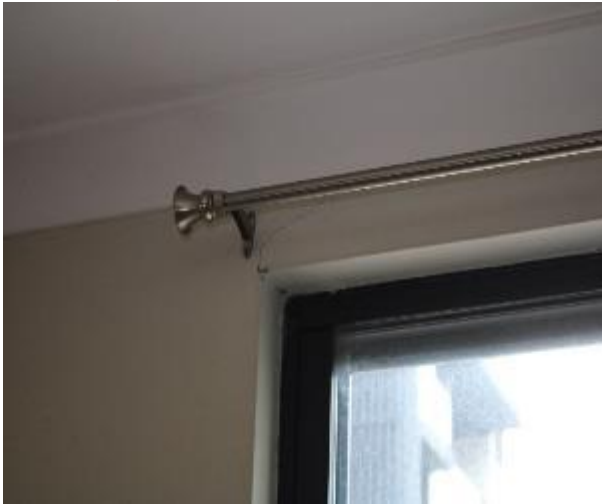
Figure 1472 - Crack propagation through bedroom 1 internal wall

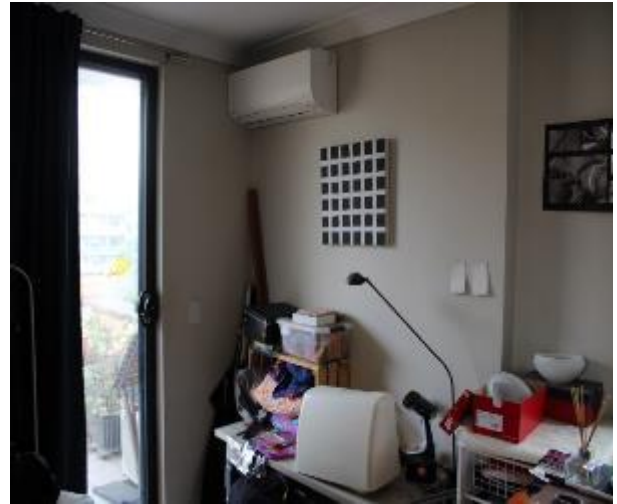
Figure 1473 - General condition of bedroom 1 internal wall

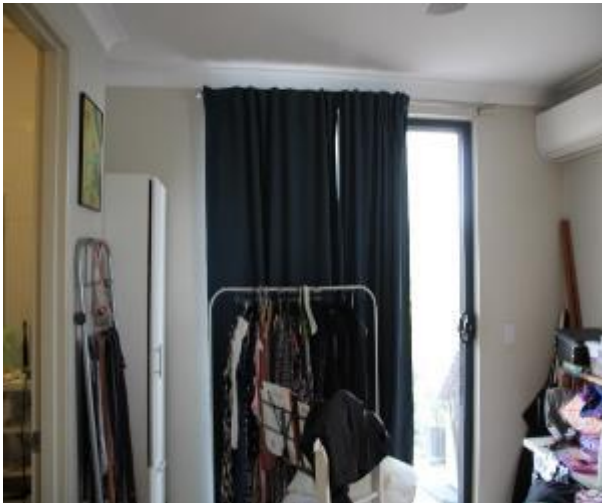
Figure 1474 - General condition of bedroom 1 internal wall

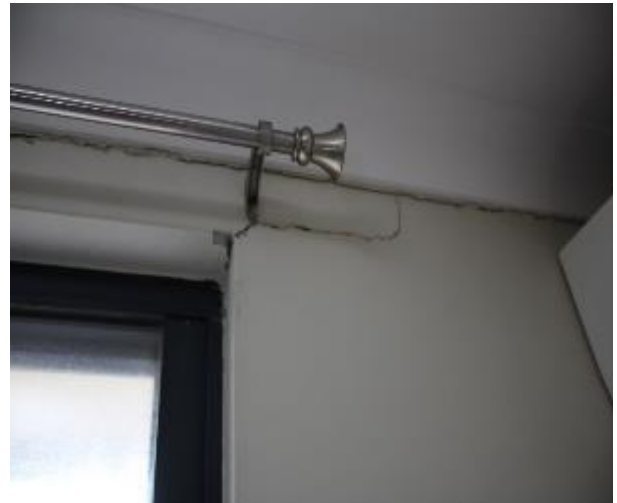
Figure 1475 - Crack propagation through bedroom 1 internal wall

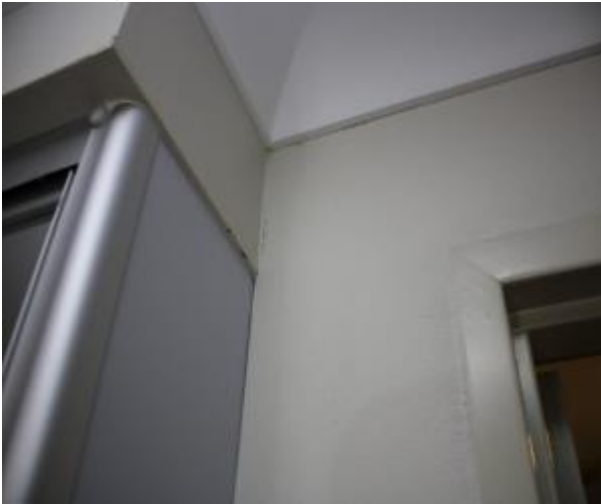
Figure 1478 - Crack propagation through bedroom 1 internal wall

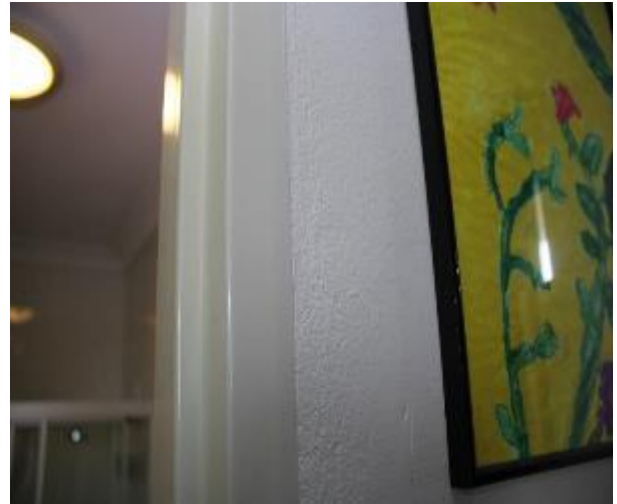
Figure 1479 - Crack propagation through bedroom 1 internal wall

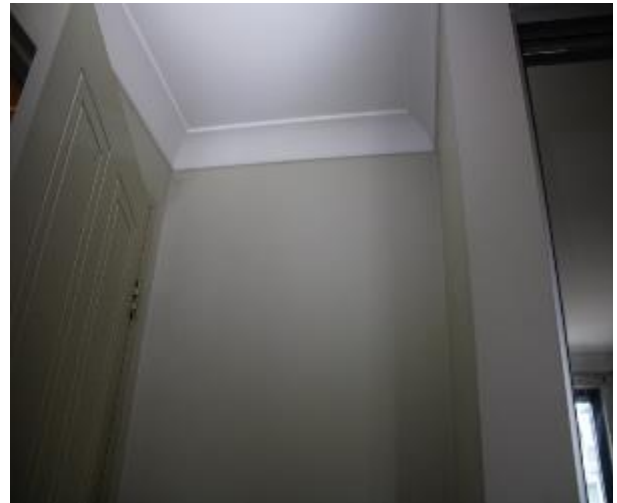
Figure 1481 - General condition of bedroom 1 internal wall

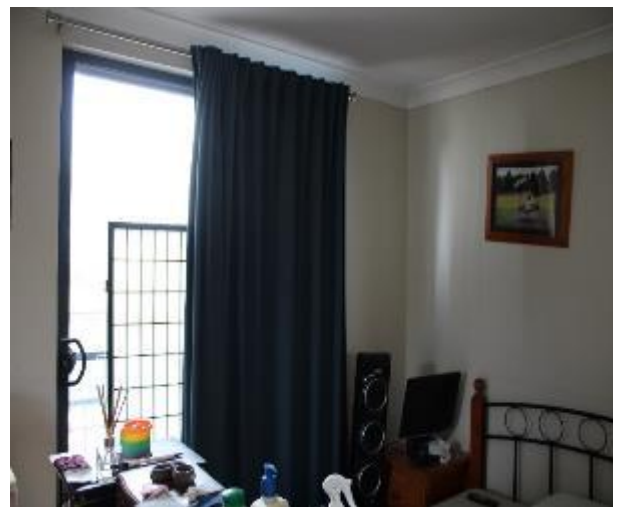
Figure 1483 - General condition of bedroom 1 internal wall

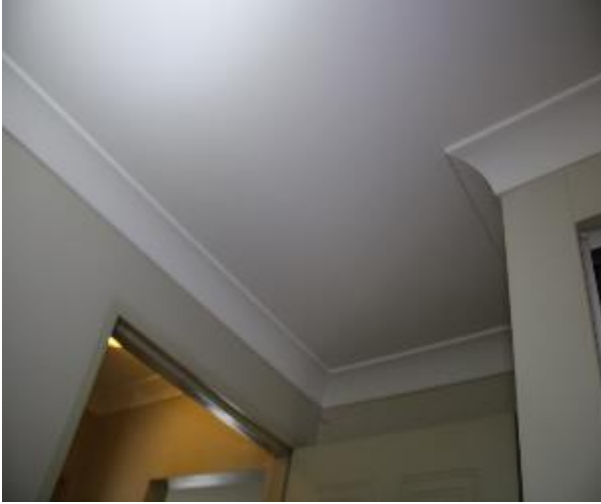
Figure 1484 - General condition of bedroom 1 ceiling

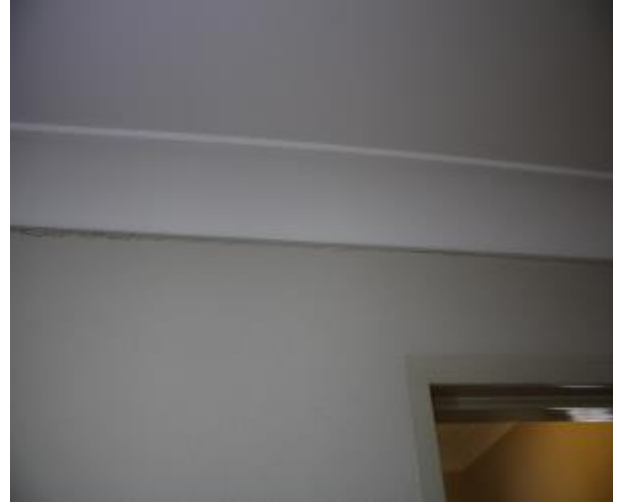
Figure 1485 - Crack propagation through bedroom 1 ceiling

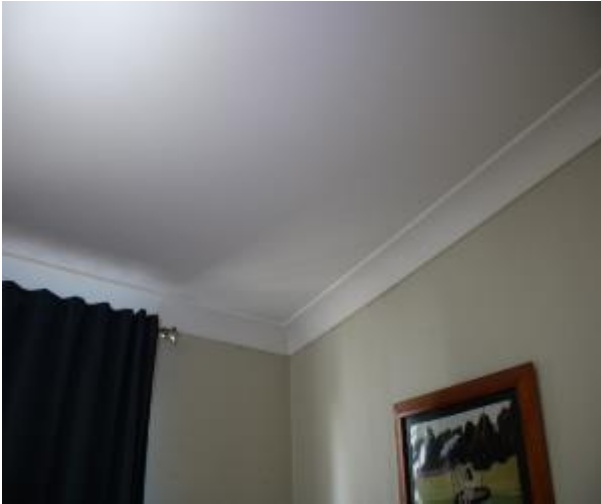
Figure 1486 - General condition of bedroom 1 ceiling

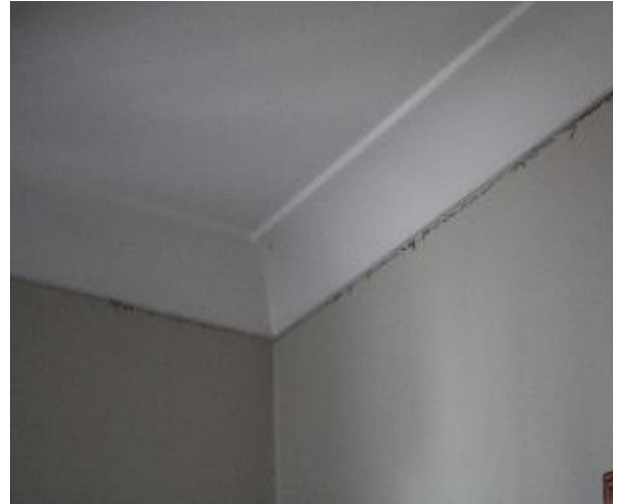
Figure 1487 - Crack propagation through bedroom 1 ceiling

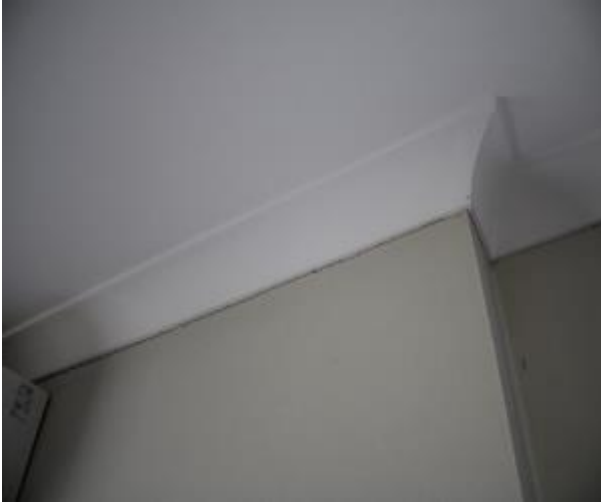
Figure 1490 - Crack propagation through bedroom 1 ceiling

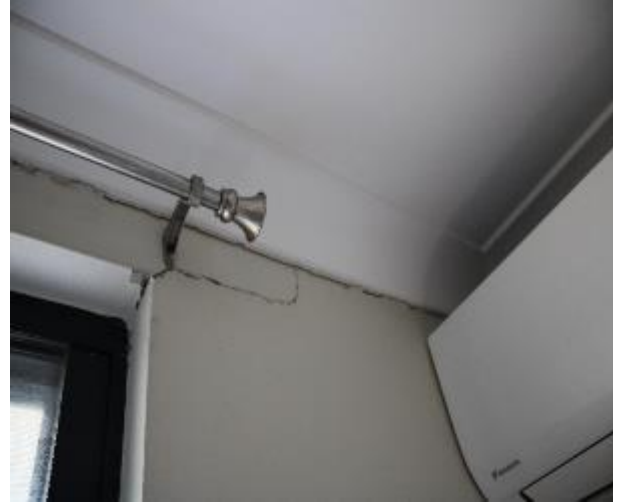
Figure 1491 - Crack propagation through bedroom 1 ceiling

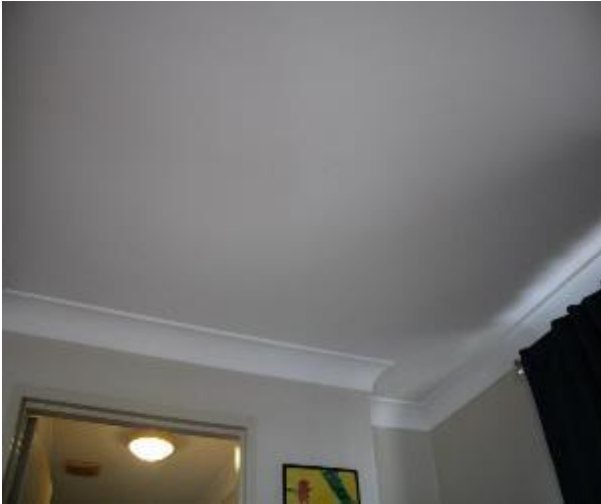
Figure 1492 - General condition of bedroom 1 ceiling

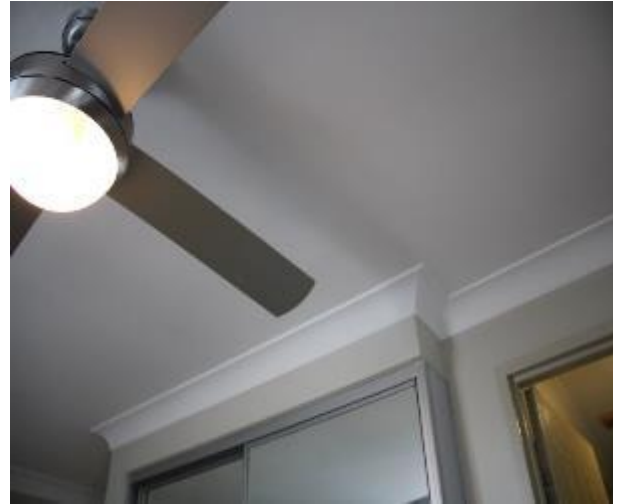
Figure 1493 - General condition of bedroom 1 ceiling

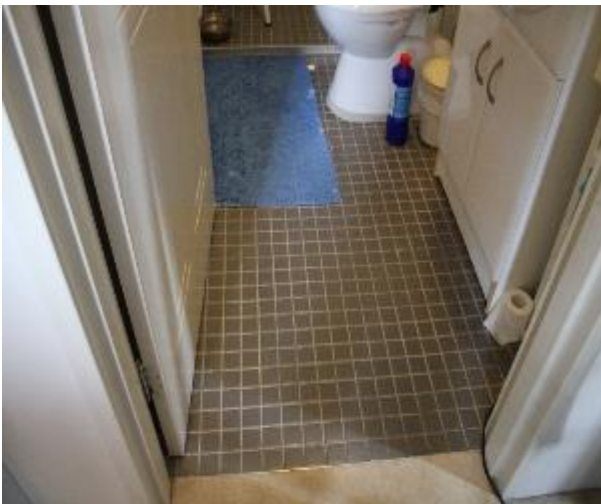
Figure 1494 - General condition of ensuite bathroom floor tiles

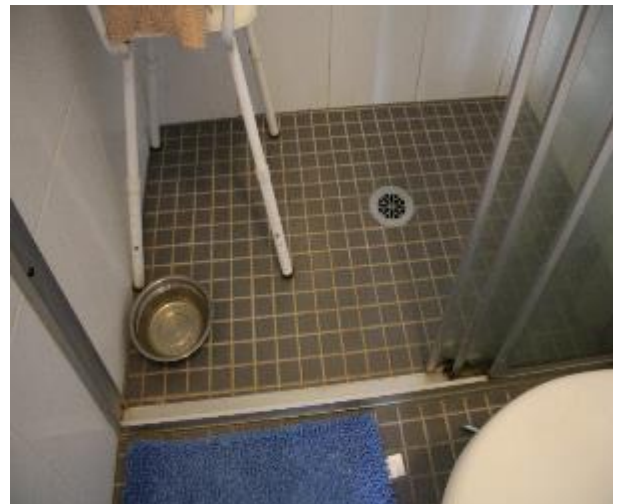
Figure 1495 - General condition of ensuite bathroom floor tiles

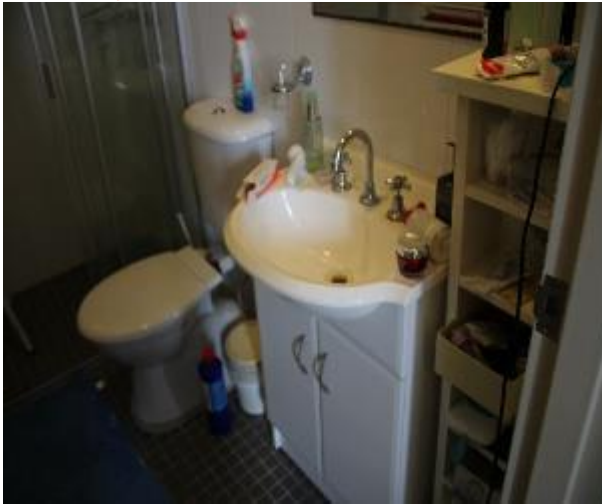
Figure 1496 - General condition of ensuite bathroom internal wall

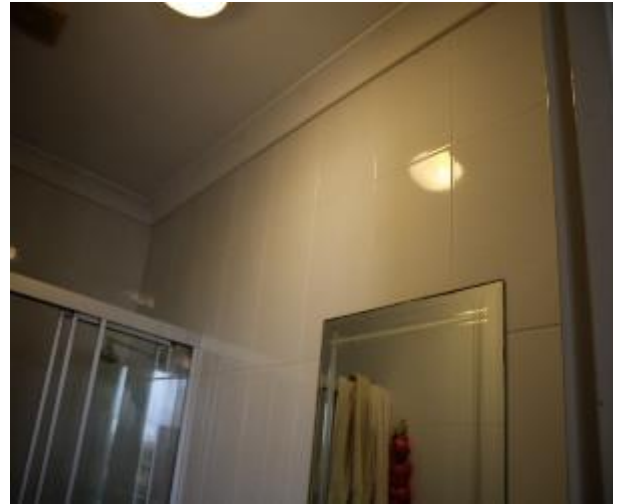
Figure 1497 - General condition of ensuite bathroom internal wall

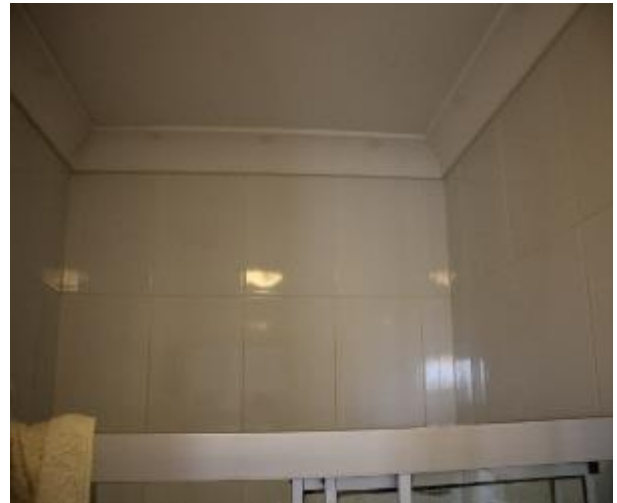
Figure 1499 - General condition of ensuite bathroom internal wall

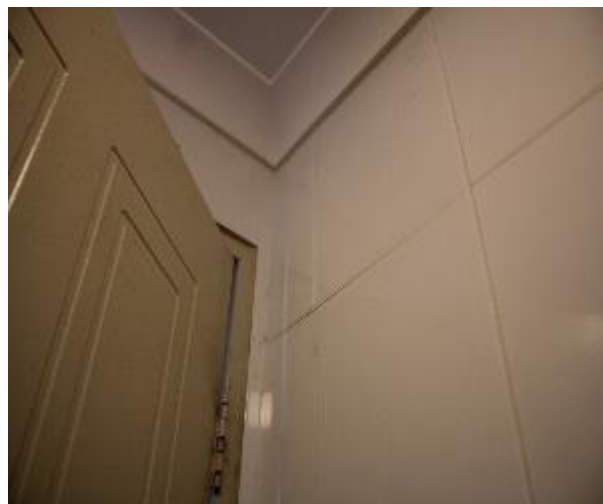
Figure 1503 - General condition of ensuite bathroom internal wall

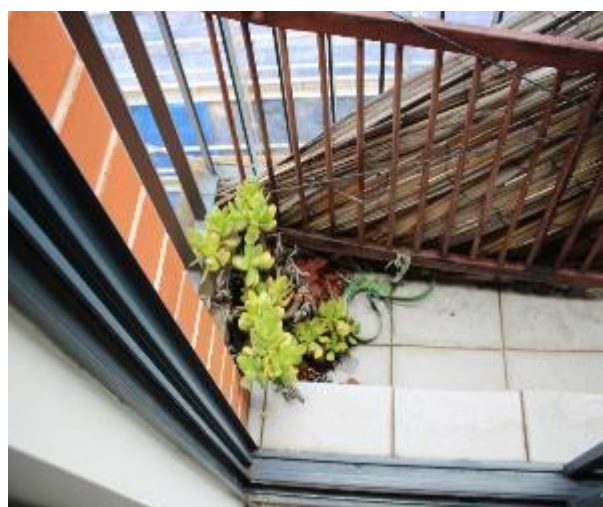
Figure 1507 - General condition of balcony 1 floor tiles

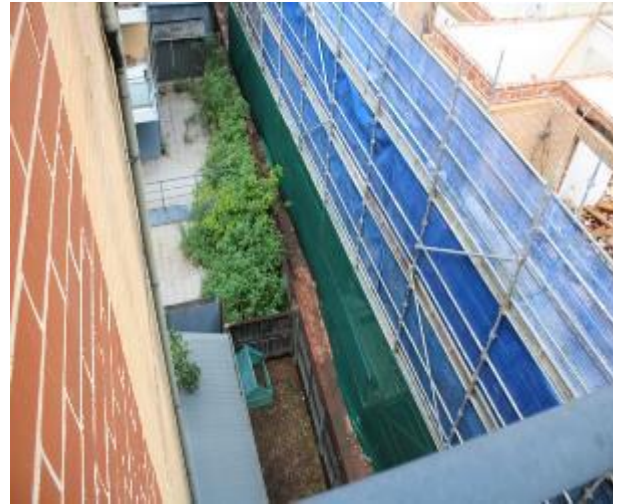
Figure 1509 - General condition of boundary as seen from Unit 29 balcony 1

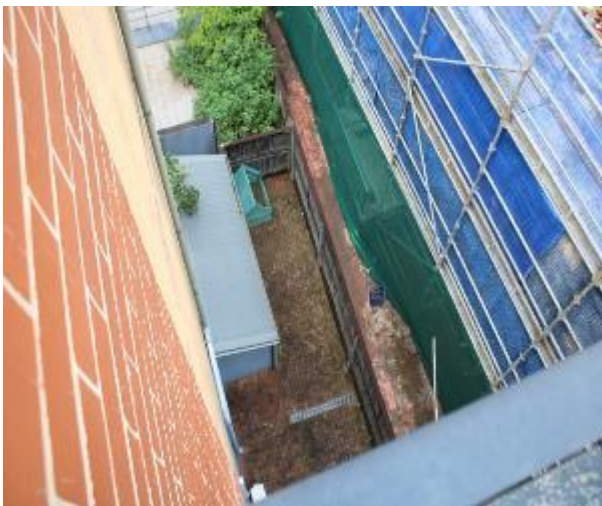
Figure 1510 - General condition of boundary as seen from Unit 29 balcony 1

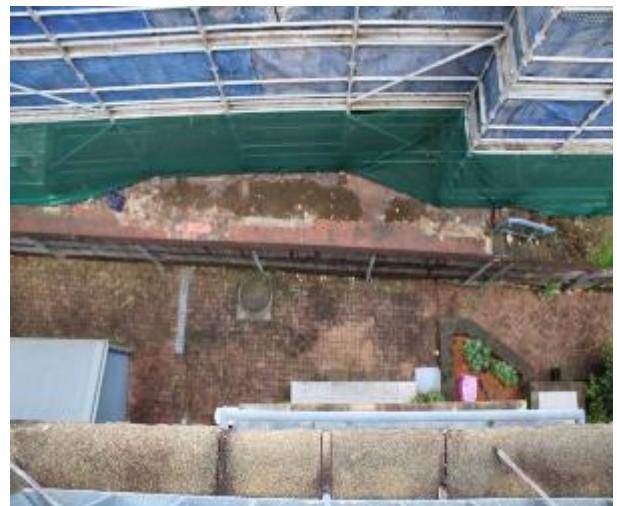
Figure 1511 - General condition of boundary as seen from Unit 29 balcony 1

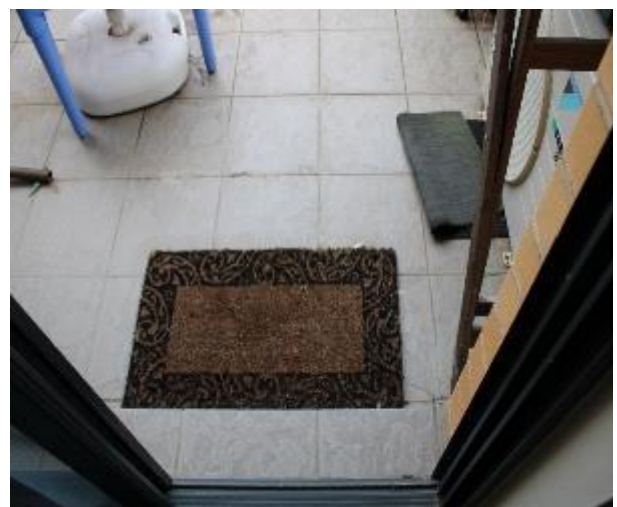
Figure 1513 - General condition of balcony 2 floor tiles
