# **Pre-Dilapidation Report**

**19 GEORGE STREET**

**REAR BUILDING (UNITS 20-29)**

Project Reference: 20250047.19G.3

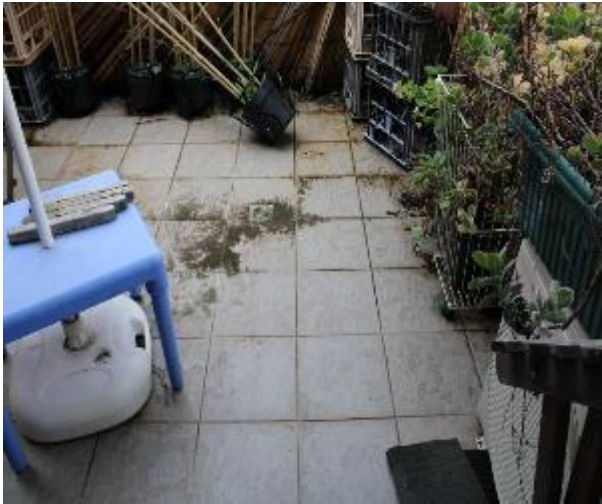
Figure 1514 - General condition of balcony 2 floor tiles

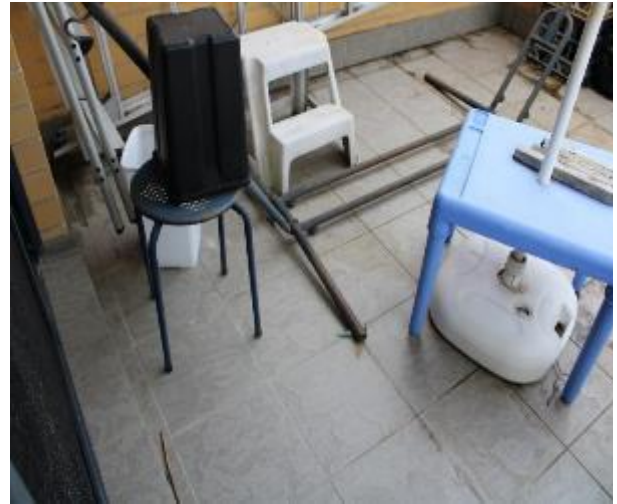
Figure 1515 - General condition of balcony 2 floor tiles

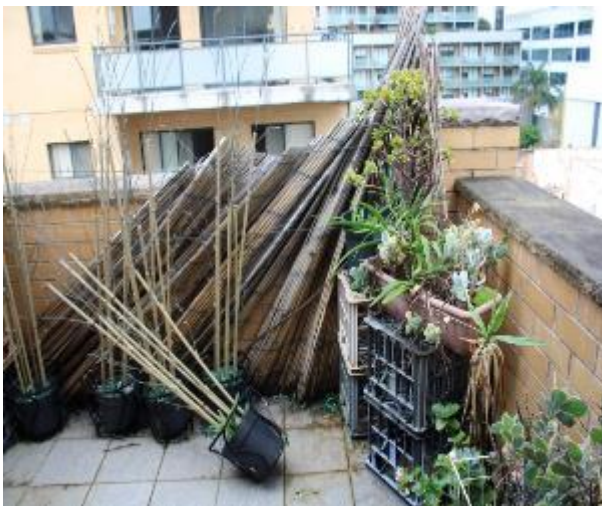
Figure 1516 - General condition of external wall

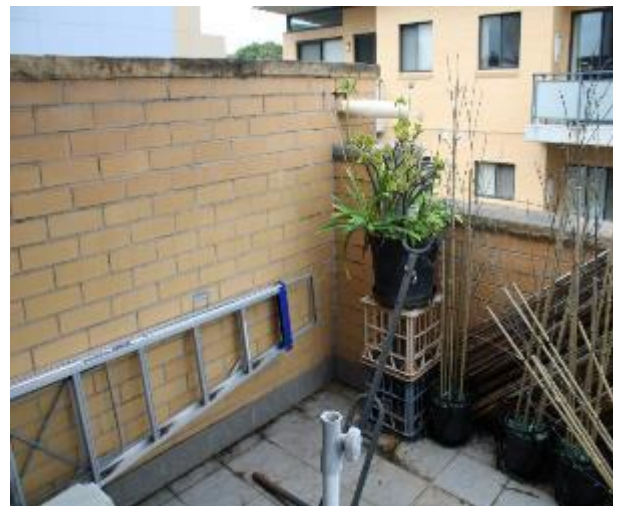
Figure 1517 - General condition of external wall

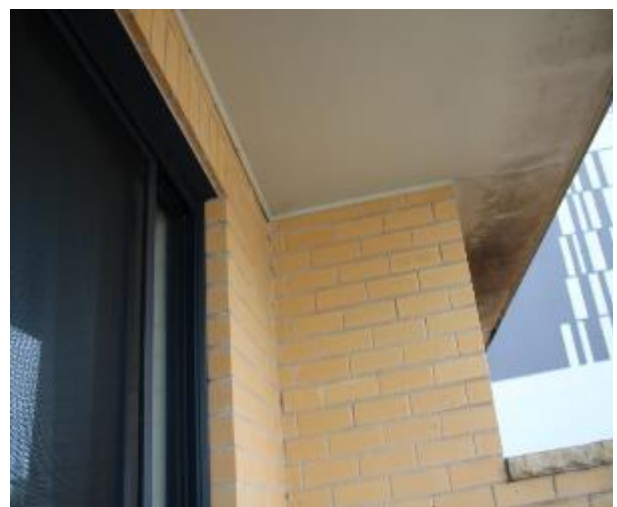
Figure 1519 - General condition of external wall

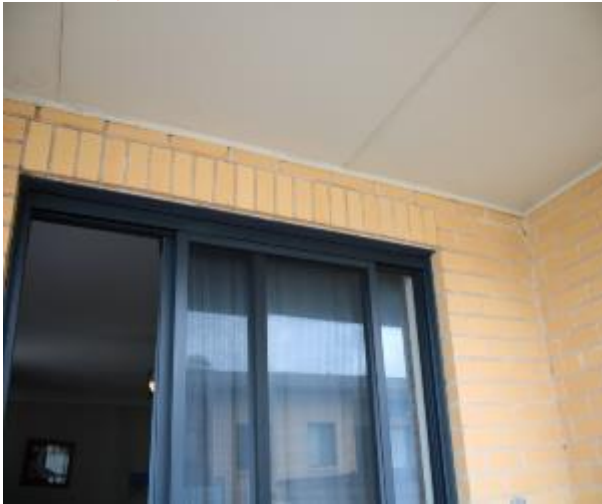
Figure 1520 - General condition of external wall

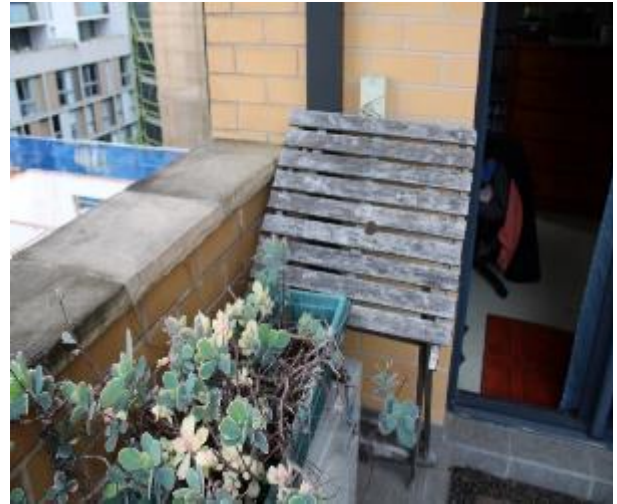
Figure 1521 - General condition of external wall

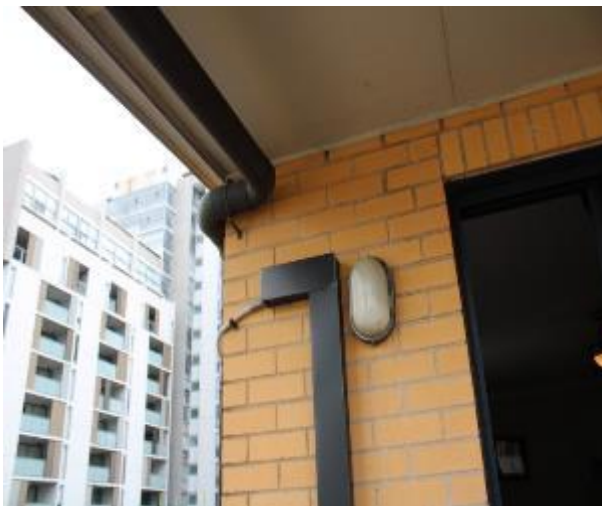
Figure 1522 - General condition of external wall

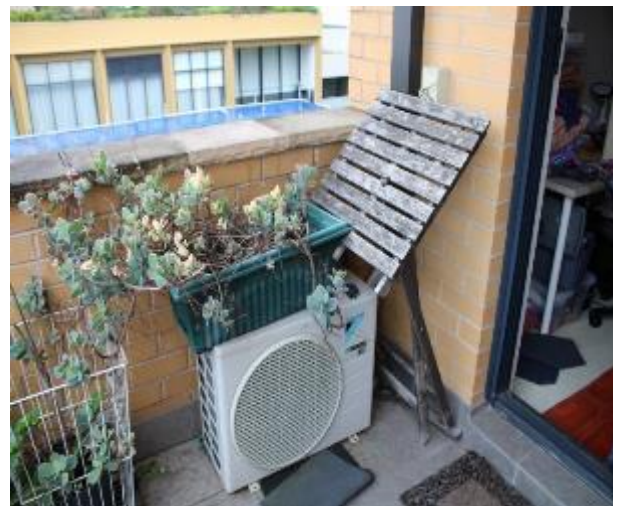
Figure 1523 - General condition of external wall

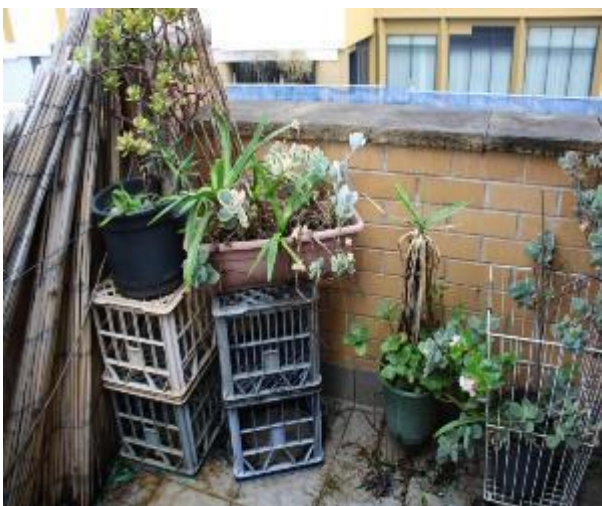
Figure 1524 - General condition of external wall

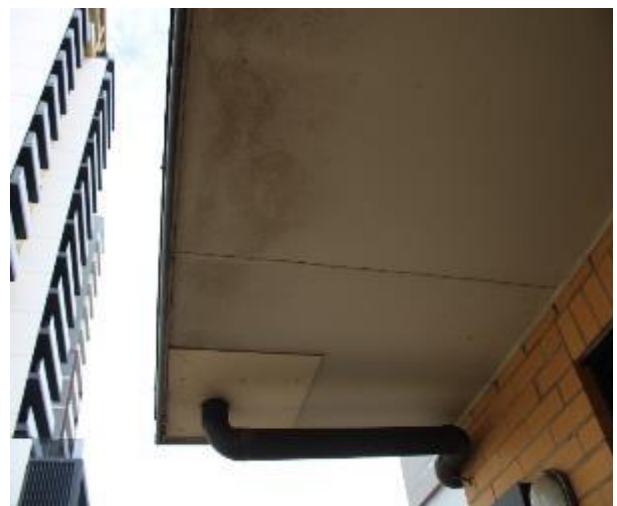
Figure 1525 - General condition of balcony underside slab

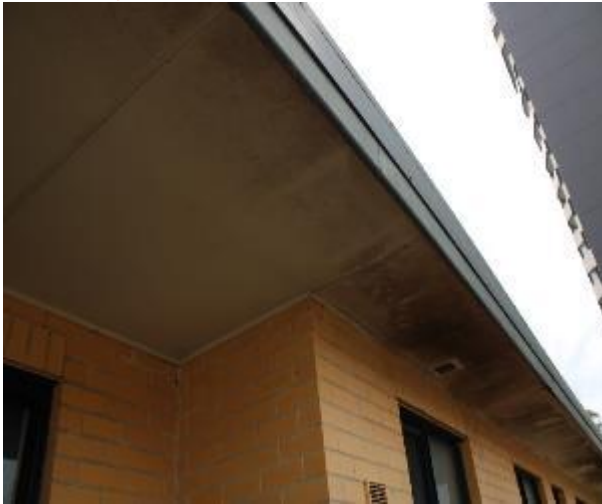
Figure 1526 - General condition of balcony underside slab

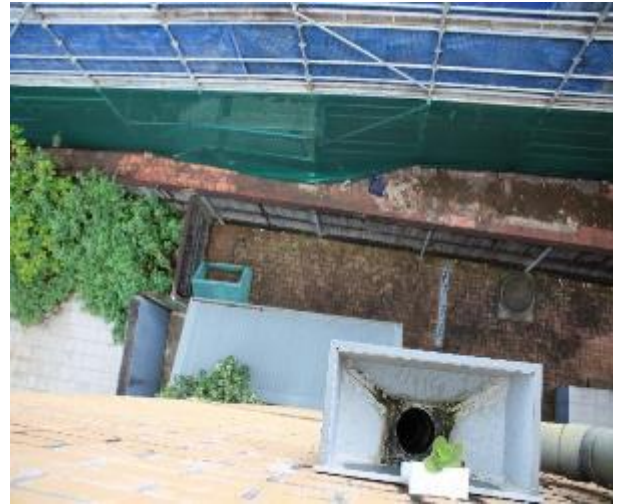
Figure 1527 - General condition of boundary as seen from Unit 29 balcony 2

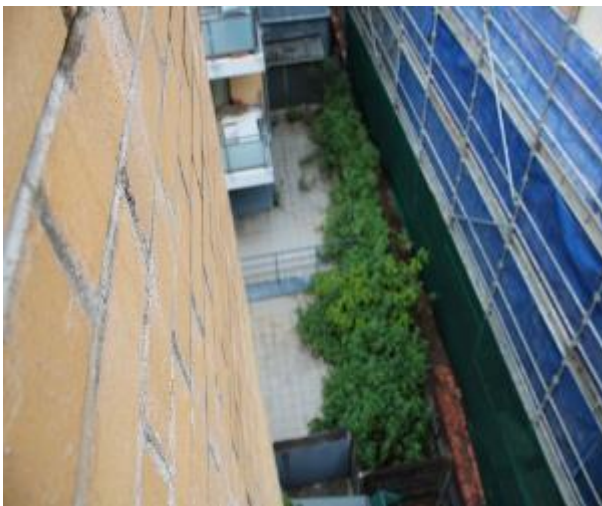
Figure 1528 - General condition of boundary as seen from Unit 29 balcony 2

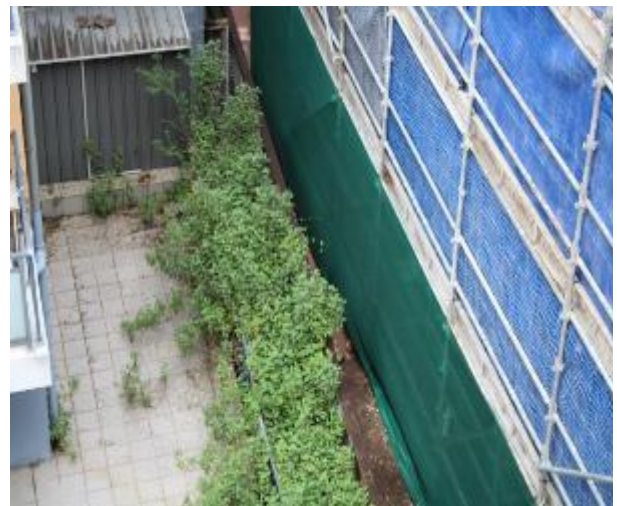
Figure 1529 - General condition of boundary as seen from Unit 29 balcony 2

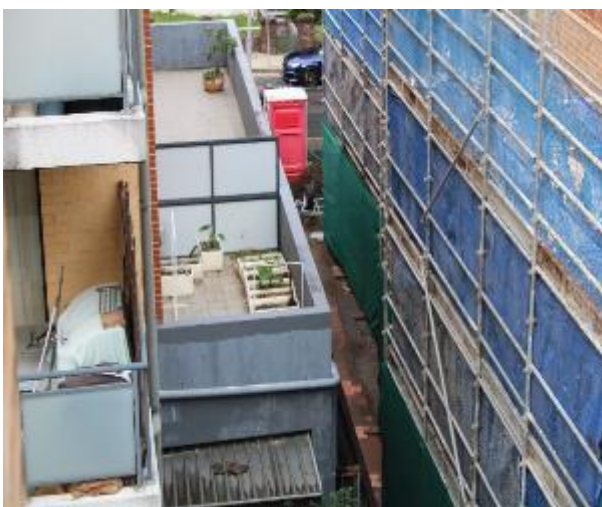
Figure 1530 - General condition of boundary as seen from Unit 29 balcony 2

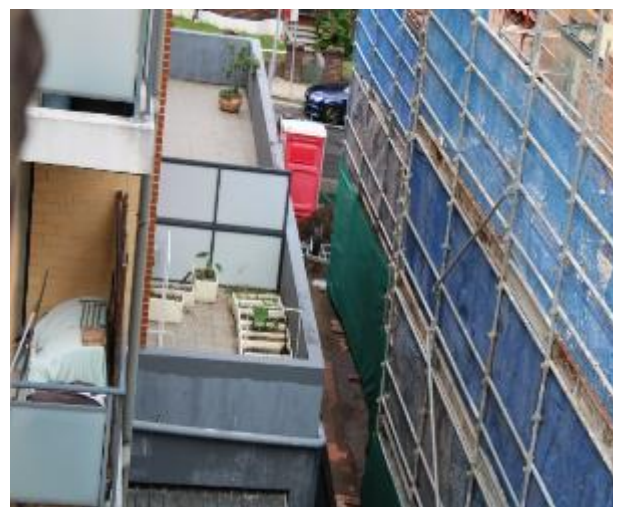
Figure 1531 - General condition of boundary as seen from Unit 29 balcony 2

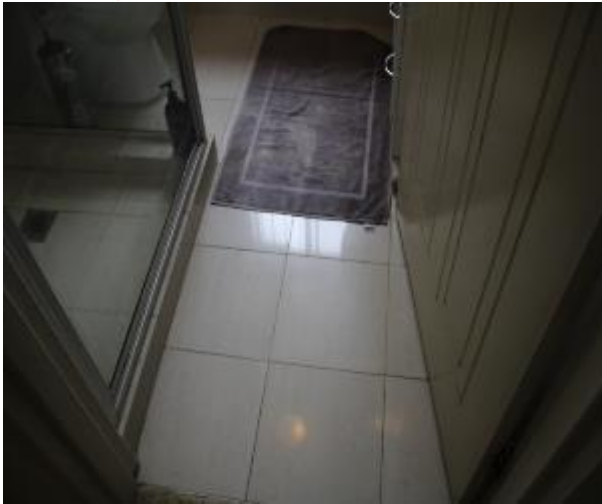
Figure 1532 - General condition of bathroom 1 floor tiles

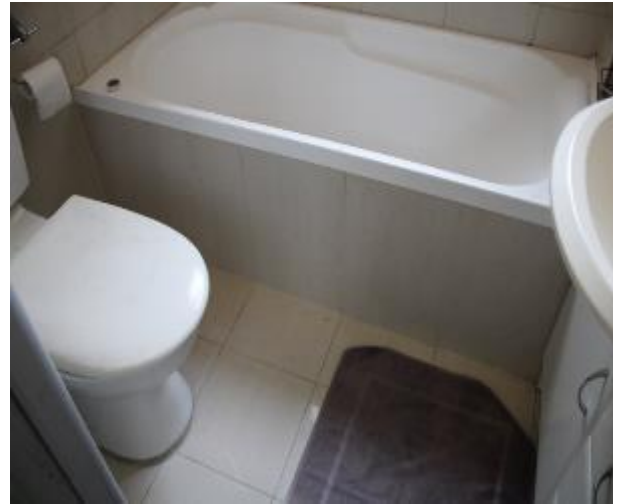
Figure 1533 - General condition of bathroom 1 floor tiles

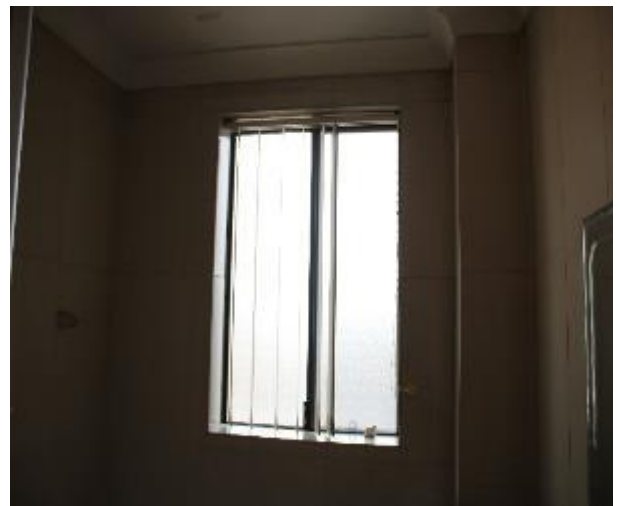
Figure 1535 - General condition of bathroom 1 internal wall

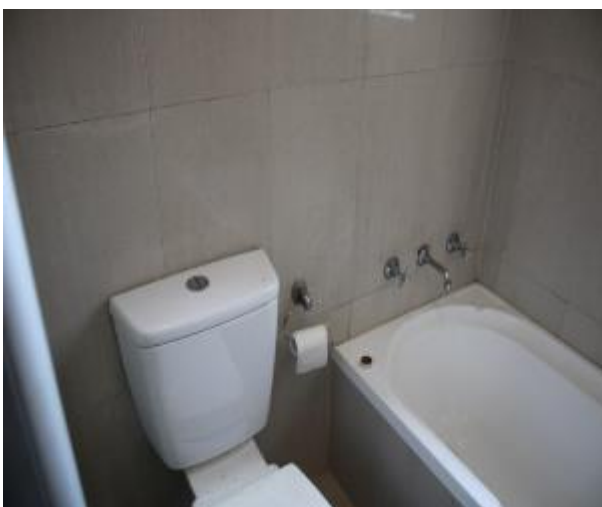
Figure 1536 - General condition of bathroom 1 internal wall

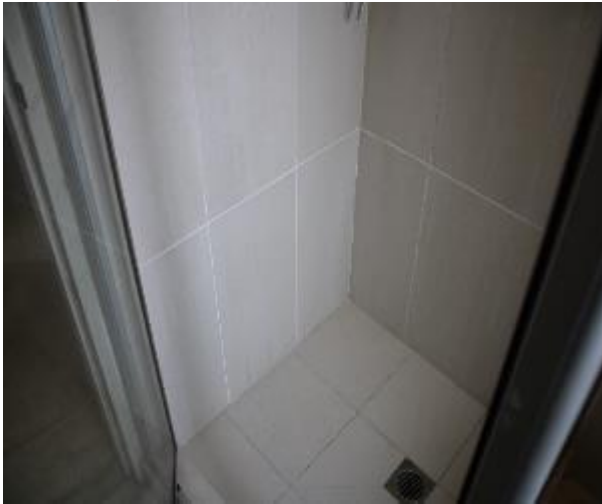
Figure 1538 - General condition of bathroom 1 internal wall

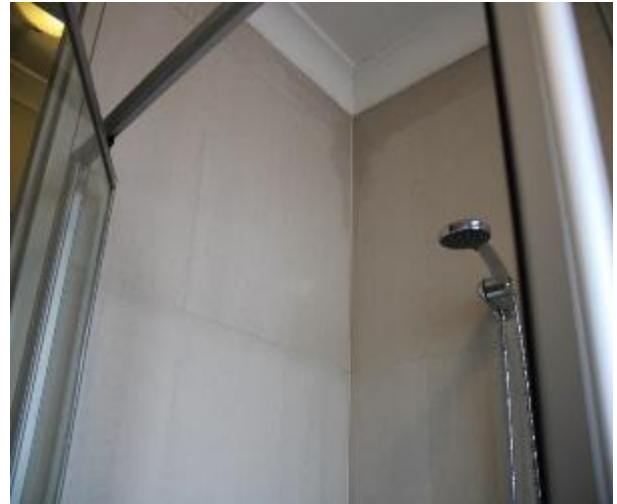
Figure 1539 - General condition of bathroom 1 internal wall

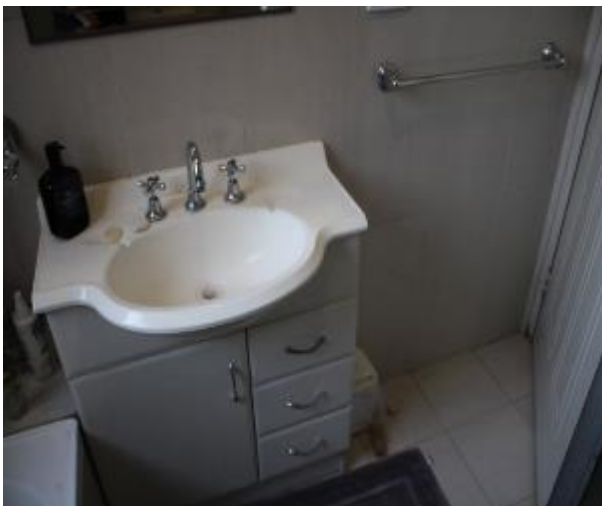
Figure 1540 - General condition of bathroom 1 internal wall

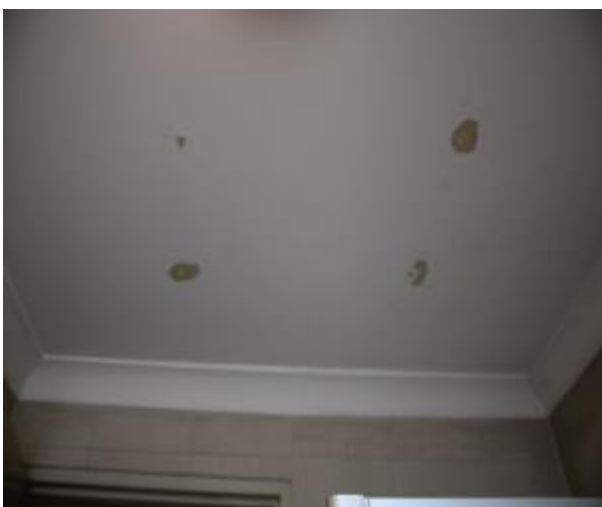
Figure 1542 - General condition of bathroom 1 ceiling

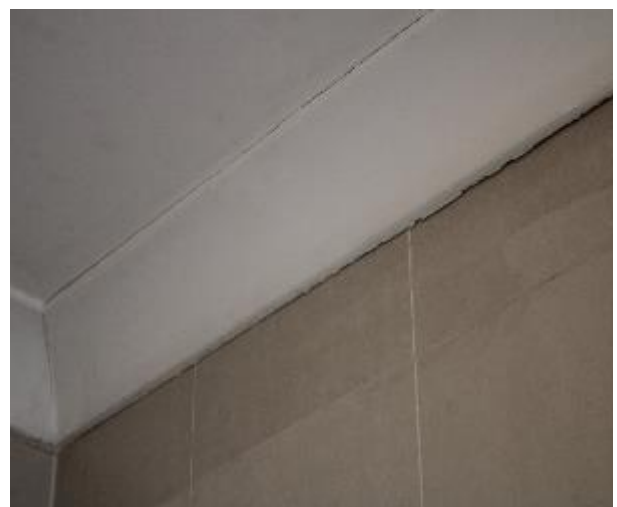
Figure 1543 - Crack propagation through bathroom 1 ceiling

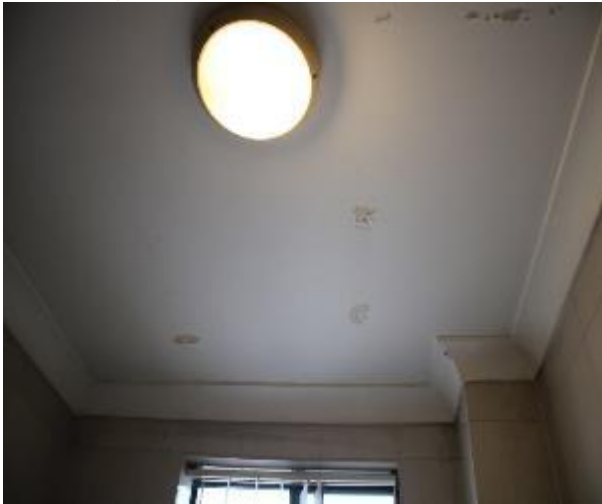
Figure 1544 - General condition of bathroom 1 ceiling

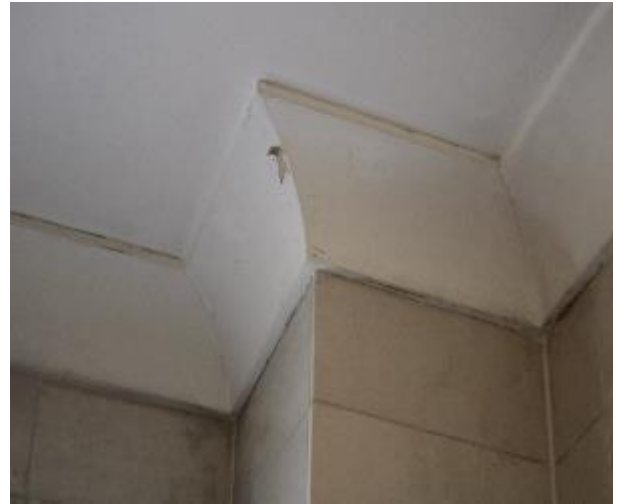
Figure 1545 - Crack propagation and paint flaking through bathroom 1 ceiling

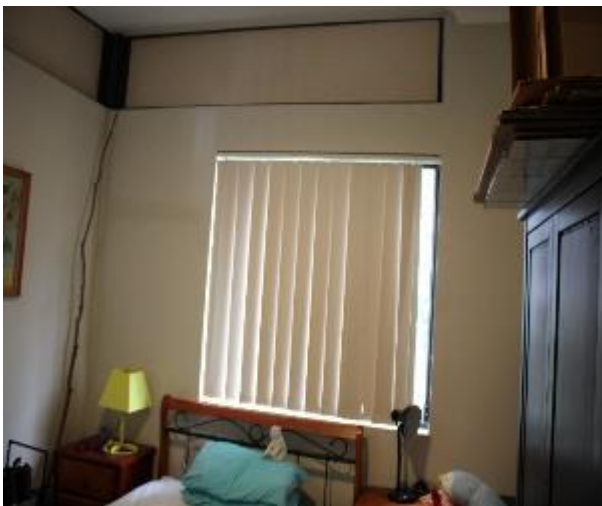
Figure 1546 - General condition of bedroom 2 internal wall

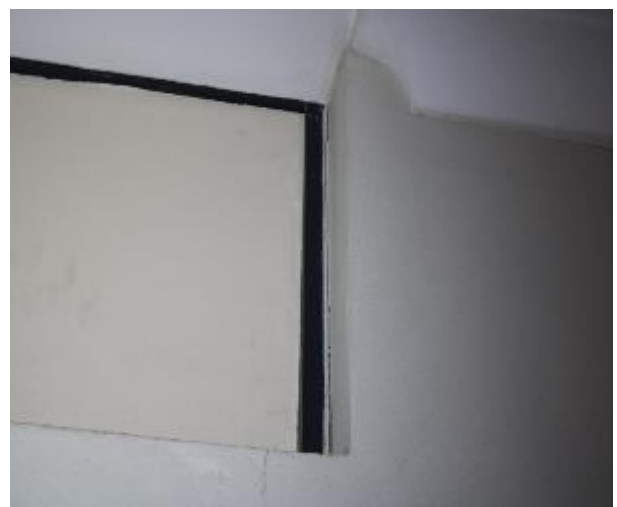
Figure 1549 - Crack propagation through bedroom 2 internal wall

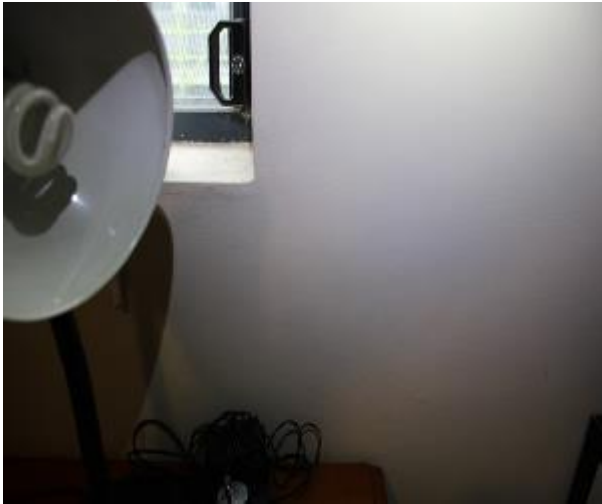
Figure 1550 - Crack propagation through bedroom 2 internal wall

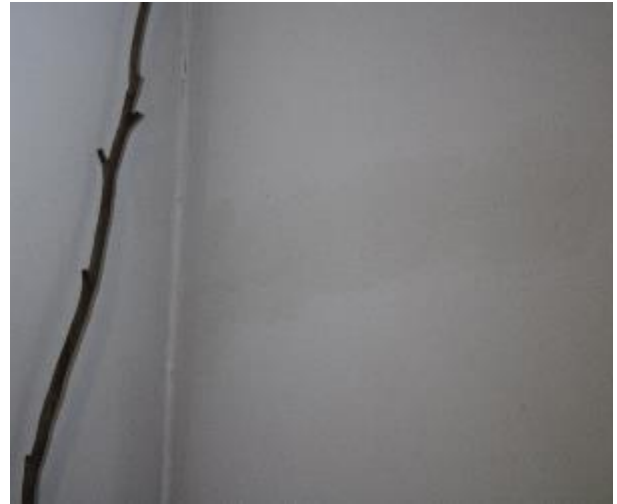
Figure 1551 - Crack propagation through bedroom 2 internal wall

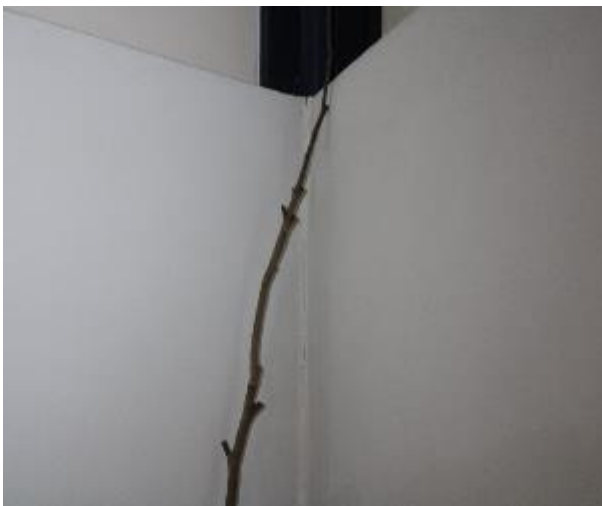
Figure 1552 - Crack propagation through bedroom 2 internal wall

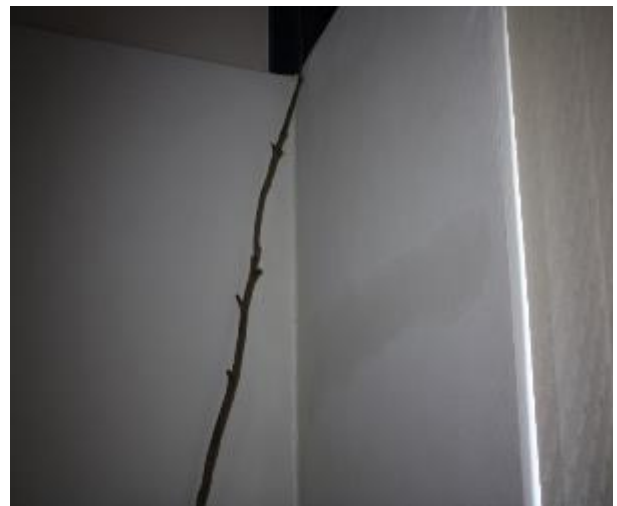
Figure 1553 - Crack propagation through bedroom 2 internal wall

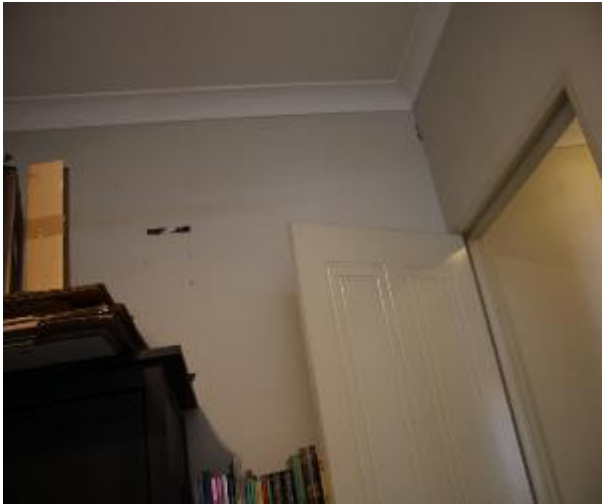
Figure 1556 - General condition of bedroom 2 internal wall

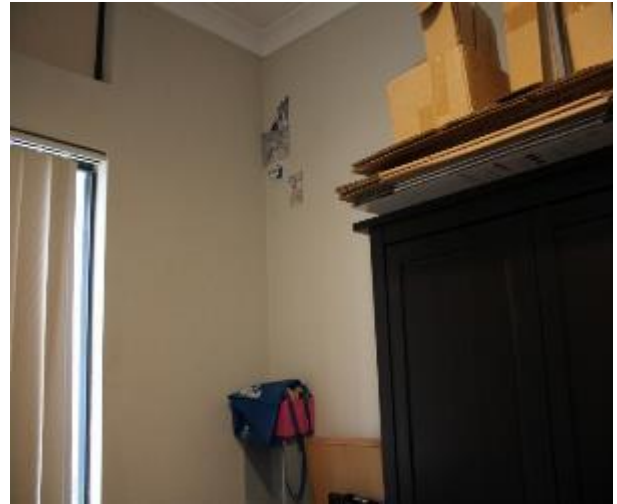
Figure 1557 - General condition of bedroom 2 internal wall

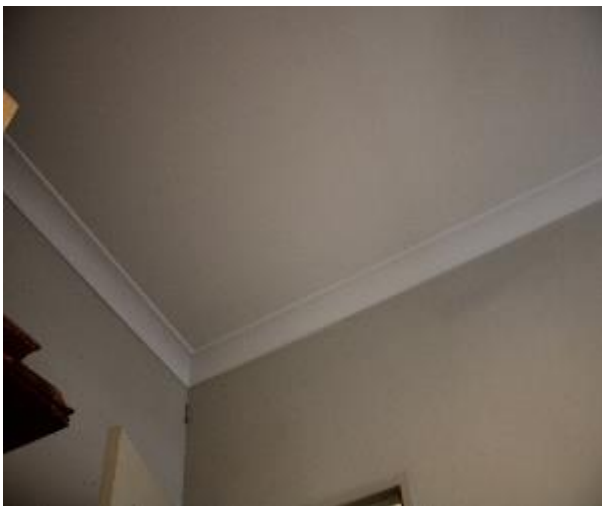
Figure 1558 - General condition of bedroom 2 ceiling

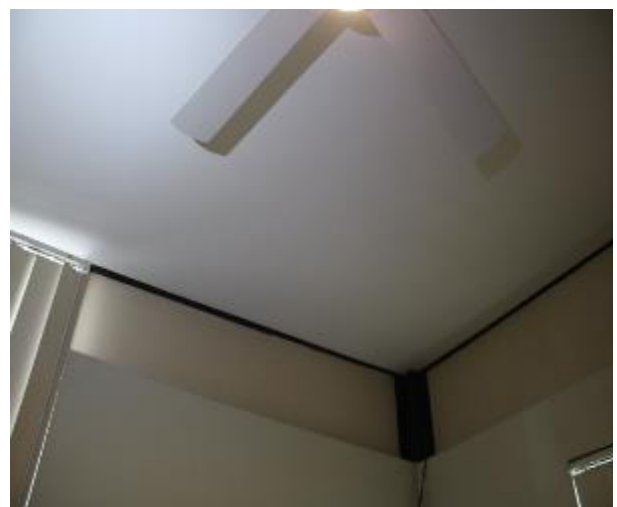
Figure 1561 - General condition of bedroom 2 ceiling

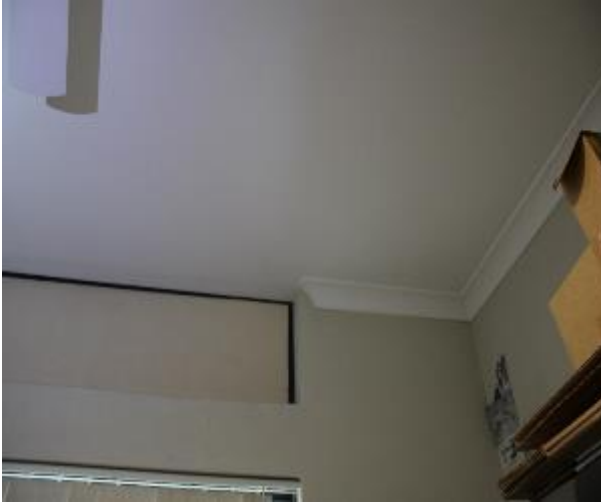
Figure 1562 - General condition of bedroom 2 ceiling

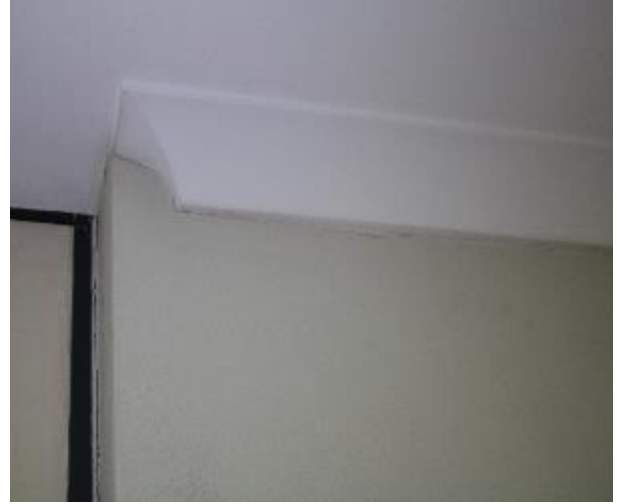
Figure 1563 - Crack propagation through bedroom 2 ceiling

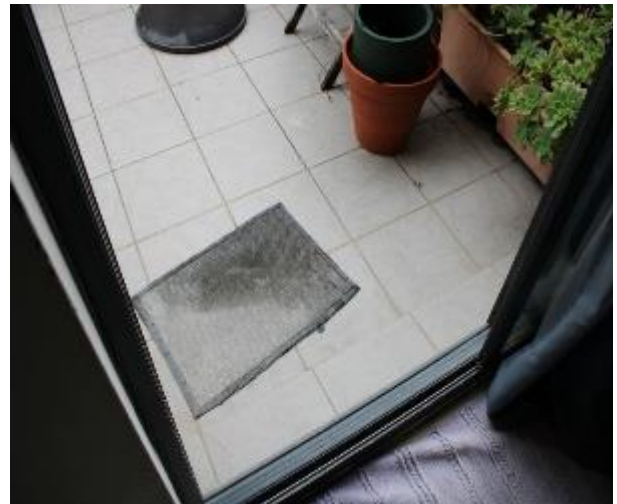
Figure 1565 - General condition of balcony 3 floor tiles

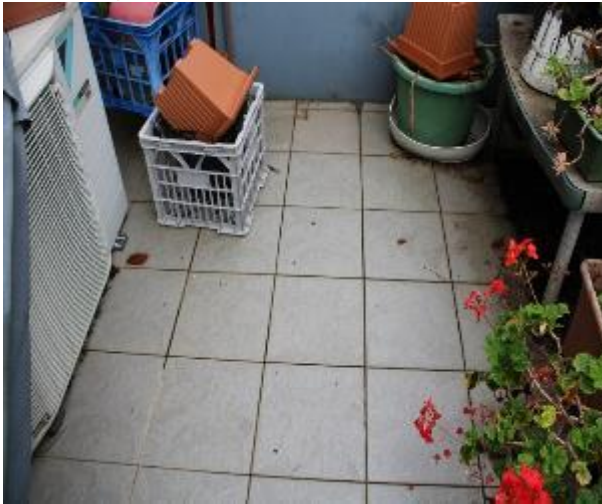
Figure 1568 - General condition of balcony 3 floor tiles

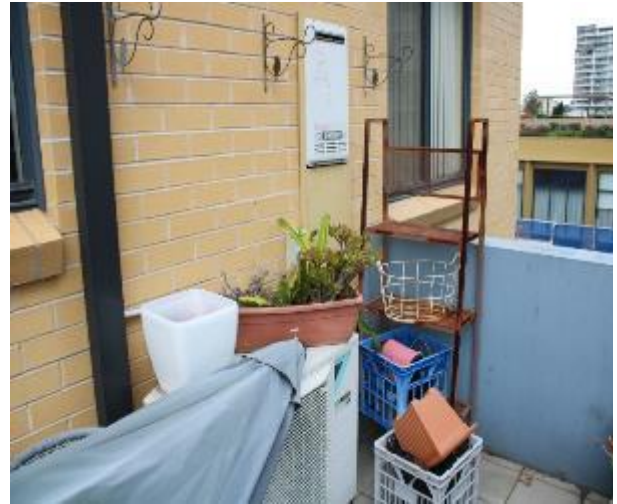
Figure 1569 - General condition of external wall

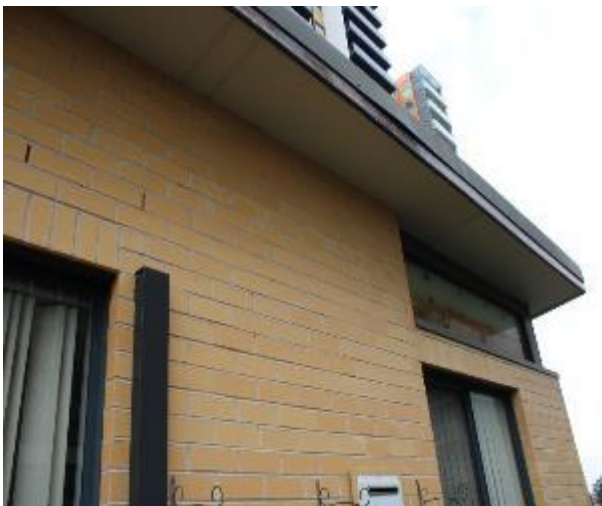
Figure 1570 - General condition of external wall

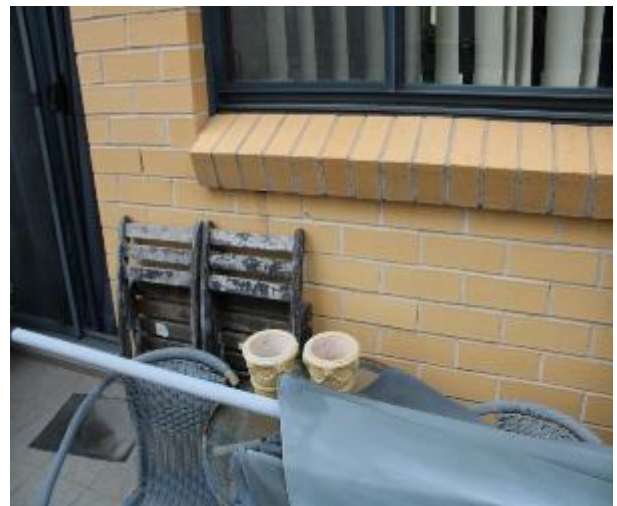
Figure 1571 - General condition of external wall

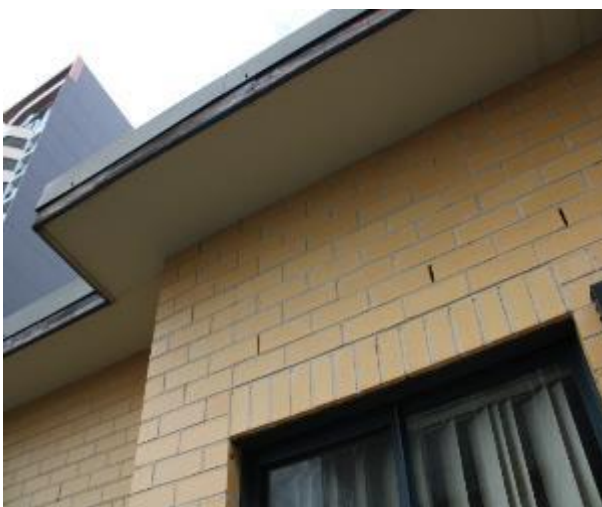
Figure 1572 - General condition of external wall

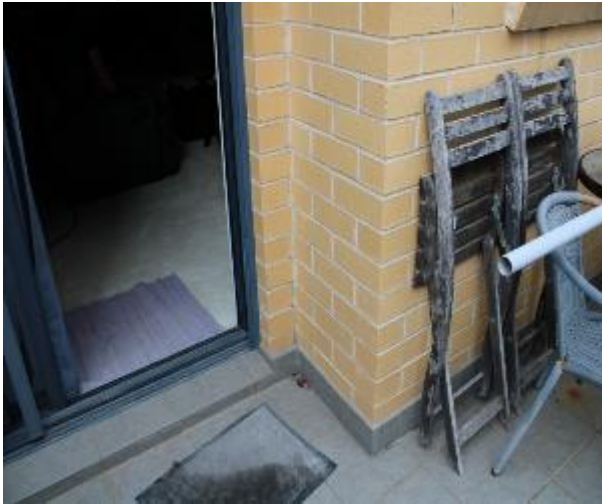
Figure 1574 - General condition of external wall

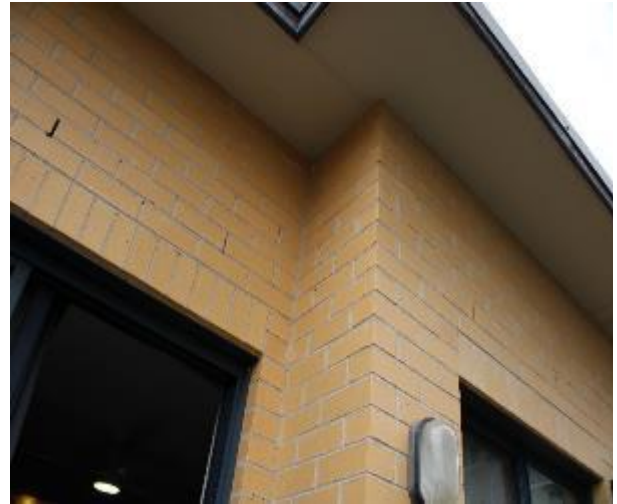
Figure 1575 - General condition of external wall

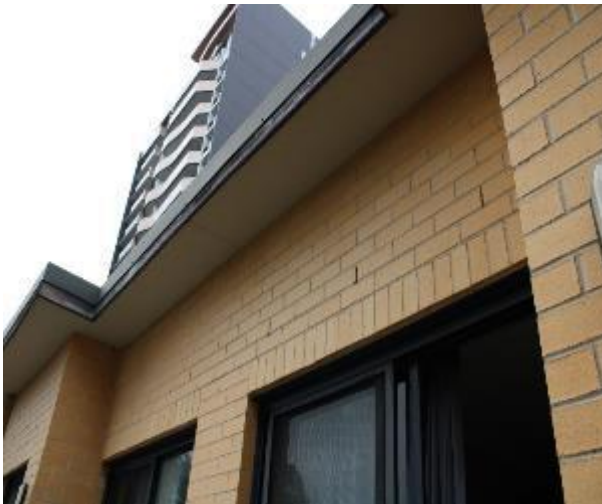
Figure 1576 - General condition of external wall

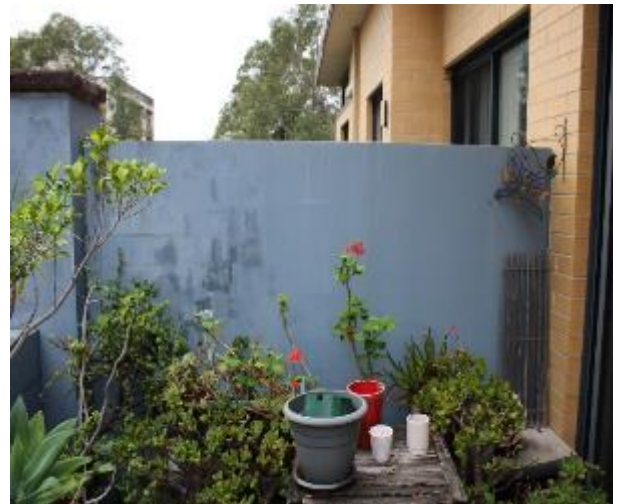
Figure 1577 - General condition of external wall

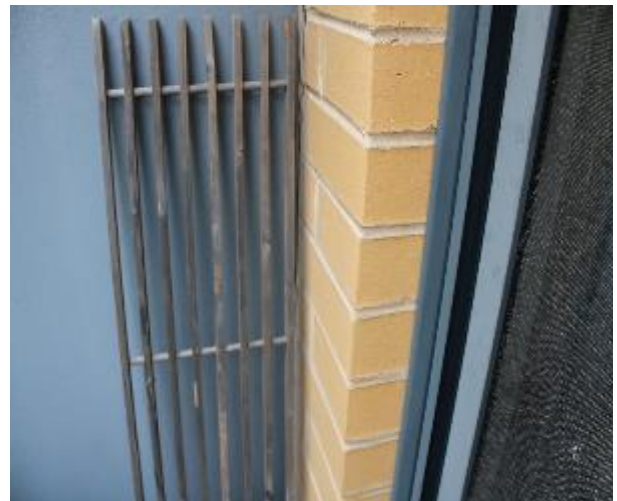
Figure 1579 - Crack propagation through external wall

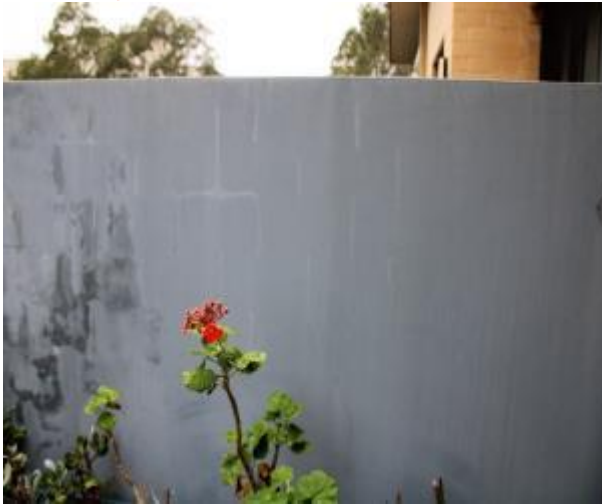
Figure 1580 - General condition of external wall

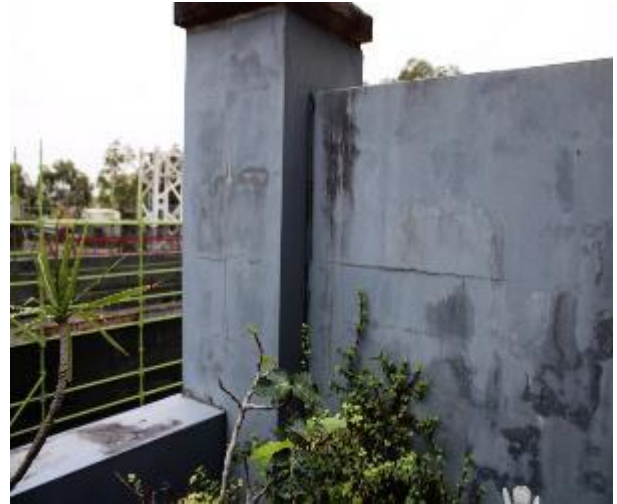
Figure 1581 - Crack propagation through external wall

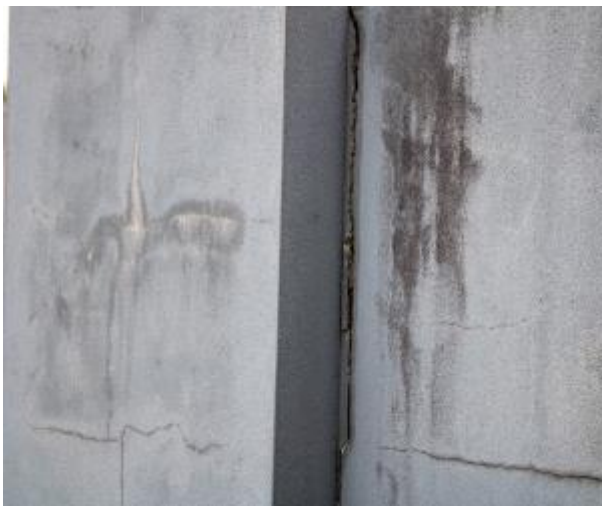
Figure 1582 - Crack propagation through external wall

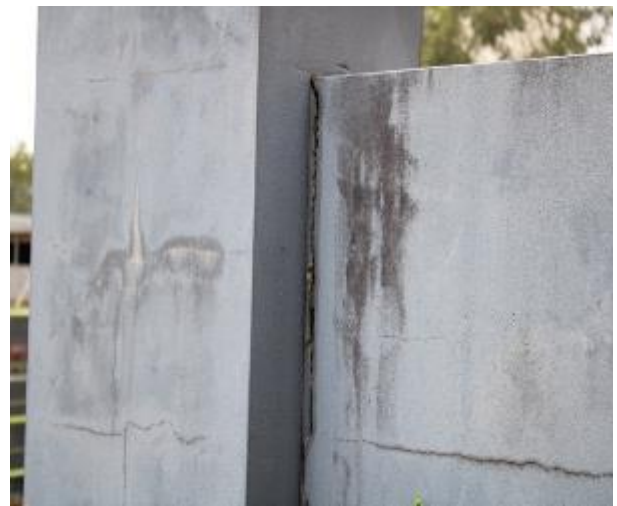
Figure 1583 - Crack propagation through external wall

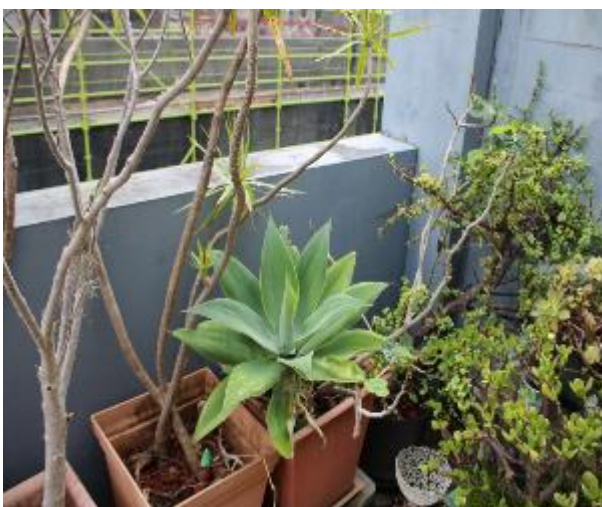
Figure 1584 - General condition of external wall

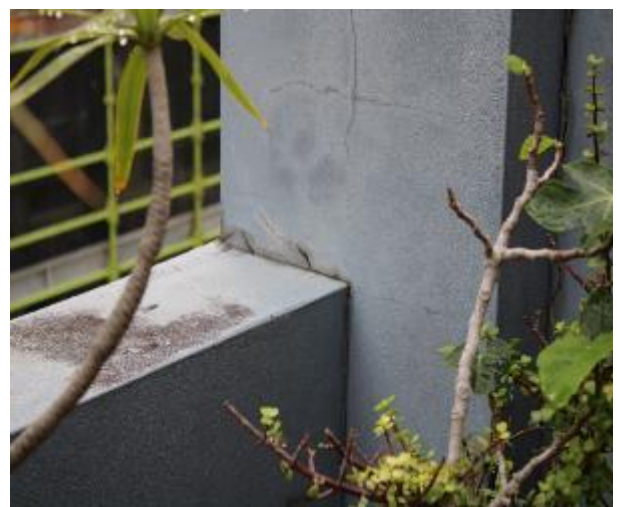
Figure 1585 - Crack propagation through external wall

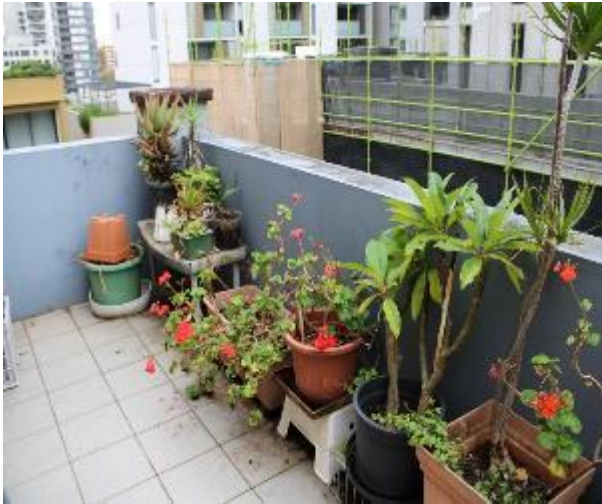
Figure 1586 - General condition of external wall

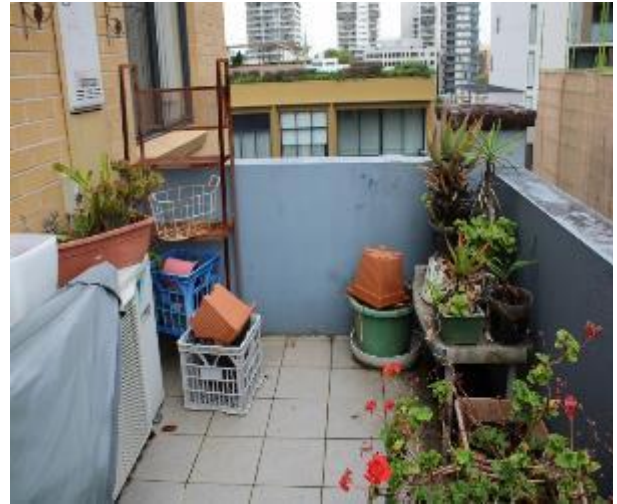
Figure 1587 - General condition of external wall

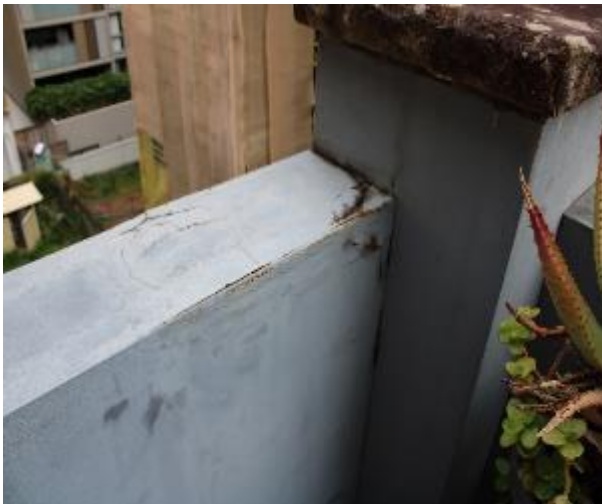
Figure 1588 - General condition of external wall

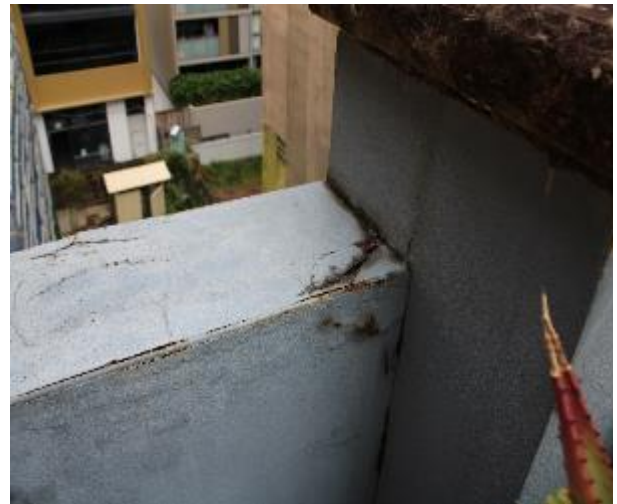
Figure 1589 - Crack propagation through external wall

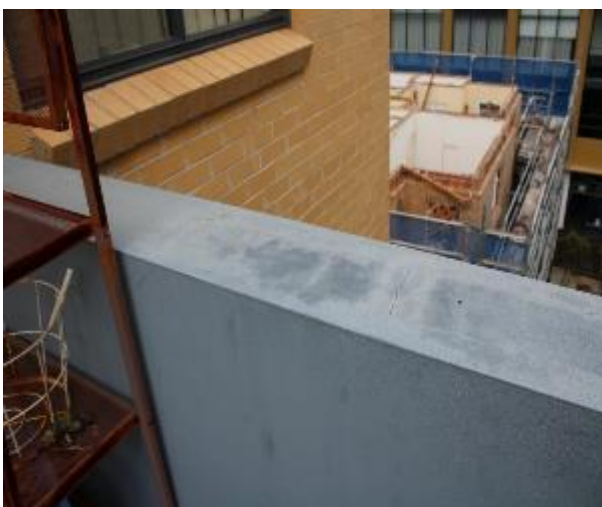
Figure 1590 - Crack propagation through external wall

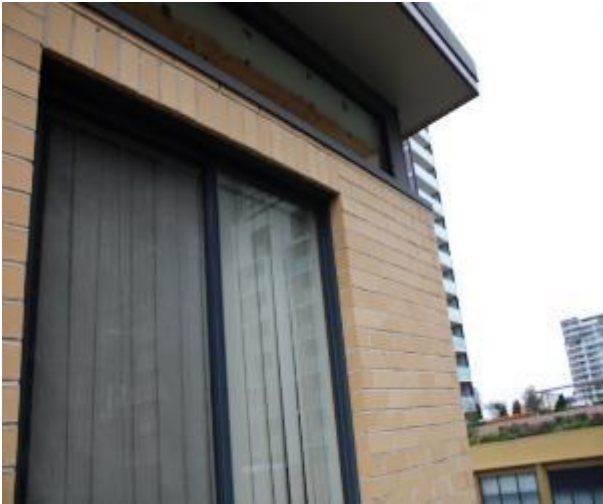
Figure 1592 - General condition of external wall

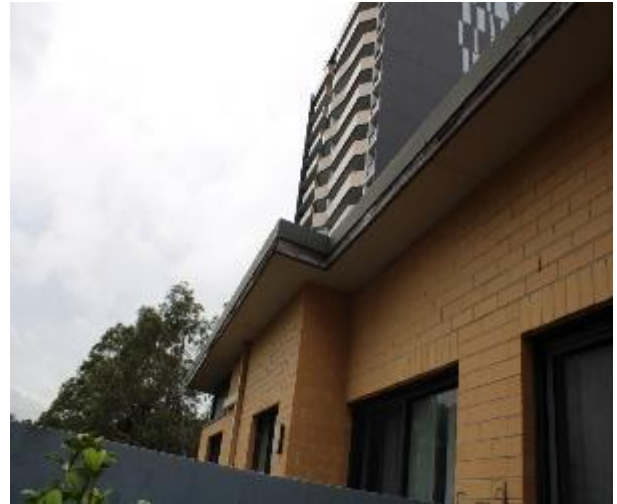
Figure 1593 - General condition of eave

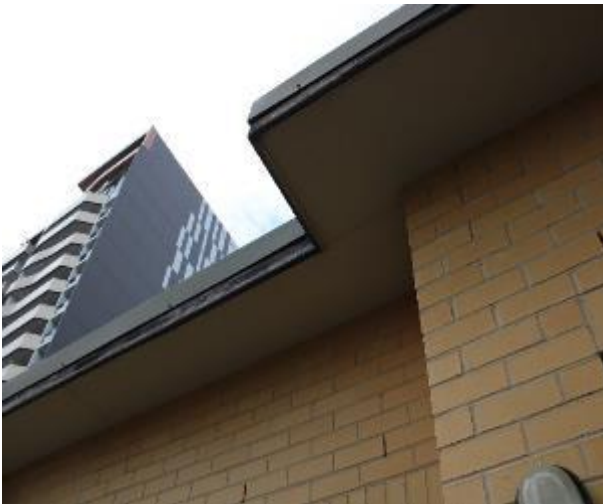
Figure 1594 - General condition of eave

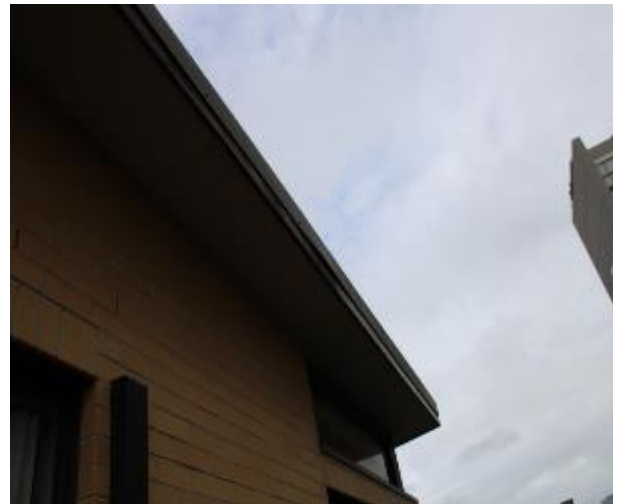
Figure 1595 - General condition of eave
