# **Pre-Dilapidation Report**

**19 GEORGE STREET**

**FRONT BUILDING (UNITS 1-19)**

Project Reference: 20250047.19G.2

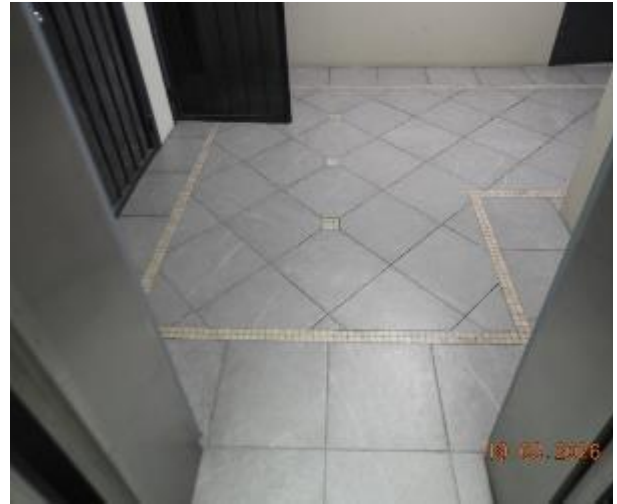
Figure 2 - General condition of level 1 common area floor tiles

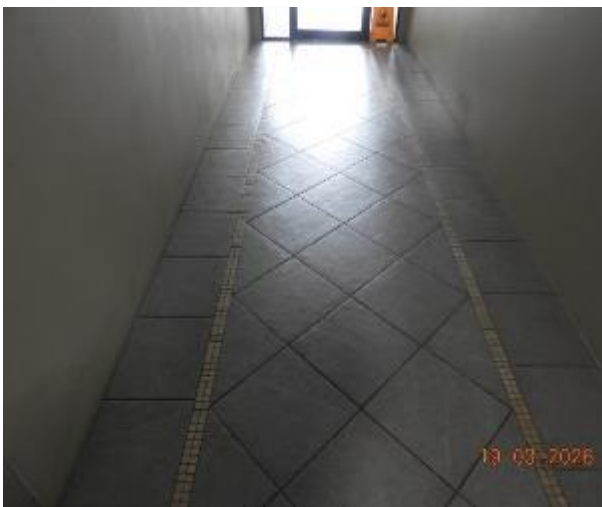
Figure 5 - General condition of level 1 common area floor tiles

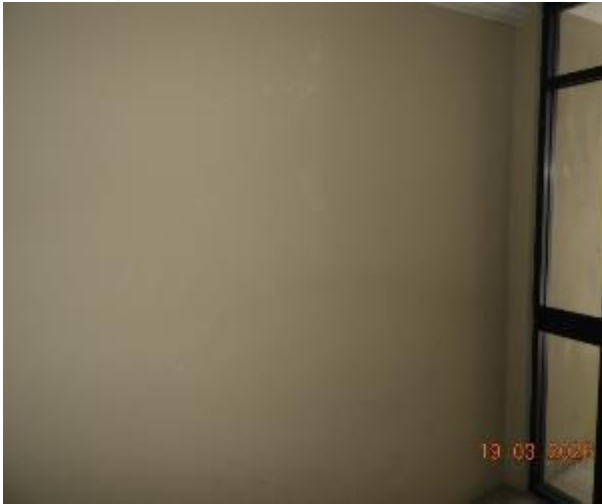
Figure 7 - General condition of level 1 common area internal wall

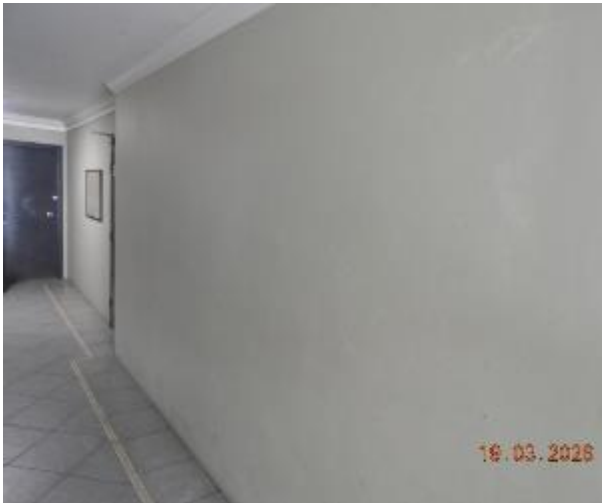
Figure 9 - General condition of level 1 common area internal wall

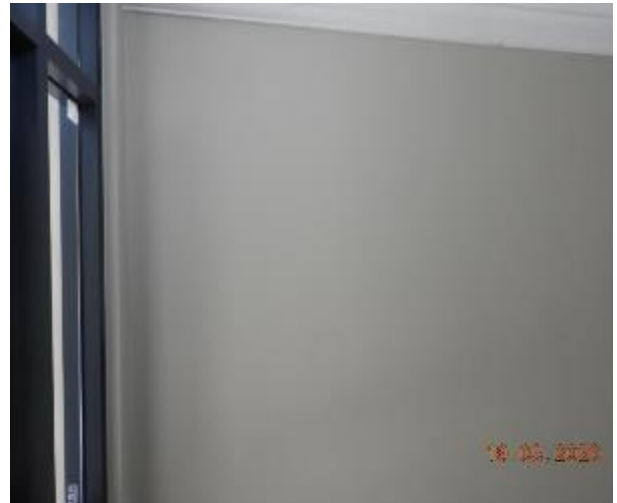
Figure 10 - General condition of level 1 common area internal wall

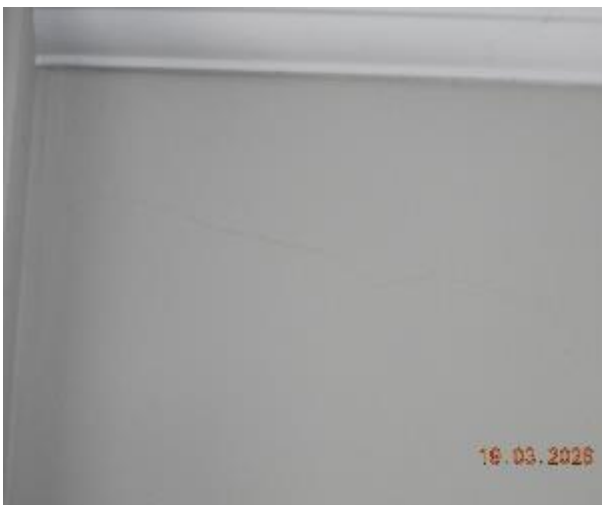
Figure 11 - Crack propagation through level 1 common area internal wall

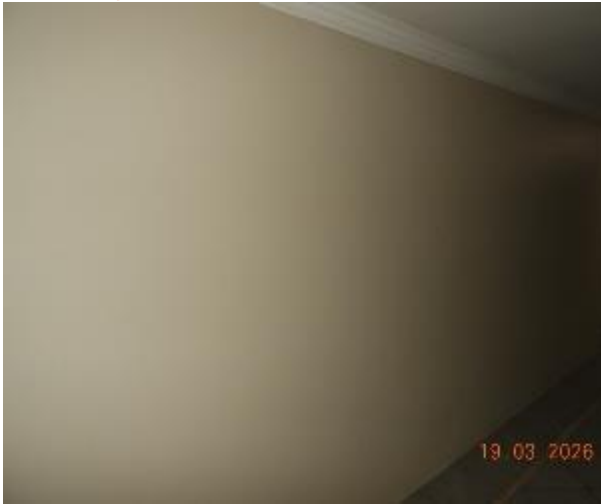
Figure 13 - General condition of level 1 common area internal wall

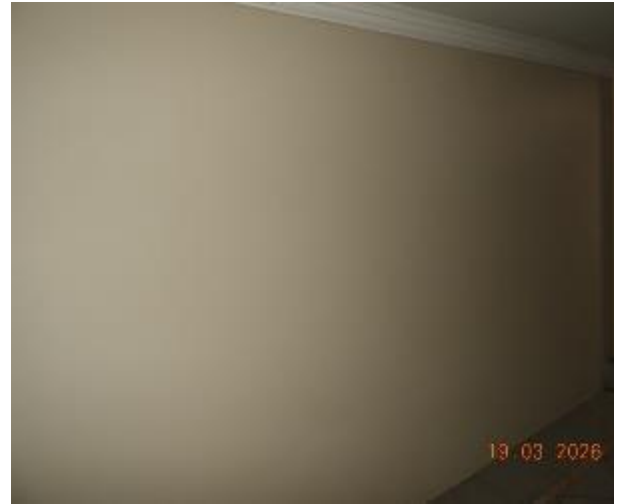
Figure 14 - General condition of level 1 common area internal wall

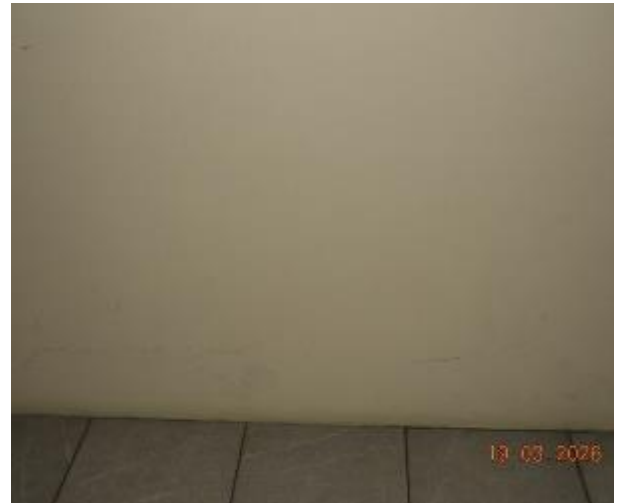
Figure 16 - Crack propagation through level 1 common area internal wall

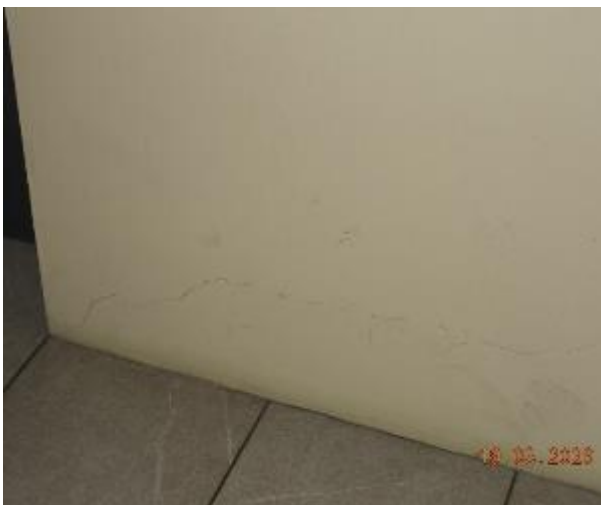
Figure 17 - Crack propagation through level 1 common area internal wall

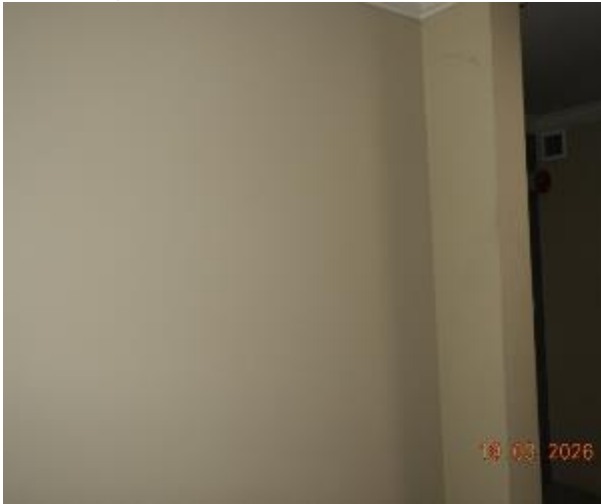
Figure 19 - General condition of level 1 common area internal wall

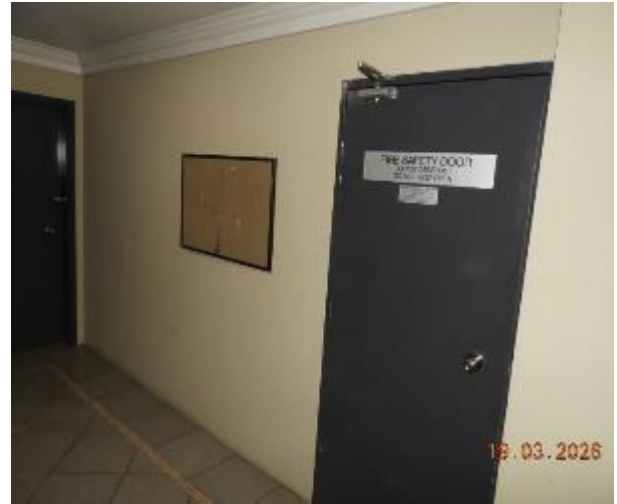
Figure 20 - General condition of level 1 common area internal wall

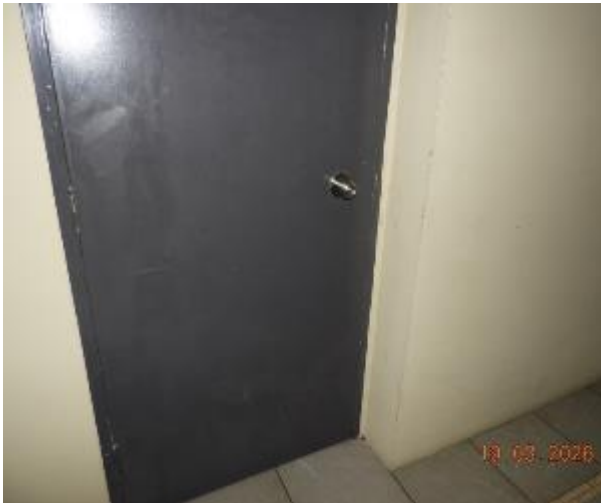
Figure 21 - General condition of level 1 common area internal wall

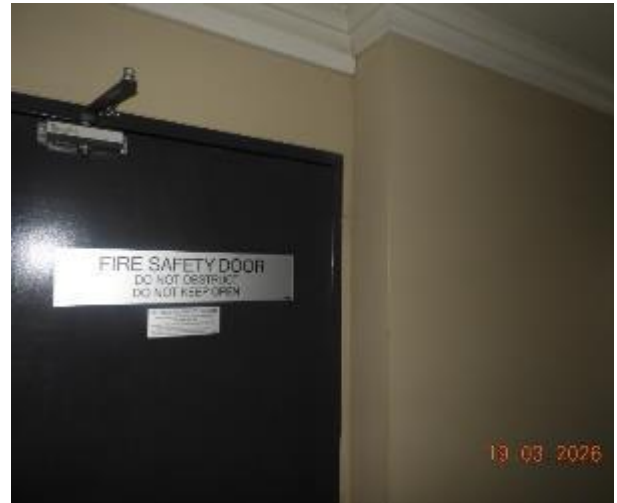
Figure 22 - General condition of level 1 common area internal wall

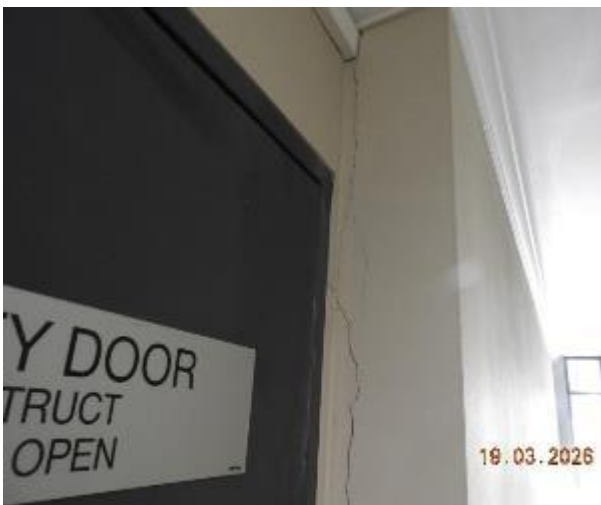
Figure 23 - Crack propagation through level 1 common area internal wall

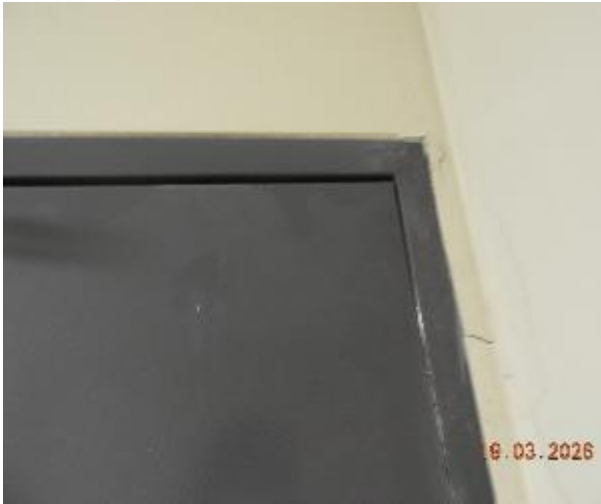
Figure 25 - Crack propagation through level 1 common area internal wall

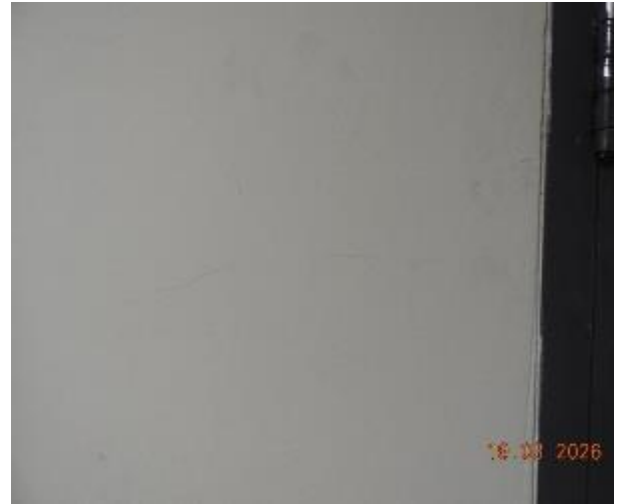
Figure 26 - Crack propagation through level 1 common area internal wall

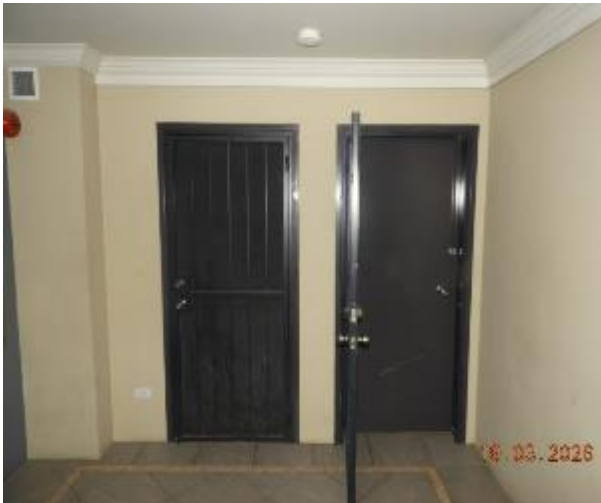
Figure 27 - General condition of level 1 common area internal wall

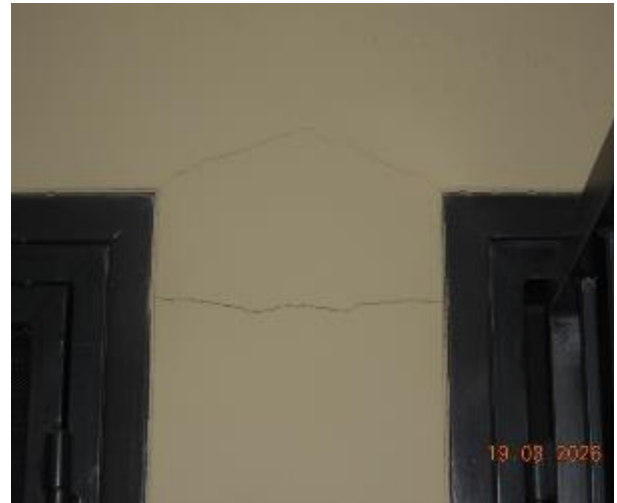
Figure 28 - Crack propagation through level 1 common area internal wall

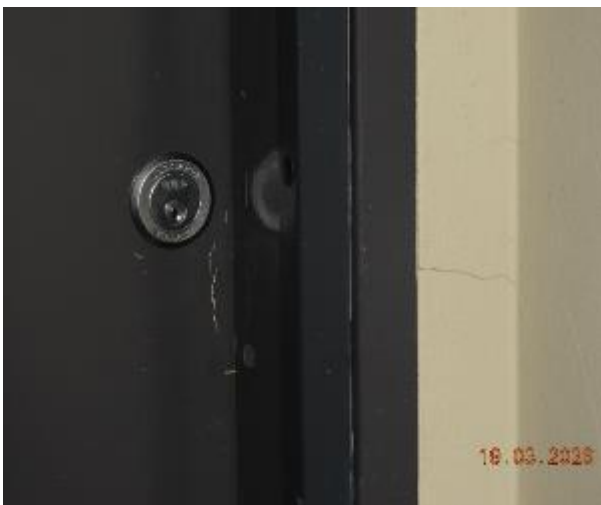
Figure 29 - Crack propagation through level 1 common area internal wall

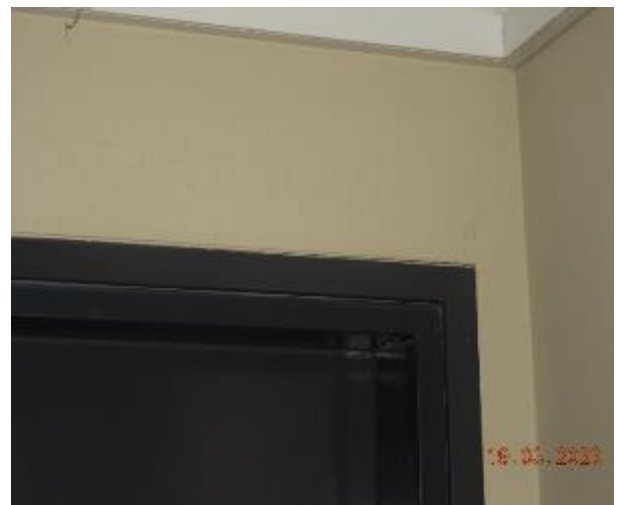
Figure 30 - Crack propagation through level 1 common area internal wall

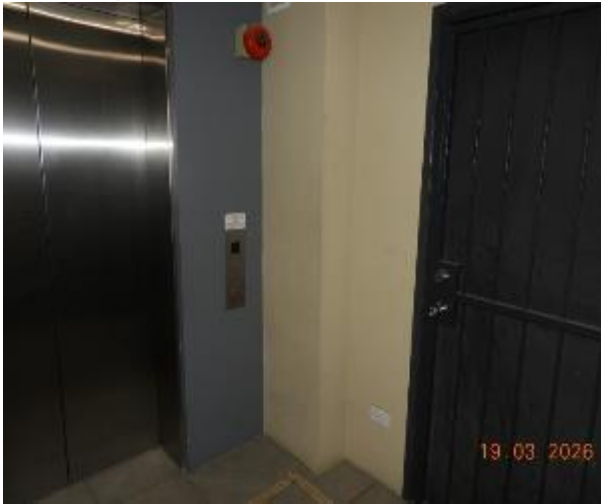
Figure 31 - General condition of level 1 common area internal wall

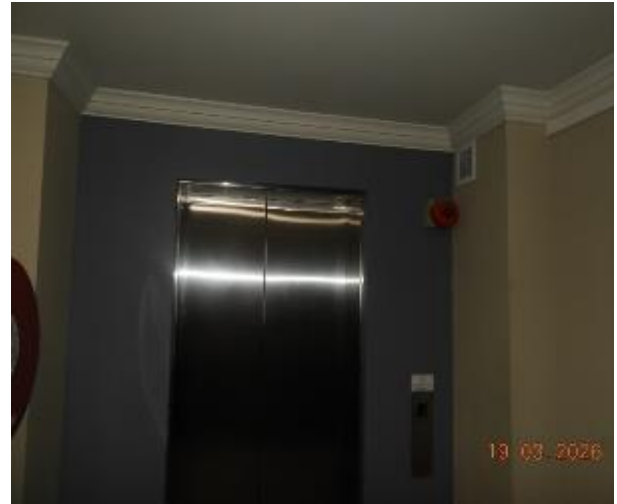
Figure 32 - General condition of level 1 common area internal wall

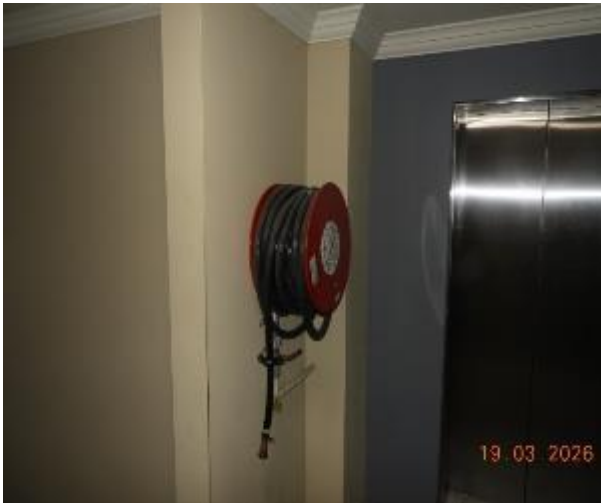
Figure 33 - General condition of level 1 common area internal wall

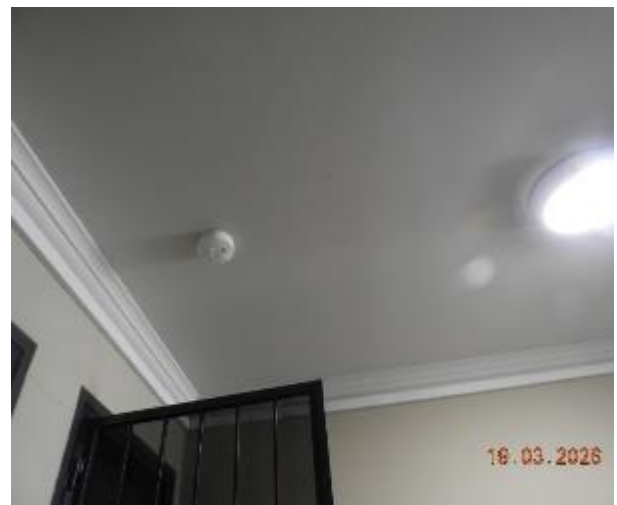
Figure 36 - General condition of level 1 common area ceiling

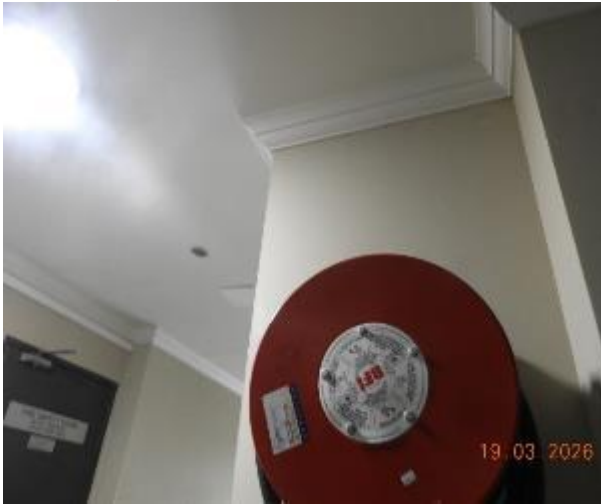
Figure 37 - General condition of level 1 common area ceiling

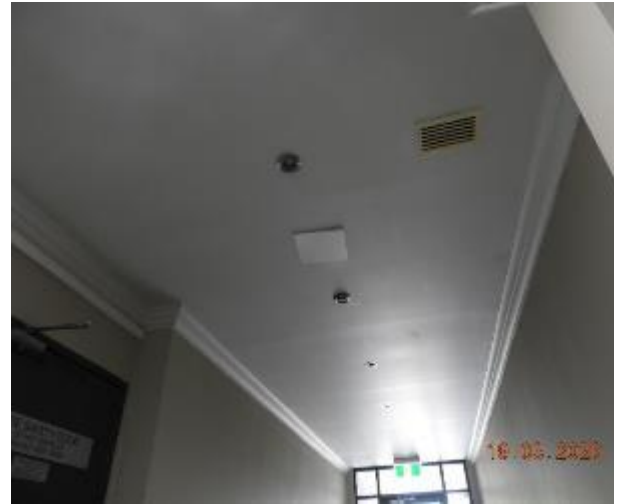
Figure 38 - General condition of level 1 common area ceiling

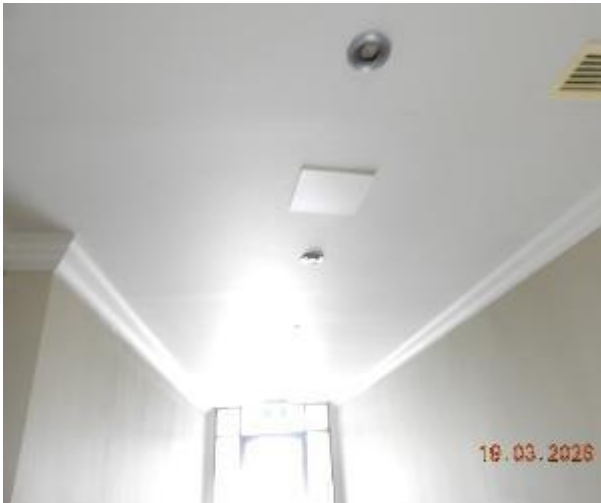
Figure 39 - General condition of level 1 common area ceiling

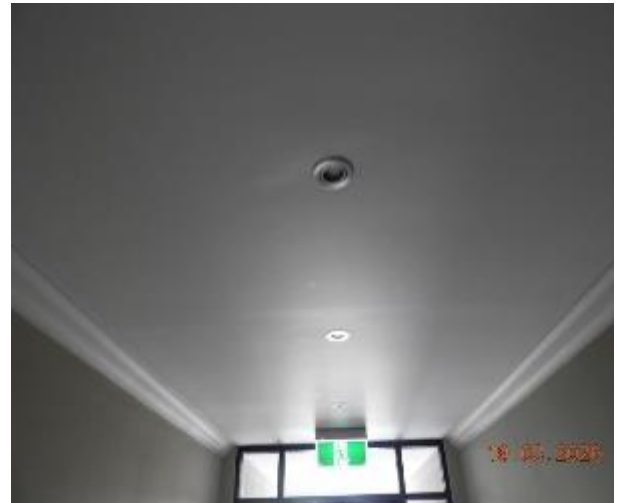
Figure 40 - General condition of level 1 common area ceiling

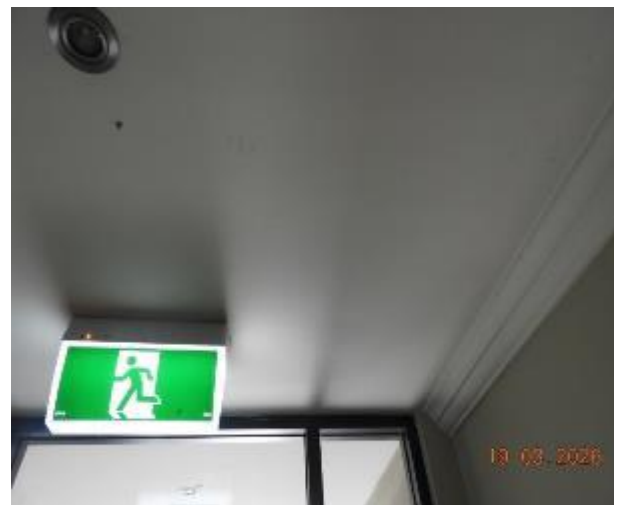
Figure 42 - General condition of level 1 common area ceiling

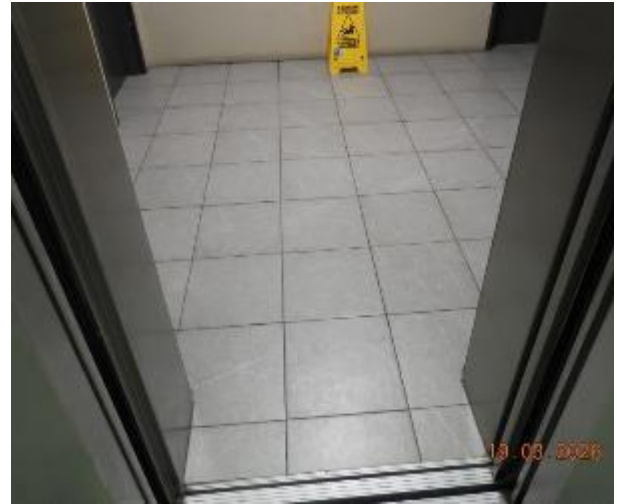
Figure 44 - General condition of level 2 common area floor tiles

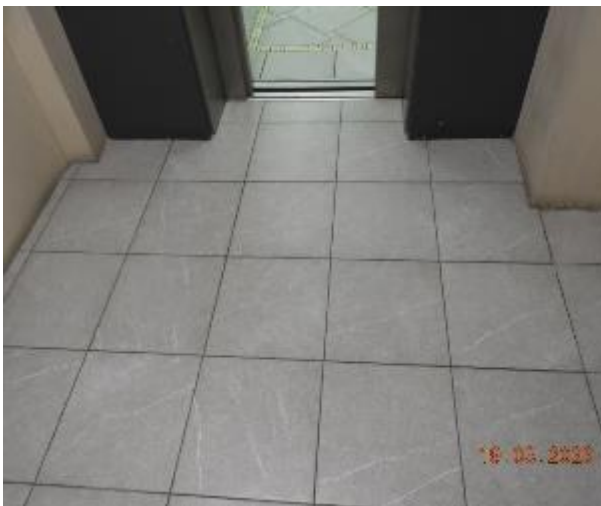
Figure 45 - General condition of level 2 common area floor tiles

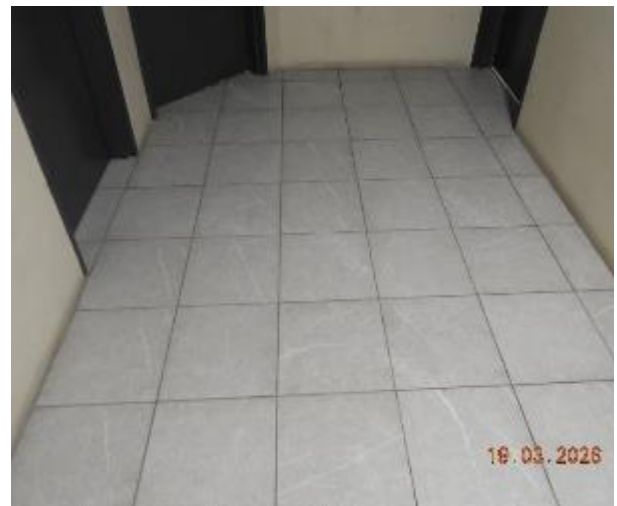
Figure 46 - General condition of level 2 common area floor tiles

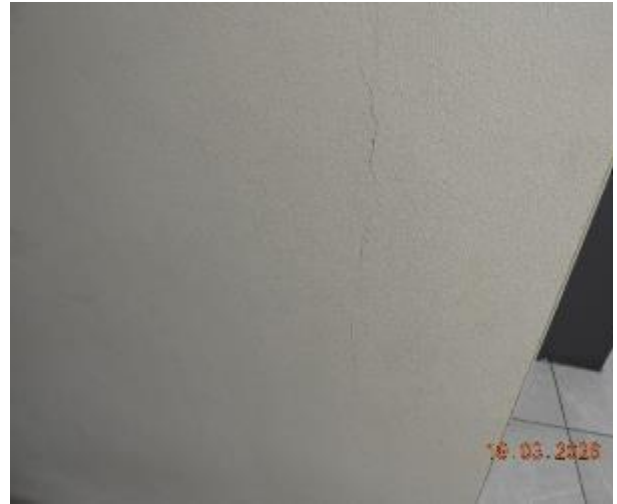
Figure 50 - Crack propagation through level 2 common area internal wall

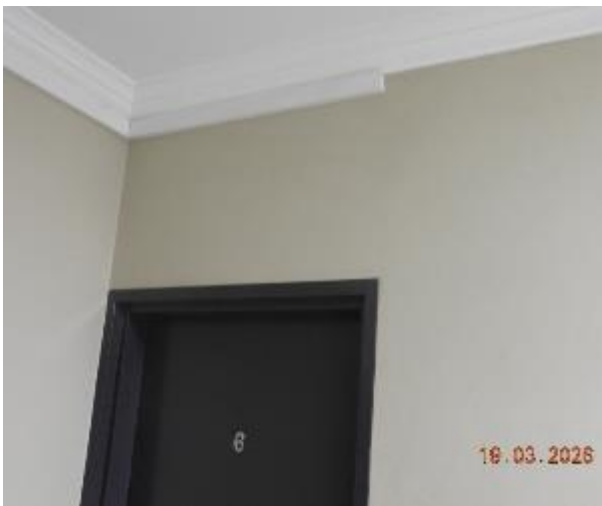
Figure 51 - General condition of level 2 common area internal wall

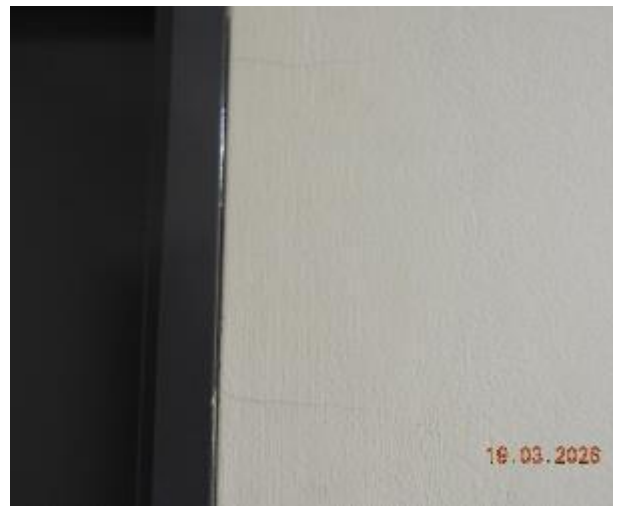
Figure 52 - Crack propagation through level 2 common area internal wall

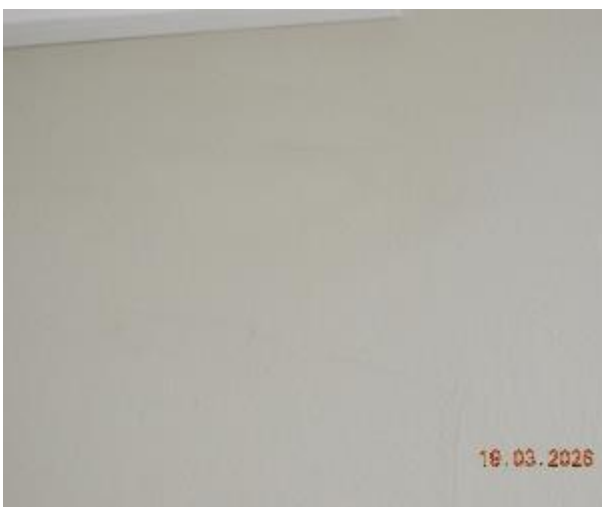
Figure 53 - Crack propagation through level 2 common area internal wall

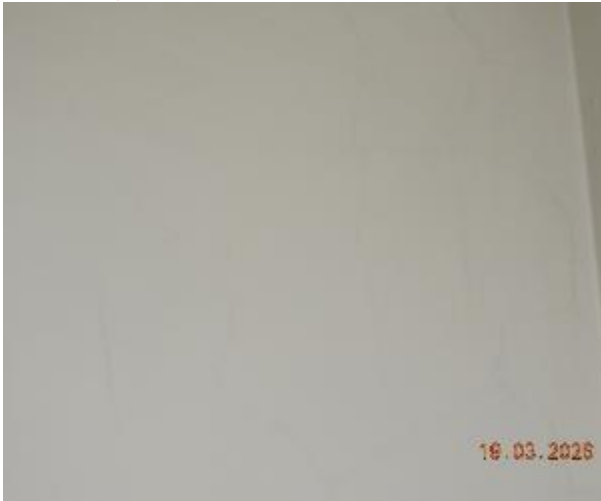
Figure 55 - Crack propagation through level 2 common area internal wall

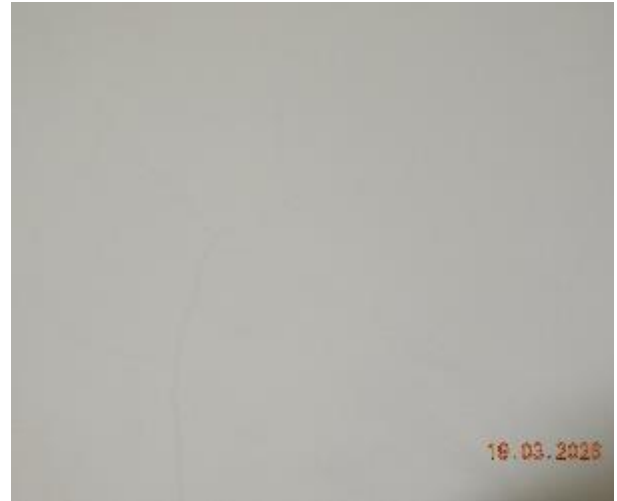
Figure 56 - Crack propagation through level 2 common area internal wall

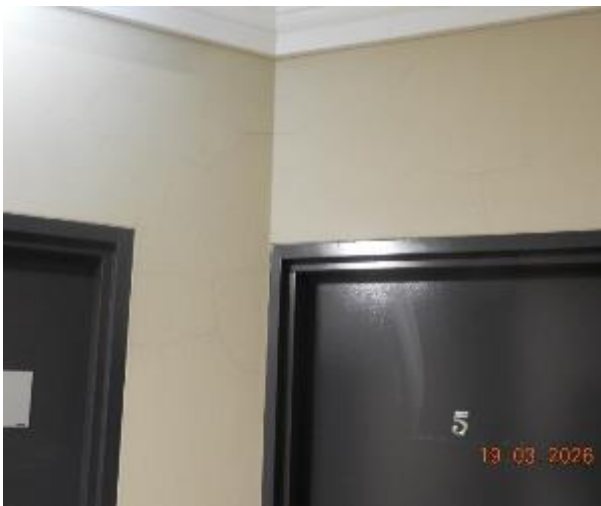
Figure 57 - Crack propagation through level 2 common area internal wall

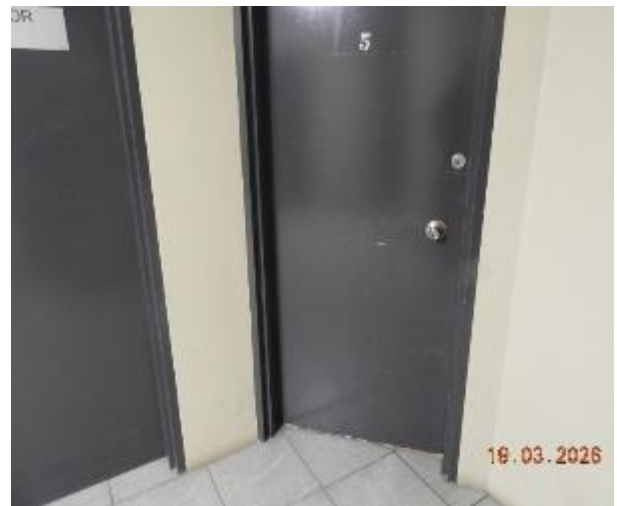
Figure 58 - General condition of level 2 common area internal wall

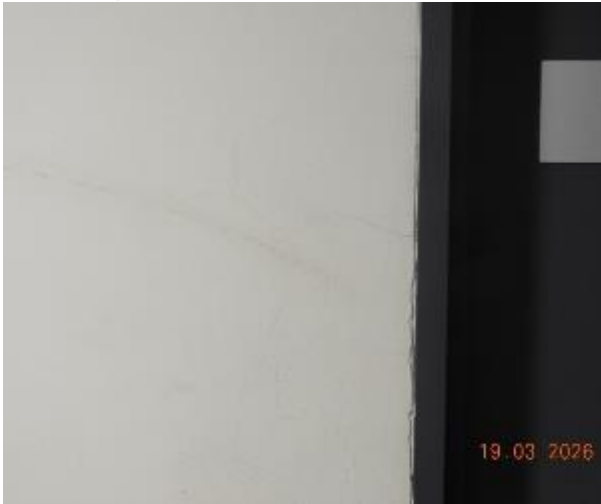
Figure 61 - Crack propagation through level 2 common area internal wall

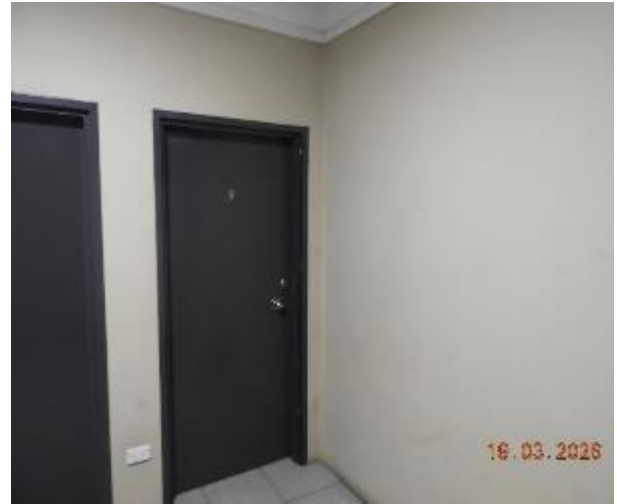
Figure 62 - General condition of level 2 common area internal wall

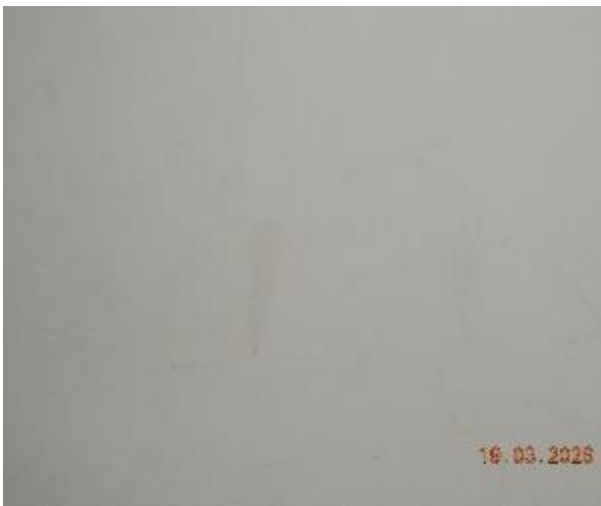
Figure 63 - Crack propagation through level 2 common area internal wall

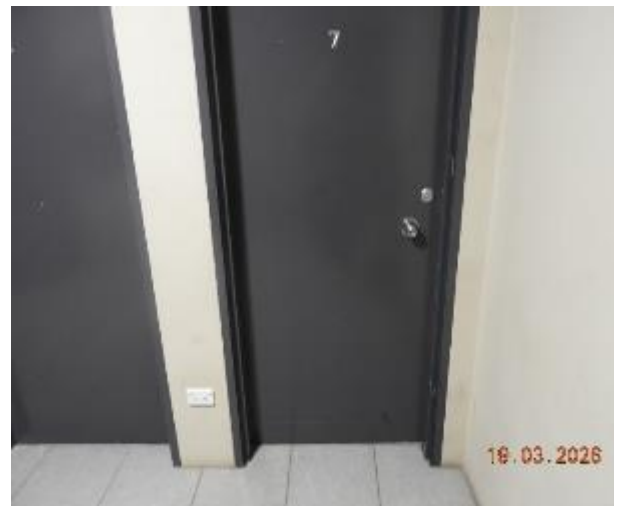
Figure 64 - General condition of level 2 common area internal wall

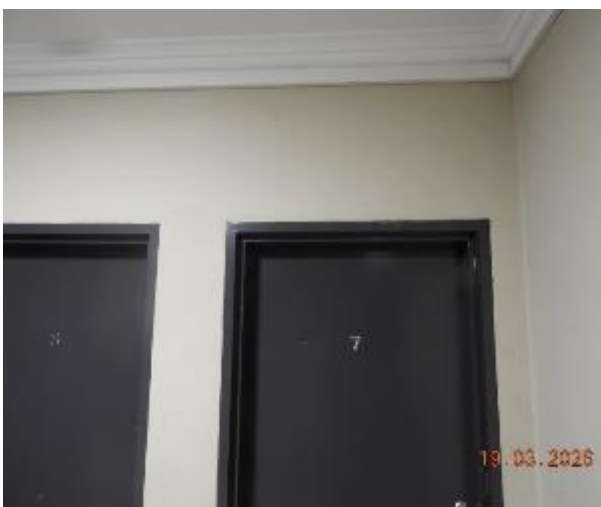
Figure 65 - General condition of level 2 common area internal wall

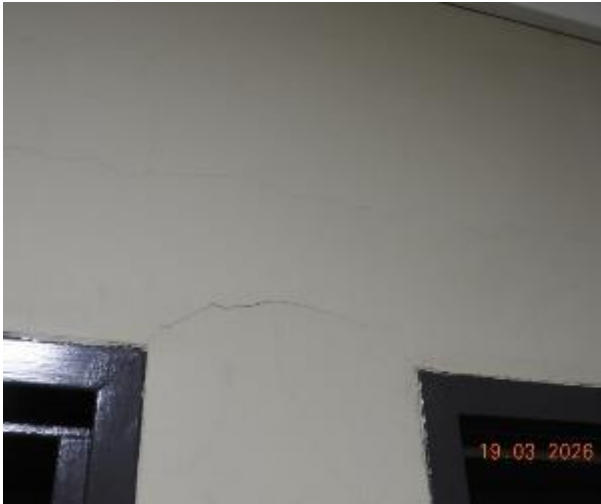
Figure 67 - Crack propagation through level 2 common area internal wall

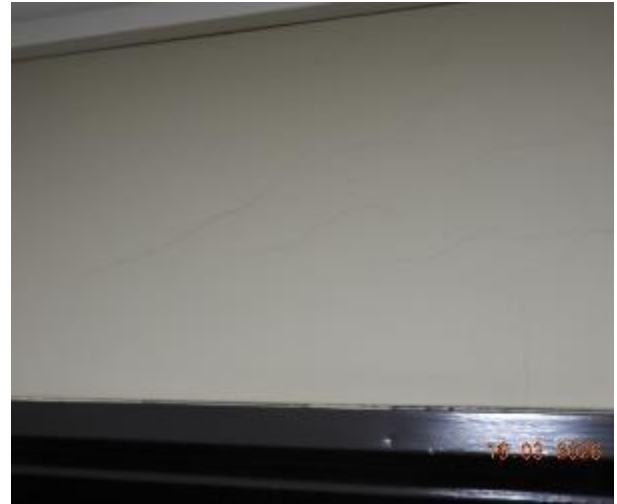
Figure 68 - Crack propagation through level 2 common area internal wall

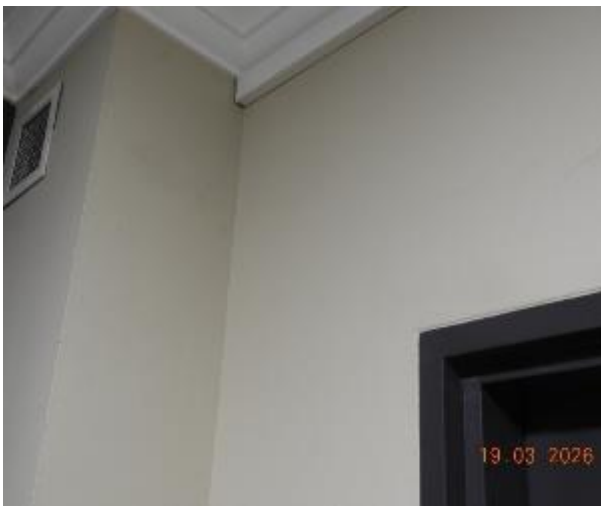
Figure 69 - General condition of level 2 common area internal wall

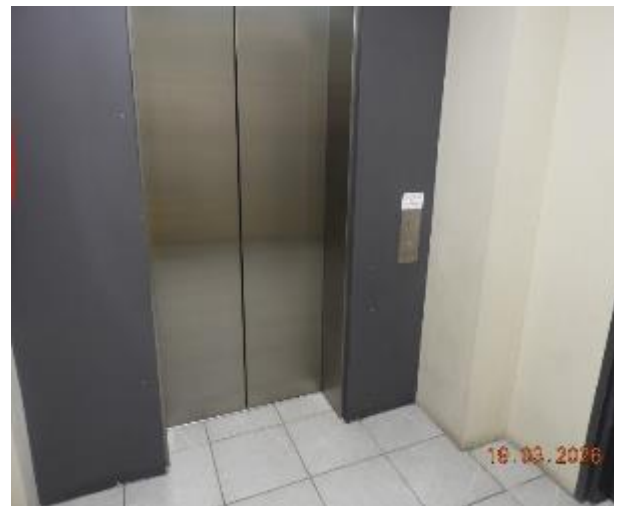
Figure 70 - General condition of level 2 common area internal wall

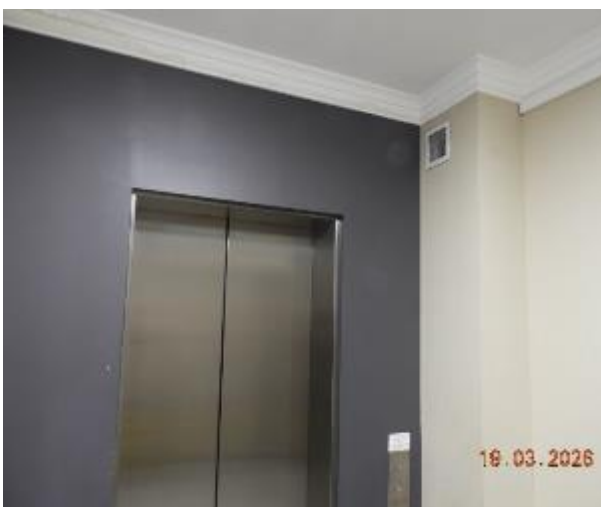
Figure 71 - General condition of level 2 common area internal wall

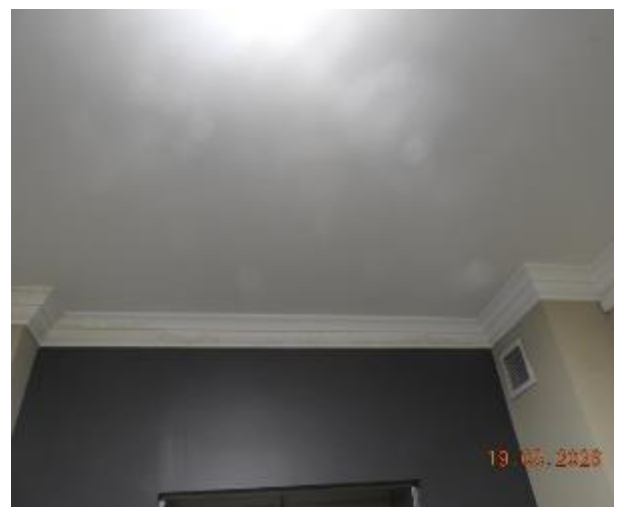
Figure 72 - General condition of level 2 common area ceiling

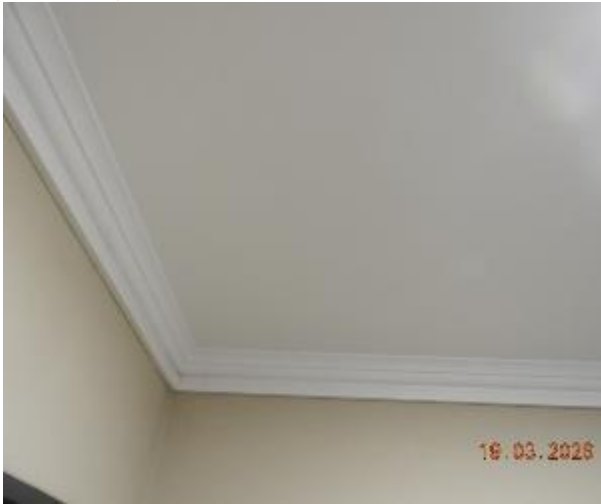
Figure 73 - General condition of level 2 common area ceiling

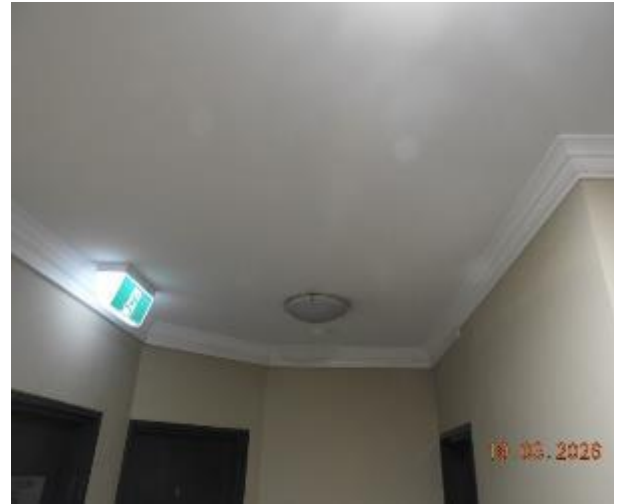
Figure 74 - General condition of level 2 common area ceiling

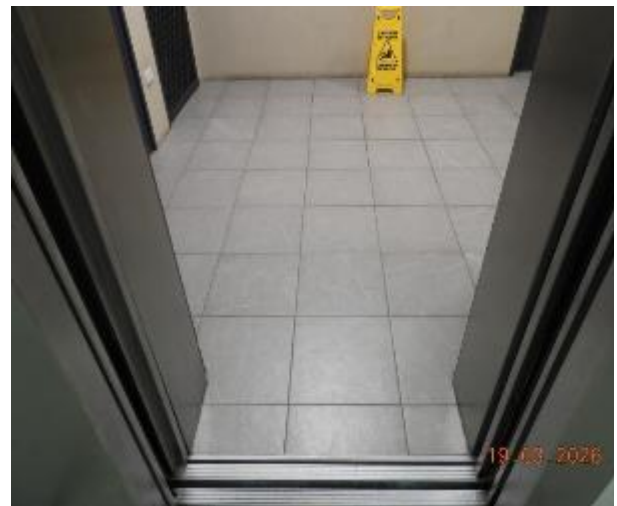
Figure 76 - General condition of level 3 common area floor tiles

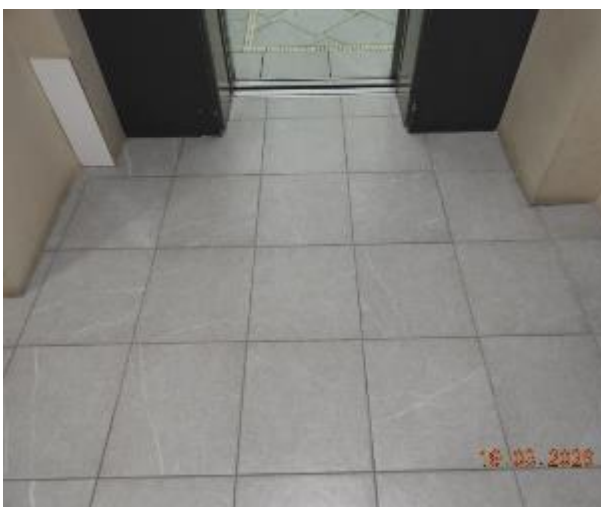
Figure 77 - General condition of level 3 common area floor tiles

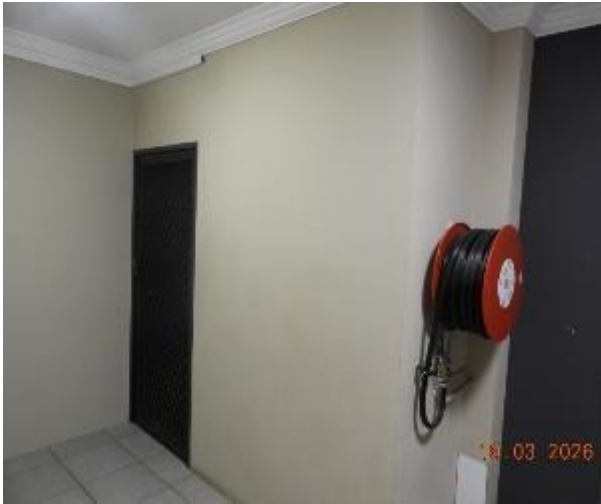
Figure 79 - General condition of level 3 common area internal wall

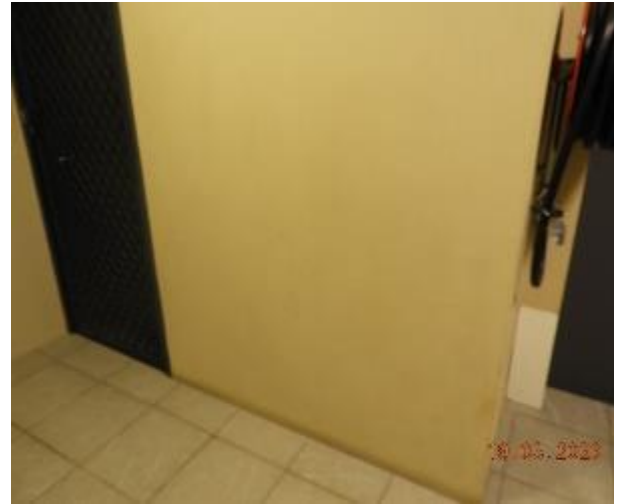
Figure 80 - General condition of level 3 common area internal wall

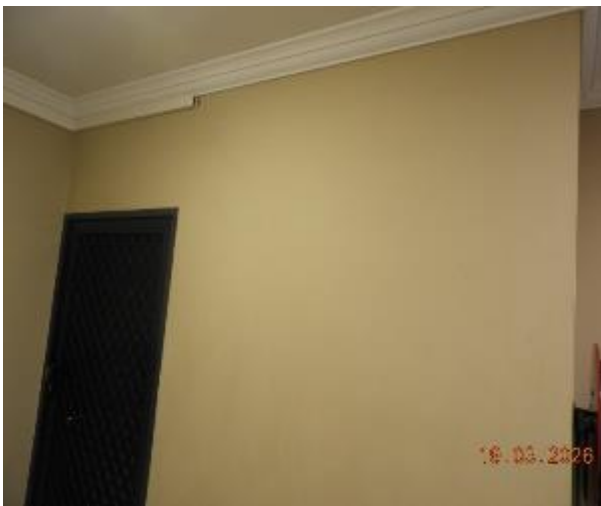
Figure 81 - General condition of level 3 common area internal wall

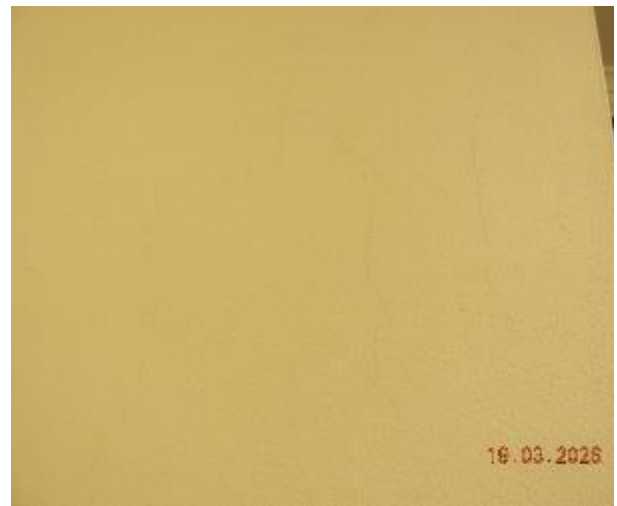
Figure 82 - Crack propagation through level 3 common area internal wall

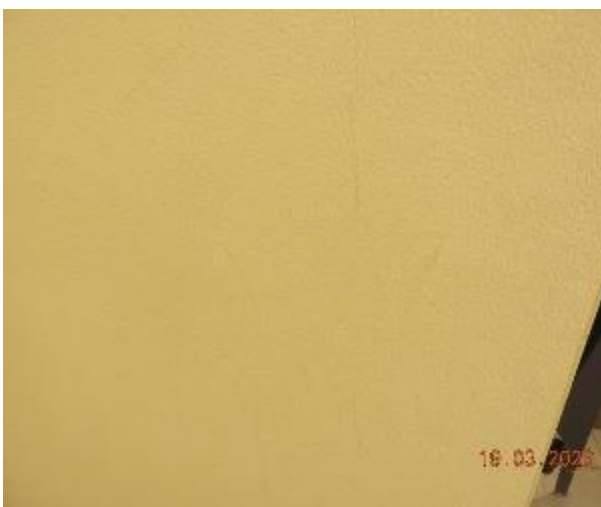
Figure 83 - Crack propagation through level 3 common area internal wall

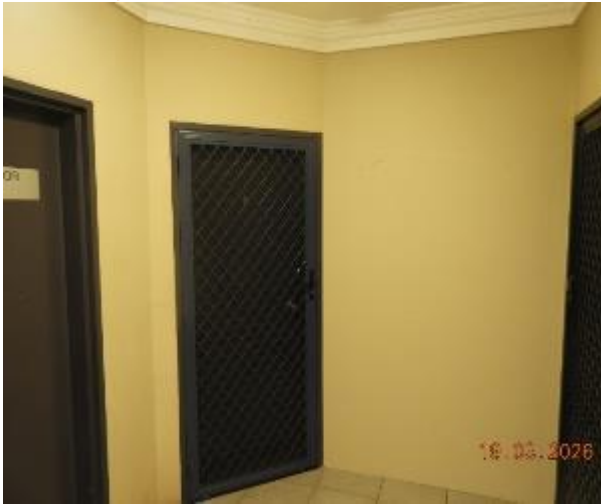
Figure 85 - General condition of level 3 common area internal wall

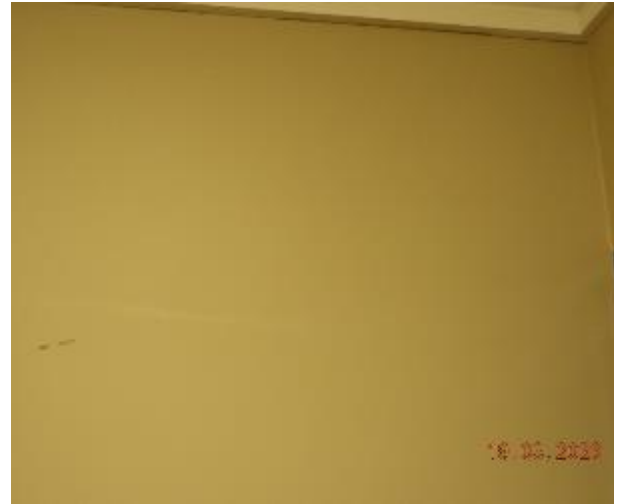
Figure 86 - Crack propagation through level 3 common area internal wall

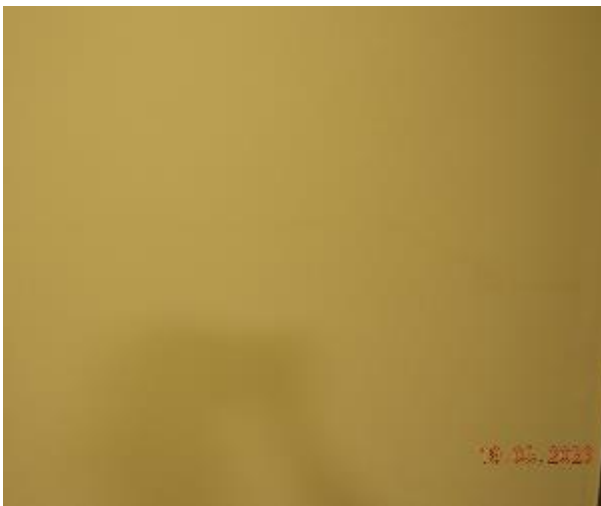
Figure 87 - Crack propagation through level 3 common area internal wall

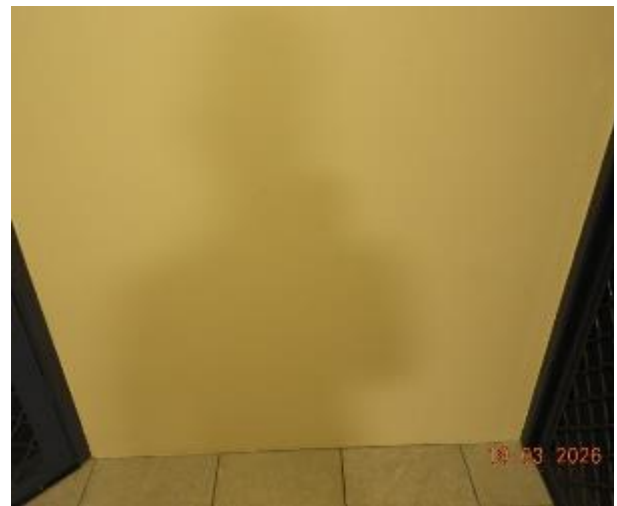
Figure 88 - General condition of level 3 common area internal wall

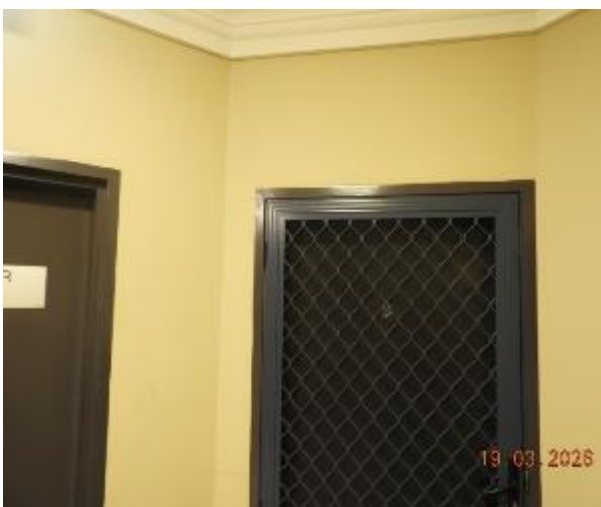
Figure 89 - General condition of level 3 common area internal wall

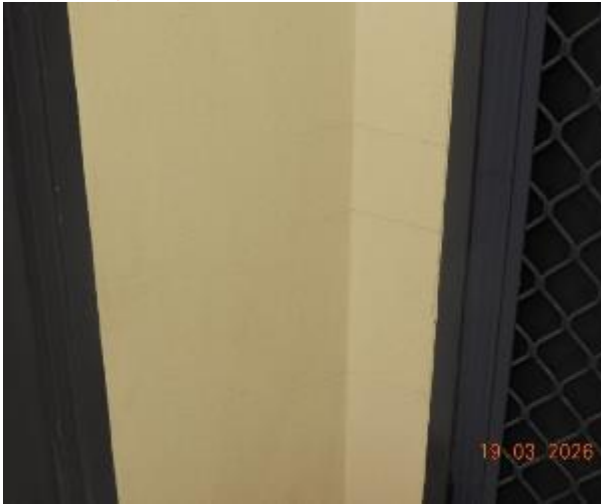
Figure 91 - Crack propagation through level 3 common area internal wall

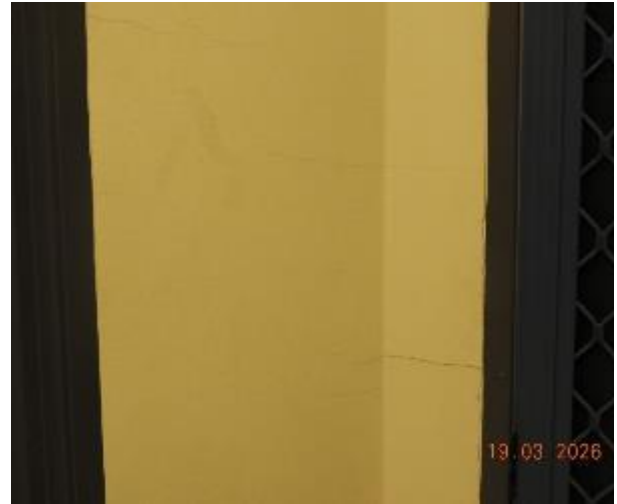
Figure 92 - Crack propagation through level 3 common area internal wall

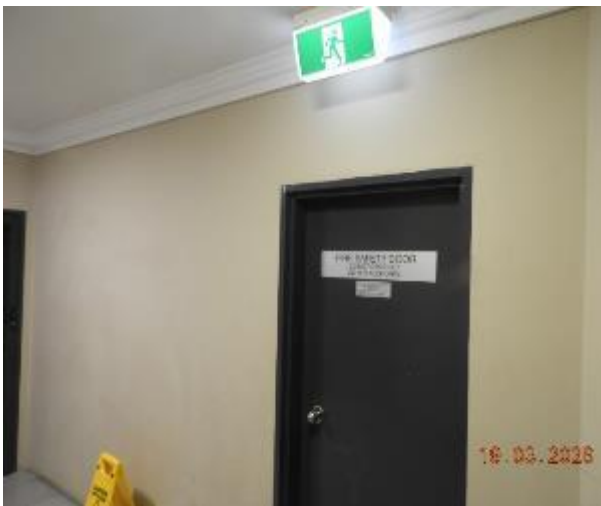
Figure 93 - General condition of level 3 common area internal wall

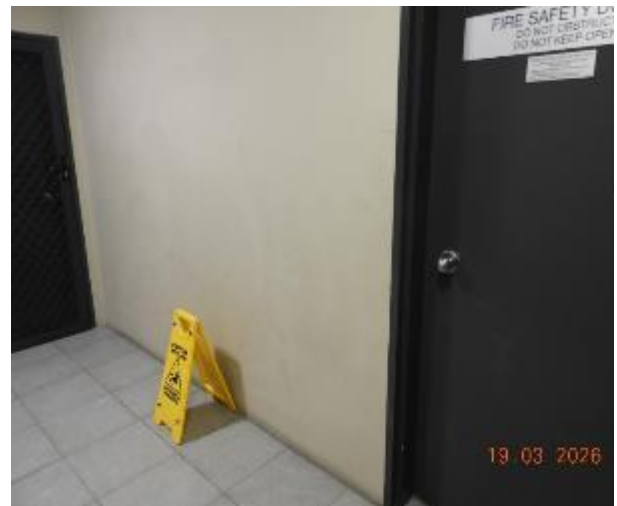
Figure 94 - General condition of level 3 common area internal wall

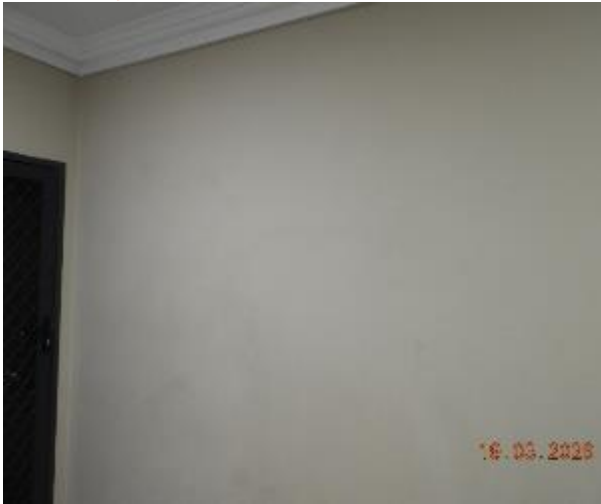
Figure 97 - General condition of level 3 common area internal wall
