# **Pre-Dilapidation Report**

**19 GEORGE STREET**

**FRONT BUILDING (UNITS 1-19)**

Project Reference: 20250047.19G.2

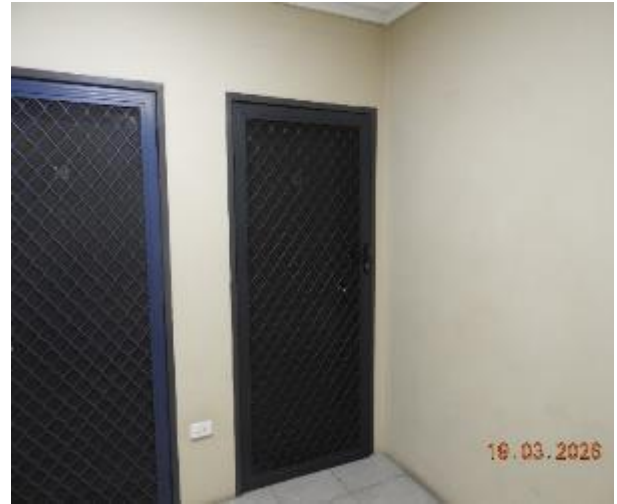
Figure 98 - General condition of level 3 common area internal wall

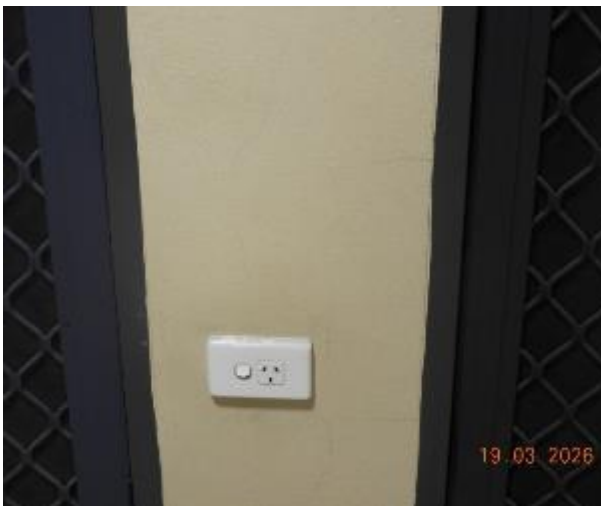
Figure 99 - Crack propagation through level 3 common area internal wall

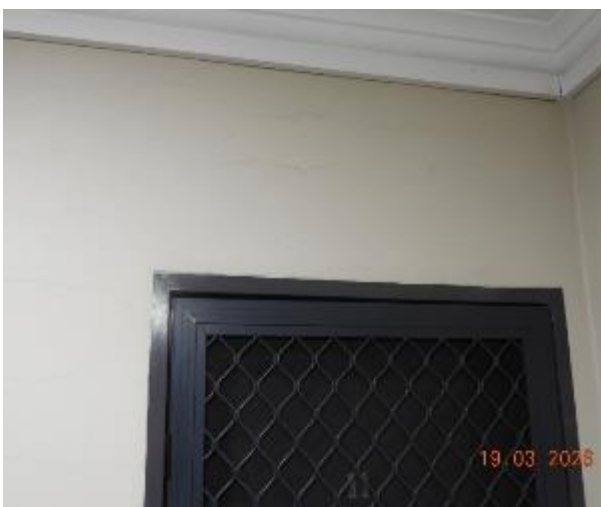
Figure 101 - General condition of level 3 common area internal wall

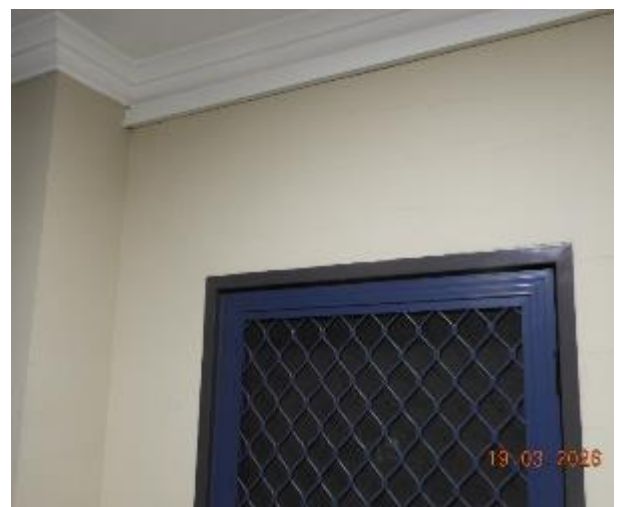
Figure 102 - General condition of level 3 common area internal wall

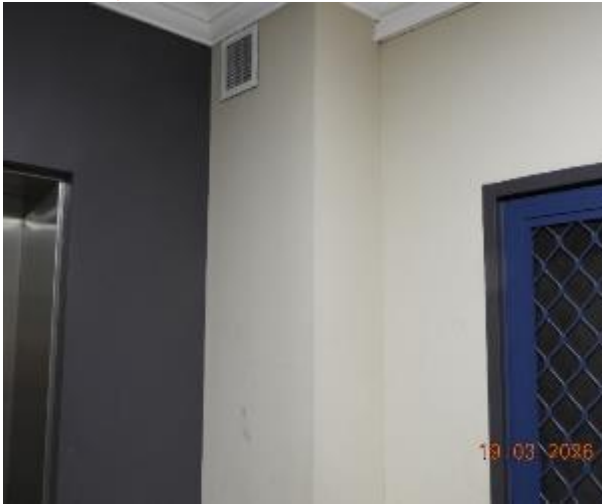
Figure 103 - General condition of level 3 common area internal wall

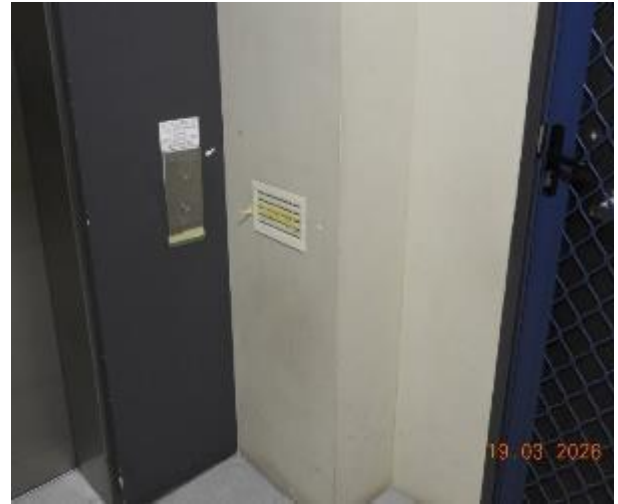
Figure 104 - General condition of level 3 common area internal wall

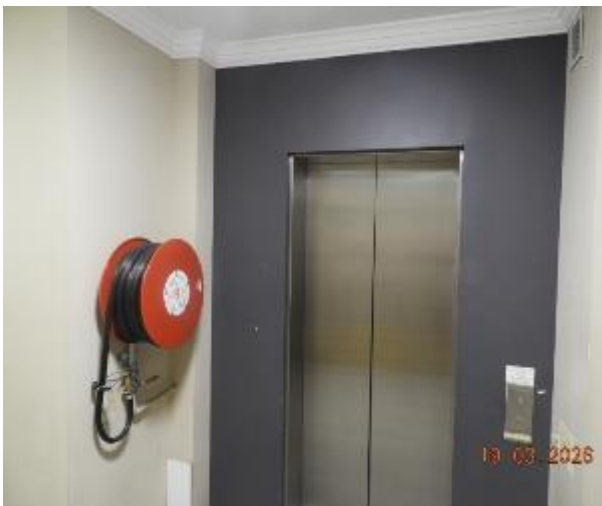
Figure 105 - General condition of level 3 common area internal wall

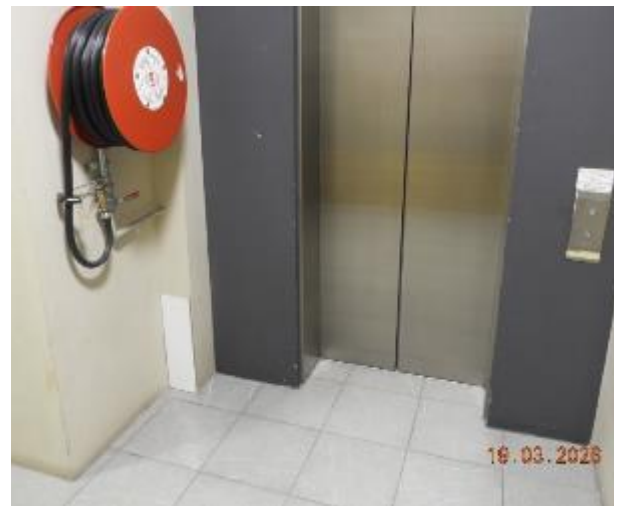
Figure 106 - General condition of level 3 common area internal wall

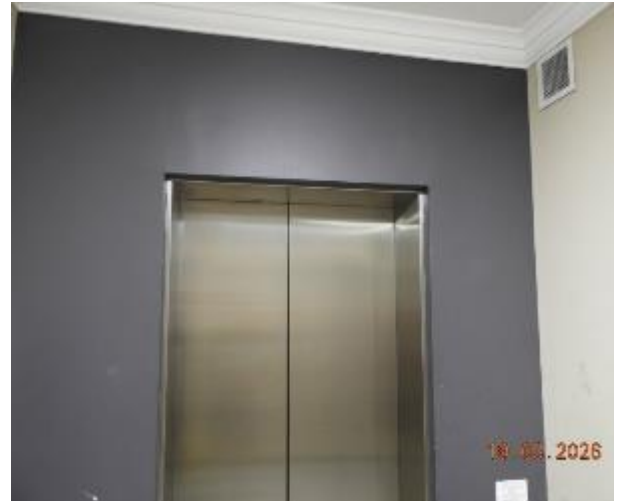
Figure 110 - General condition of level 3 common area internal wall

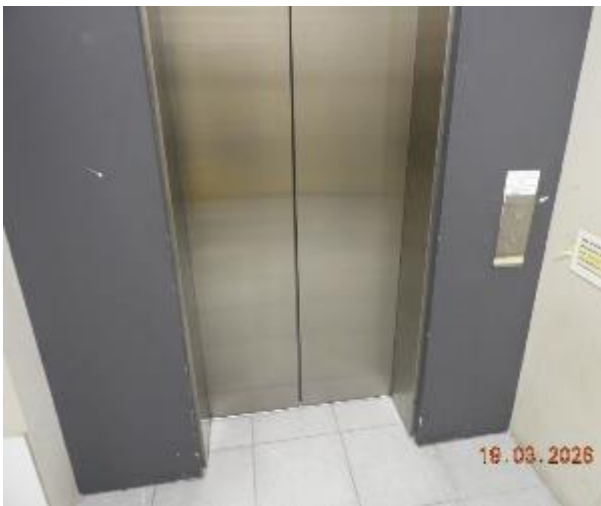
Figure 111 - General condition of level 3 common area internal wall

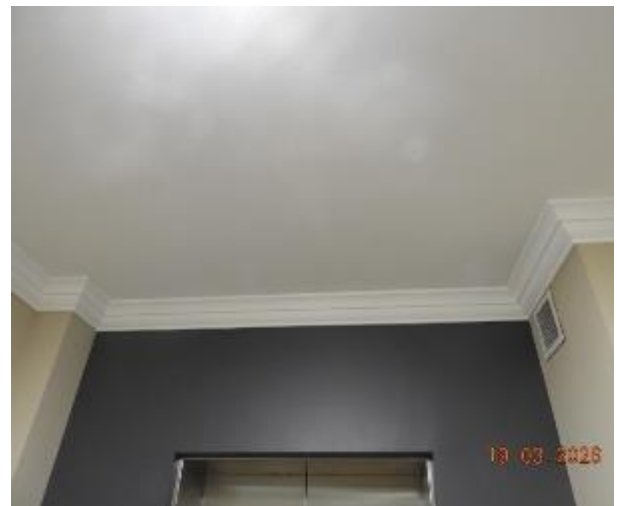
Figure 112 - General condition of level 3 common area ceiling

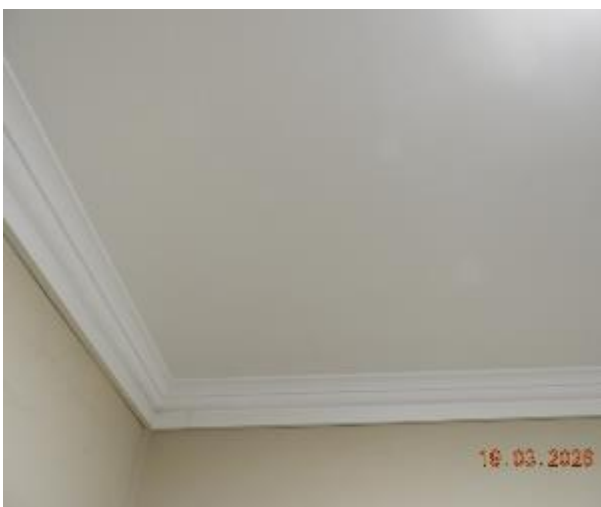
Figure 113 - General condition of level 3 common area ceiling

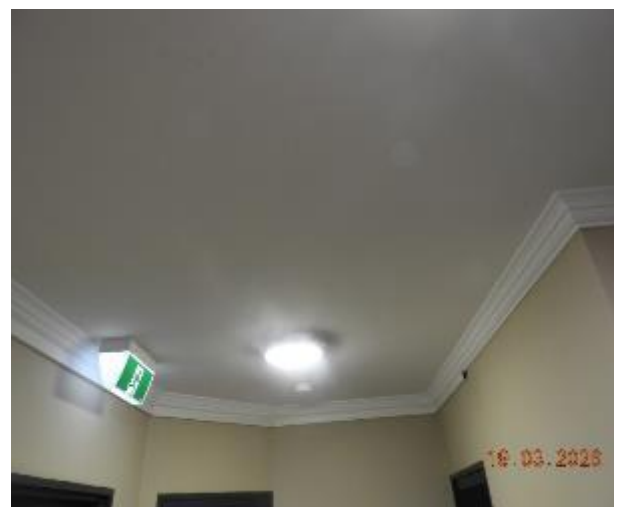
Figure 114 - General condition of level 3 common area ceiling

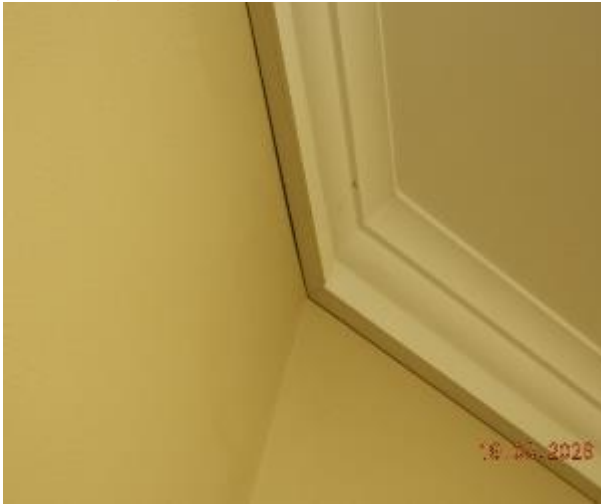
Figure 115 - General condition of level 3 common area ceiling

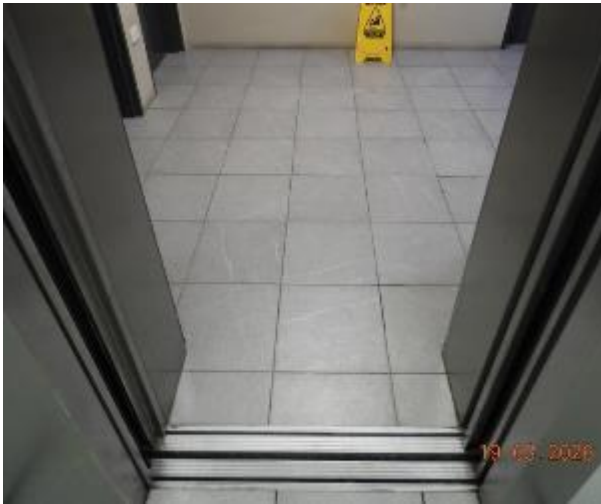
Figure 117 - General condition of level 4 common area floor tiles

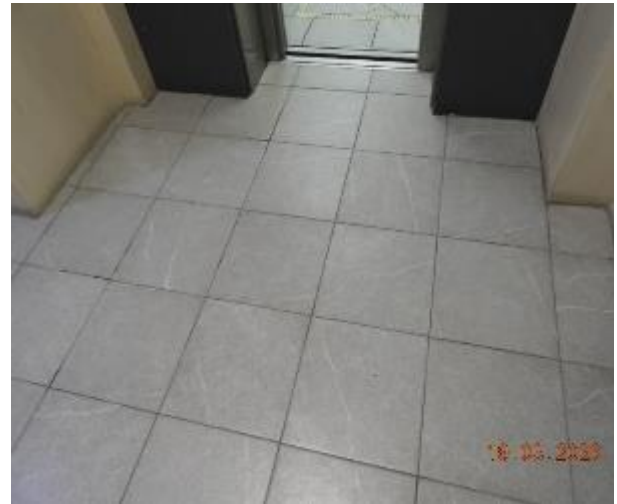
Figure 118 - General condition of level 4 common area floor tiles

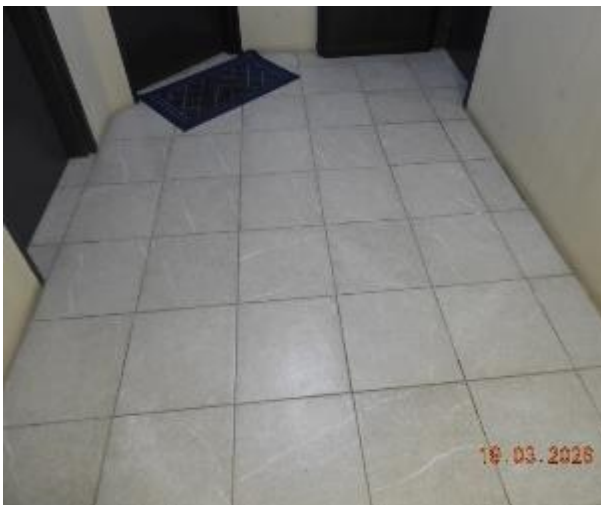
Figure 119 - General condition of level 4 common area floor tiles

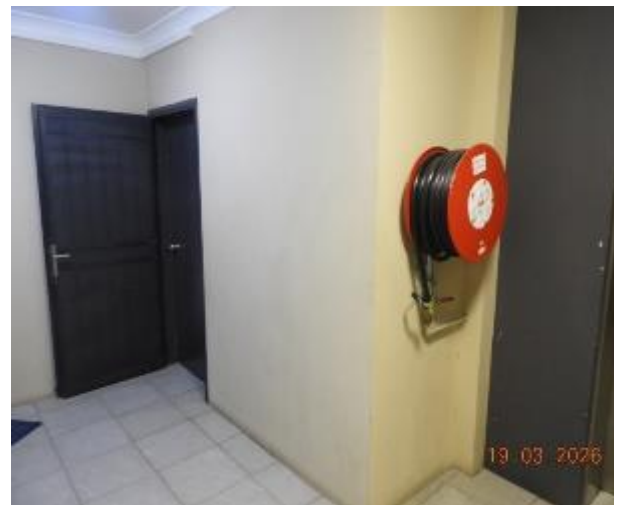
Figure 120 - General condition of level 4 common area internal wall

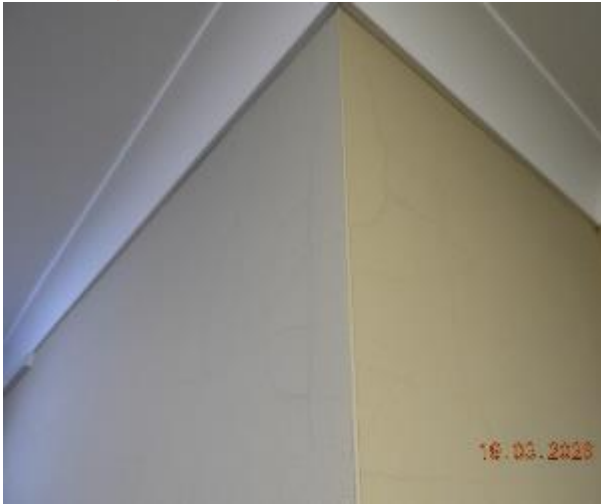
Figure 121 - Crack propagation through level 4 common area internal wall

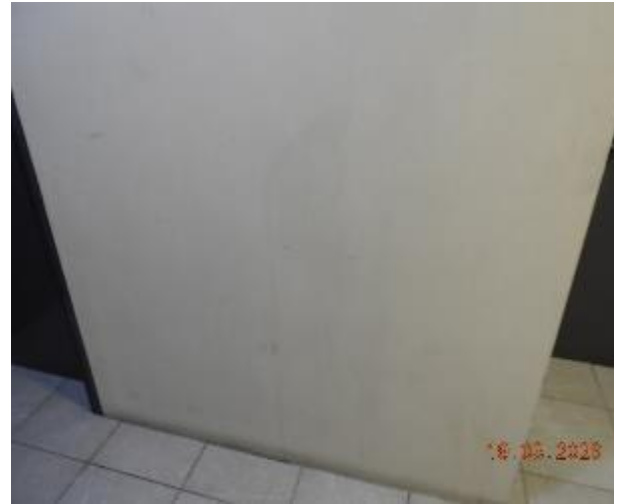
Figure 122 - General condition of level 4 common area internal wall

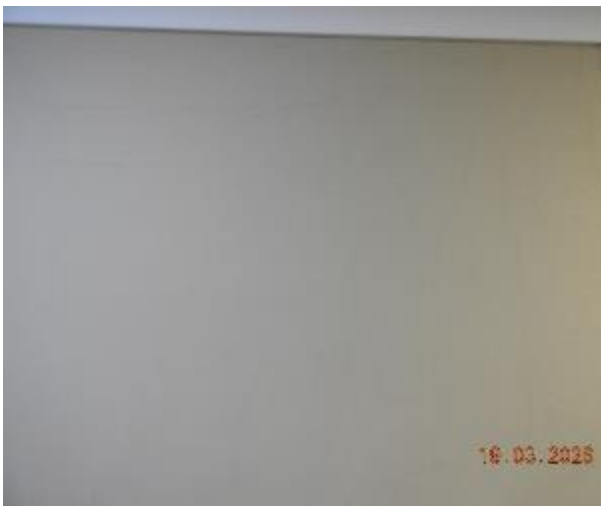
Figure 123 - Crack propagation through level 4 common area internal wall

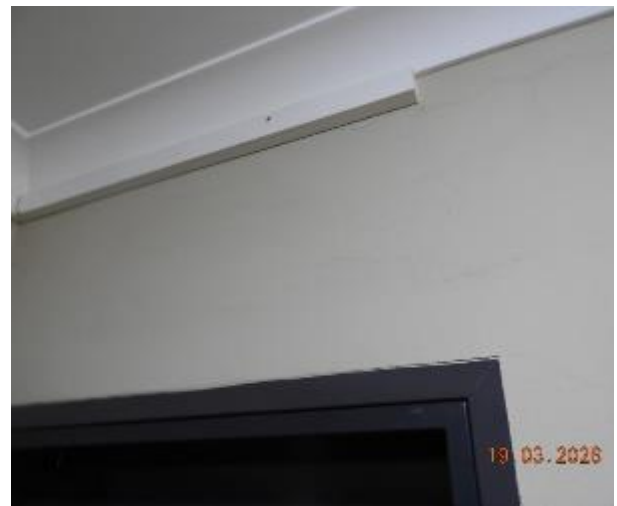
Figure 124 - General condition of level 4 common area internal wall

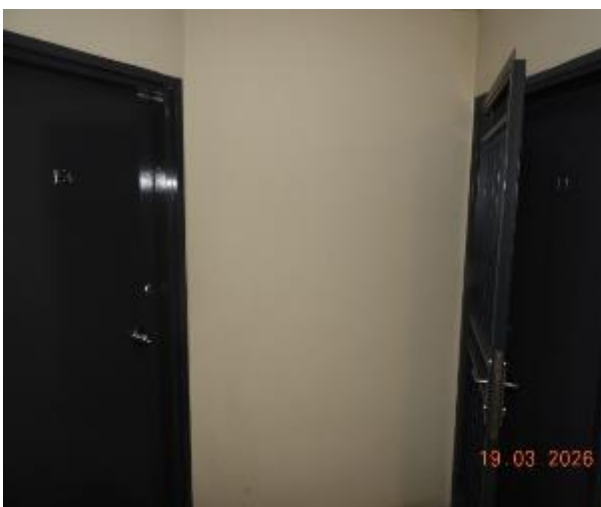
Figure 125 - General condition of level 4 common area internal wall

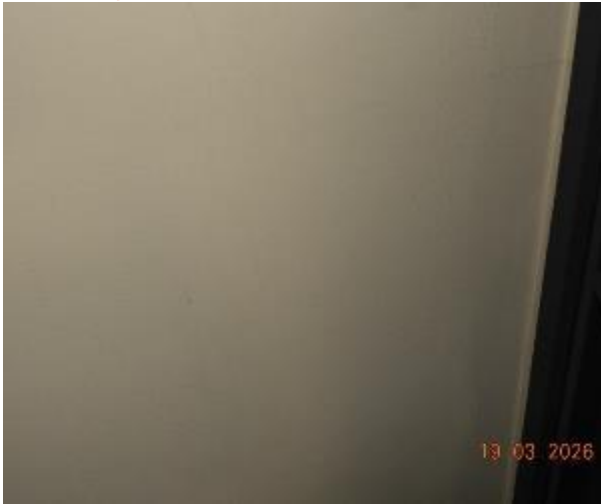
Figure 127 - Crack propagation through level 4 common area internal wall

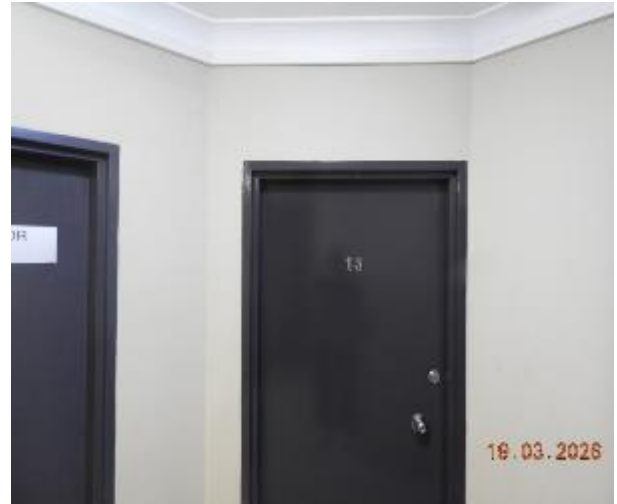
Figure 128 - General condition of level 4 common area internal wall

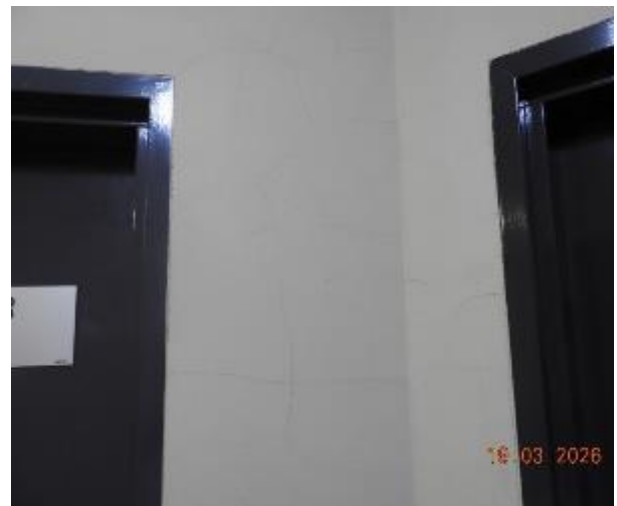
Figure 130 - Crack propagation through level 4 common area internal wall

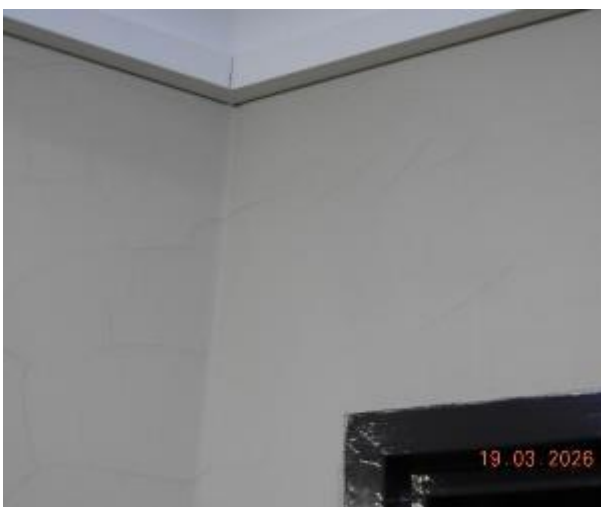
Figure 131 - Crack propagation through level 4 common area internal wall

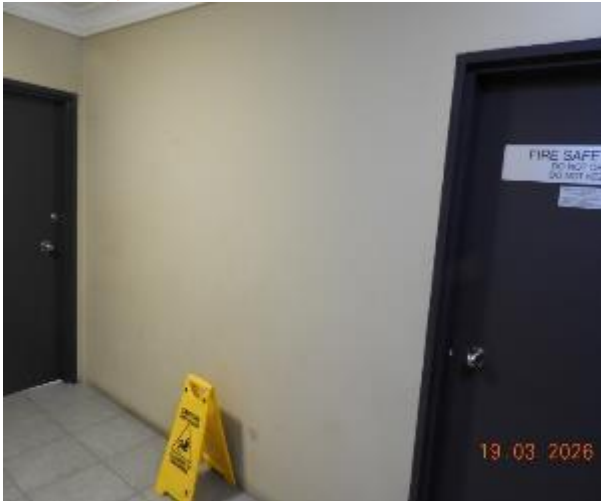
Figure 133 - General condition of level 4 common area internal wall

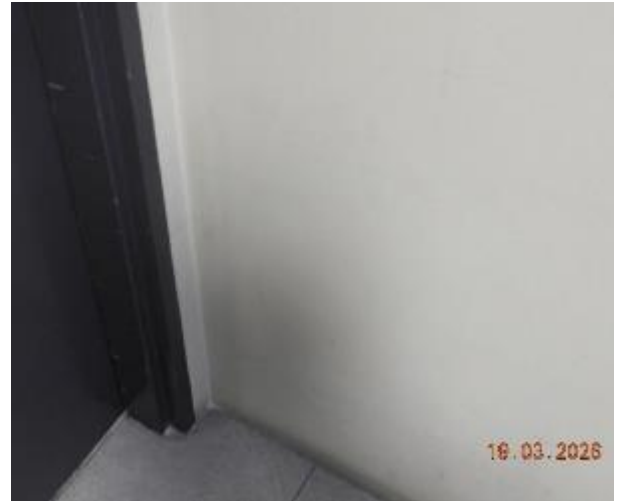
Figure 134 - General condition of level 4 common area internal wall

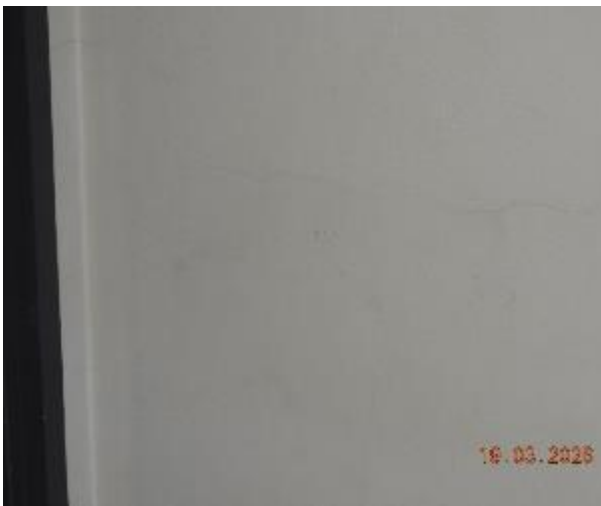
Figure 135 - Crack propagation through level 4 common area internal wall

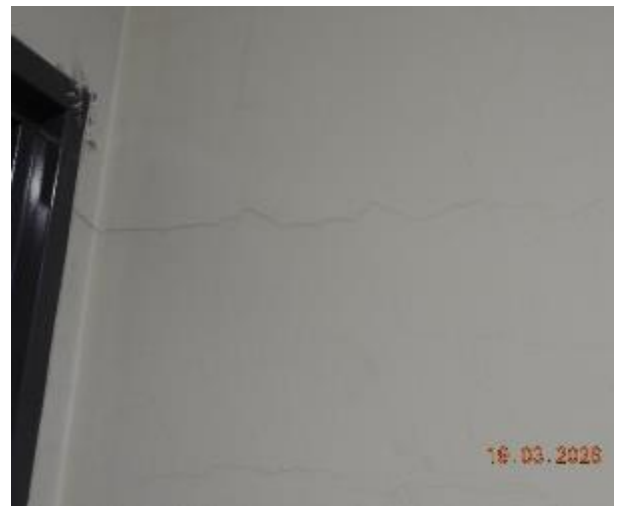
Figure 136 - Crack propagation through level 4 common area internal wall

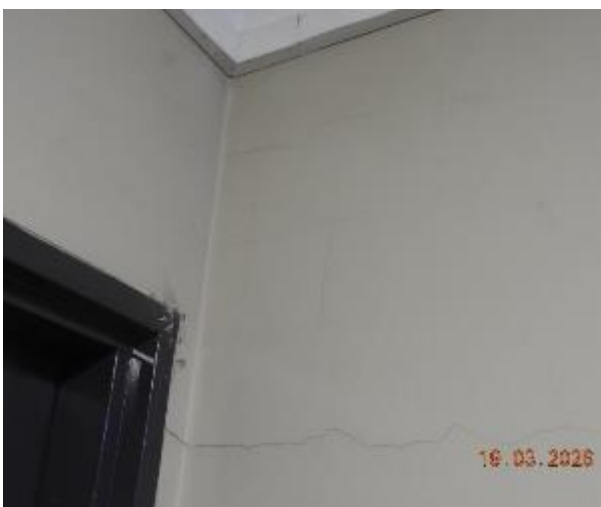
Figure 137 - Crack propagation through level 4 common area internal wall

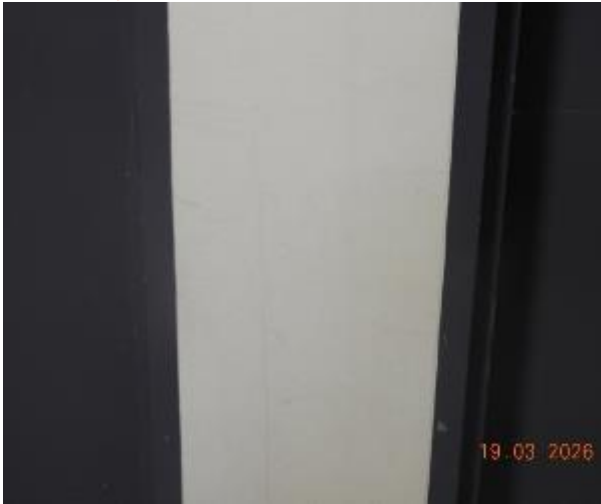
Figure 139 - Crack propagation through level 4 common area internal wall

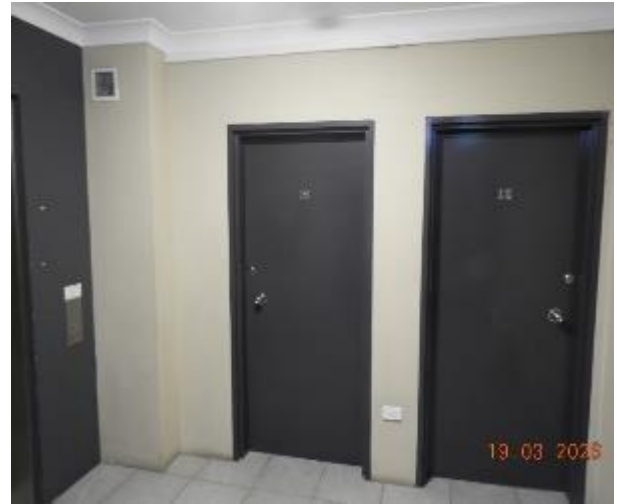
Figure 140 - General condition of level 4 common area internal wall

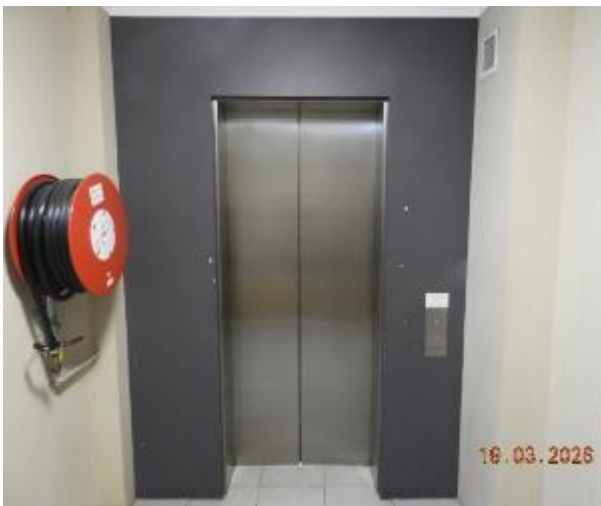
Figure 141 - General condition of level 4 common area internal wall

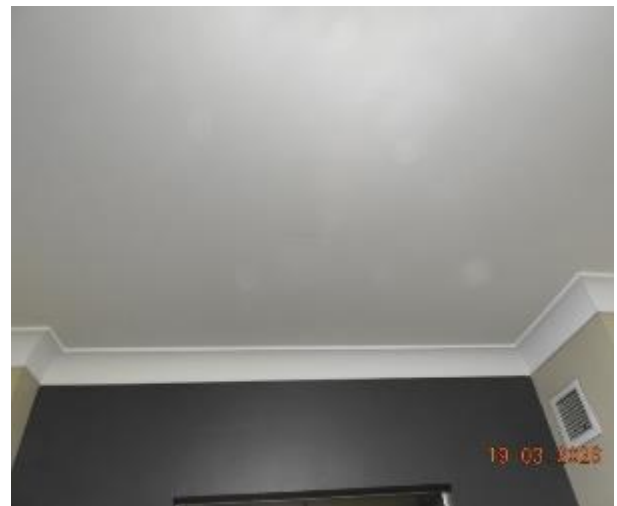
Figure 142 - General condition of level 4 common area ceiling

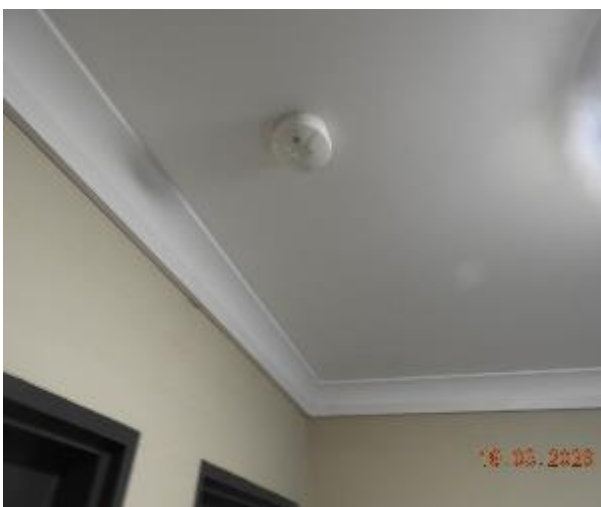
Figure 143 - General condition of level 4 common area ceiling

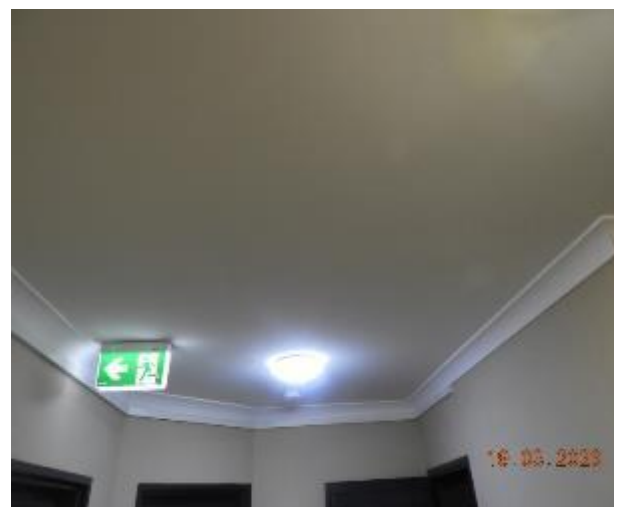
Figure 144 - General condition of level 4 common area ceiling

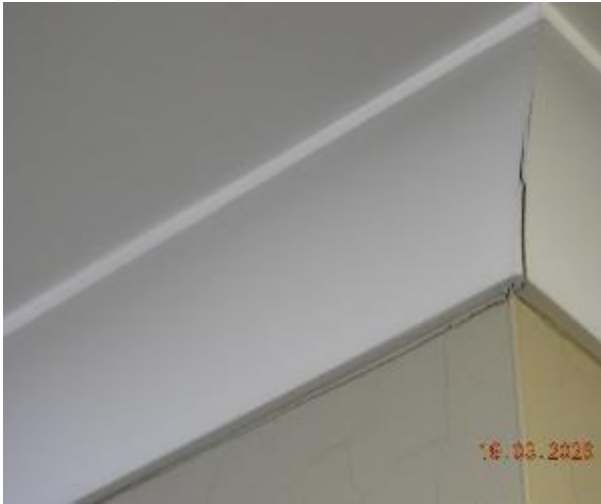
Figure 145 - Crack propagation through level 4 common area ceiling

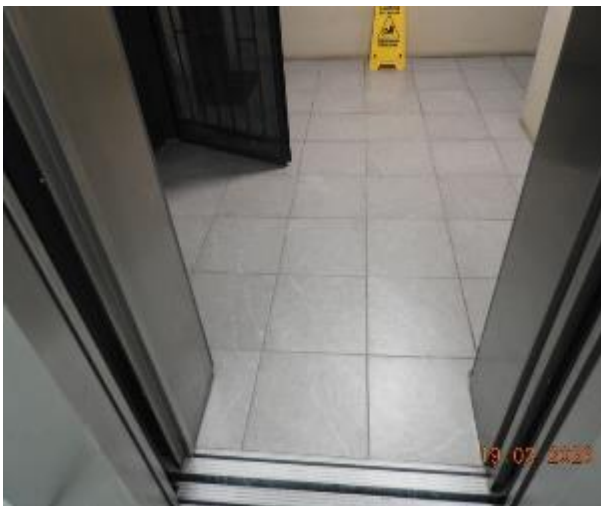
Figure 147 - General condition of level 5 common area floor tiles

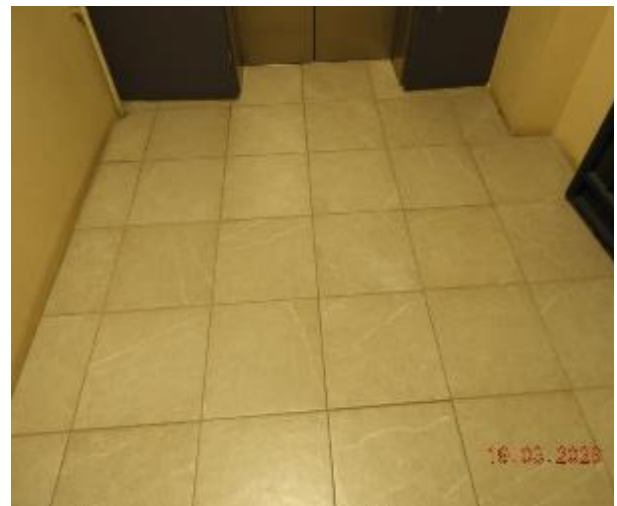
Figure 148 - General condition of level 5 common area floor tiles

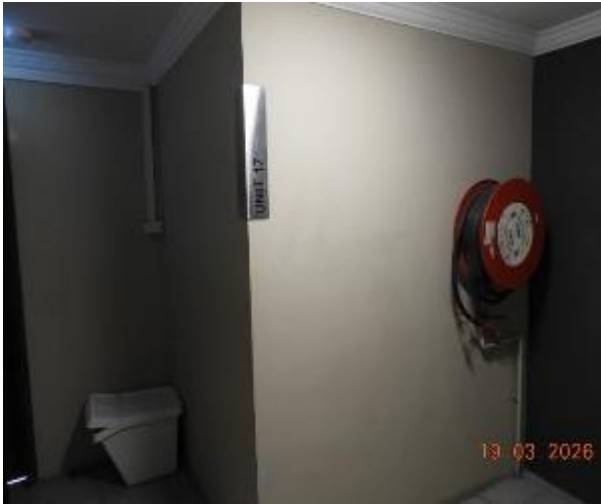
Figure 151 - General condition of level 5 common area internal wall

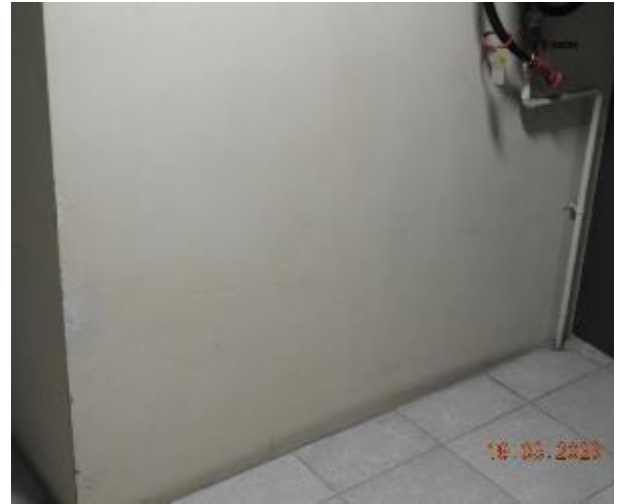
Figure 152 - General condition of level 5 common area internal wall

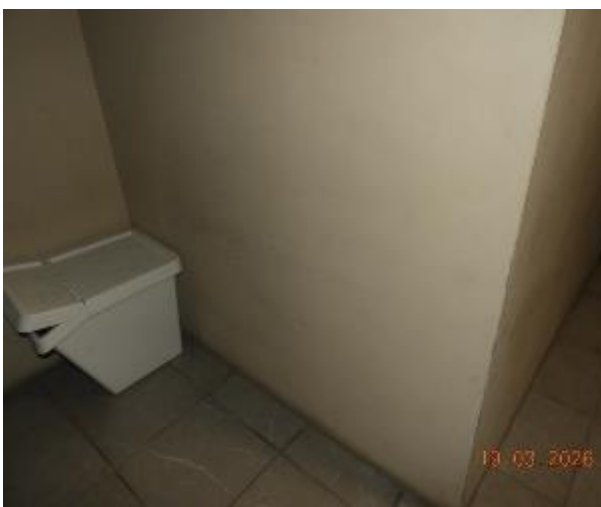
Figure 155 - General condition of level 5 common area internal wall

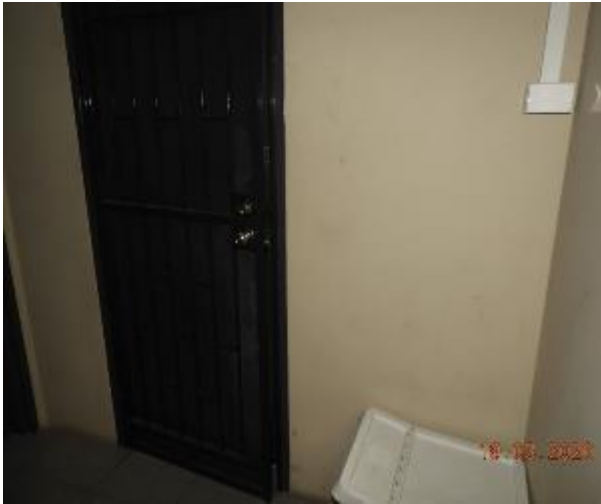
Figure 157 - General condition of level 5 common area internal wall

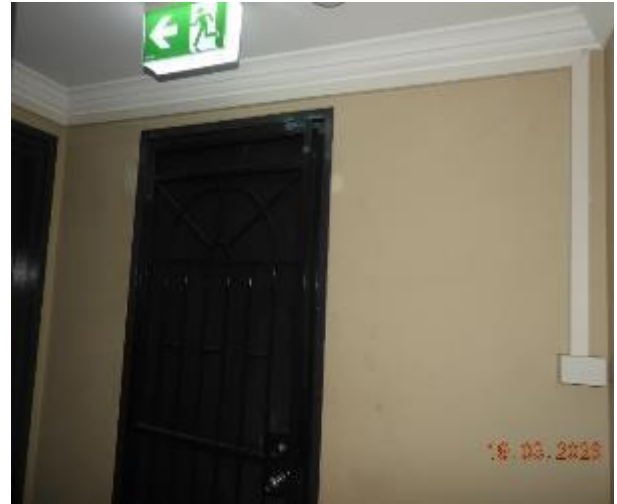
Figure 158 - General condition of level 5 common area internal wall

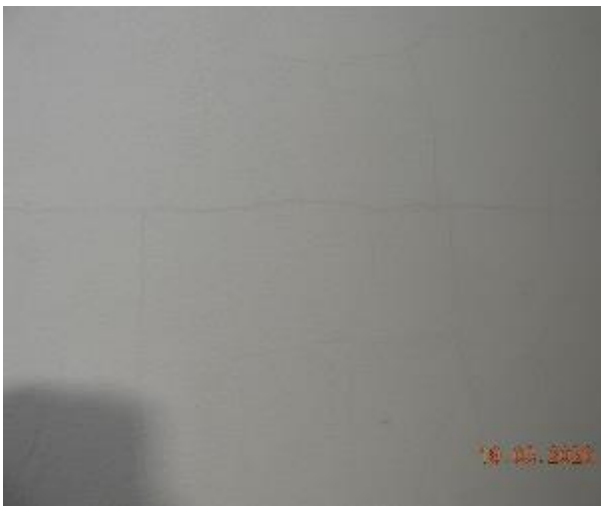
Figure 159 - Crack propagation through level 5 common area internal wall

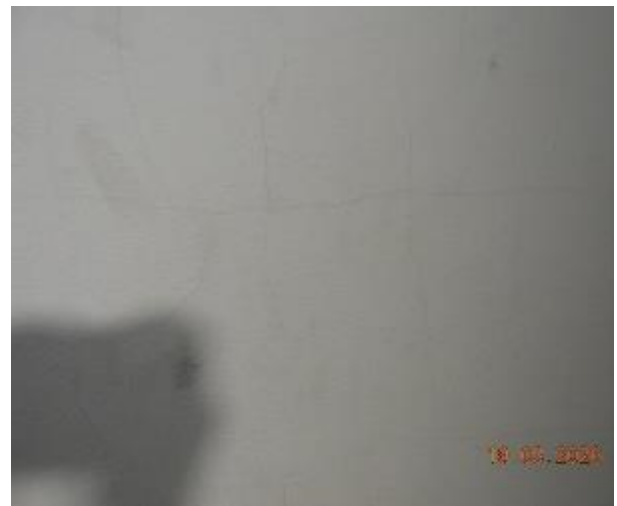
Figure 160 - Crack propagation through level 5 common area internal wall

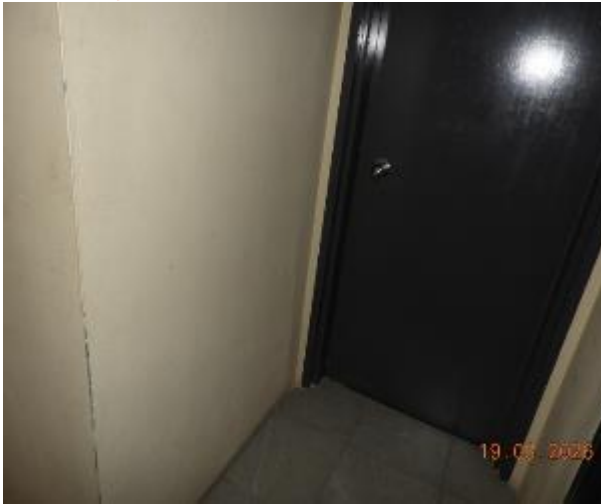
Figure 163 - General condition of level 5 common area internal wall

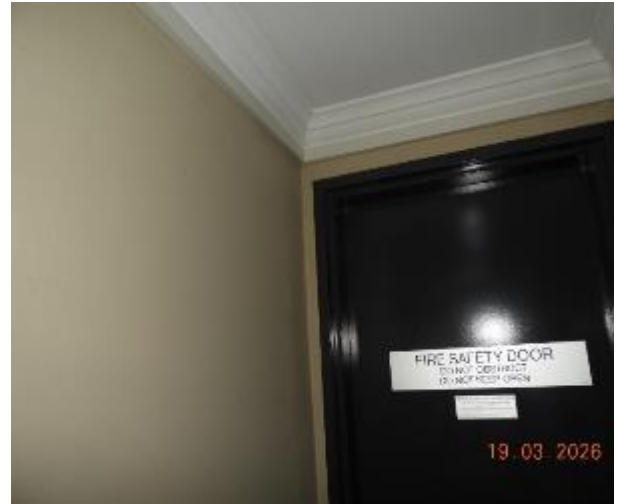
Figure 164 - General condition of level 5 common area internal wall

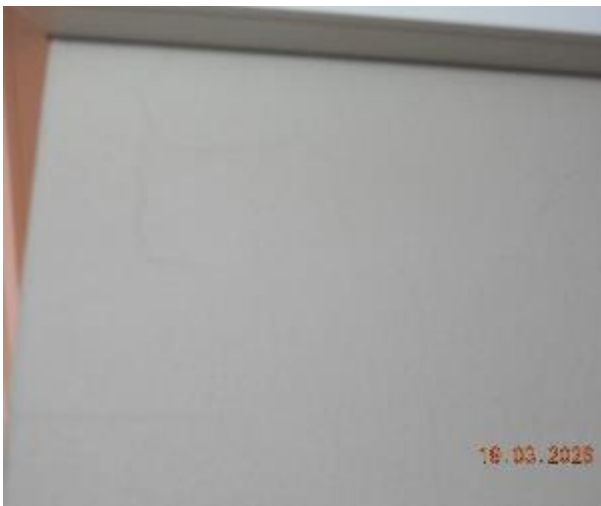
Figure 165 - Crack propagation through level 5 common area internal wall

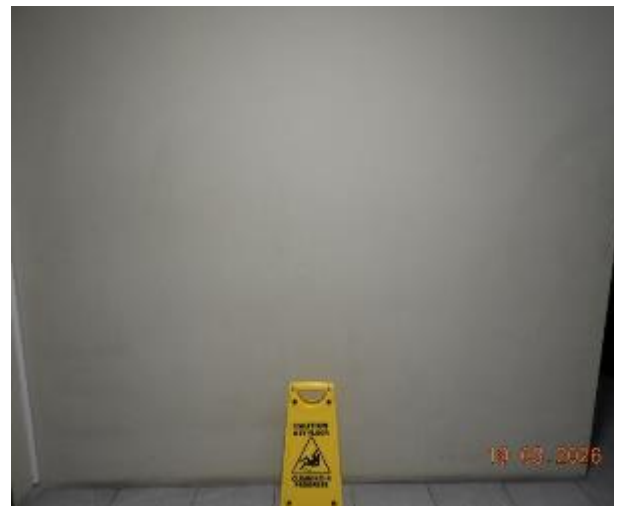
Figure 166 - General condition of level 5 common area internal wall

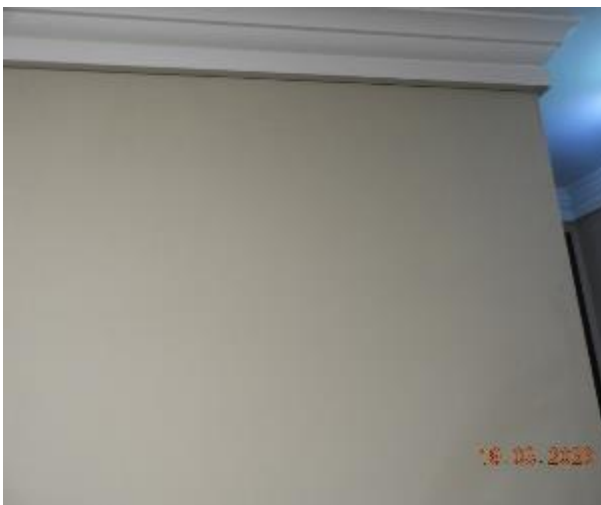
Figure 167 - General condition of level 5 common area internal wall

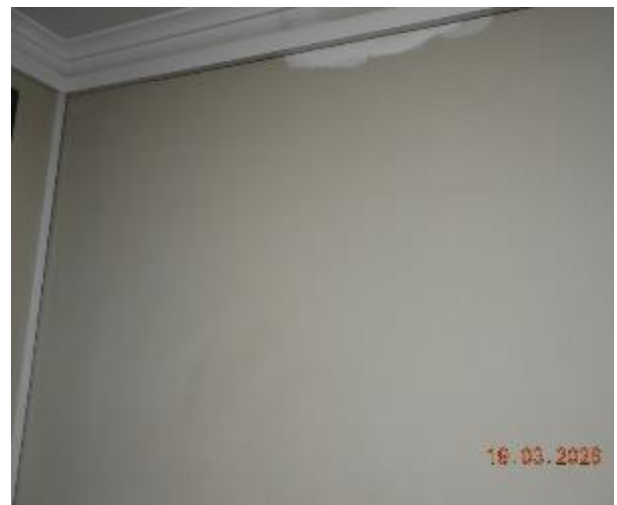
Figure 168 - General condition of level 5 common area internal wall

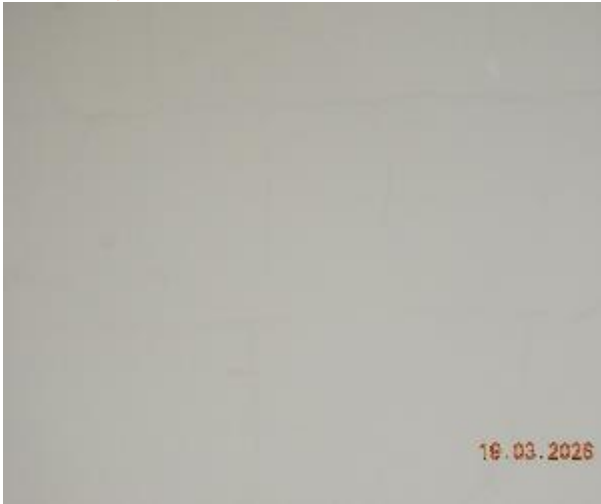
Figure 169 - Crack propagation through level 5 common area internal wall

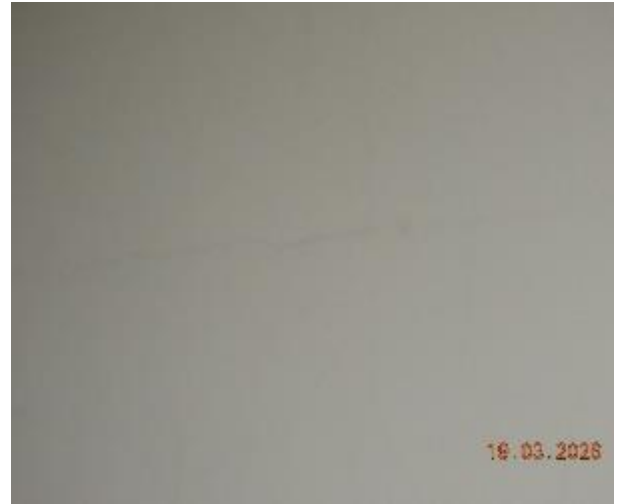
Figure 170 - Crack propagation through level 5 common area internal wall

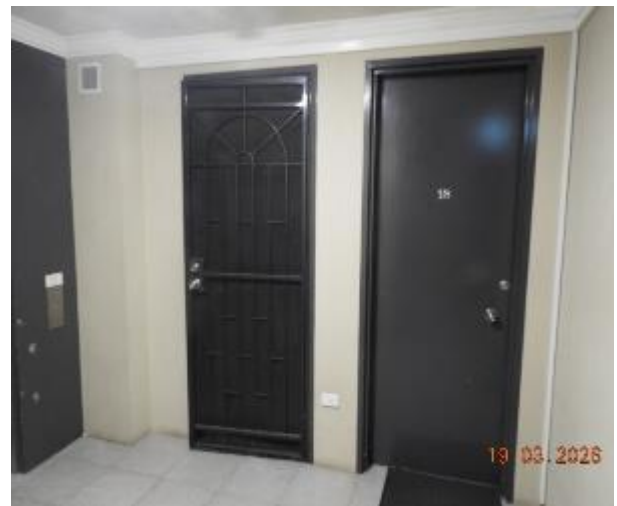
Figure 172 - General condition of level 5 common area internal wall

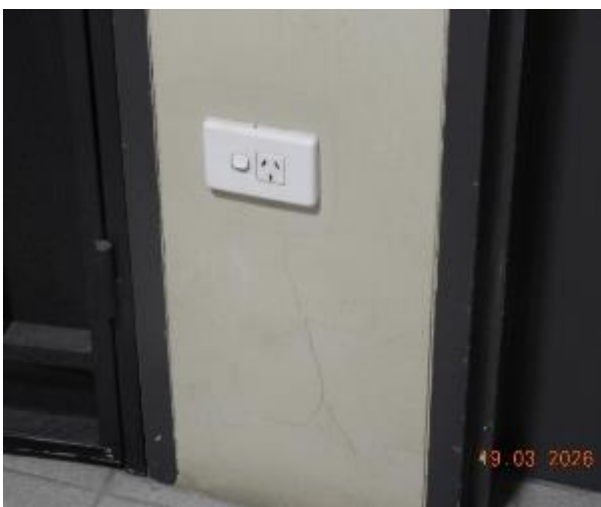
Figure 173 - Crack propagation through level 5 common area internal wall

The common areas of the front building were inspected and determined to be in reasonable condition. There was evidence of cracking through the internal walls, as well as isolated cracking through the ceiling.

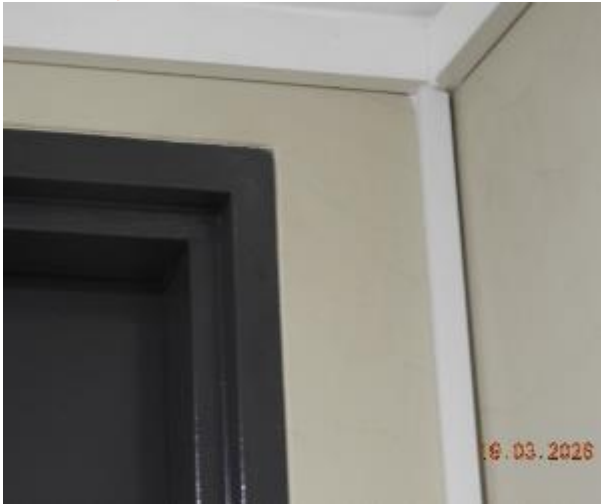
Figure 175 - Crack propagation through level 5 common area internal wall

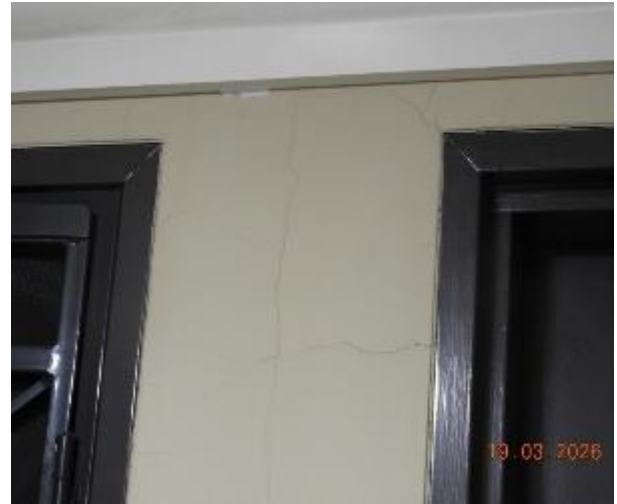
Figure 176 - Crack propagation through level 5 common area internal wall

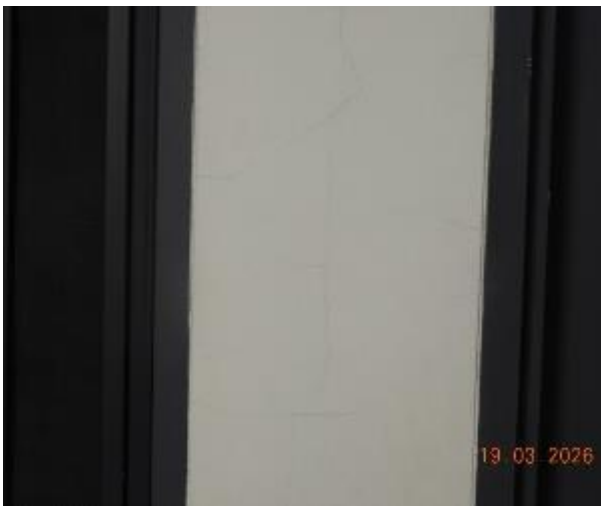
Figure 177 - Crack propagation through level 5 common area internal wall

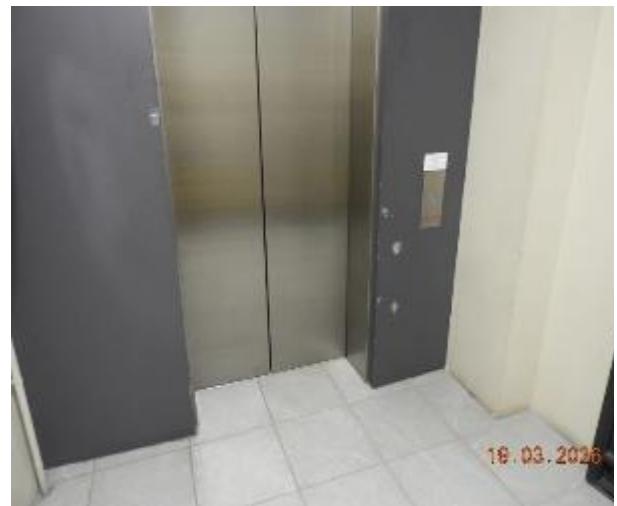
Figure 178 - General condition of level 5 common area internal wall

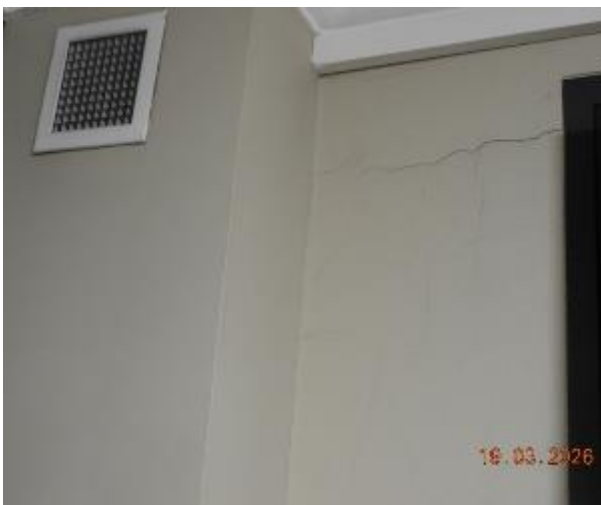
Figure 179 - Crack propagation through level 5 common area internal wall

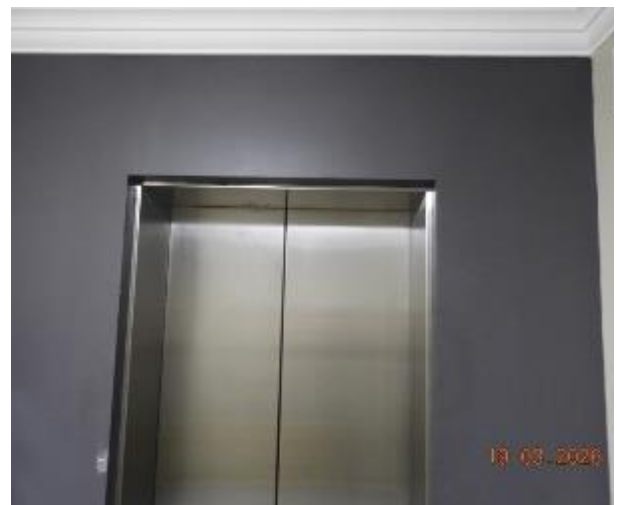
Figure 180 - General condition of level 5 common area internal wall

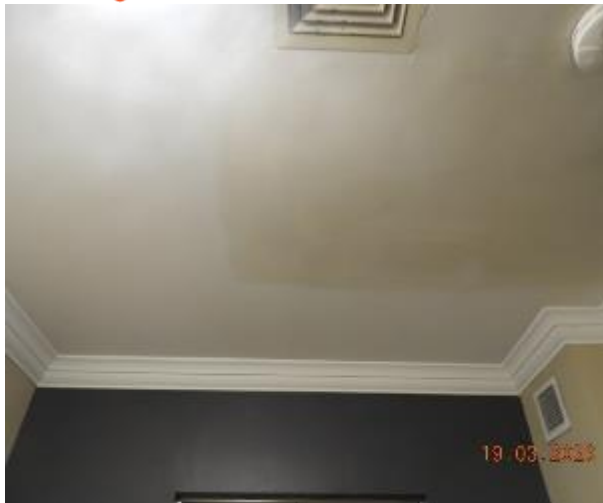
Figure 181 - General condition of level 5 common area ceiling

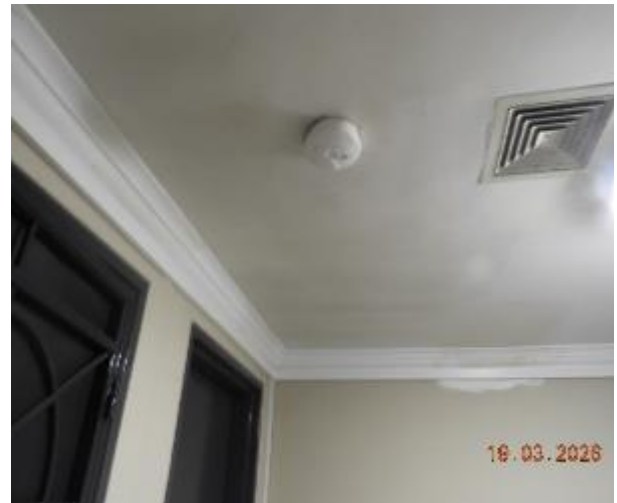
Figure 182 - General condition of level 5 common area ceiling

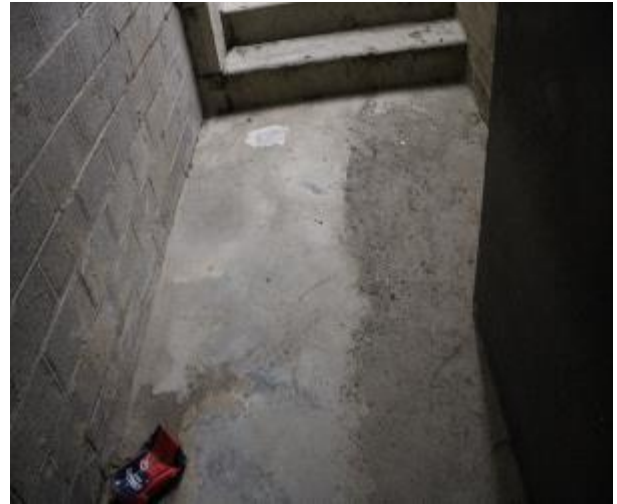
Figure 186 - General condition of B2 fire stairs concrete floor

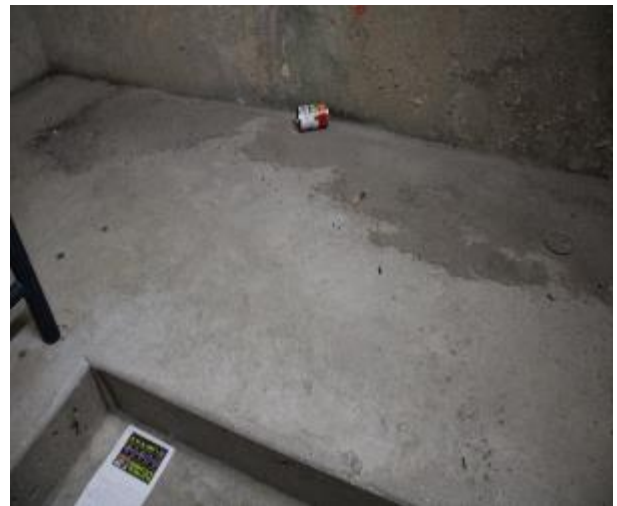
Figure 188 - General condition of B2 fire stairs concrete floor

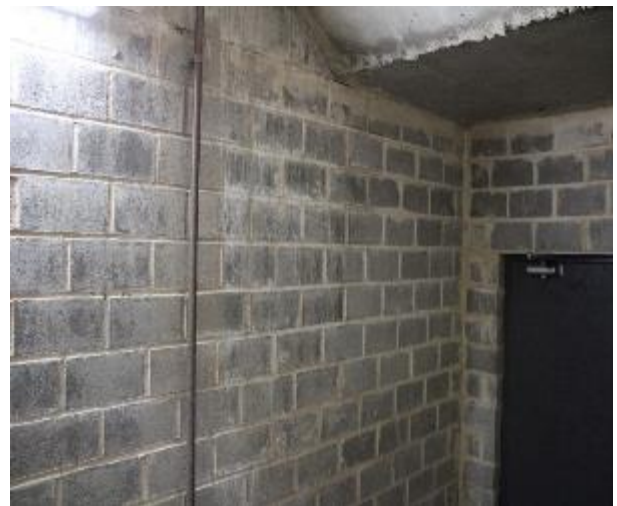
Figure 194 - General condition of B2 fire stairs internal wall

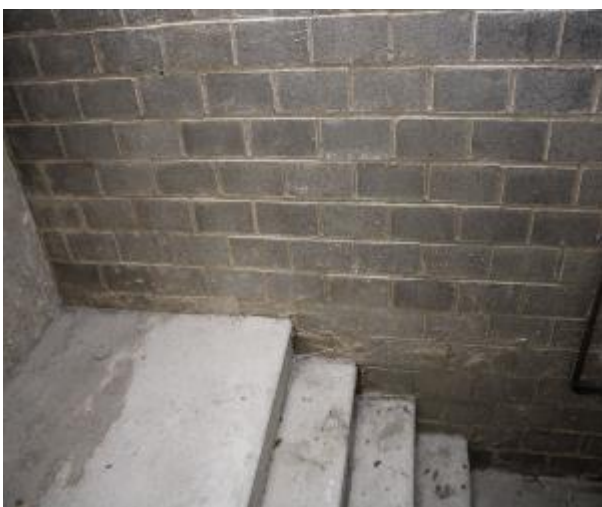
Figure 195 - General condition of B2 fire stairs internal wall

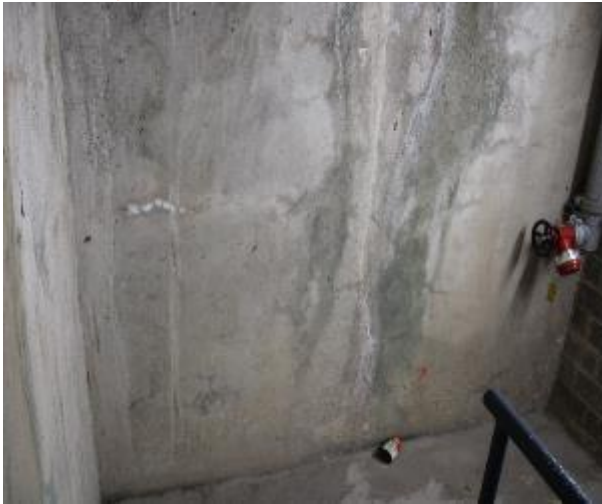
Figure 197 - General condition of B2 fire stairs internal wall
