# **Pre-Dilapidation Report**

**19 GEORGE STREET**

**FRONT BUILDING (UNITS 1-19)**

Project Reference: 20250047.19G.2

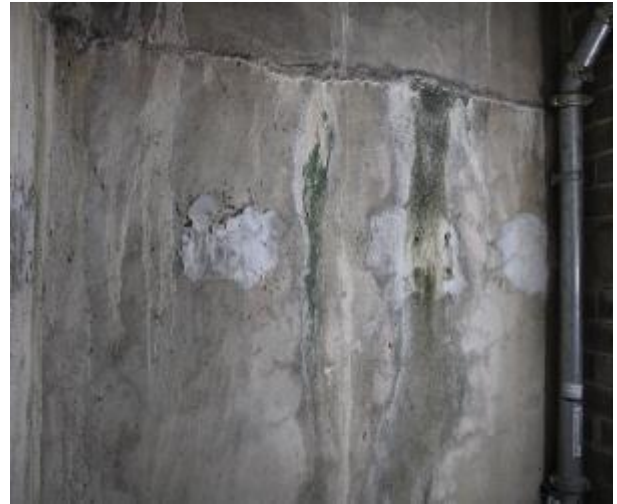
Figure 198 - General condition of B2 fire stairs internal wall

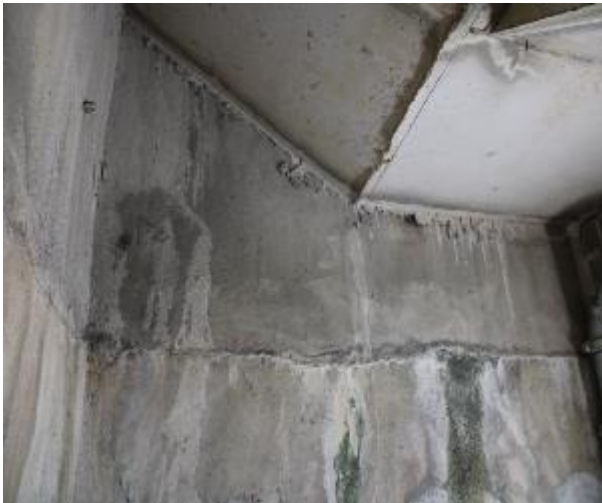
Figure 199 - General condition of B2 fire stairs internal wall

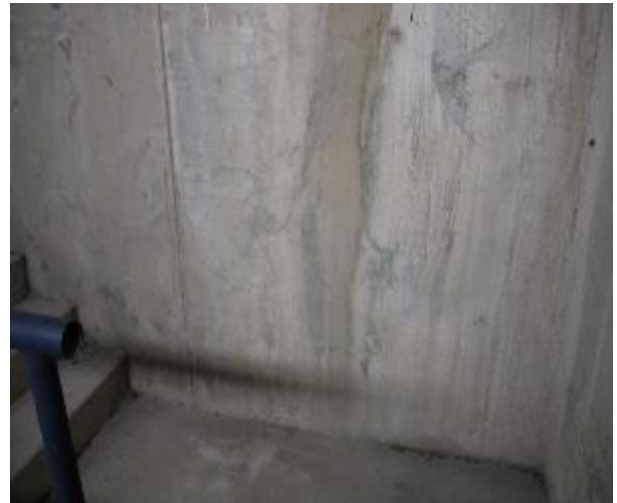
Figure 200 - General condition of B2 fire stairs internal wall

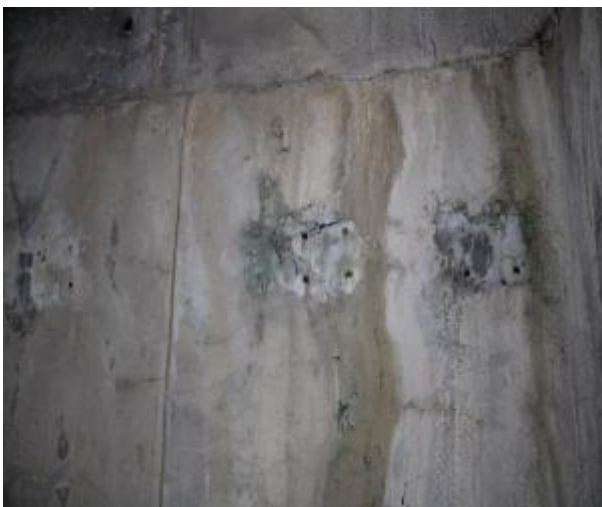
Figure 201 - General condition of B2 fire stairs internal wall

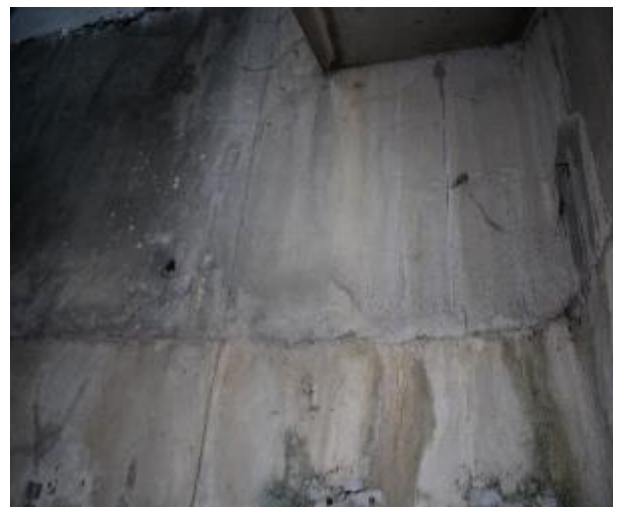
Figure 202 - General condition of B2 fire stairs internal wall

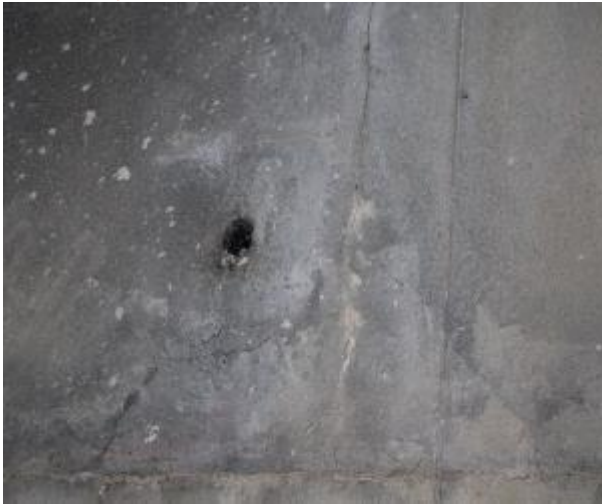
Figure 203 - General condition of B2 fire stairs internal wall

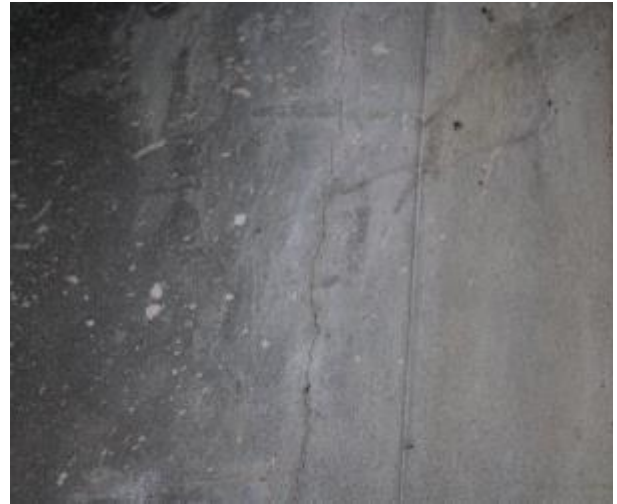
Figure 204 - Crack propagation through B2 fire stairs internal wall

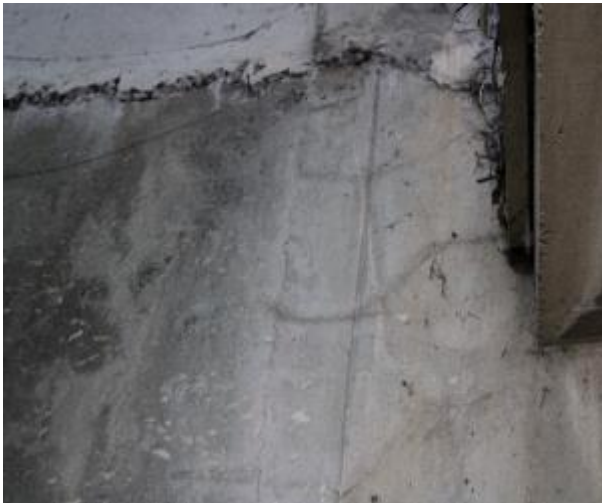
Figure 205 - Crack propagation through B2 fire stairs internal wall

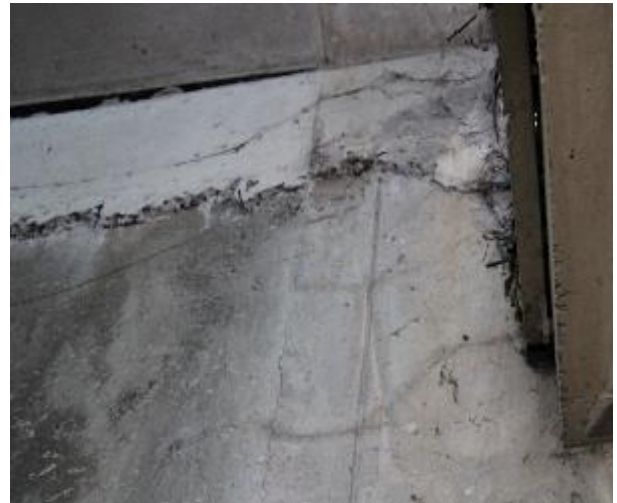
Figure 206 - General condition of B2 fire stairs internal wall

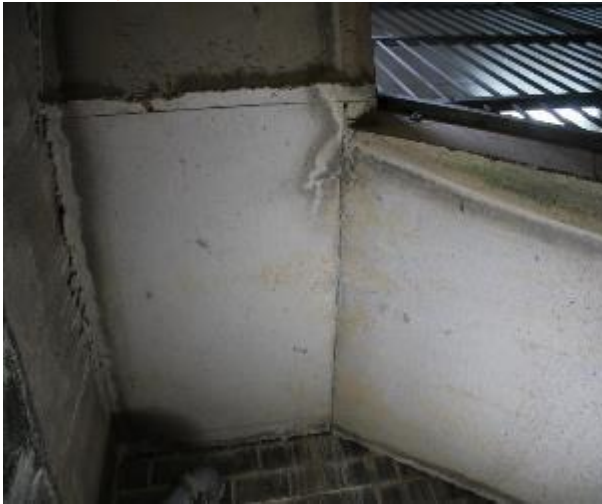
Figure 209 - General condition of B2 fire stairs underside stairs

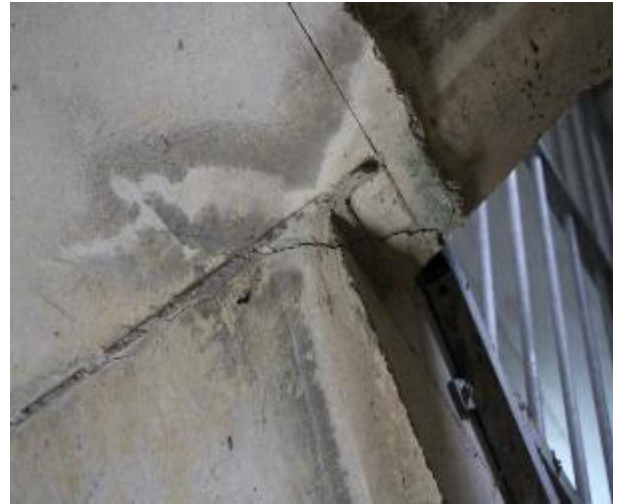
Figure 210 - Crack propagation through B2 fire stairs underside stairs

The fire stairs from Basement B2 to Level 1 were inspected and determined to be in reasonable condition. There were cases of cracking through the internal walls, underside stairs, and underside slab.

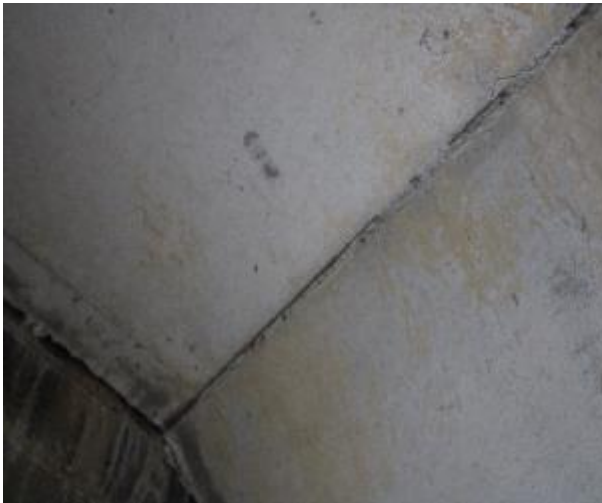
Figure 211 - General condition of B2 fire stairs underside stairs

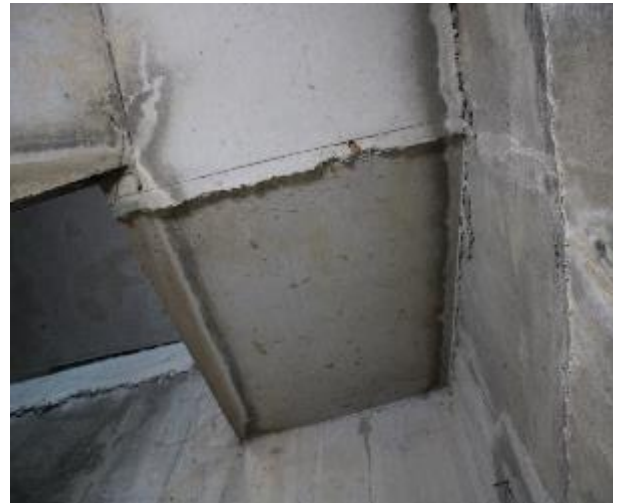
Figure 212 - General condition of B2 fire stairs underside stairs

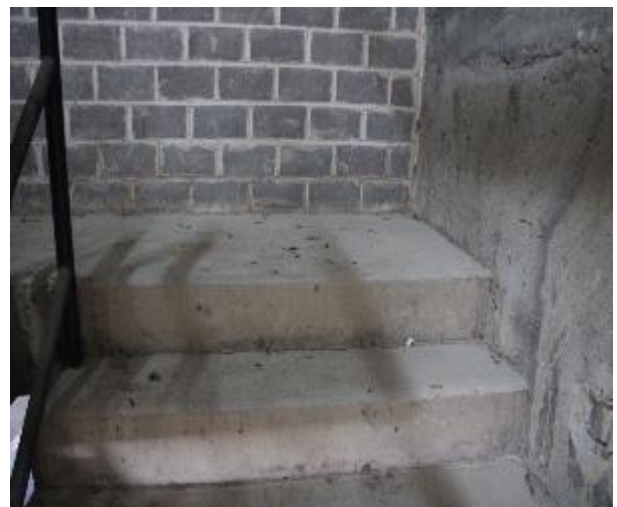
Figure 214 - General condition of B1 fire stairs

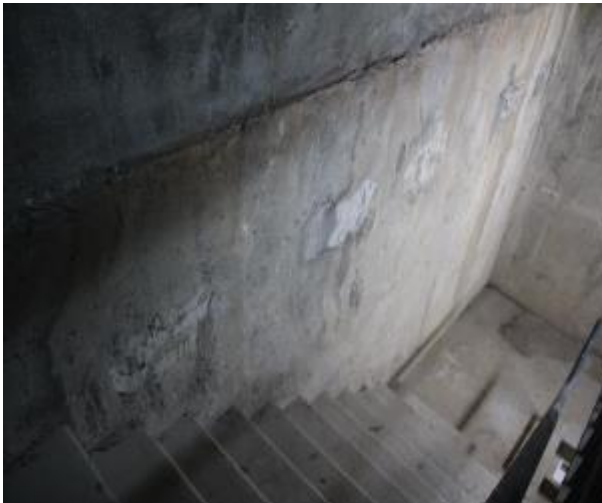
Figure 217 - General condition of B1 fire stairs internal wall

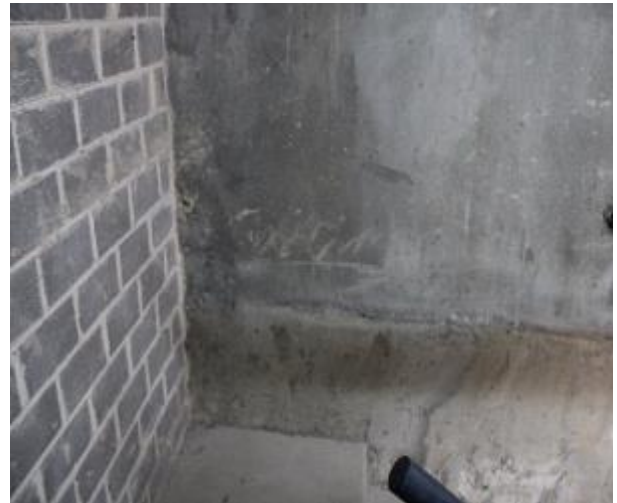
Figure 218 - General condition of B1 fire stairs internal wall

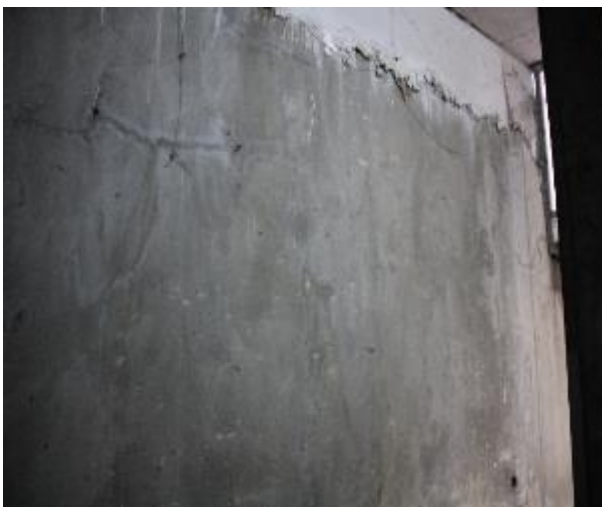
Figure 219 - General condition of B1 fire stairs internal wall

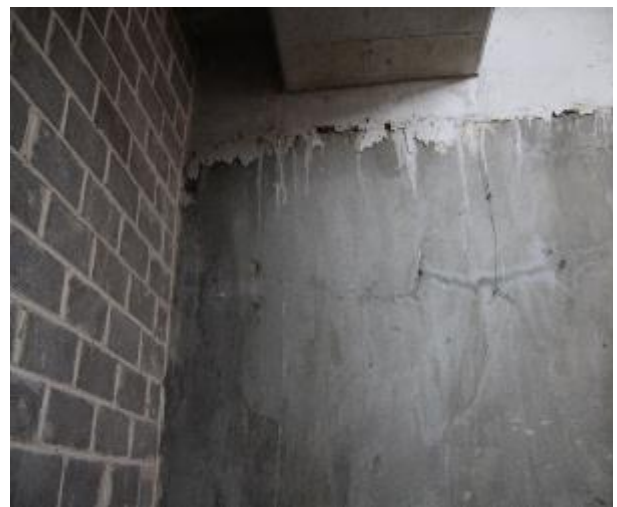
Figure 220 - General condition of B1 fire stairs internal wall

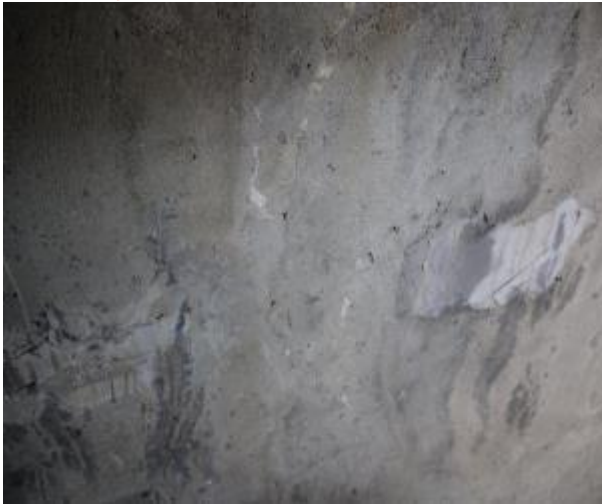
Figure 221 - General condition of B1 fire stairs internal wall

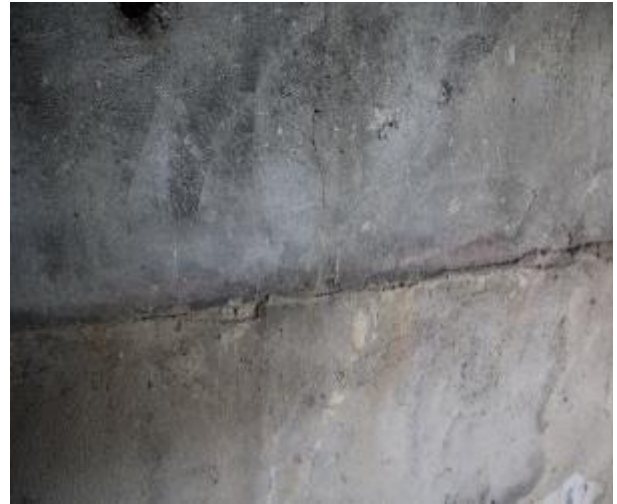
Figure 222 - Crack propagation through B1 fire stairs internal wall

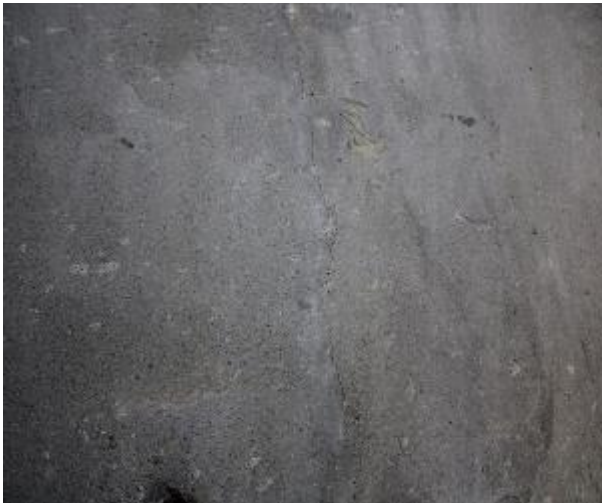
Figure 223 - Crack propagation through B1 fire stairs internal wall

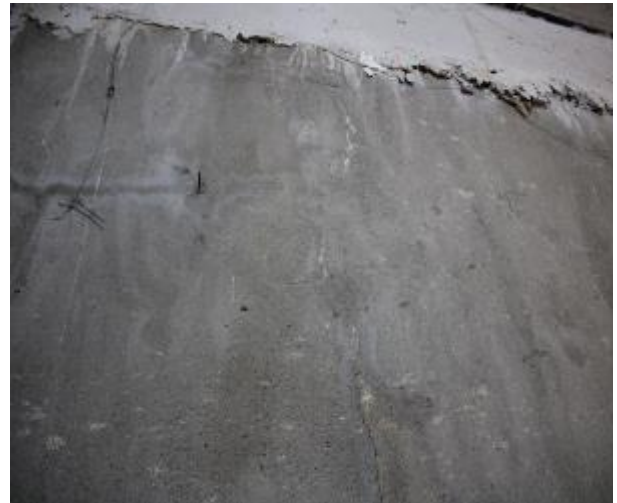
Figure 224 - Crack propagation through B1 fire stairs internal wall

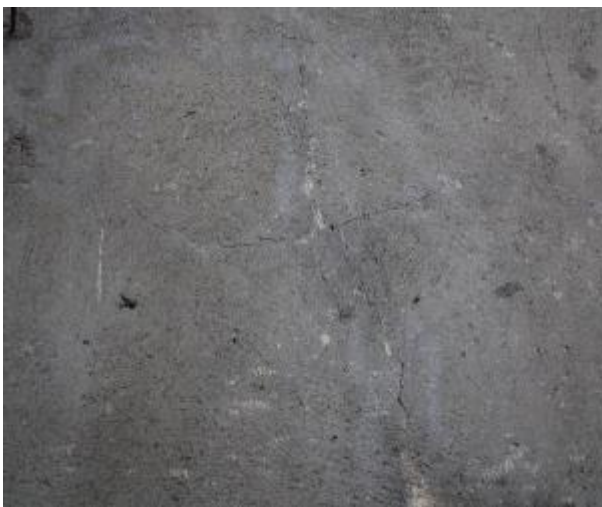
Figure 225 - Crack propagation through B1 fire stairs internal wall

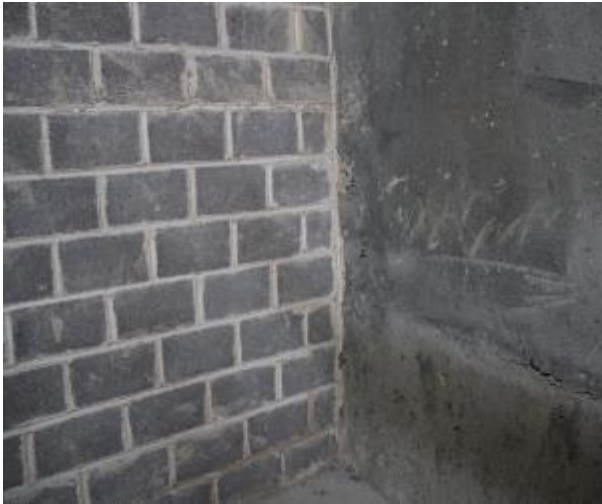
Figure 227 - General condition of B1 fire stairs internal wall

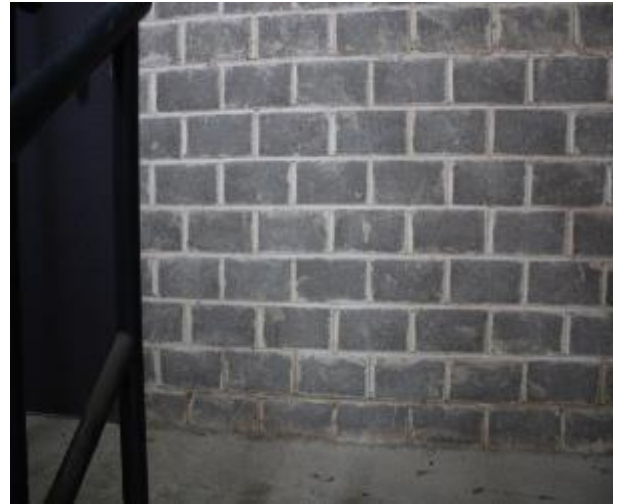
Figure 228 - General condition of B1 fire stairs internal wall

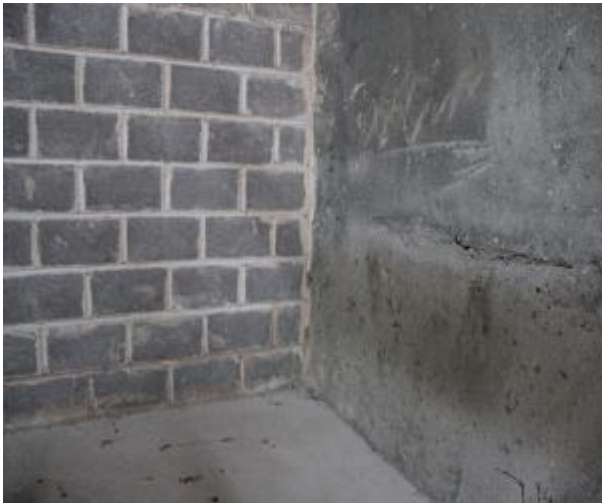
Figure 229 - General condition of B1 fire stairs internal wall

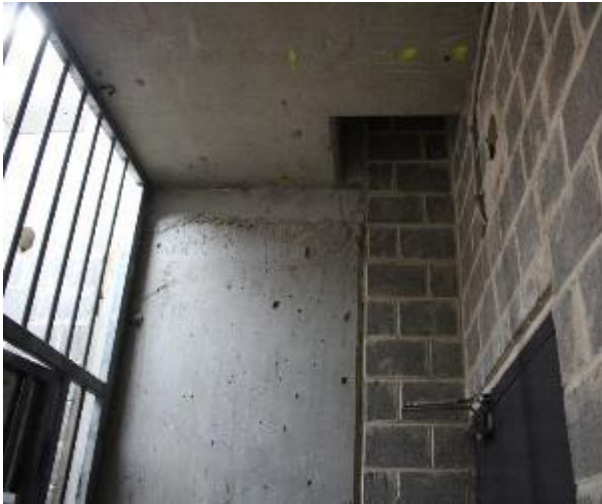
Figure 233 - General condition of B1 fire stairs internal wall

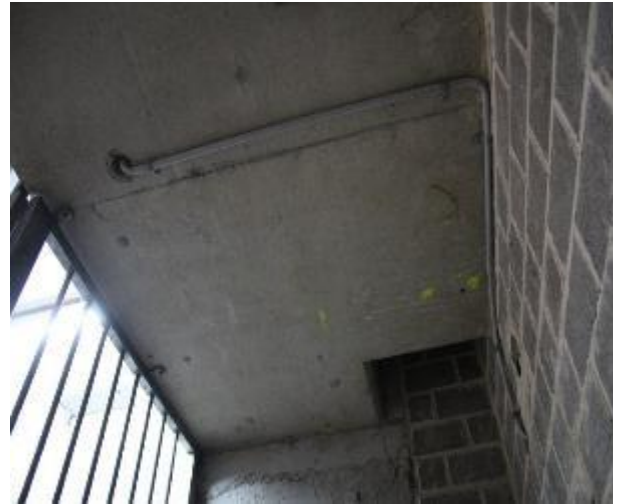
Figure 234 - General condition of B1 fire stairs underside slab

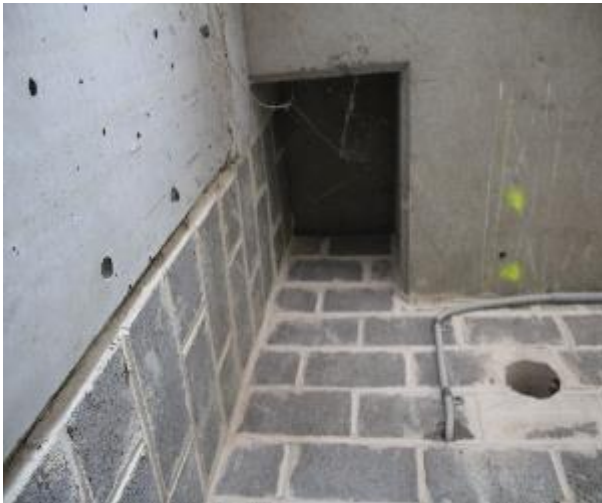
Figure 235 - General condition of B1 fire stairs underside slab

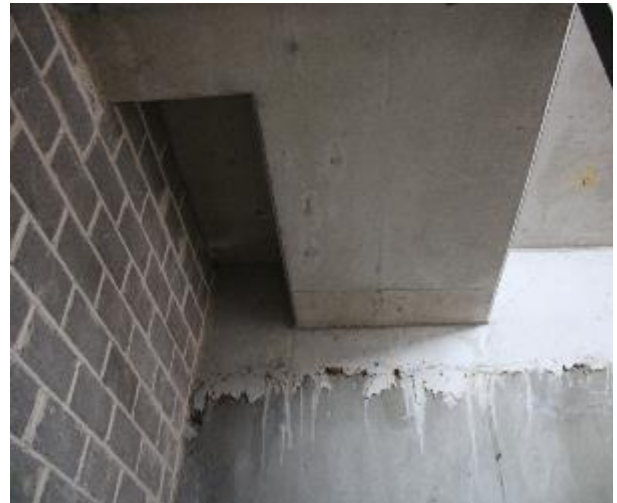
Figure 236 - General condition of B1 fire stairs underside slab

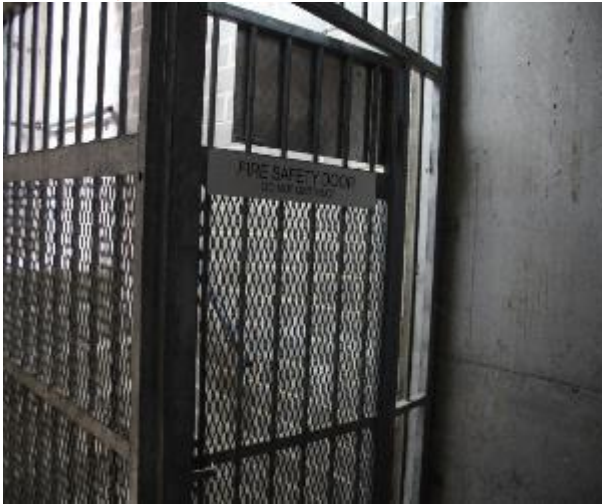
Figure 239 - General condition of level 1 fire stairs

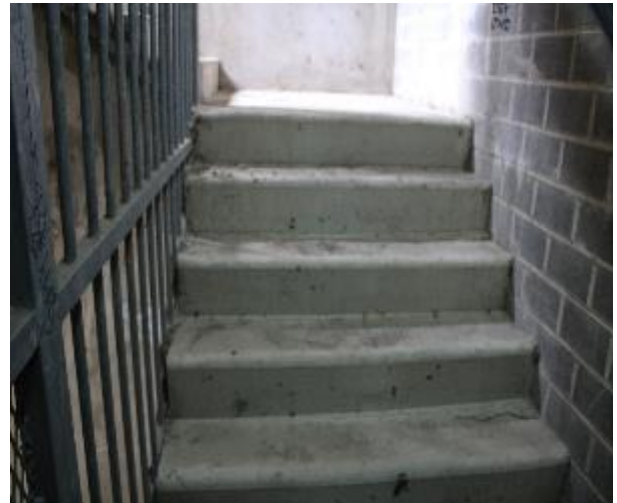
Figure 242 - General condition of level 1 fire stairs

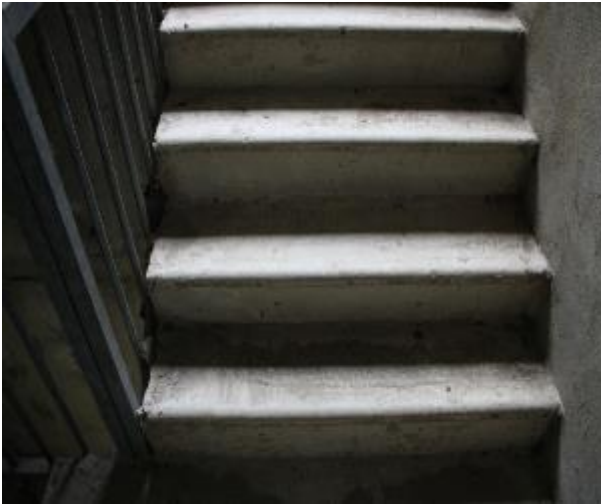
Figure 245 - General condition of level 1 fire stairs

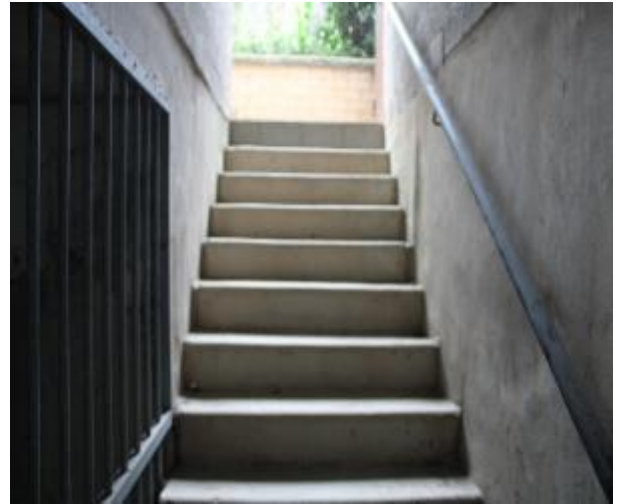
Figure 246 - General condition of level 1 fire stairs

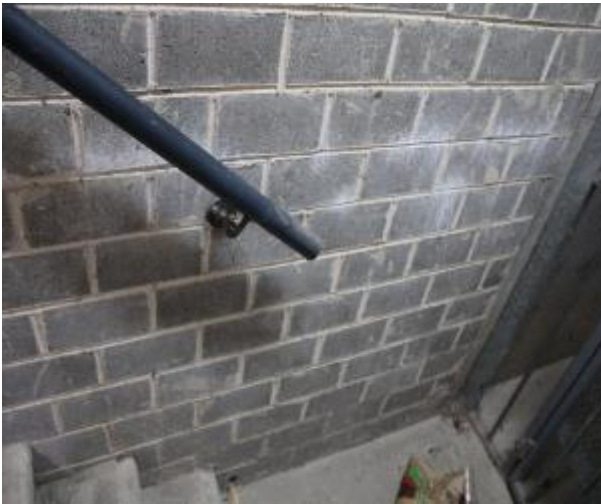
Figure 247 - General condition of level 1 fire stairs internal wall

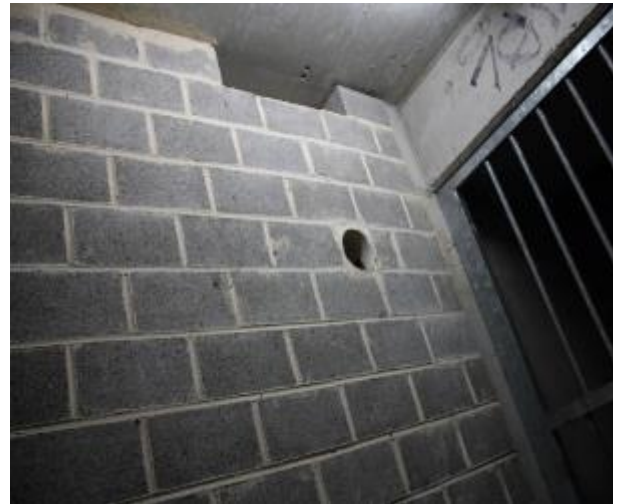
Figure 248 - General condition of level 1 fire stairs internal wall

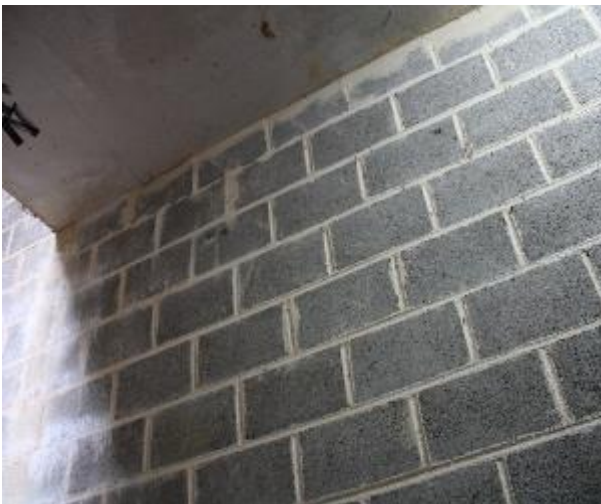
Figure 249 - General condition of level 1 fire stairs internal wall

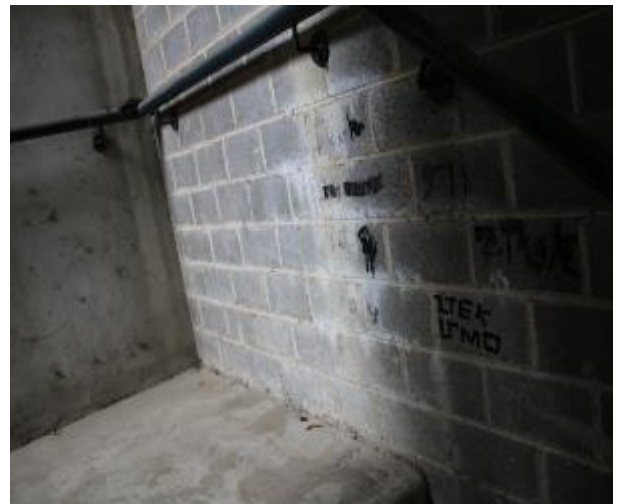
Figure 250 - General condition of level 1 fire stairs internal wall

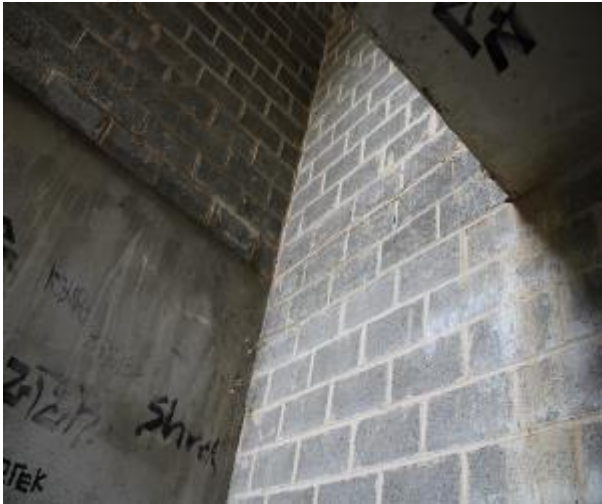
Figure 251 - General condition of level 1 fire stairs internal wall

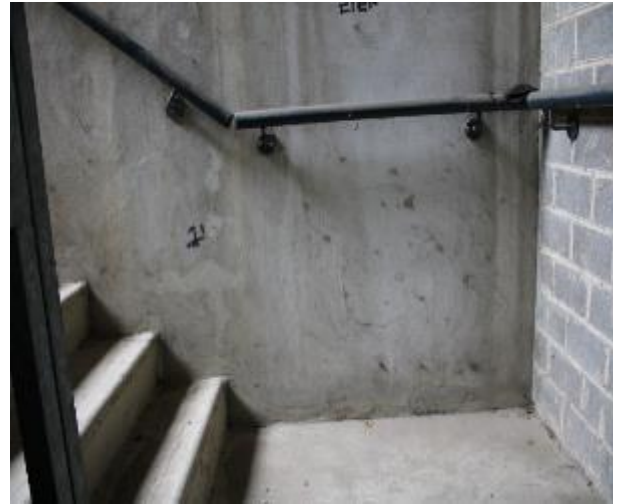
Figure 252 - General condition of level 1 fire stairs internal wall

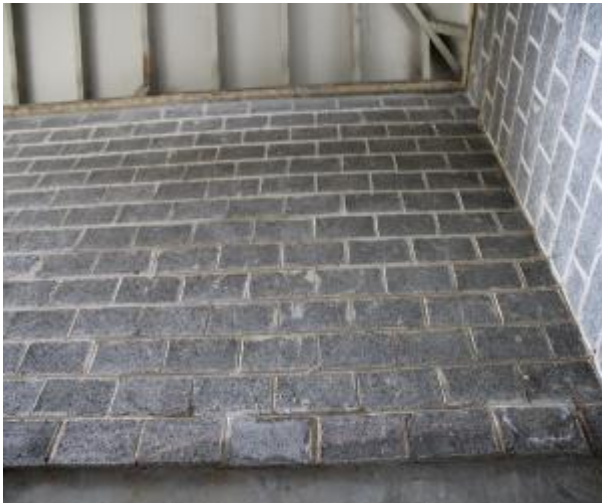
Figure 253 - General condition of level 1 fire stairs internal wall

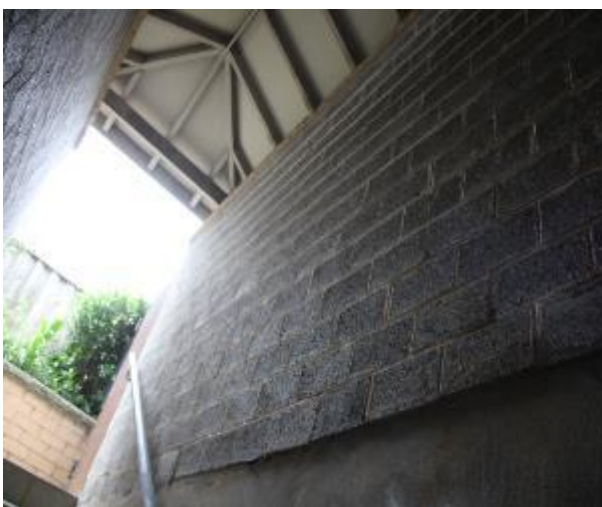
Figure 255 - General condition of level 1 fire stairs internal wall

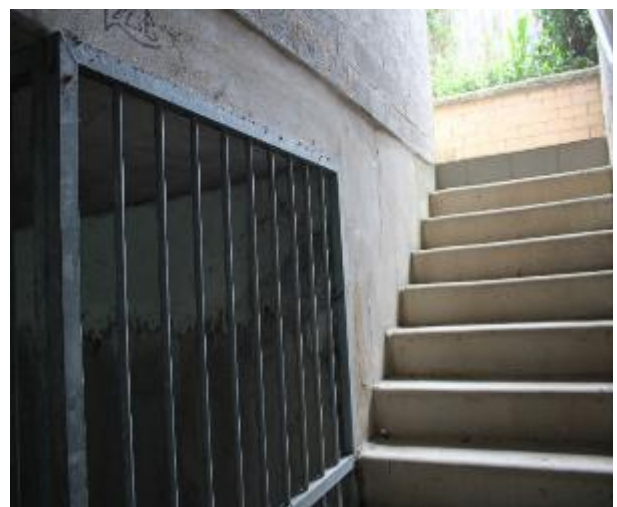
Figure 256 - General condition of level 1 fire stairs internal wall

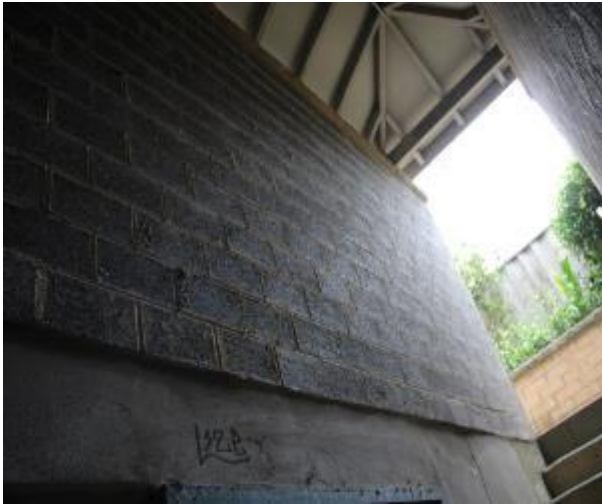
Figure 257 - General condition of level 1 fire stairs internal wall

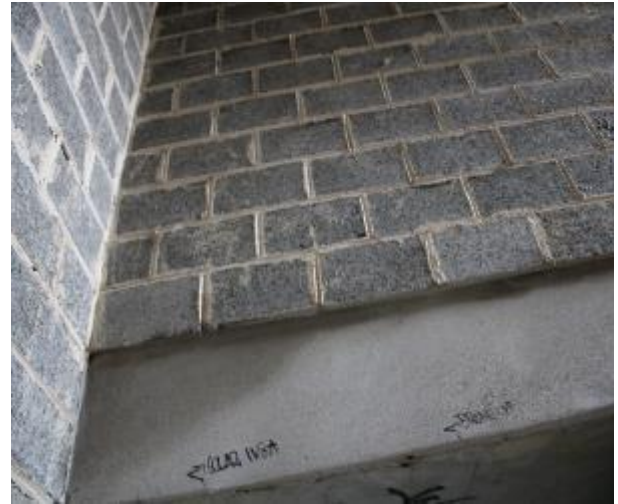
Figure 258 - General condition of level 1 fire stairs internal wall

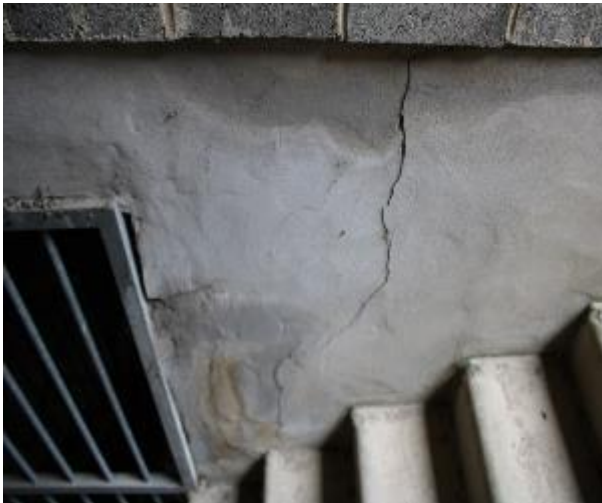
Figure 259 - Crack propagation through level 1 fire stairs internal wall

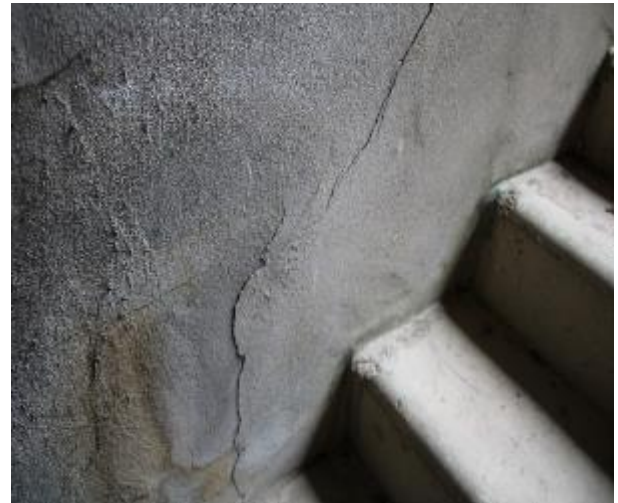
Figure 260 - Crack propagation through level 1 fire stairs internal wall

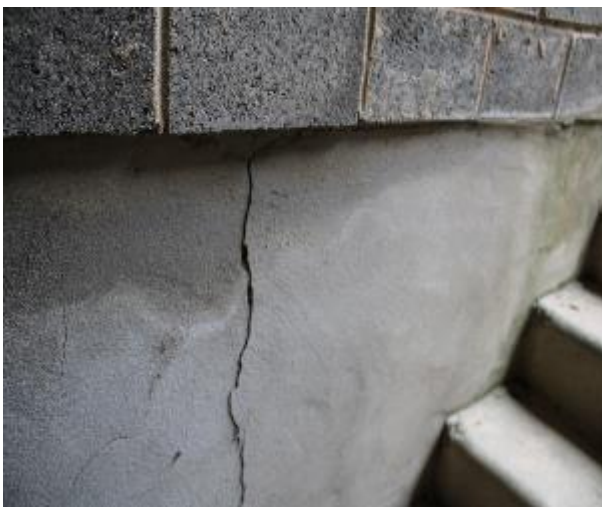
Figure 261 - Crack propagation through level 1 fire stairs internal wall

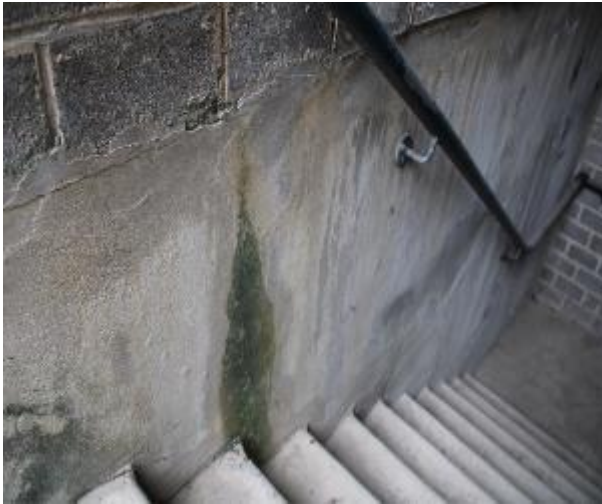
Figure 263 - General condition of level 1 fire stairs internal wall

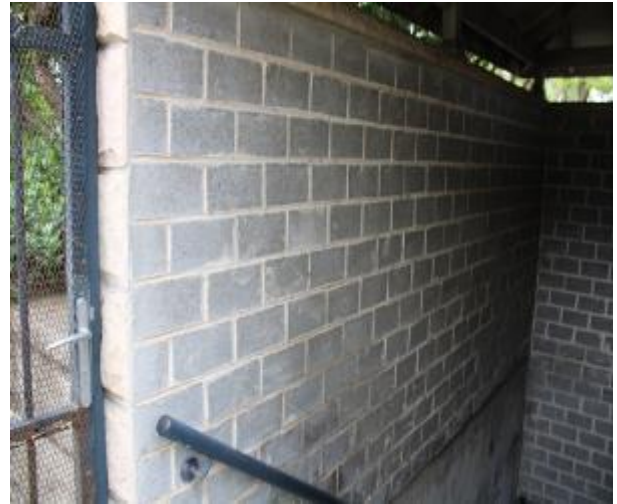
Figure 264 - General condition of level 1 fire stairs internal wall

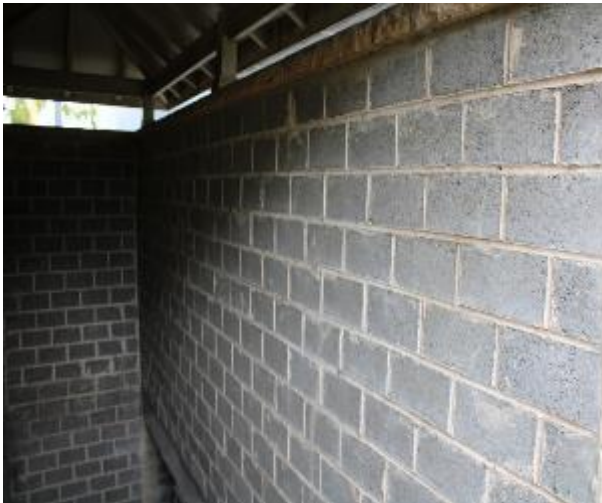
Figure 265 - General condition of level 1 fire stairs internal wall

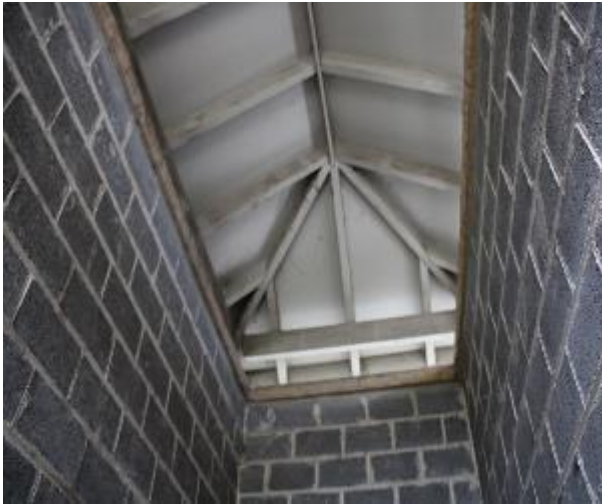
Figure 269 - General condition of level 1 fire stairs roof structure

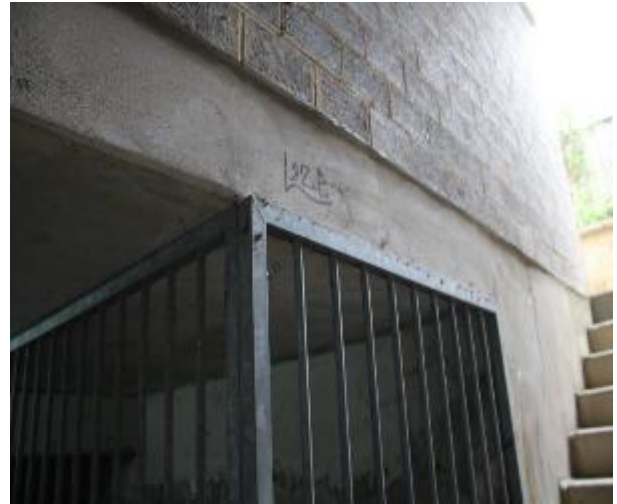
Figure 270 - General condition of fire stairs underside slab

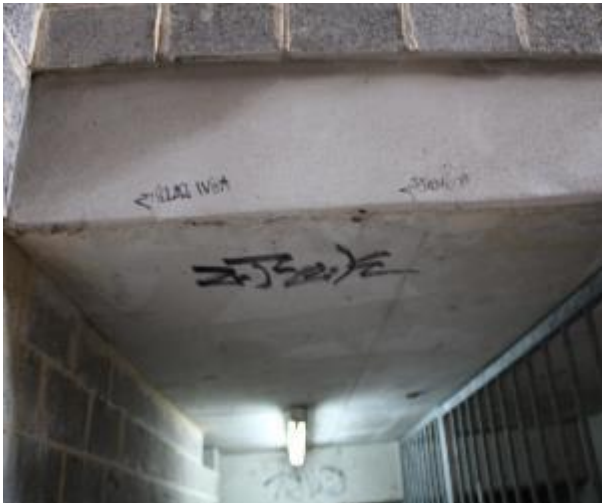
Figure 271 - General condition of fire stairs underside slab

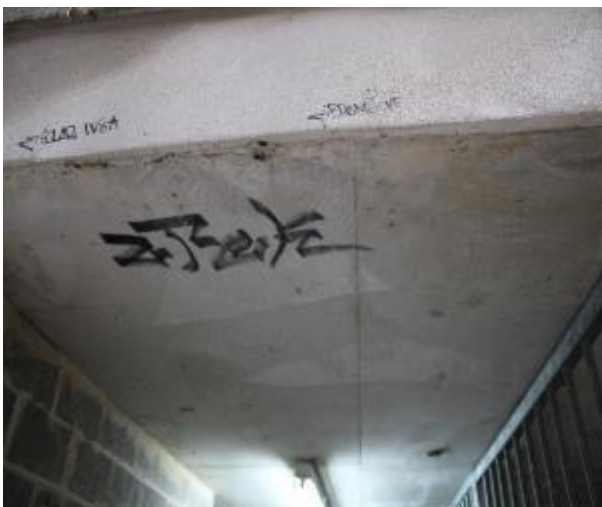
Figure 273 - General condition of fire stairs underside slab

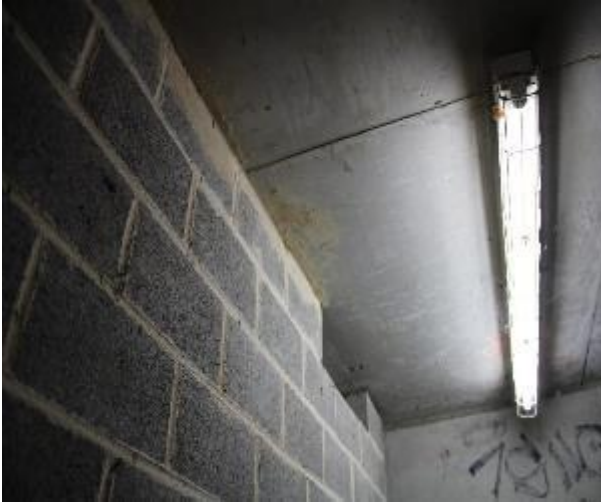
Figure 275 - General condition of fire stairs underside slab

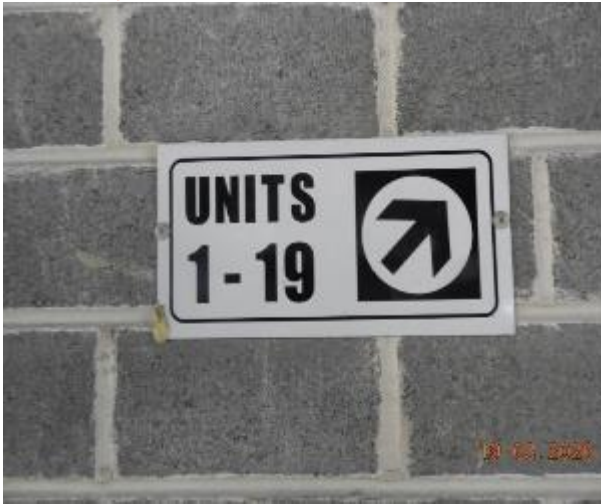
Figure 276 - The following images display the condition of the fire stairs from Level 5 to B2

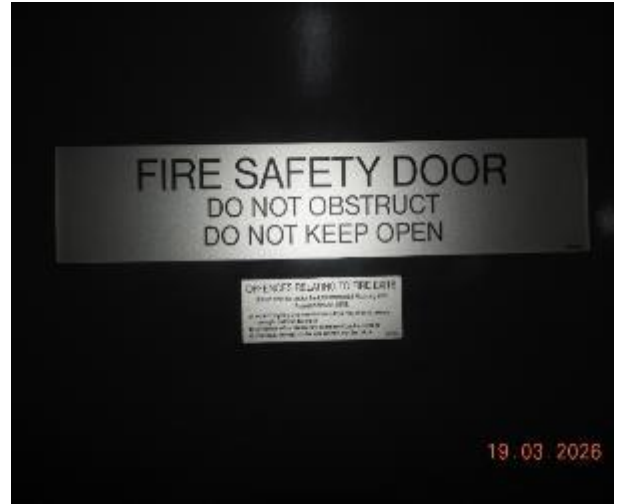
Figure 277 - The following images display the condition of the fire stairs from Level 5 to B2

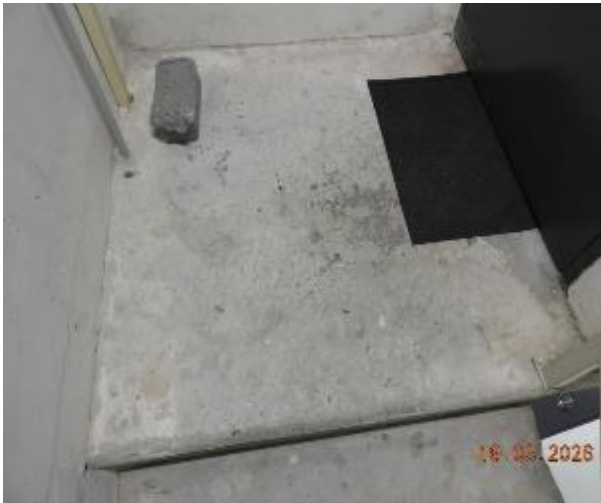
Figure 278 - General condition of level 5 fire stairs concrete floor

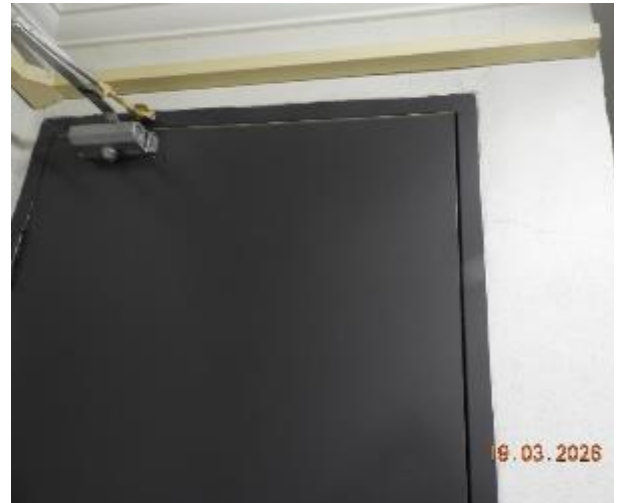
Figure 279 - General condition of level 5 fire stairs internal wall

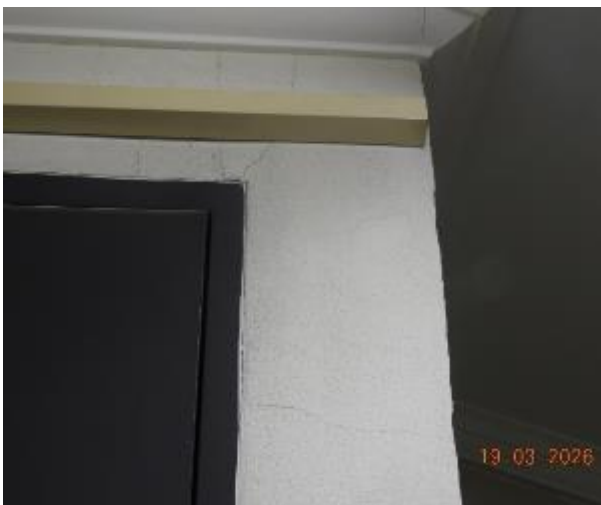
Figure 280 - Crack propagation through level 5 fire stairs internal wall

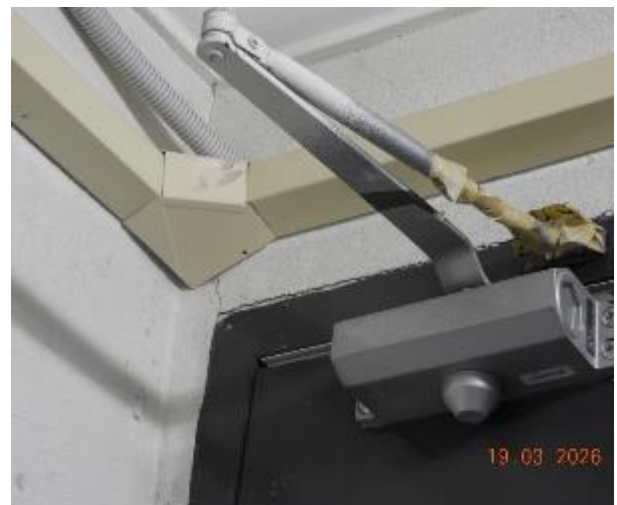
Figure 281 - Crack propagation through level 5 fire stairs internal wall

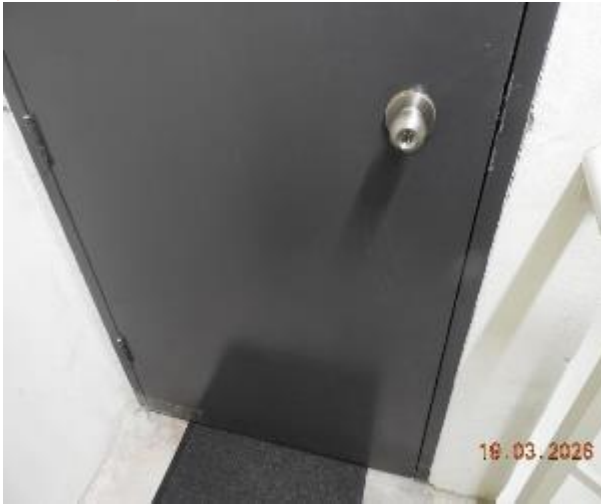
Figure 282 - General condition of level 5 fire stairs internal wall

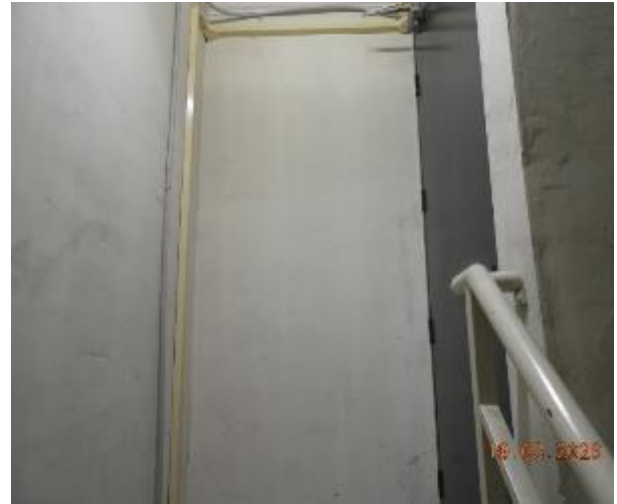
Figure 283 - General condition of level 5 fire stairs internal wall

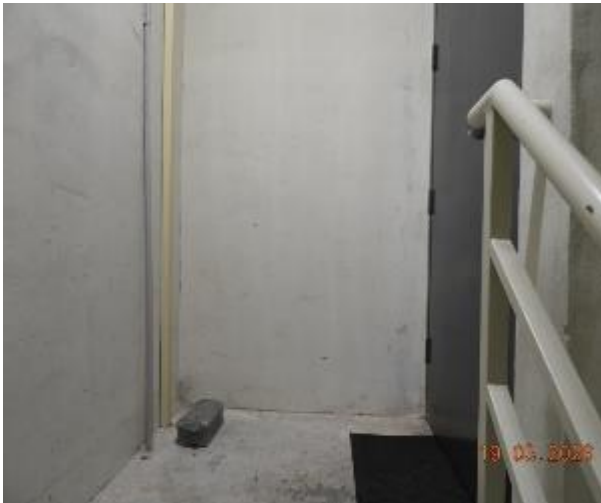
Figure 284 - General condition of level 5 fire stairs internal wall

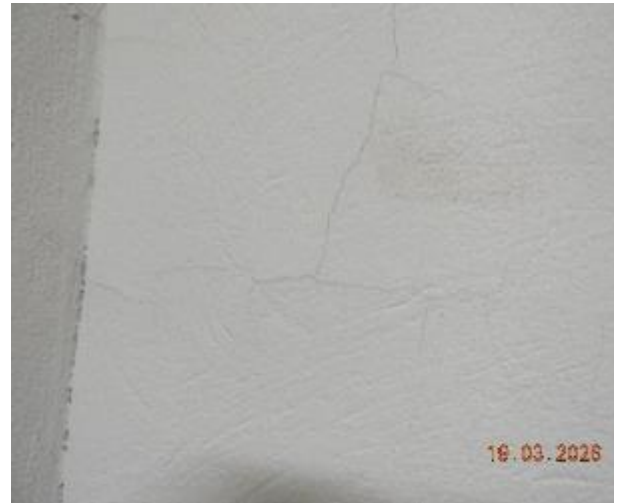
Figure 285 - Crack propagation through level 5 fire stairs internal wall

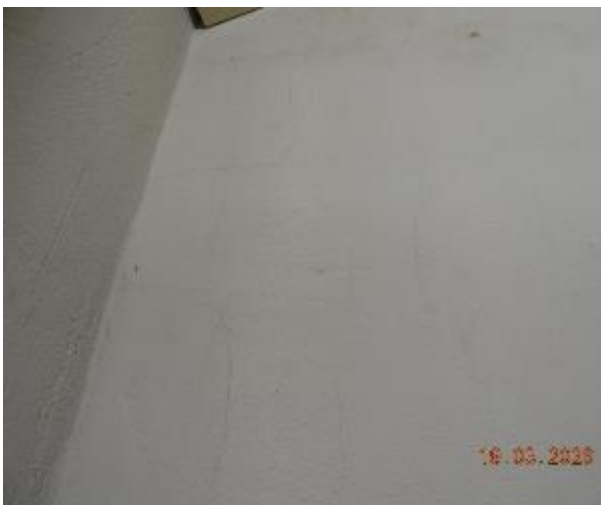
Figure 286 - Crack propagation through level 5 fire stairs internal wall

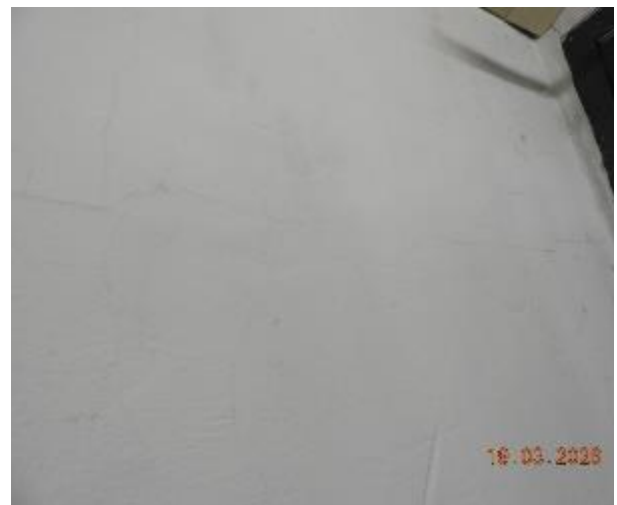
Figure 287 - Crack propagation through level 5 fire stairs internal wall

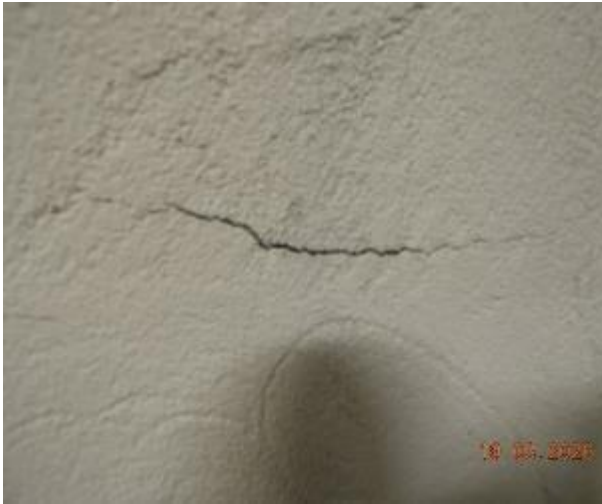
Figure 288 - Crack propagation through level 5 fire stairs internal wall

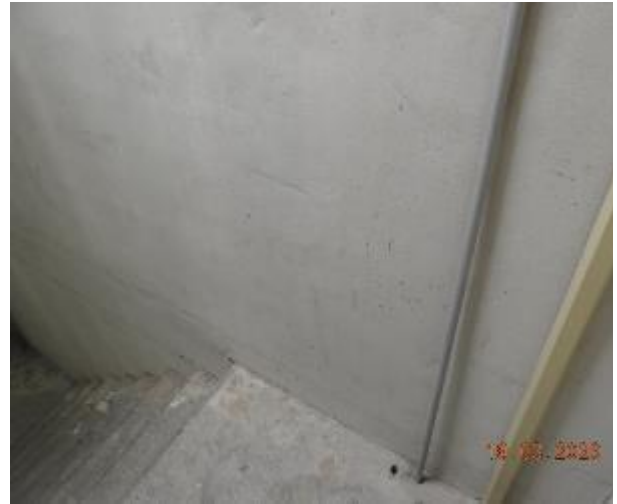
Figure 289 - General condition of level 5 fire stairs internal wall

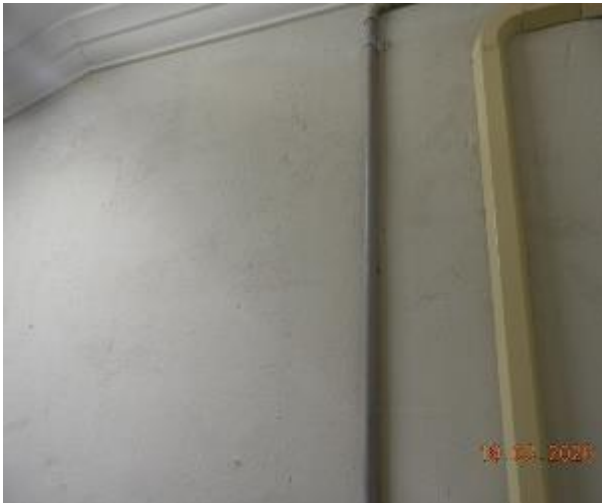
Figure 290 - General condition of level 5 fire stairs internal wall
