# **Pre-Dilapidation Report**

**19 GEORGE STREET**

**FRONT BUILDING (UNITS 1-19)**

Project Reference: 20250047.19G.2

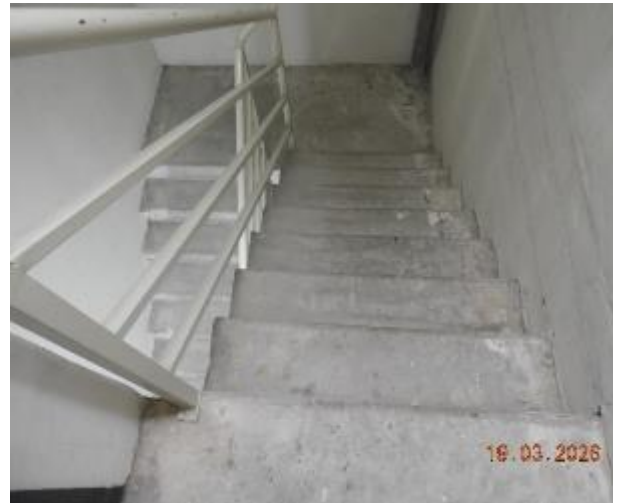
Figure 291 - General condition of level 5 fire stairs

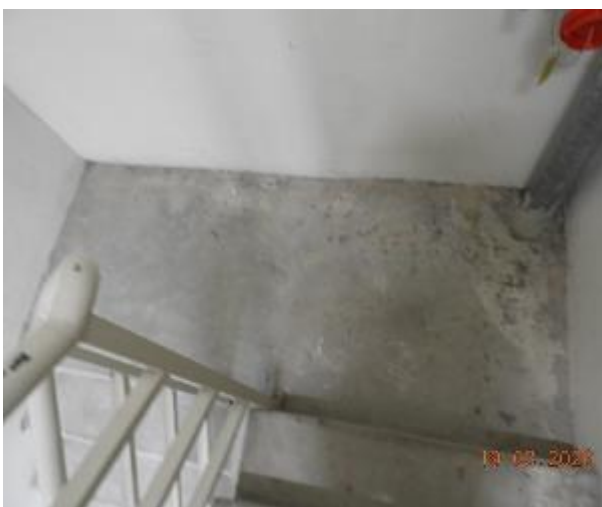
Figure 292 - General condition of level 5 fire stairs

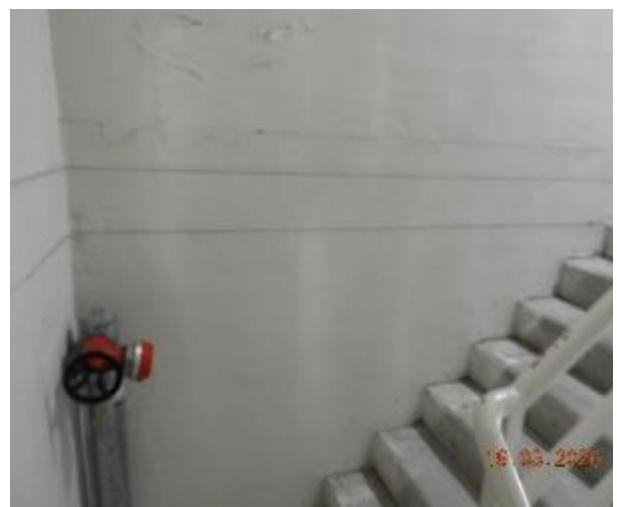
Figure 293 - General condition of level 5 fire stairs internal wall

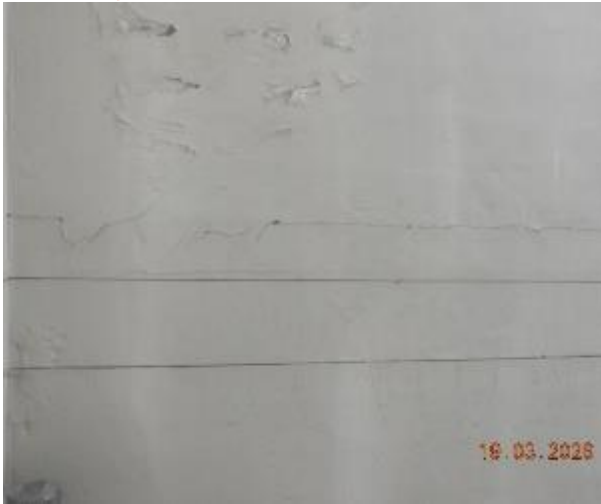
Figure 294 - Crack propagation and paint flaking through level 5 fire stairs internal wall

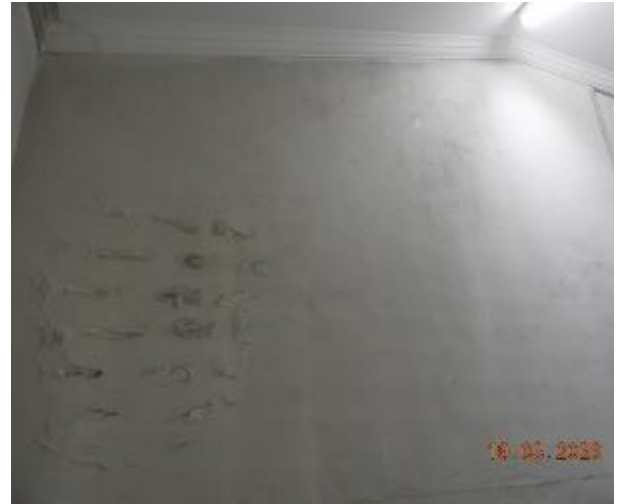
Figure 295 - General condition of level 5 fire stairs internal wall

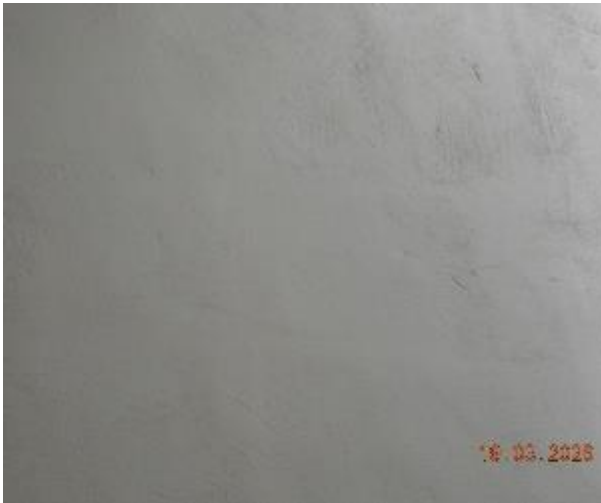
Figure 296 - Crack propagation through level 5 fire stairs internal wall

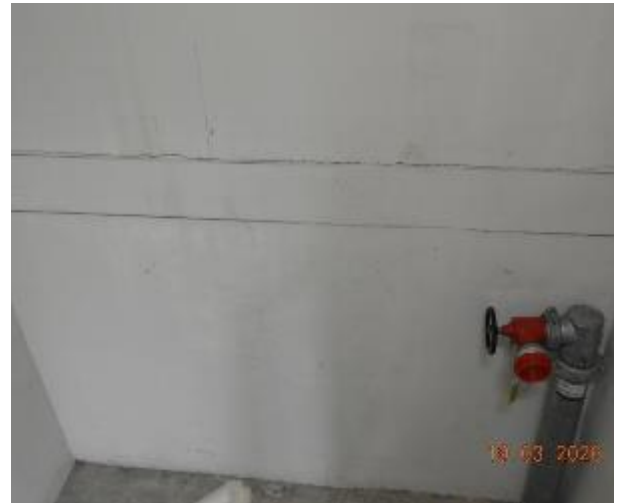
Figure 297 - General condition of level 5 fire stairs internal wall

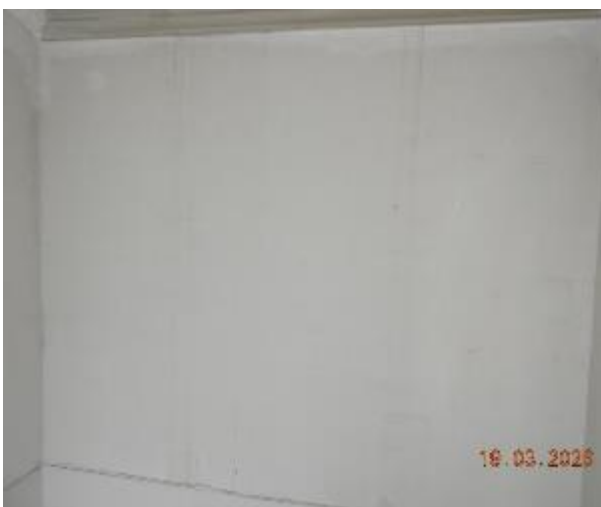
Figure 298 - General condition of level 5 fire stairs internal wall

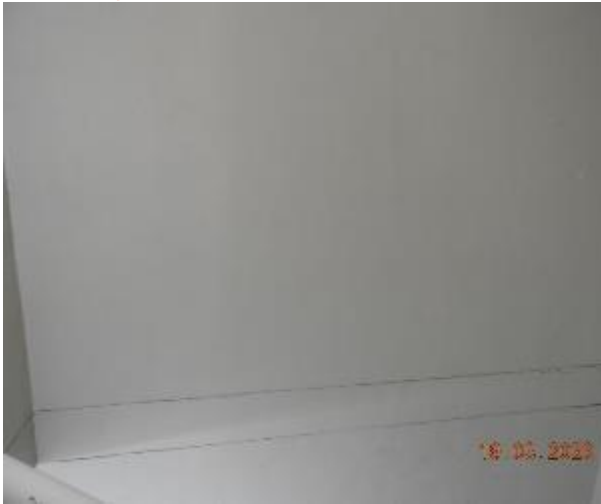
Figure 300 - General condition of level 5 fire stairs internal wall

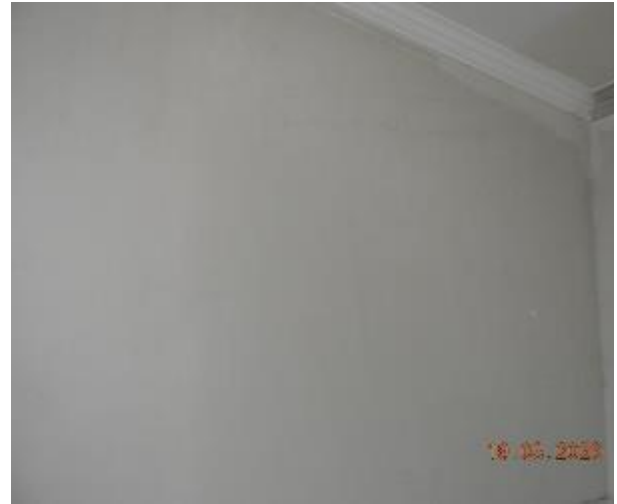
Figure 301 - General condition of level 5 fire stairs internal wall

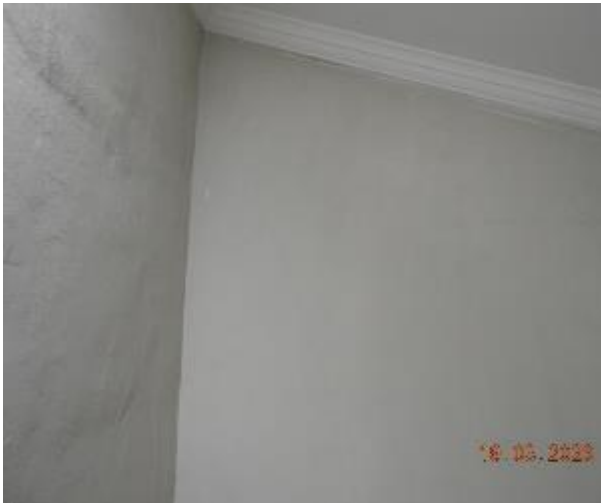
Figure 302 - General condition of level 5 fire stairs internal wall

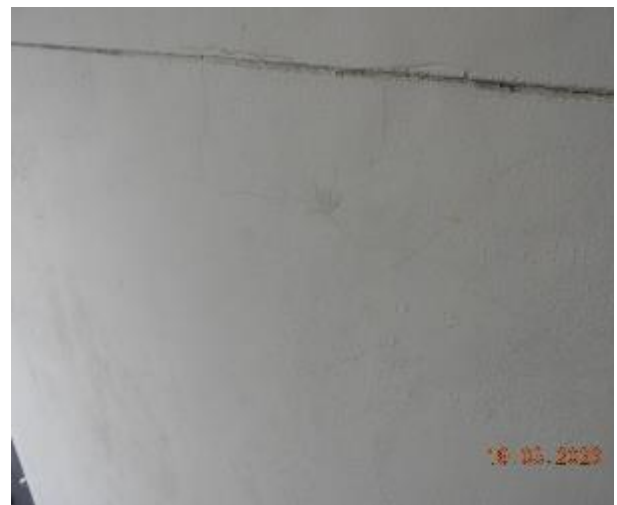
Figure 305 - Crack propagation through level 5 fire stairs internal wall

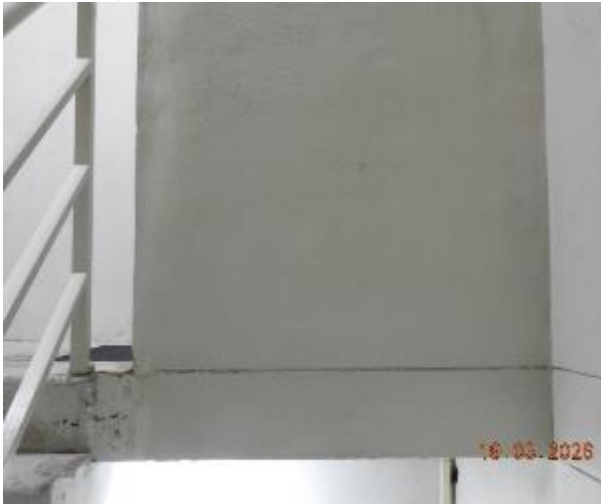
Figure 306 - General condition of level 5 fire stairs internal wall

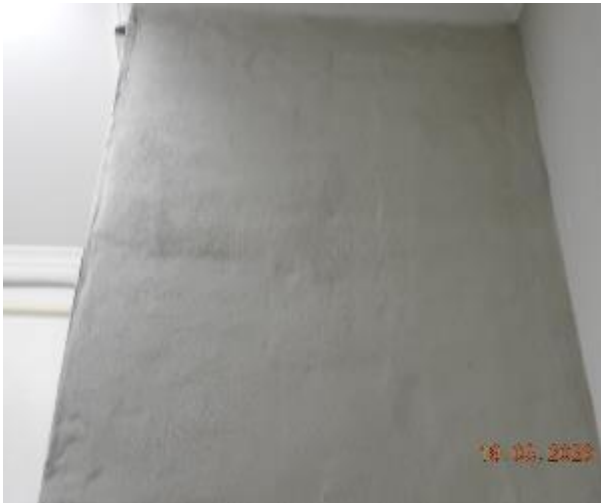
Figure 308 - General condition of level 5 fire stairs internal wall

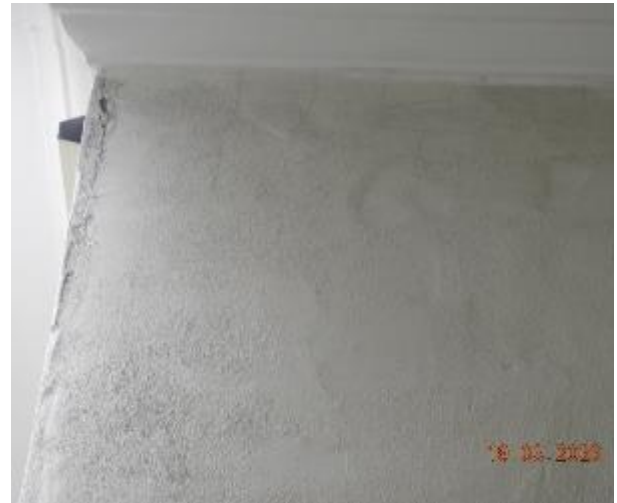
Figure 309 - Crack propagation through level 5 fire stairs internal wall

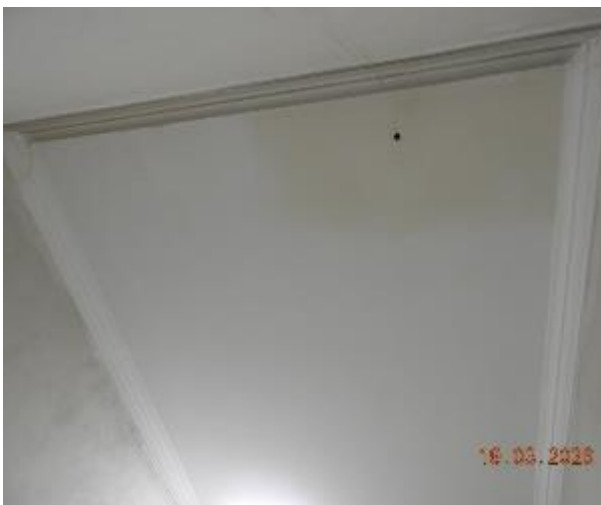
Figure 310 - General condition of level 5 fire stairs ceiling

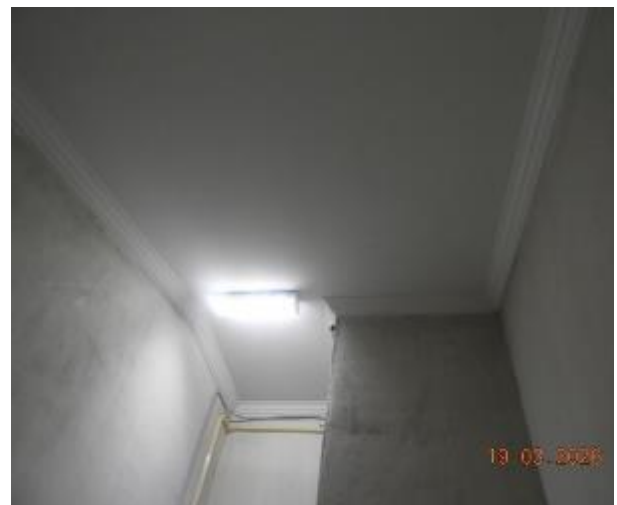
Figure 311 - General condition of level 5 fire stairs ceiling

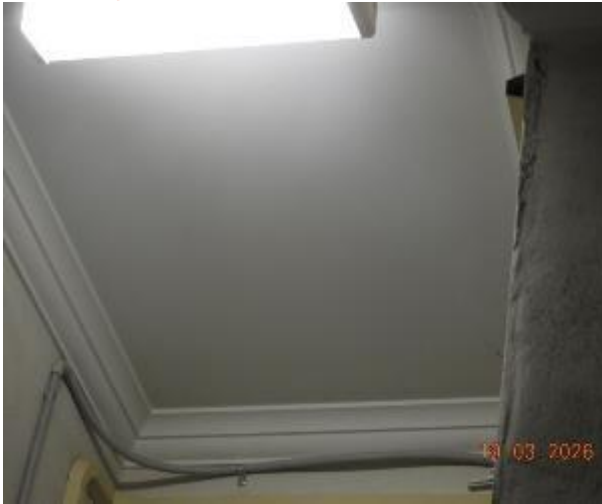
Figure 312 - General condition of level 5 fire stairs ceiling

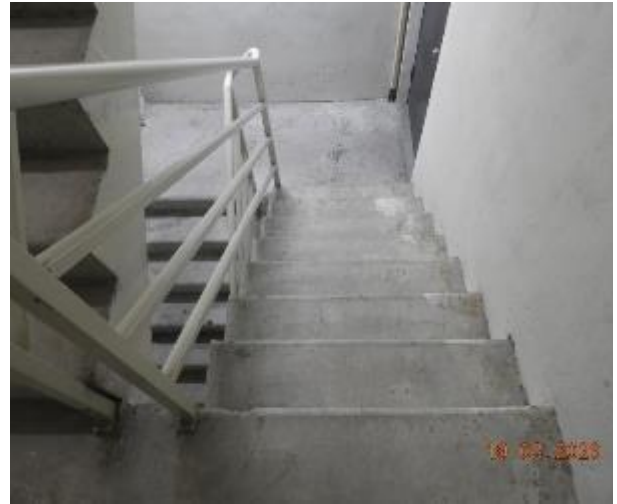
Figure 313 - General condition of level 4 fire stairs

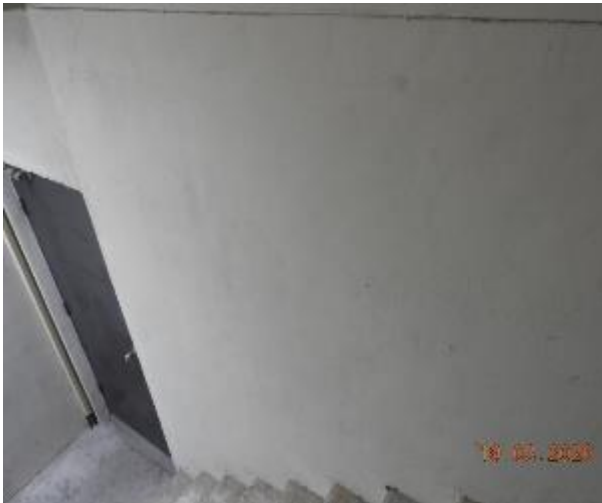
Figure 314 - General condition of level 4 fire stairs internal wall

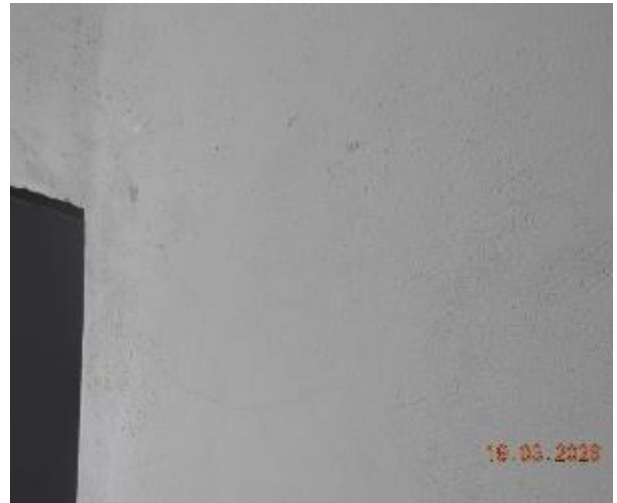
Figure 315 - Crack propagation through level 4 fire stairs internal wall

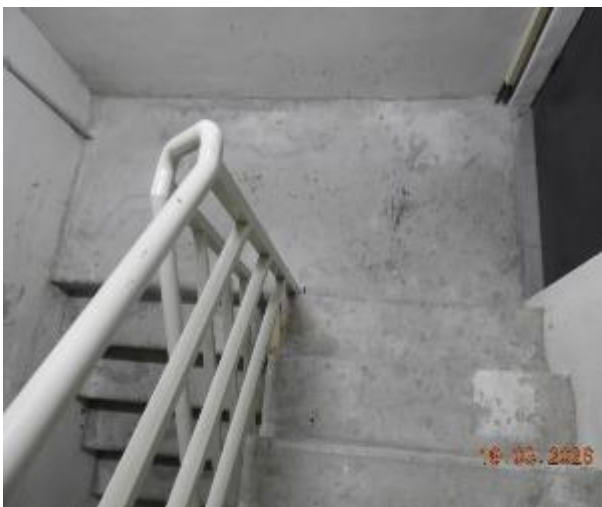
Figure 316 - General condition of level 4 fire stairs concrete floor

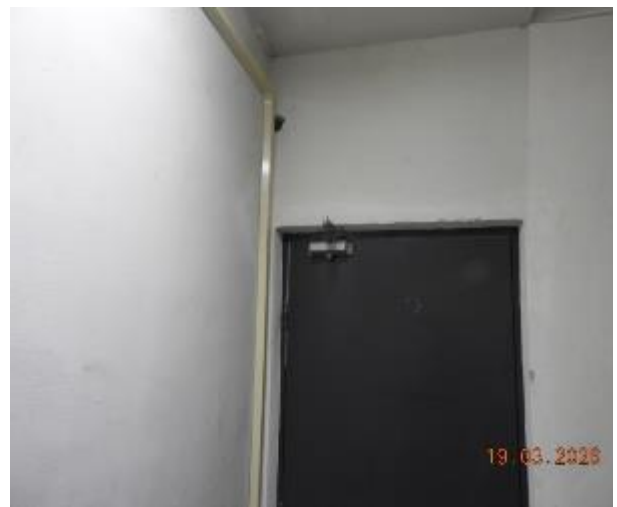
Figure 317 - General condition of level 4 fire stairs internal wall

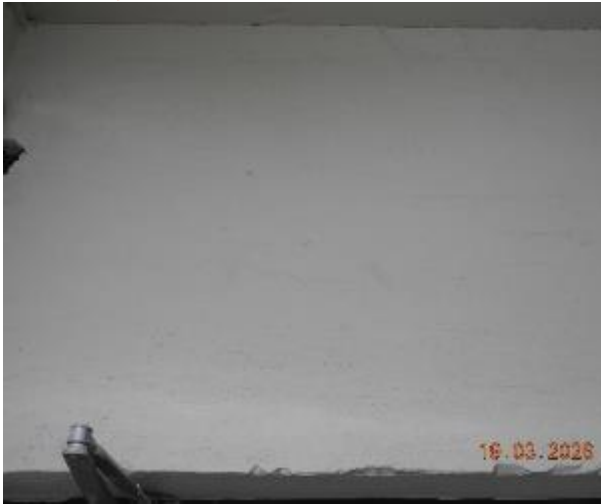
Figure 318 - Crack propagation through level 4 fire stairs internal wall

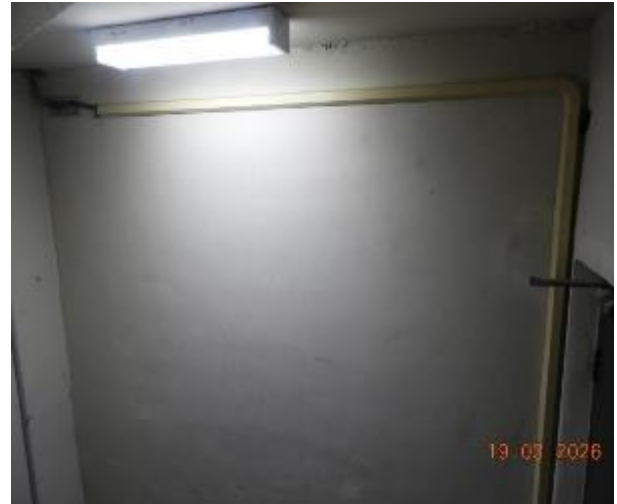
Figure 319 - General condition of level 4 fire stairs internal wall

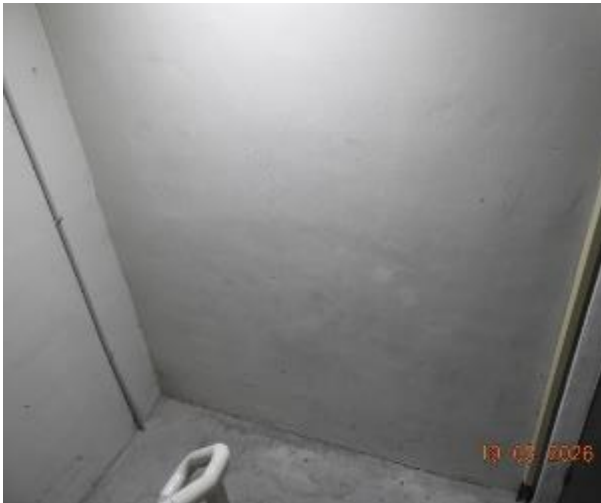
Figure 320 - General condition of level 4 fire stairs internal wall

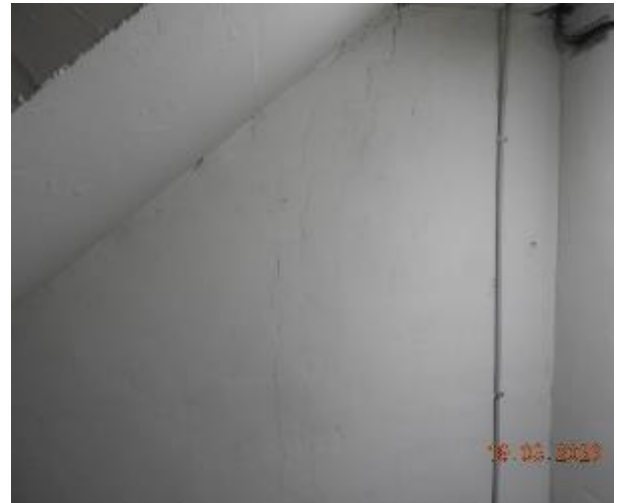
Figure 321 - Crack propagation through level 4 fire stairs internal wall

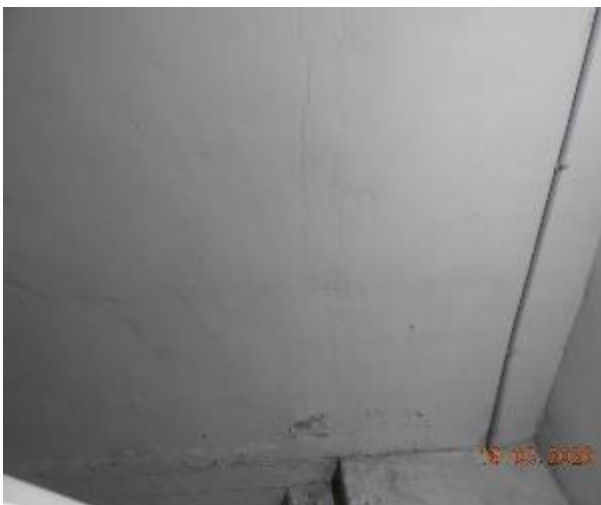
Figure 322 - Crack propagation through level 4 fire stairs internal wall

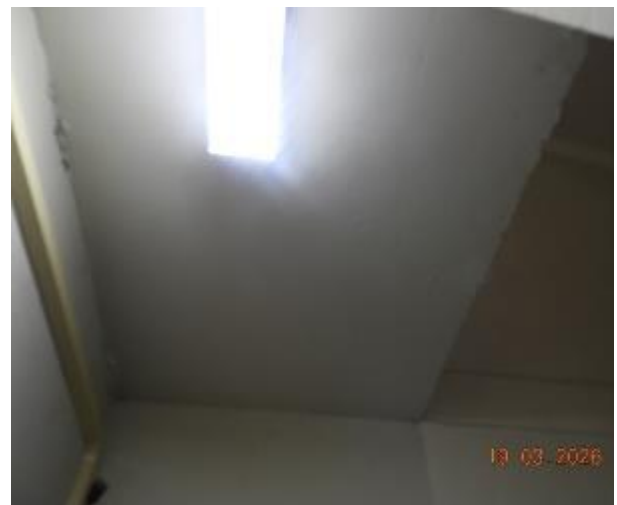
Figure 323 - General condition of level 4 fire stairs underside stairs

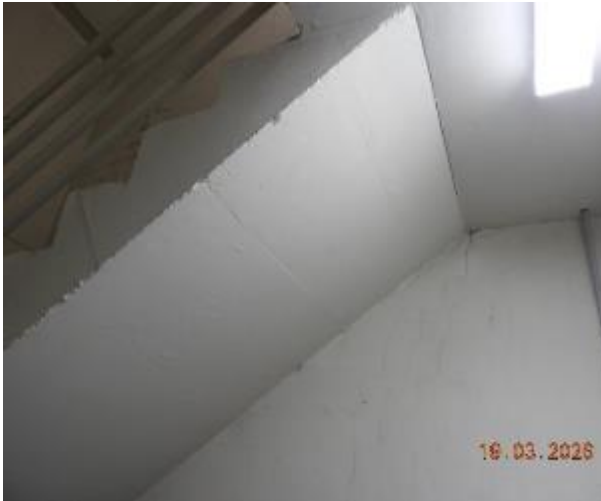
Figure 324 - General condition of level 4 fire stairs underside stairs

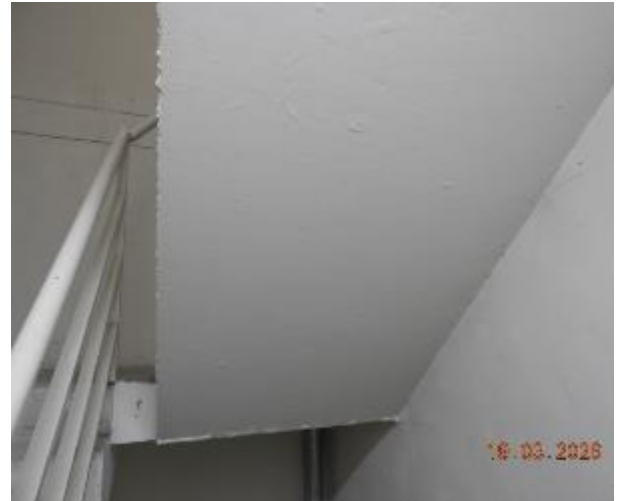
Figure 325 - General condition of level 4 fire stairs underside stairs

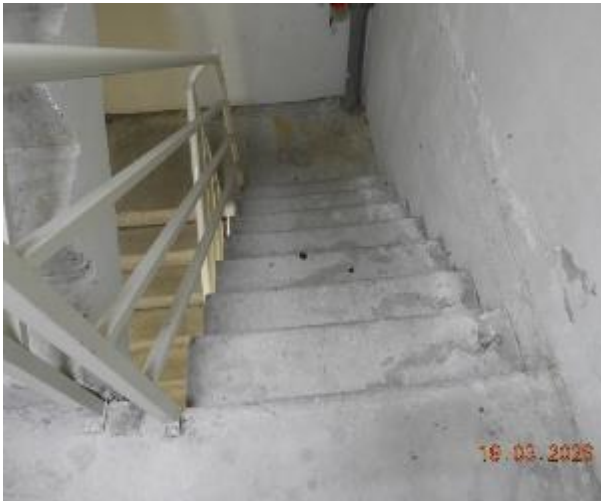
Figure 326 - General condition of level 3 fire stairs

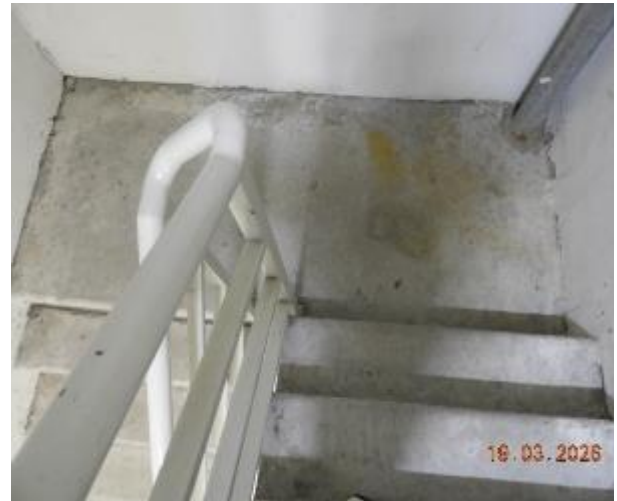
Figure 327 - General condition of level 3 fire stairs

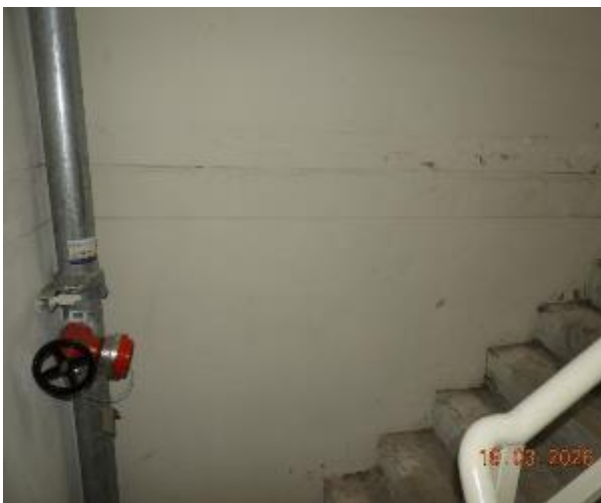
Figure 328 - General condition of level 3 fire stairs internal wall

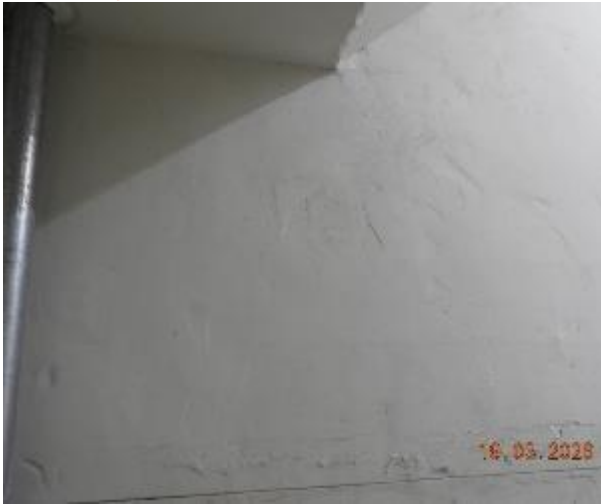
Figure 330 - General condition of level 3 fire stairs internal wall

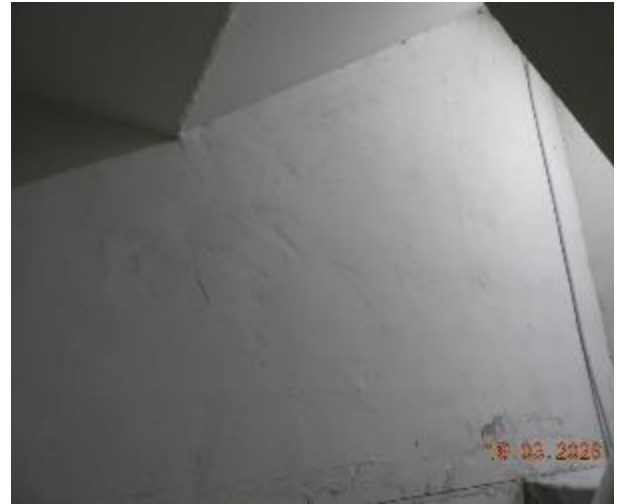
Figure 331 - General condition of level 3 fire stairs internal wall

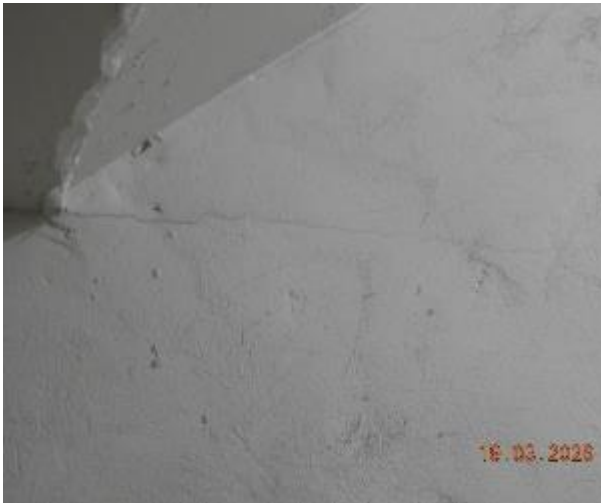
Figure 332 - Crack propagation through level 3 fire stairs internal wall

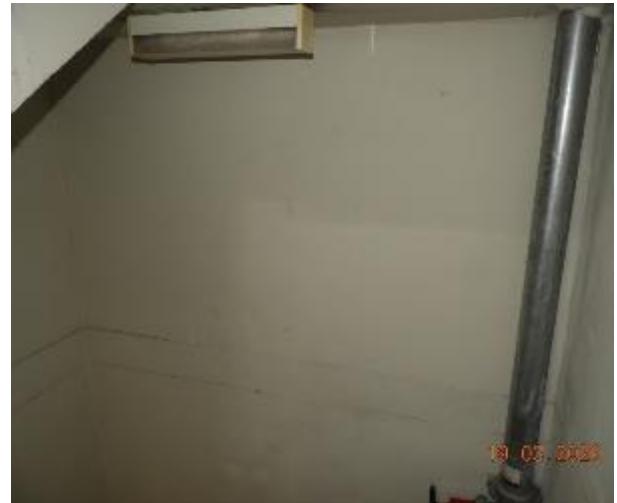
Figure 333 - General condition of level 3 fire stairs internal wall

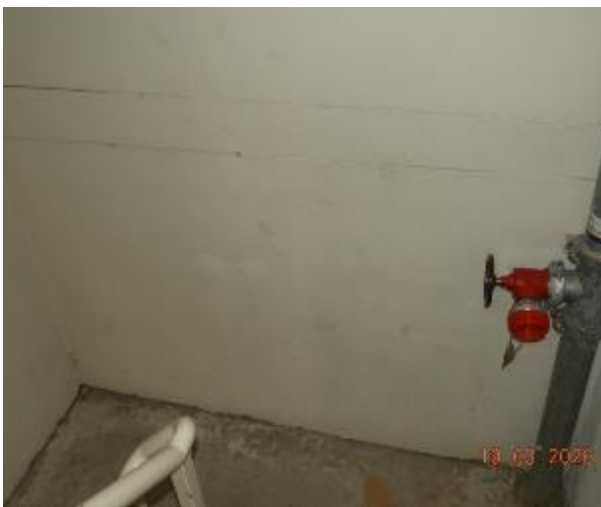
Figure 334 - General condition of level 3 fire stairs internal wall

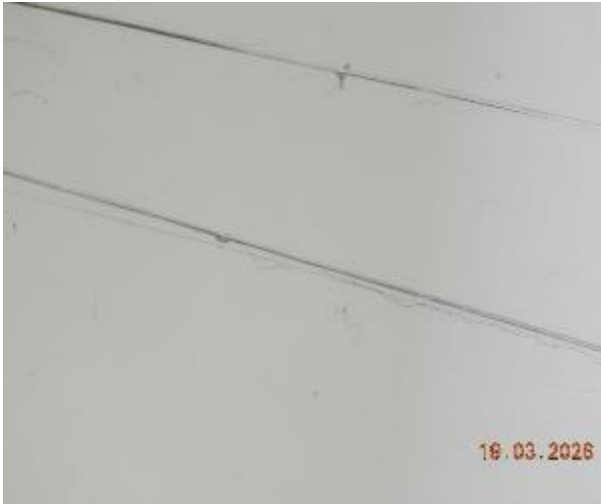
Figure 336 - Crack propagation through level 3 fire stairs internal wall

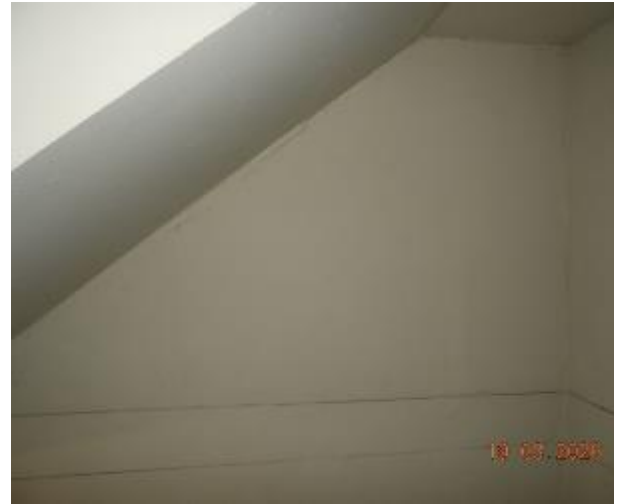
Figure 337 - General condition of level 3 fire stairs internal wall

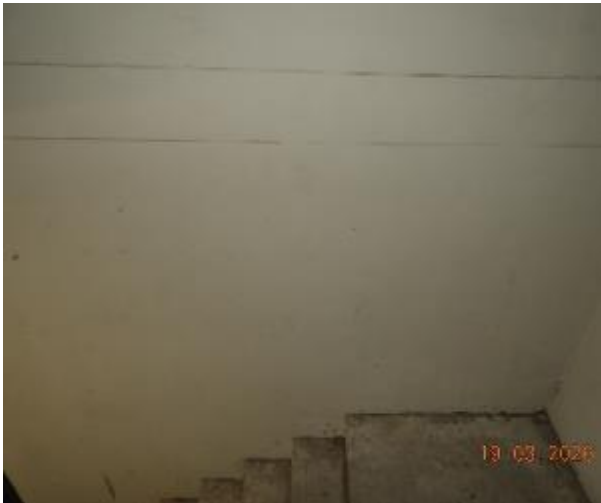
Figure 338 - General condition of level 3 fire stairs internal wall

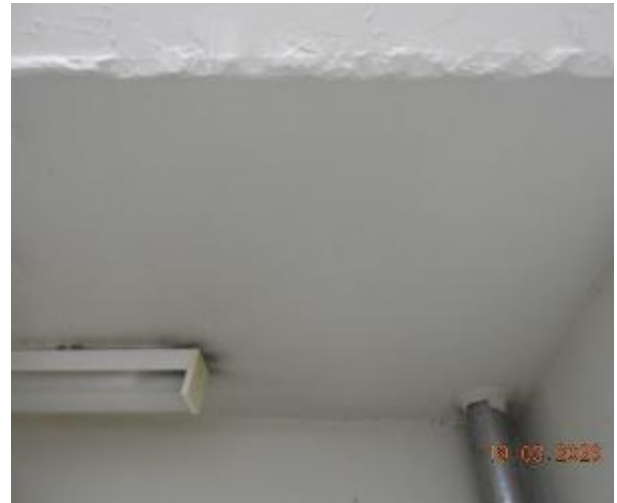
Figure 339 - General condition of level 3 fire stairs underside stairs

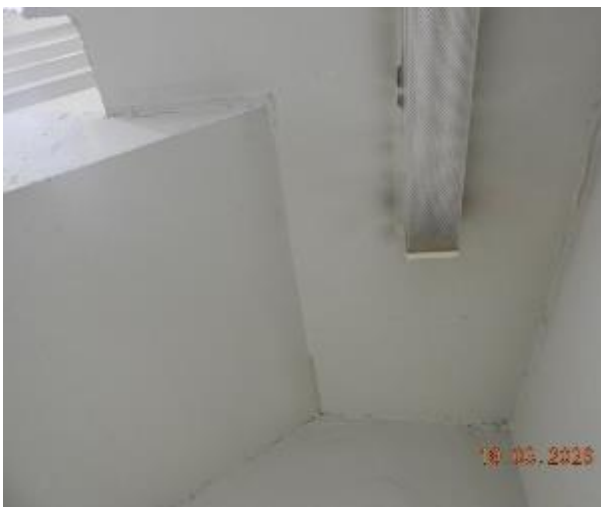
Figure 340 - General condition of level 3 fire stairs underside stairs

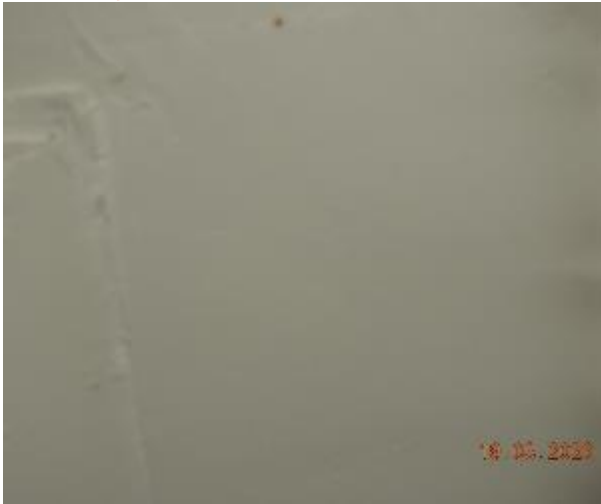
Figure 342 - Crack propagation through level 3 fire stairs underside stairs

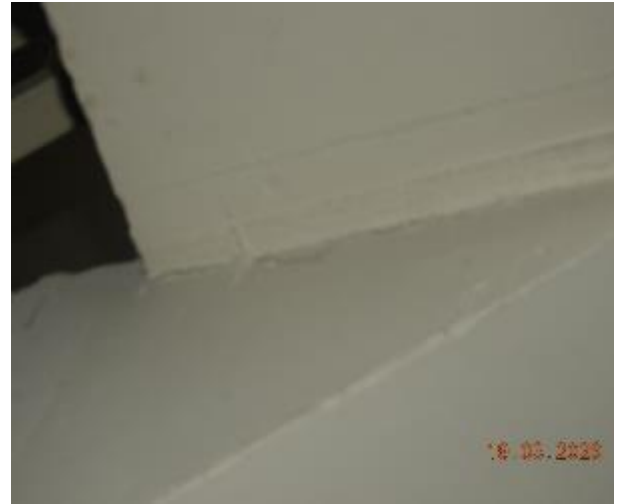
Figure 343 - Crack propagation through level 3 fire stairs underside stairs

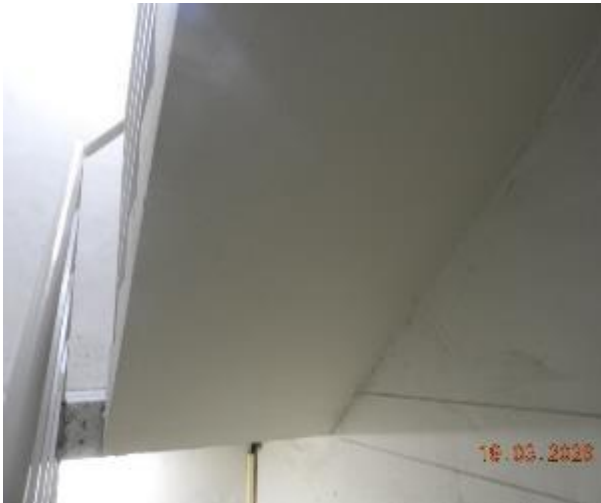
Figure 344 - General condition of level 3 fire stairs underside stairs

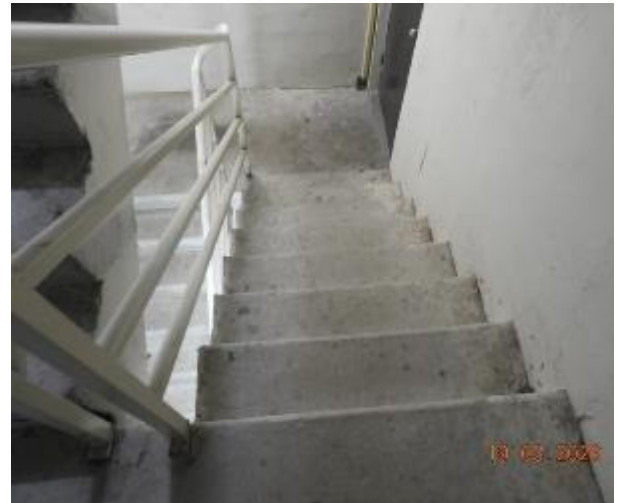
Figure 345 - General condition of level 3 fire stairs

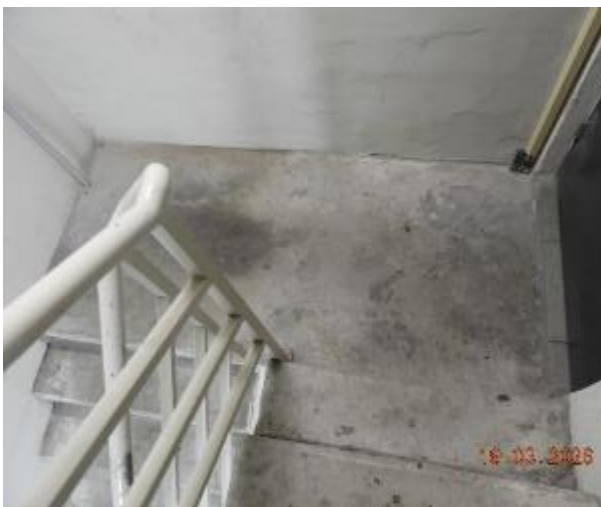
Figure 346 - General condition of level 3 fire stairs

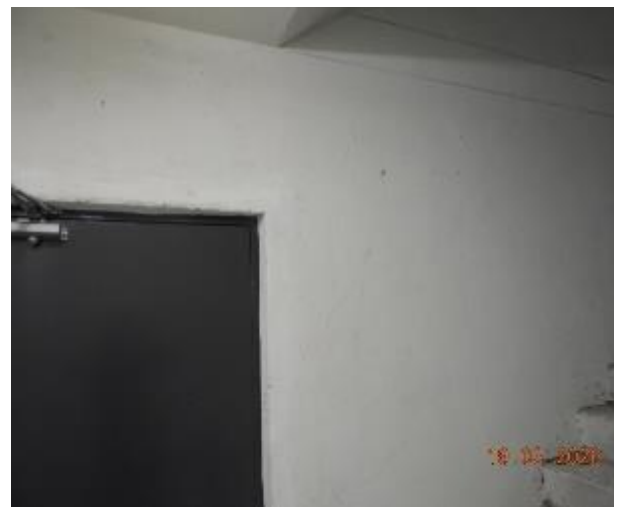
Figure 347 - General condition of level 3 fire stairs internal wall

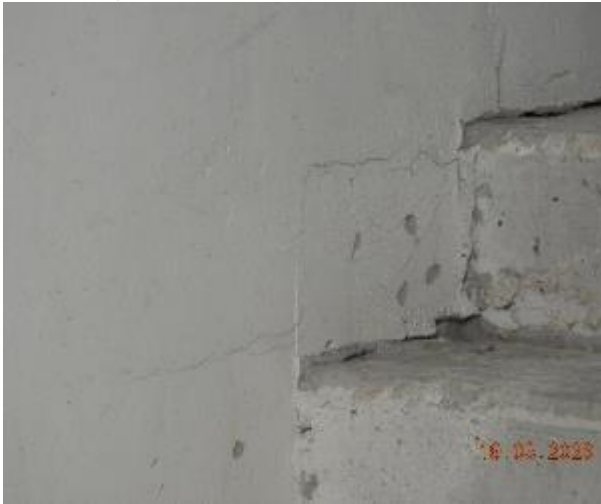
Figure 348 - Crack propagation through level 3 fire stairs internal wall

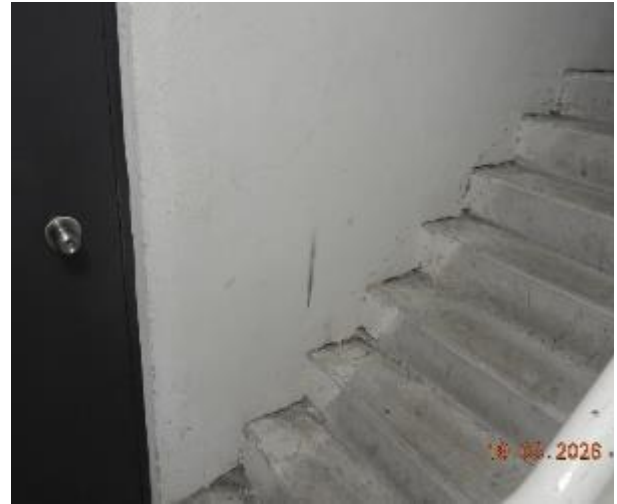
Figure 349 - General condition of level 3 fire stairs internal wall

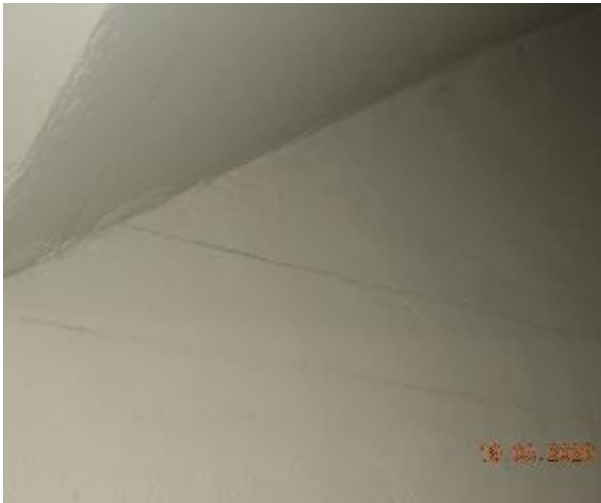
Figure 350 - Crack propagation through level 3 fire stairs internal wall

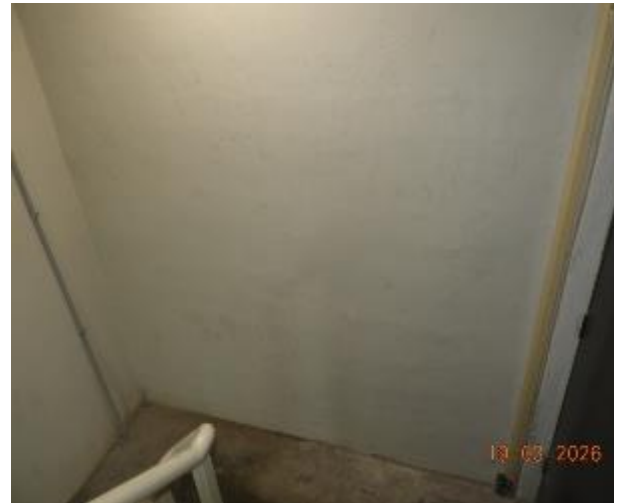
Figure 351 - General condition of level 3 fire stairs internal wall

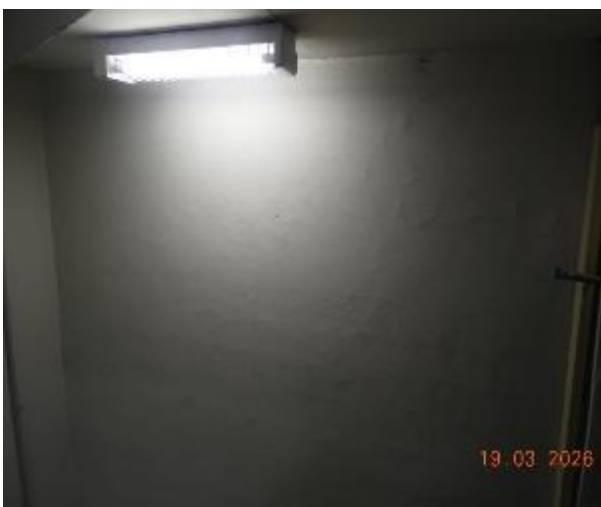
Figure 352 - General condition of level 3 fire stairs internal wall

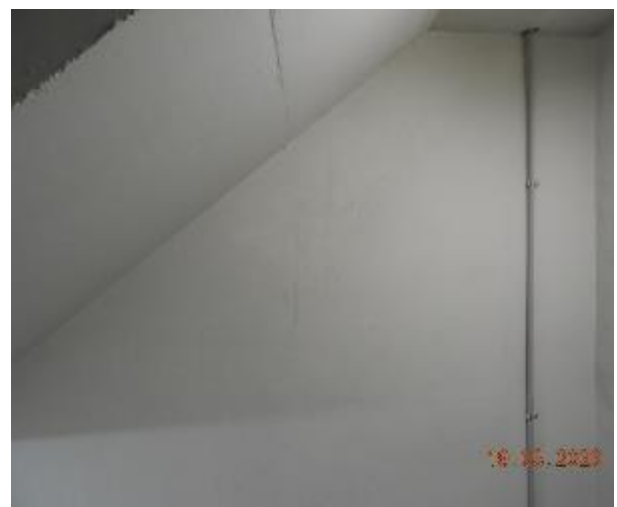
Figure 353 - General condition of level 3 fire stairs internal wall

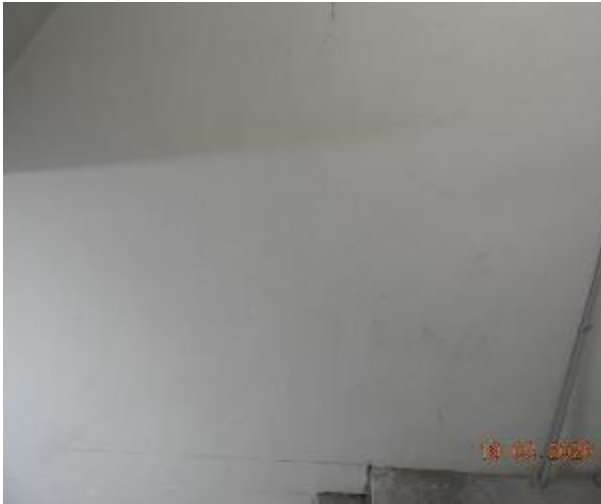
Figure 354 - General condition of level 3 fire stairs internal wall

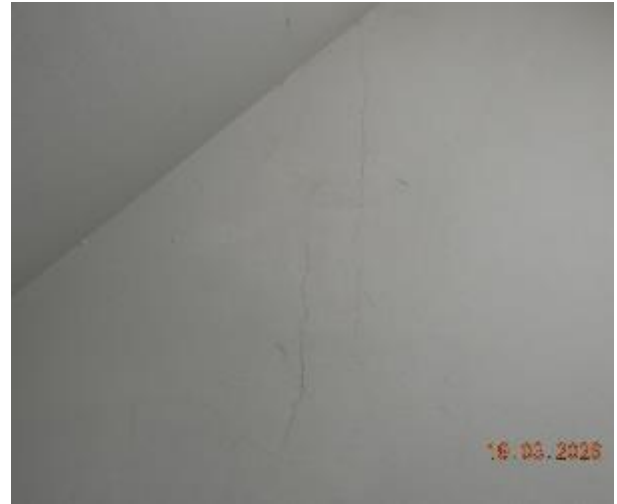
Figure 355 - Crack propagation through level 3 fire stairs internal wall

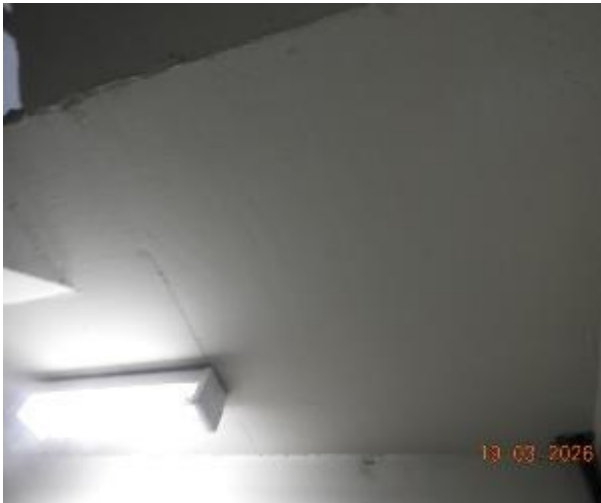
Figure 356 - General condition of level 3 fire stairs underside stairs

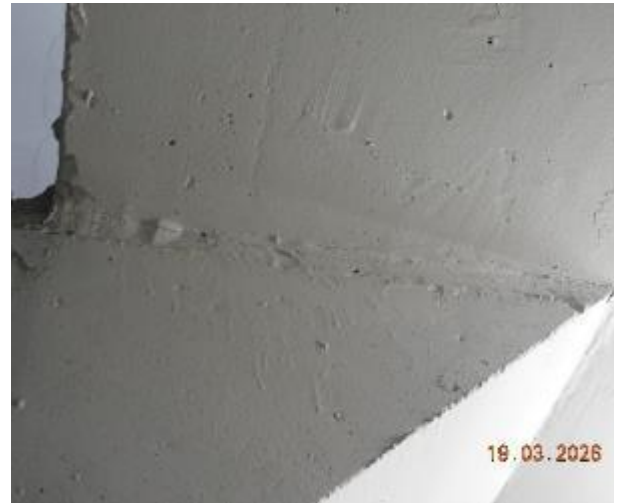
Figure 357 - Crack propagation through level 3 fire stairs underside stairs

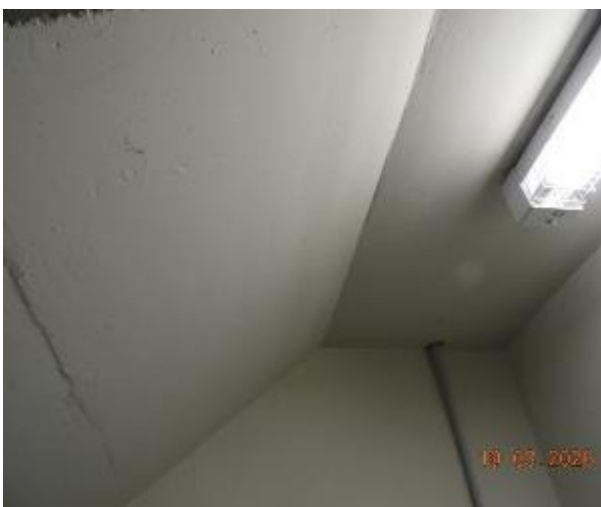
Figure 358 - General condition of level 3 fire stairs underside stairs

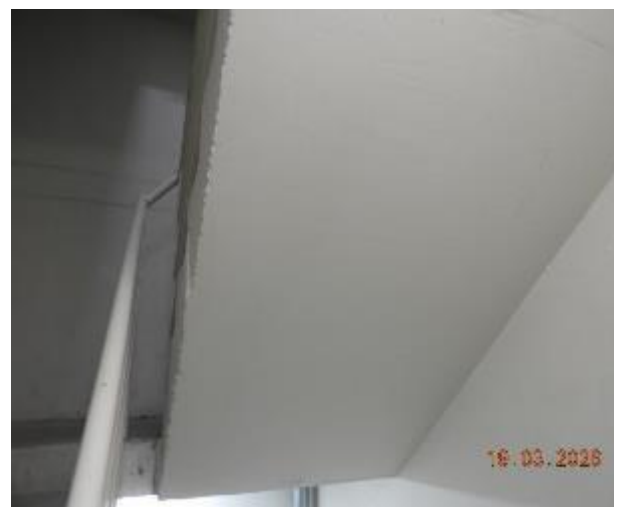
Figure 359 - General condition of level 3 fire stairs underside stairs

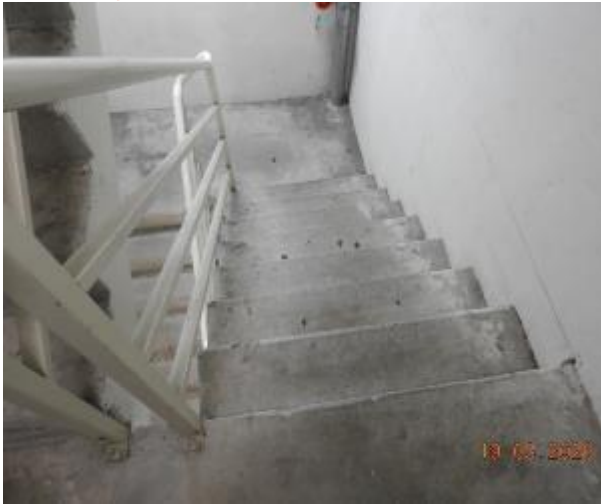
Figure 360 - General condition of level 2 fire stairs

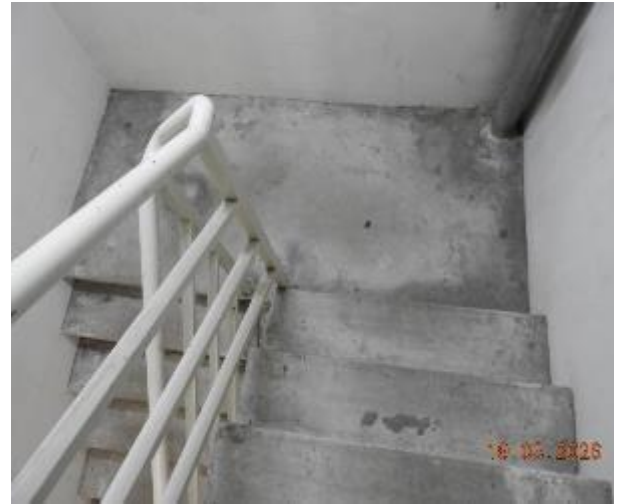
Figure 361 - General condition of level 2 fire stairs

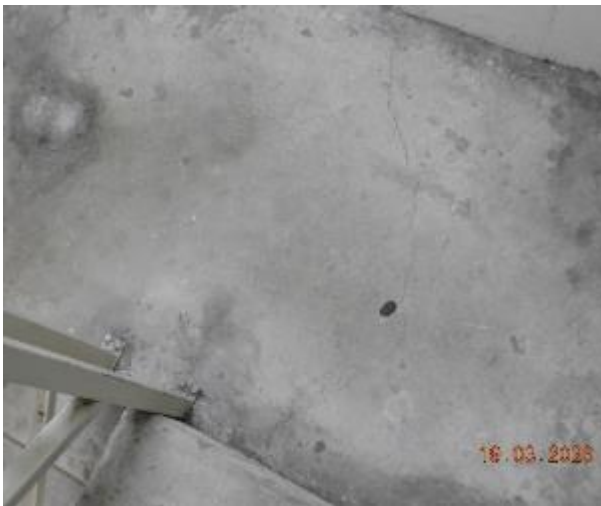
Figure 362 - Crack propagation through level 2 fire stairs concrete floor

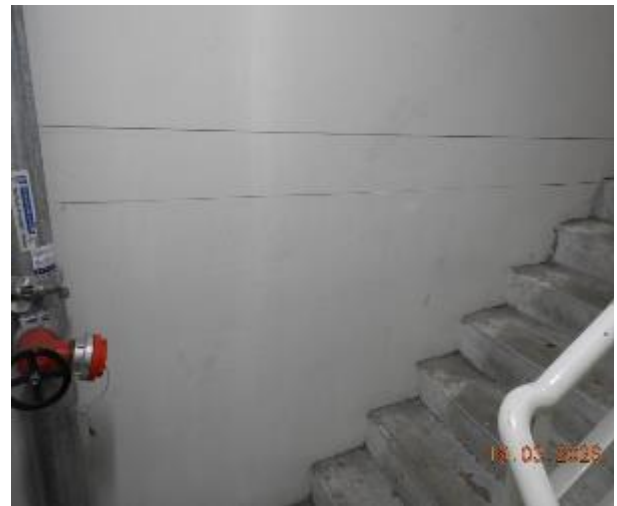
Figure 363 - General condition of level 2 fire stairs internal wall

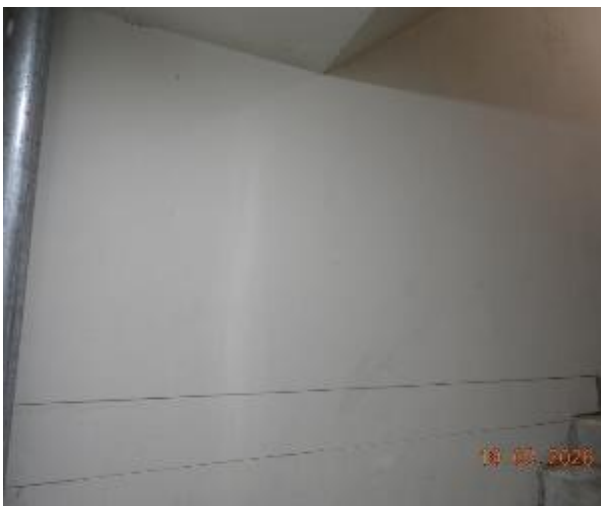
Figure 364 - General condition of level 2 fire stairs internal wall

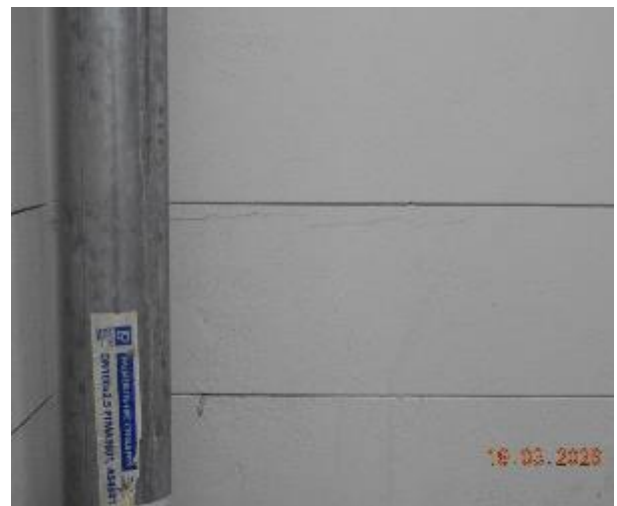
Figure 365 - Crack propagation through level 2 fire stairs internal wall

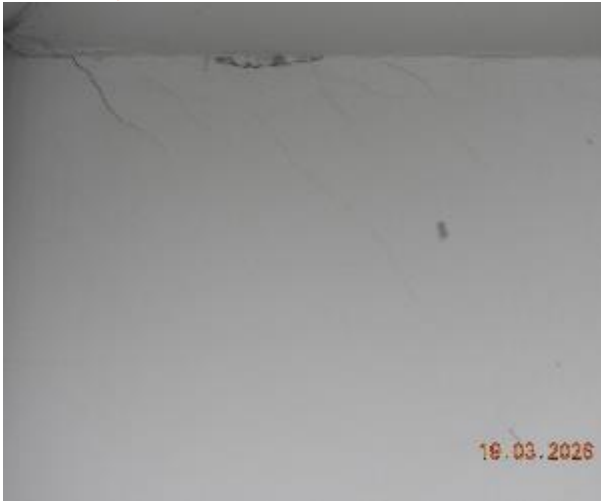
Figure 366 - Crack propagation through level 2 fire stairs internal wall

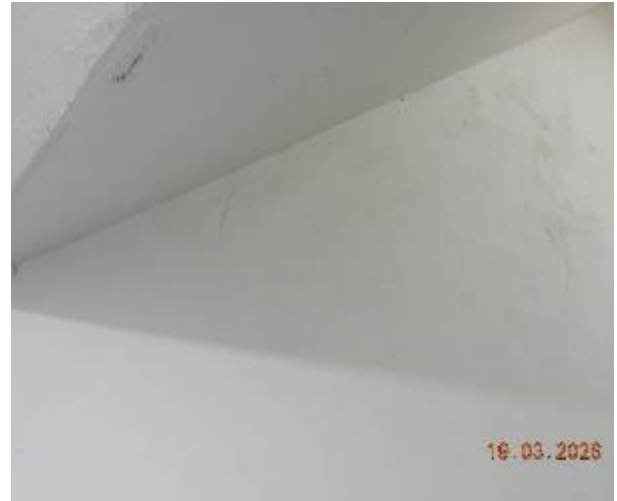
Figure 367 - Crack propagation through level 2 fire stairs internal wall

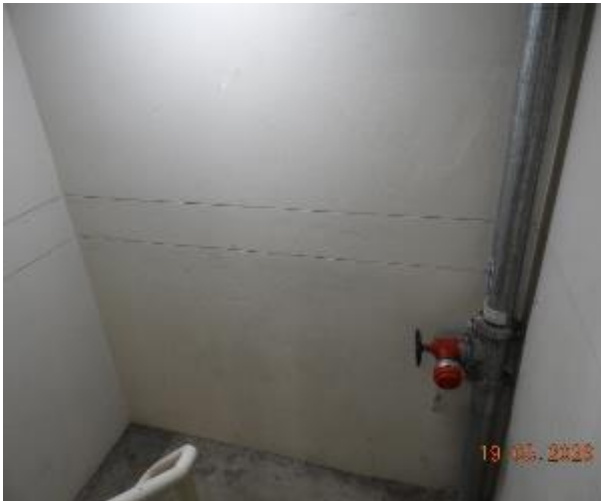
Figure 368 - General condition of level 2 fire stairs internal wall
