# **Pre-Dilapidation Report**

**19 GEORGE STREET**

**FRONT BUILDING (UNITS 1-19)**

Project Reference: 20250047.19G.2

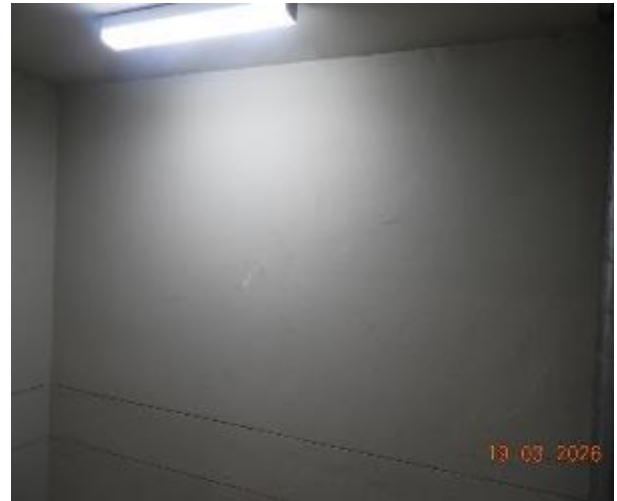
Figure 369 - General condition of level 2 fire stairs internal wall

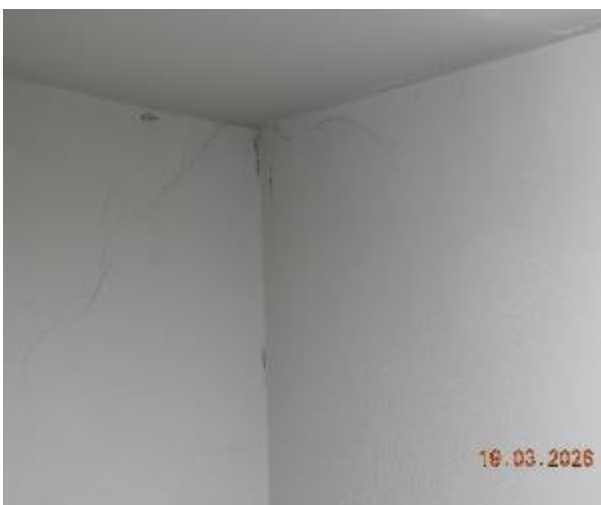
Figure 370 - Crack propagation through level 2 fire stairs internal wall

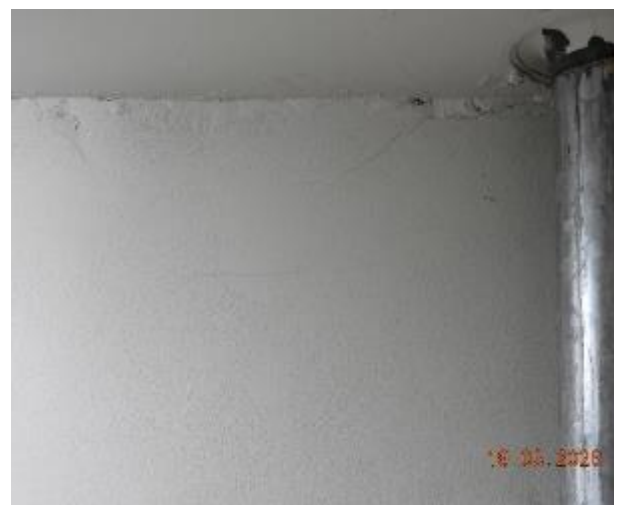
Figure 371 - Crack propagation through level 2 fire stairs internal wall

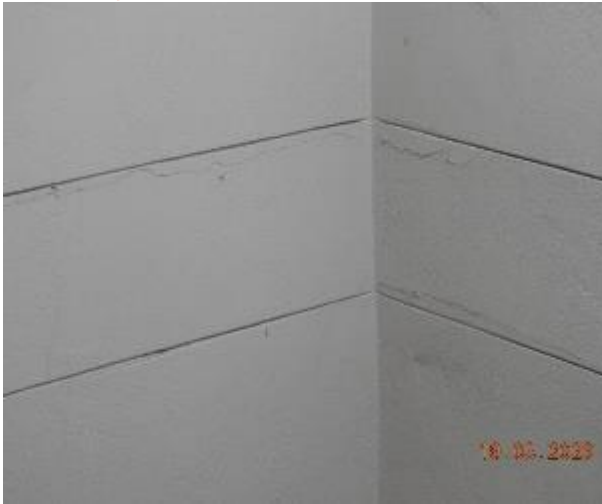
Figure 372 - Crack propagation through level 2 fire stairs internal wall

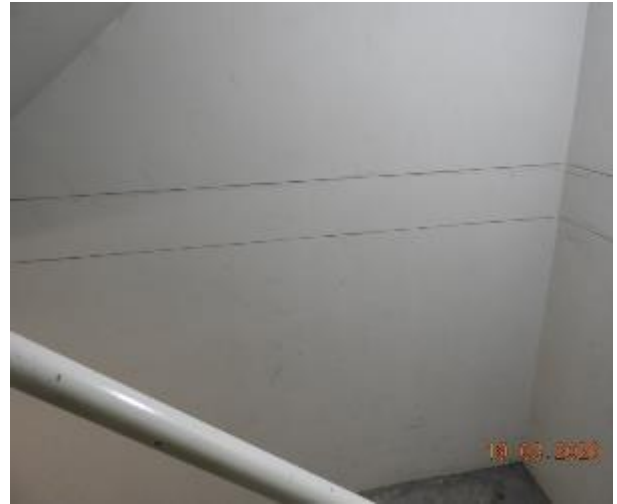
Figure 373 - General condition of level 2 fire stairs internal wall

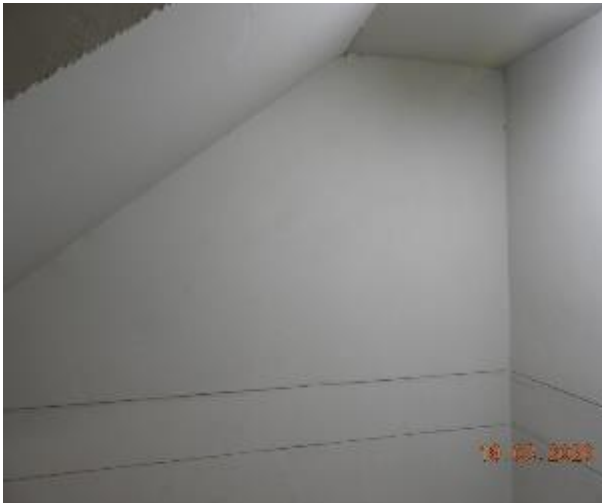
Figure 374 - General condition of level 2 fire stairs internal wall

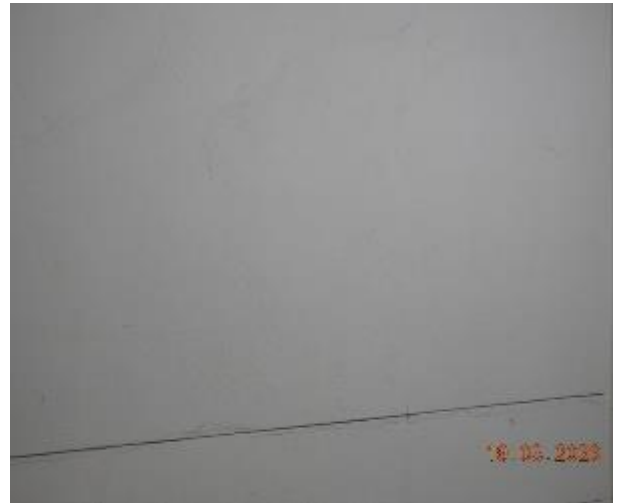
Figure 375 - Crack propagation through level 2 fire stairs internal wall

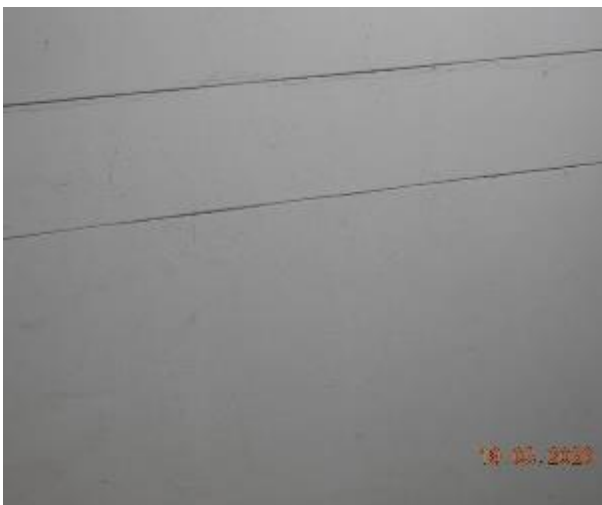
Figure 376 - Crack propagation through level 2 fire stairs internal wall

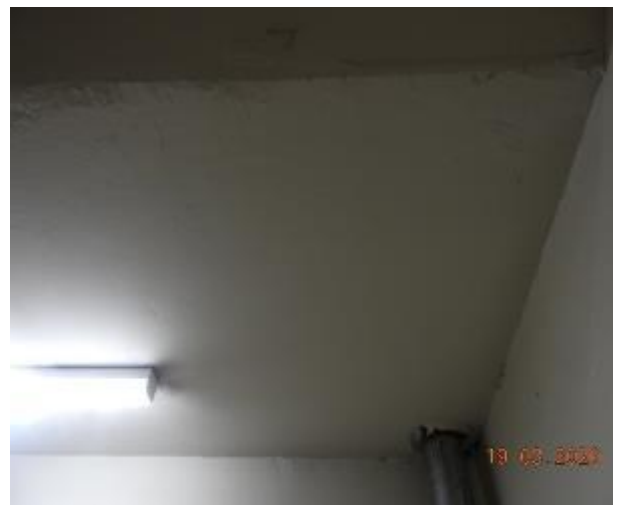
Figure 377 - General condition of level 2 fire stairs underside stairs

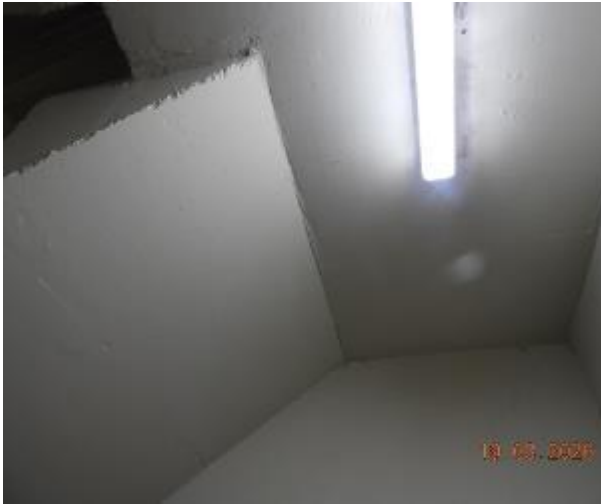
Figure 378 - General condition of level 2 fire stairs underside stairs

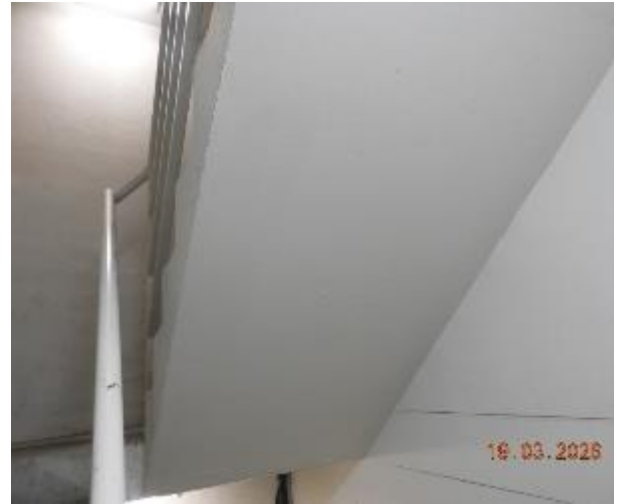
Figure 379 - General condition of level 2 fire stairs underside stairs

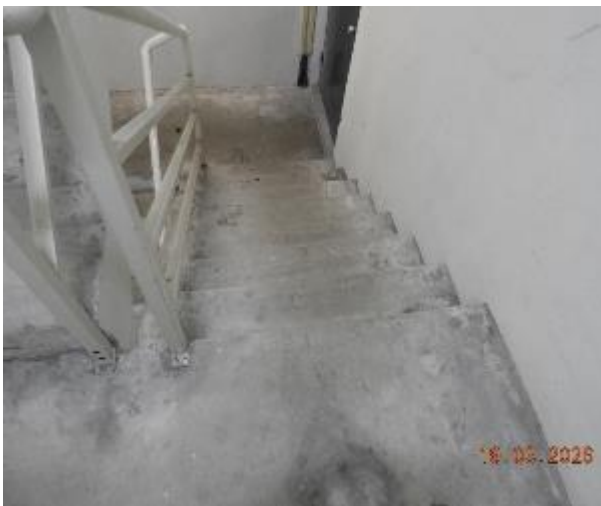
Figure 380 - General condition of level 2 fire stairs

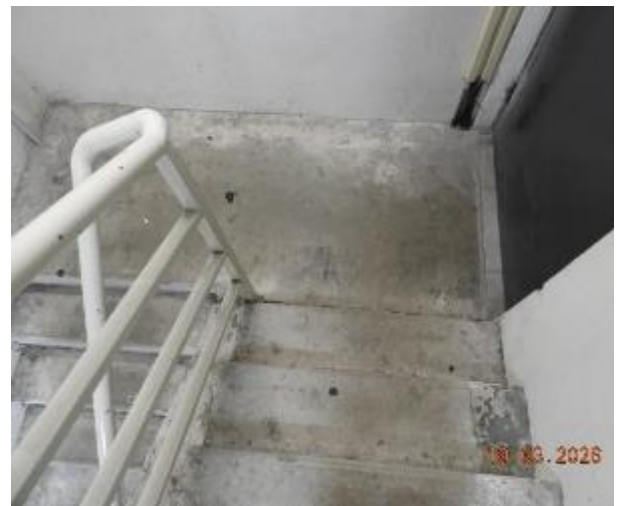
Figure 381 - General condition of level 2 fire stairs

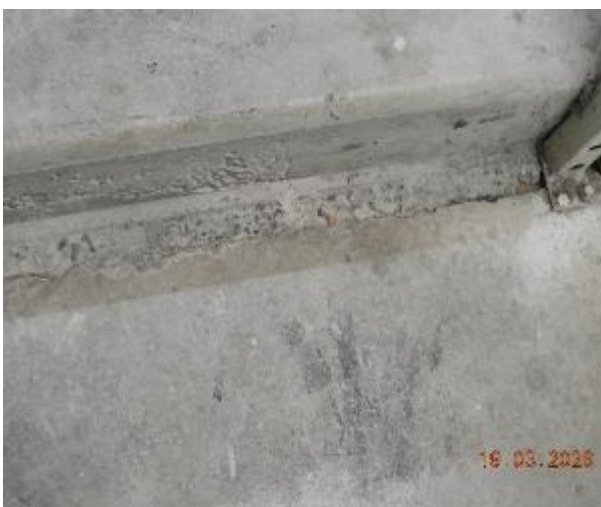
Figure 382 - General condition of level 2 fire stairs

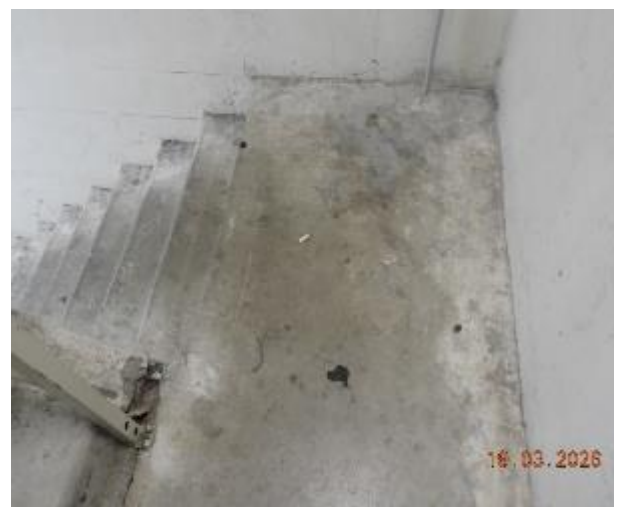
Figure 383 - General condition of level 2 fire stairs

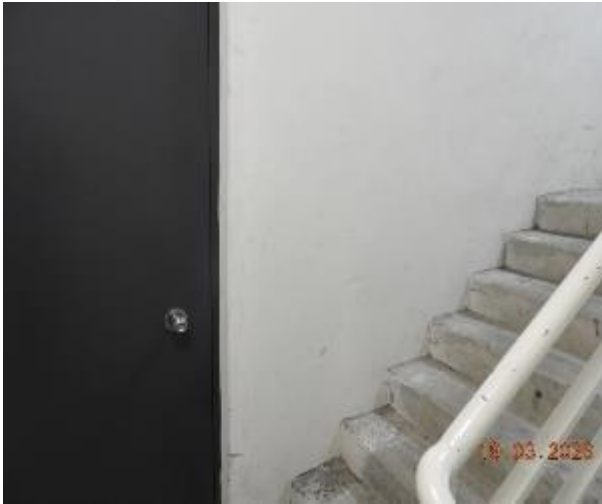
Figure 384 - General condition of level 2 fire stairs internal wall

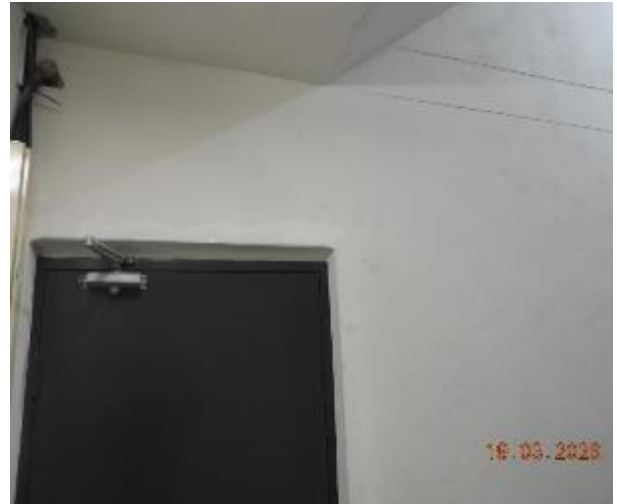
Figure 385 - General condition of level 2 fire stairs internal wall

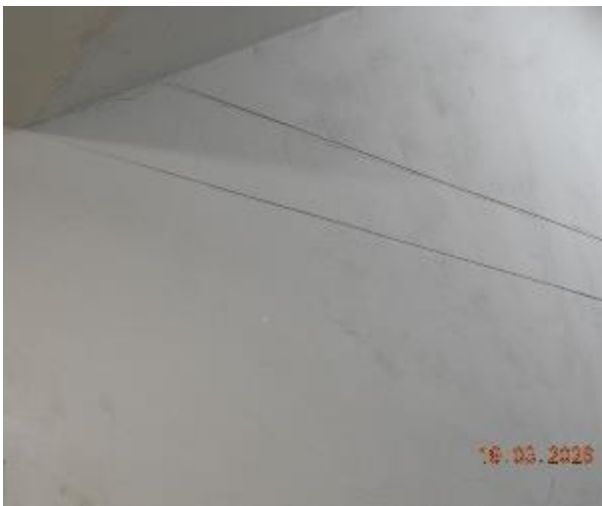
Figure 386 - General condition of level 2 fire stairs internal wall

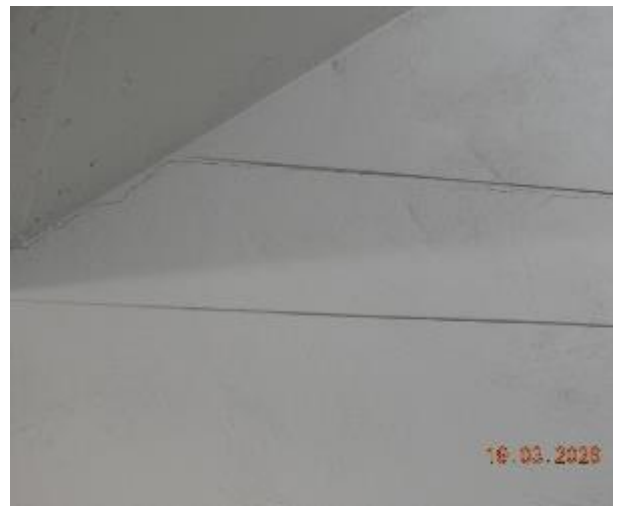
Figure 387 - Crack propagation through level 2 fire stairs internal wall

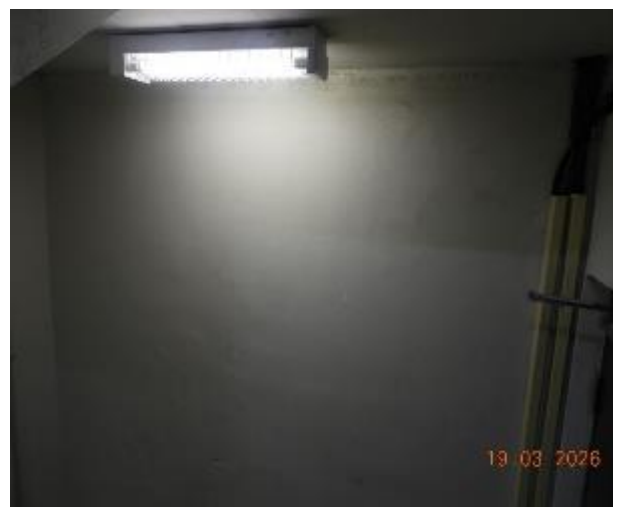
Figure 389 - General condition of level 2 fire stairs internal wall

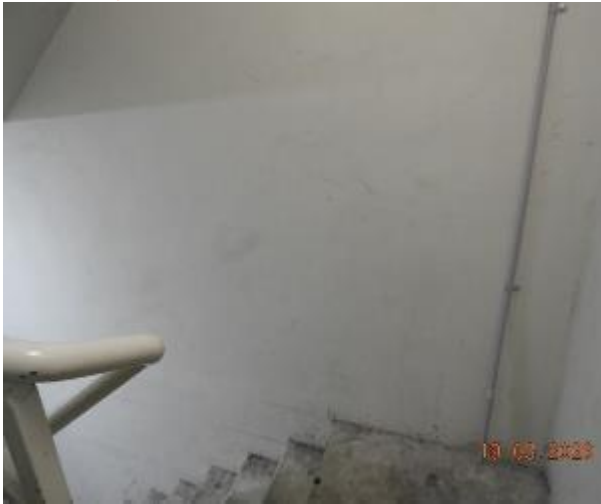
Figure 390 - General condition of level 2 fire stairs internal wall

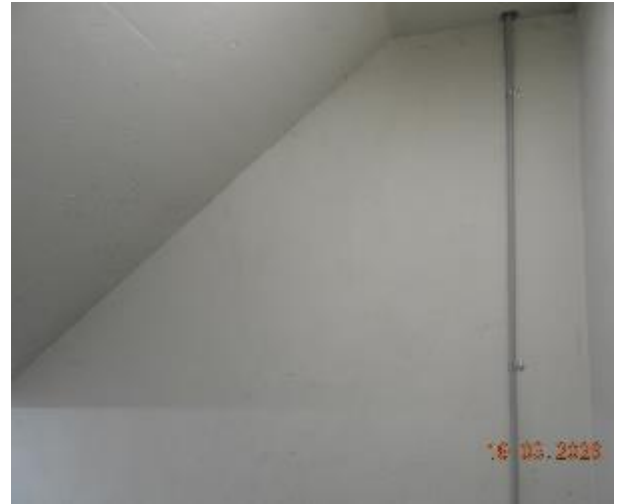
Figure 391 - General condition of level 2 fire stairs internal wall

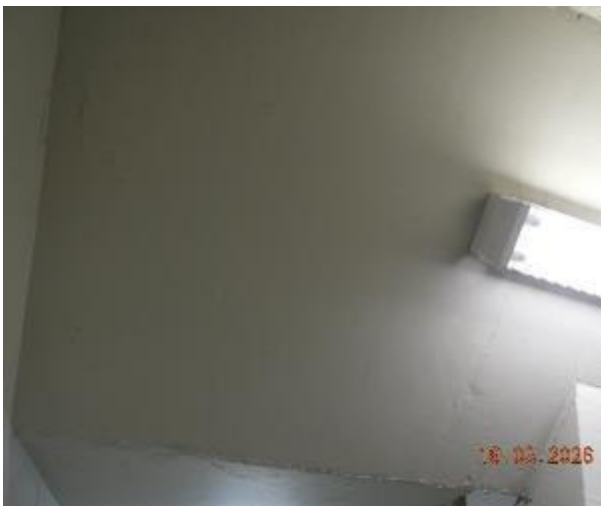
Figure 392 - General condition of level 2 fire stairs underside stairs

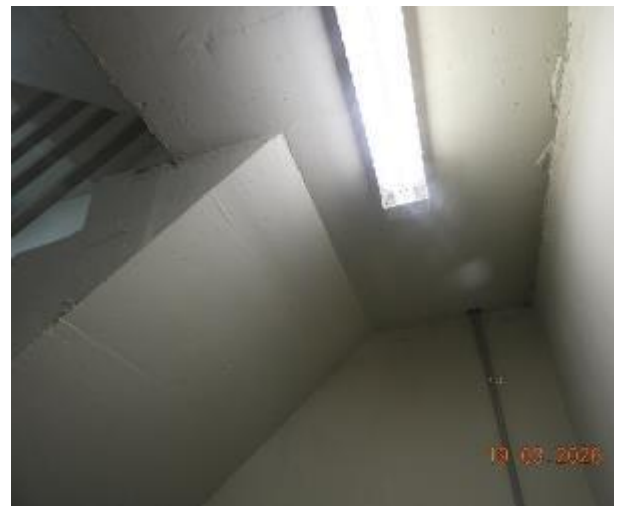
Figure 393 - General condition of level 2 fire stairs underside stairs

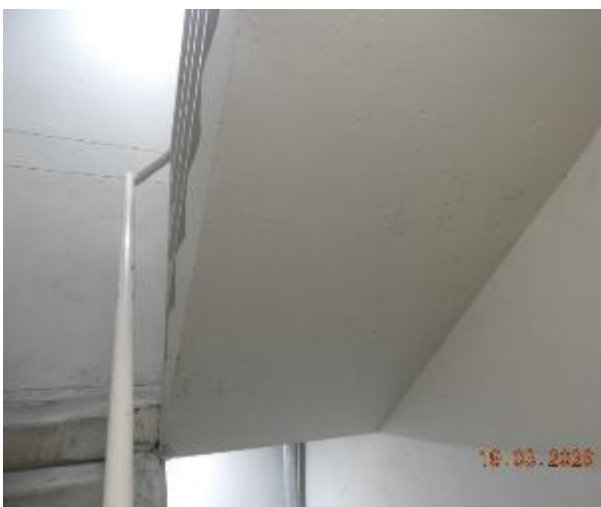
Figure 394 - General condition of level 2 fire stairs underside stairs

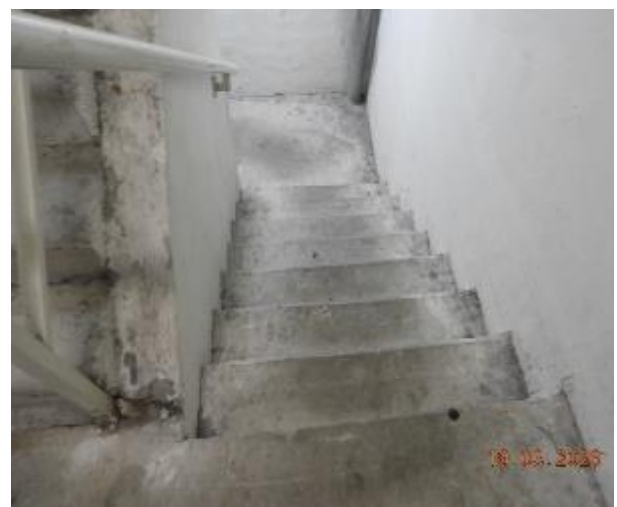
Figure 395 - General condition of level 1 fire stairs

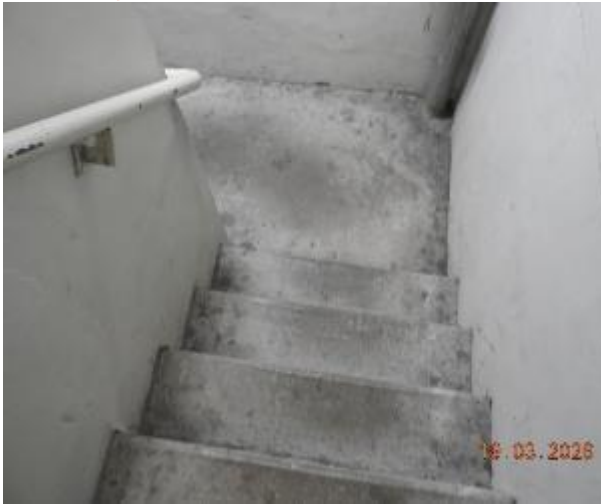
Figure 396 - General condition of level 1 fire stairs

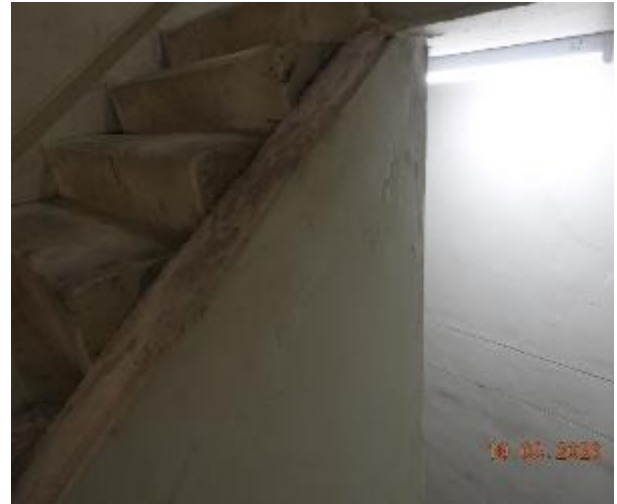
Figure 397 - General condition of level 1 fire stairs internal wall

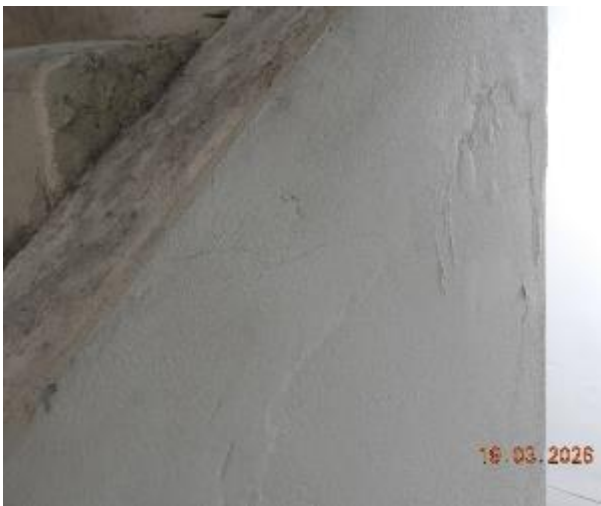
Figure 398 - Crack propagation through level 1 fire stairs internal wall

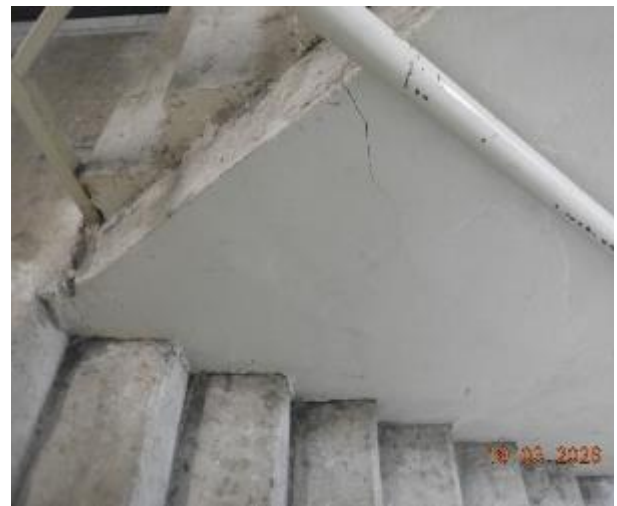
Figure 399 - Crack propagation through level 1 fire stairs internal wall

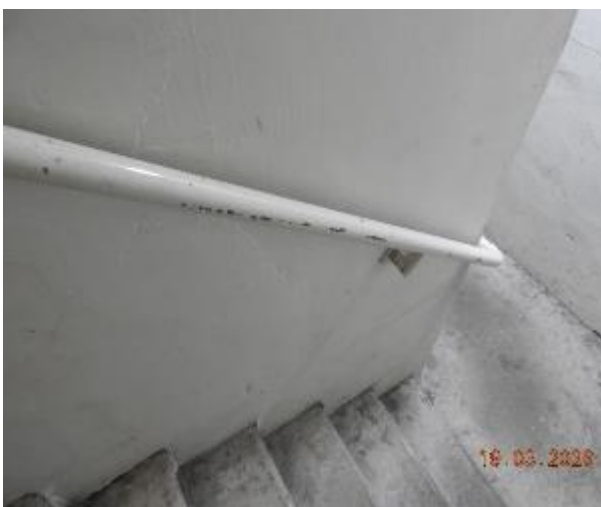
Figure 400 - General condition of level 1 fire stairs internal wall

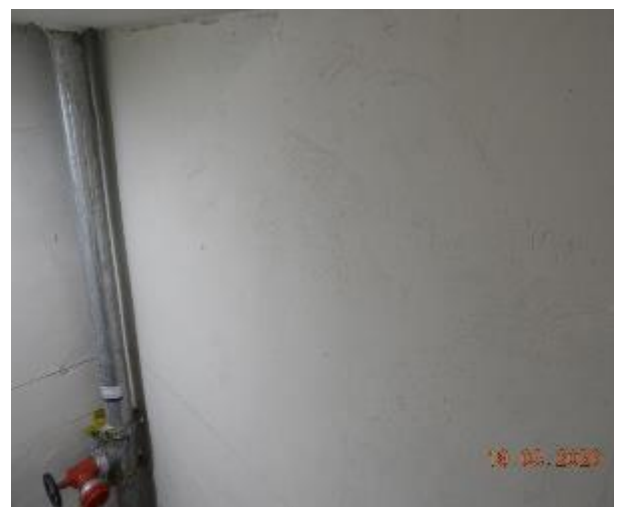
Figure 401 - General condition of level 1 fire stairs internal wall

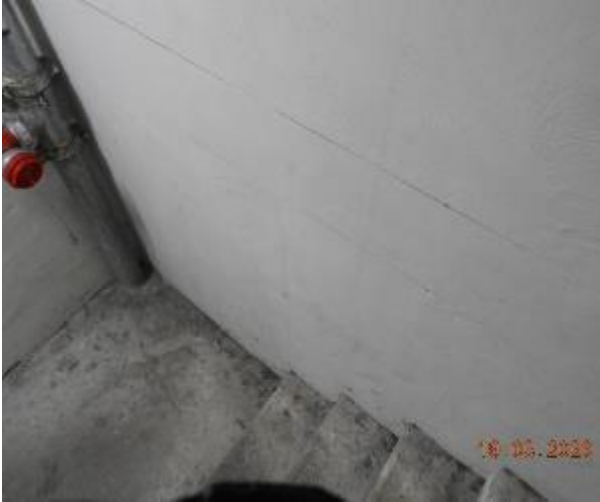
Figure 402 - General condition of level 1 fire stairs internal wall

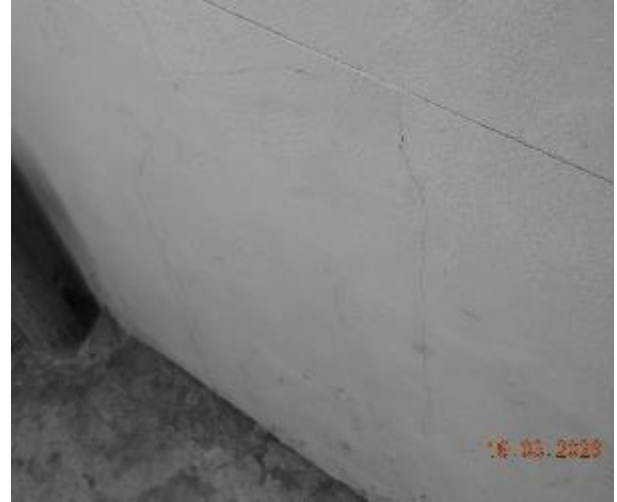
Figure 403 - Crack propagation through level 1 fire stairs internal wall

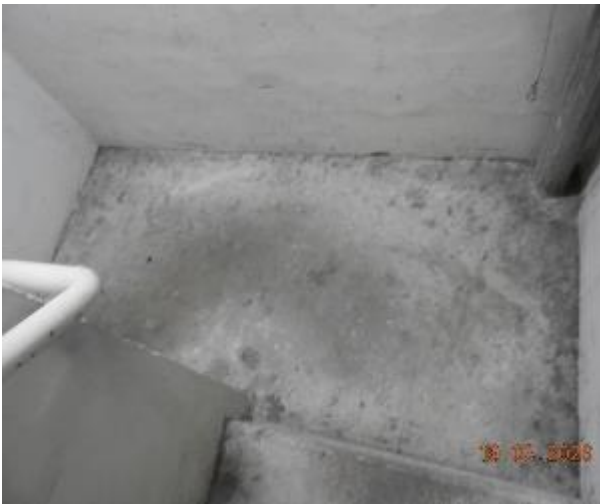
Figure 404 - General condition of level 1 fire stairs

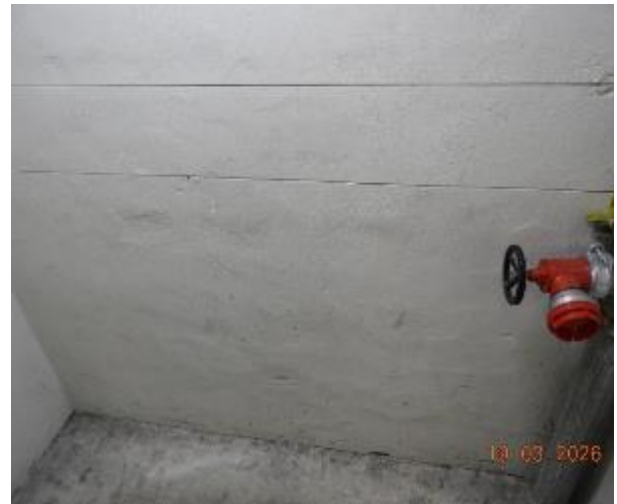
Figure 405 - General condition of level 1 fire stairs internal wall

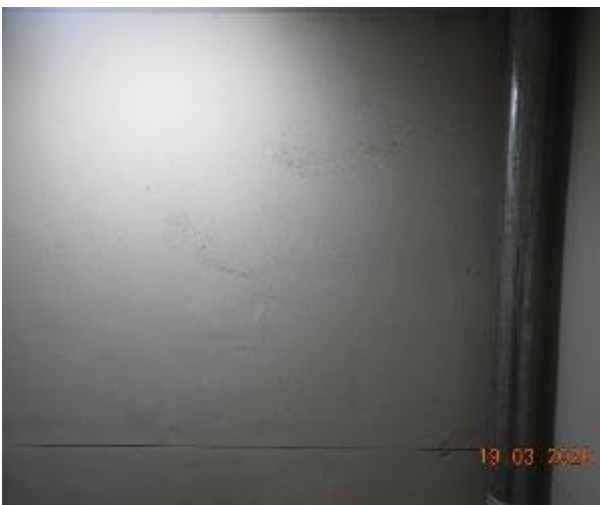
Figure 406 - General condition of level 1 fire stairs internal wall

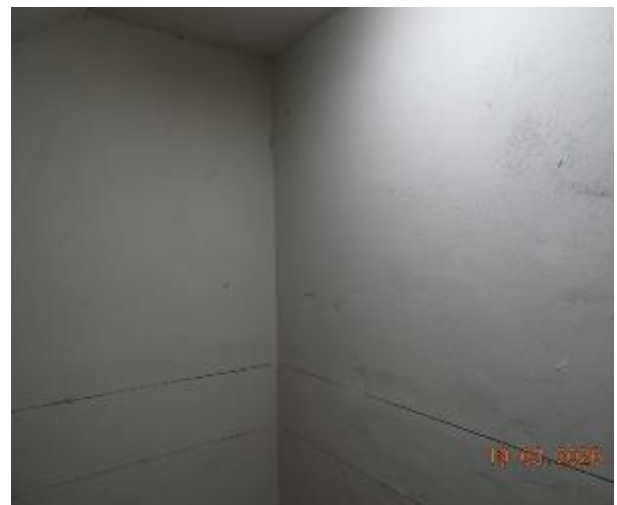
Figure 407 - General condition of level 1 fire stairs internal wall

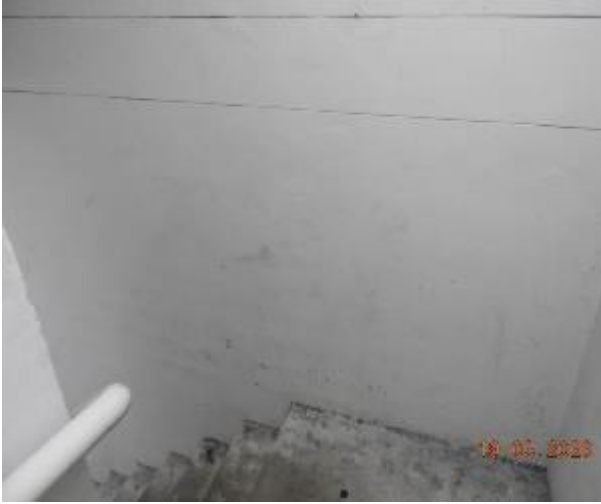
Figure 408 - General condition of level 1 fire stairs internal wall

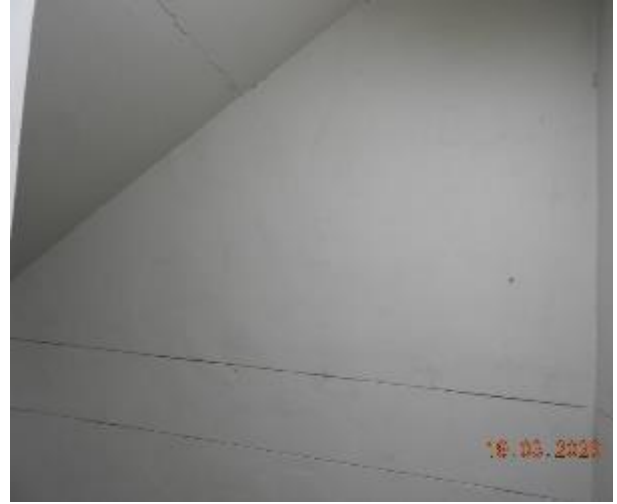
Figure 409 - General condition of level 1 fire stairs internal wall

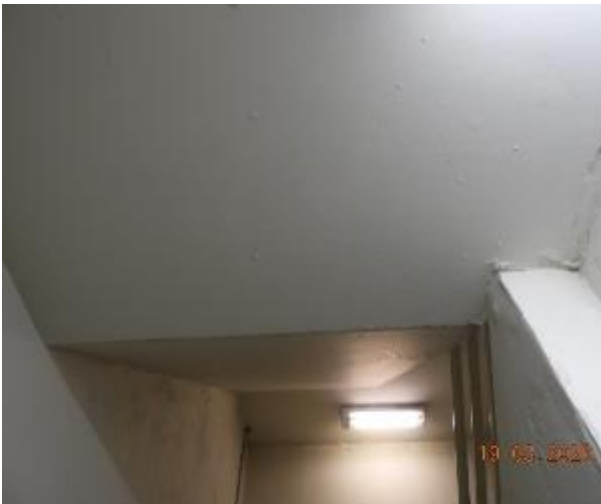
Figure 410 - General condition of level 1 fire stairs underside stairs

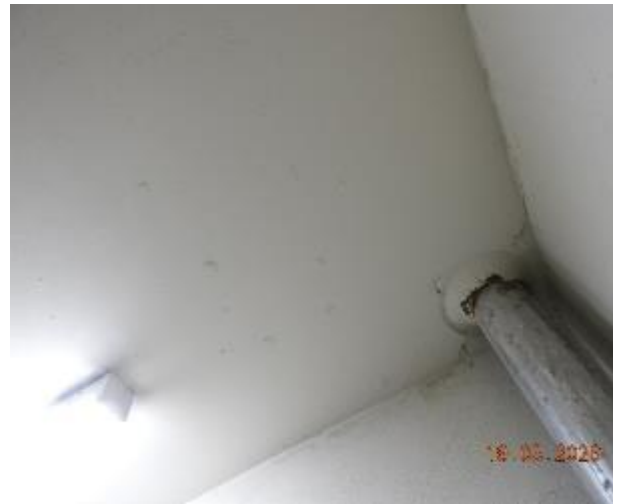
Figure 411 - General condition of level 1 fire stairs underside stairs

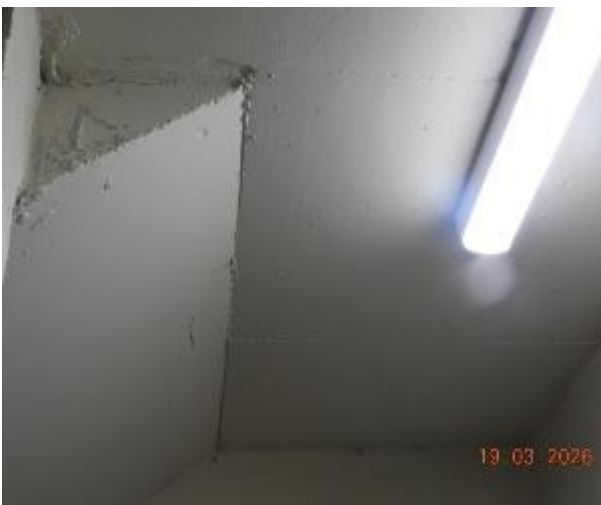
Figure 412 - General condition of level 1 fire stairs underside stairs

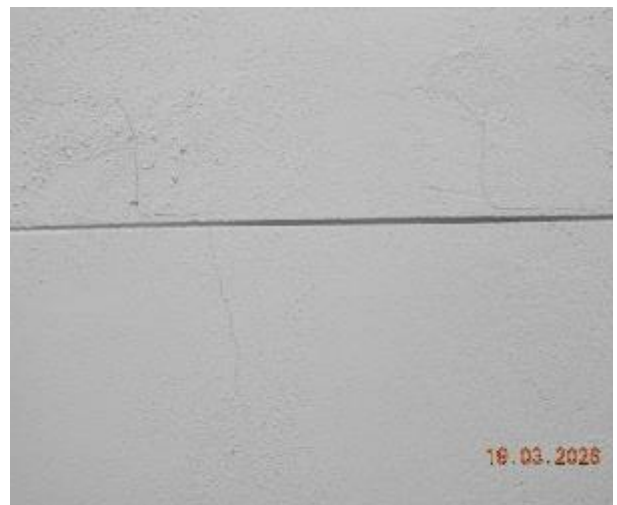
Figure 413 - Crack propagation through level 1 fire stairs underside stairs

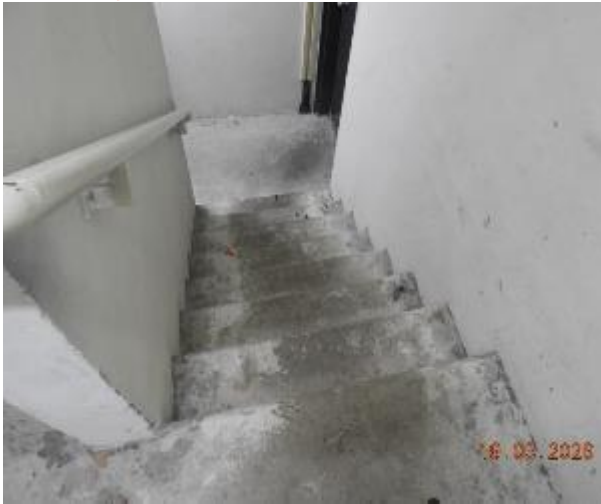
Figure 414 - General condition of level 1 fire stairs

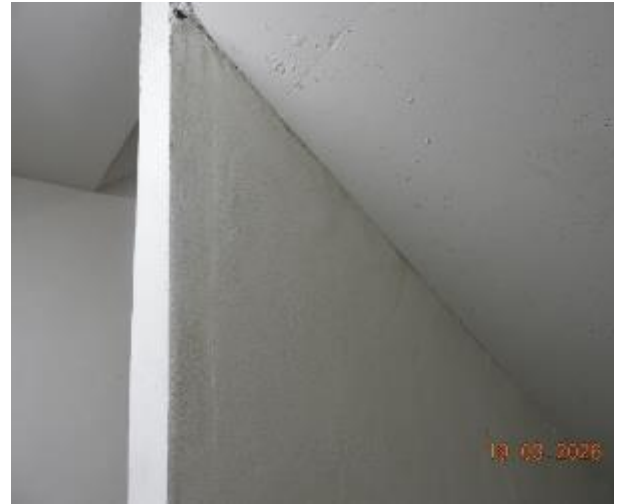
Figure 415 - General condition of level 1 fire stairs internal wall

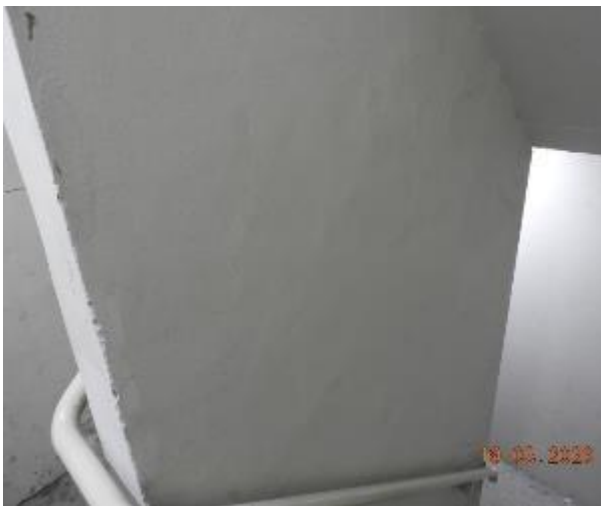
Figure 416 - General condition of level 1 fire stairs internal wall

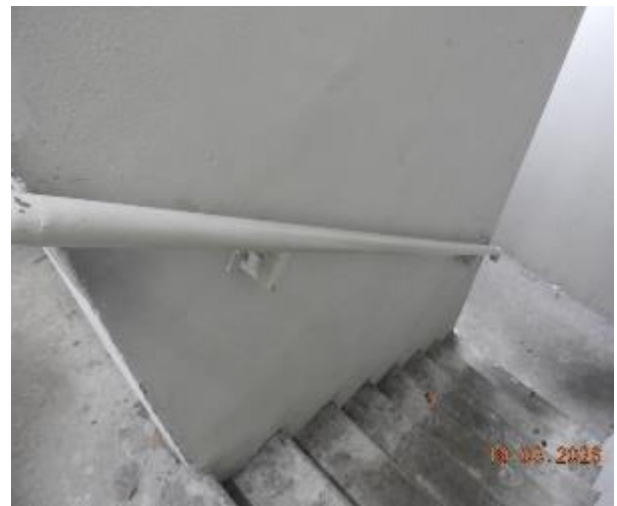
Figure 417 - General condition of level 1 fire stairs internal wall

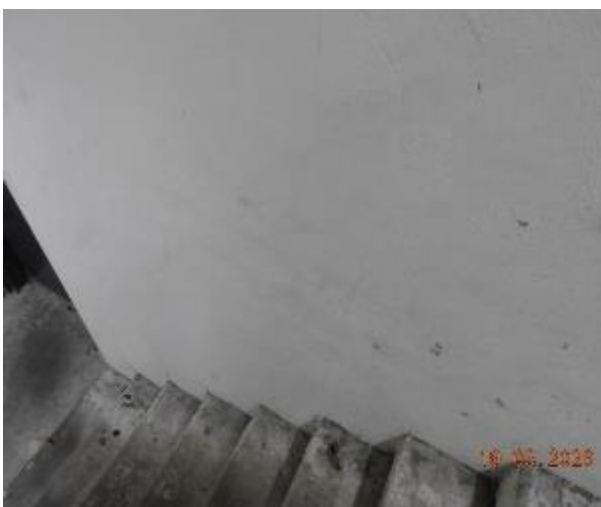
Figure 418 - General condition of level 1 fire stairs internal wall

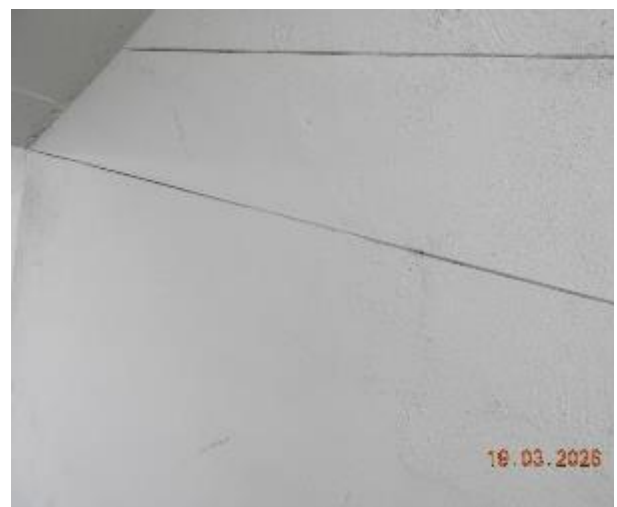
Figure 419 - General condition of level 1 fire stairs internal wall

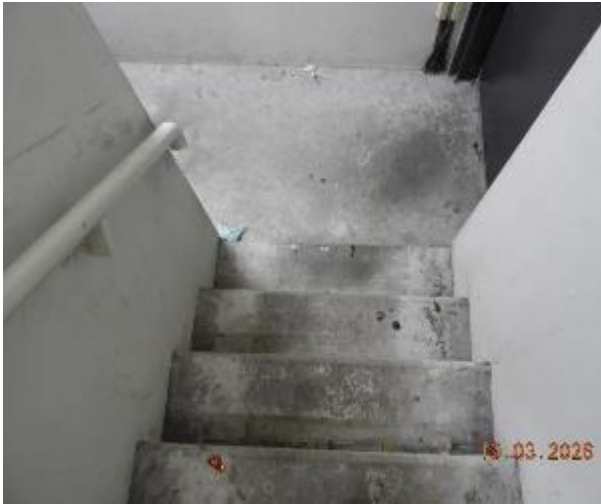
Figure 420 - General condition of level 1 fire stairs concrete floor

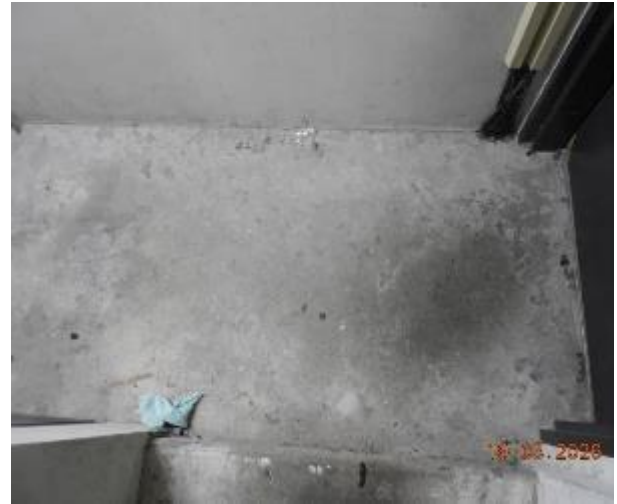
Figure 421 - General condition of level 1 fire stairs concrete floor

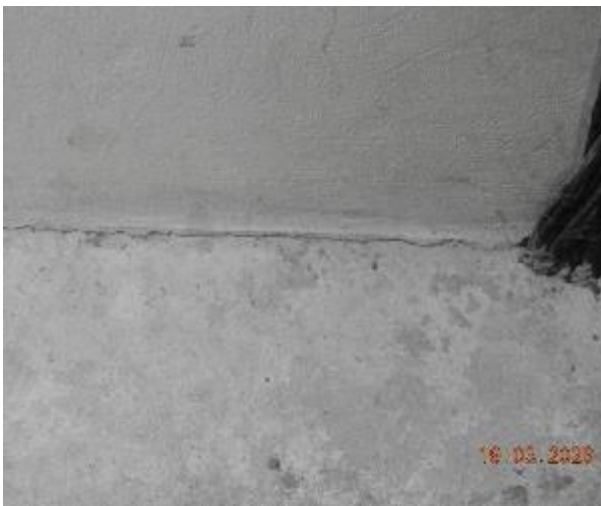
Figure 422 - Crack propagation through level 1 fire stairs concrete floor

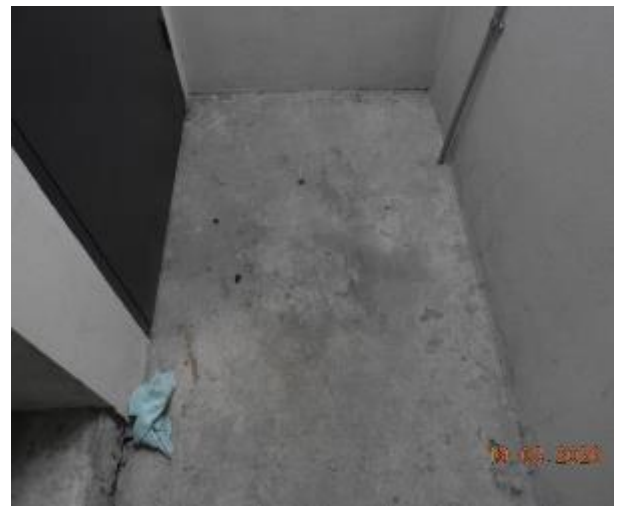
Figure 423 - General condition of level 1 fire stairs concrete floor

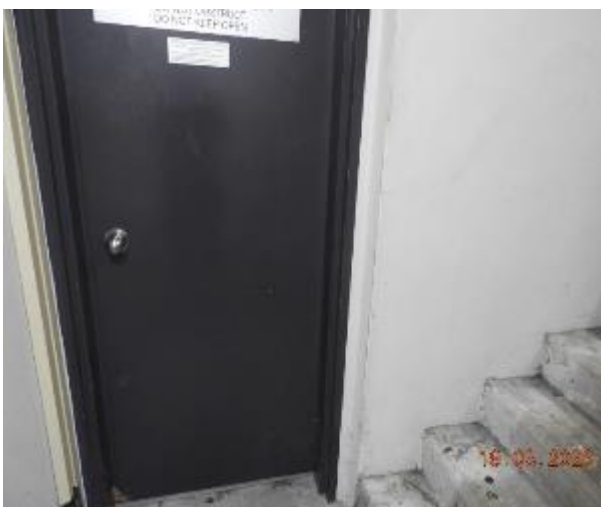
Figure 424 - General condition of level 1 fire stairs internal wall

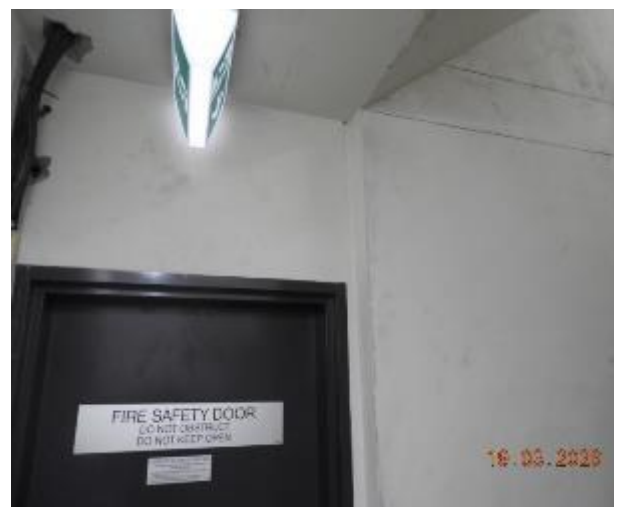
Figure 425 - General condition of level 1 fire stairs internal wall

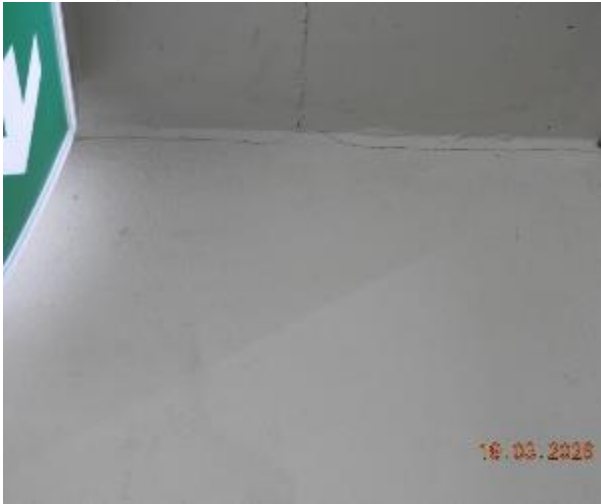
Figure 426 - Crack propagation through level 1 fire stairs internal wall

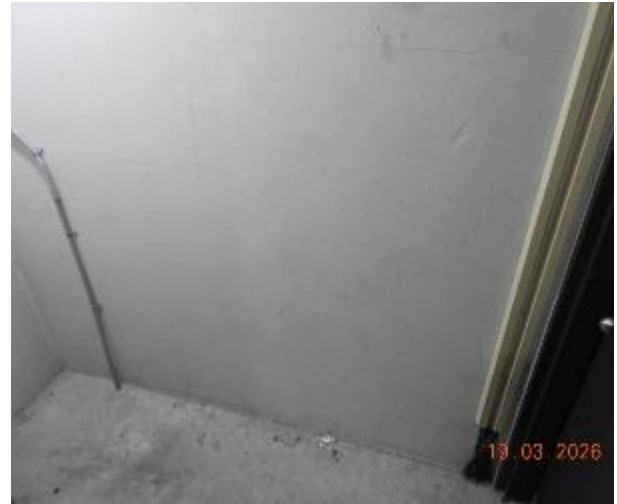
Figure 427 - General condition of level 1 fire stairs internal wall

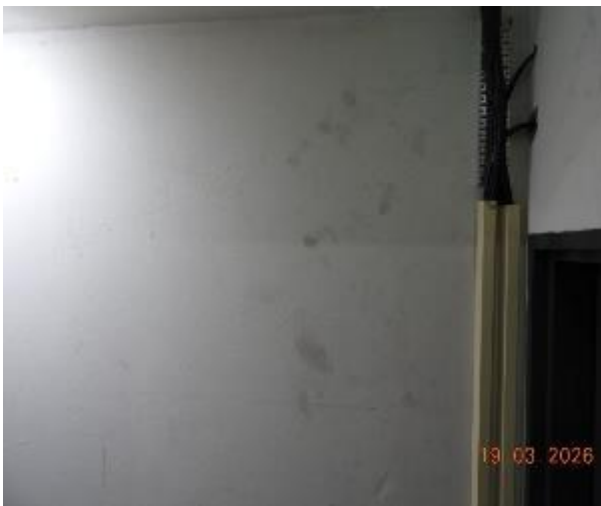
Figure 428 - General condition of level 1 fire stairs internal wall

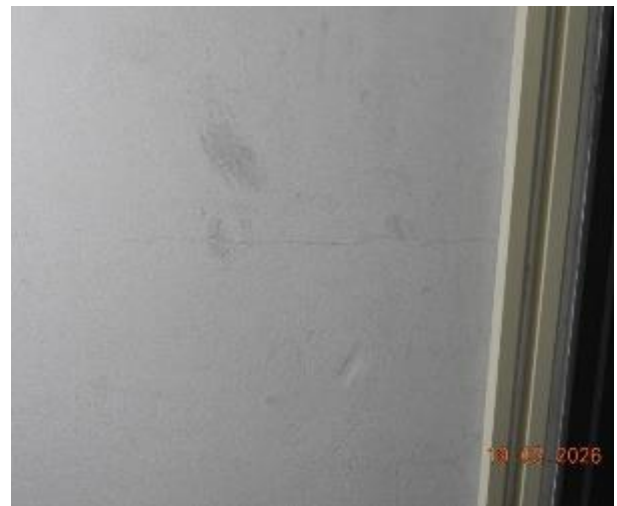
Figure 429 - Crack propagation through level 1 fire stairs internal wall

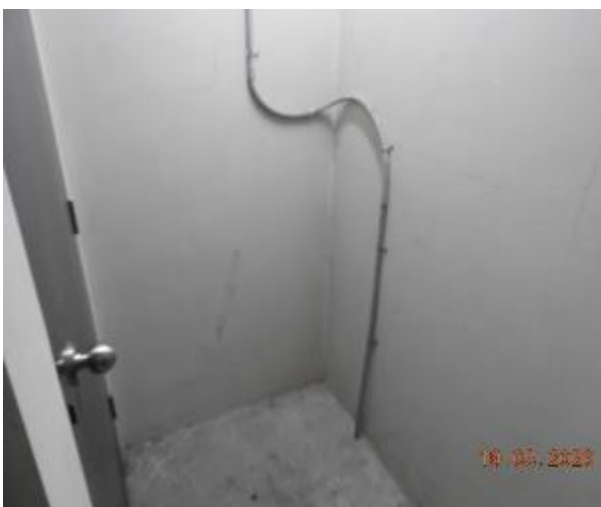
Figure 430 - General condition of level 1 fire stairs internal wall

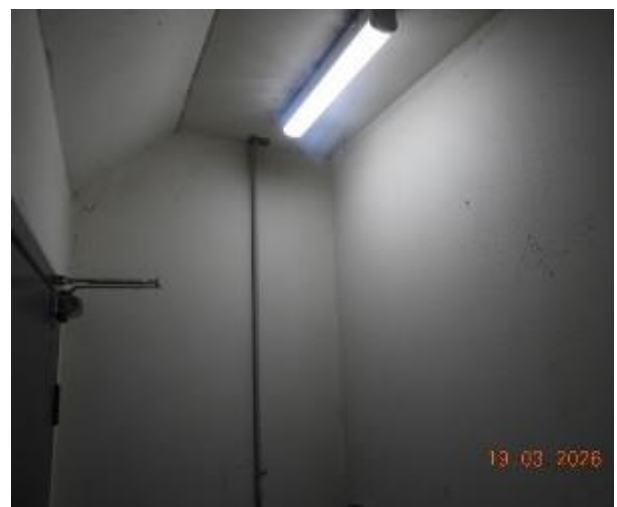
Figure 431 - General condition of level 1 fire stairs internal wall

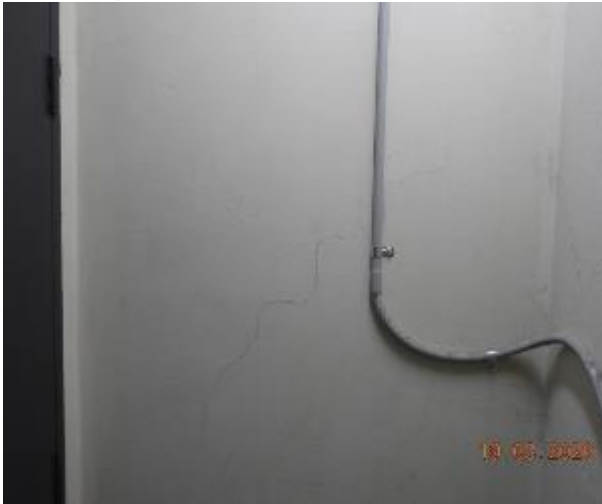
Figure 432 - Crack propagation through level 1 fire stairs internal wall

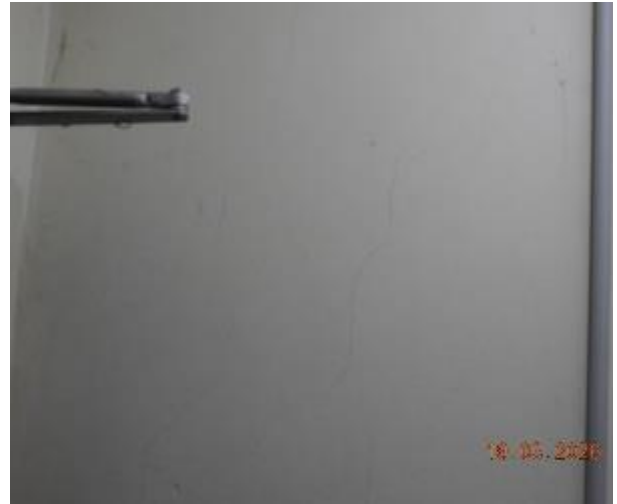
Figure 433 - Crack propagation through level 1 fire stairs internal wall

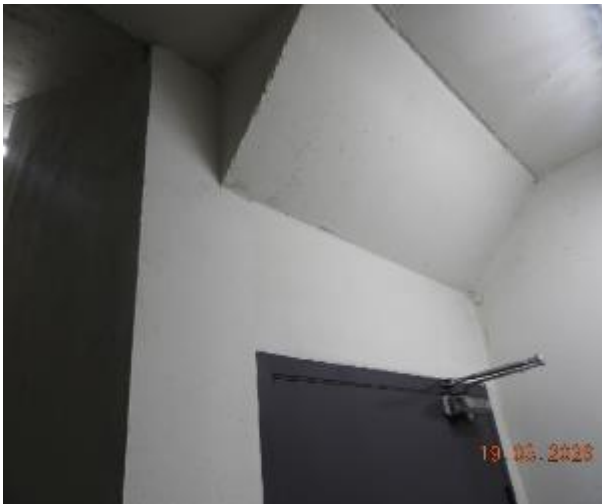
Figure 434 - General condition of level 1 fire stairs internal wall

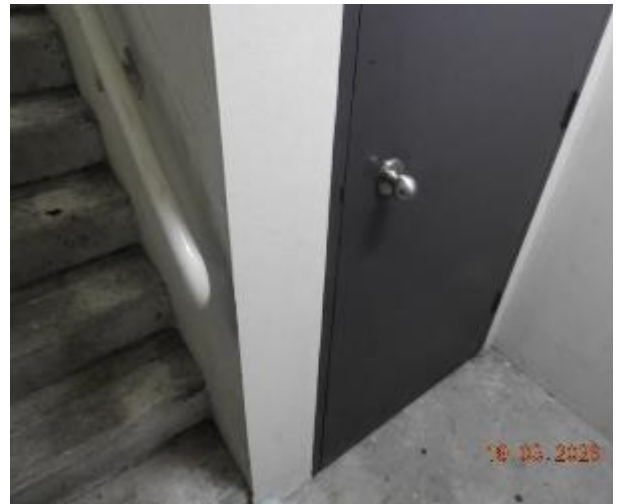
Figure 435 - General condition of level 1 fire stairs internal wall

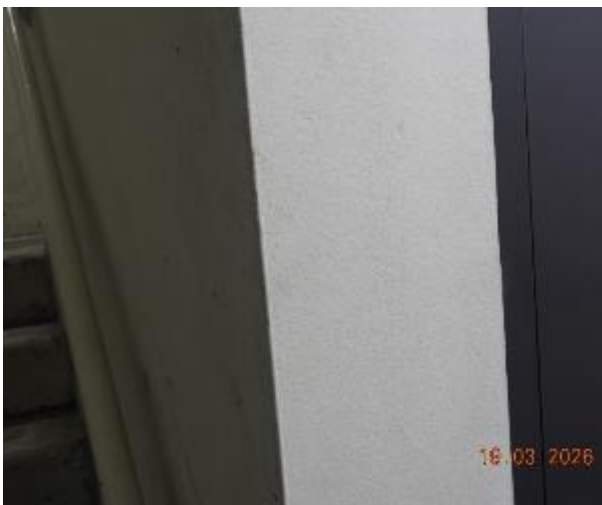
Figure 436 - Crack propagation through level 1 fire stairs internal wall

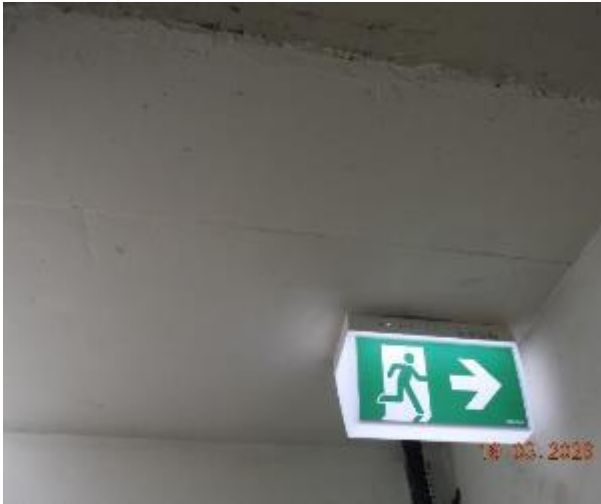
Figure 438 - General condition of level 1 fire stairs underside stairs

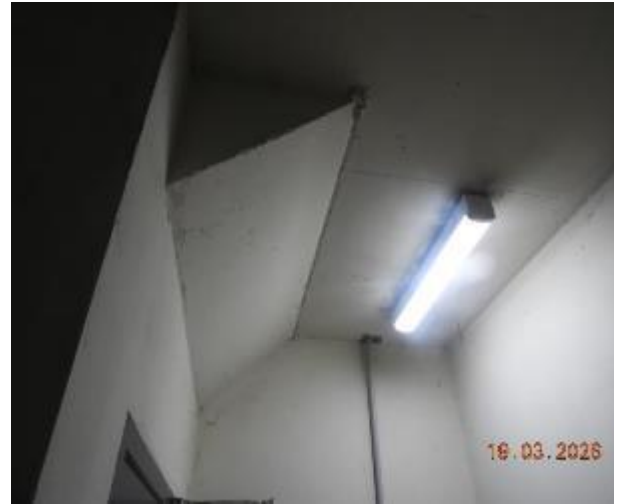
Figure 439 - General condition of level 1 fire stairs underside stairs

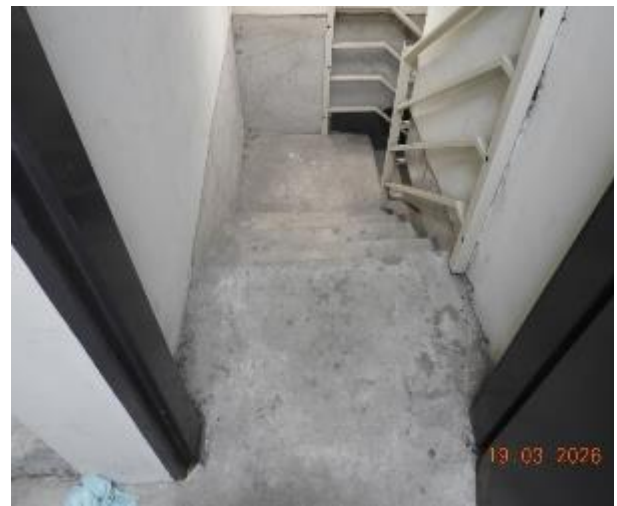
Figure 441 - General condition of basement fire stairs

The fire stairs from Level 5 to Basement B2 were also inspected and determined to be in reasonable condition. There were cases of cracking through the internal walls, underside stairs, and concrete floor. There was also some evidence of paint flaking through the internal walls.

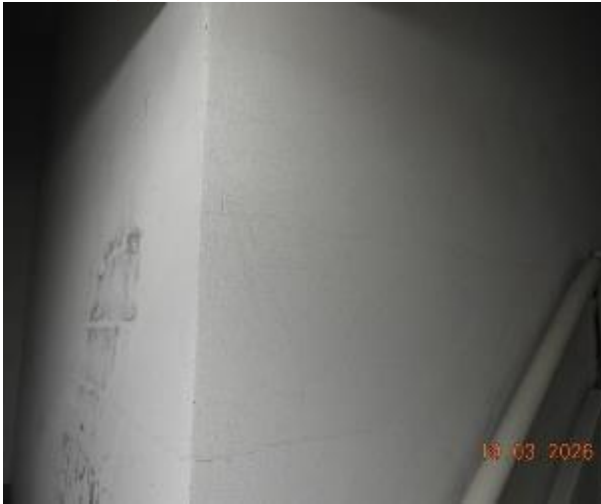
Figure 444 - Crack propagation through basement fire stairs internal wall
