# **Pre-Dilapidation Report**

**19 GEORGE STREET**

**FRONT BUILDING (UNITS 1-19)**

Project Reference: 20250047.19G.2

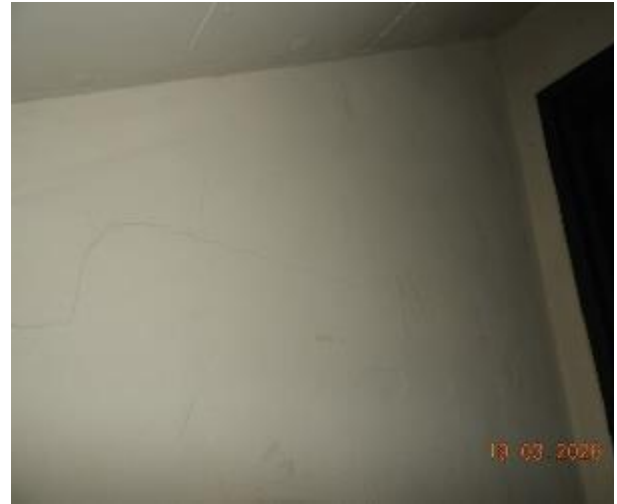
Figure 445 - Crack propagation through basement fire stairs internal wall

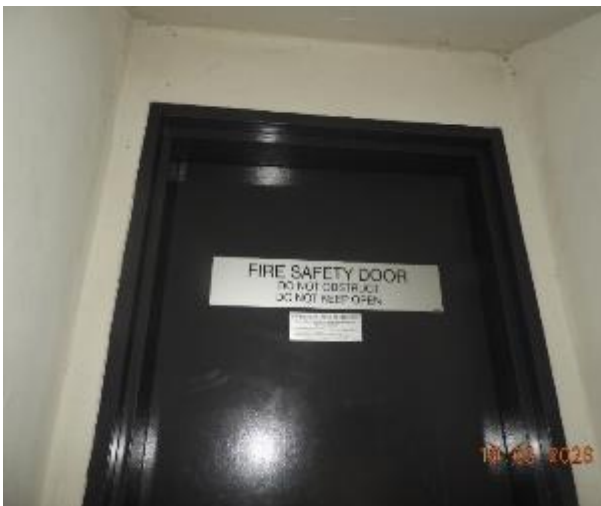
Figure 446 - General condition of basement fire stairs internal wall

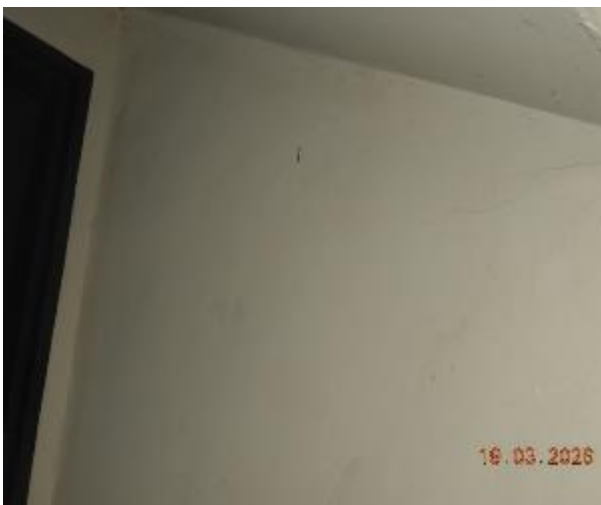
Figure 448 - General condition of basement fire stairs internal wall

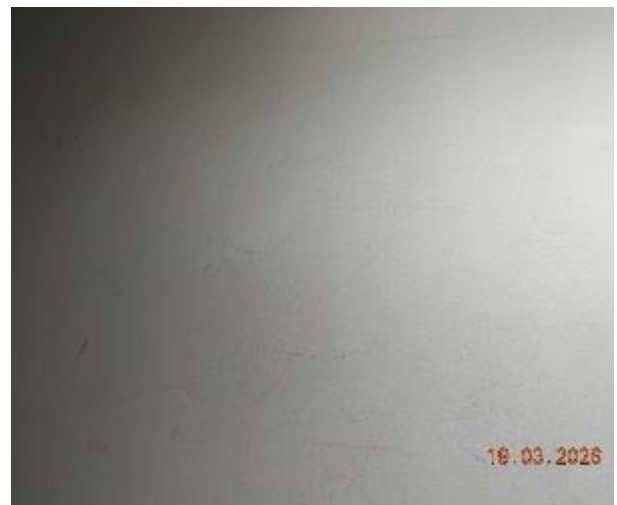
Figure 449 - Crack propagation through basement fire stairs internal wall

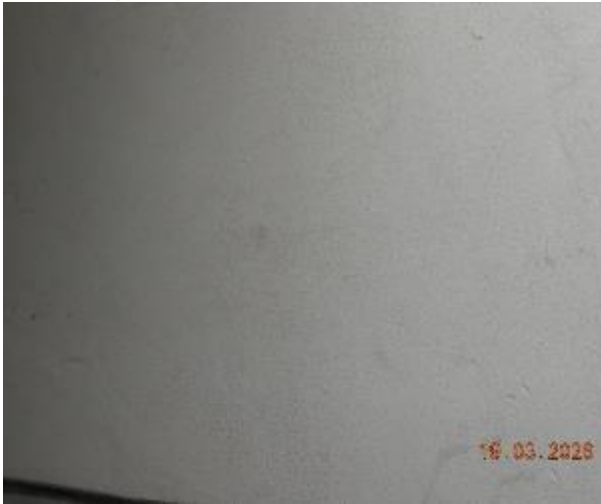
Figure 450 - Crack propagation through basement fire stairs internal wall

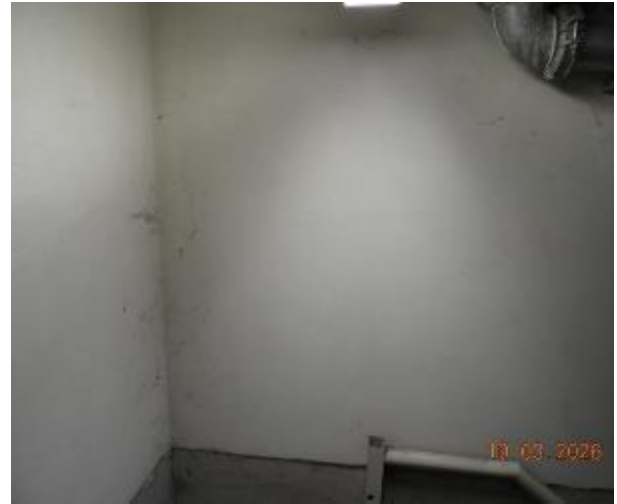
Figure 451 - General condition of basement fire stairs internal wall

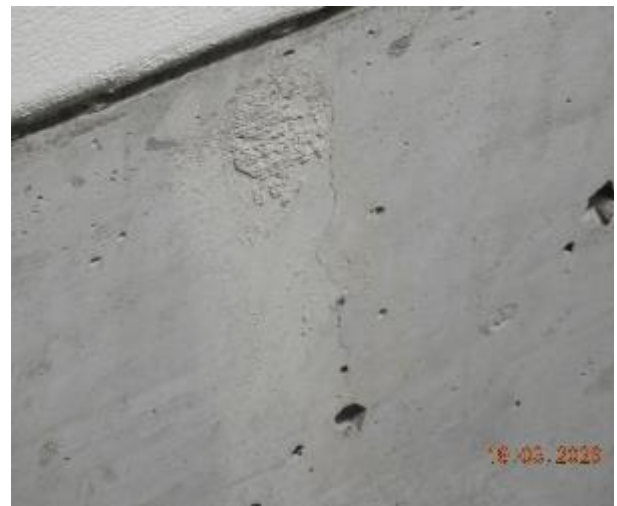
Figure 453 - Crack propagation through basement fire stairs internal wall

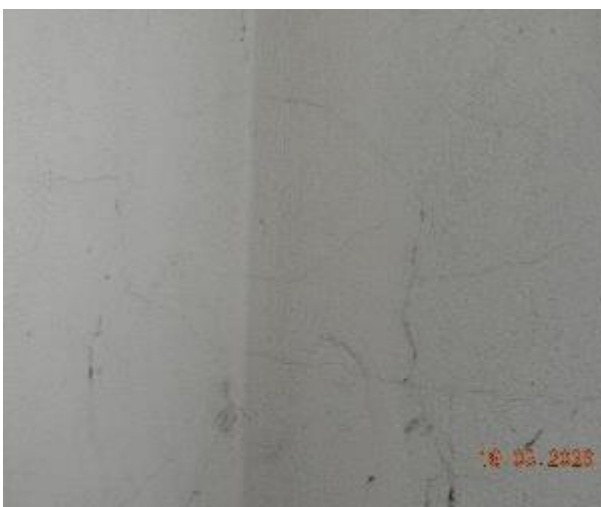
Figure 454 - Crack propagation through basement fire stairs internal wall

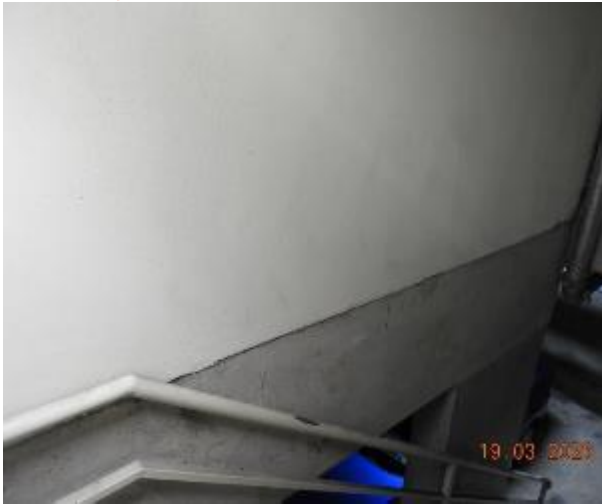
Figure 456 - General condition of basement fire stairs internal wall

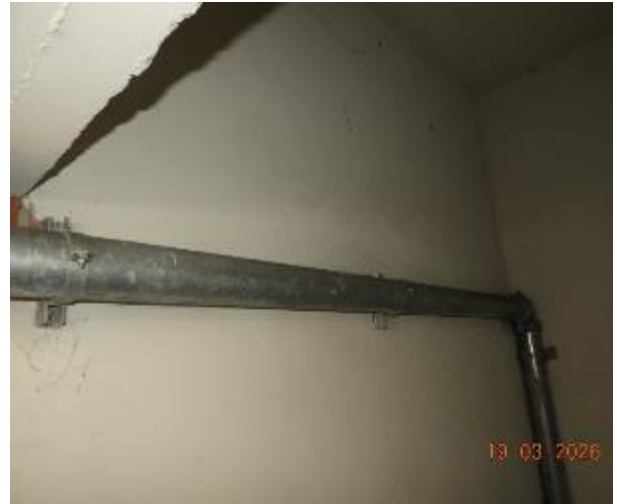
Figure 457 - General condition of basement fire stairs internal wall

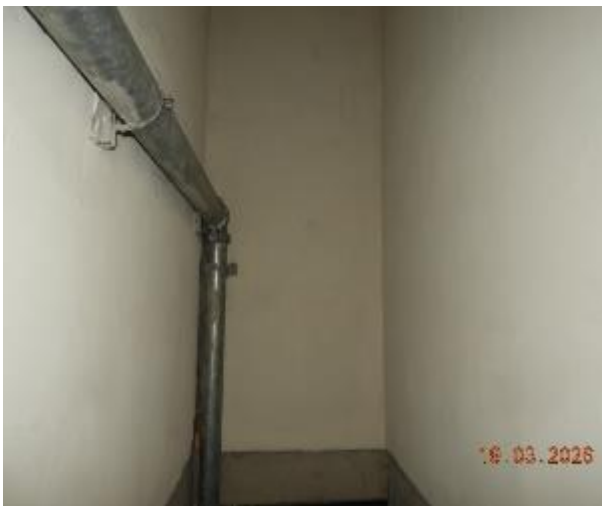
Figure 458 - General condition of basement fire stairs internal wall

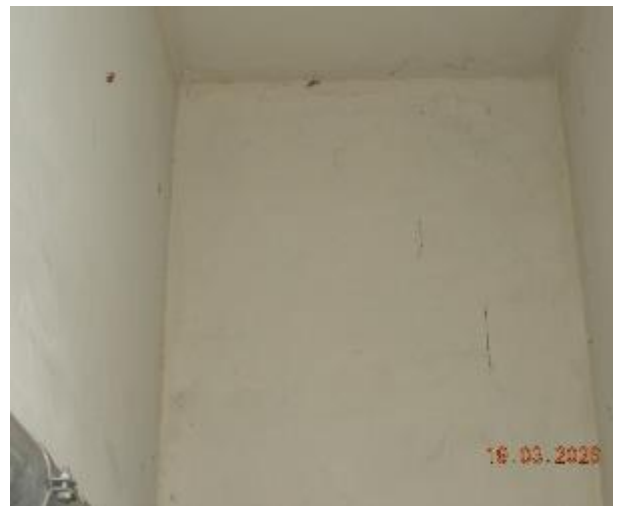
Figure 459 - General condition of basement fire stairs internal wall

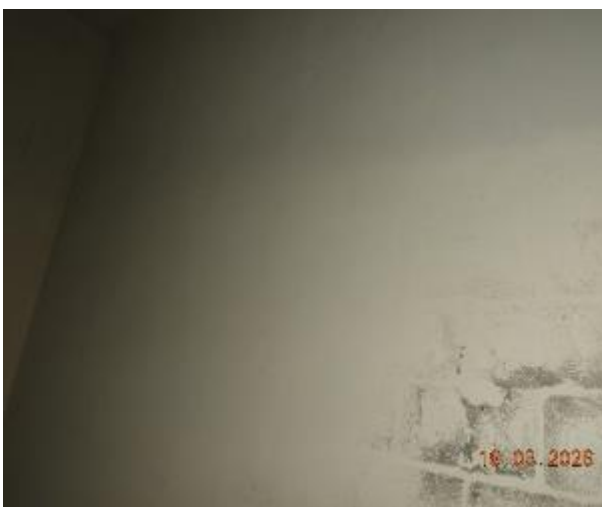
Figure 460 - General condition of basement fire stairs internal wall

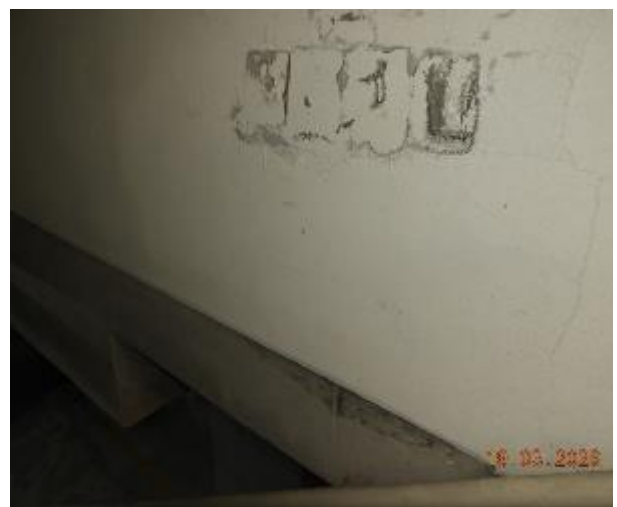
Figure 461 - General condition of basement fire stairs internal wall

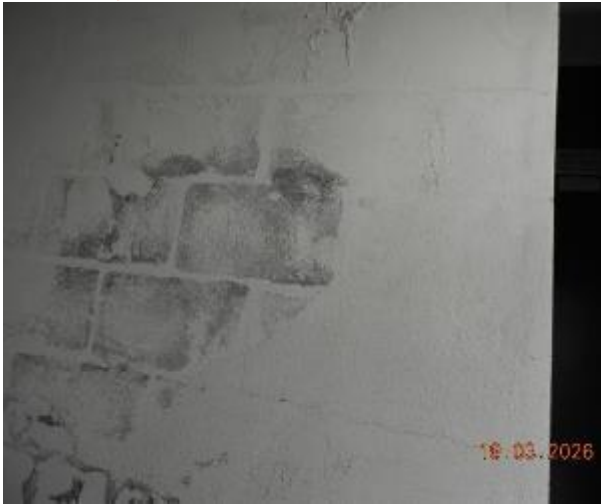
Figure 462 - General condition of basement fire stairs internal wall

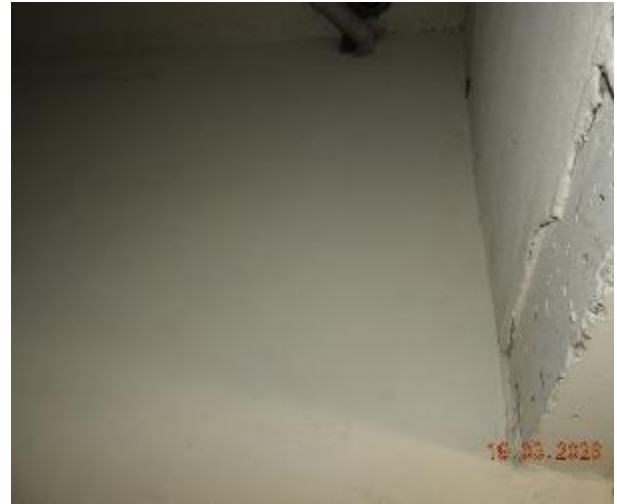
Figure 463 - General condition of basement fire stairs internal wall

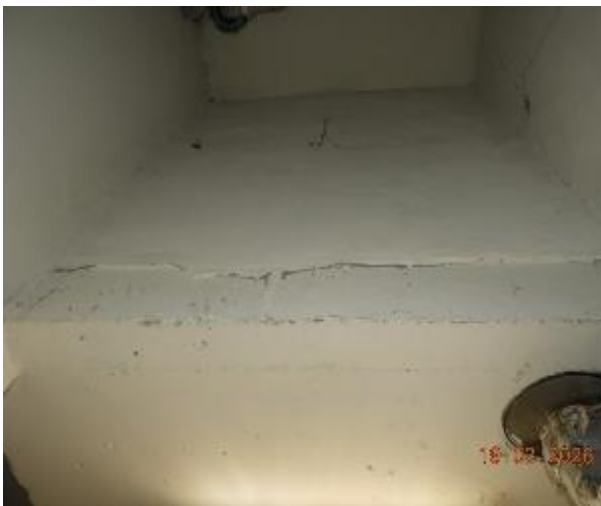
Figure 464 - General condition of basement fire stairs internal wall

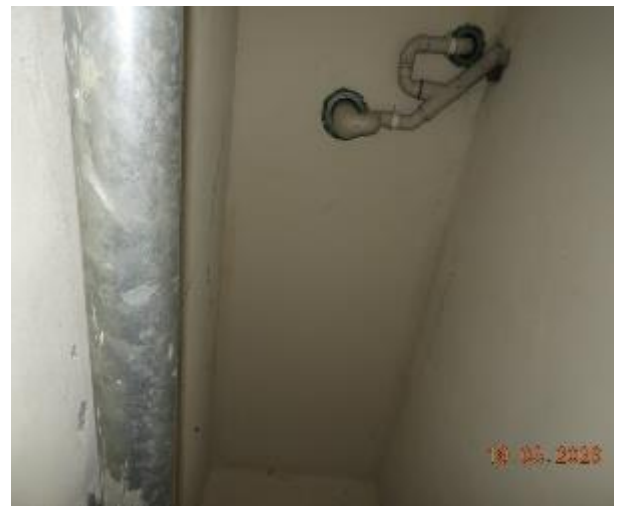
Figure 465 - General condition of basement fire stairs underside slab

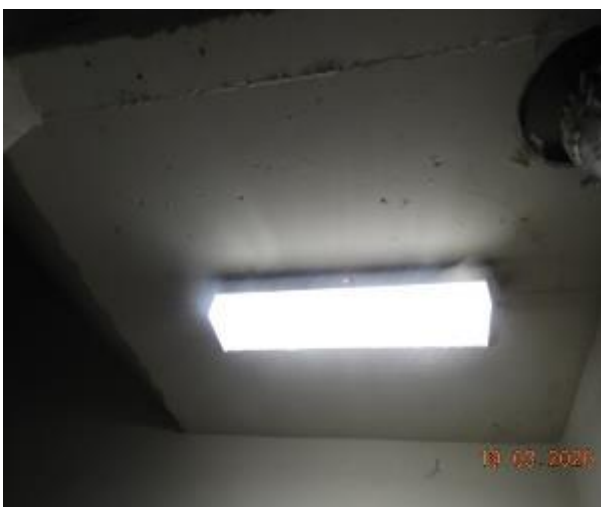
Figure 466 - General condition of basement fire stairs underside slab

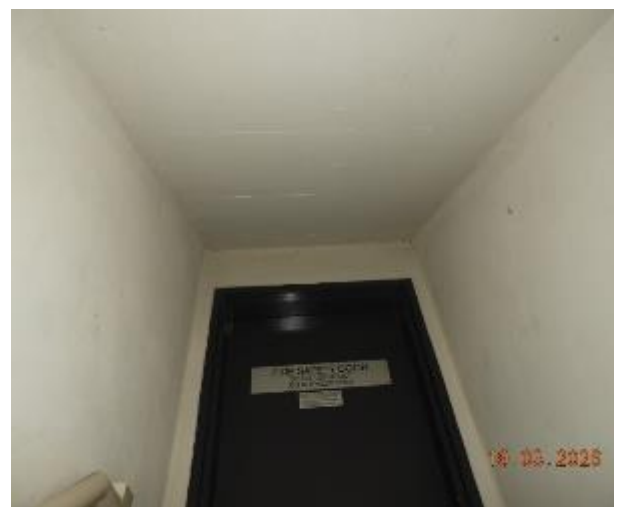
Figure 467 - General condition of basement fire stairs underside slab

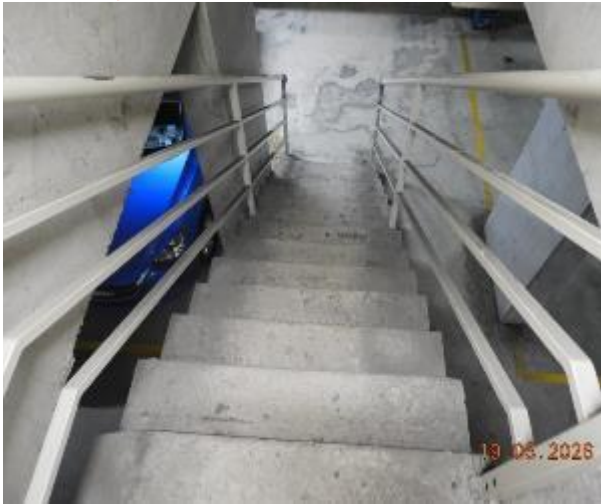
Figure 468 - General condition of basement fire stairs

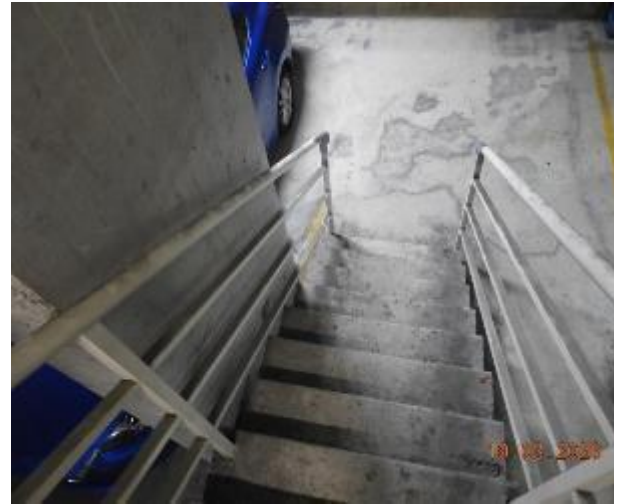
Figure 469 - General condition of basement fire stairs

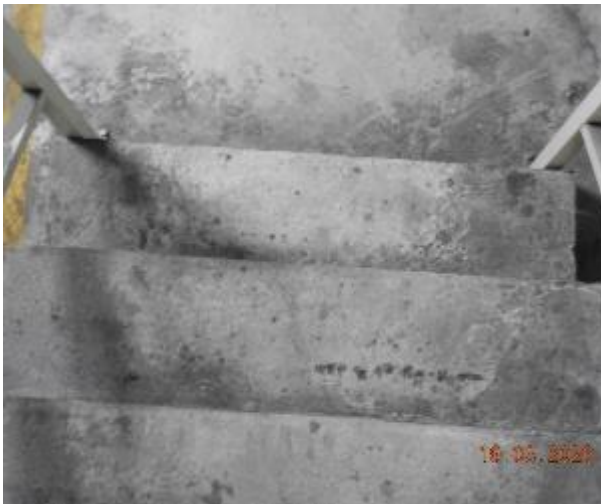
Figure 470 - General condition of basement fire stairs

The fire stairs from Level 5 to Basement B2 were also inspected and determined to be in reasonable condition. There were cases of cracking through the internal walls, underside stairs, and concrete floor. There was also some evidence of paint flaking through the internal walls.

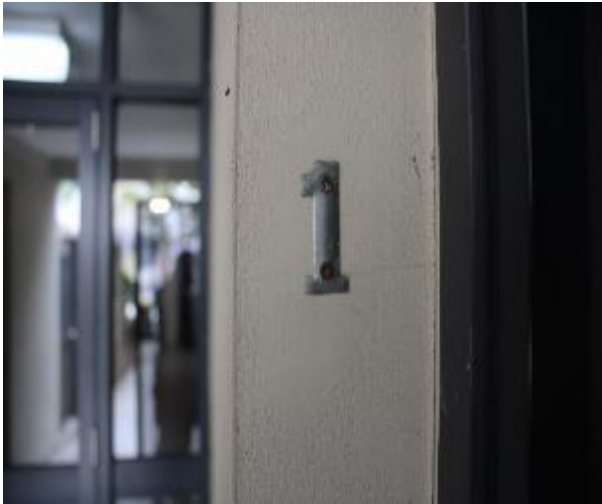
Figure 471 - The following images display the condition of Unit 1

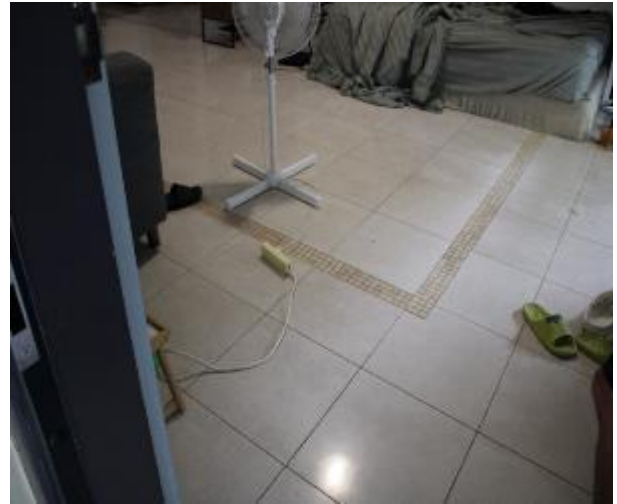
Figure 472 - General condition of open kitchen/ lounge room floor tiles

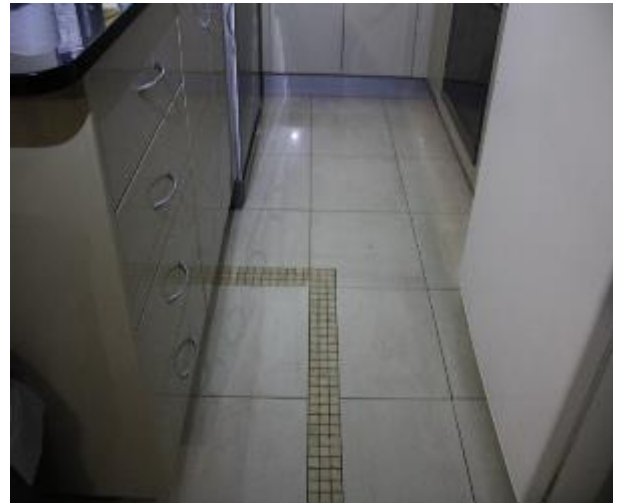
Figure 474 - General condition of open kitchen/ lounge room floor tiles

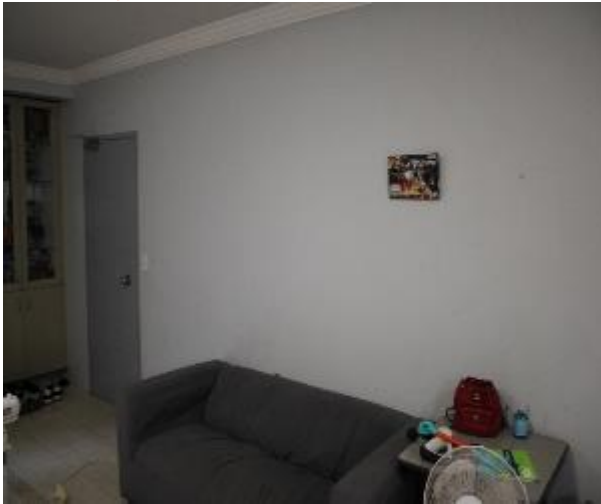
Figure 477 - General condition of open kitchen/  
lounge room internal wall

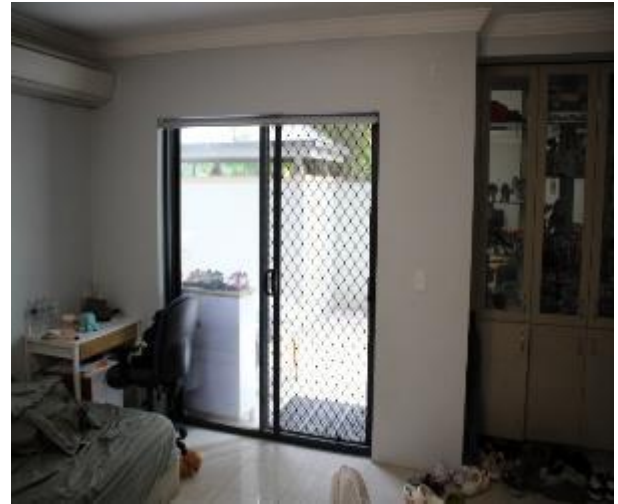
Figure 478 - General condition of open kitchen/  
lounge room internal wall

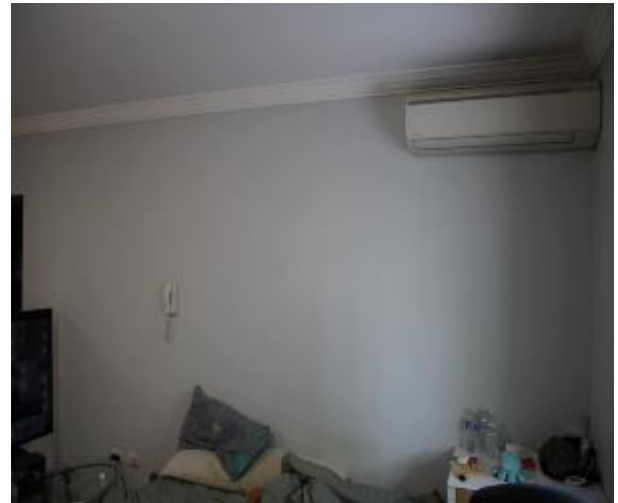
Figure 480 - General condition of open kitchen/  
lounge room internal wall

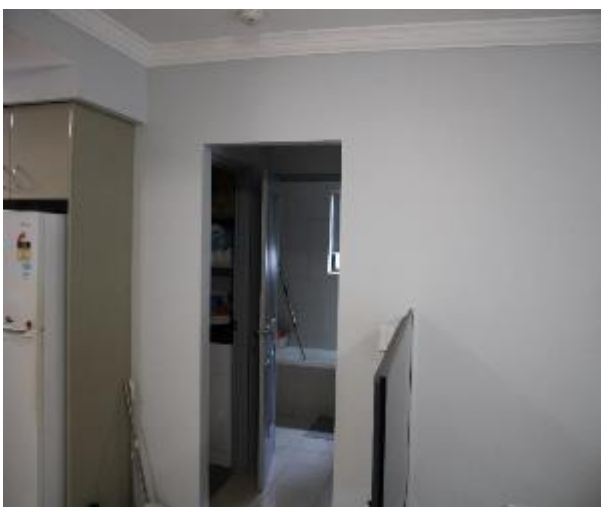
Figure 481 - General condition of open kitchen/  
lounge room internal wall

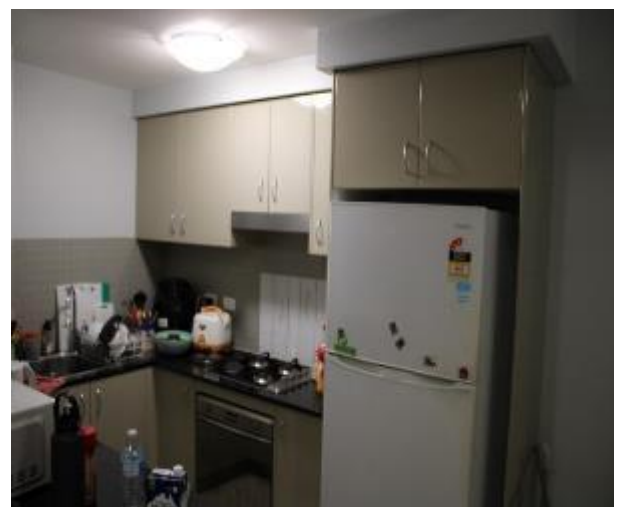
Figure 482 - General condition of open kitchen/  
lounge room internal wall

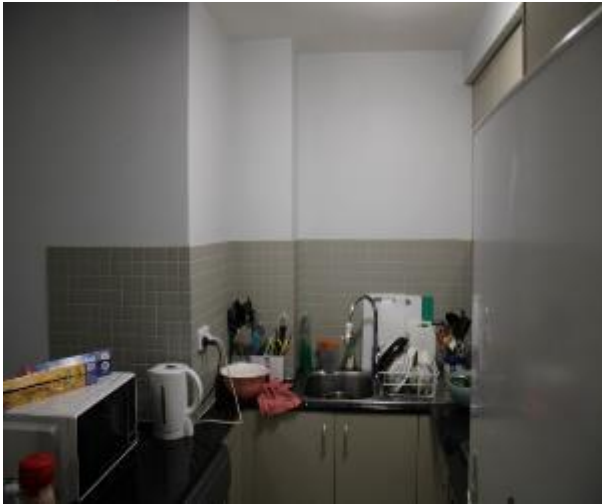
Figure 483 - General condition of open kitchen/  
lounge room internal wall

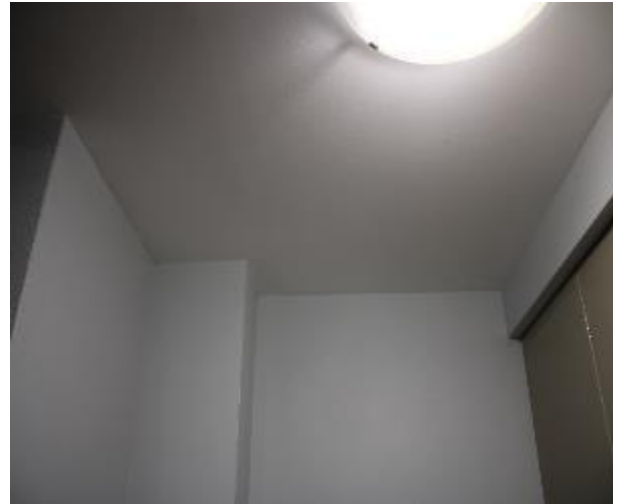
Figure 484 - General condition of open kitchen/  
lounge room ceiling

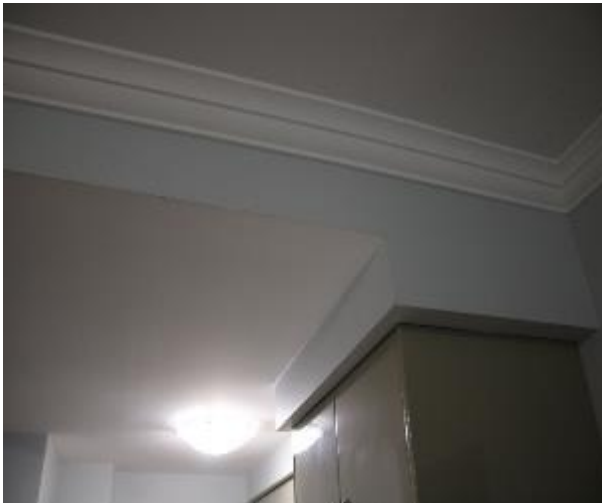
Figure 485 - General condition of open kitchen/  
lounge room ceiling

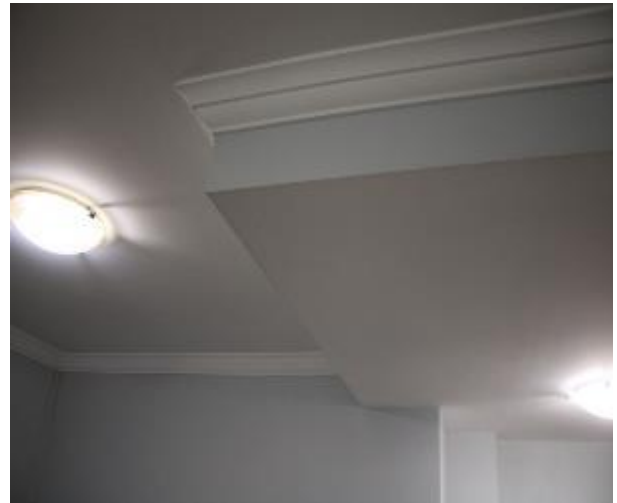
Figure 486 - General condition of open kitchen/  
lounge room ceiling

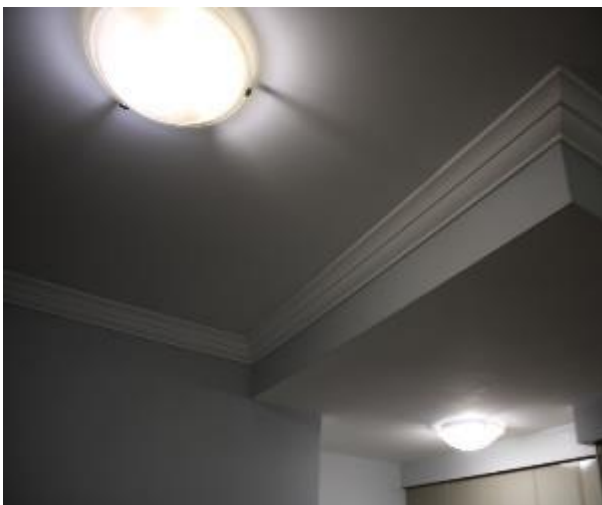
Figure 487 - General condition of open kitchen/  
lounge room ceiling

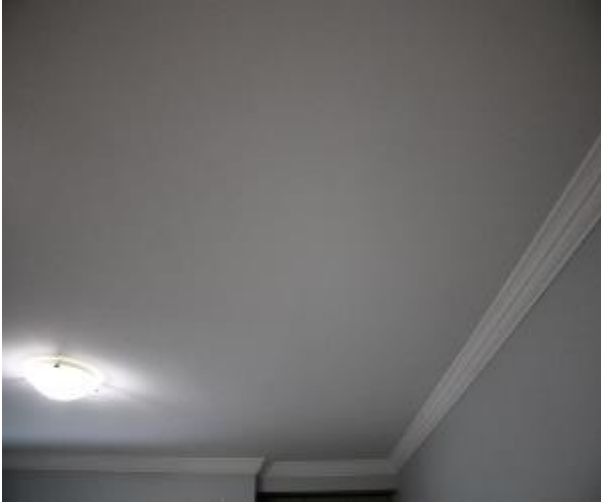
Figure 489 - General condition of open kitchen/  
lounge room ceiling

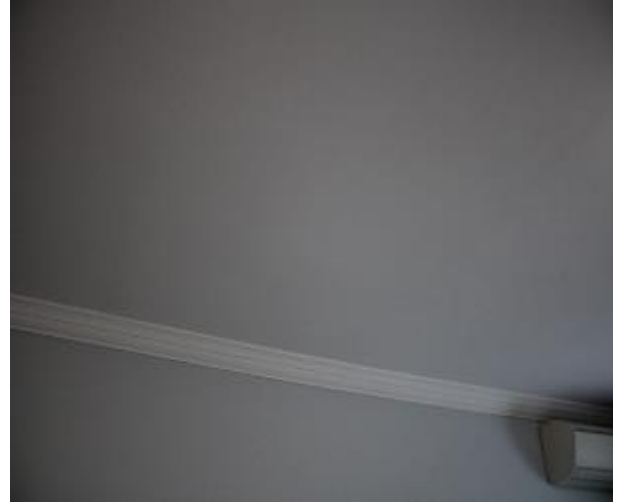
Figure 490 - General condition of open kitchen/  
lounge room ceiling

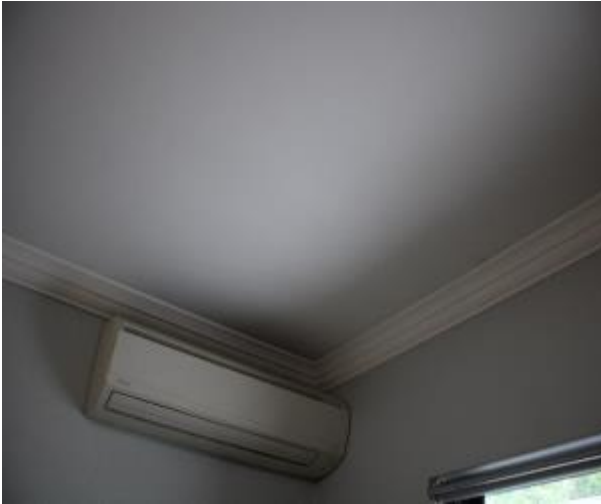
Figure 491 - General condition of open kitchen/  
lounge room ceiling

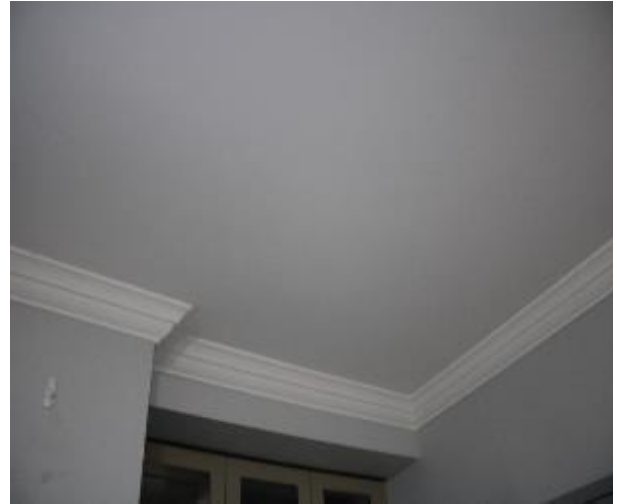
Figure 492 - General condition of open kitchen/  
lounge room ceiling

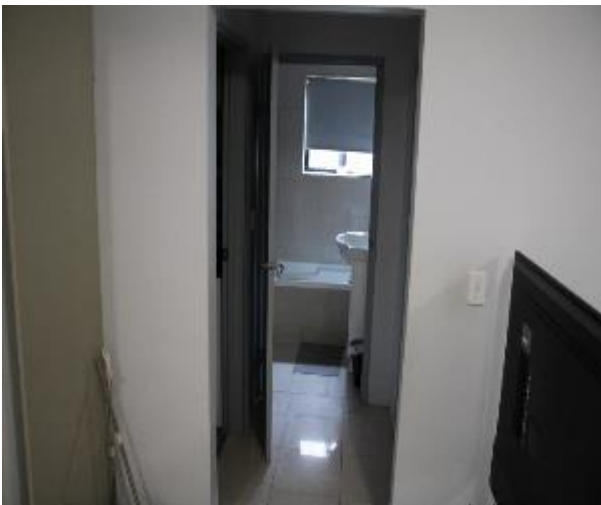
Figure 493 - General condition of corridor

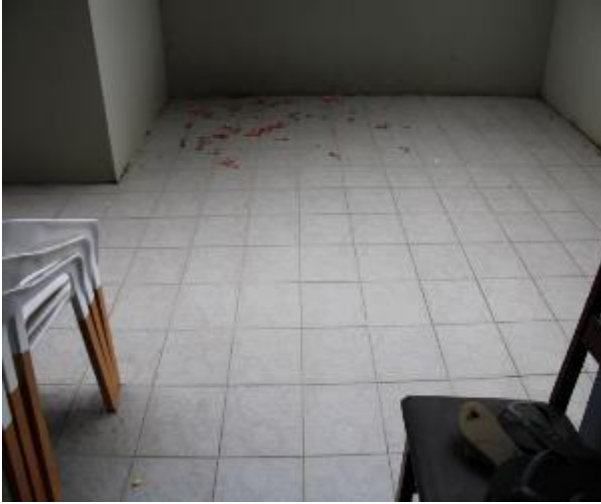
Figure 495 - General condition of courtyard floor tiles

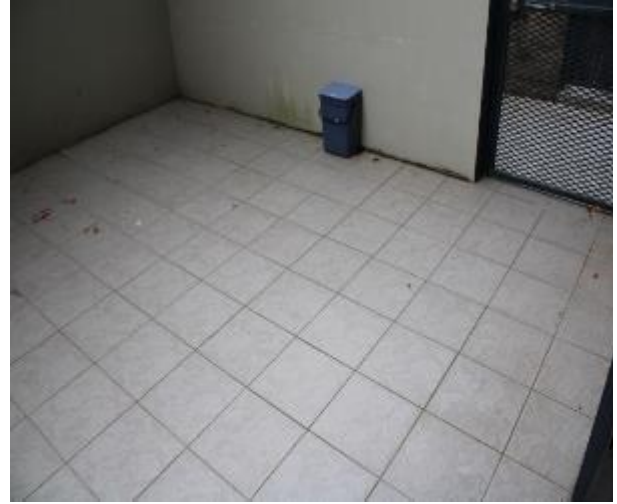
Figure 496 - General condition of courtyard floor tiles

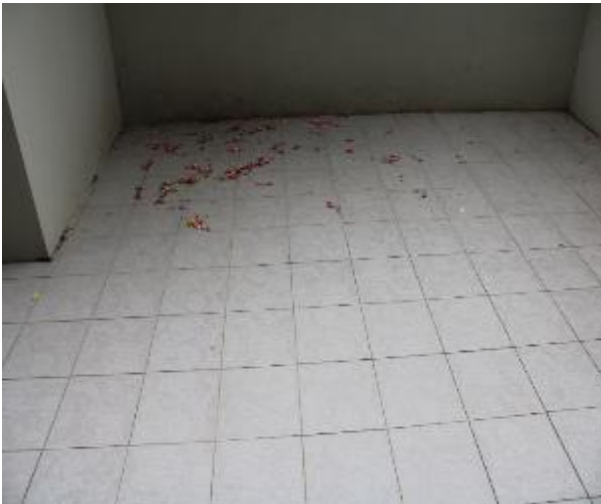
Figure 497 - General condition of courtyard floor tiles

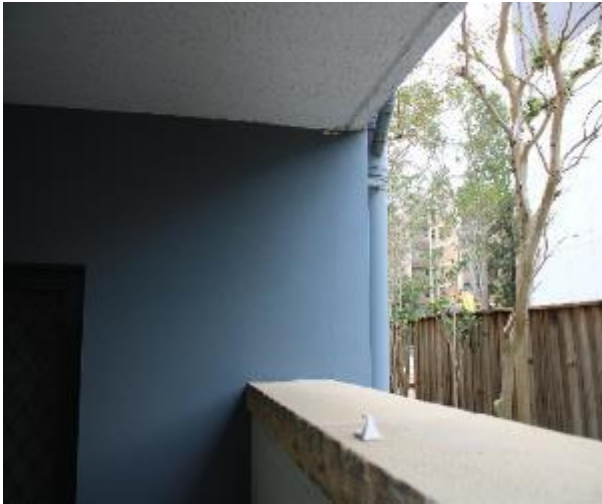
Figure 501 - General condition of external wall

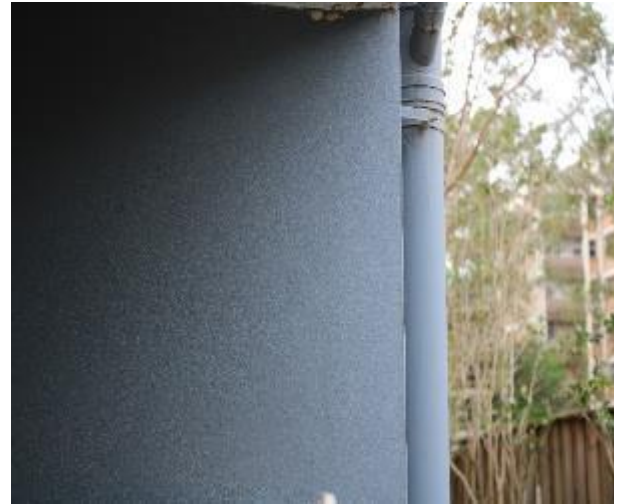
Figure 502 - Crack propagation through external wall

Unit 1 was inspected and determined to be in reasonable condition with evidence of cracking through the internal and external walls.

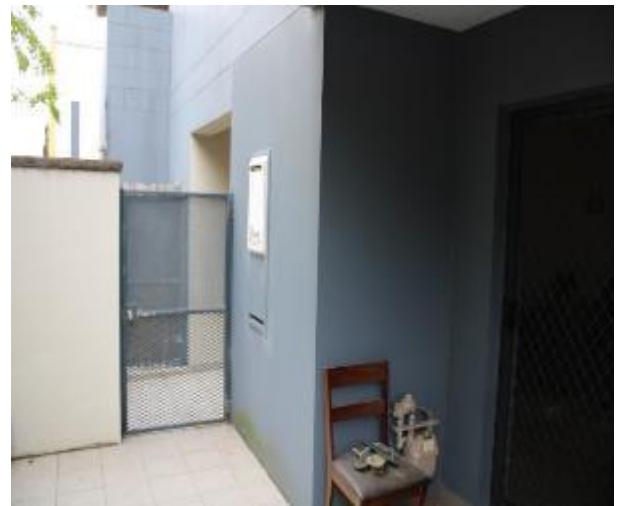
Figure 504 - General condition of external wall

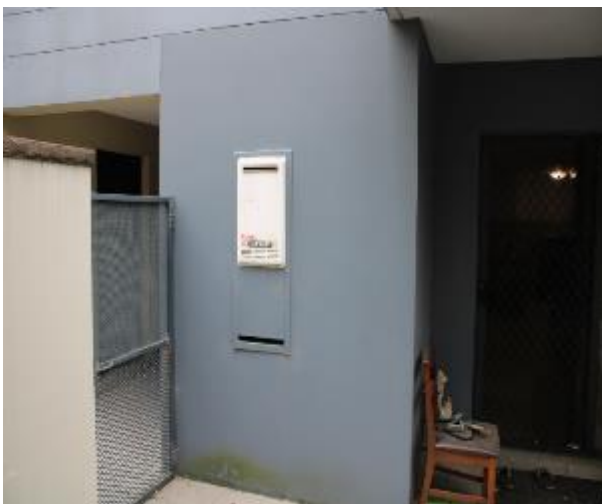
Figure 505 - General condition of external wall

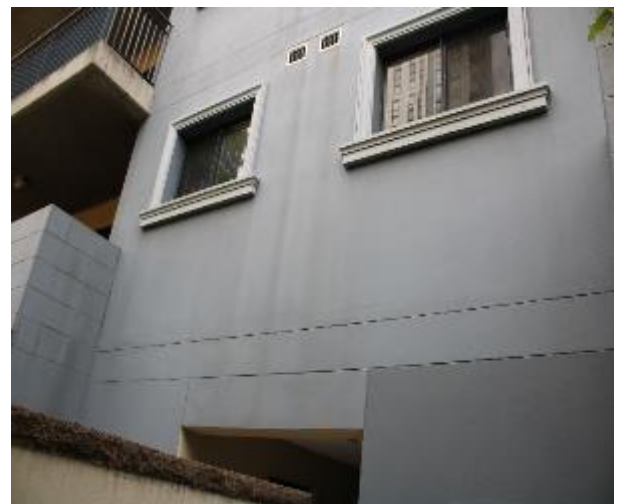
Figure 506 - General condition of external wall

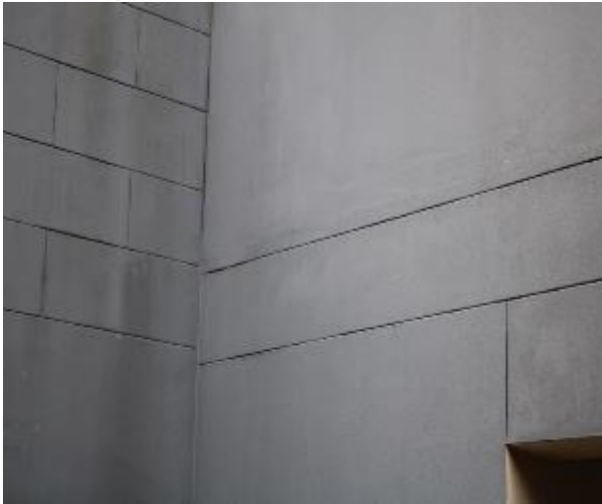
Figure 507 - Crack propagation through external wall

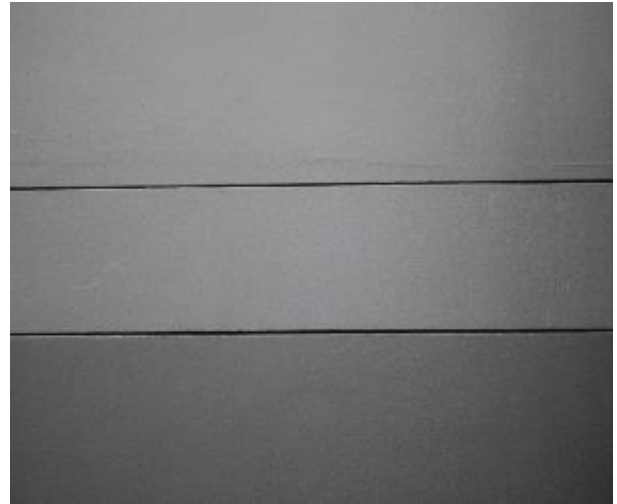
Figure 508 - Crack propagation through external wall

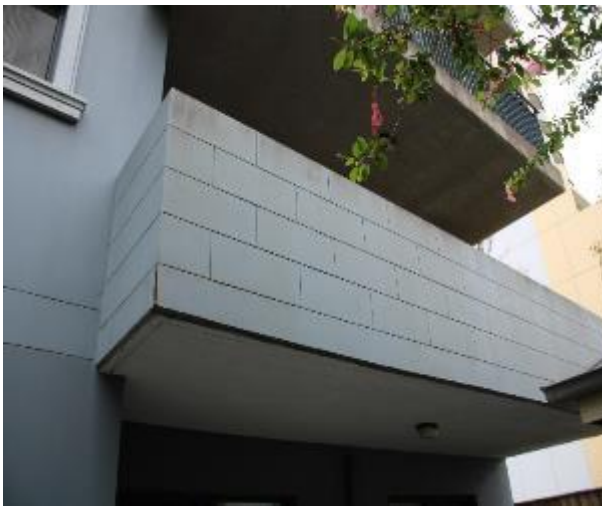
Figure 509 - General condition of external wall

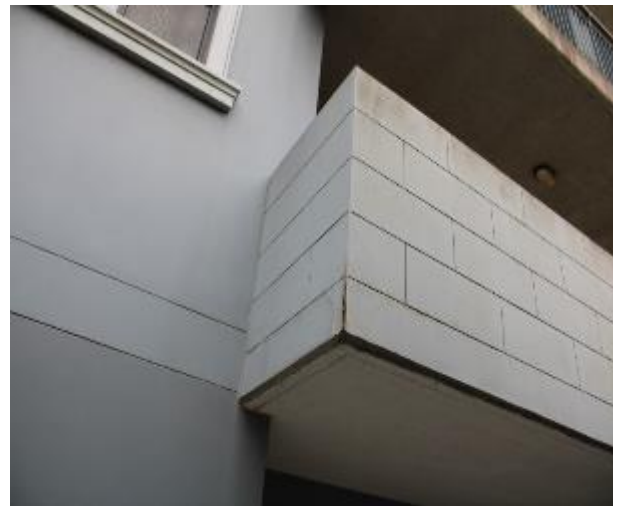
Figure 510 - General condition of external wall

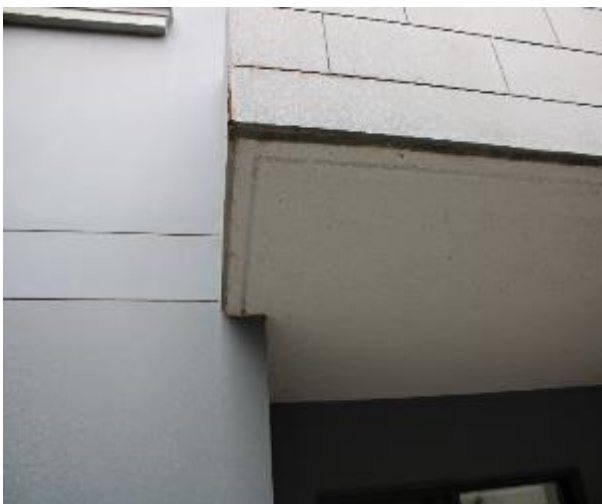
Figure 511 - General condition of balcony underside slab

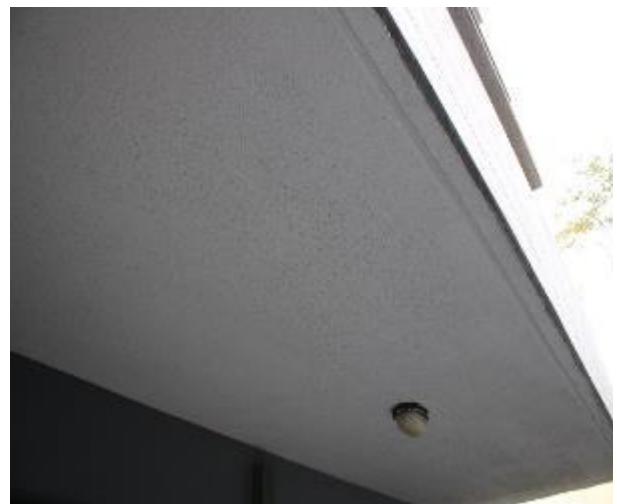
Figure 512 - General condition of balcony underside slab

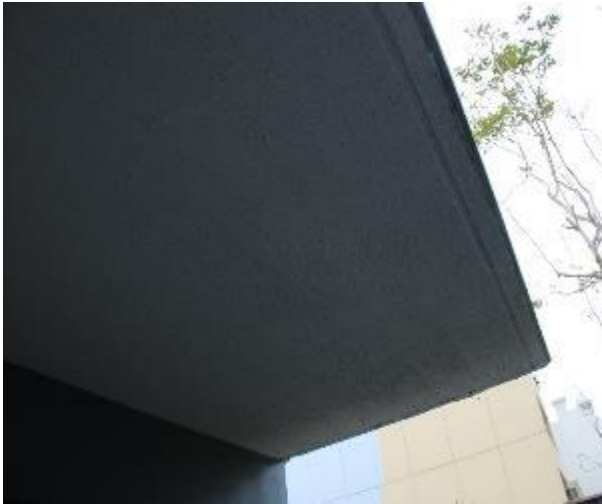
Figure 513 - General condition of balcony underside slab

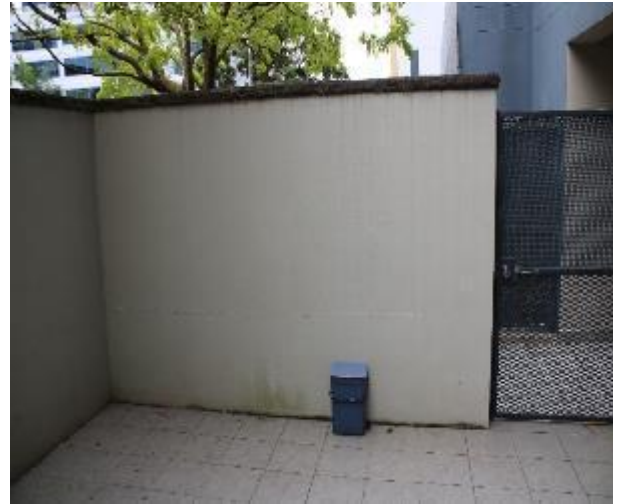
Figure 514 - General condition of courtyard external wall

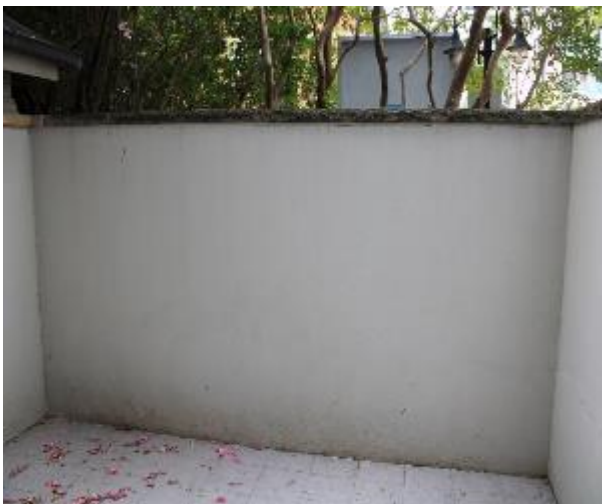
Figure 515 - General condition of courtyard external wall

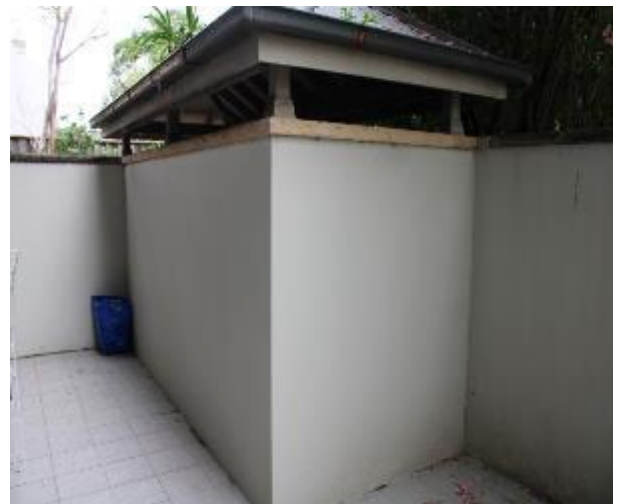
Figure 516 - General condition of courtyard external wall

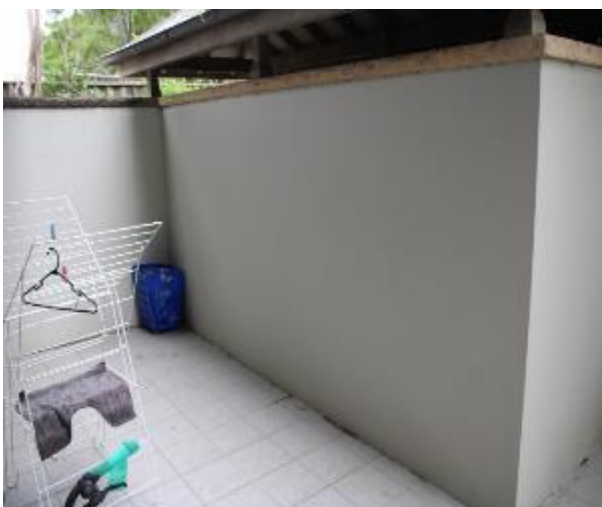
Figure 517 - General condition of courtyard external wall

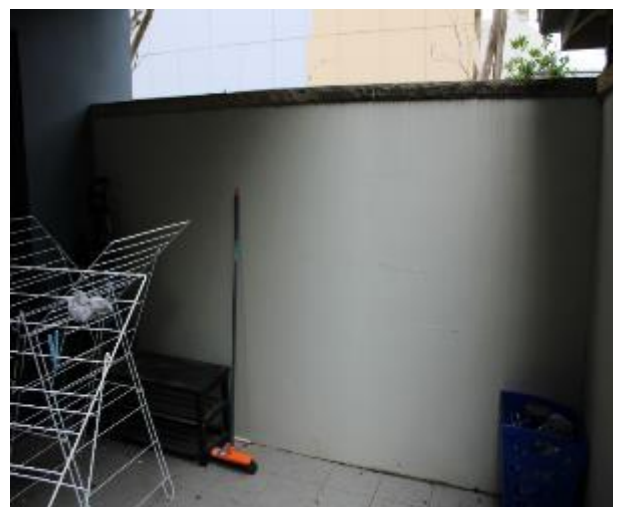
Figure 518 - General condition of courtyard external wall

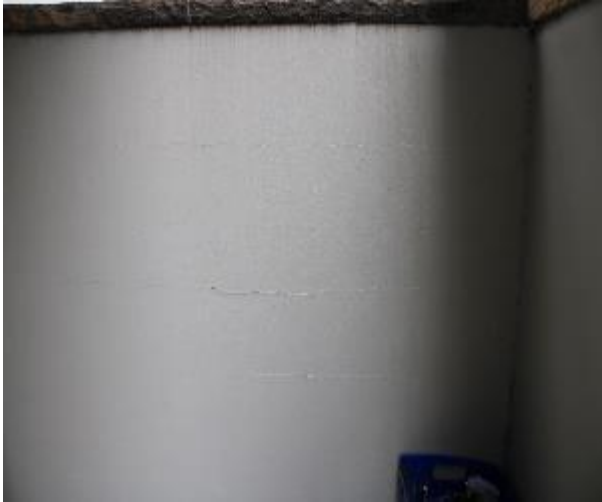
Figure 519 - Crack propagation through courtyard external wall

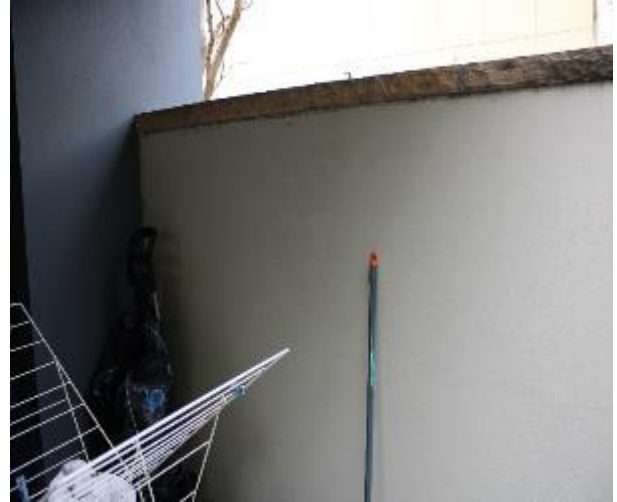
Figure 520 - General condition of courtyard external wall

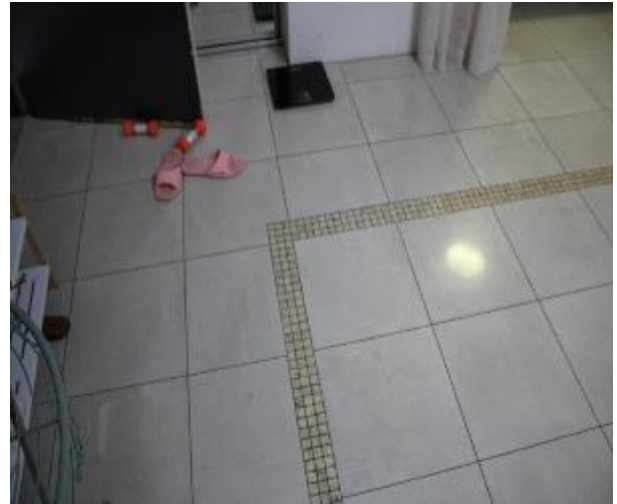
Figure 522 - General condition of open kitchen/ lounge room floor tiles

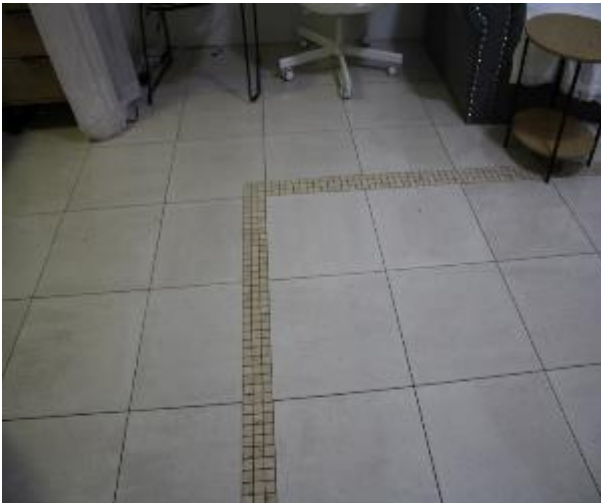
Figure 523 - General condition of open kitchen/ lounge room floor tiles

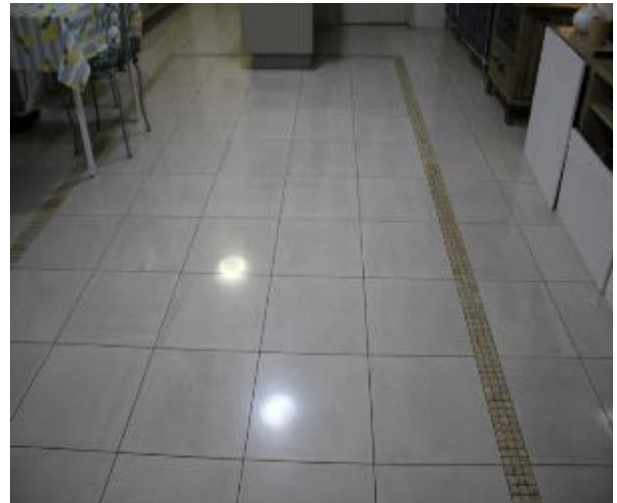
Figure 524 - General condition of open kitchen/ lounge room floor tiles

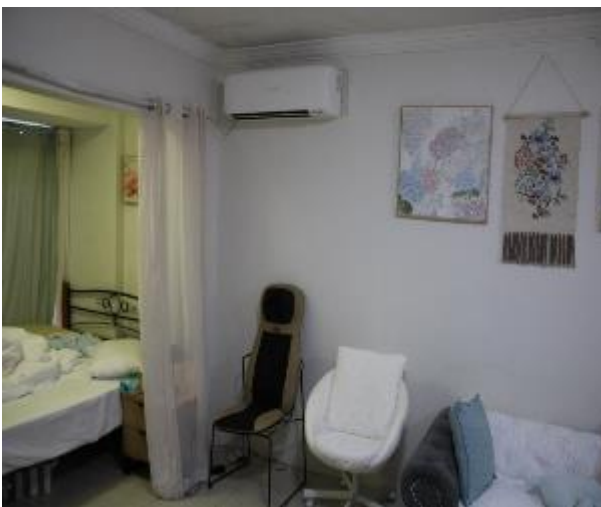
Figure 525 - General condition of open kitchen/ lounge room internal wall

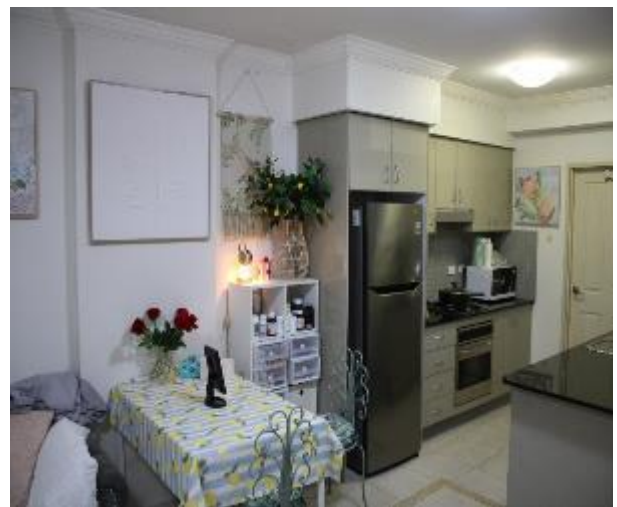
Figure 526 - General condition of open kitchen/ lounge room internal wall

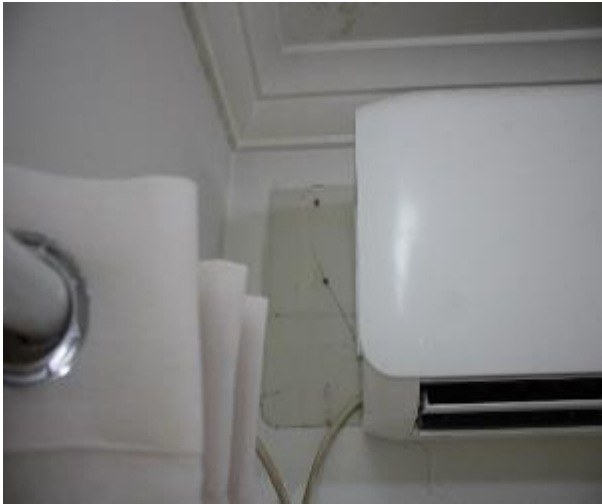
Figure 527 - Crack propagation through open kitchen/ lounge room internal wall

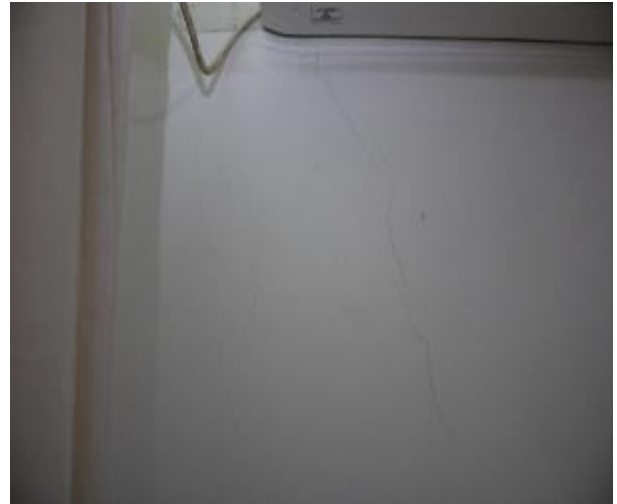
Figure 528 - Crack propagation through open kitchen/ lounge room internal wall

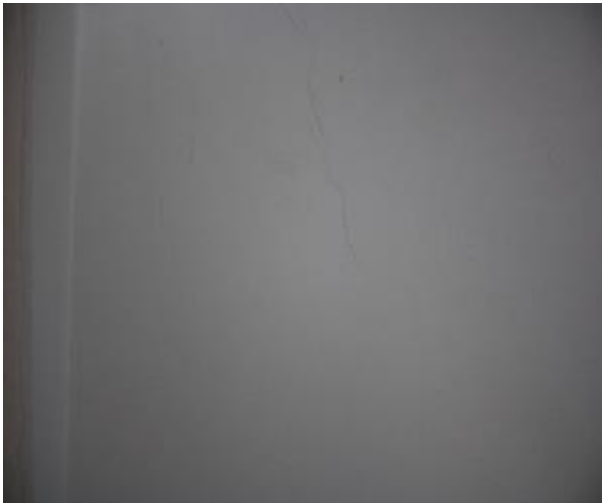
Figure 529 - Crack propagation through open kitchen/ lounge room internal wall
