# **Pre-Dilapidation Report**

**19 GEORGE STREET**

**FRONT BUILDING (UNITS 1-19)**

Project Reference: 20250047.19G.2

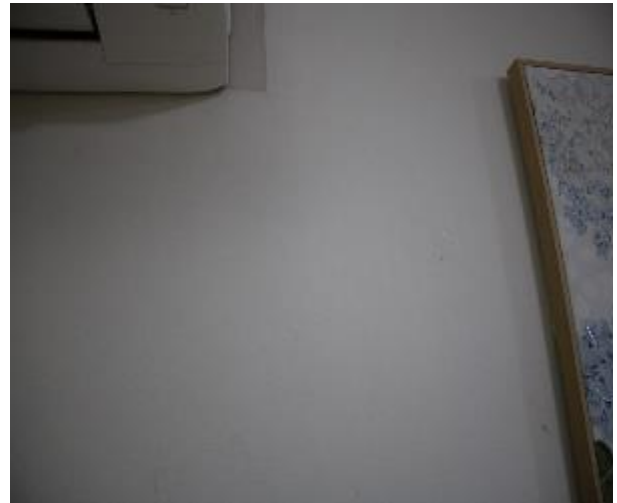
Figure 530 - Crack propagation through open kitchen/ lounge room internal wall

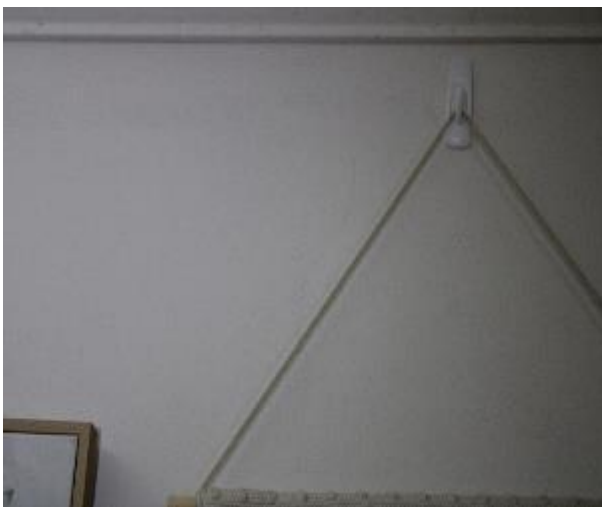
Figure 531 - Crack propagation through open kitchen/ lounge room internal wall

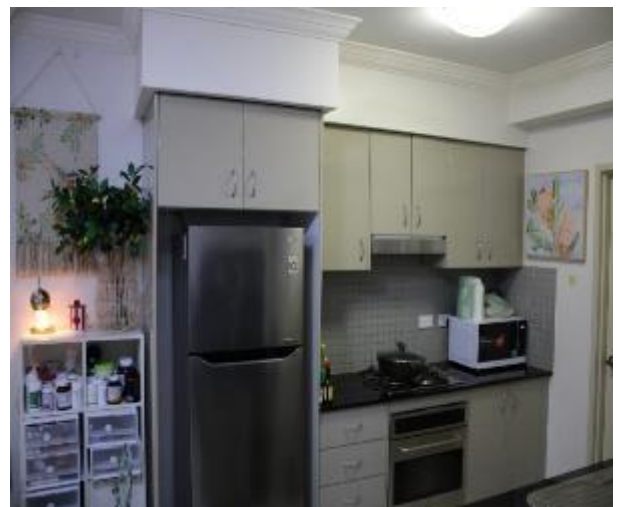
Figure 532 - General condition of open kitchen/ lounge room internal wall

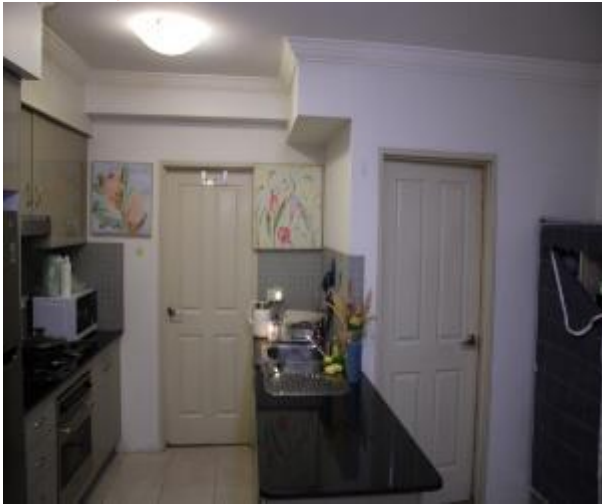
Figure 533 - General condition of open kitchen/ lounge room internal wall

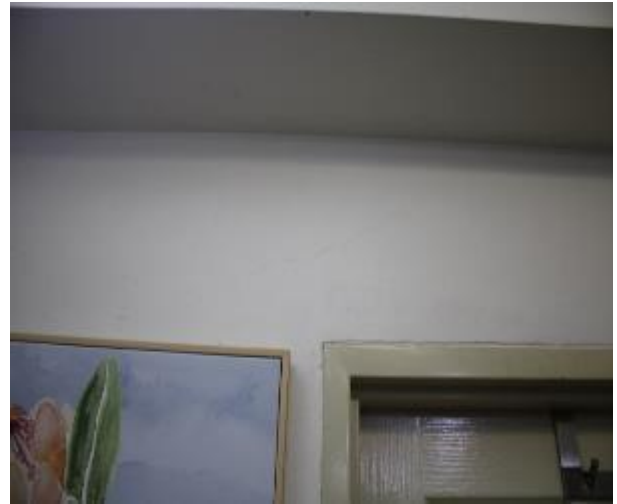
Figure 534 - Crack propagation through open kitchen/ lounge room internal wall

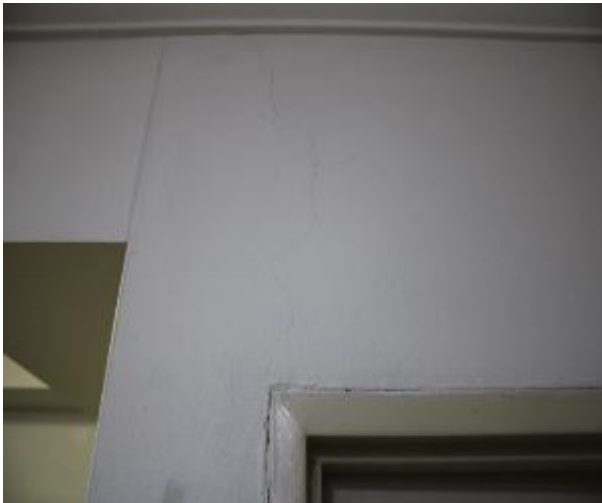
Figure 535 - Crack propagation through open kitchen/ lounge room internal wall

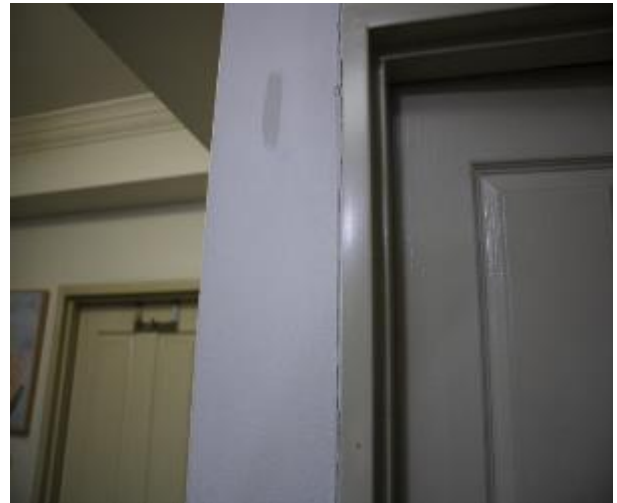
Figure 536 - Crack propagation through open kitchen/ lounge room internal wall

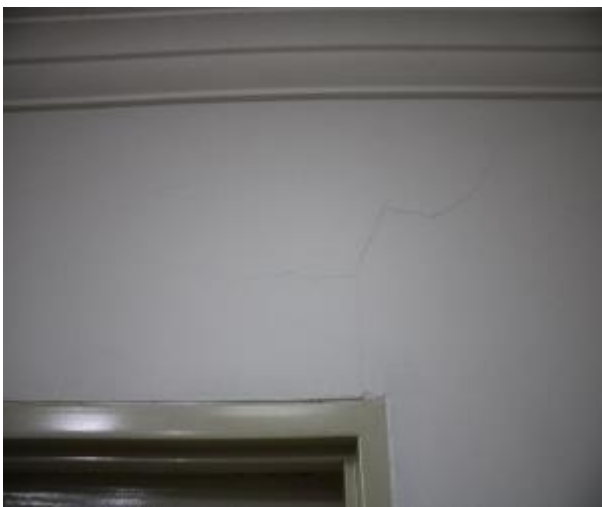
Figure 537 - Crack propagation through open kitchen/ lounge room internal wall

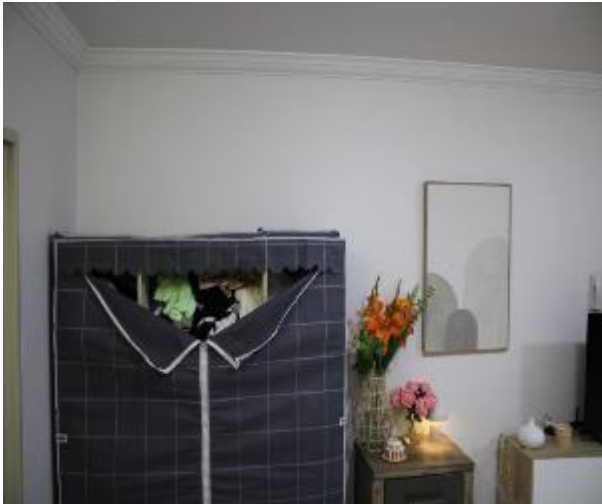
Figure 539 - General condition of open kitchen/ lounge room internal wall

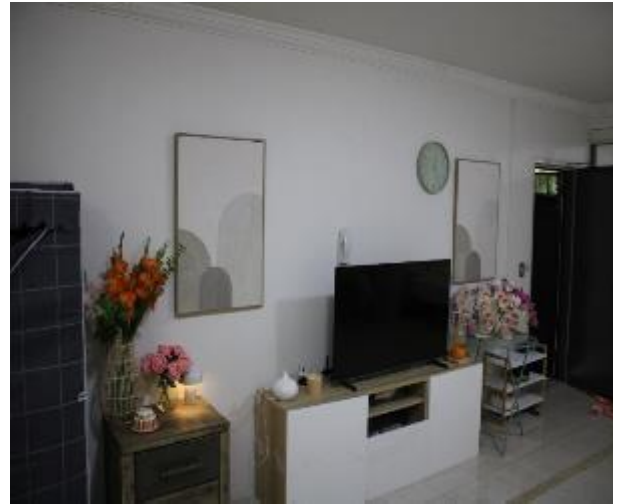
Figure 540 - General condition of open kitchen/ lounge room internal wall

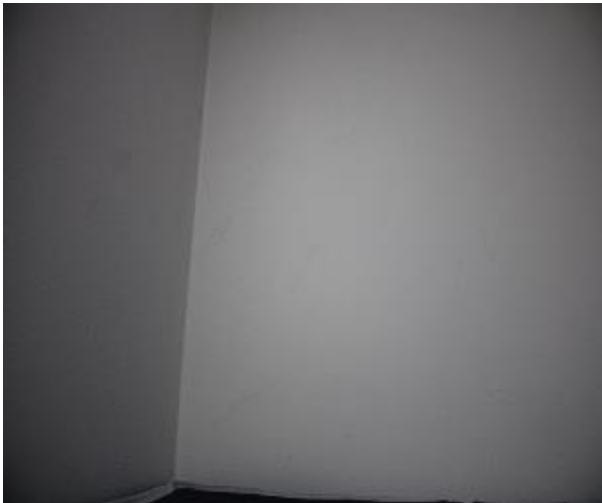
Figure 541 - Crack propagation through open kitchen/ lounge room internal wall

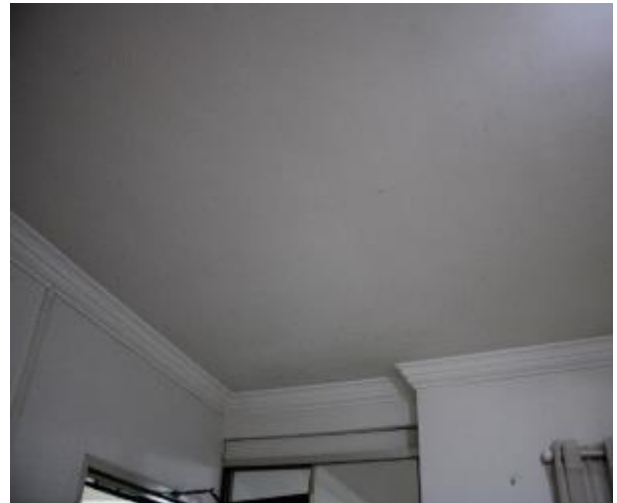
Figure 542 - General condition of open kitchen/ lounge room ceiling

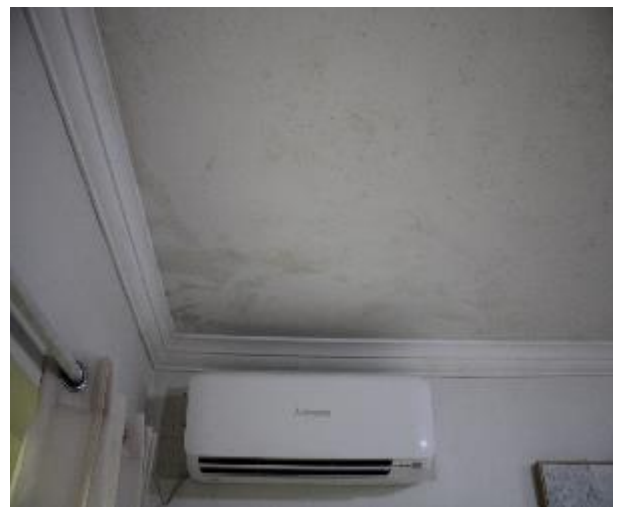
Figure 544 - Water damage evident through open kitchen/ lounge room ceiling

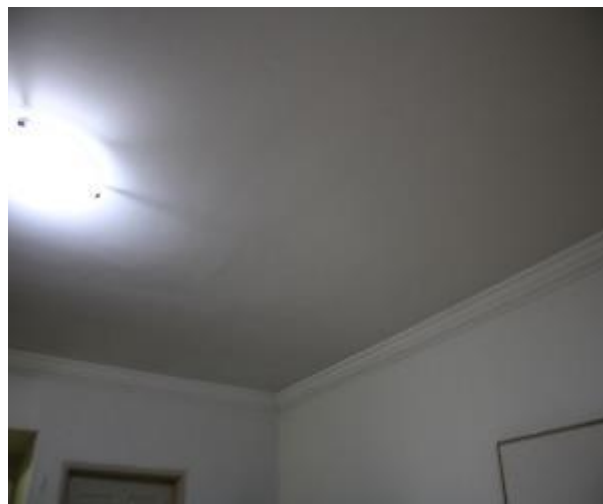
Figure 546 - General condition of open kitchen/  
lounge room ceiling

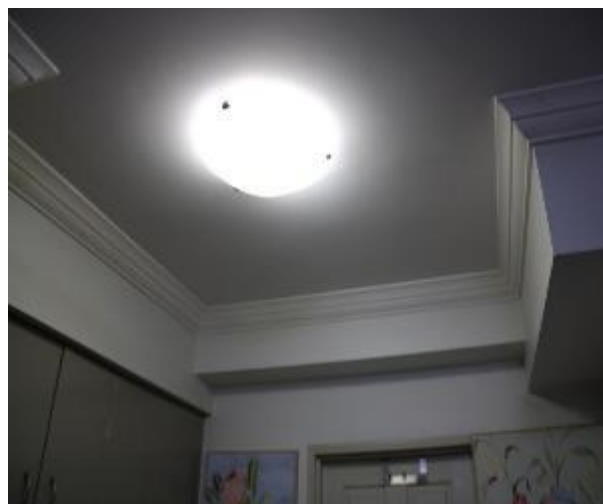
Figure 548 - General condition of open kitchen/  
lounge room ceiling

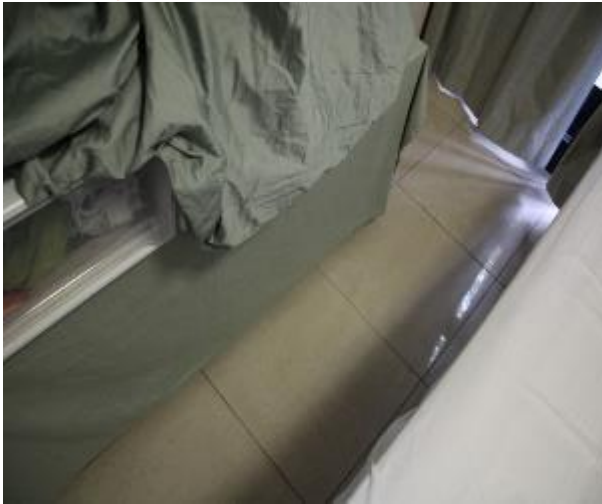
Figure 551 - General condition of bedroom 1 floor tiles

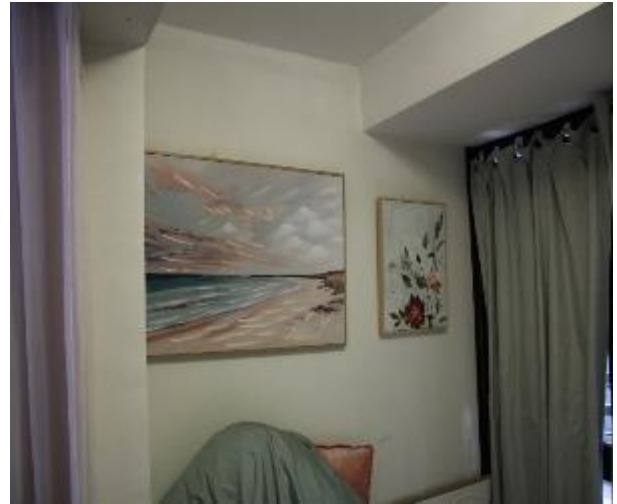
Figure 552 - General condition of bedroom 1 internal wall

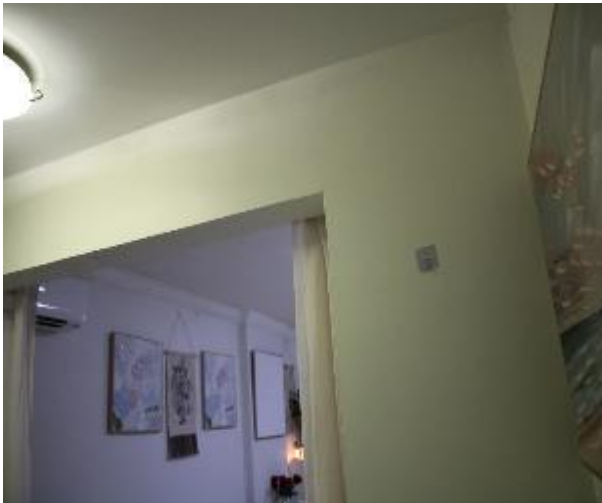
Figure 553 - General condition of bedroom 1 internal wall

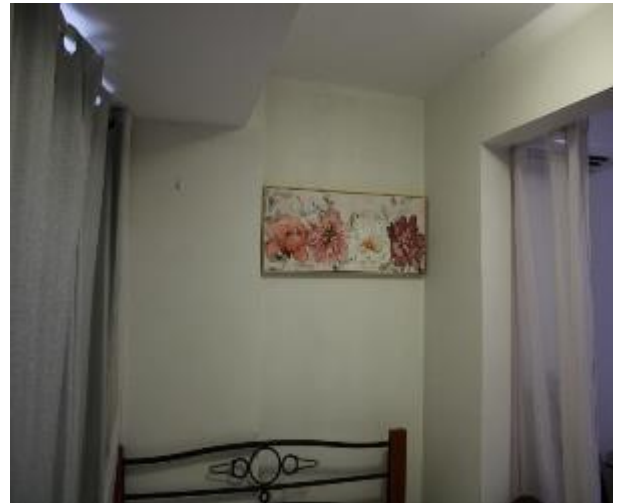
Figure 554 - General condition of bedroom 1 internal wall

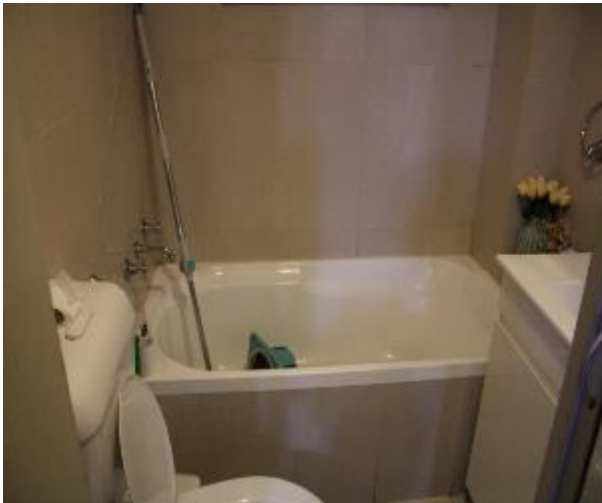
Figure 559 - General condition of bathroom 1 internal wall

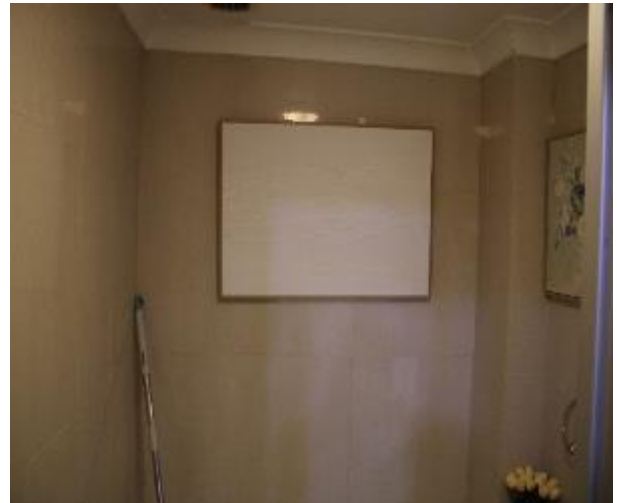
Figure 560 - General condition of bathroom 1 internal wall

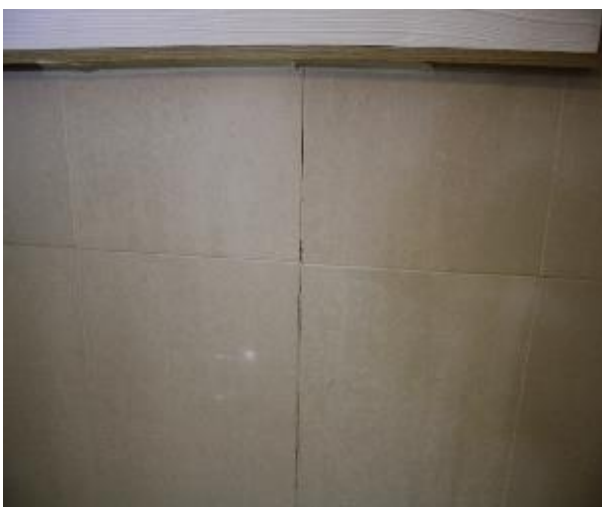
Figure 561 - Crack propagation through bathroom 1 internal wall

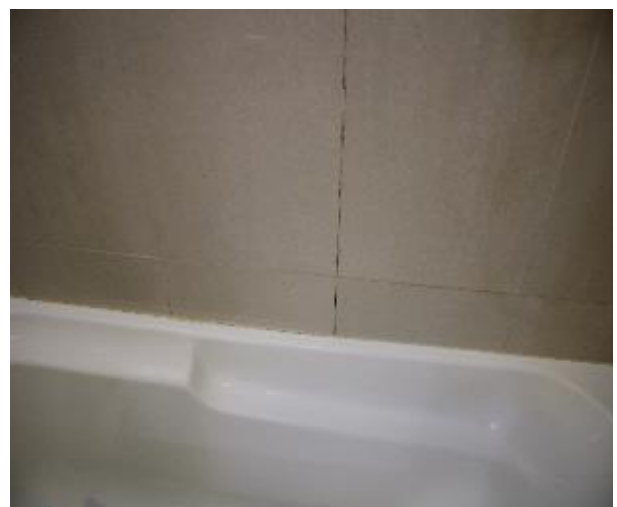
Figure 562 - Crack propagation through bathroom 1 internal wall

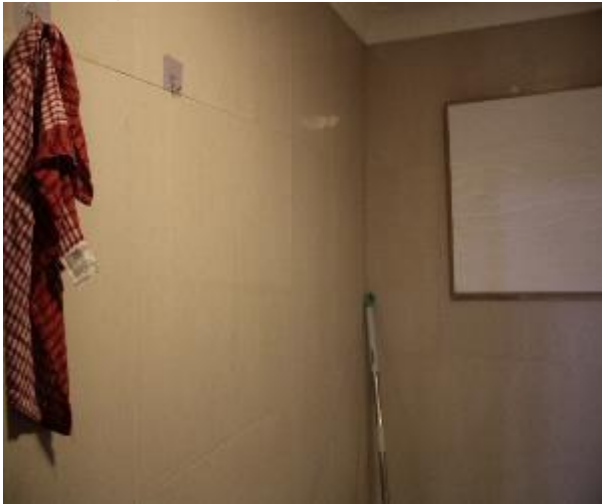
Figure 563 - General condition of bathroom 1 internal wall

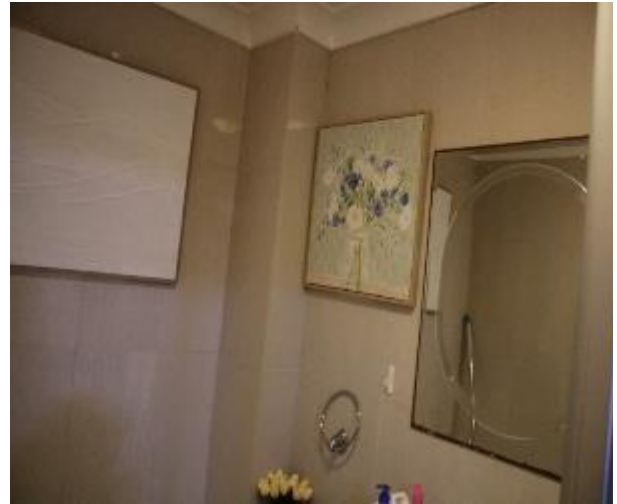
Figure 564 - General condition of bathroom 1 internal wall

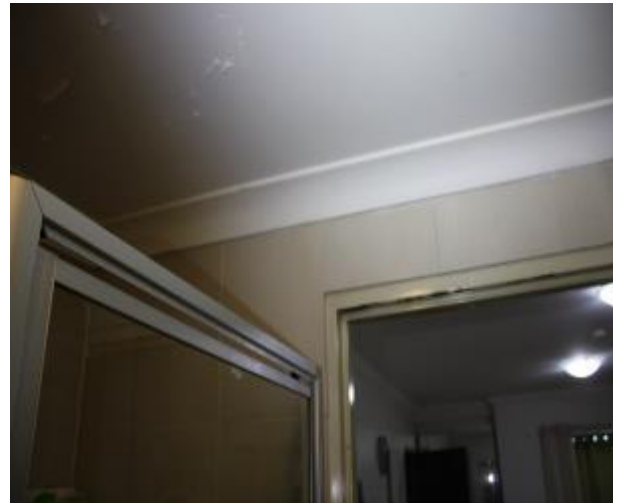
Figure 566 - General condition of bathroom 1 internal wall

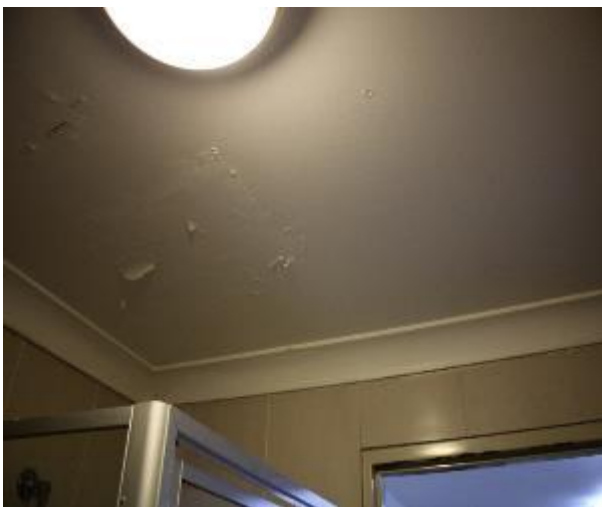
Figure 567 - Paint flaking through bathroom 1 ceiling

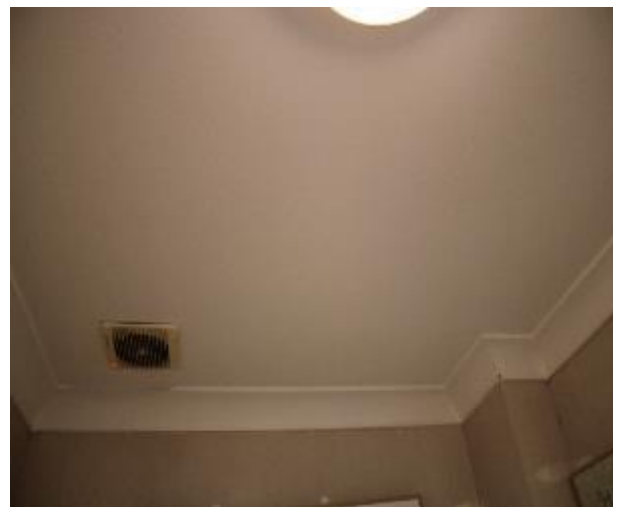
Figure 568 - General condition of bathroom 1 ceiling

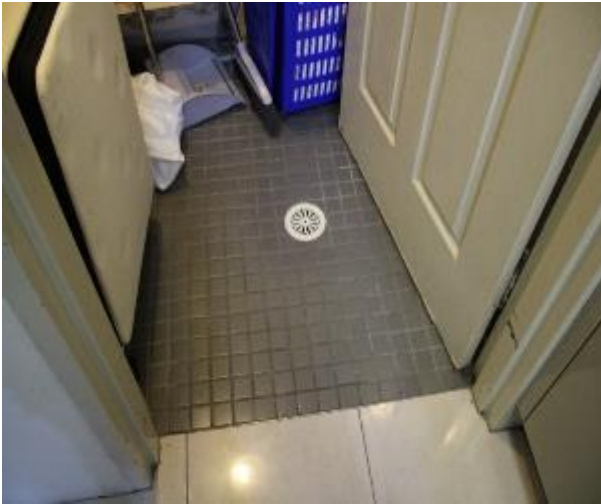
Figure 569 - General condition of laundry floor tiles

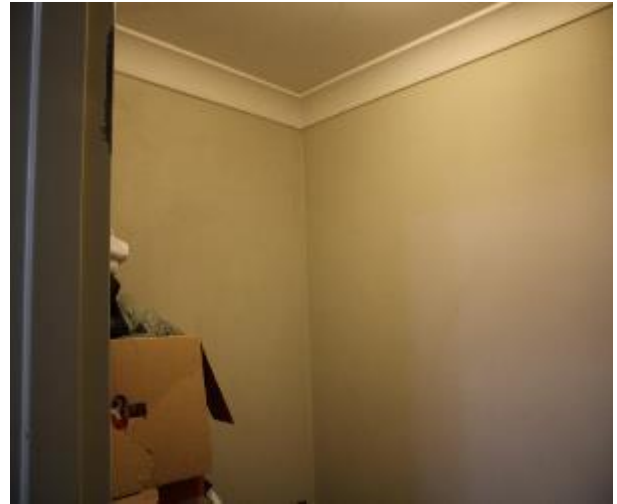
Figure 570 - General condition of laundry internal wall

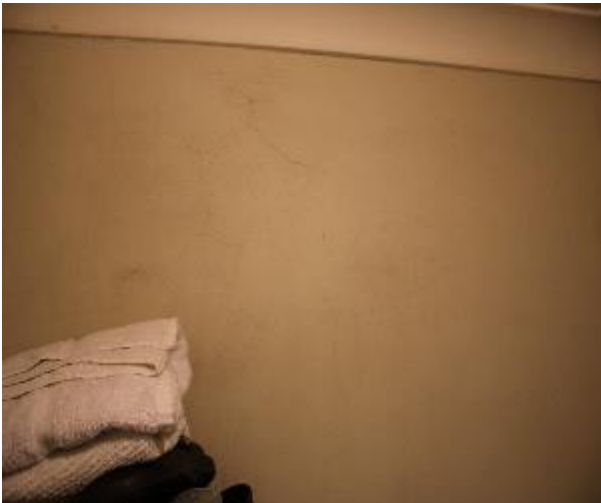
Figure 571 - Crack propagation through laundry internal wall

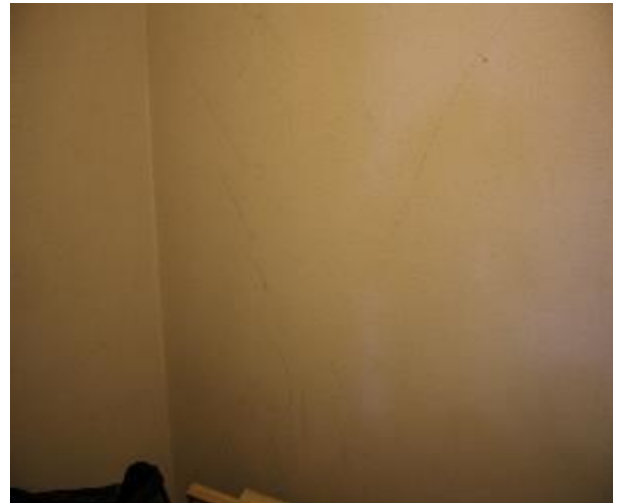
Figure 572 - Crack propagation through laundry internal wall

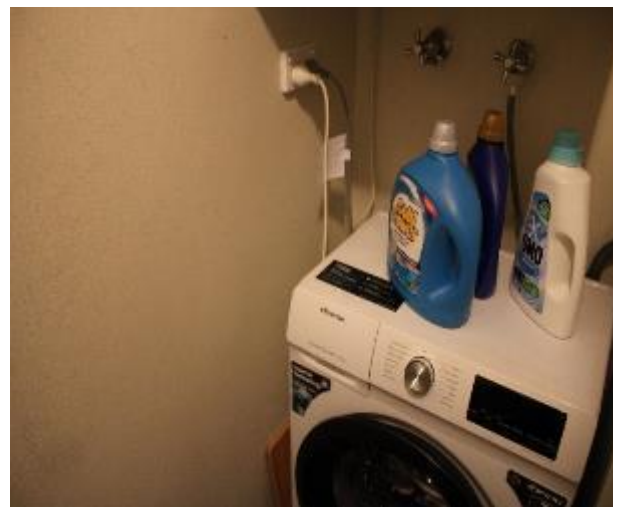
Figure 574 - General condition of laundry internal wall

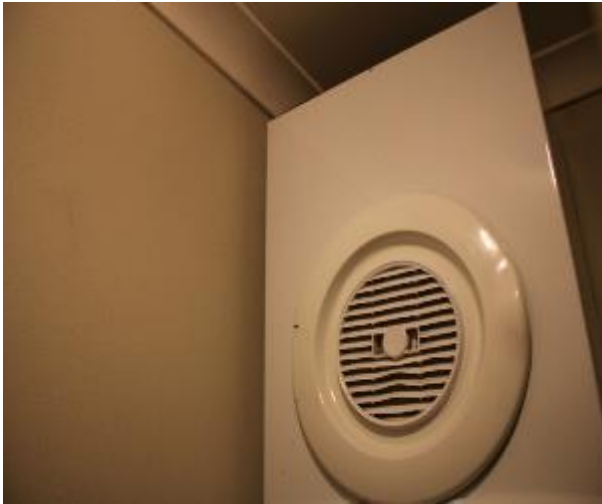
Figure 575 - General condition of laundry internal wall

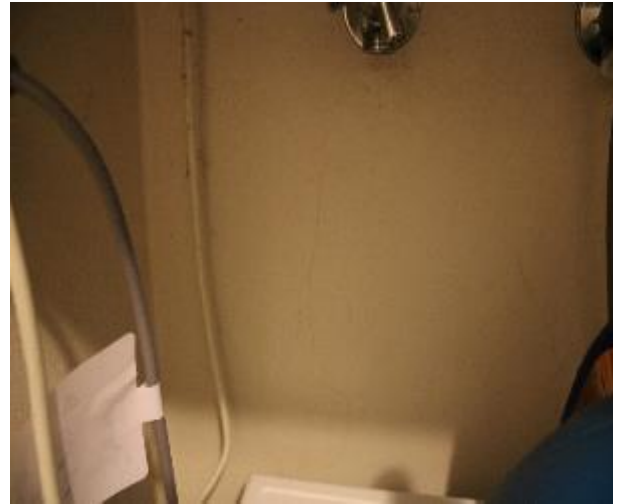
Figure 576 - Crack propagation through laundry internal wall

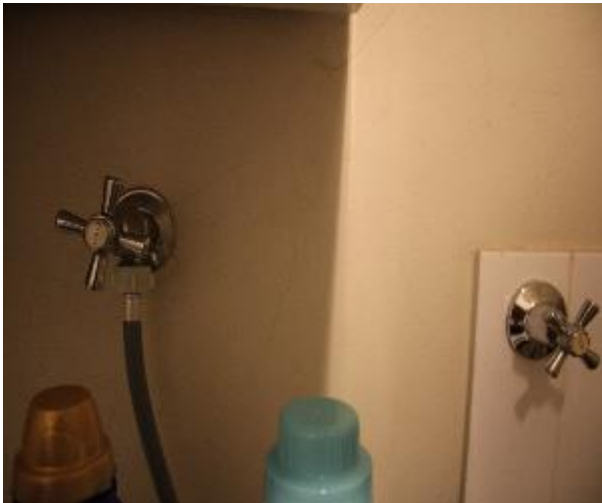
Figure 577 - Crack propagation through laundry internal wall

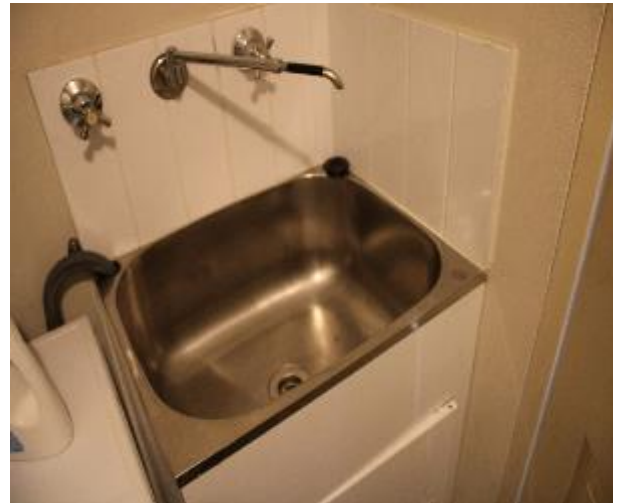
Figure 578 - General condition of laundry internal wall

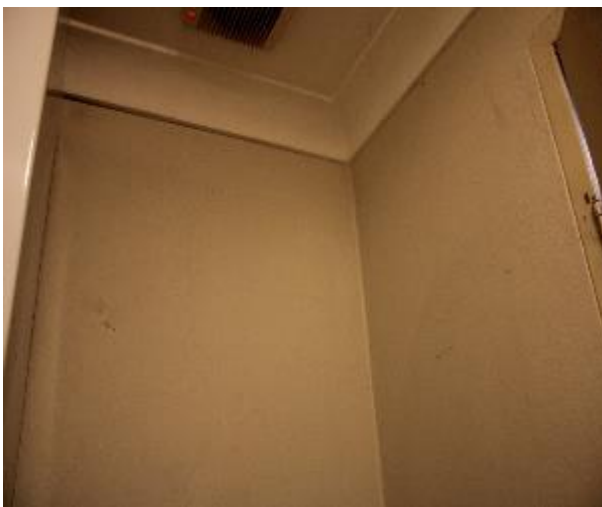
Figure 579 - General condition of laundry internal wall

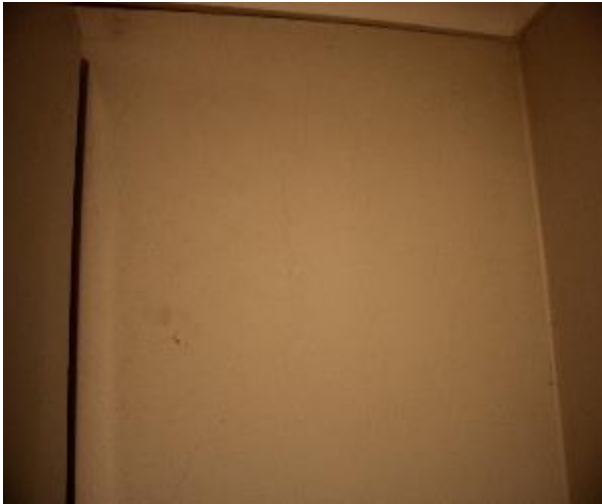
Figure 581 - Crack propagation through laundry internal wall

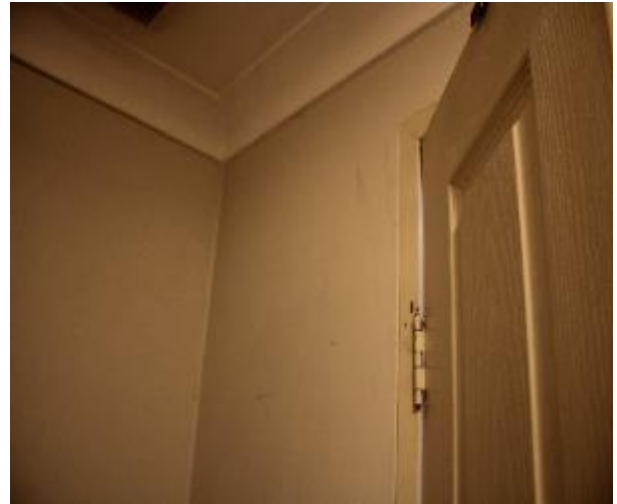
Figure 582 - General condition of laundry internal wall

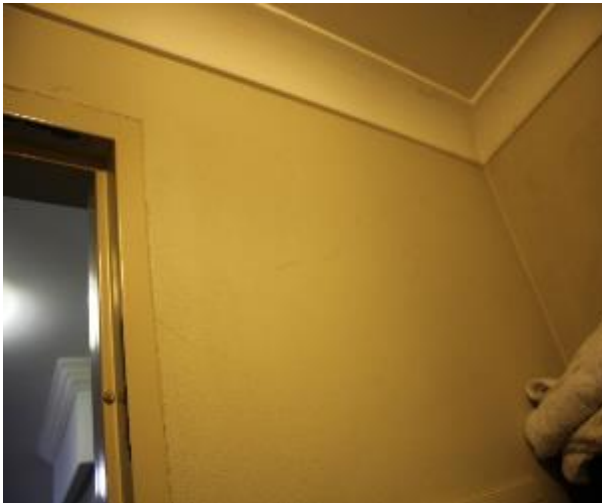
Figure 583 - General condition of laundry internal wall

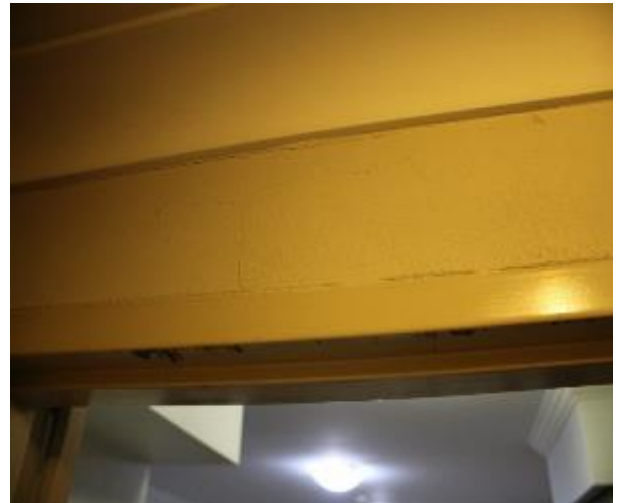
Figure 584 - Crack propagation through laundry internal wall

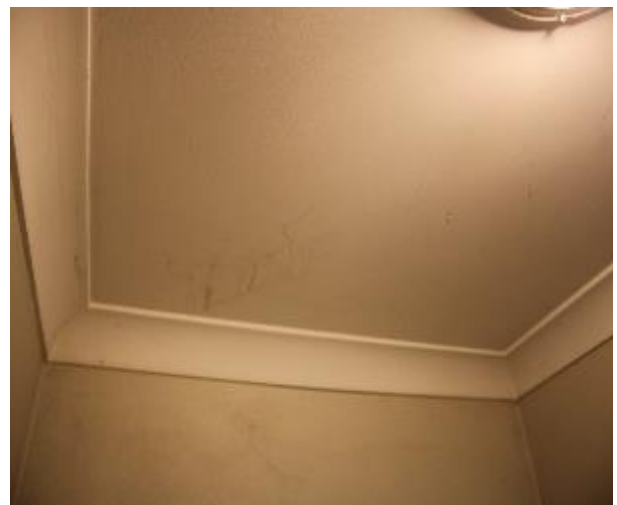
Figure 586 - General condition of laundry ceiling

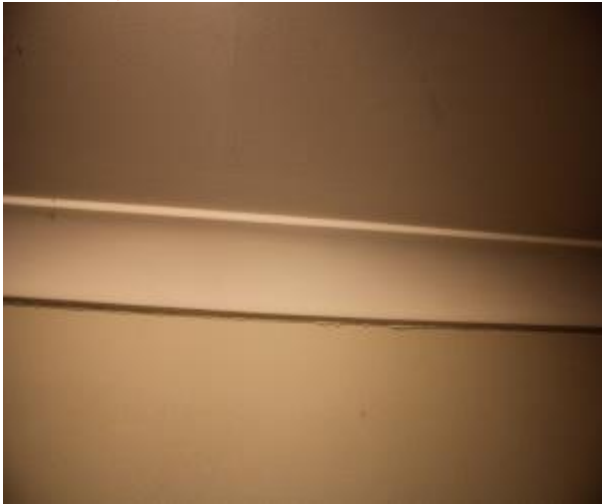
Figure 587 - Crack propagation through laundry ceiling

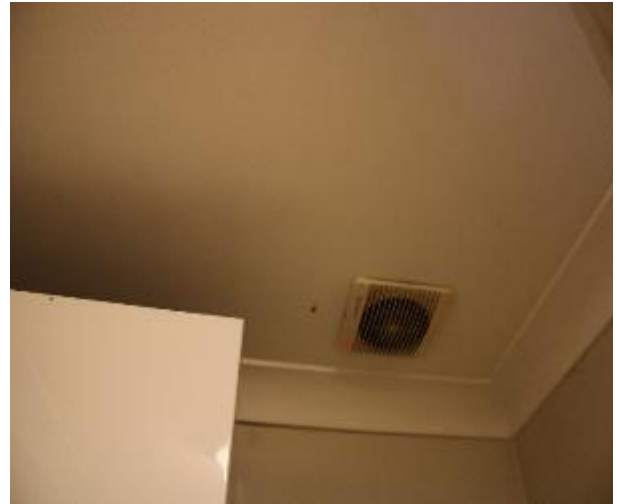
Figure 588 - General condition of laundry ceiling

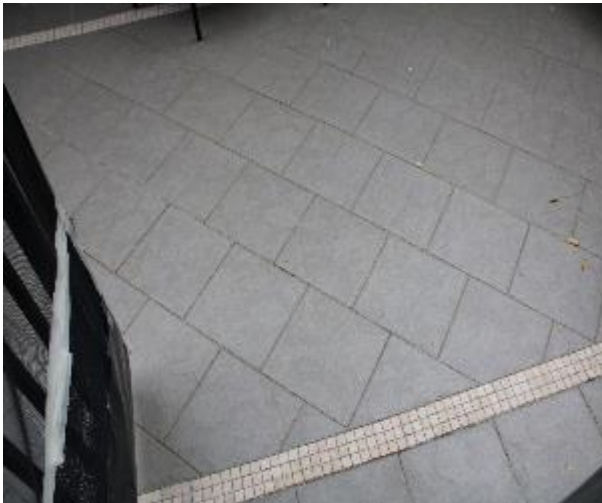
Figure 589 - General condition of courtyard floor tiles

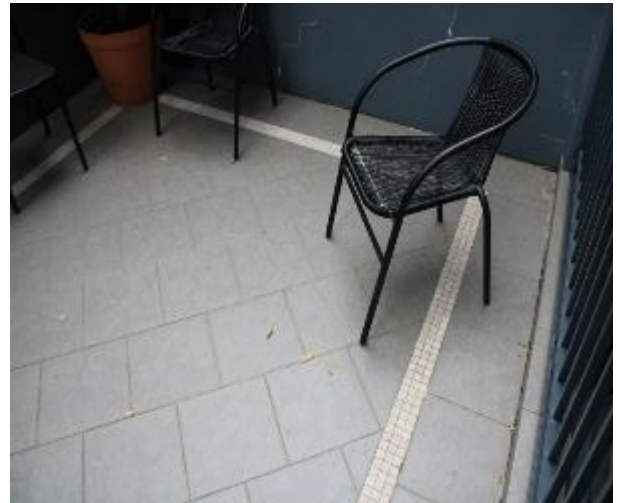
Figure 590 - General condition of courtyard floor tiles

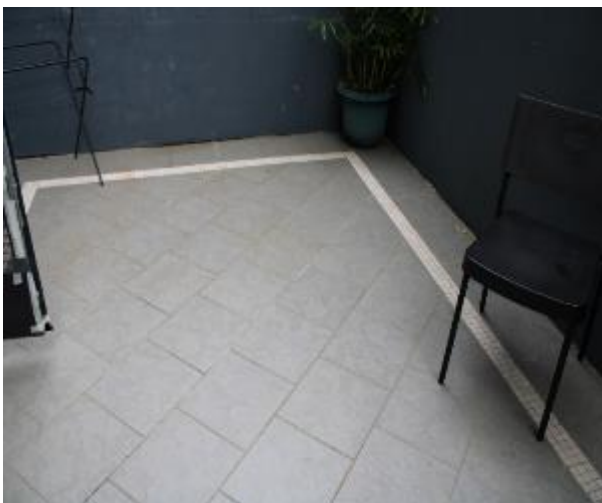
Figure 591 - General condition of courtyard floor tiles

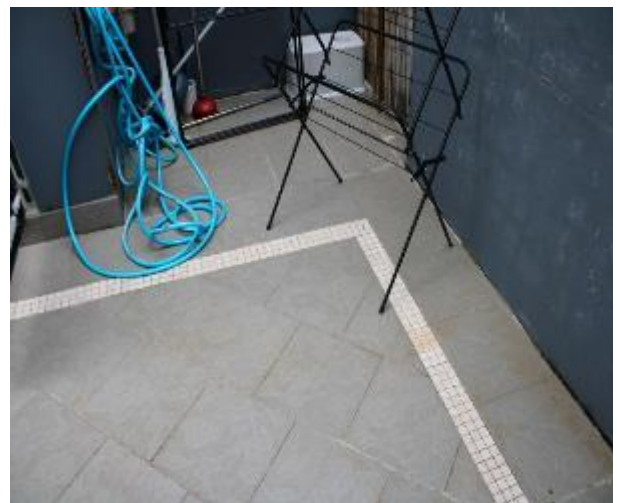
Figure 592 - General condition of courtyard floor tiles

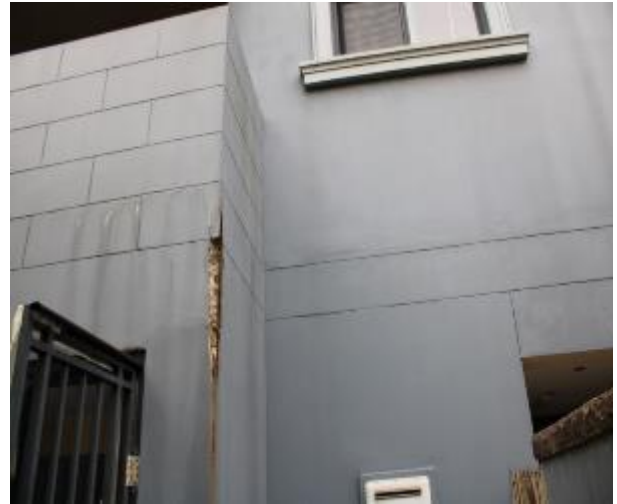
Figure 594 - General condition of external wall

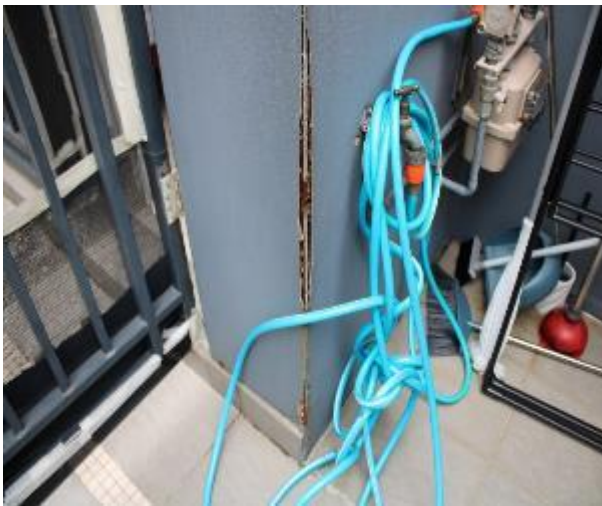
Figure 595 - Water damage evident through external wall

Unit 2 was also inspected and found to be in reasonable condition. Here were cases of cracking through the internal and external walls, as well as minor cases of water damage and paint flaking through the ceiling. There was also evidence of water damage through the external wall.

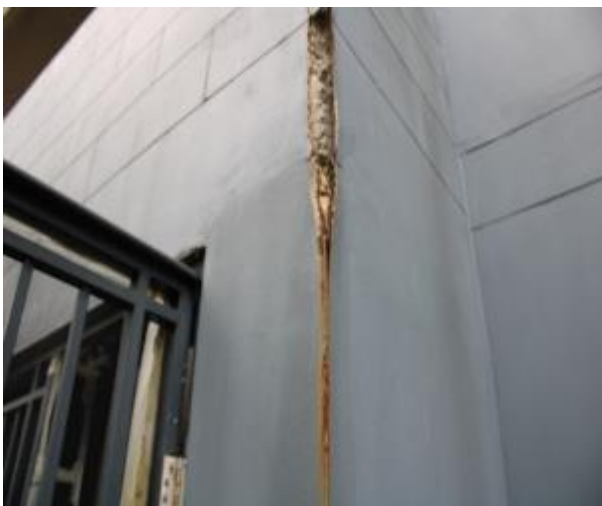
Figure 597 - Water damage evident through external wall

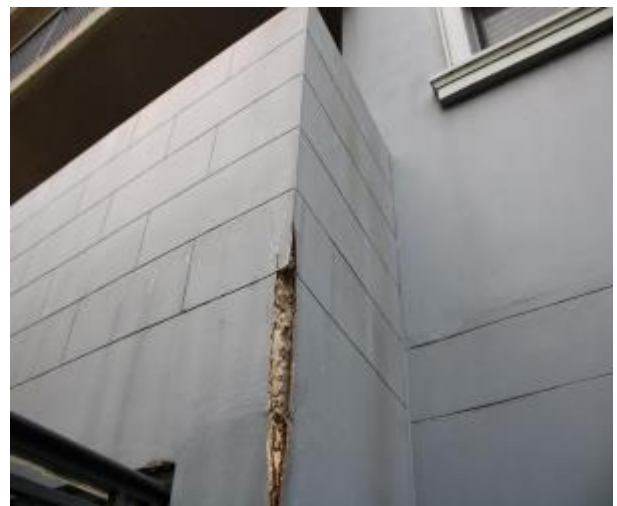
Figure 598 - Water damage evident through external wall

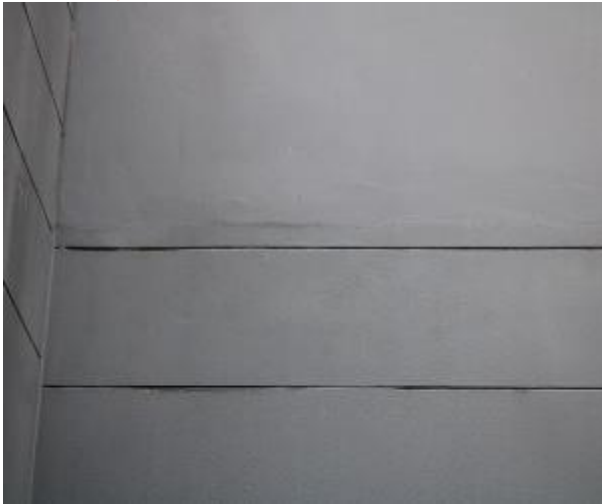
Figure 599 - Crack propagation through external wall

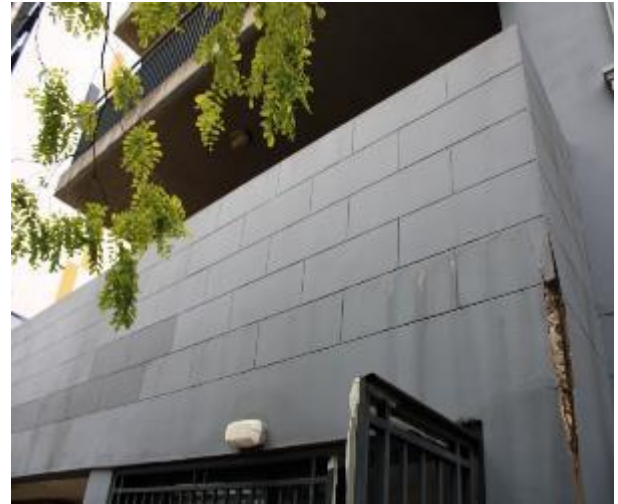
Figure 600 - General condition of external wall

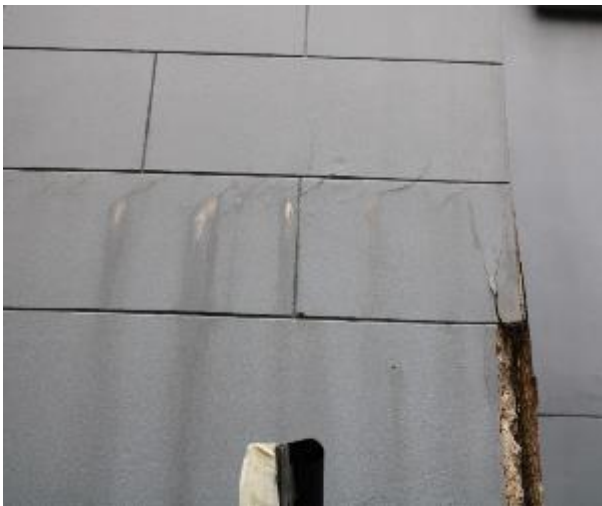
Figure 601 - Crack propagation through external wall

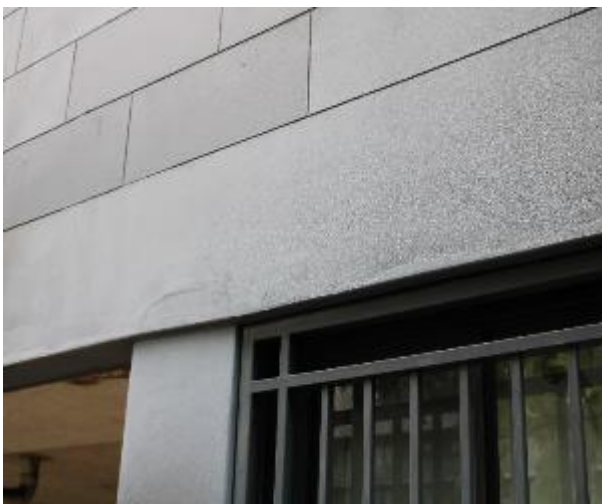
Figure 603 - General condition of external wall

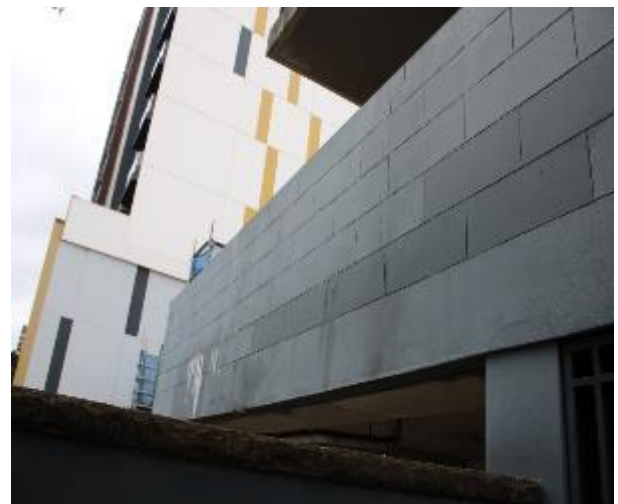
Figure 604 - General condition of external wall

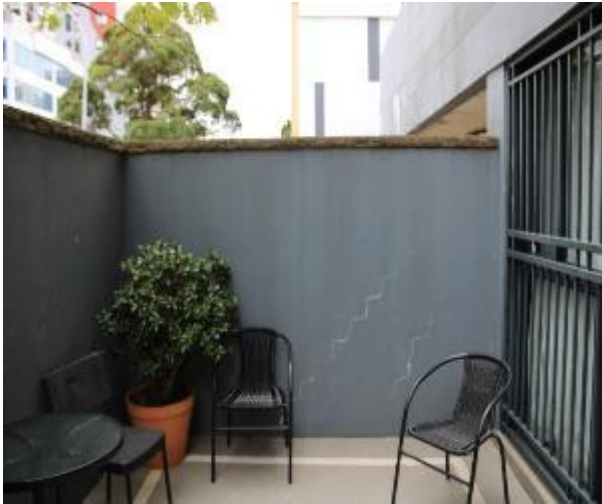
Figure 605 - General condition of courtyard external wall

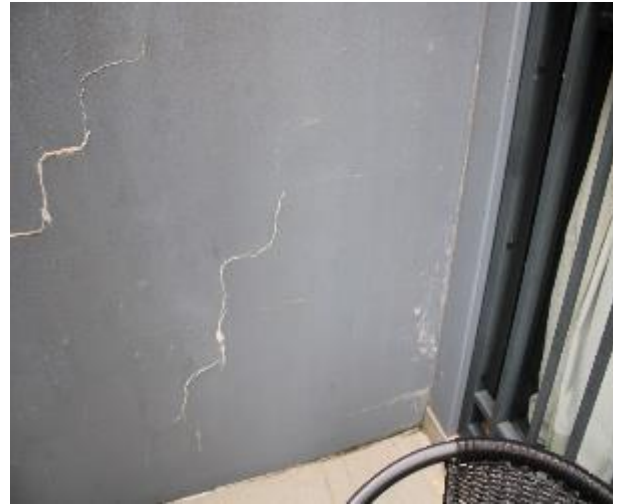
Figure 606 - Crack propagation through courtyard external wall

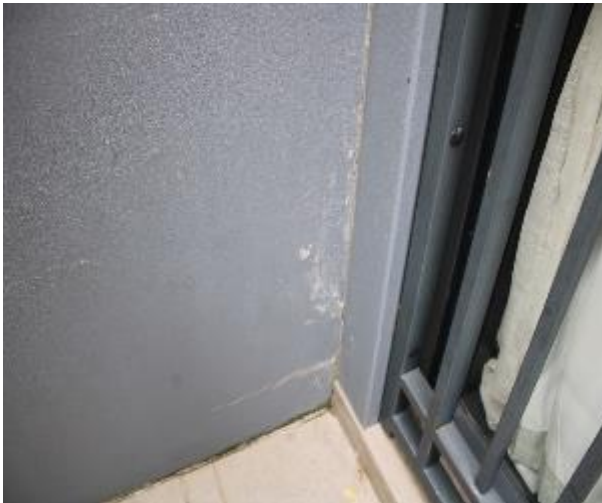
Figure 607 - Crack propagation through courtyard external wall

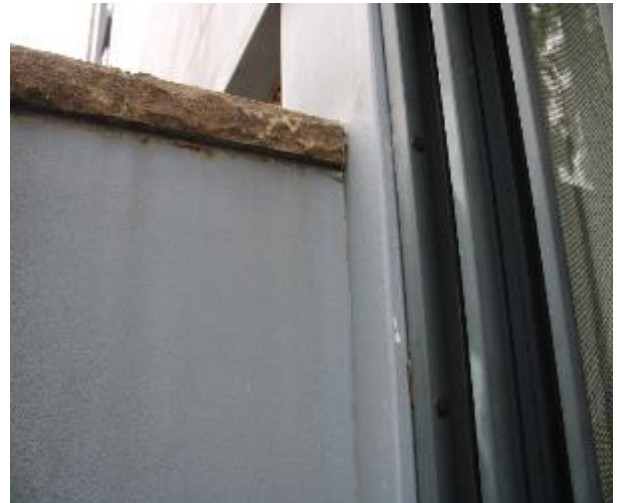
Figure 608 - Crack propagation through courtyard external wall

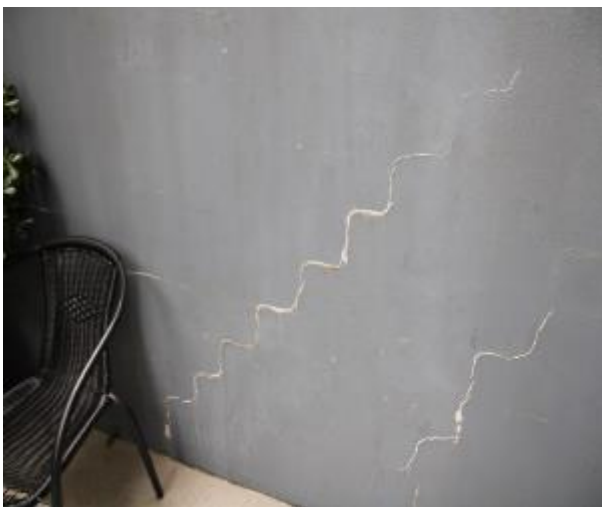
Figure 609 - Crack propagation through courtyard external wall

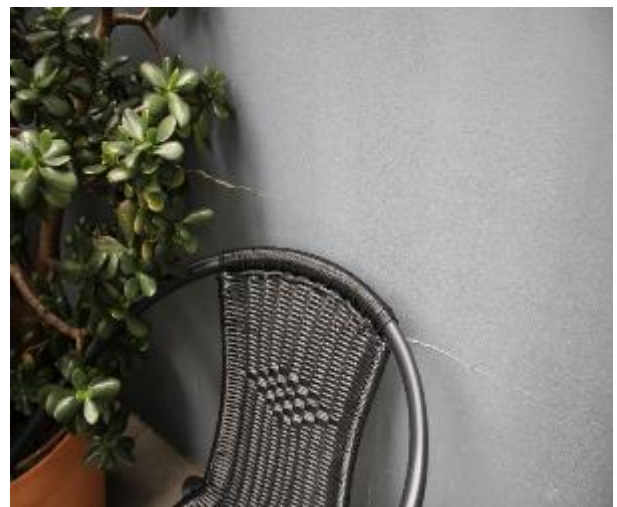
Figure 610 - Crack propagation through courtyard external wall

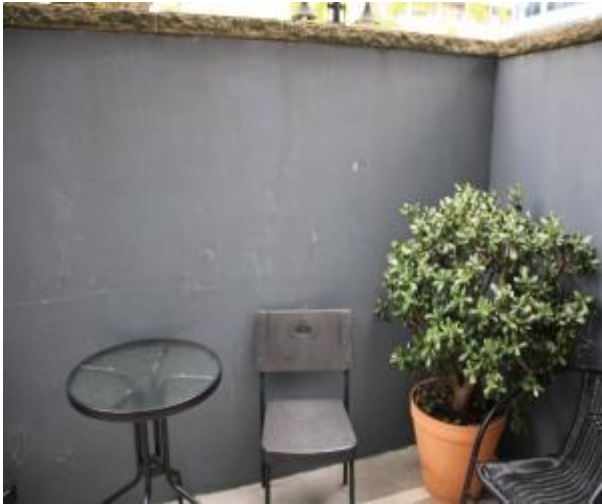
Figure 611 - General condition of courtyard external wall

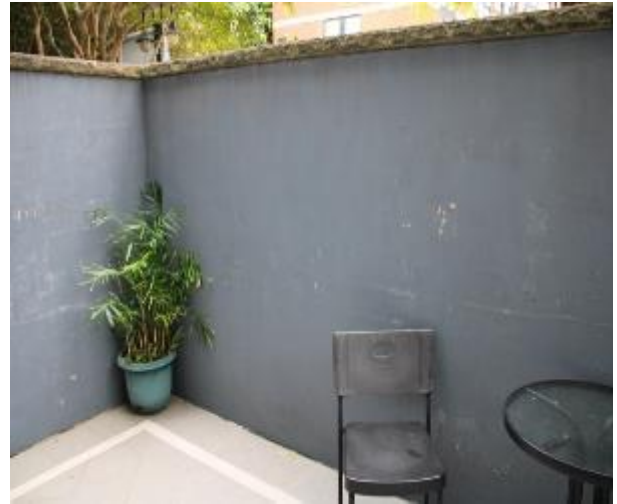
Figure 612 - General condition of courtyard external wall

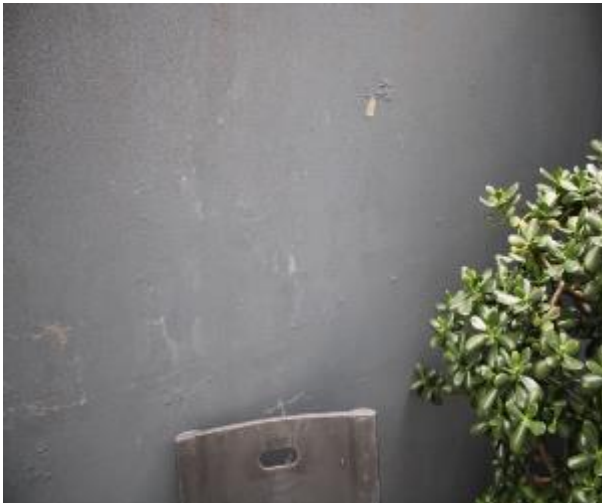
Figure 613 - General condition of courtyard external wall

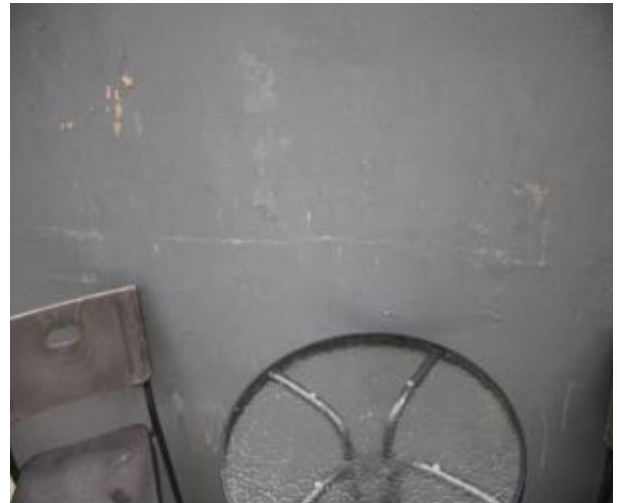
Figure 614 - Crack propagation through courtyard external wall

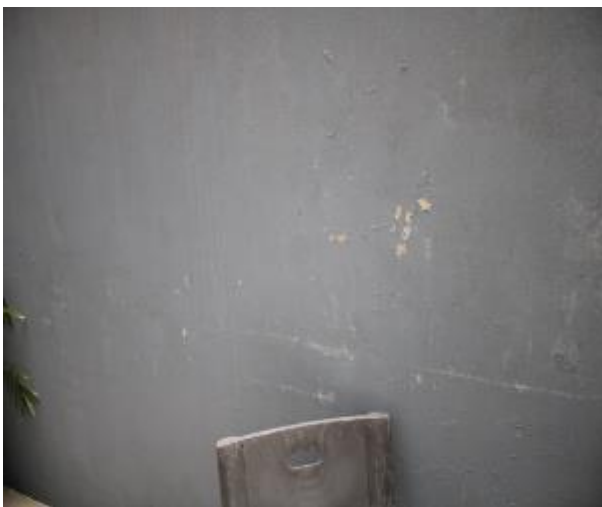
Figure 615 - General condition of courtyard external wall

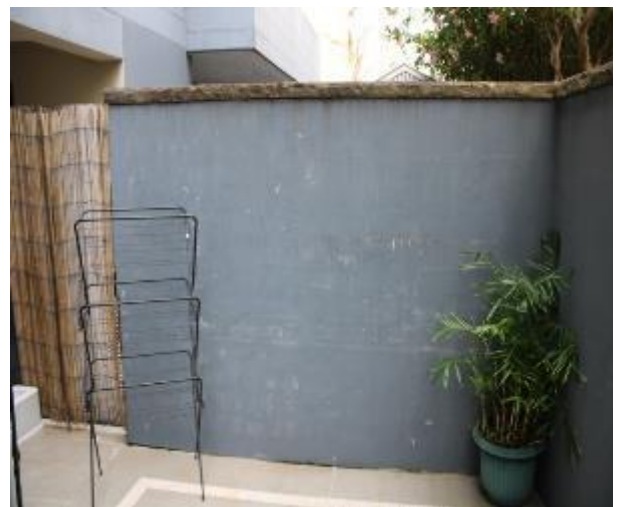
Figure 616 - General condition of courtyard external wall

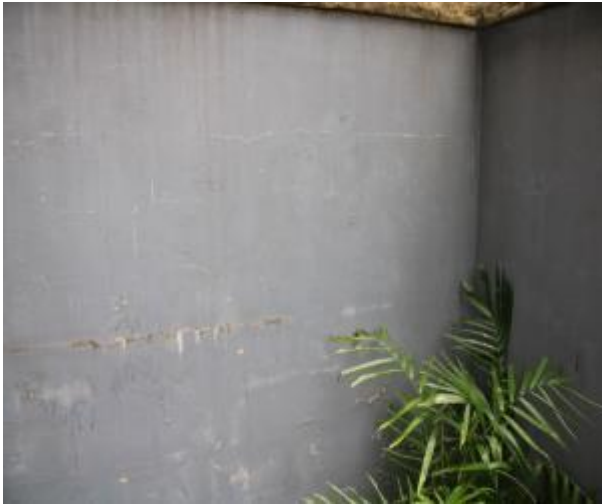
Figure 617 - General condition of courtyard external wall
