# **Pre-Dilapidation Report**

**19 GEORGE STREET**

**FRONT BUILDING (UNITS 1-19)**

Project Reference: 20250047.19G.2

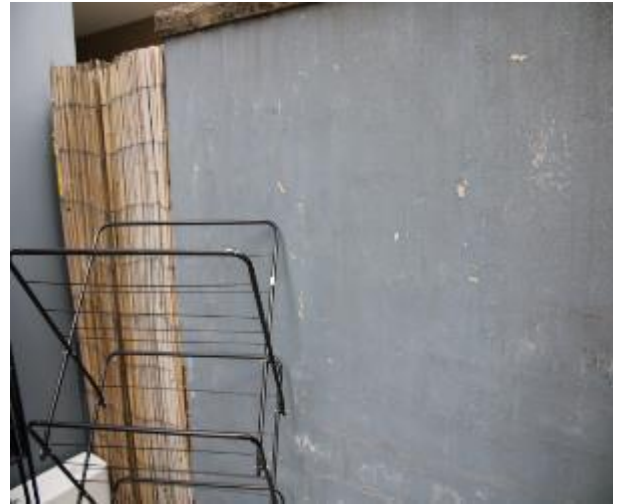
Figure 618 - General condition of courtyard external wall

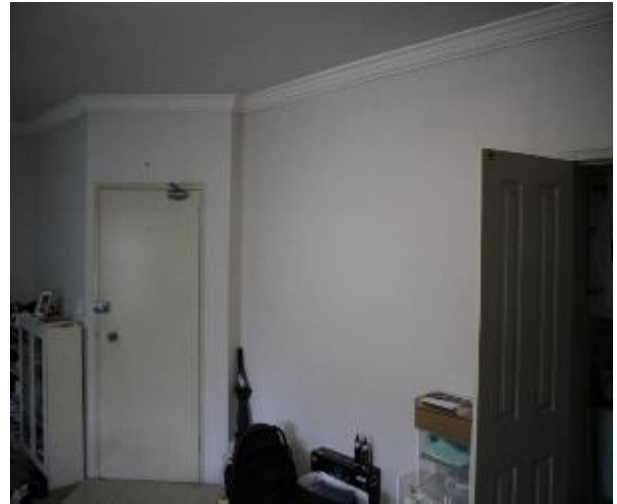
Figure 620 - General condition of lounge room internal wall

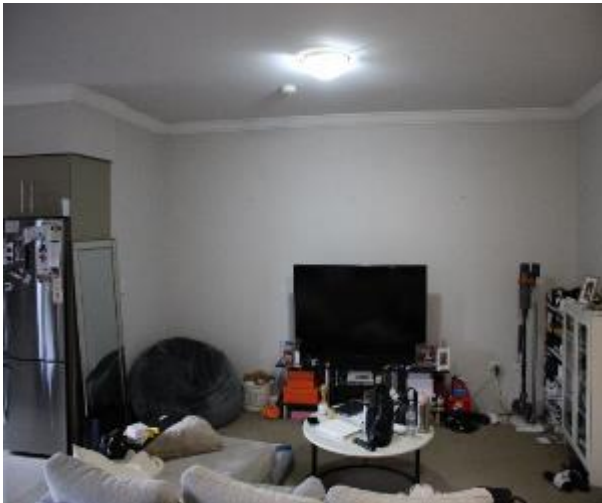
Figure 621 - General condition of lounge room internal wall

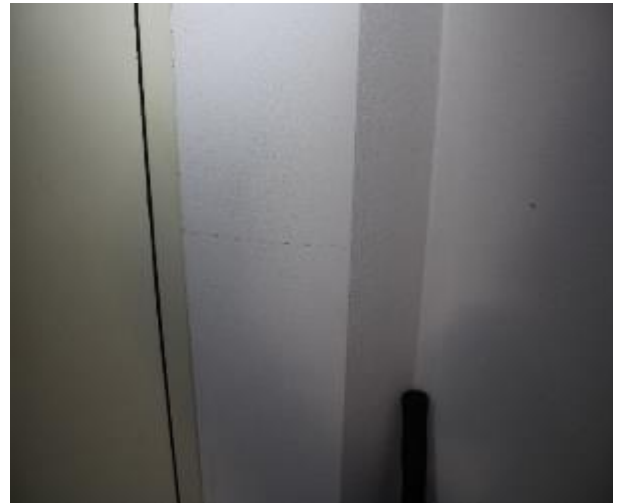
Figure 622 - Crack propagation through lounge room internal wall

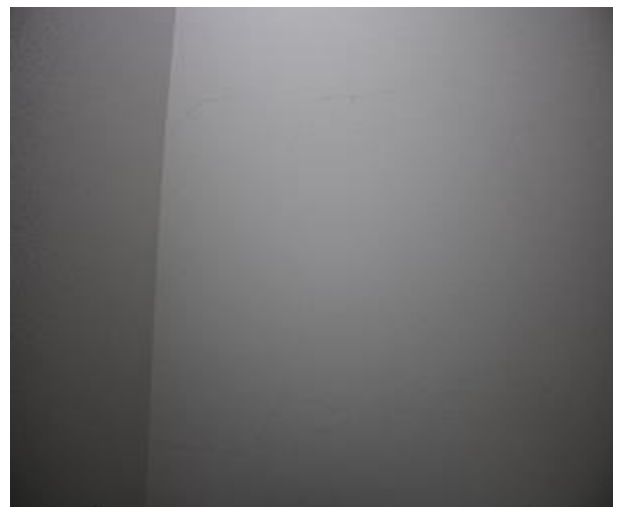
Figure 624 - Crack propagation through lounge room internal wall

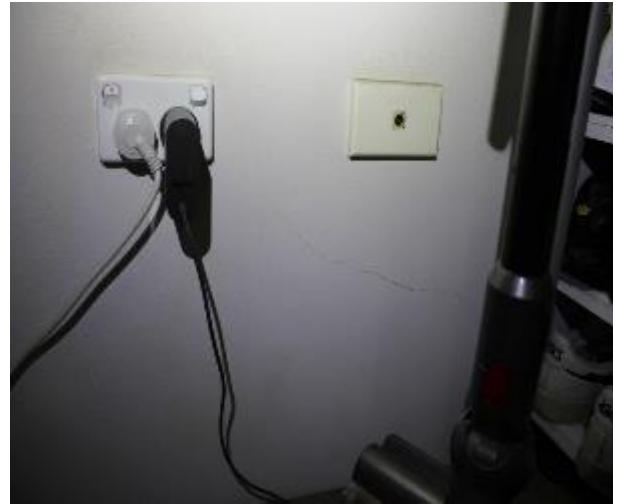
Figure 626 - Crack propagation through lounge room internal wall

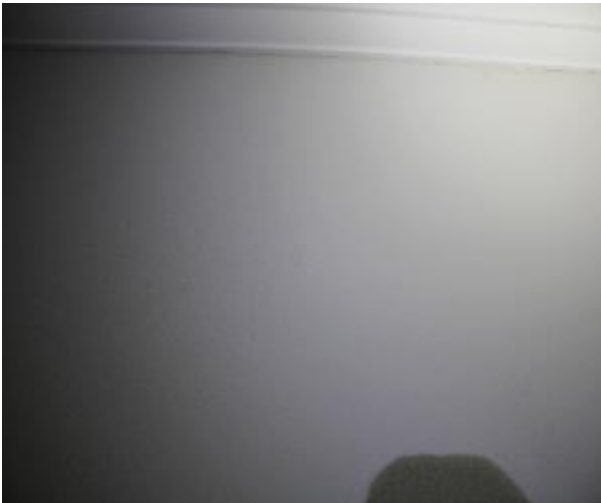
Figure 627 - Crack propagation through lounge room internal wall

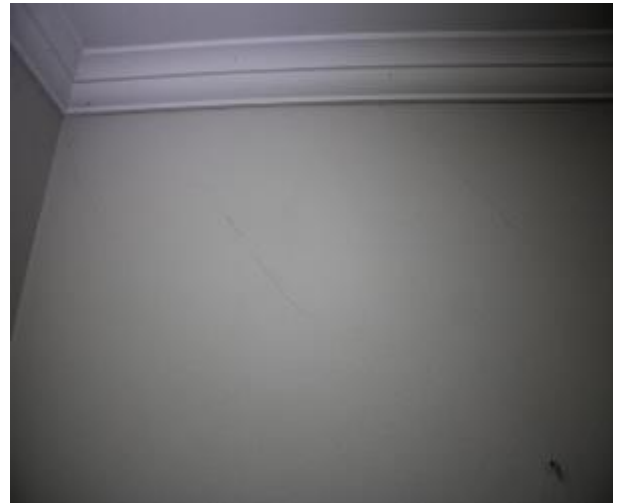
Figure 628 - Crack propagation through lounge room internal wall

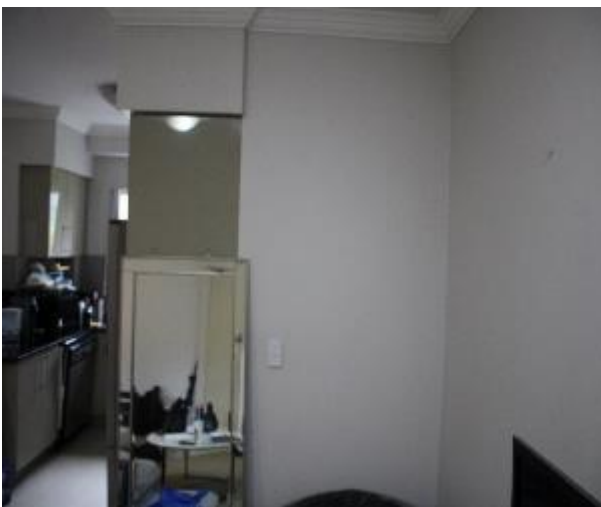
Figure 629 - General condition of lounge room internal wall

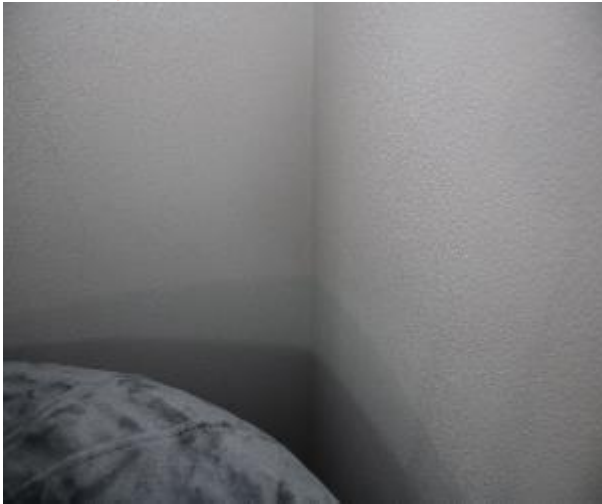
Figure 631 - Crack propagation through lounge room internal wall

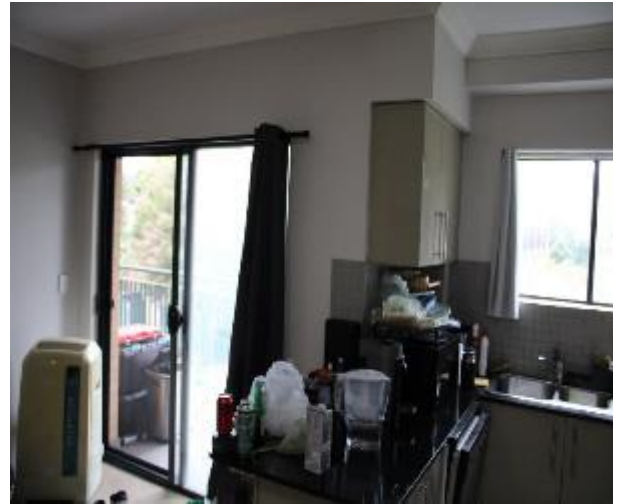
Figure 632 - General condition of lounge room internal wall

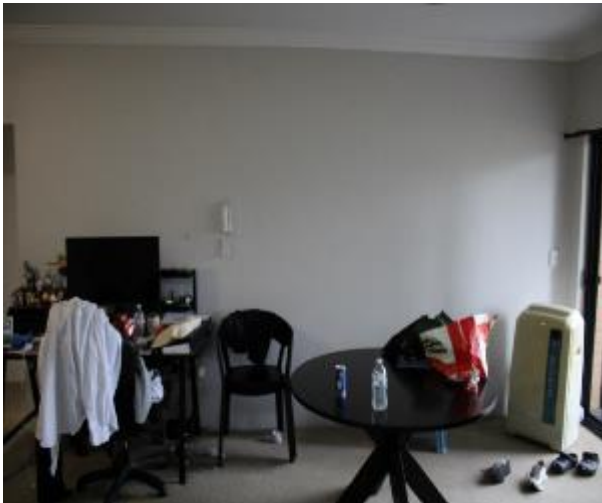
Figure 633 - General condition of lounge room internal wall

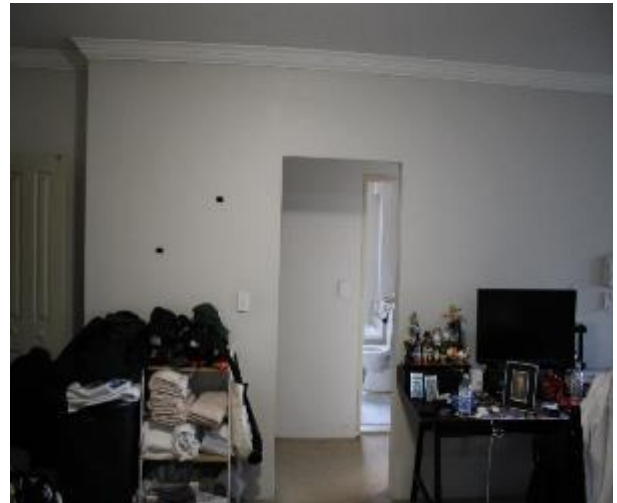
Figure 634 - General condition of lounge room internal wall

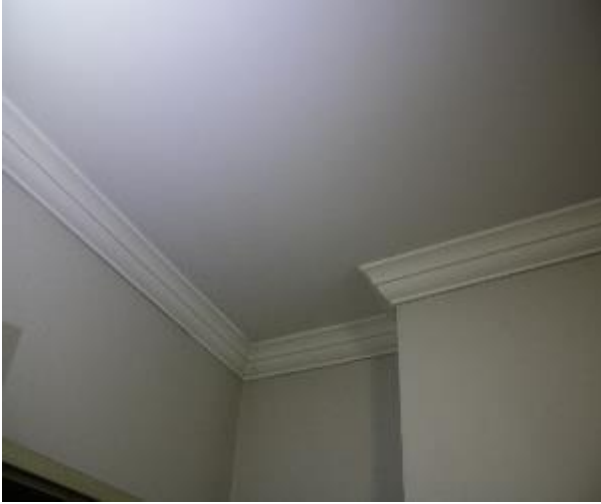
Figure 637 - General condition of lounge room ceiling

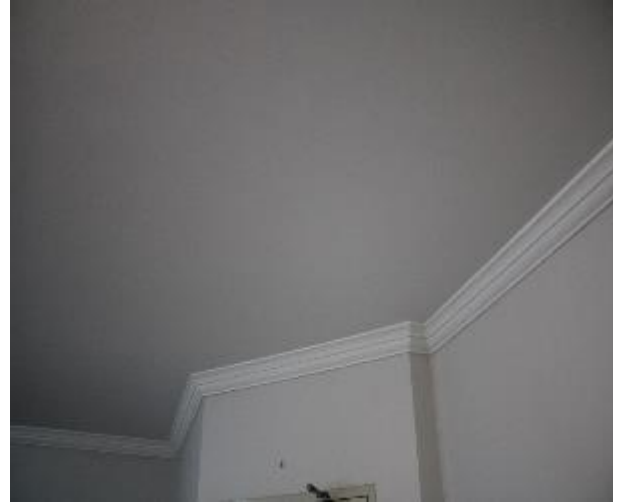
Figure 638 - General condition of lounge room ceiling

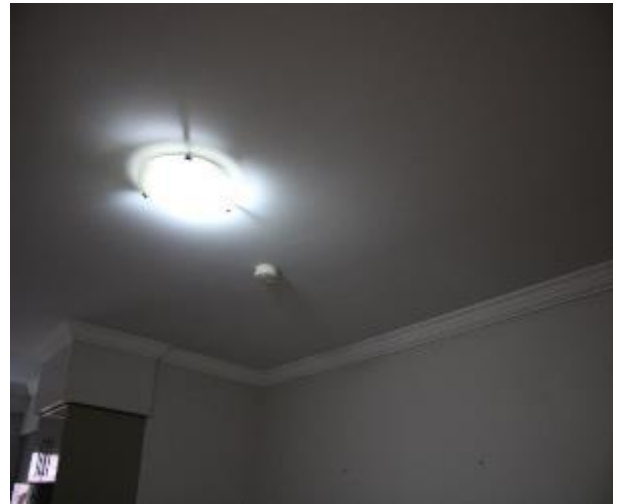
Figure 640 - General condition of lounge room ceiling

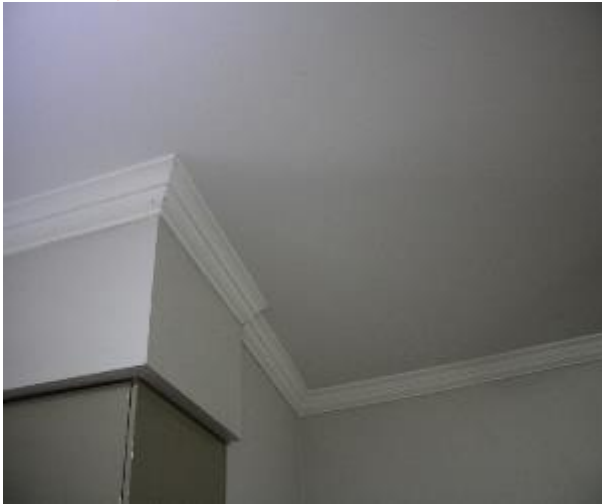
Figure 643 - General condition of lounge room ceiling

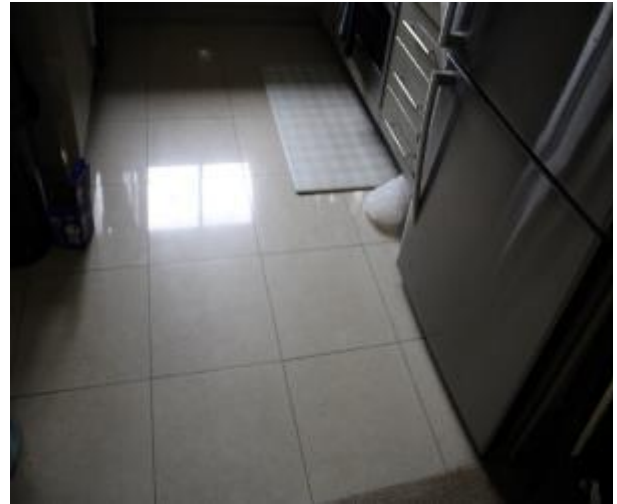
Figure 644 - General condition of kitchen floor tiles

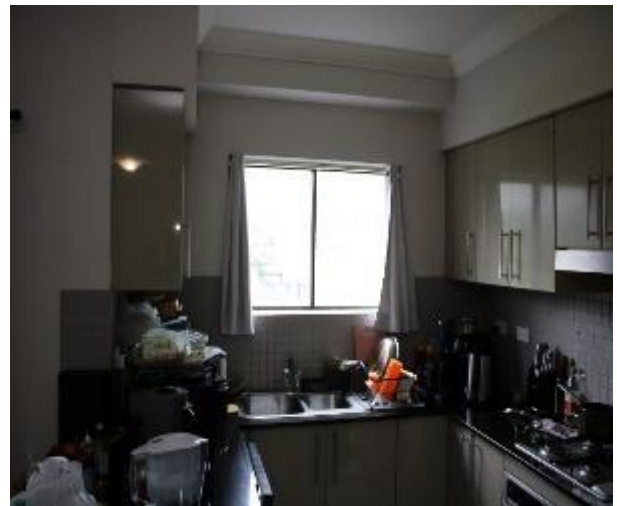
Figure 645 - General condition of kitchen internal wall

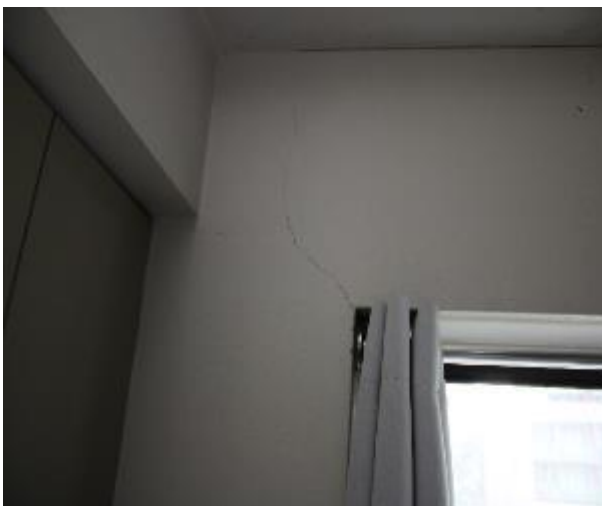
Figure 646 - General condition of kitchen internal wall

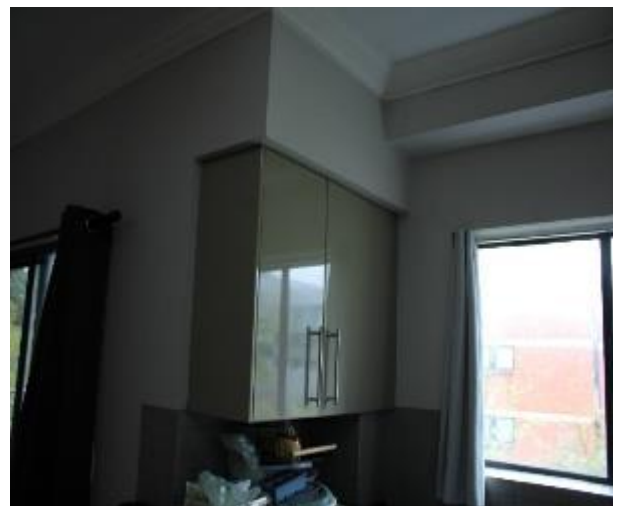
Figure 647 - Crack propagation through kitchen internal wall

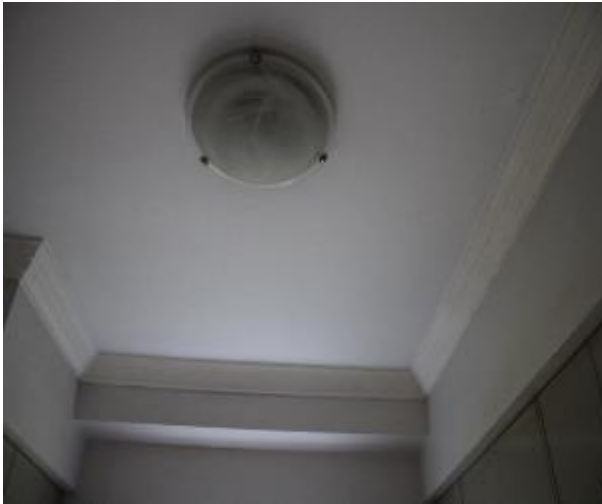
Figure 648 - General condition of kitchen internal wall

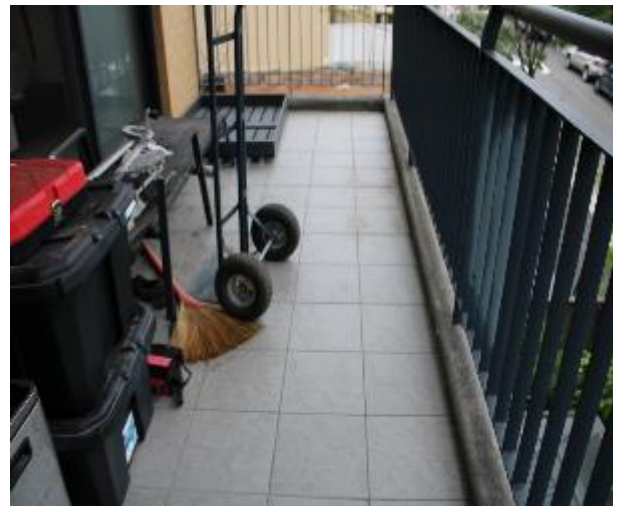
Figure 651 - General condition of balcony floor tiles

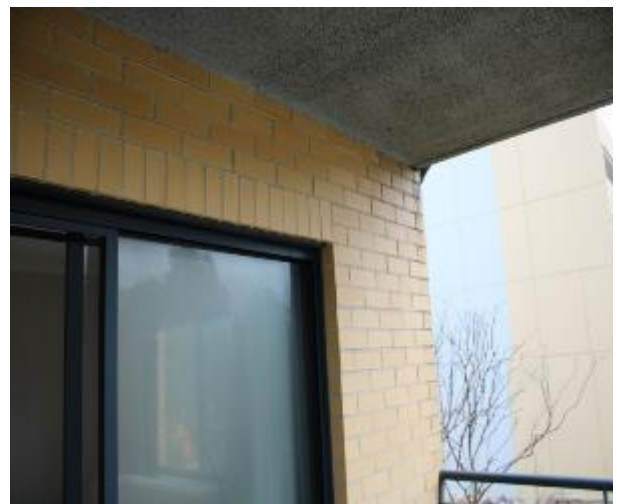
Figure 653 - General condition of external wall

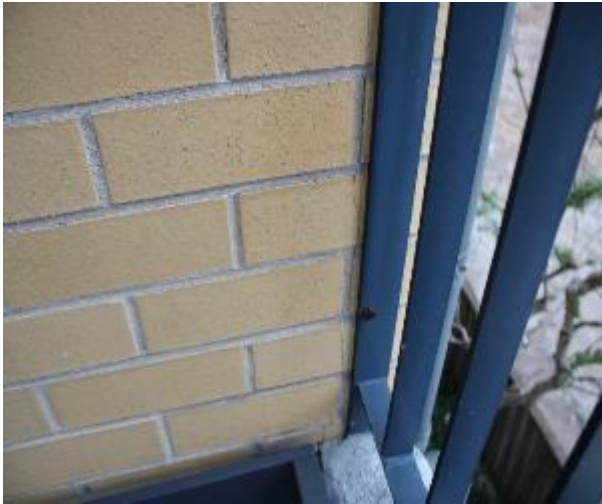
Figure 654 - General condition of external wall

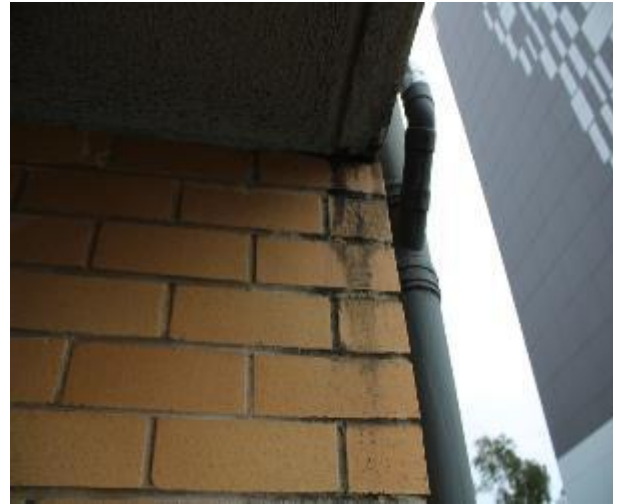
Figure 655 - Crack propagation through external wall

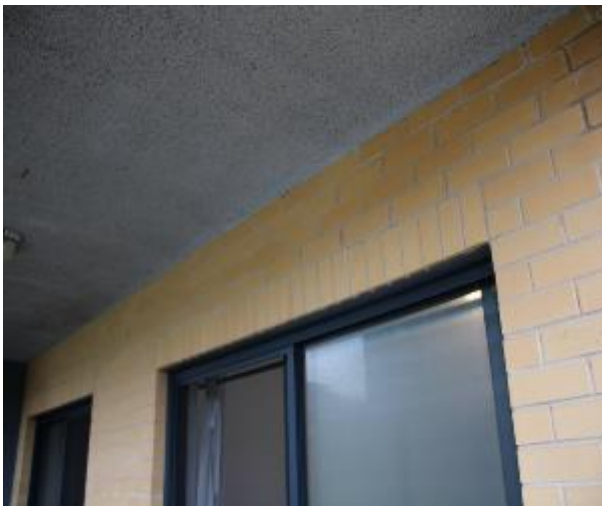
Figure 656 - Crack propagation through external wall

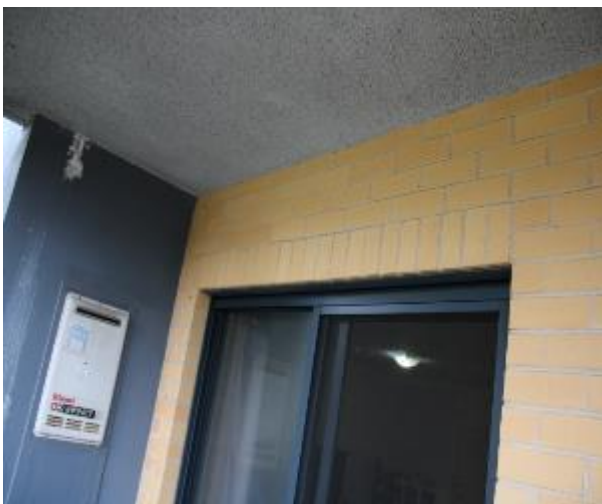
Figure 658 - General condition of external wall

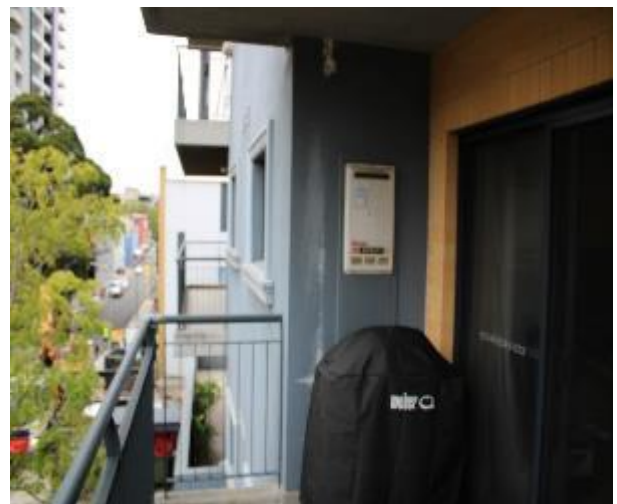
Figure 659 - General condition of external wall

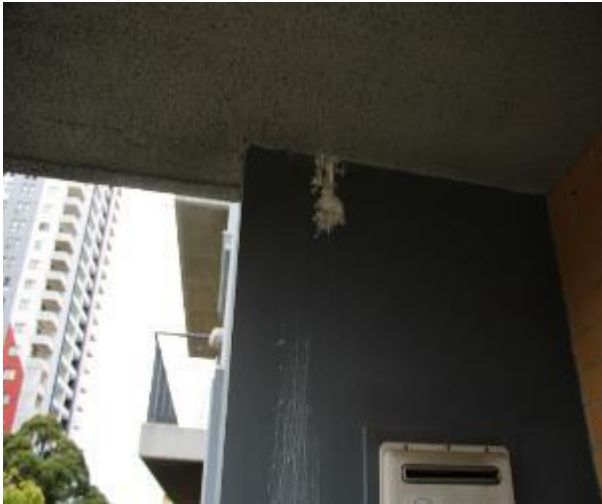
Figure 660 - General condition of external wall

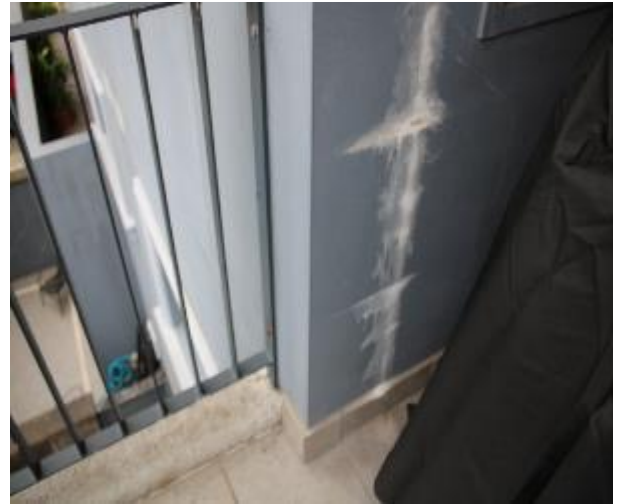
Figure 661 - General condition of external wall

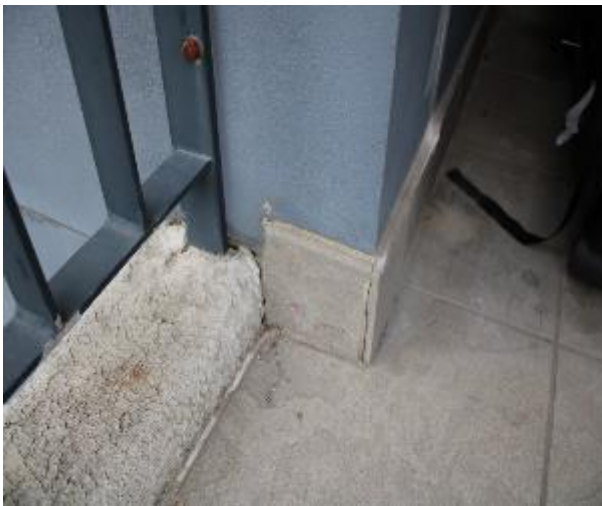
Figure 662 - General condition of external wall

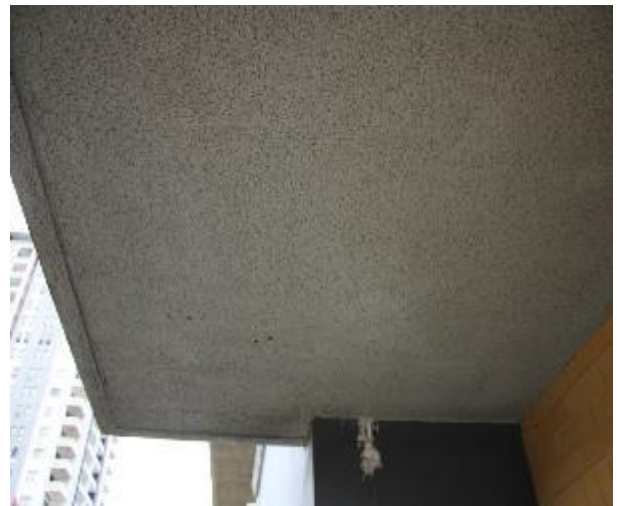
Figure 663 - Crack propagation through external wall

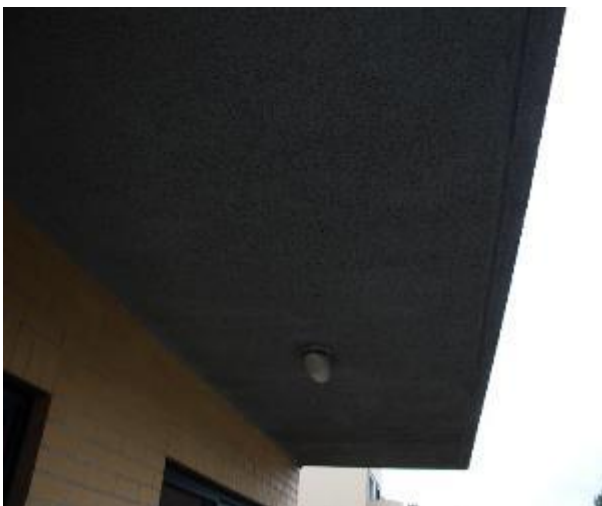
Figure 664 - General condition of balcony underside slab

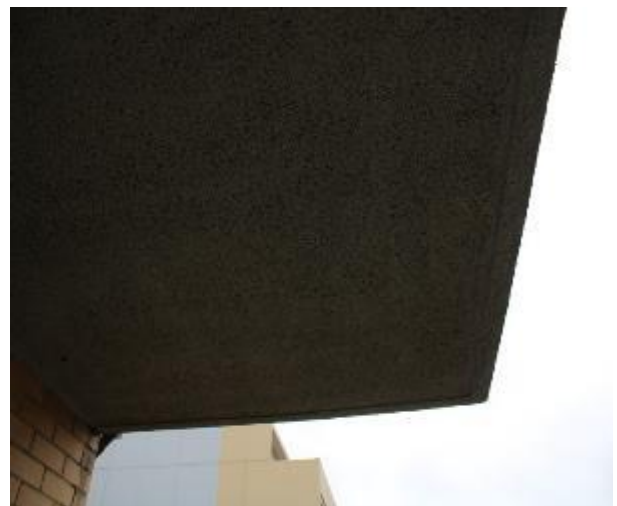
Figure 665 - General condition of balcony underside slab

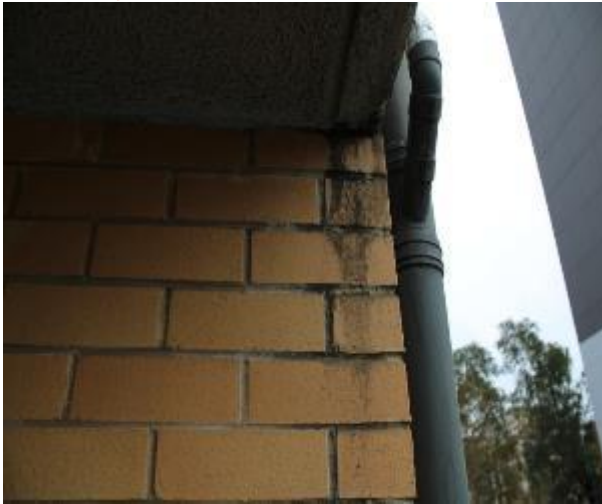
Figure 666 - General condition of balcony underside slab

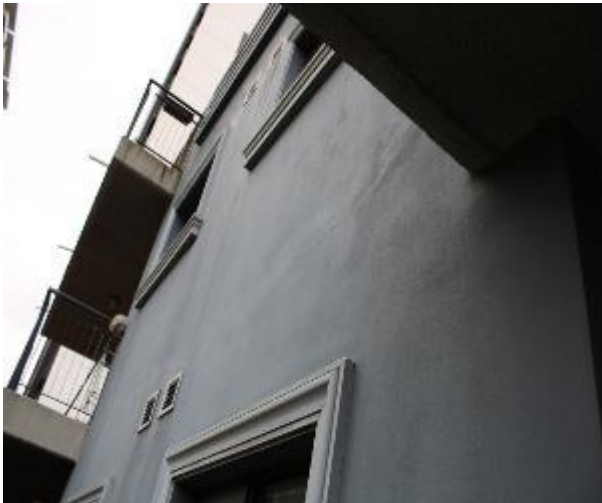
Figure 668 - General condition of external wall

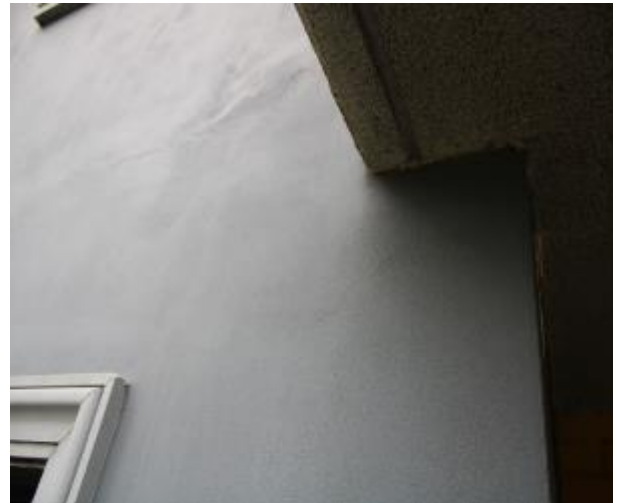
Figure 669 - General condition of external wall

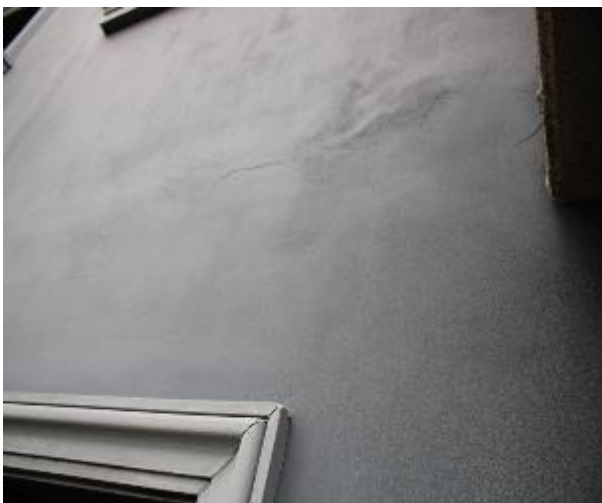
Figure 670 - General condition of external wall

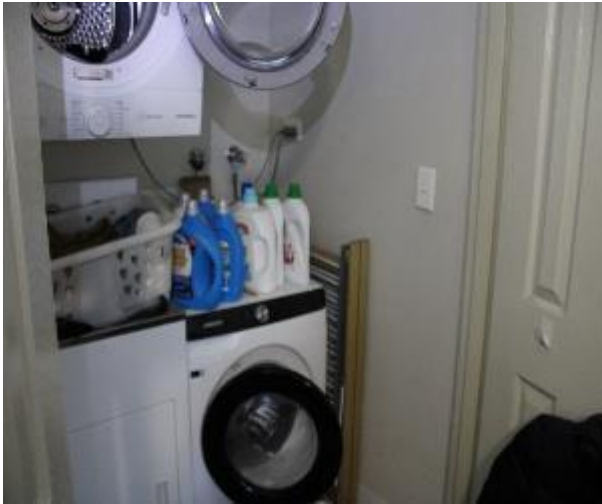
Figure 672 - General condition of laundry floor tiles

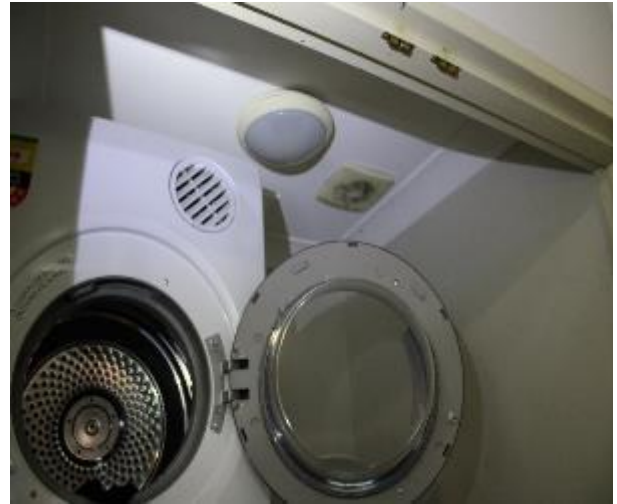
Figure 673 - General condition of laundry internal wall

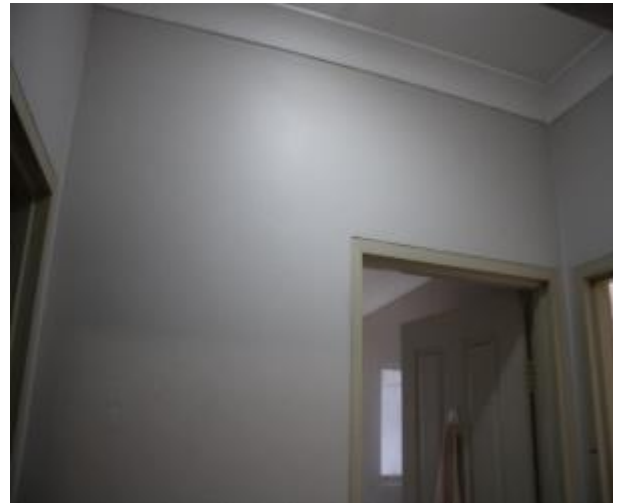
Figure 675 - General condition of corridor internal wall

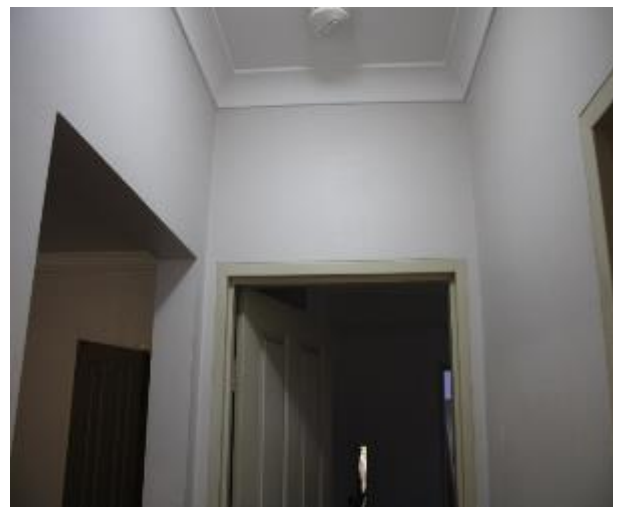
Figure 677 - General condition of corridor internal wall

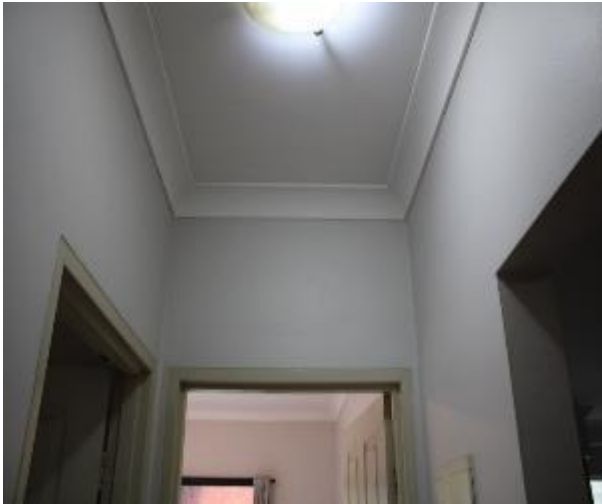
Figure 678 - General condition of corridor internal wall

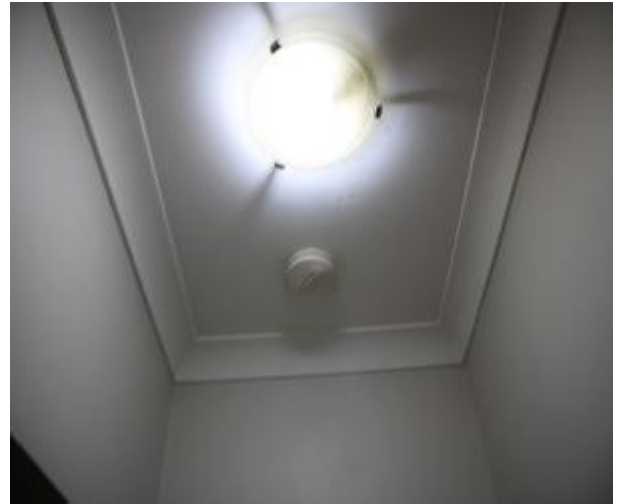
Figure 679 - General condition of corridor internal wall

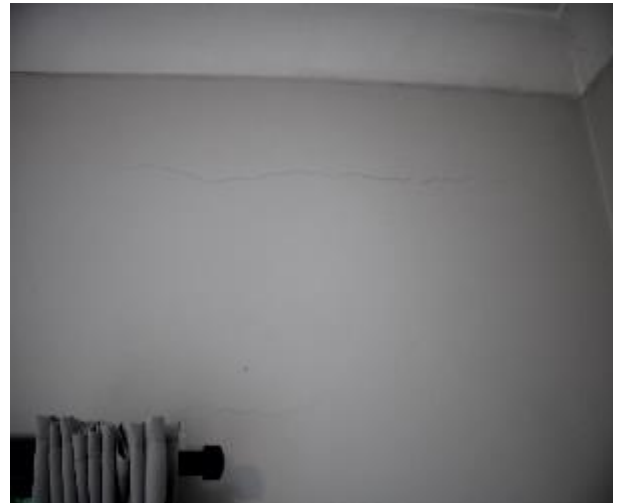
Figure 681 - General condition of bedroom 1 internal wall

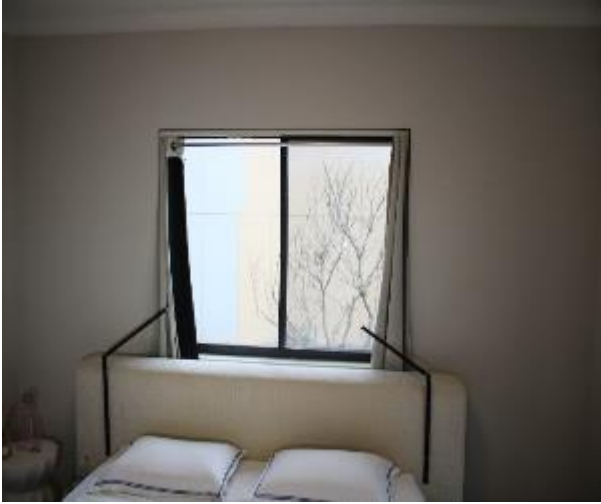
Figure 684 - Crack propagation through bedroom 1 internal wall

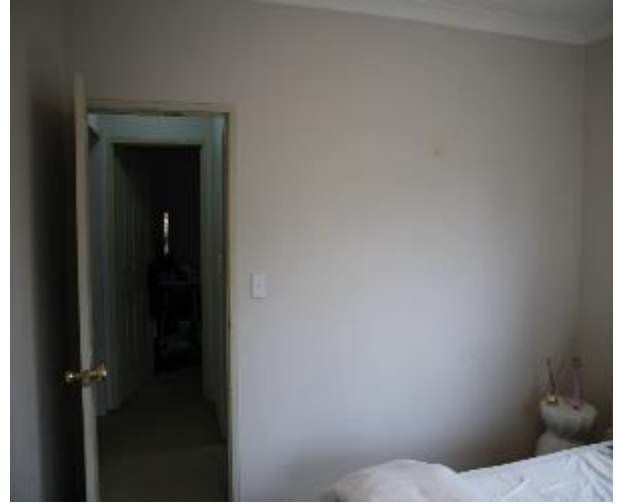
Figure 685 - General condition of bedroom 1 internal wall

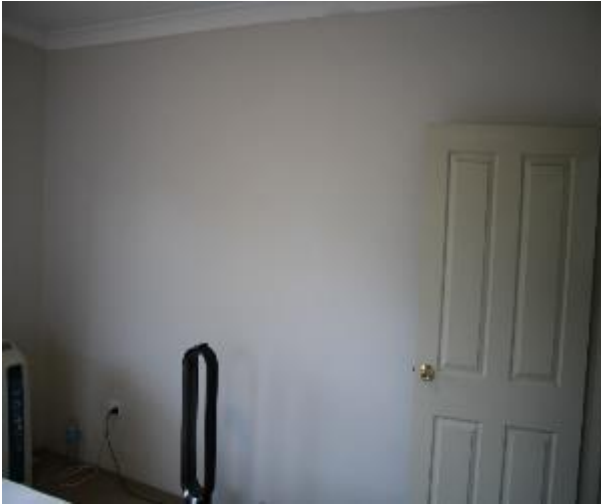
Figure 686 - General condition of bedroom 1 internal wall

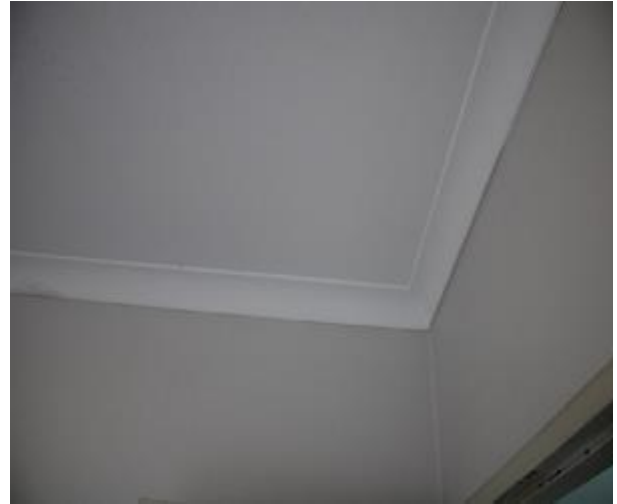
Figure 687 - General condition of bedroom 1 internal wall

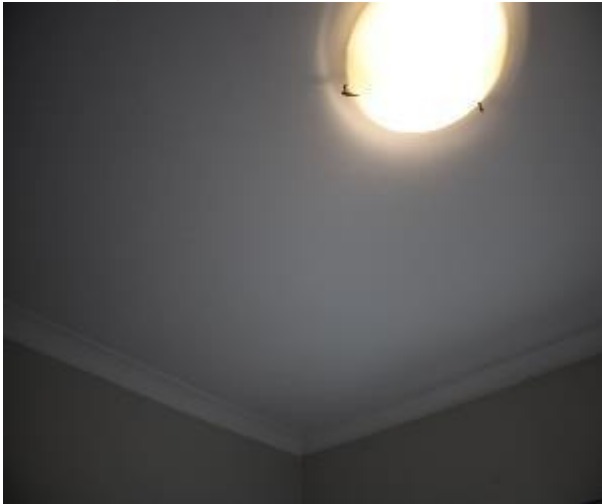
Figure 690 - General condition of bedroom 1 ceiling

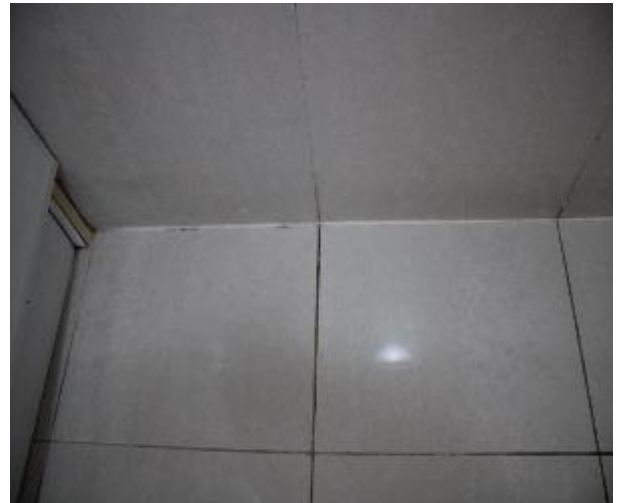
Figure 693 - General condition of bathroom 1 floor tiles

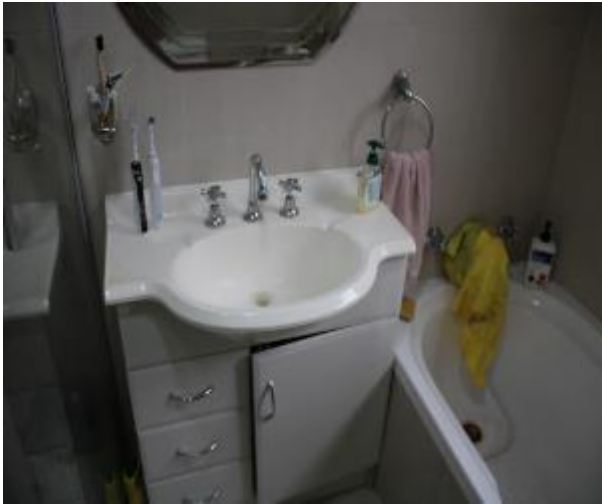
Figure 696 - General condition of bathroom 1 internal wall

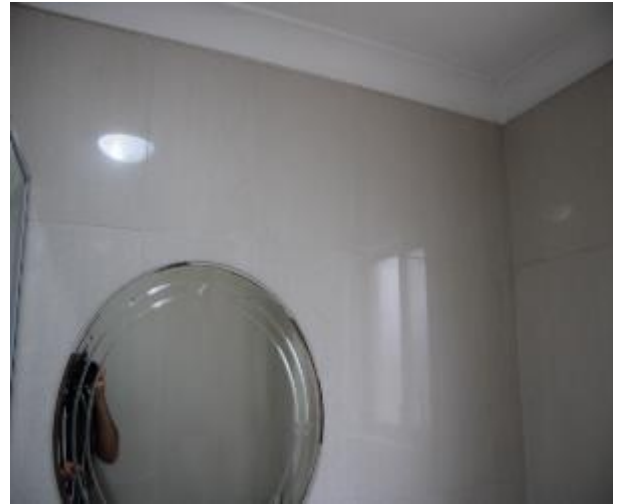
Figure 697 - General condition of bathroom 1 internal wall

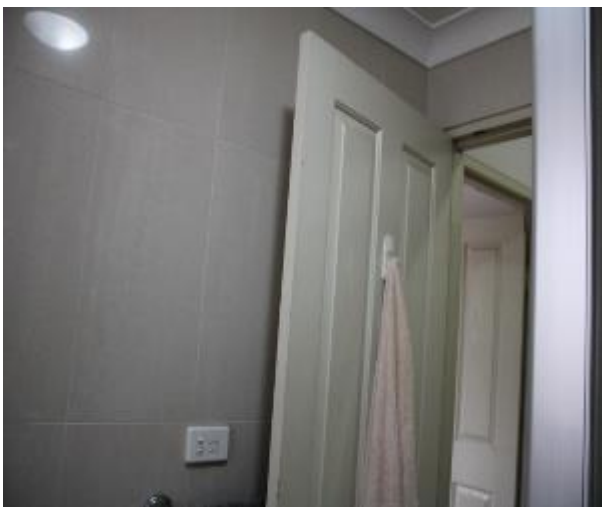
Figure 700 - General condition of bathroom 1 internal wall

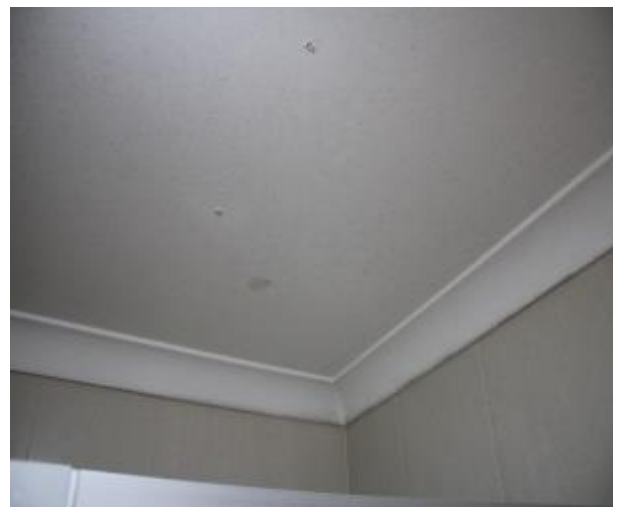
Figure 701 - General condition of bathroom 1 internal wall

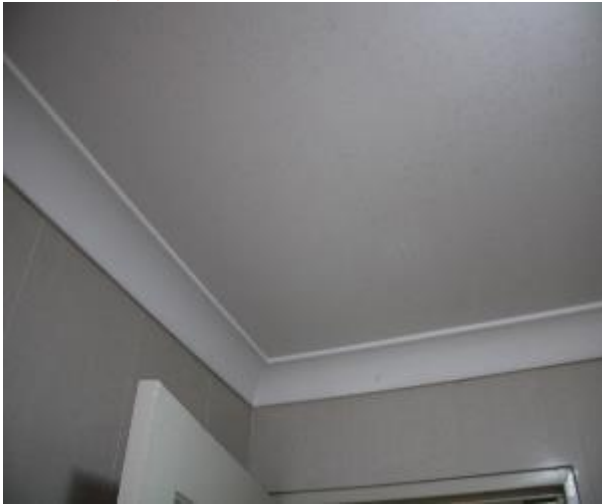
Figure 702 - General condition of bathroom 1 ceiling

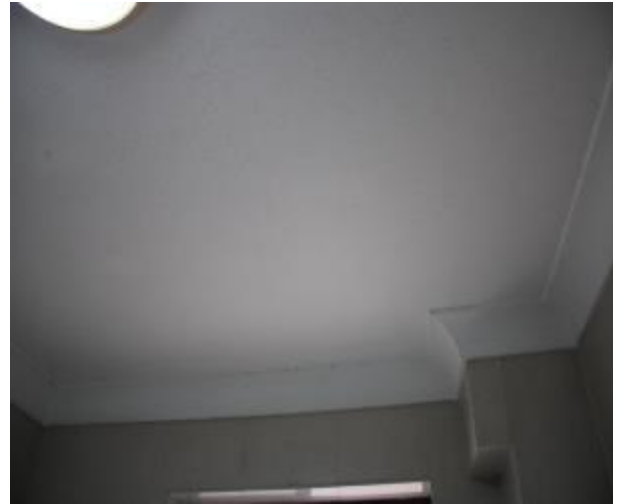
Figure 703 - General condition of bathroom 1 ceiling

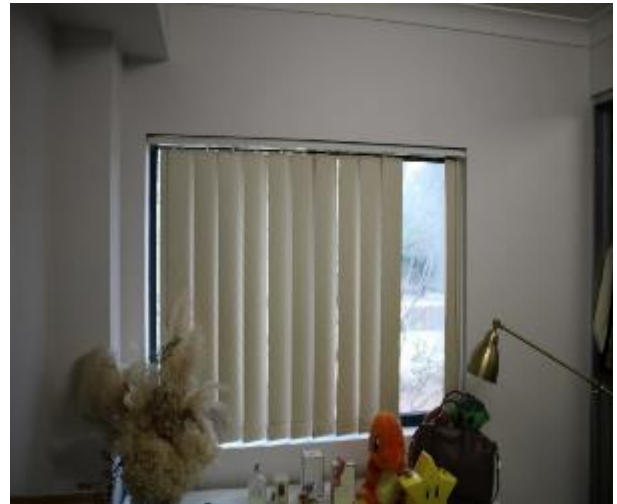
Figure 705 - General condition of dressing room internal wall

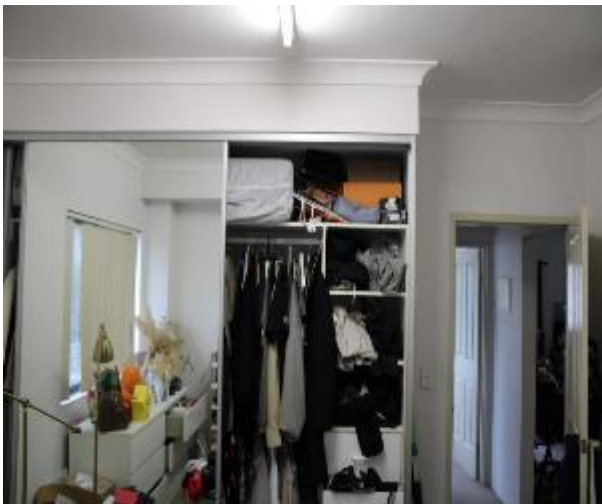
Figure 706 - General condition of dressing room internal wall

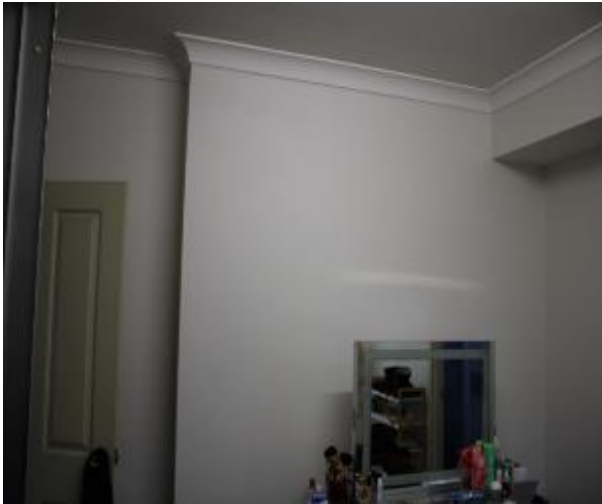
Figure 708 - General condition of dressing room internal wall

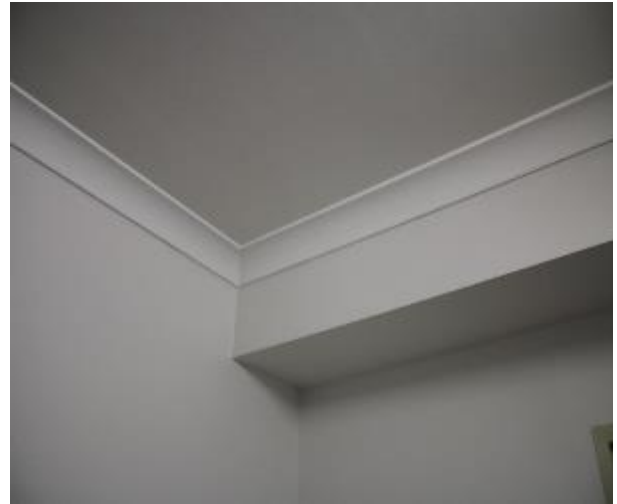
Figure 709 - General condition of dressing room internal wall

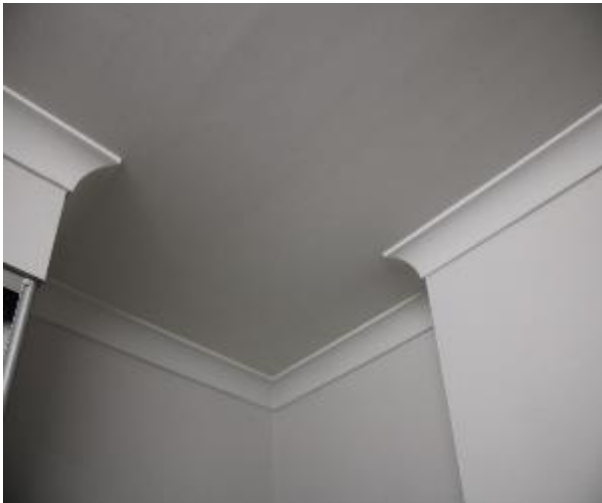
Figure 710 - General condition of dressing room ceiling

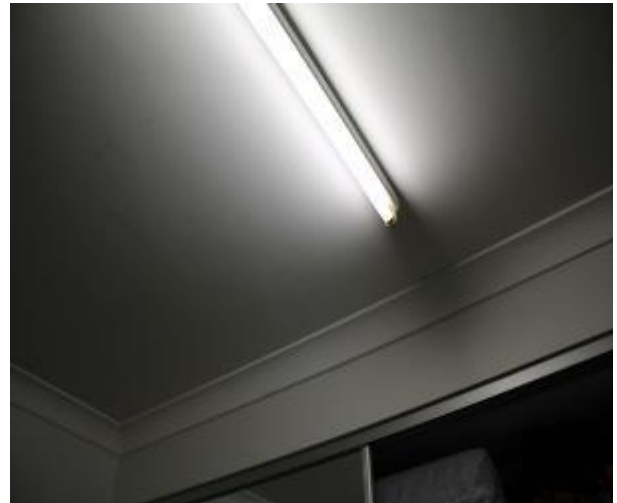
Figure 711 - General condition of dressing room ceiling

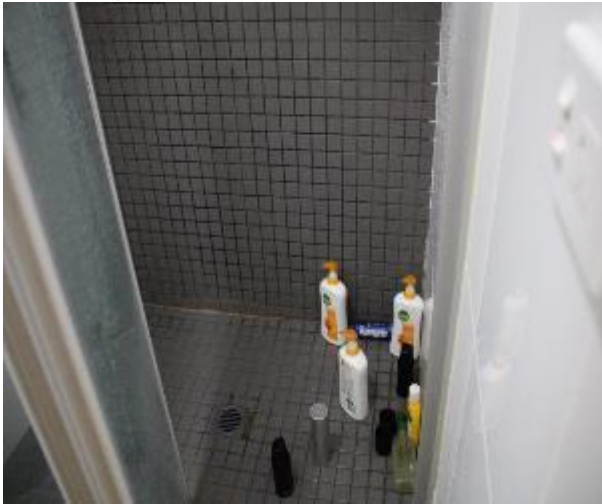
Figure 714 - General condition of ensuite bathroom floor tiles

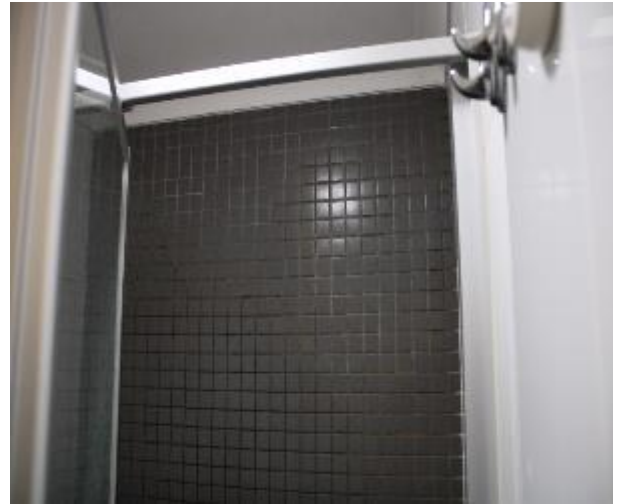
Figure 715 - General condition of ensuite bathroom internal wall

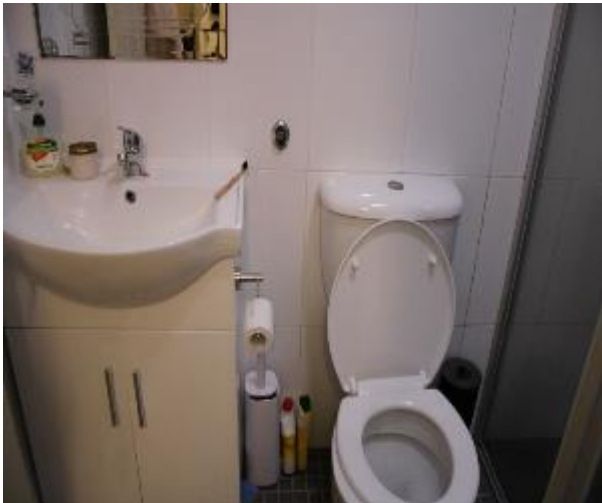
Figure 716 - General condition of ensuite bathroom internal wall

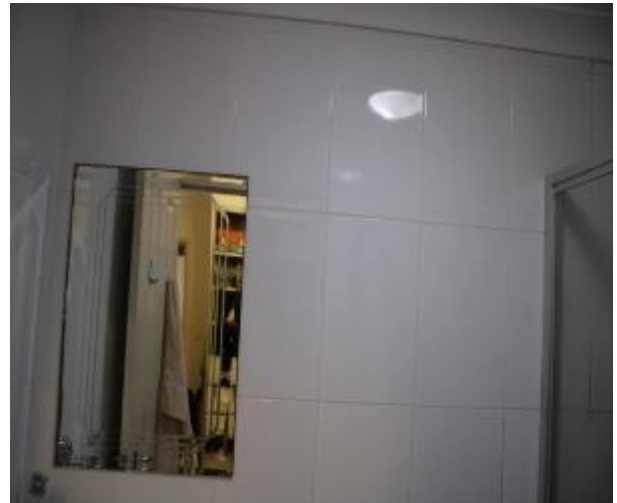
Figure 717 - General condition of ensuite bathroom internal wall

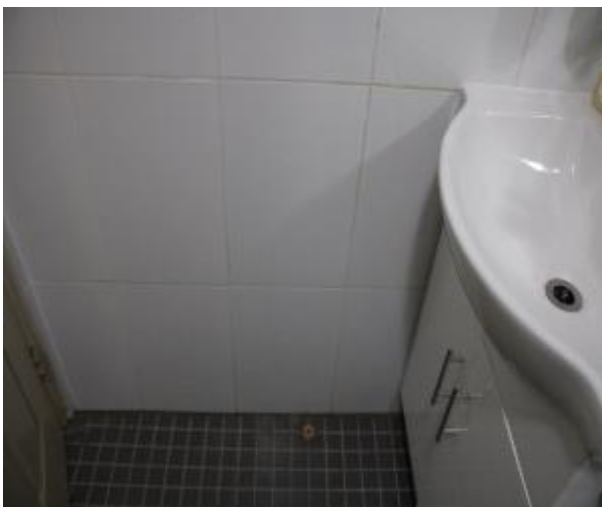
Figure 718 - General condition of ensuite bathroom internal wall

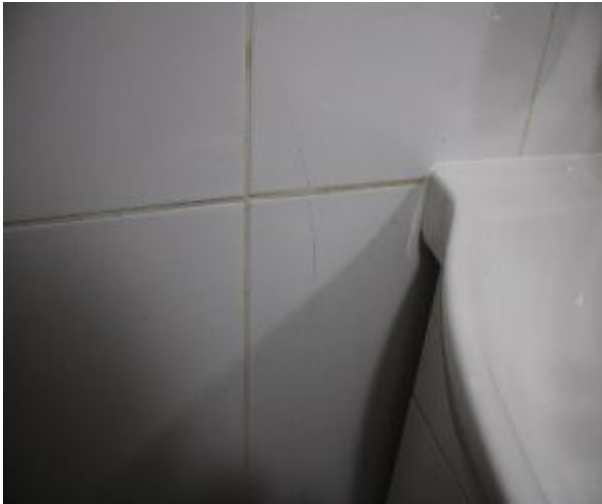
Figure 720 - General condition of ensuite bathroom internal wall

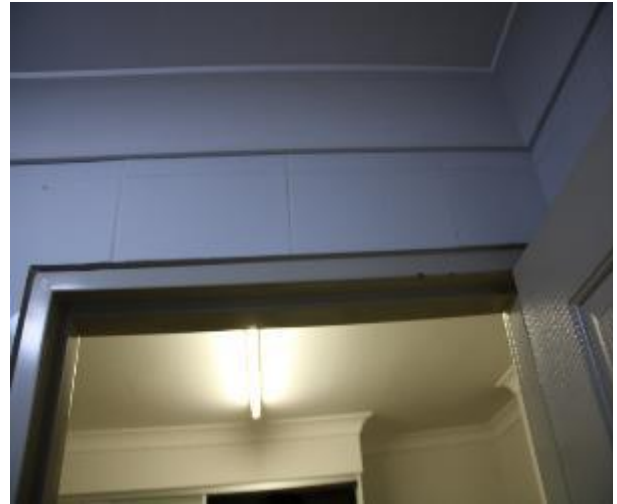
Figure 721 - Crack propagation through ensuite bathroom internal wall

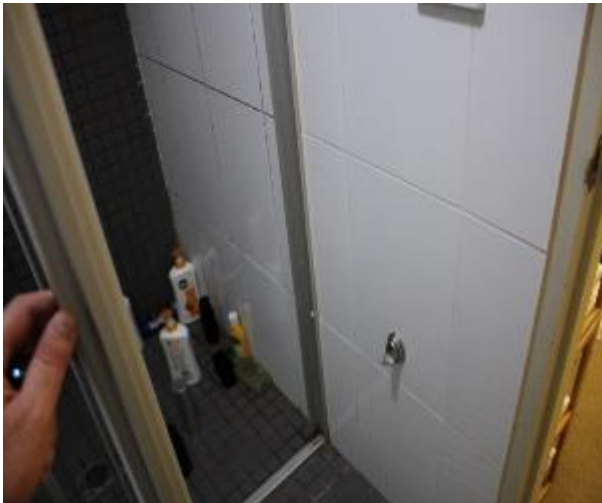
Figure 722 - General condition of ensuite bathroom internal wall
