# **Pre-Dilapidation Report**

**19 GEORGE STREET**

**FRONT BUILDING (UNITS 1-19)**

Project Reference: 20250047.19G.2

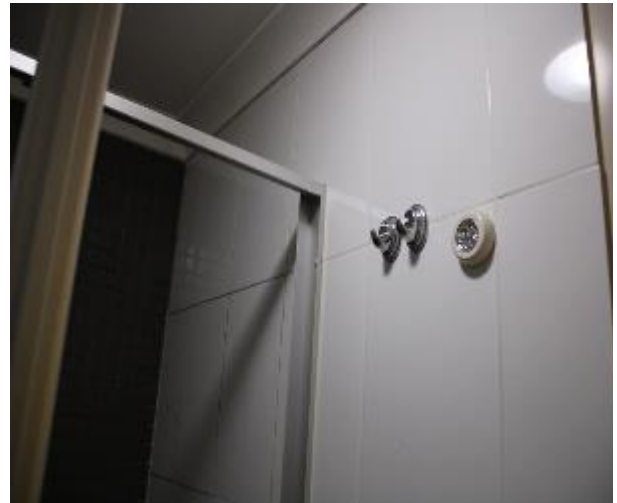
Figure 723 - General condition of ensuite bathroom internal wall

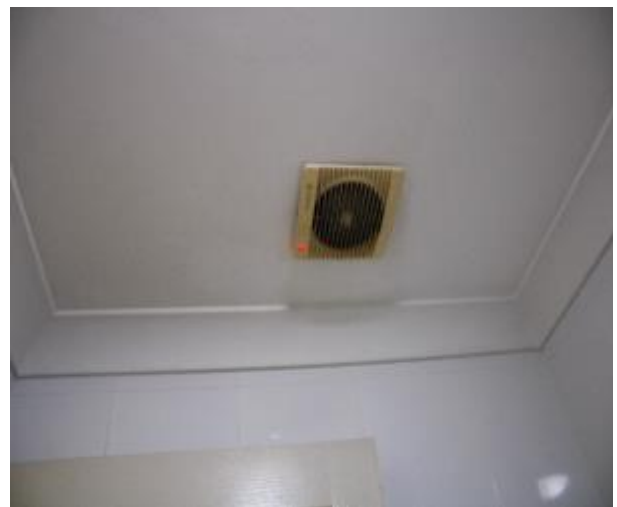
Figure 726 - General condition of ensuite bathroom ceiling

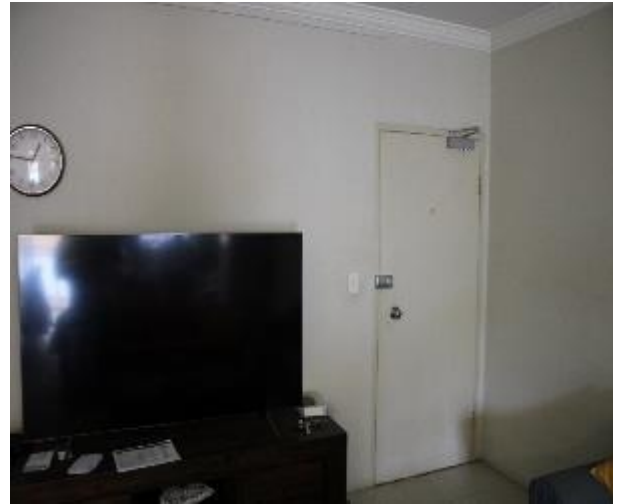
Figure 728 - General condition of open kitchen/ lounge room internal wall

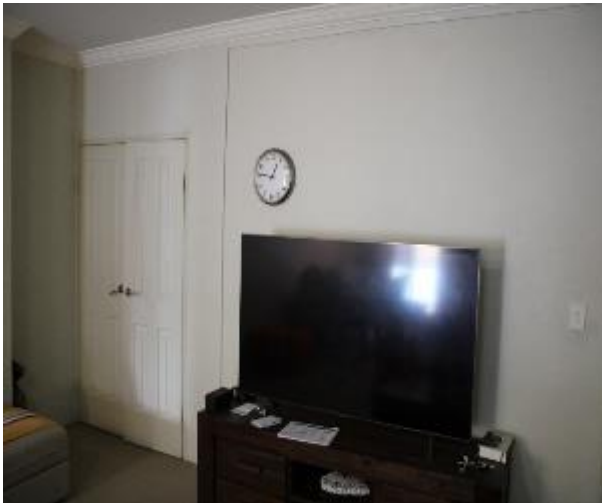
Figure 729 - General condition of open kitchen/ lounge room internal wall

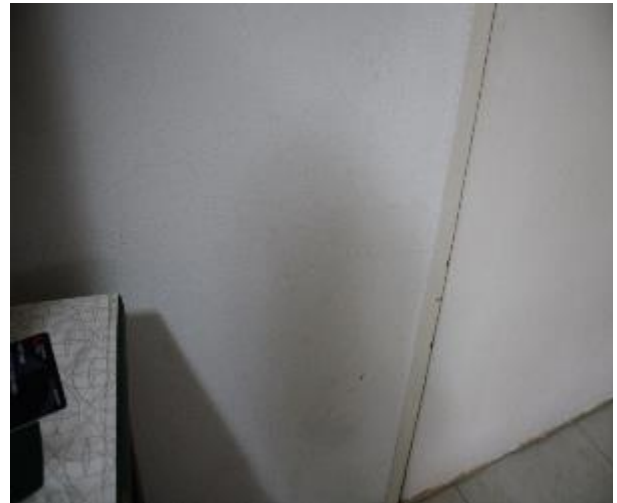
Figure 730 - Crack propagation through open kitchen/ lounge room internal wall

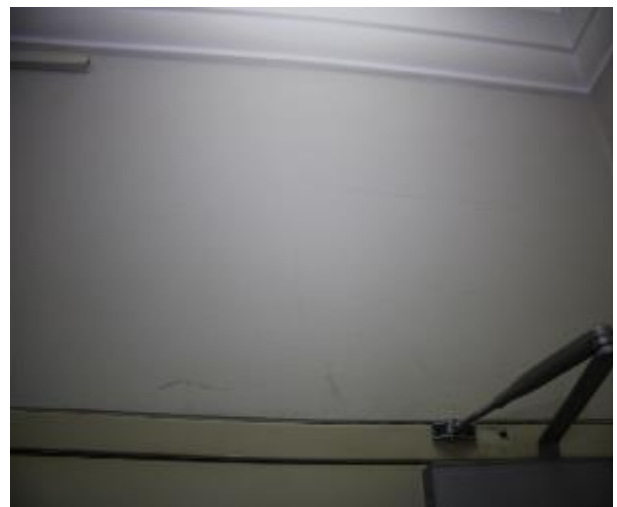
Figure 732 - Crack propagation through open kitchen/ lounge room internal wall

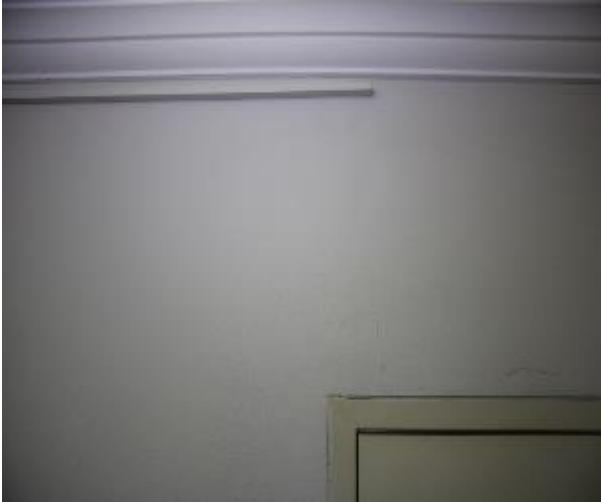
Figure 733 - Crack propagation through open kitchen/ lounge room internal wall

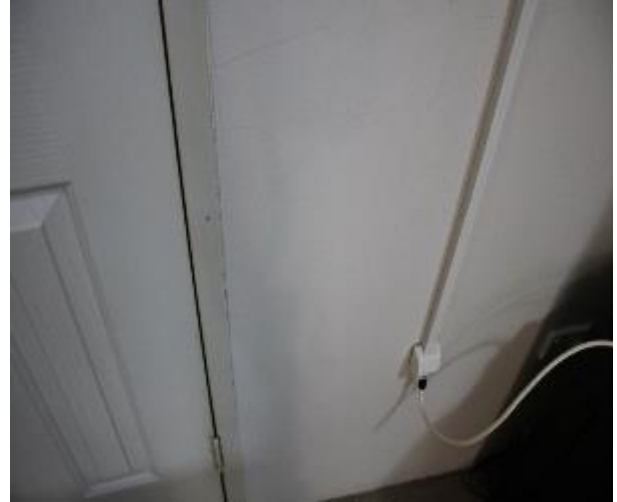
Figure 734 - Crack propagation through open kitchen/ lounge room internal wall

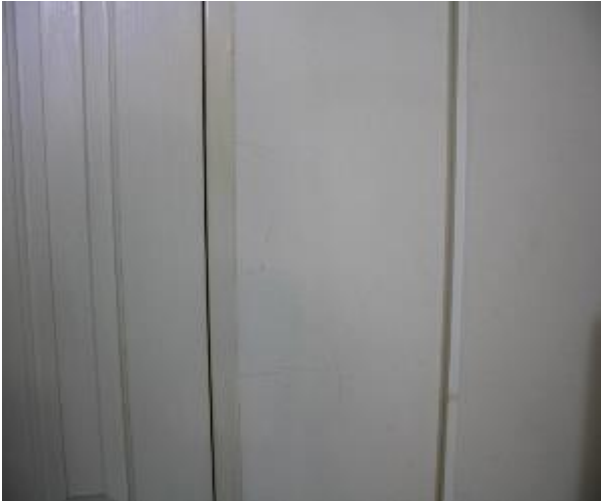
Figure 735 - General condition of open kitchen/ lounge room internal wall

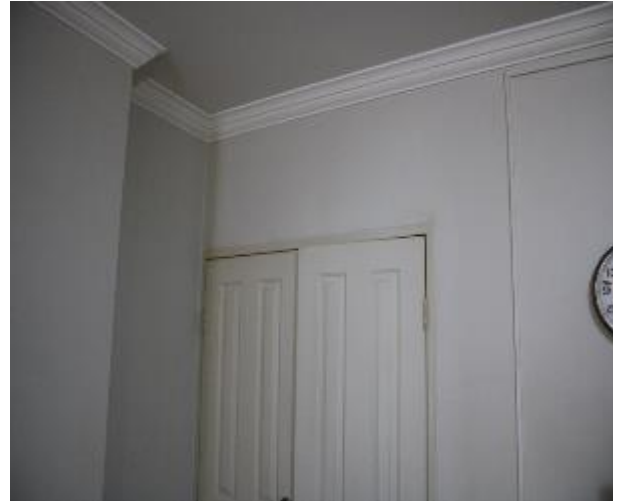
Figure 736 - General condition of open kitchen/ lounge room internal wall

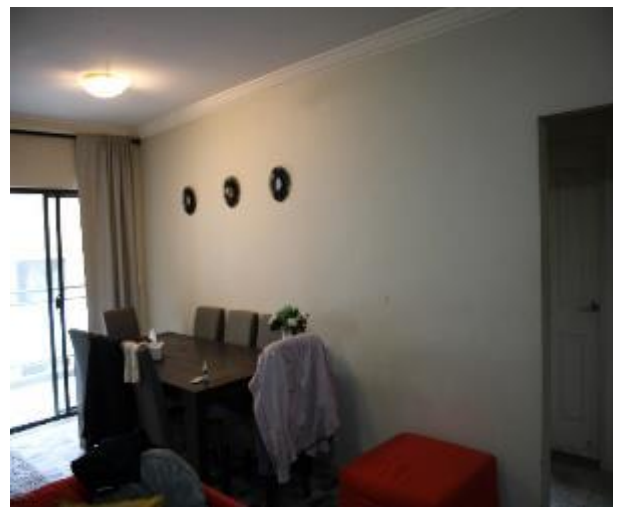
Figure 738 - General condition of open kitchen/ lounge room internal wall

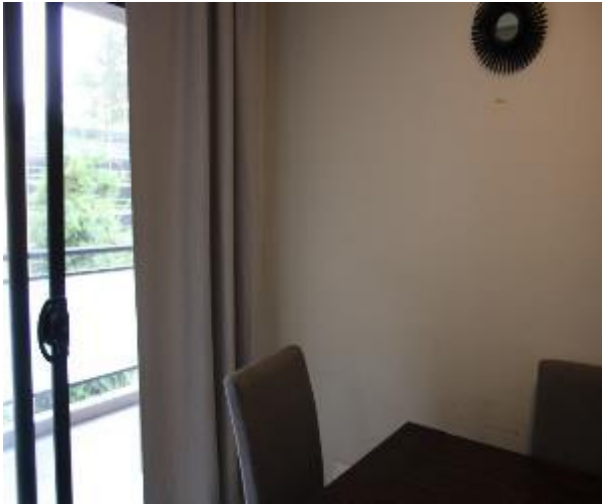
Figure 739 - General condition of open kitchen/  
lounge room internal wall

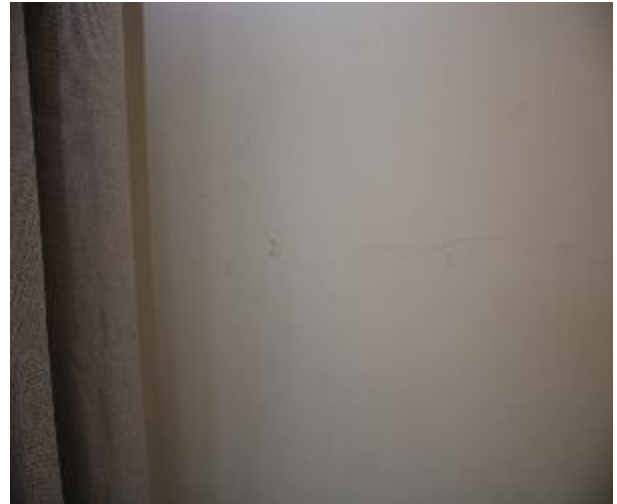
Figure 740 - Crack propagation through open  
kitchen/ lounge room internal wall

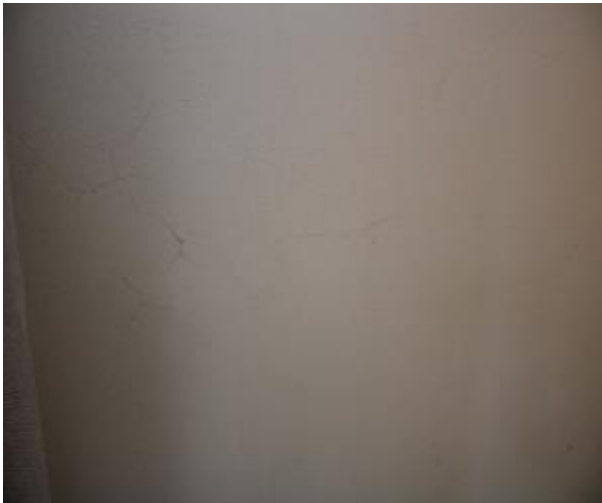
Figure 741 - Crack propagation through open  
kitchen/ lounge room internal wall

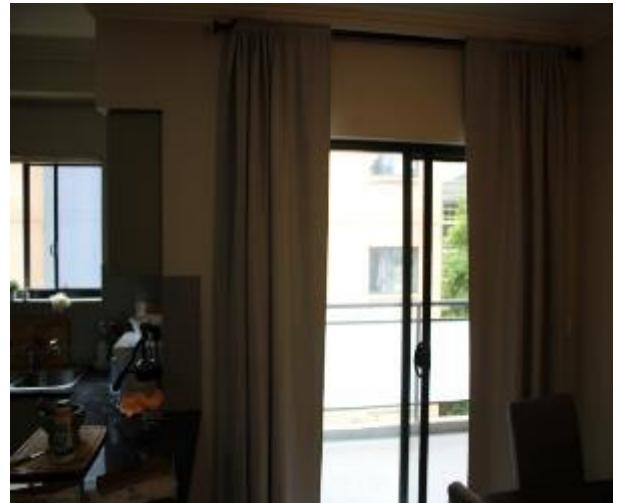
Figure 742 - General condition of open kitchen/  
lounge room internal wall

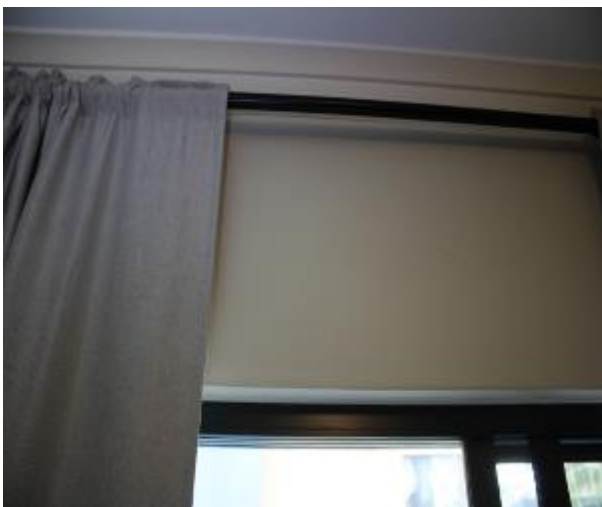
Figure 743 - General condition of open kitchen/  
lounge room internal wall

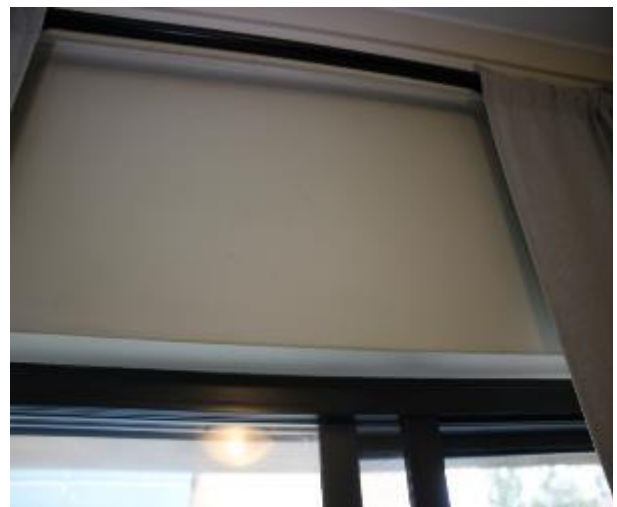
Figure 744 - Crack propagation through open  
kitchen/ lounge room internal wall

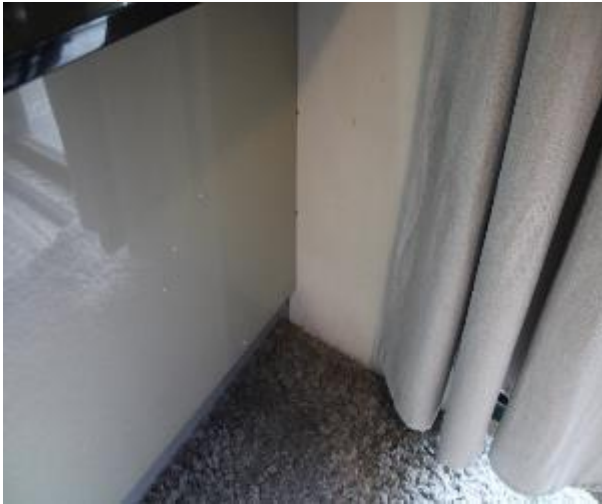
Figure 745 - Crack propagation through open kitchen/ lounge room internal wall

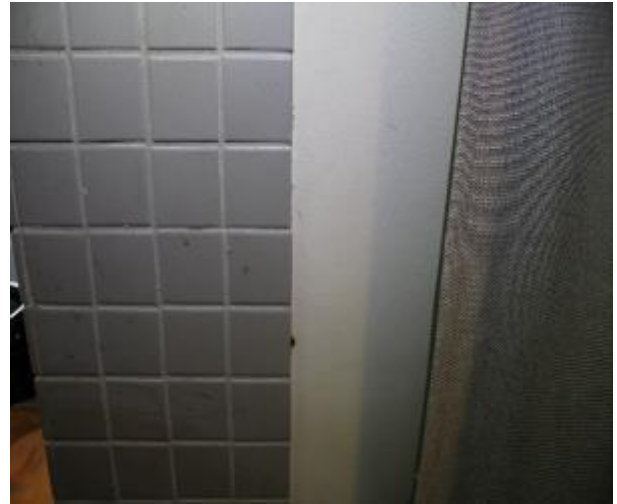
Figure 746 - Crack propagation through open kitchen/ lounge room internal wall

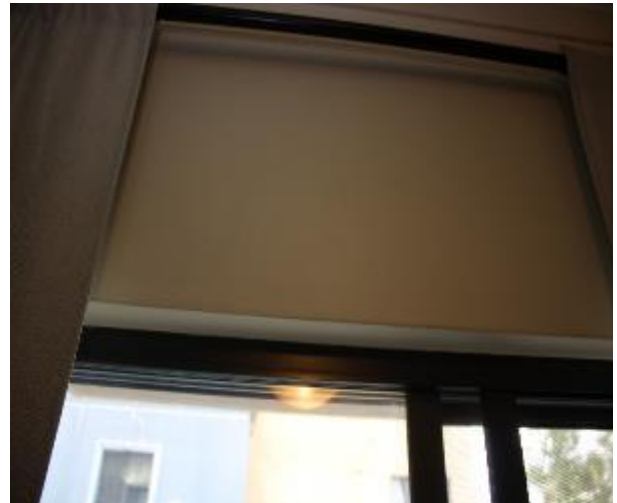
Figure 748 - General condition of open kitchen/ lounge room internal wall

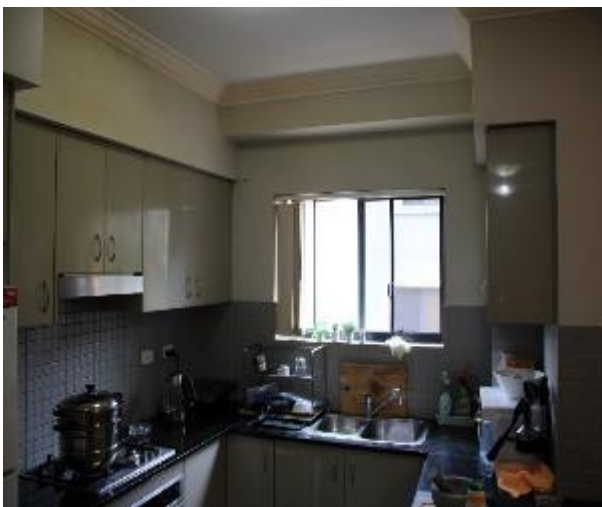
Figure 749 - General condition of open kitchen/ lounge room internal wall

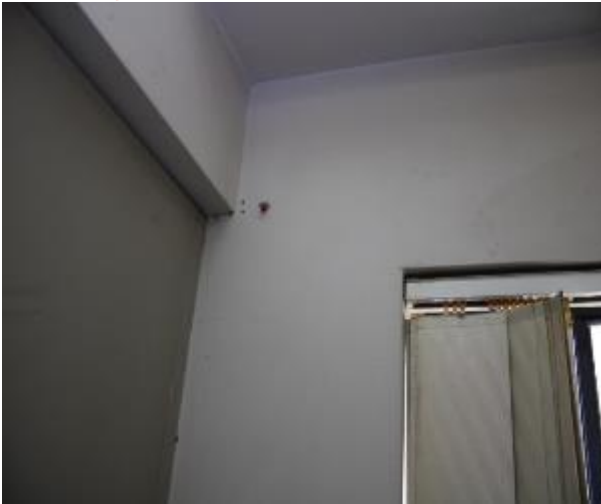
Figure 751 - General condition of open kitchen/ lounge room internal wall

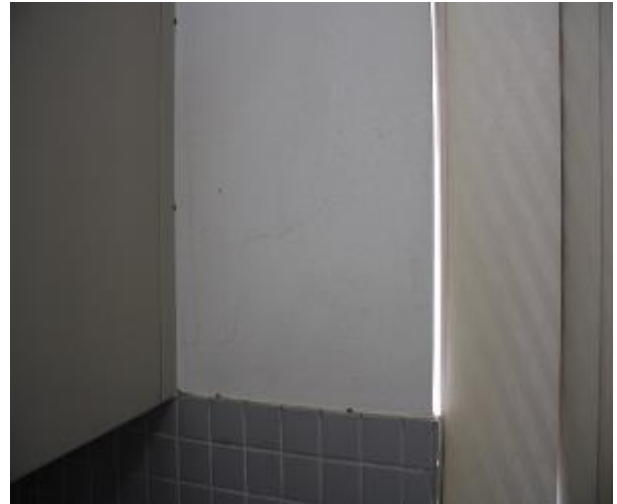
Figure 752 - Crack propagation through open kitchen/ lounge room internal wall

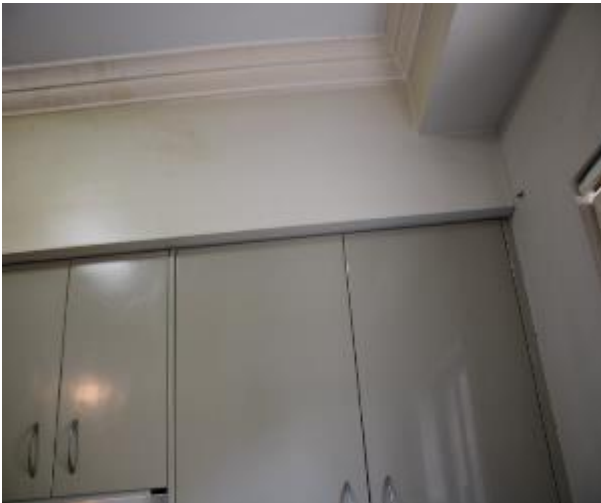
Figure 753 - General condition of open kitchen/ lounge room internal wall

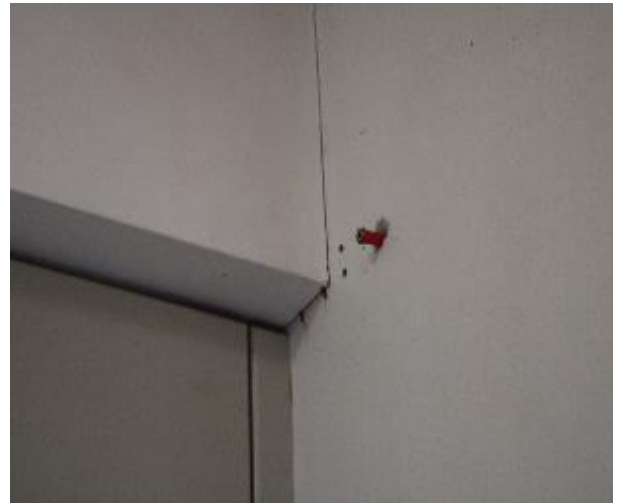
Figure 754 - Crack propagation through open kitchen/ lounge room internal wall

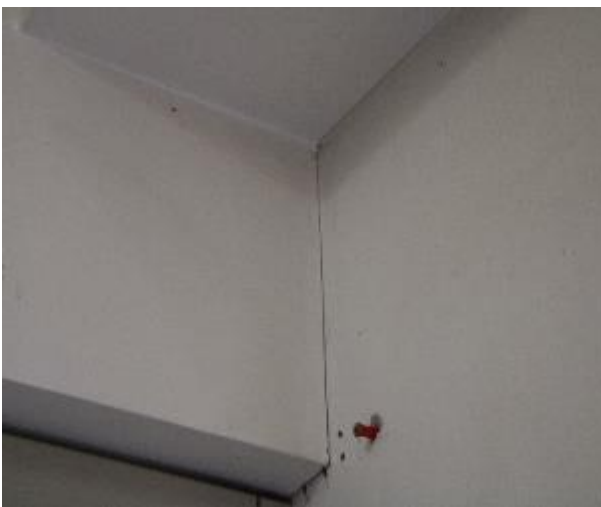
Figure 755 - Crack propagation through open kitchen/ lounge room internal wall

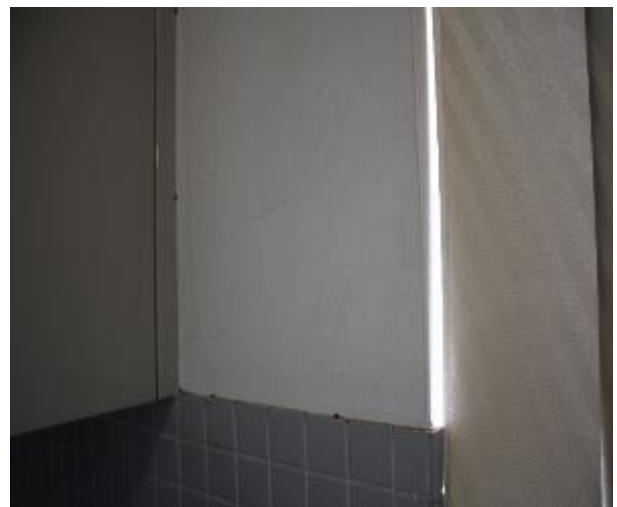
Figure 756 - General condition of open kitchen/ lounge room internal wall

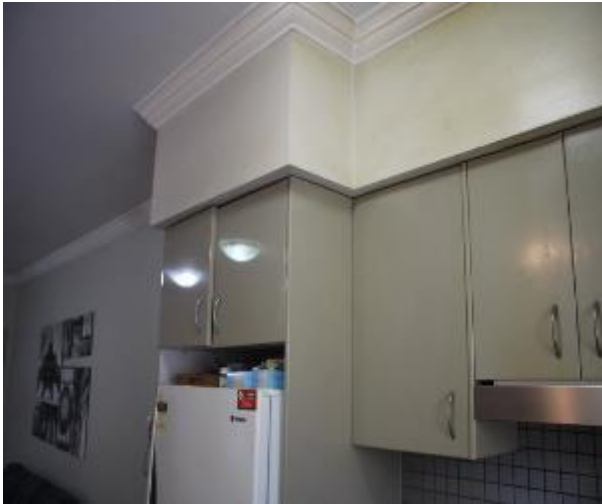
Figure 757 - General condition of open kitchen/  
lounge room internal wall

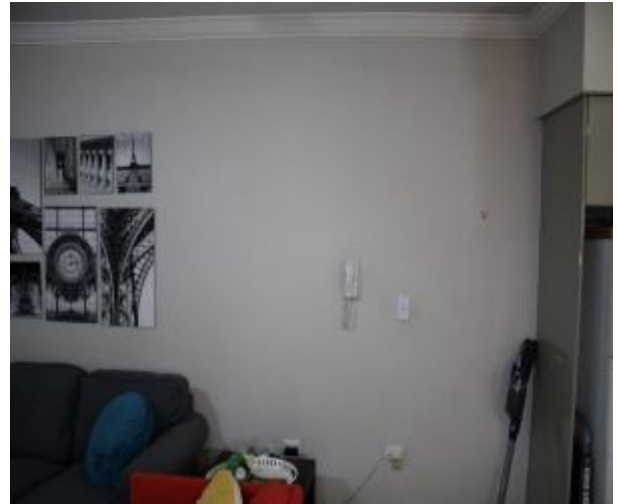
Figure 758 - General condition of open kitchen/  
lounge room internal wall

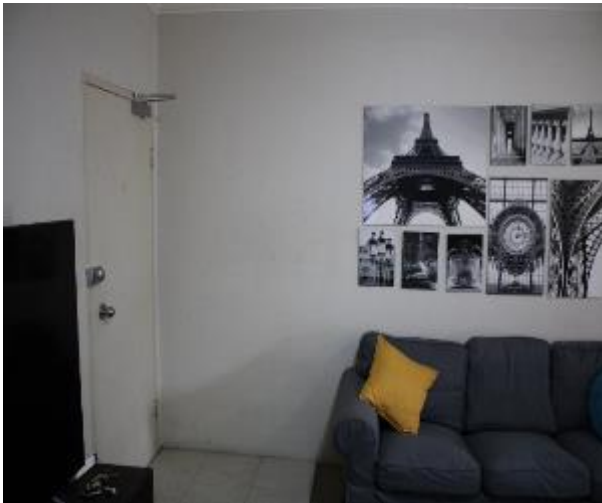
Figure 759 - General condition of open kitchen/  
lounge room internal wall

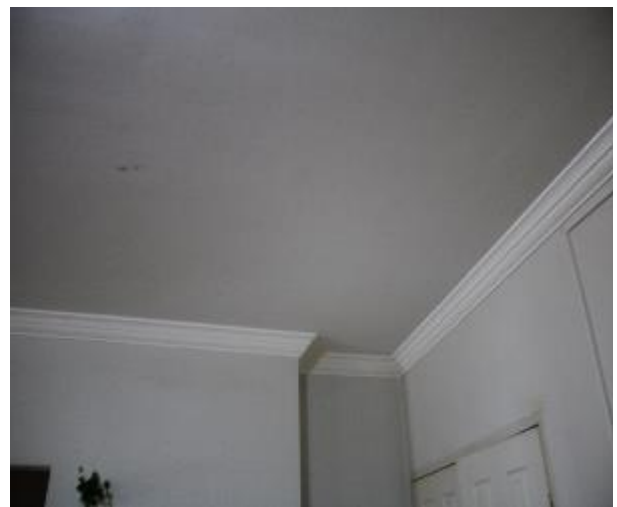
Figure 762 - General condition of open kitchen/  
lounge room ceiling

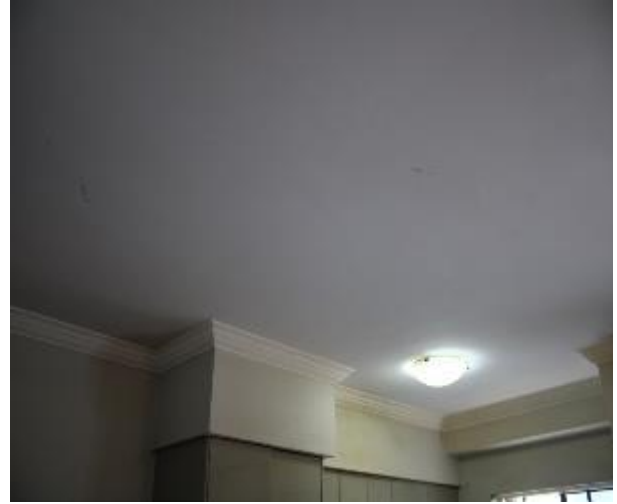
Figure 763 - General condition of open kitchen/  
lounge room ceiling

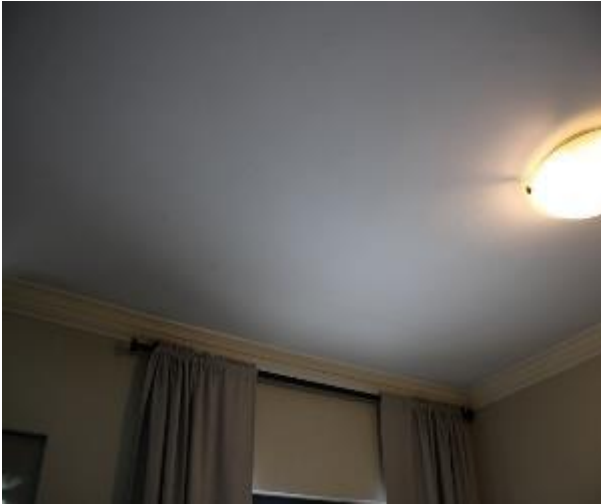
Figure 764 - General condition of open kitchen/  
lounge room ceiling

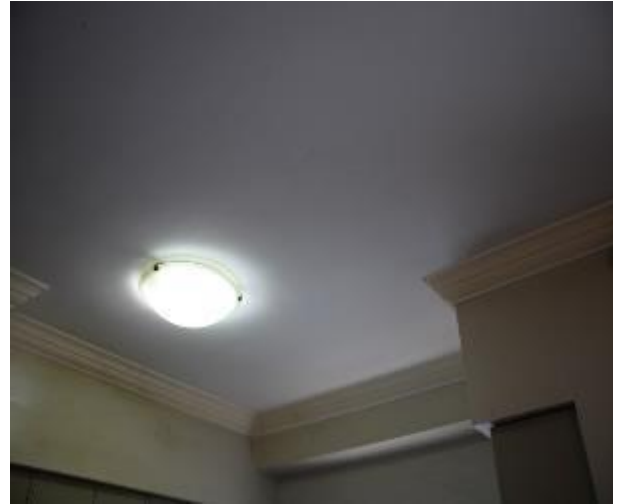
Figure 765 - General condition of open kitchen/  
lounge room ceiling

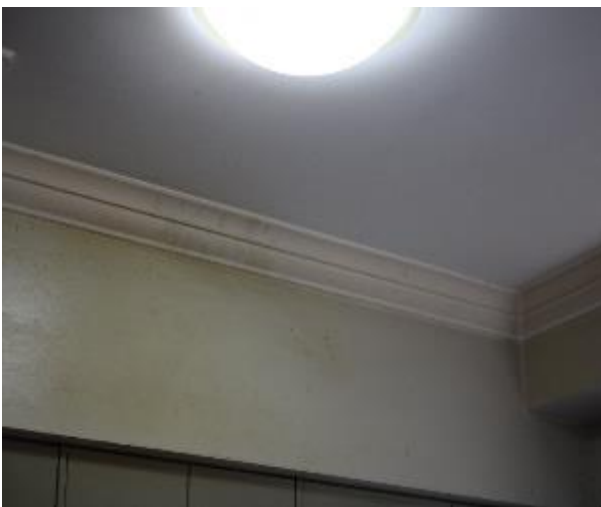
Figure 766 - General condition of open kitchen/  
lounge room ceiling

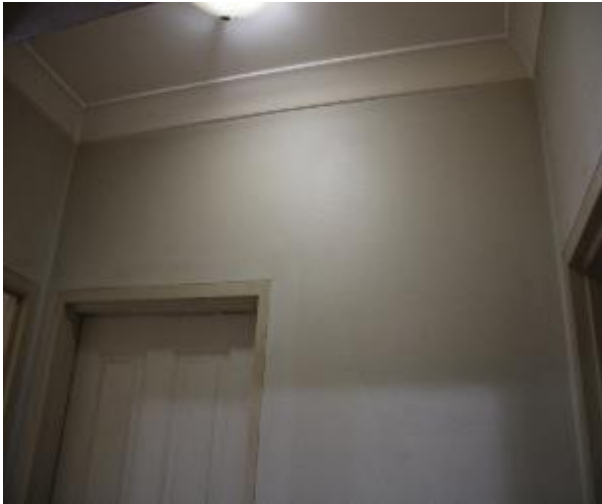
Figure 768 - General condition of corridor internal  
wall

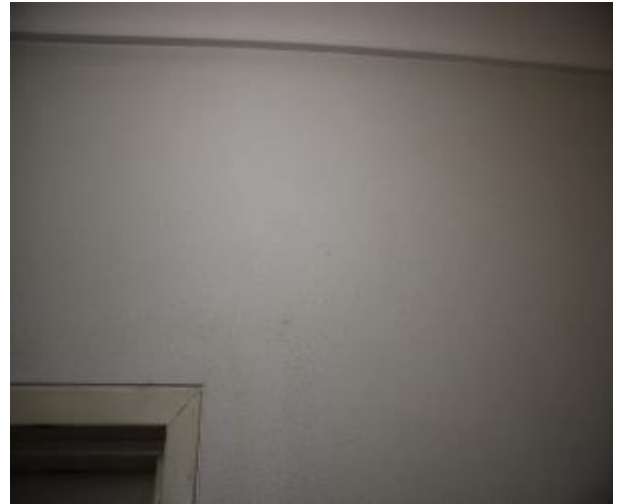
Figure 769 - General condition of corridor internal wall

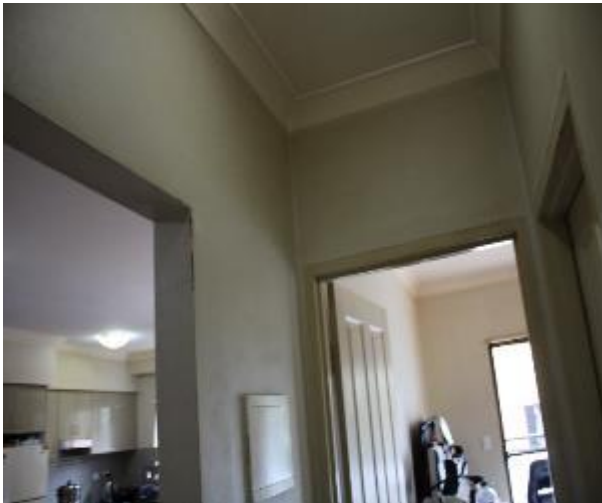
Figure 770 - Crack propagation through corridor internal wall

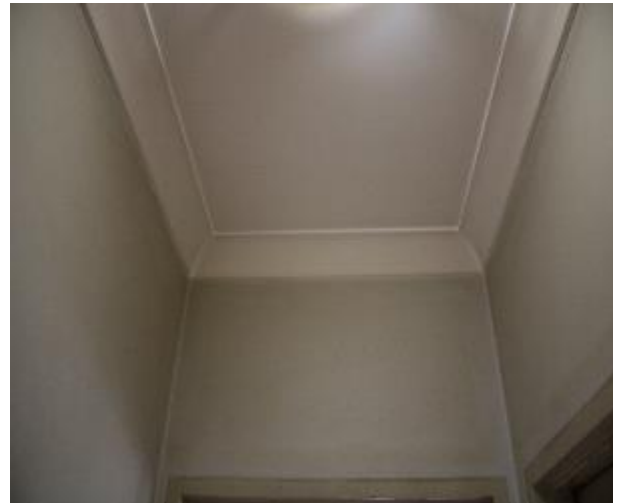
Figure 771 - General condition of corridor internal wall

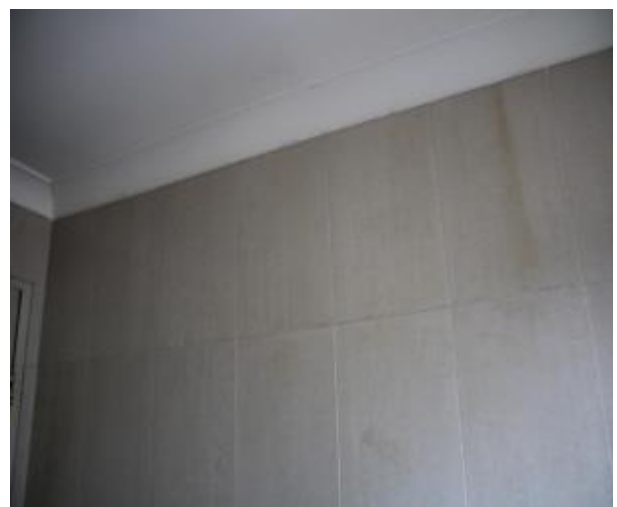
Figure 779 - General condition of bathroom 1 internal wall

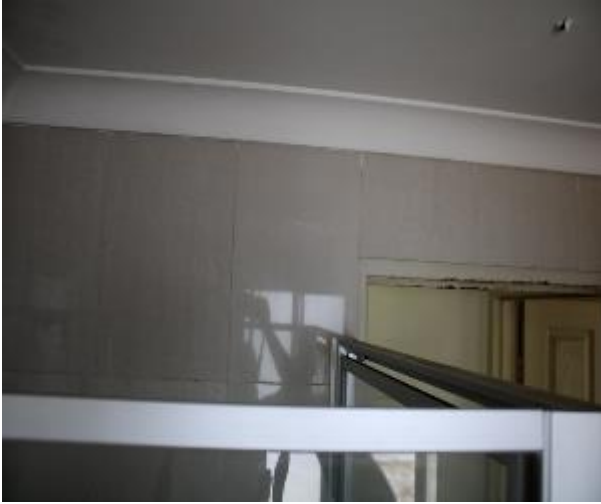
Figure 780 - General condition of bathroom 1 internal wall

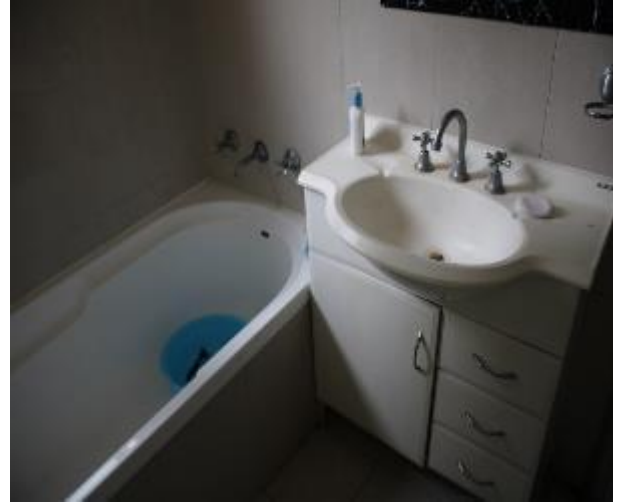
Figure 781 - General condition of bathroom 1 internal wall

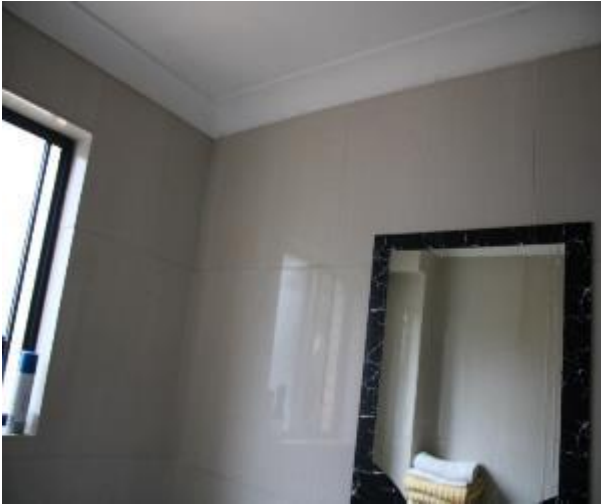
Figure 782 - General condition of bathroom 1 internal wall

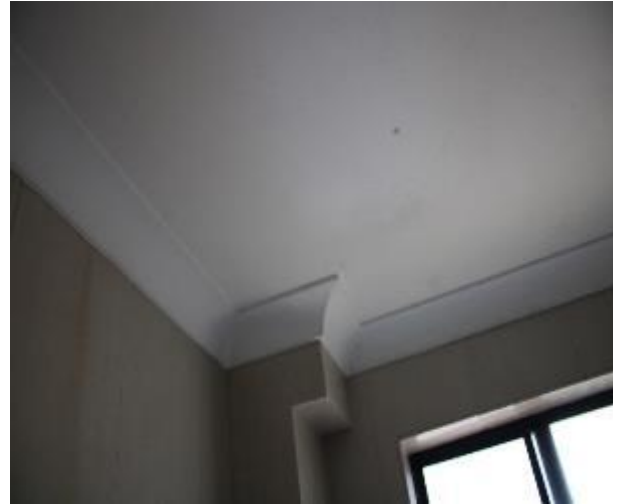
Figure 783 - General condition of bathroom 1 internal wall

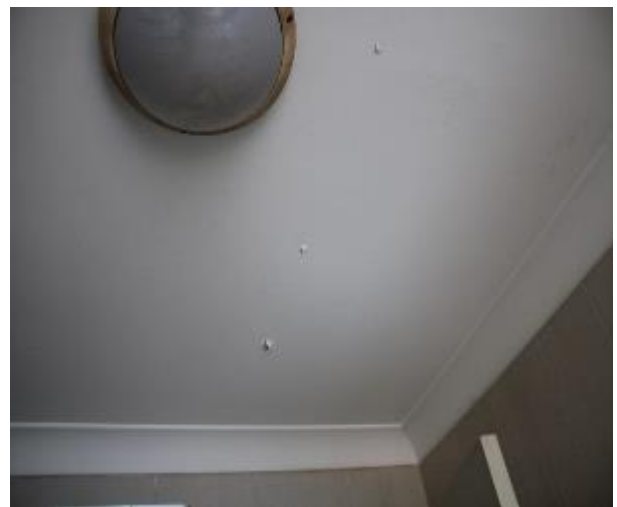
Figure 785 - General condition of bathroom 1 ceiling

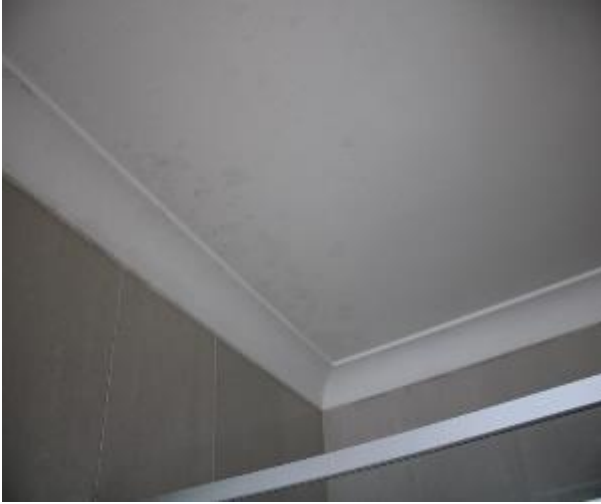
Figure 786 - General condition of bathroom 1 ceiling

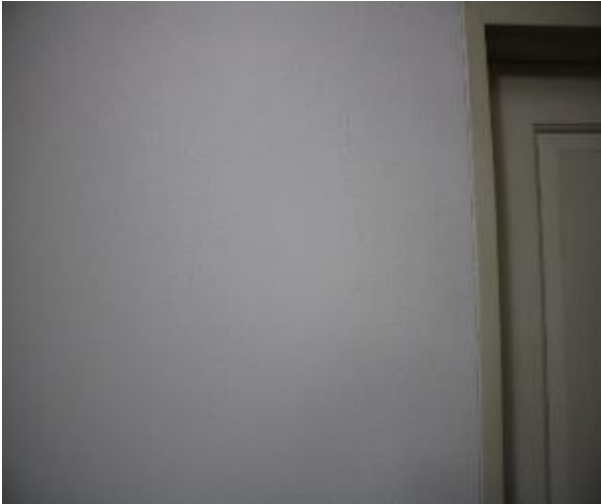
Figure 788 - General condition of bedroom 1 internal wall

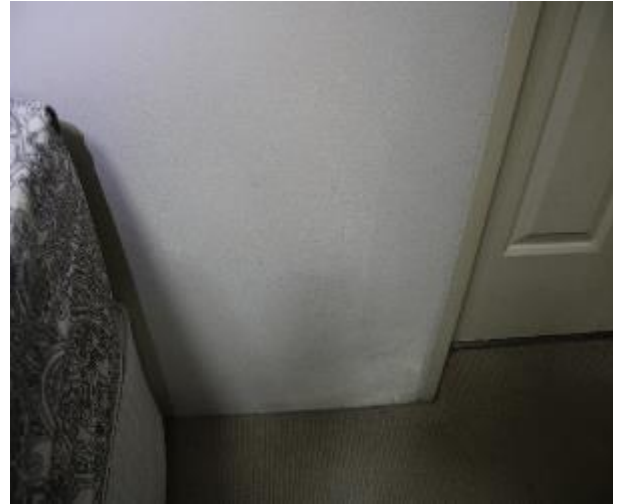
Figure 789 - Crack propagation through bedroom 1 internal wall

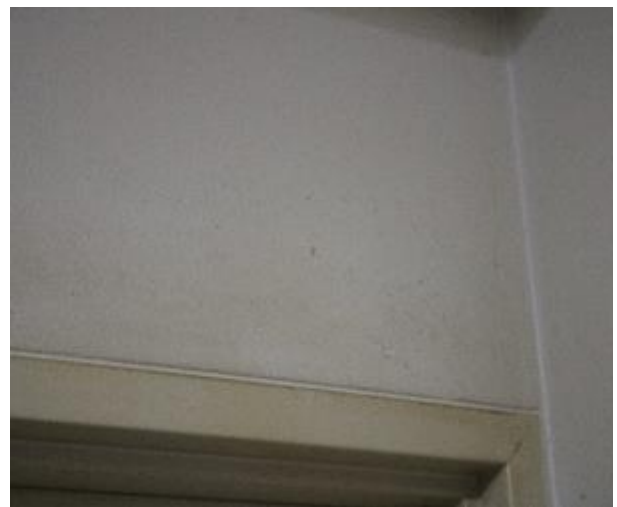
Figure 791 - Crack propagation through bedroom 1 internal wall

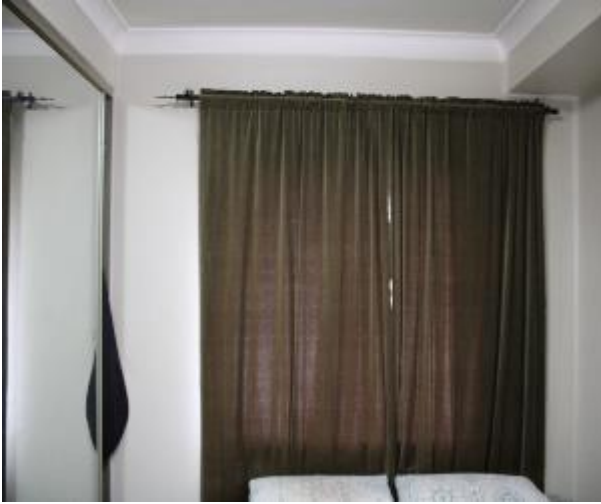
Figure 792 - Crack propagation through bedroom 1 internal wall

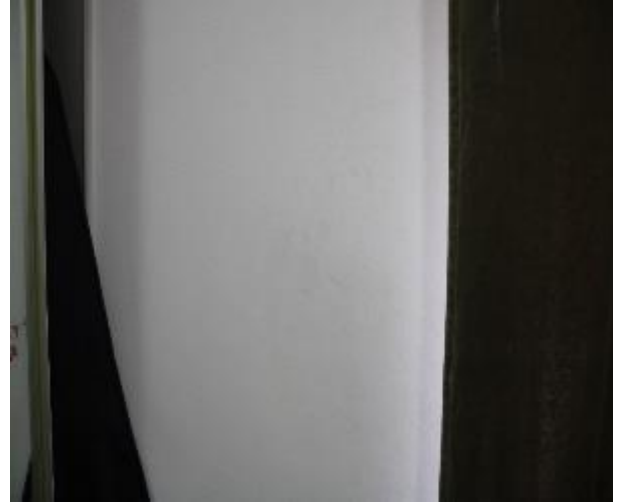
Figure 793 - General condition of bedroom 1 internal wall

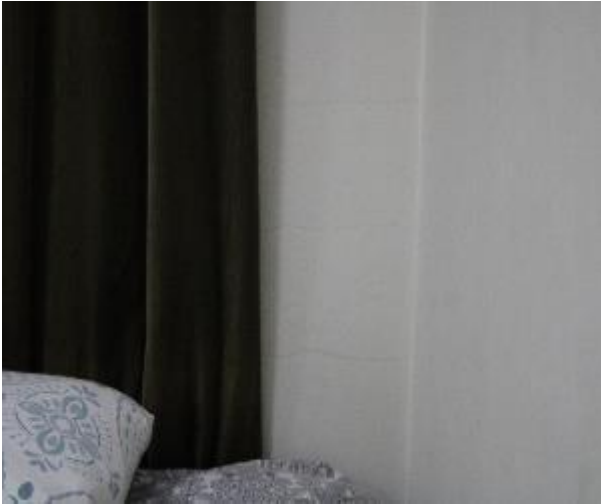
Figure 794 - Crack propagation through bedroom 1 internal wall

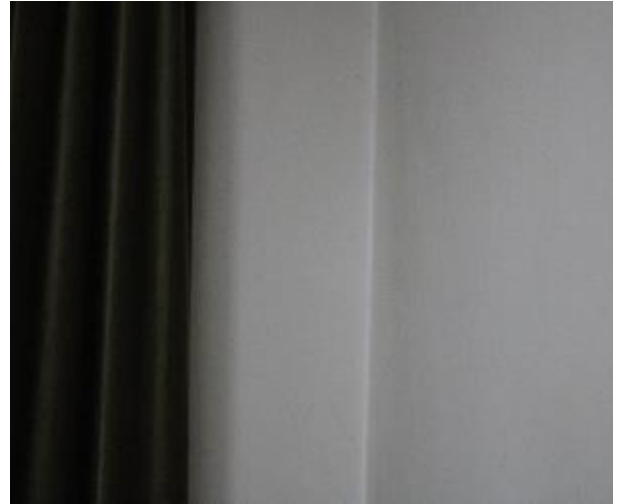
Figure 795 - Crack propagation through bedroom 1 internal wall

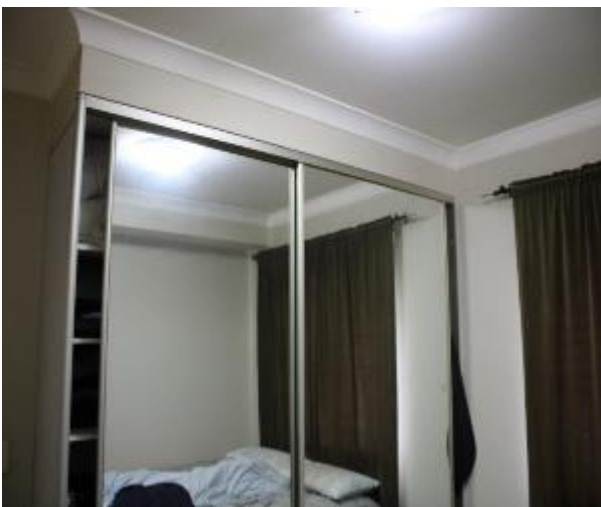
Figure 796 - Crack propagation through bedroom 1 internal wall

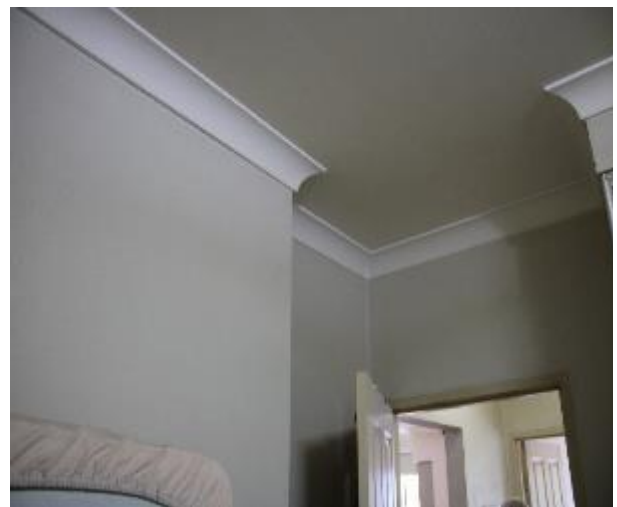
Figure 797 - General condition of bedroom 1 internal wall

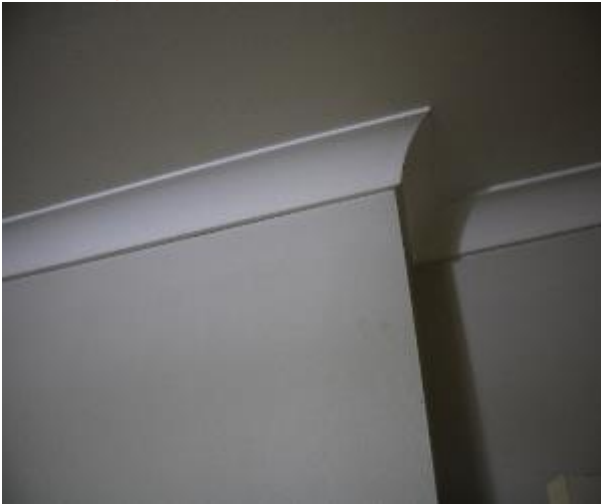
Figure 798 - General condition of bedroom 1 internal wall

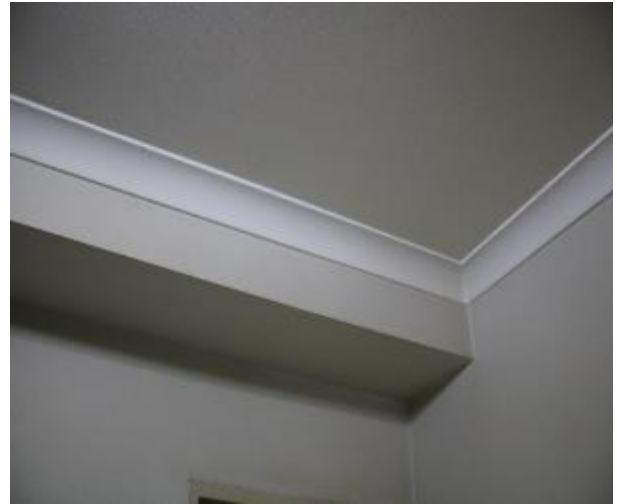
Figure 799 - General condition of bedroom 1 internal wall

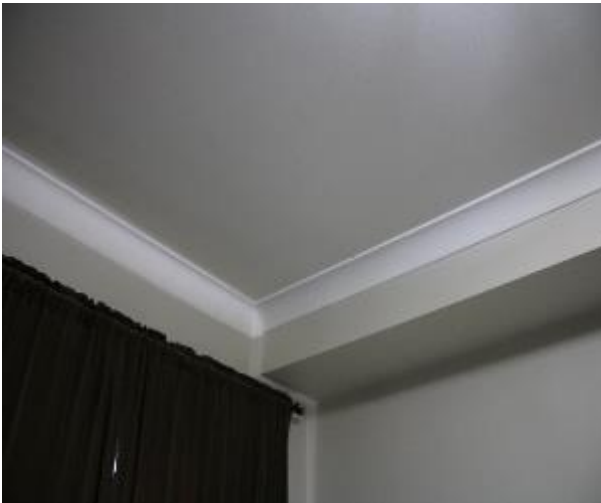
Figure 800 - General condition of bedroom 1 ceiling

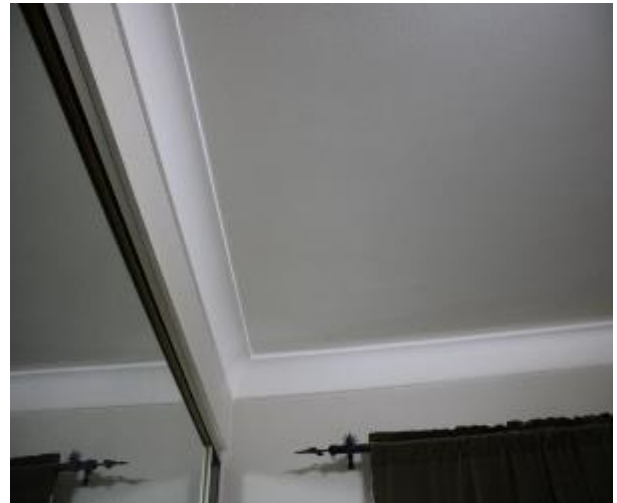
Figure 801 - General condition of bedroom 1 ceiling

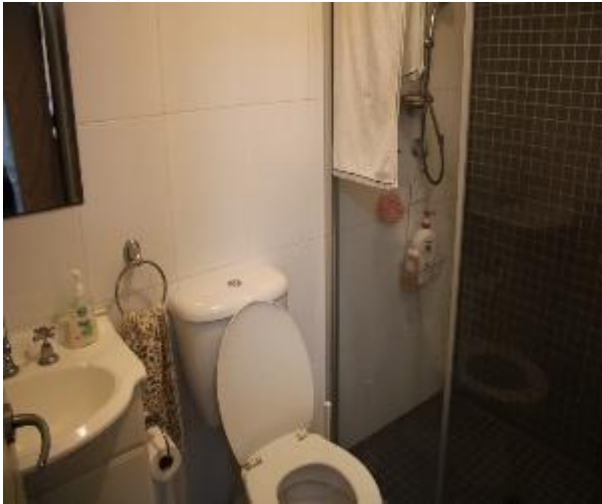
Figure 805 - General condition of ensuite bathroom internal wall

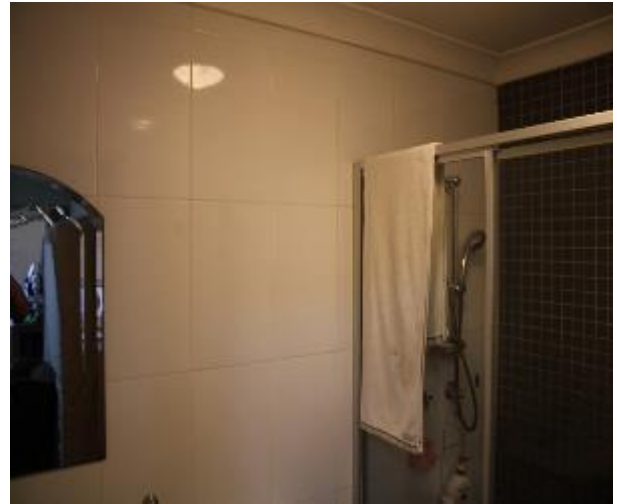
Figure 806 - General condition of ensuite bathroom internal wall

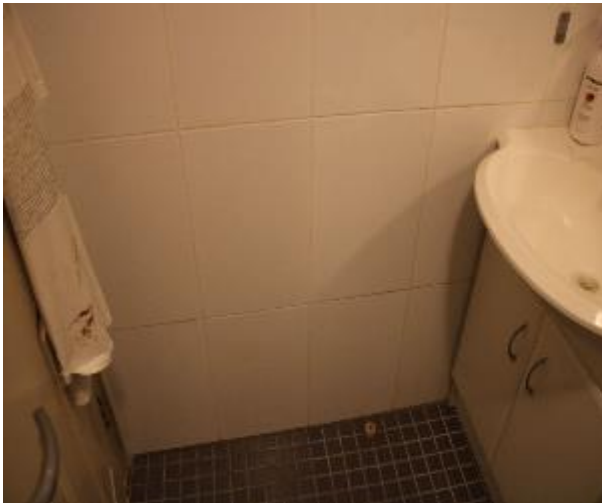
Figure 807 - General condition of ensuite bathroom internal wall

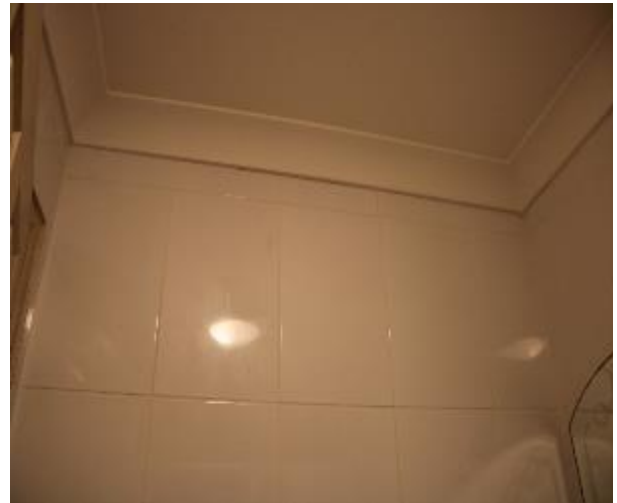
Figure 808 - General condition of ensuite bathroom internal wall

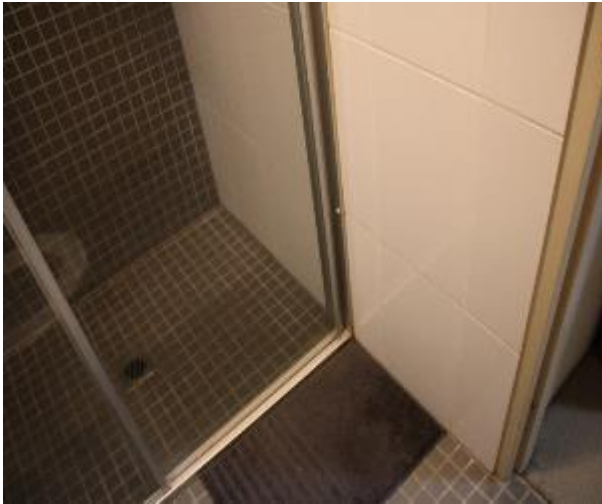
Figure 811 - General condition of ensuite bathroom internal wall

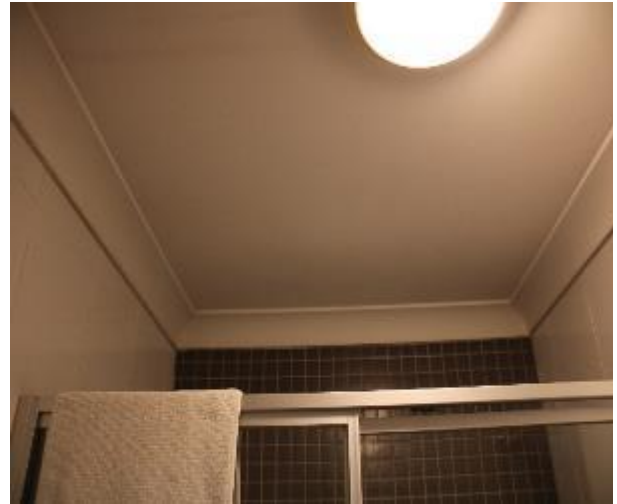
Figure 812 - General condition of ensuite bathroom ceiling

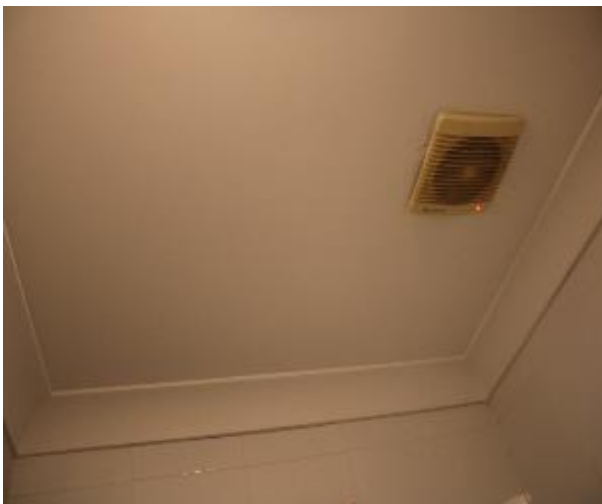
Figure 813 - General condition of ensuite bathroom ceiling

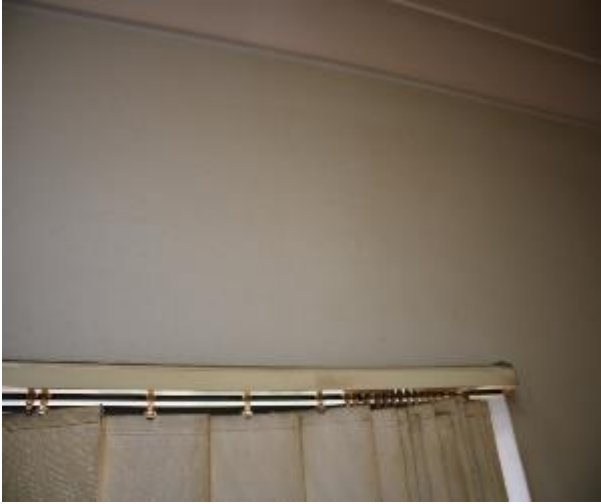
Figure 817 - Crack propagation through study internal wall

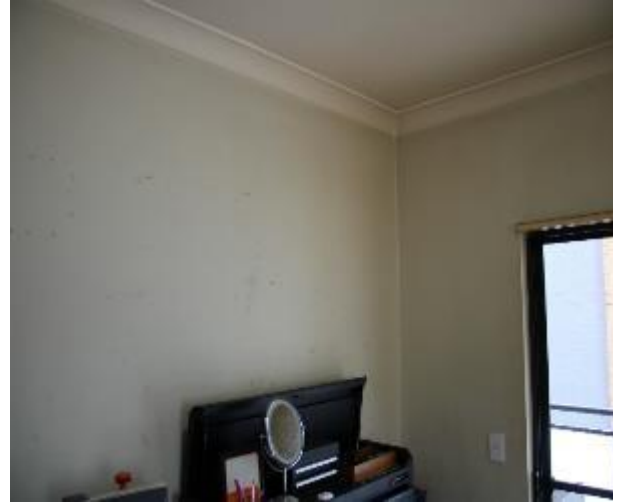
Figure 818 - General condition of study internal wall

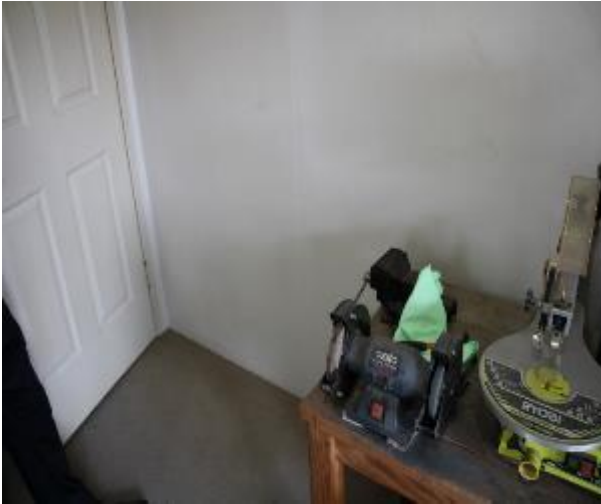
Figure 819 - General condition of study internal wall

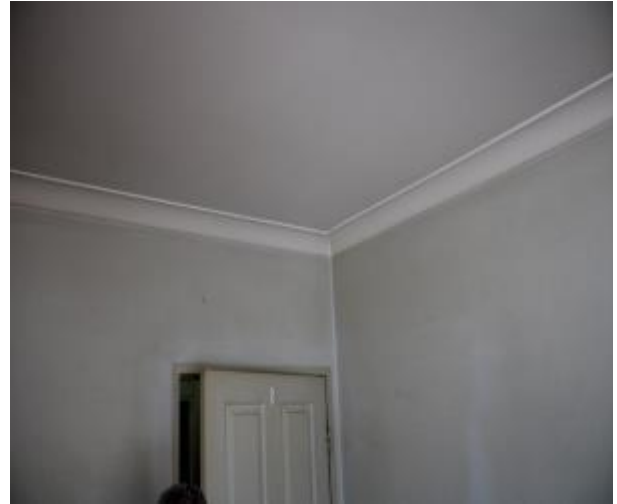
Figure 820 - General condition of study internal wall

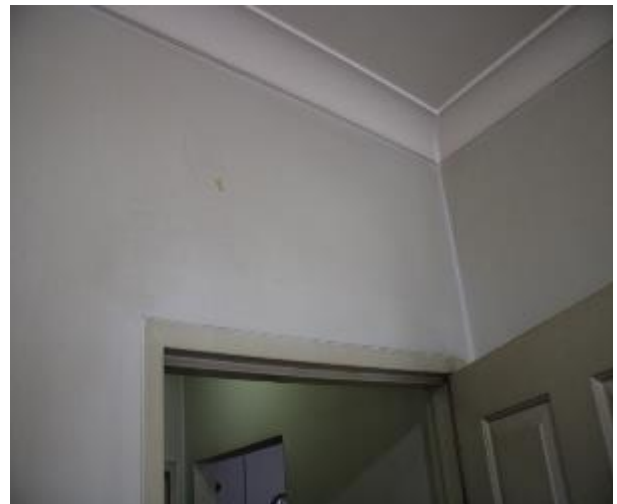
Figure 822 - General condition of study internal wall
