# **Pre-Dilapidation Report**

**19 GEORGE STREET**

**FRONT BUILDING (UNITS 1-19)**

Project Reference: 20250047.19G.2

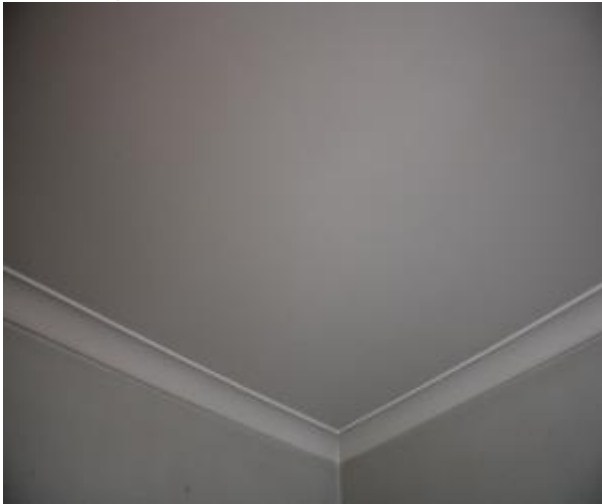
Figure 823 - General condition of study ceiling

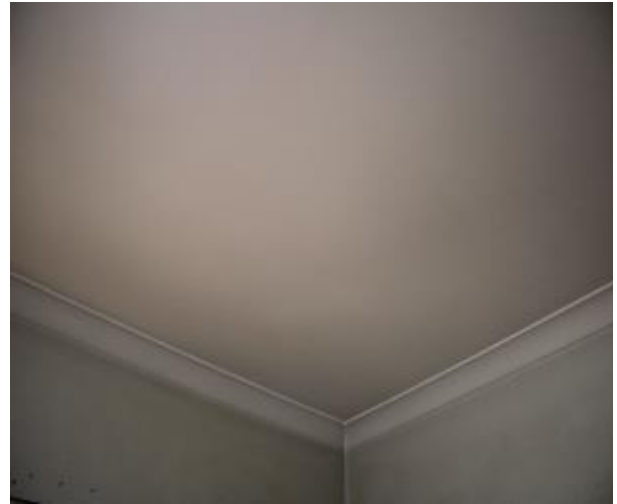
Figure 824 - General condition of study ceiling

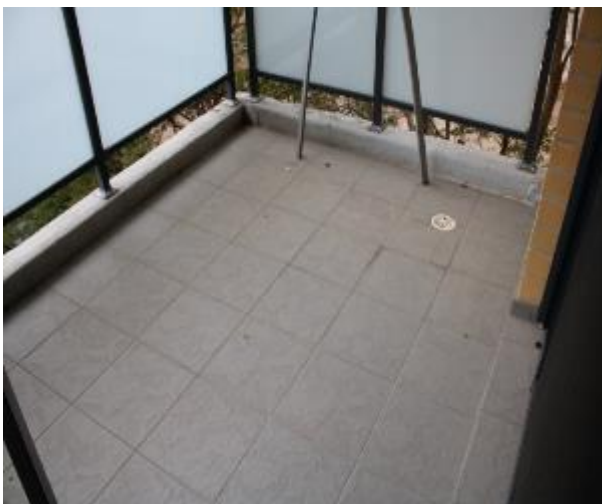
Figure 827 - General condition of balcony floor tiles

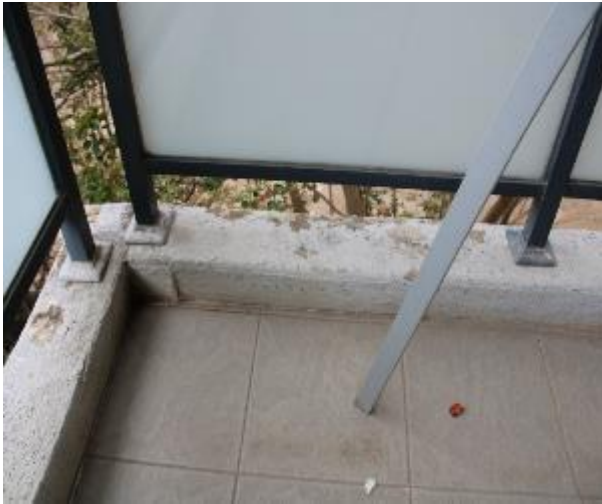
Figure 829 - General condition of balcony floor tiles

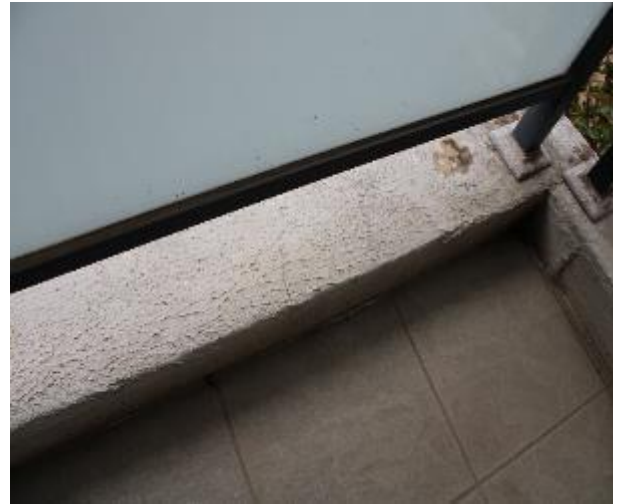
Figure 830 - Crack propagation through external wall

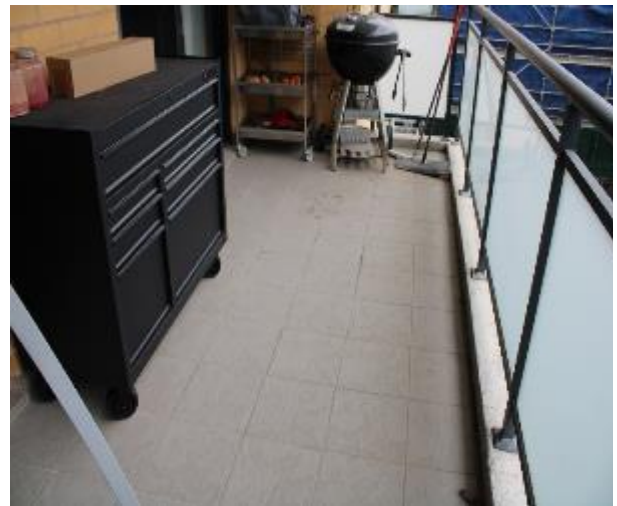
Figure 832 - General condition of balcony floor tiles

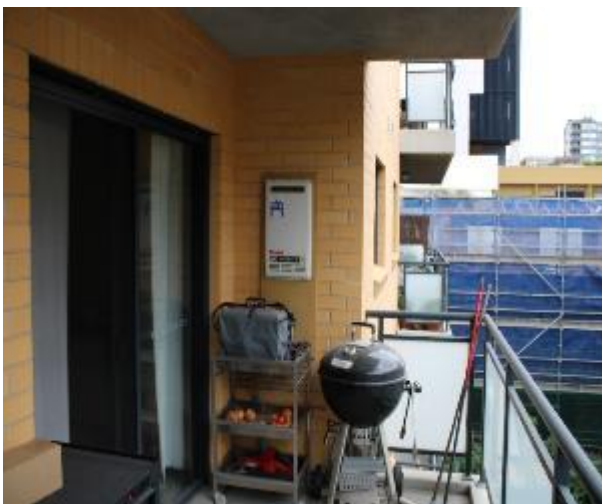
Figure 833 - General condition of external wall

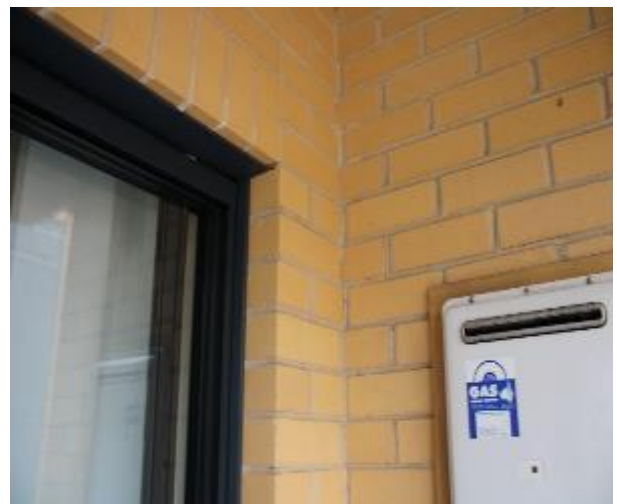
Figure 834 - Crack propagation through external wall

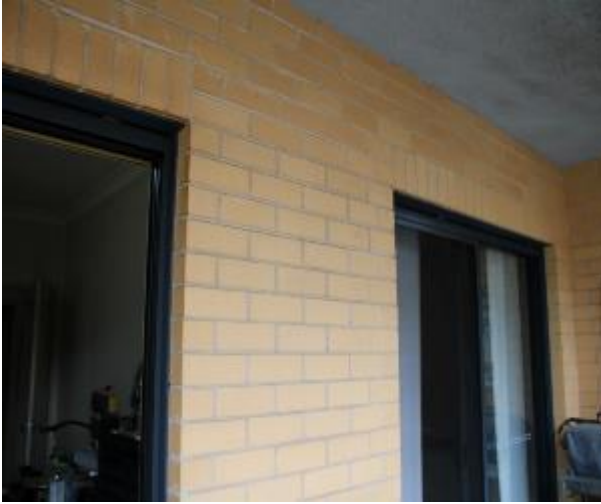
Figure 835 - General condition of external wall

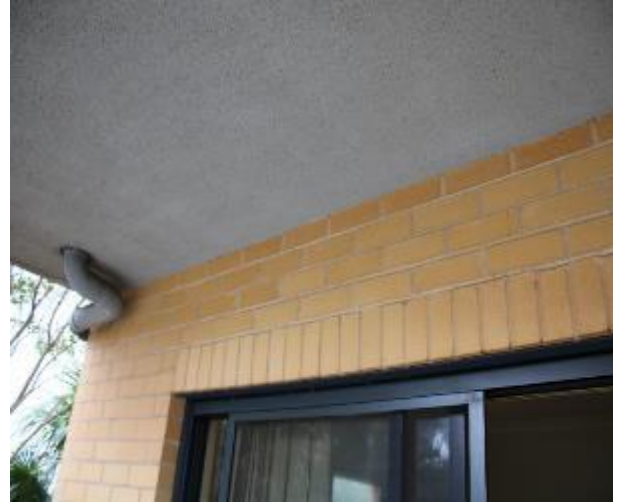
Figure 836 - General condition of external wall

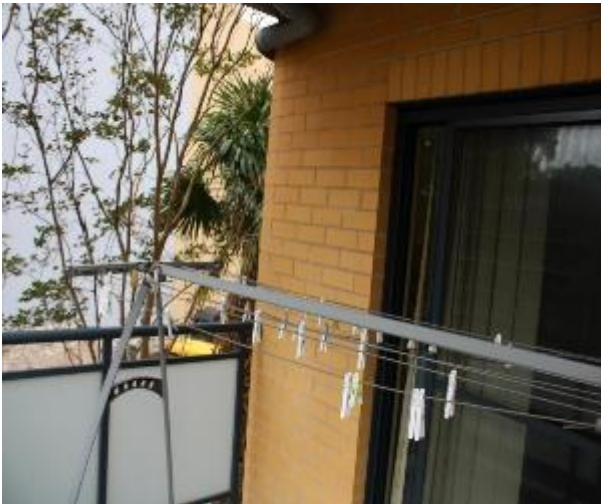
Figure 837 - General condition of external wall

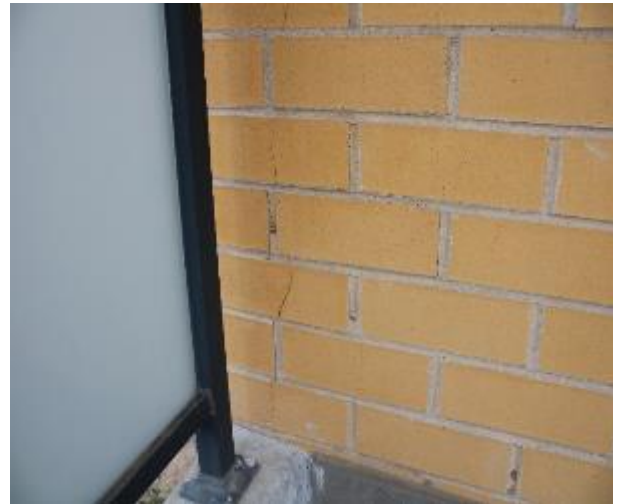
Figure 838 - Crack propagation through external wall

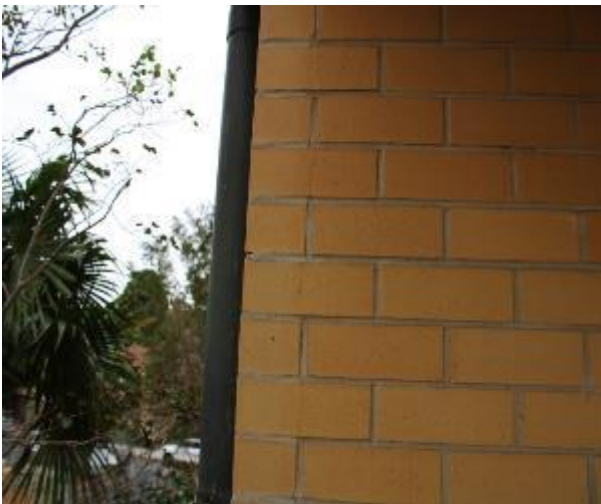
Figure 839 - Crack propagation through external wall

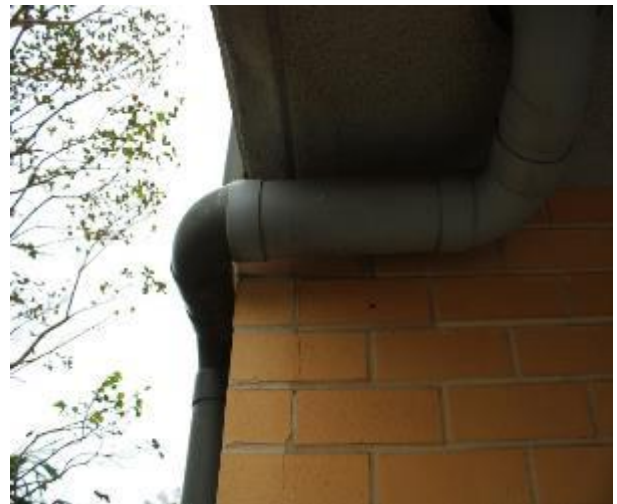
Figure 840 - Crack propagation through external wall

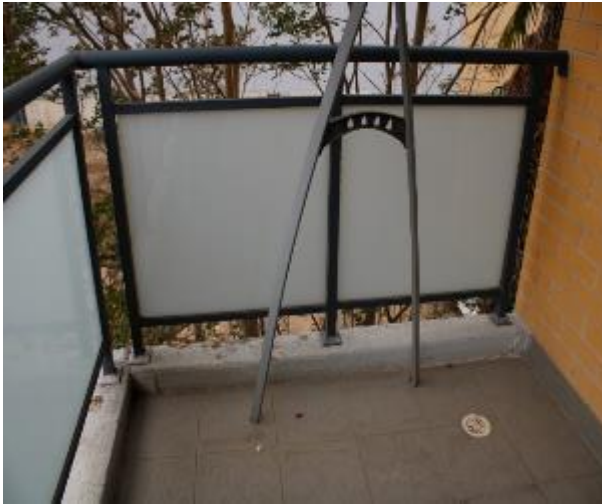
Figure 841 - General condition of balcony balustrade

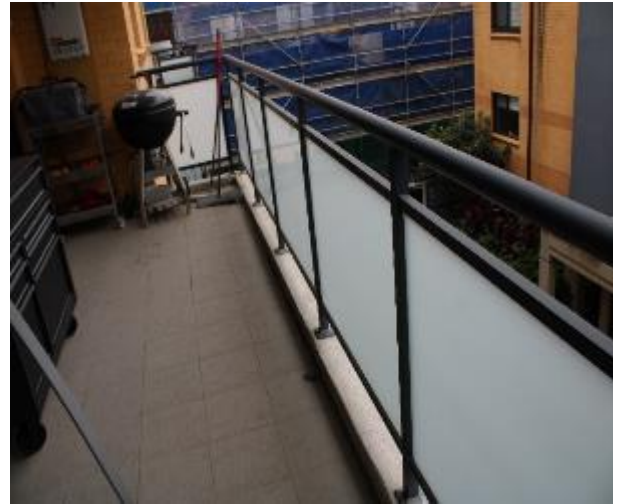
Figure 842 - General condition of balcony balustrade

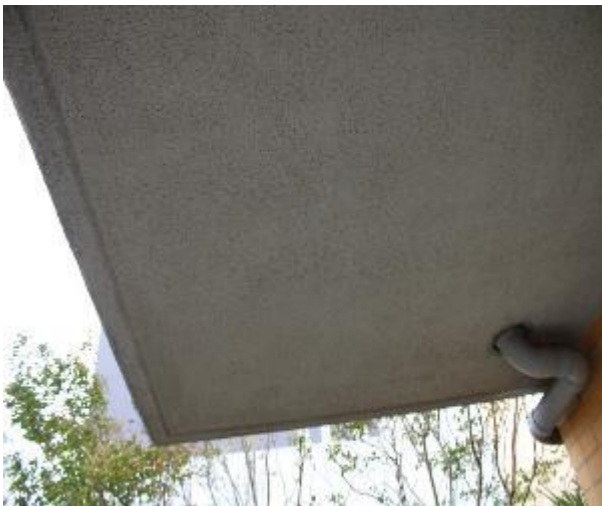
Figure 843 - General condition of balcony underside slab

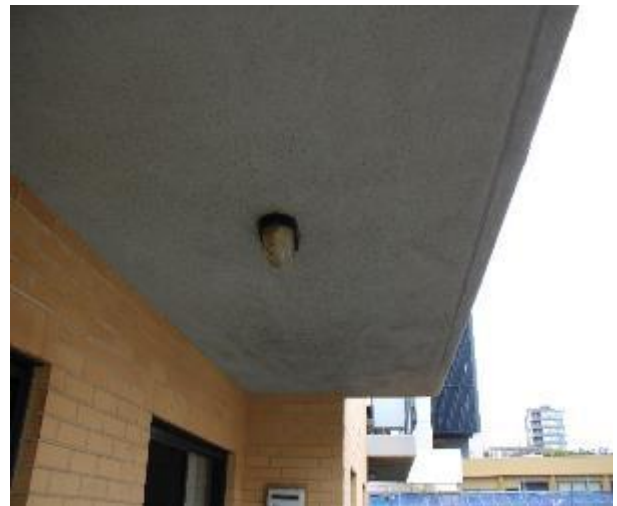
Figure 844 - General condition of balcony underside slab

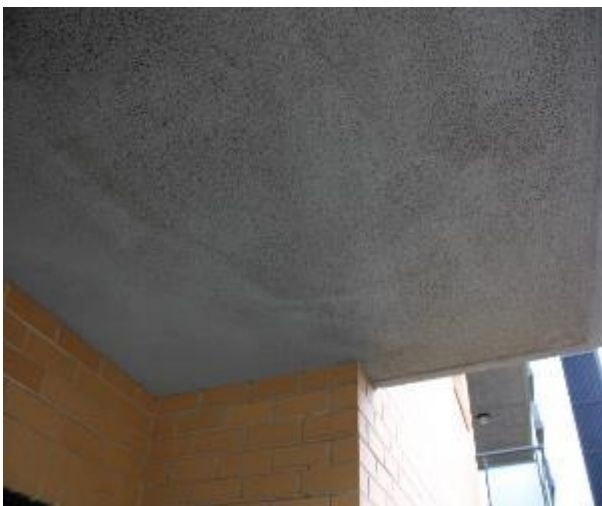
Figure 845 - General condition of balcony underside slab

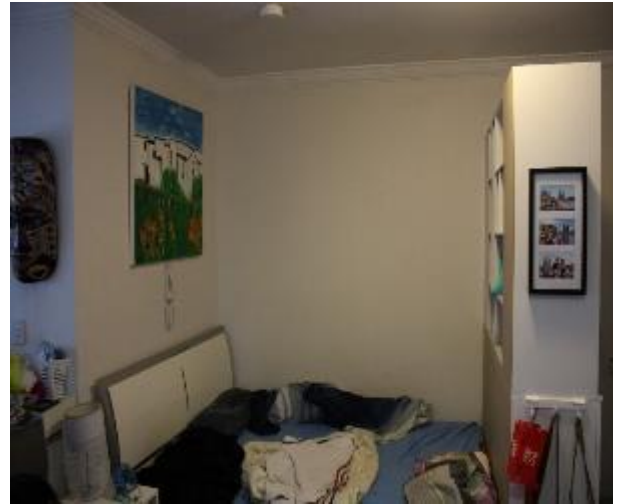
Figure 847 - General condition of bedroom 1 internal wall

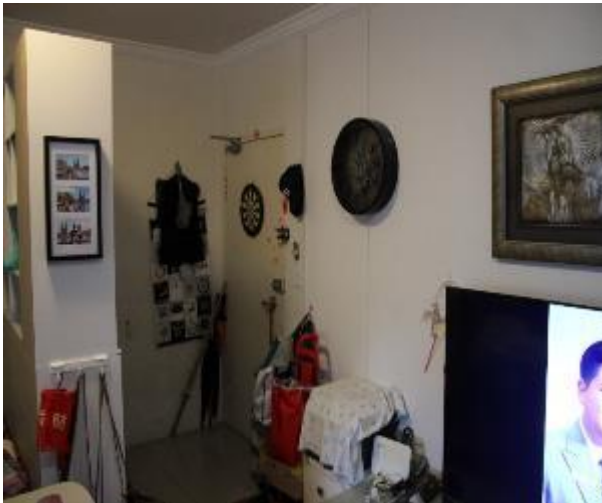
Figure 848 - General condition of bedroom 1 internal wall

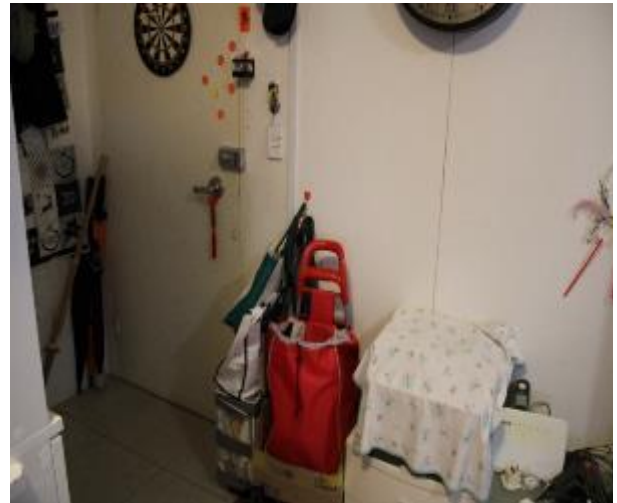
Figure 849 - General condition of bedroom 1 internal wall

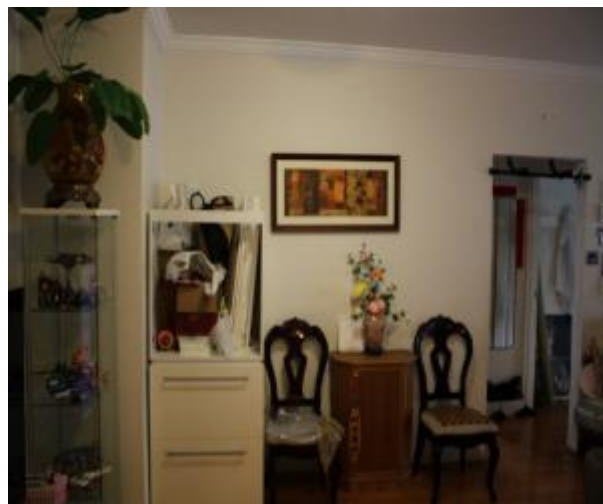
Figure 853 - General condition of bedroom 1 internal wall

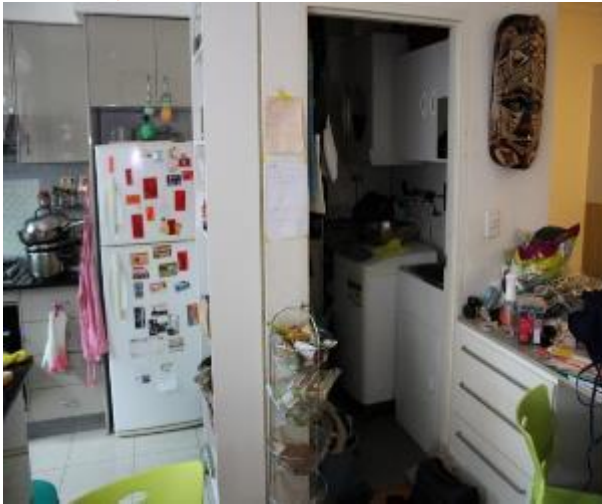
Figure 858 - General condition of bedroom 1 internal wall

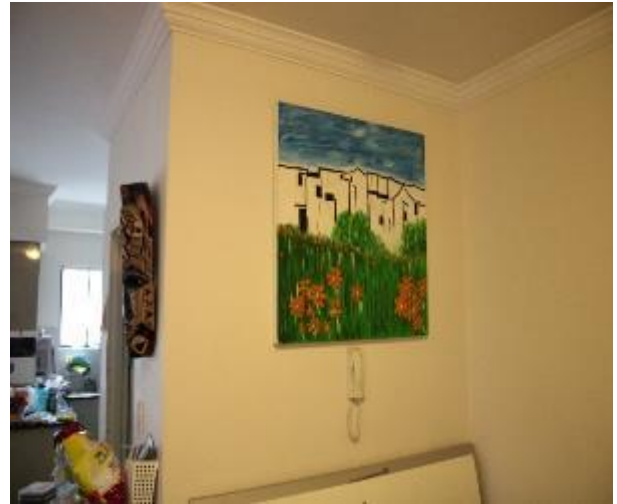
Figure 859 - General condition of bedroom 1 internal wall

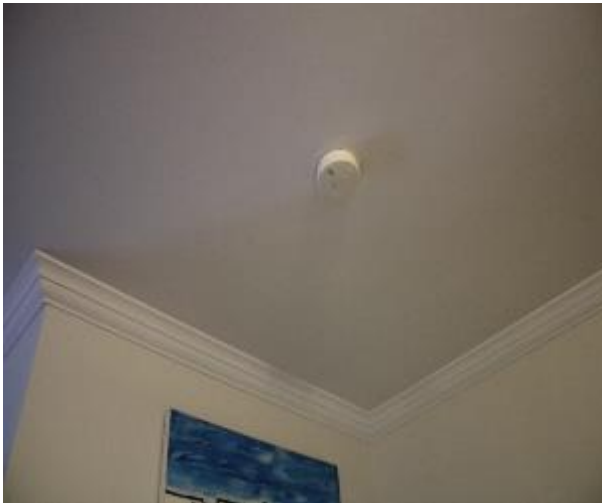
Figure 860 - General condition of bedroom 1 ceiling

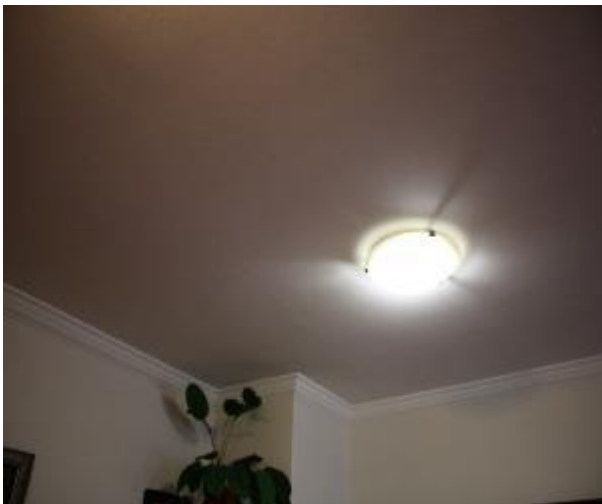
Figure 862 - General condition of bedroom 1 ceiling

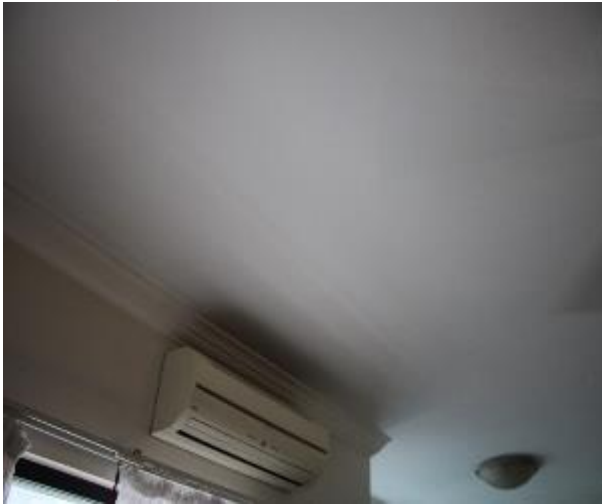
Figure 864 - General condition of bedroom 1 ceiling

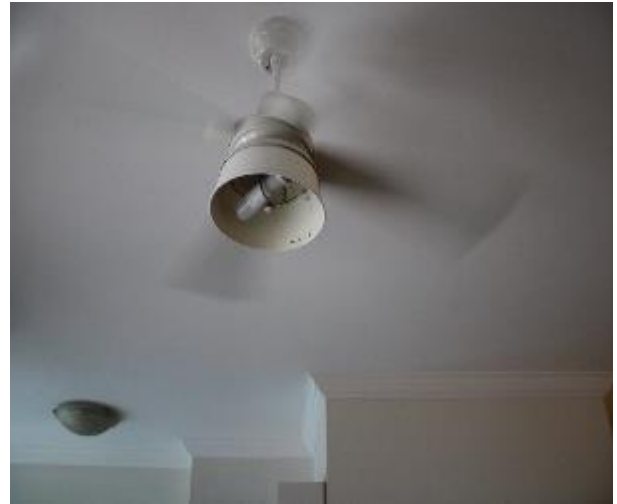
Figure 865 - General condition of bedroom 1 ceiling

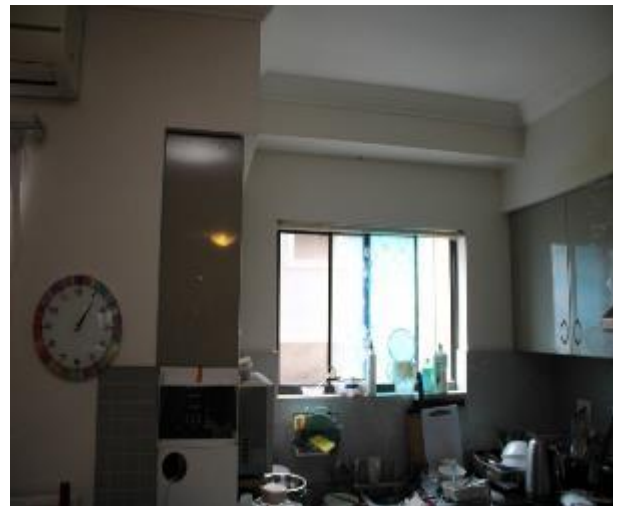
Figure 867 - General condition of kitchen internal wall

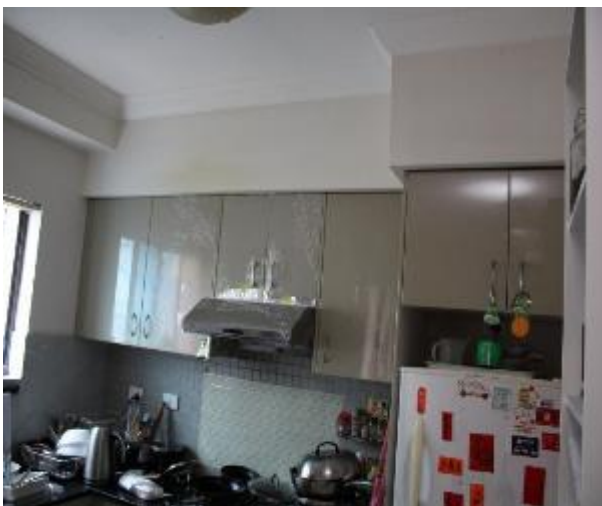
Figure 868 - General condition of kitchen internal wall

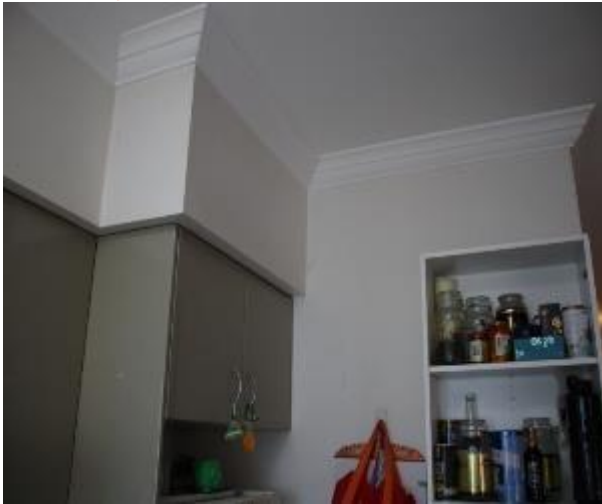
Figure 870 - General condition of kitchen internal wall

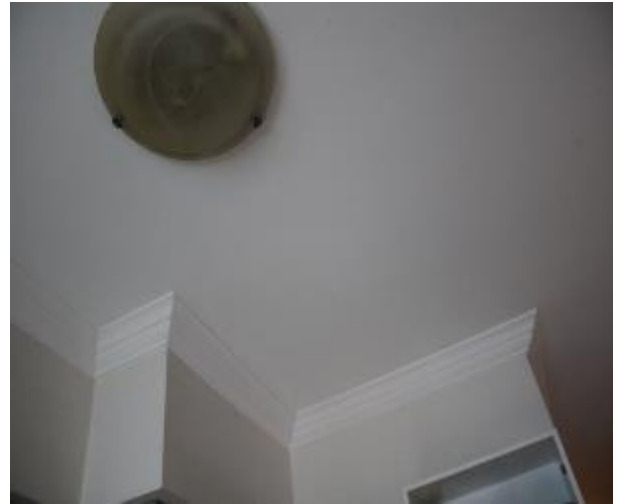
Figure 871 - General condition of kitchen ceiling

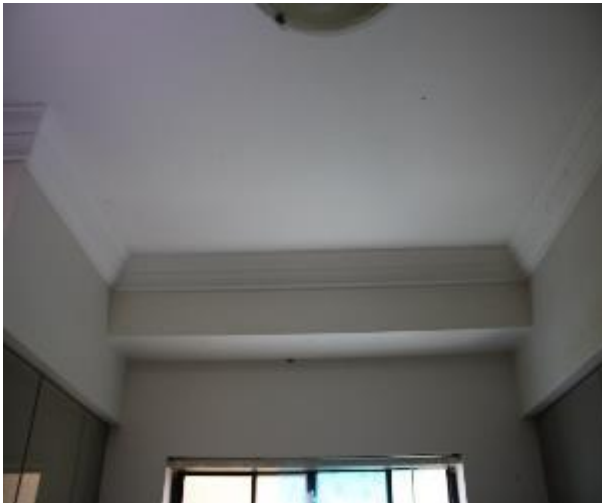
Figure 872 - General condition of kitchen ceiling

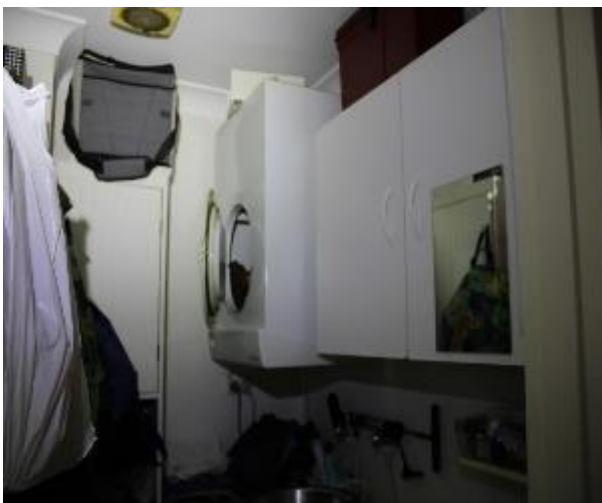
Figure 874 - General condition of laundry internal wall

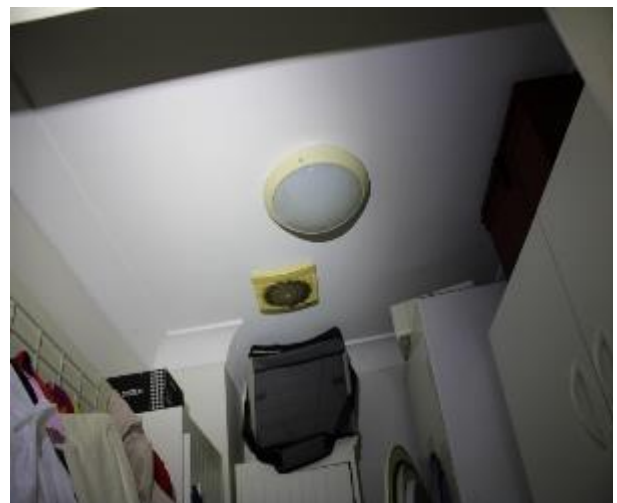
Figure 875 - General condition of laundry ceiling

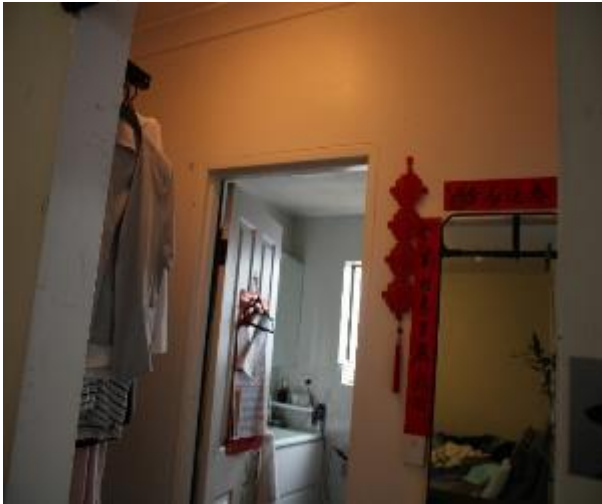
Figure 876 - General condition of corridor internal wall

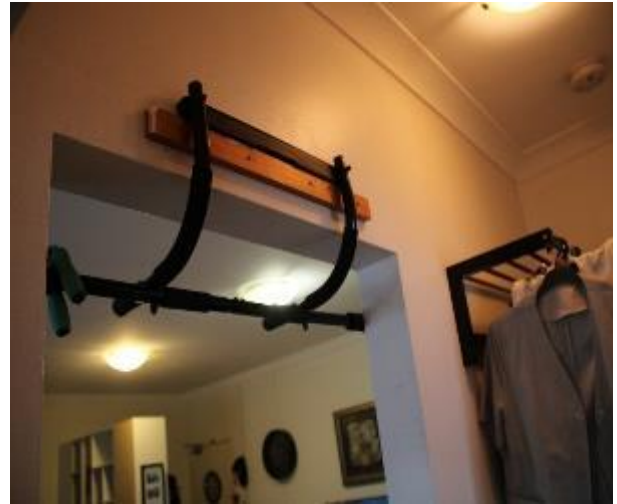
Figure 877 - General condition of corridor internal wall

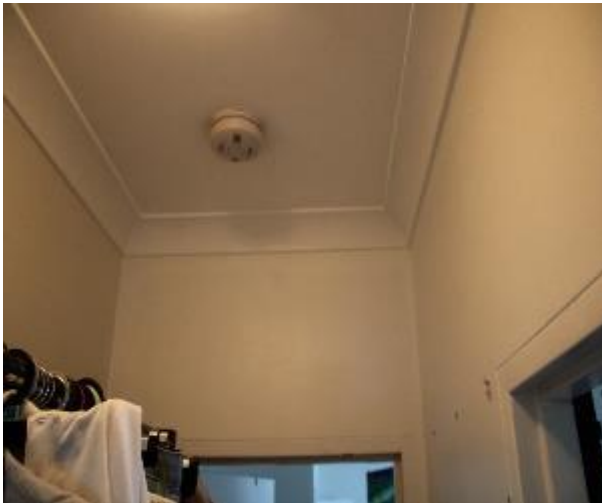
Figure 878 - General condition of corridor internal wall

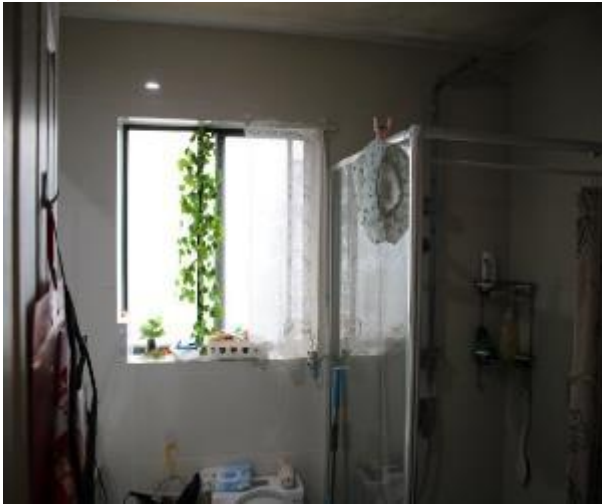
Figure 882 - General condition of bathroom 1 internal wall

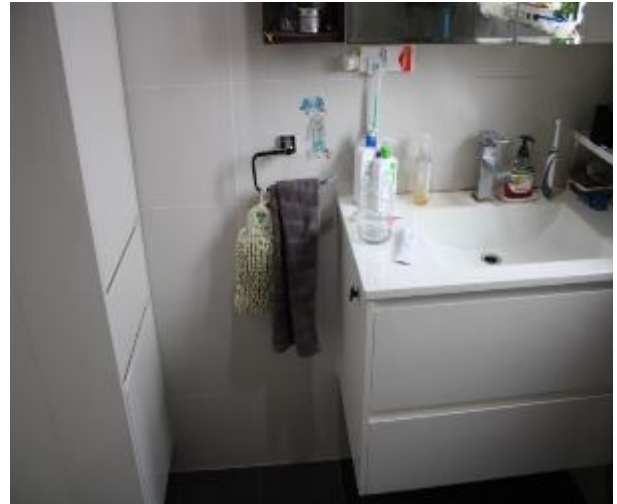
Figure 883 - General condition of bathroom 1 internal wall

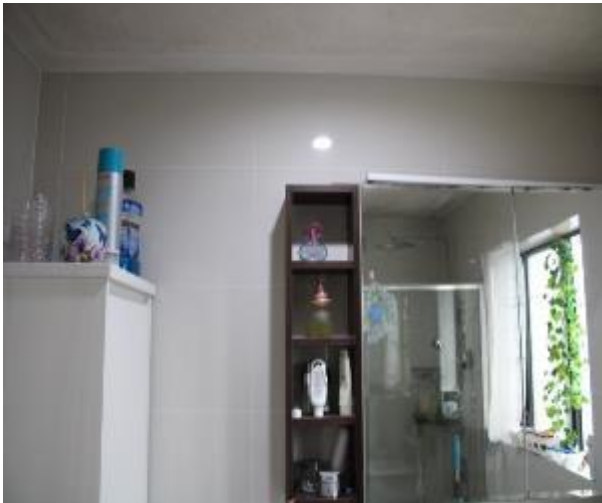
Figure 884 - General condition of bathroom 1 internal wall

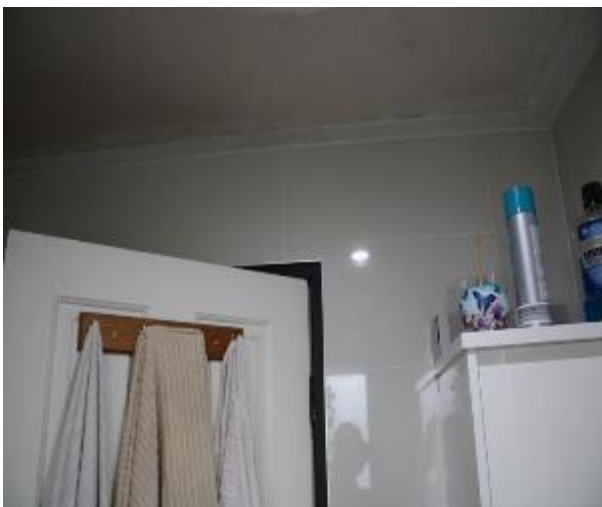
Figure 886 - General condition of bathroom 1 internal wall

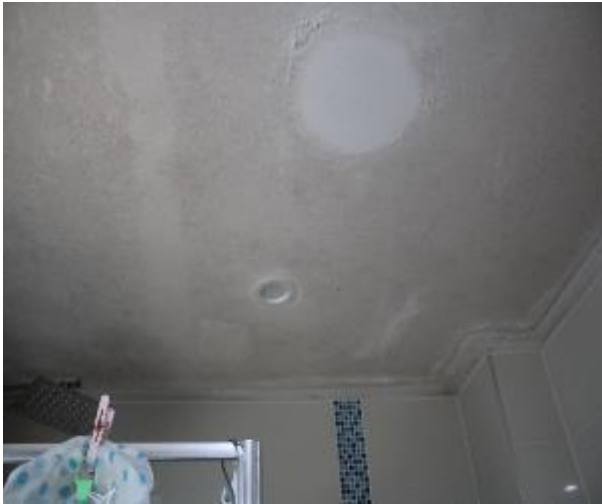
Figure 888 - General condition of bathroom 1 ceiling

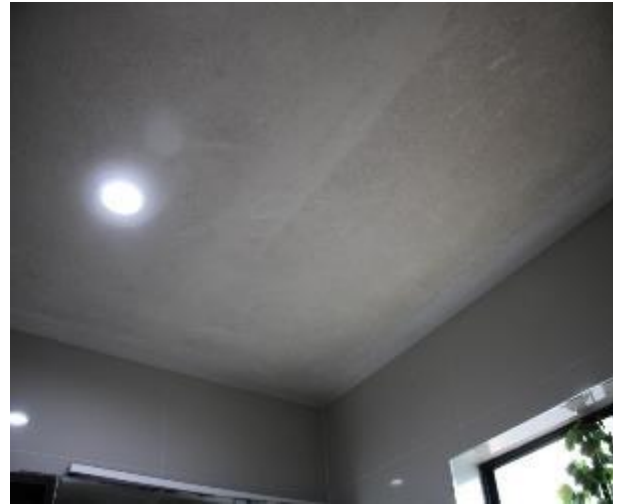
Figure 889 - General condition of bathroom 1 ceiling

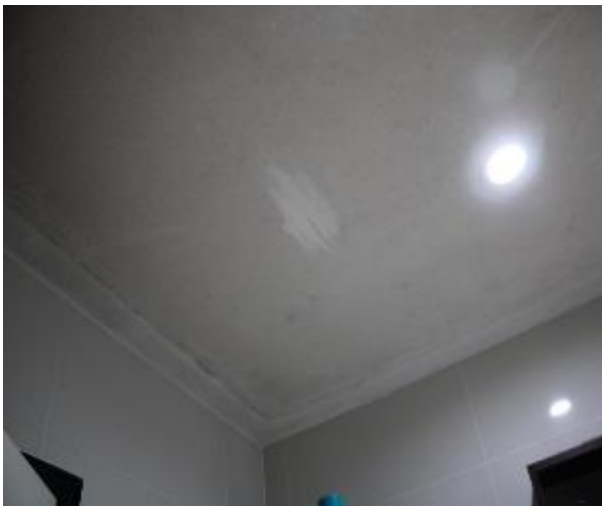
Figure 890 - General condition of bathroom 1 ceiling

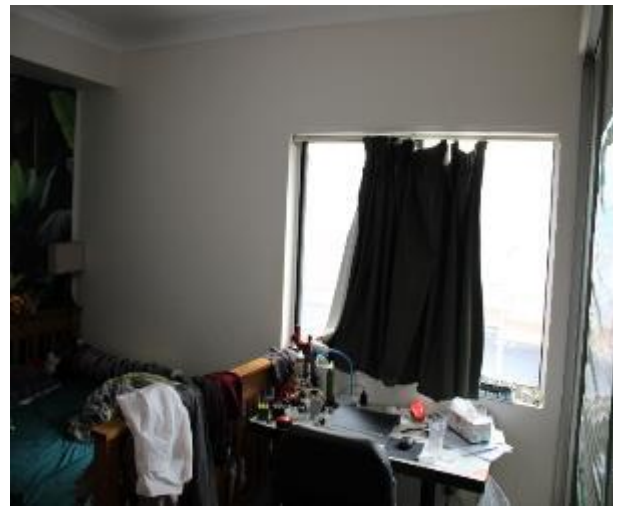
Figure 891 - General condition of bedroom 2 internal wall

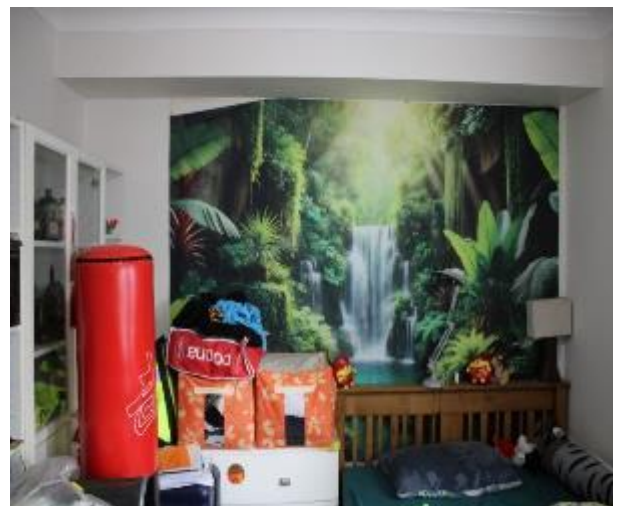
Figure 893 - General condition of bedroom 2 internal wall

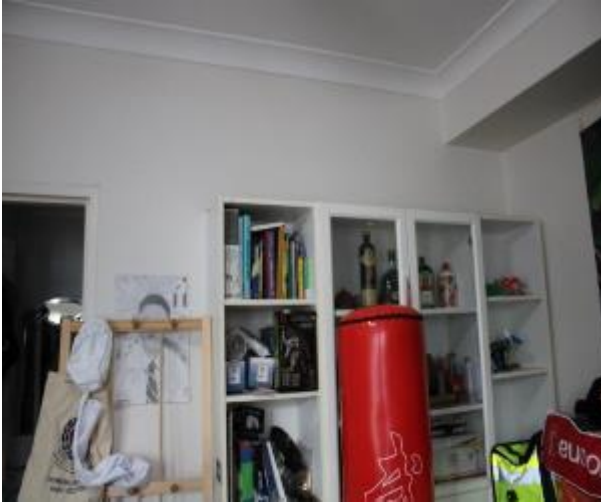
Figure 894 - General condition of bedroom 2 internal wall

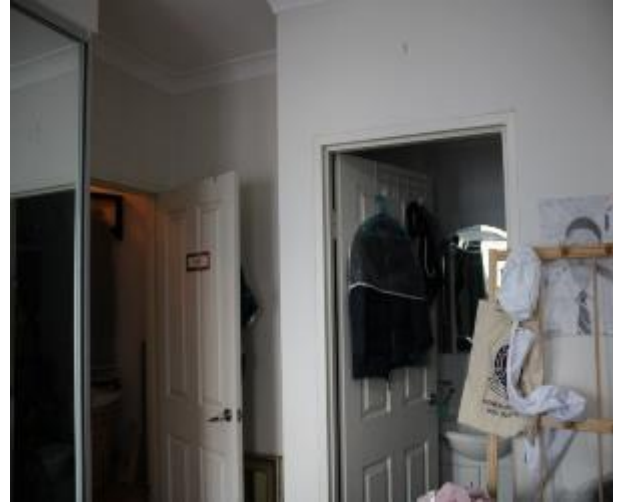
Figure 895 - General condition of bedroom 2 internal wall

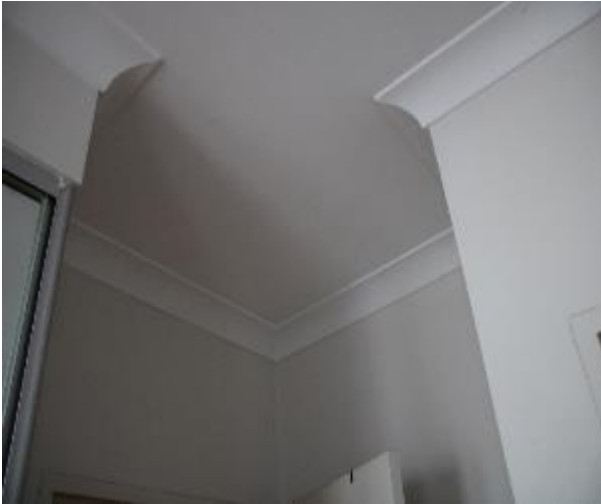
Figure 896 - General condition of bedroom 2 ceiling

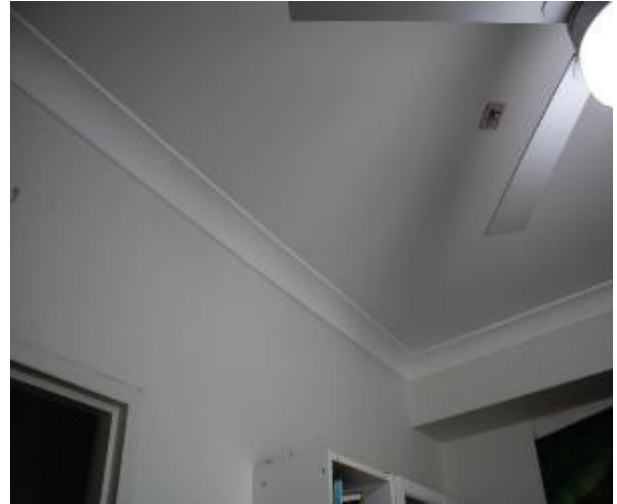
Figure 897 - General condition of bedroom 2 ceiling

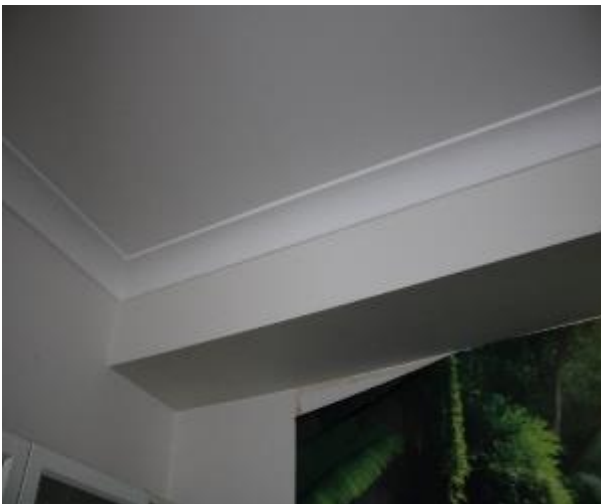
Figure 898 - General condition of bedroom 2 ceiling

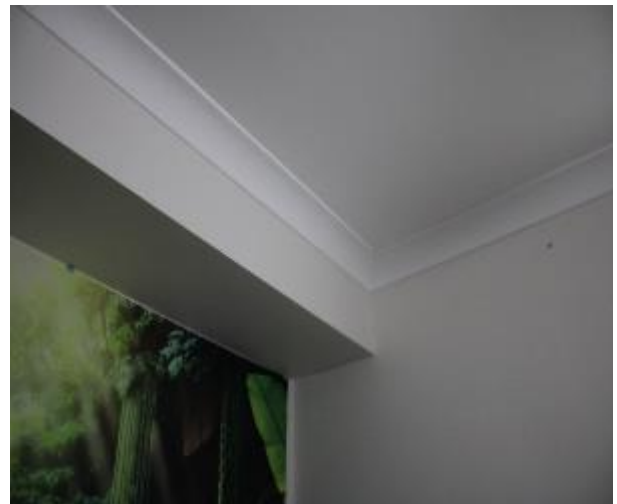
Figure 899 - General condition of bedroom 2 ceiling

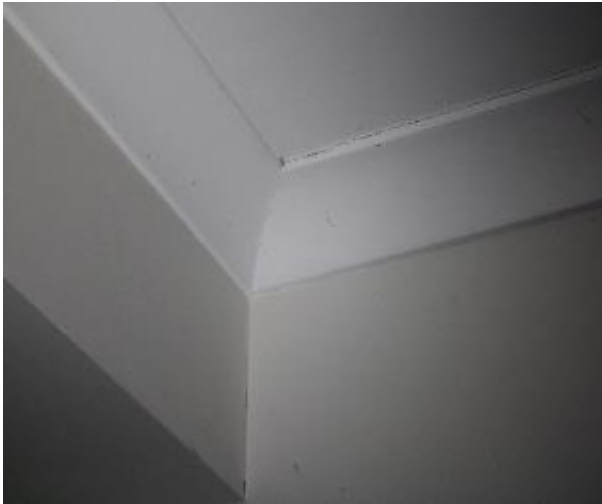
Figure 900 - Crack propagation through bedroom 2 ceiling

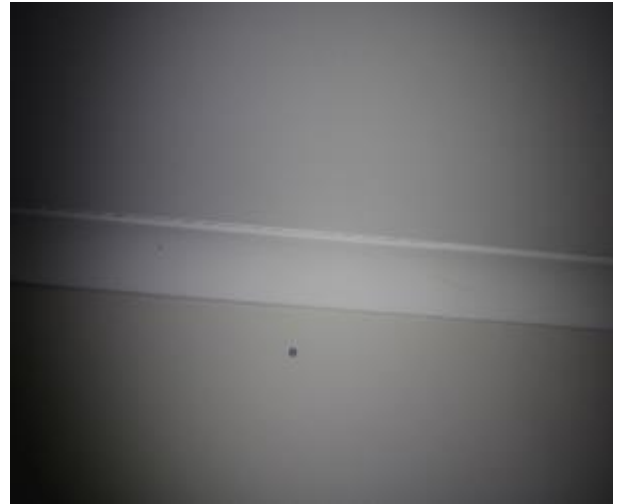
Figure 901 - Crack propagation through bedroom 2 ceiling

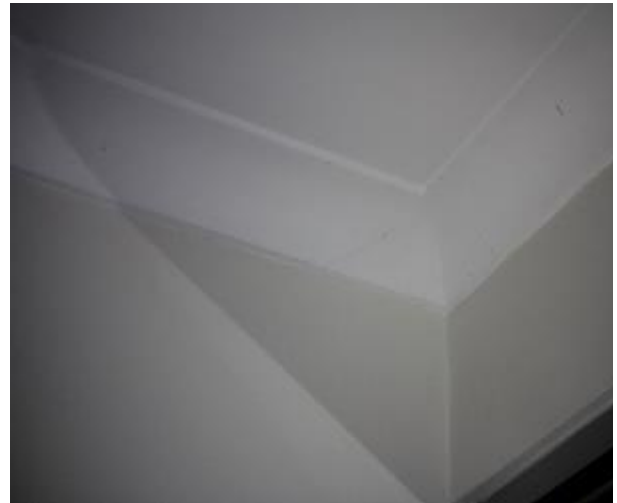
Figure 903 - Crack propagation through bedroom 2 ceiling

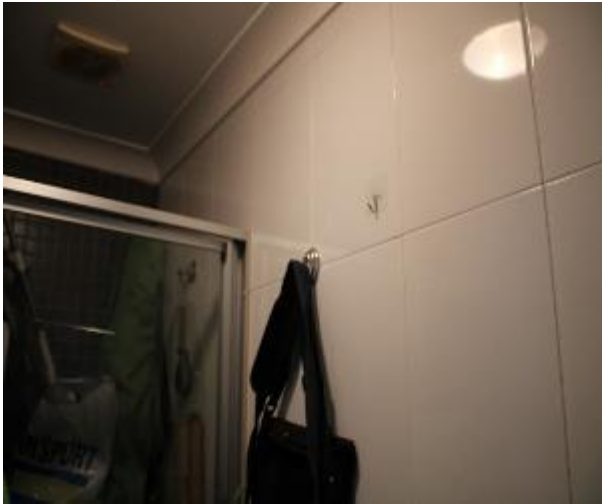
Figure 906 - General condition of ensuite bathroom internal wall

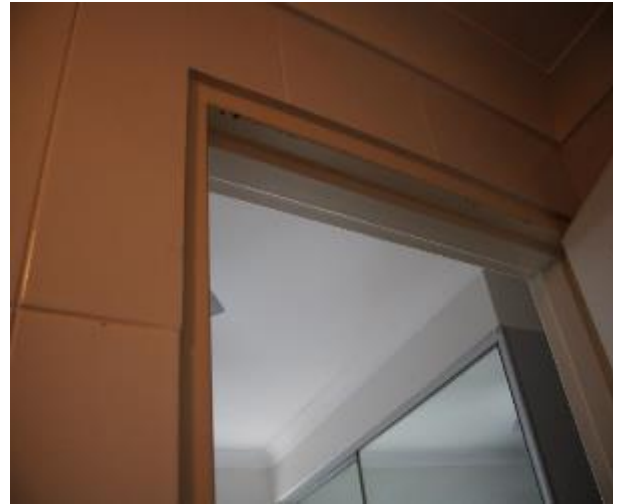
Figure 907 - General condition of ensuite bathroom internal wall

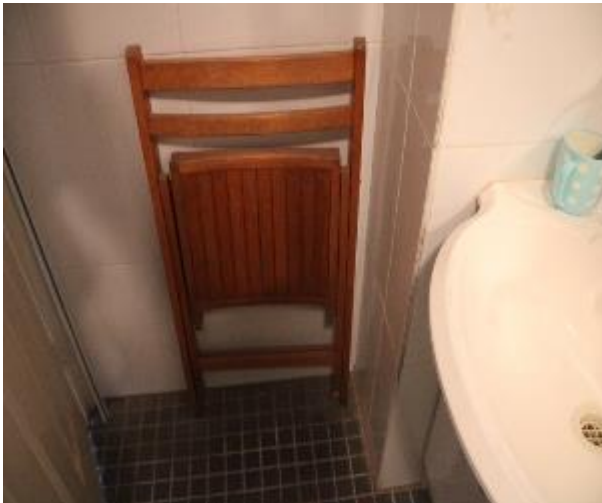
Figure 908 - General condition of ensuite bathroom internal wall

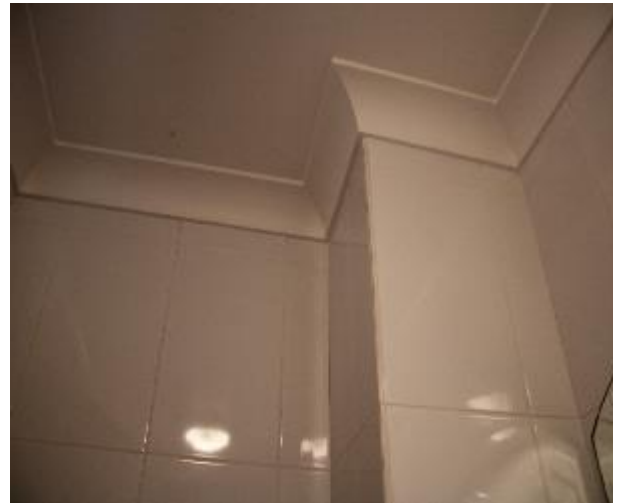
Figure 909 - General condition of ensuite bathroom internal wall

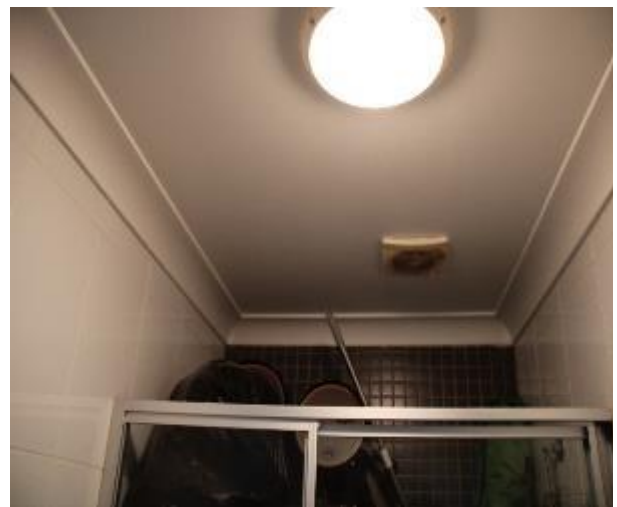
Figure 911 - General condition of ensuite bathroom ceiling

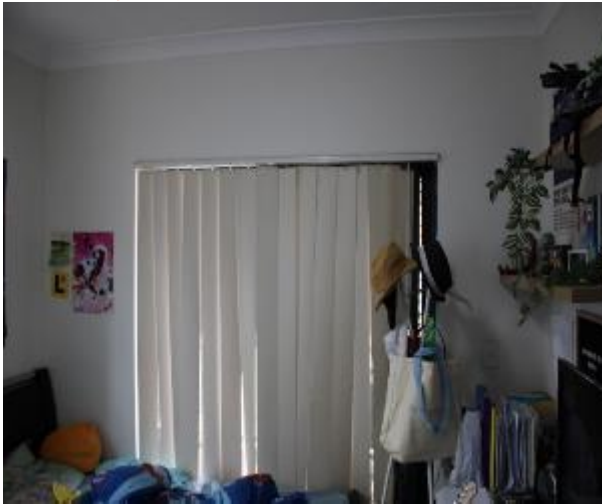
Figure 912 - General condition of bedroom 3 internal wall

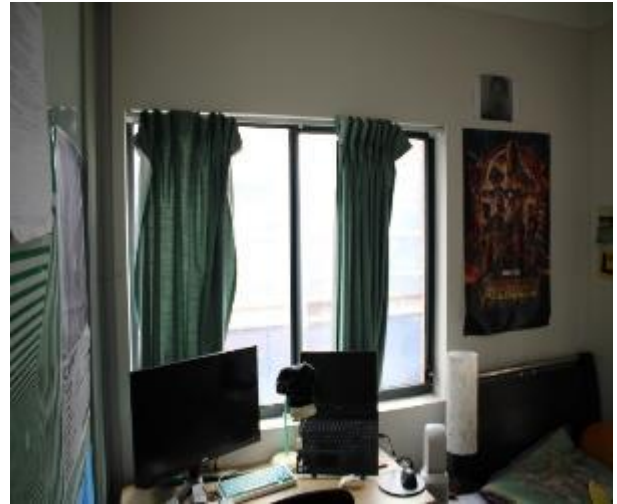
Figure 913 - General condition of bedroom 3 internal wall

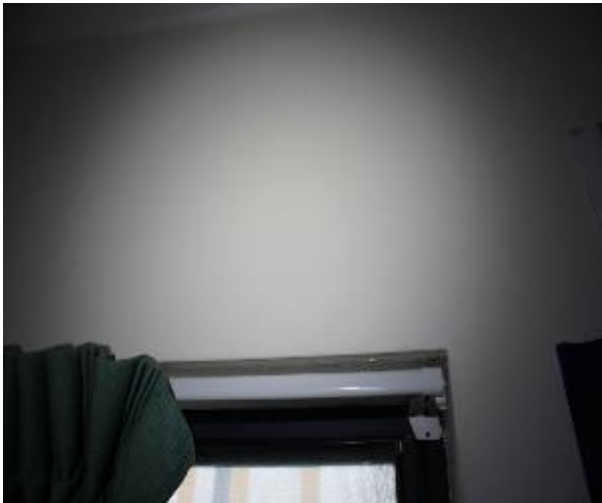
Figure 914 - General condition of bedroom 3 internal wall

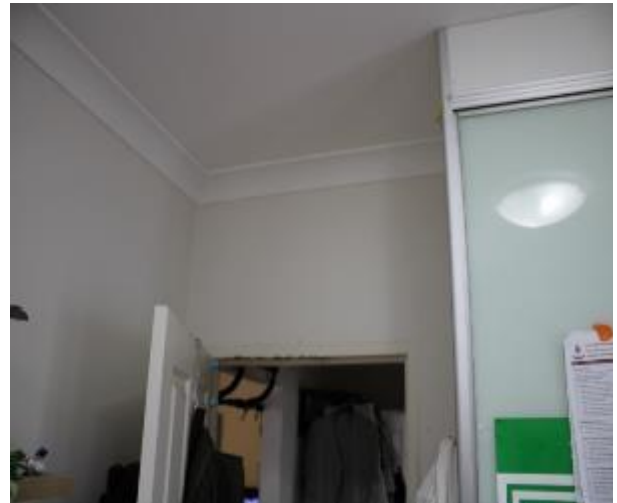
Figure 915 - General condition of bedroom 3 internal wall

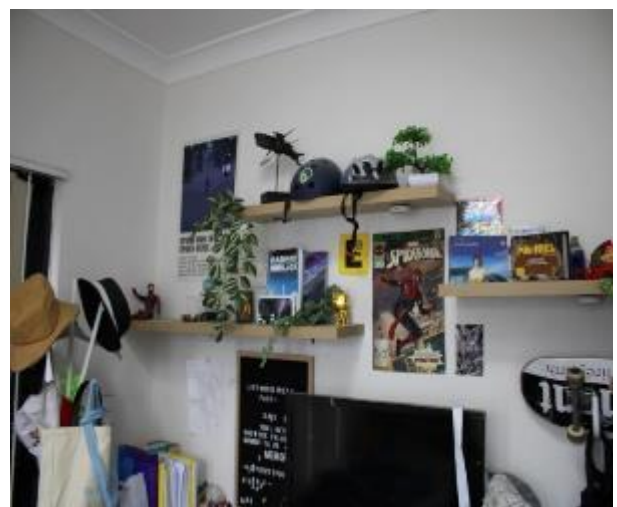
Figure 917 - General condition of bedroom 3 internal wall

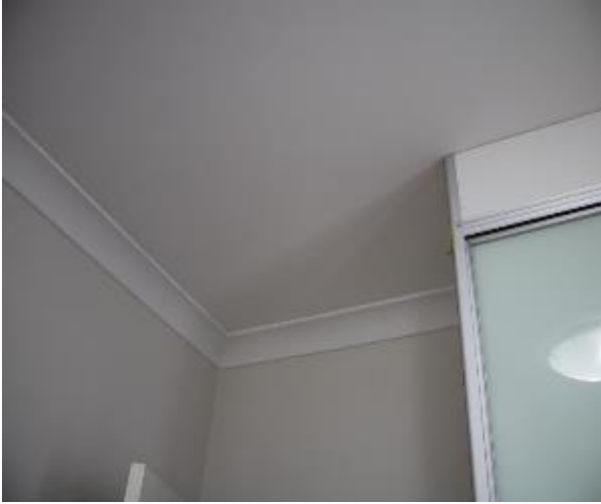
Figure 918 - General condition of bedroom 3 ceiling

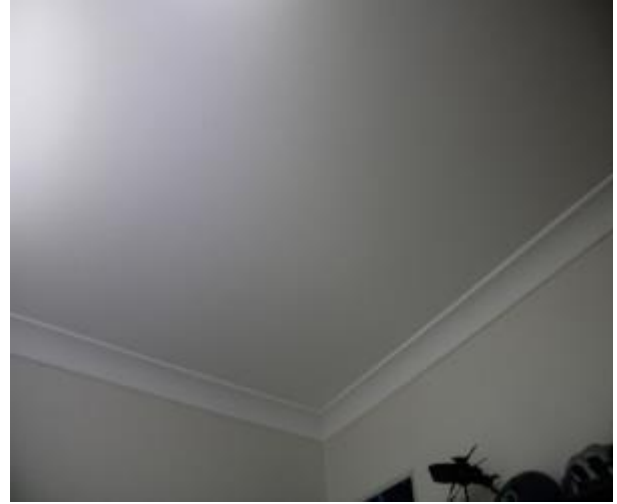
Figure 919 - General condition of bedroom 3 ceiling

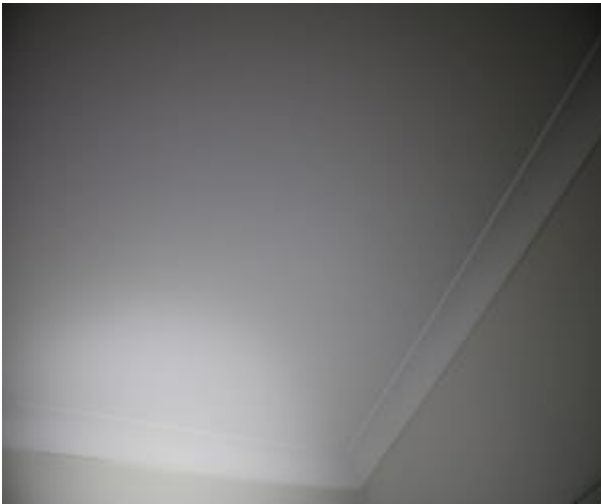
Figure 920 - General condition of bedroom 3 ceiling

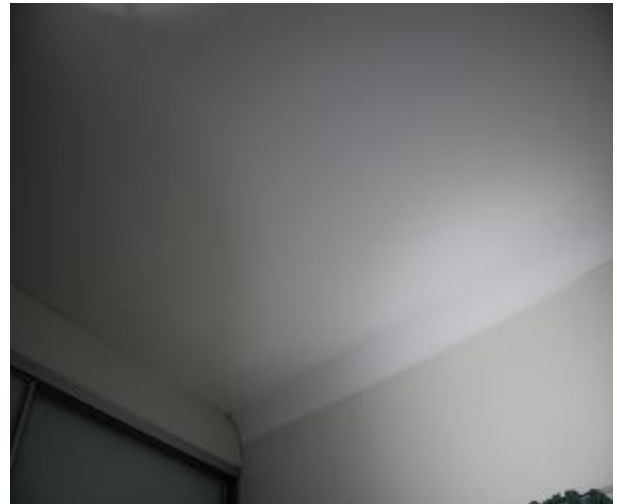
Figure 921 - General condition of bedroom 3 ceiling

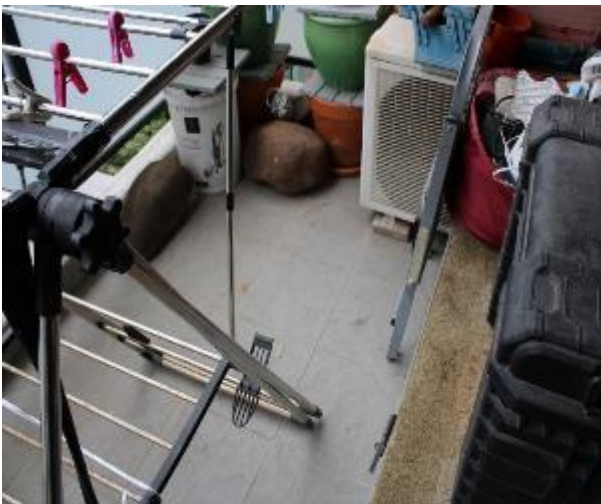
Figure 922 - General condition of balcony floor tiles
